COMMUNITY ATTENTION BUILDING (E JEFFERSON)
907 EAST JEFFERSON STREET
CHARLOTTESVILLE, VIRGINIA

ECS PROJECT NO. 46:6713

CITY OF CHARLOTTESVILLE - FACILITIES DEVELOPMENT

Reference: Facility Condition Assessment Report for Community Attention Building (E Jefferson), 907 East Jefferson Street, Charlottesville, Virginia

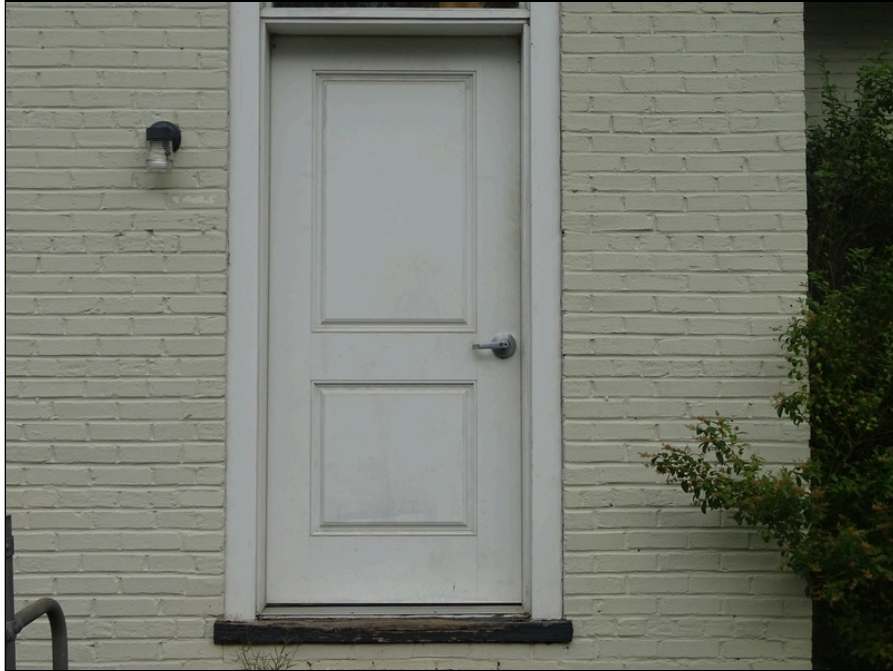
29 - Personnel wooden door

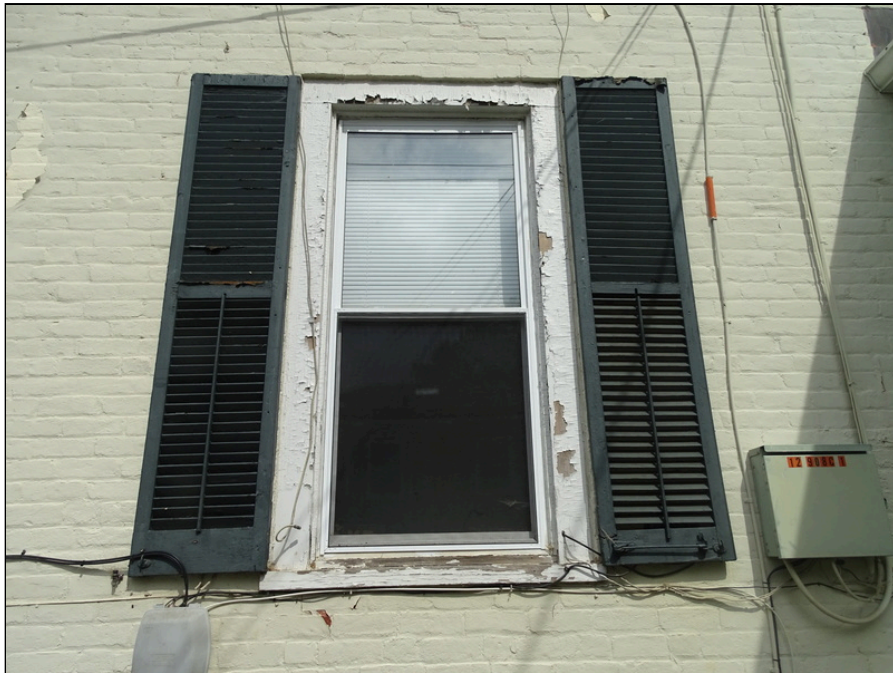
30 - Exterior window with wood framing

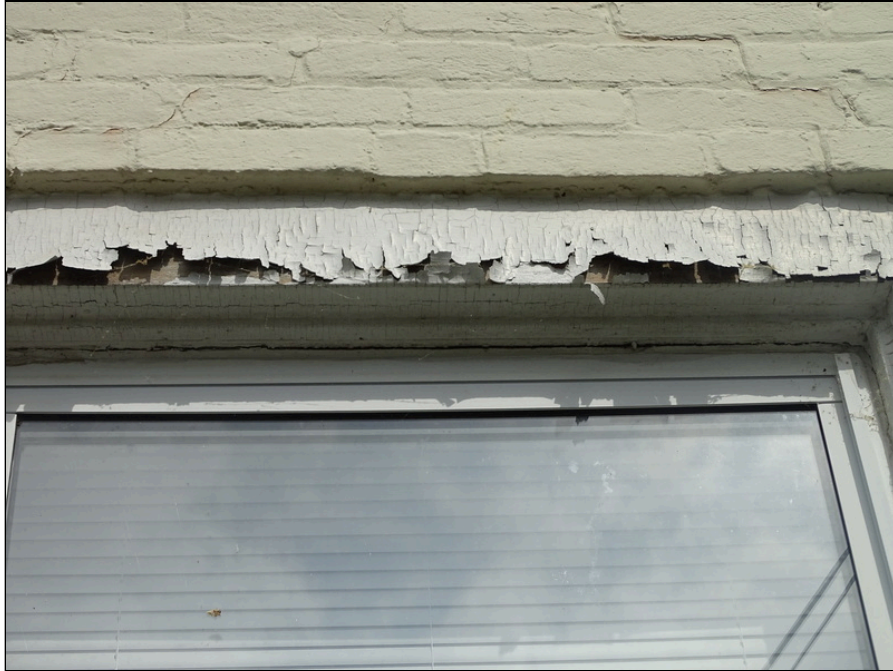
31 - Exterior window with wood framing - note peeling paint

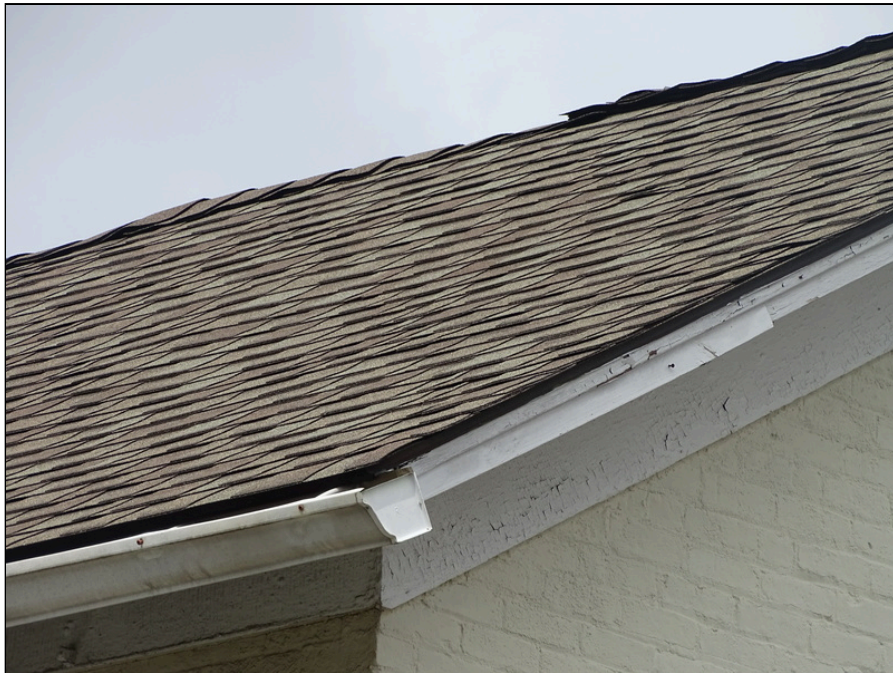
32 - Asphalt shingle roofing system

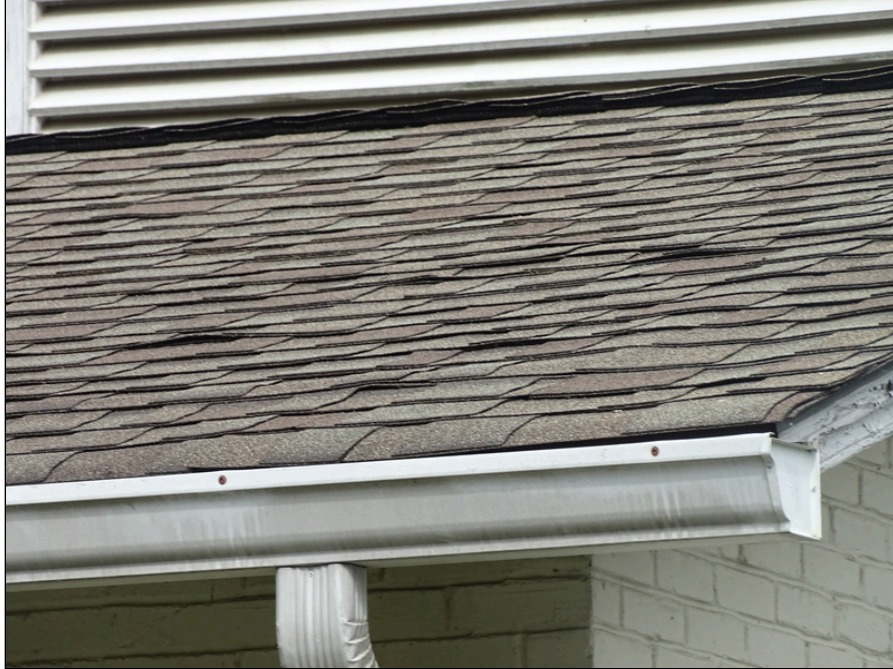
33 - Asphalt shingle roofing system

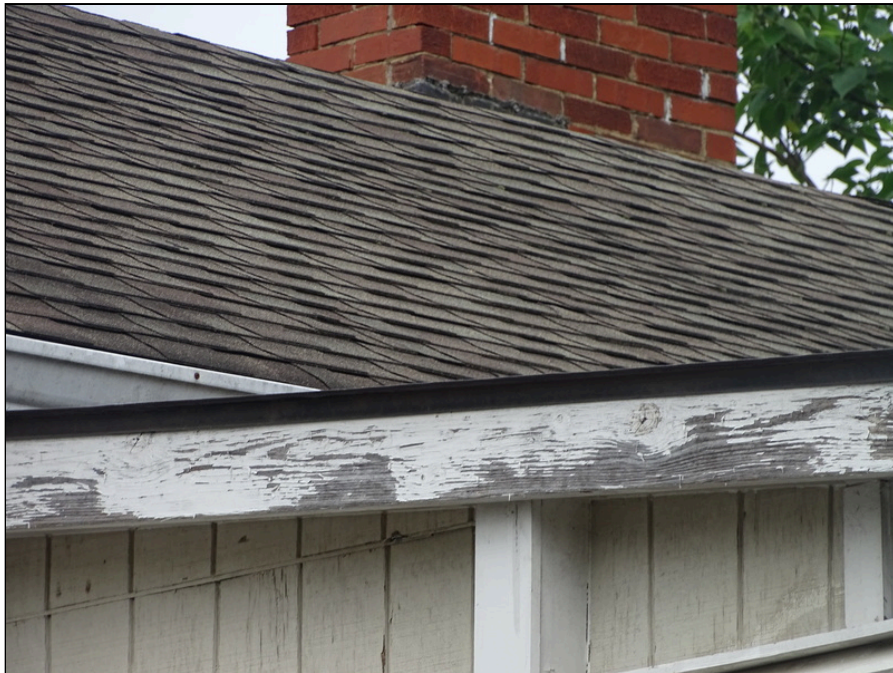
34 - Asphalt shingle roofing system

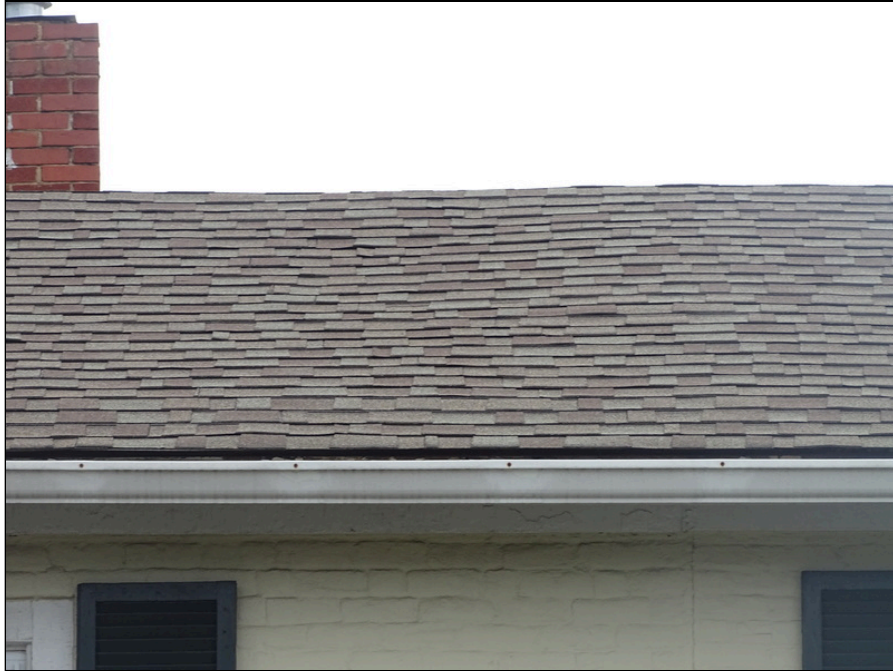
35 - Asphalt shingle roofing system

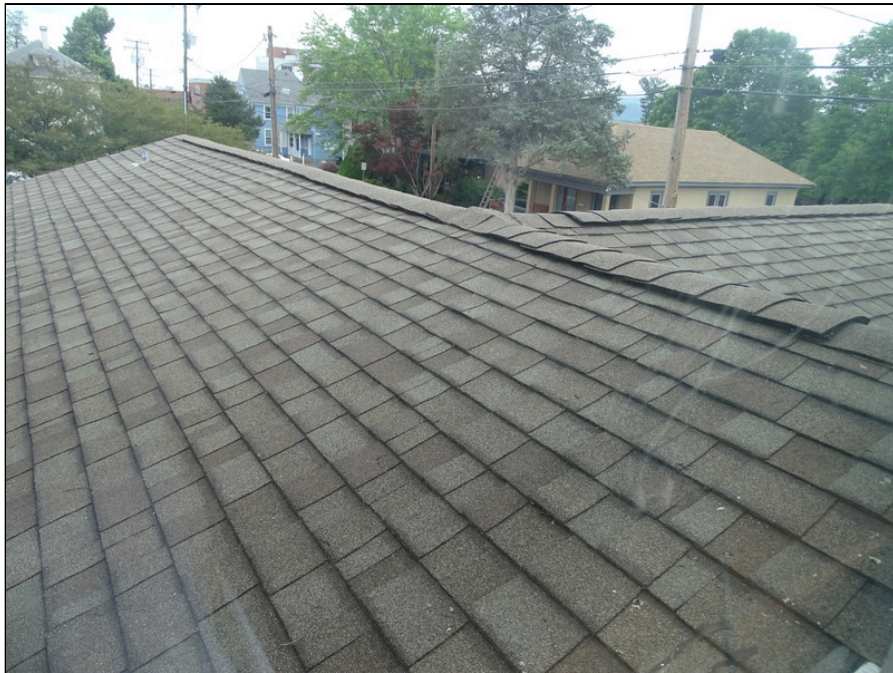
36 - Asphalt shingle roofing system

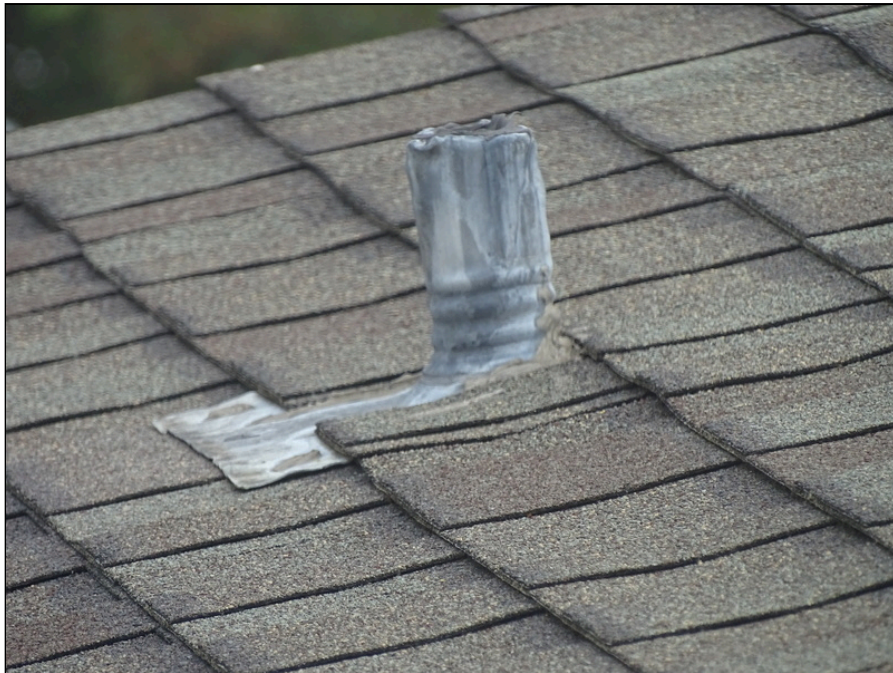
38 - Typical plumbing penetration

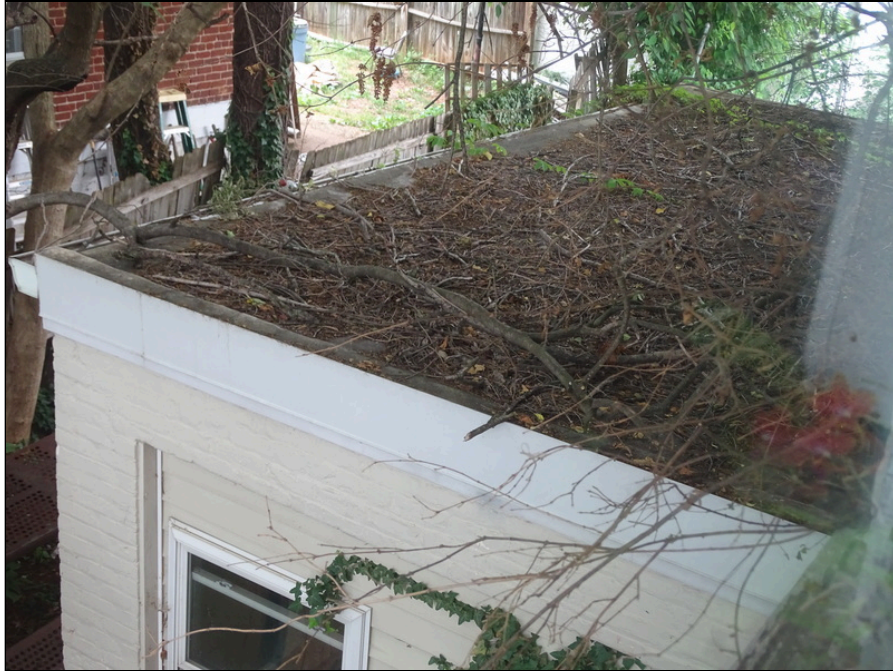
39 - Single-ply roofing system at west addition

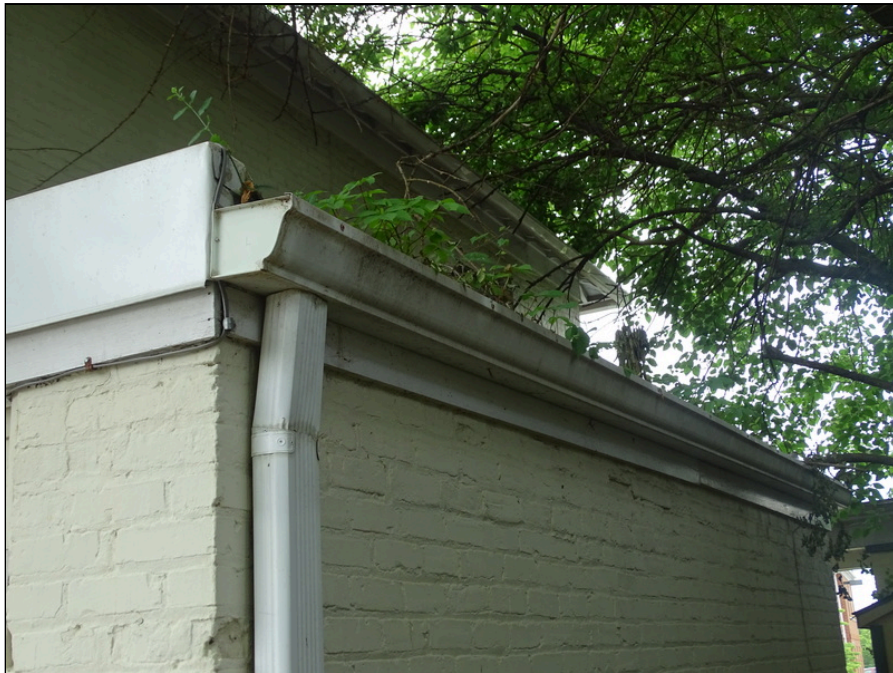
42 - Gutter and downspout

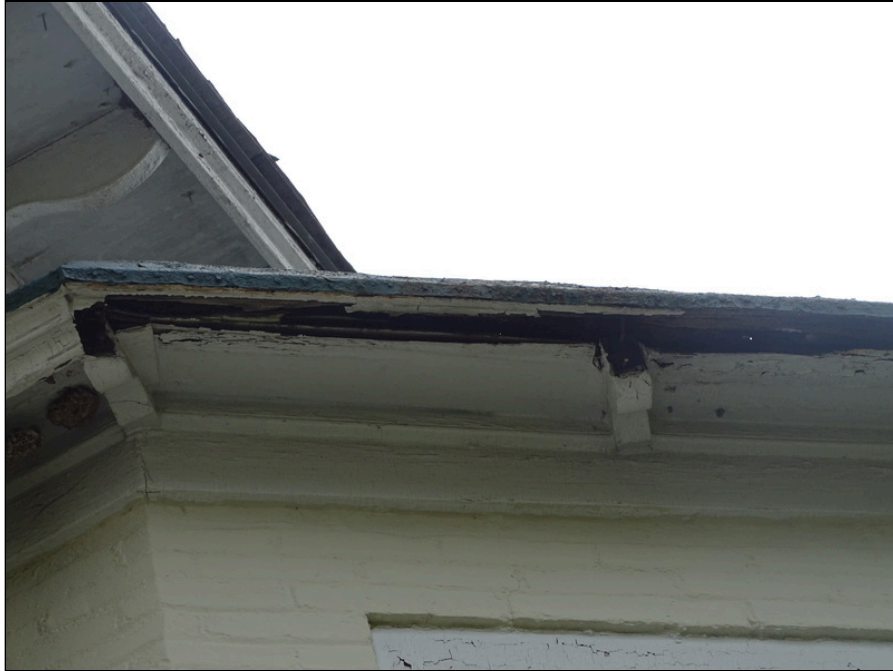
47 - Typical soffit - note peeling paint

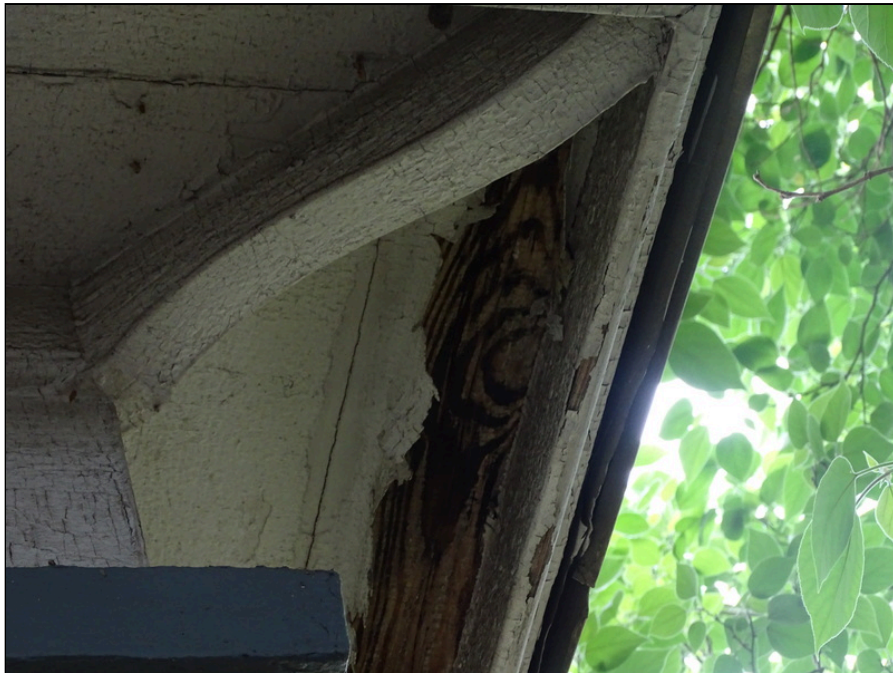
48 - Typical soffit - note peeling paint

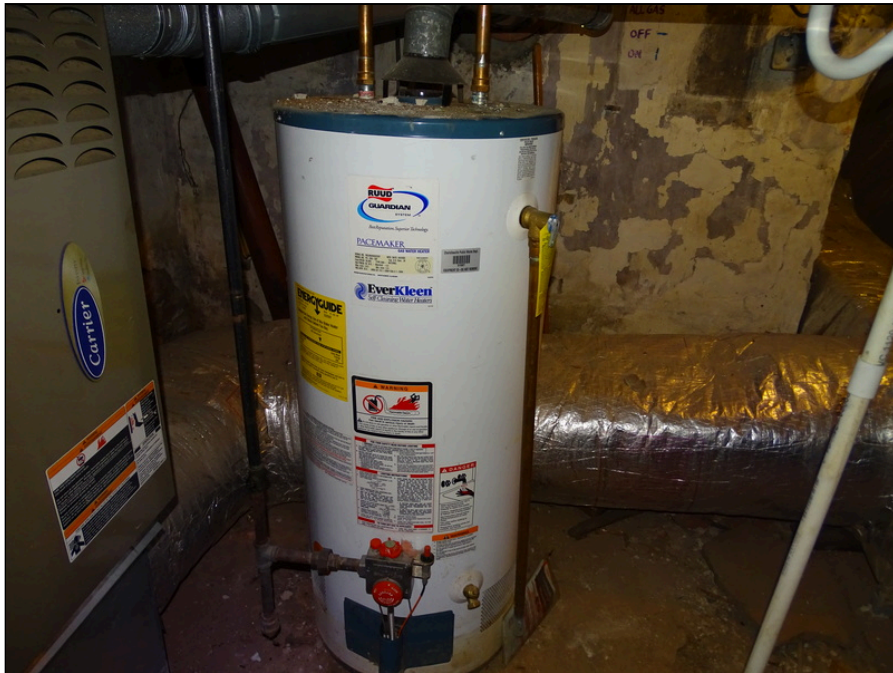
52 - Gas domestic water heater

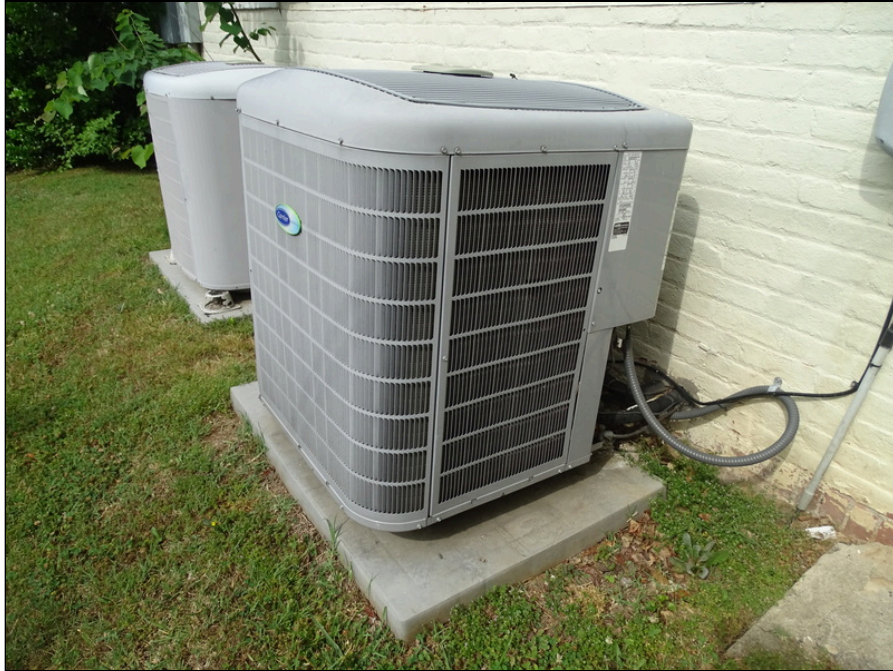
53 - Condenser Units

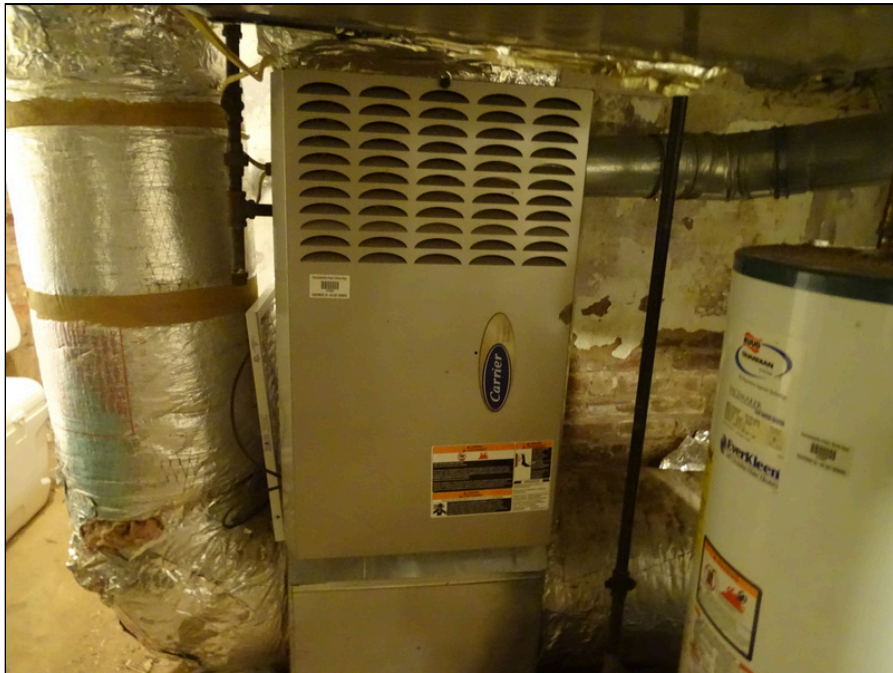
54 - Gas furnace - air handler unit

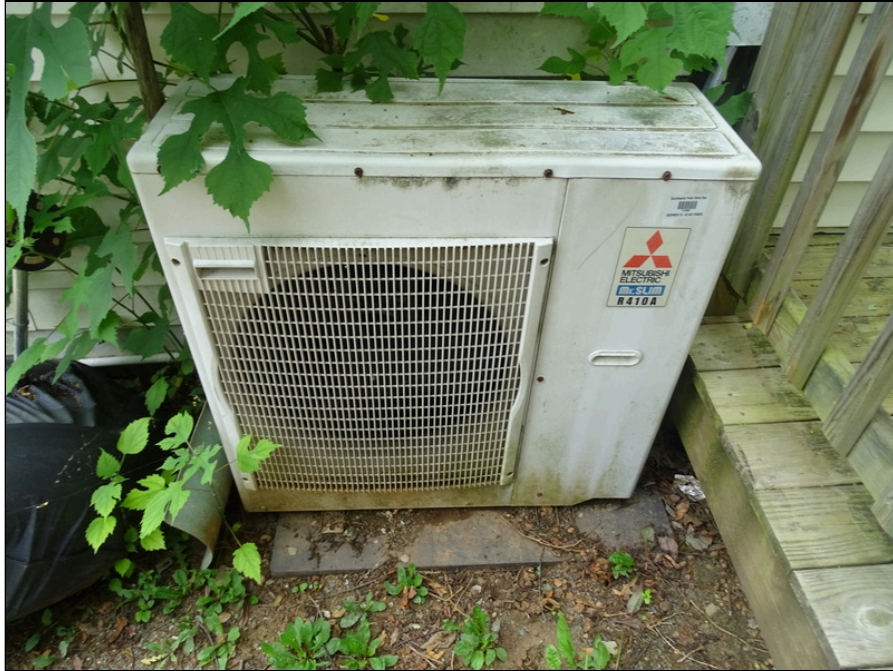
55 - Split system exterior condenser

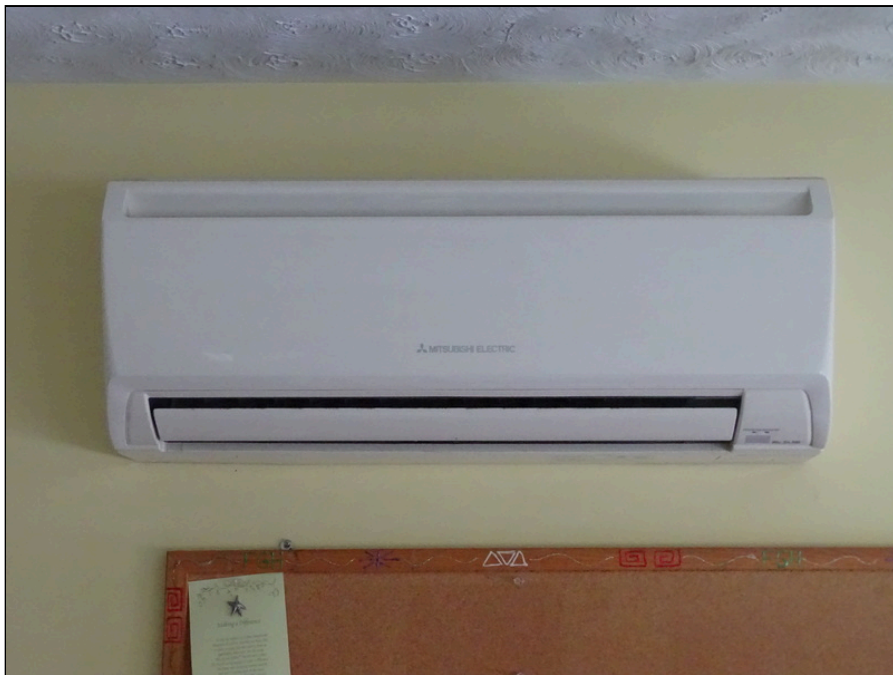
56 - Split system wall mounted unit

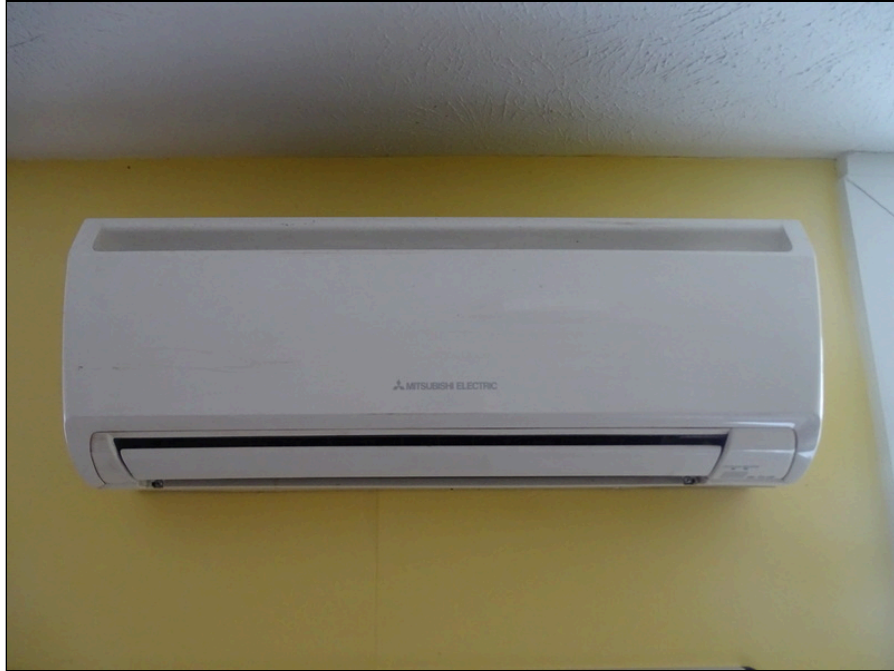
57 - Split system wall mounted unit

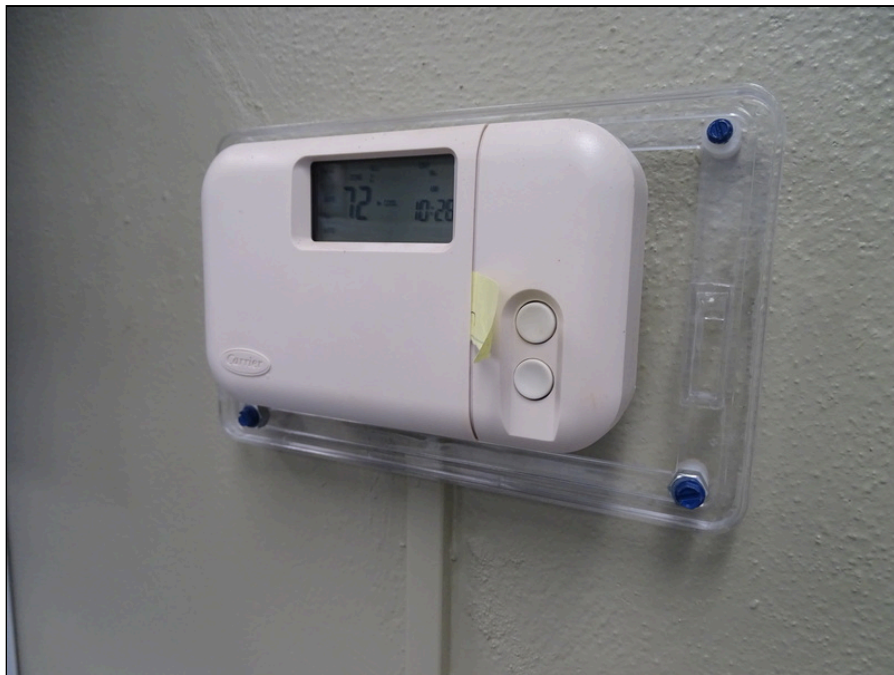
58 - Typical thermostat control

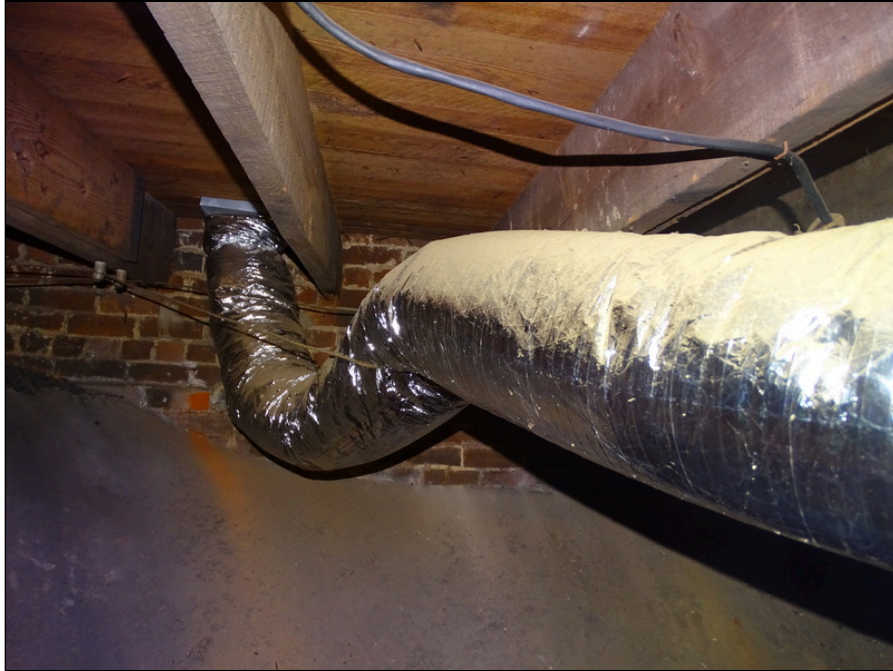
59 - Typical mechanical duct

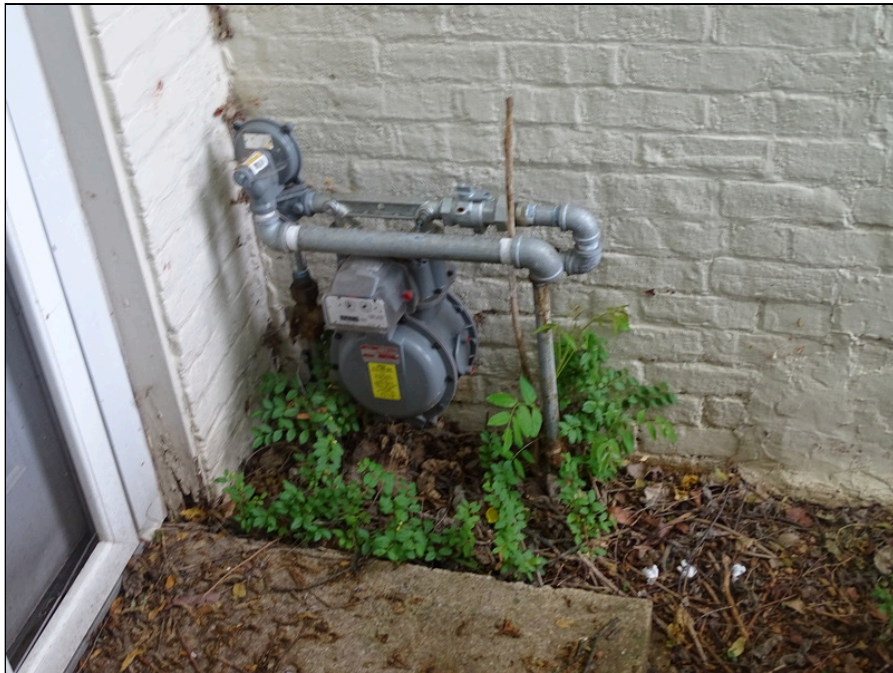
60 - Typical gas meter

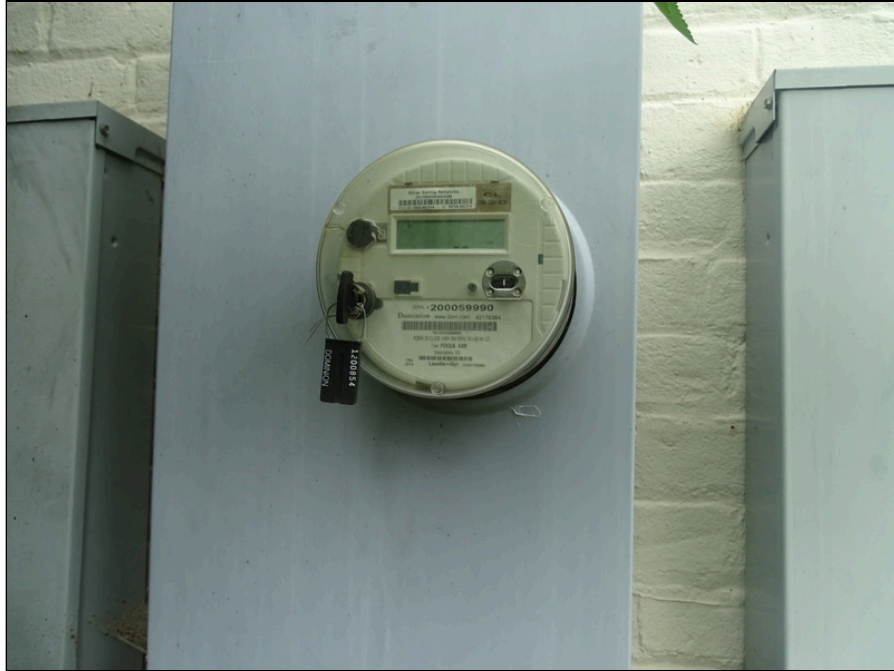
61 - Electrical meter on east side of the building

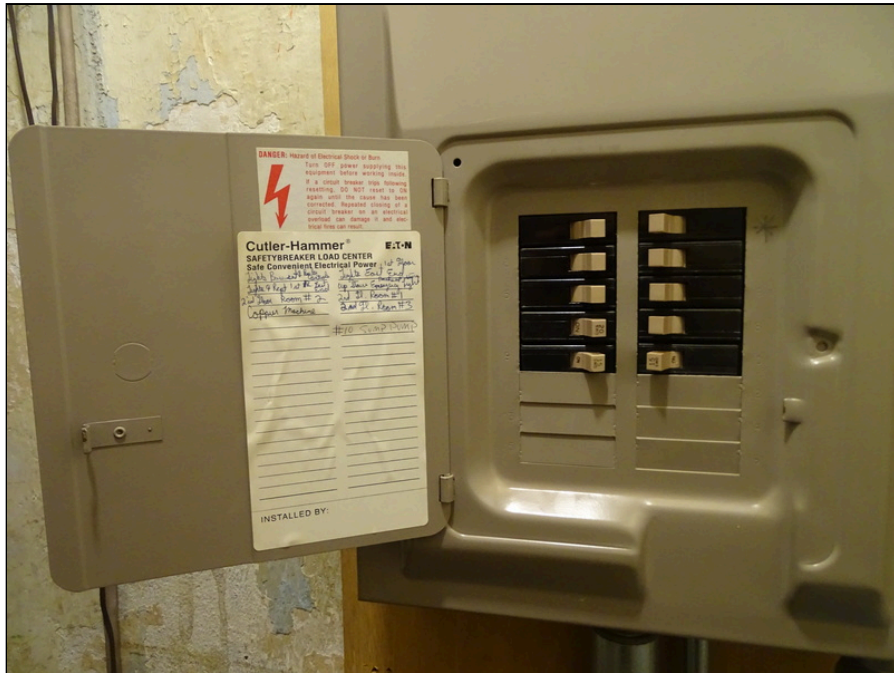
62 - Typical circuit breaker panel

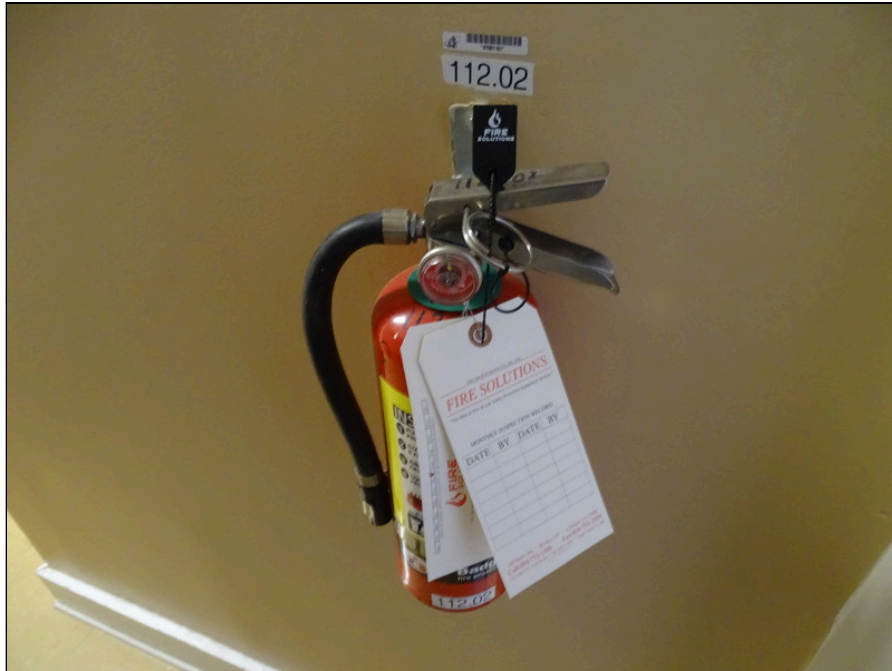
63 - Typical fire extinguisher

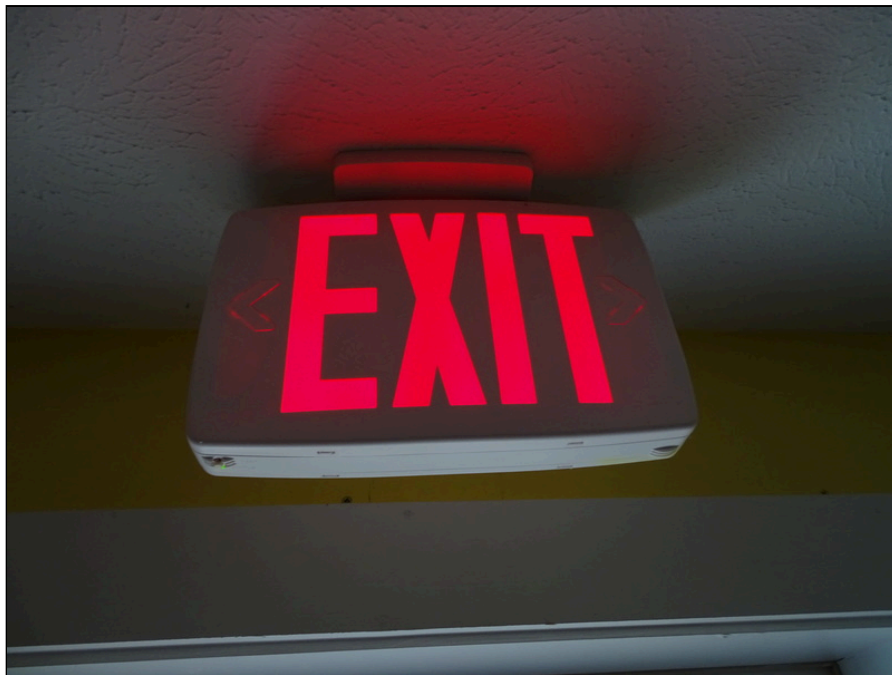
64 - Typical exit sign

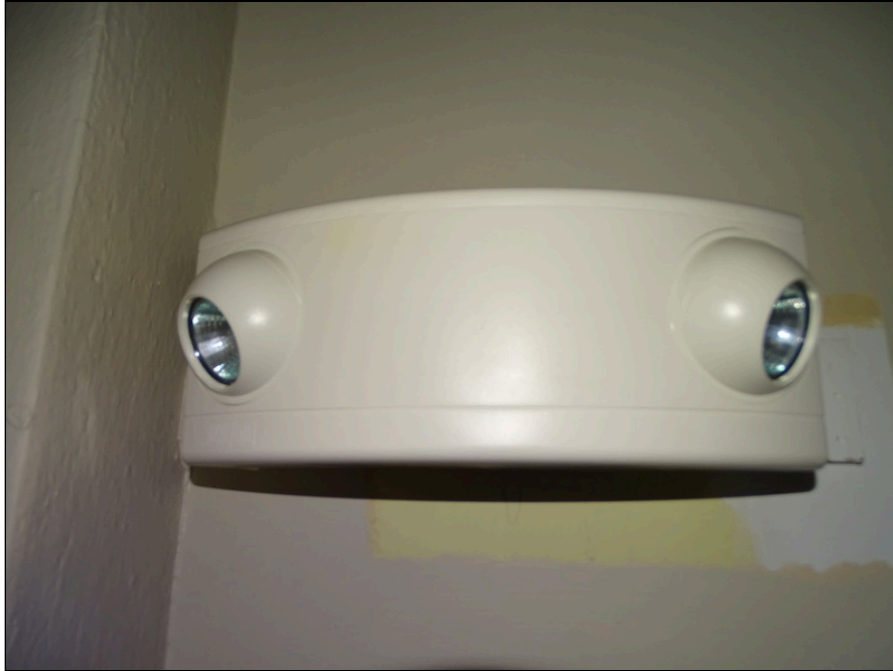
65 - Typical emergency lighting

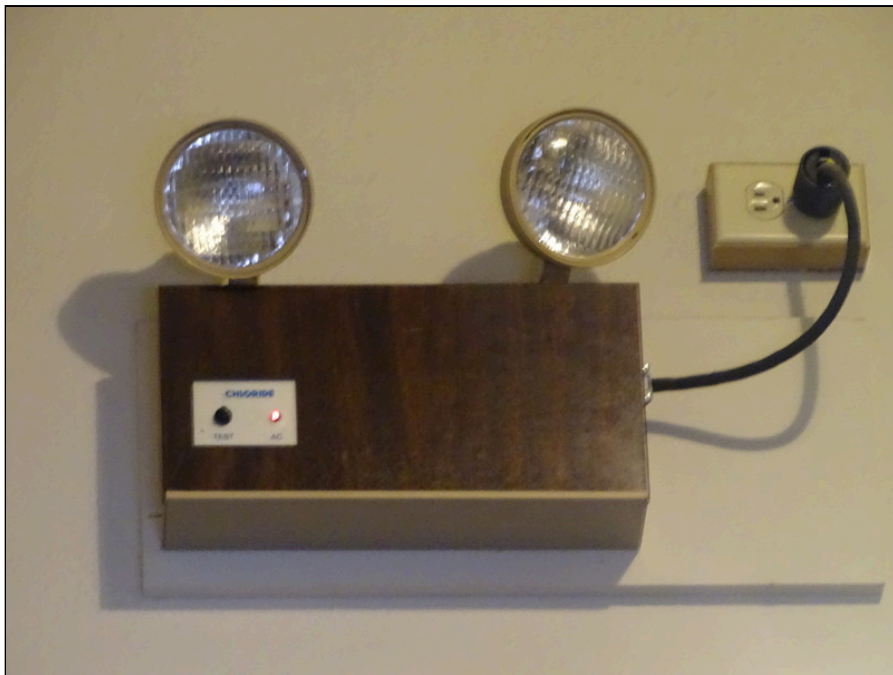
66 - Typical emergency lighting

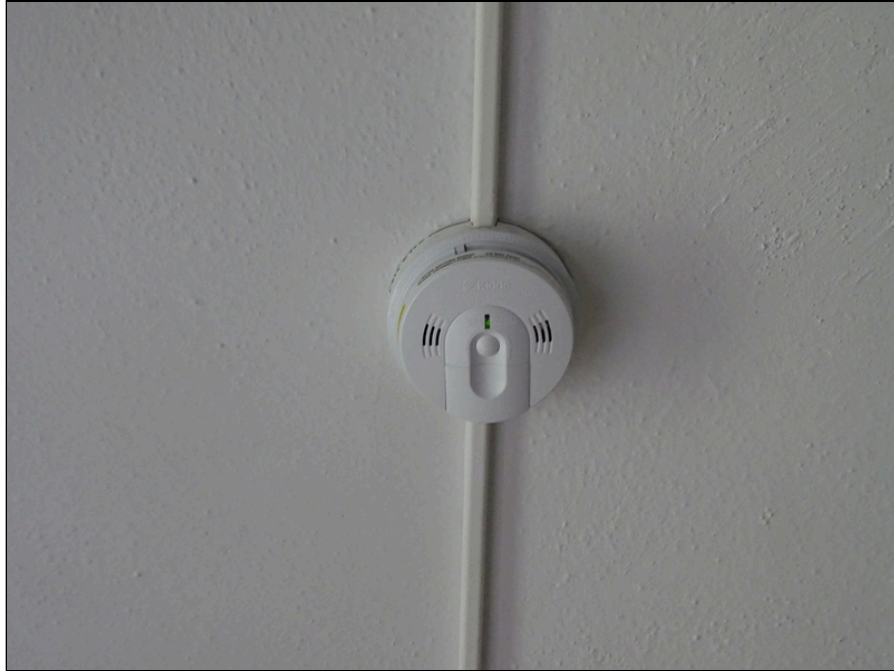
67 - Typical smoke detector

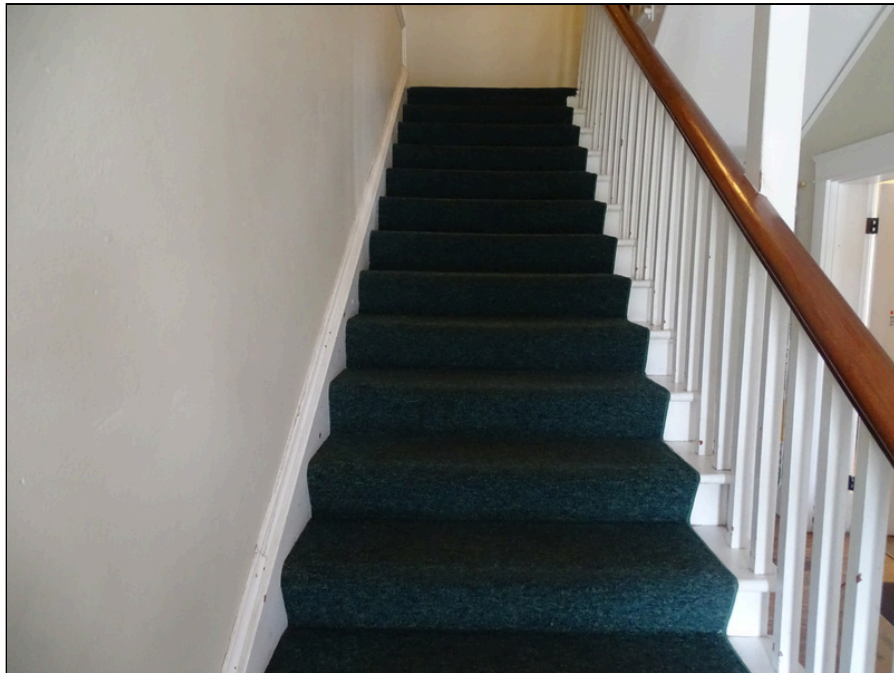
68 - Interior finishes entrance area

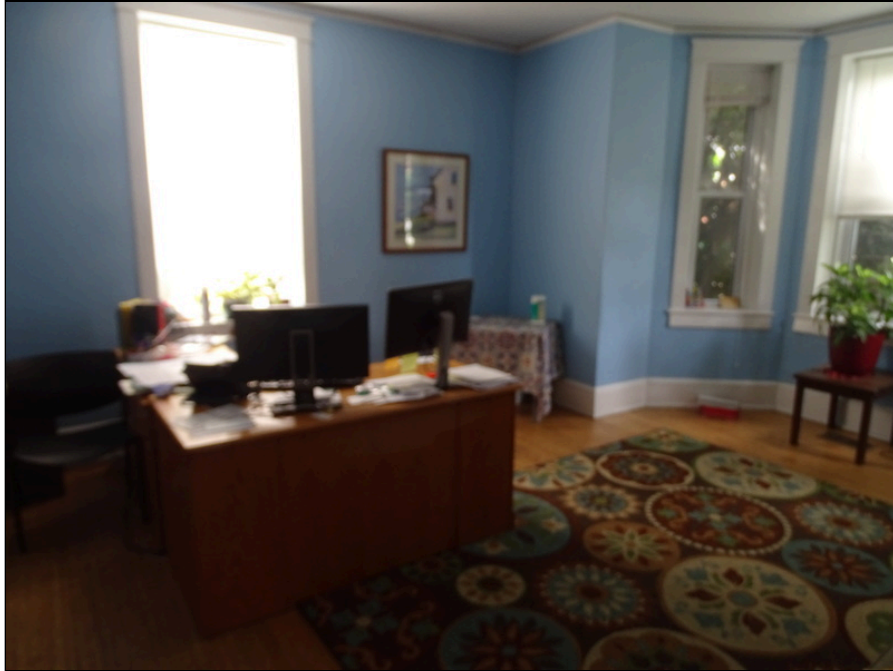
69 - Interior finishes meeting area

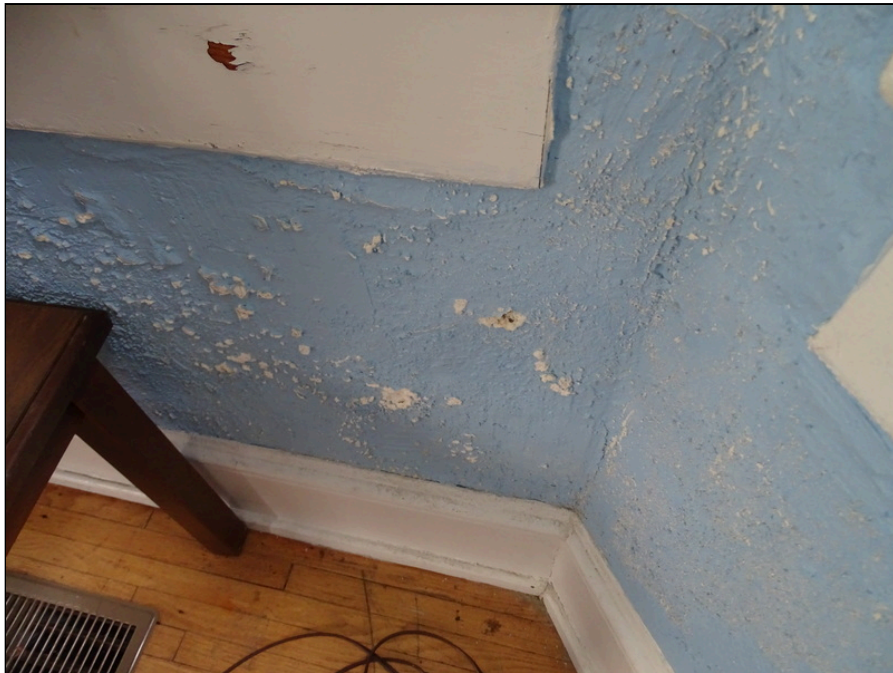
70 - Interior finishes meeting area - note efflorescence

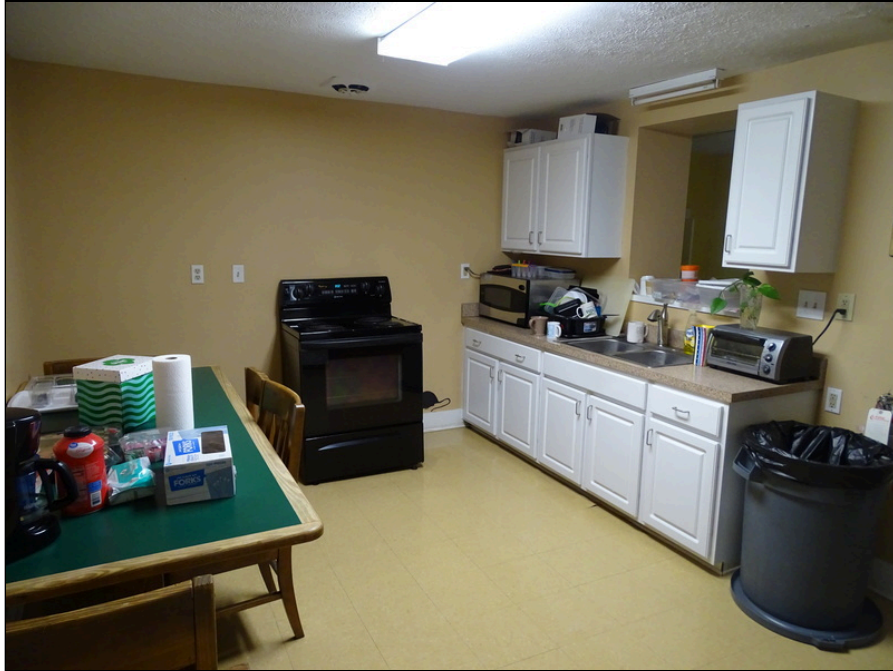
71 - Interior finishes kitchen area

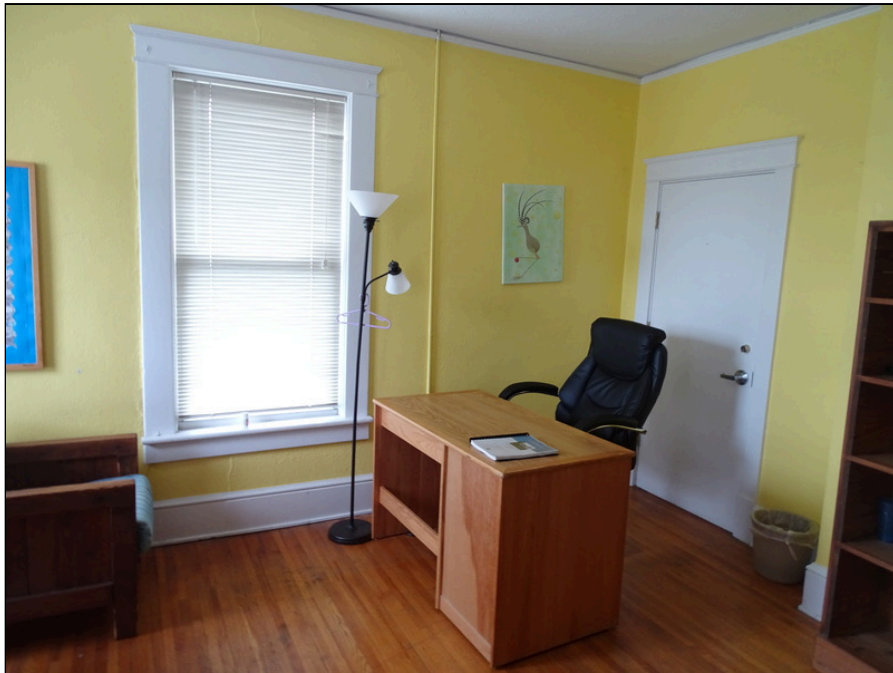
72 - Interior finishes office area

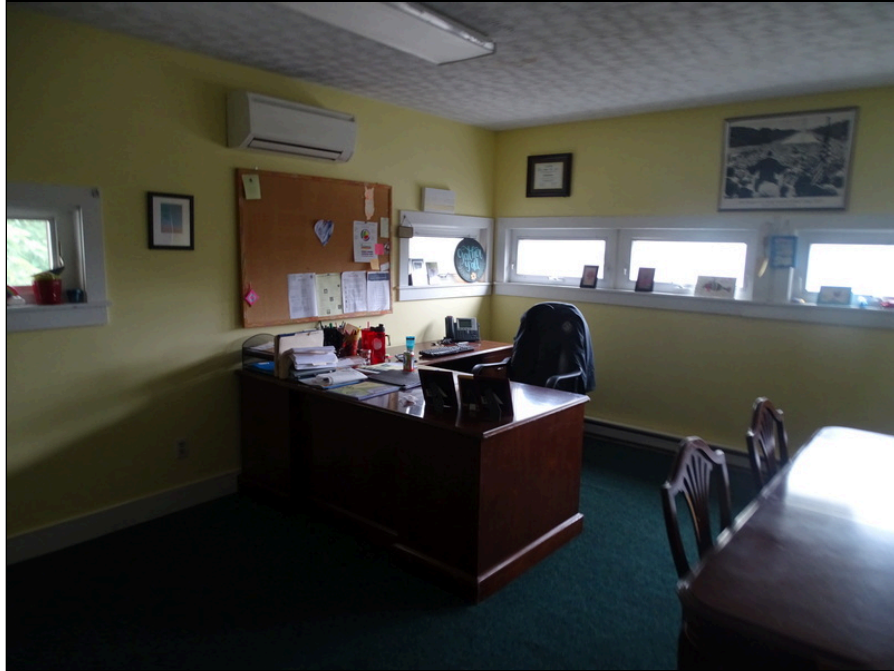
73 - Interior finishes office area

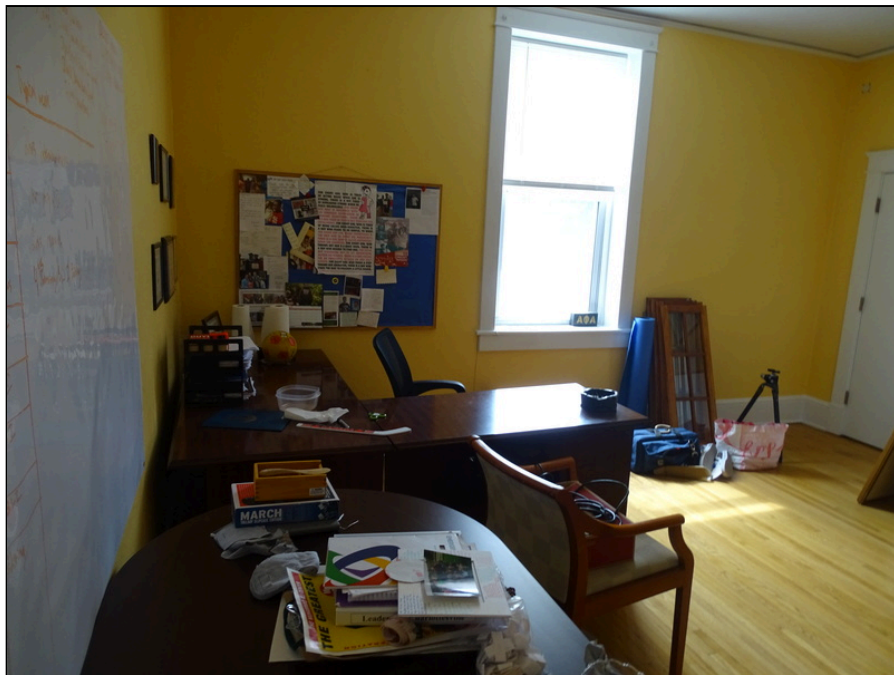
74 - Interior finishes office area

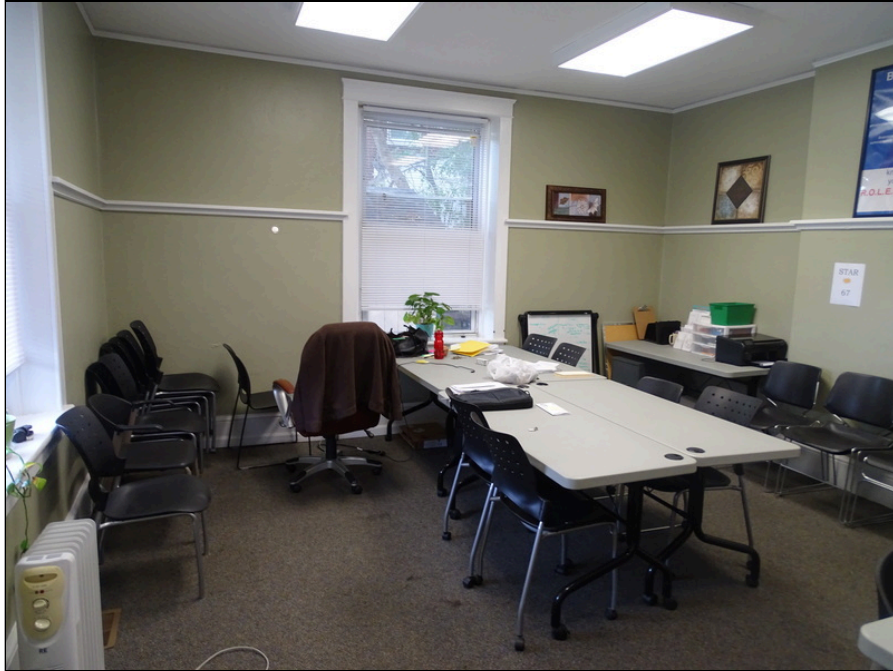
75 - Interior finishes meeting room area

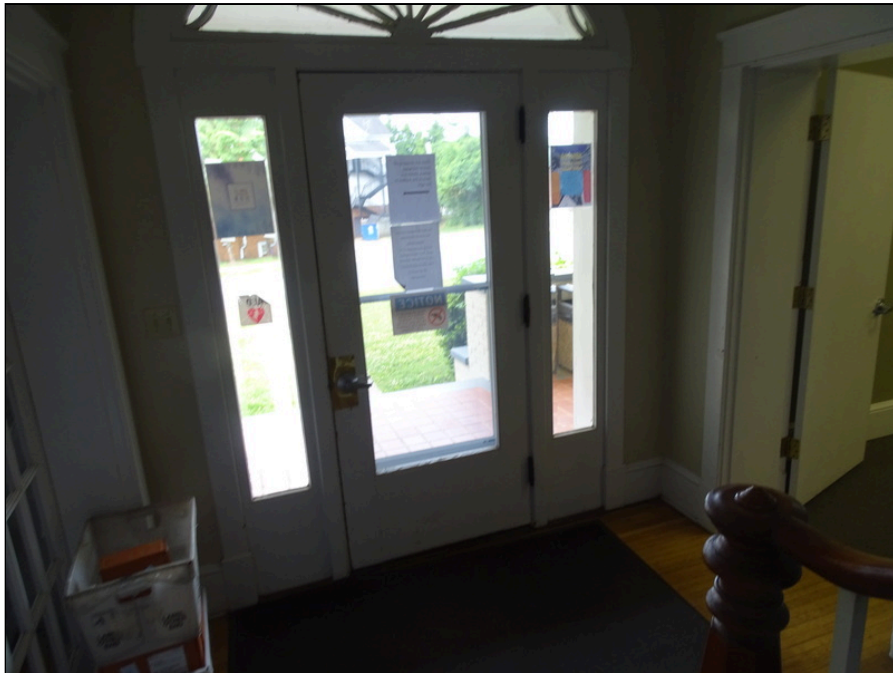
76 - Interior finishes corridor area
