COMMUNITY ATTENTION BUILDING (E JEFFERSON)
907 EAST JEFFERSON STREET
CHARLOTTESVILLE, VIRGINIA

ECS PROJECT NO. 46:6713

CITY OF CHARLOTTESVILLE - FACILITIES DEVELOPMENT

Reference: Facility Condition Assessment Report for Community Attention Building (E Jefferson), 907 East Jefferson Street, Charlottesville, Virginia

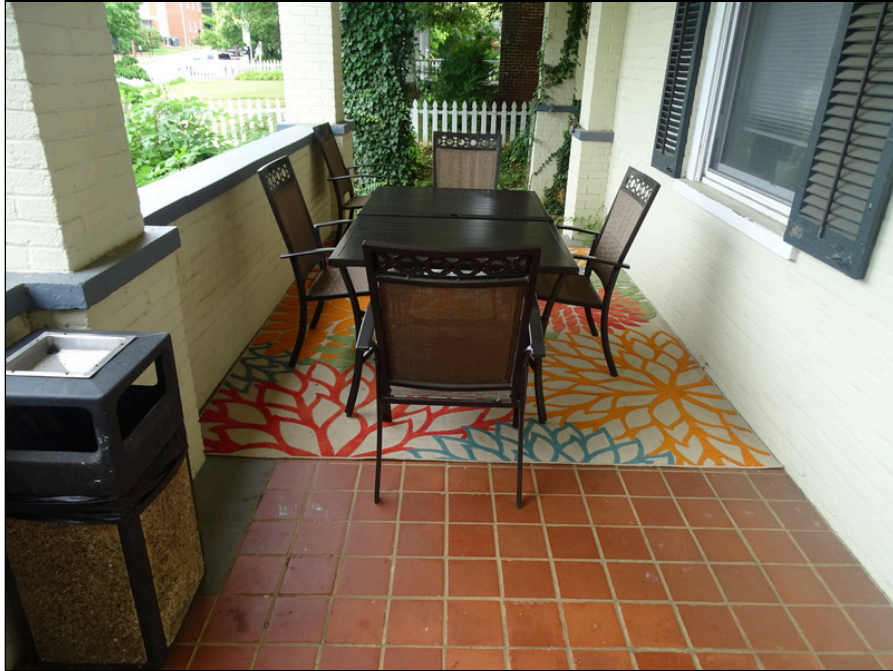
77 - Interior finishes patio area

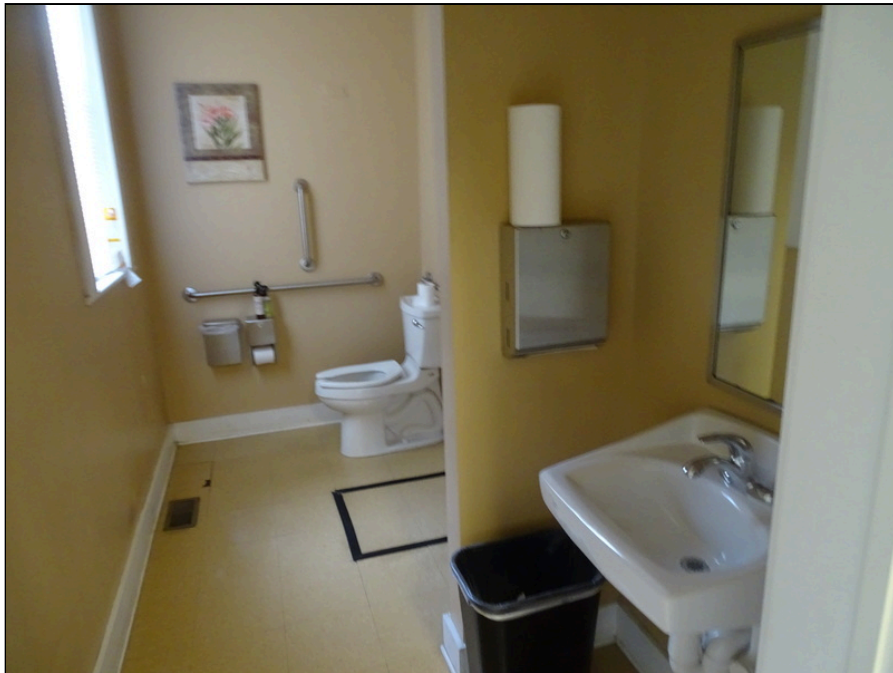
78 - Interior finishes restroom area

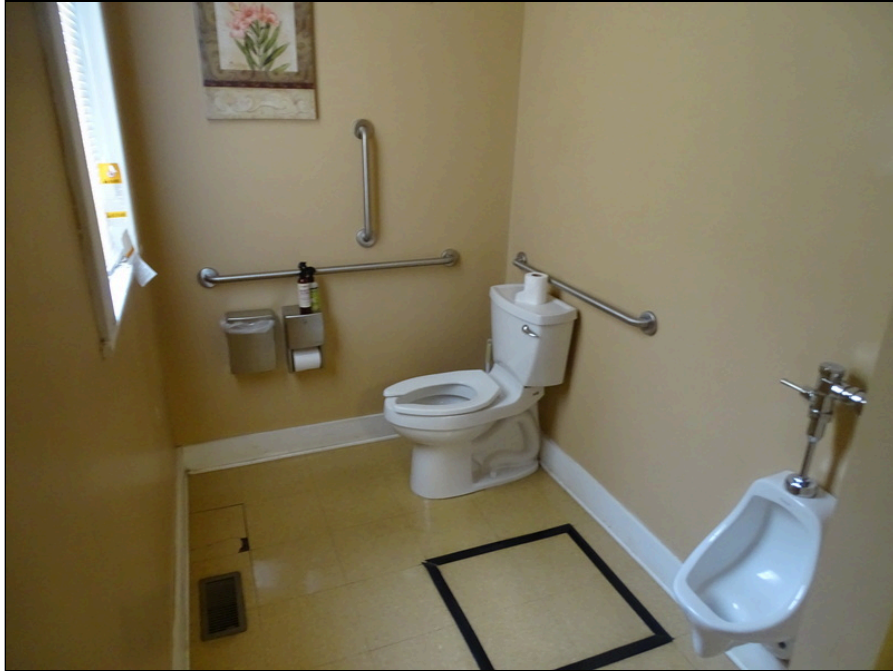
79 - Interior finishes restroom area

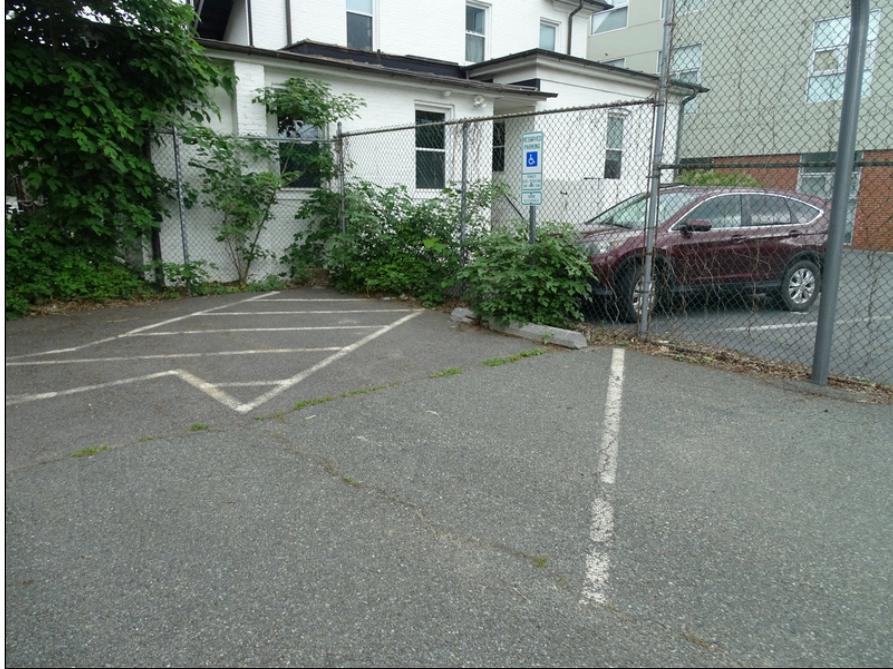
81 - Accessible parking north side of the building - note stripping faded

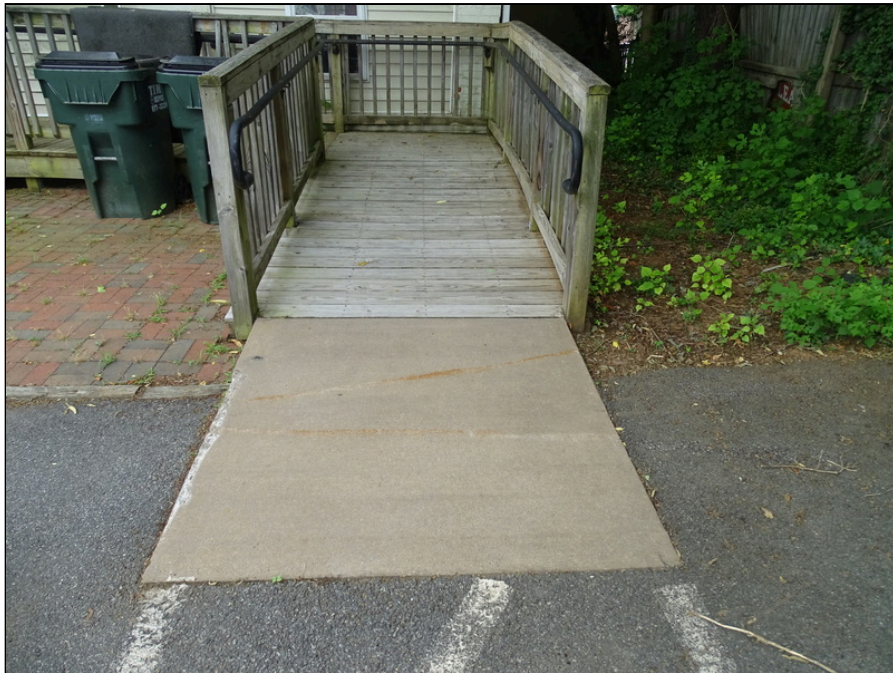
82 - Accessible ramp

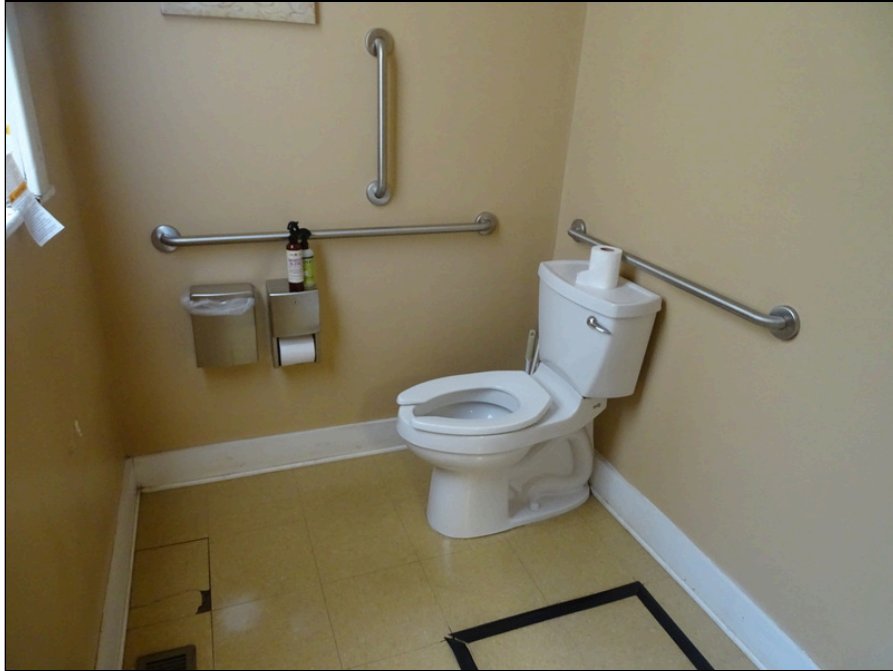
83 - Accessible toilet
