COMMUNITY ATTENTION BUILDING (E MARKET)
909 EAST MARKET STREET
CHARLOTTESVILLE, VIRGINIA

ECS PROJECT NO. 46:6713

CITY OF CHARLOTTESVILLE - FACILITIES DEVELOPMENT

Reference: Facility Condition Assessment Report for Community Attention Building (E Market), 909 East Market Street, Charlottesville, Virginia

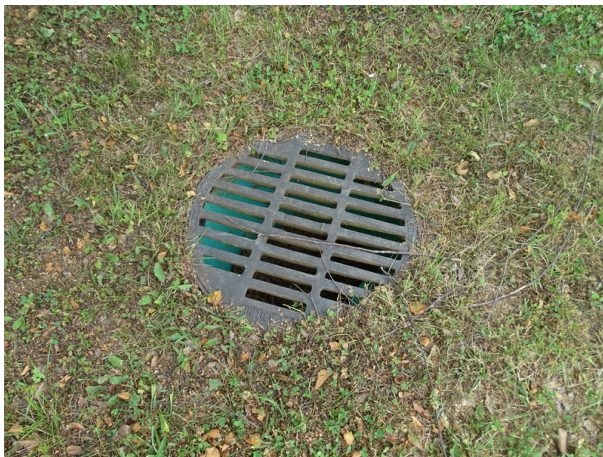
Typical drainage

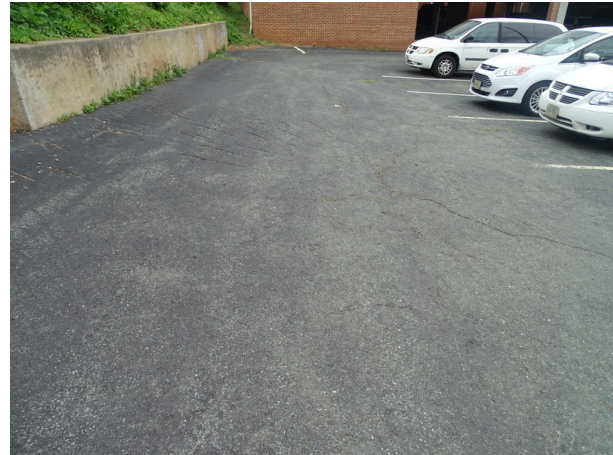
Asphalt parking north side of the building - note stripping faded

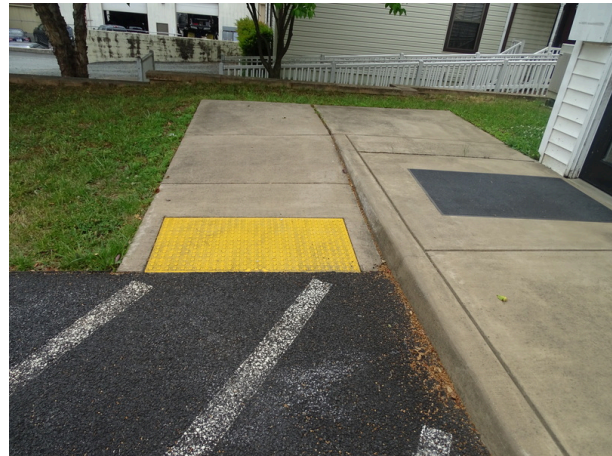
Concrete sidewalk north side of the building
with truncated domes

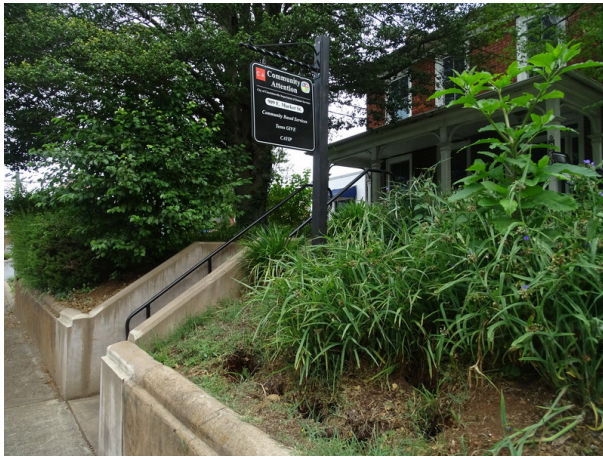
Typical landscape

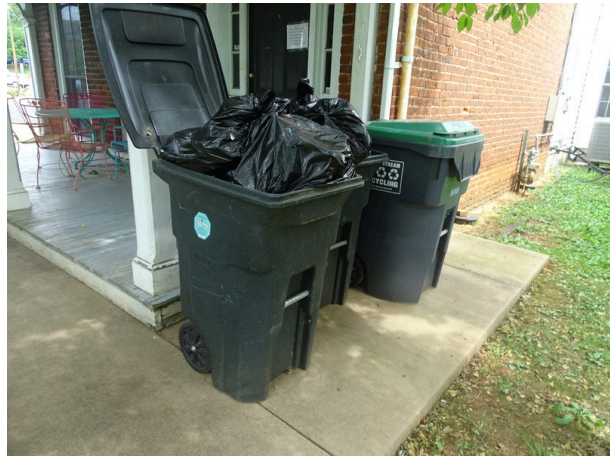
Trash containers at the south side of the building

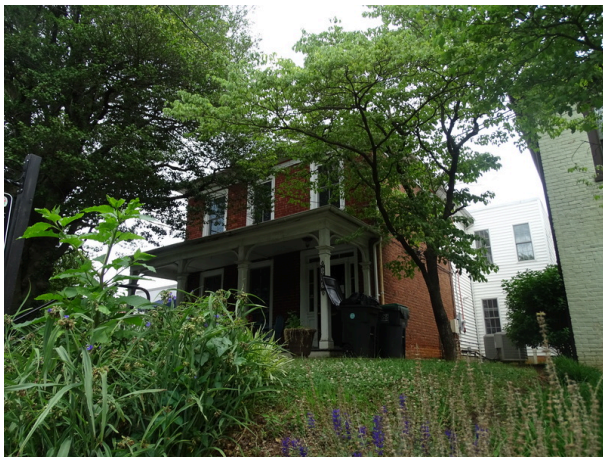
Typical landscape

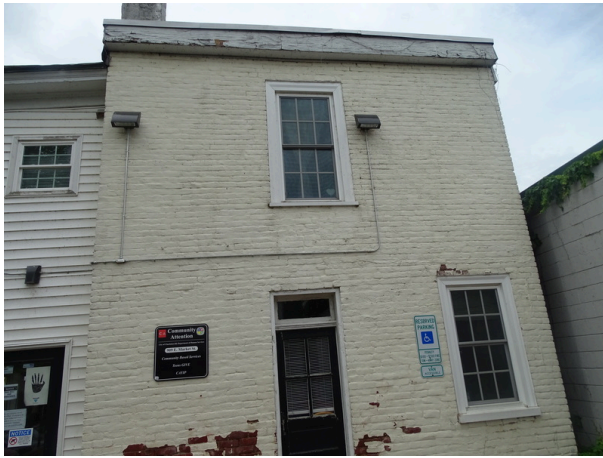
Building exterior at north end of the building

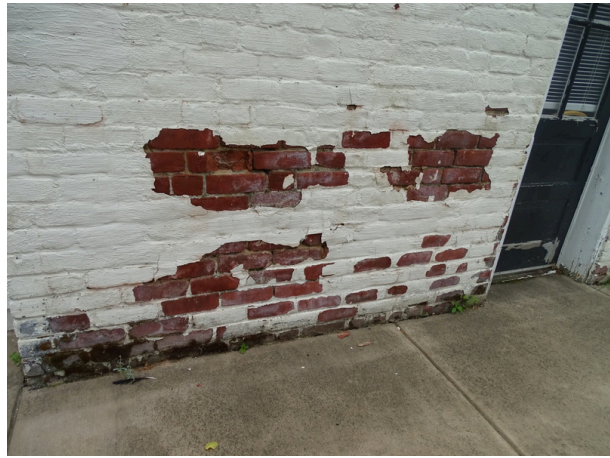
Building exterior at north end of the building -
note peeling paint

3.3.3 Building Exteriors																													
PAINT EXTERIOR AND REPAIR DETERIORATED WOOD TRIM AS NEEDED	7	6	1	3	EA	\$15,000.00	\$45,000	100%	\$15,000							\$15,000									\$15,000				\$45,000
REPOINT BRICKWORK	20	19	1	1	LS	\$15,000.00	\$15,000	100%	\$15,000																				\$15,000

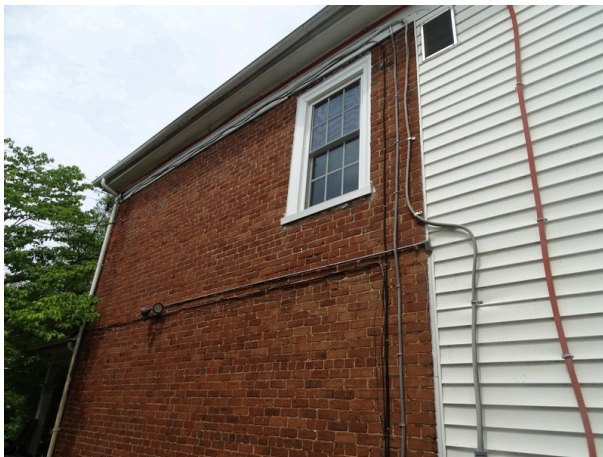
Building exterior at southeast end of the
building

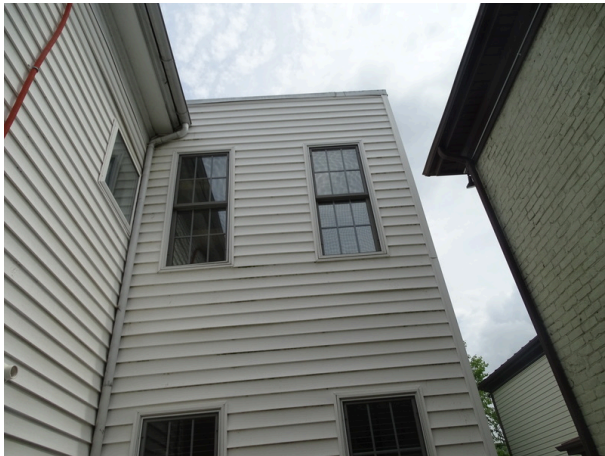
Building exterior at northeast end of the
building

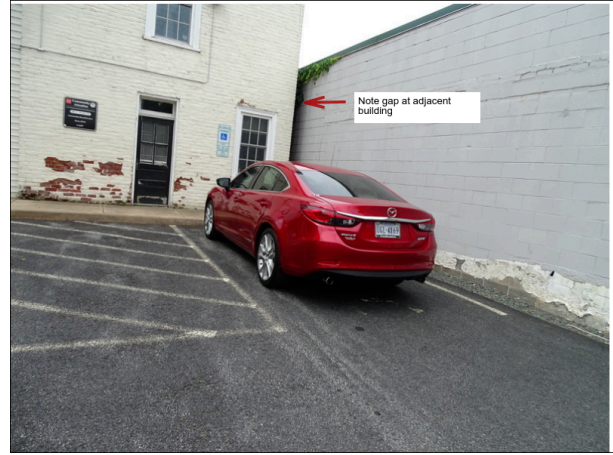
Accessible parking

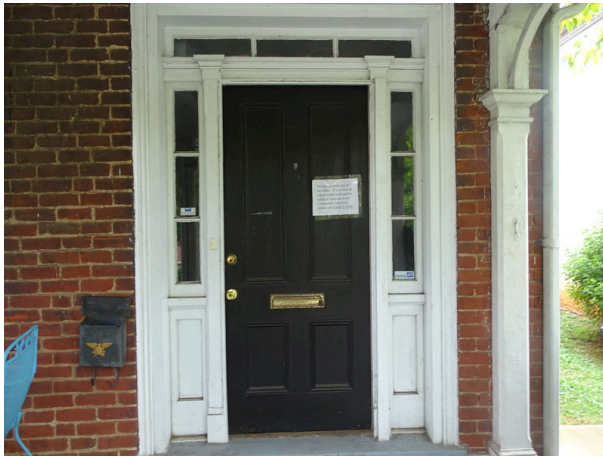
Main entrance door south side of the building

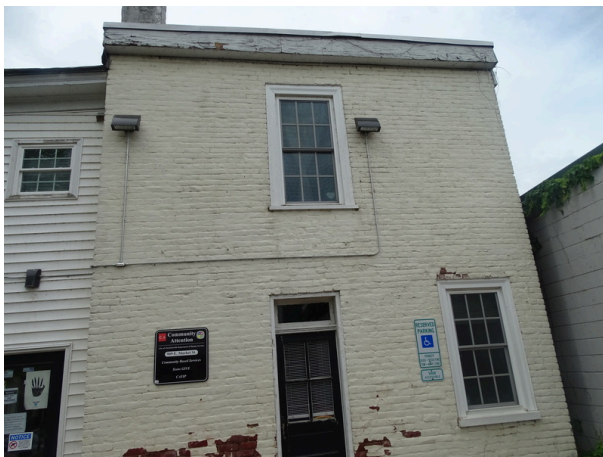
Building exterior at north end of the building

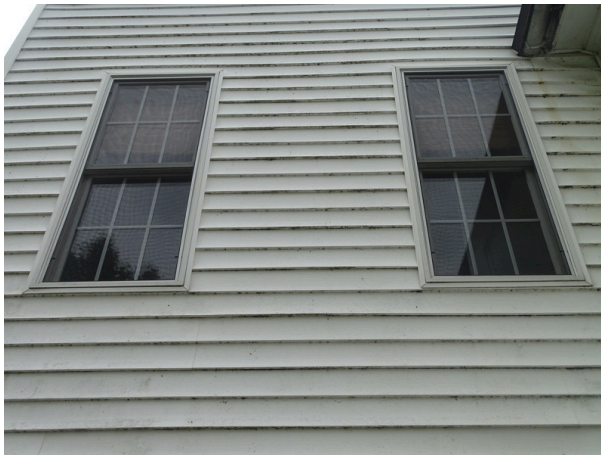
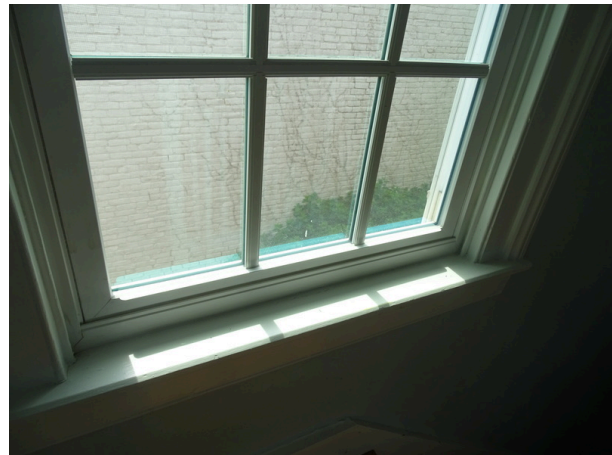
The window system for the building primarily consists of Wood frame double pane - operable window units. The window units have been replaced with the older wood framing kept in place. The condition of the wood framing ranged from good to poor. The expected useful life of windows is typically 30 years. The window units were in generally in fair condition. We recommend the windows and wood framing be replaced during the report period as needed.

Exterior windows south side of the building east addition

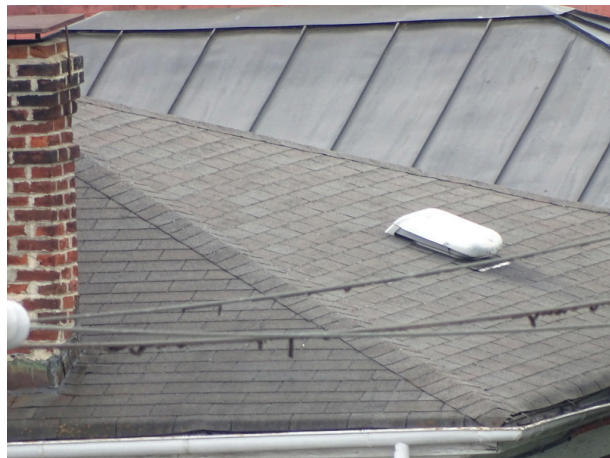
Asphalt shingle roofing system

3.3.6 Roofing Systems																													
REPLACE ASPHALT SHINGLED ROOFING SYSTEM	20	19	1	1,500	SF	\$5.00	\$7,500	100%	\$7,500																				\$7,500
REPLACE SINGLE-PLY ROOFING SYSTEM	20	19	1	1,600	SF	\$14.00	\$22,400	100%	\$22,400																				\$22,400

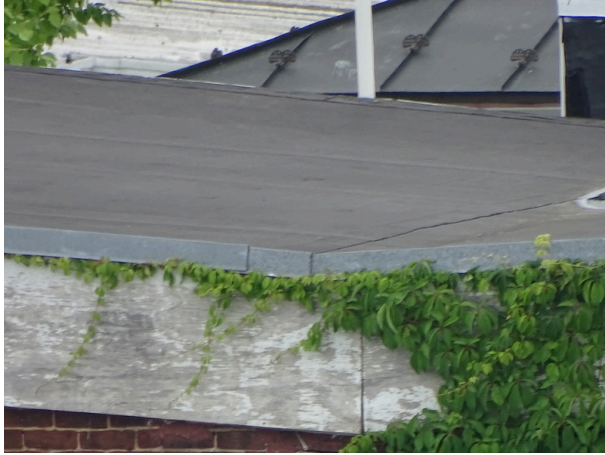
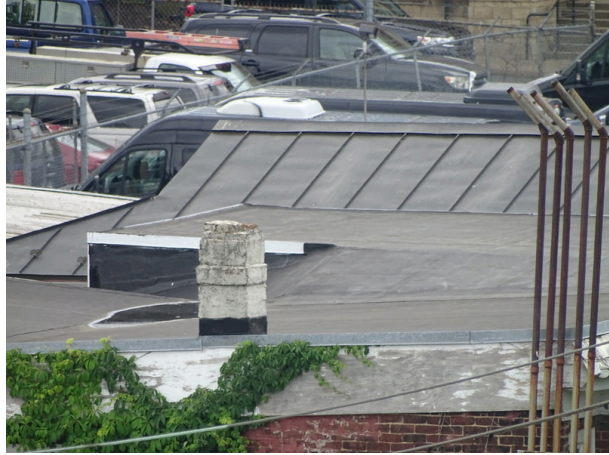
Single-ply membrane roofing system

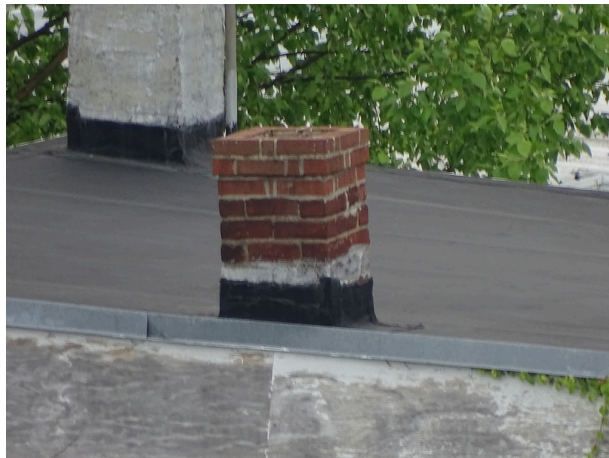
Typical chimney

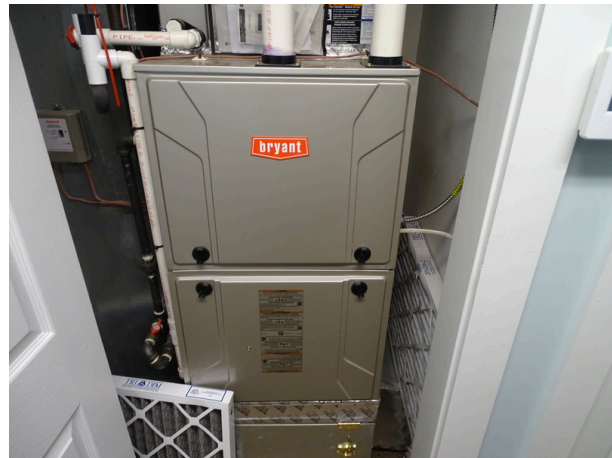
Gas Furnace - Air Handler Unit located in utility closet

3.4.2.1 Equipment																													
REPLACE CONDENSER UNITS	15	7	8	2	EA	\$5,500.00	\$11,000	100%							\$11,000														\$11,000
REPLACE GAS FURNACE - AIR HANDLER UNITS	15	7	8	2	EA	\$5,000.00	\$10,000	100%							\$10,000														\$10,000
REPLACE SPLIT SYTEM	15	7	8	1	EA	\$2,500.00	\$2,500	100%							\$2,500														\$2,500
Total (Uninflated)									\$60,900.00	\$0.00	\$0.00	\$0.00	\$0.00	\$0.00	\$0.00	\$23,500.00	\$15,000.00	\$0.00	\$0.00	\$0.00	\$1,000.00	\$0.00	\$0.00	\$0.00	\$15,000.00	\$0.00	\$0.00	\$0.00	\$115,400.00

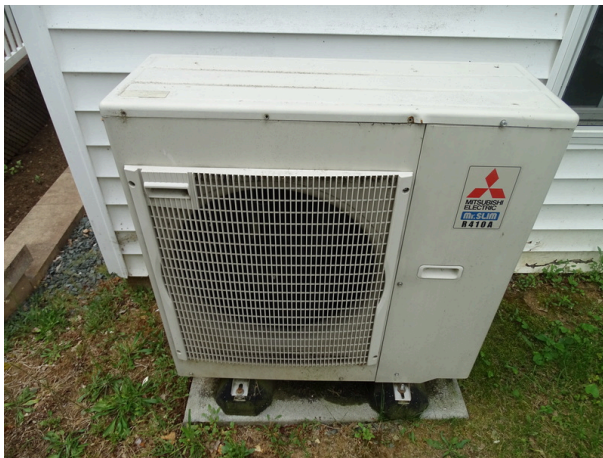
Split system servicing meeting room area

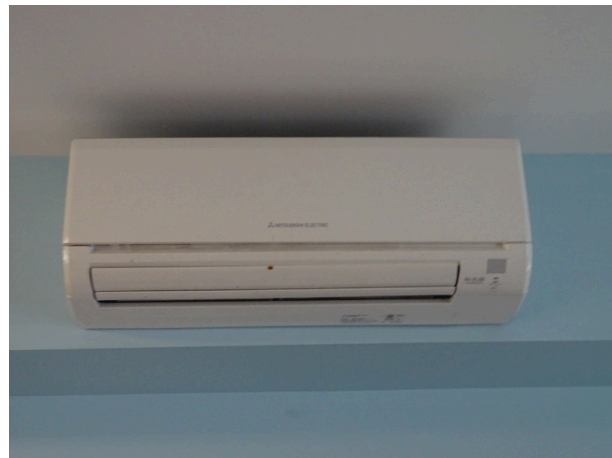
Wall mounted split system unit servicing meeting room area

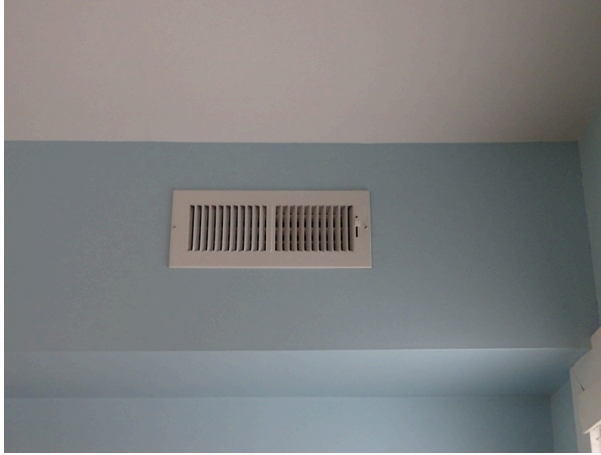
Typical mechanical duct

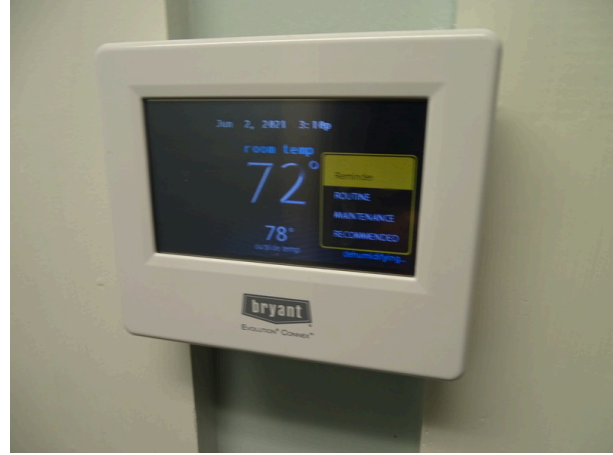
Typical digital thermostat control

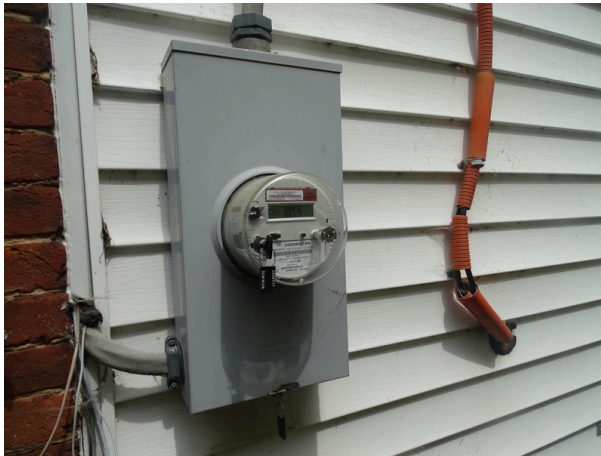
Electric utility meter located on the east side of the building

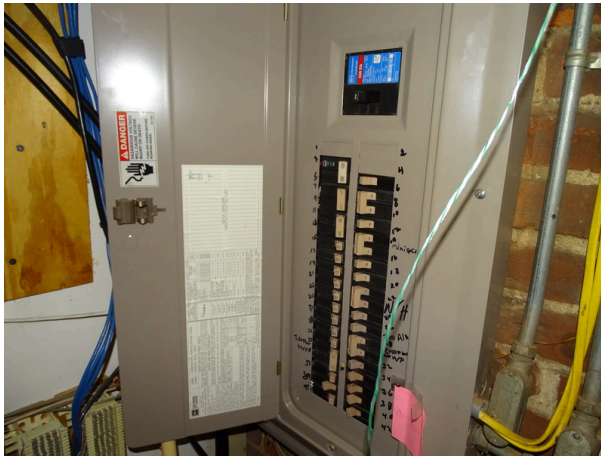
Power is distributed by copper wire from circuit a breaker panel located in a closet. The circuit breaker panel was generally in good condition.

Main electrical disconnect and circuit breaker panel

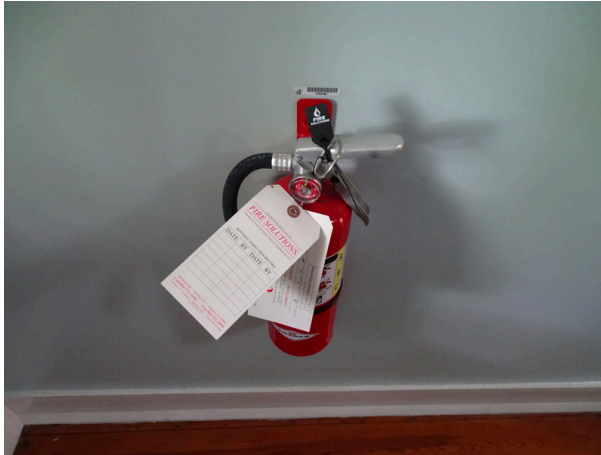
The fire suppression system consists of Fire extinguishers. The fire suppression system was observed but not tested. Fire extinguishers were observed throughout the building. The fire extinguishers were observed to have inspection tags issued by Fire Solutions in April 2021). These devices are required to be inspected annually. Replacement of the fire extinguishers is considered routine maintenance.

Typical fire extinguisher

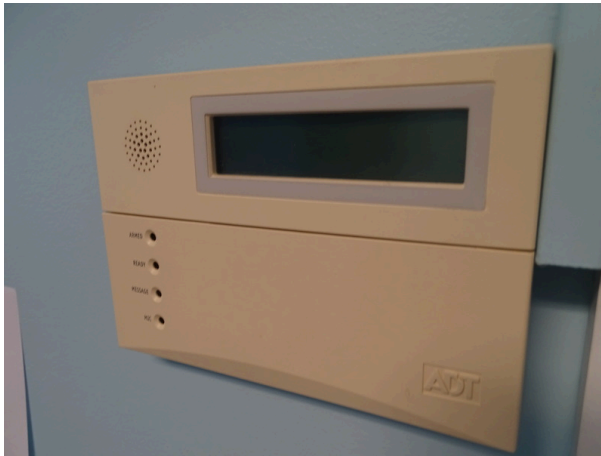
The building has an electronic alarm system and secure access with hardware locks. The security system was generally in good condition.

Security system electronic alarm

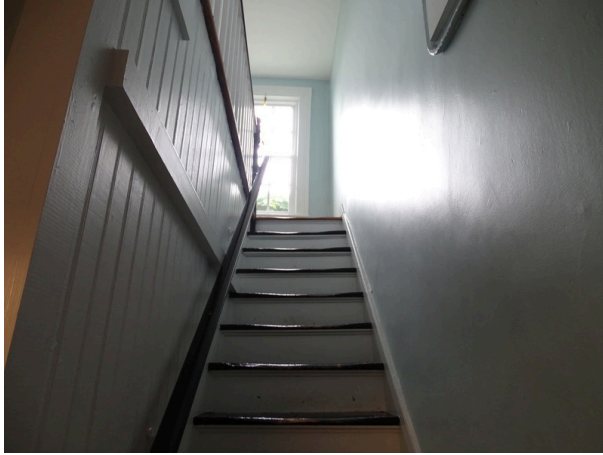
Interior finishes entrance area

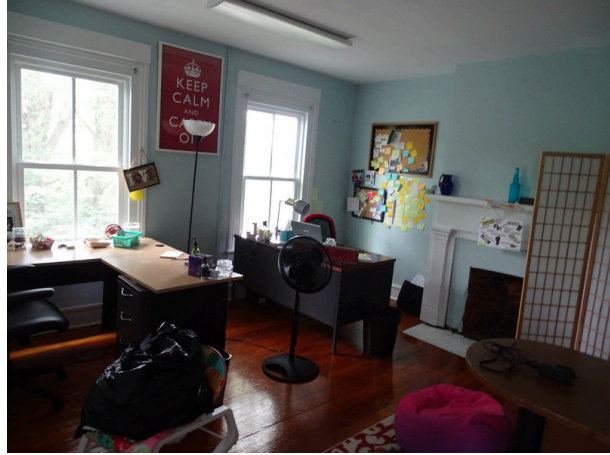
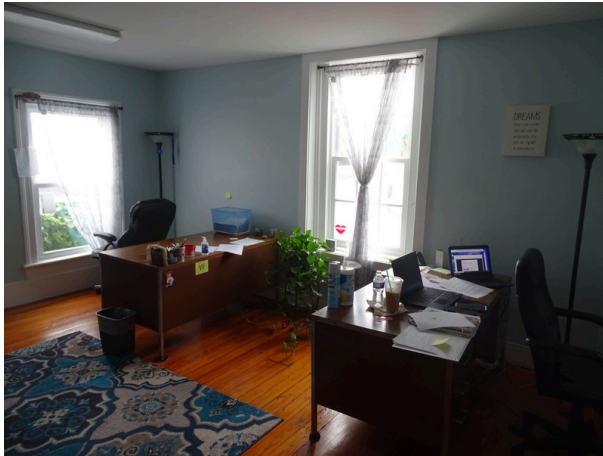
Interior finishes office area

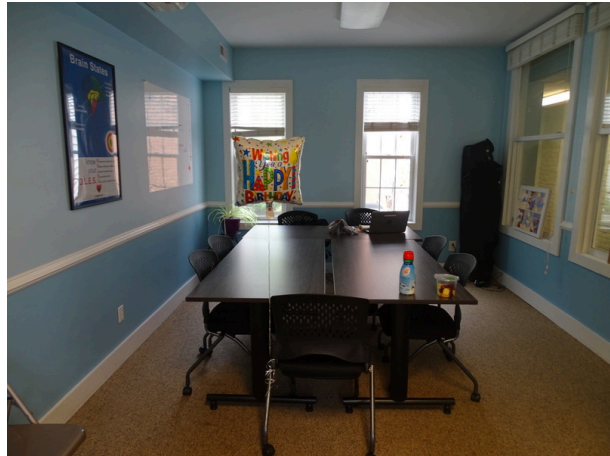
Interior finishes meeting room area

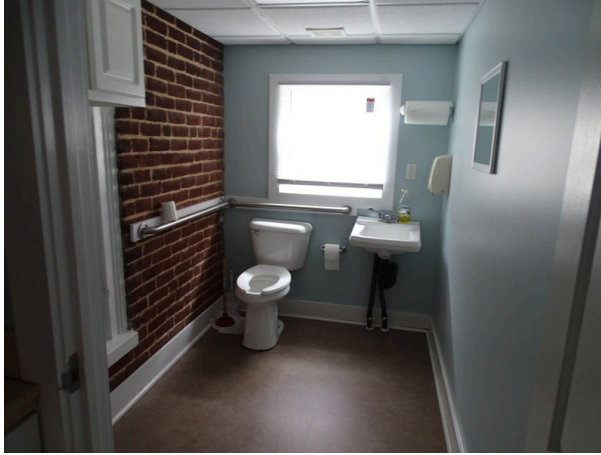
Interior finishes restroom area

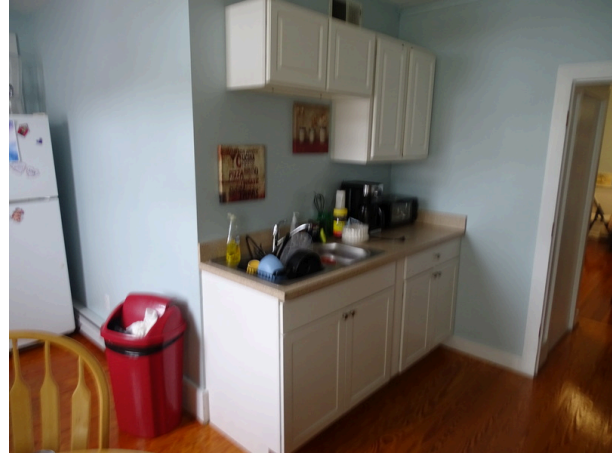
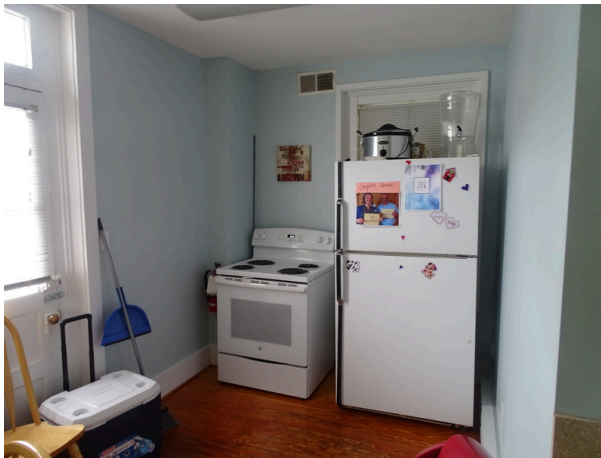
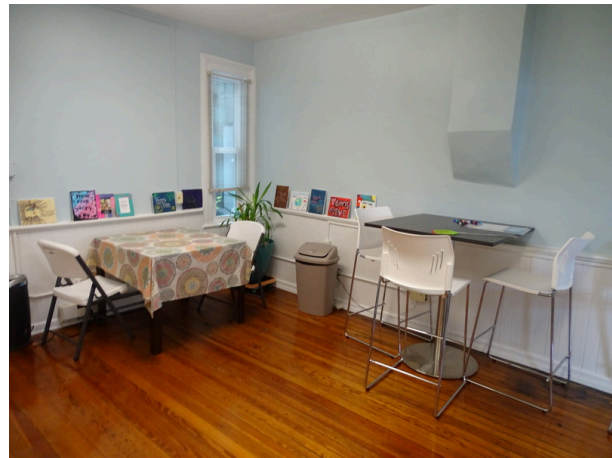
Interior finishes kitchen area

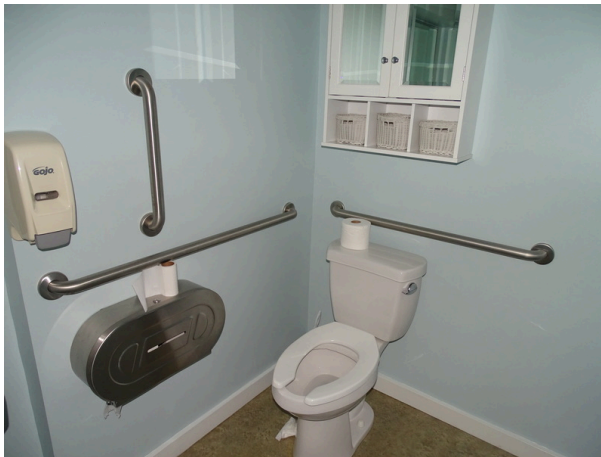
Accessible restroom

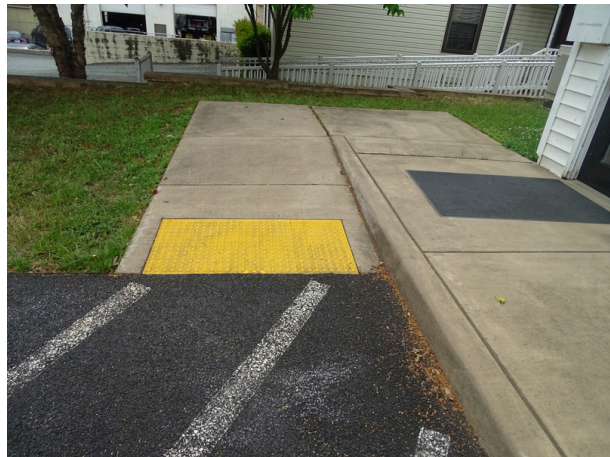
Concrete sidewalk north side of the building
with truncated domes

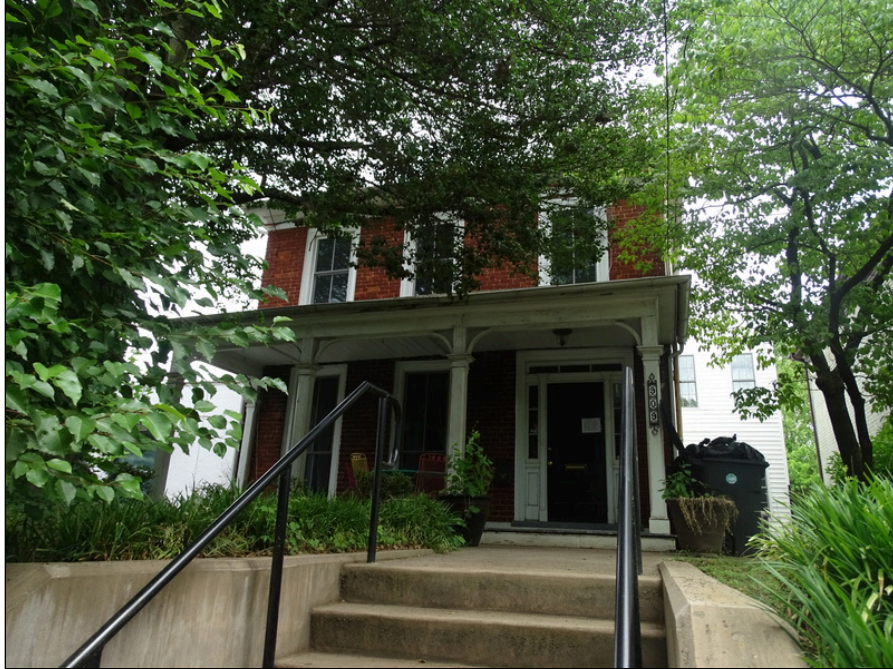
1 - Community Attention Building - south side of the building

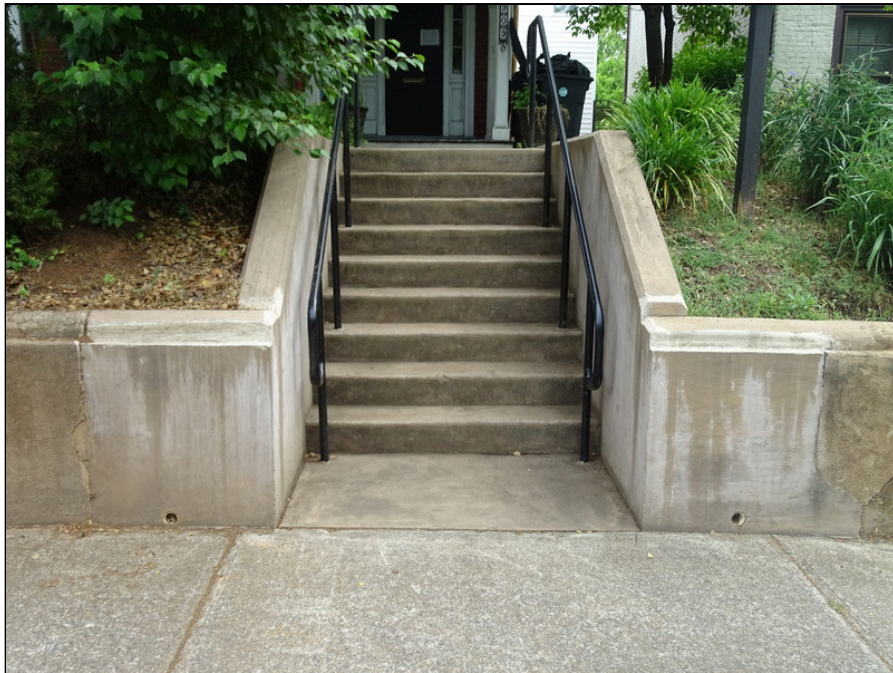
4 - Typical concrete steps

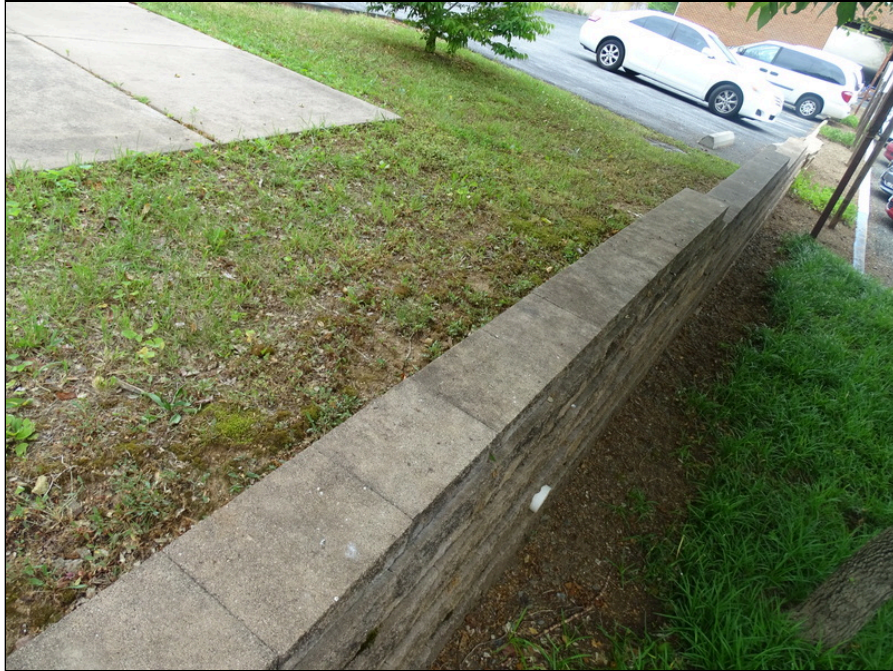
5 - Retaining wall at north end of the site

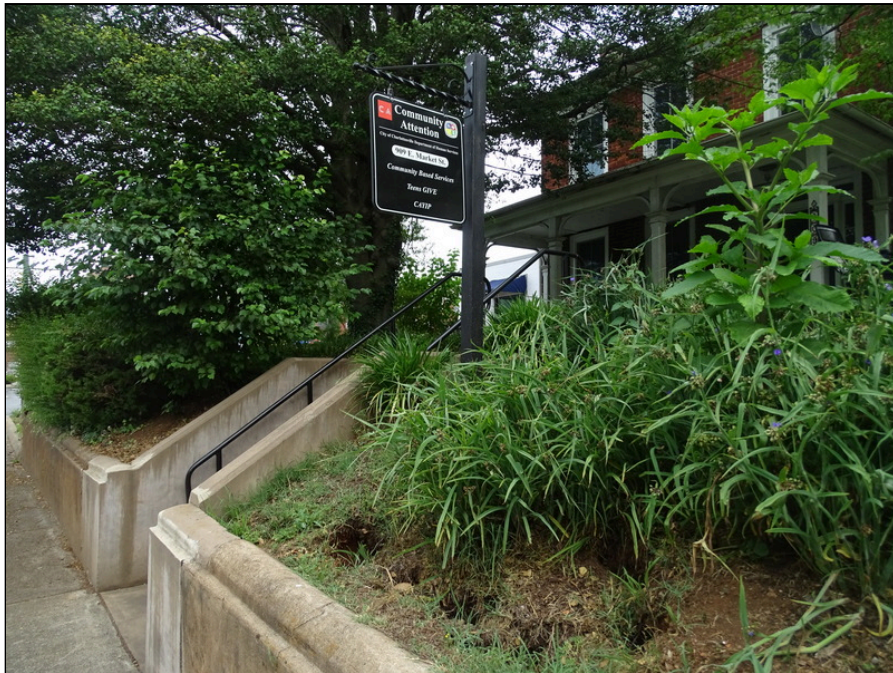
6 - Typical landscape

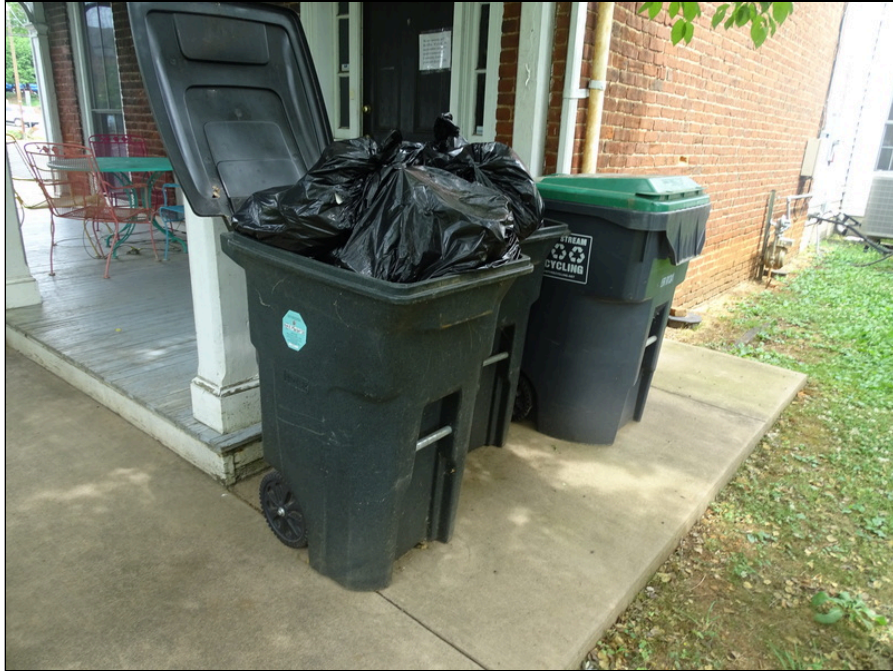
7 - Trash containers at the south side of the building

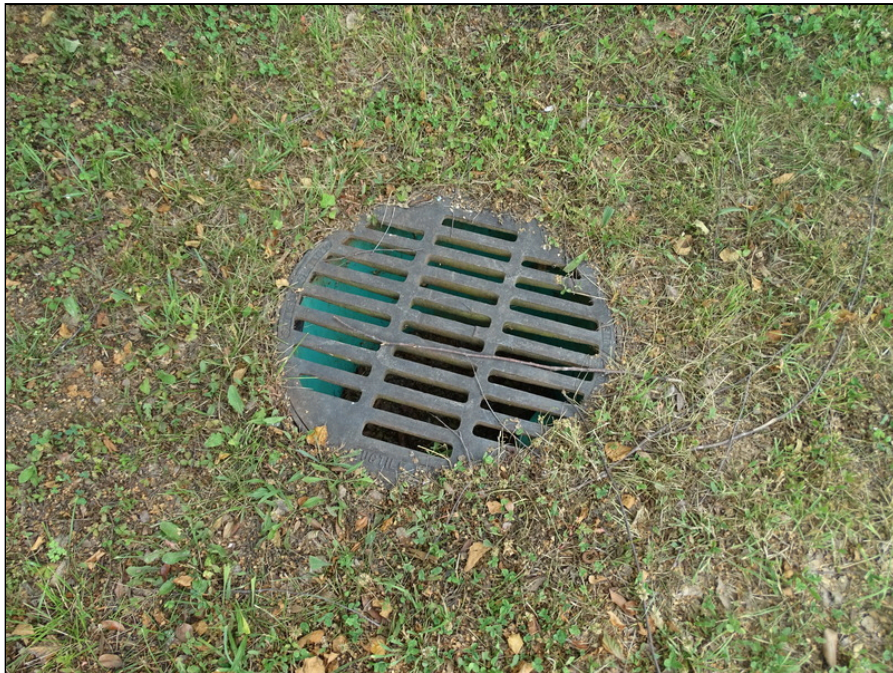
8 - Typical drainage

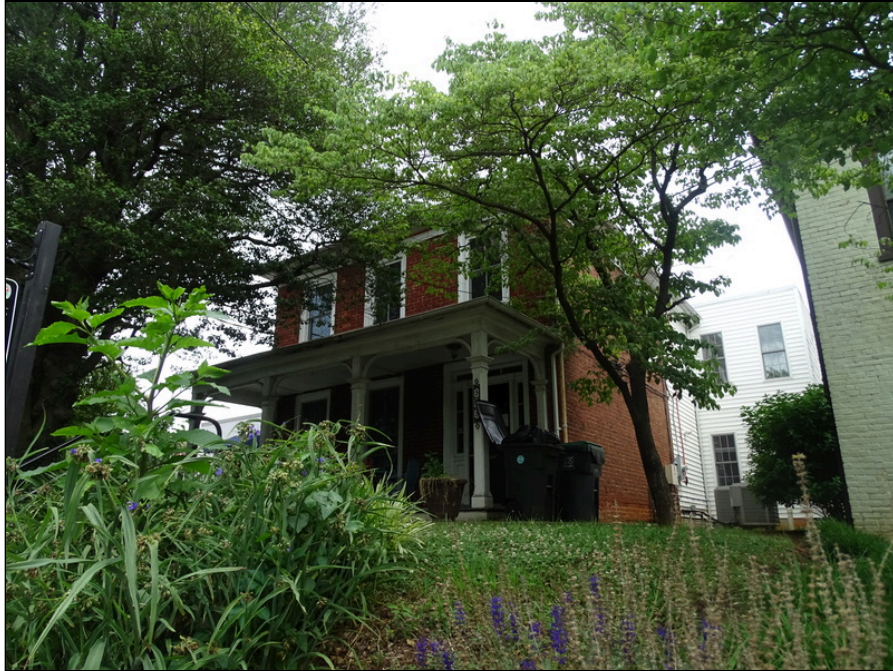
9 - Typical landscape

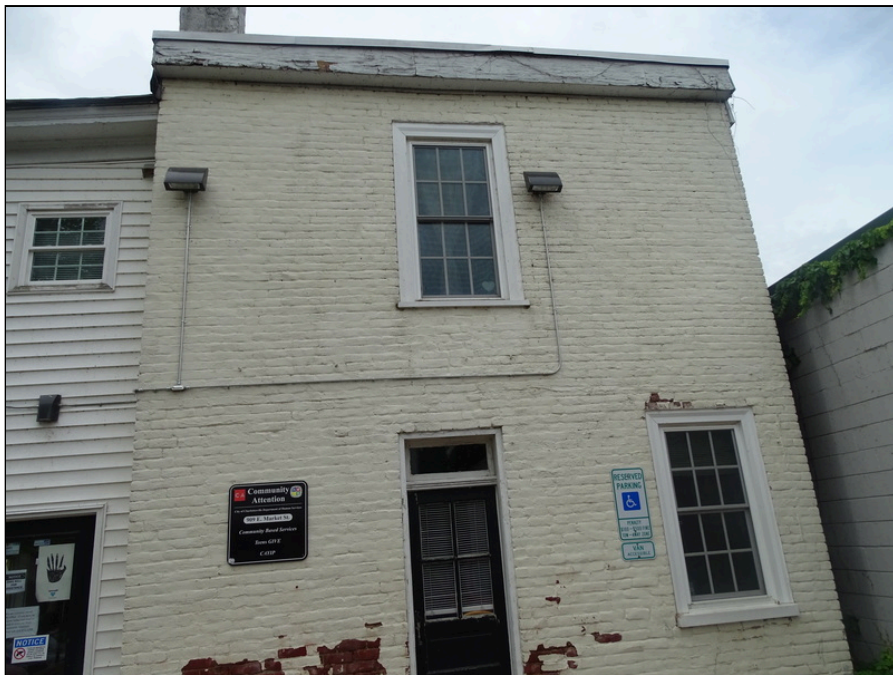
10 - Building exterior at north end of the building

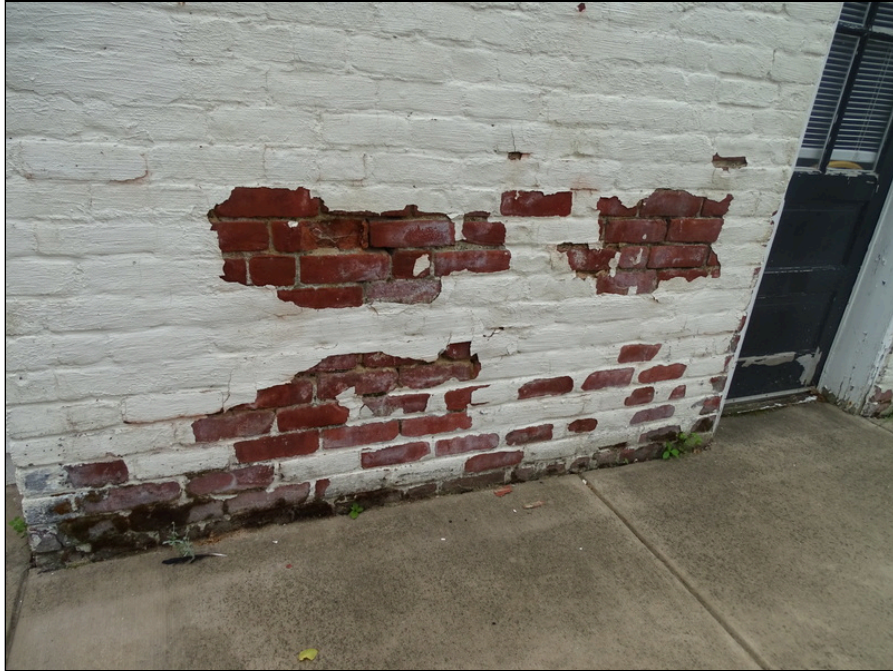
11 - Building exterior at north end of the building - note peeling paint

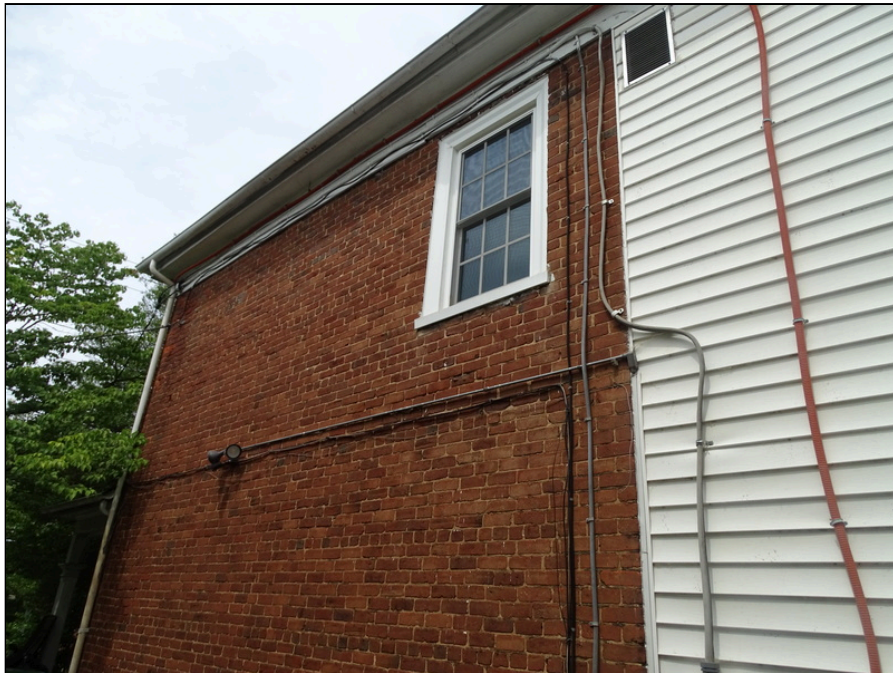
12 - Building exterior at southeast end of the building

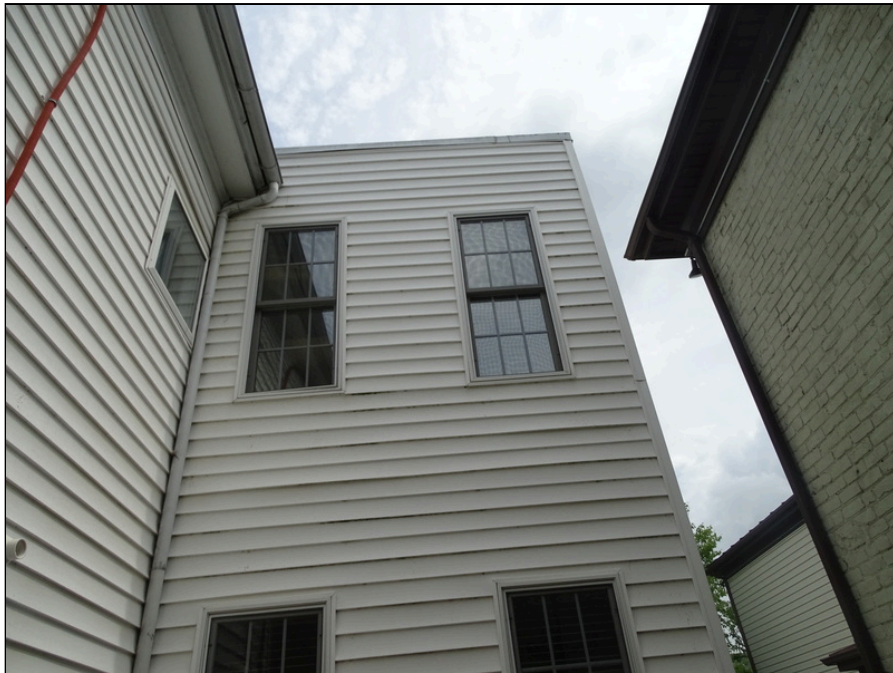
16 - Building exterior at northeast end of the building

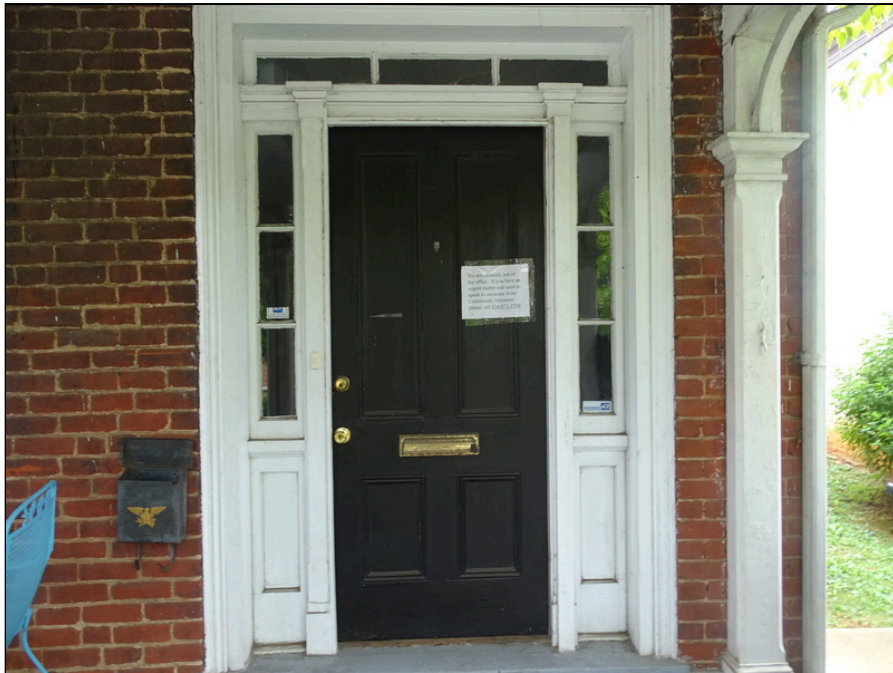
18 - Main entrance door south side of the building

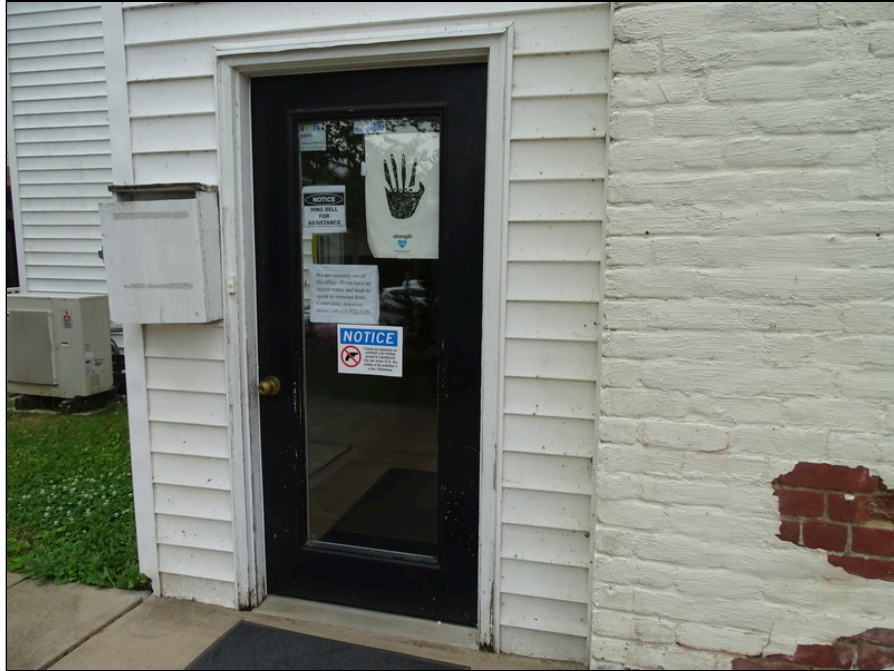
19 - Exterior door north side of the building

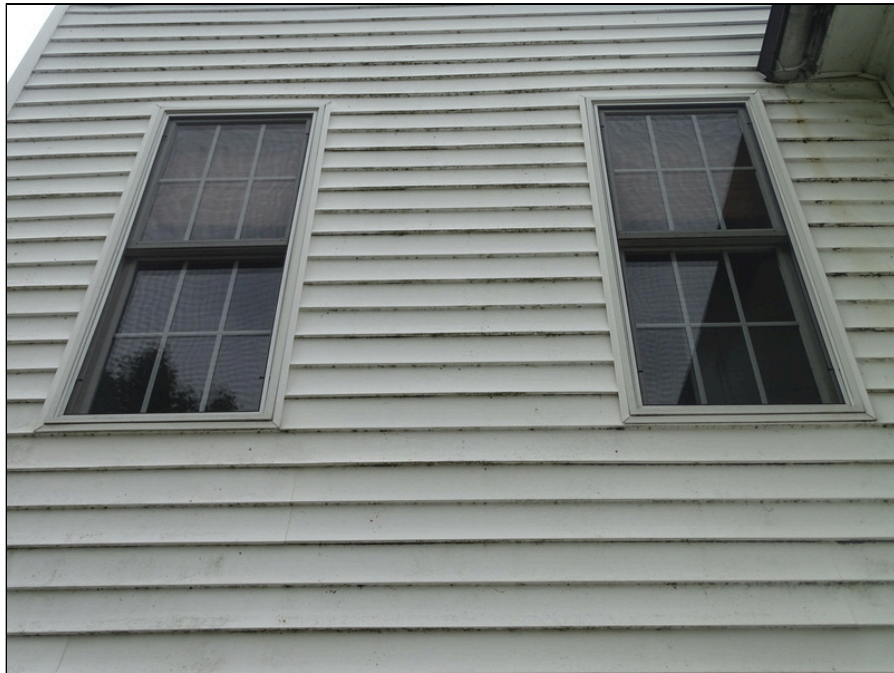
20 - Exterior windows south side of the building east addition

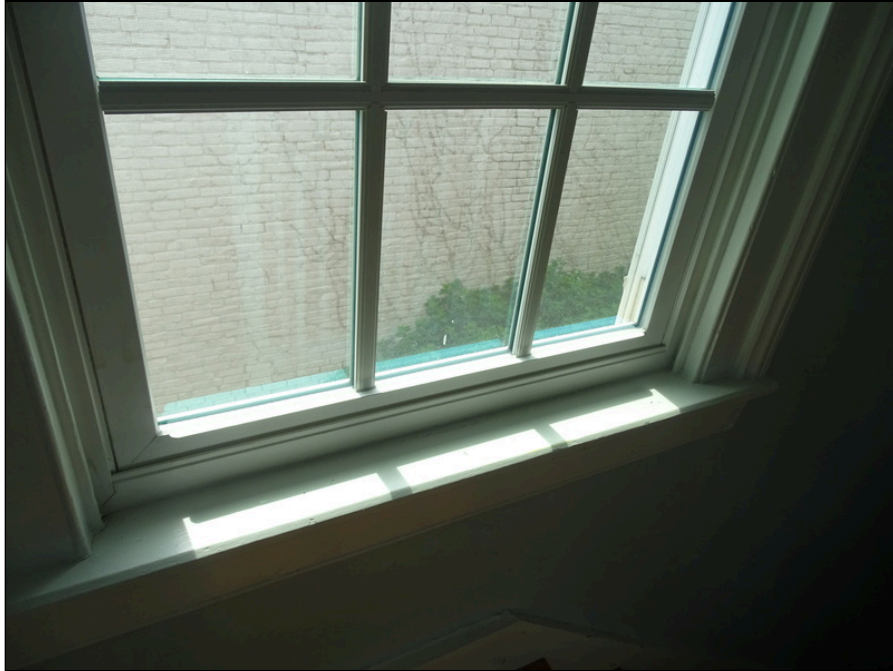
21 - Exterior windows south side of the building east addition

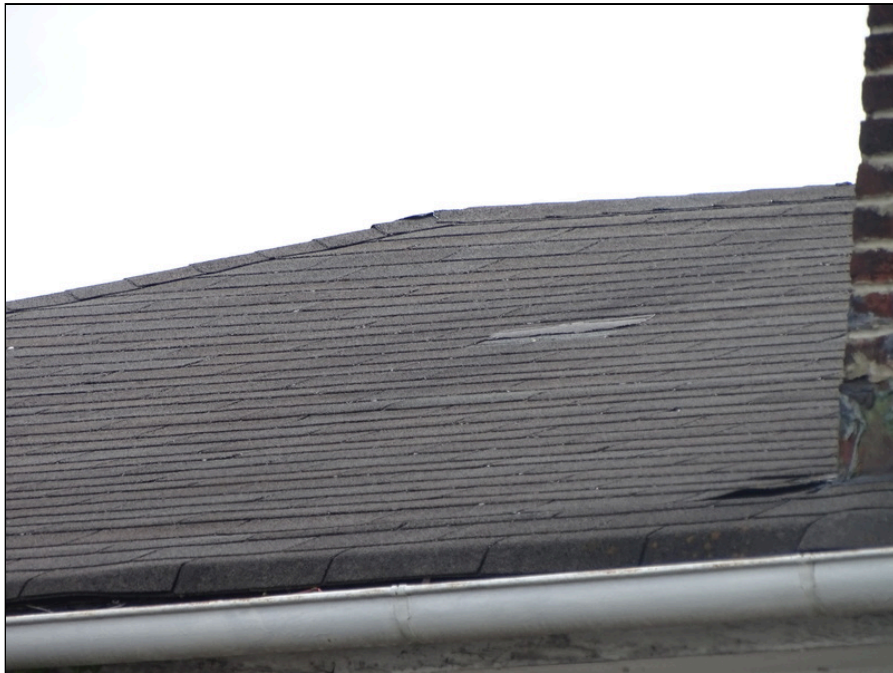
22 - Asphalt shingle roofing system

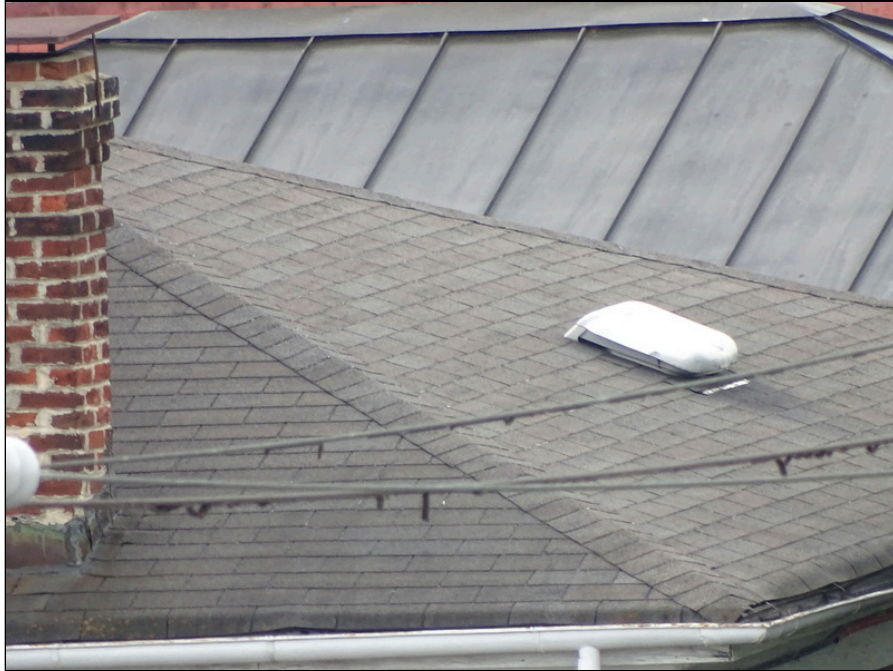
23 - Asphalt shingle roofing system

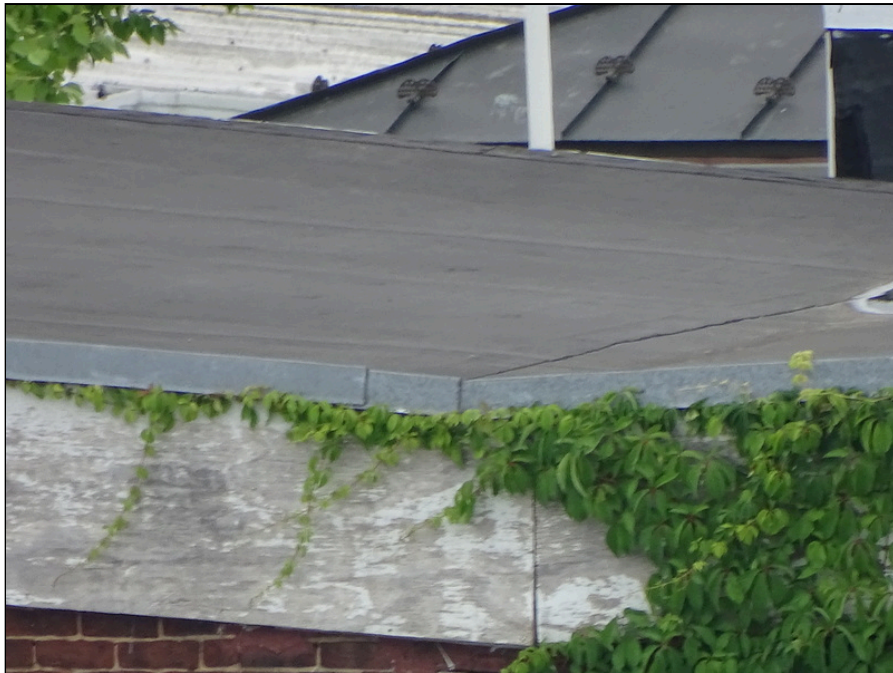
24 - Single-ply membrane roofing system

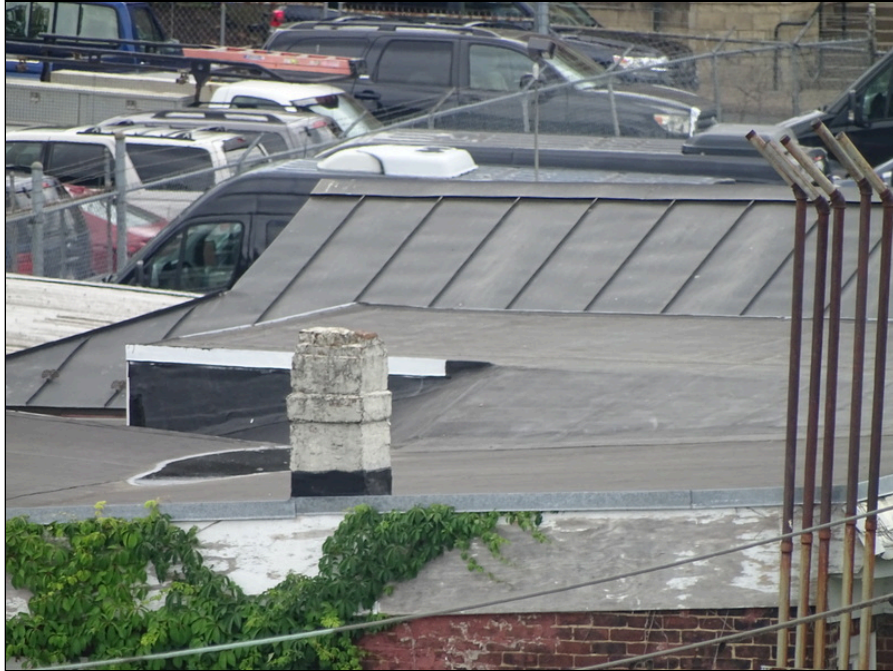
25 - Single-ply membrane roofing system
