COMMUNITY ATTENTION BUILDING (E MARKET)
909 EAST MARKET STREET
CHARLOTTESVILLE, VIRGINIA

ECS PROJECT NO. 46:6713

CITY OF CHARLOTTESVILLE - FACILITIES DEVELOPMENT

Reference: Facility Condition Assessment Report for Community Attention Building (E Market), 909 East Market Street, Charlottesville, Virginia

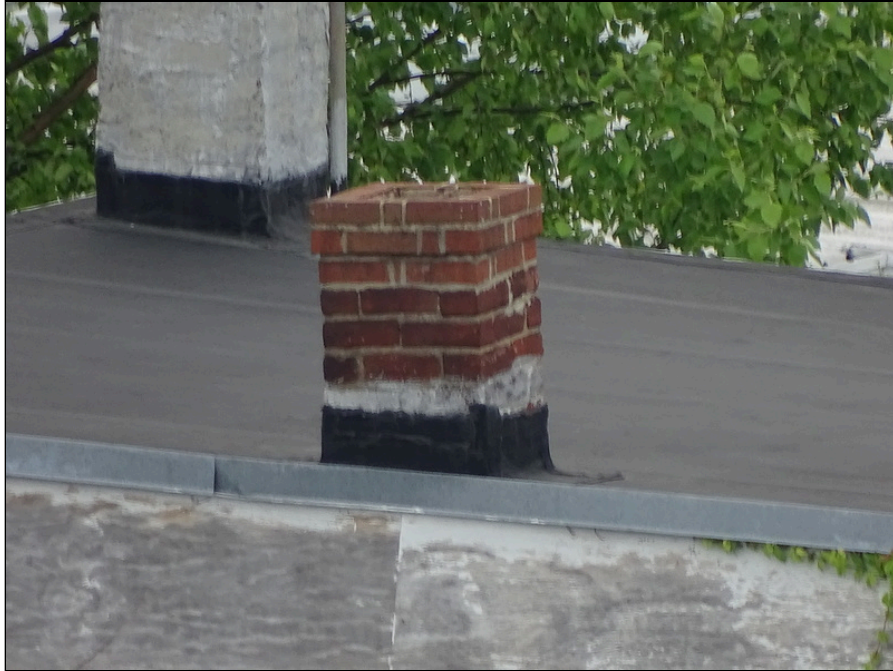
27 - Typical chimney

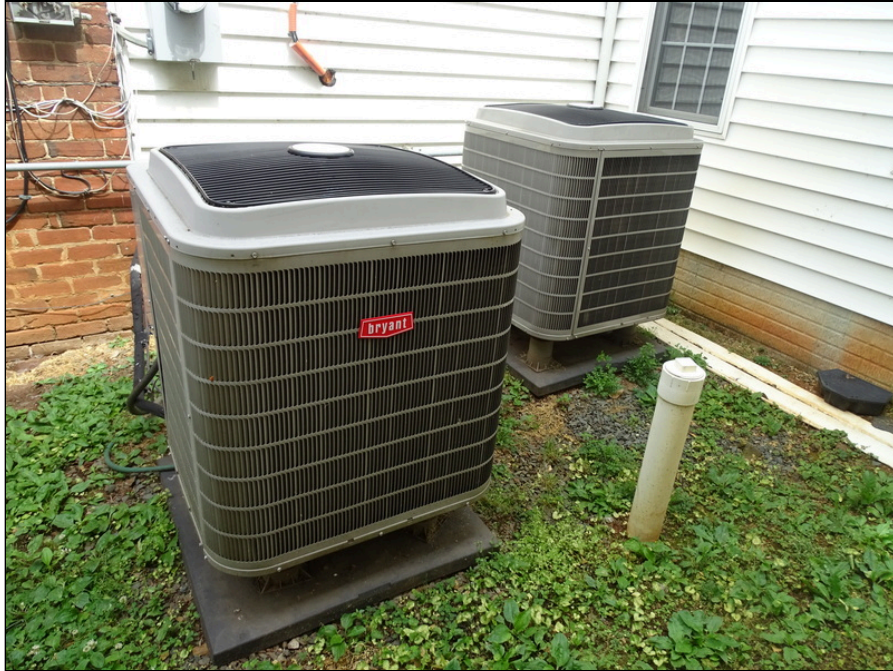
31 - Condenser unit on east side of the building

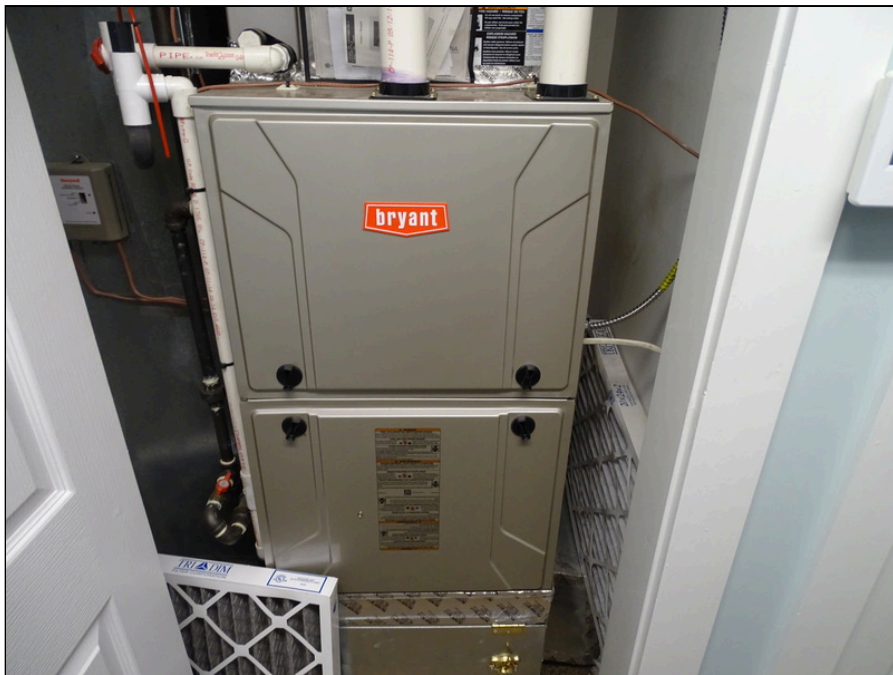
32 - Gas Furnace - Air Handler Unit located in utility closet

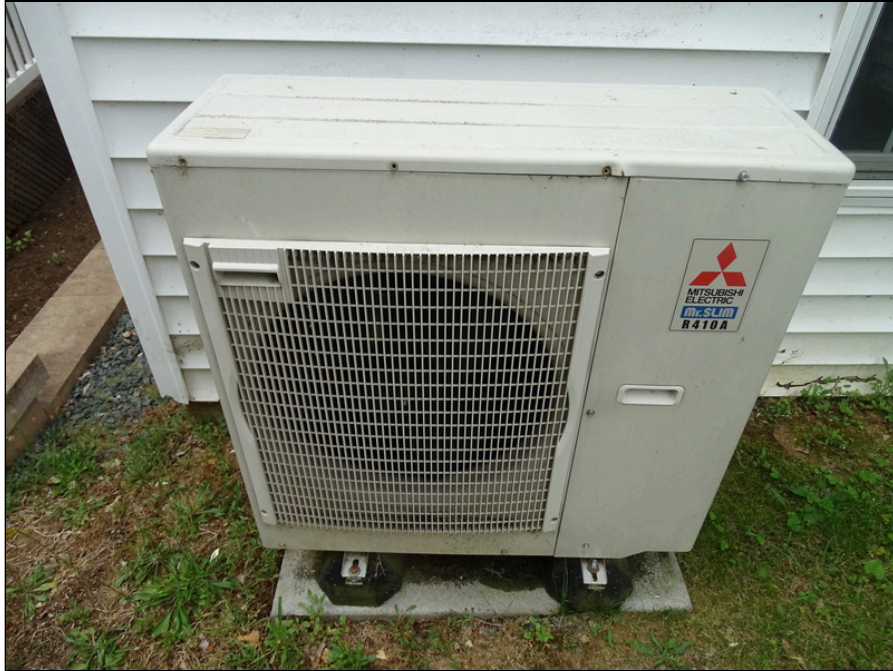
33 - Split system servicing meeting room area

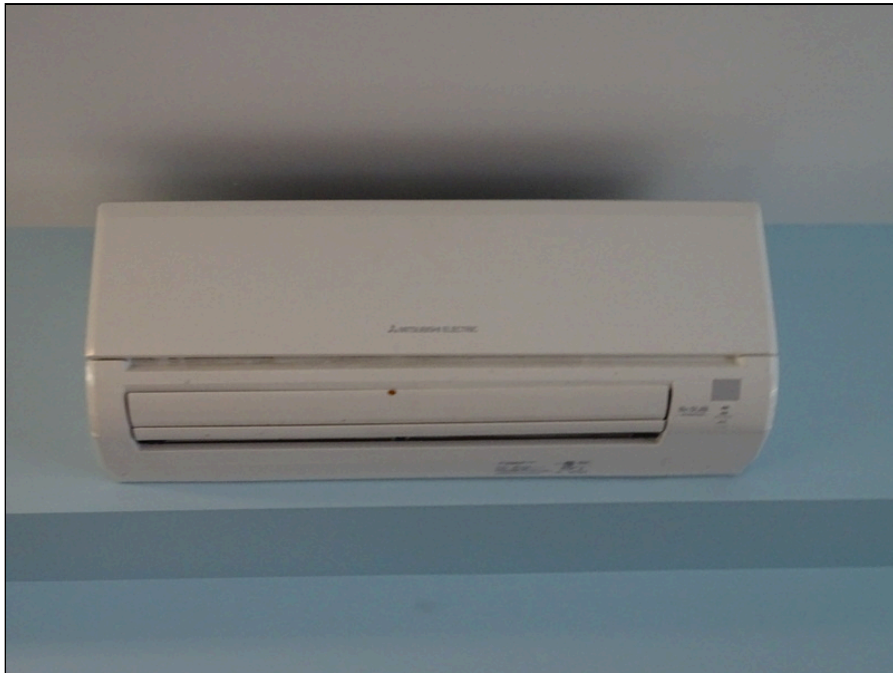
34 - Wall mounted split system unit servicing meeting room area

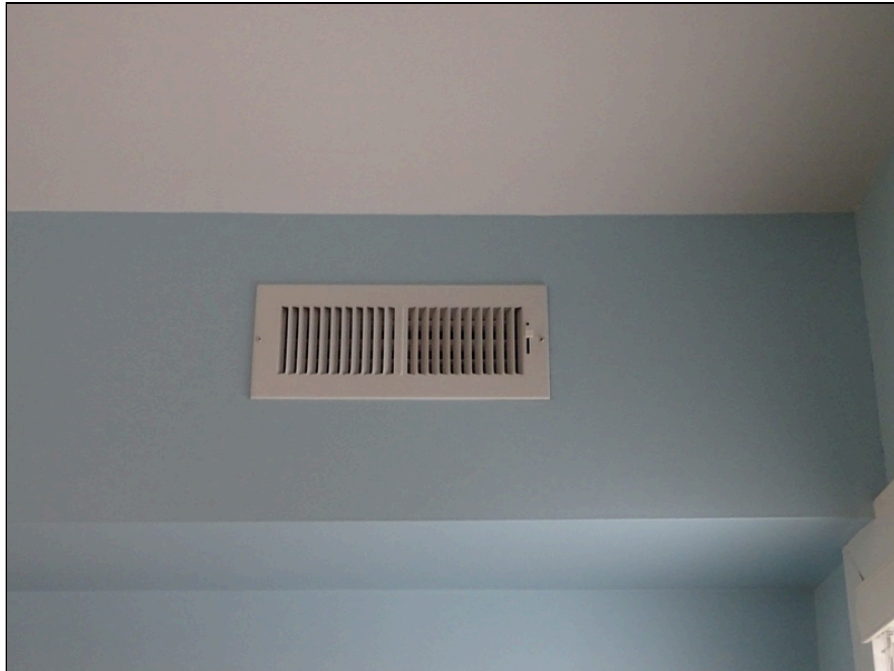
35 - Typical mechanical duct

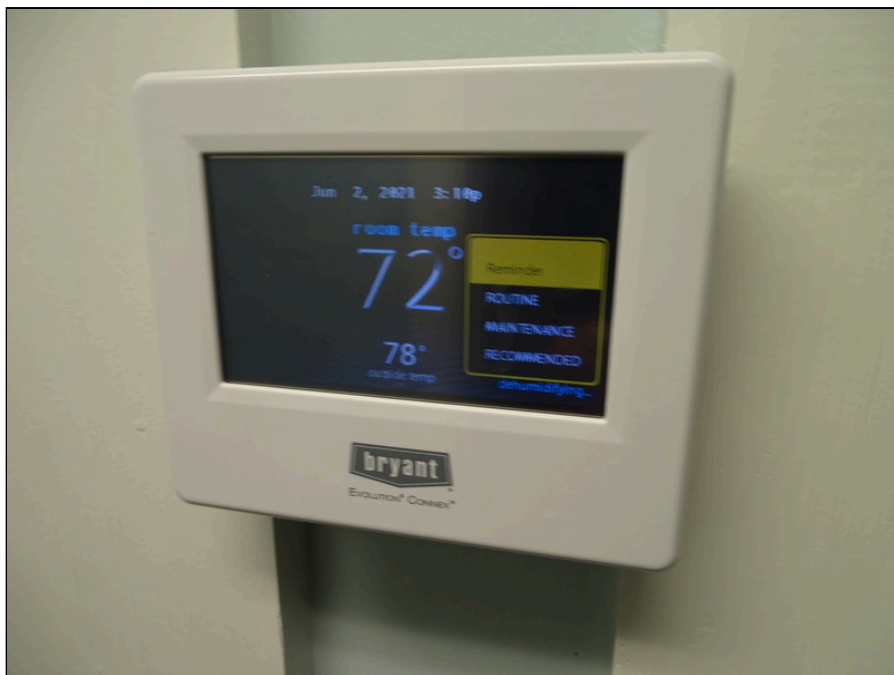
36 - Typical digital thermostat control

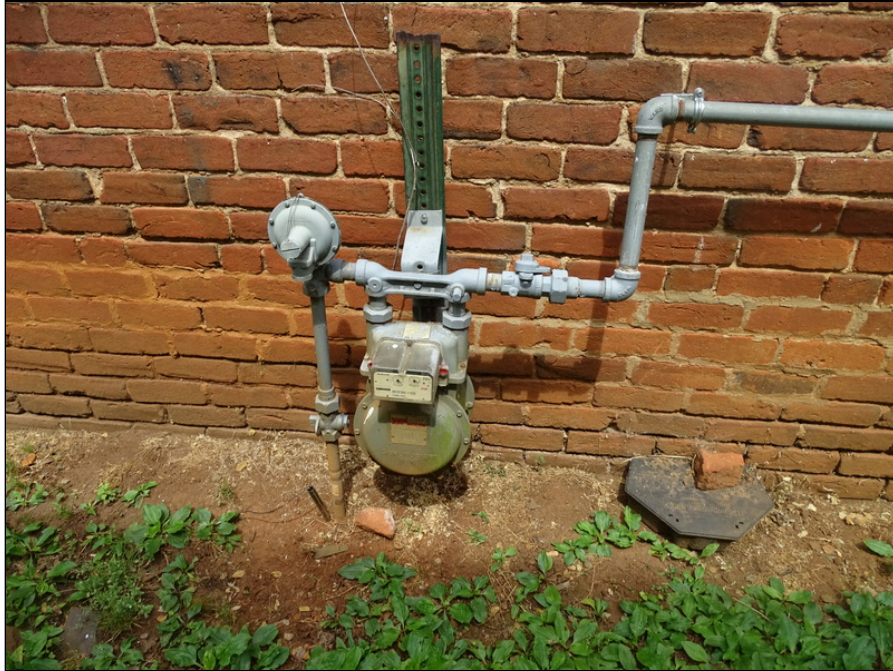
37 - Typical gas water

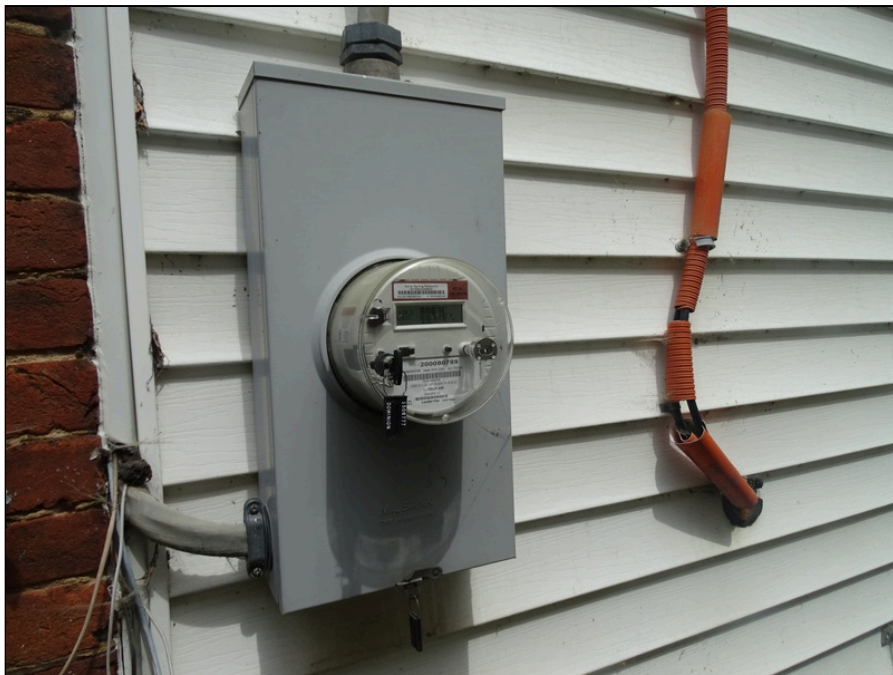
38 - Electric utility meter located on the east side of the building

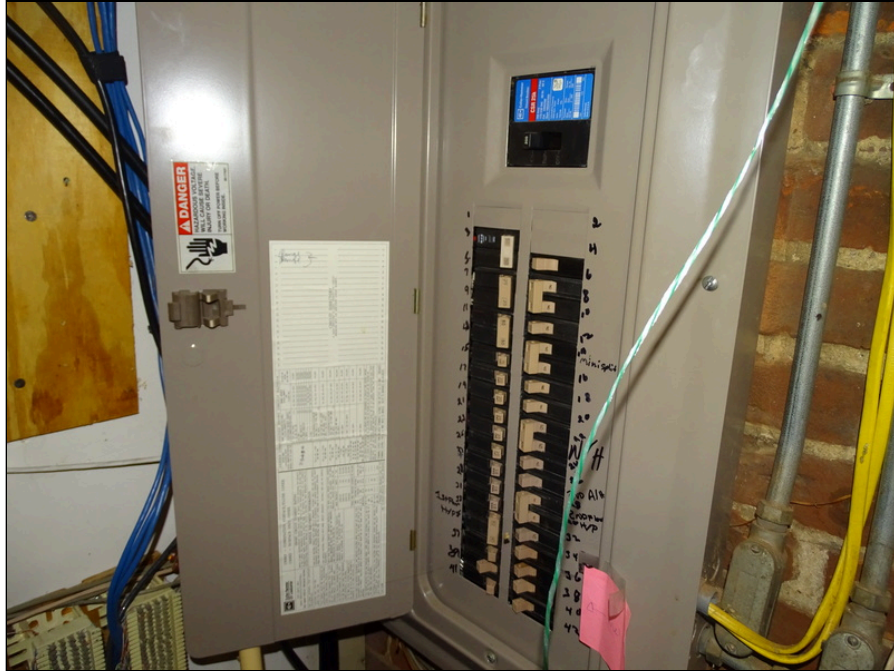
39 - Main electrical disconnect and circuit breaker panel

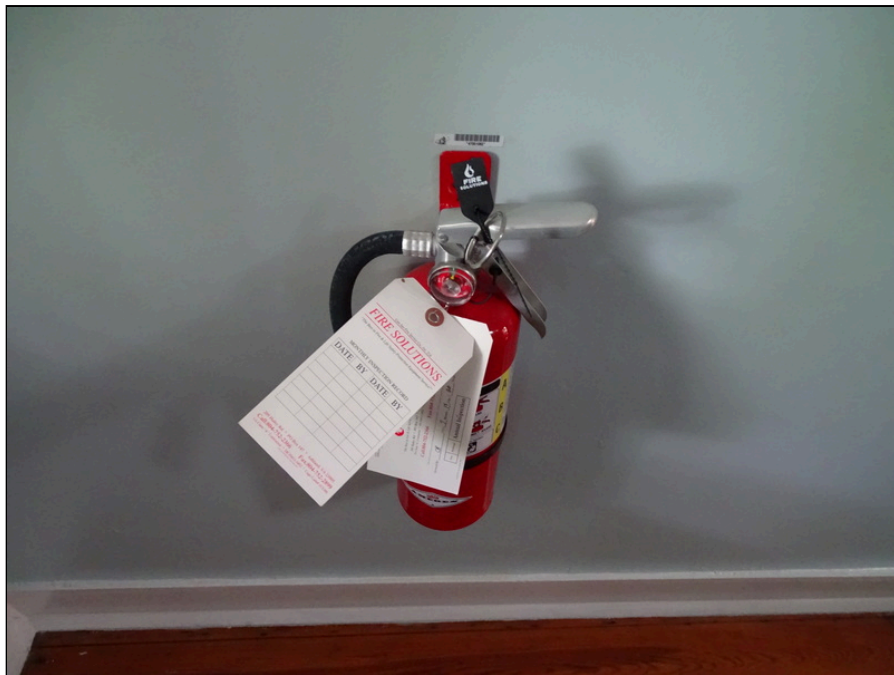
40 - Typical fire extinguisher

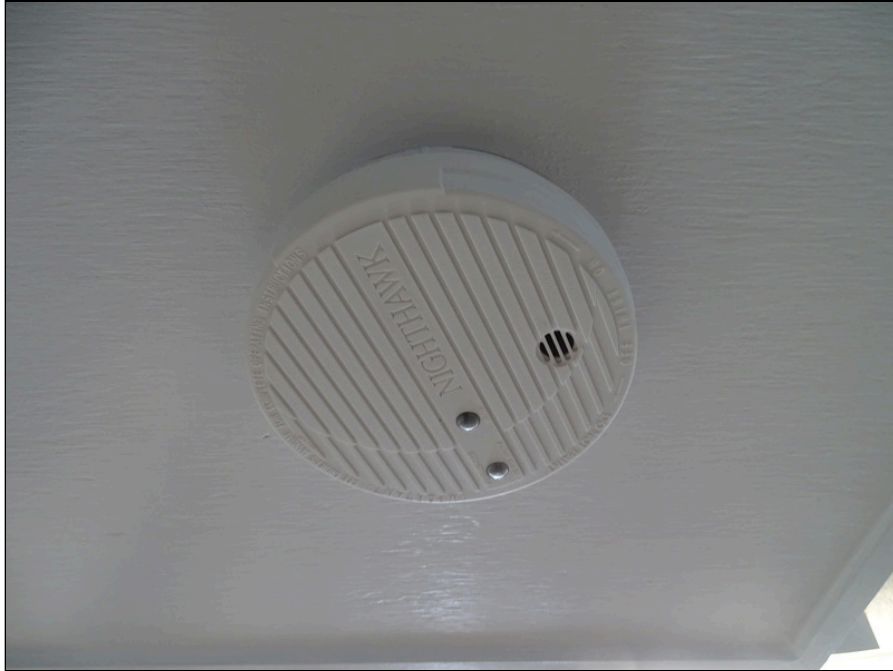
41 - Typical smoke detector

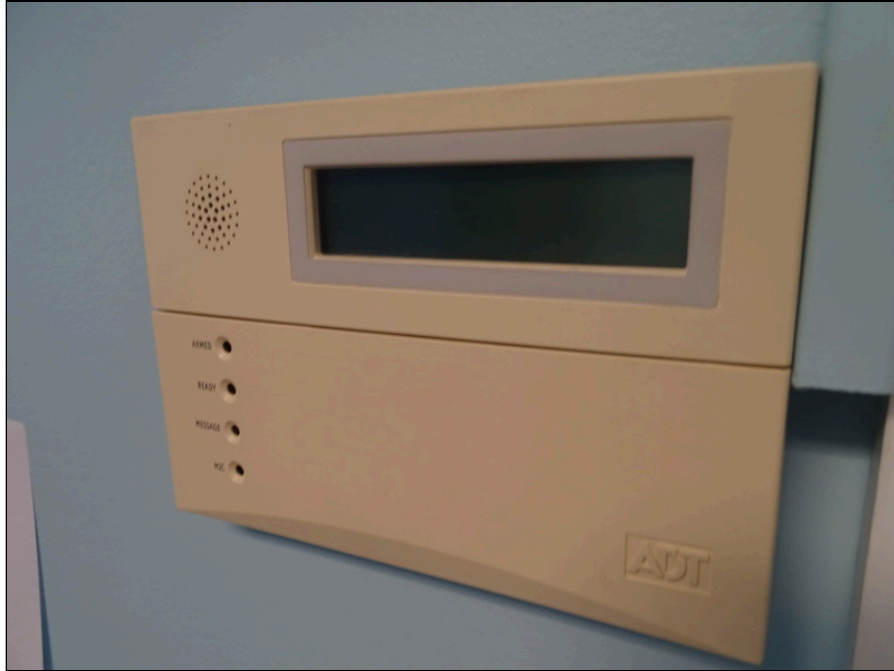
43 - Security system electronic alarm

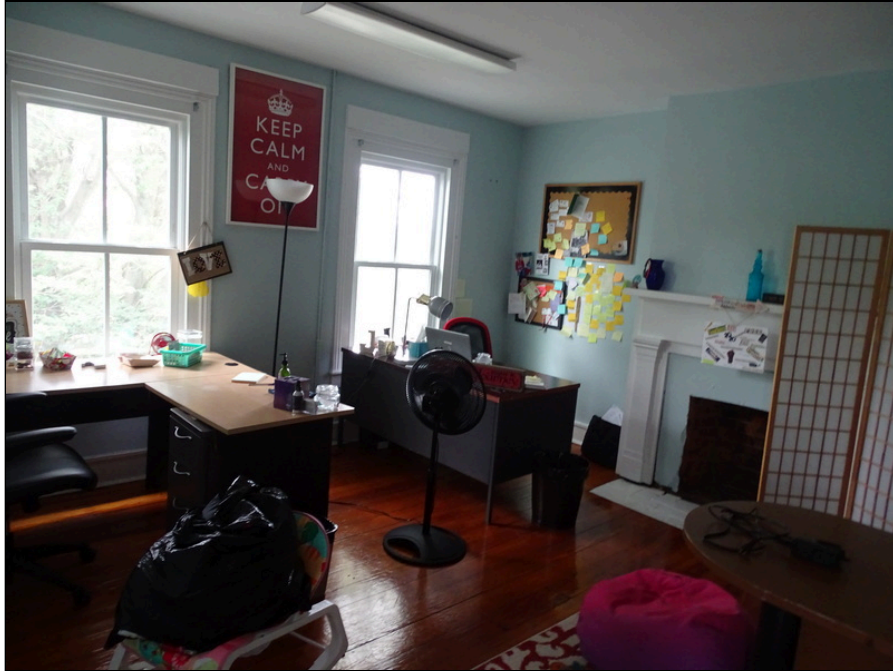
45 - Interior finishes office area

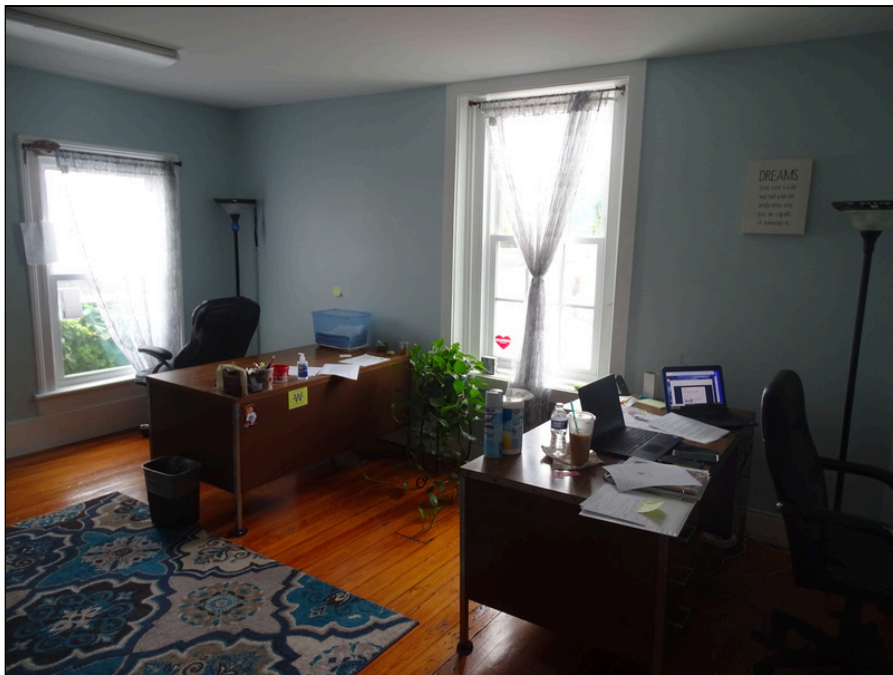
46 - Interior finishes office area

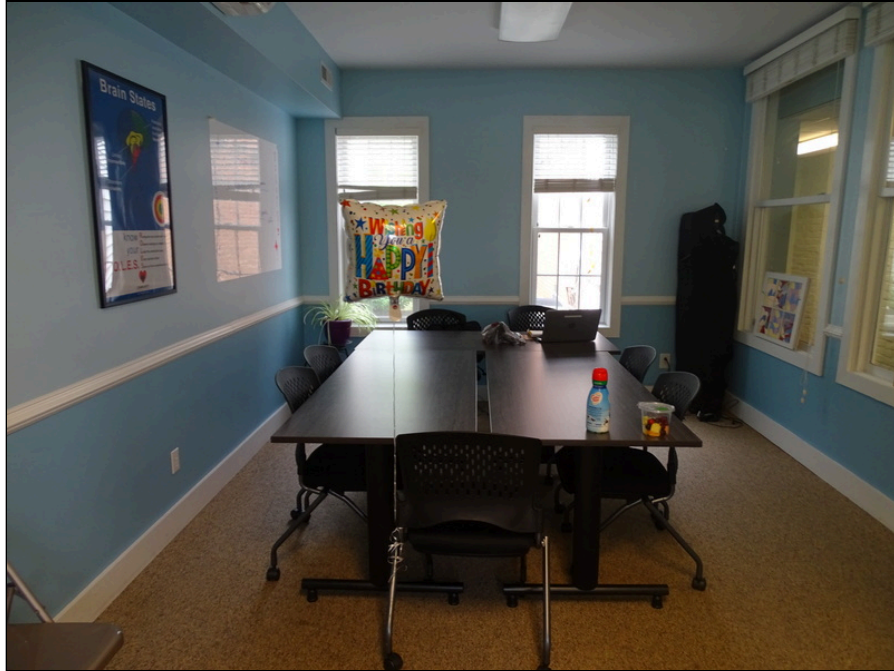
47 - Interior finishes meeting room area

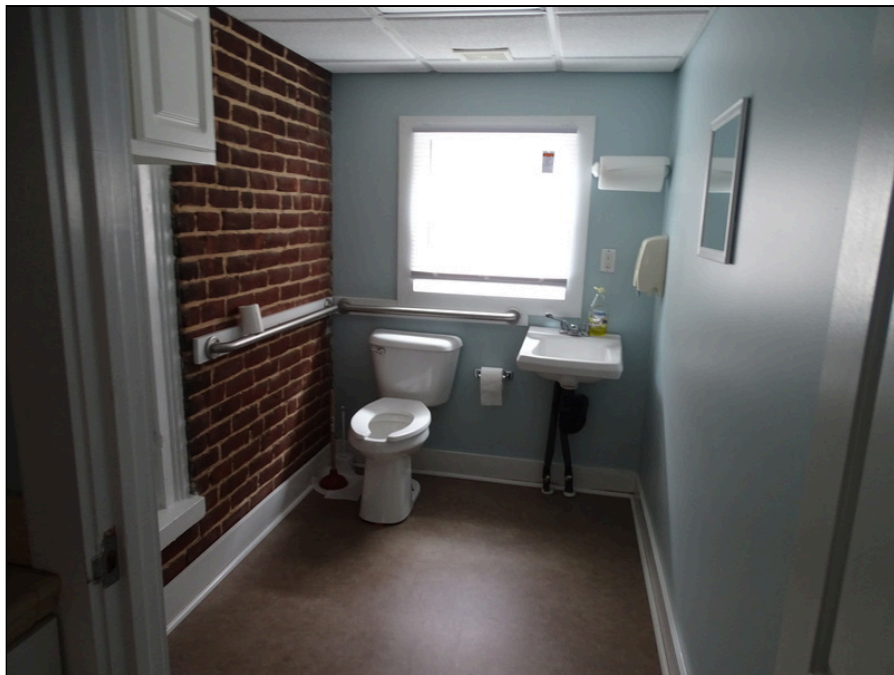
48 - Interior finishes restroom area

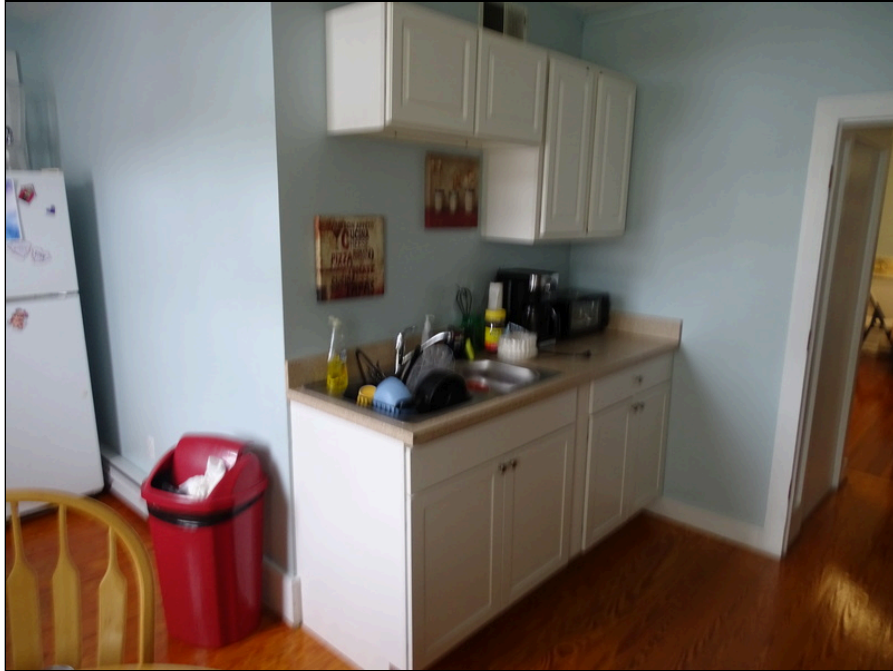
49 - Interior finishes kitchen area

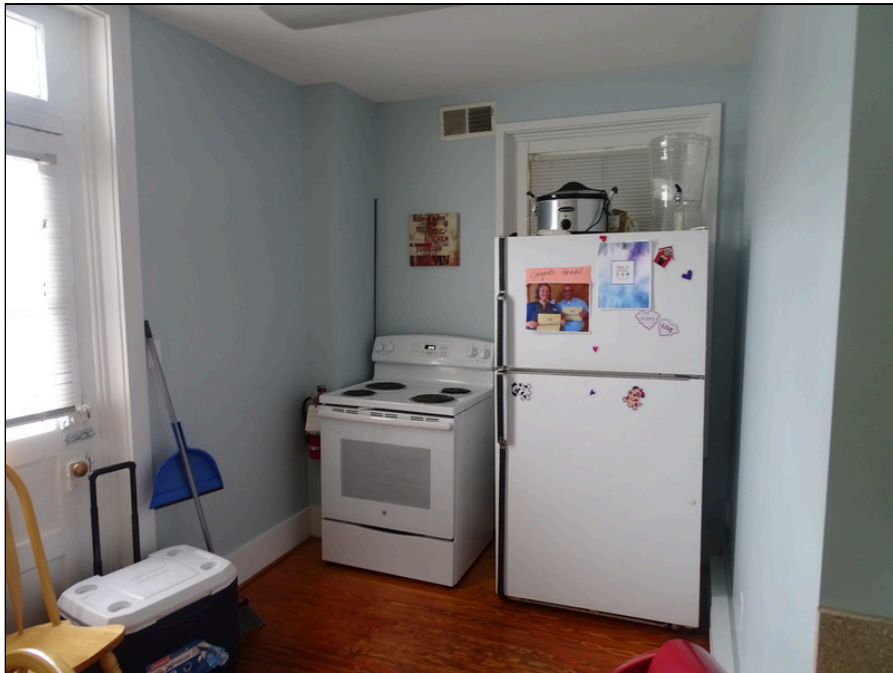
50 - Interior finishes kitchen area

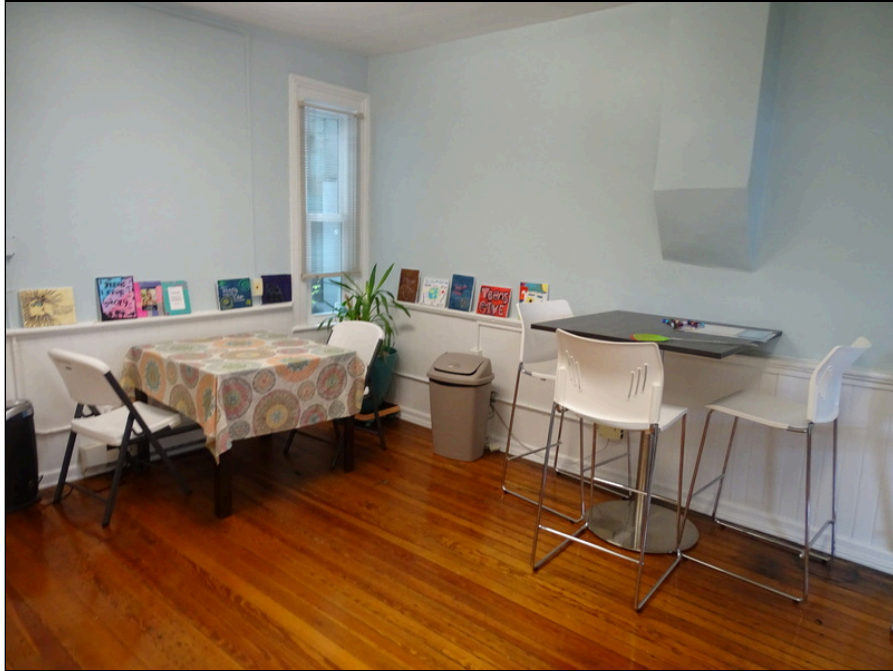
51 - Interior finishes kitchen area

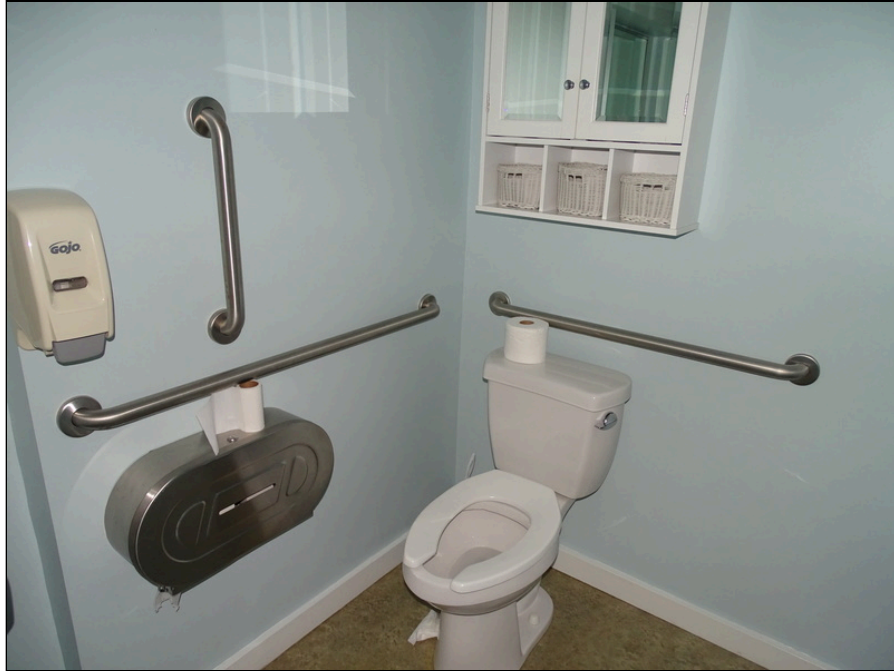
53 - Accessible restroom

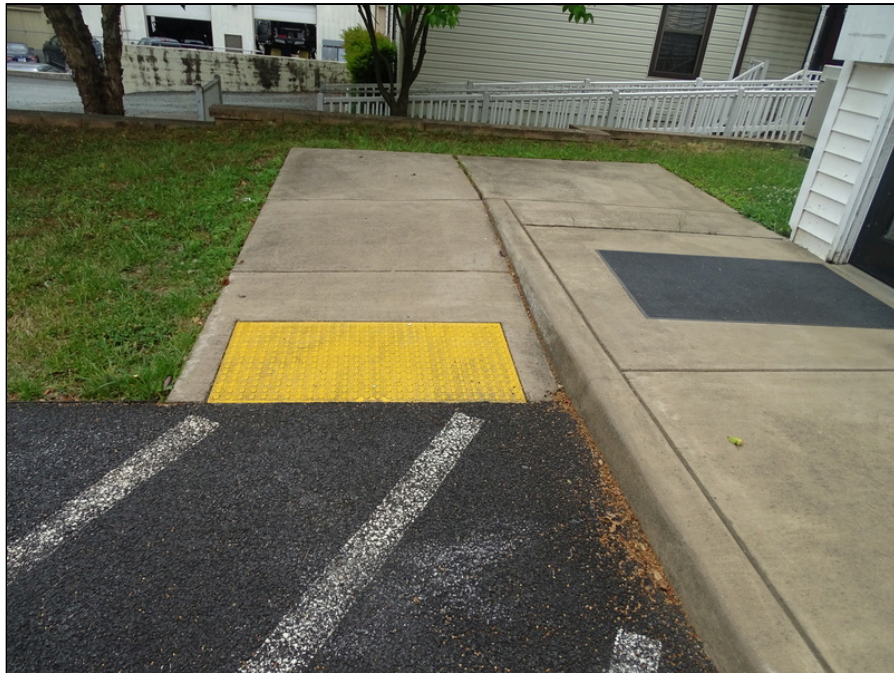
54 - Concrete sidewalk north side of the building with truncated domes

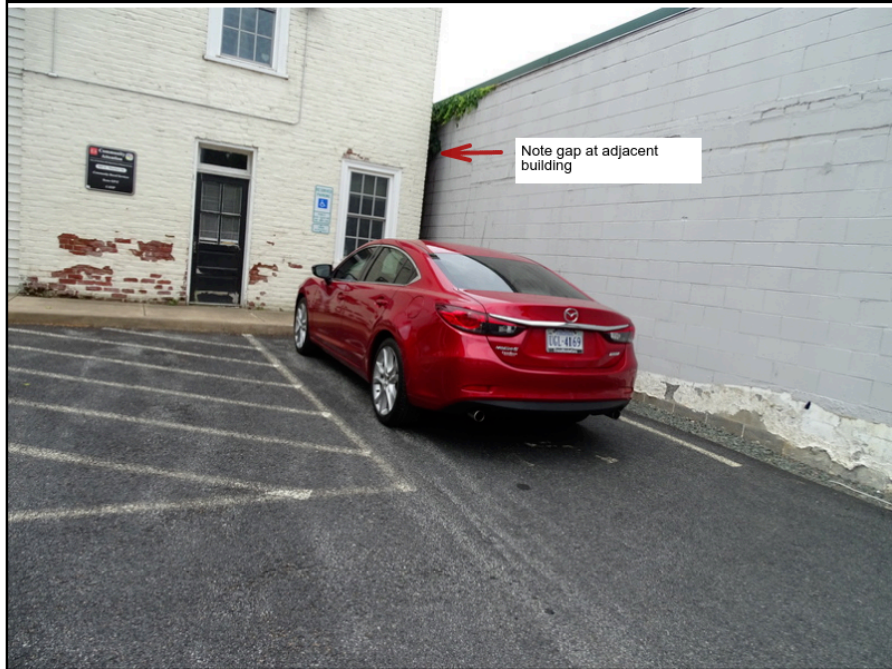
55 - Accessible parking
