JUVENILE AND DOMESTIC RELATIONS COURT - SHERIFF'S OFFICE -
PARKING GARAGE COMPLEX
411 EAST HIGH STREET
CHARLOTTESVILLE, VIRGINIA

ECS PROJECT NO. 46:6713

CITY OF CHARLOTTESVILLE - FACILITIES DEVELOPMENT

Reference: Facility Condition Assessment Report for Juvenile and Domestic Relations Court - Sherriff's Office - Parking Garage Complex, 411 East High Street, Charlottesville, Virginia

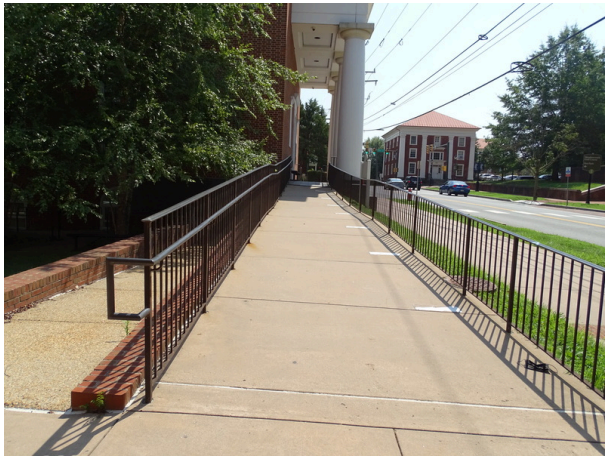
Ramp at southwest side of courthouse building

The ramp handrail was observed to be loose and should be repaired as a maintenance item.

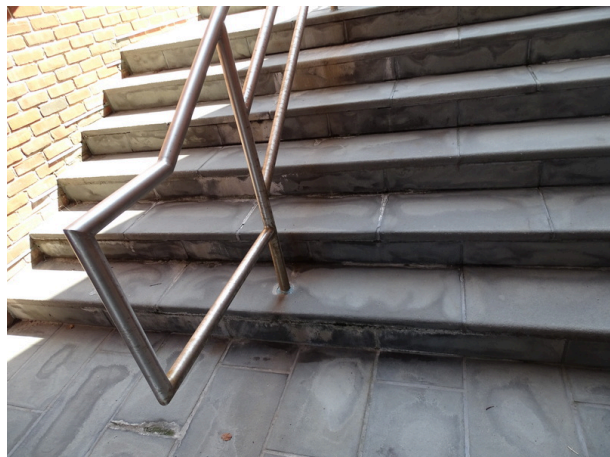
Typical stair at north side of courthouse - note efflorescence

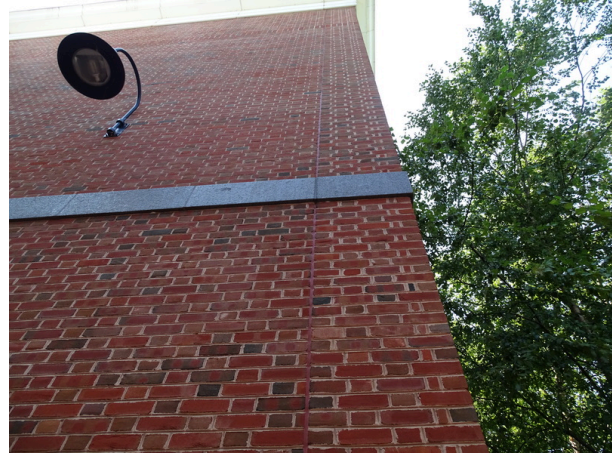
Vertical sealant at east side of the building

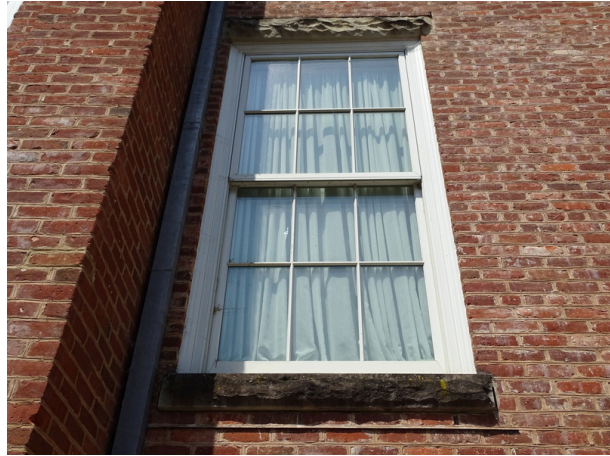
Typical window at courthouse - note
efflorescence

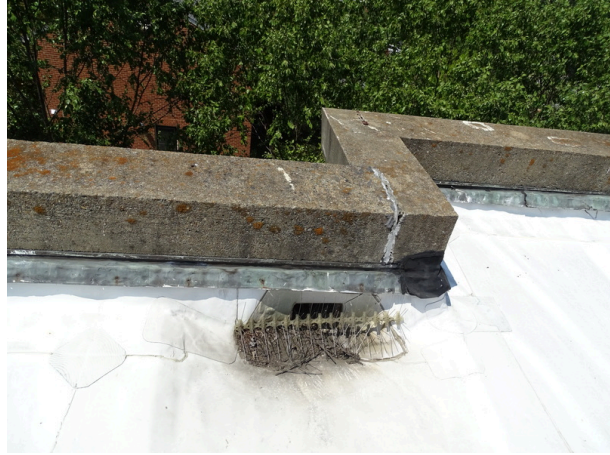
Parapet wall on courts building center portion -
note patching

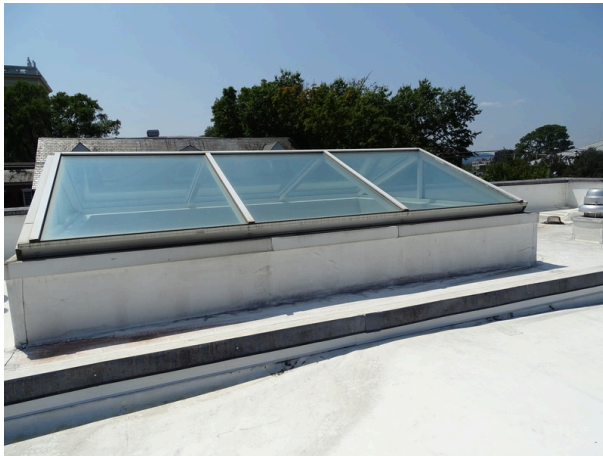
Roofing penetrations included plumbing vents, equipment curbs, and exhaust vents throughout the roofing system. A skylight is located on the roof at the south end of the courts building. The glass was cracked on the east and west side of the skylight and leaks were reported. The skylights are original to the building. The expected useful life of the skylight is approximately 20 years. We recommend that the skylights be replaced.

Skylight located at the south end of the courts
building

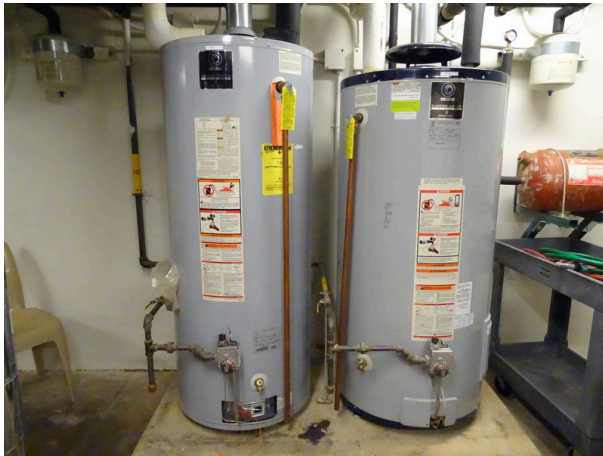
Domestic hot water to the building is provided by two Gas domestic water heaters located in the main utility room in the sheriffs building. The Gas domestic water heaters were manufactured by State Industries. The expected useful life of a Gas domestic water heaters is approximately 12 to 15 years. We recommend the Gas domestic water heaters be replaced during the report period.

Domestic water heaters

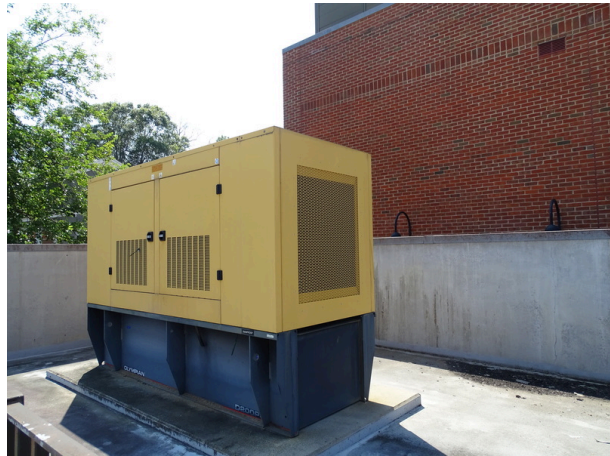
Emergency back up power generator

Electricity is provided to the building by Dominion Virginia Power. The main electrical entrance is located on the east side of the building and provides 3-phase, 4-wire, 800 amp service. The switchgear was manufactured by Square D. The expected useful life of switchgear is 50 years with proper maintenance. There is an emergency power generator located on the top level east side of the parking garage. Based on the age of the emergency generator and typical replacement schedule, we recommend replacing the emergency generator during the report period.

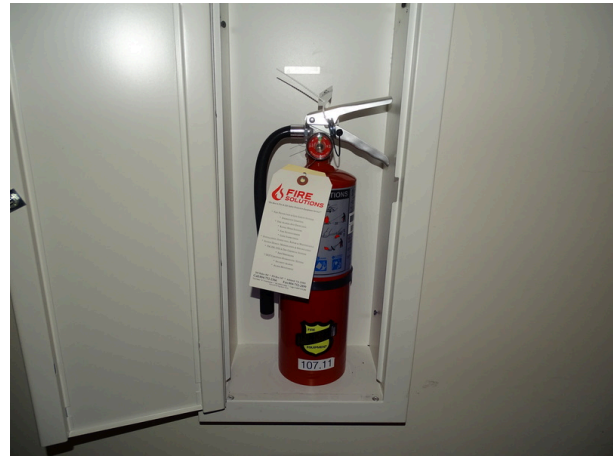
Fire extinguisher

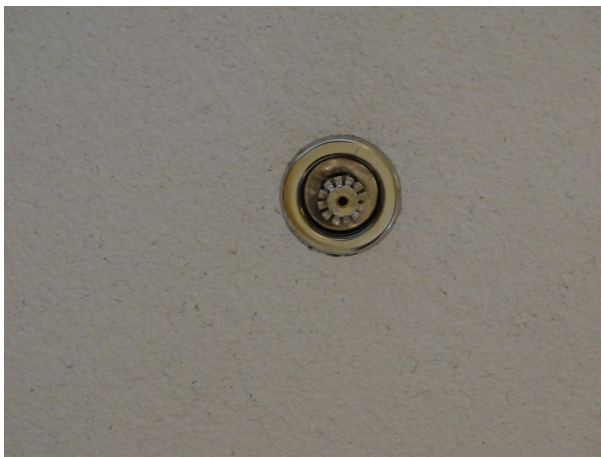
Typical sprinkler head

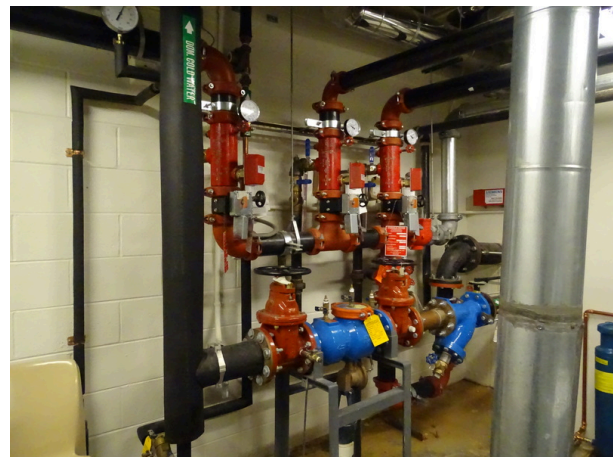
Sprinkler system

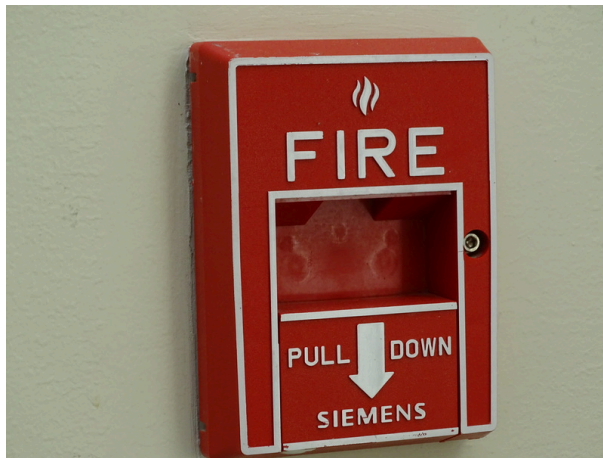
Typical fire alarm pull station

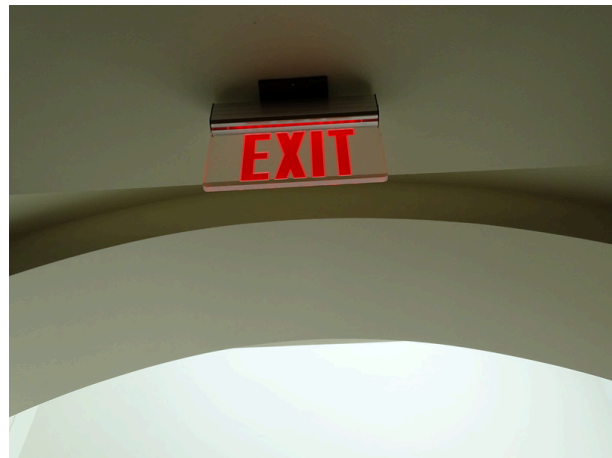
Typical exit sign

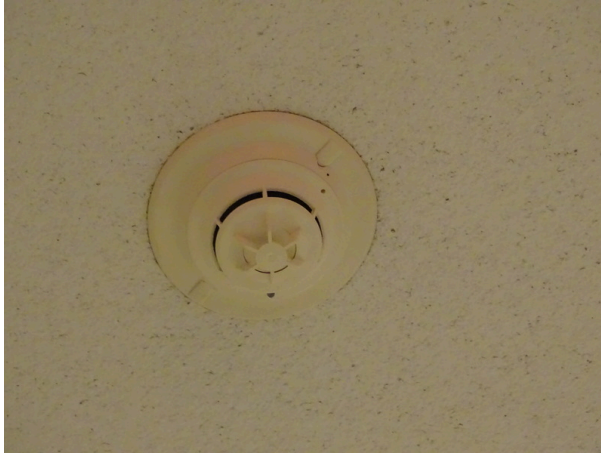
Typical smoke detector

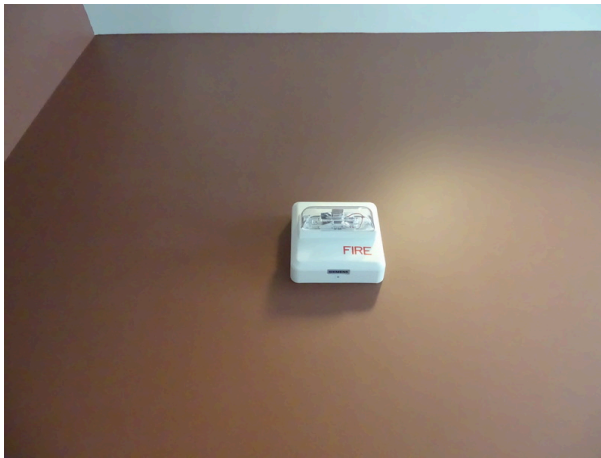
Typical fire alarm bell and strobe

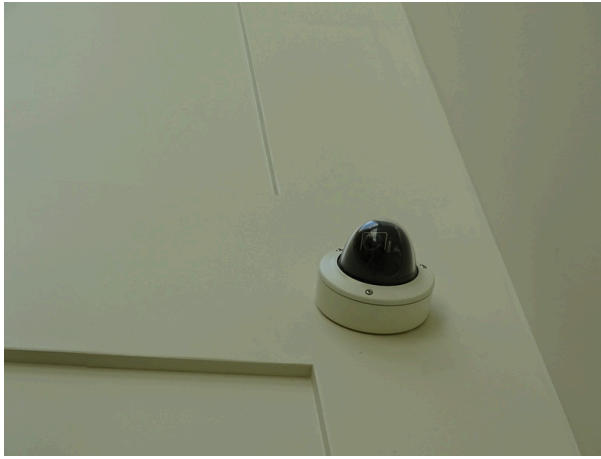
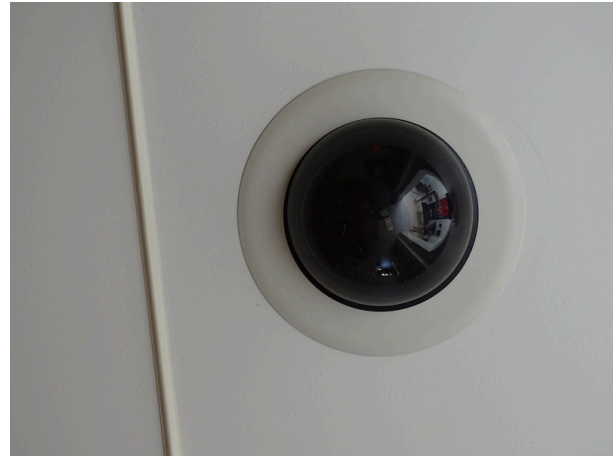
The building is monitored 24-hours a day by a computerized security system with cameras. Security cameras were observed at locations at the building interior and exterior. The security cameras reportedly black out intermittently. The resolution of the cameras was also grainy and coverage areas incomplete on the exterior. The replacement parts for the security system were reportedly limited in supply. The security system was generally in fair to poor condition. We recommend replacing the security system.

Typical security camera

Cost Recommendation	EUL	EFF AGE	RUL	Year	Cost
REPLACE SECURITY SYSTEM	20	19	1	1	\$100,000
Total					\$100,000

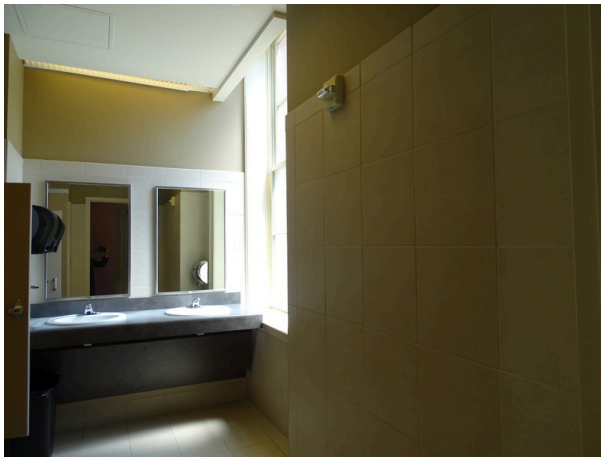
One restroom each for men and women is located on each floor. The finishes in the restrooms include ceramic tile floors and walls and painted gypsum board ceilings. The restrooms were observed to be in generally good condition.

Restroom interior area

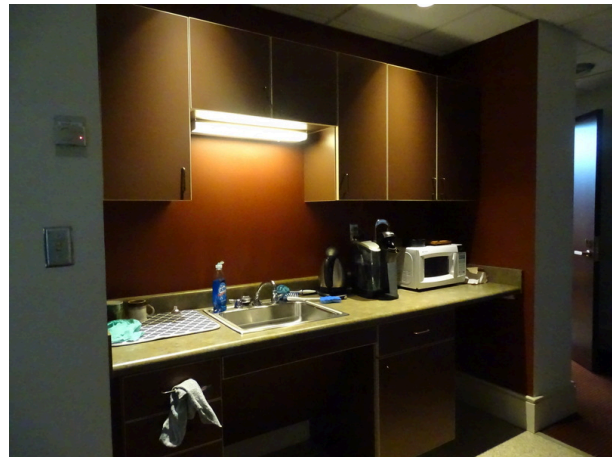
The finishes in the kitchens include vinyl tile floors, painted gypsum board walls, and acoustical tile ceilings. The finishes in the kitchens were observed to be in generally good condition.

Kitchen interior area

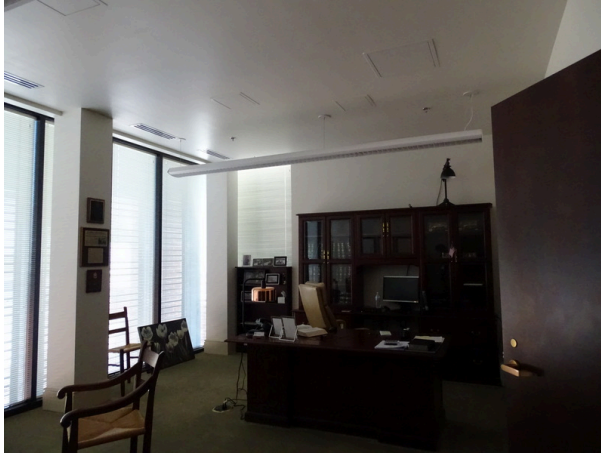
The office finishes include carpet floors, painted gypsum board walls and ceilings. The finishes in the offices were observed to be in generally good condition.

Typical office area

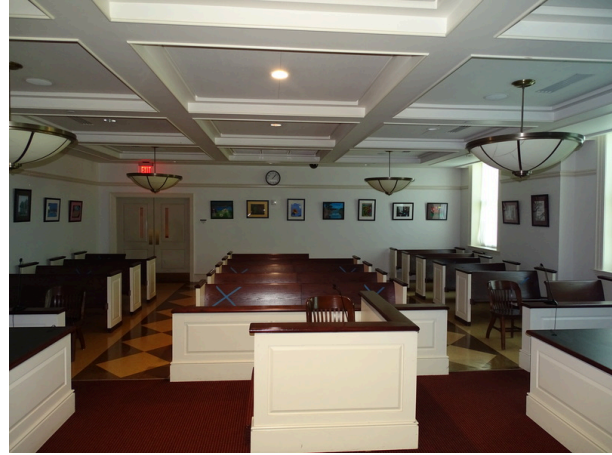
The courtroom finishes include carpet and tile floors and painted gypsum board walls and ceilings. The courtroom finishes were in good condition.

Courtroom interior area

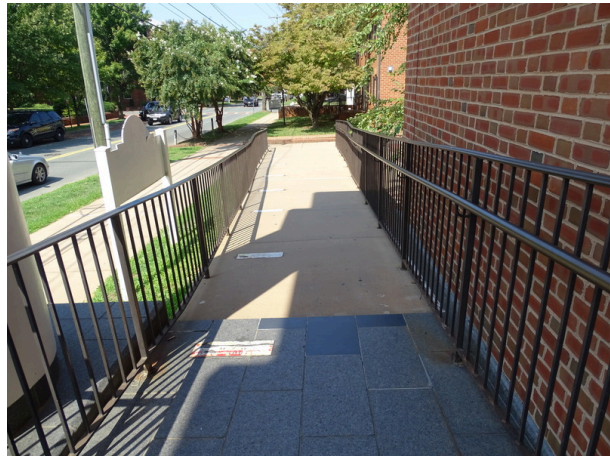
Accessible route with ramp at main entrance to courthouse

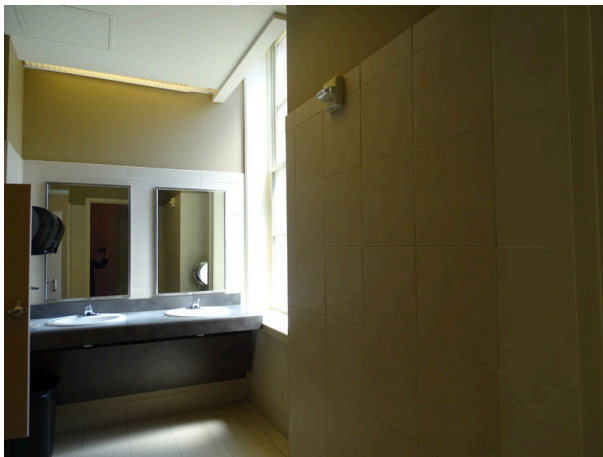
Restroom interior area

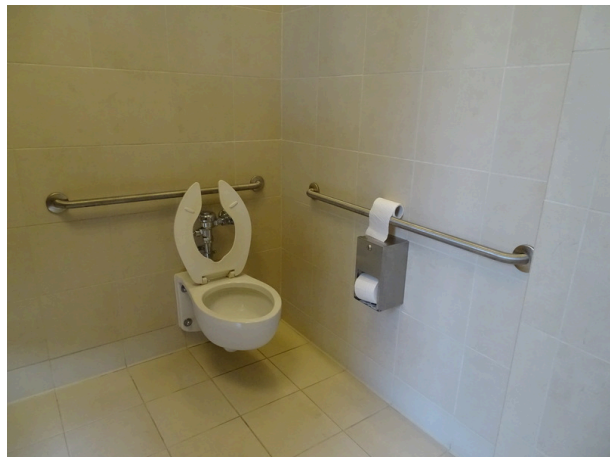
Restroom interior area

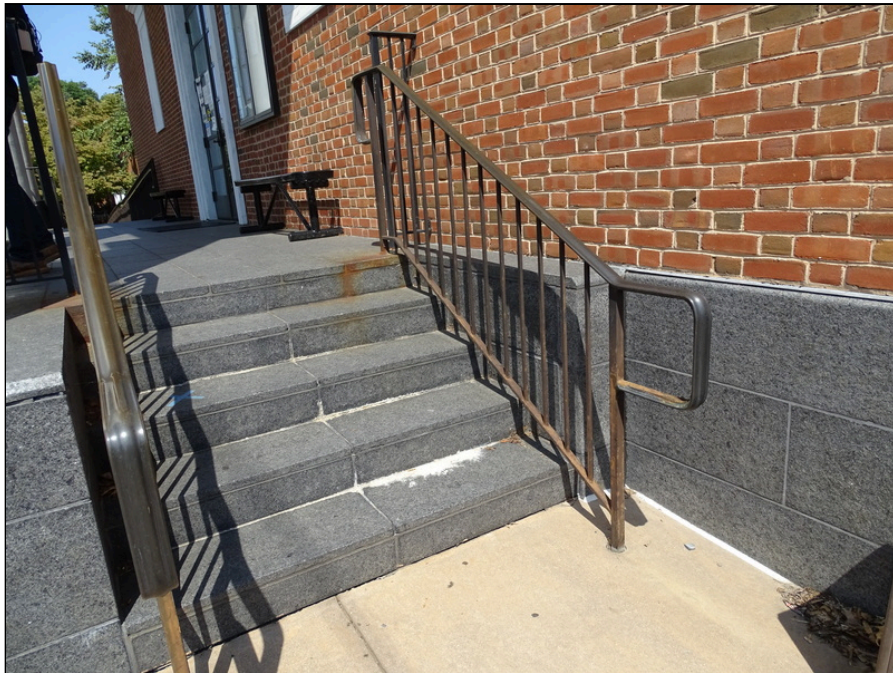
2 - Stairs at southeast side of the courthouse building

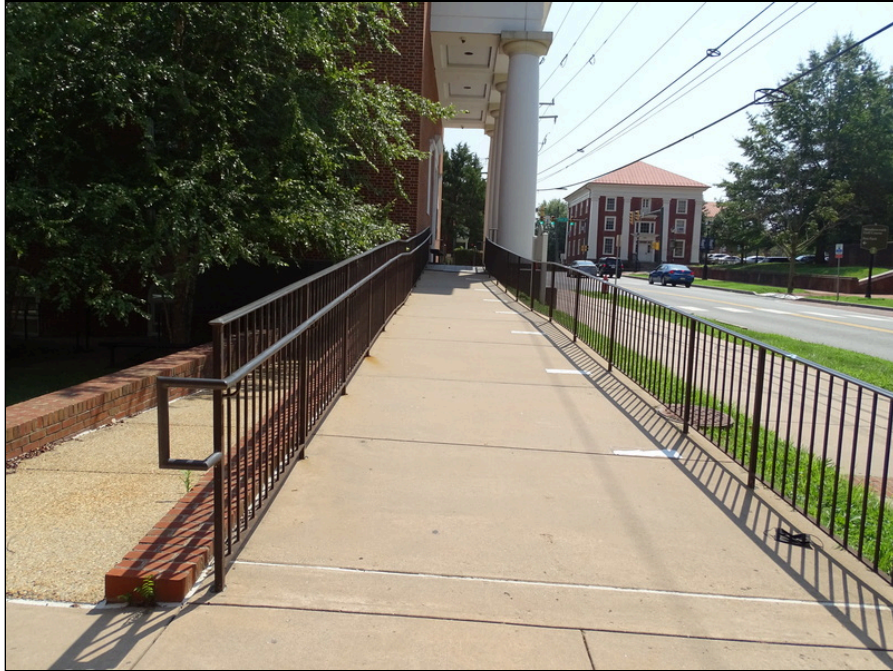
3 - Ramp at southwest side of courthouse building

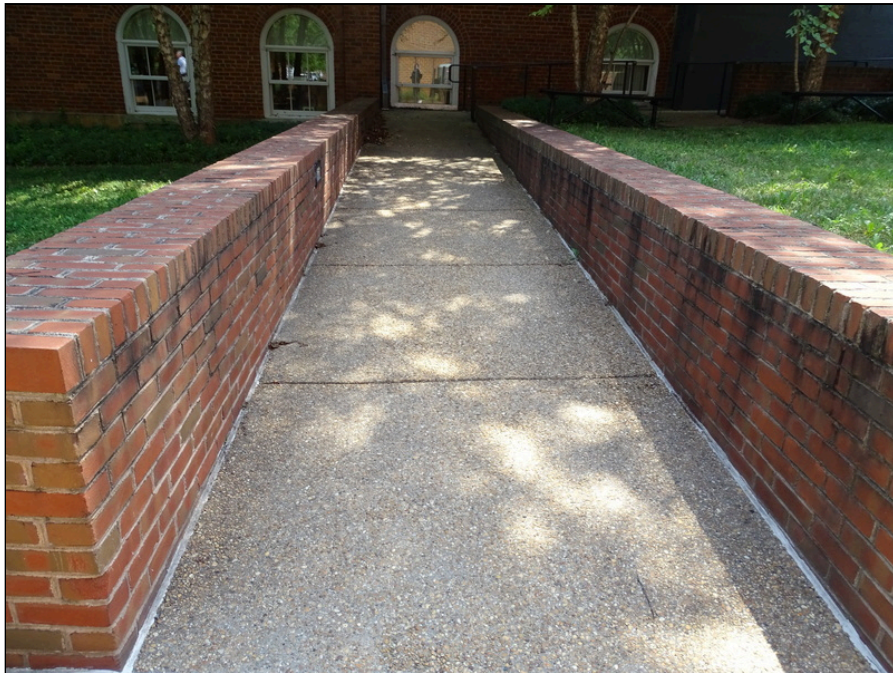
6 - Concrete ramp on the west side of property

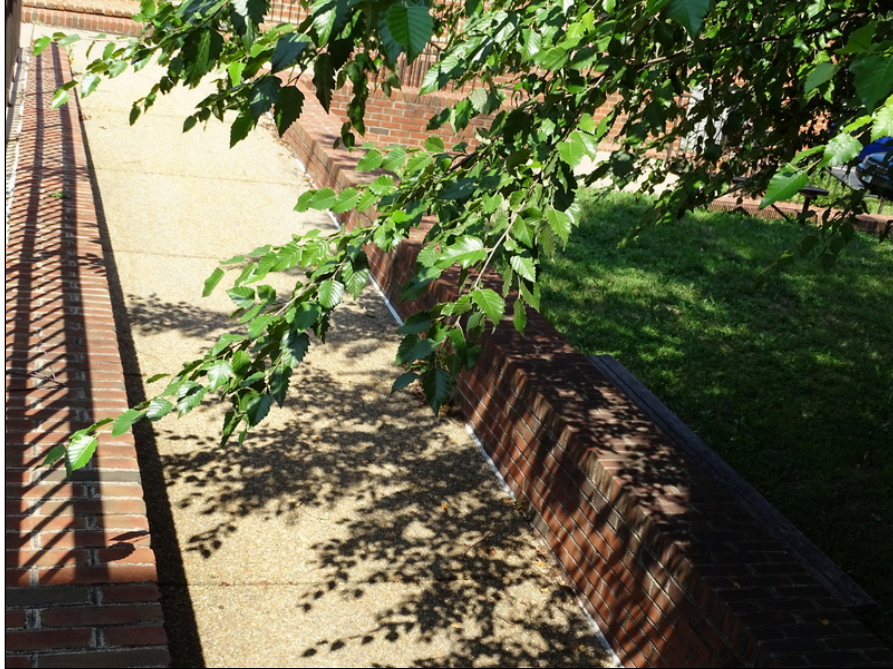
7 - Concrete ramp on the west side of property

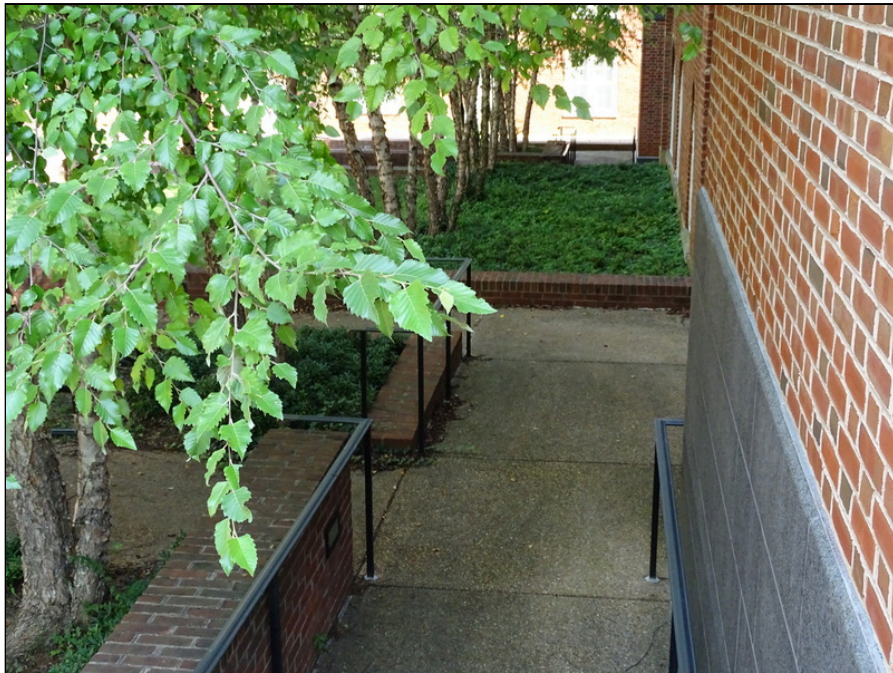
8 - Concrete walkways west side of the site

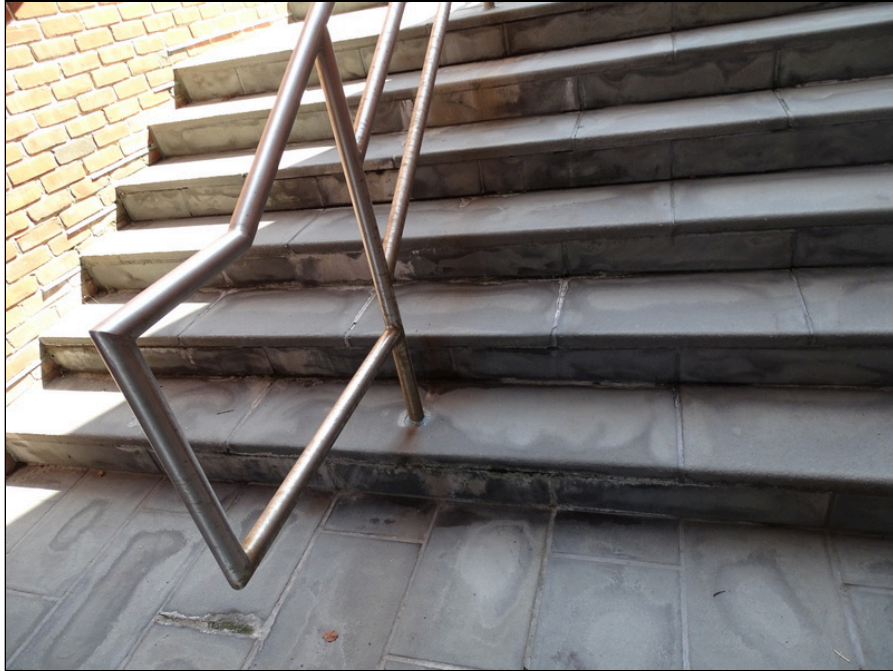
9 - Typical stair at north side of courthouse - note efflorescence

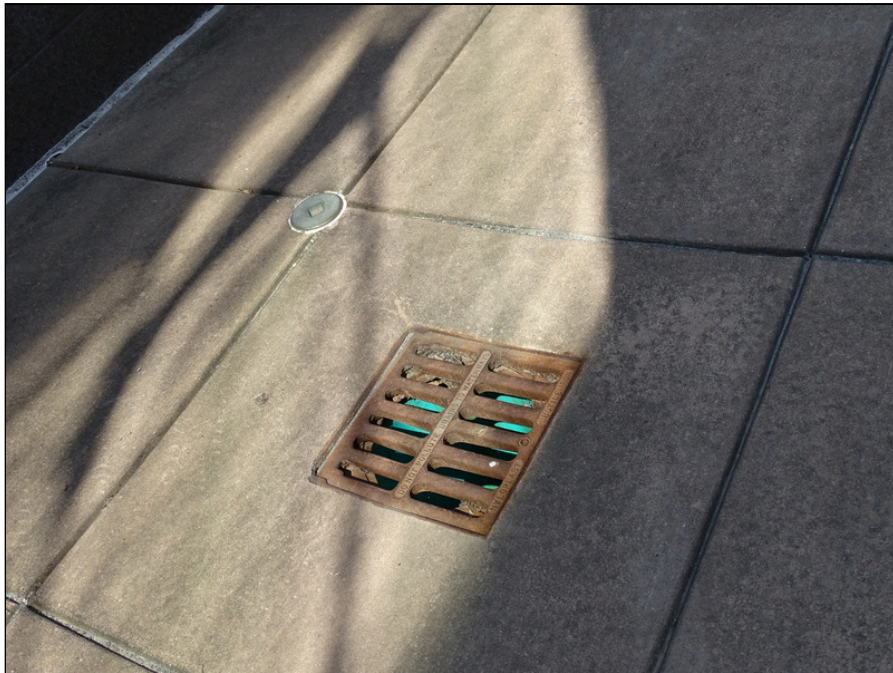
12 - Storm water yard inlet drainage

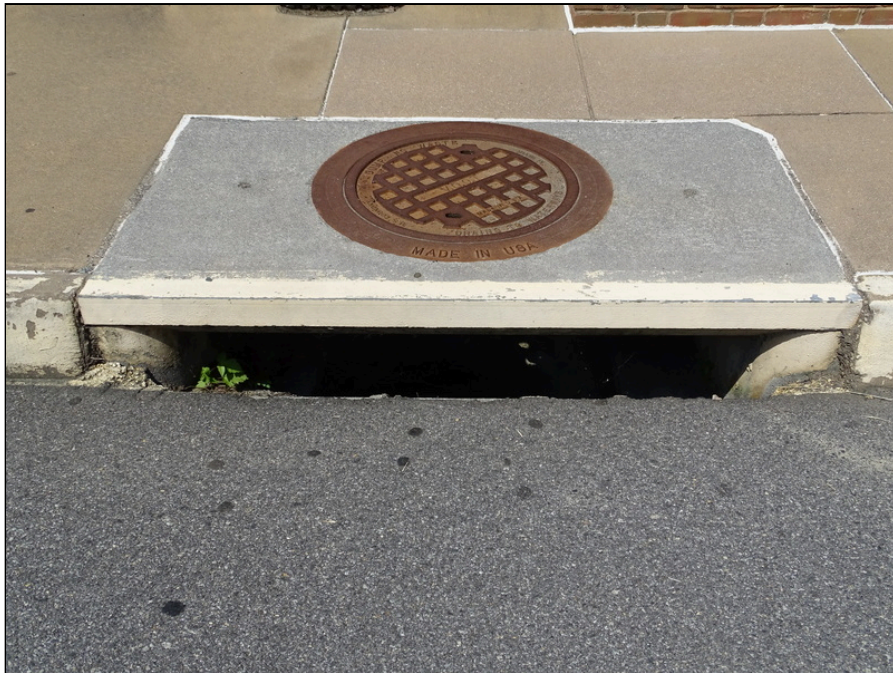
14 - Storm water drainage

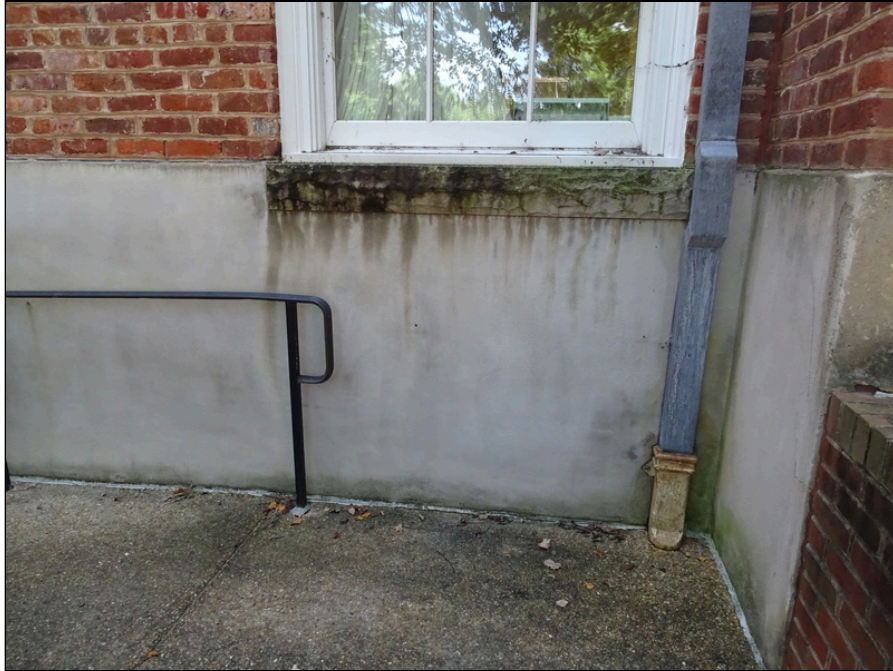
15 - Typical downspout and efflorescence in wall

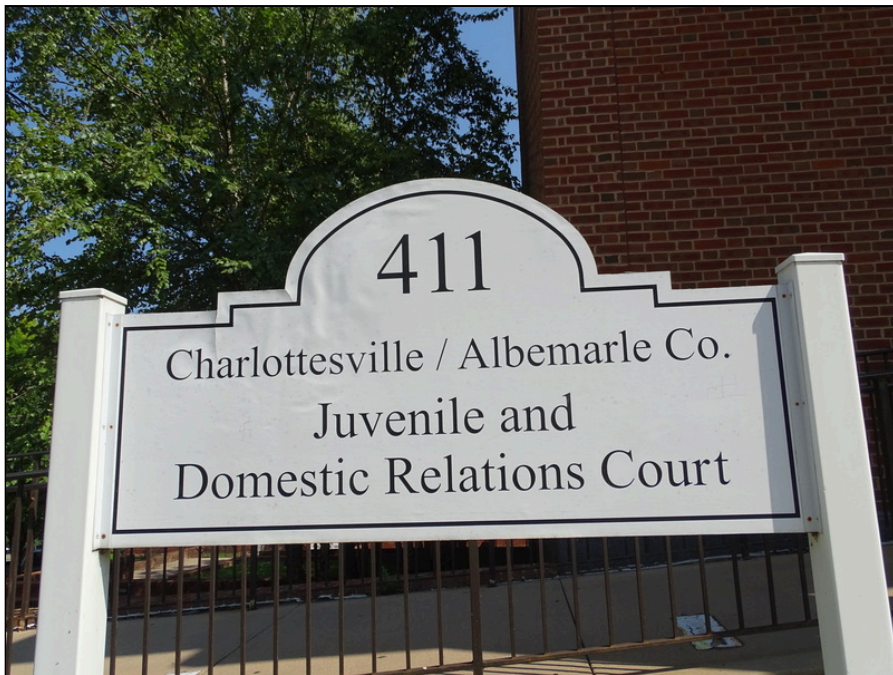
16 - Monumental sign

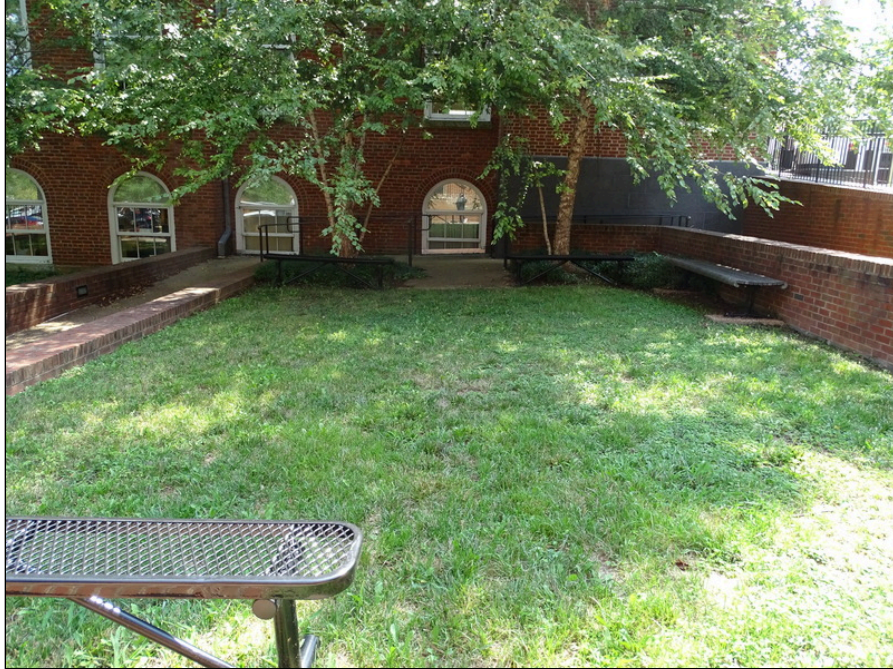
17 - Landscaping on west side of the site

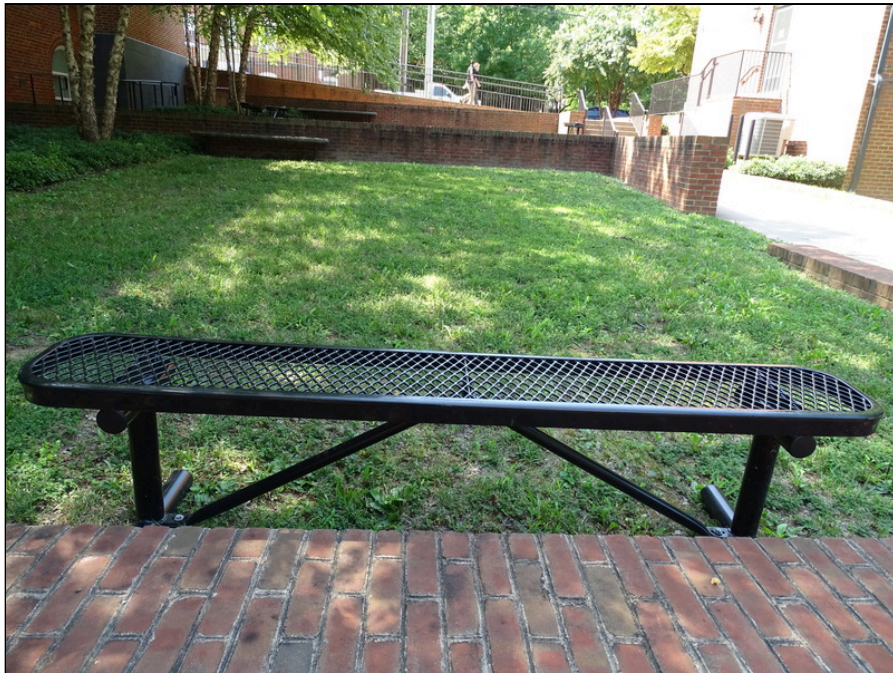
18 - Landscaping on west side of the site

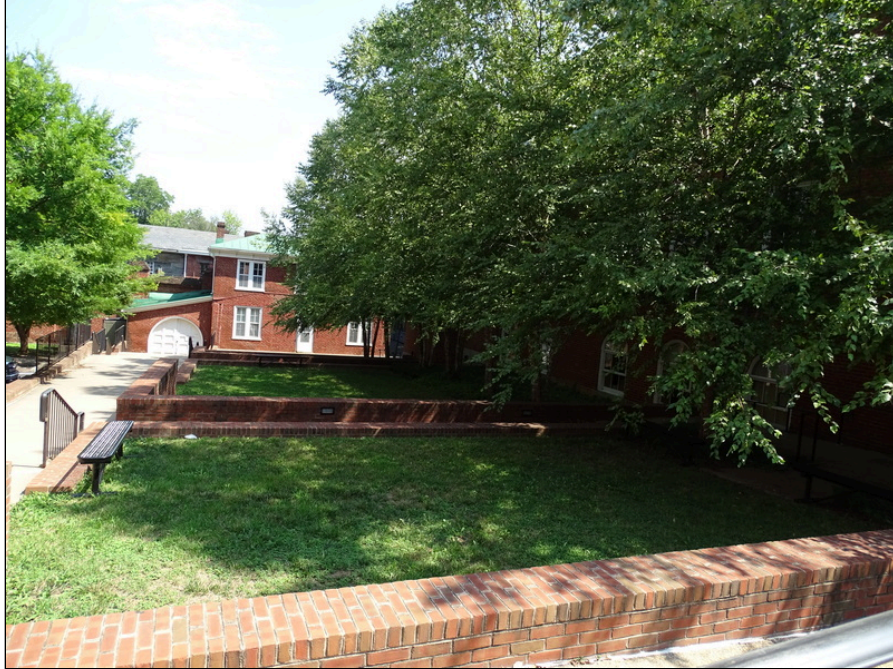
19 - Landscaping on west side of the site

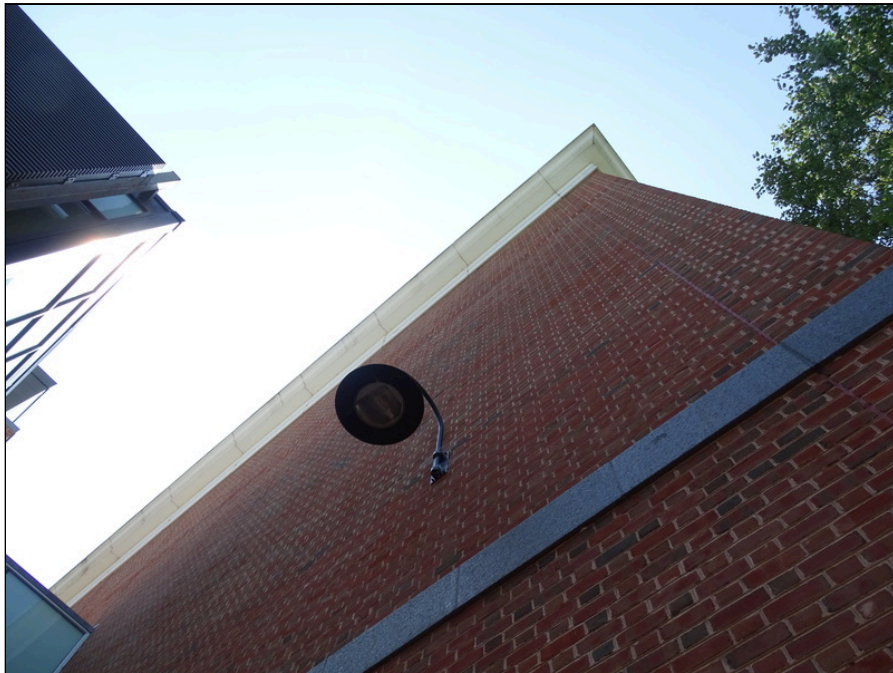
20 - Building mounted light fixtures

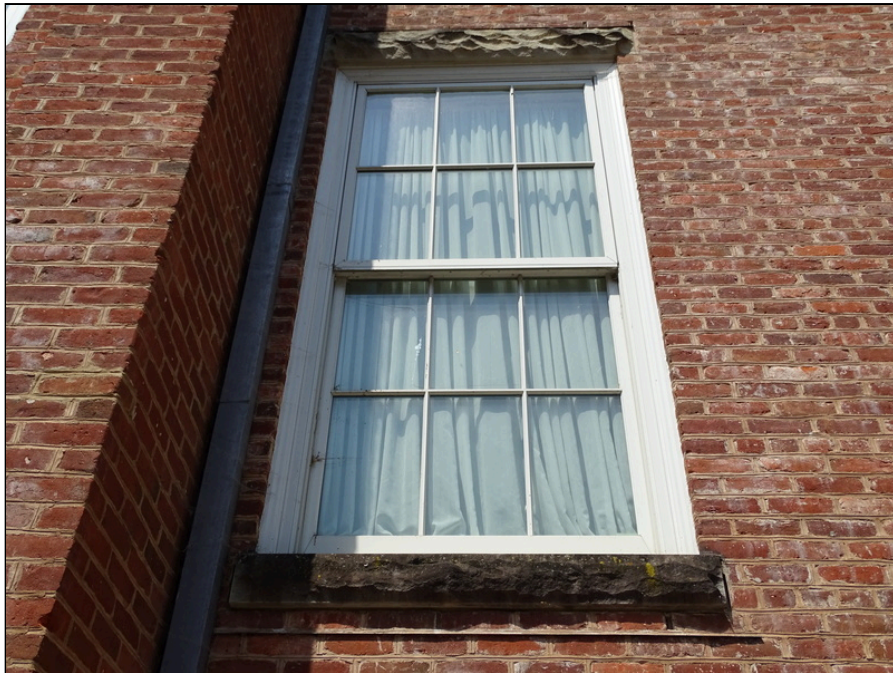
33 - Typical window at courthouse - note efflorescence

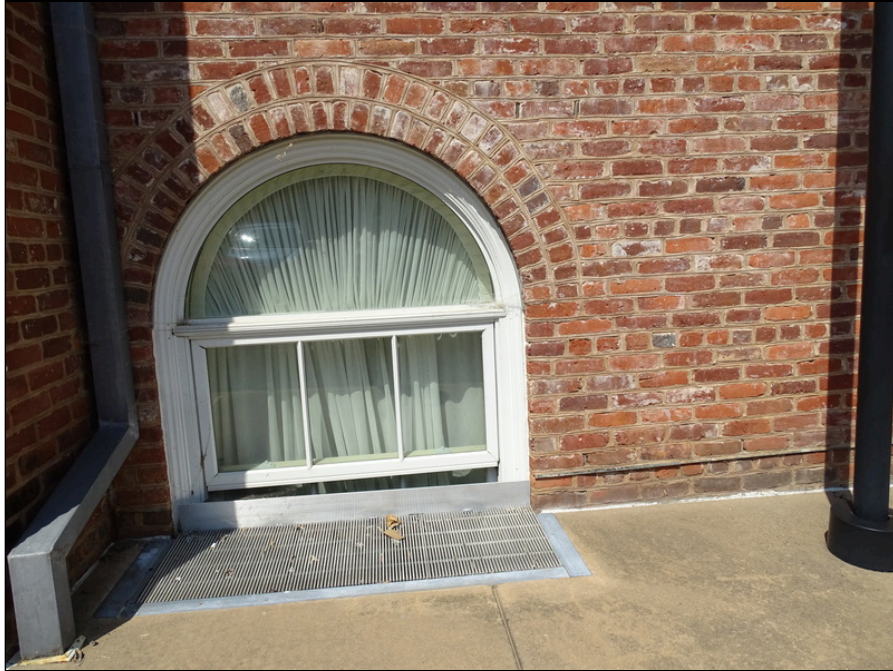
34 - Typical window at courthouse - note efflorescence

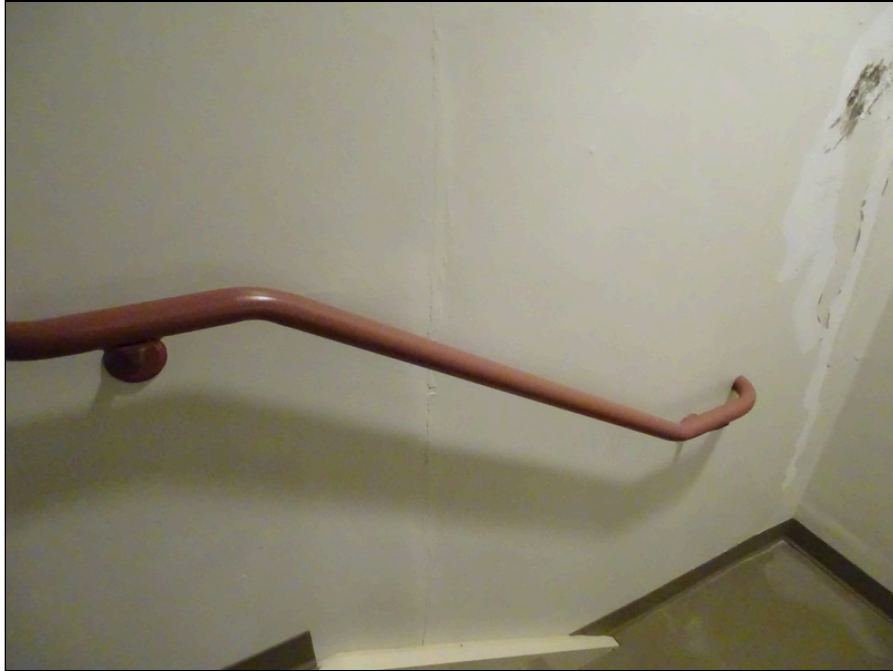
95 - Interior stair - note efflorescence

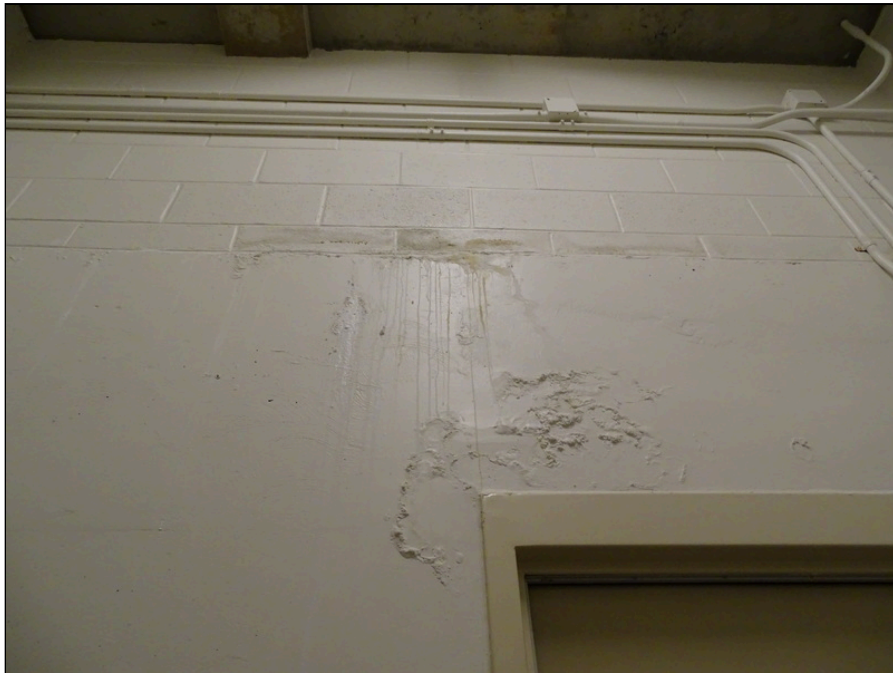
96 - Interior stair - note efflorescence

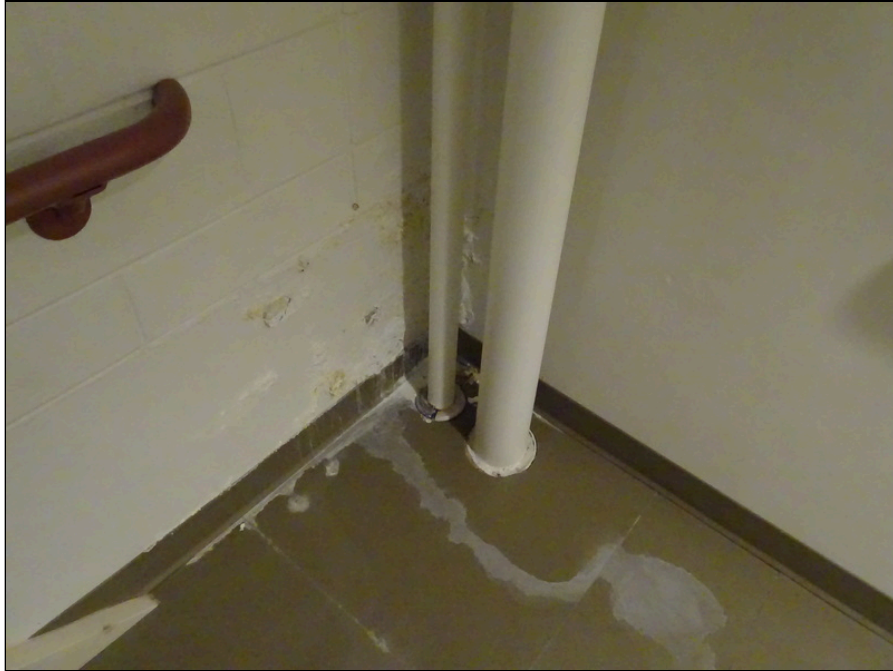
97 - Interior stair - note efflorescence

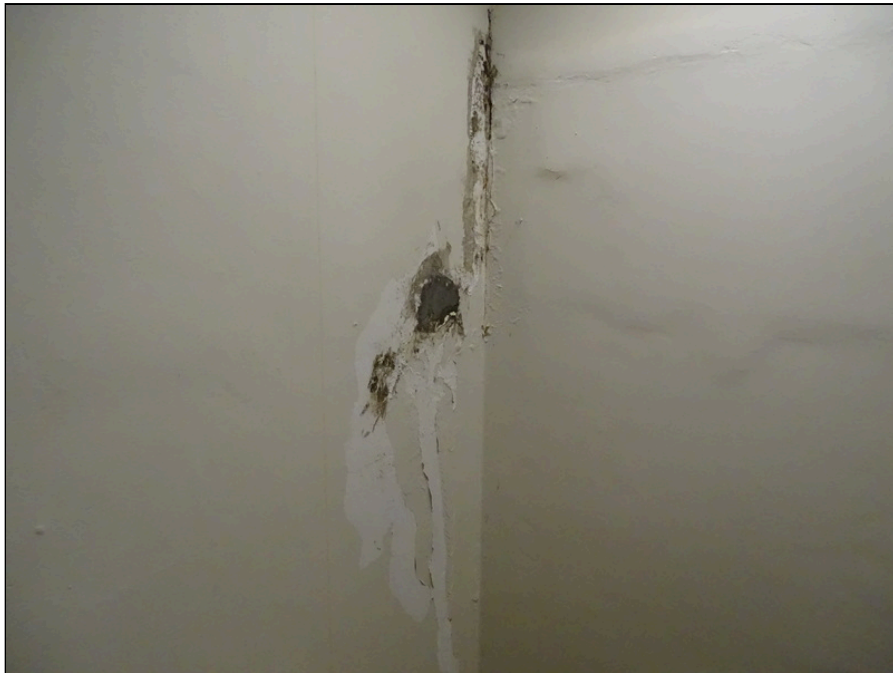
98 - Interior stair - note efflorescence
