JACKSON VIA ELEMENTARY SCHOOL
508 HARRIS ROAD
CHARLOTTESVILLE, VIRGINIA

ECS PROJECT NO. 46:6713

CITY OF CHARLOTTESVILLE - FACILITIES DEVELOPMENT

Reference: Facility Condition Assessment Report for Jackson Via Elementary School, 508 Harris Road,
Charlottesville, Virginia

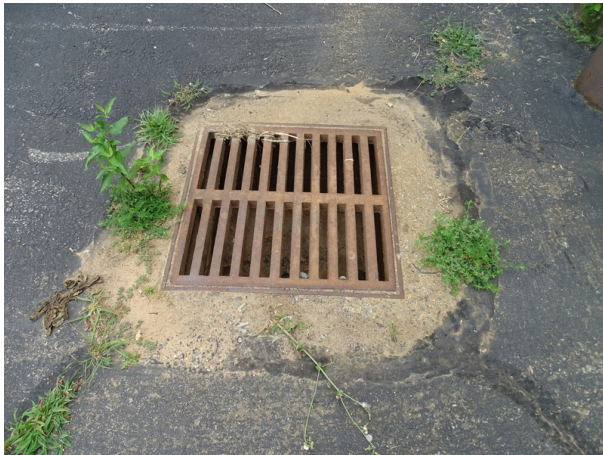
Typical storm drainage

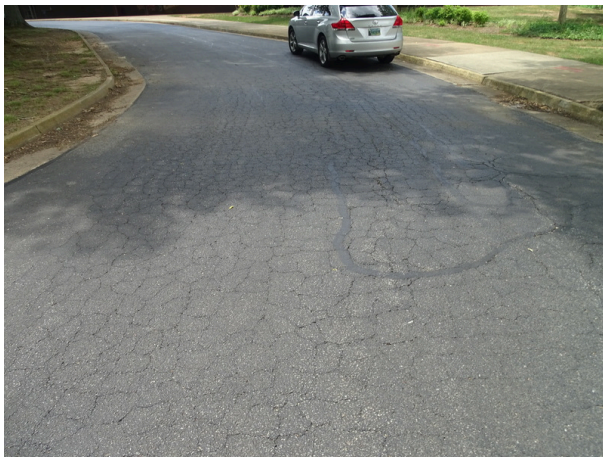
Asphalt drive lane entrance - note cracking

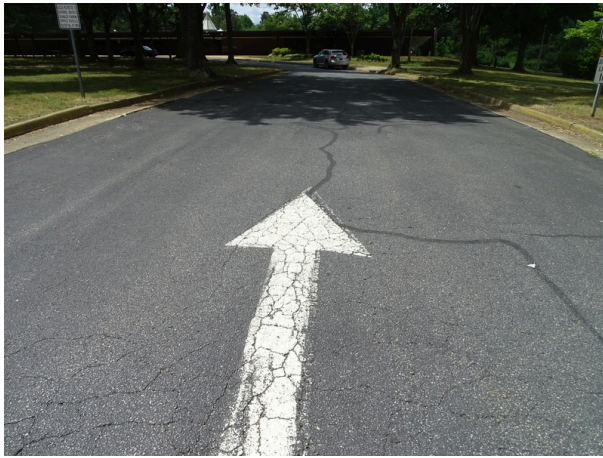
Asphalt drive lane west side of the site

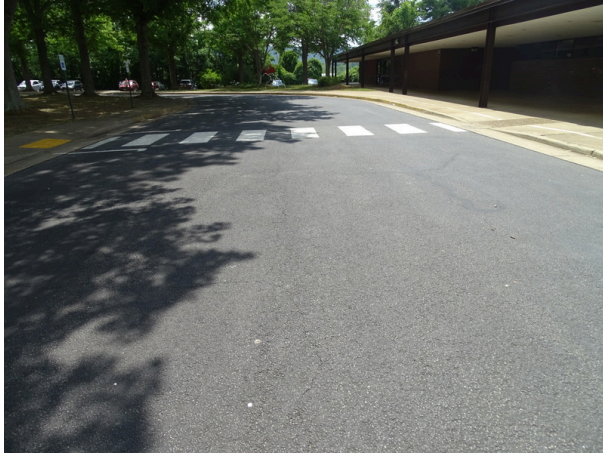
Asphalt-paved drive lanes and parking areas are located on the north and south side of the site which also provides access to the site. Additional parking is provided along the southern drive lane. The asphalt pavement was observed to be in generally fair condition with alligator cracks observed on the pavement. Striping was in fair condition. The expected useful life of asphalt pavement is 20 years. We have provided allowances to repair the cracked areas of asphalt pavement.

Asphalt drive lane - note cracking

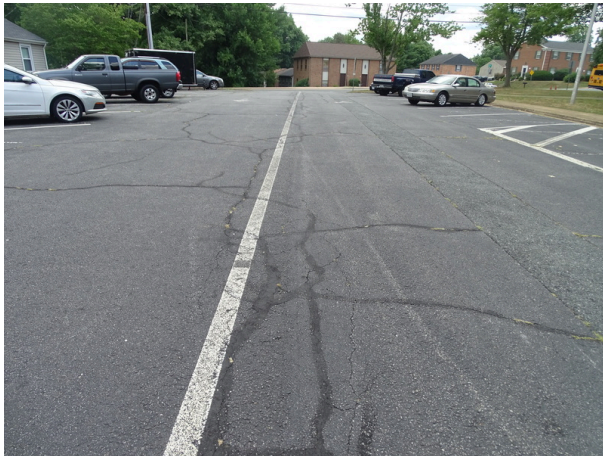
Asphalt drive lane east side of the site - note
cracking and previous repair

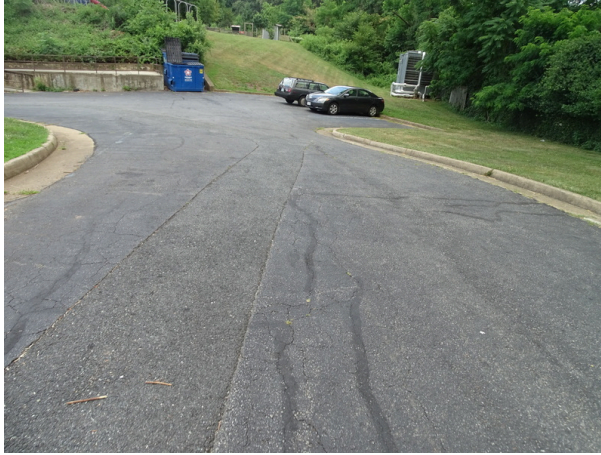
Asphalt parking east side of site

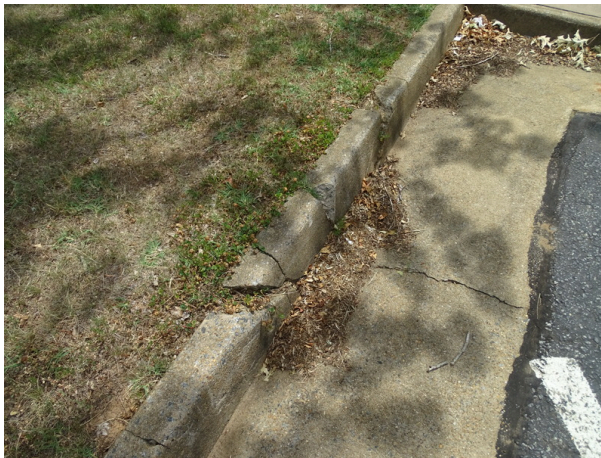
Concrete curb and gutter- note deterioration

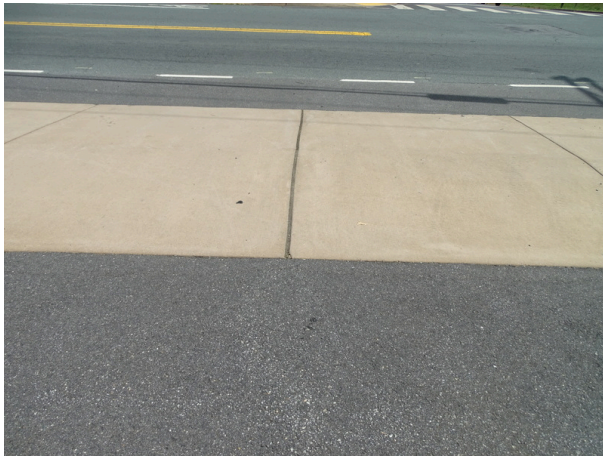
Concrete apron and asphalt drive lane west side
of the site

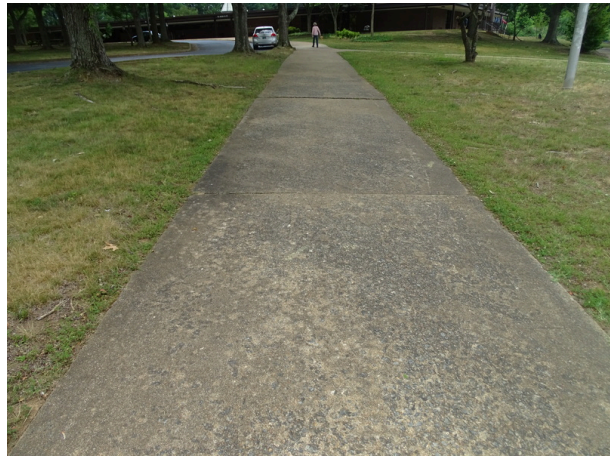
Concrete sidewalk

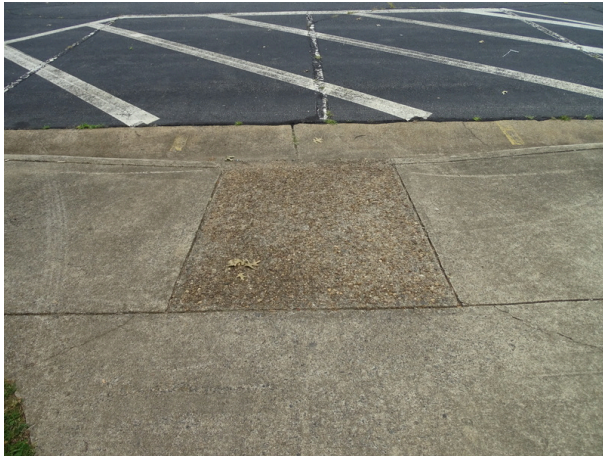
Concrete ramp - note need to install truncated
domes

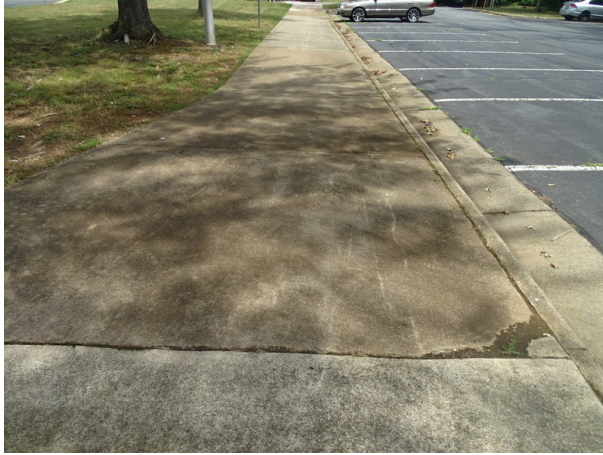
Concrete sidewalk - note cracking

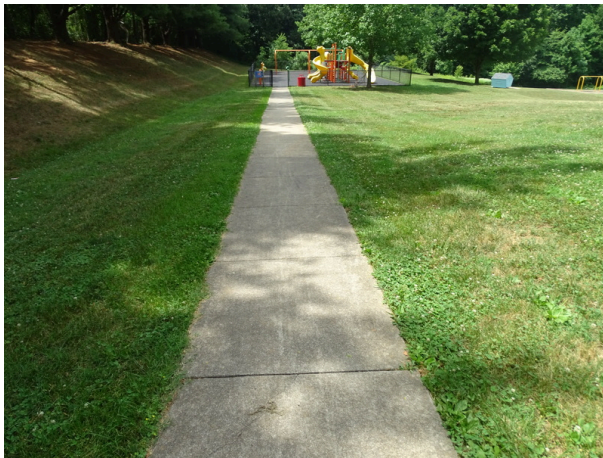
Concrete sidewalk - note cracking

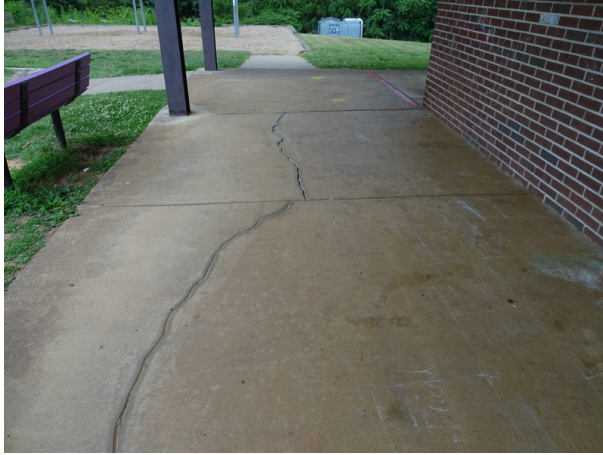
Concrete sidewalk - note cracking

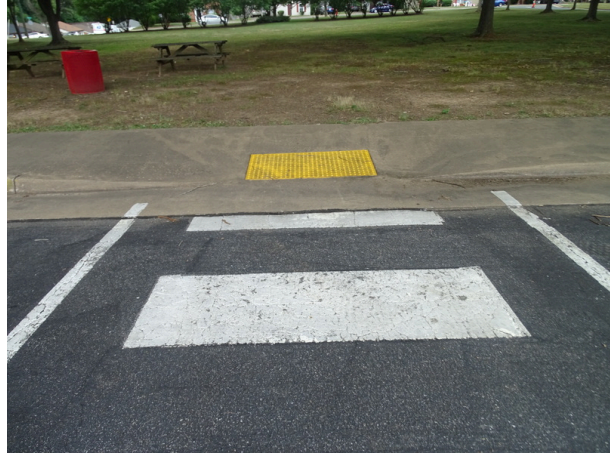
Concrete sidewalk and ramp

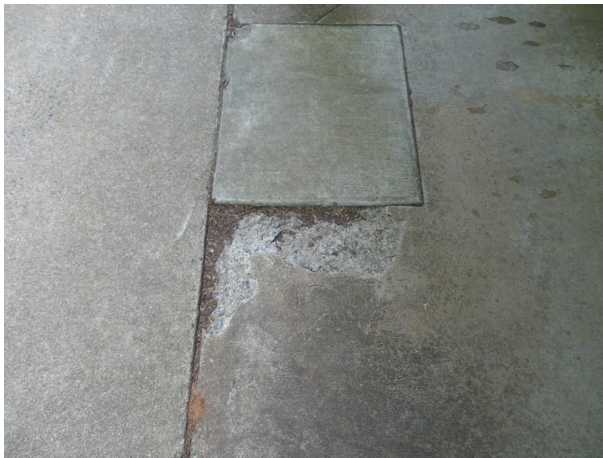
Concrete sidewalk - note deterioration

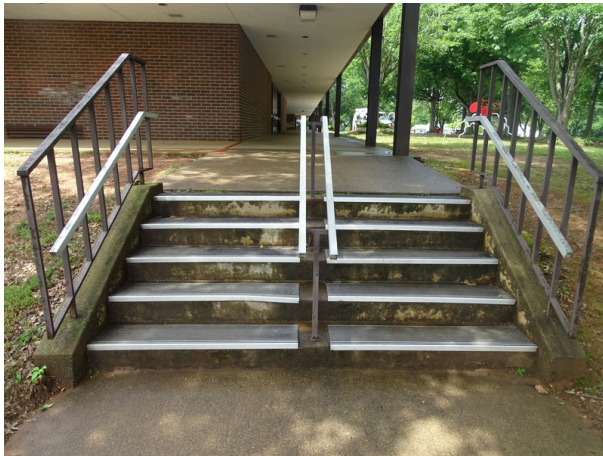
Concrete stair - note stained

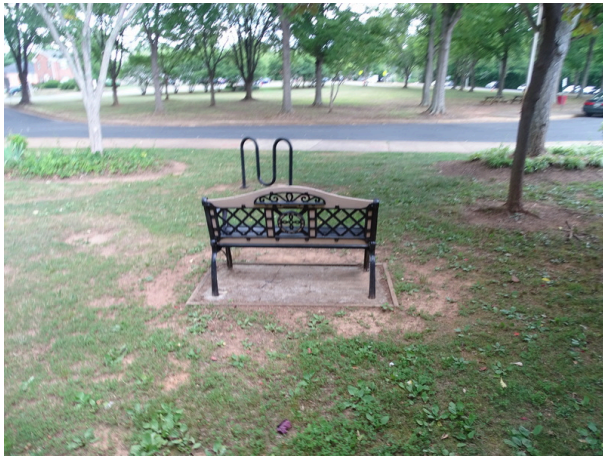
Typical landscape and setting area

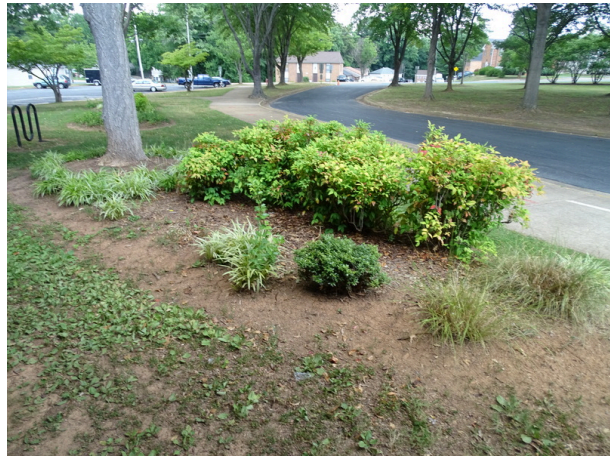
Typical landscape

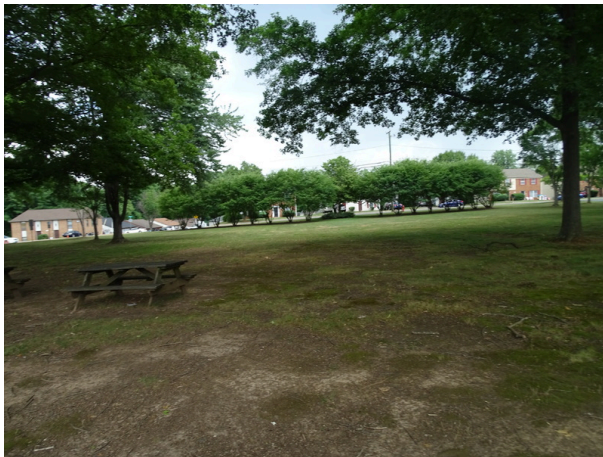
Typical lawn area

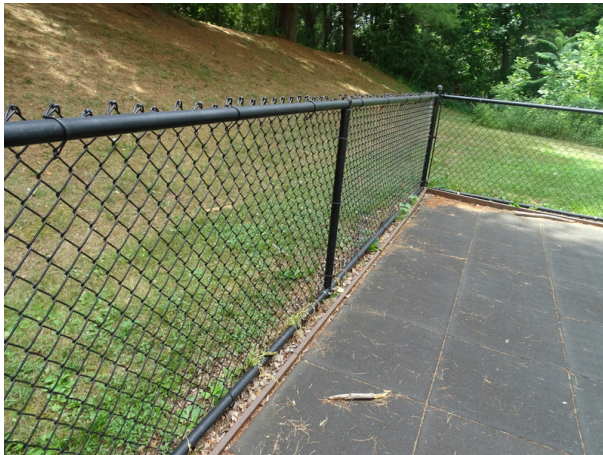
Typical fencing overview

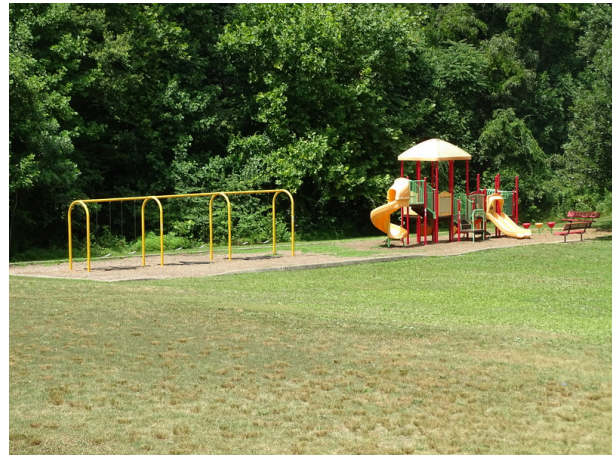
Playground south end of the site

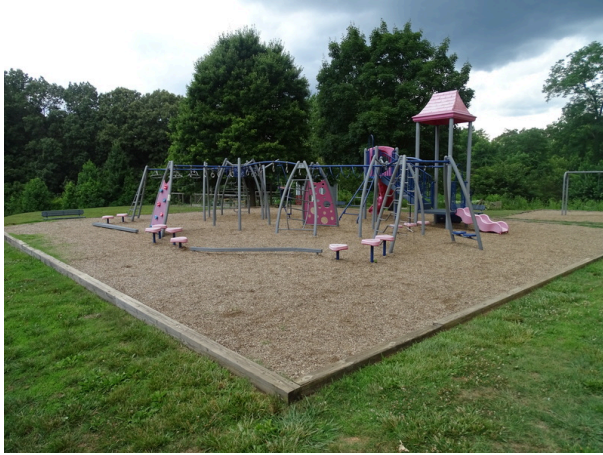
Playground southwest end of the site

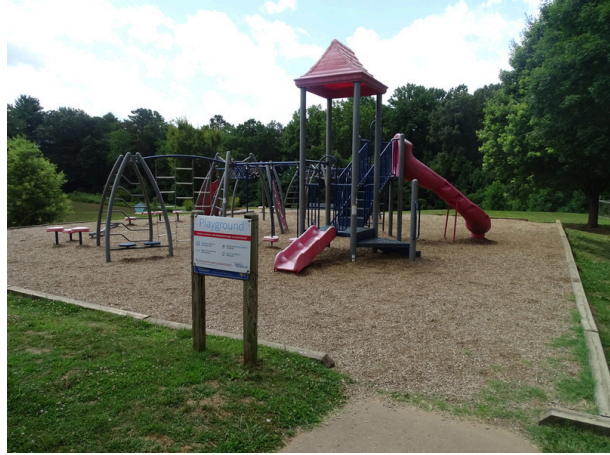
Playground overview

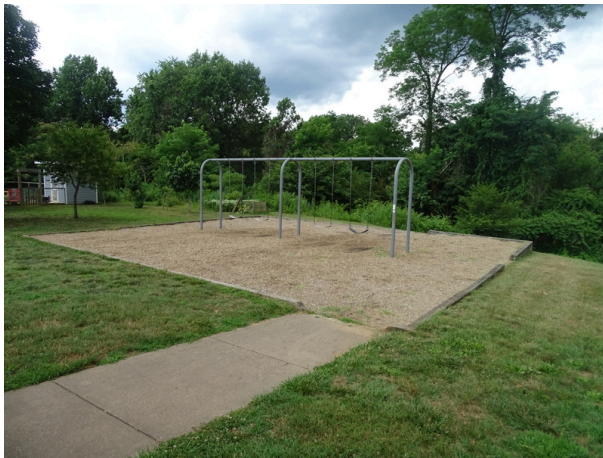
Playground overview

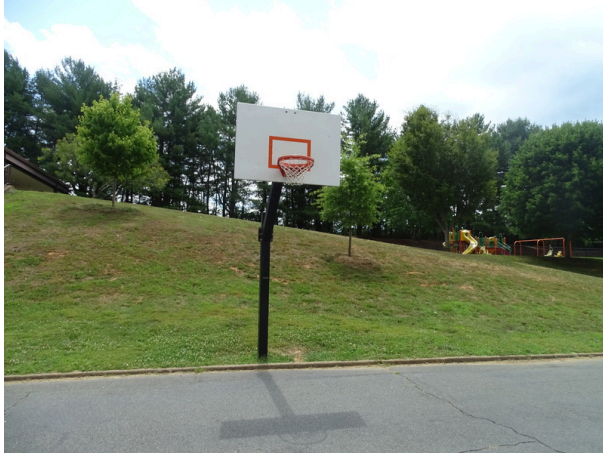
Basketball court south of the building

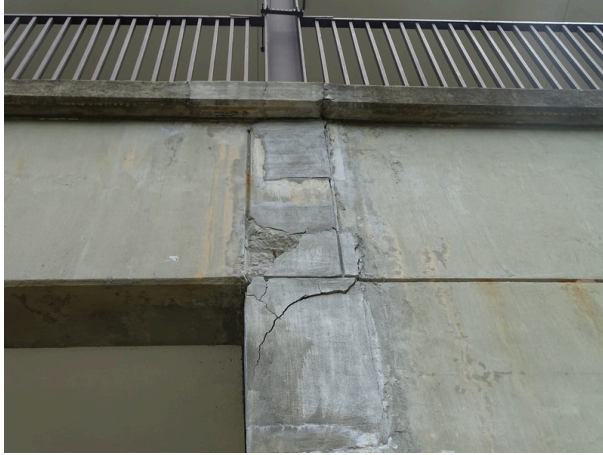
The structure of the building consists of Structural steel with concrete elevated slabs. The structural frame of the building was generally in fair condition. On the south side of the structure, major cracking and signs of previous patching were apparent on the concrete supports for steel columns above. We recommend a professional structural evaluation of the existing conditions be performed in the immediate future. This service can be provided by ECS.

Building exterior - note column cracking

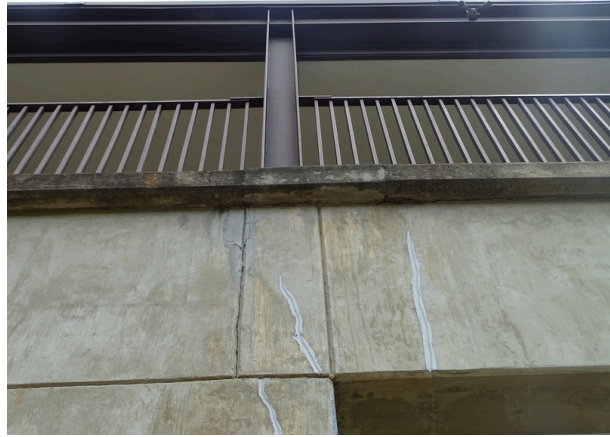
Building exterior - note stained and sealant repair

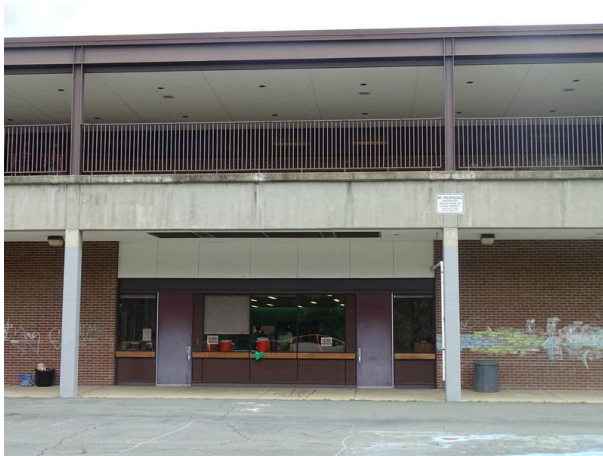
Building exterior - note staining in the parapet

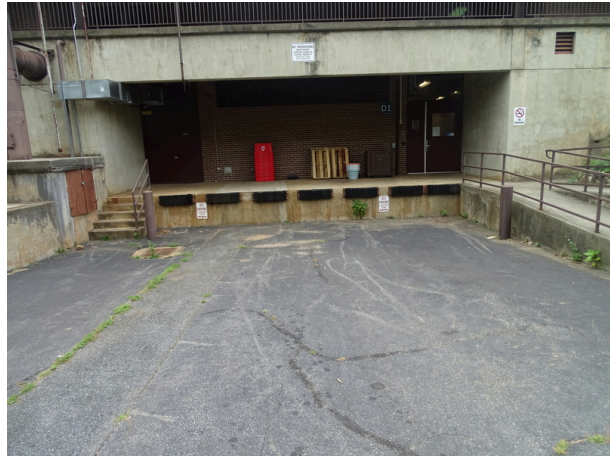
Building exterior west side of the building

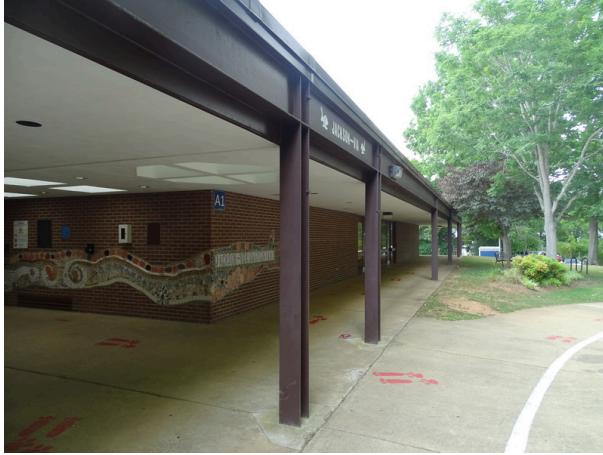
Building exterior

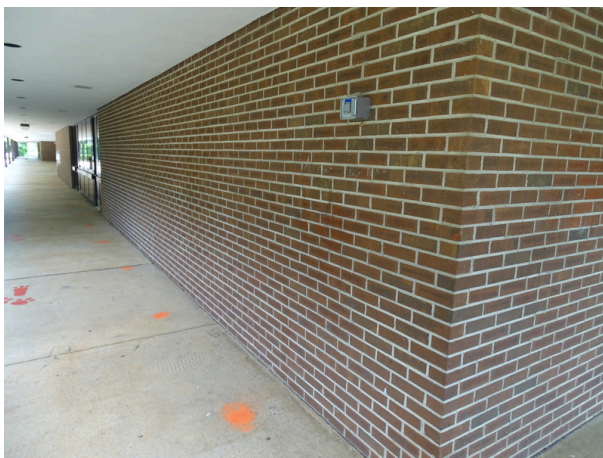
Building exteriors

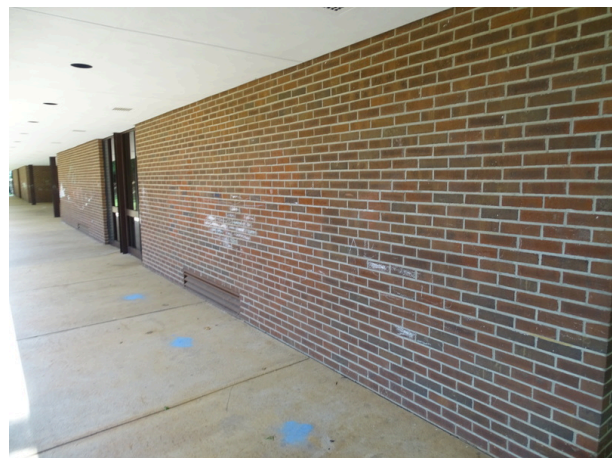
Building exterior southwest side of the building

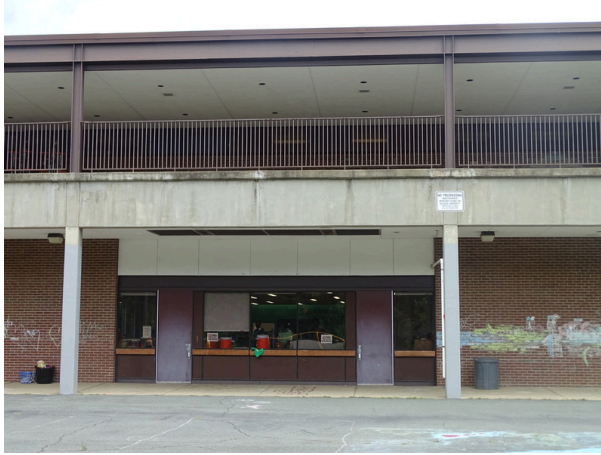
Building exterior - note staining in the parapet

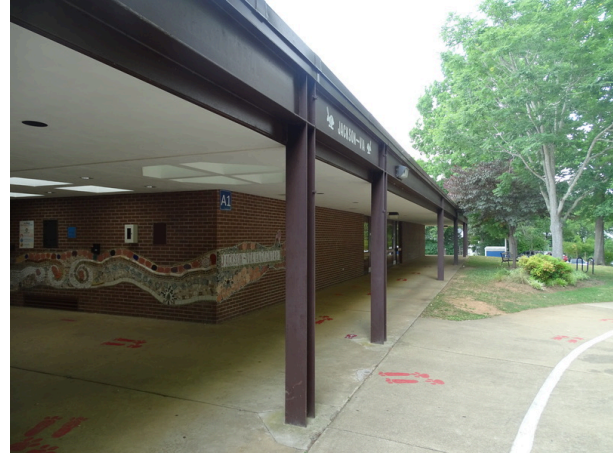
Building exterior

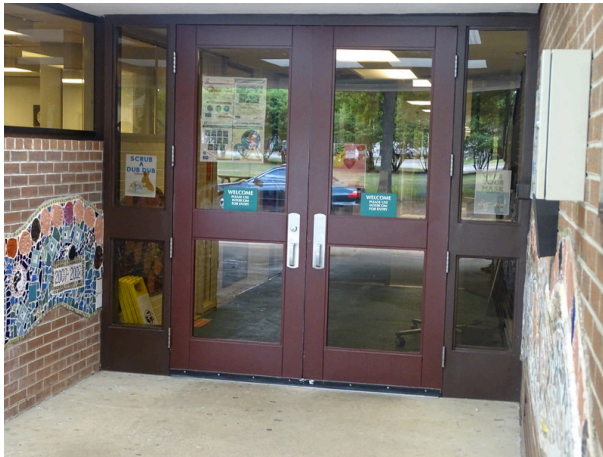
Main entrance doors

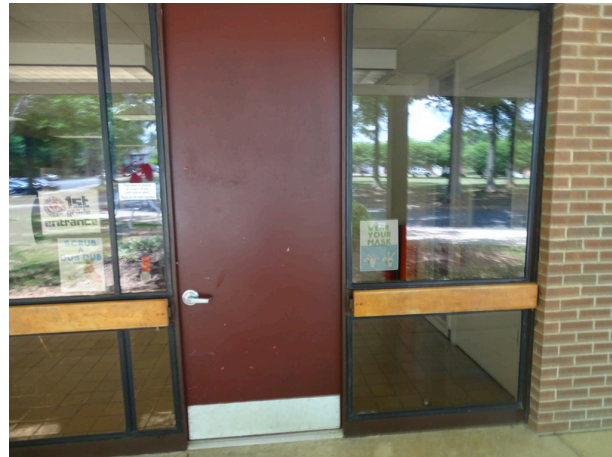
Typical personnel door

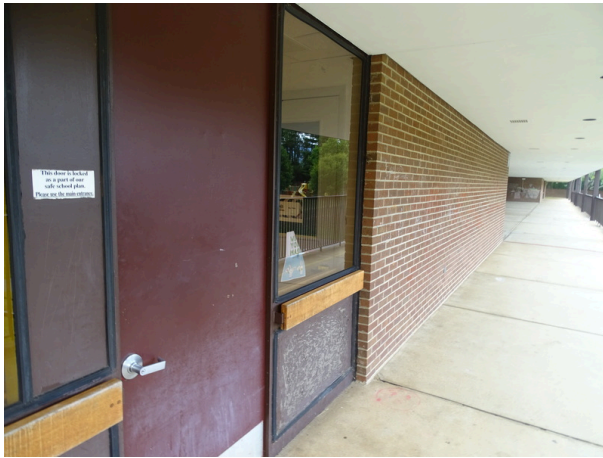
Metal frame single-pane windows have a typical expected useful life of 25 years. Replacement of windows has been included in the study period.

Older exterior window unit

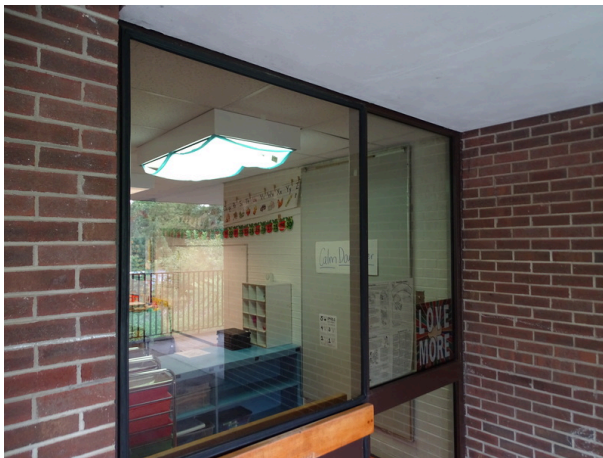
Typical exterior window

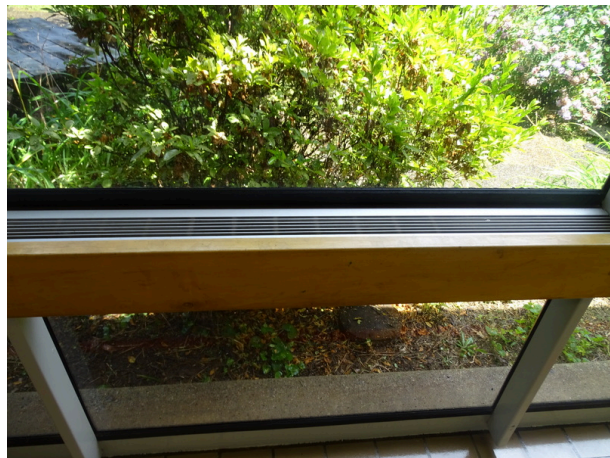
Older exterior window unit

Cost Recommendation	EUL	EFF AGE	RUL	Year	Cost
REPLACE WINDOW UNITS	20	19	1	1	\$50,000
				2	\$50,000
Total					\$100,000

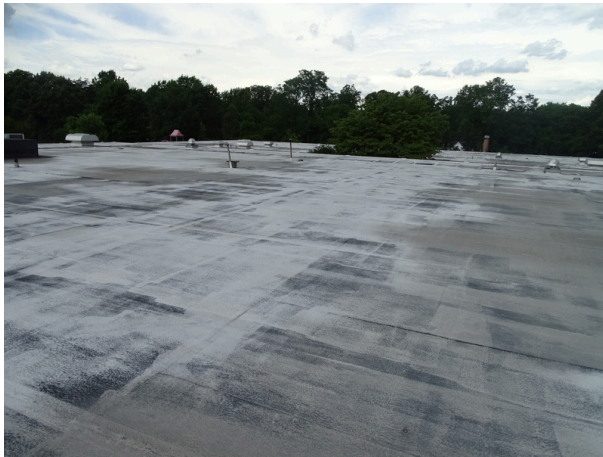
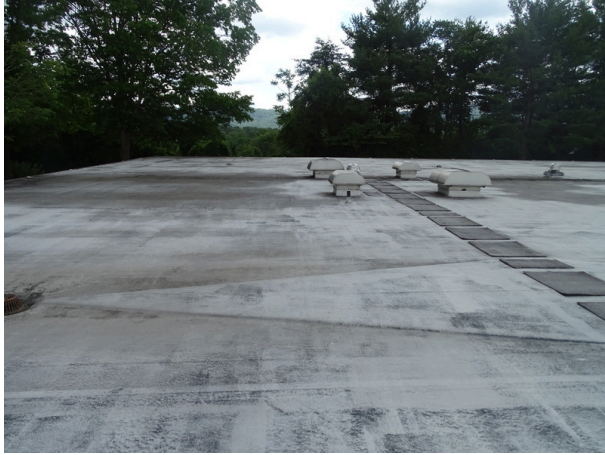
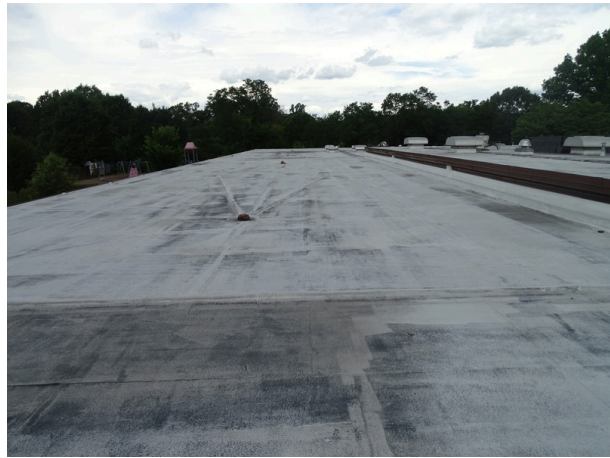
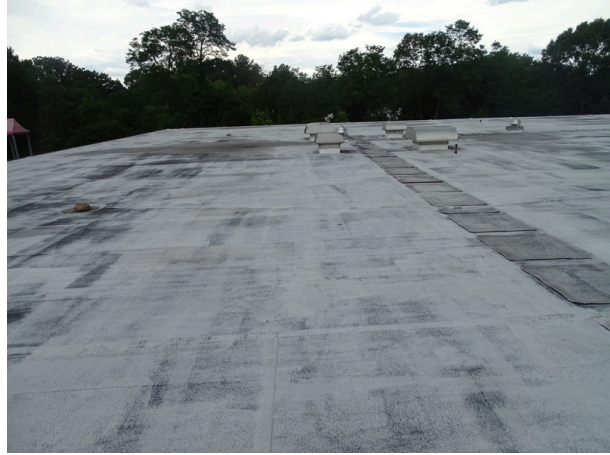
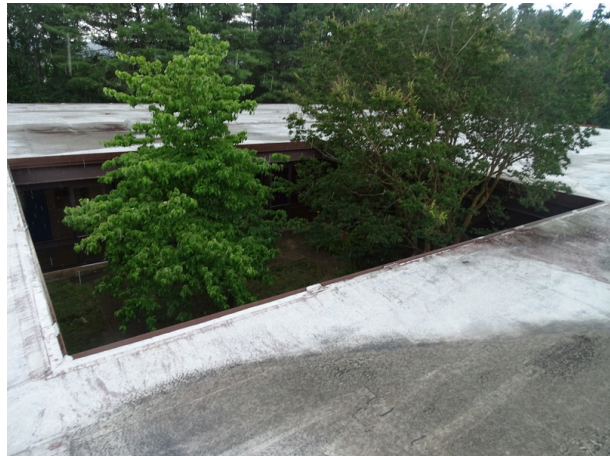
The main roofing system consists of a single-ply roofing system. The roofing system was reportedly replaced in 1999 and some leaks were reported. The expected useful life of a sheet membrane roofing system is typically 15 years. We recommend replacing the roofing system during the report period.

Single-ply membrane roofing system

Cost Recommendation	EUL	EFF AGE	RUL	Year	Cost
REPLACE SINGLE-PLY ROOFING SYSTEM	15	15	0	1	\$770,000
REPLACE SKYLIGHTS AS NEEDED	20	19	1	1	\$10,000
Total					\$780,000

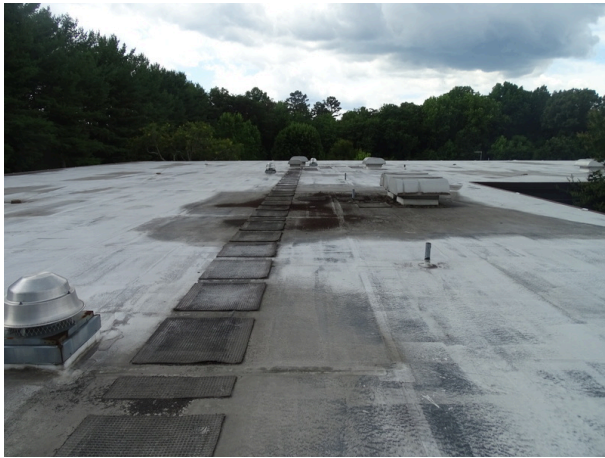
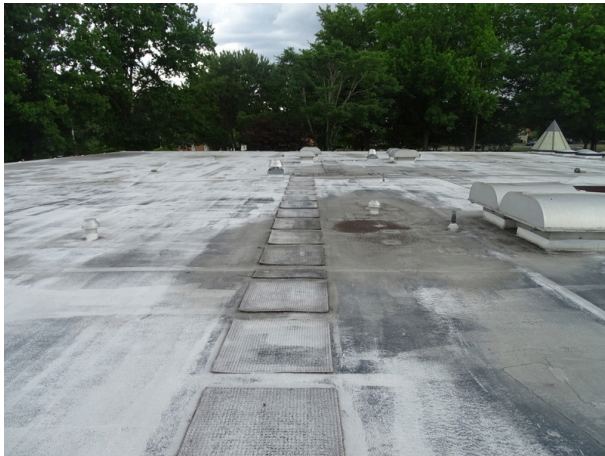
ROOFING		
Item	Description	Condition
Single-Ply Sheet Membrane	Patching and ponding observed	Poor
Slate Shingle		N/A
Parapet Walls		N/A
Cap Flashing/Coping	Metal coping	Fair
Insulation	Rigid	Good
Substrate/Deck	Metal decking	Good
Slope/Pitch	Ponding noted	Fair
Drainage	Internal drains	Good
Plumbing Vents	Clamped boots	Good
Exhaust Vents	Counter flashed	Good
Equipment Curbs	Counter flashed	Good
Pitch Pockets		N/A
Skylights	Located on north side of the building	Poor
Flashing	Metal	Good
Expansion Joints	Flush bellows	Good
Roof Age	Reportedly replaced in 1999	Poor
Warranty		N/A

Single-ply membrane roofing system looking
west - note ponding

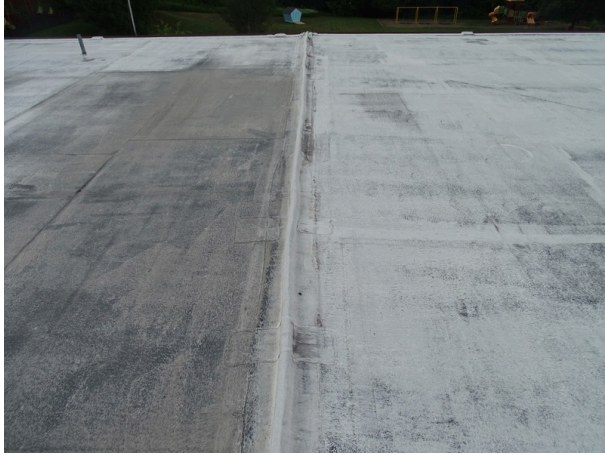
Single-ply membrane roofing system - note
patching

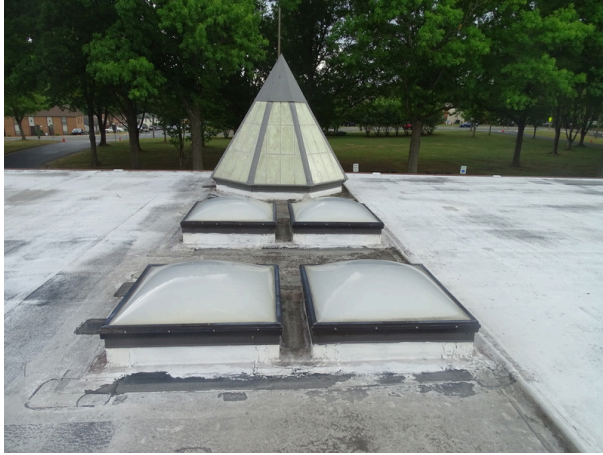
There are five skylights on the north side of the building. The skylight frames were corroded and were generally in poor condition. Cracked glass was also noted. We recommend the skylights be replaced during roof replacement.

Skylights located on north side of the building

Skylight located on north side of the building

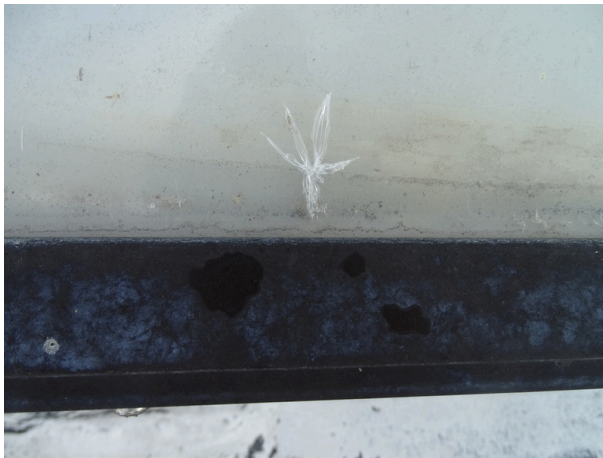
Skylights located on north side of the building -
note glass cracked

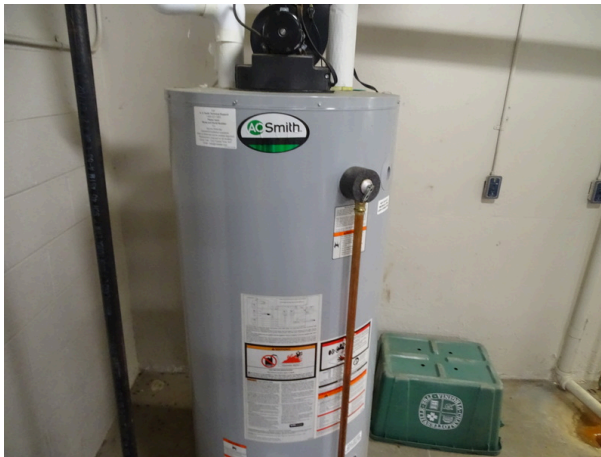
The expected useful life of a Gas domestic water heater is approximately 15 years with proper maintenance. We recommend the Gas domestic water heaters be replaced during the study period.

Gas domestic water heater

Cost Recommendation	EUL	EFF AGE	RUL	Year	Cost
REPLACE WATER HEATERS	12	4	8	8	\$4,400
Total					\$4,400

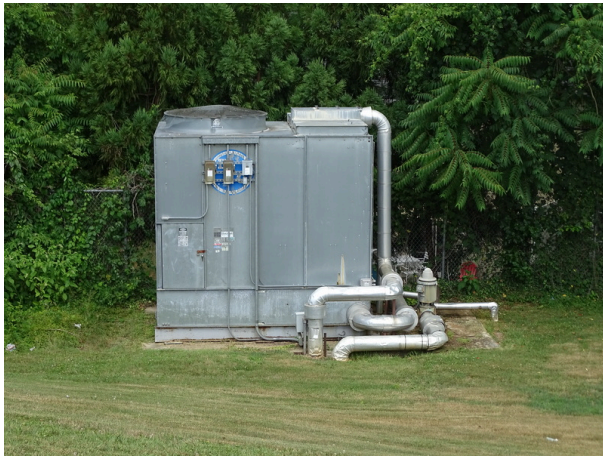
The cooling tower is located at the west side of the building near the mechanical room. The BAC cooling tower was installed in 2003 and was in fair condition. Cooling towers have a typical expected useful life of approximately 18 years. The cooling tower should be replaced during the study period.

Cooling Tower located at west end of the site

Cost Recommendation	EUL	EFF AGE	RUL	Year	Cost
REPLACE WATER SOURCE HEAT PUMPS	20	7	13	13	\$42,500
				14	\$42,500
				15	\$42,500
				16	\$42,500
				17	\$42,500
REPLACE DEHUMIDIFIER UNITS	15	11	4	4	\$50,000
REPLACE COOLING TOWER	18	17	1	1	\$30,000
REPLACE SPACE HEATERS	20	15	5	5	\$1,000
REPLACE SPLIT SYSTEM	15	9	6	6	\$2,000
REPLACE FAN COIL UNITS	20	15	5	5	\$100,000
Total					\$515,500

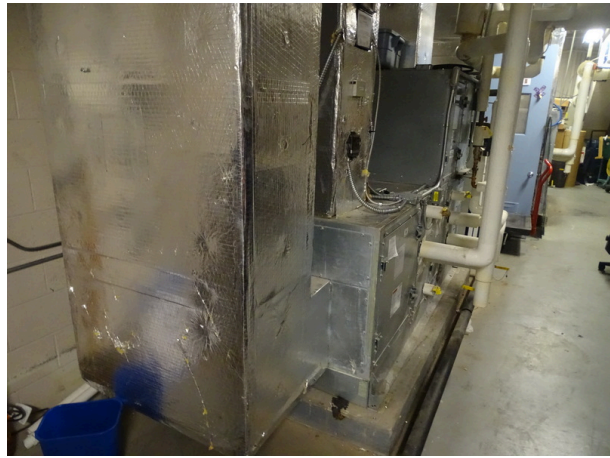
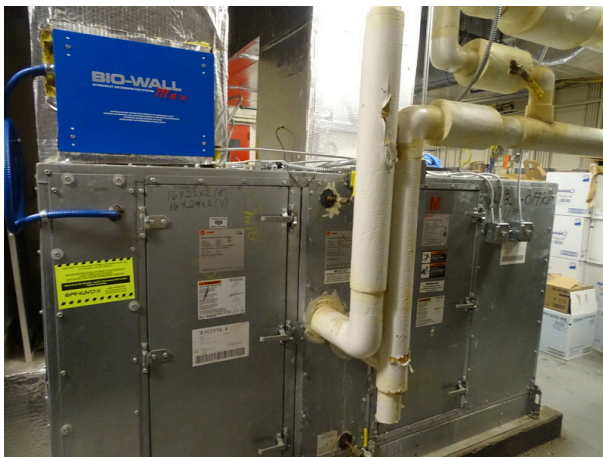
Three of the air handlers are located in the mechanical room on the north side of the building and others are located throughout the building. The units in the mechanical room were manufactured by Trane in 2005 and were in fair condition. The expected useful life of air handlers is 15 years with proper maintenance. We recommend that the air handlers be replaced during the report period.

Typical Air Handler Unit

Cost Recommendation	EUL	EFF AGE	RUL	Year	Cost
REPLACE BOILERS	20	18	2	2	\$50,000
REPLACE HEAT PUMP	15	14	1	1 16	\$5,000 \$5,000
REPLACE AIR HANDLERS	15	14	1	1	\$60,000

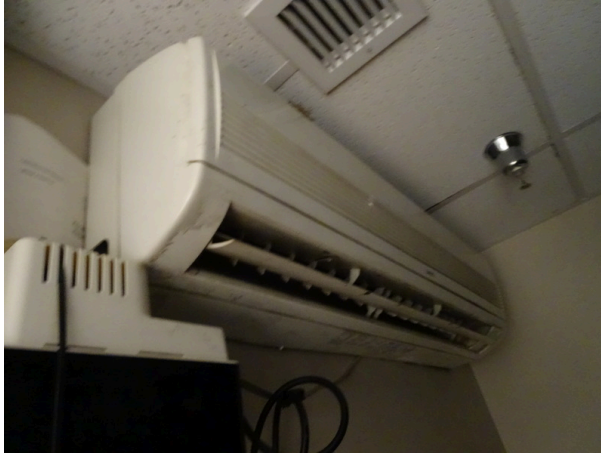
A split system manufactured by Sanyo was located in the IT room. The system installation date was unknown and was in fair condition. Split systems have an expected useful life of 15 years and should be replaced during the study period.

Split system located in IT room

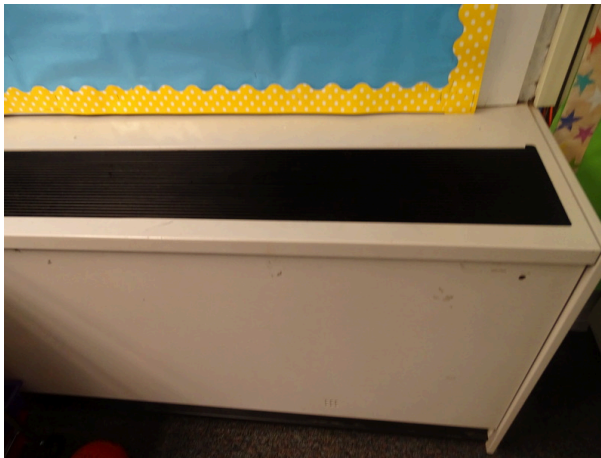
Fan coil units are located throughout the building and were replaced in 2005. The approximately 50 fan coil units and radiators have a typical expected life of 20 years. Replacement or refurbishment of the units is recommended during the study period.

Typical fan coil unit

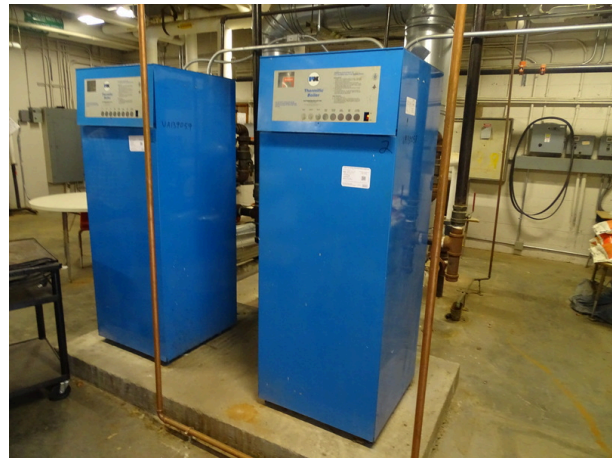
The Patterson Kelly Boilers have an expected useful life of 20 years with proper maintenance. The two boilers were located in the mechanical room at the west side of the building. The boilers were installed in 2003 and were generally in fair condition. We recommend replacing the boilers during the report period.

Boilers located in mechanical room

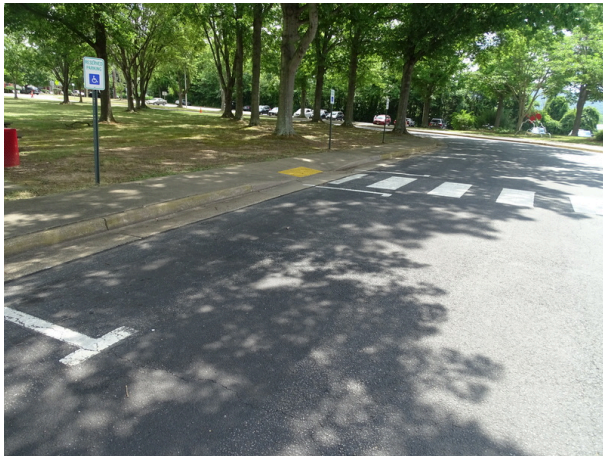
The parking area serving the property has a total of approximately 123 parking spaces. Of the parking spaces, Two are accessible with Two being van accessible. Accessibility requires that five accessible parking spaces be provided in parking areas with a total of 101 to 150 spaces. One in six of the accessible parking spaces are required to be van accessible. A minimum of a 60-inch wide access aisle is required to be provided for every two accessible parking spaces. Accessible aisles were observed to not be provided. The number of parking spaces provided does not meet accessibility requirements. We recommend installing three additional accessible spaces with accessible aisles.

Accessible parking spaces - note only two of five needed spaces provided

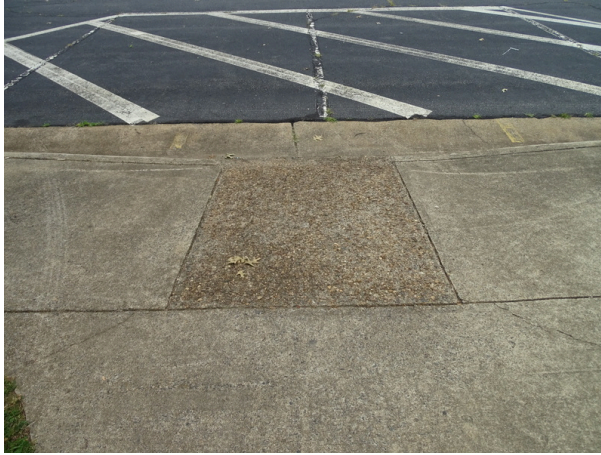
Concrete ramp - note need to install truncated domes

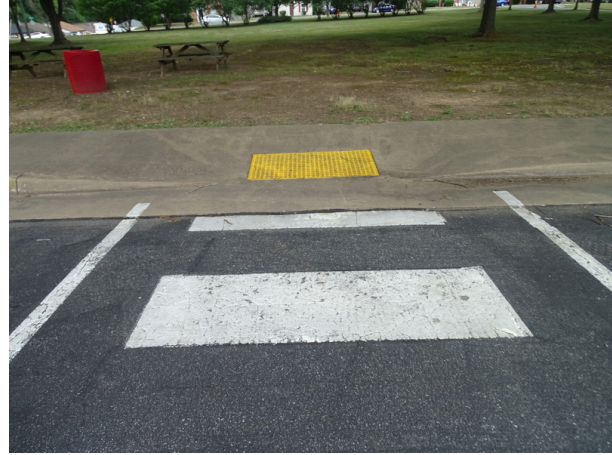
Concrete sidewalk and ramp

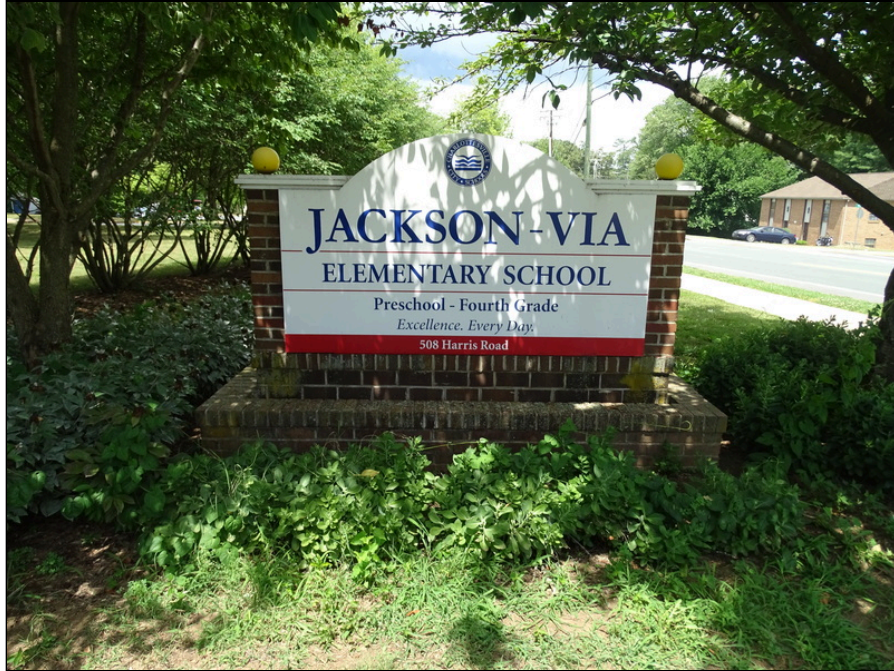
1 - Monument sign at north end of the site

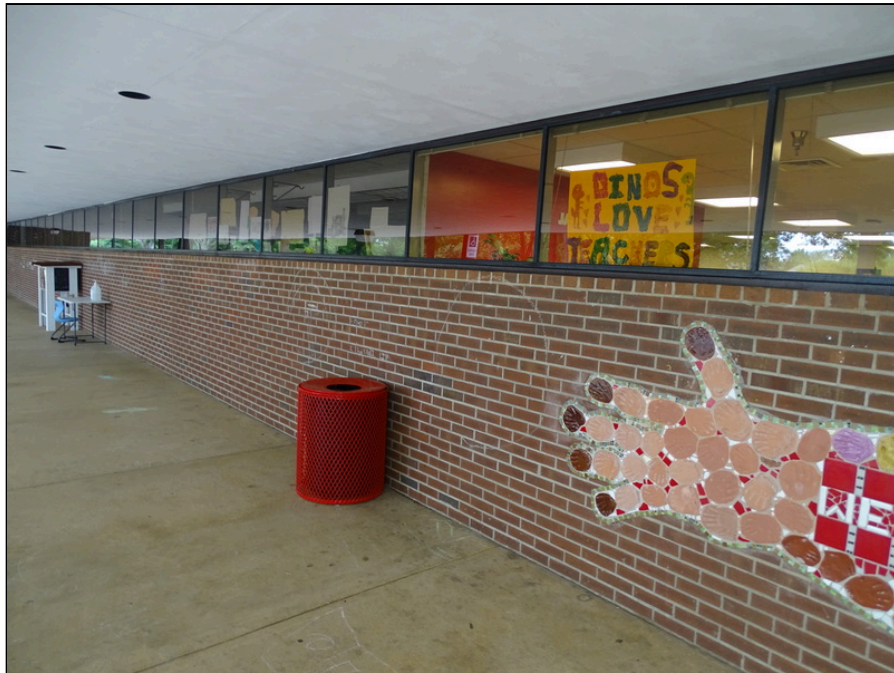
2 - Jackson Via Elementary School

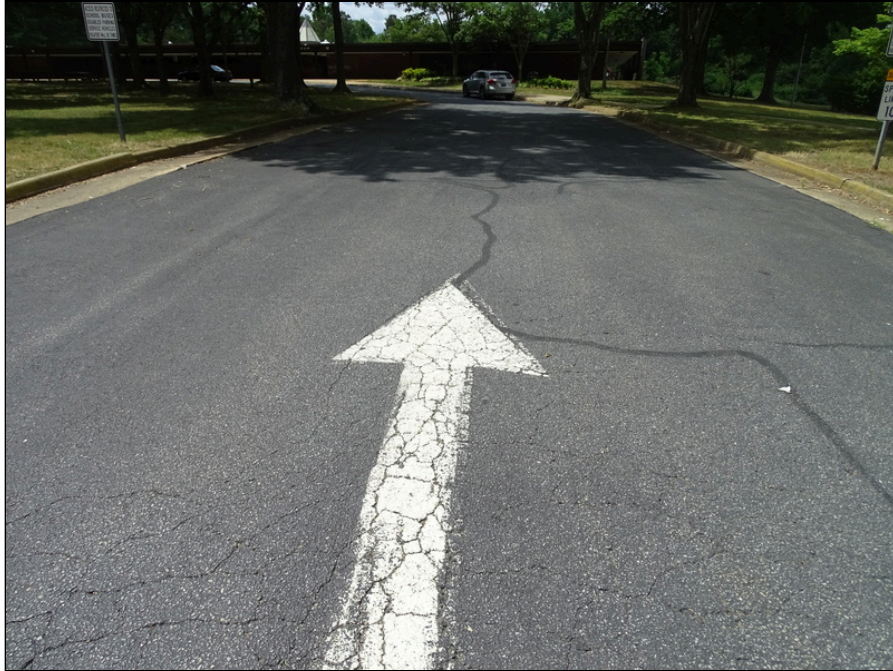
3 - Asphalt drive lane west side of the site

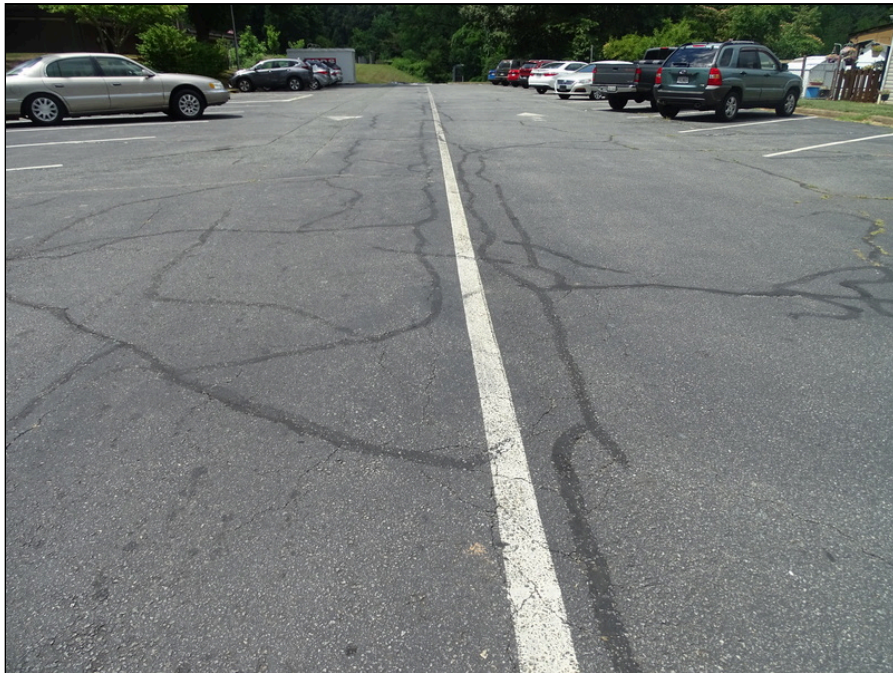
4 - Asphalt drive lane east side of the site - note cracking and previous repair

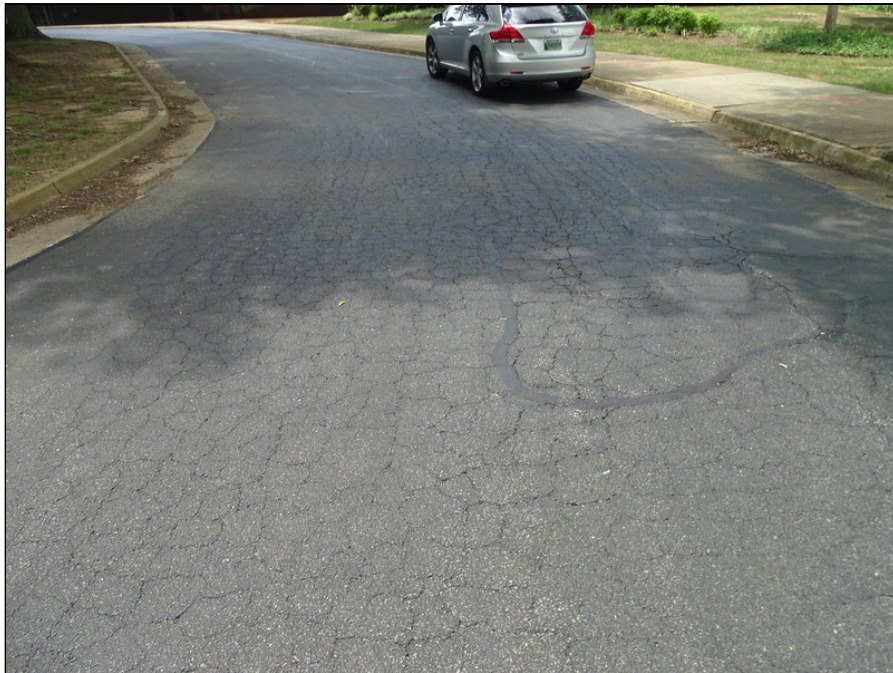
6 - Asphalt drive lane west side of the site - note cracking

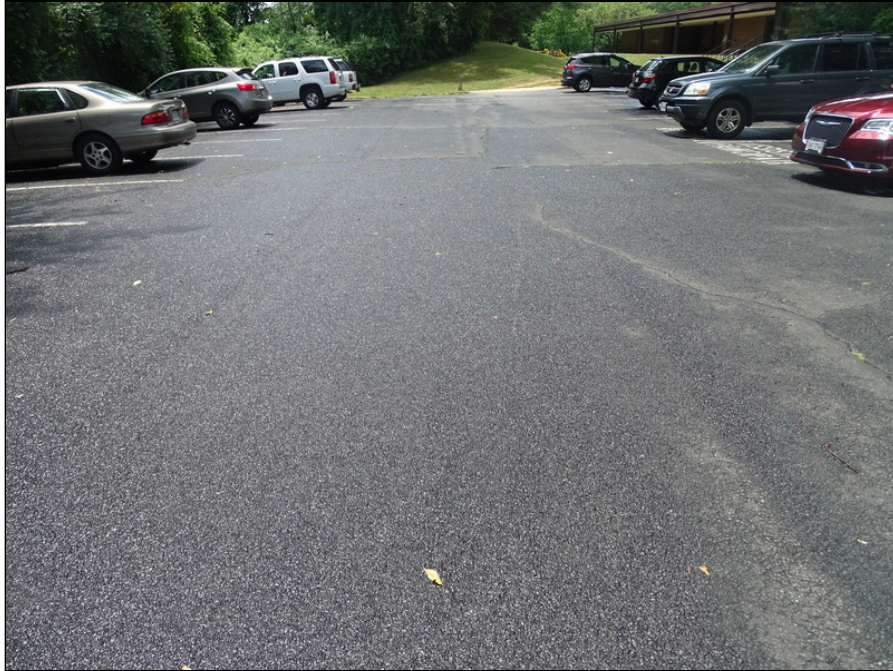
13 - Asphalt parking east side of site - note cracking

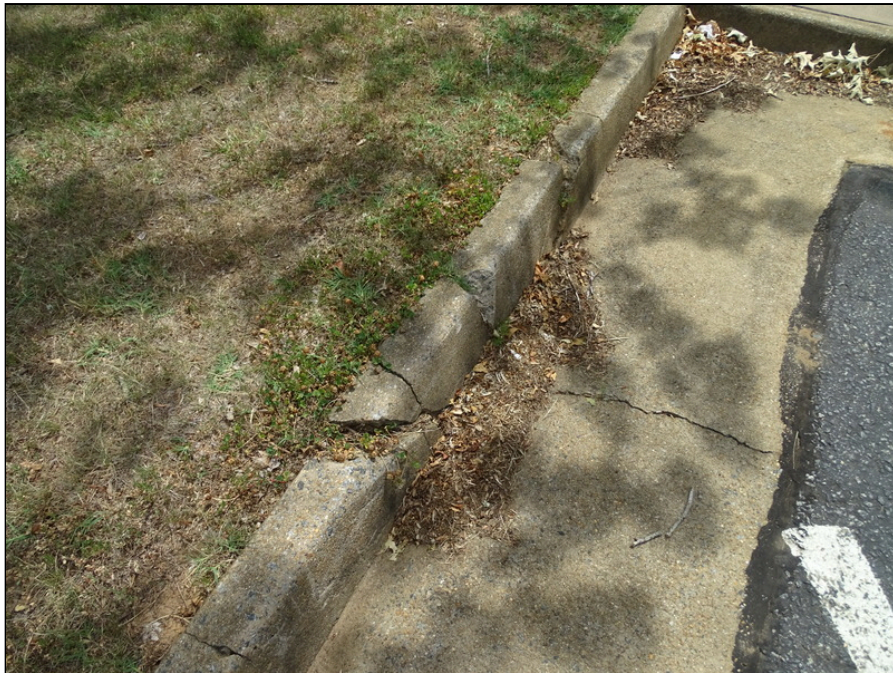
16 - Concrete ramp - note deterioration
