JACKSON VIA ELEMENTARY SCHOOL
508 HARRIS ROAD
CHARLOTTESVILLE, VIRGINIA

ECS PROJECT NO. 46:6713

CITY OF CHARLOTTESVILLE - FACILITIES DEVELOPMENT

Reference: Facility Condition Assessment Report for Jackson Via Elementary School, 508 Harris Road,
Charlottesville, Virginia

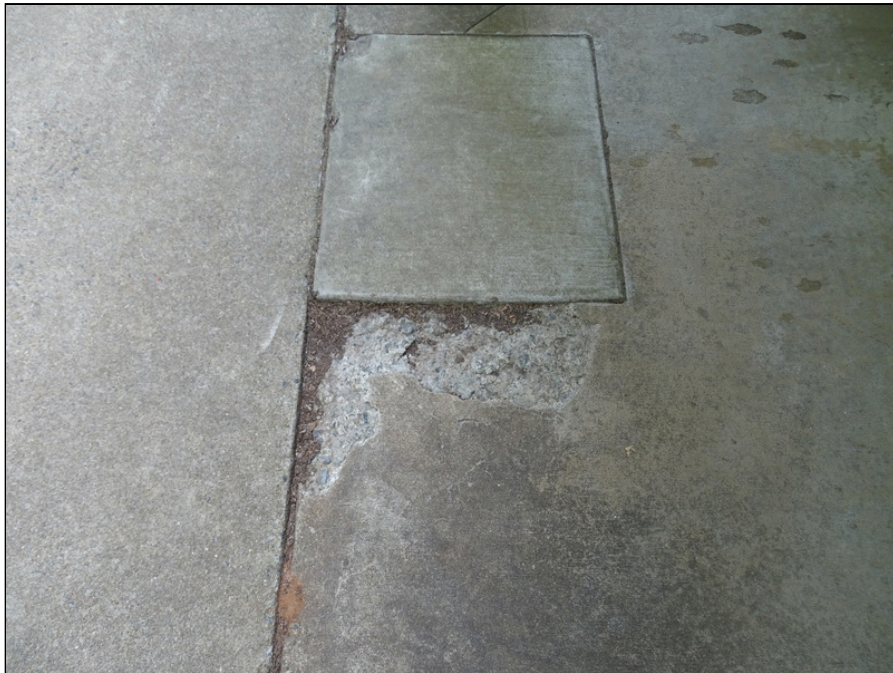
30 - Concrete sidewalk - note deterioration

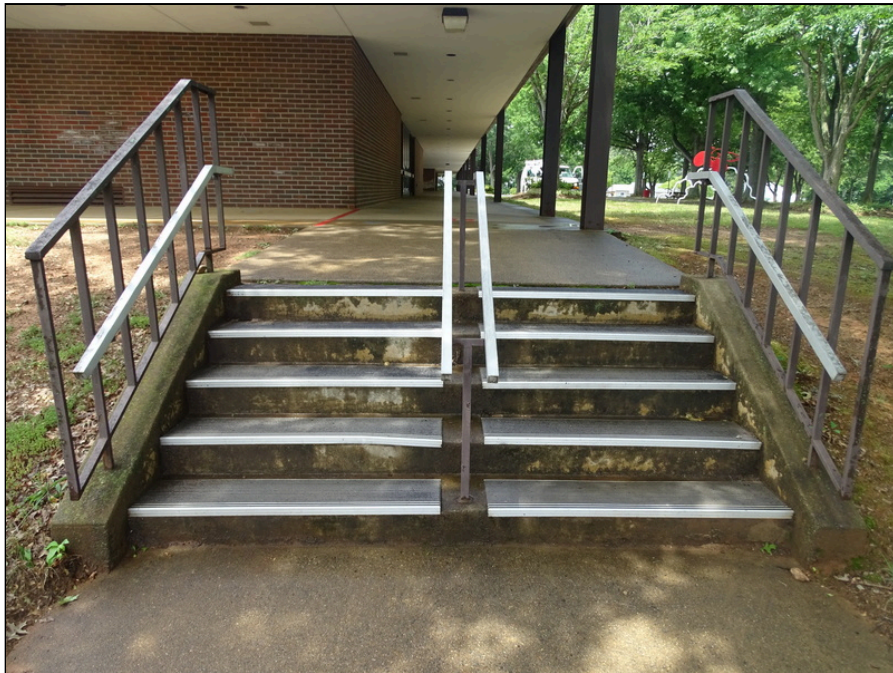
32 - Concrete stair - note stained

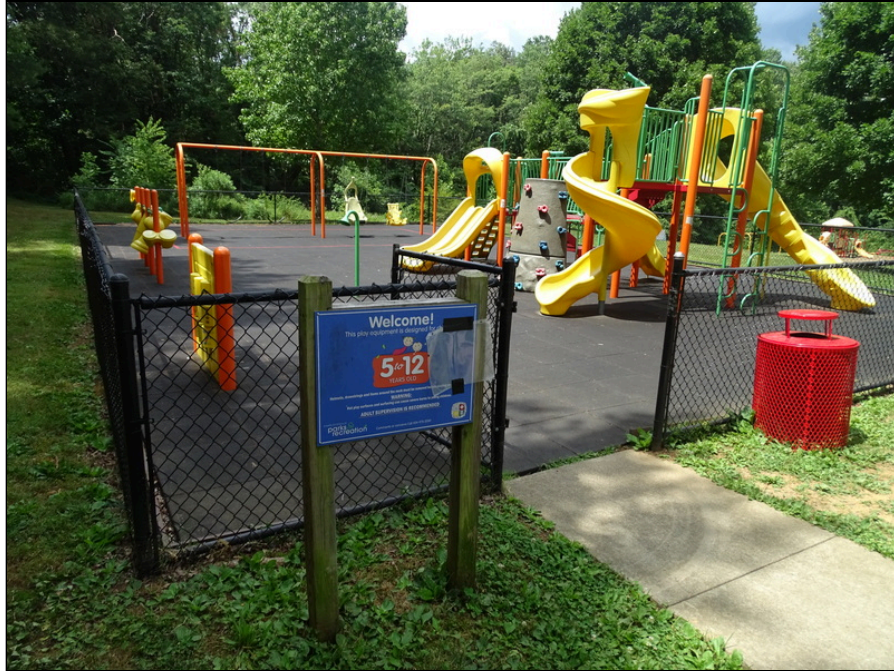
39 - Playground overview

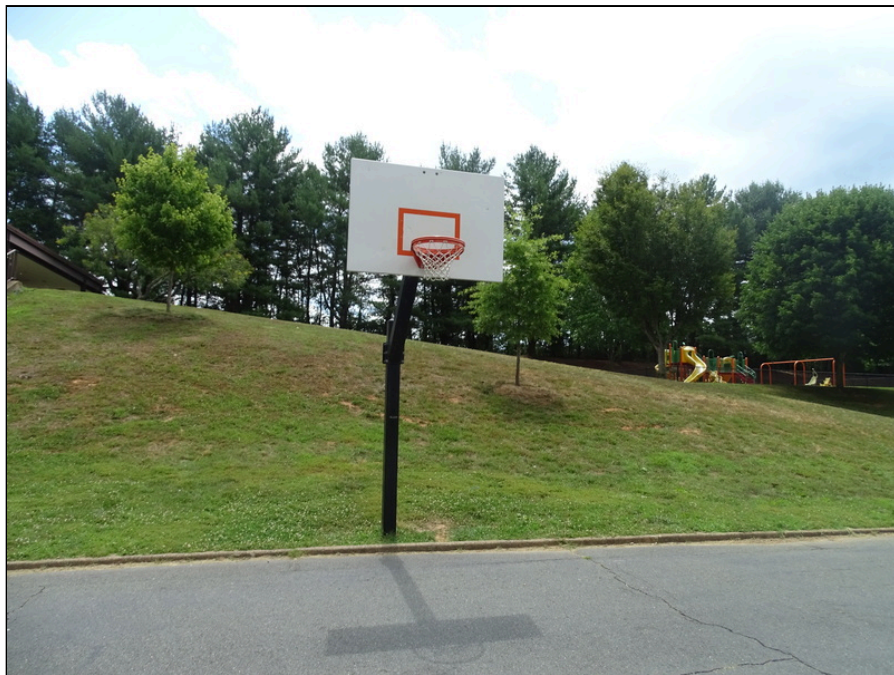
40 - Basketball court south of the building

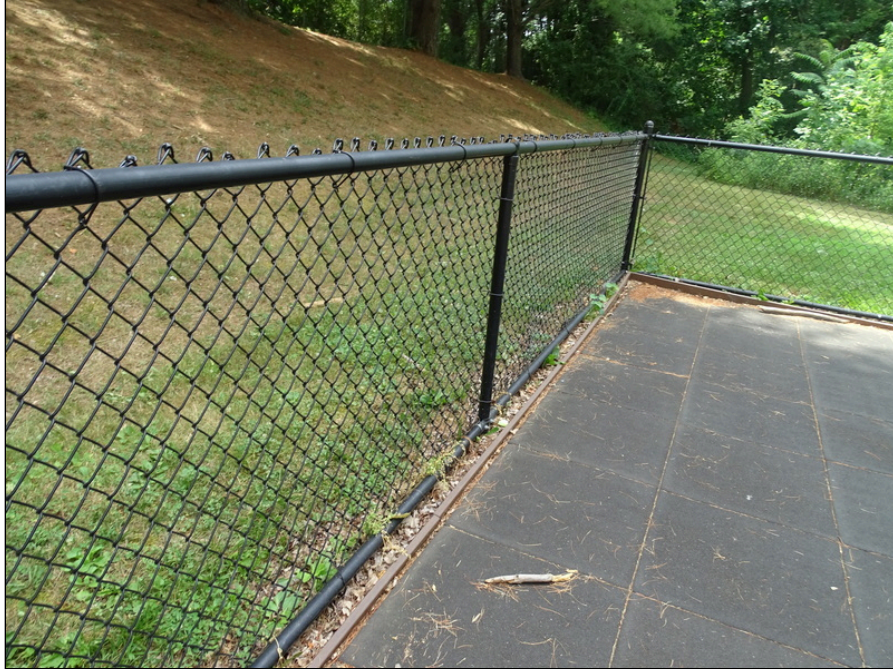
41 - Typical fencing overview

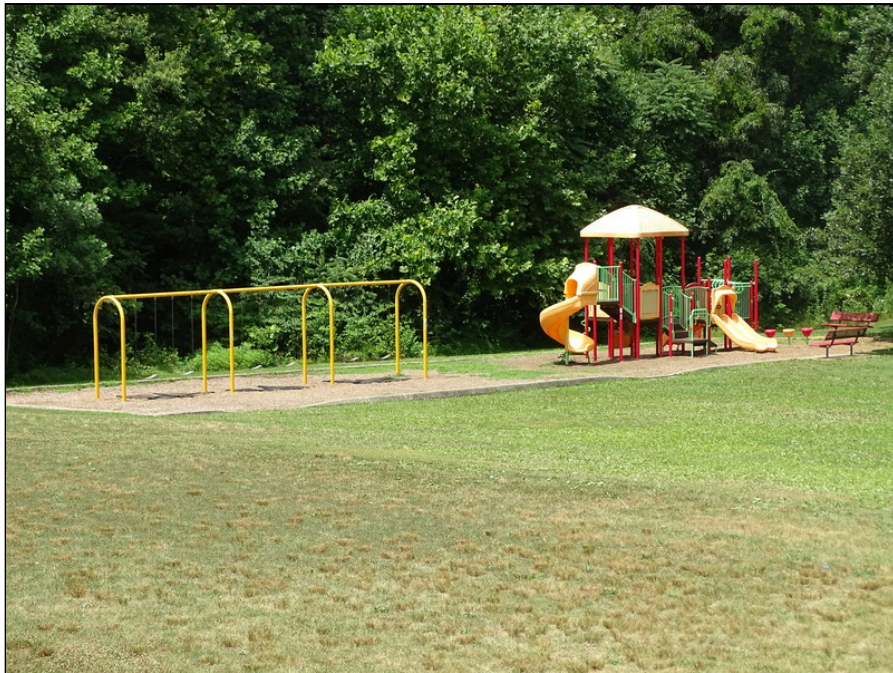
42 - Playground south end of the site

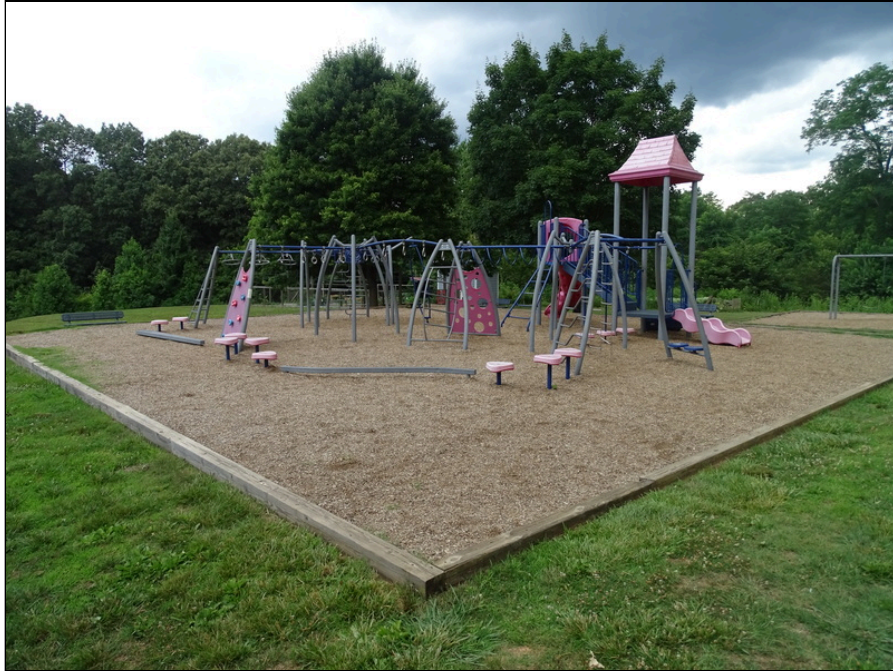
43 - Playground southwest end of the site

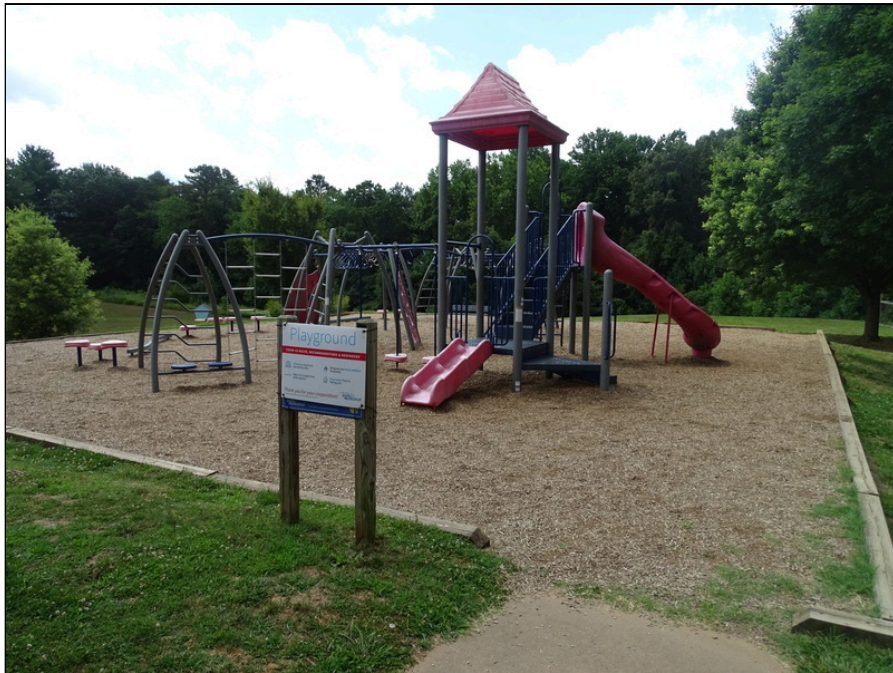
44 - Playground overview

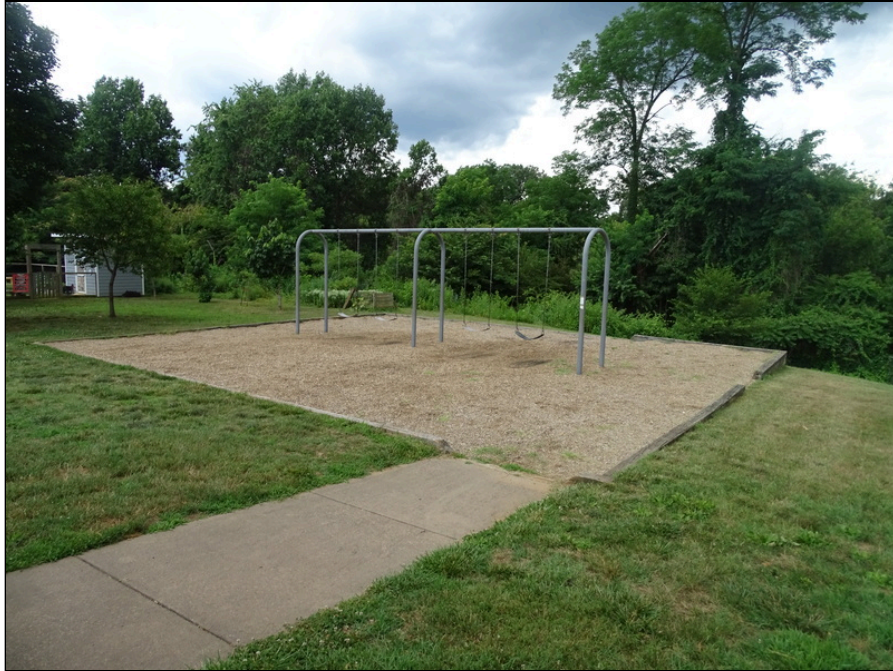
45 - Playground overview

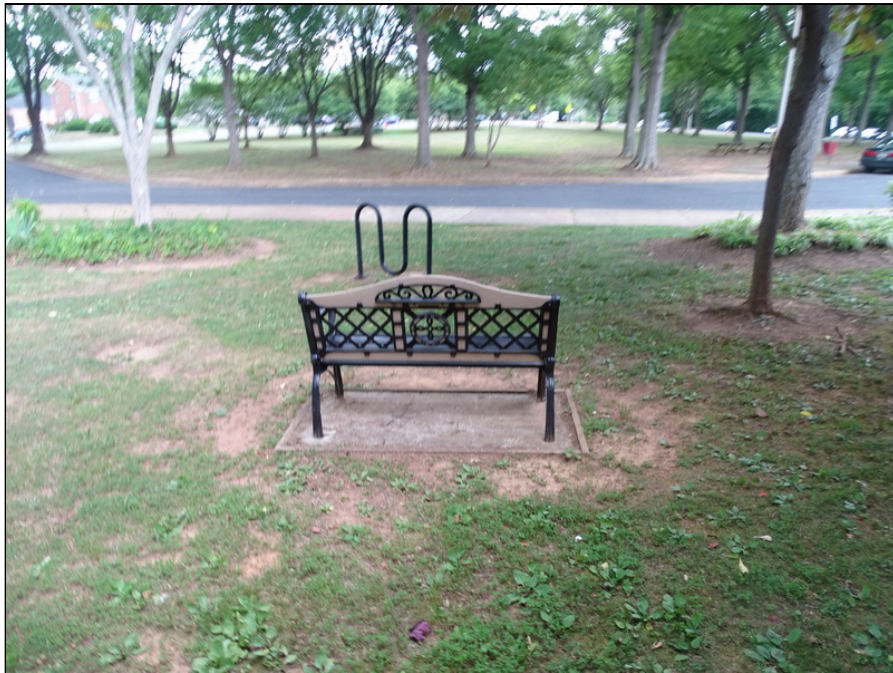
46 - Typical landscape and setting area

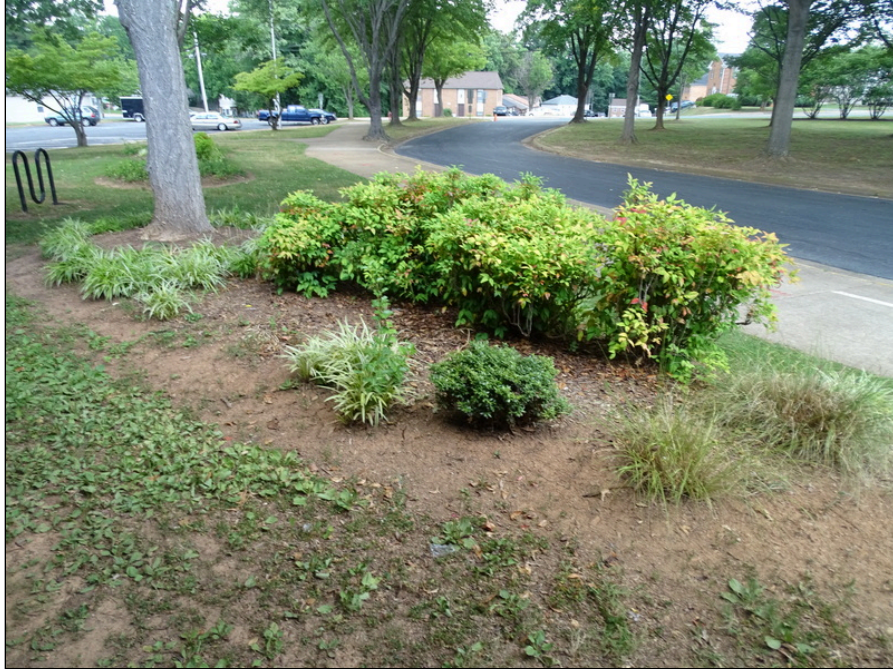
47 - Typical landscape

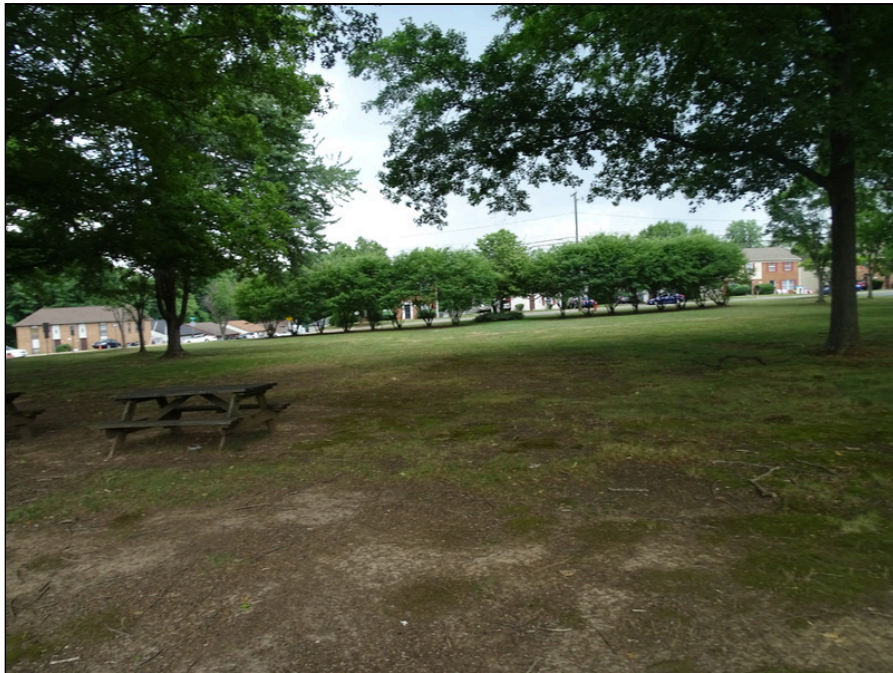
48 - Typical lawn area

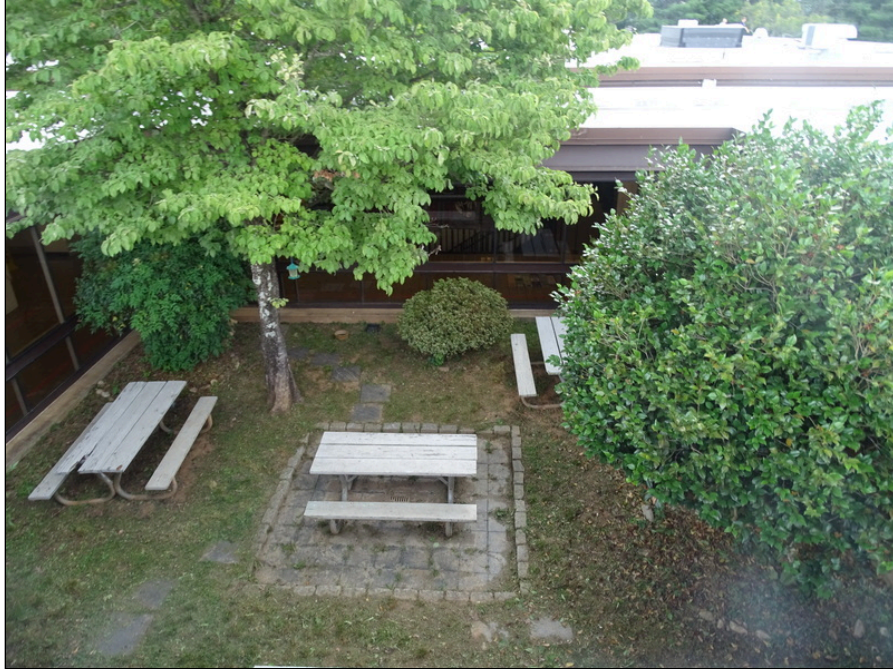
49 - Typical landscape and setting area - note table broken

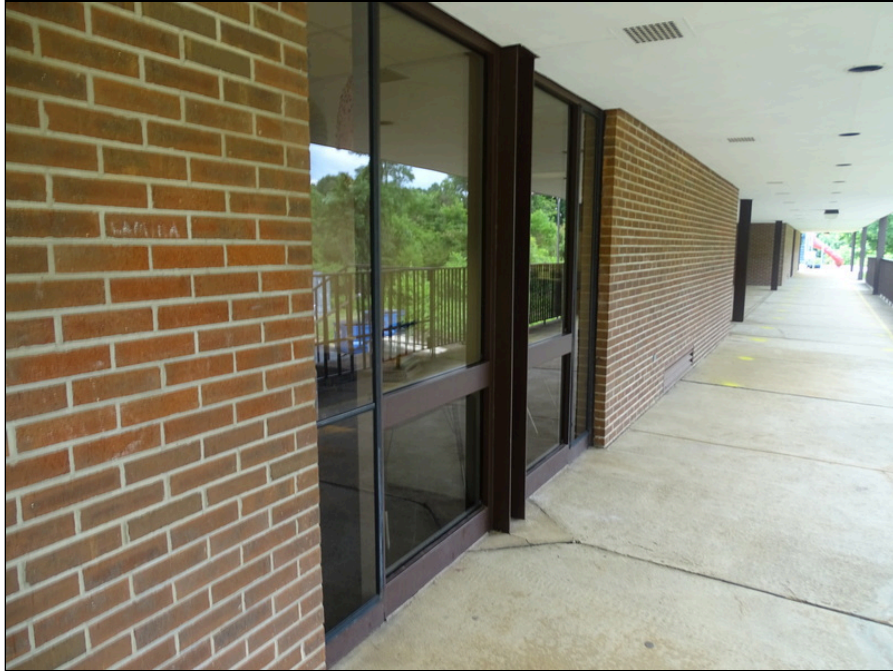
51 - Building exterior southwest side of the building

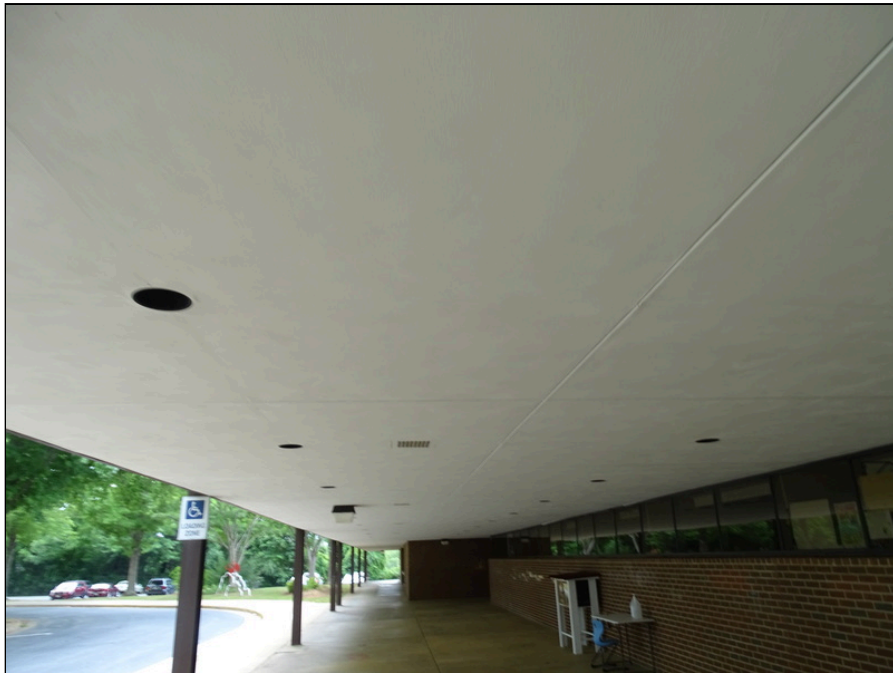
52 - Typical perimeter soffit

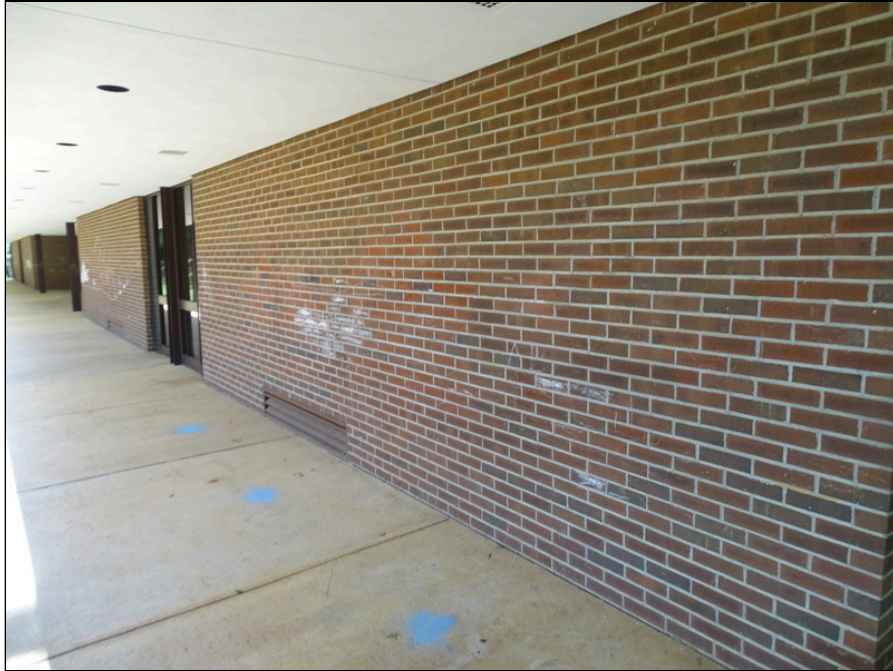
53 - Building exterior southwest side of the building

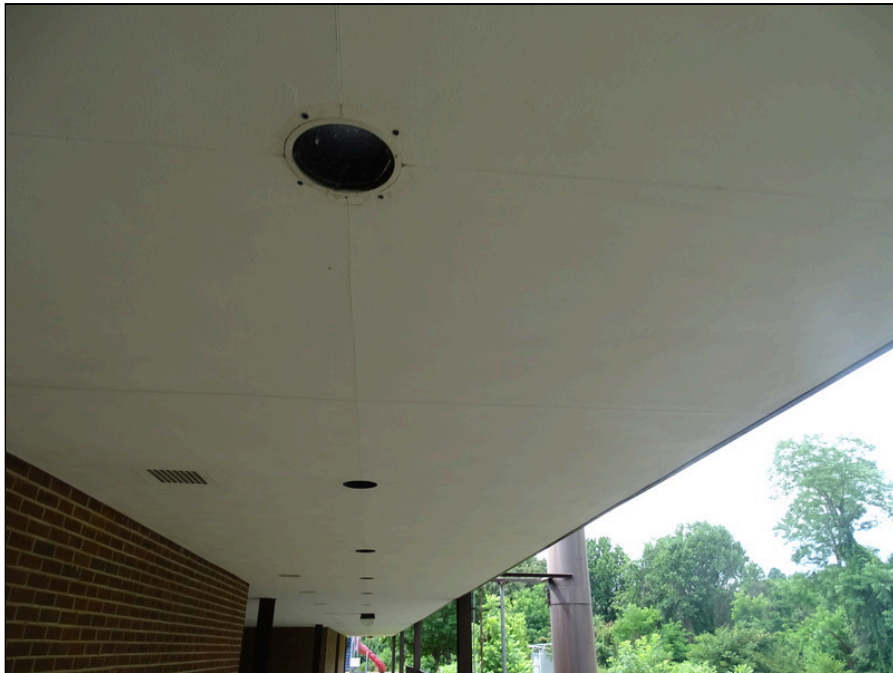
54 - Building exterior soffit

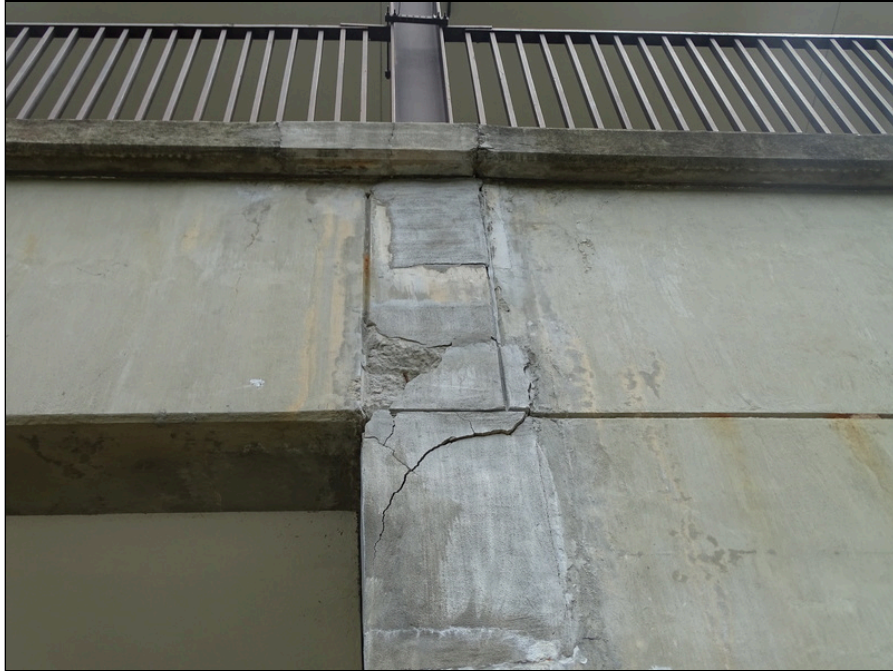
55 - Building exterior - note column cracking

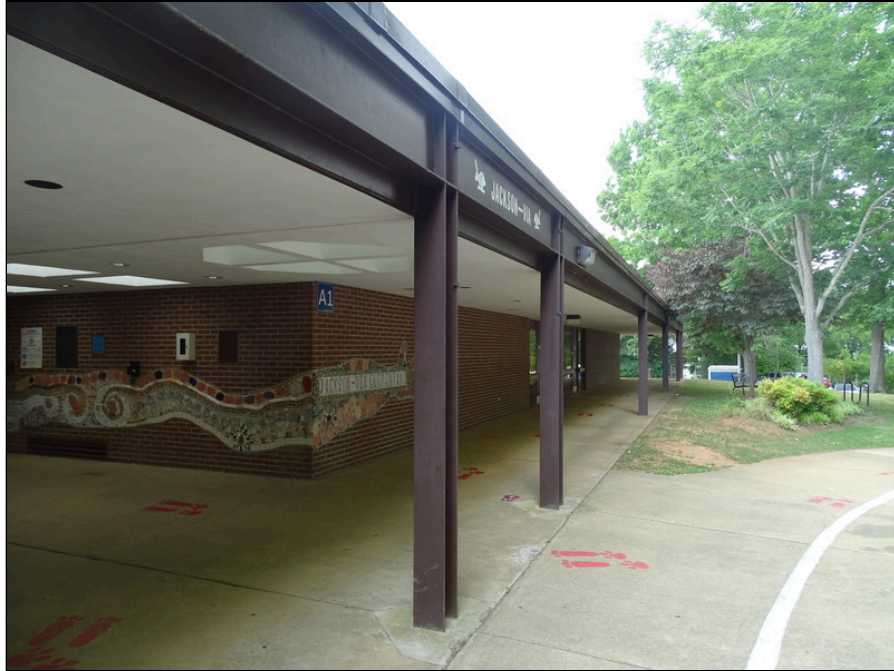
59 - Building exterior

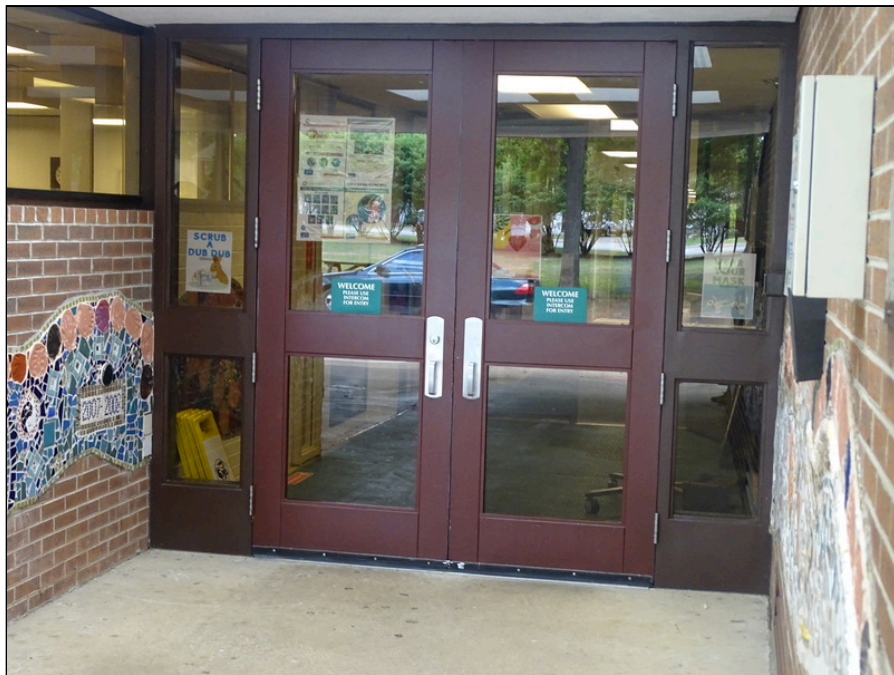
60 - Main entrance doors

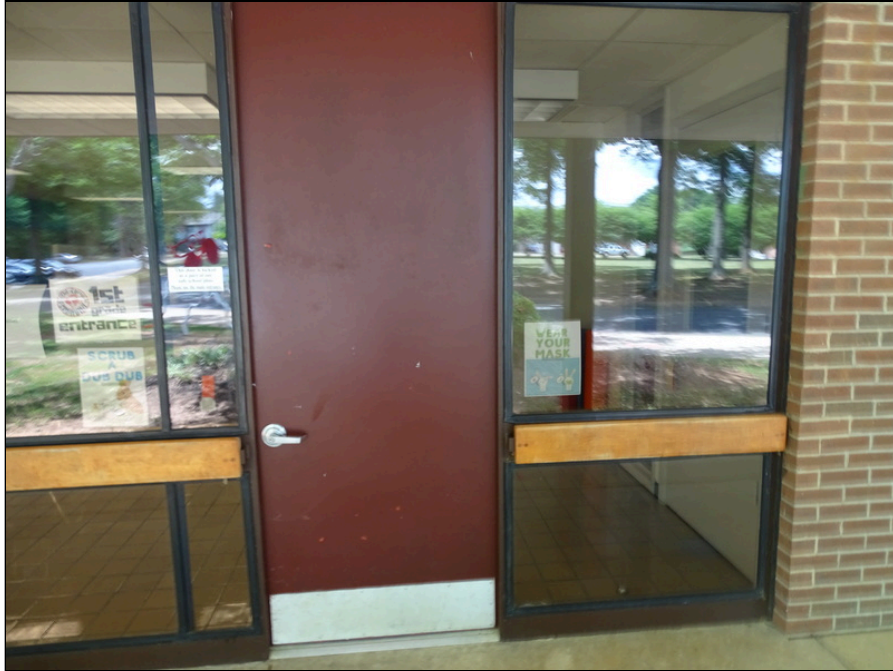
61 - Typical personnel door

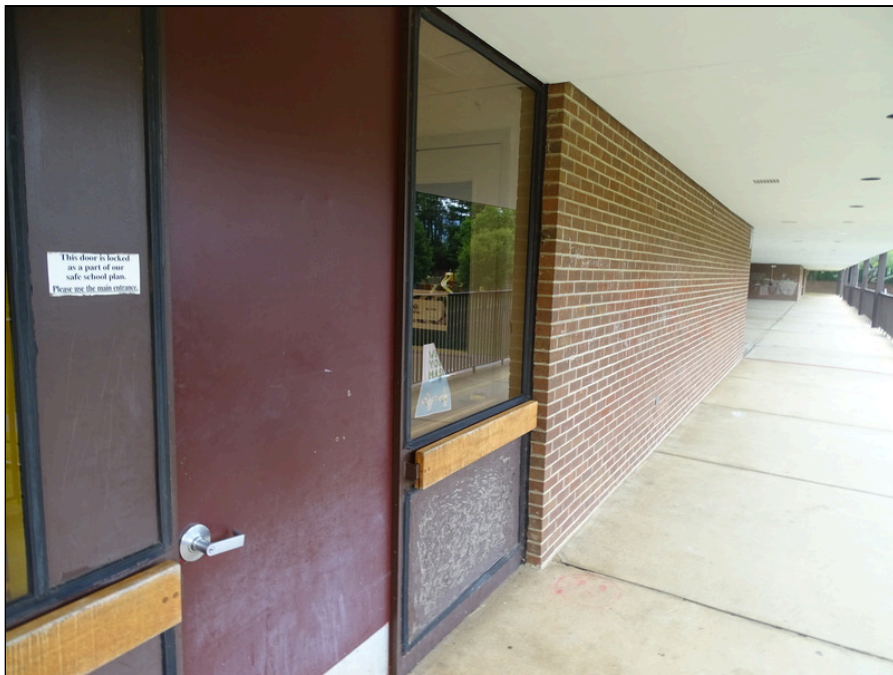
62 - Older exterior window unit

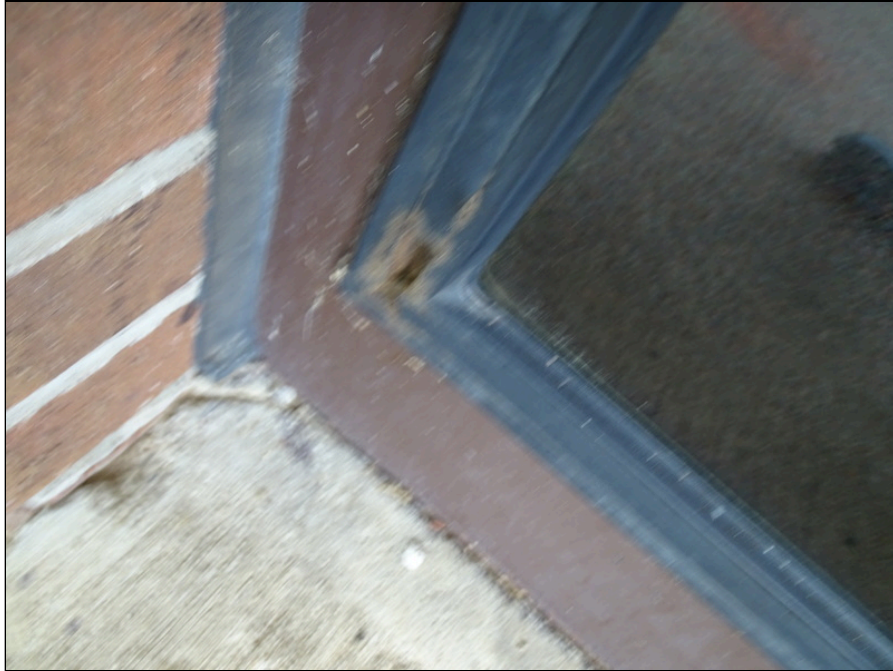
63 - Typical exterior window - note deterioration of gasket

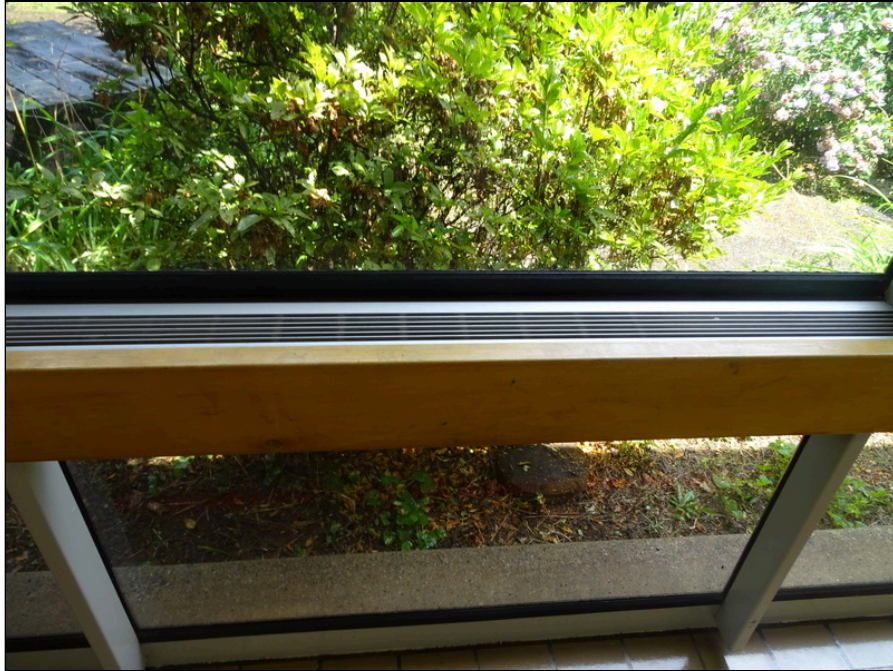
65 - Older exterior window unit

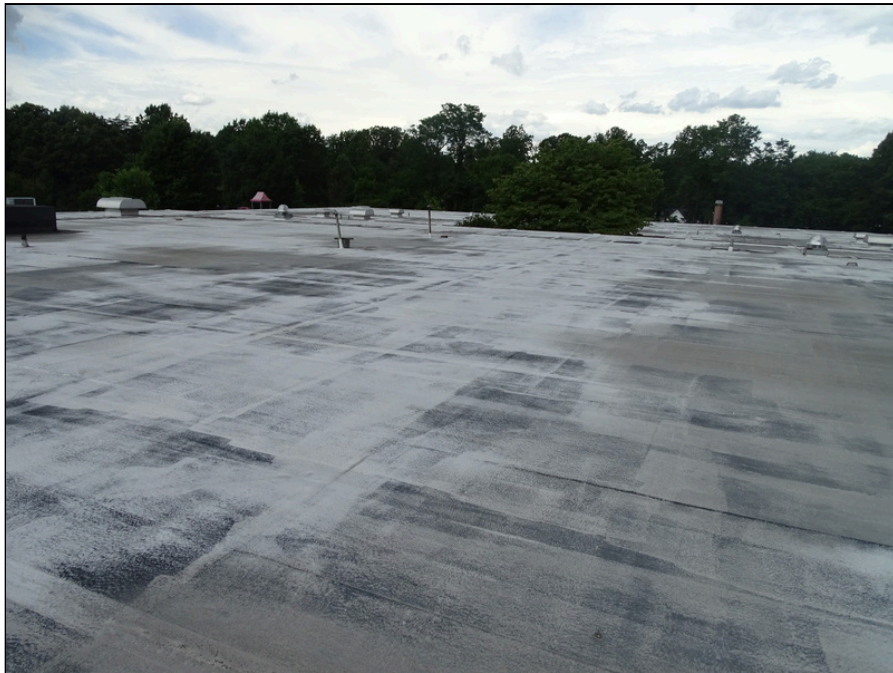
66 - Single-ply membrane roofing system

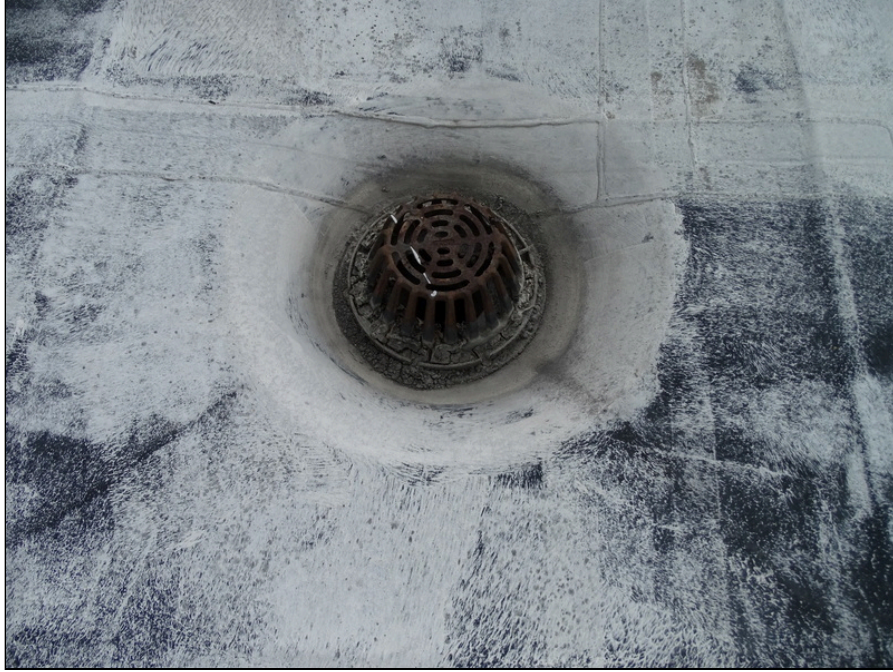
67 - Typical interior drain

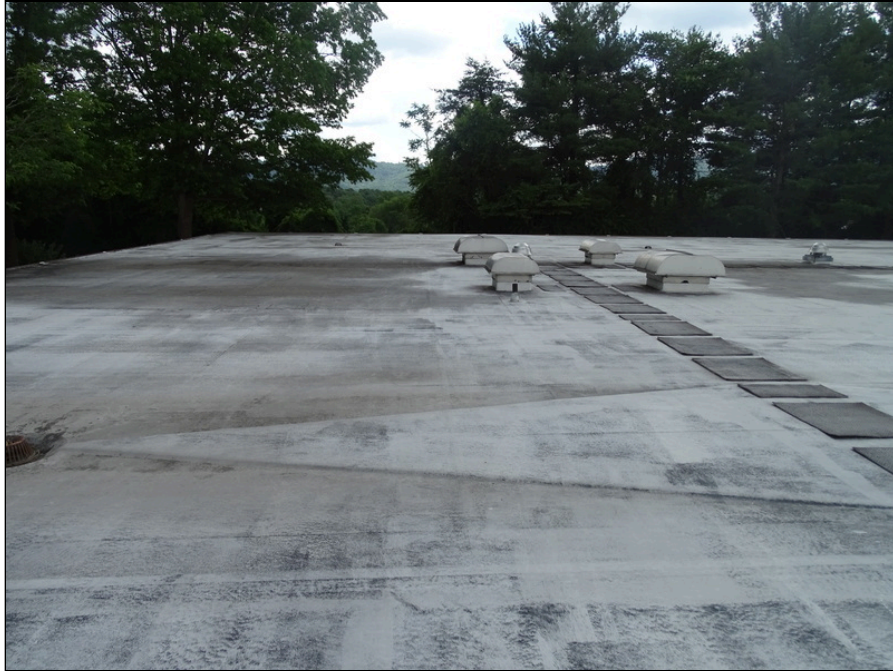
69 - Single-ply membrane roofing system looking west

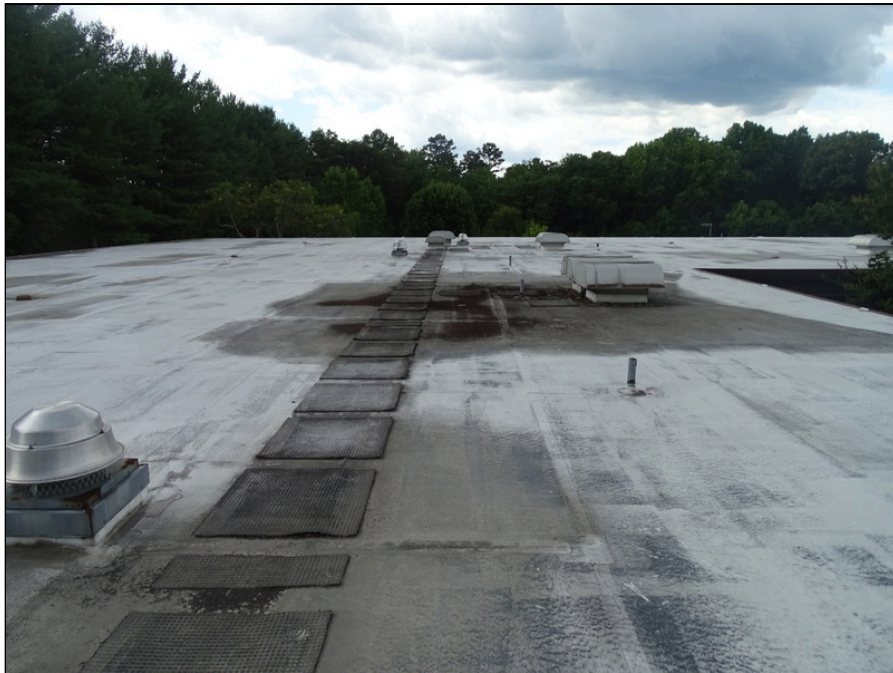
70 - Single-ply membrane roofing system looking west - note ponding

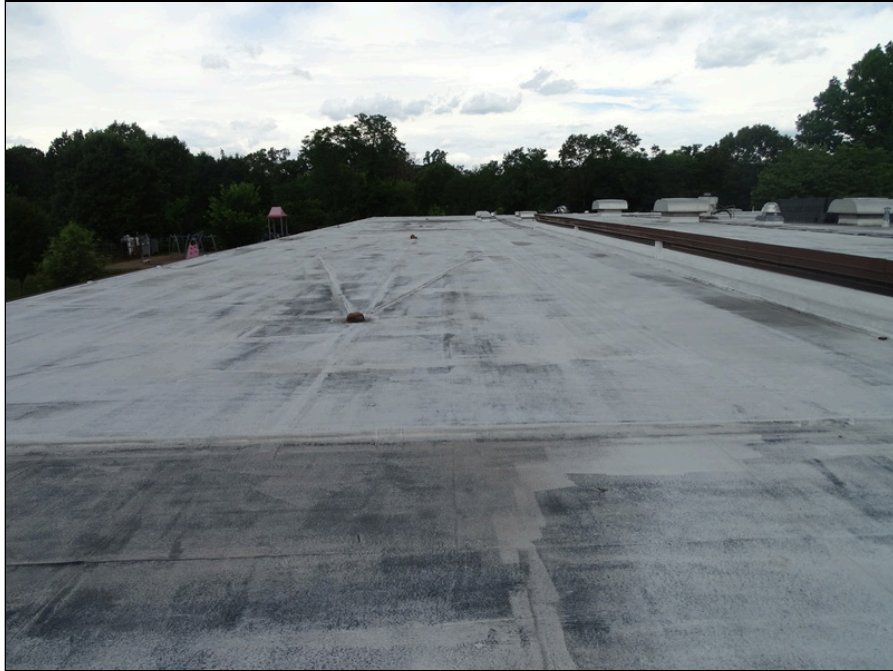
71 - Single-ply membrane roofing system looking west

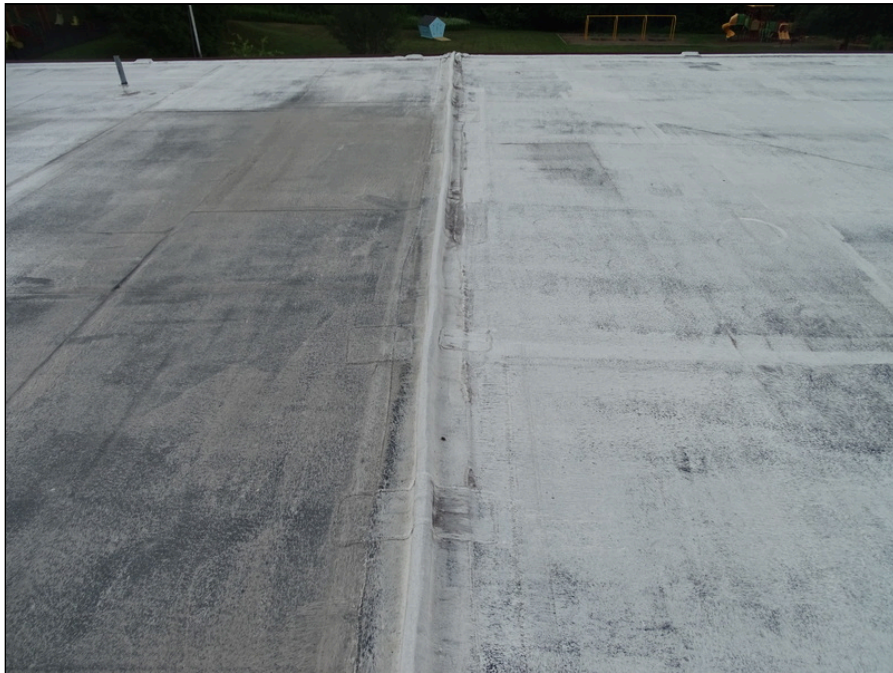
72 - Single-ply membrane roofing system - note patching

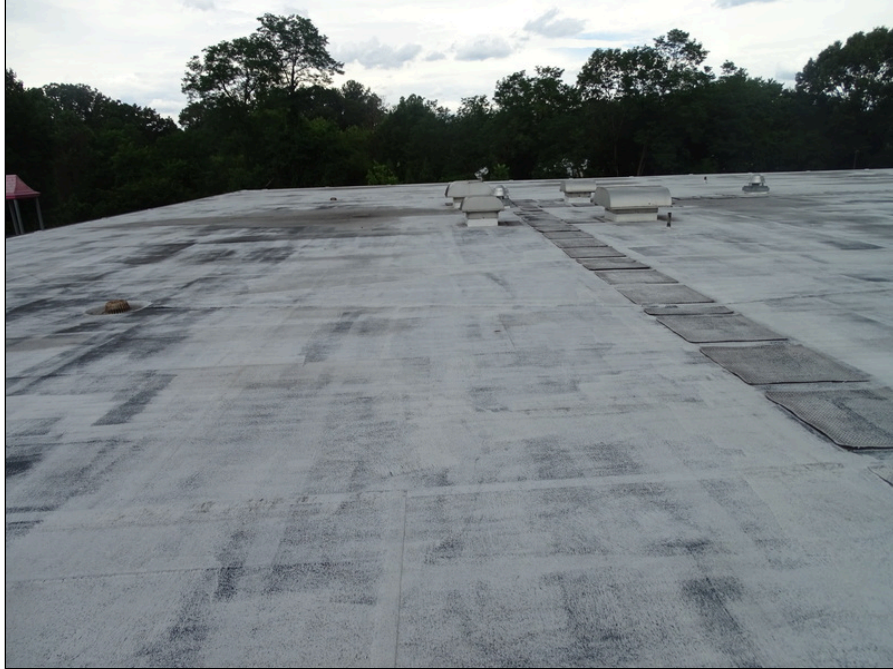
73 - Single-ply membrane roofing system looking west

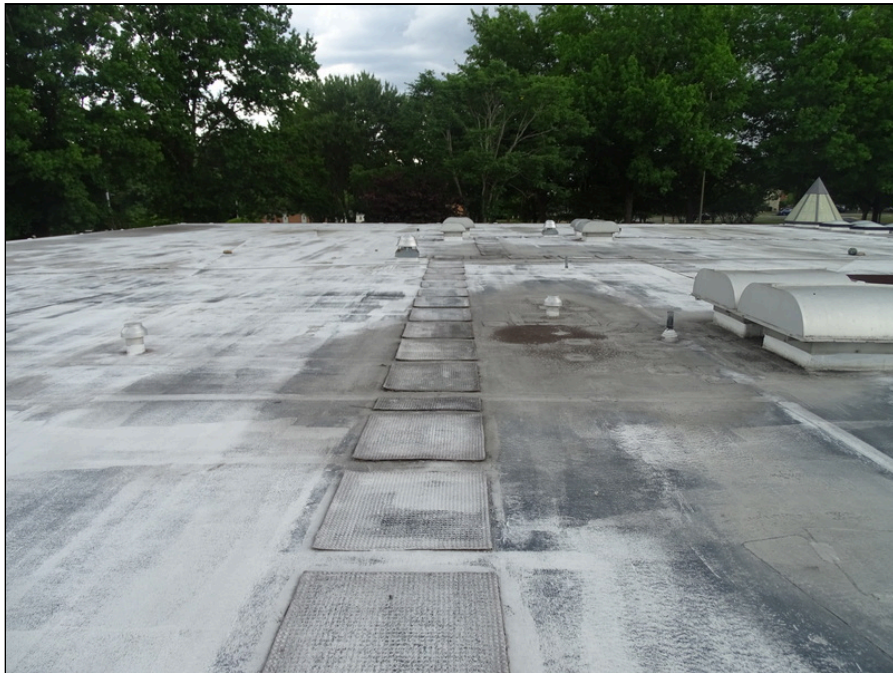
74 - Single-ply membrane roofing system looking west - note ponding

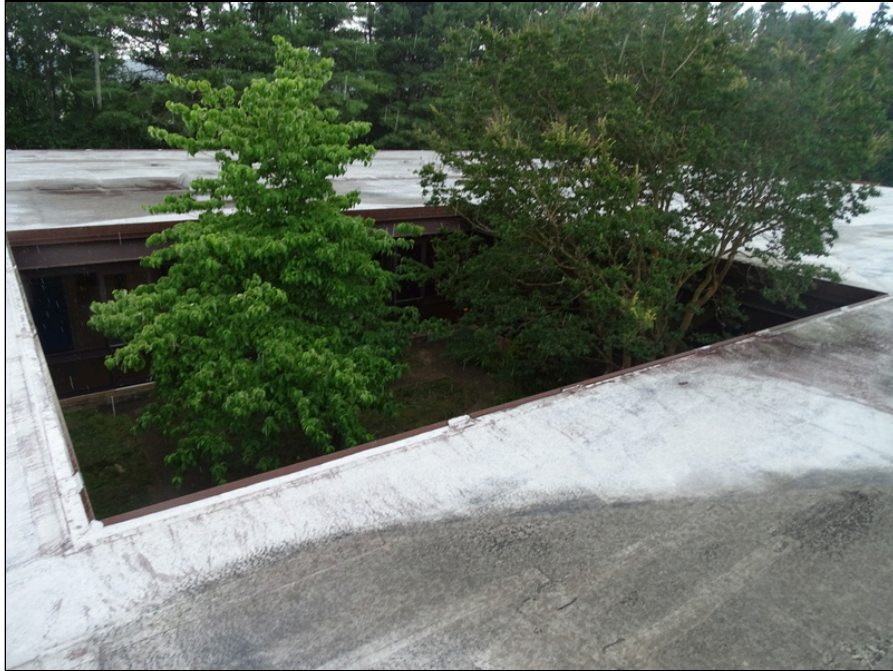
75 - Single-ply membrane roofing system

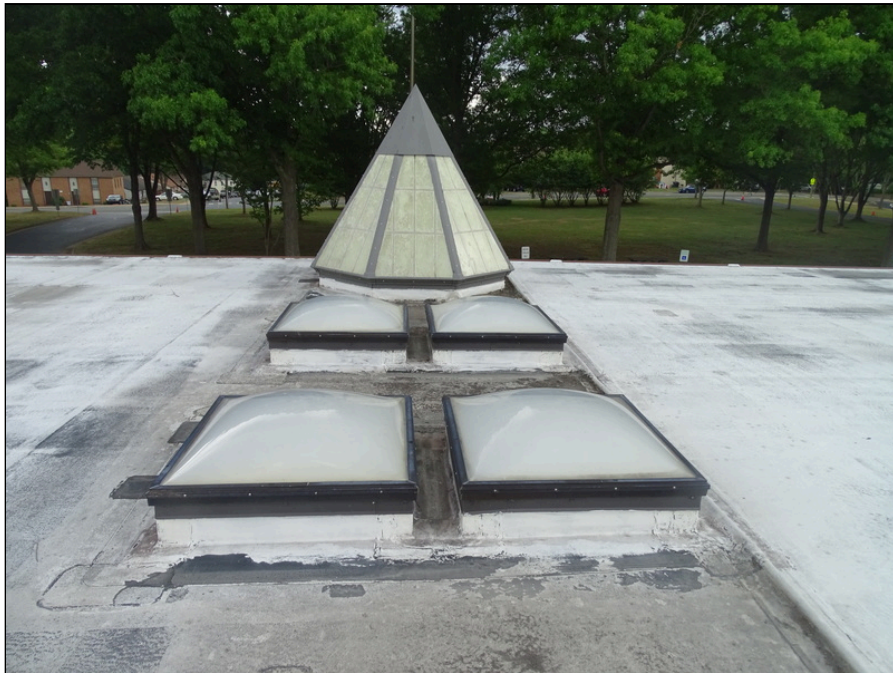
76 - Skylights located on north side of the building

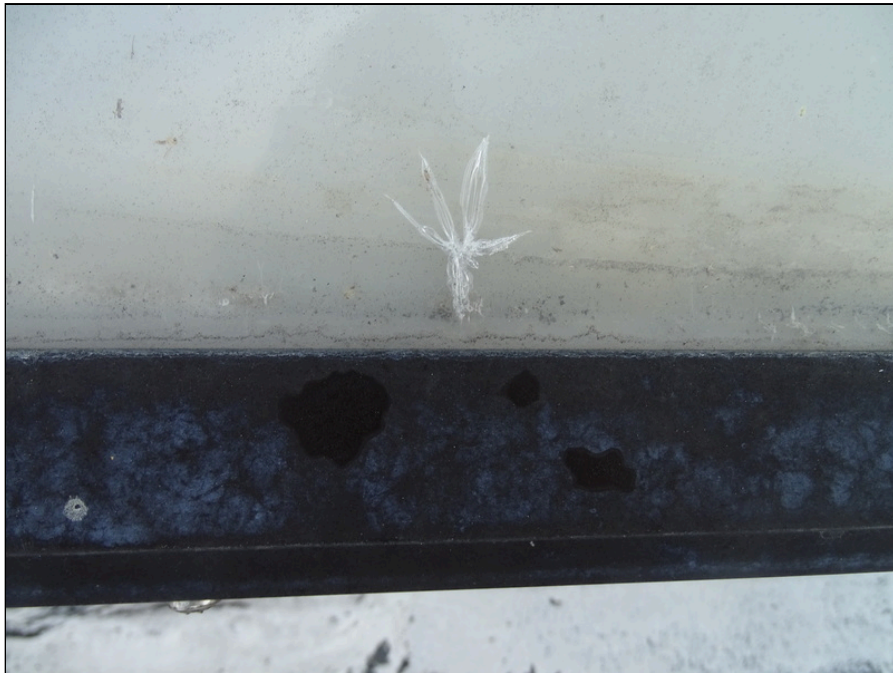
78 - Skylights located on north side of the building - note glass cracked

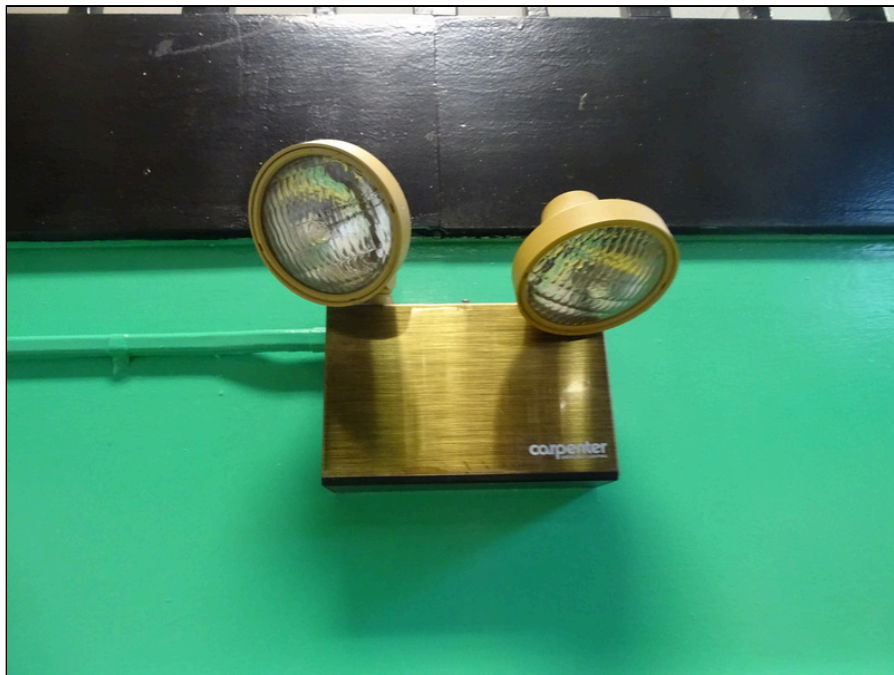
112 - Typical emergency lighting

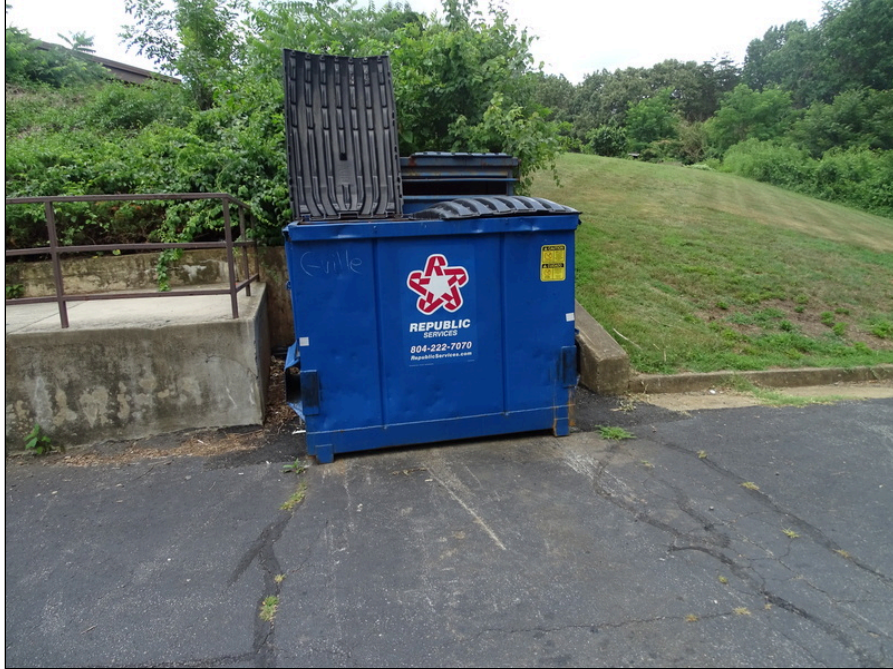
113 - Dumpster area at northeast end of the site

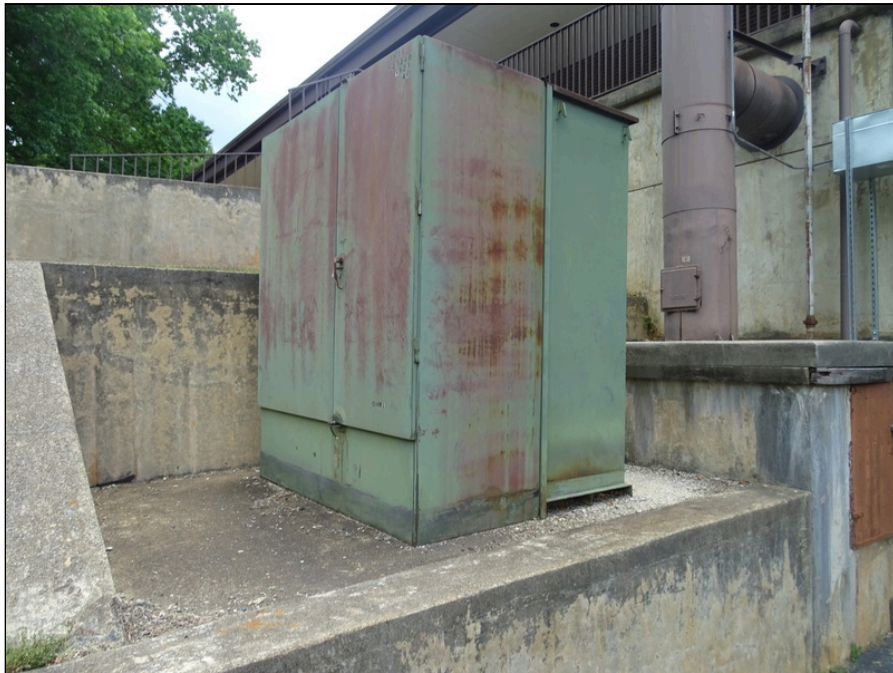
114 - Electric utility transformer at west side of the building
