JACKSON VIA ELEMENTARY SCHOOL
508 HARRIS ROAD
CHARLOTTESVILLE, VIRGINIA

ECS PROJECT NO. 46:6713

CITY OF CHARLOTTESVILLE - FACILITIES DEVELOPMENT

Reference: Facility Condition Assessment Report for Jackson Via Elementary School, 508 Harris Road,
Charlottesville, Virginia

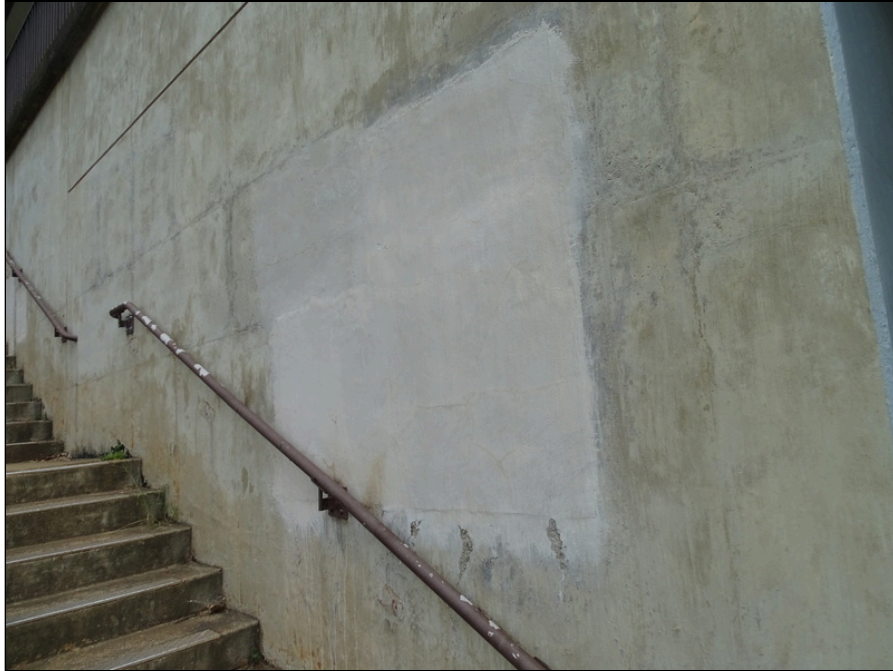
115 - Building exteriors concrete - note recent repairs

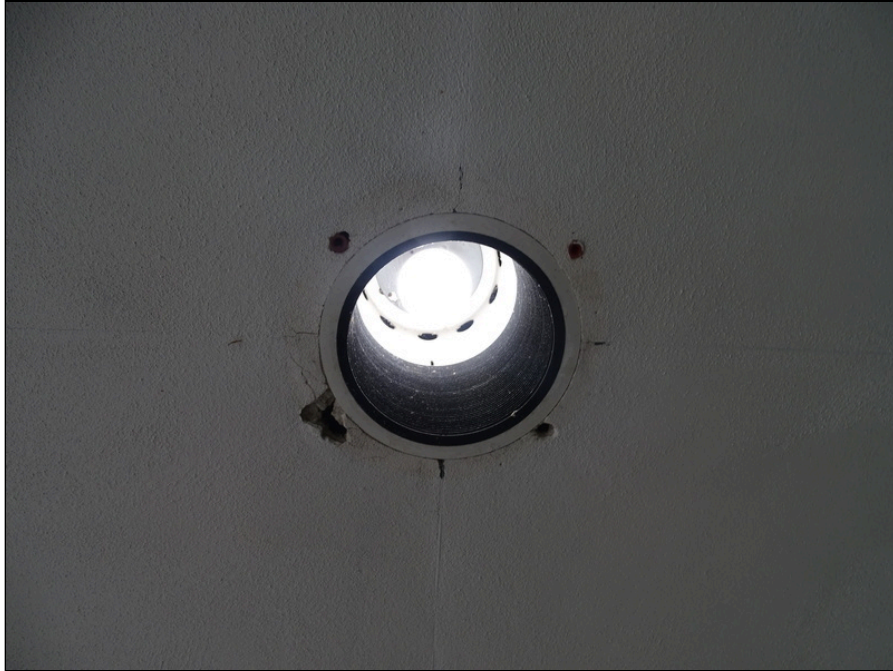
117 - Building exterior lighting

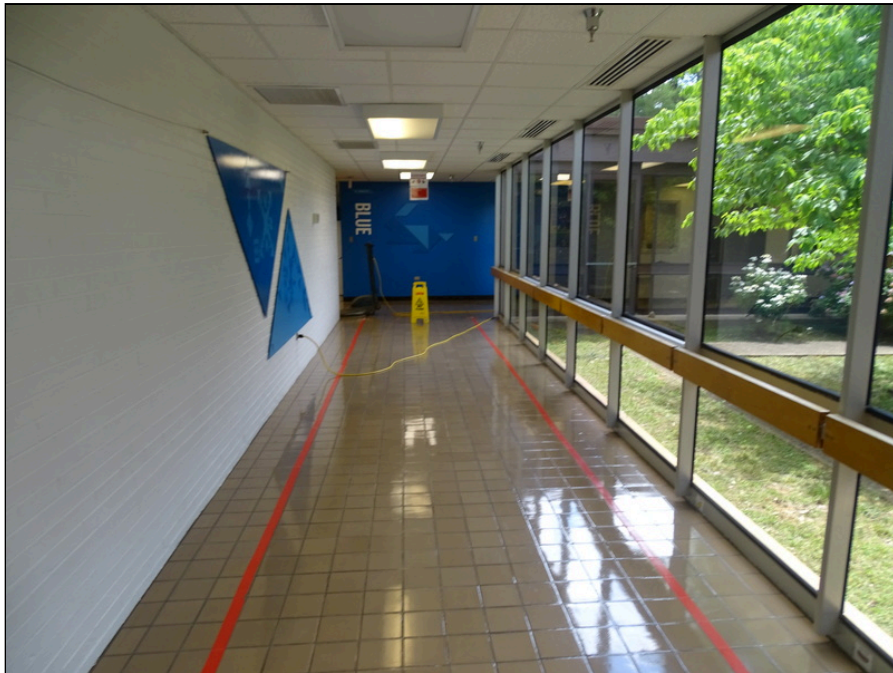
118 - Building interior finishes of corridor area

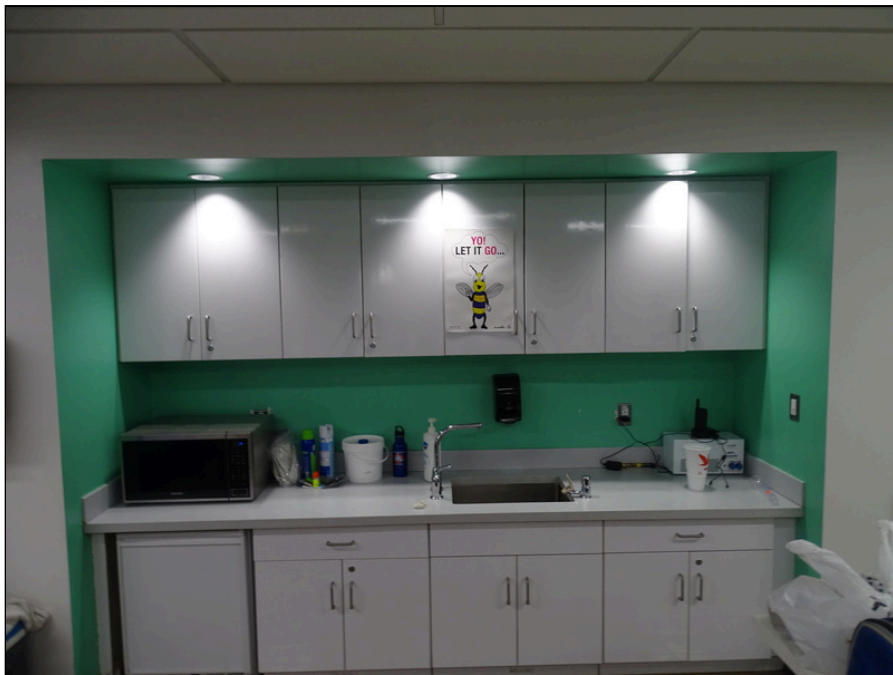
124 - Interior finishes of typical classroom area - note recent renovation

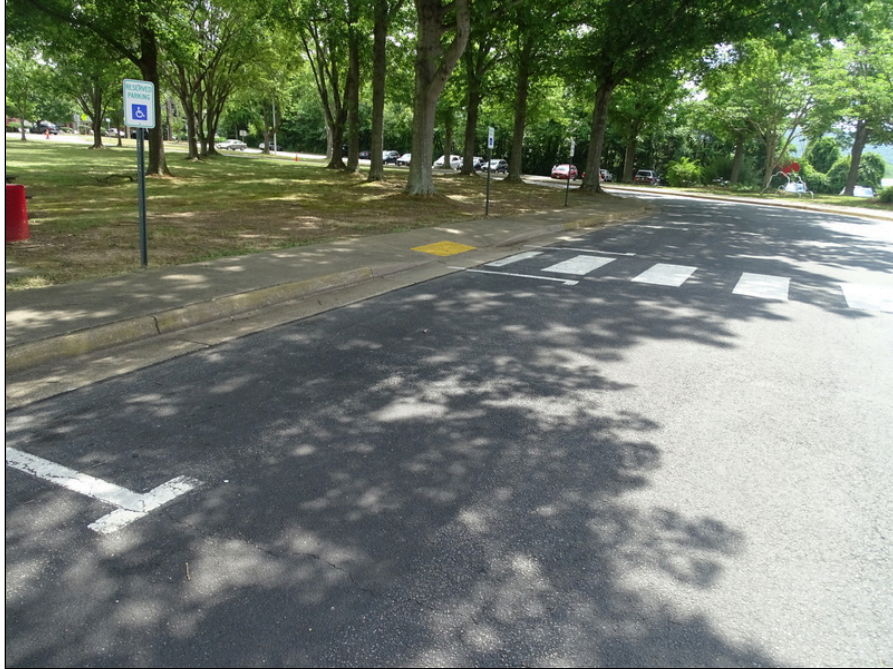
135 - Accessible parking spaces - note only two of five needed spaces provided

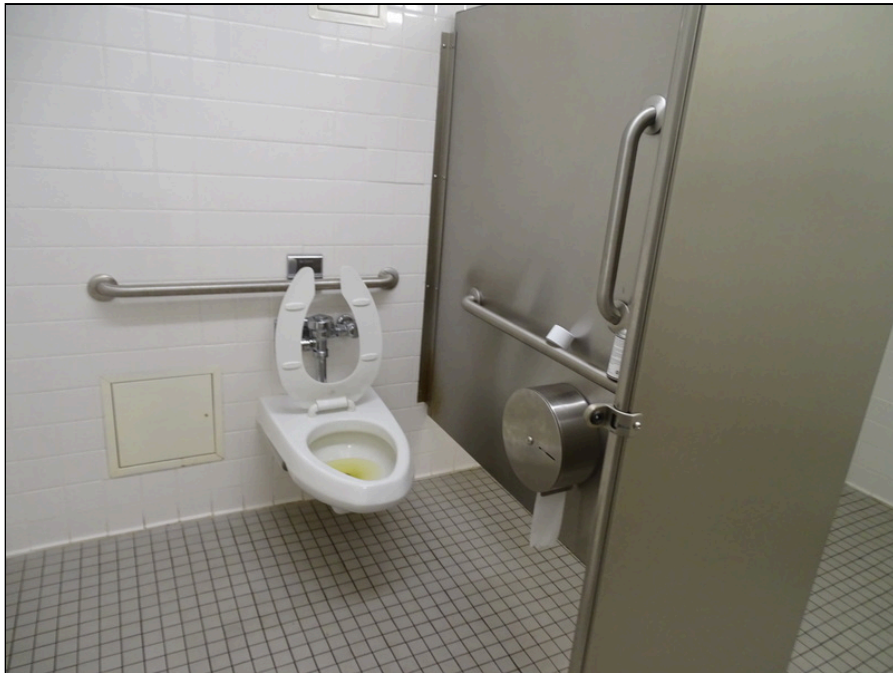
136 - Accessible toilet

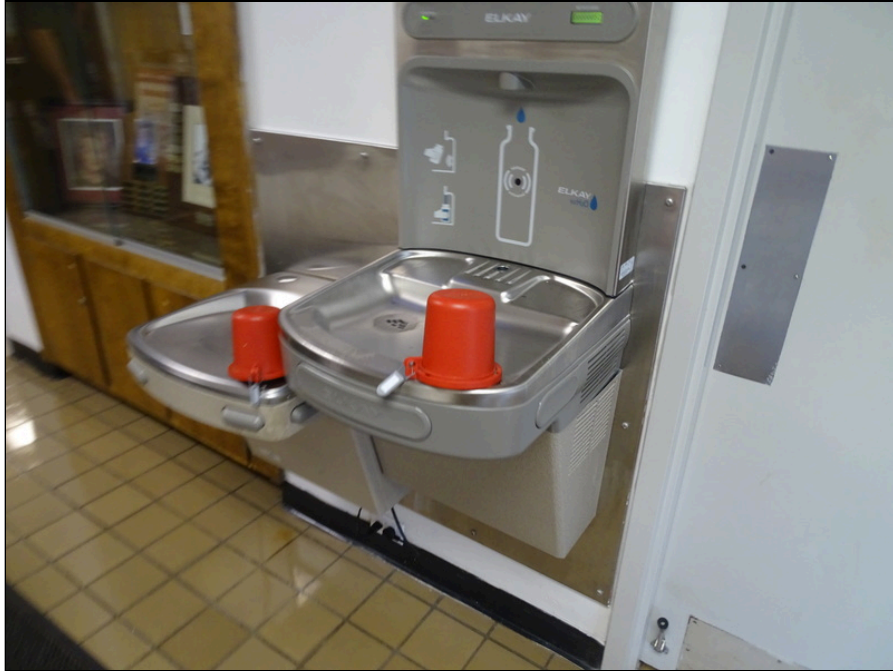
137 - Accessible drinking fountain

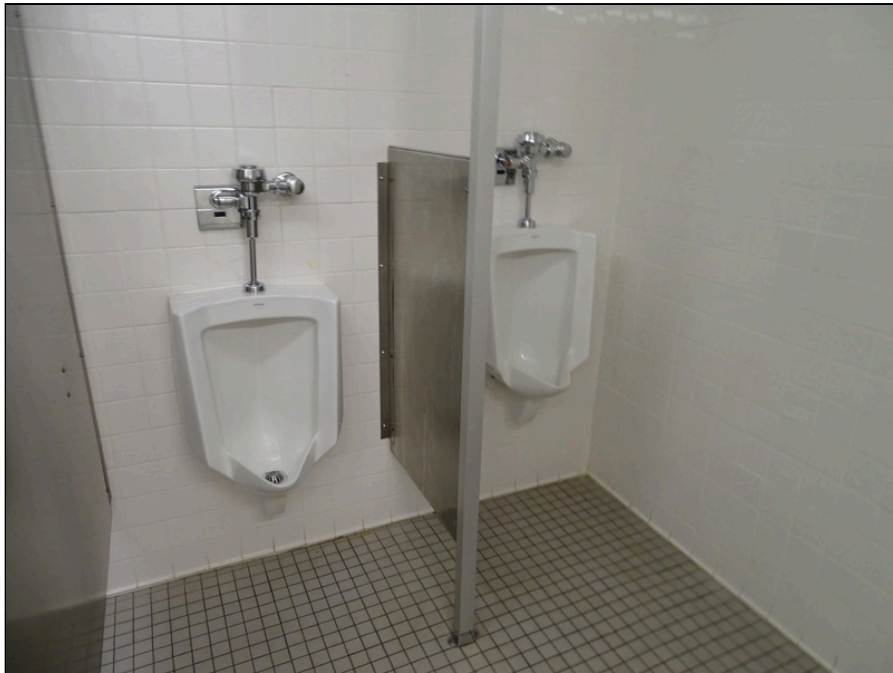
138 - Accessible urinal

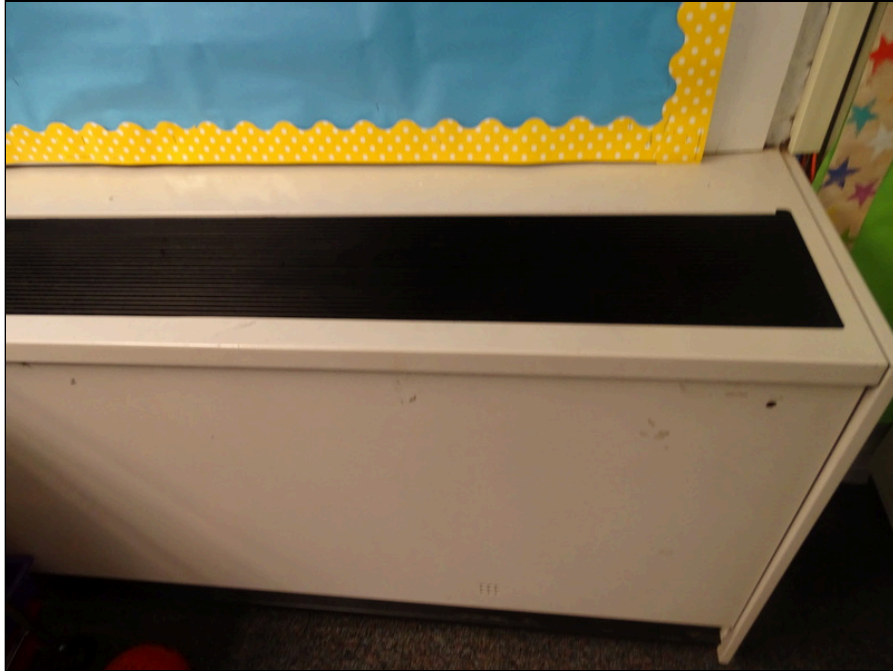
139 - Typical fan coil unit
