JESSUP HOUSE
614 EAST HIGH STREET
CHARLOTTESVILLE, VIRGINIA

ECS PROJECT NO. 46:6713

CITY OF CHARLOTTESVILLE - FACILITIES DEVELOPMENT

Reference: Facility Condition Assessment Report for Jessup House, 614 East High Street,
Charlottesville, Virginia

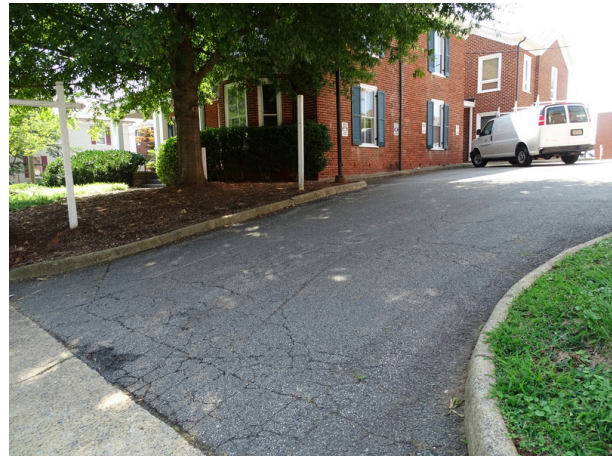
Site access from the US-250 Bus road

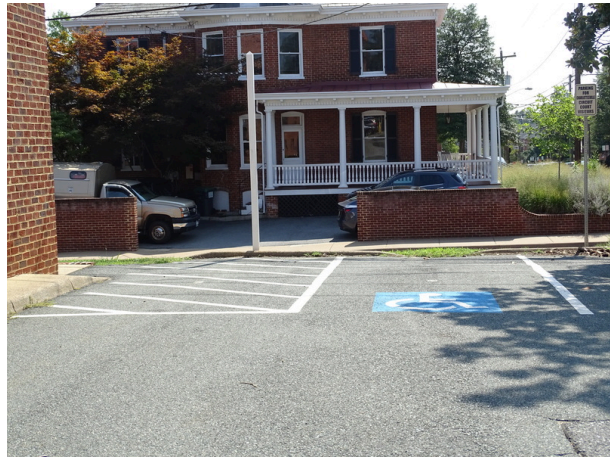
Accessible parking

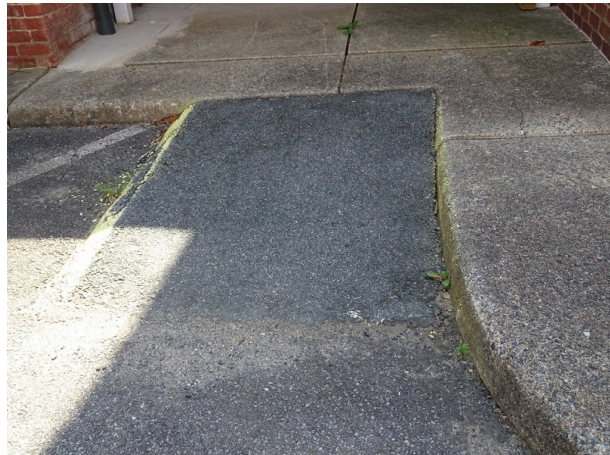
Typical ramp and sidewalk

3.2.5 Flatwork																													
REPAIR CONCRETE STEPS AND SIDEWALKS AS NEEDED	20	19	1	1	EA	\$2,500.00	\$2,500	200%	\$2,500																			\$2,500	\$5,000

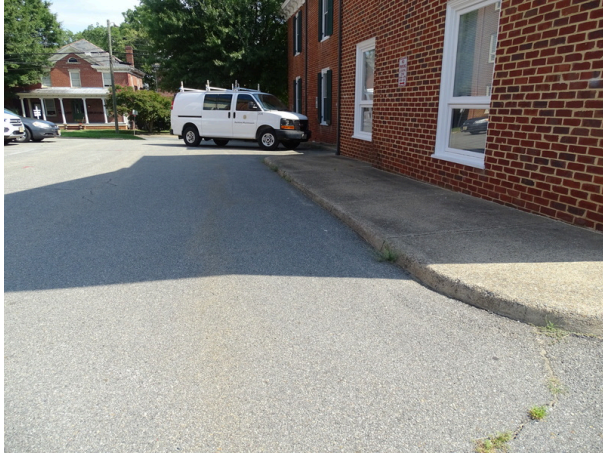
Concrete sidewalks and asphalt pavements

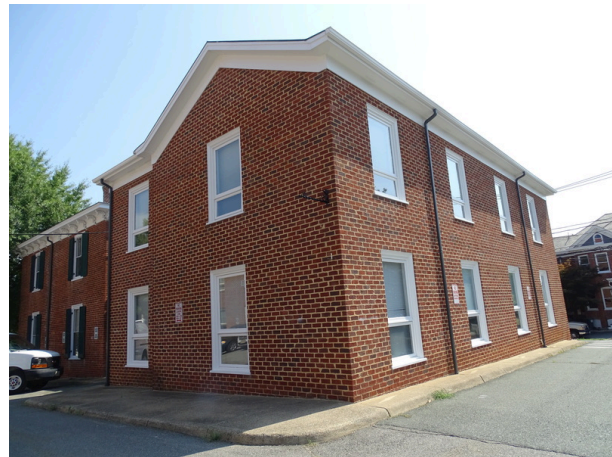
Building exterior wall finishes

3.3.3 Building Exteriors																													
REPOINT BRICKWORK - PAINT AND REPAIR WOOD TRIM AS NEEDED	20	19	1	1	LS	\$20,000.00	\$20,000	200%	\$20,000																			\$20,000	\$40,000

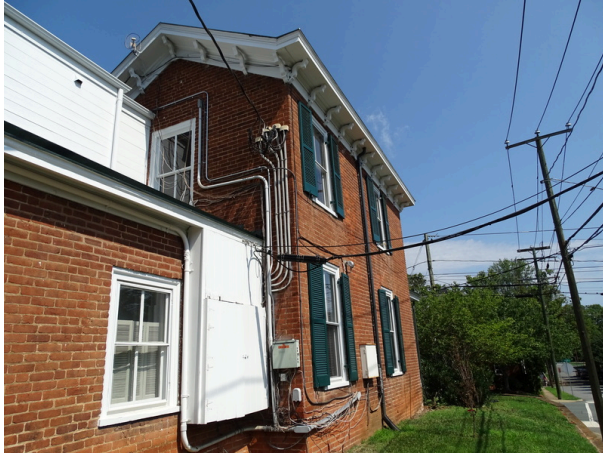
Building exterior wall

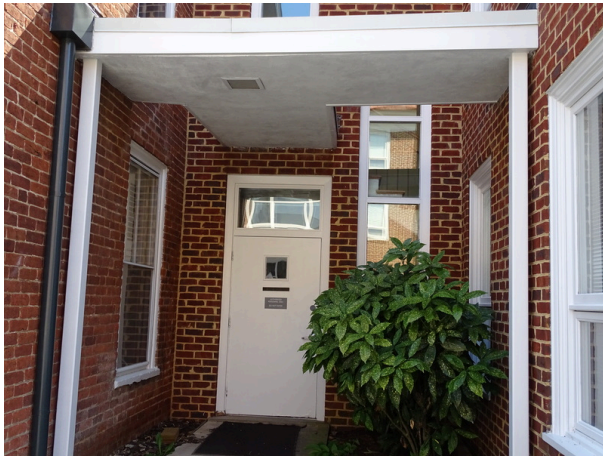
The main entrance is a Wood door. The main entrance door was generally in good condition. Exterior doors typically have an expected useful life of 20 to 30 years. The north entrance door was older and reportedly difficult to operate. We recommend replacing the the northwest entrance door as a maintenance item.

Main entrance

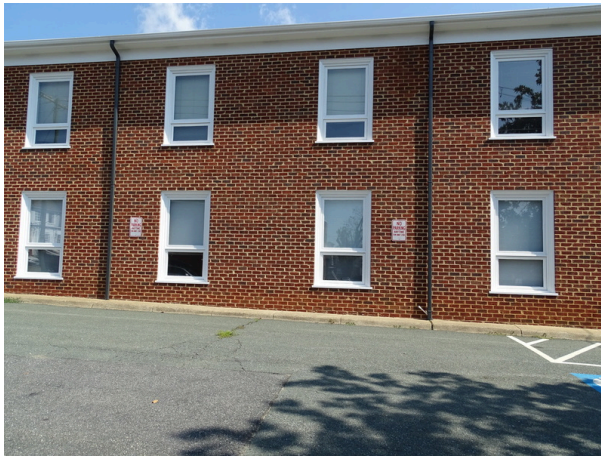
The window system for the building primarily consists of Wood frame double pane - operable window units. The window units were recently replaced with the older wood framing kept in place. The condition of the wood framing ranged from good to poor. The expected useful life of windows is typically 30 years. The window units were in generally in fair condition. We recommend the windows and wood framing be replaced during the report period as needed.

Building exterior wall and windows

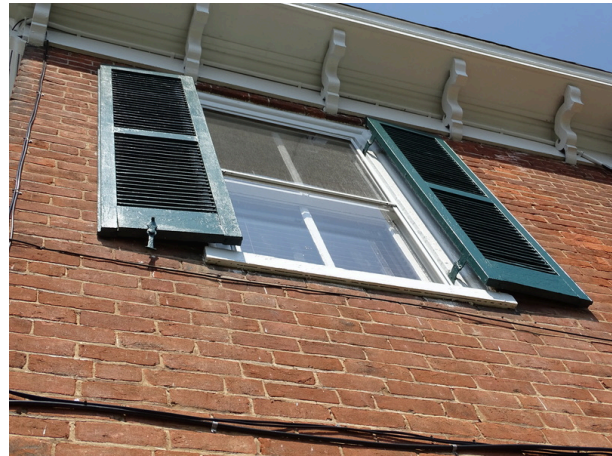
Typical exterior window

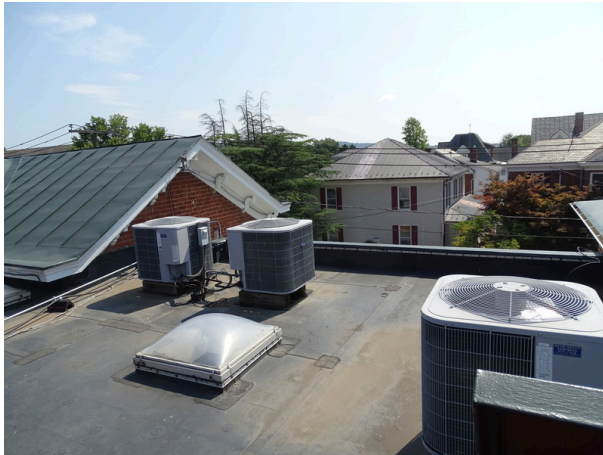
Roofing system overview

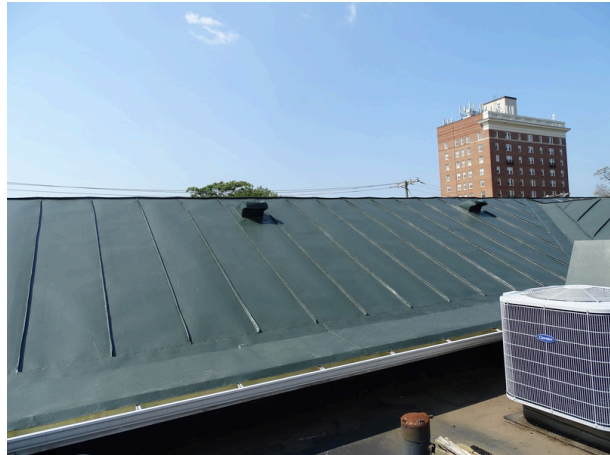
Metal roof overview

3.3.6 Roofing Systems																													
CLEAN AND PAINT METAL ROOFING SYSTEM	10	1	9	1	LS	\$45,000.00	\$45,000	200%								\$45,000											\$45,000		\$90,000
REPLACE SINGLE-PLY ROOFING SYSTEM	20	19	1	750	SF	\$14.00	\$10,500	200%	\$10,500																			\$10,500	\$21,000
REPLACE SKYLIGHTS	20	15	5	2	EA	\$1,500.00	\$3,000	200%	\$3,000																			\$3,000	\$6,000

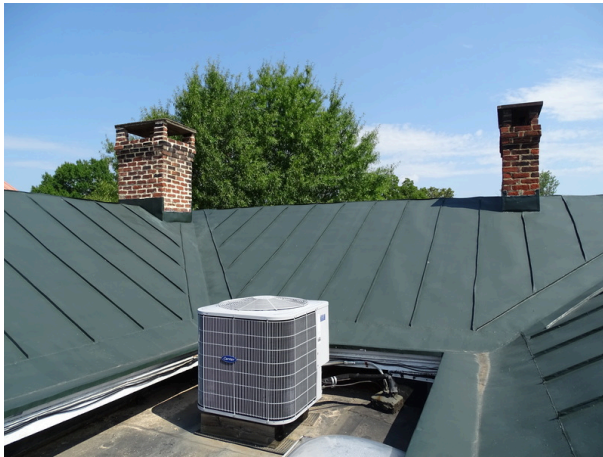
Metal roofing system overview

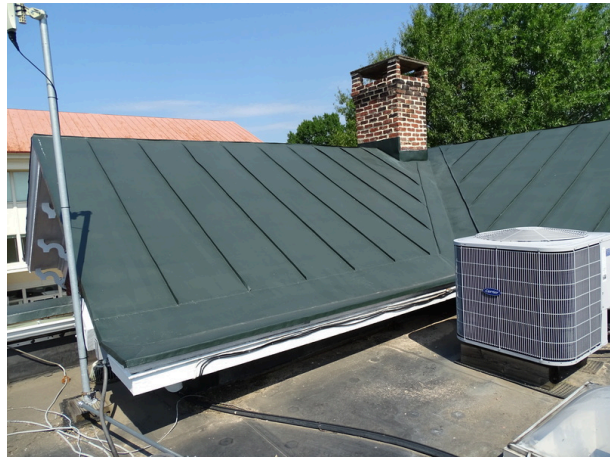
Metal roofing system overview

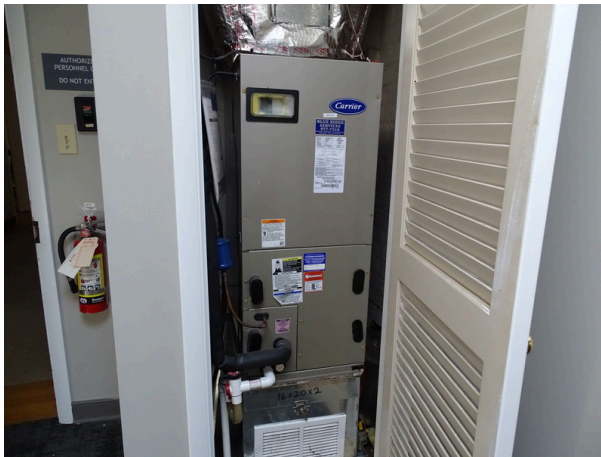
Typical air handler located in second floor closet

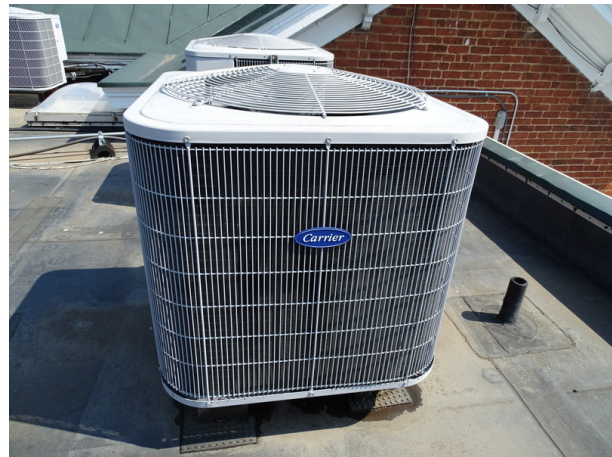
Typical condensing unit

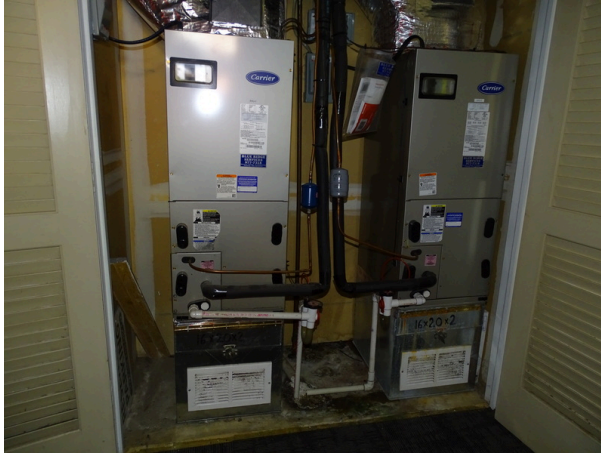
Typical air handler

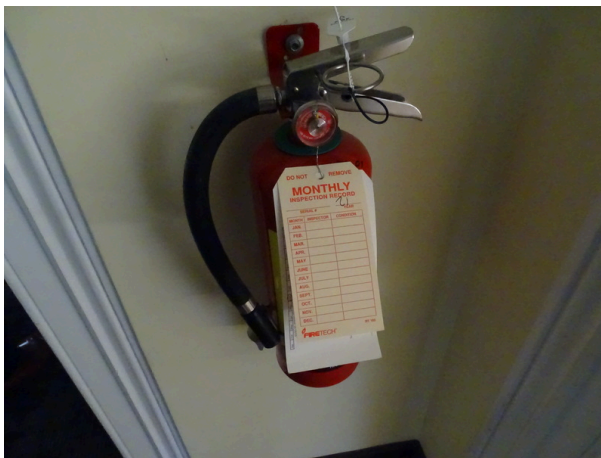
The fire suppression system consists of Fire extinguishers. Fire extinguishers were observed throughout the building. The fire extinguishers were observed to have inspection tags issued in July 2021. These devices are required to be inspected annually. Replacement of the fire extinguishers is considered routine maintenance.

Typical fire extinguishers

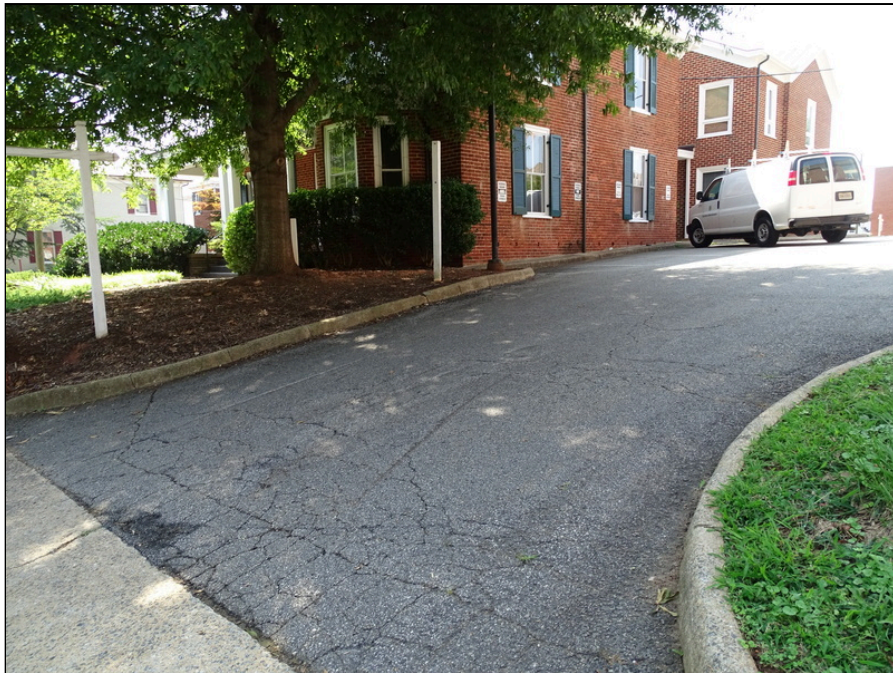
6 - Site access from the US-250 Bus road

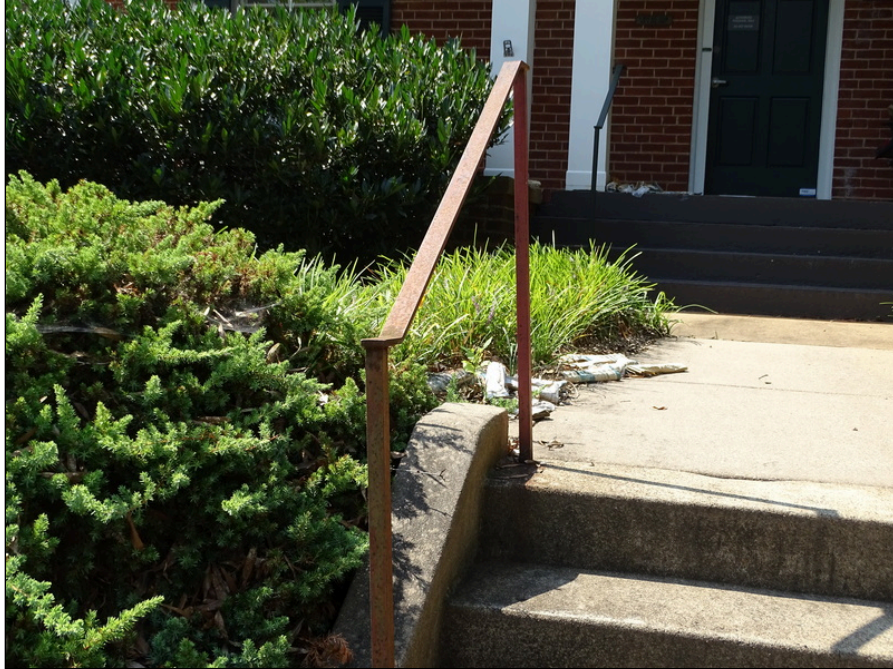
11 - Exterior concrete stair handrail - note not with standard height

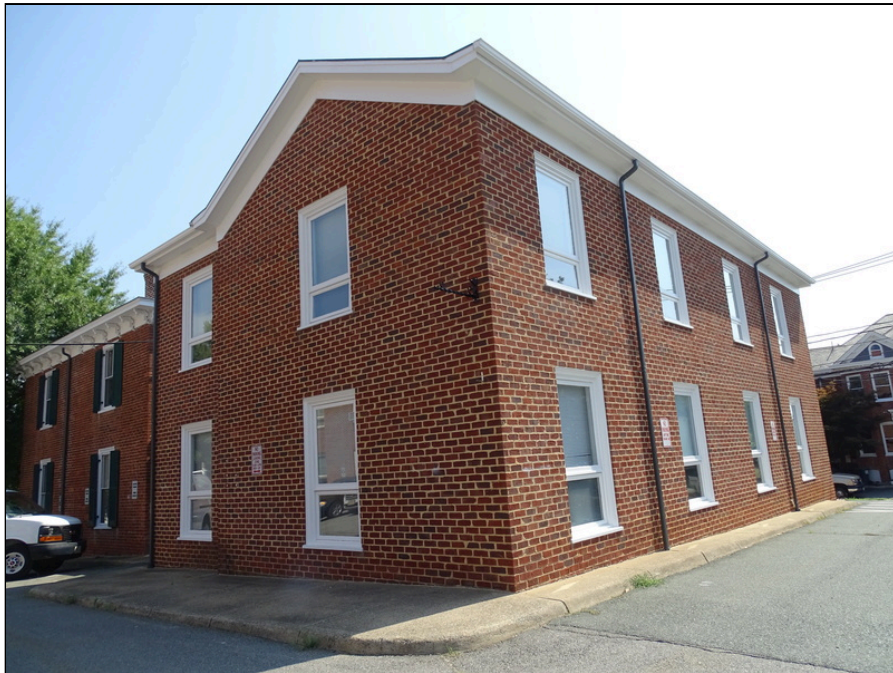
20 - Building exterior wall finishes

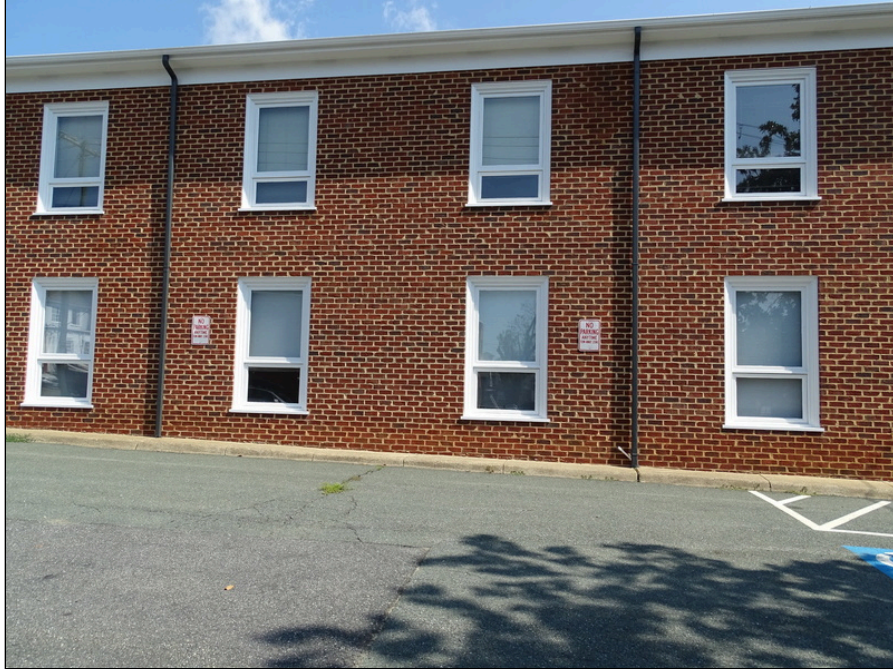
21 - Building exterior wall and windows

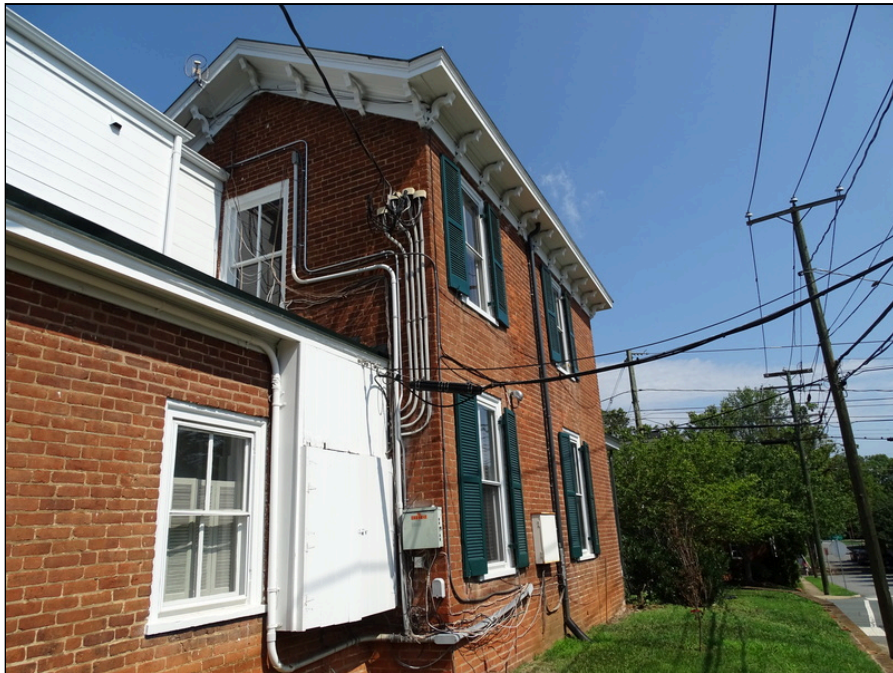
22 - Building exterior wall

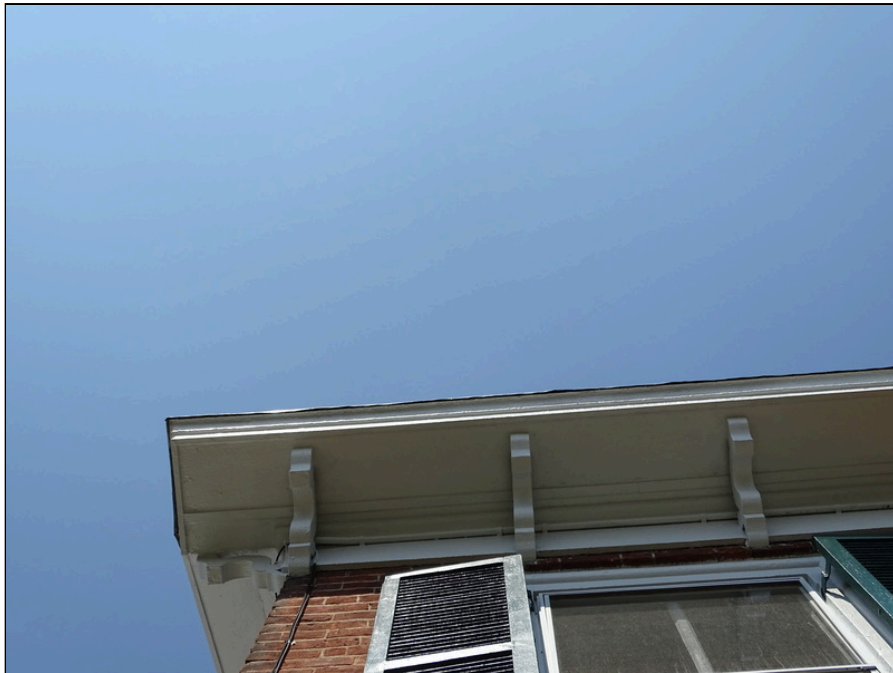
24 - Typical wooden cornice

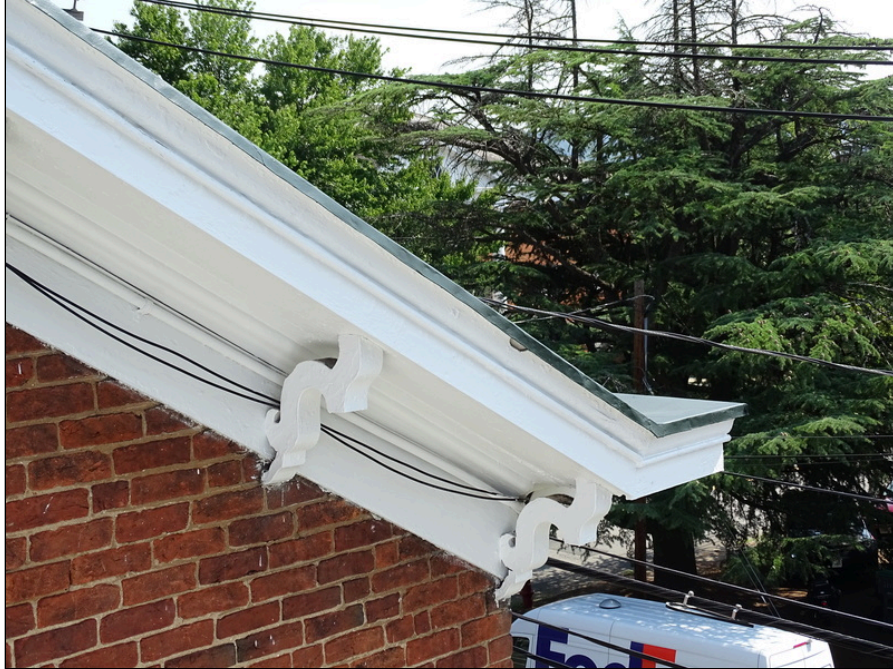
25 - Typical wooden cornice

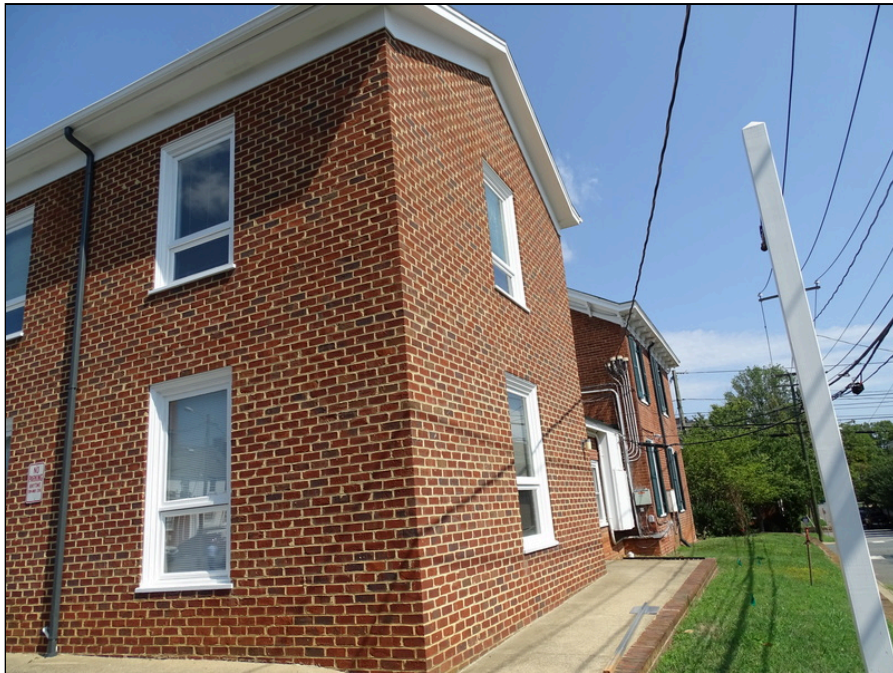
26 - Gutter and downspouts

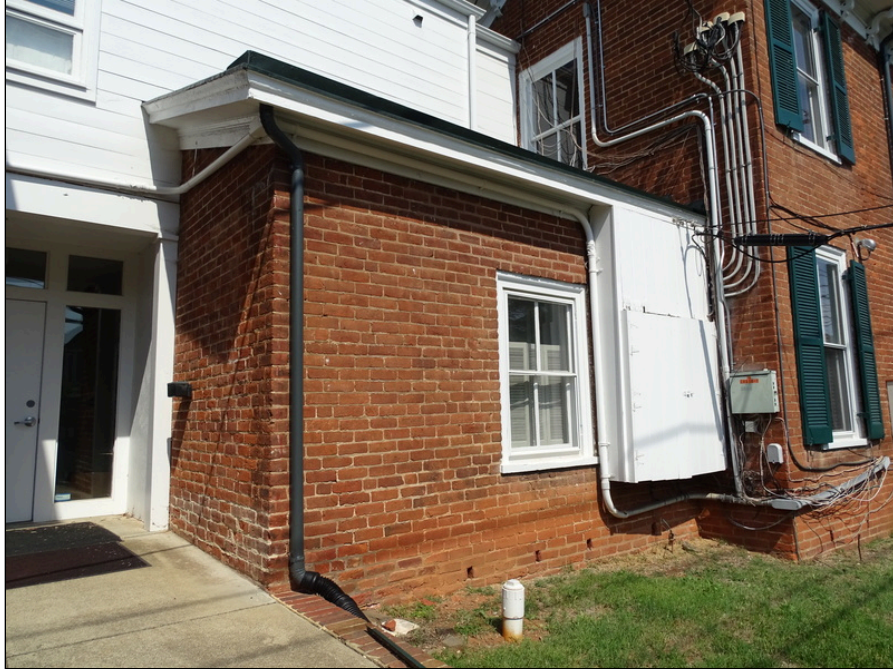
27 - Gutter and downspouts overview

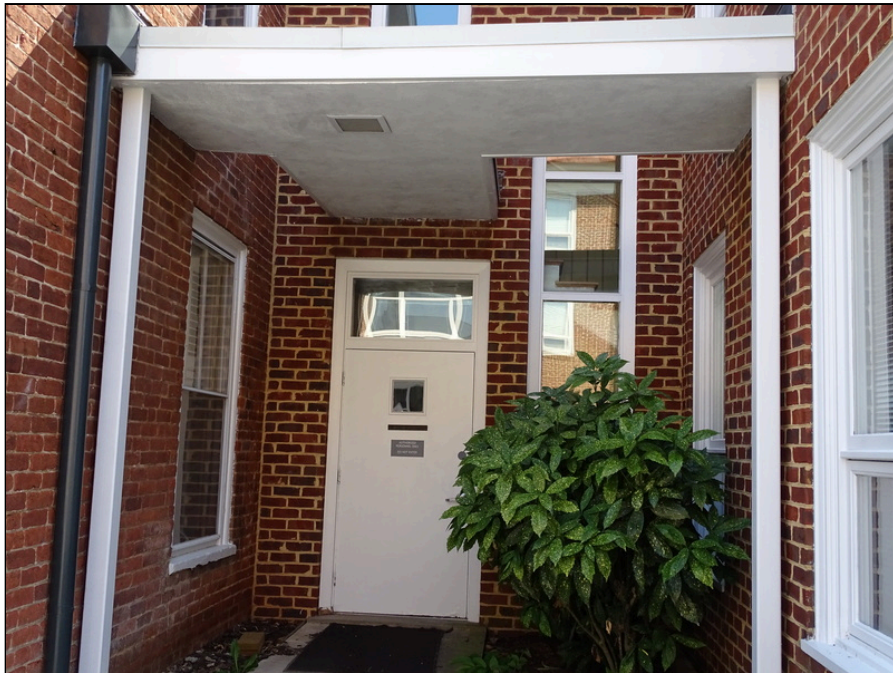
28 - Main entrance

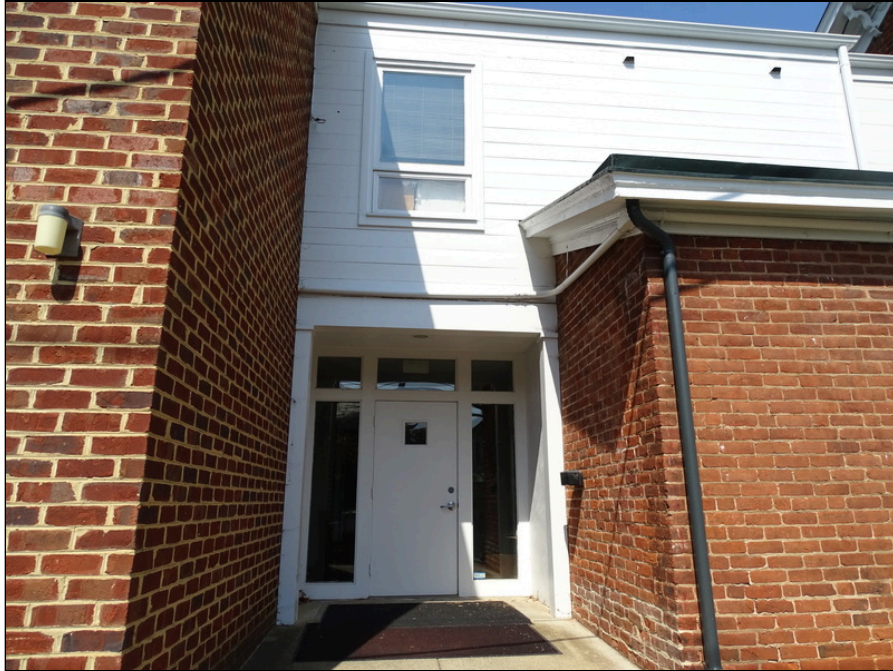
29 - Door from back of the building

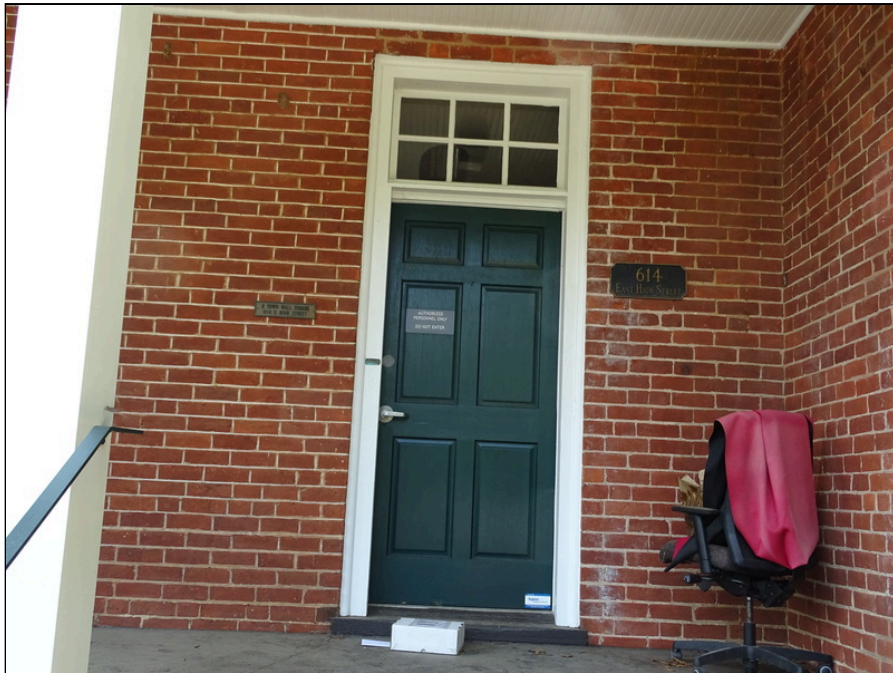
30 - Personnel wood door

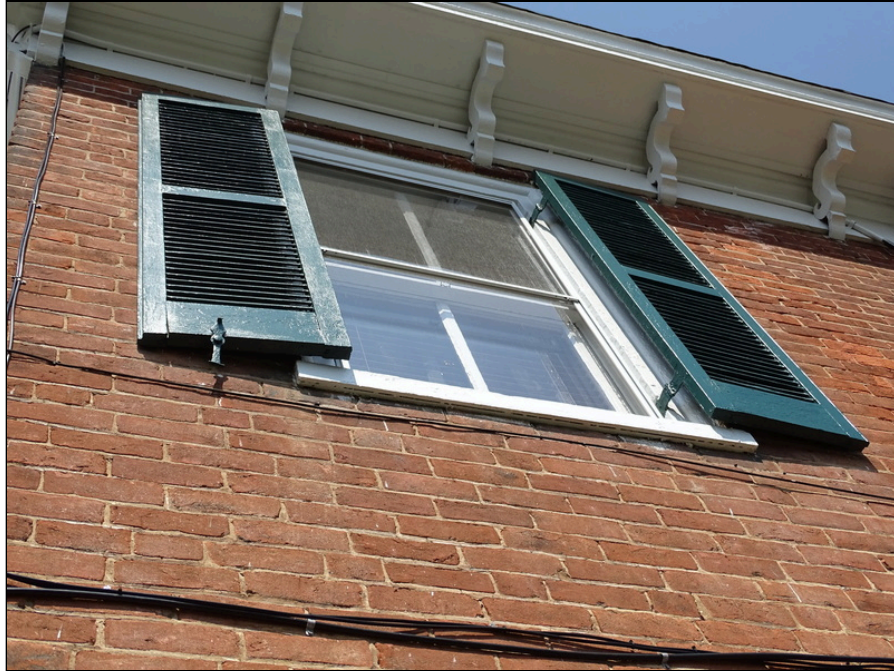
31 - Typical exterior window

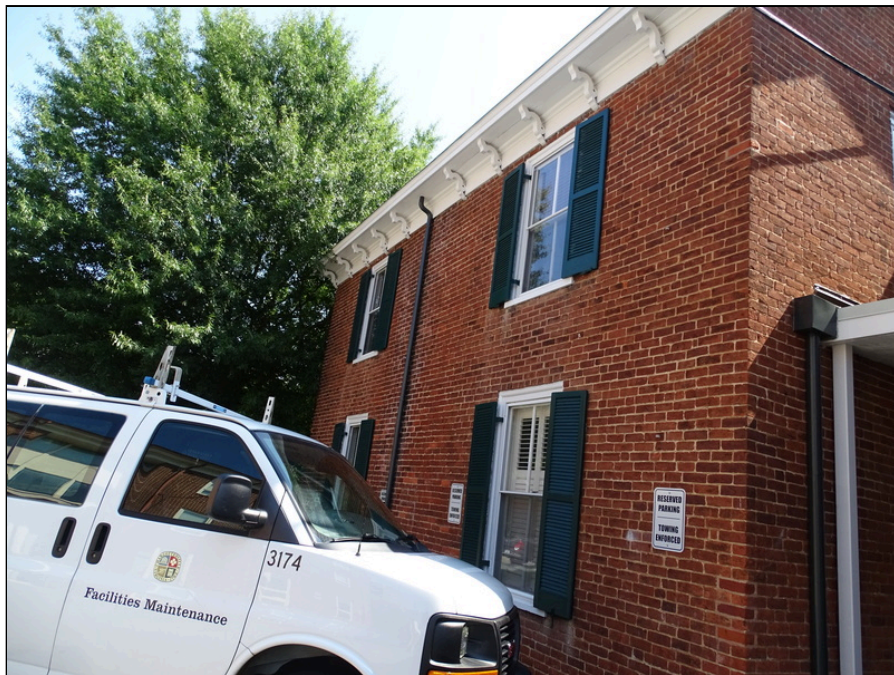
32 - Typical exterior windows

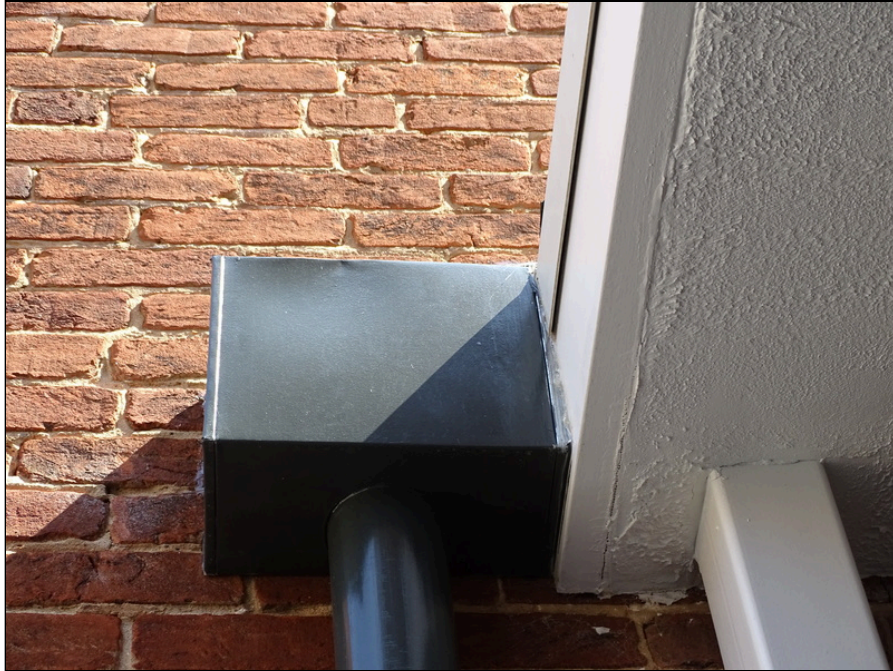
33 - Typical scupper overview

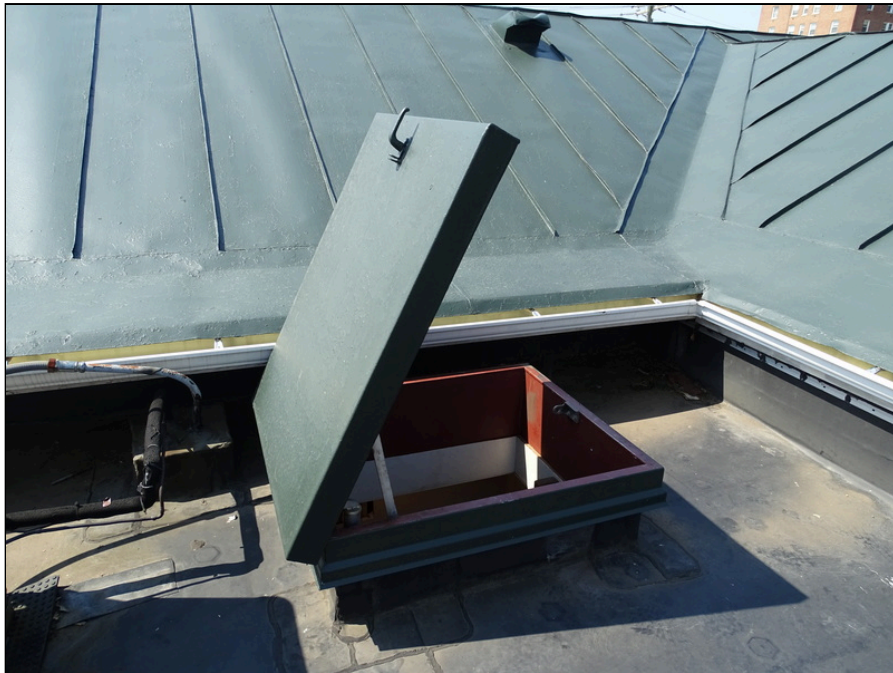
34 - Roof access

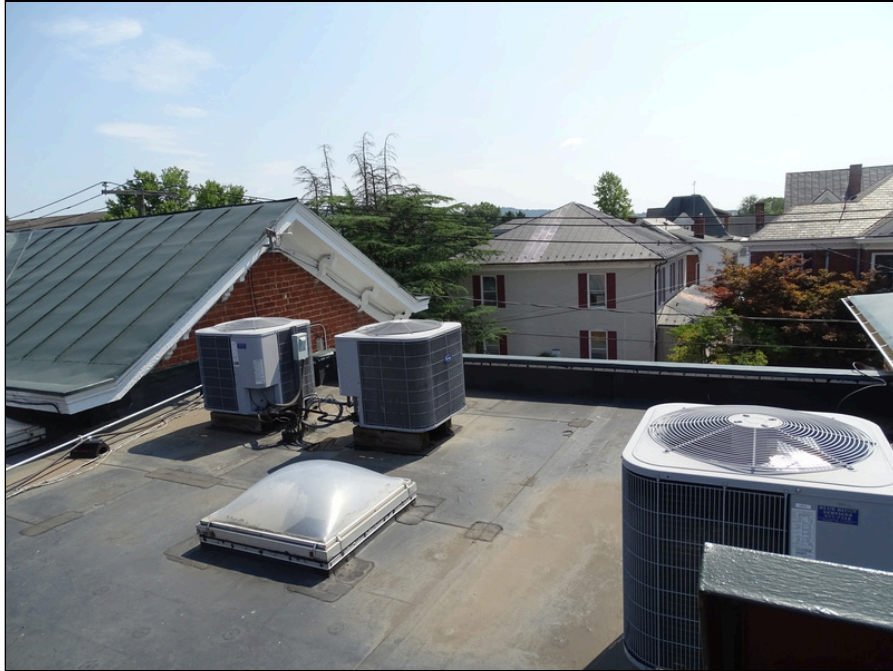
35 - Roofing system overview

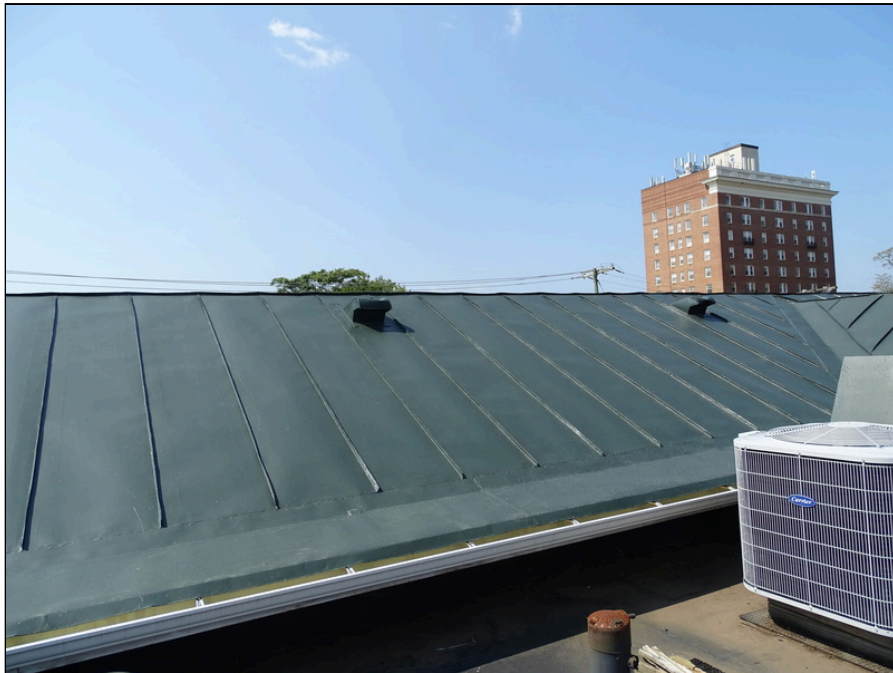
36 - Metal roof overview

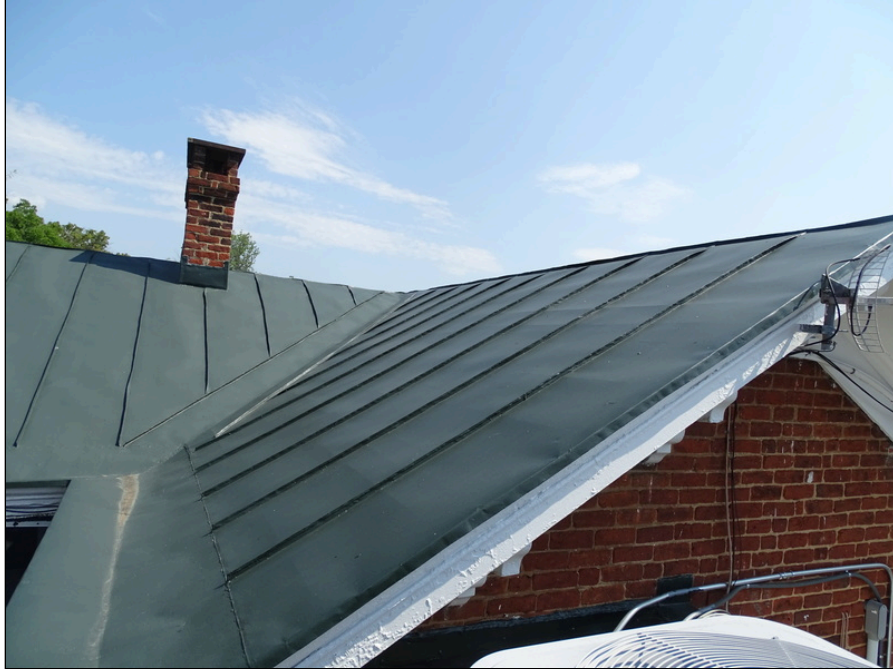
37 - Metal roofing system overview

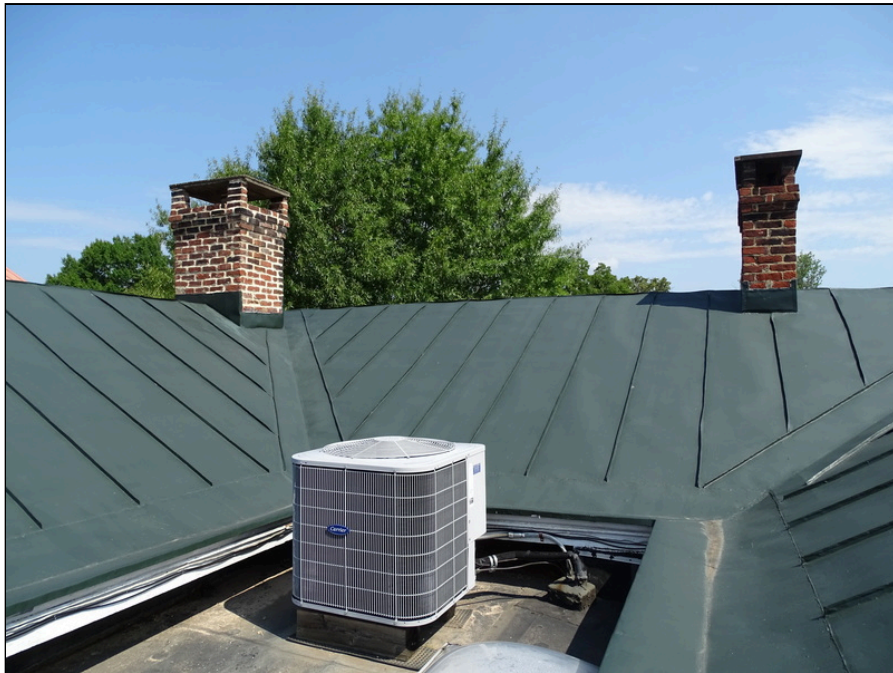
38 - Metal roofing system overview

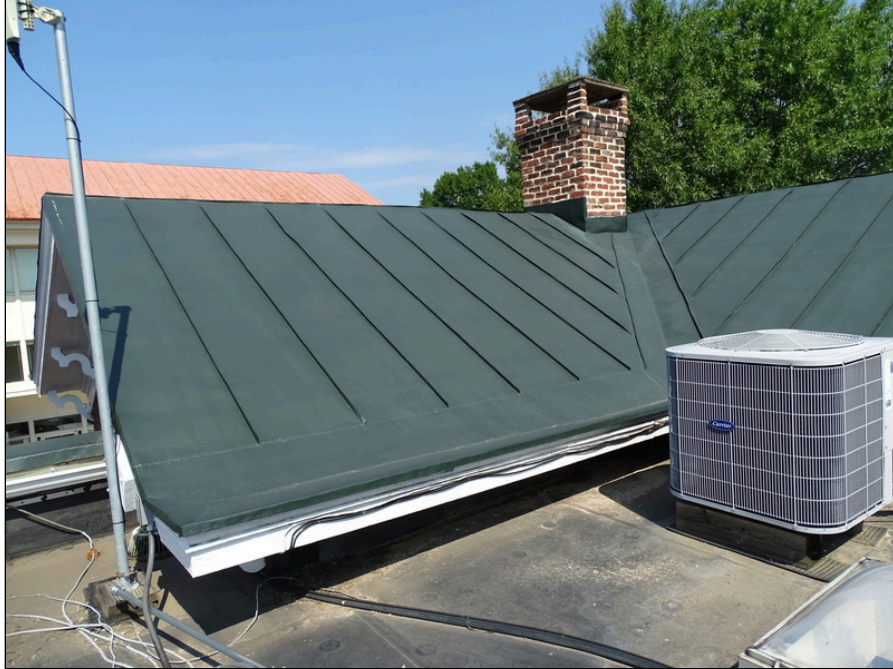
39 - Metal roofing system overview

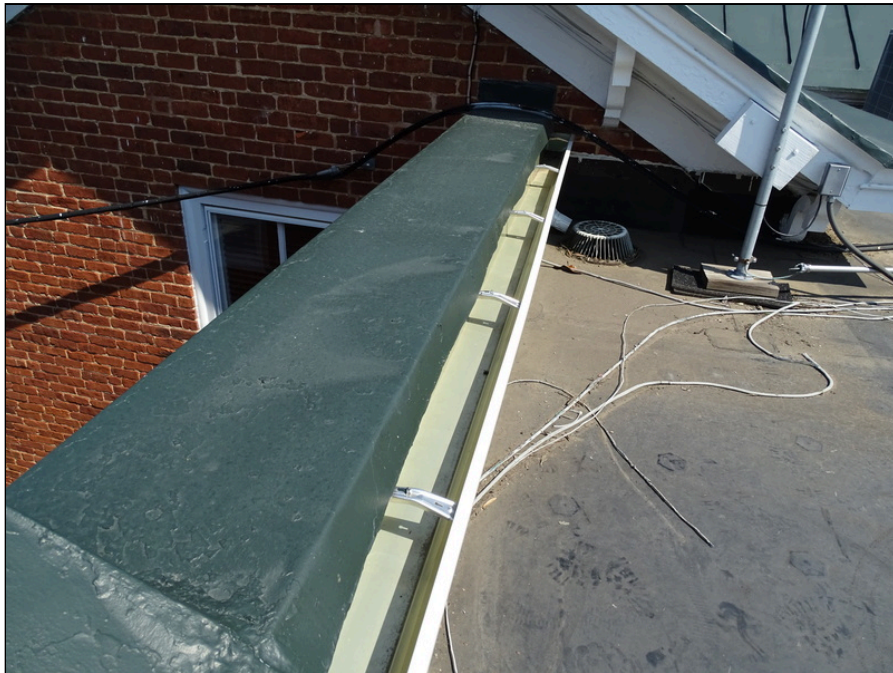
40 - Typical gutter overview

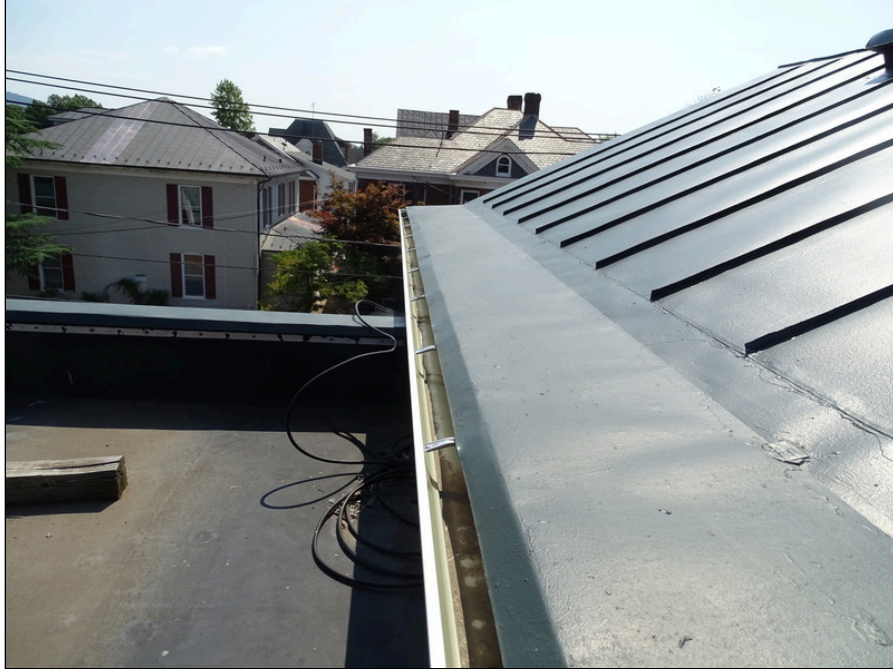
41 - Typical gutter overview

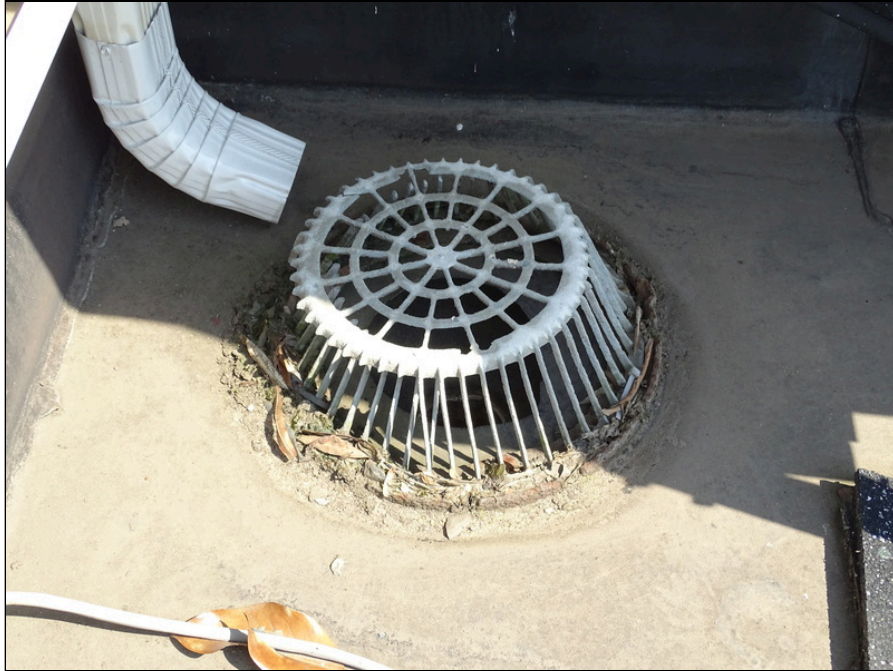
43 - Typical downspouts and internal drain overview - note need maintenance

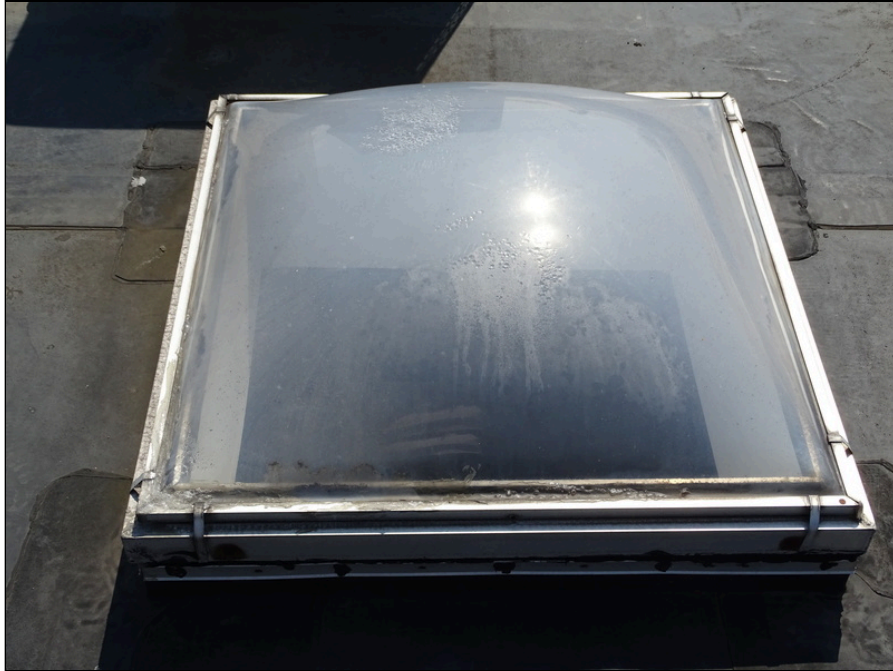
45 - Typical skylight

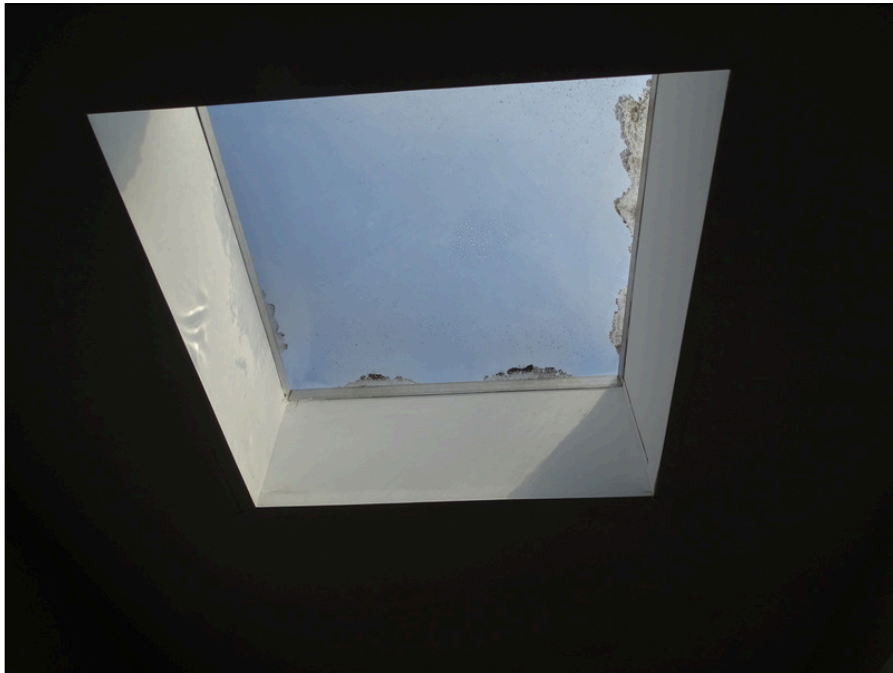
46 - Typical skylight overview from inside

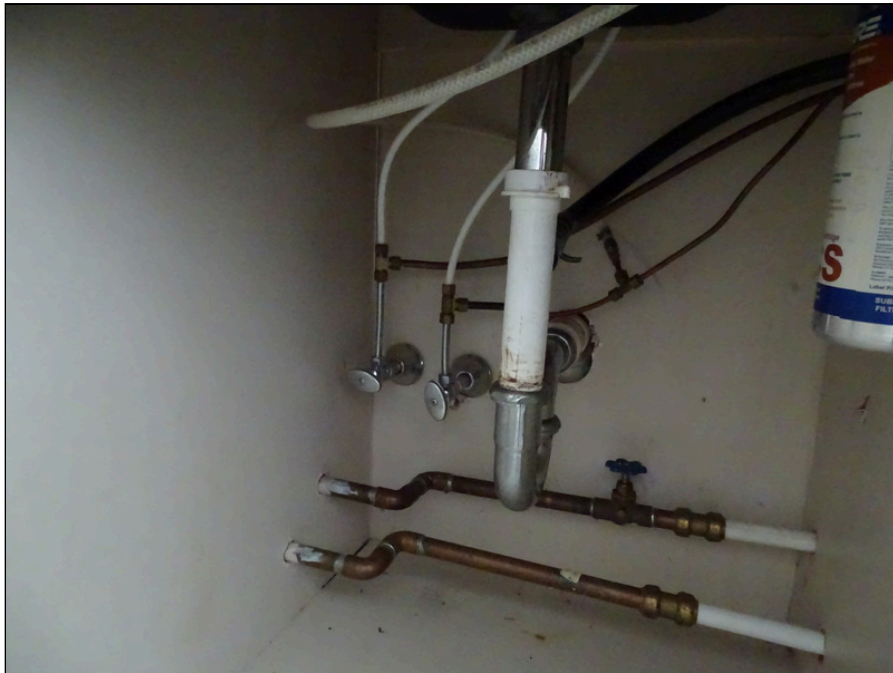
48 - Typical water piping system

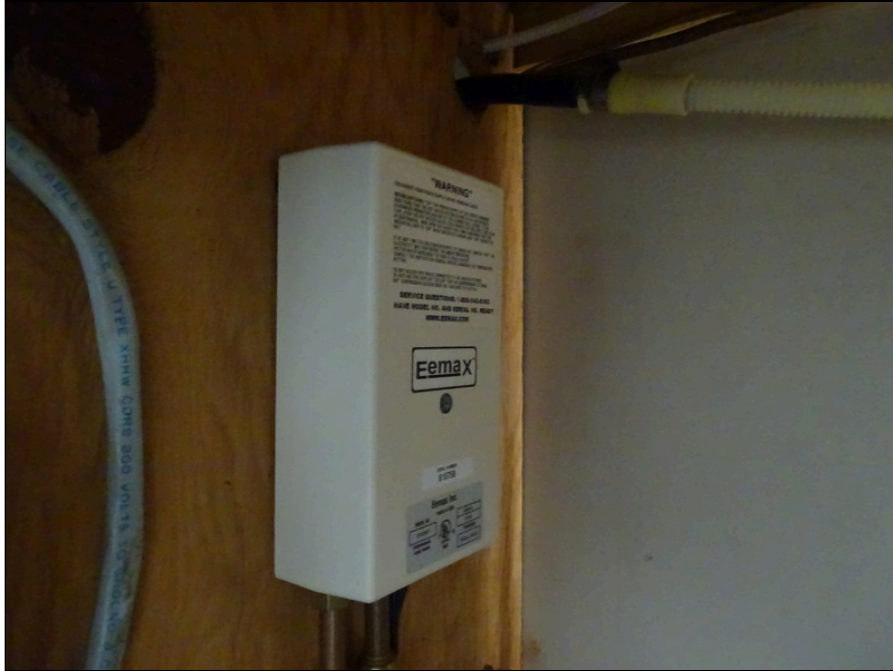
49 - Tankless water heater

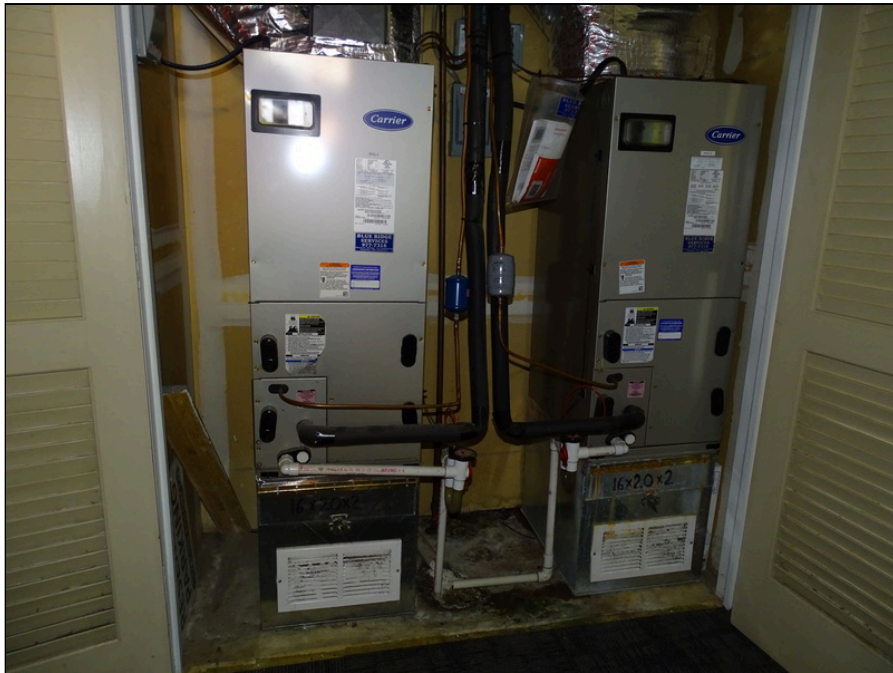
50 - Typical air handler
