JESSUP HOUSE
614 EAST HIGH STREET
CHARLOTTESVILLE, VIRGINIA

ECS PROJECT NO. 46:6713

CITY OF CHARLOTTESVILLE - FACILITIES DEVELOPMENT

Reference: Facility Condition Assessment Report for Jessup House, 614 East High Street,
Charlottesville, Virginia

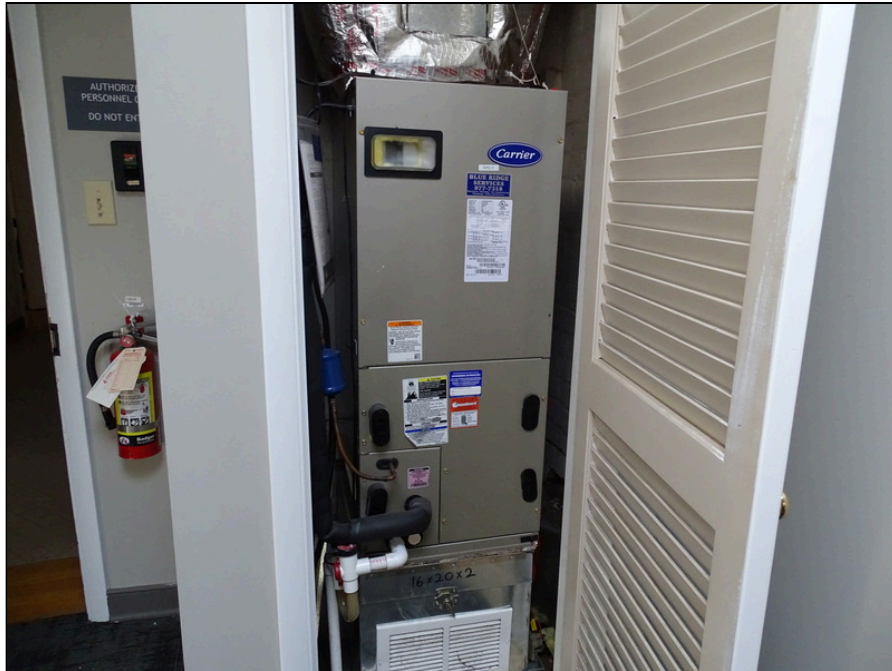
51 - Typical air handler located in second floor closet

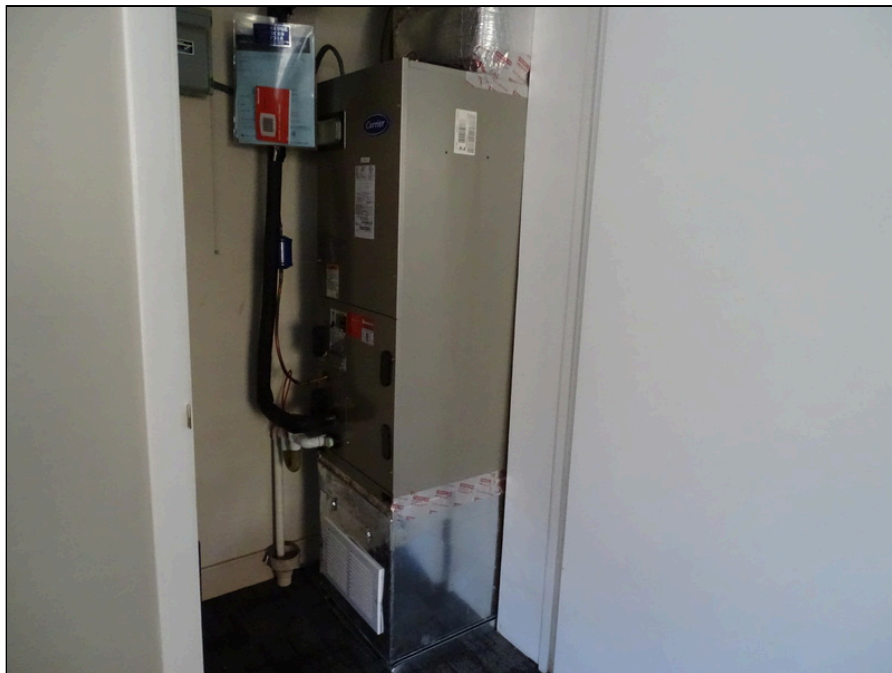
52 - Typical air handler located in second floor closet

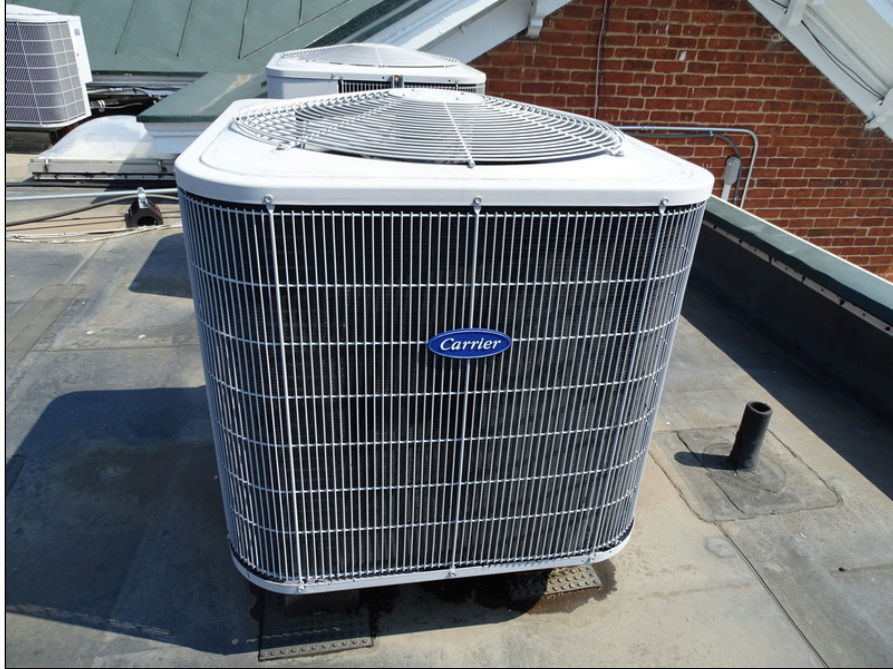
53 - Typical condensing unit

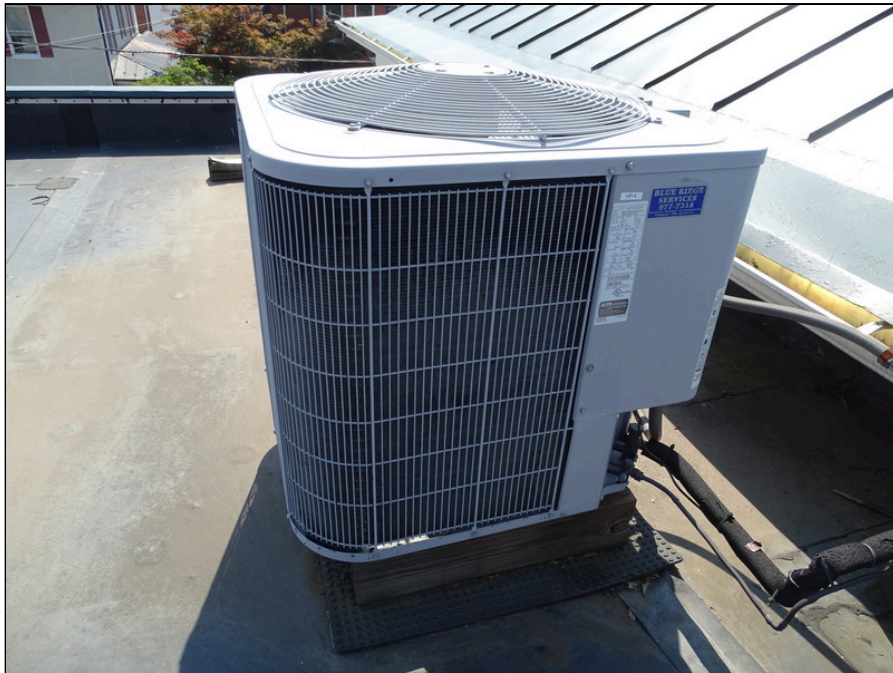
54 - Typical condensing unit

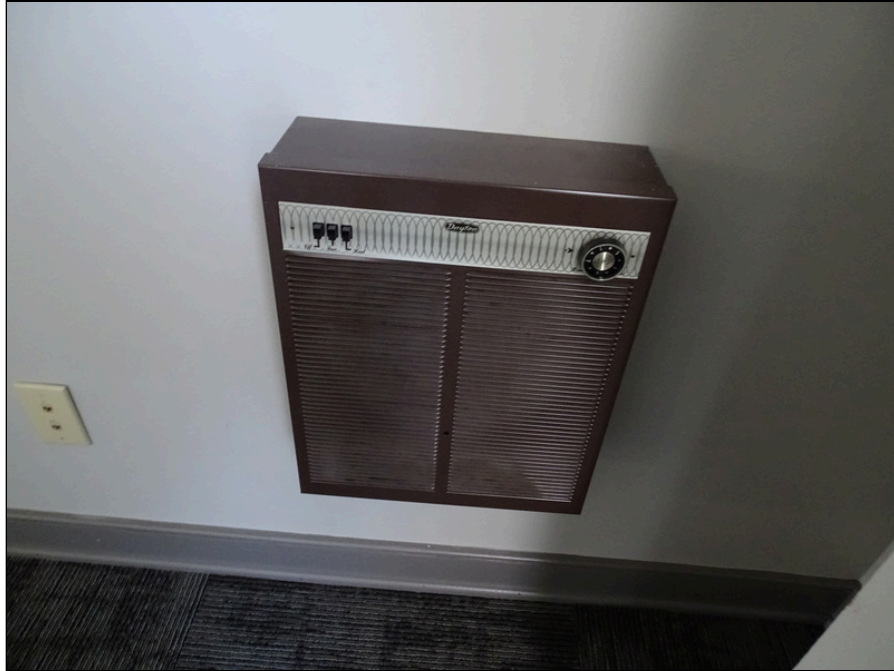
55 - Typical space heater

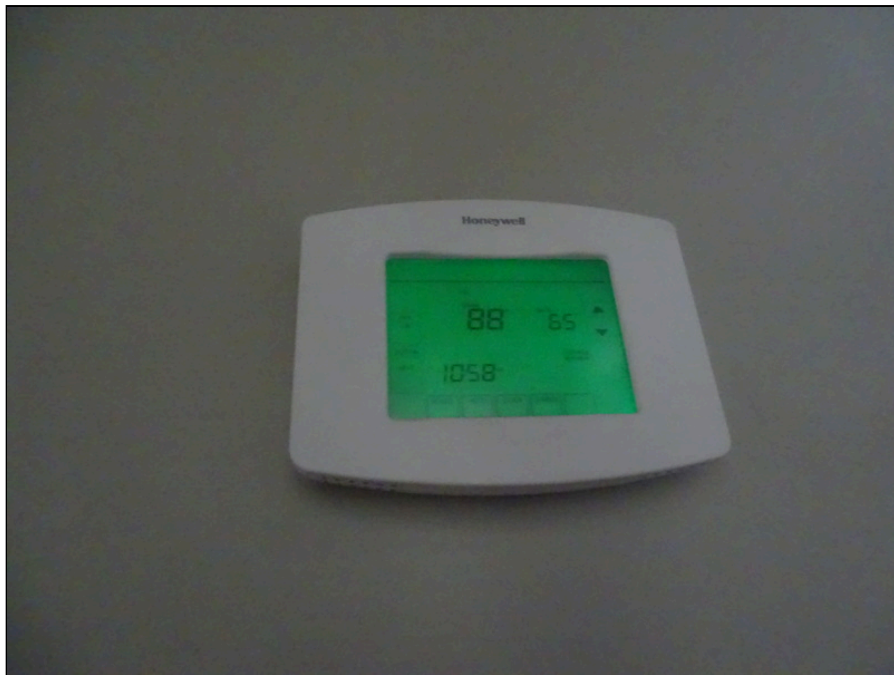
56 - Typical thermostat

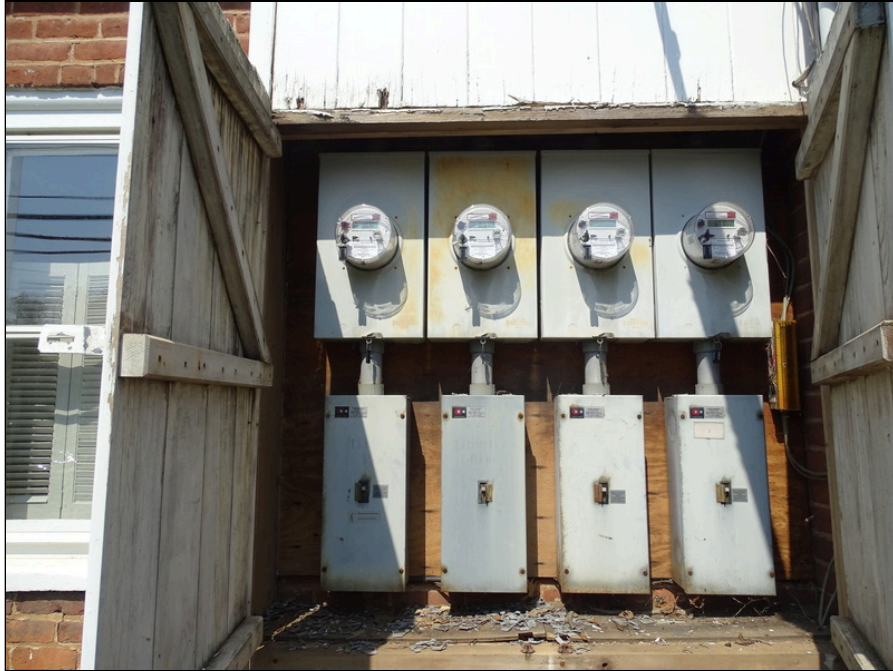
57 - Typical electric service panels and meters

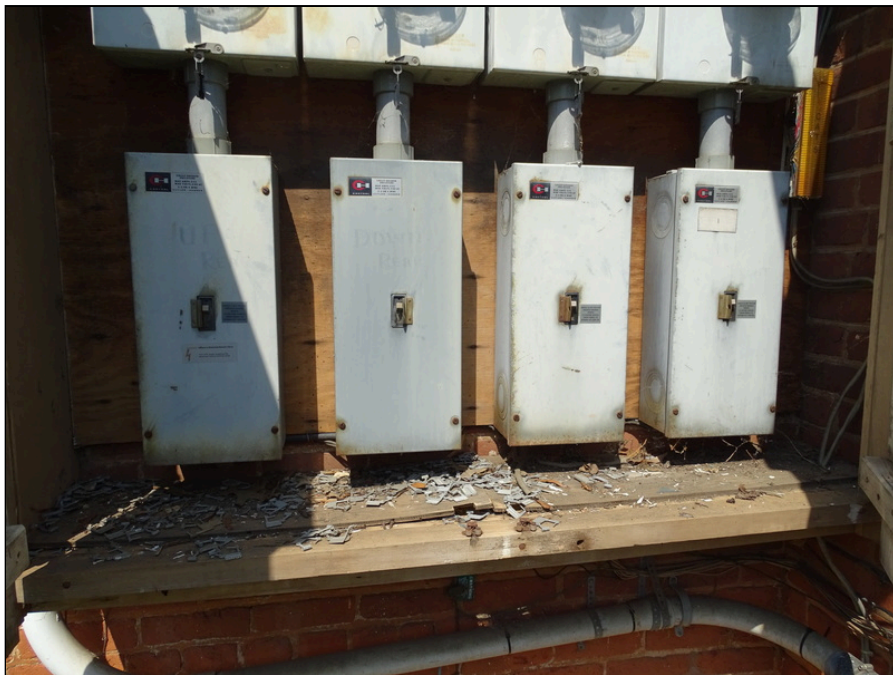
58 - Main electrical disconnects

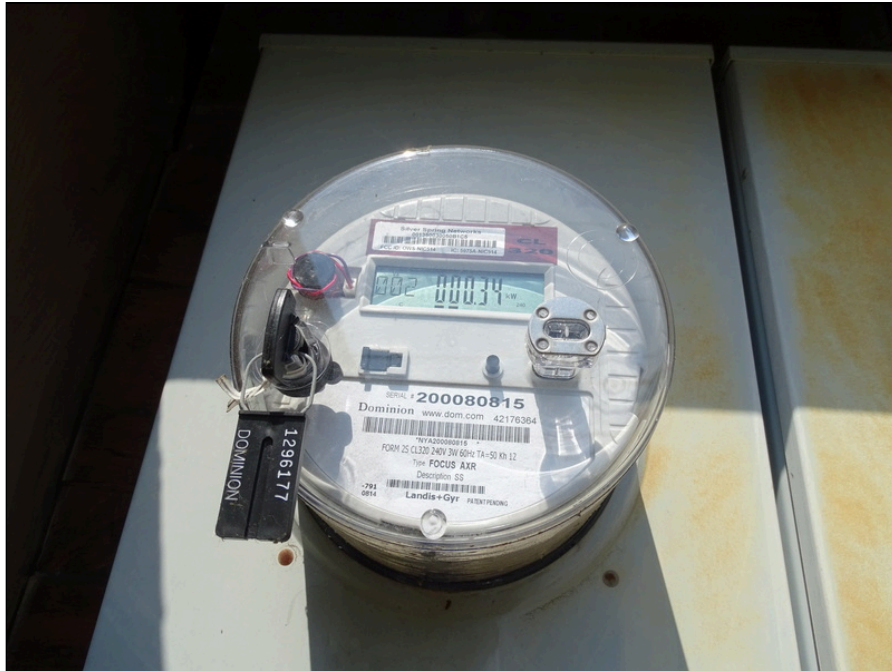
59 - Typical electrical meter

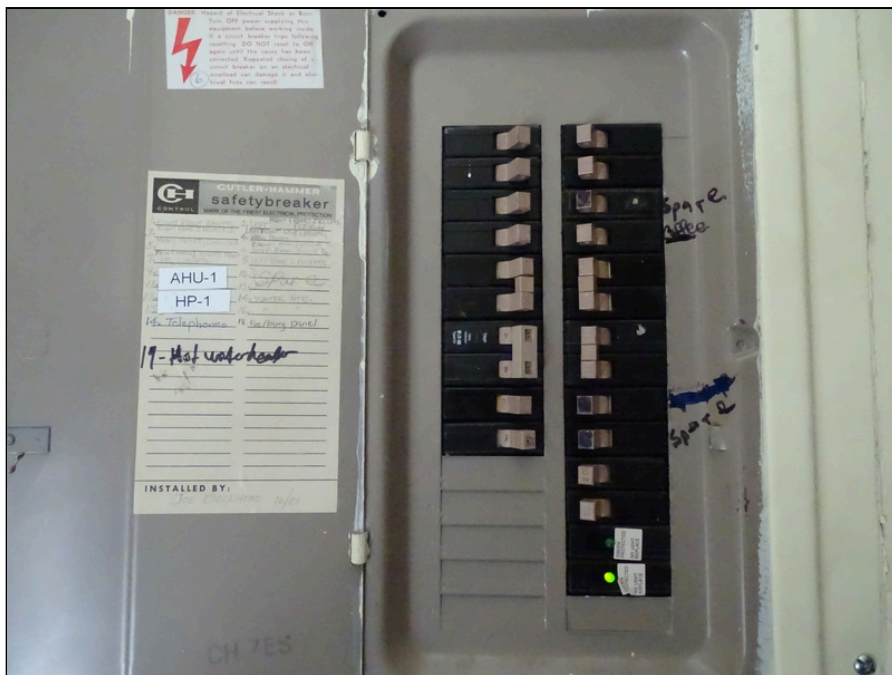
60 - Typical circuit breaker panel

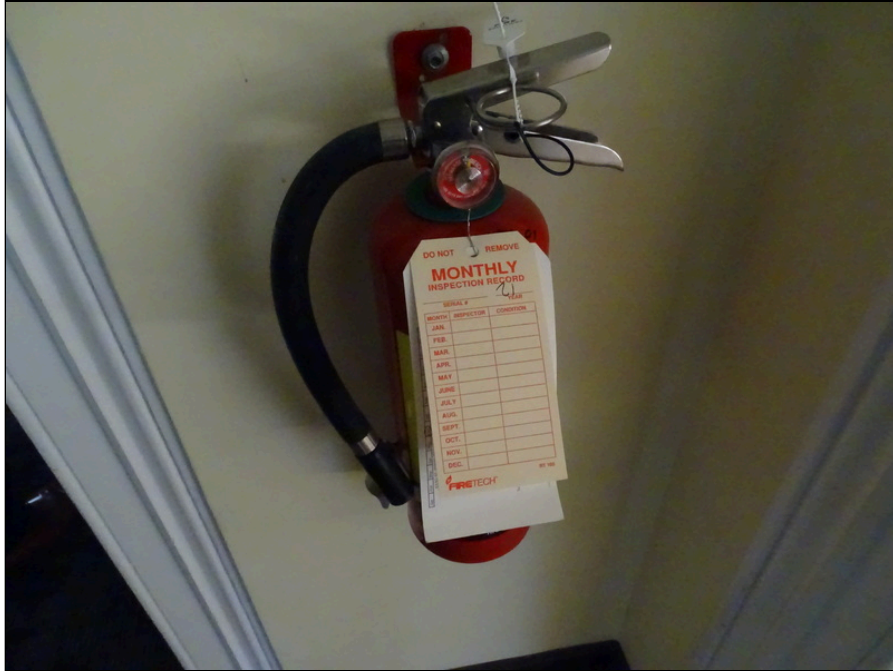
61 - Typical fire extinguishers

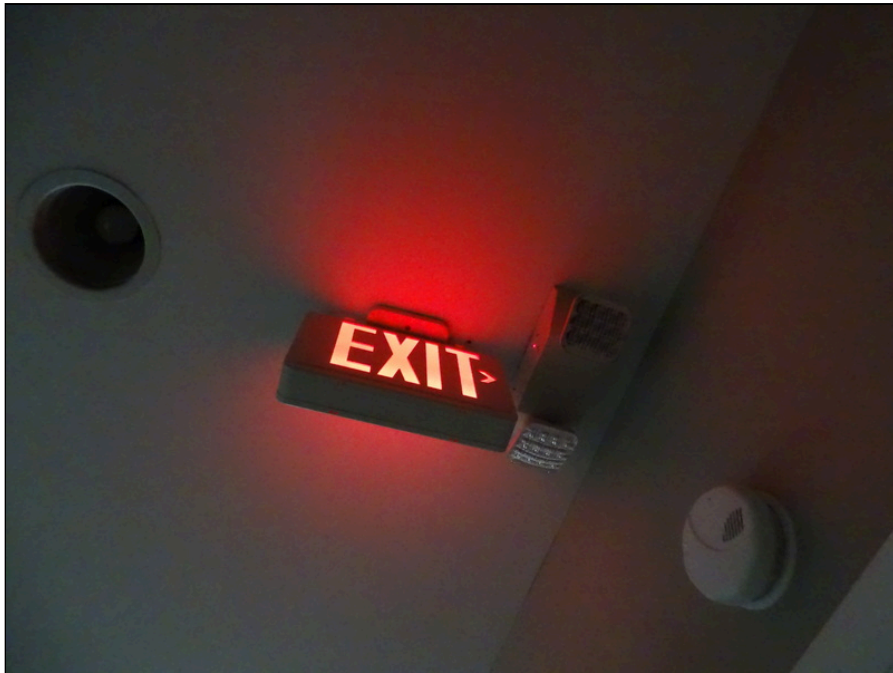
62 - Typical exit sign

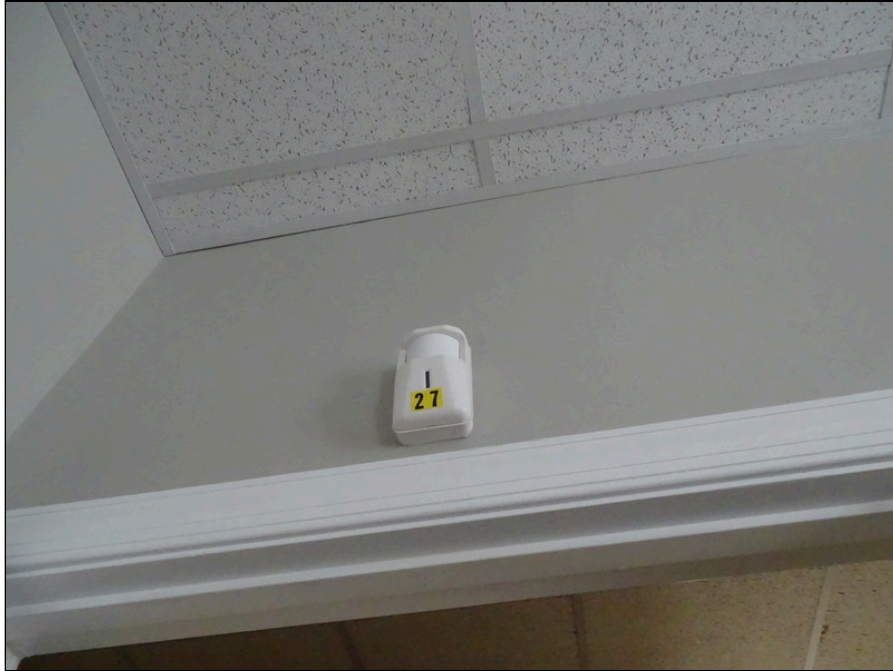
63 - Typical motion sensor

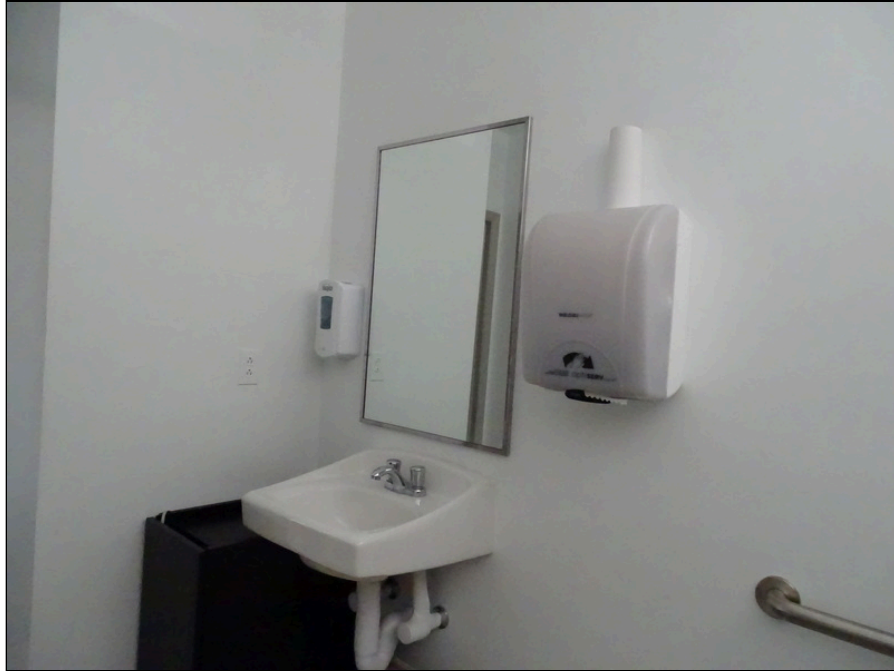
65 - Accessible restroom interior

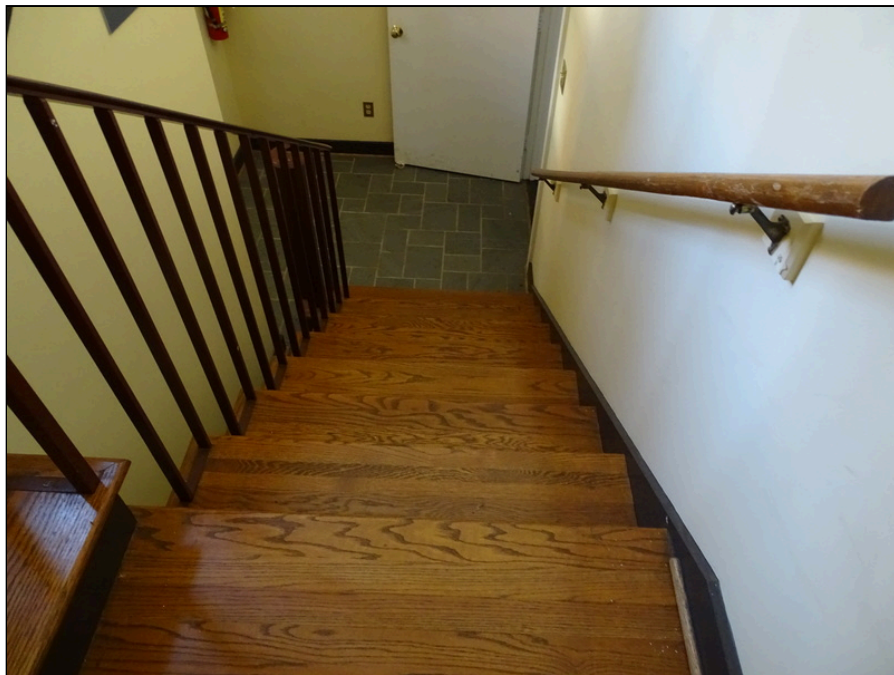
66 - Interior finishes of entrance area and stairs

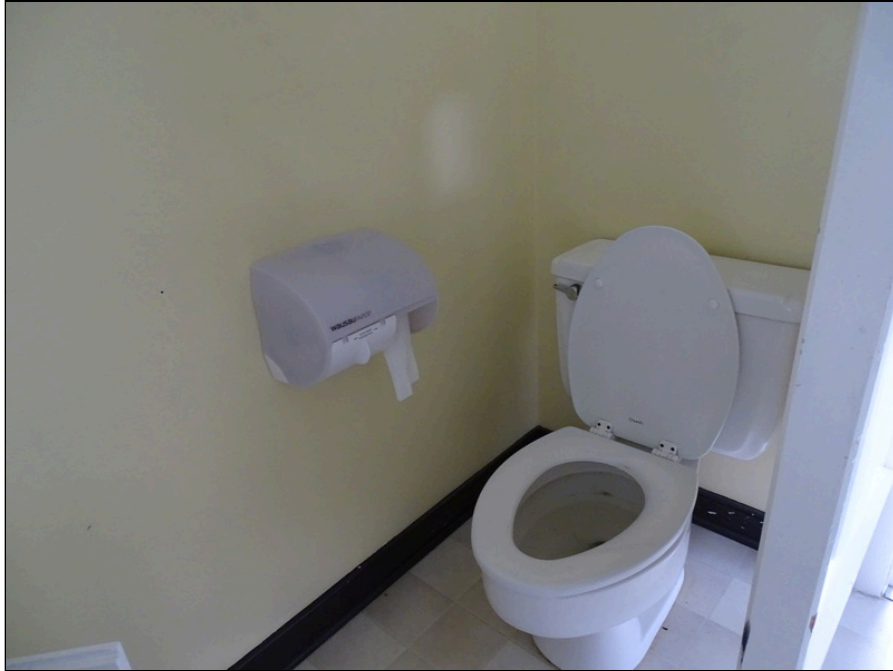
67 - Interior finishes of restroom area

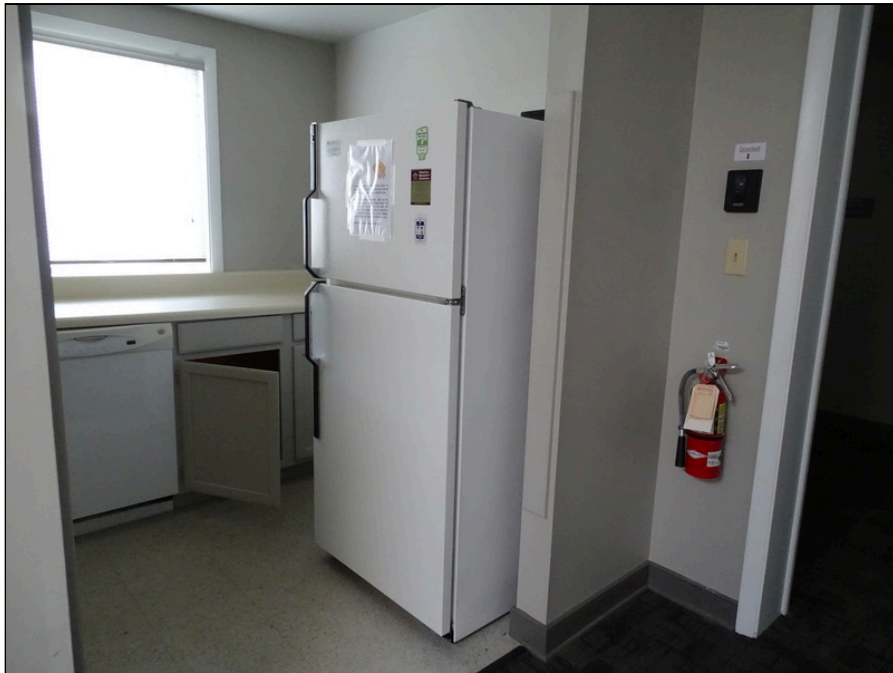
68 - Interior finishes of kitchen area

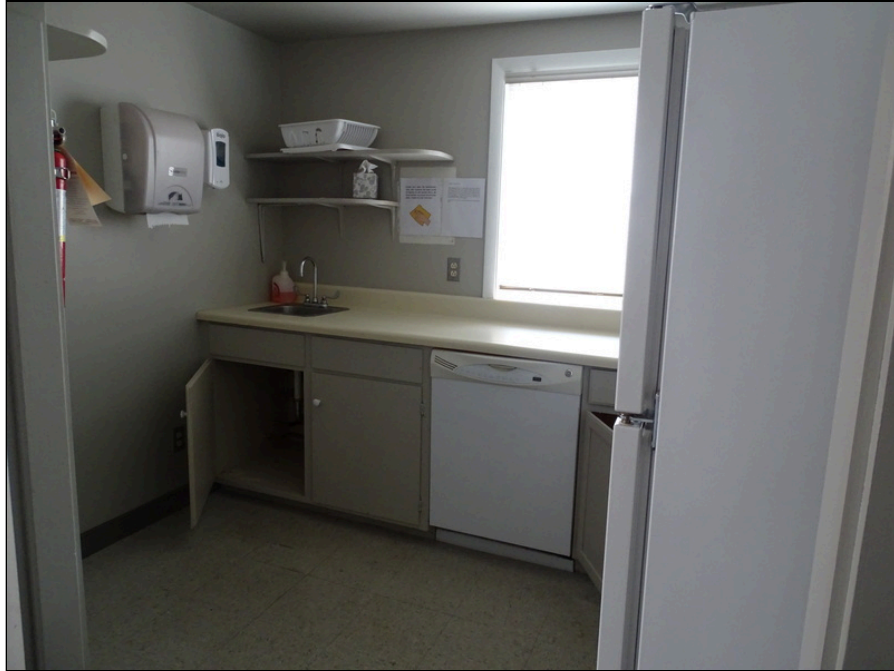
69 - Interior finishes of kitchen area

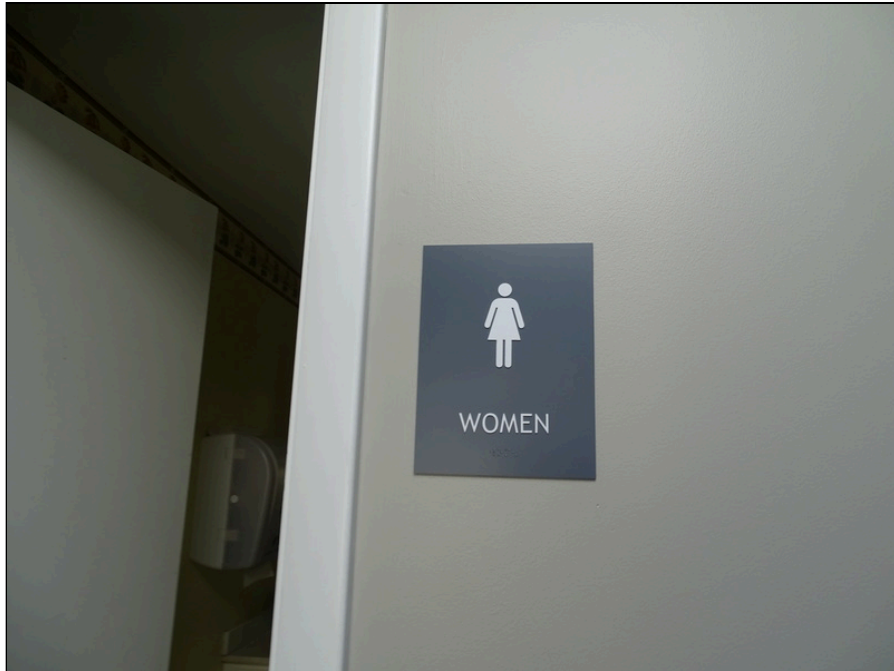
71 - Women restroom signage

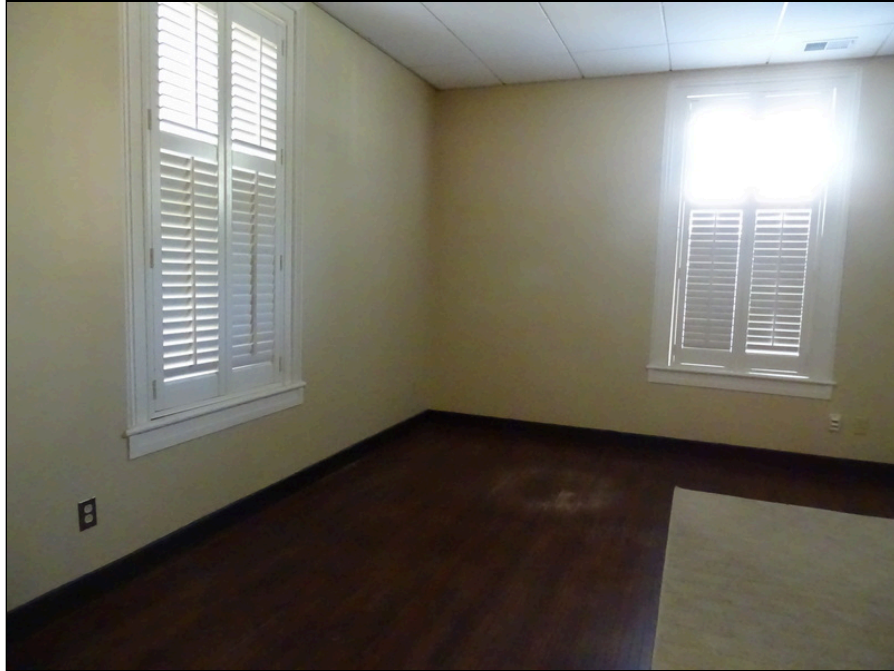
73 - Interior finishes of office area

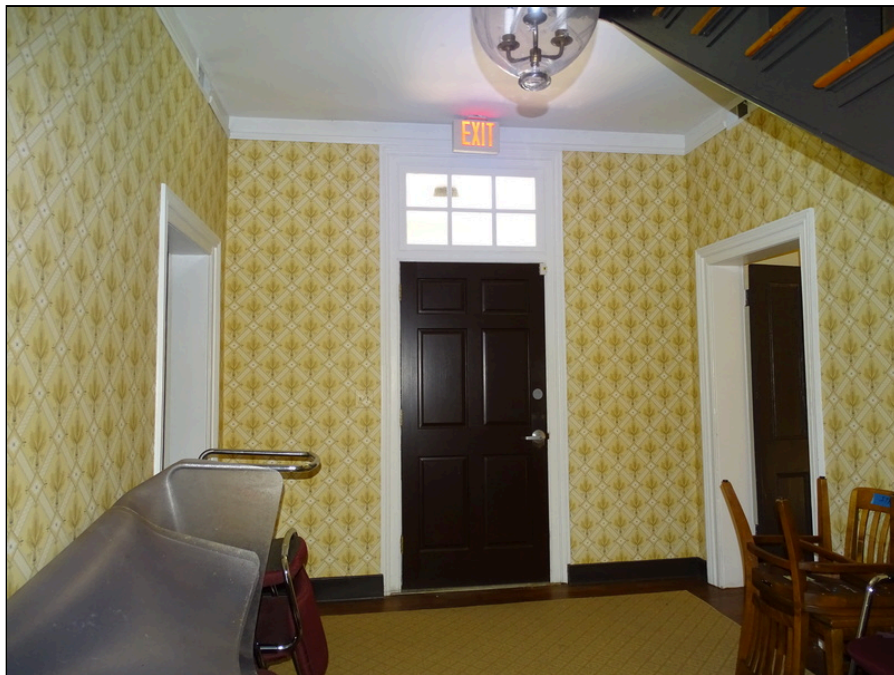
74 - Interior finishes of lobby area

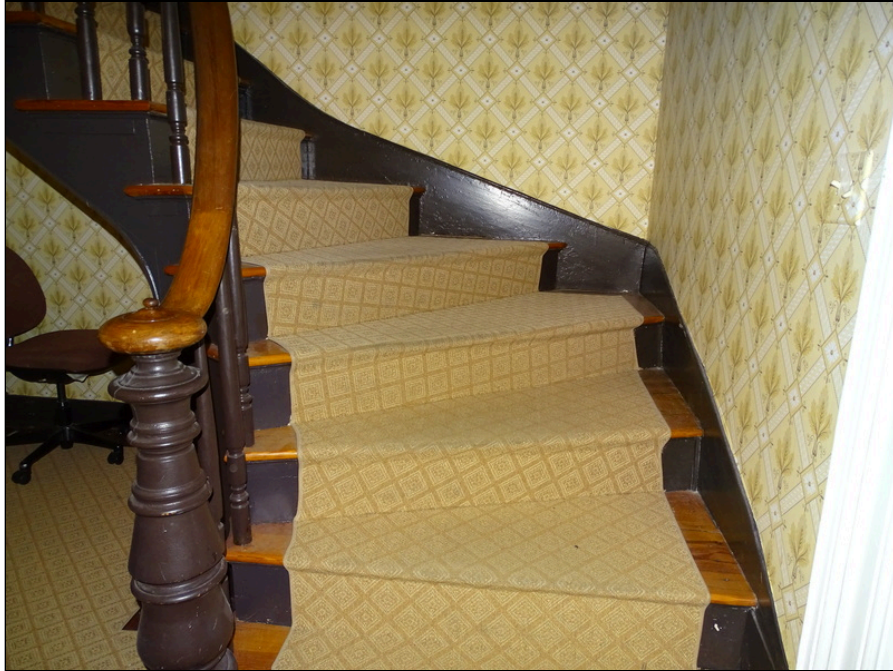
75 - Interior finishes of stair

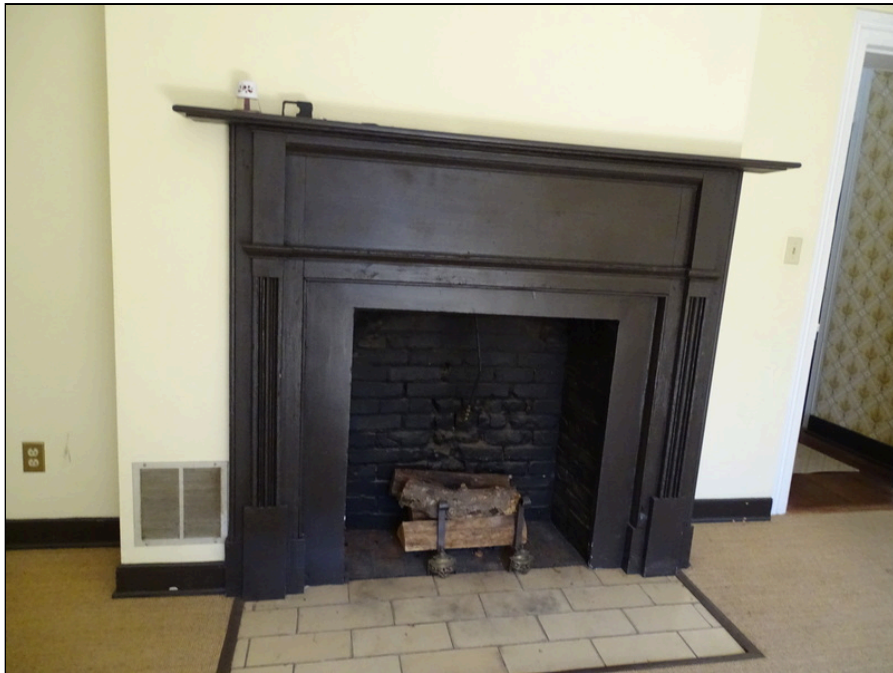
76 - Typical fire place

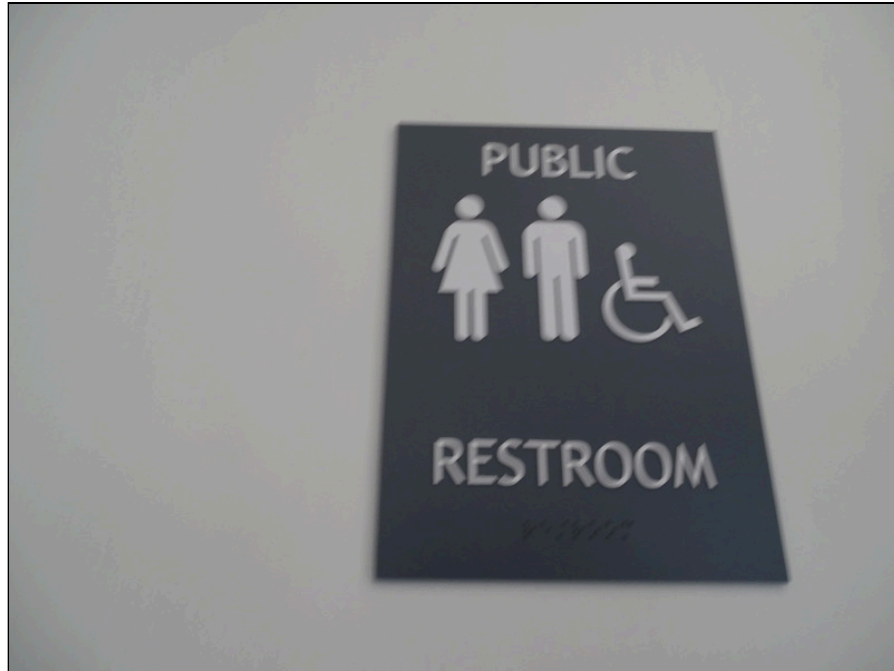
77 - Accessible restroom signage

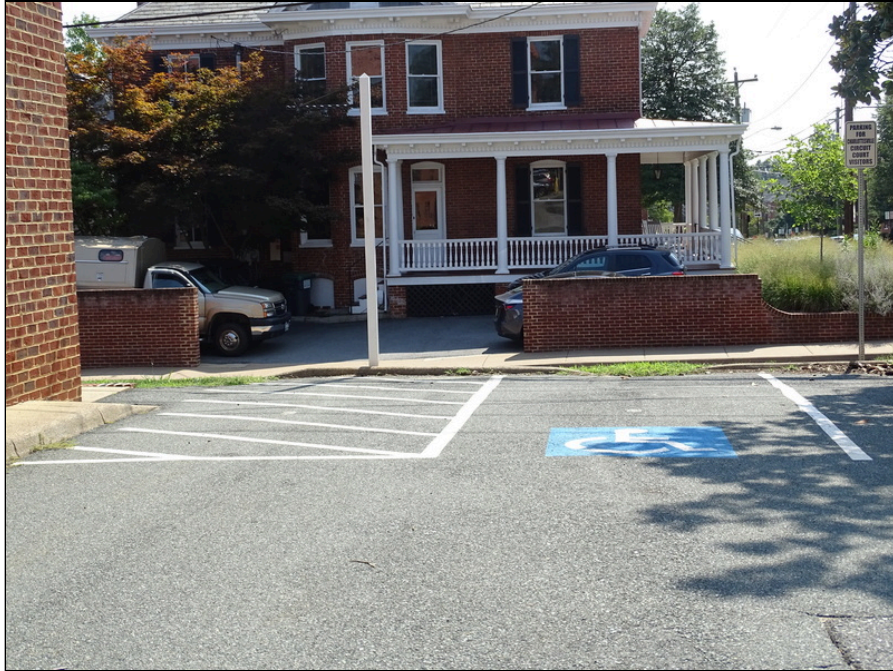
79 - Accessible parking
