JOHNSON ELEMENTARY SCHOOL  
1645 CHERRY AVENUE  
CHARLOTTESVILLE, VIRGINIA

ECS PROJECT NO. 46:6713

CITY OF CHARLOTTESVILLE - FACILITIES DEVELOPMENT

Reference: Facility Condition Assessment Report for Johnson Elementary School, 1645 Cherry Avenue,  
Charlottesville, Virginia

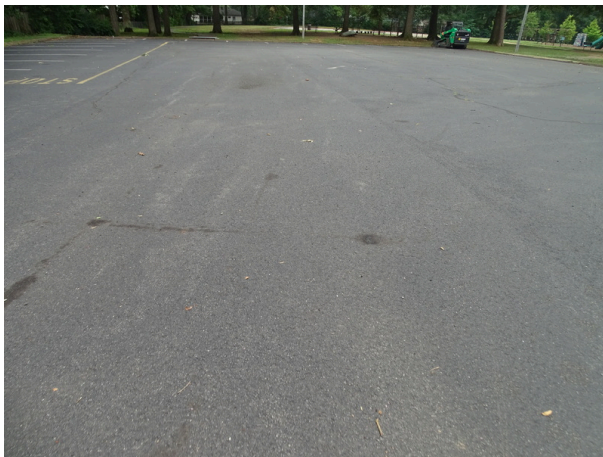
Asphalt pavement parking area north side of site

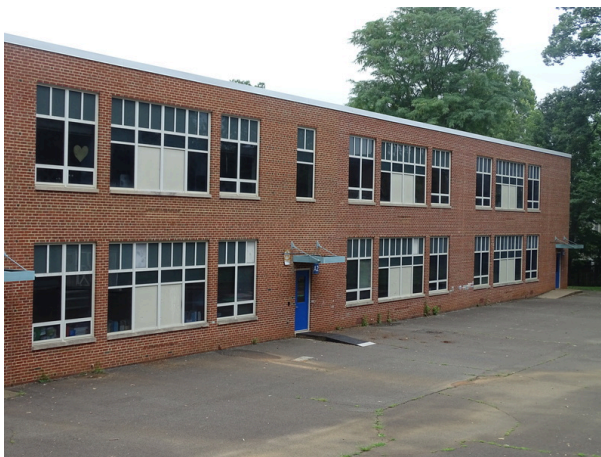
Exterior sealants are located around the window and door frames. The expected useful life of exterior sealants is approximately 10 to 12 years before replacement is needed. The exterior sealants were generally in fair condition. The sealants were observed to be hard and separated from the substrate. We recommend that the exterior sealants be replaced.

Building exterior northwest side of the building

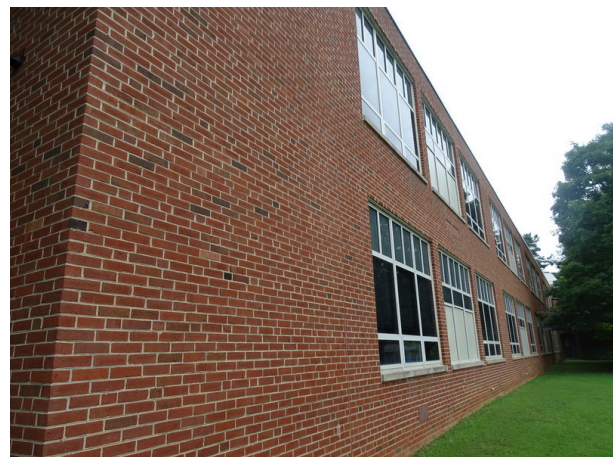
Building exterior southwest side of the building

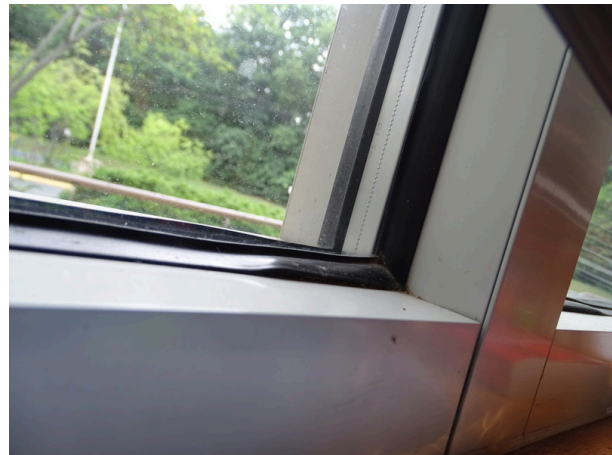
Window gaskets typically have an expected useful life of 15 to 20 years. Some of the gaskets were observed to be separating. We recommend replacing the window gaskets.

Typical exterior windows - note separation of gasket

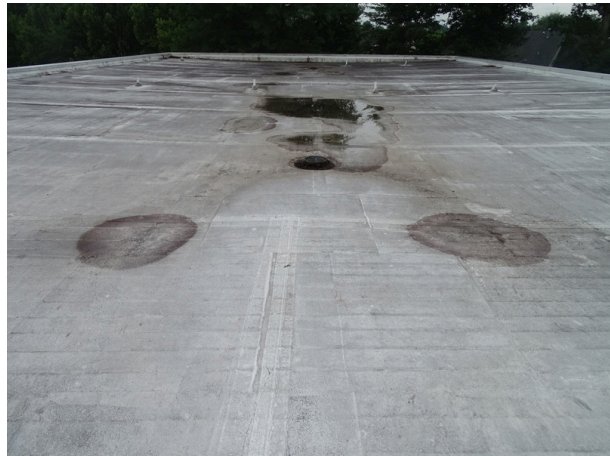
Single-ply membrane roofing system - note ponding

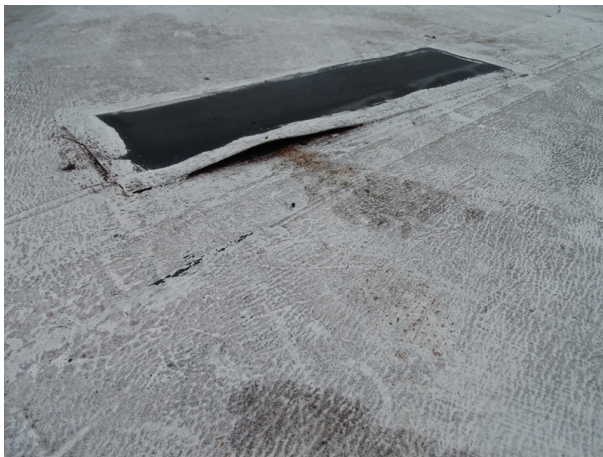
Single-ply membrane roofing system - note patching separation

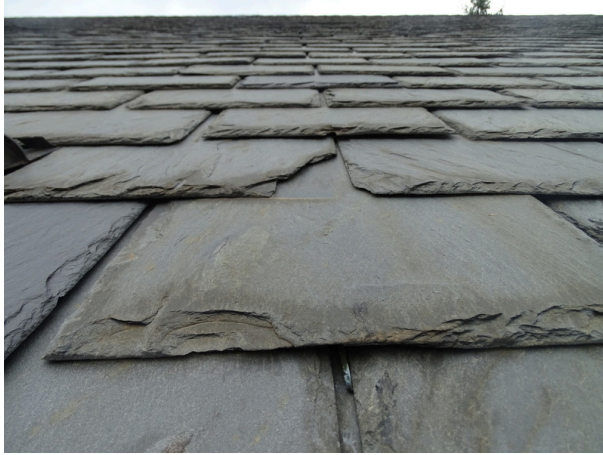
Slate shingle roofing system - note misalignment of slate

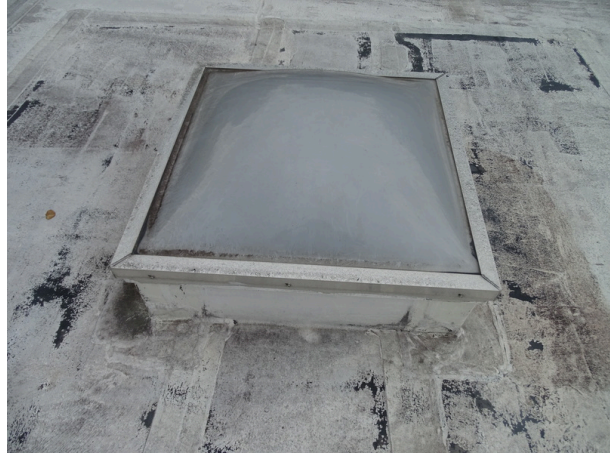
The skylights are showing noticeable signs of deterioration. The expected useful life of skylights of this type is typically 20 years. We recommend the skylights be replaced early in the report period.

Typical skylight

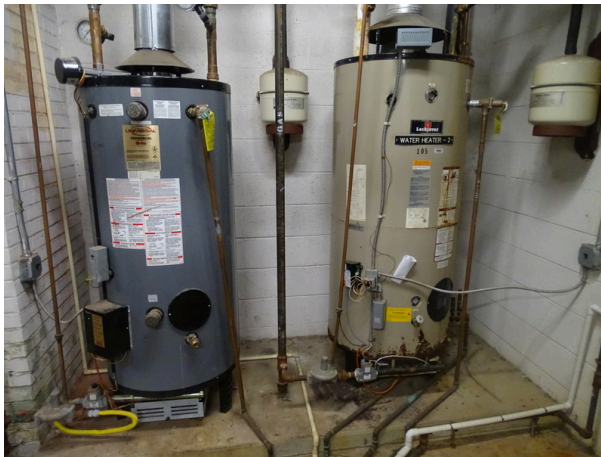
The expected useful life of a Gas domestic water heater is approximately 15 years with proper maintenance. We recommend the Gas domestic water heaters be replaced during the study period.

Gas domestic water heaters

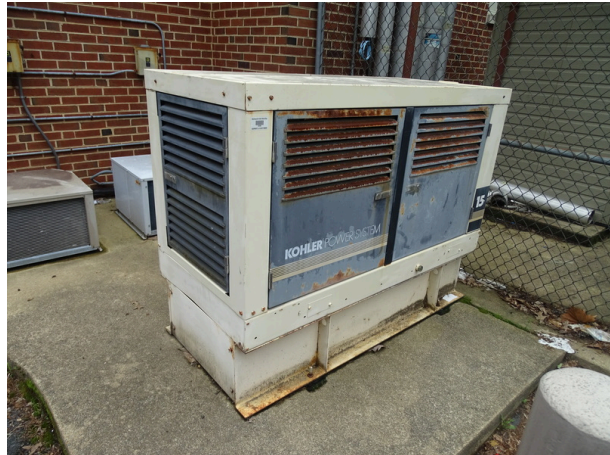
Emergency power generator

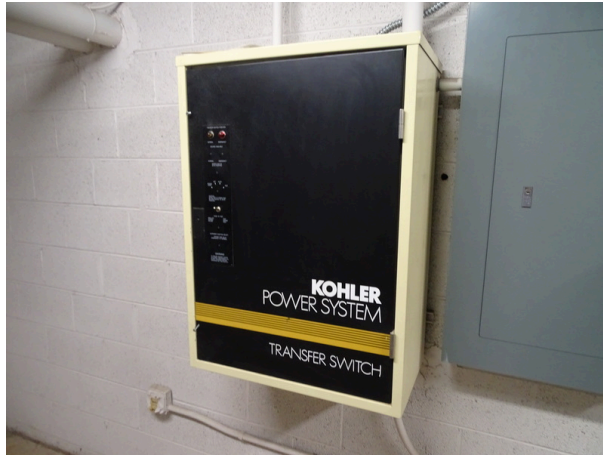
The emergency back up power generator transfer switch was manufactured by Kohler and is located in the main mechanical room. The transfer switch installation date was unknown with an expected useful life of 25 years with proper maintenance. The transfer switch should be replaced in conjunction with the generator.

Emergency power transfer switch

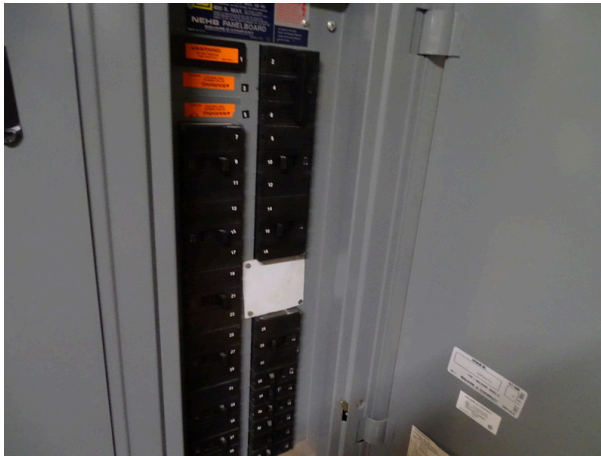
Power is distributed by copper wire from circuit breaker panels located throughout the building. The expected useful life of sub-panels is 50 years with proper maintenance. The circuit breaker panels were reportedly recently replaced. The circuit breaker panels were observed to be in generally good condition.

Typical circuit breaker panel

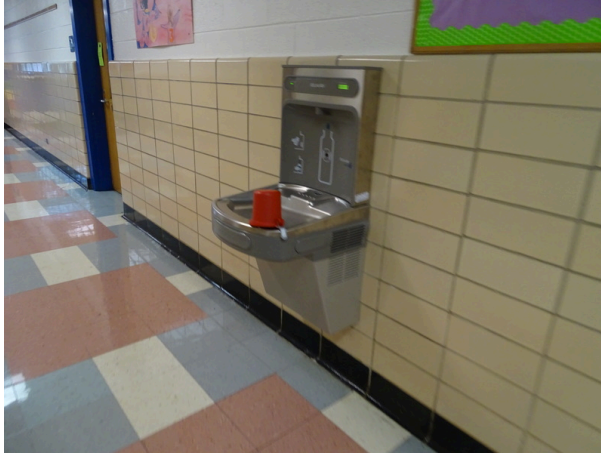
Water fountain - note protruding and not accessible

Cost Recommendation	EUL	EFF AGE	RUL	Year	Cost
REPLACE OR RELOCATE DRINKING FOUNTAINS	-	-	-	Immediate	\$12,000
Total					\$12,000

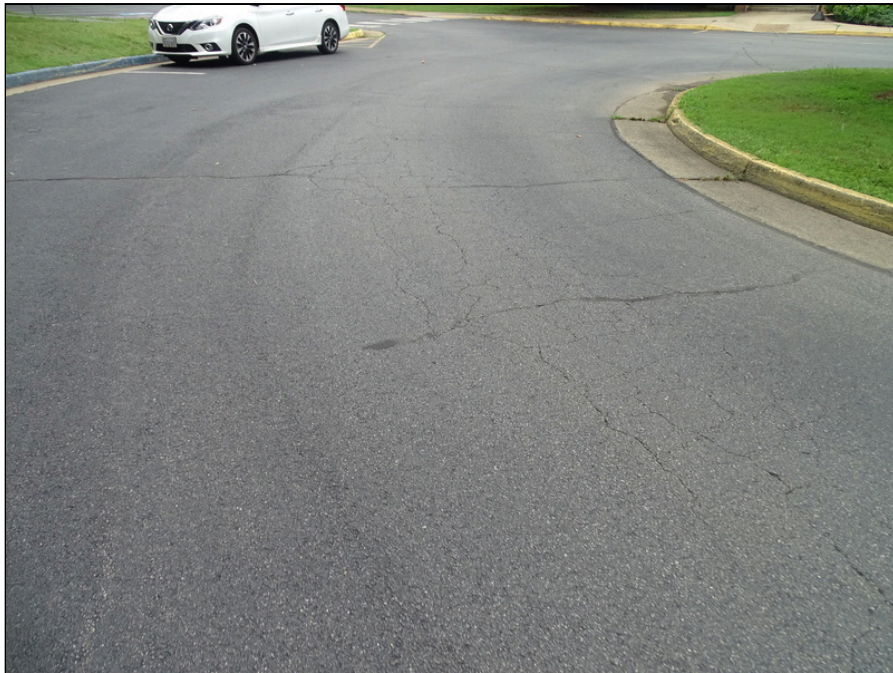
4 - Asphalt drive lane - note cracking

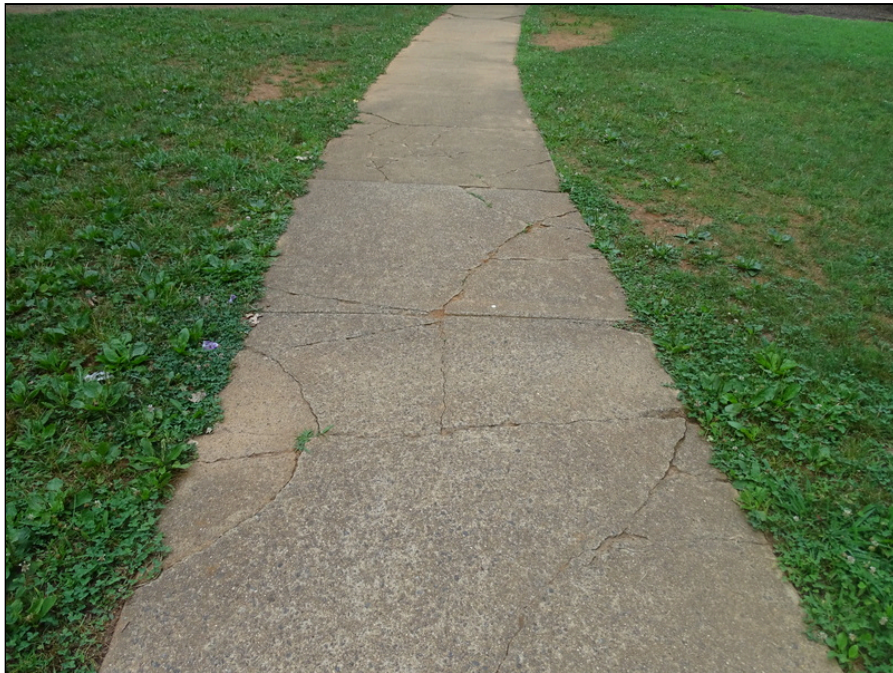
10 - Typical concrete sidewalk - note cracking

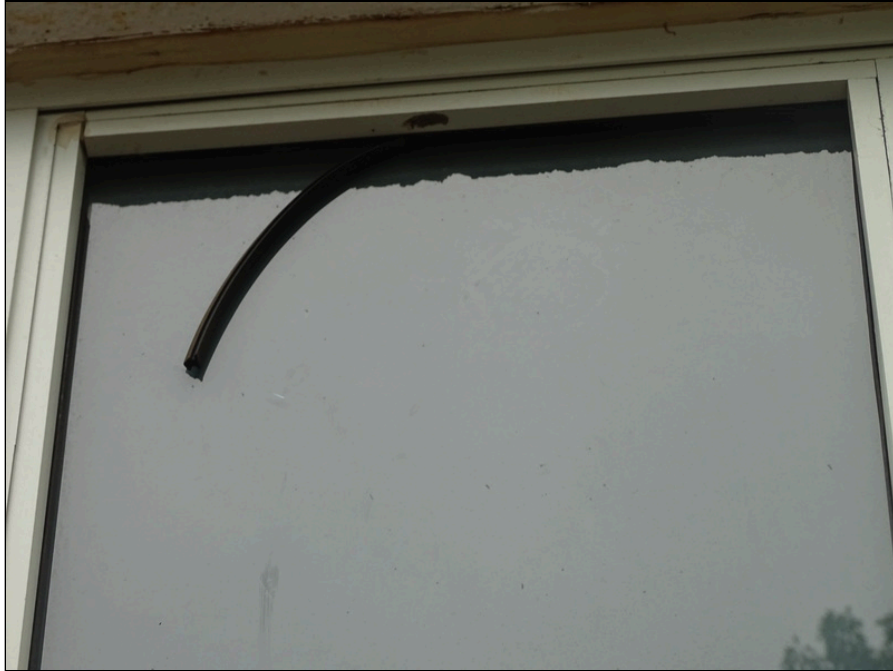
35 - Typical exterior windows - note separation of gasket

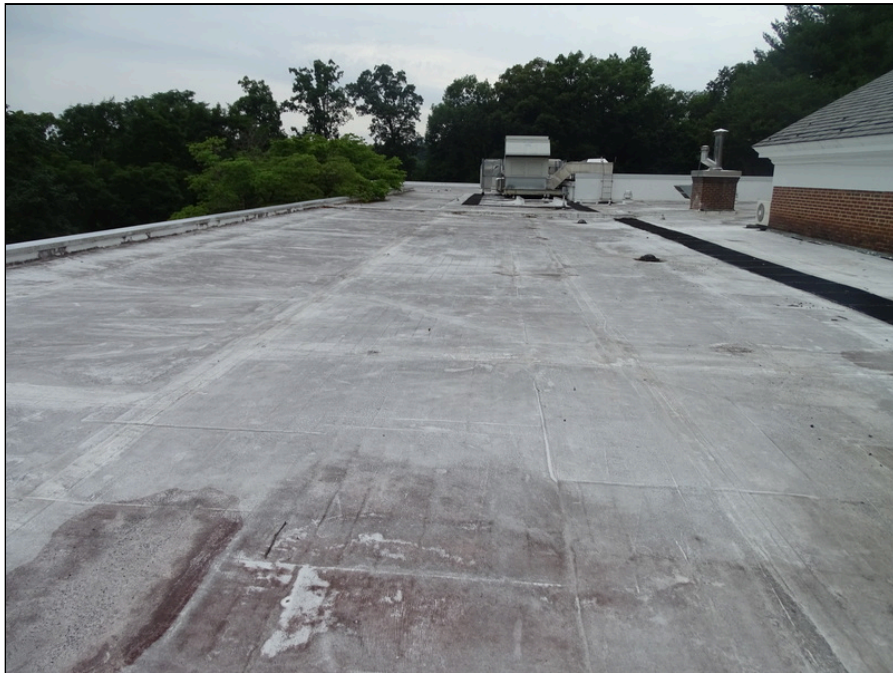
36 - Single-ply membrane roofing system looking west

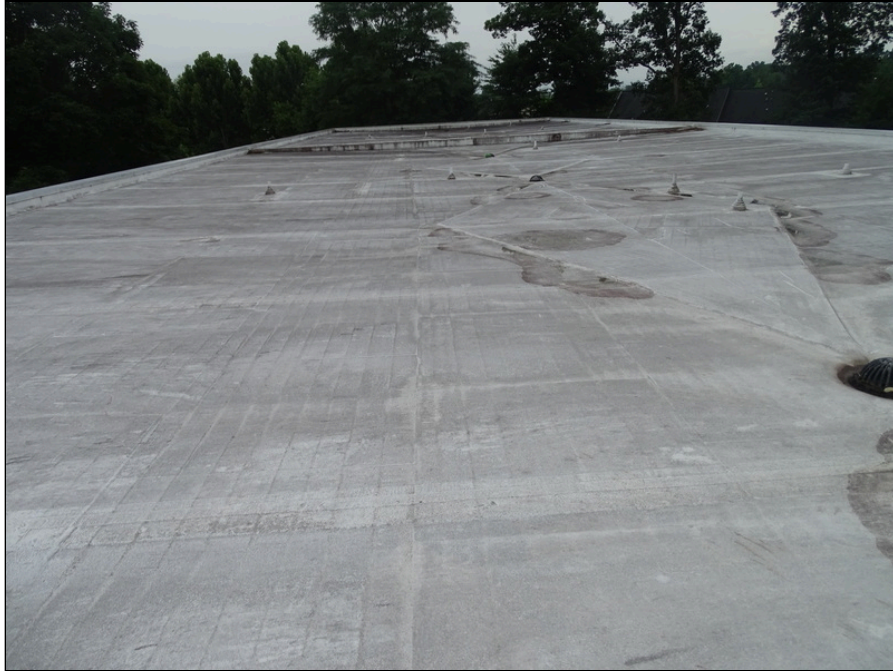
37 - Single-ply membrane roofing system looking southwest

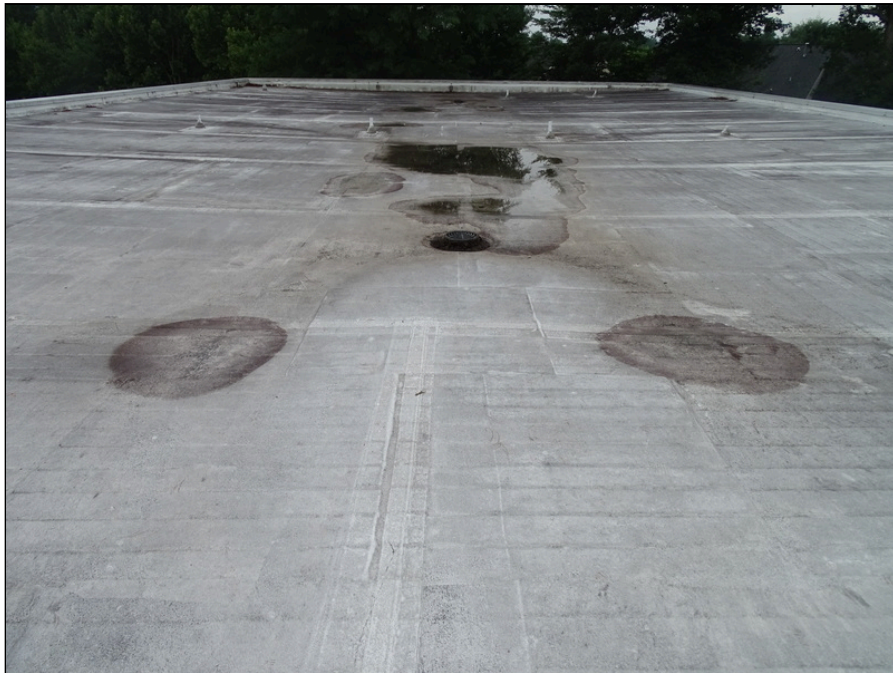
38 - Single-ply membrane roofing system - note ponding

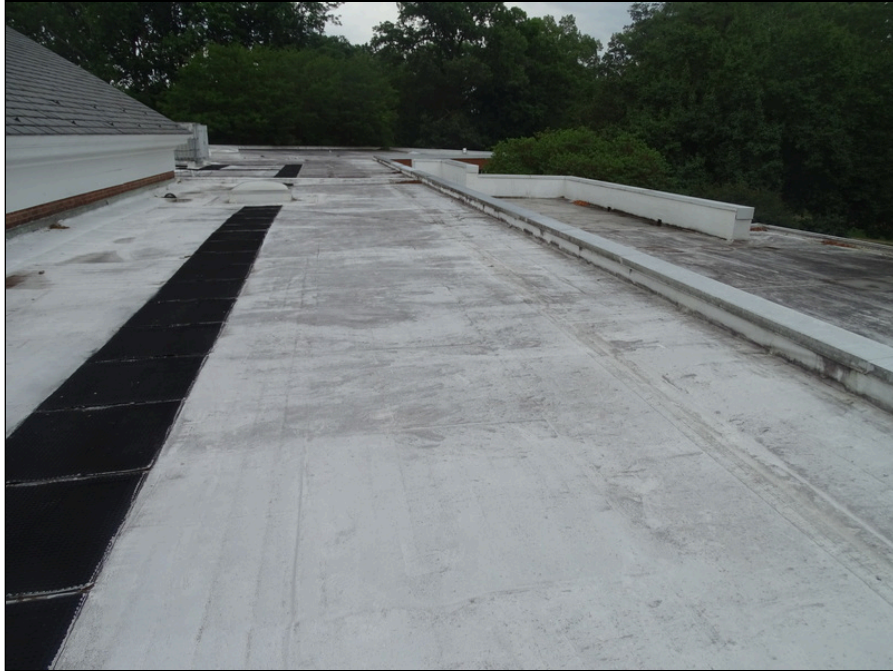
39 - Single-ply membrane roofing system looking east

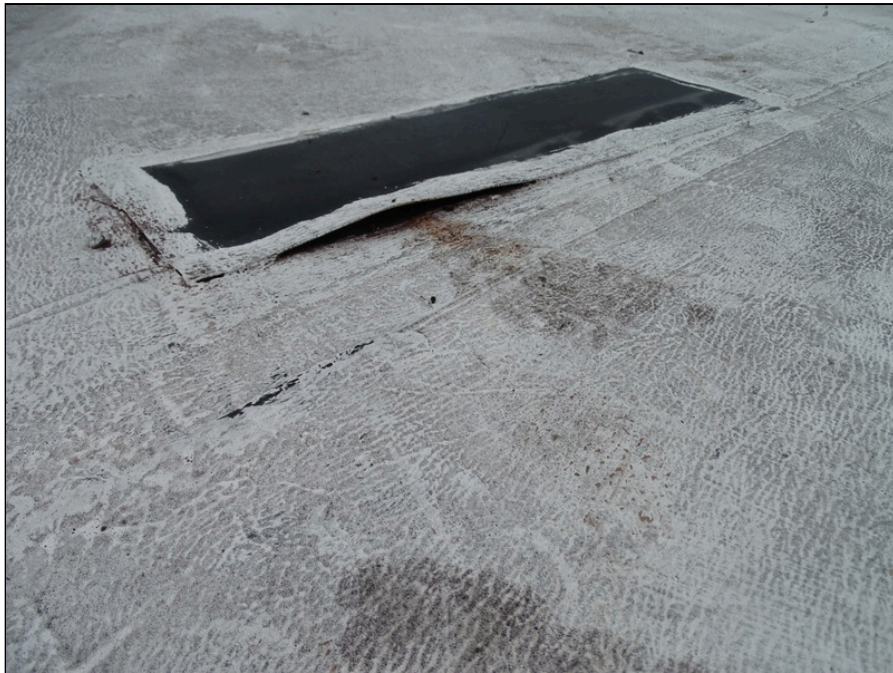
40 - Single-ply membrane roofing system - note patching separation

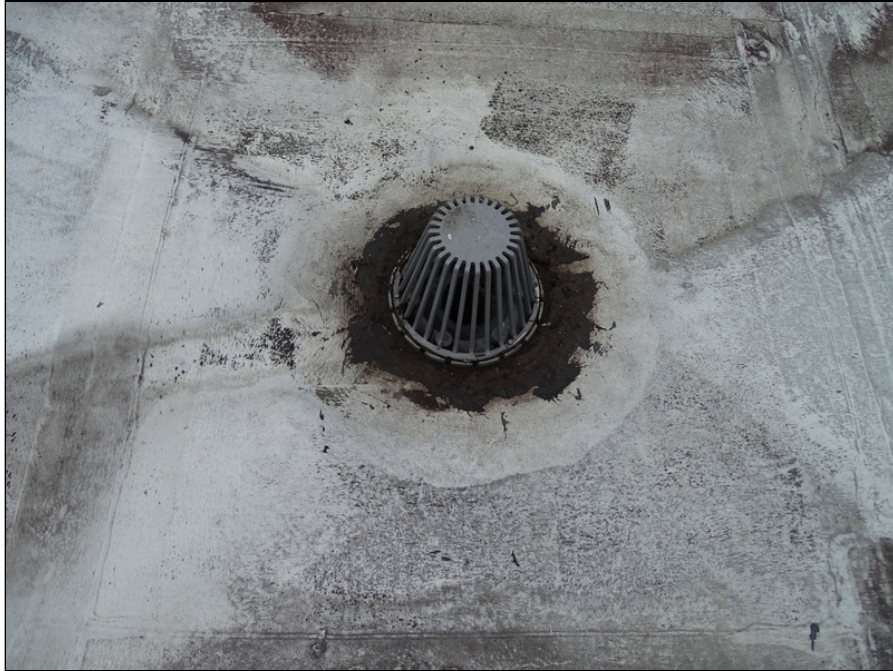
41 - Typical internal drain

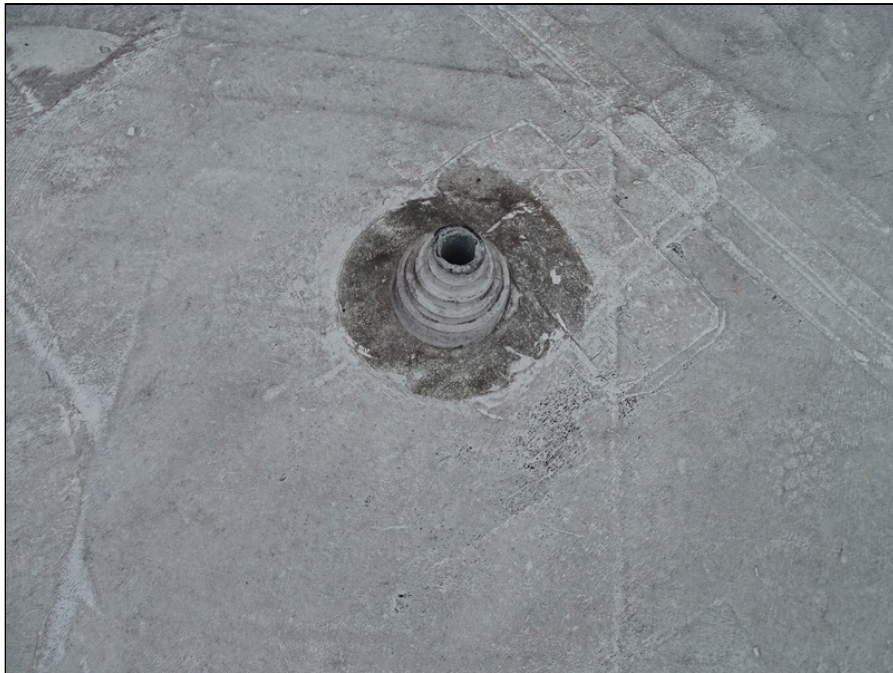
42 - Typical mechanical vent

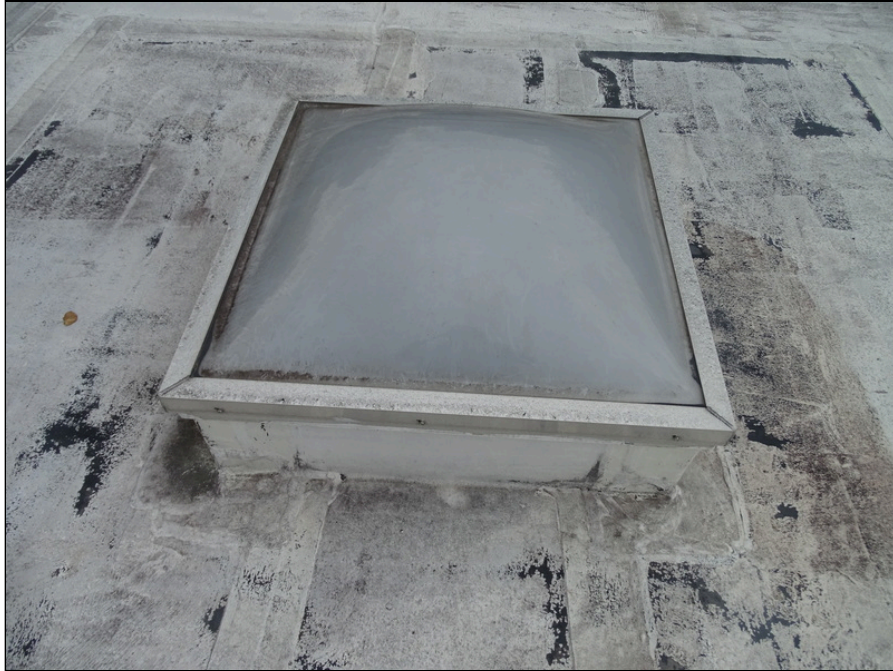
43 - Typical skylight

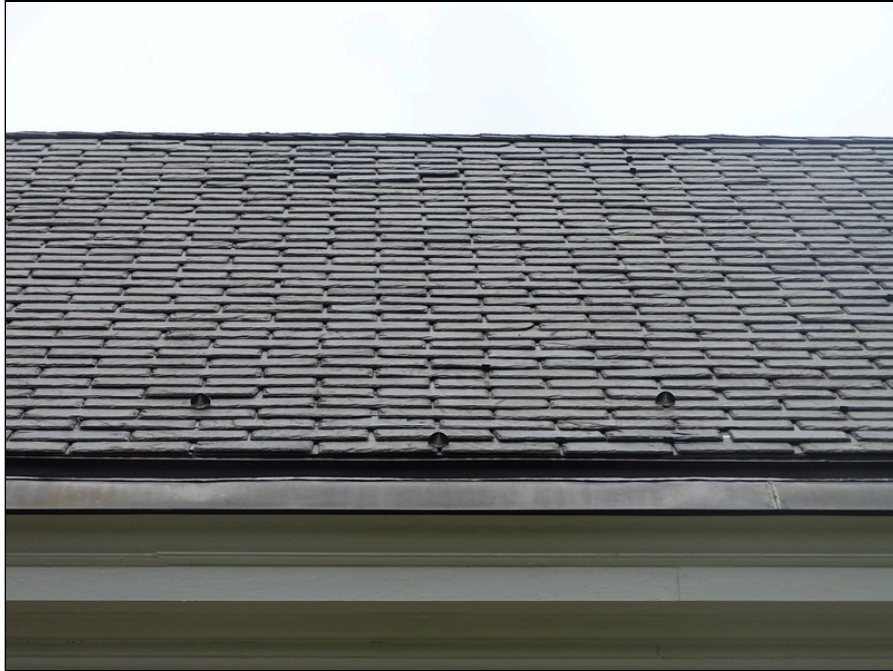
45 - Slate shingle roofing system

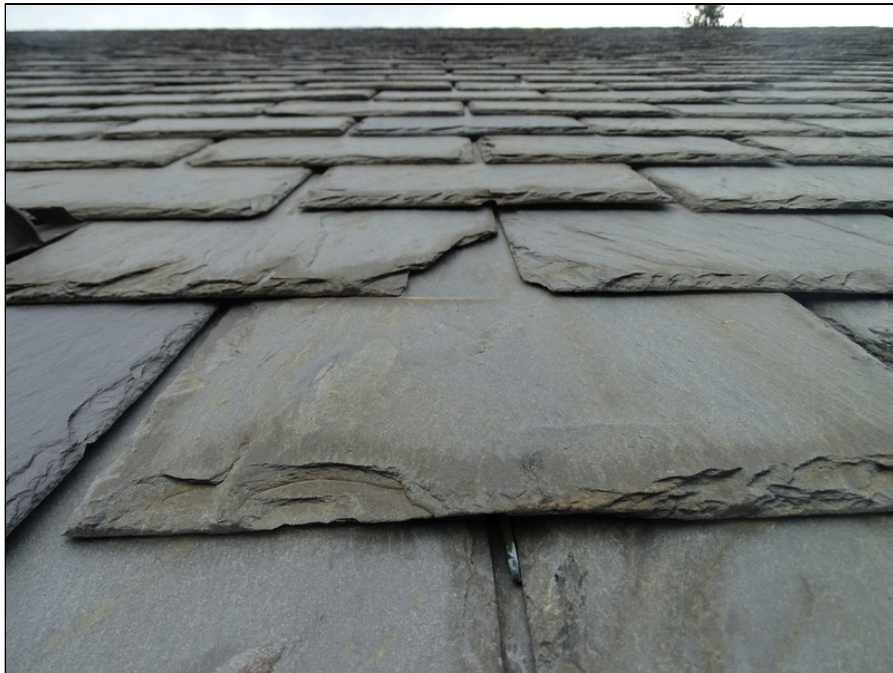
46 - Slate shingle roofing system - note misalignment of slate

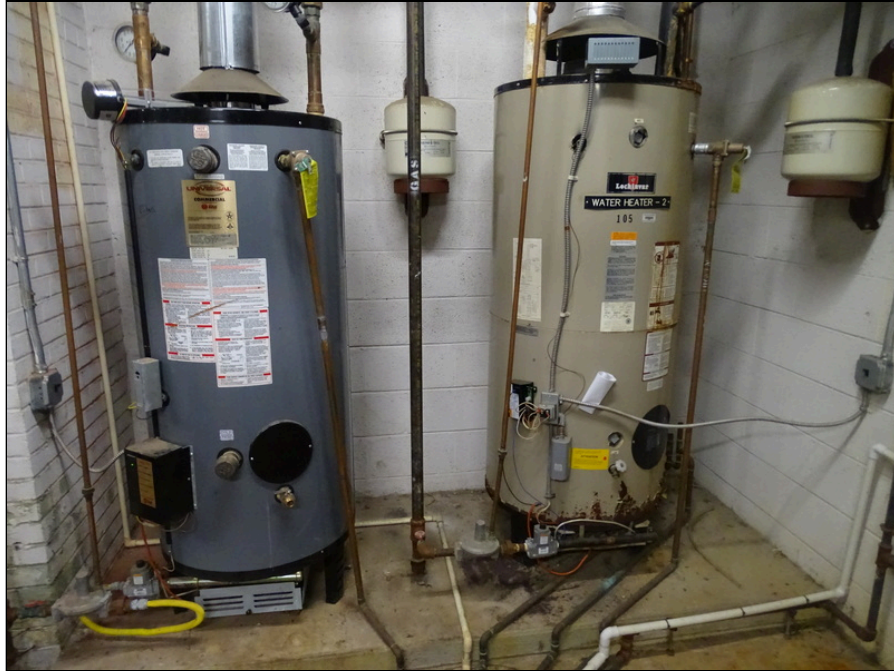
47 - Gas domestic water heaters

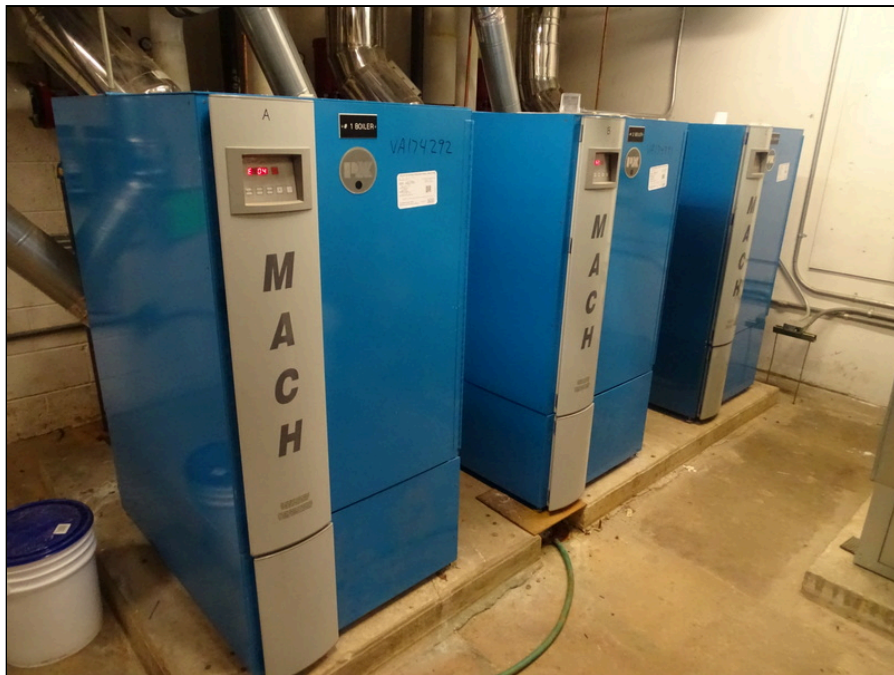
48 - Boilers located in mechanical room

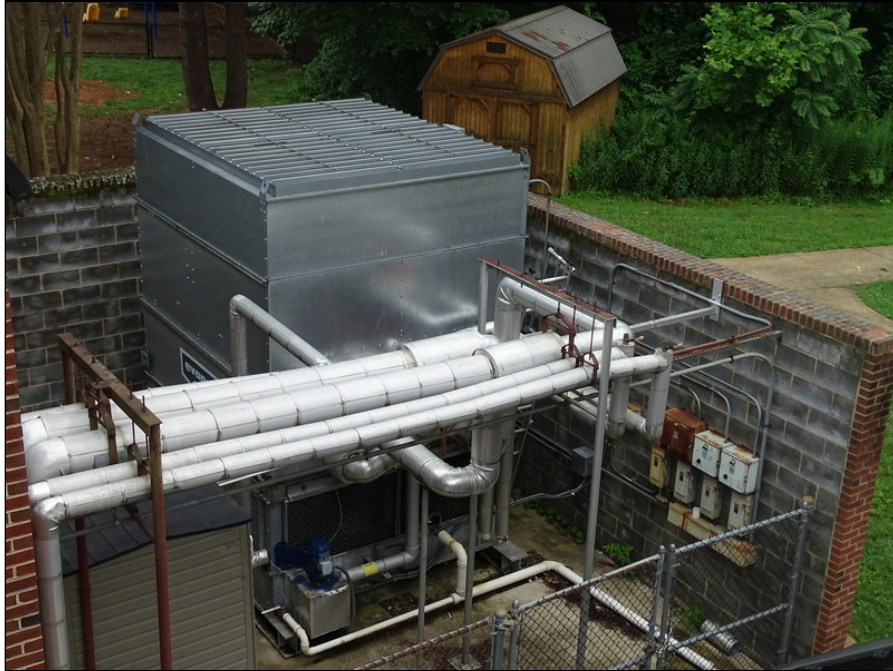
49 - Cooling Tower located at north side of the building

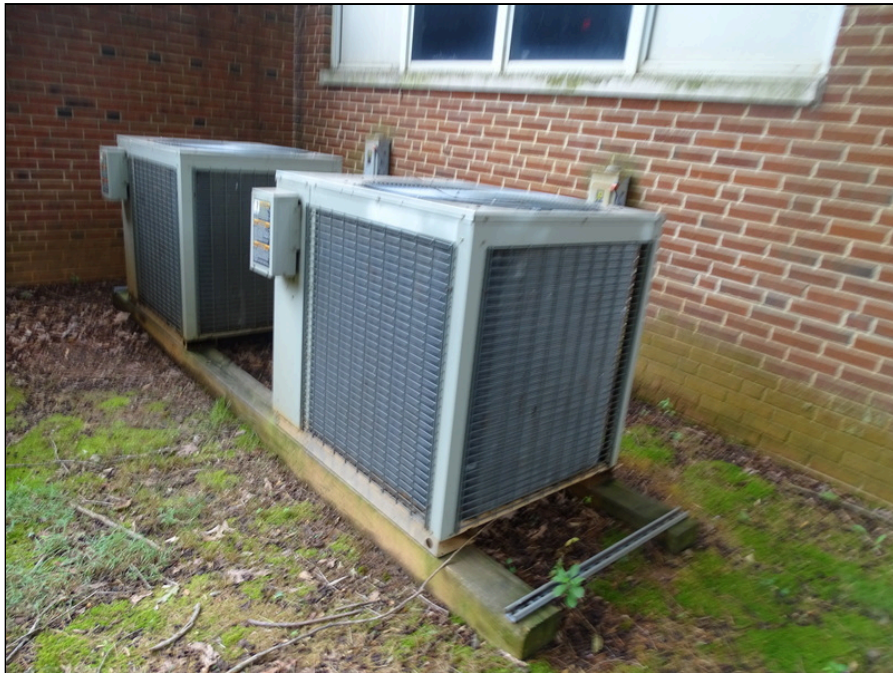
50 - Condenser Units located exterior north side of the building

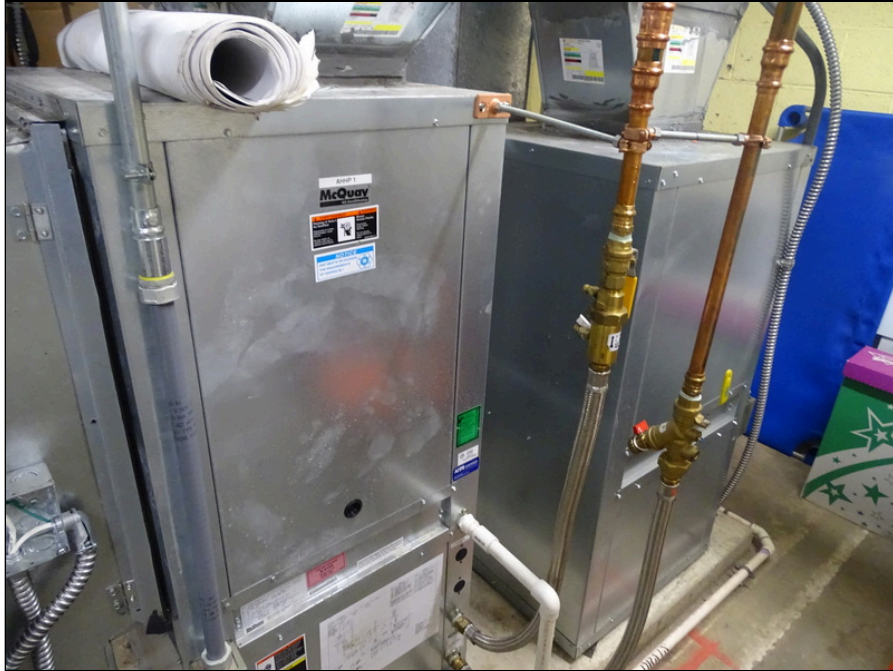
51 - Typical Air Handler Unit

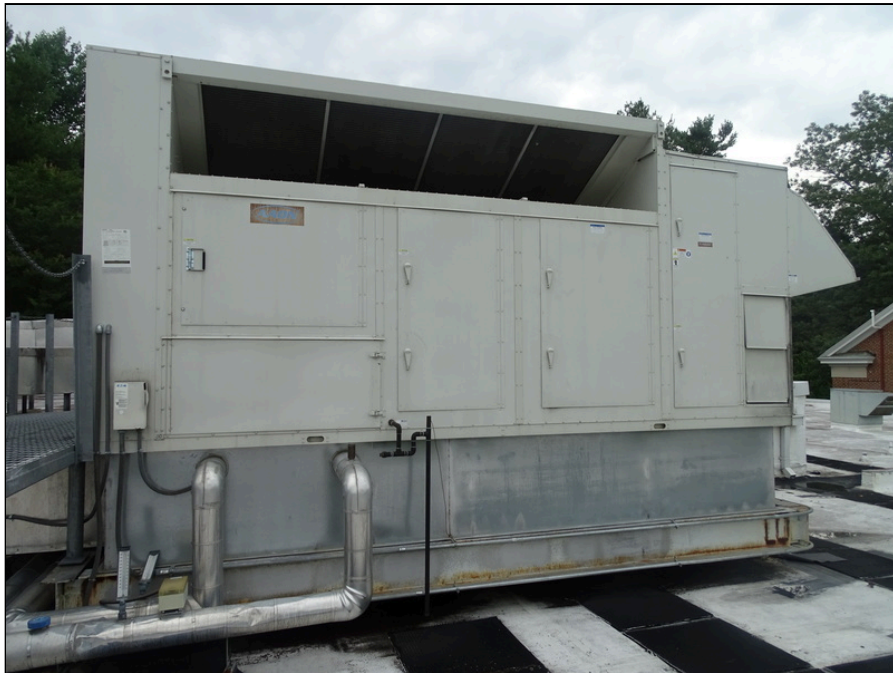
52 - Typical Package Unit

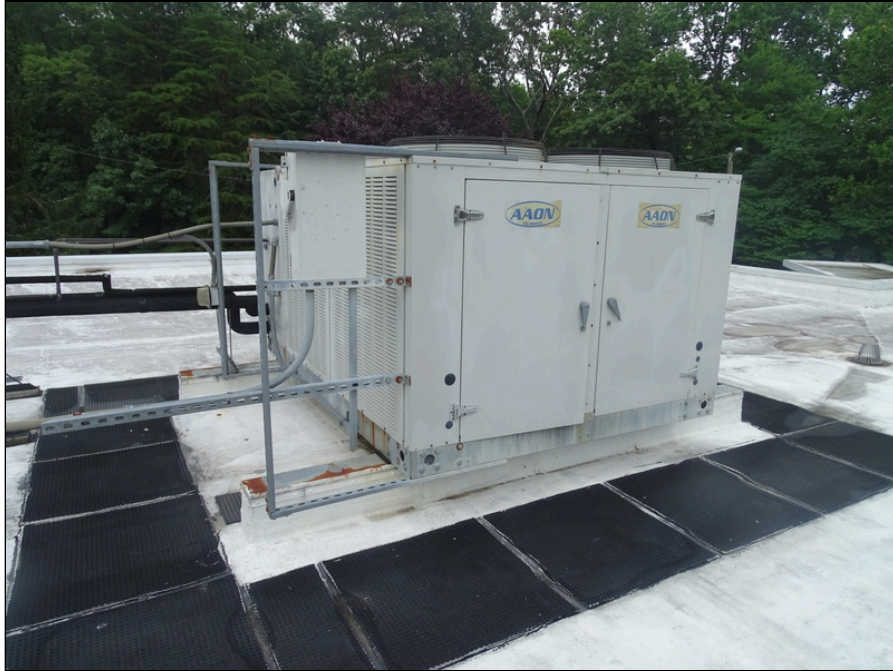
53 - Typical Package Unit

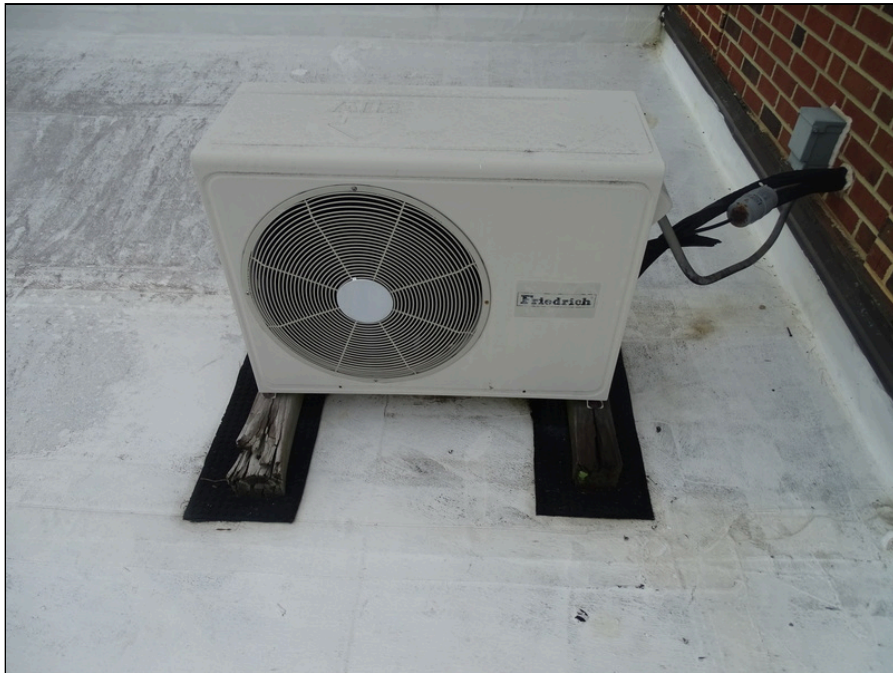
54 - Typical split system

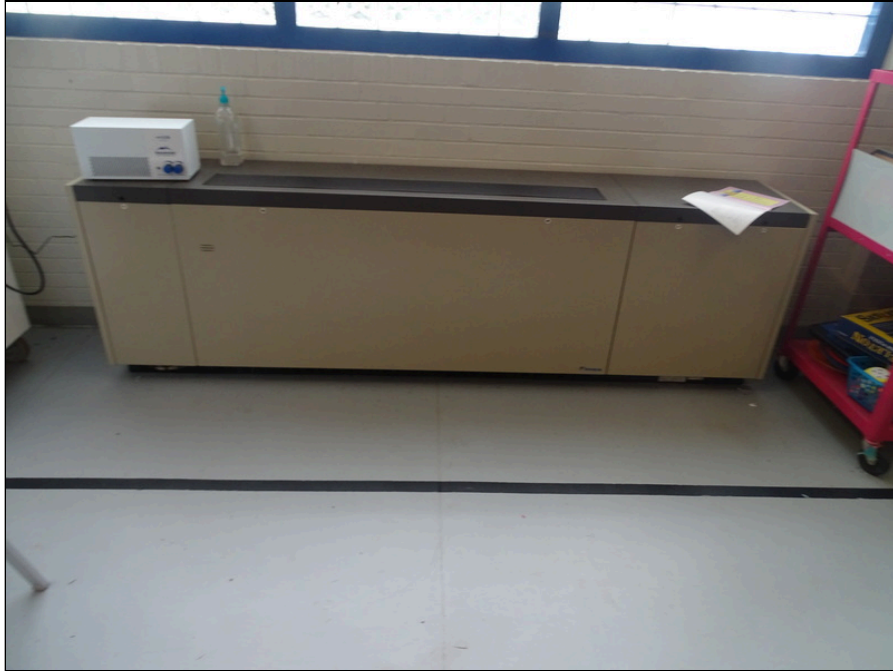
55 - Typical Water Source Heat Pump

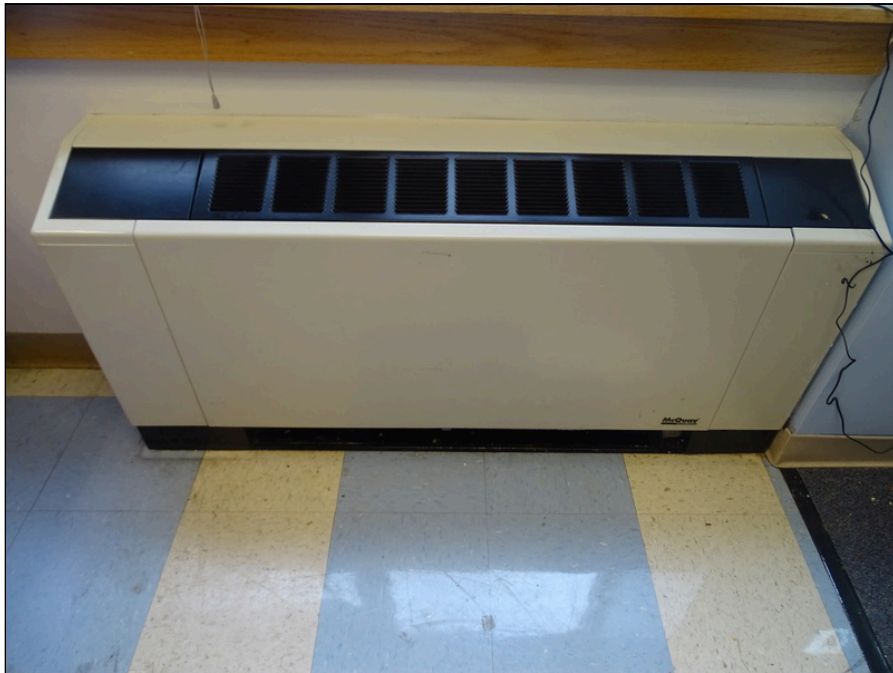
56 - Typical Water Source Heat Pump

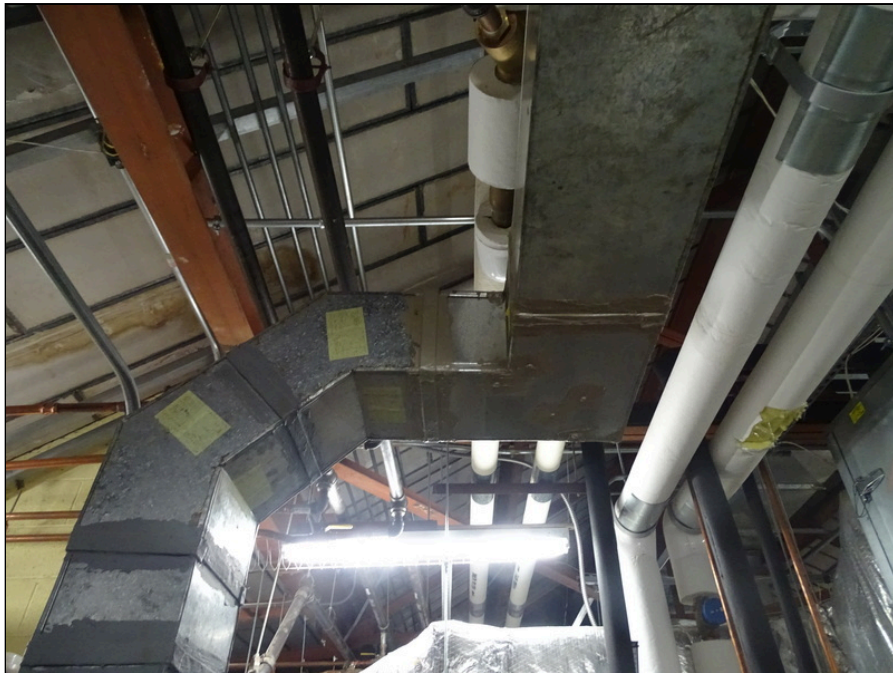
58 - Typical mechanical duct

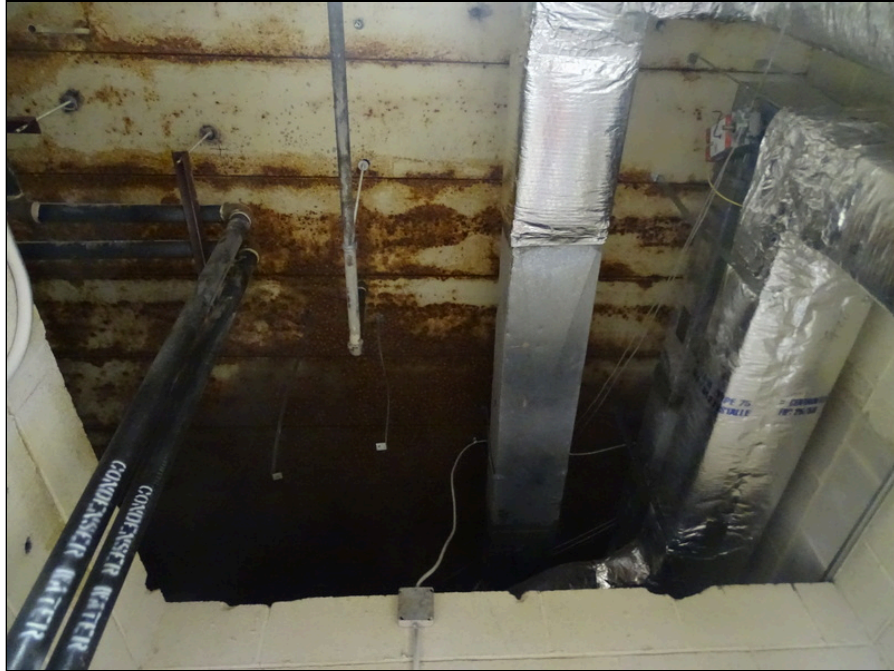
59 - Typical mechanical duct

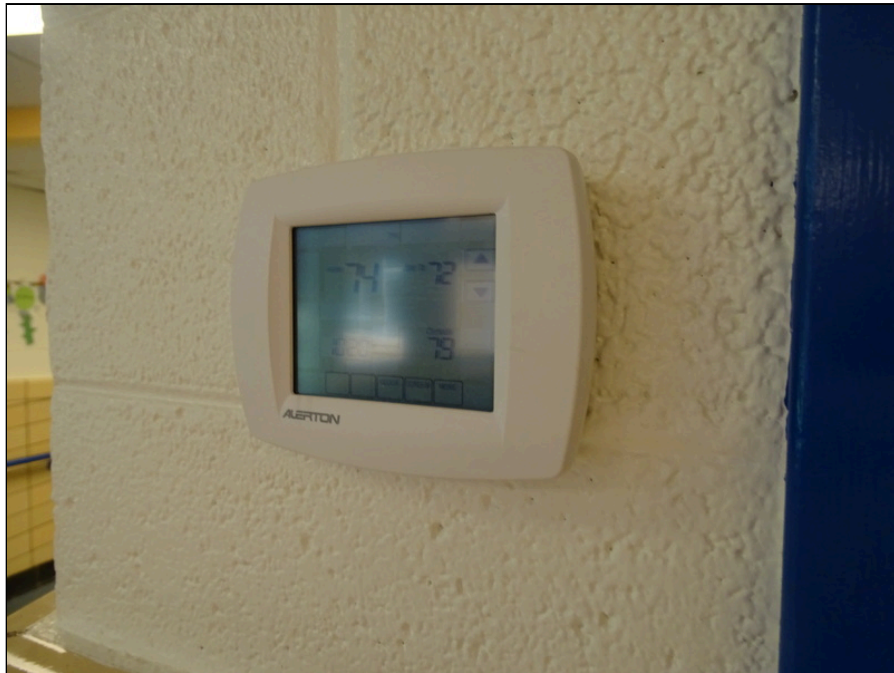
60 - Typical thermostat

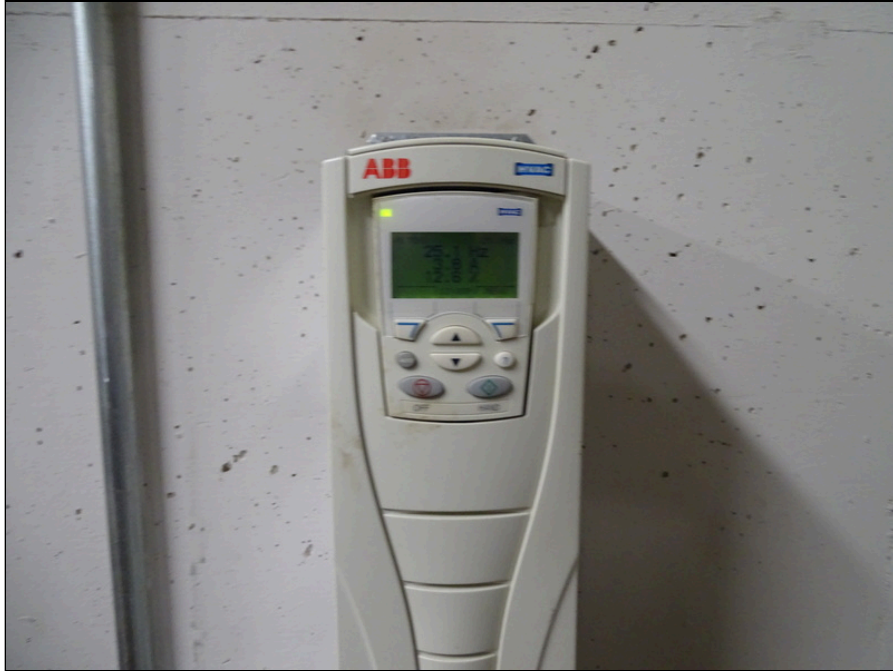
61 - Variable frequency drive for mechanical system

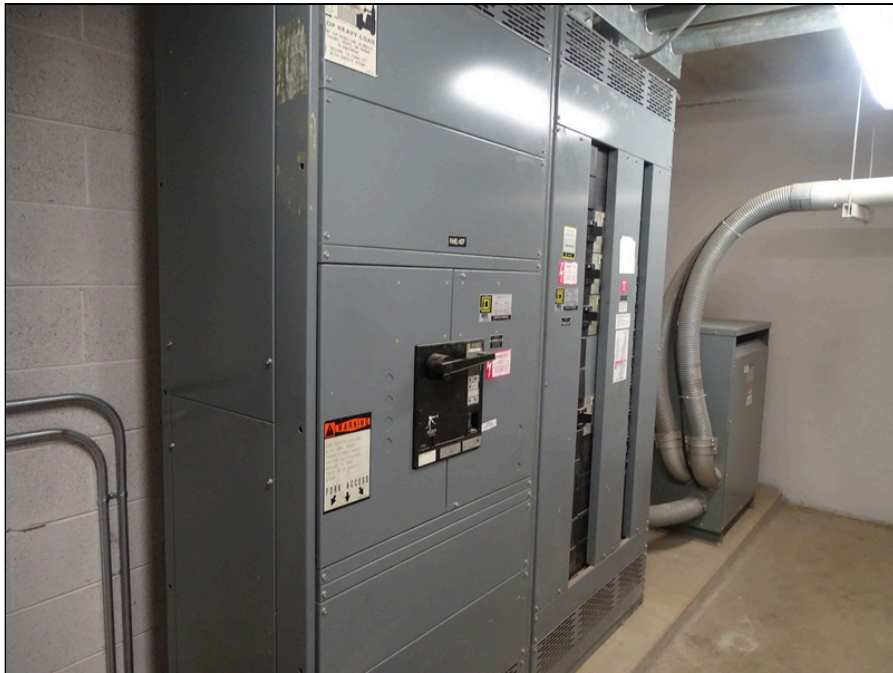
62 - Main electrical switchgear

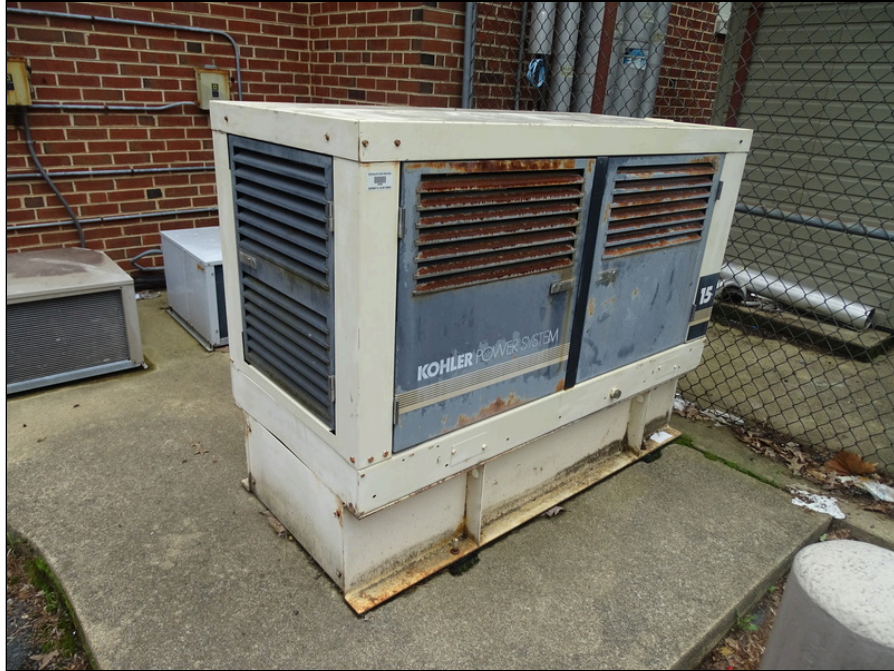
63 - Emergency power generator

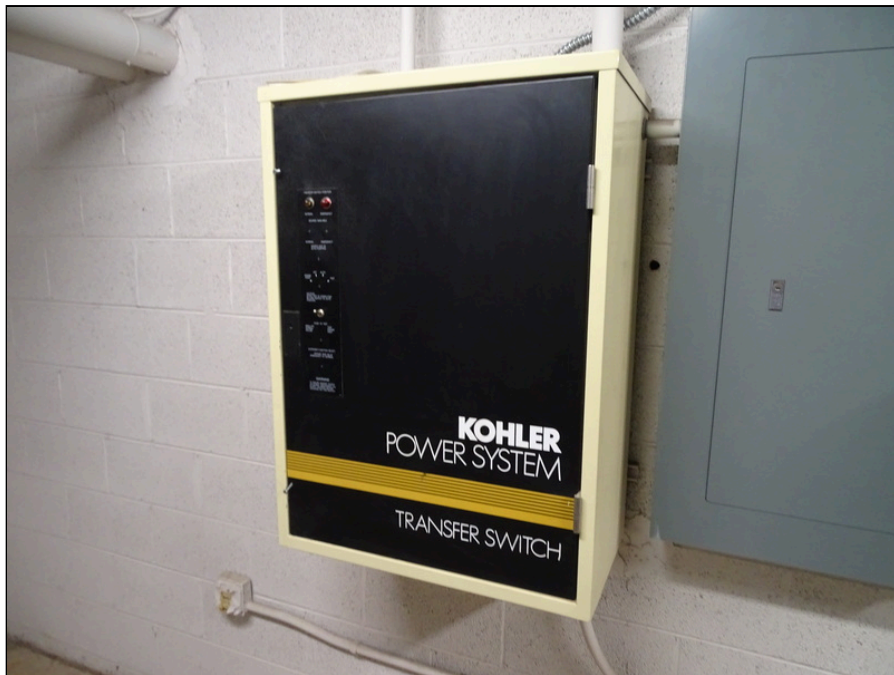
64 - Emergency power transfer switch

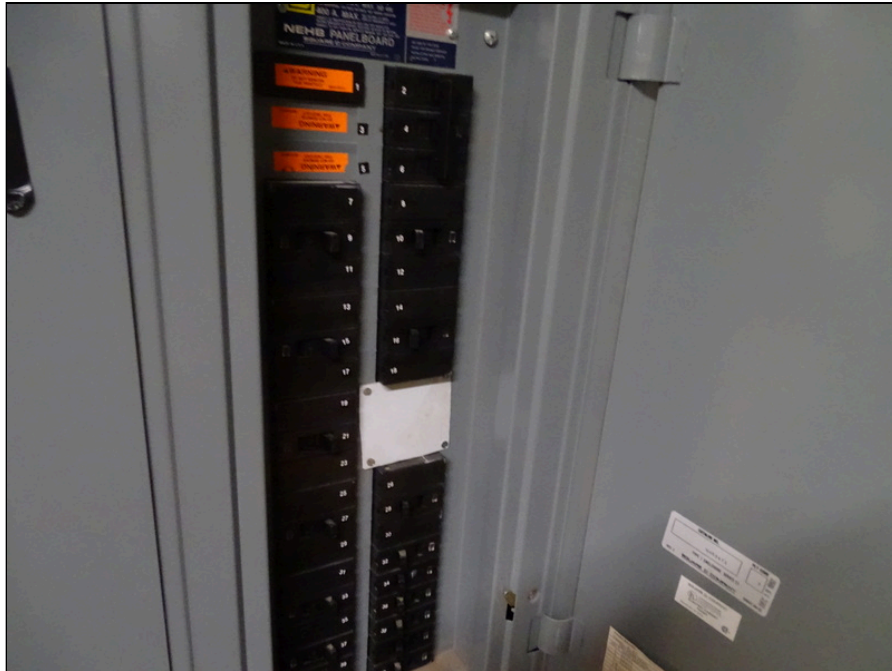
65 - Typical circuit breaker panel
