JOHNSON ELEMENTARY SCHOOL  
1645 CHERRY AVENUE  
CHARLOTTESVILLE, VIRGINIA

ECS PROJECT NO. 46:6713

CITY OF CHARLOTTESVILLE - FACILITIES DEVELOPMENT

Reference: Facility Condition Assessment Report for Johnson Elementary School, 1645 Cherry Avenue,  
Charlottesville, Virginia

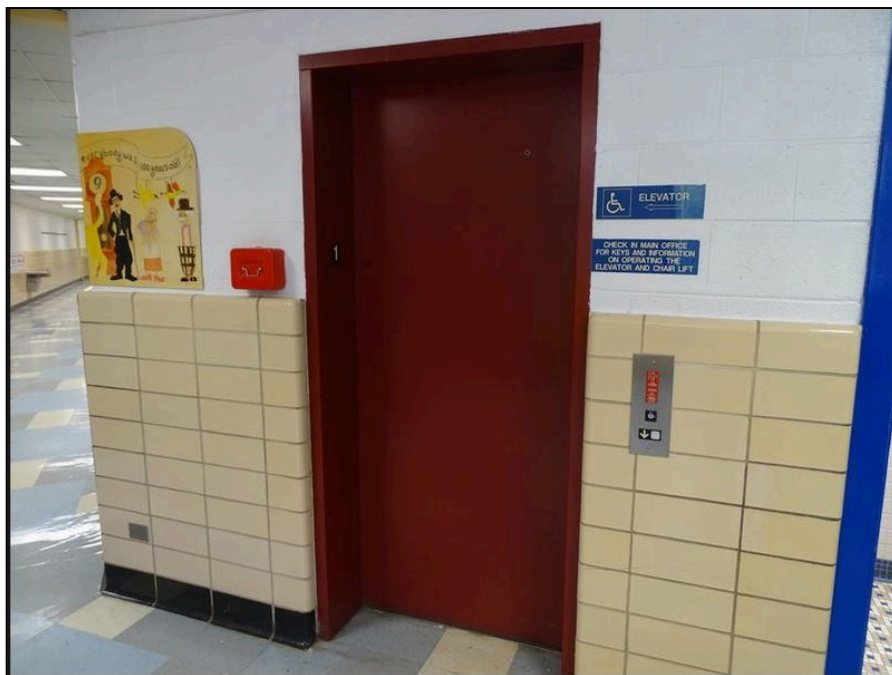
66 - Elevator system

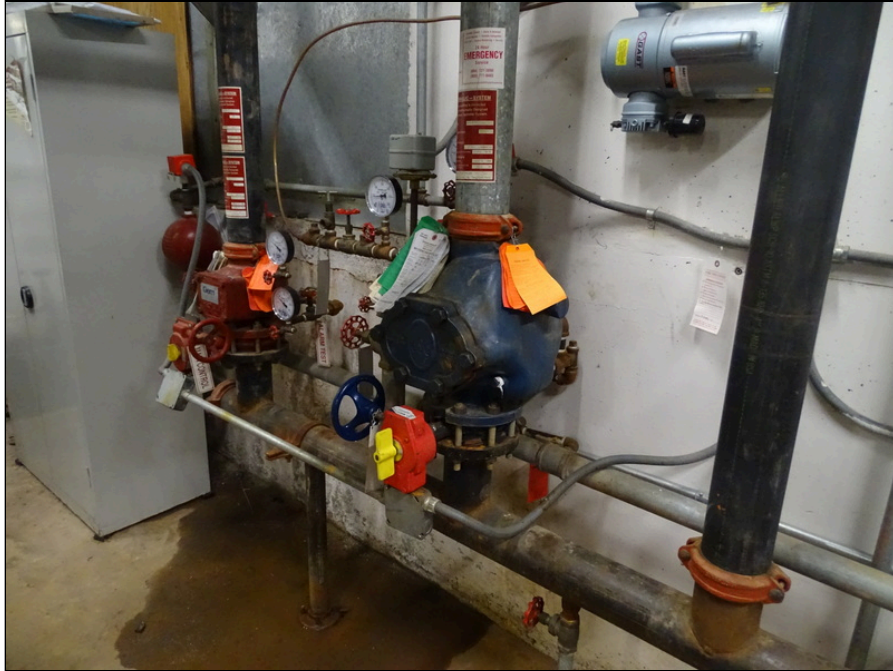
67 - Fire sprinkler system

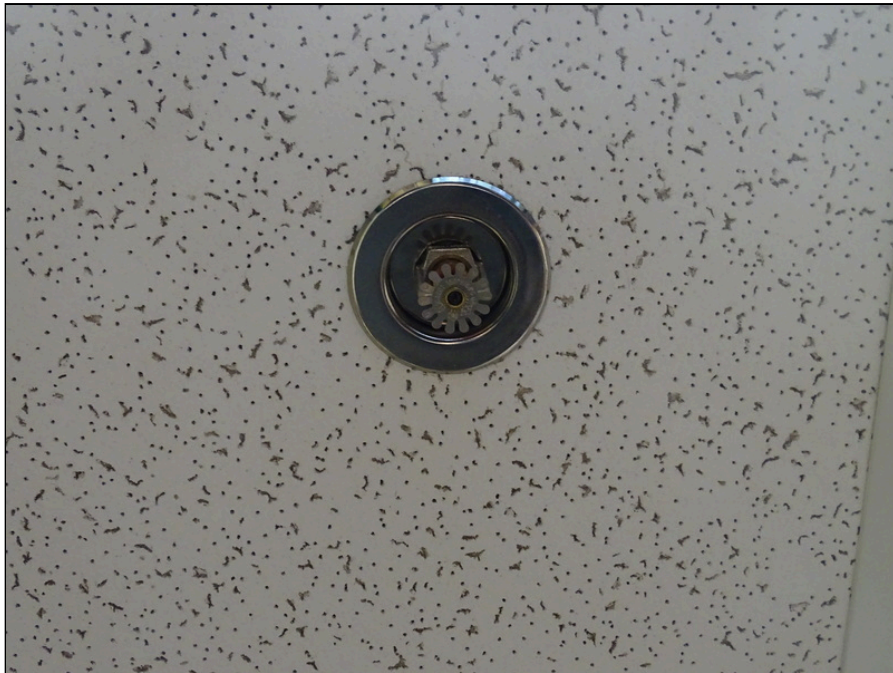
68 - Typical fire sprinkler head

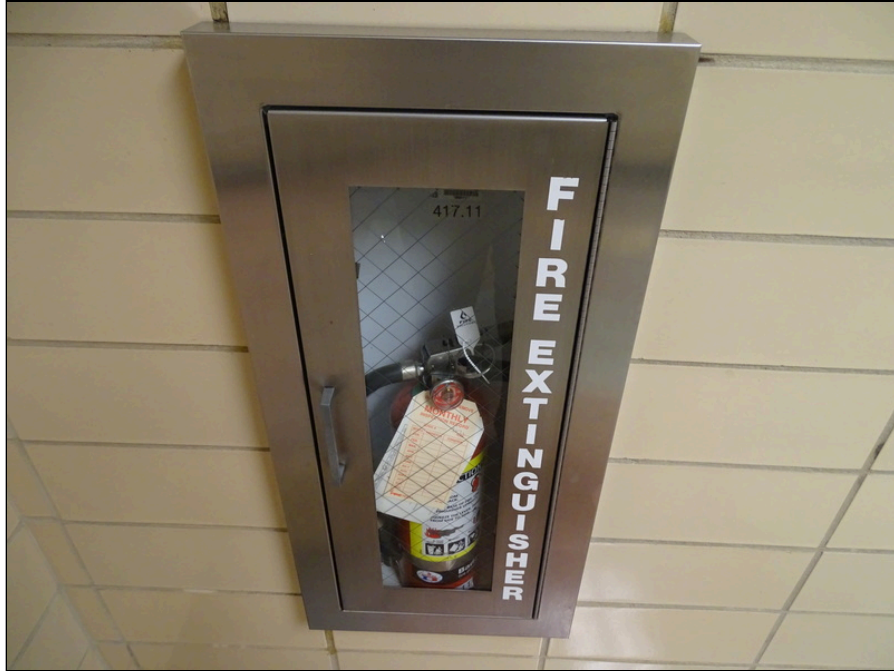
69 - Typical fire extinguisher

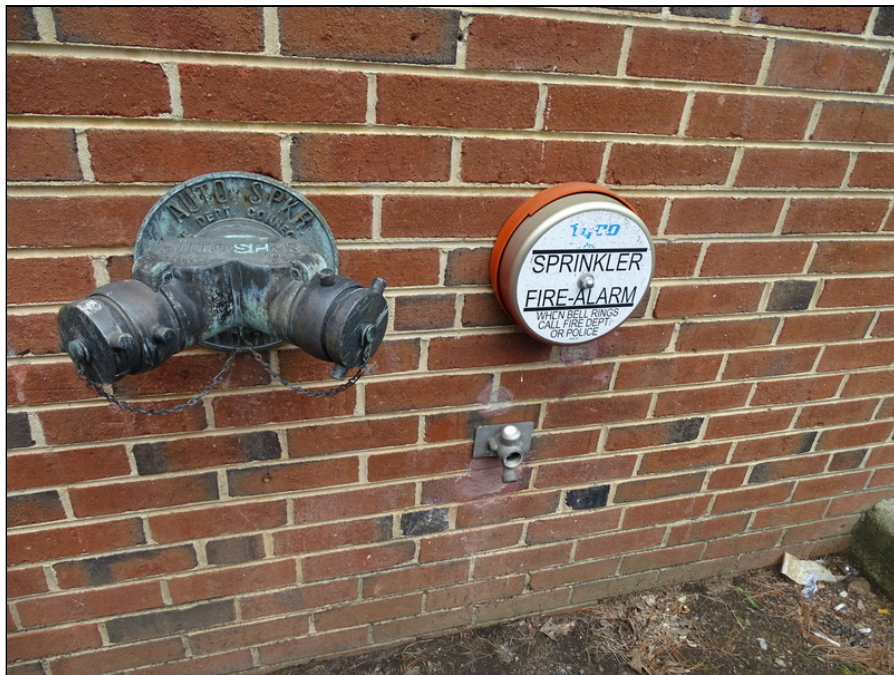
70 - Fire Department connections

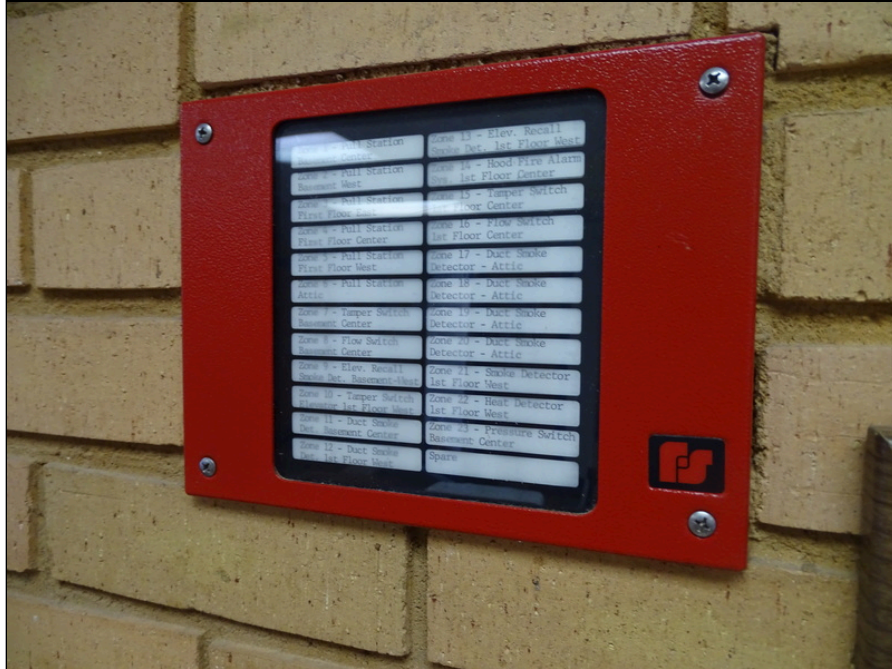
71 - Fire alarm panel - note older panel

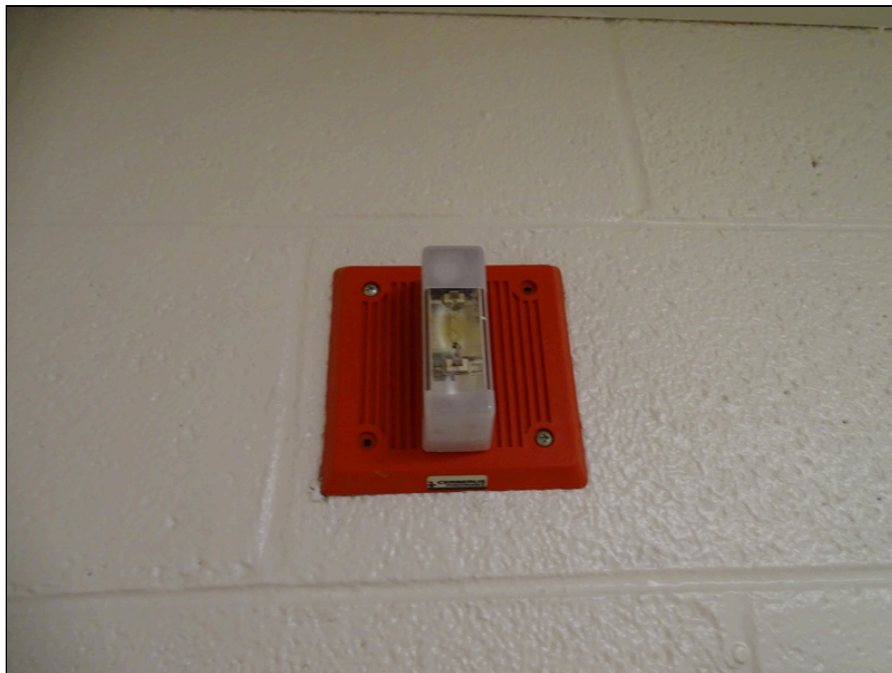
72 - Typical fire alarm bell and strobe

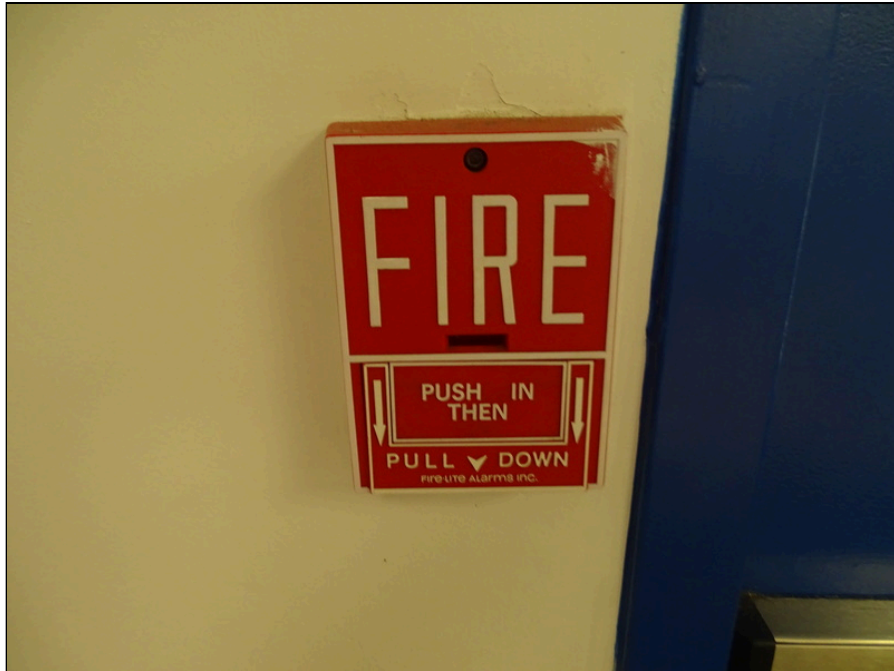
73 - Fire alarm pull station

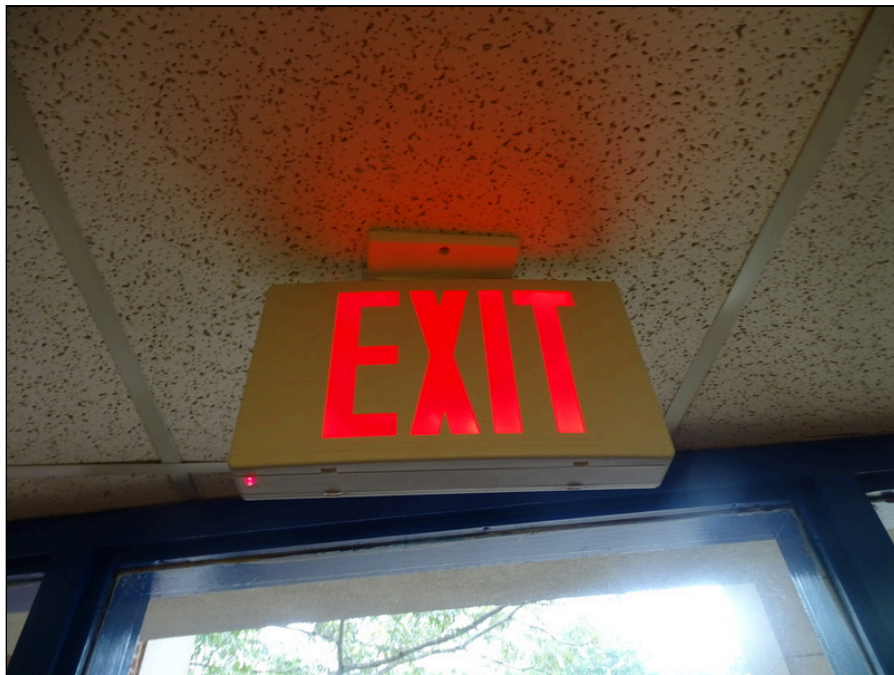
74 - Typical exit sign

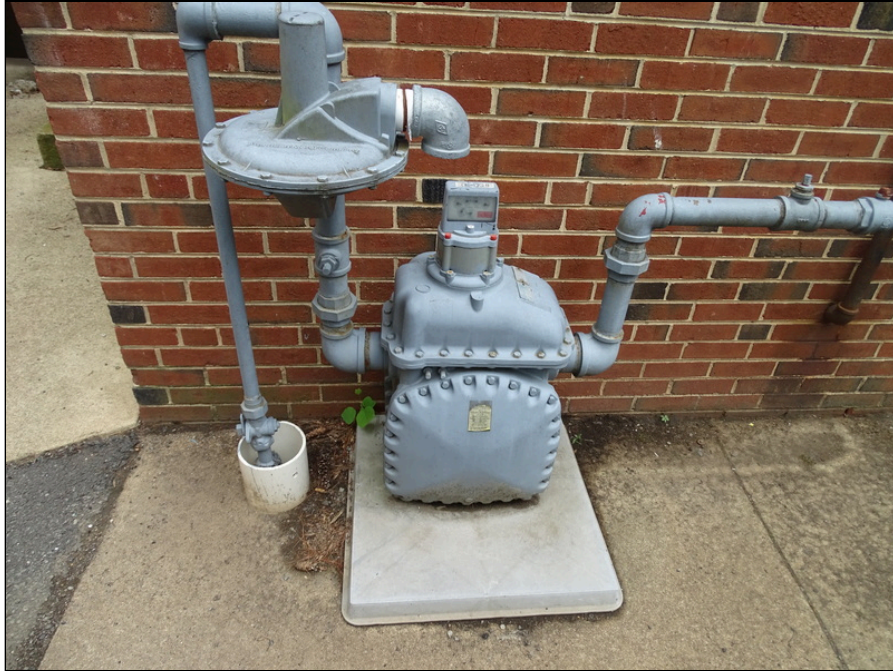
75 - Typical gas meter

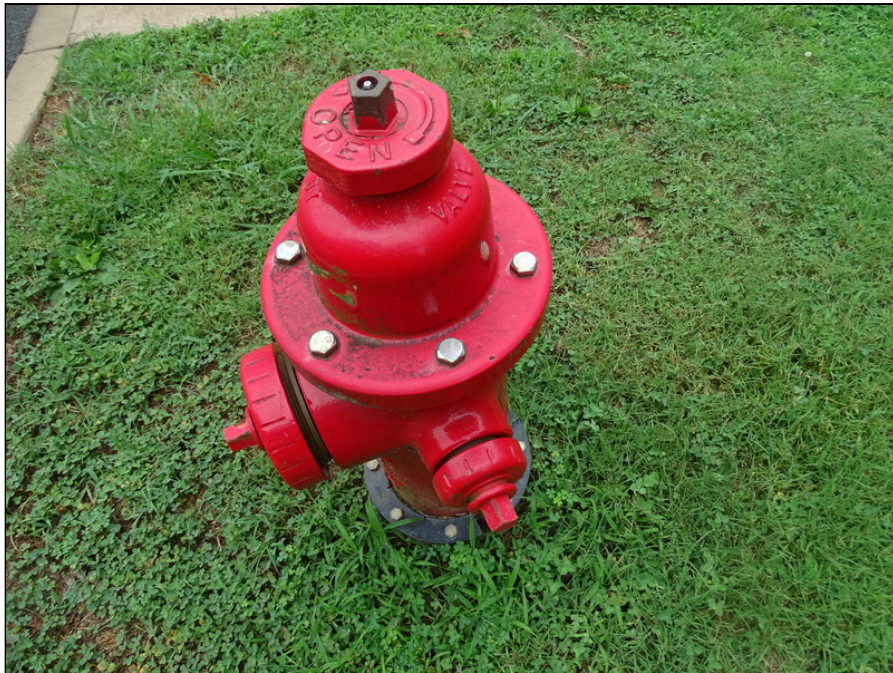
76 - Typical fire hydrant

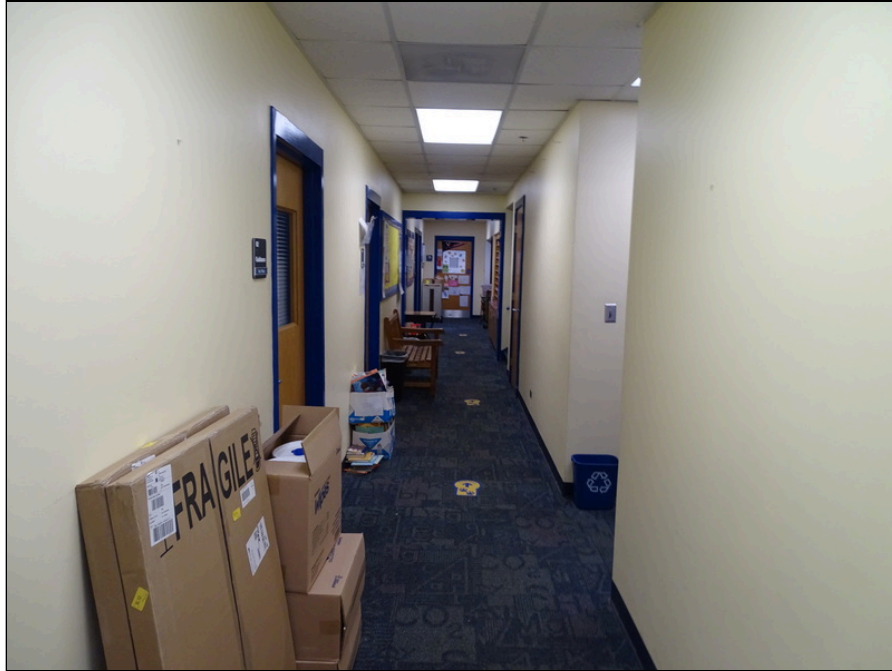
77 - Typical corridor interior

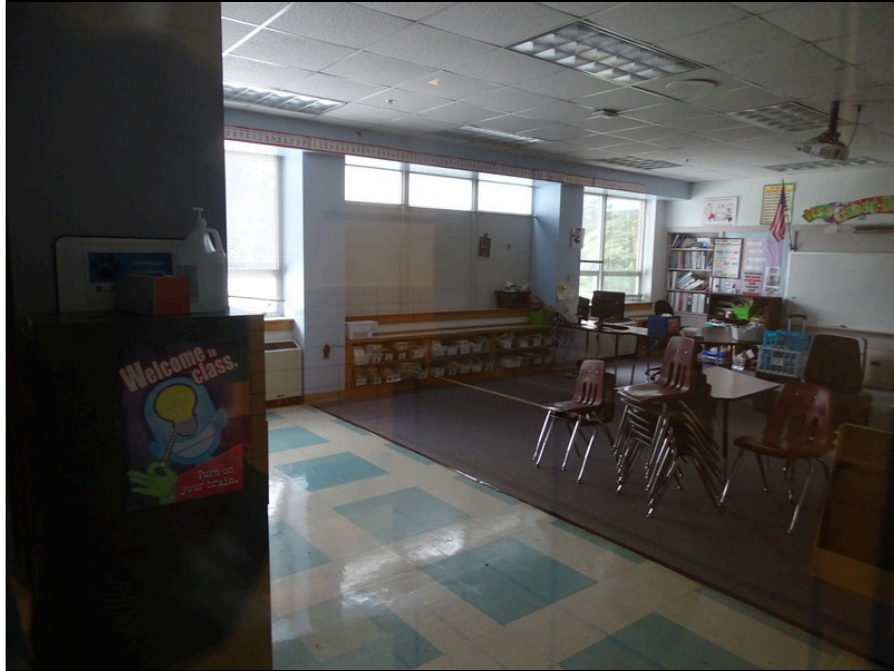
79 - Interior finishes of the classroom area

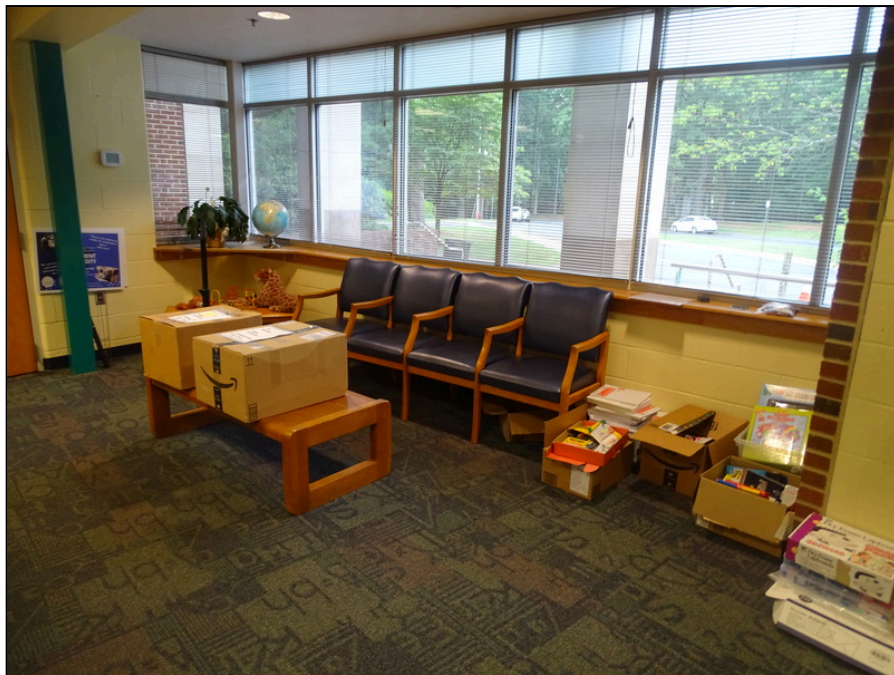
80 - Interior finishes of the classroom area

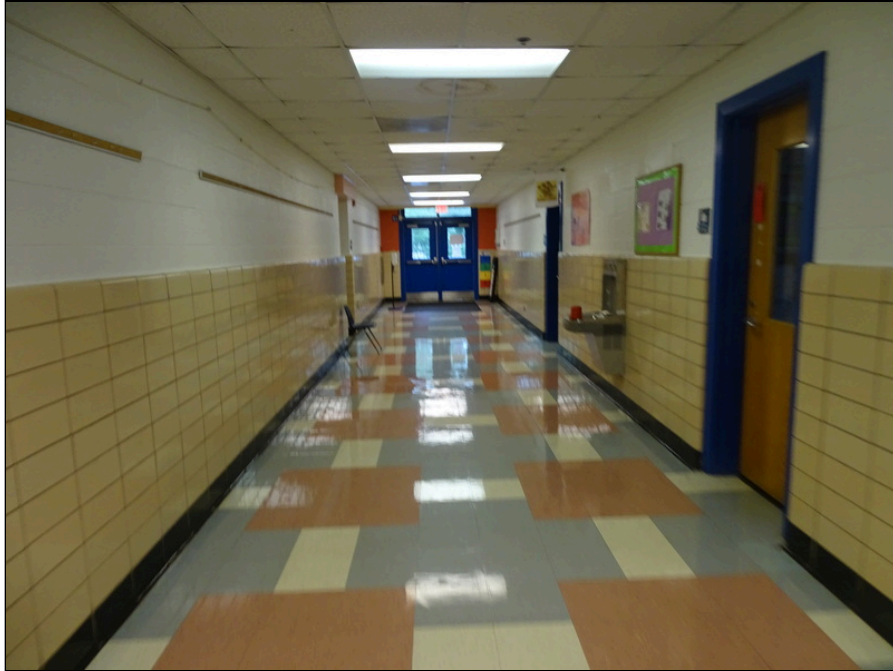
81 - Corridor Finishes

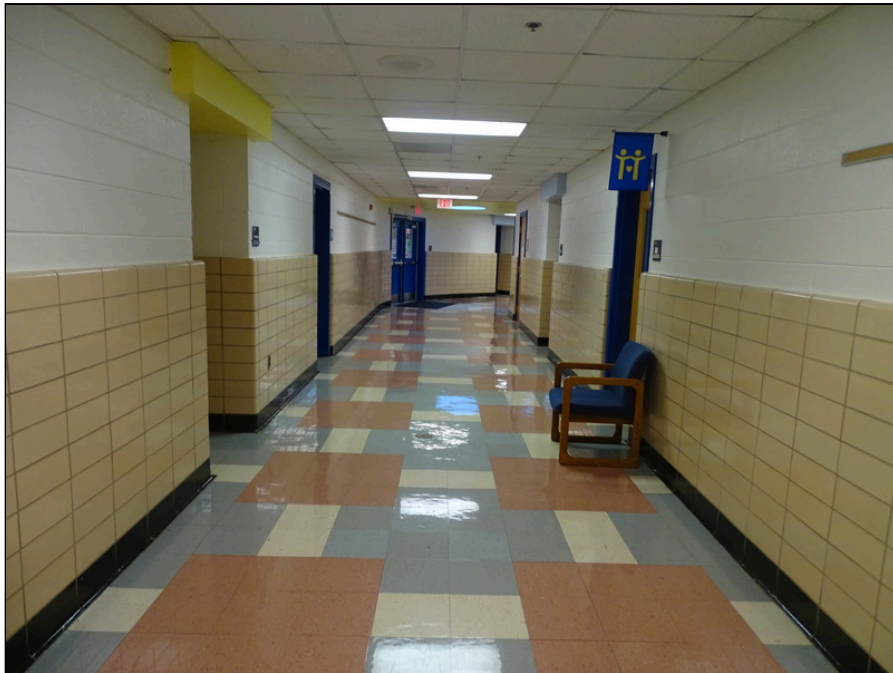
82 - Interior finishes of corridor area

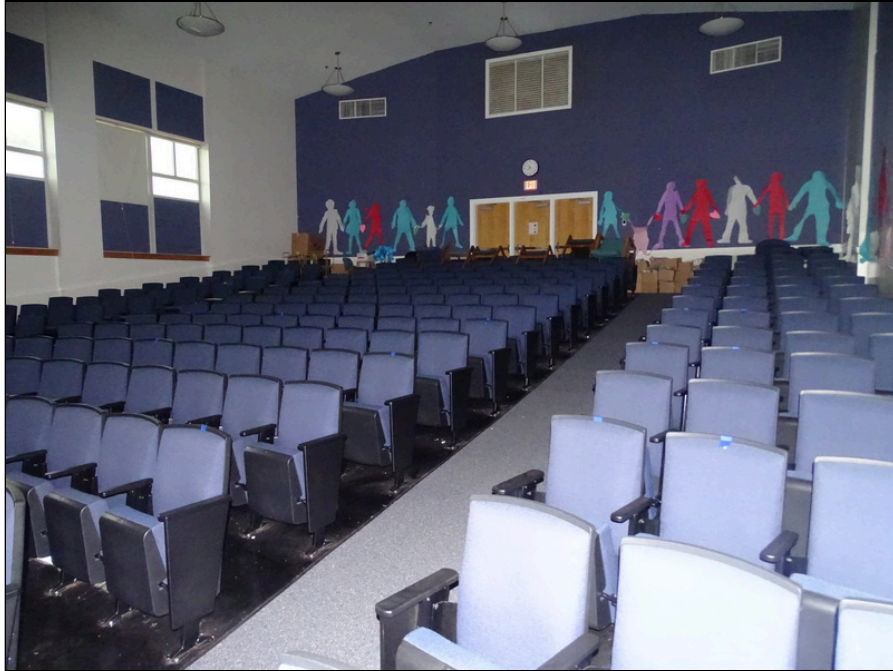
83 - Interior finishes of auditorium area

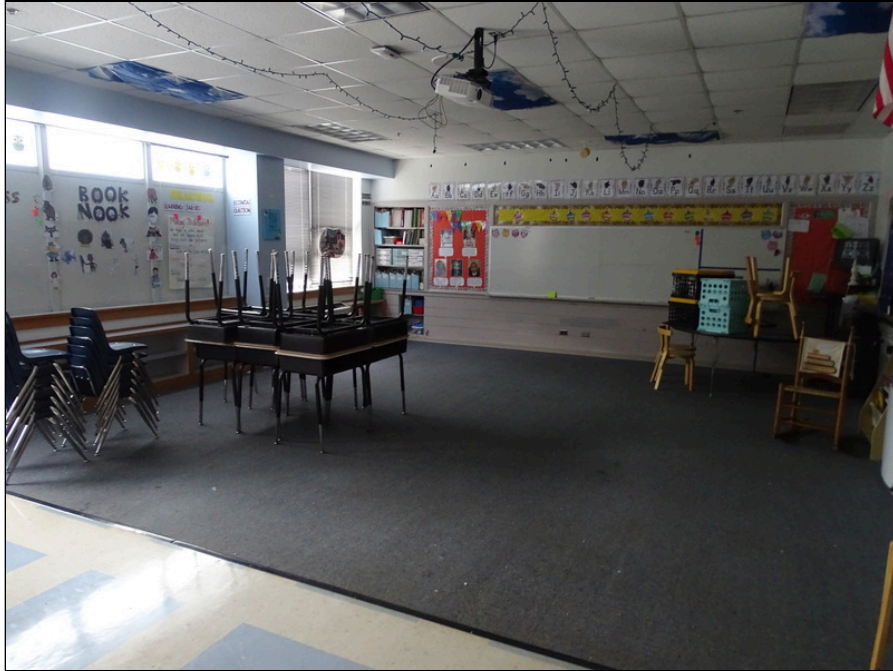
85 - Interior finishes of the classroom area

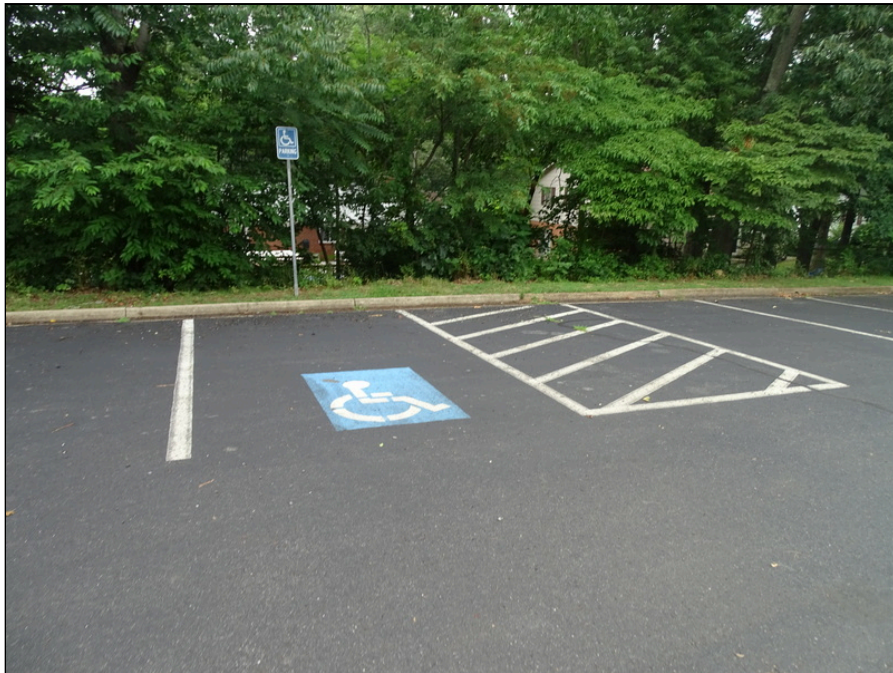
86 - Accessible asphalt pavement parking area northeast side of site

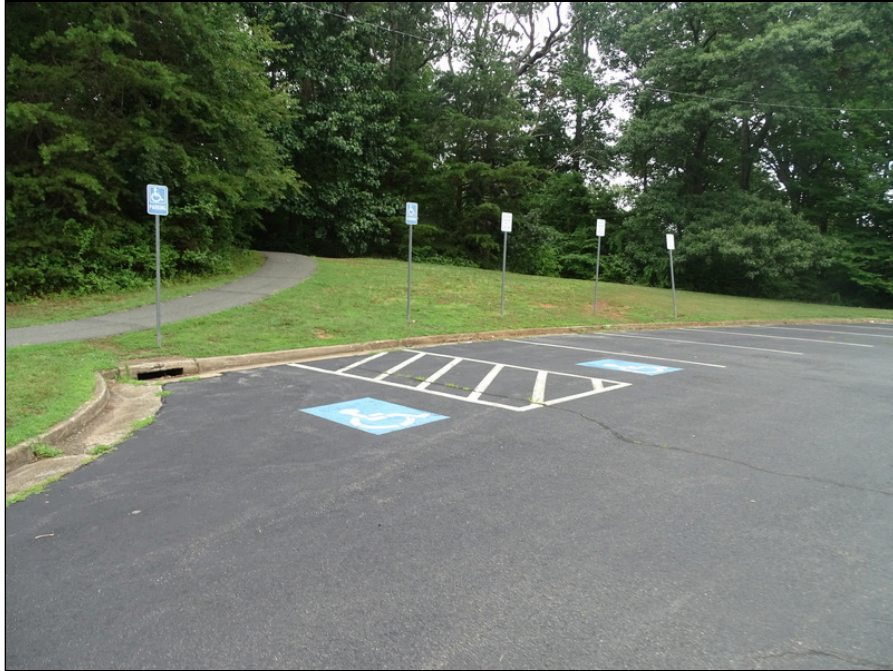
87 - Accessible asphalt pavement parking area northeast side of site

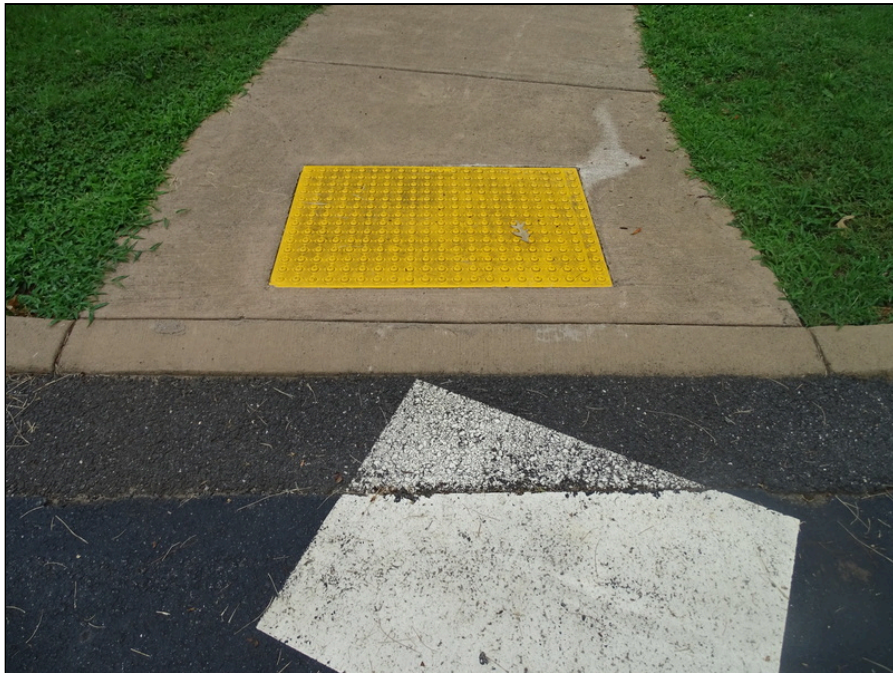
88 - Accessible curb cut ramp with truncated domes

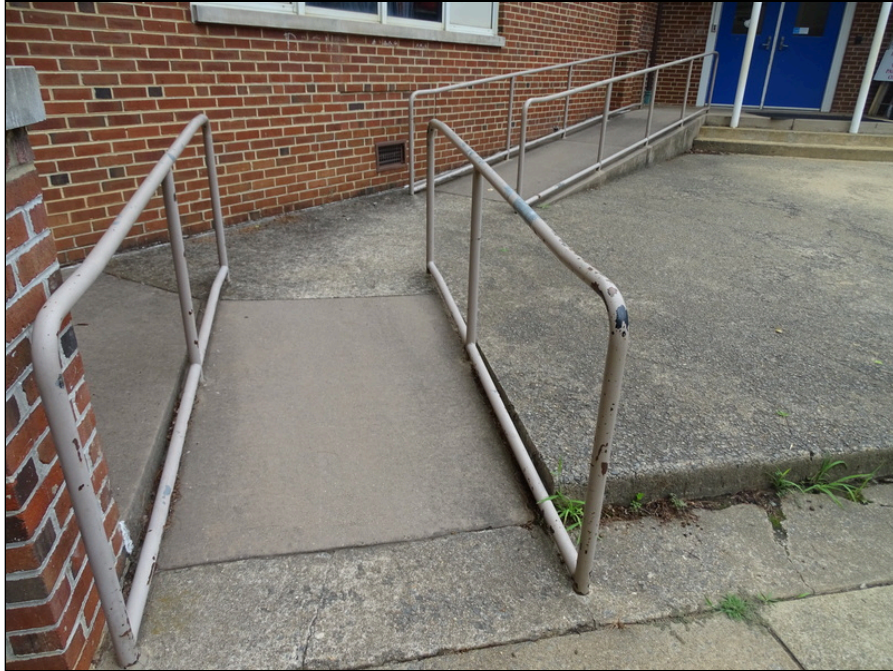
89 - Accessible ramp

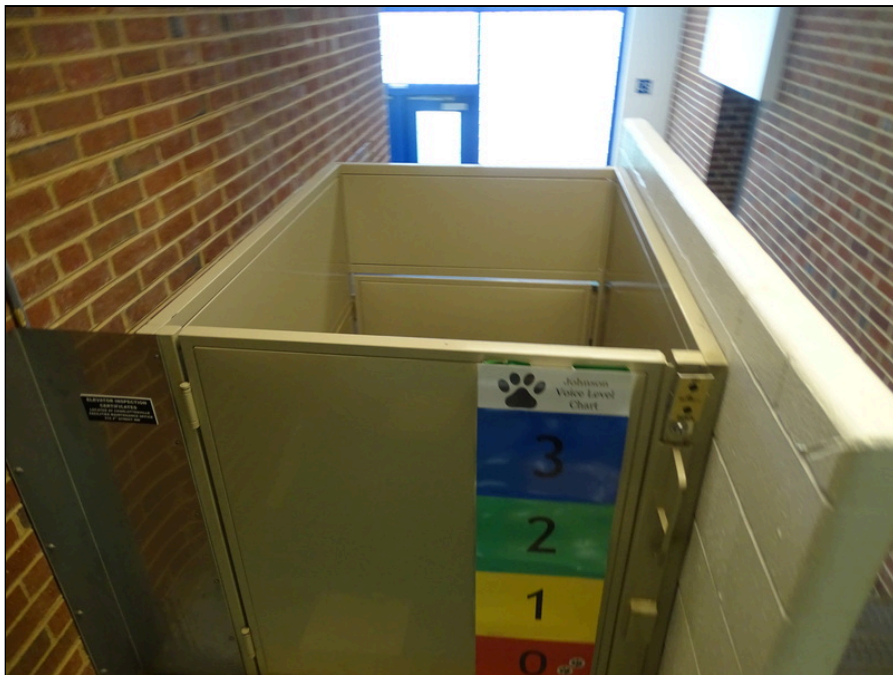
90 - Accessible chair lift

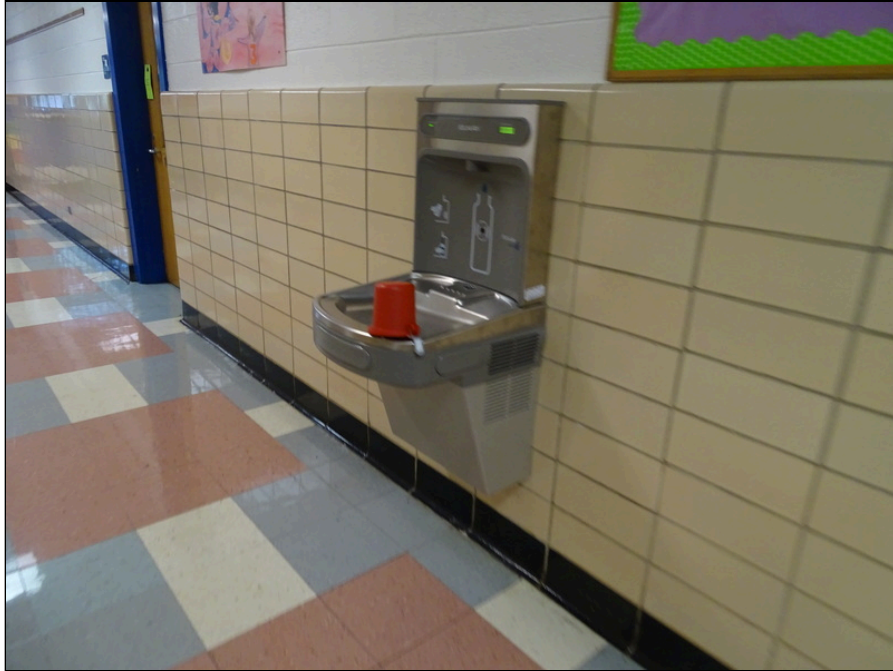
91 - Water fountain - note protruding and not accessible

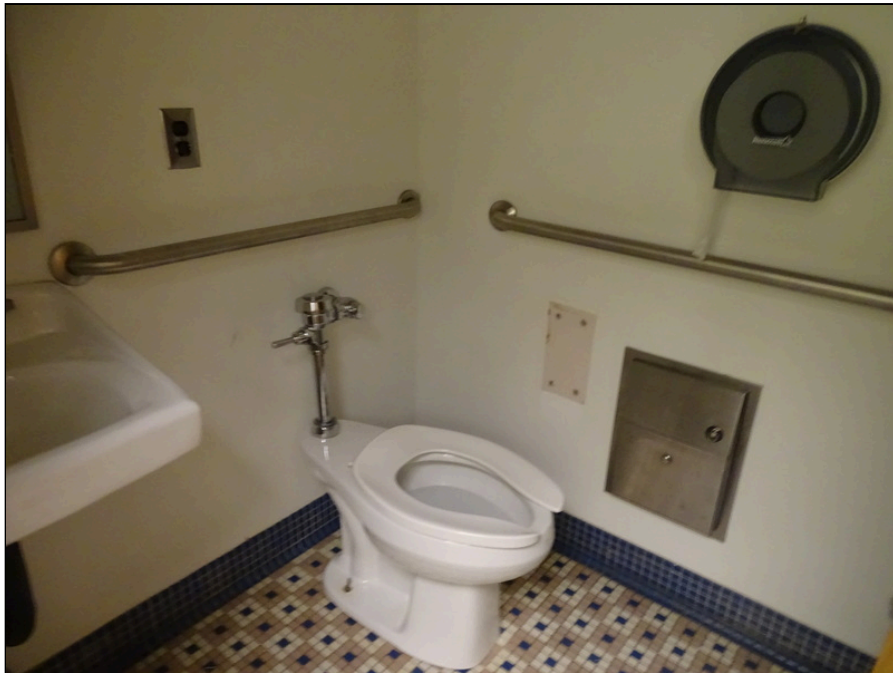
92 - Accessible toilet
