KEY RECREATION CENTER
800 EAST MARKET STREET
CHARLOTTESVILLE, VIRGINIA

ECS PROJECT NO. 46:6713

CITY OF CHARLOTTESVILLE - FACILITIES DEVELOPMENT

Reference: Facility Condition Assessment Report for Key Recreation Center, 800 East Market Street ,
Charlottesville, Virginia

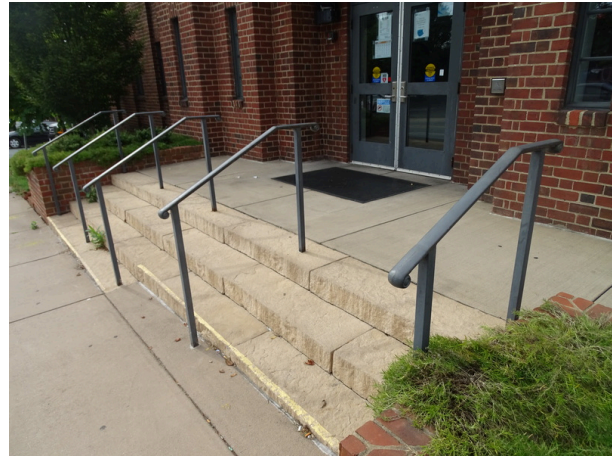
Stone steps at main entrance

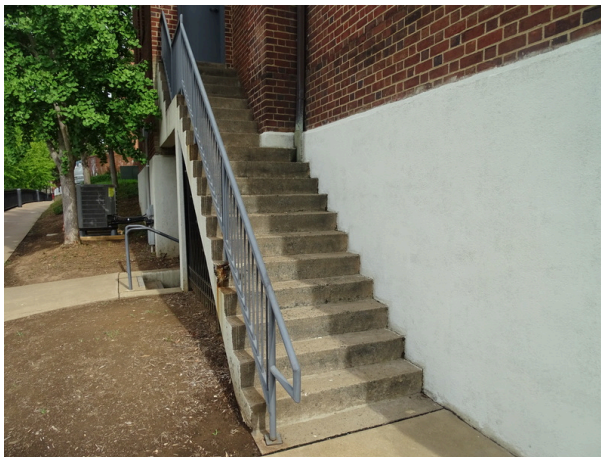
Concrete steps on south side of the building

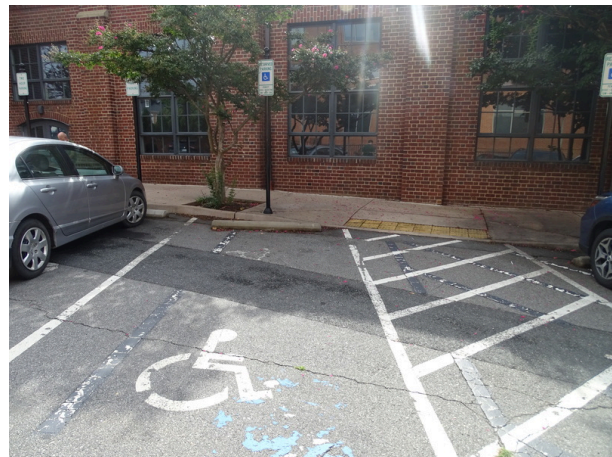
Accessible parking space

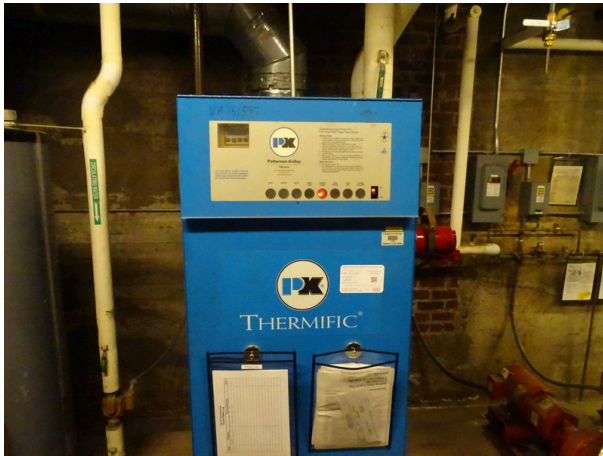
Boiler located in main utility room

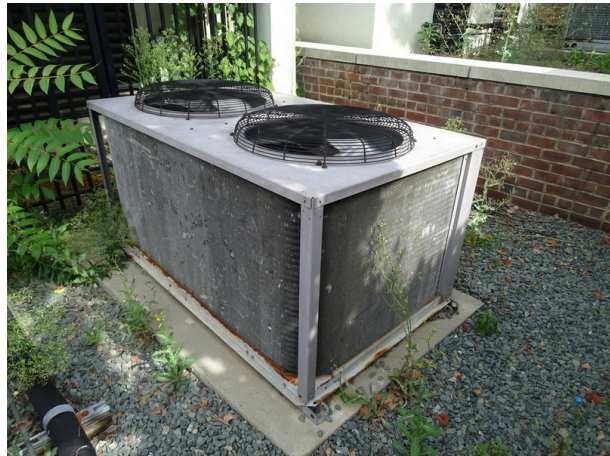
Condenser unit located on east side of the building

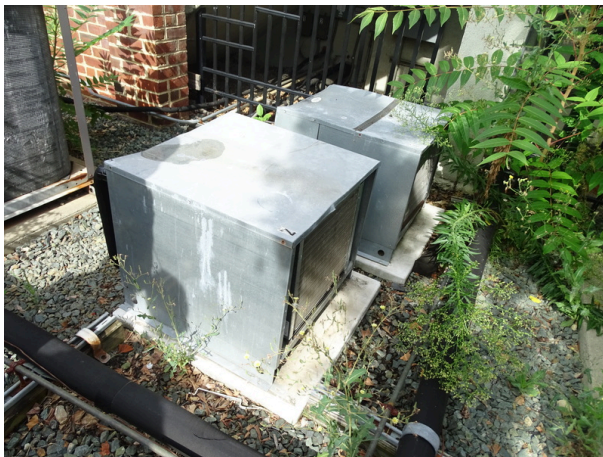
Condenser units located on east side of the building

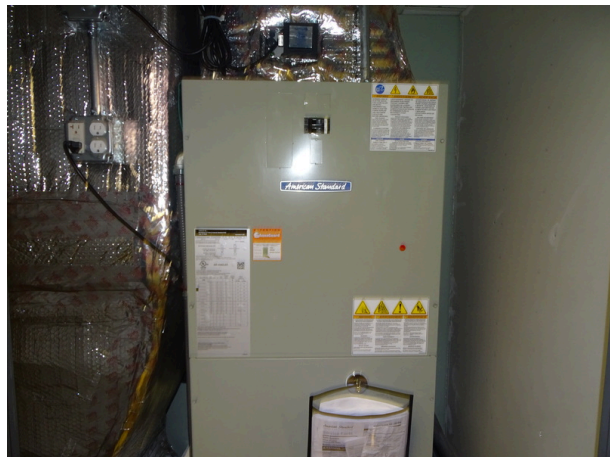
Split system furnace unit located at interior closet space

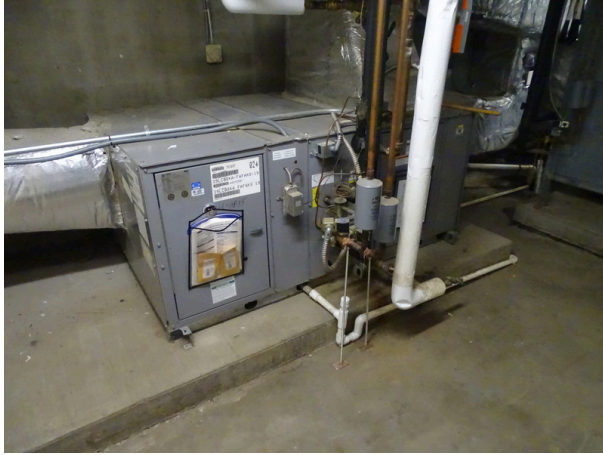
Air handler unit

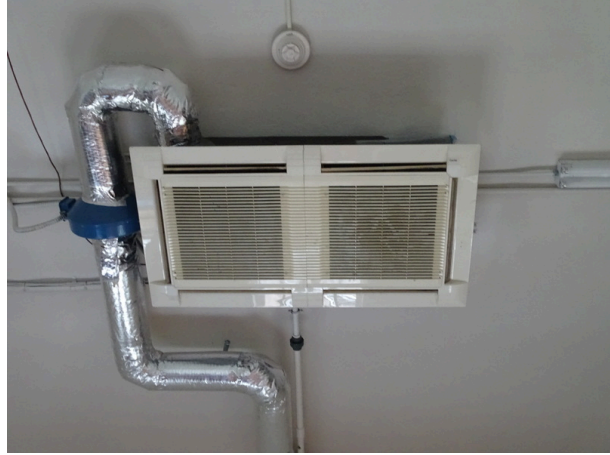
Split system ductless interior unit

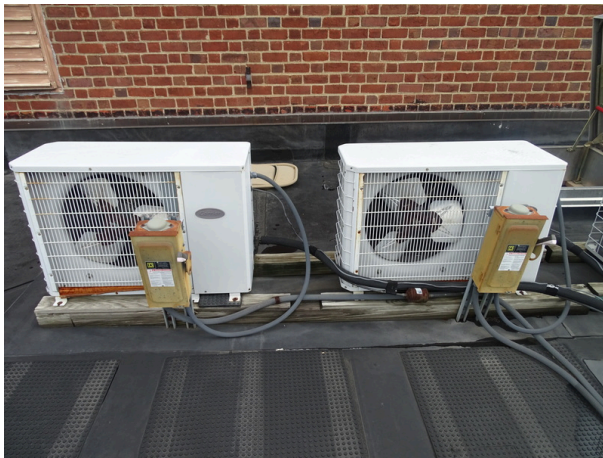
Split system ductless outdoor units

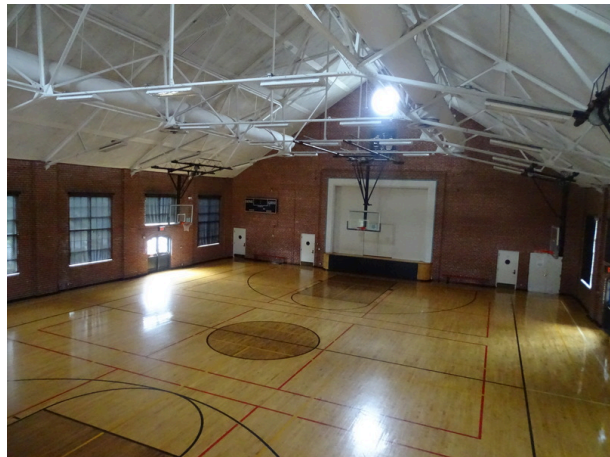
Interior finishes of gymnasium area

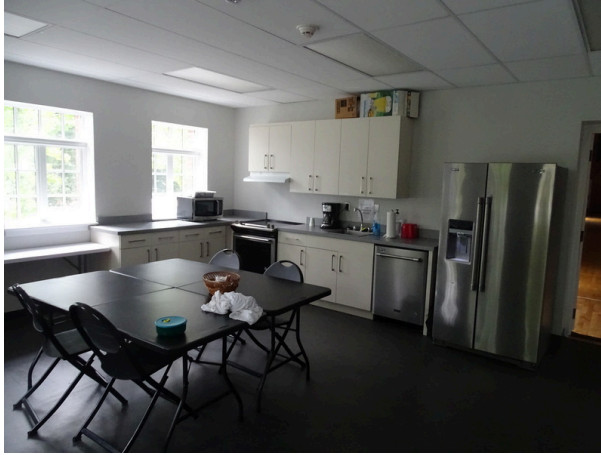
Interior finishes of kitchen and dining area

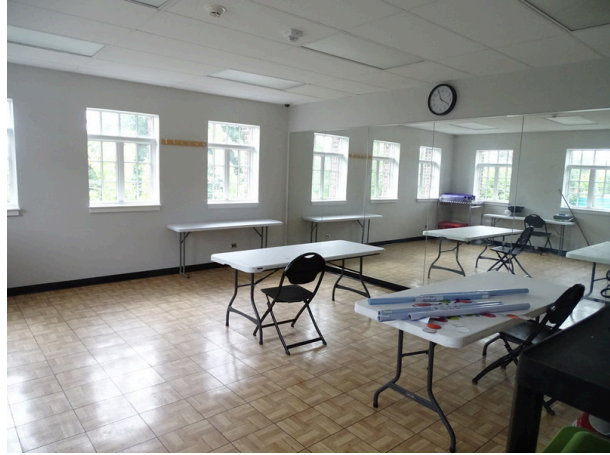
Interior finishes of mezzanine level meeting area

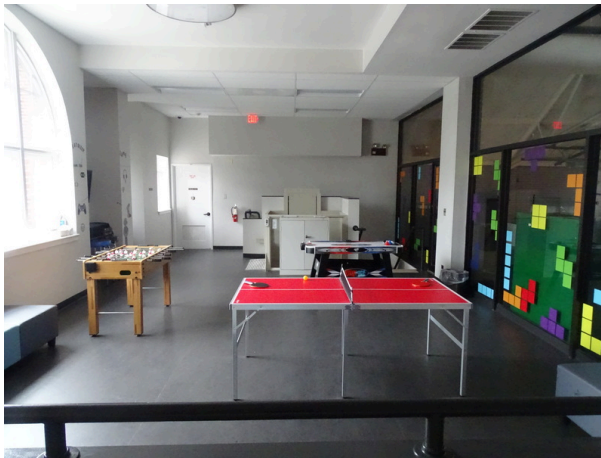
Interior finishes of mezzanine level recreation
area

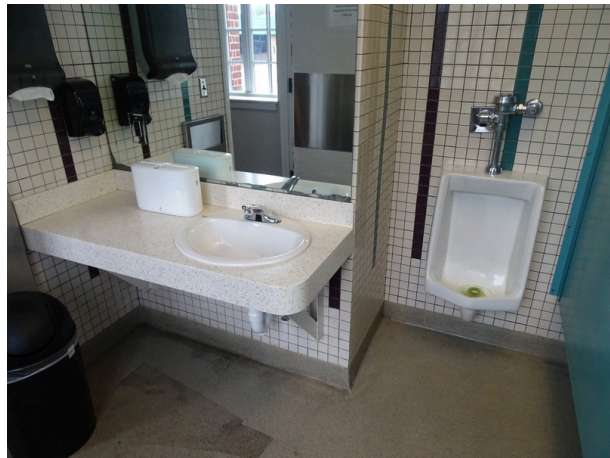
Interior finishes of restroom area

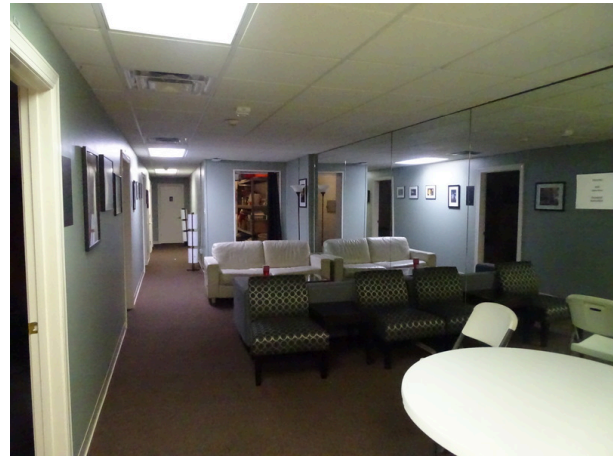
Interior finishes of musician area

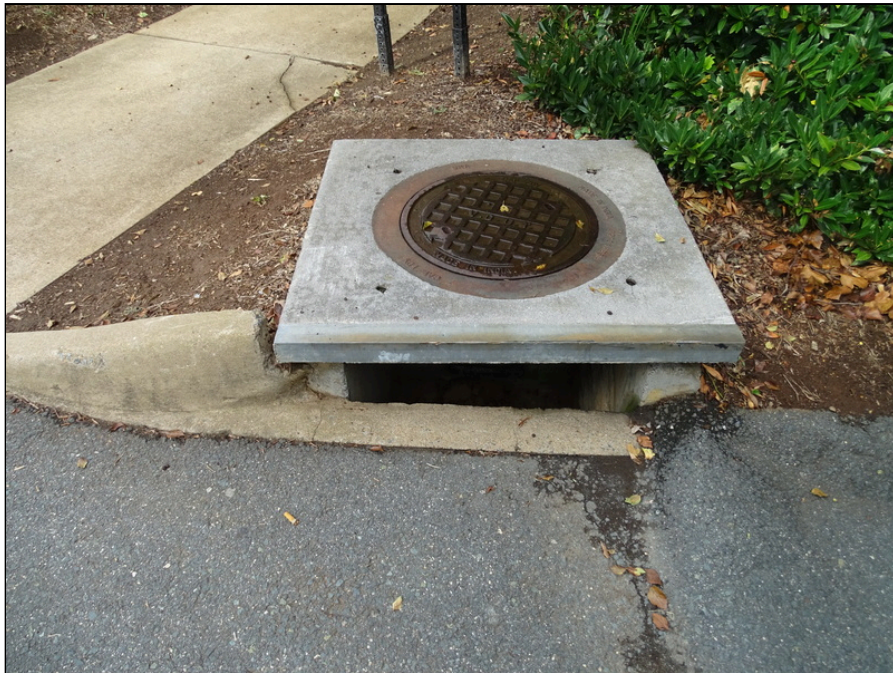
2 - Storm sewer curb inlet

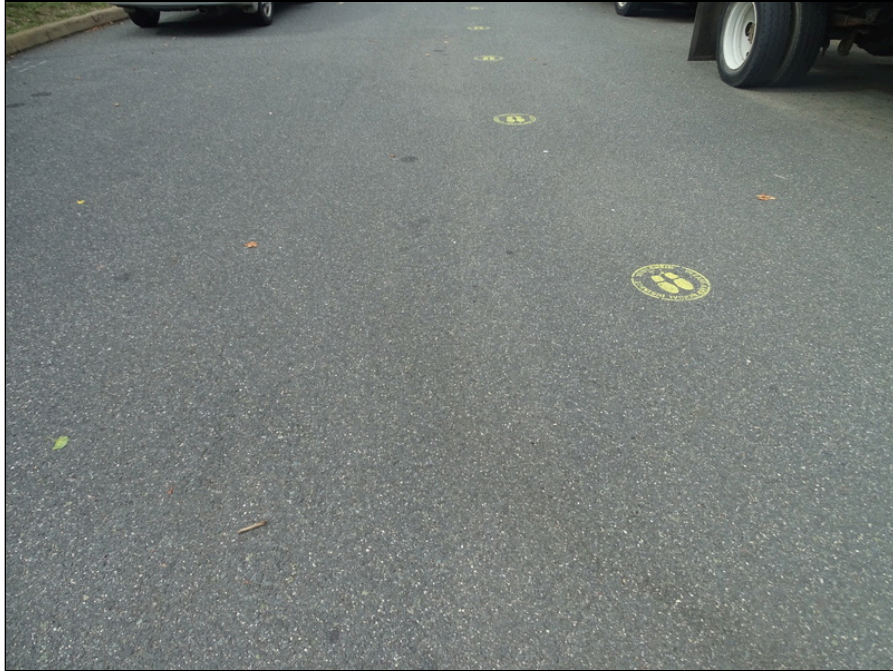
3 - Asphalt pavement

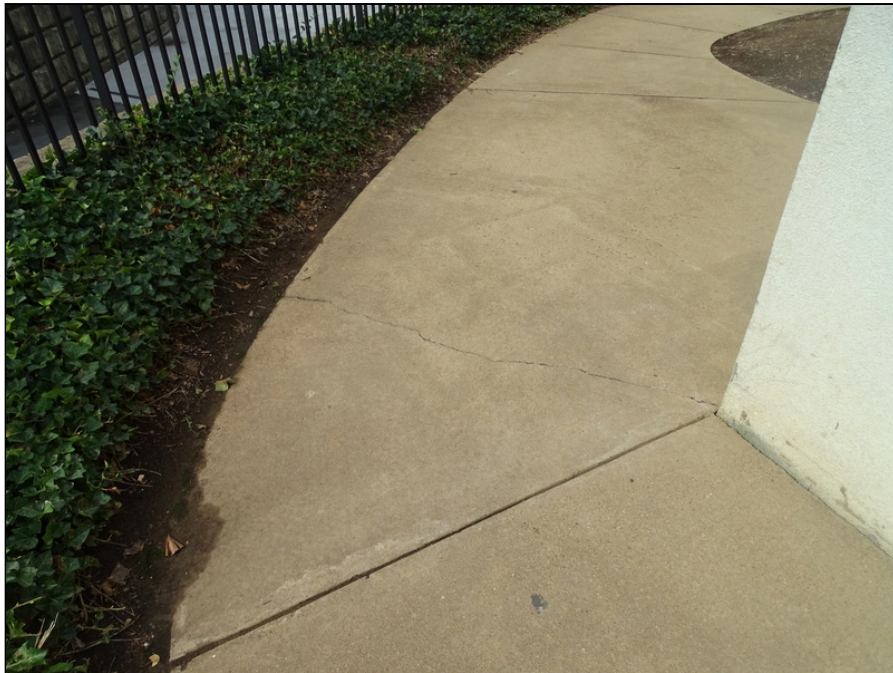
4 - Concrete sidewalk

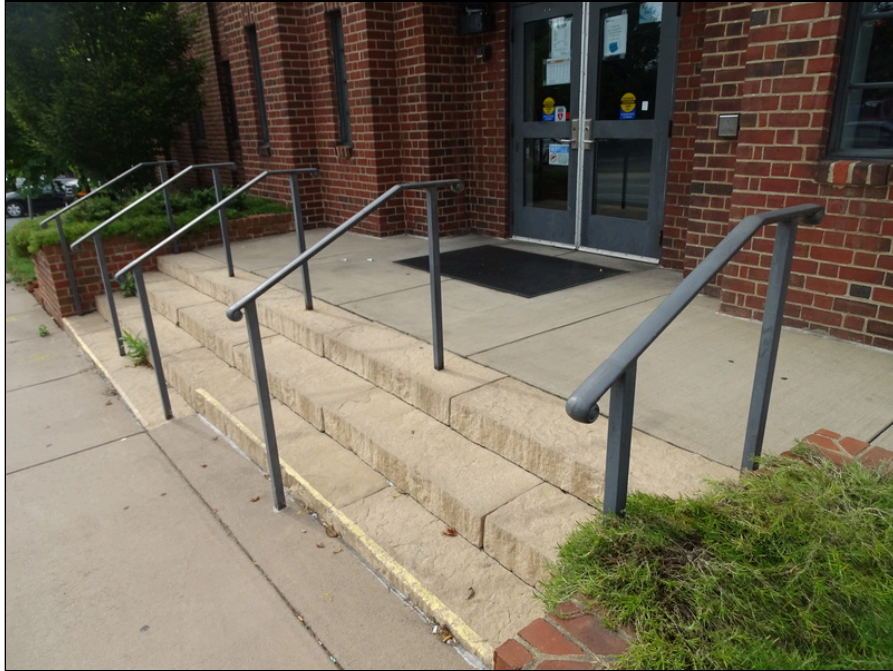
5 - Stone steps at main entrance

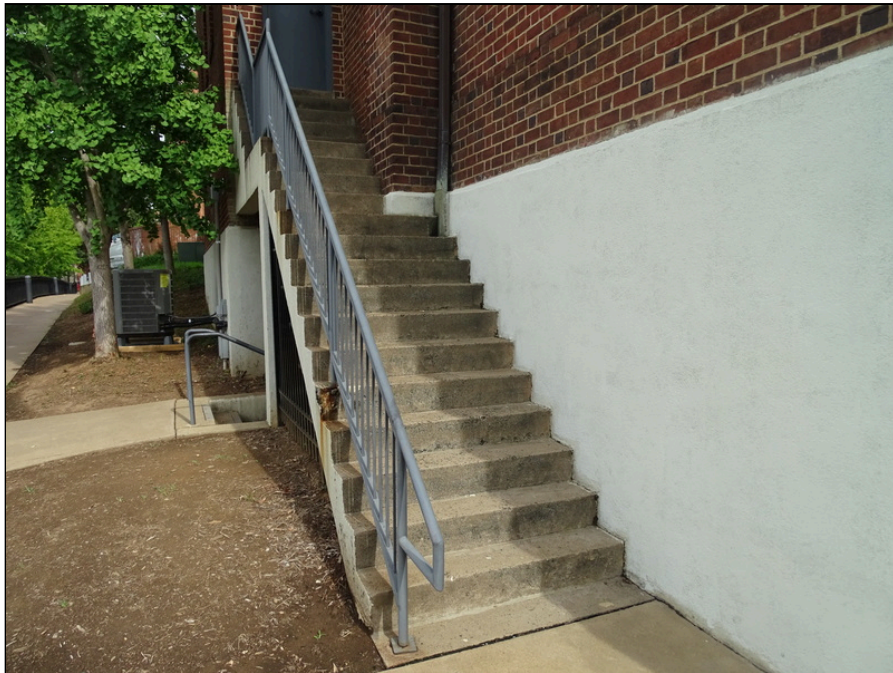
6 - Concrete steps on south side of the building

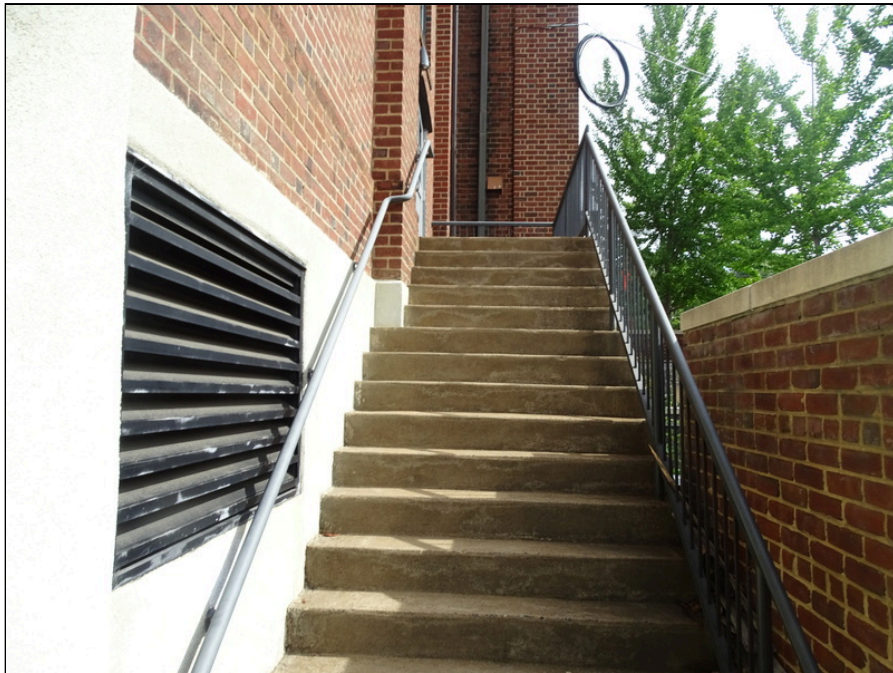
8 - Concrete steps on east side of the building

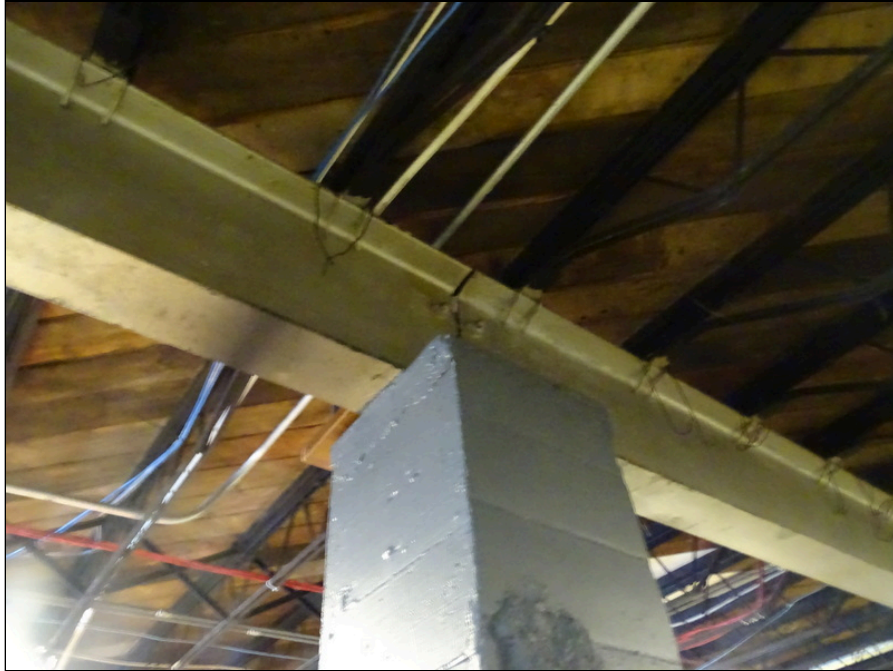
11 - Structural framing

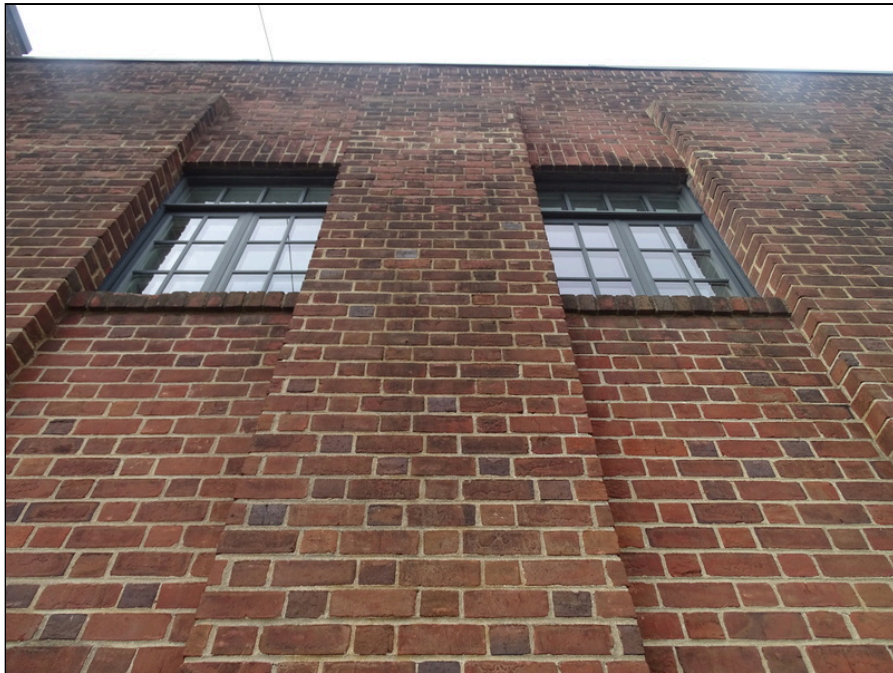
12 - Building exteriors

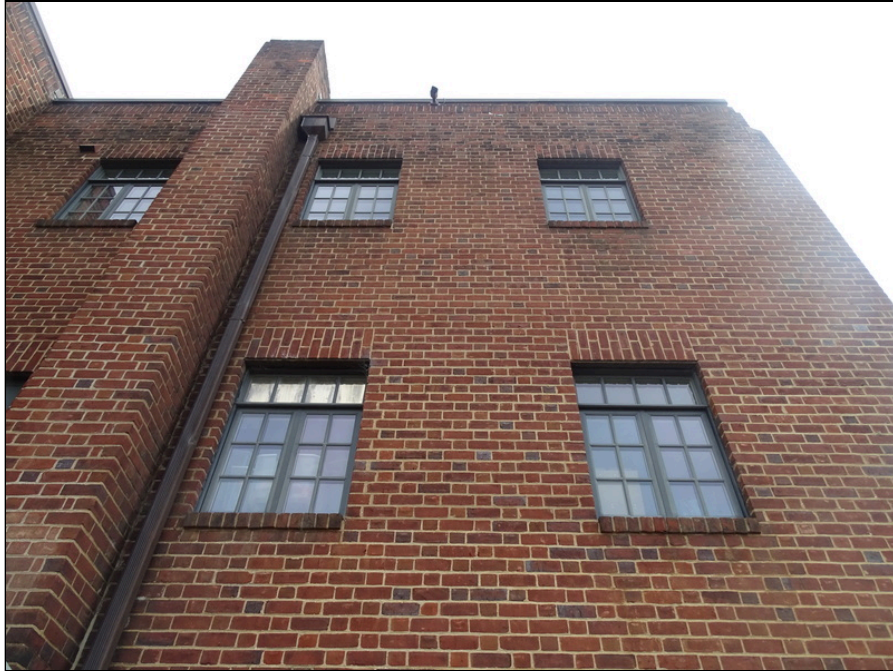
13 - Building exteriors

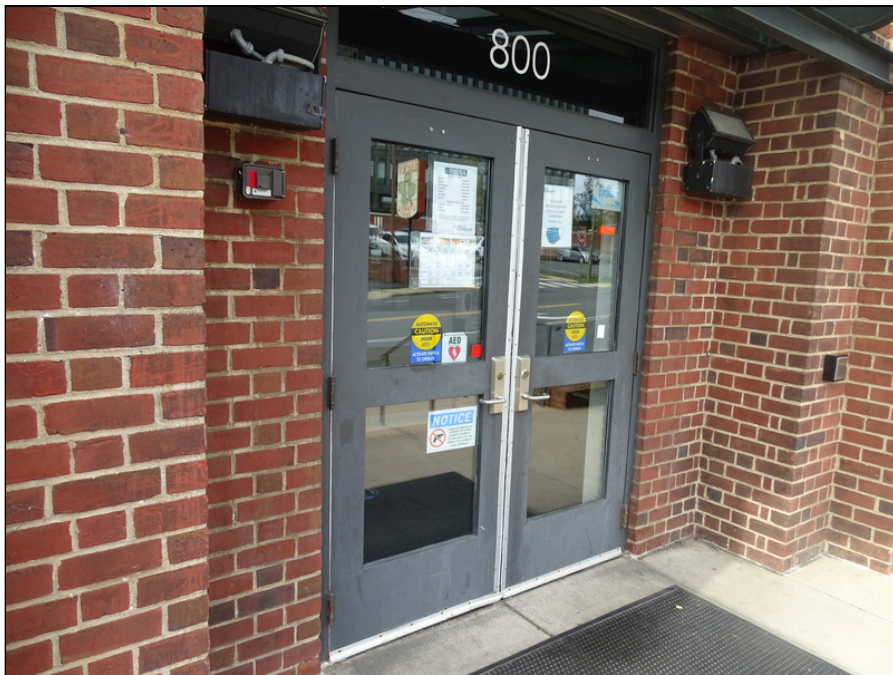
20 - Main entrance doors

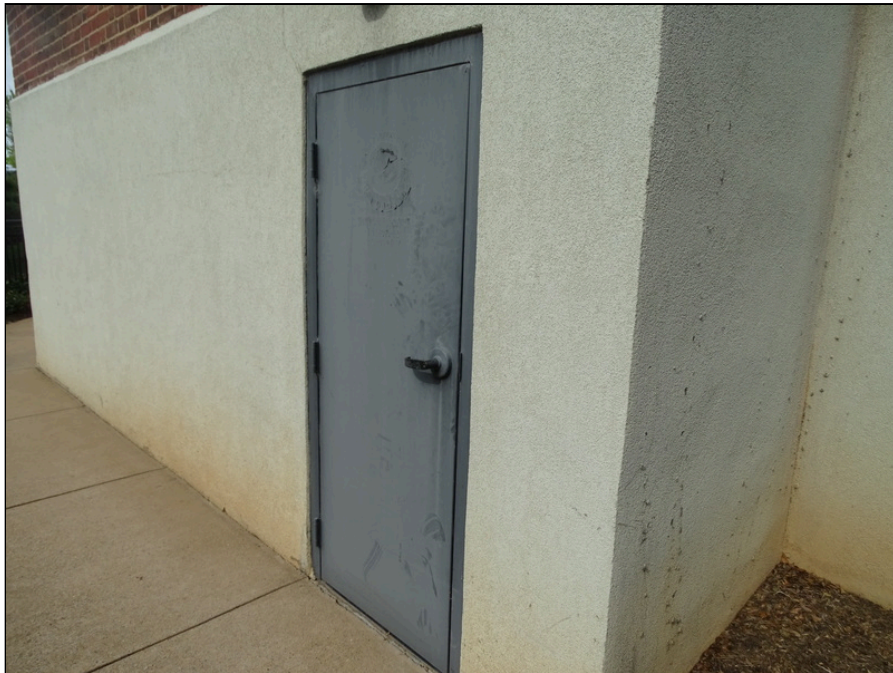
22 - Typical personnel door

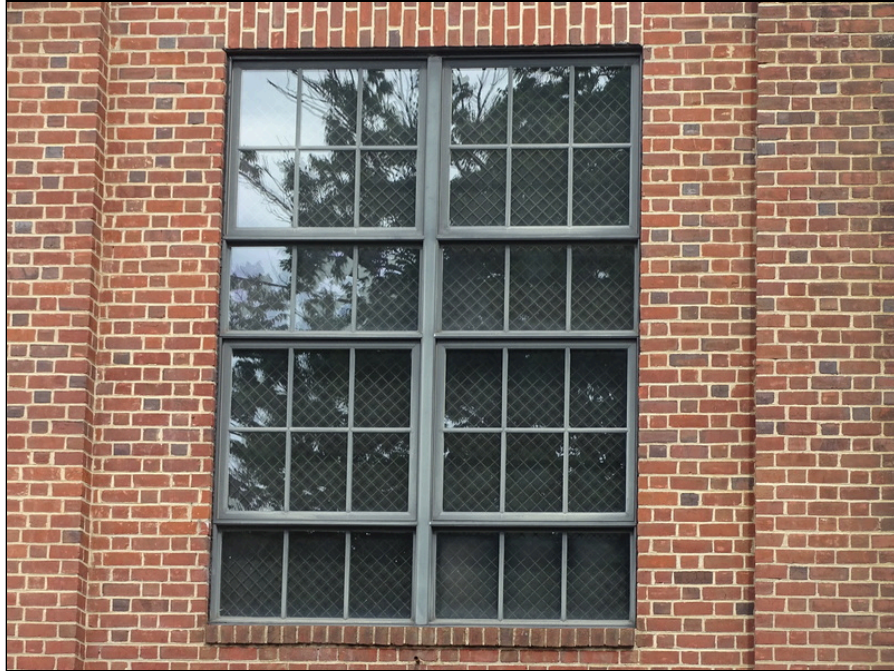
23 - Exterior windows

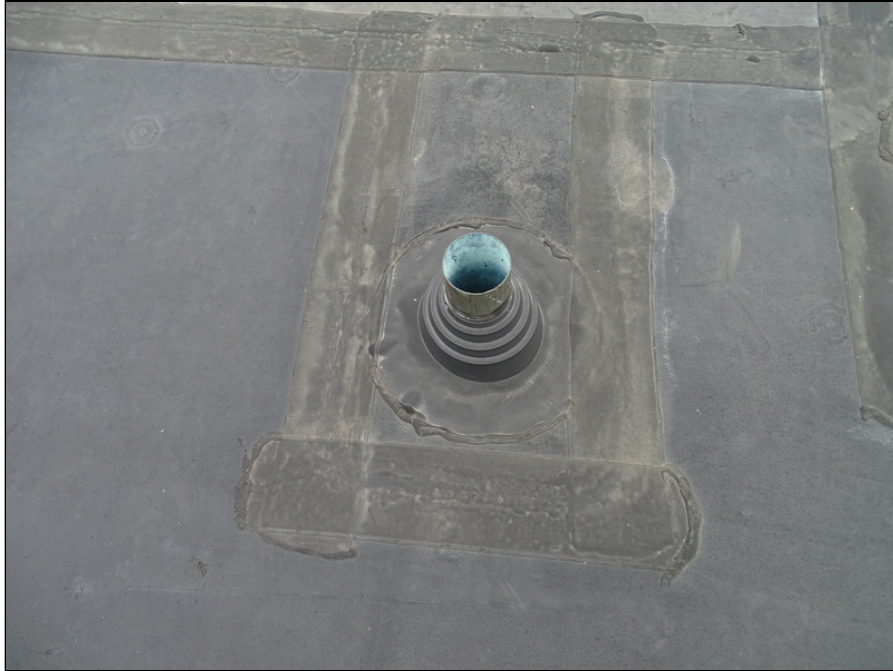
31 - Single-ply membrane roofing system - plumbing penetration

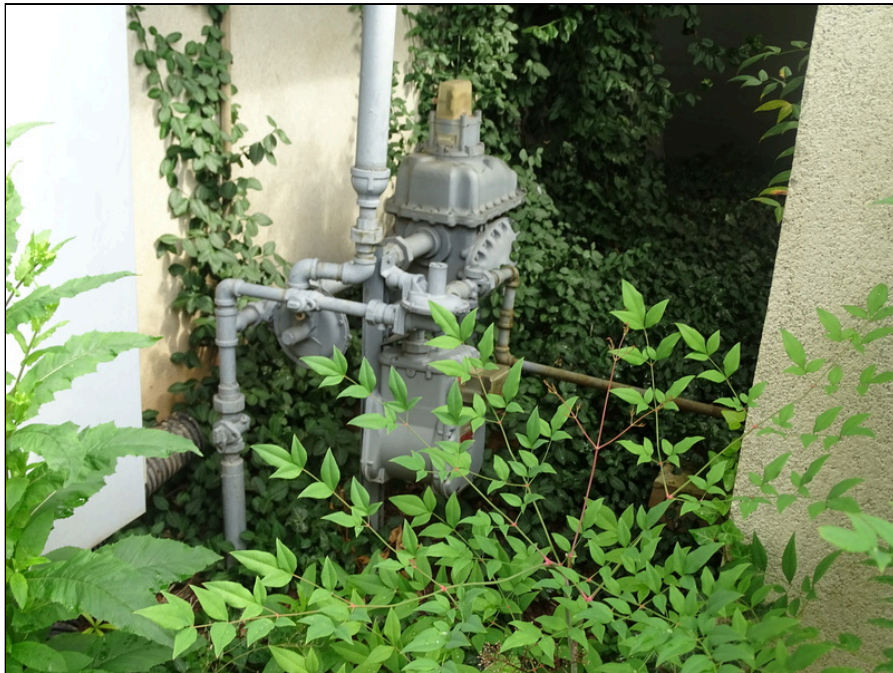
38 - Natural gas utility supply and meter

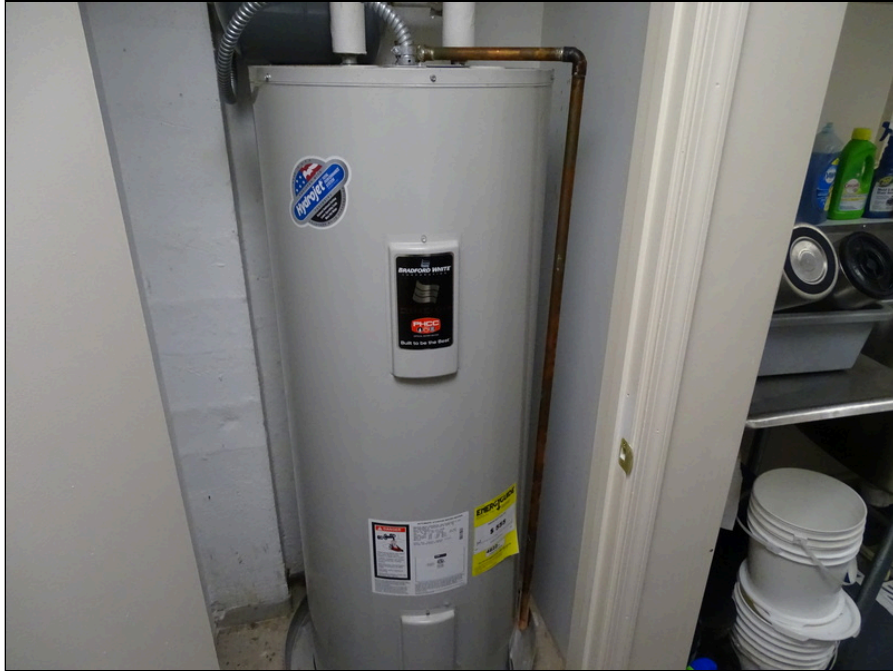
39 - Electric domestic water heater

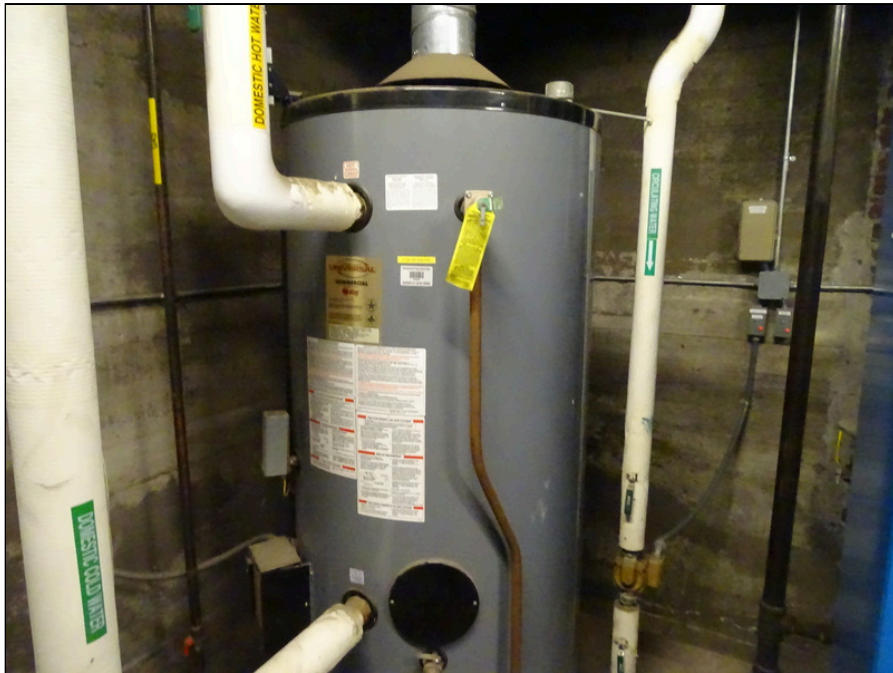
40 - Natural gas domestic water heater

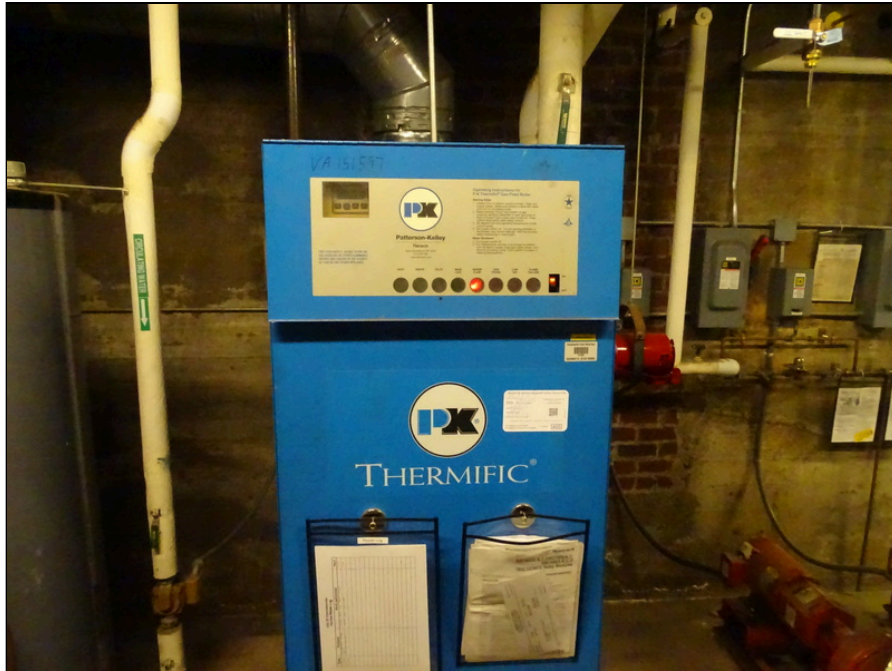
41 - Boiler located in main utility room

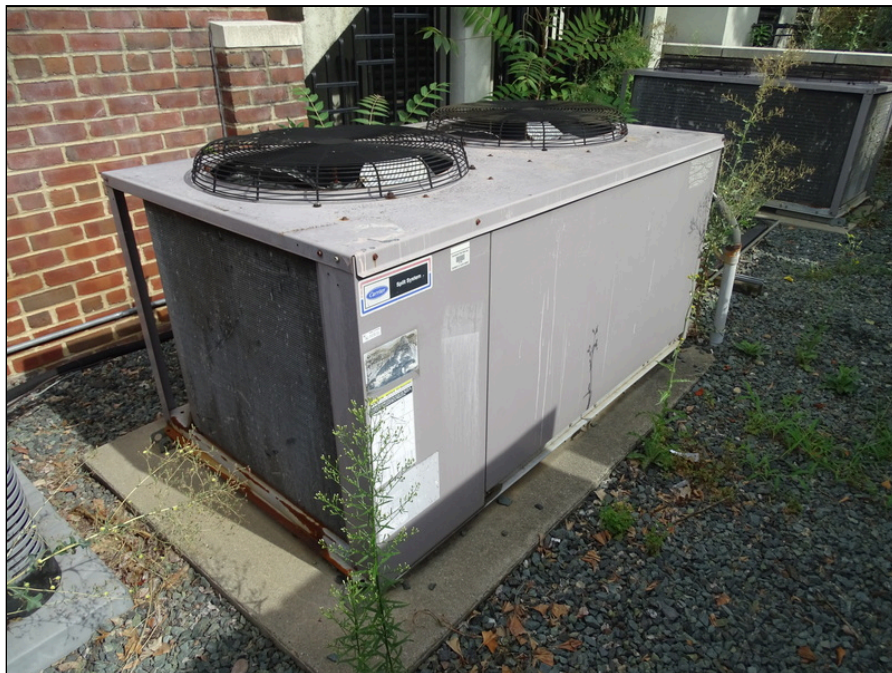
42 - Condenser unit located on east side of the building

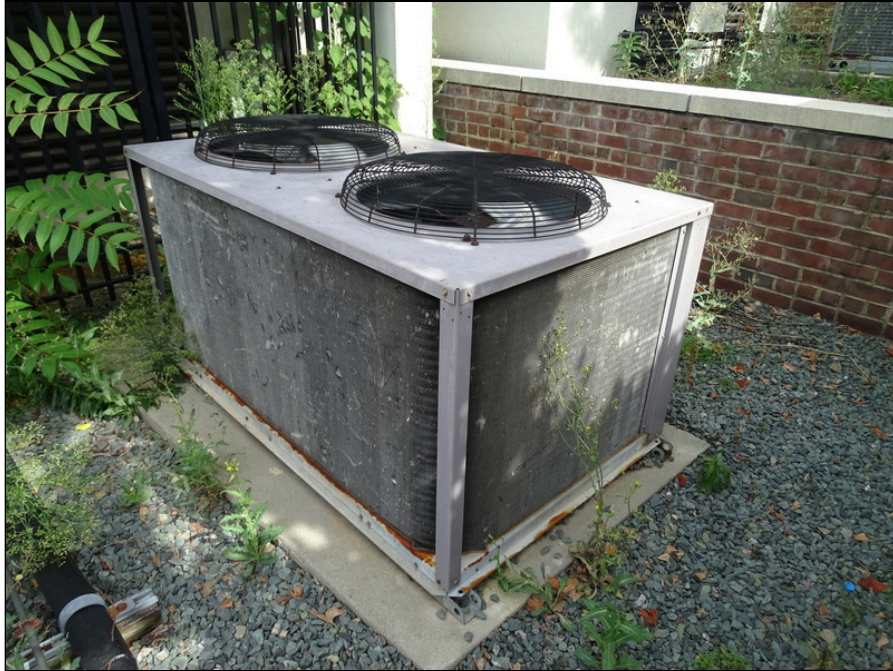
43 - Condenser unit located on east side of the building

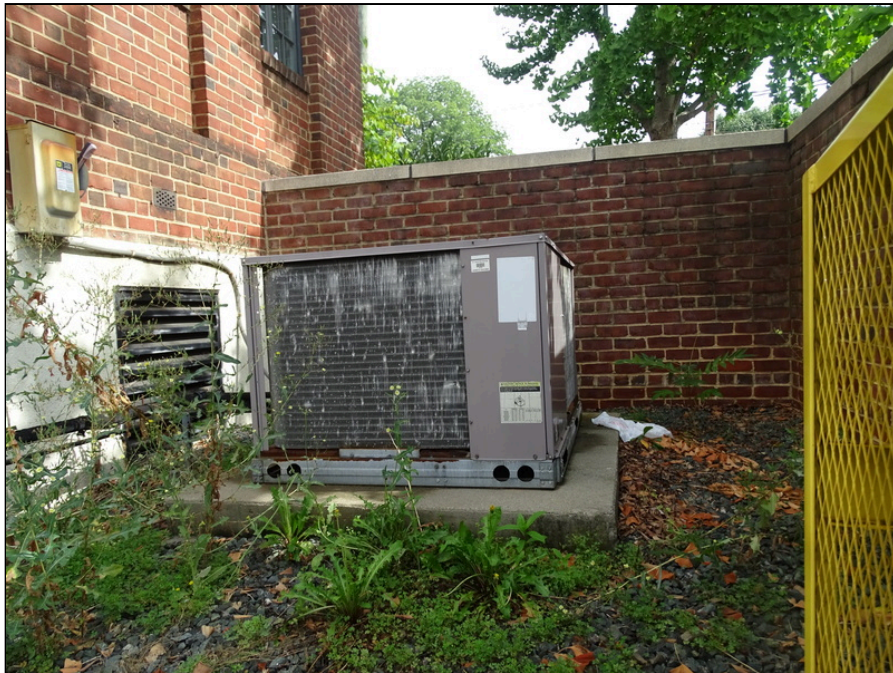
44 - Condenser unit located on east side of the building

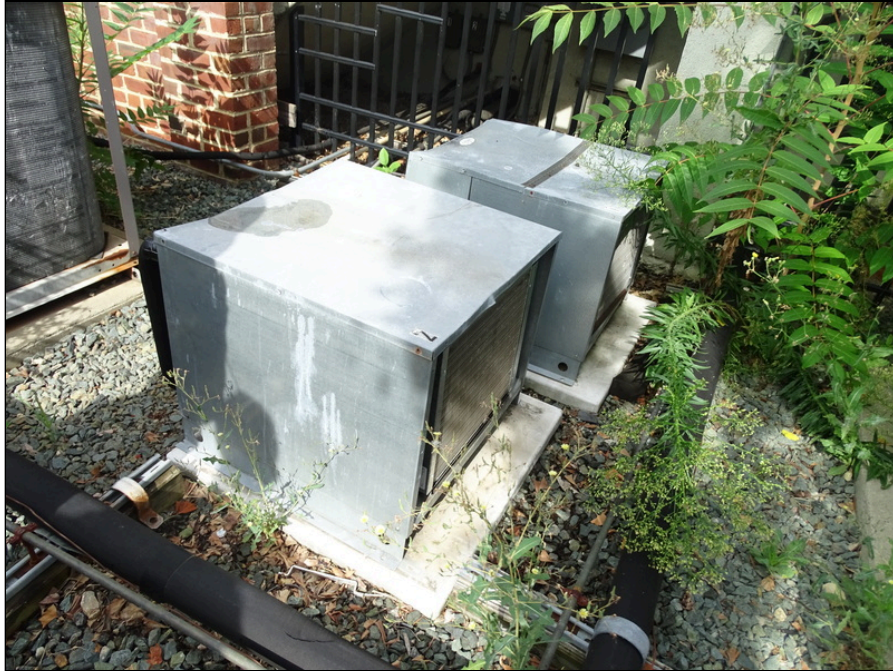
45 - Condenser units located on east side of the building

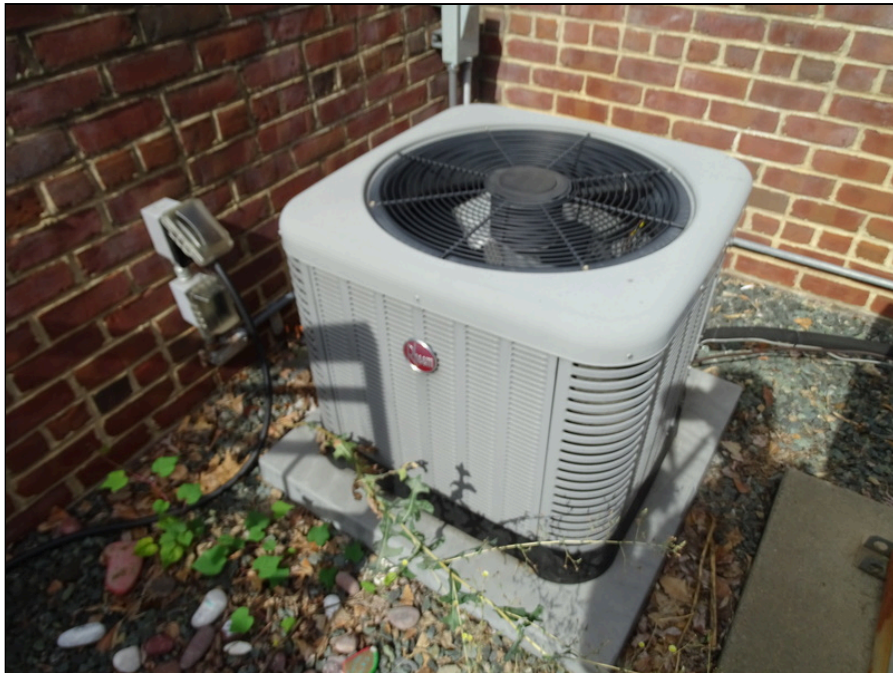
46 - Split system condenser unit located on east side of the building

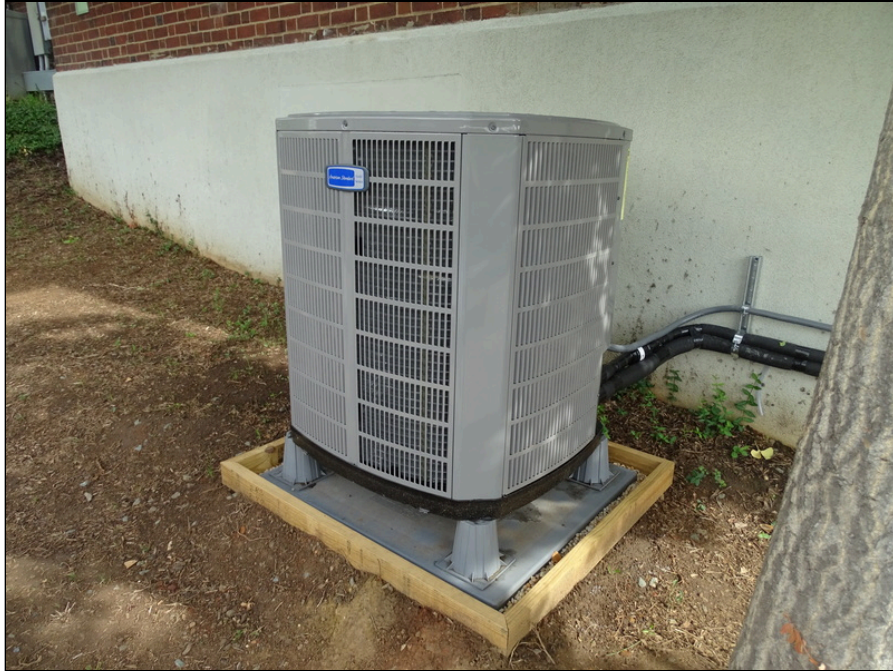
47 - Split system condenser unit located on south side of the building - reportedly installer within the last year

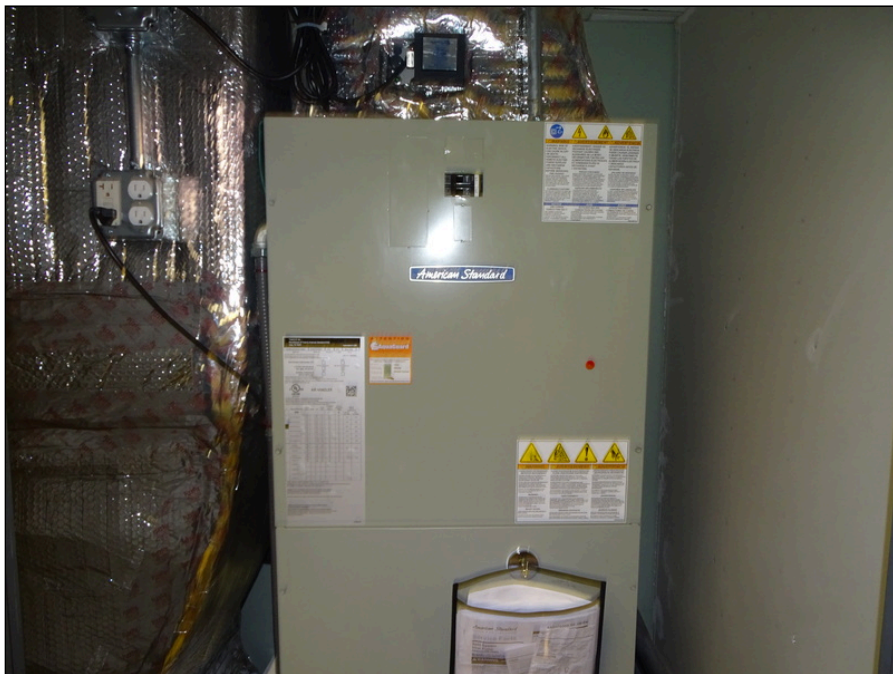
48 - Split system furnace unit located at interior closet space

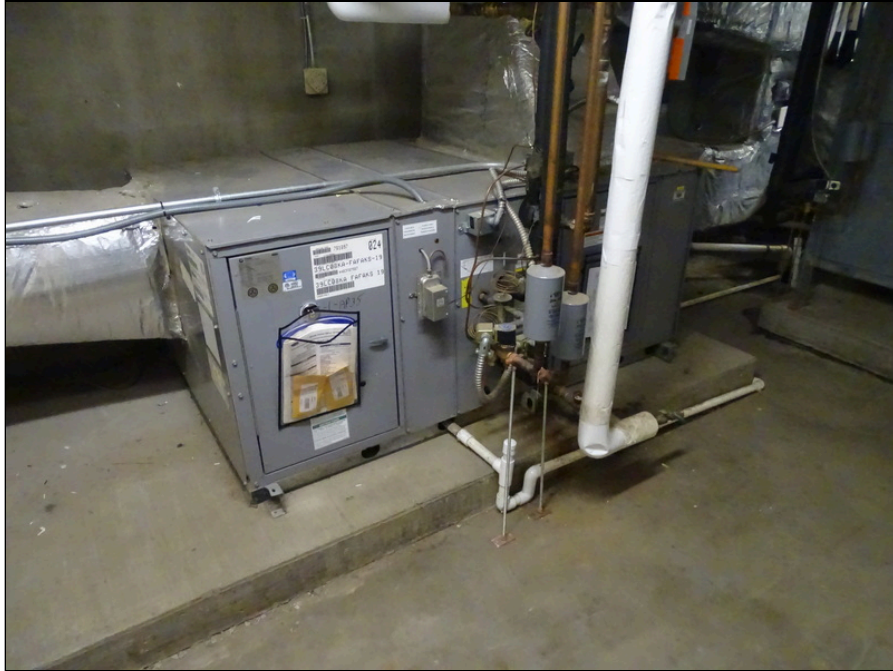
49 - Air handler unit

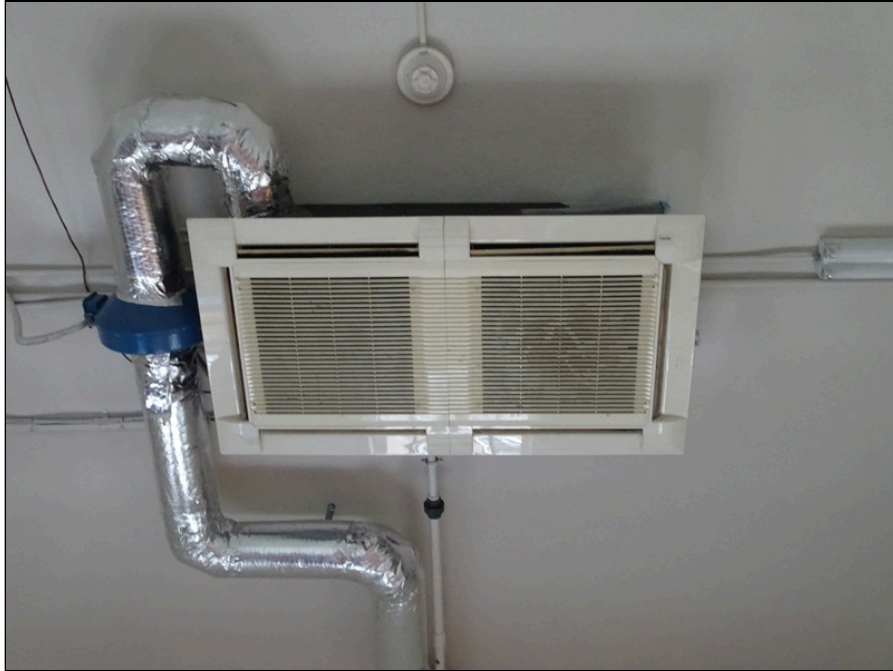
51 - Split system ductless interior unit

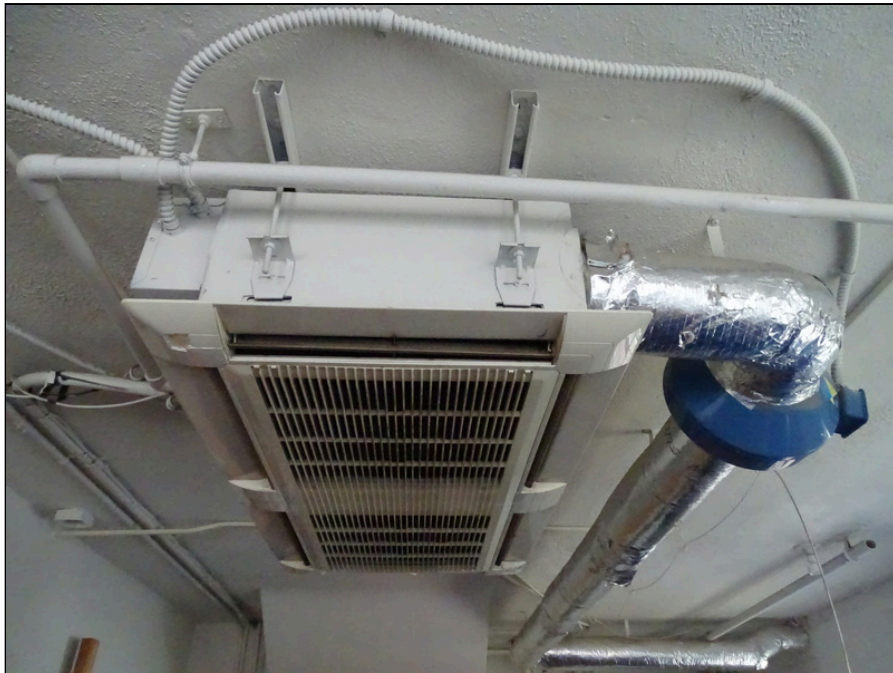
52 - Split system ductless interior unit

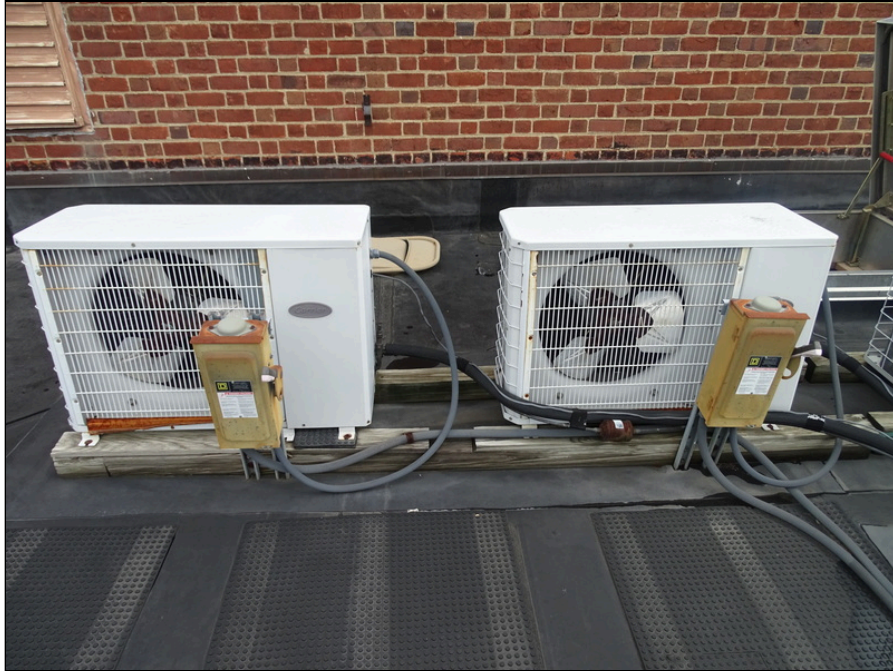
53 - Split system ductless outdoor units

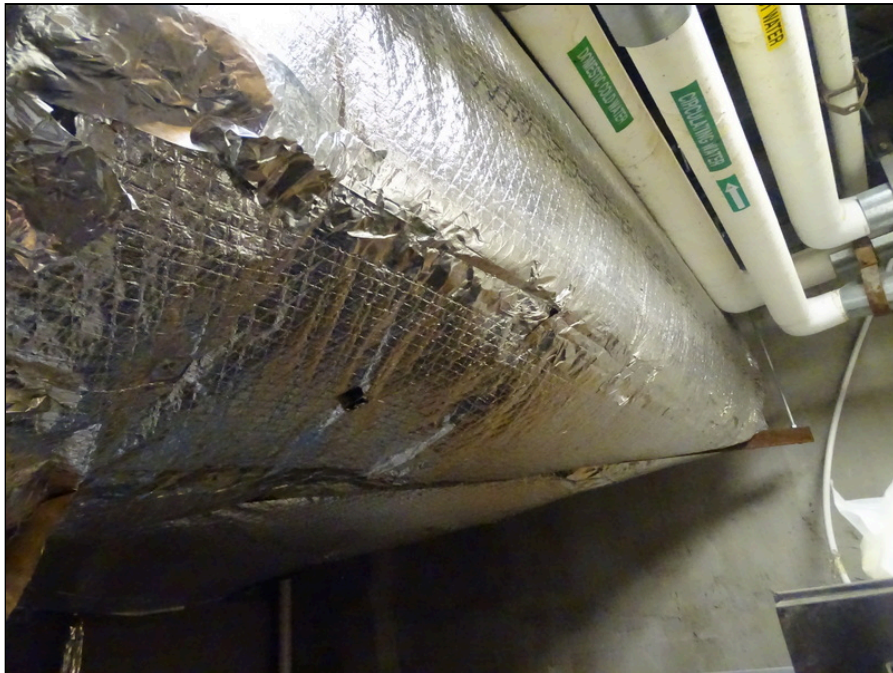
54 - Typical mechanical duct and piping

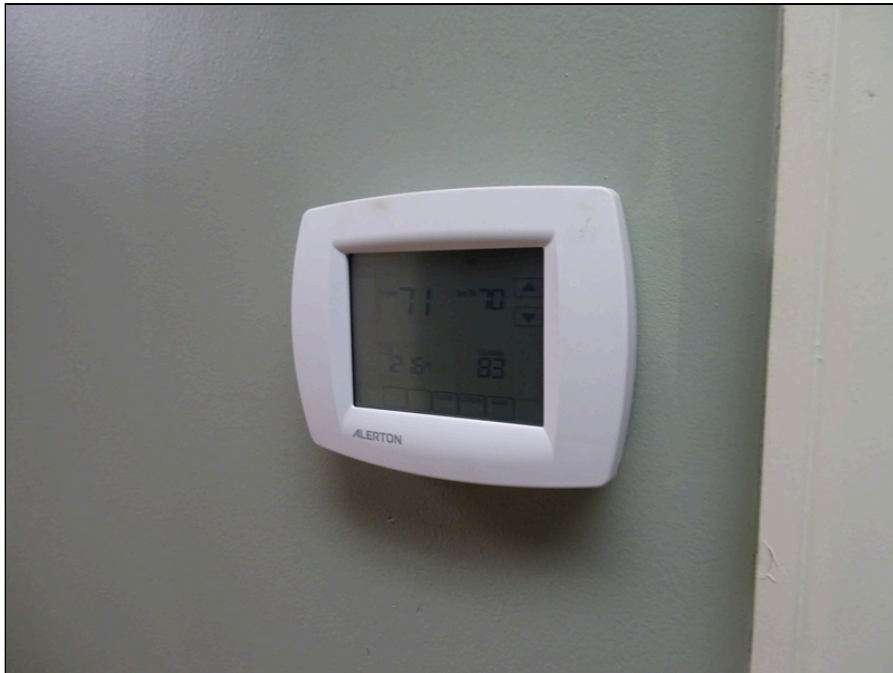
56 - Typical mechanical thermostat control
