KEY RECREATION CENTER
800 EAST MARKET STREET
CHARLOTTESVILLE, VIRGINIA

ECS PROJECT NO. 46:6713

CITY OF CHARLOTTESVILLE - FACILITIES DEVELOPMENT

Reference: Facility Condition Assessment Report for Key Recreation Center, 800 East Market Street ,
Charlottesville, Virginia

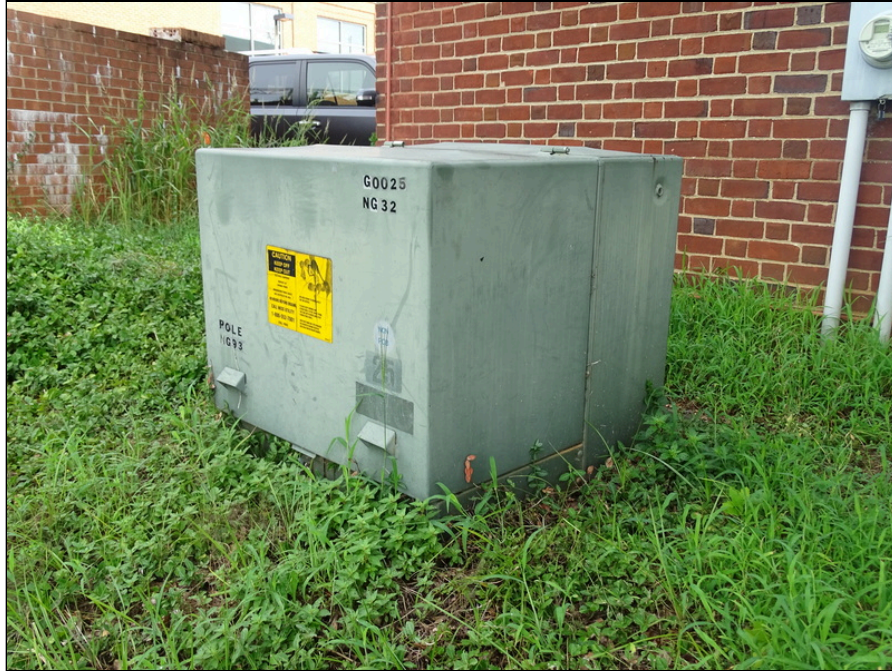
57 - Electrical utility transformer

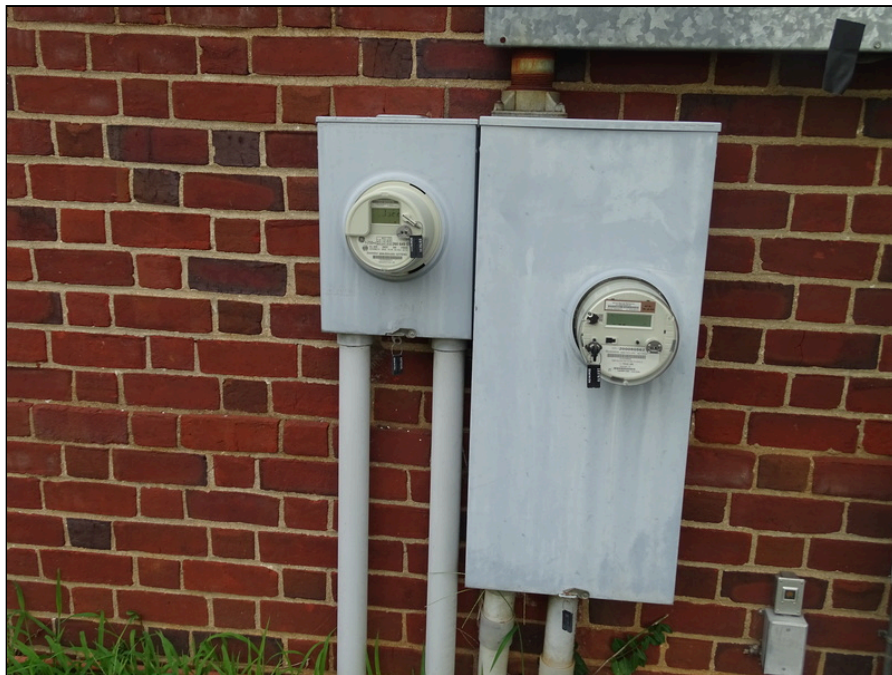
58 - Electrical utility meter

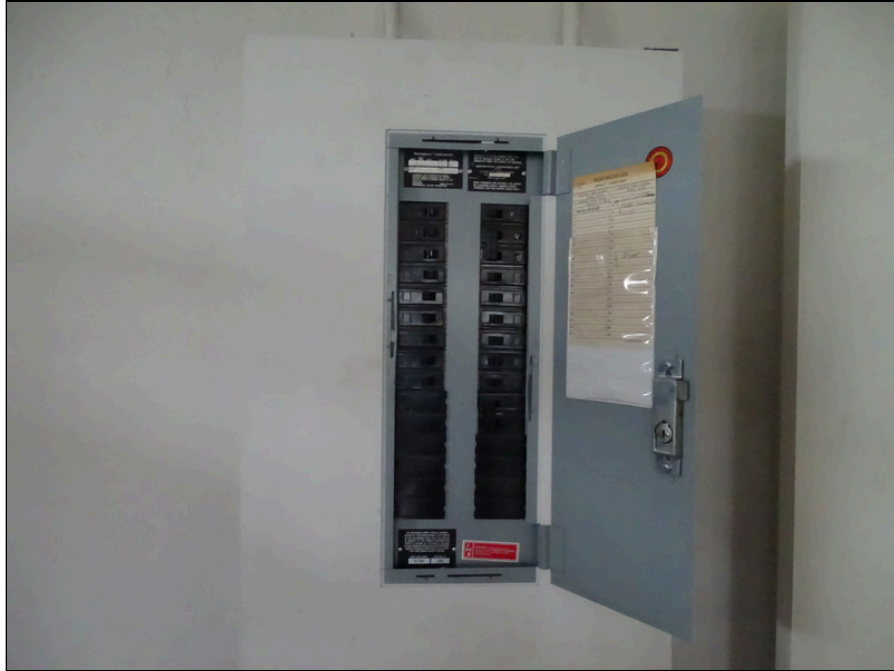
61 - Typical newer electrical circuit breaker panel

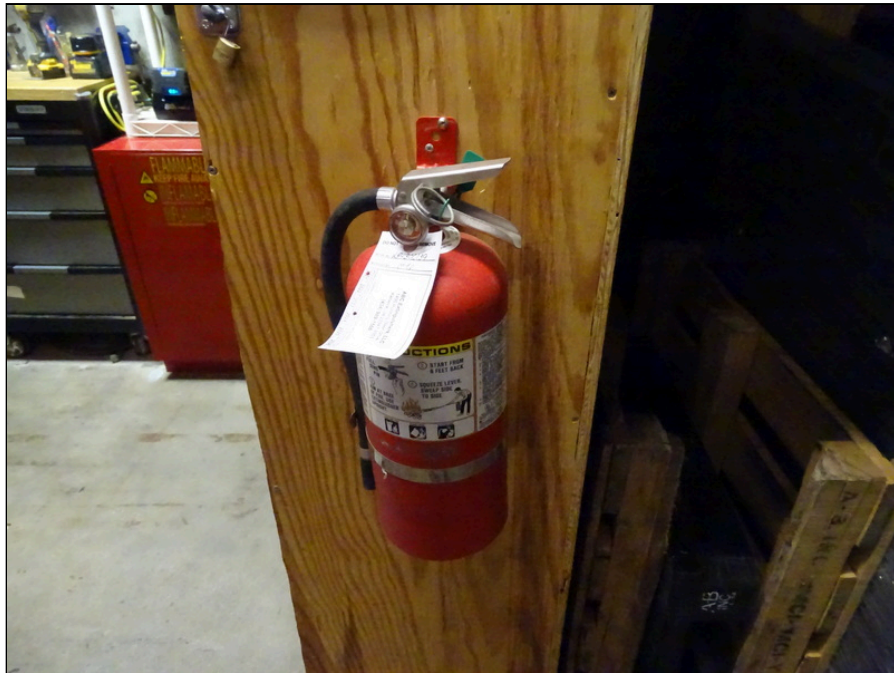
62 - Fire extinguisher

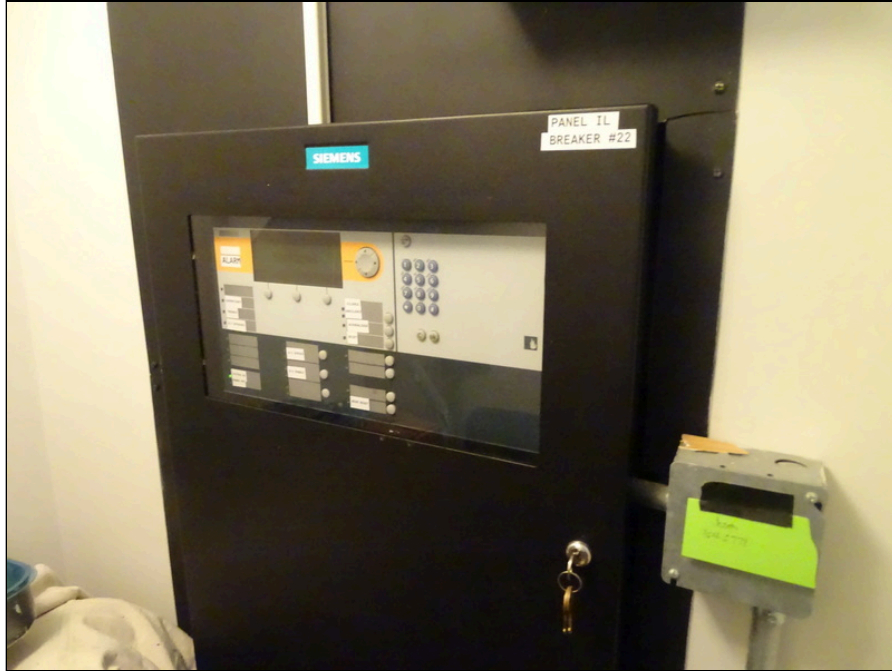
63 - Fire alarm control panel

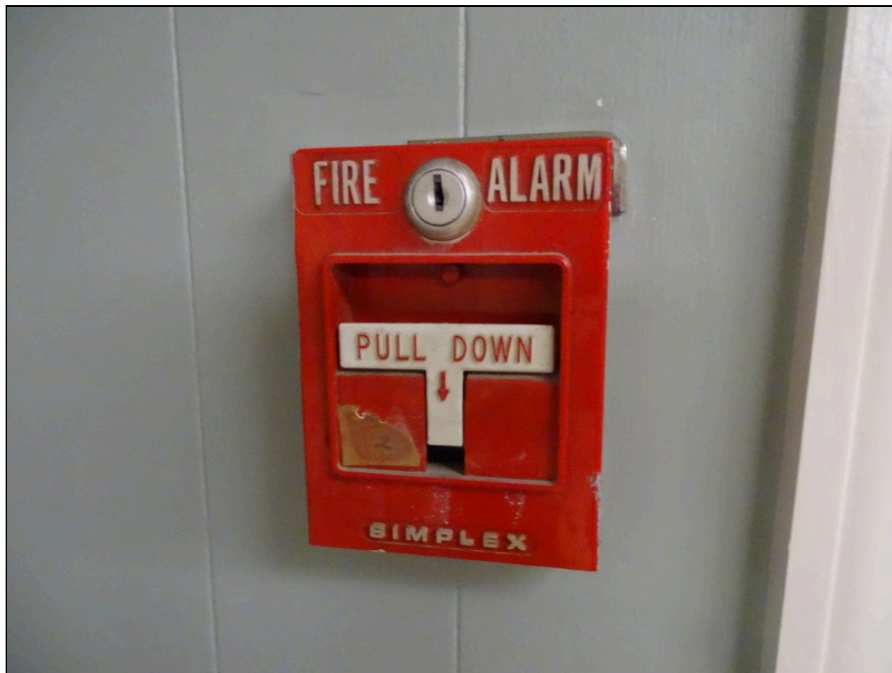
64 - Fire alarm pull station

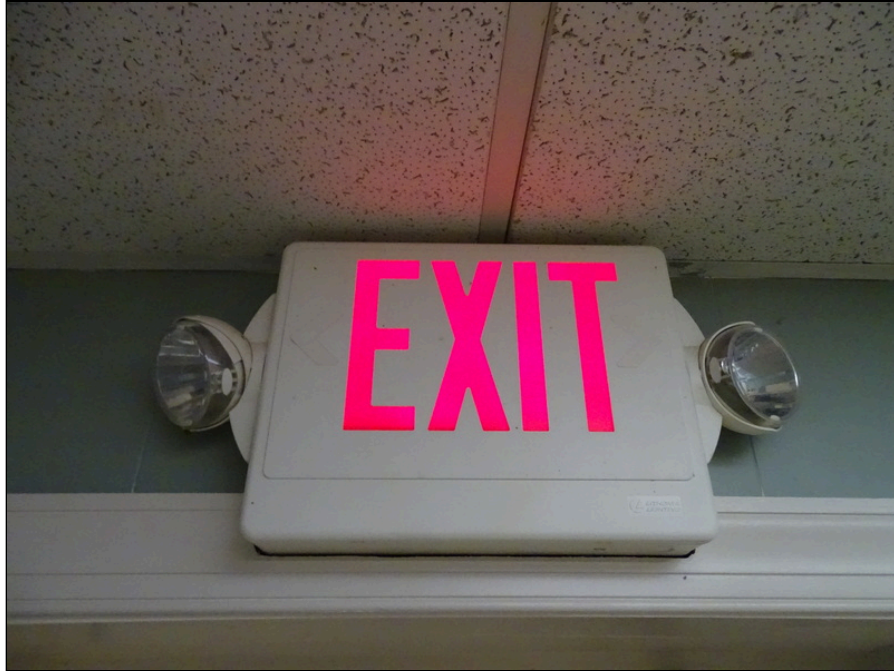
65 - Emergency lighting and exit sign

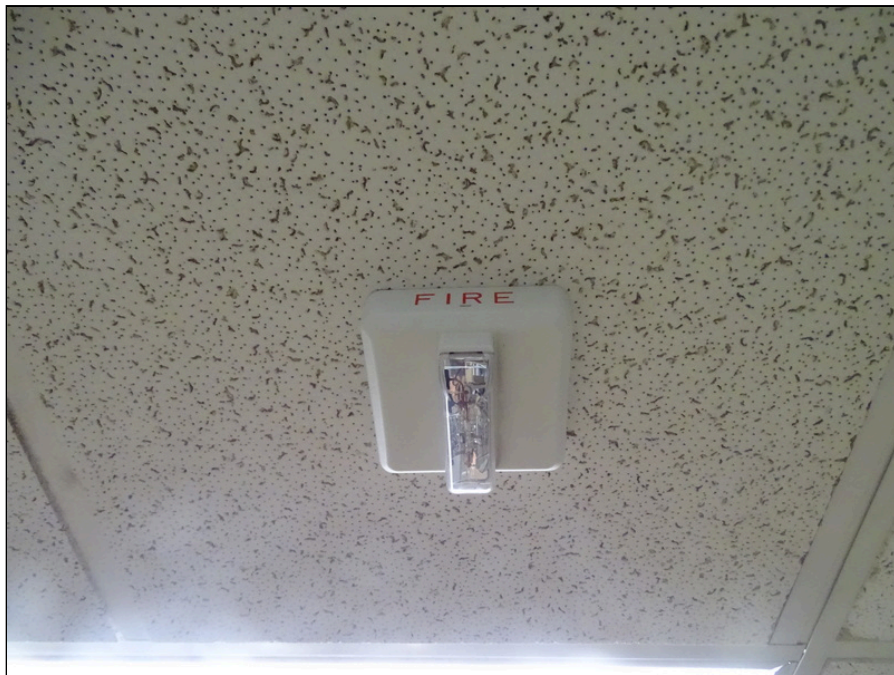
66 - Fire alarm bell and strobe

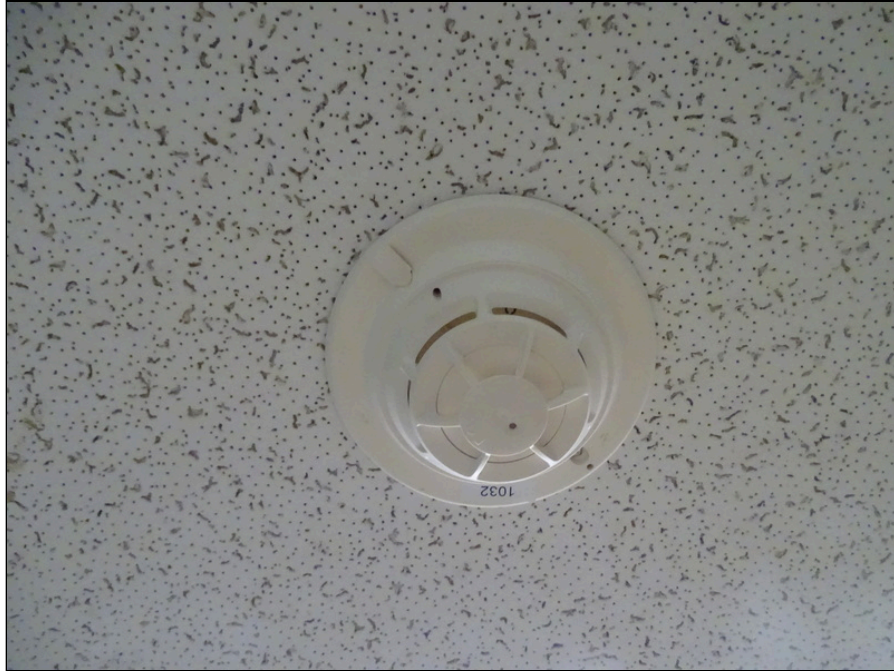
67 - Smoke detector

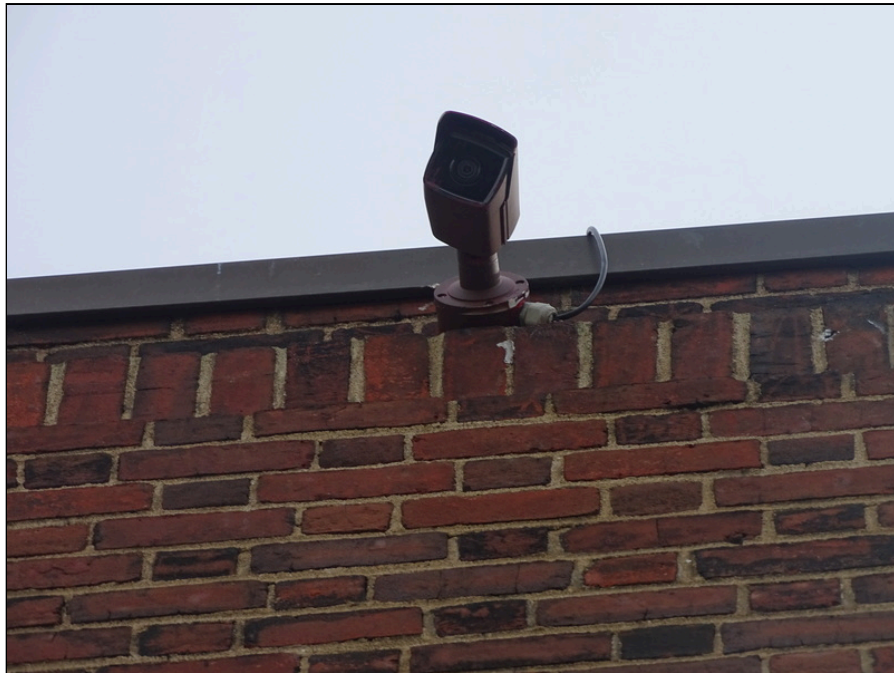
68 - Security camera

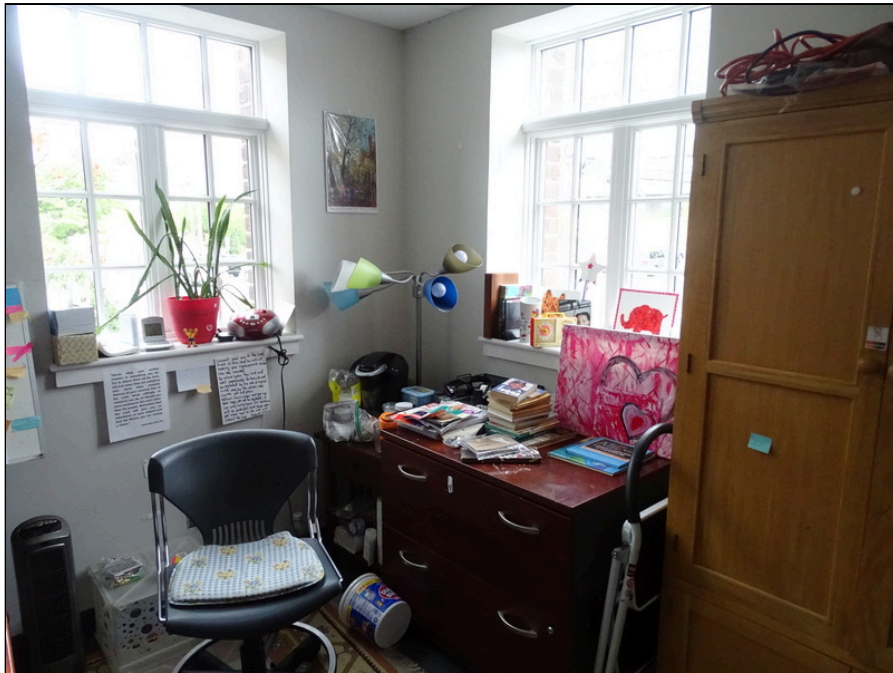
70 - Interior finishes of office area

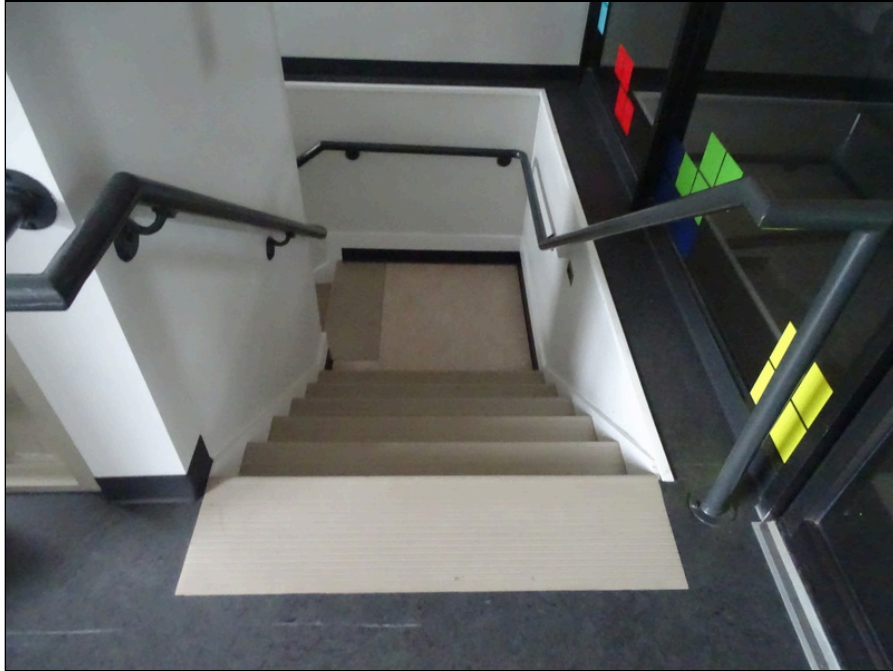
71 - Interior finishes of stair area

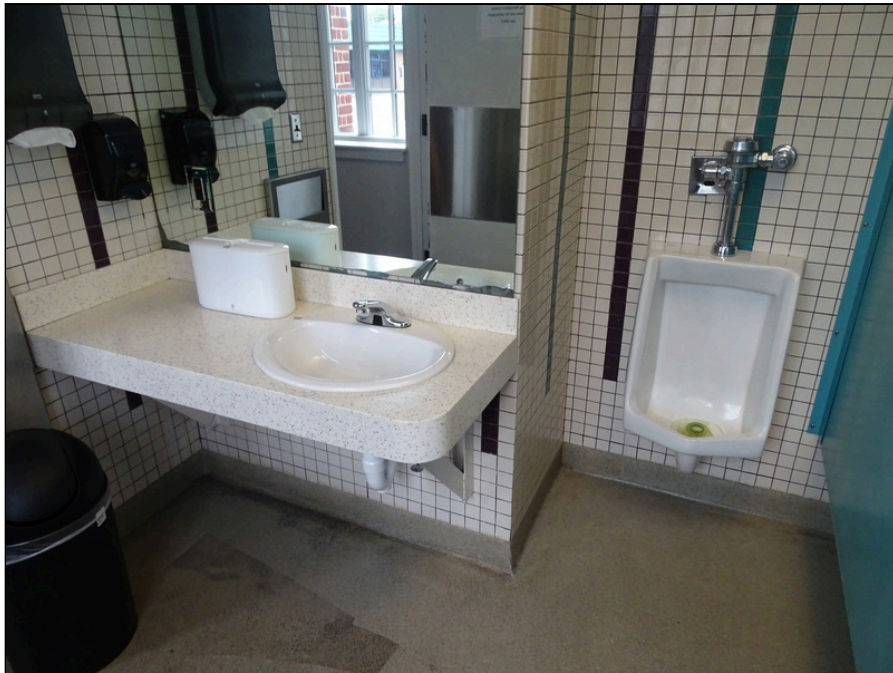
72 - Interior finishes of restroom area

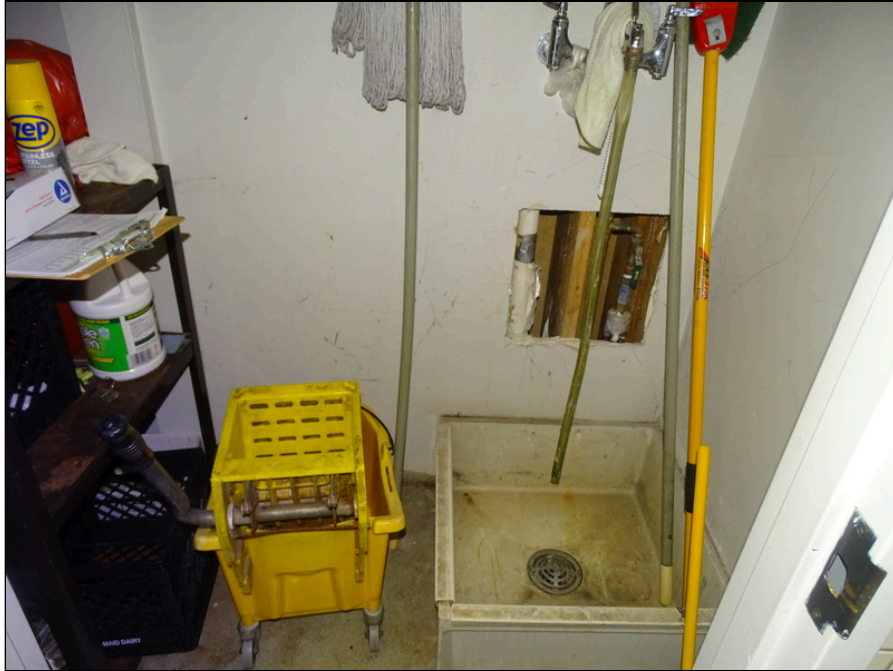
73 - Interior finishes of janitors closet area

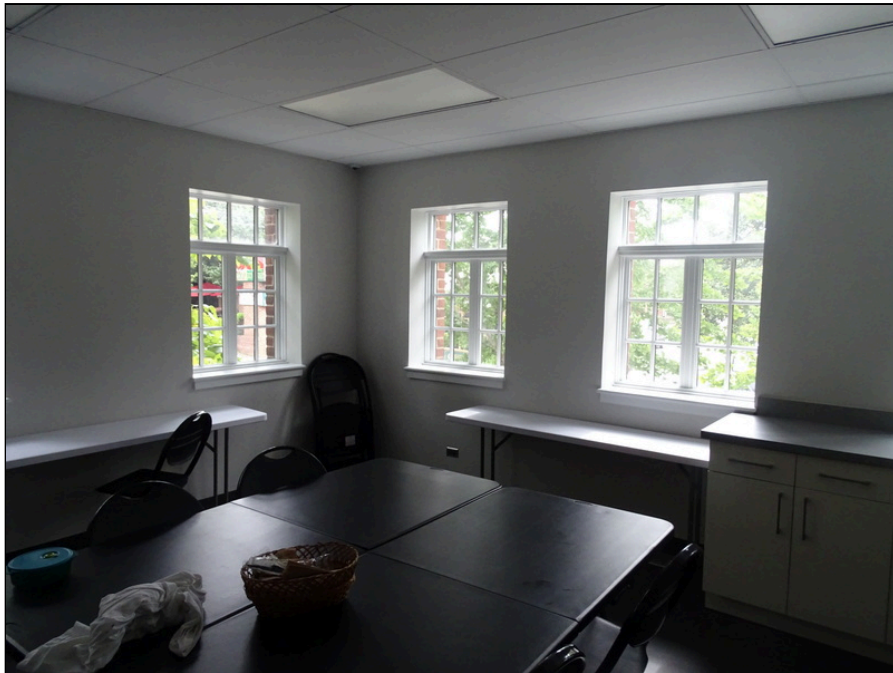
74 - Interior finishes of meeting area

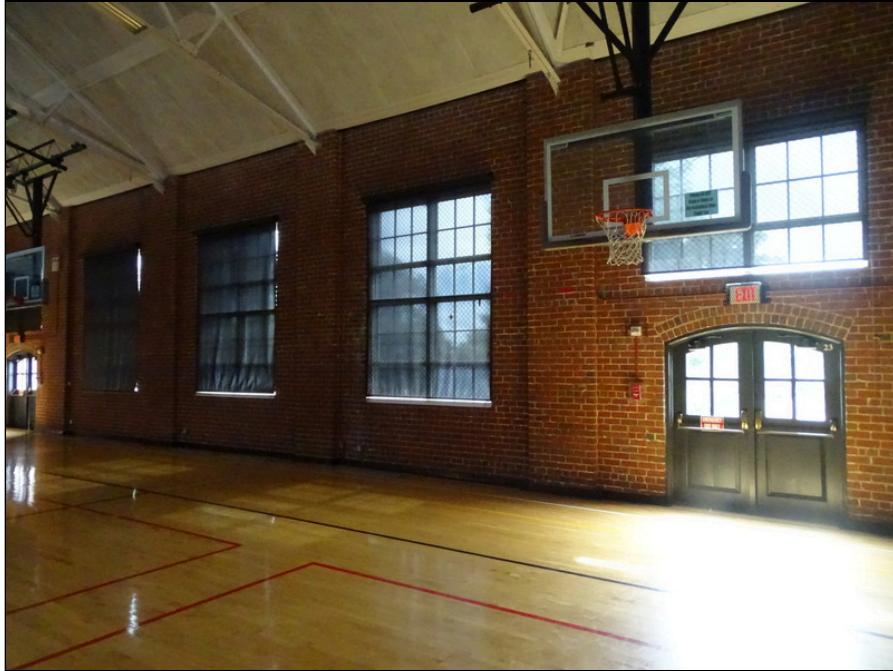
75 - Interior finishes of gymnasium area

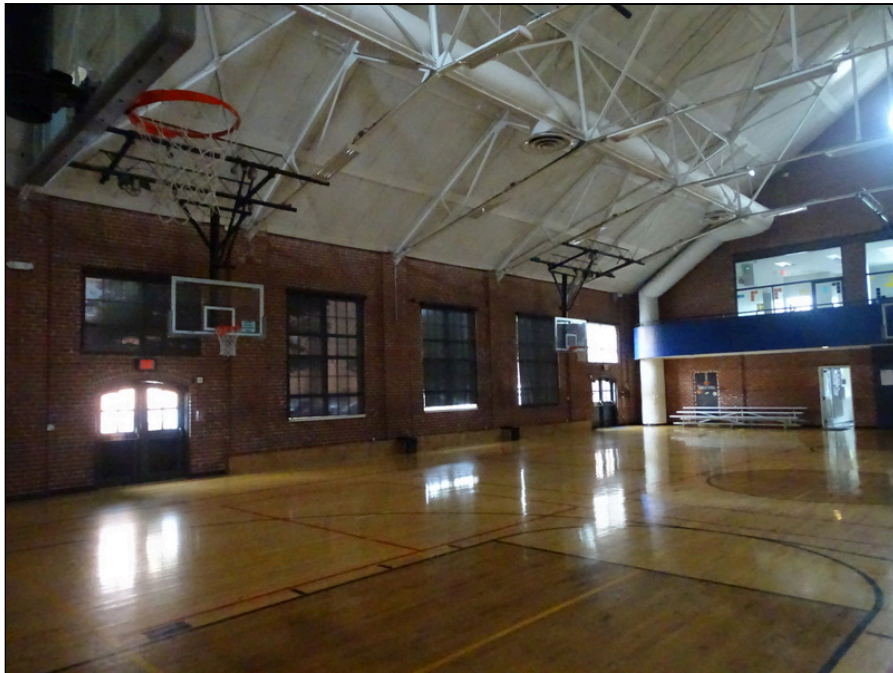
76 - Interior finishes of gymnasium area

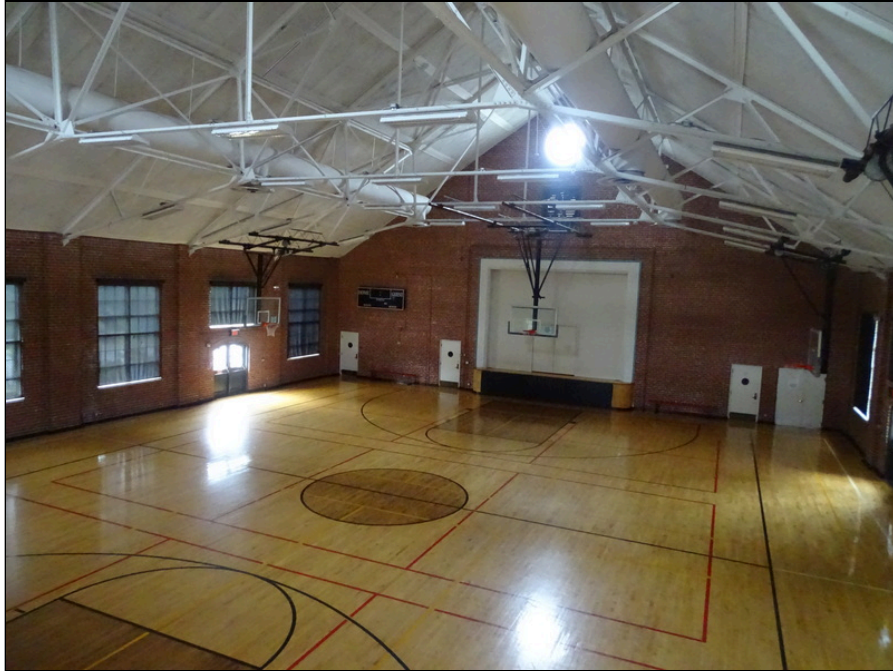
77 - Interior finishes of gymnasium area

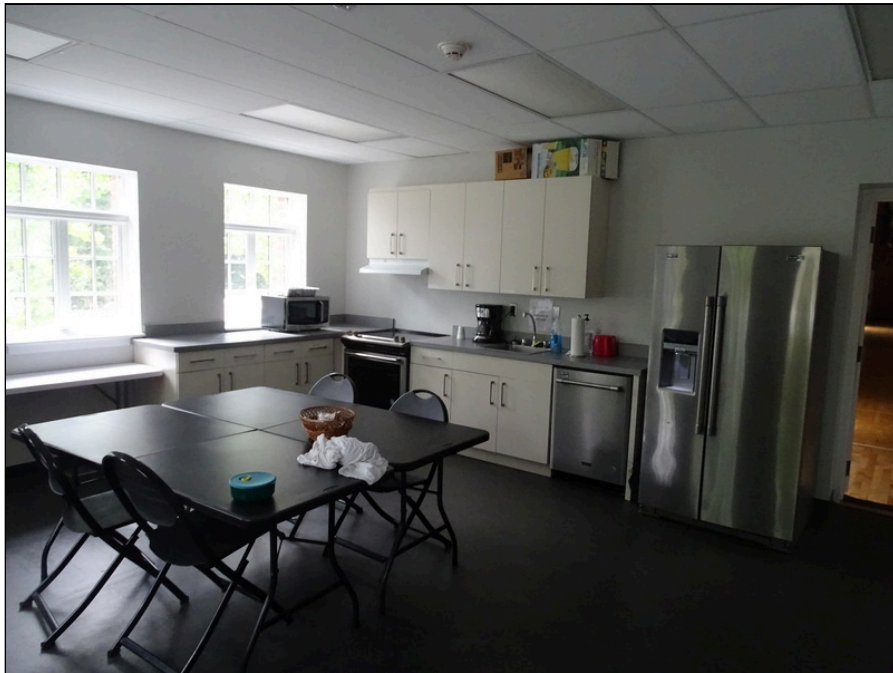
78 - Interior finishes of kitchen and dining area

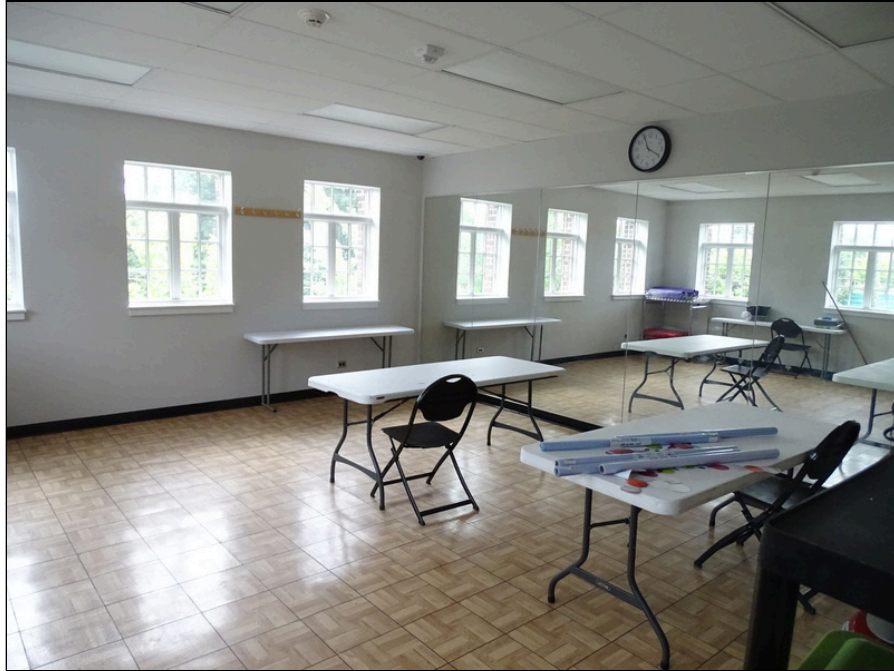
79 - Interior finishes of mezzanine level meeting area

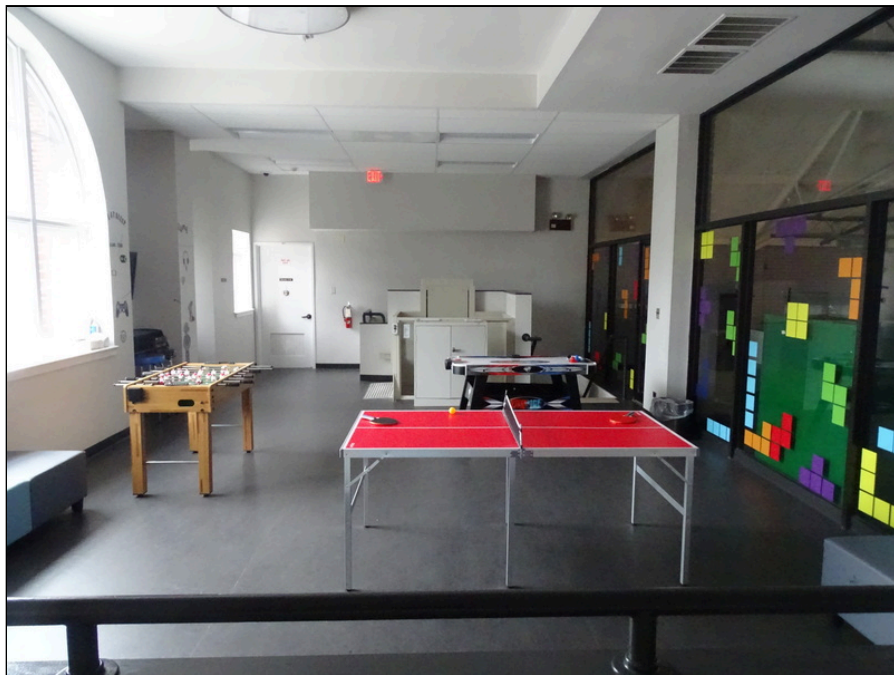
80 - Interior finishes of mezzanine level recreation area

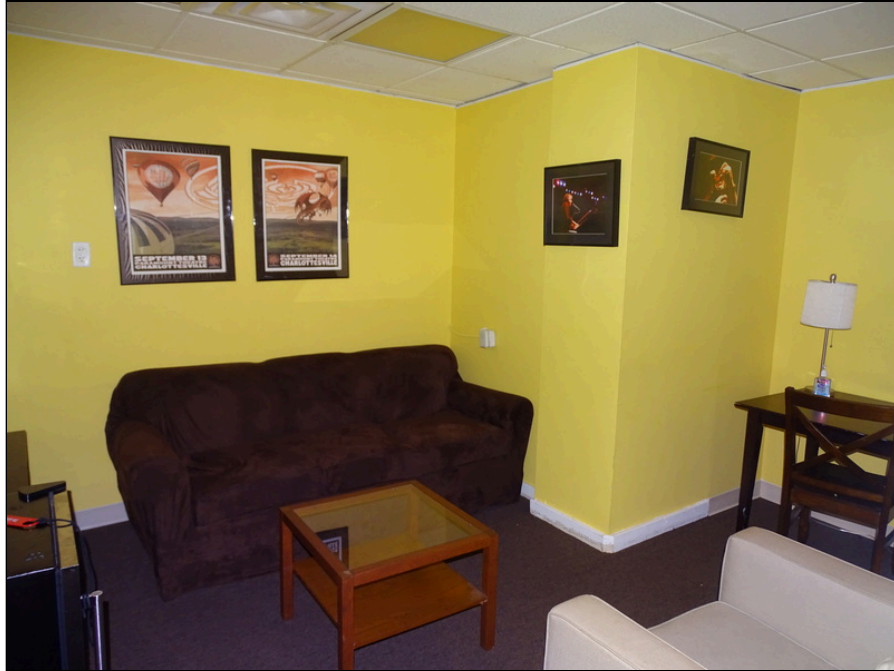
81 - Interior finishes of musician area

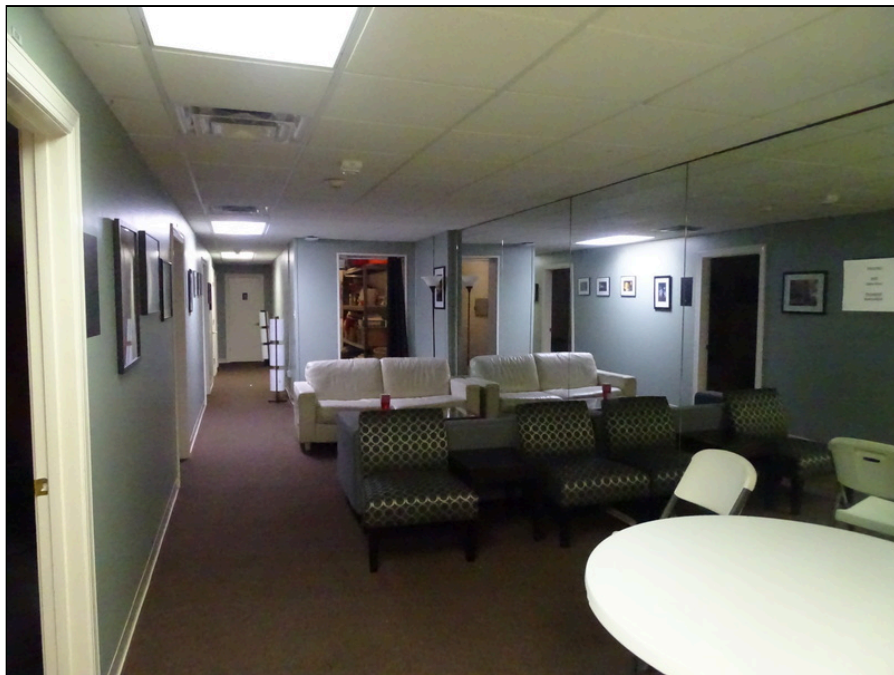
82 - Interior finishes of musician area

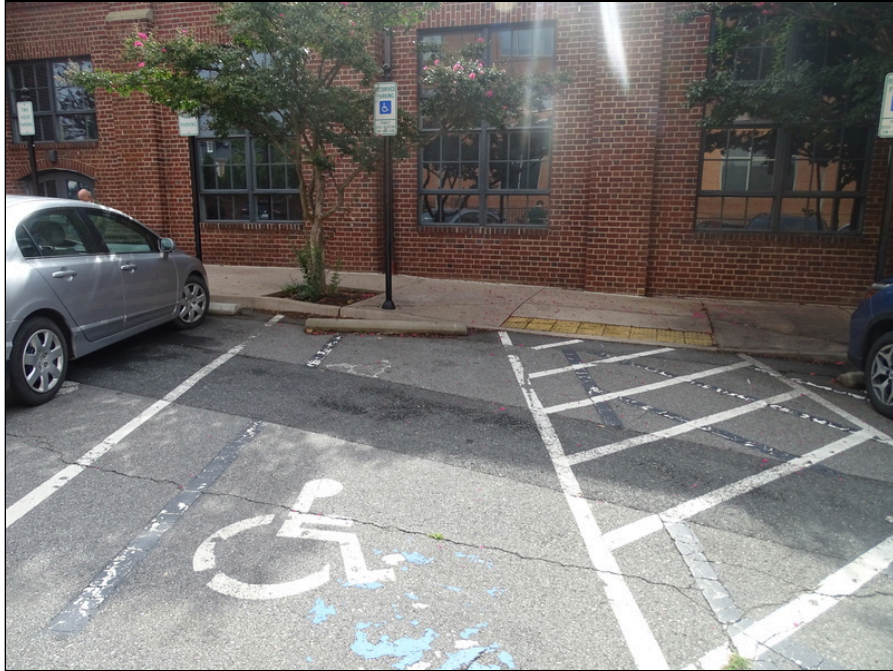
83 - Accessible parking space

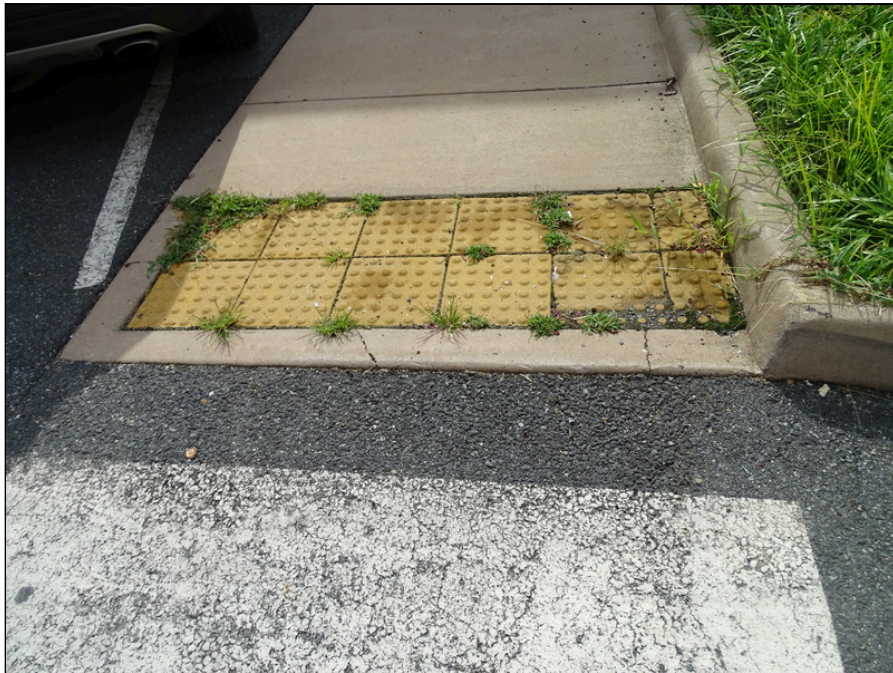
84 - Accessible curb cut ramp with truncated domes

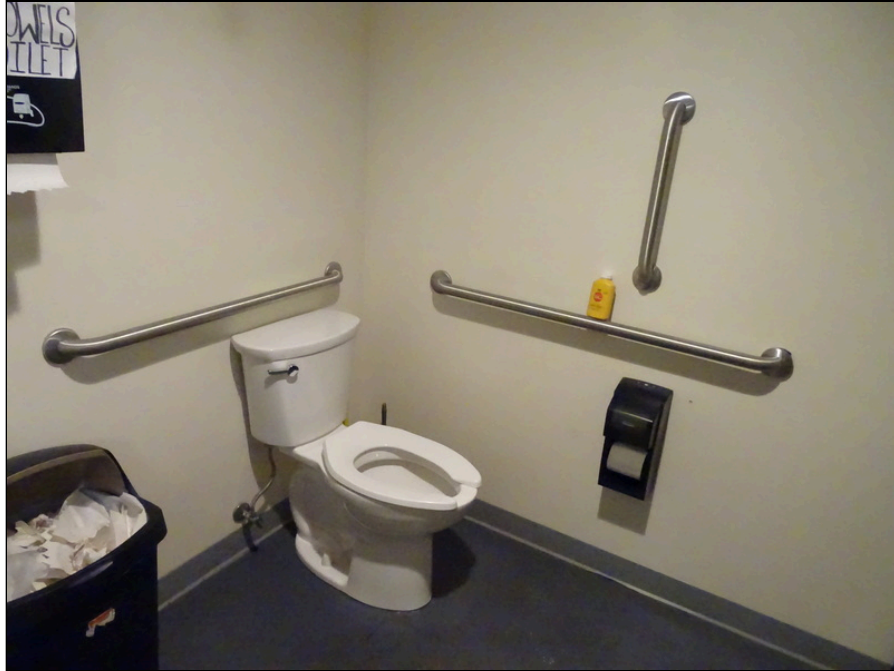
85 - Accessible toilet

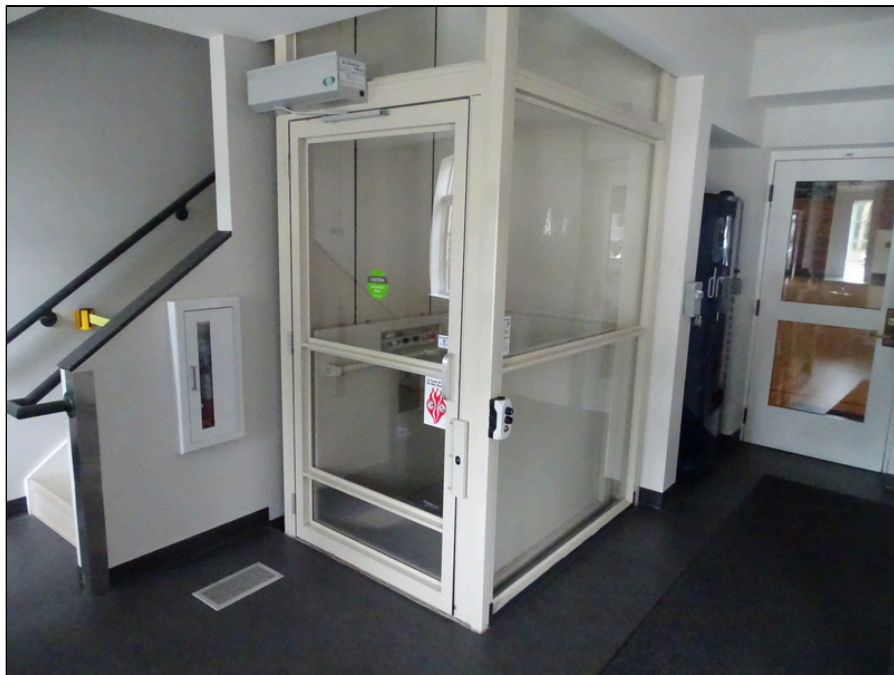
86 - Accessible wheelchair lift

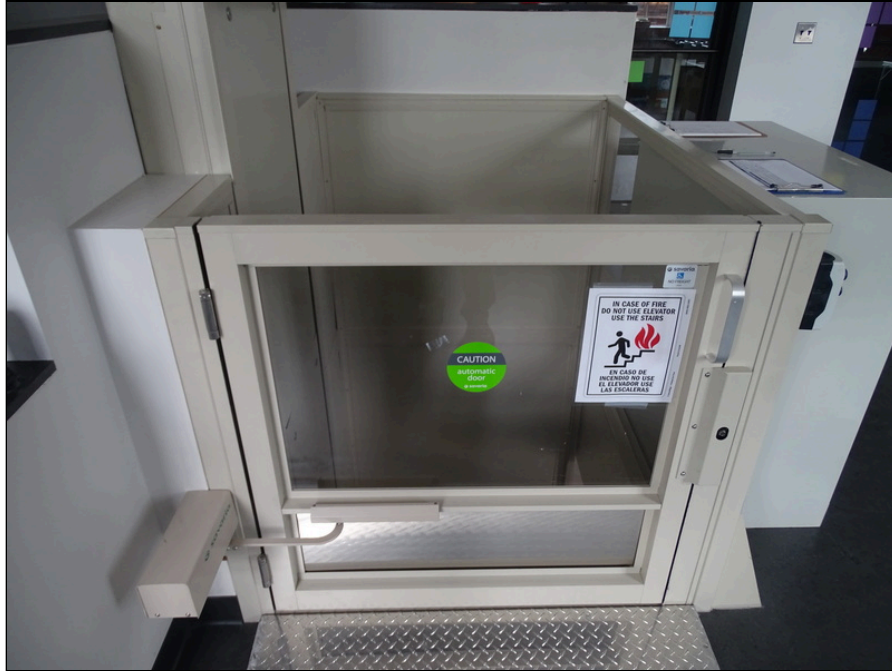
87 - Accessible wheelchair lift

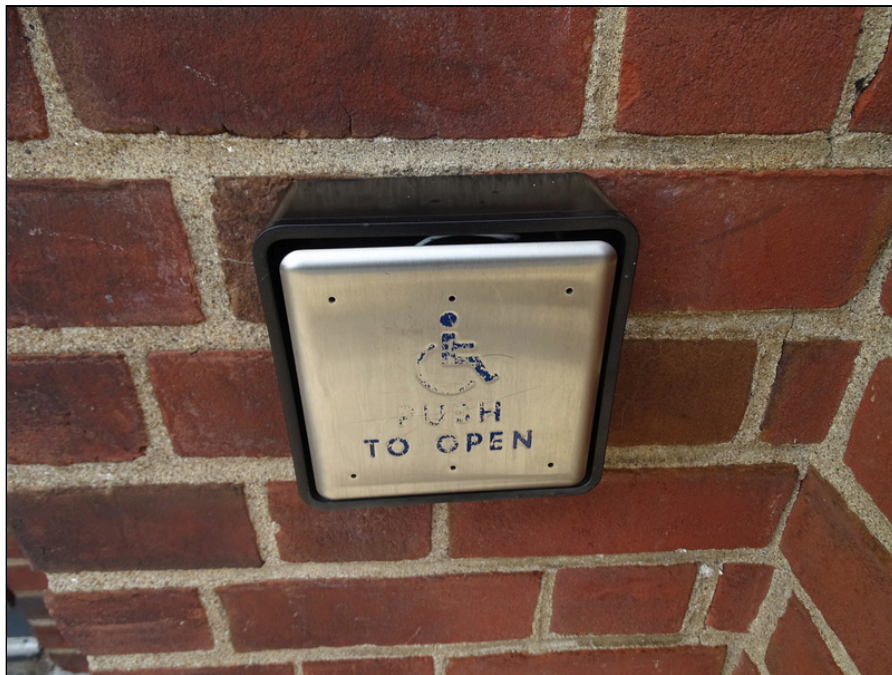
88 - Accessible door controls

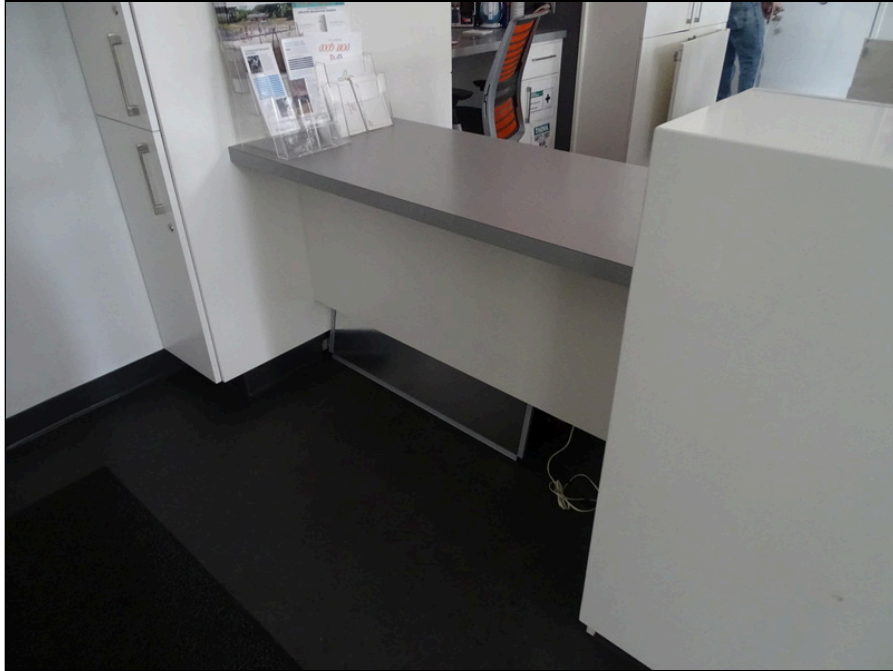
89 - Accessible counter for public transactions

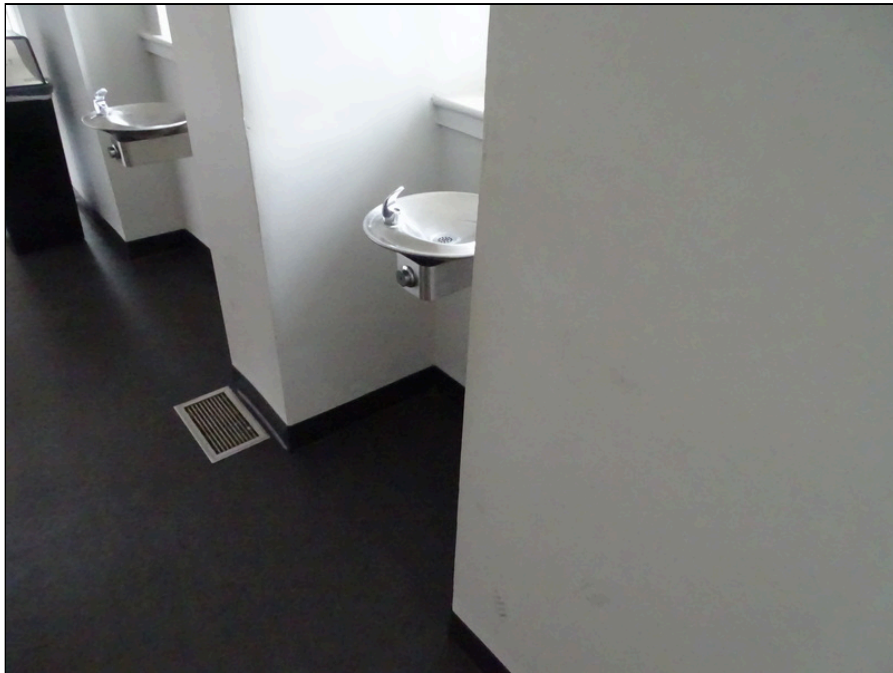
90 - Accessible drinking fountain
