LUGO MCGINNESS ACADEMY
341-(A) 11TH STREET NW
CHARLOTTESVILLE, VIRGINIA

ECS PROJECT NO. 46:6713

CITY OF CHARLOTTESVILLE - FACILITIES DEVELOPMENT

Reference: Facility Condition Assessment Report for Lugo McGinness Academy, 341-(A) 11th Street NW, Charlottesville, Virginia

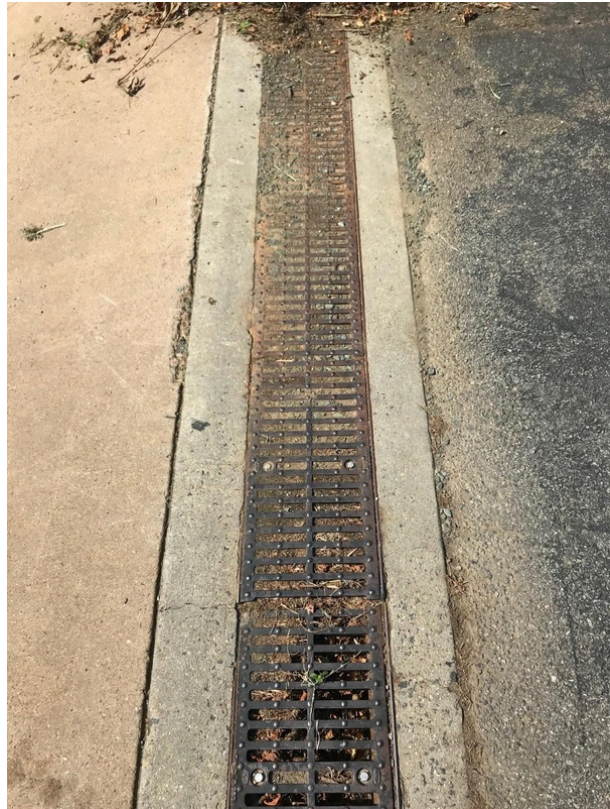
Channel Drain - Clogged

Item	Quantity	Unit	Unit Cost	Replacement Percent	Immediate Total
3.2.2 Storm Water Drainage					
CLEAN STORM DRAINAGE AND INSTALL UNDERGROUND LINE	1	EA	\$2,600.00	100%	\$2,600
Total Repair Cost					\$2,600.00

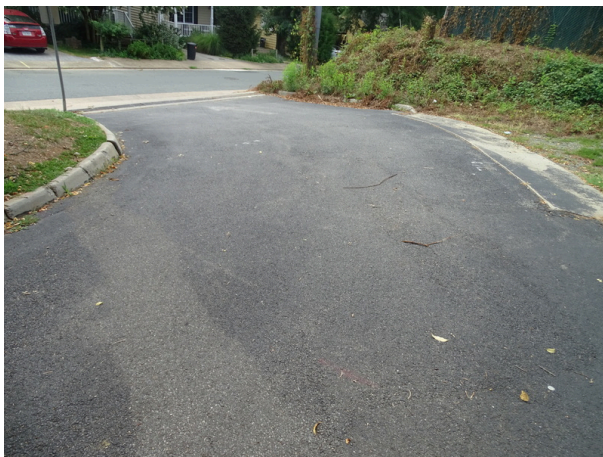
Asphalt drive lane looking east

3.2.4 Paving, Curbing, and Parking																													
REPAIR ASPHALT AS NEEDED	20	7	13	1	LS	\$6,000.00	\$6,000	100%													\$6,000								\$6,000

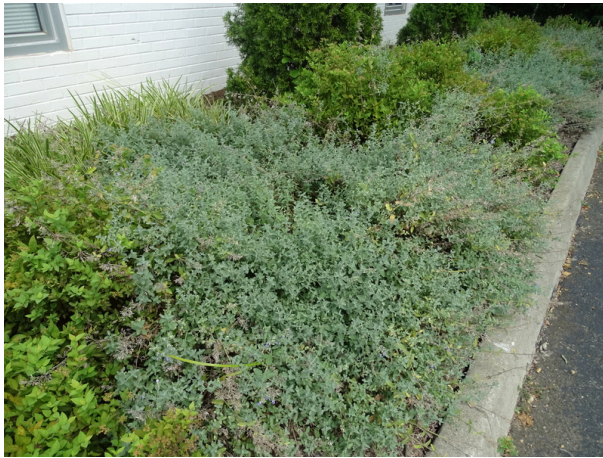
The landscaping consists generally of small trees, shrubs, and grassed areas around the site. The landscaping was observed to be in generally good condition. The property was surrounded on 3 sides by a chain link fence. Vegetation to the south of the parking lot exit should be cut back to improve visibility.

Typical landscape

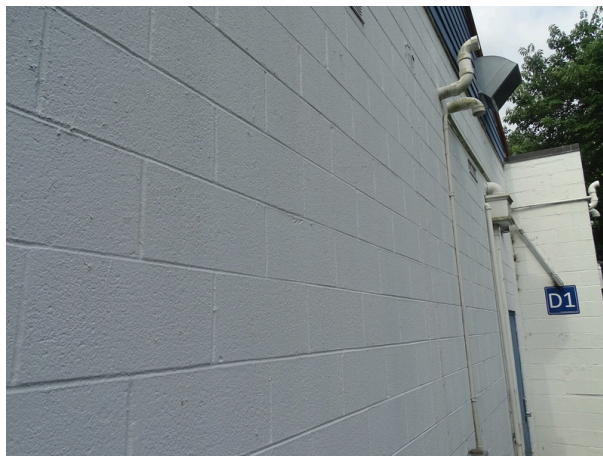
Exterior sealants are located around the window and door frames. The expected useful life of exterior sealants is approximately 10 to 12 years before replacement is needed. The exterior sealants were generally in fair condition. We recommend that the exterior sealants be replaced.

Building exterior north side of north building

3.2.5 Flatwork																													
REPAIR CONCRETE SIDEWALKS AS NEEDED	20	19	1	1	LS	\$3,000.00	\$3,000	100%	\$3,000																				\$3,000
3.3.3 Building Exteriors																													
REPLACE SEALANTS	12	6	6	1	EA	\$5,000.00	\$5,000	100%						\$5,000															\$5,000
REPLACE FIBER CEMENT SIDING	20	19	1	1	EA	\$8,000.00	\$8,000	100%	\$8,000																				\$8,000

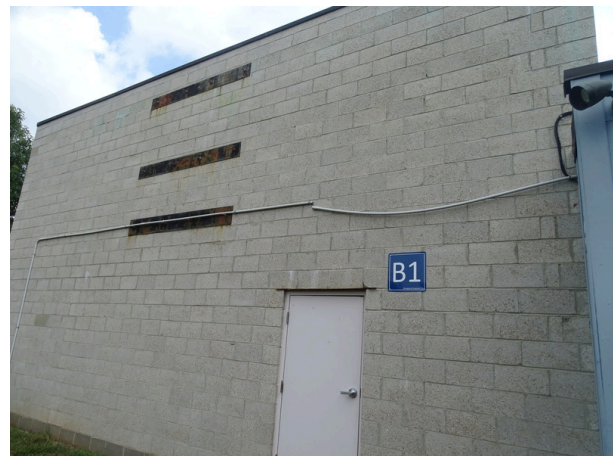
Building exterior south side of south building

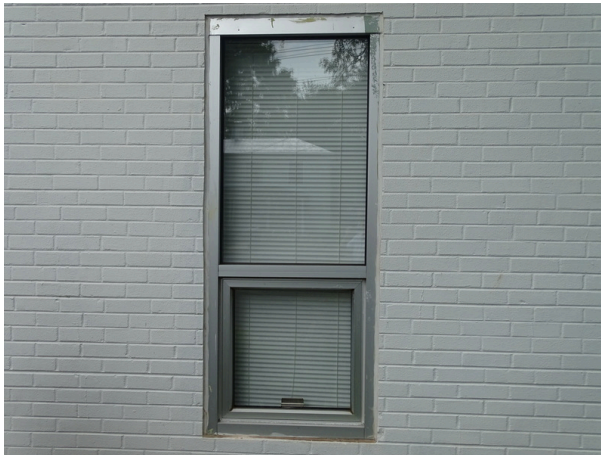
The window system for the building primarily consists of Aluminum frame double pane window units reportedly replaced during past renovations. The gaskets in the windows were generally in fair condition as some have become detached in places. The expected useful life of gaskets is typically 20 years.

Typical exterior windows north building

3.3.5 Exterior Windows																													
REPLACE WINDOW GASKETS AS NEEDED	20	19	1	1	EA	\$2,500.00	\$2,500	100%	\$2,500																				\$2,500

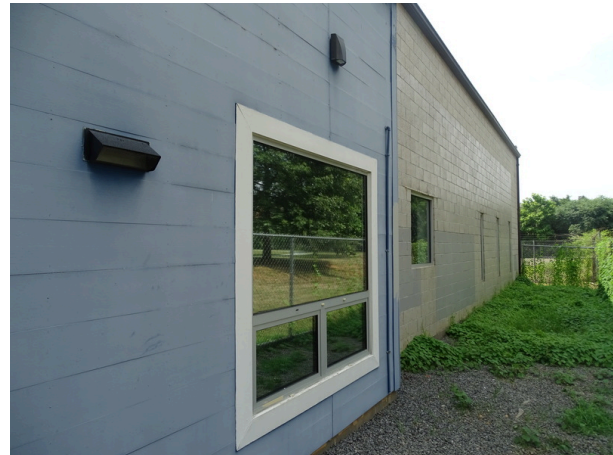
Typical exterior windows

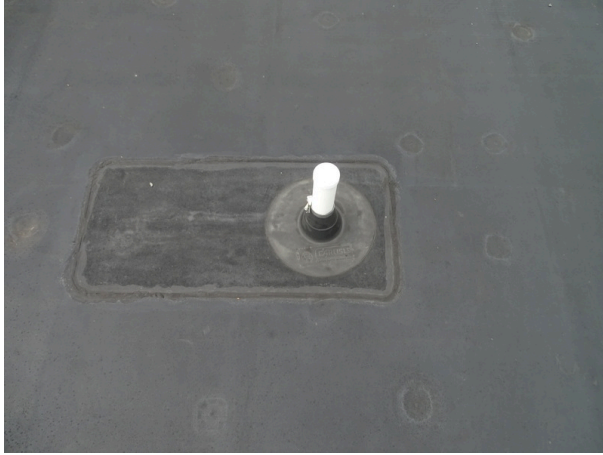
Roofing penetrations included plumbing vents and exhaust vents throughout the roofing system. All of the plumbing vent were observed to be capped. We recommend removing the caps as an immediate maintenance item.

Typical plumbing penetration and patching

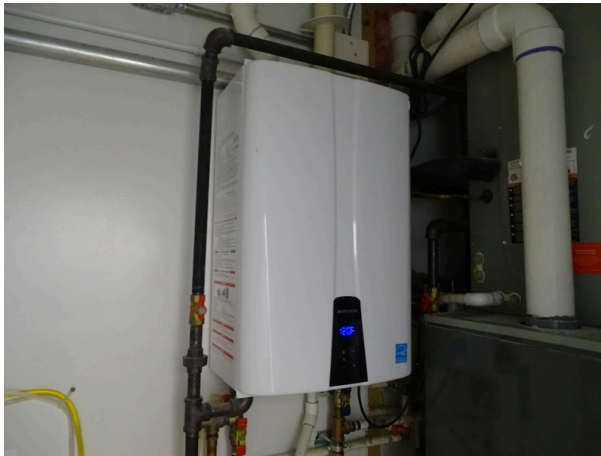
Domestic hot water to the north building is provided by a tankless water heater manufactured by Navien. The tankless water heater was installed in 2014. Domestic hot water to the south building is provided by an Electric domestic water heater manufactured by Ruud. The expected useful life of water heaters is approximately 12 to 15 years with proper maintenance. We recommend the water heaters be replaced during the study period.

Tankless water heater in north building

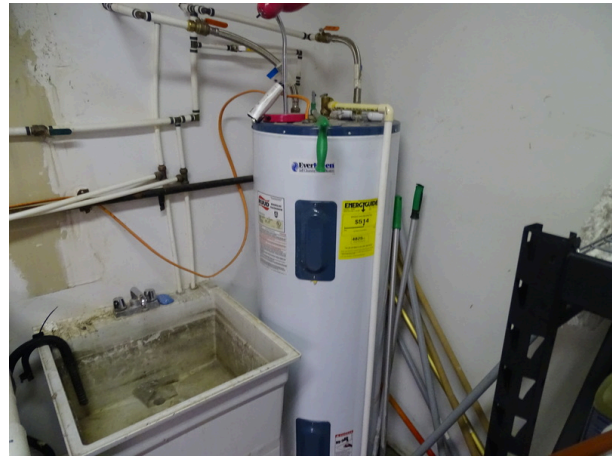
Electric water heater in south building

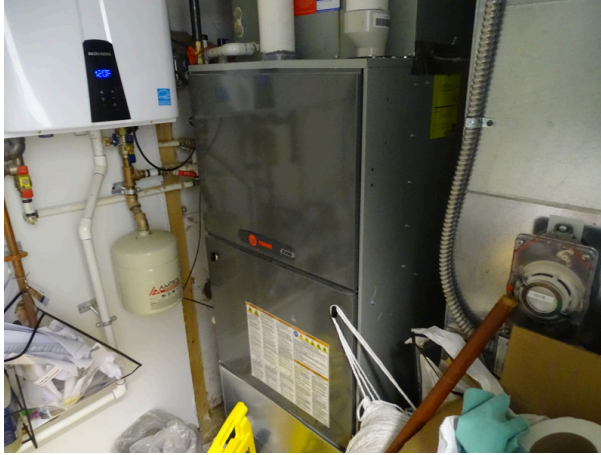
The furnace-air handler units for the north building were manufactured by Trane in 2014. The furnace-air handler units for the south building were manufactured by Rheem in 2006. The expected useful life of a condensing unit is 15 years with proper maintenance. The furnace-air handler units were observed to be in good to fair condition. We recommend that the condensing units be replaced during the report period.

Typical furnace-air handler unit at north building

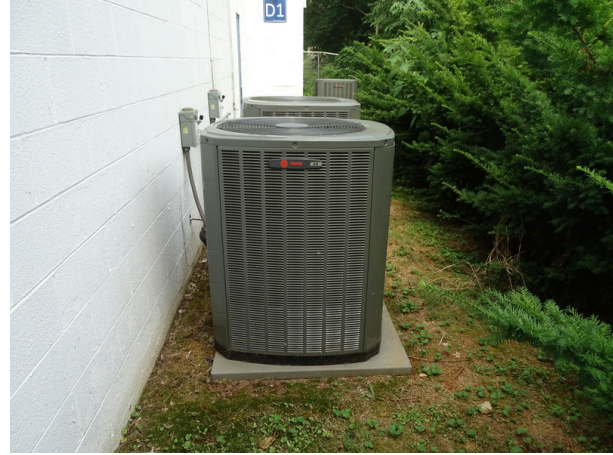
Typical condenser unit at north building

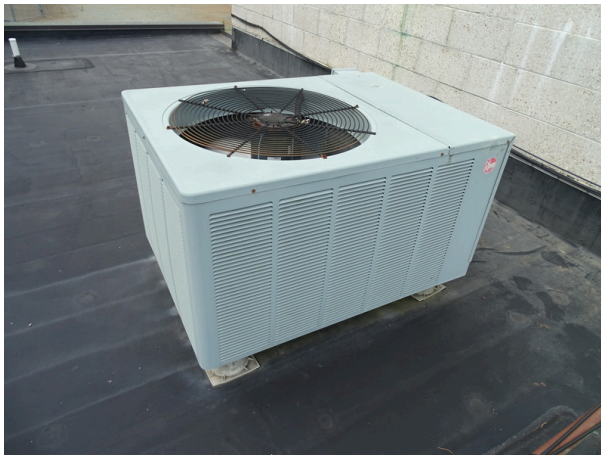
Typical condenser unit

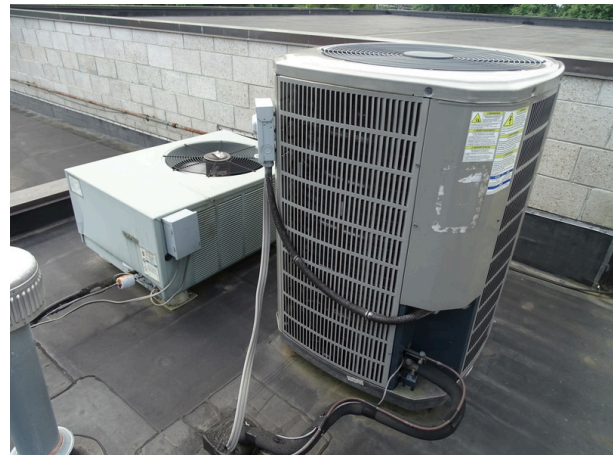
Typical condenser unit

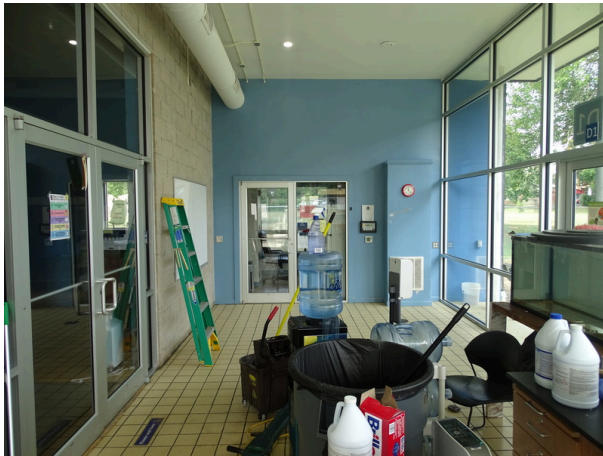
Interior finishes lobby area

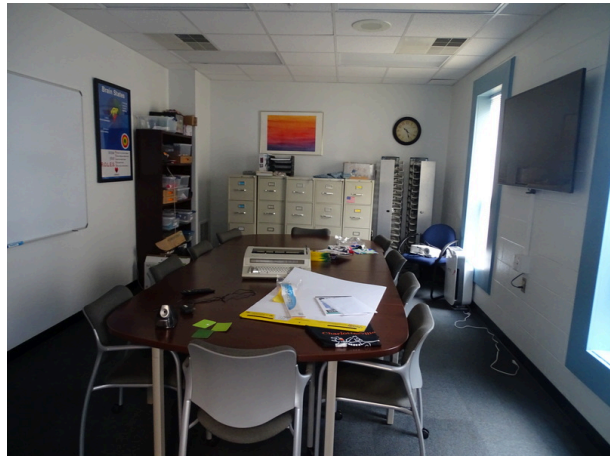
Interior finishes meeting area

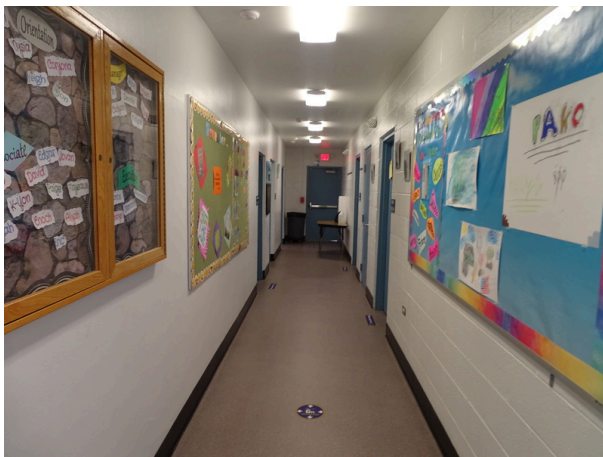
Interior finishes corridor area

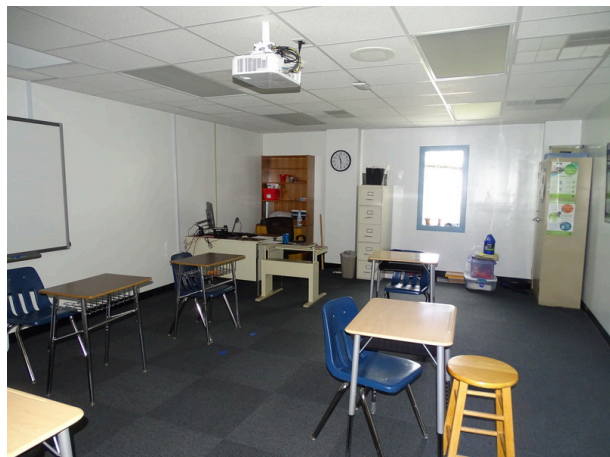
Interior finishes classroom area

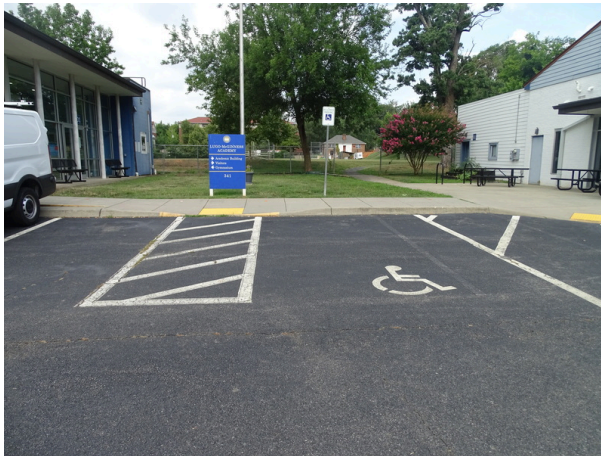
Accessible parking space

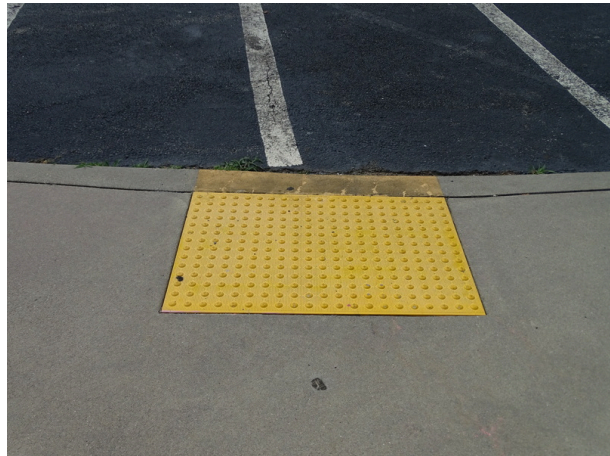
Curb ramp with truncated domes

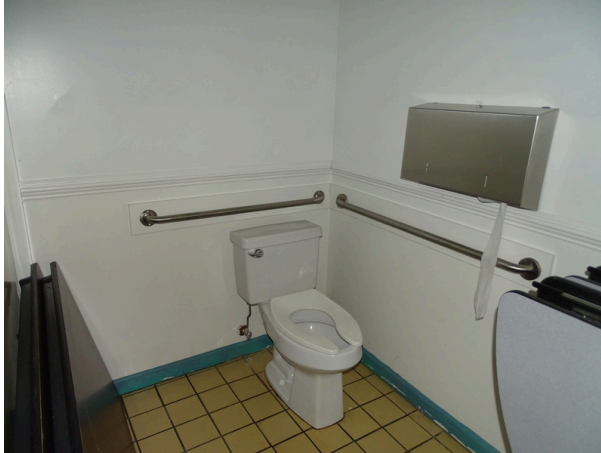
Accessible toilet

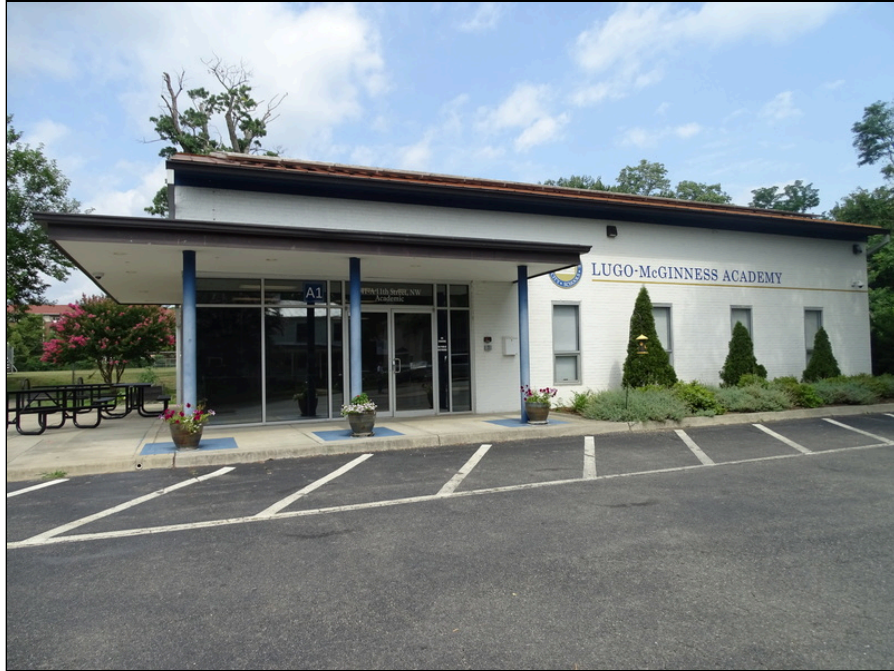
1 - Lugo-McGinness Academy north building

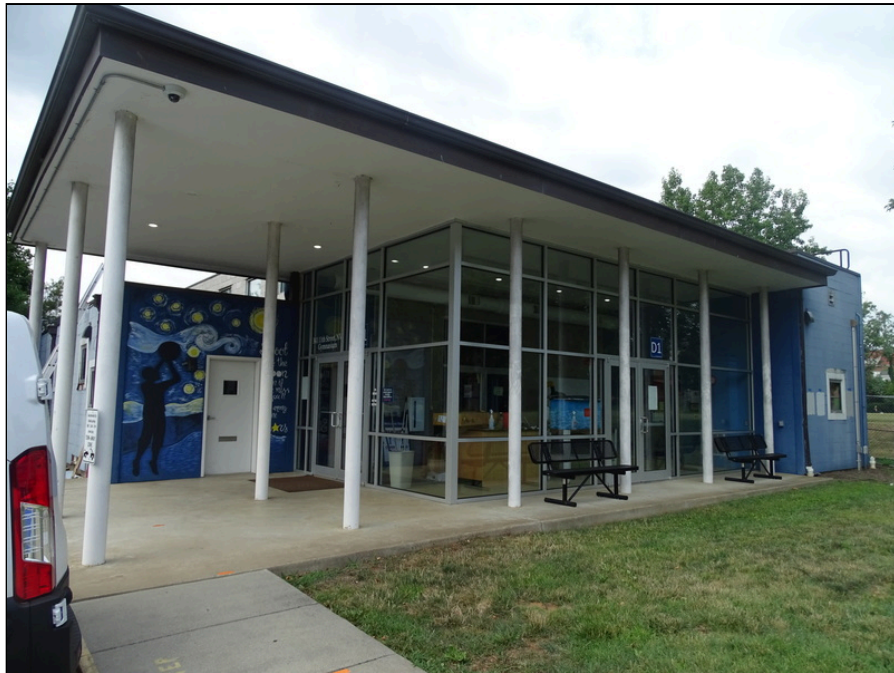
2 - Lugo-McGinness Academy south building

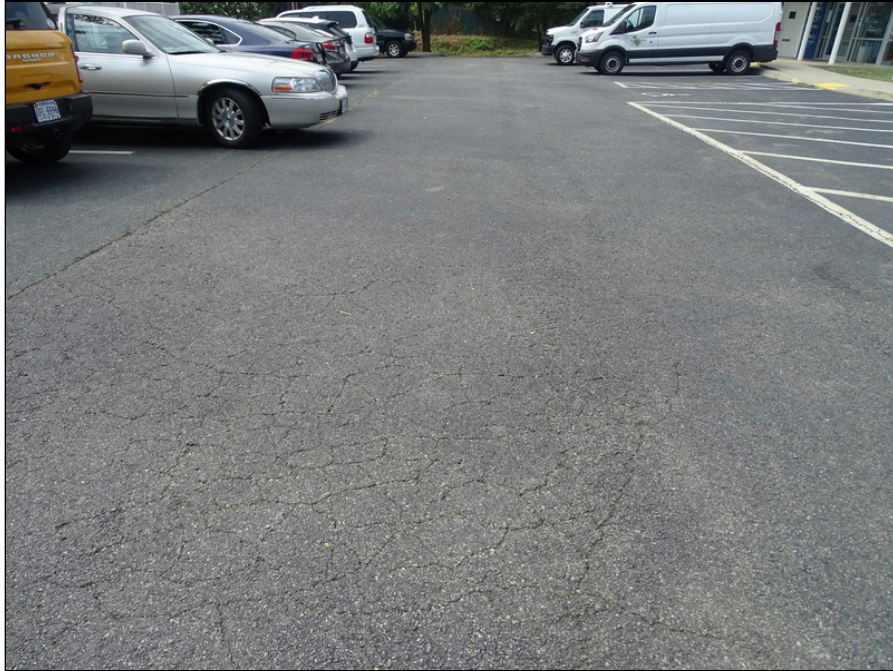
3 - Asphalt drive lane and parking - note cracking

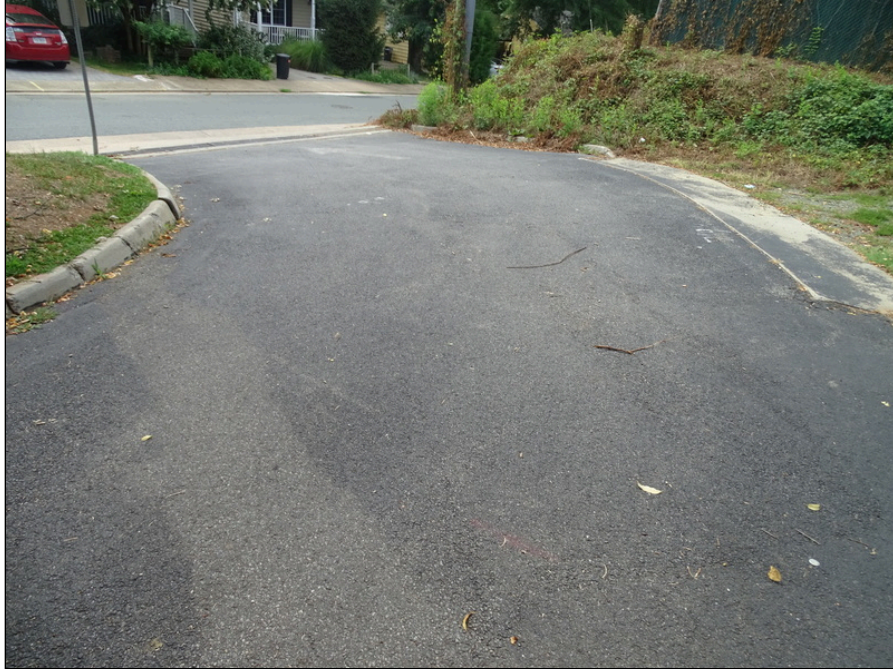
5 - Asphalt drive lane looking east

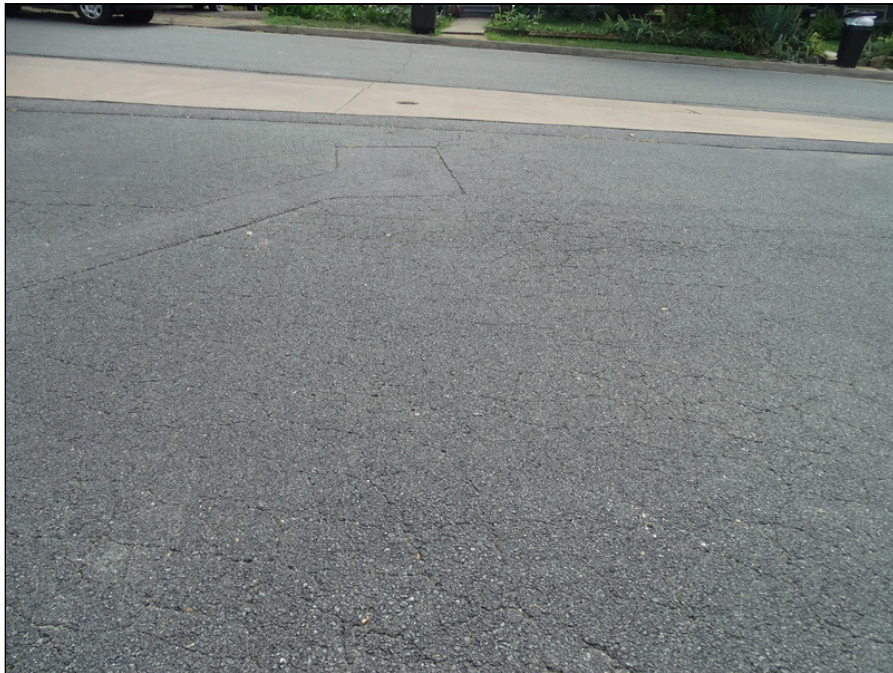
6 - Asphalt drive lane looking east - note cracking

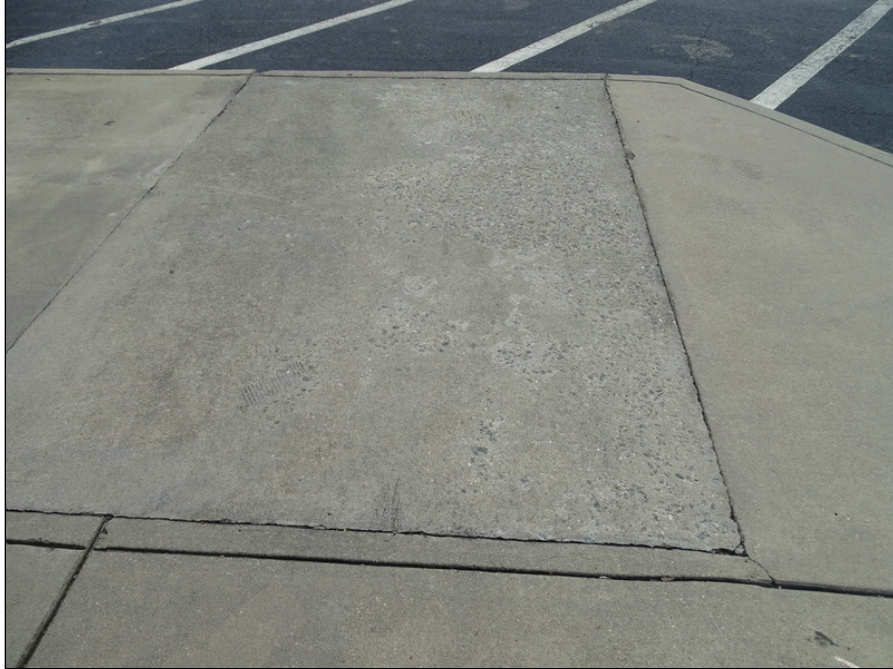
9 - Typical concrete sidewalk

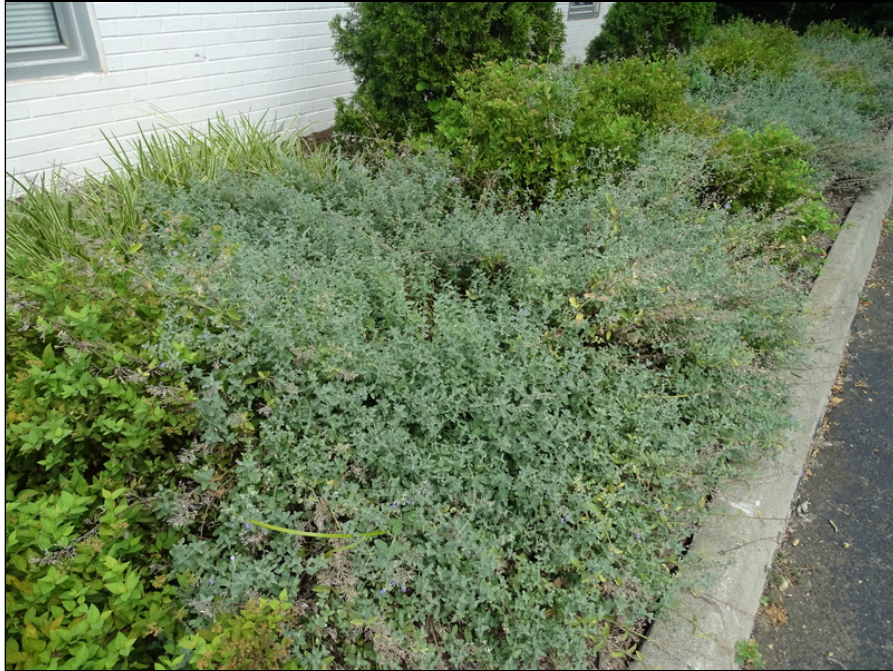
11 - Typical landscape

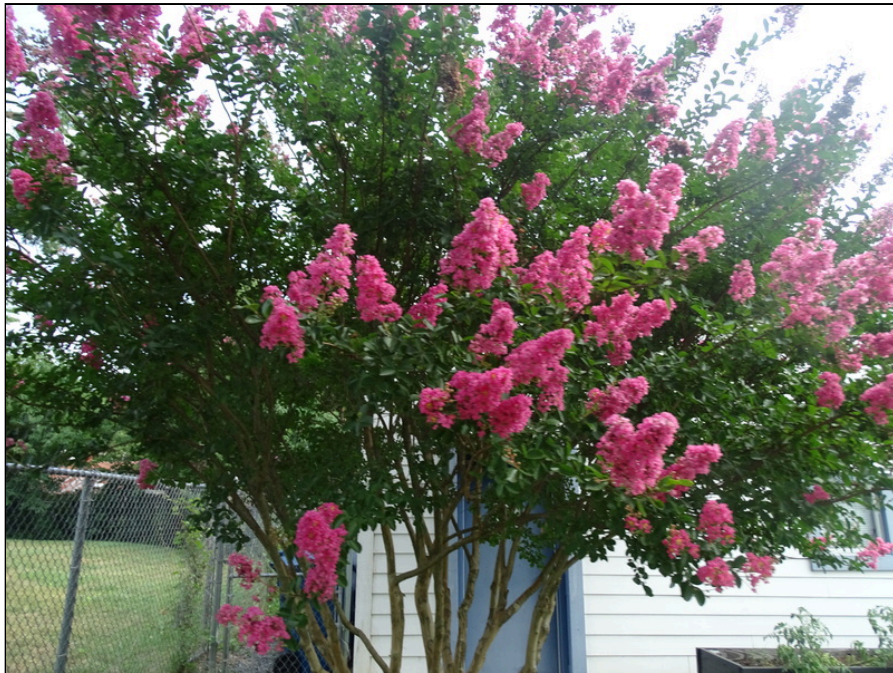
12 - Typical landscape

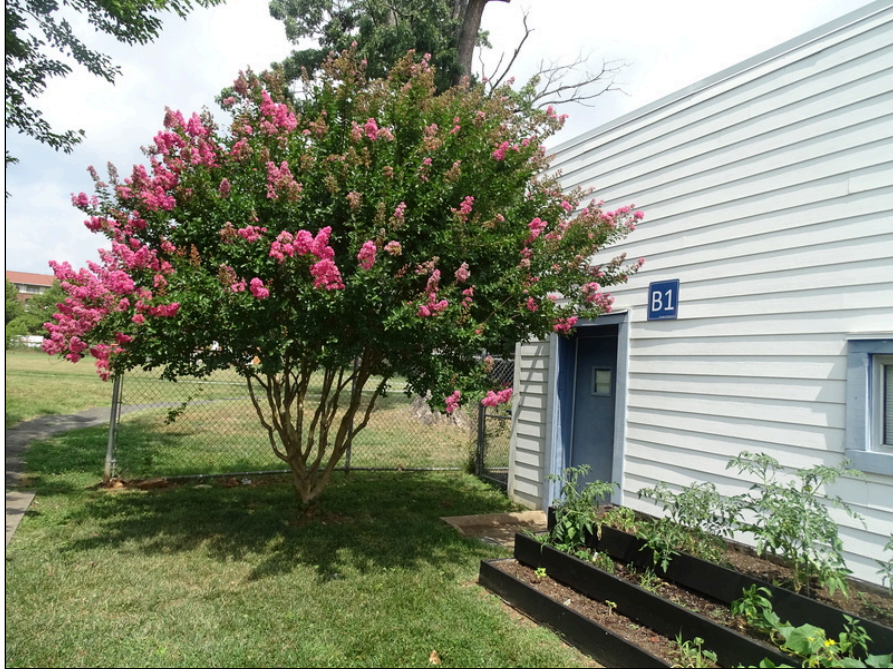
13 - Typical landscape

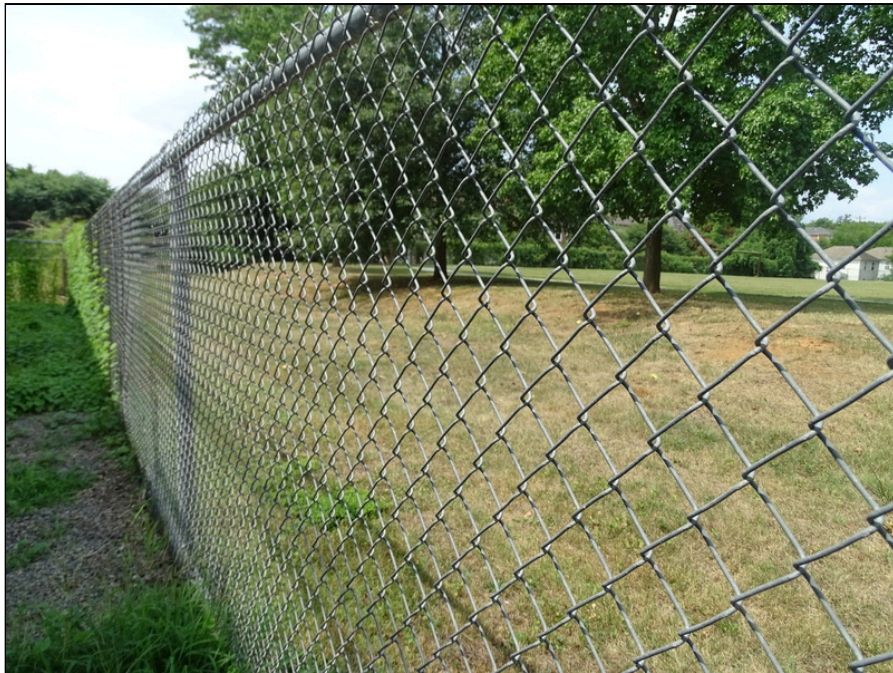
14 - Typical chain-link fence

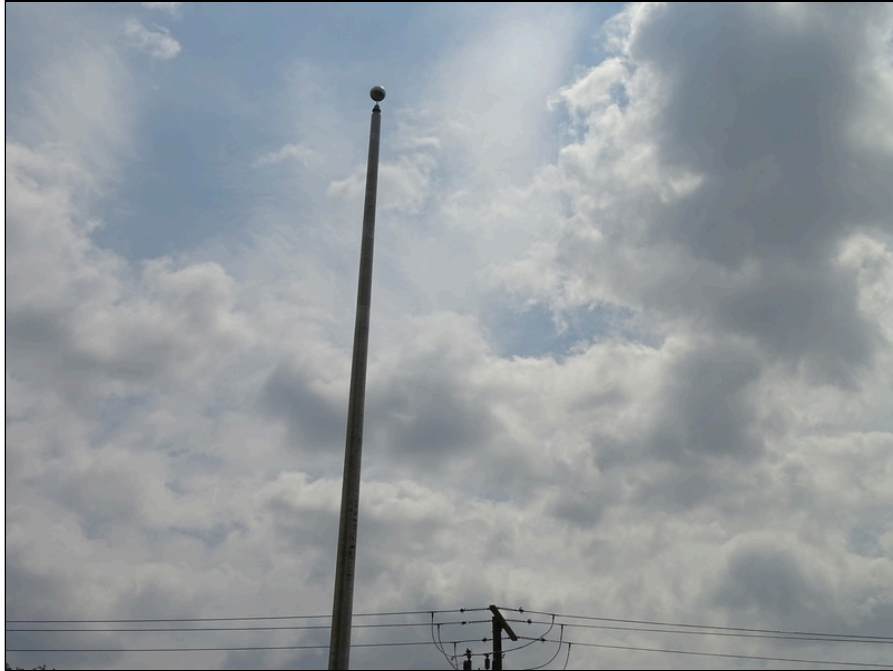
15 - Flag pole

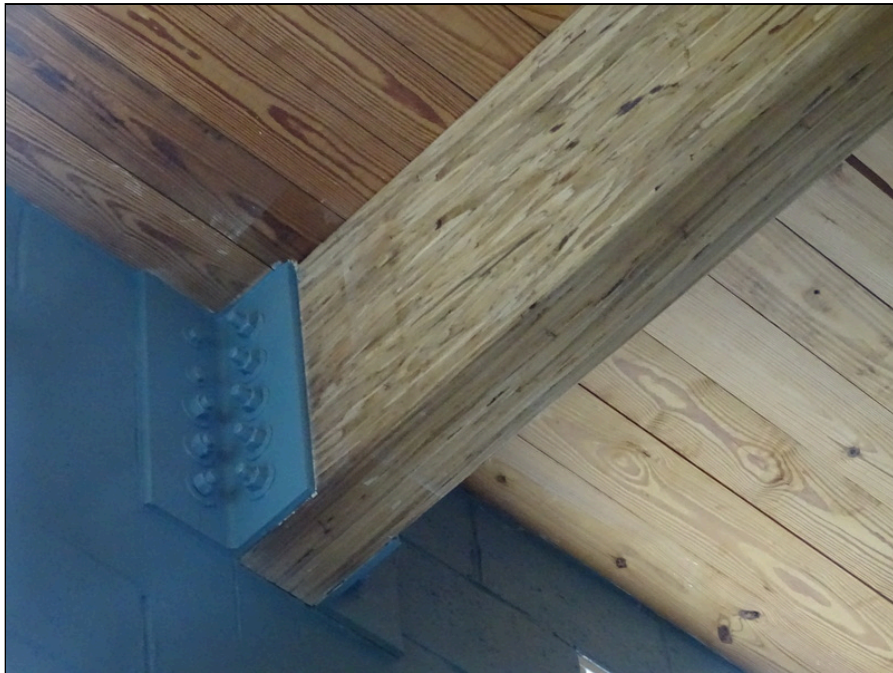
16 - Structural framing

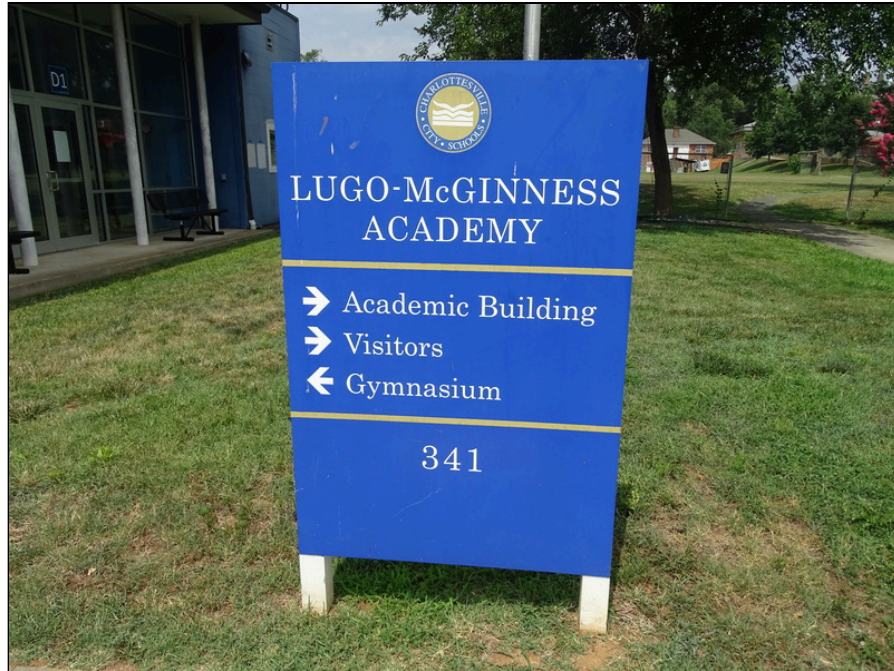
17 - Monument singe

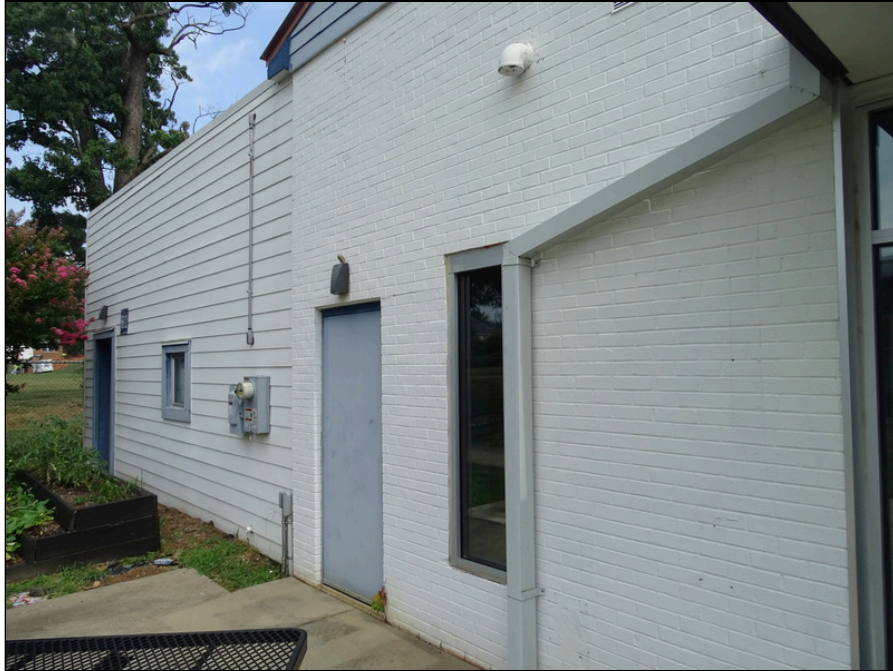
19 - Building exterior south side of north building

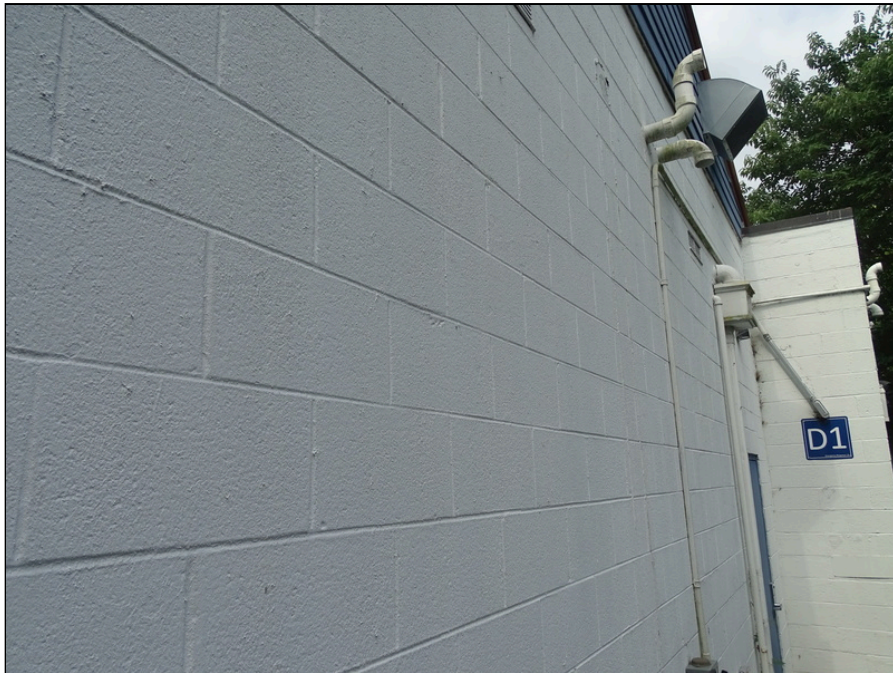
20 - Building exterior north side of north building

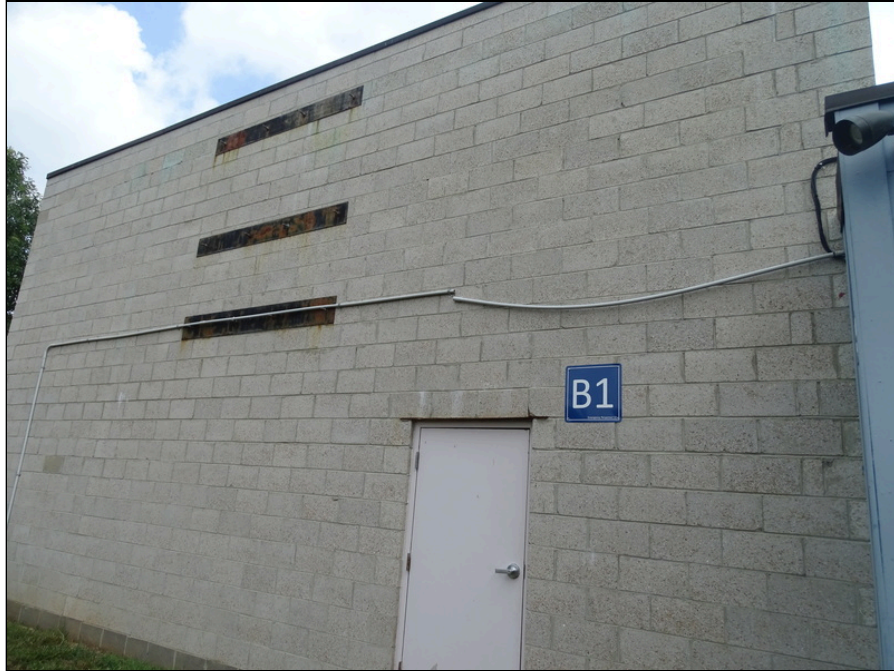
21 - Building exterior south side of south building

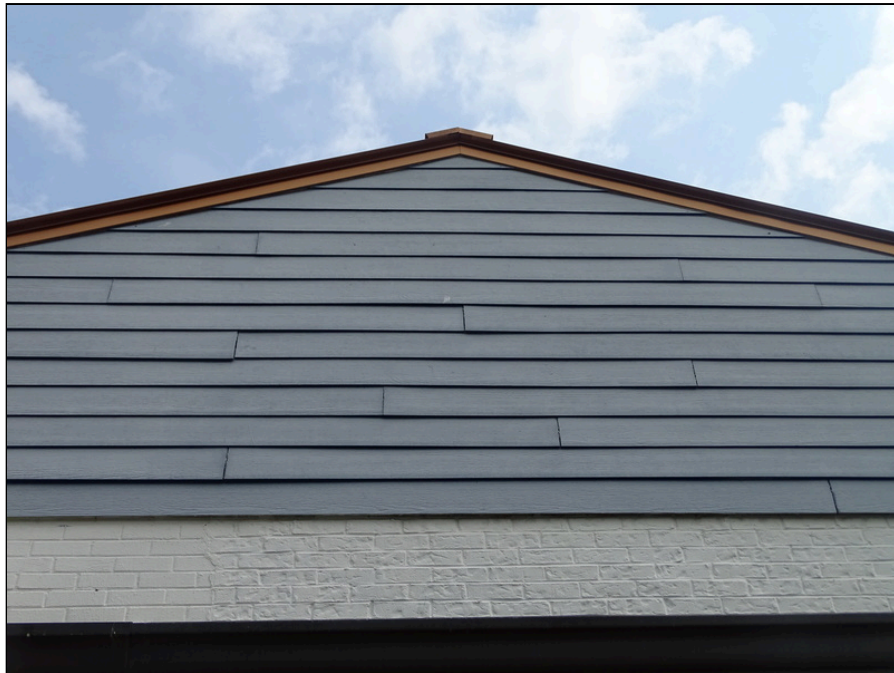
22 - Typical wood siding and trim

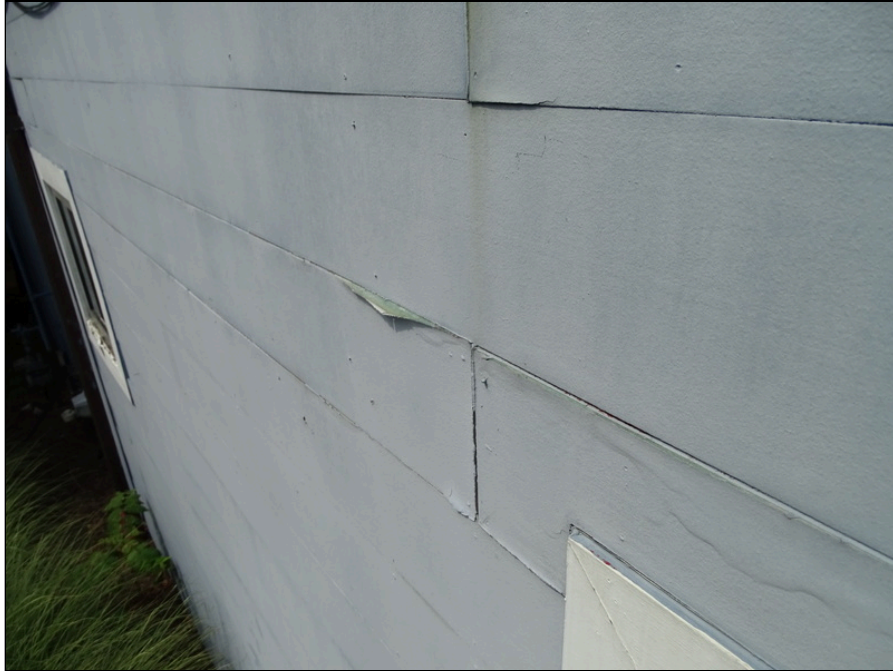
23 - Typical exterior wall - note peeling paint

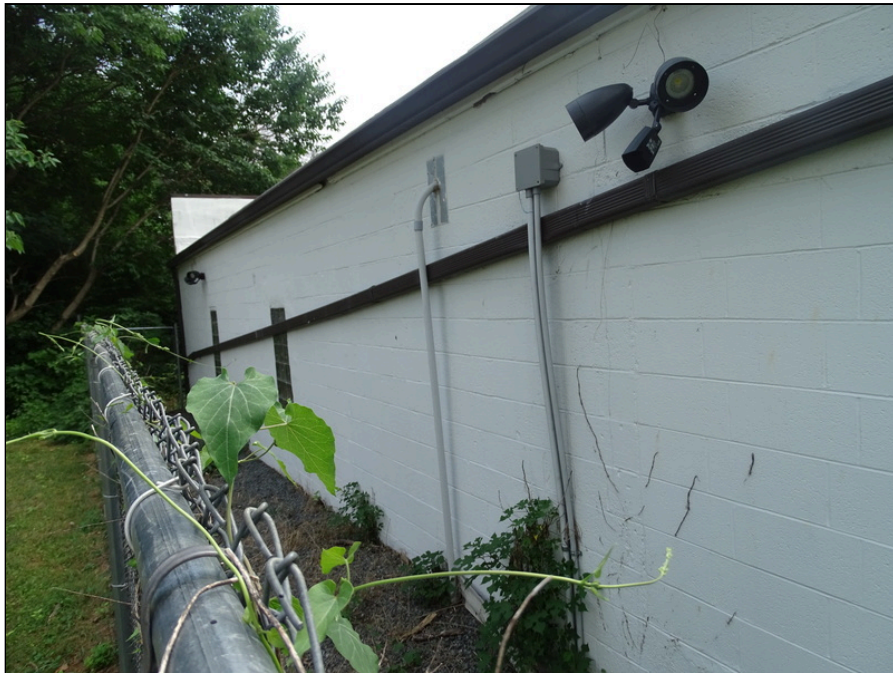
24 - Building exterior north side of north building

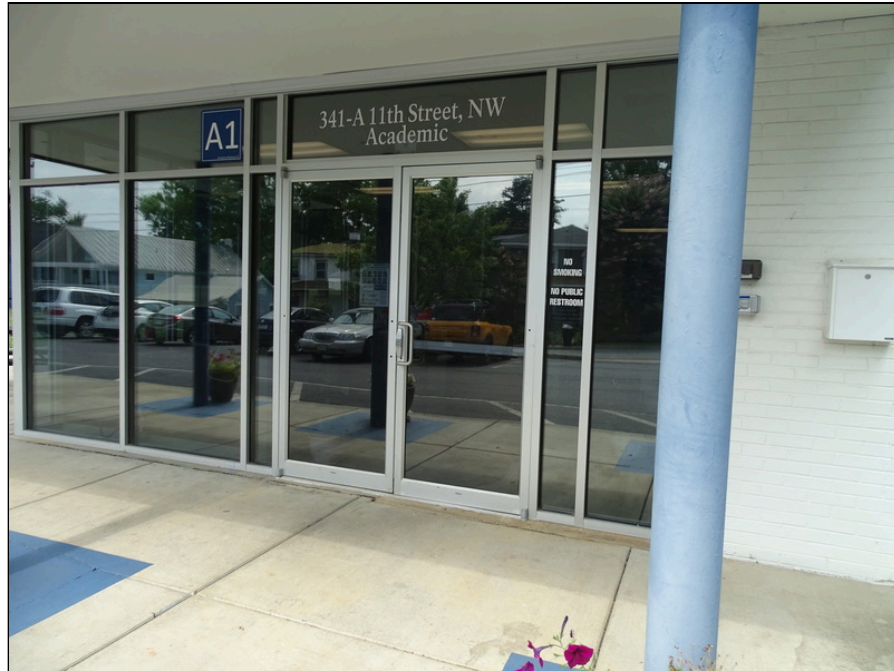
25 - Main entrance doors north building

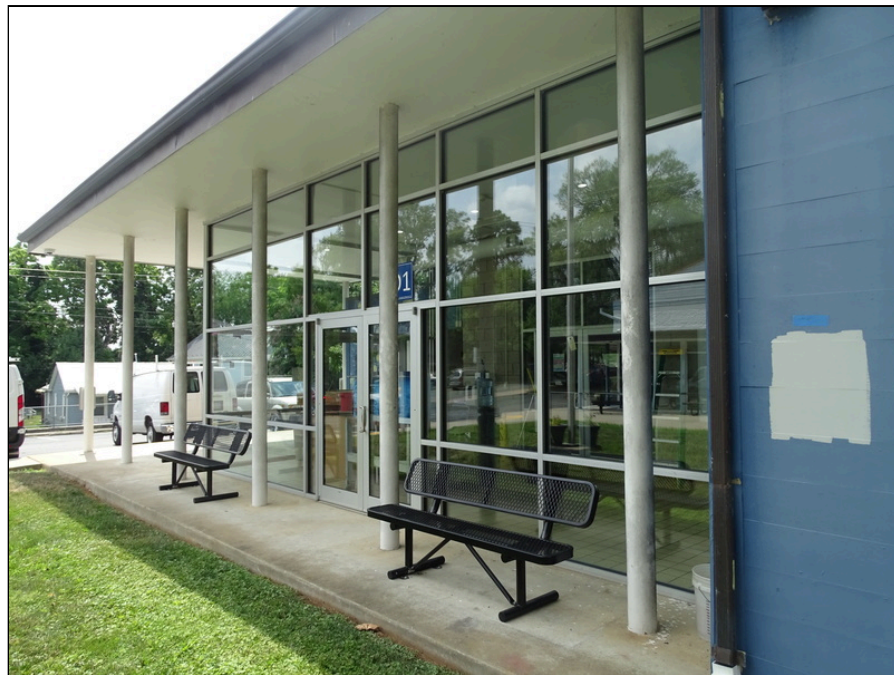
26 - Main entrance doors and windows at south building

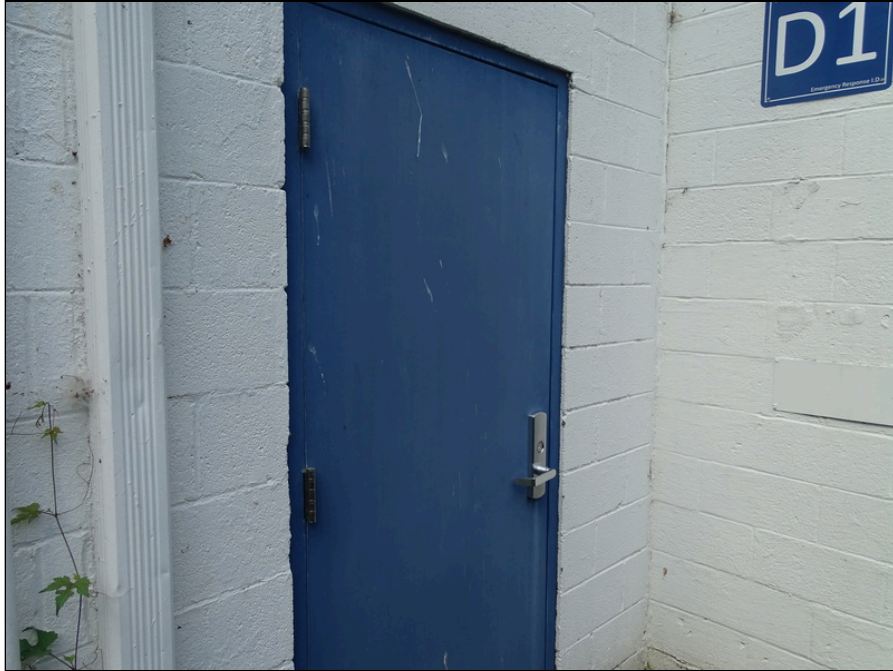
27 - Personnel door north building

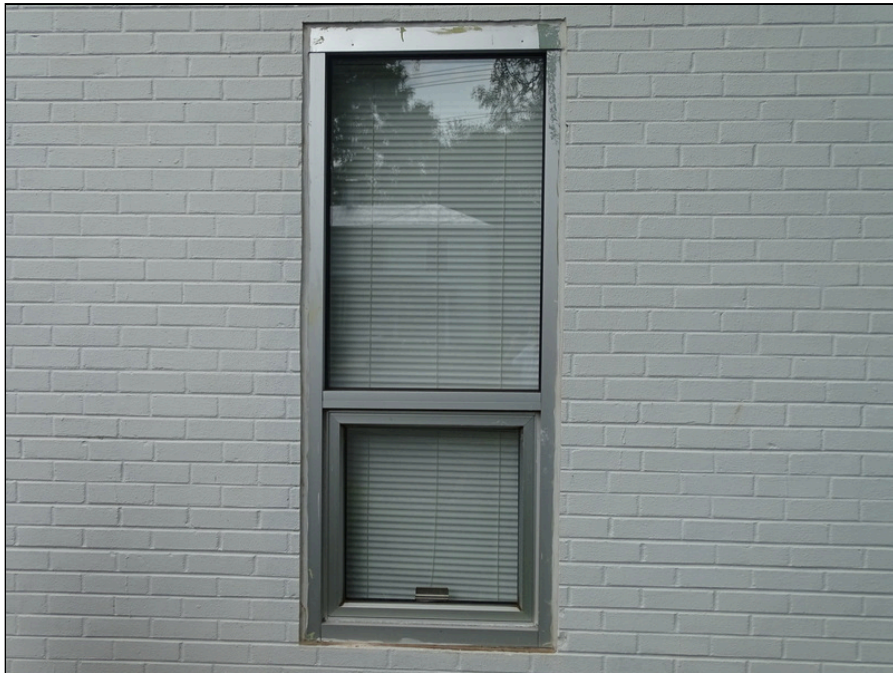
28 - Typical exterior windows north building

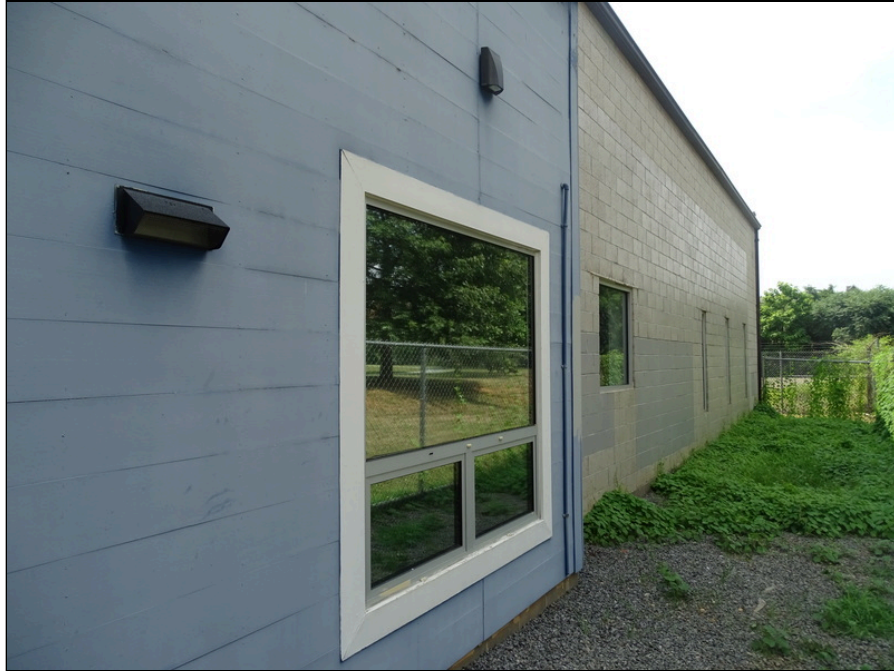
29 - Typical exterior windows

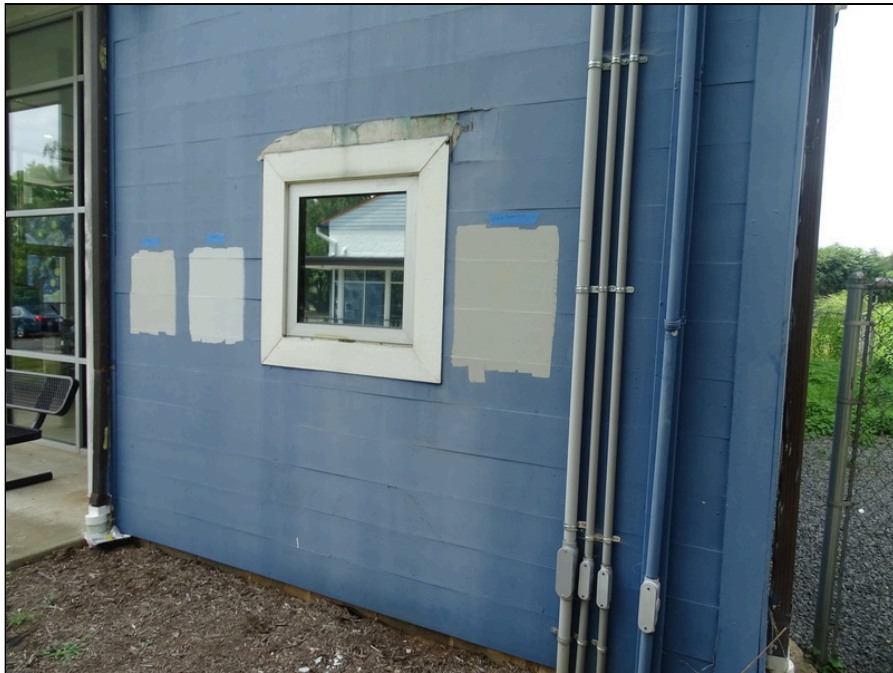
32 - Typical exterior windows

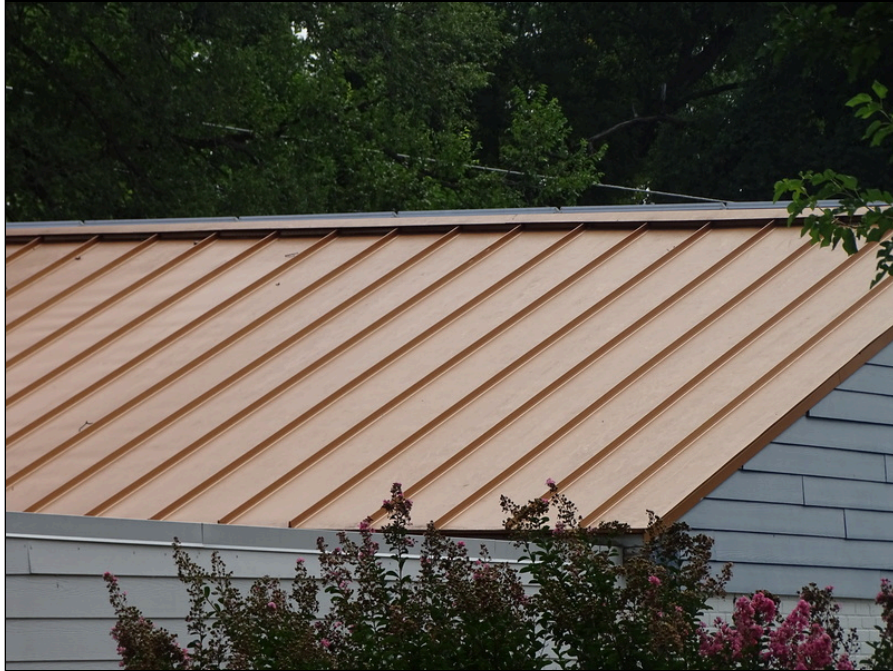
33 - Metal roofing system north building
