LUGO MCGINNESS ACADEMY
341-(A) 11TH STREET NW
CHARLOTTESVILLE, VIRGINIA

ECS PROJECT NO. 46:6713

CITY OF CHARLOTTESVILLE - FACILITIES DEVELOPMENT

Reference: Facility Condition Assessment Report for Lugo McGinness Academy, 341-(A) 11th Street NW, Charlottesville, Virginia

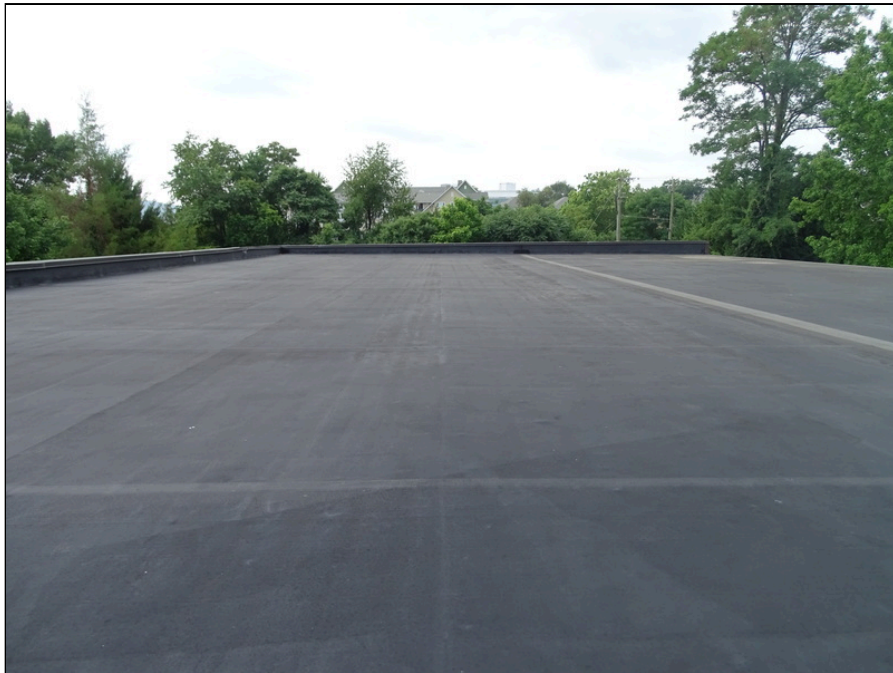
34 - Single-ply roofing system

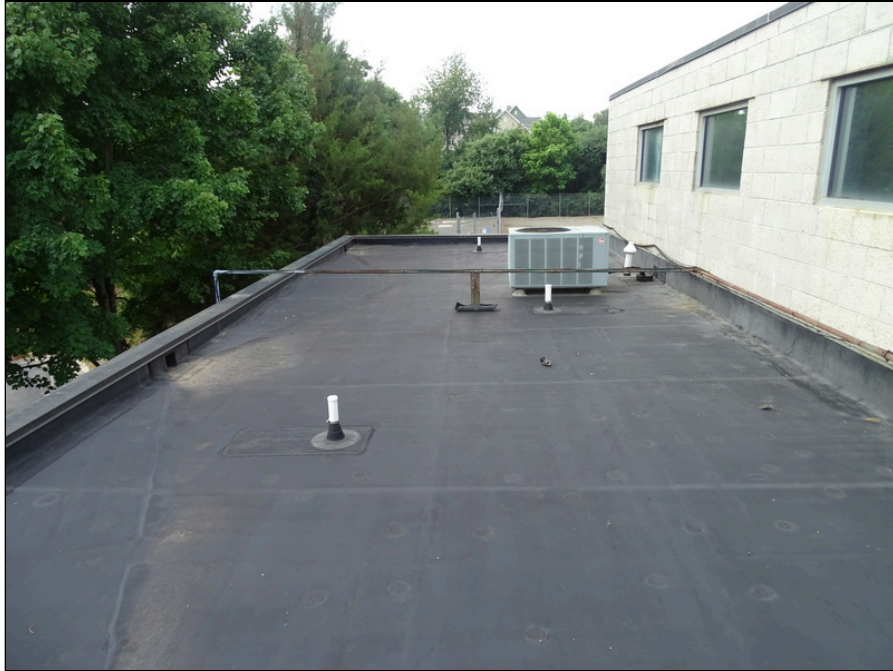
35 - Single-ply roofing system

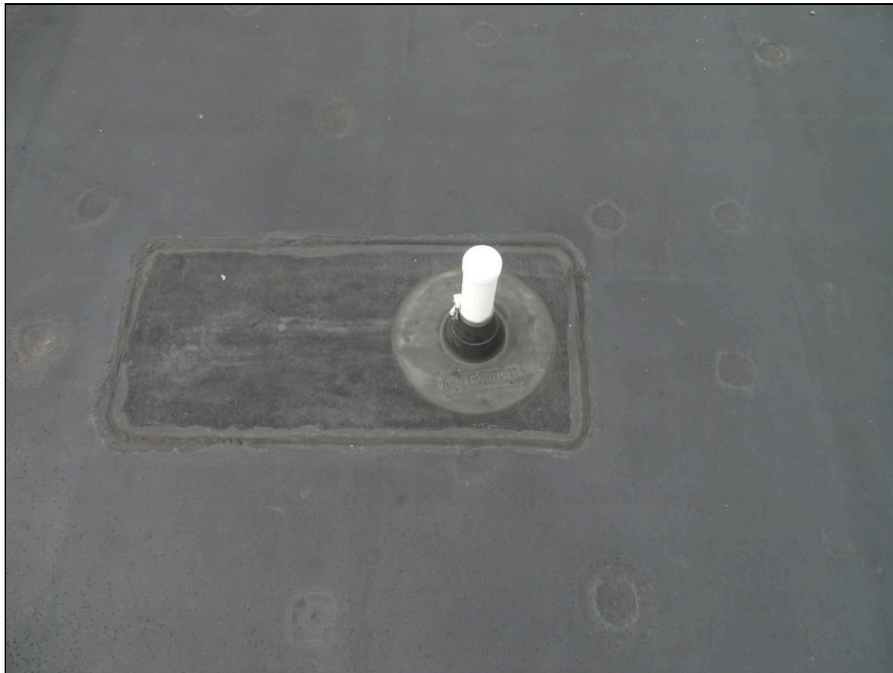
36 - Typical plumbing penetration and patching

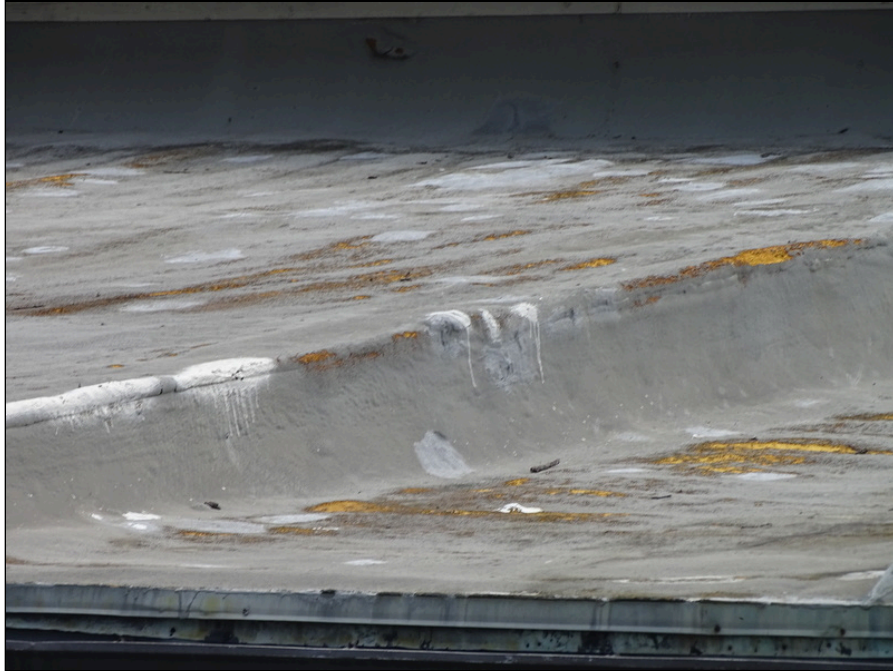
37 - Coated polyurethane roofing system

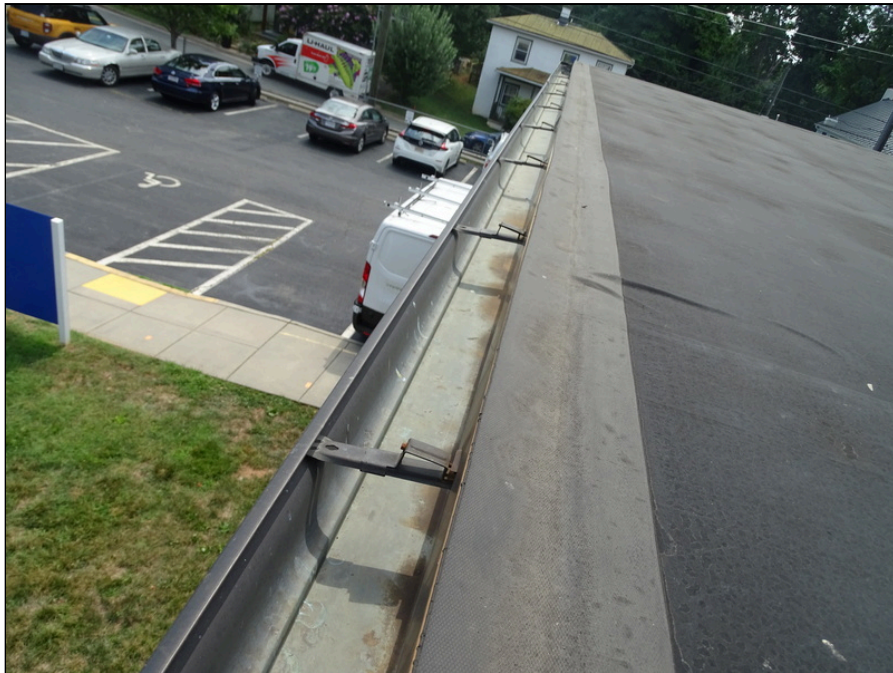
40 - Typical gutter

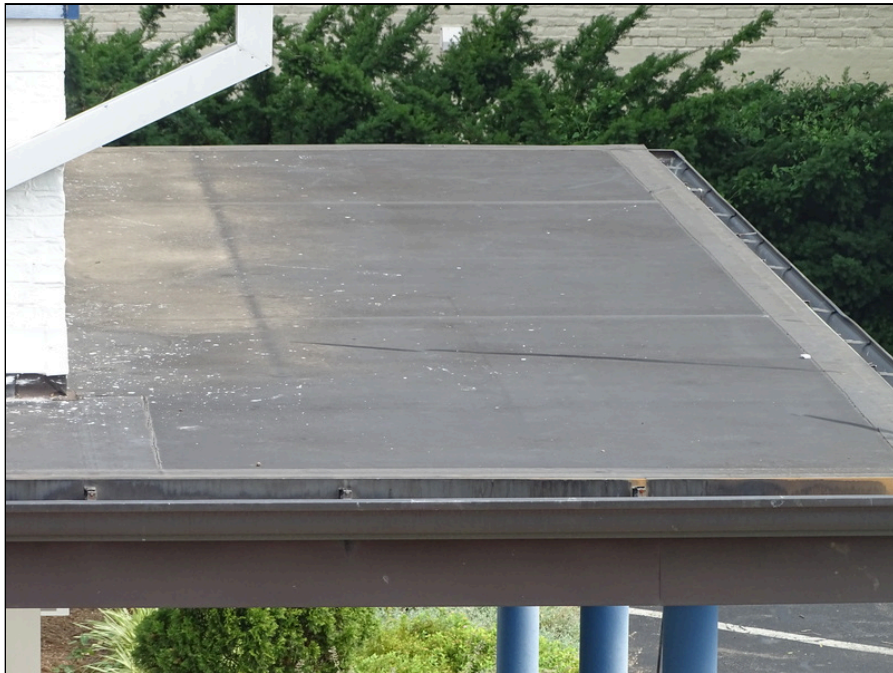
42 - Single-ply roofing system

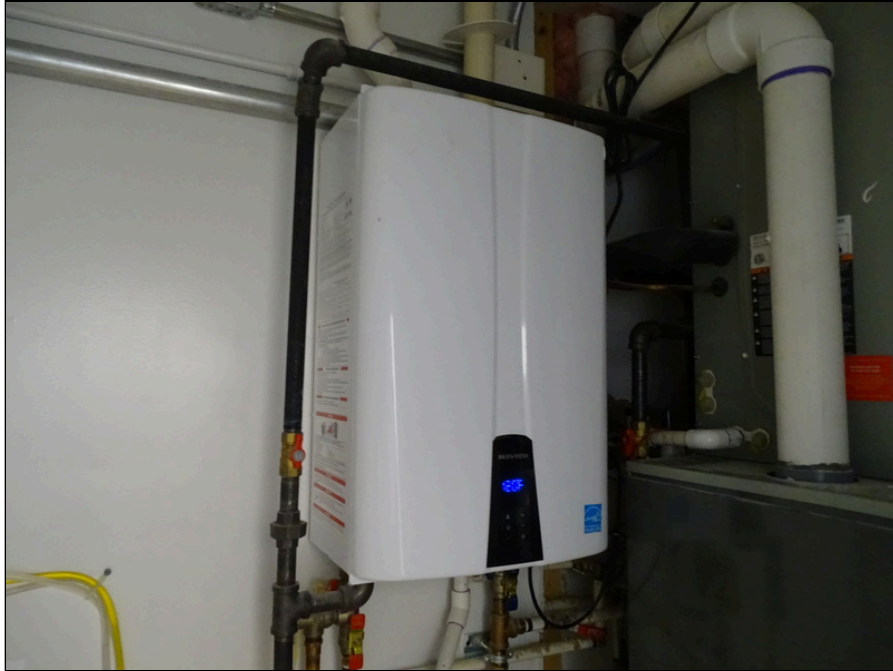
43 - Tankless water heater in north building

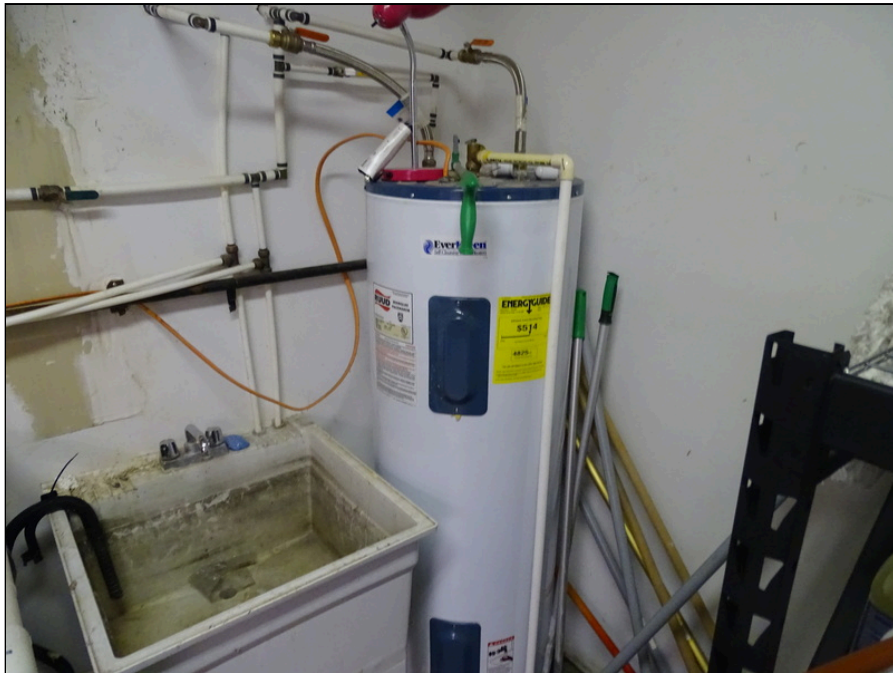
44 - Electric water heater in south building

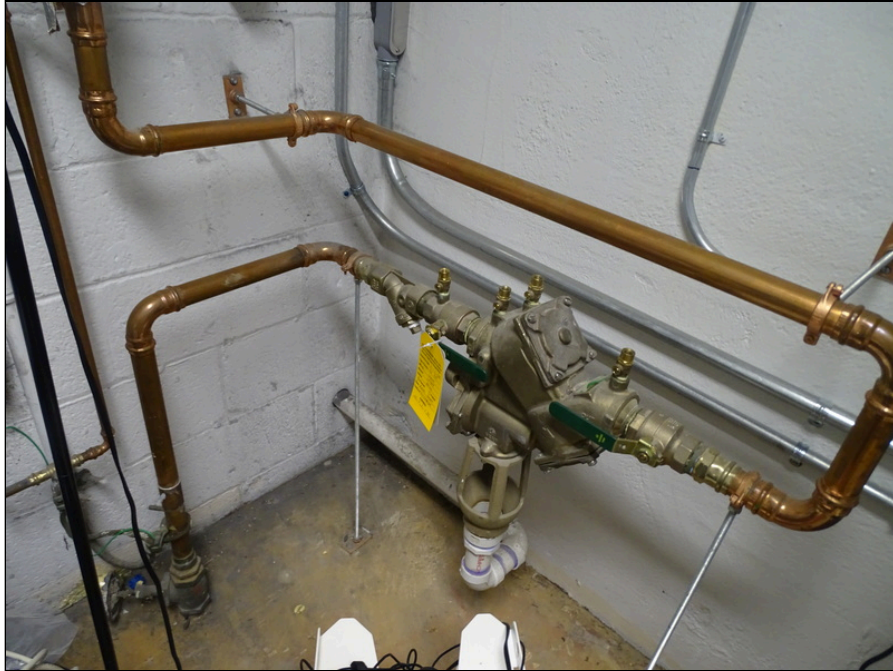
45 - water system piping

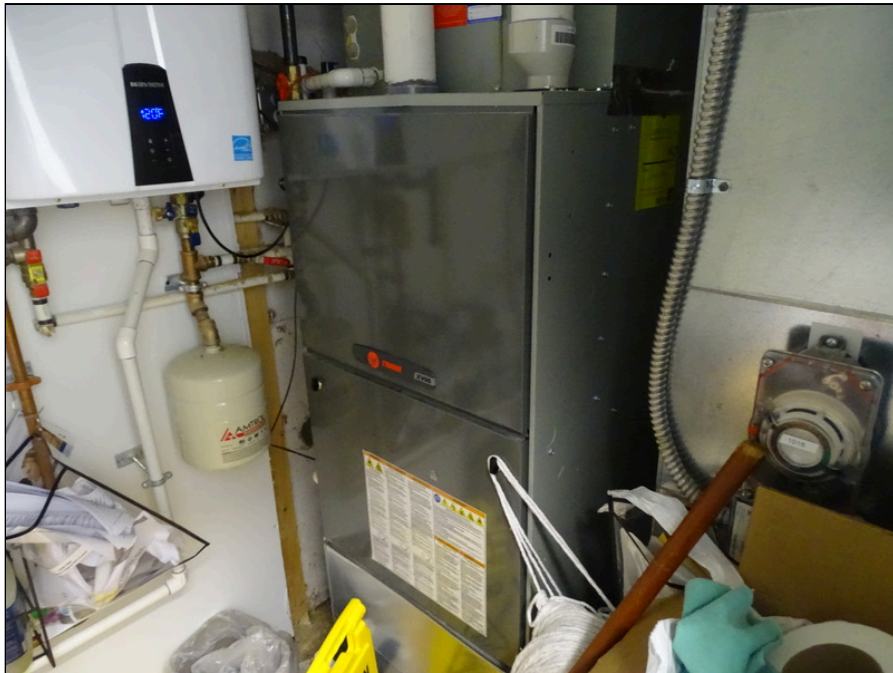
46 - Typical furnace-air handler unit at north building

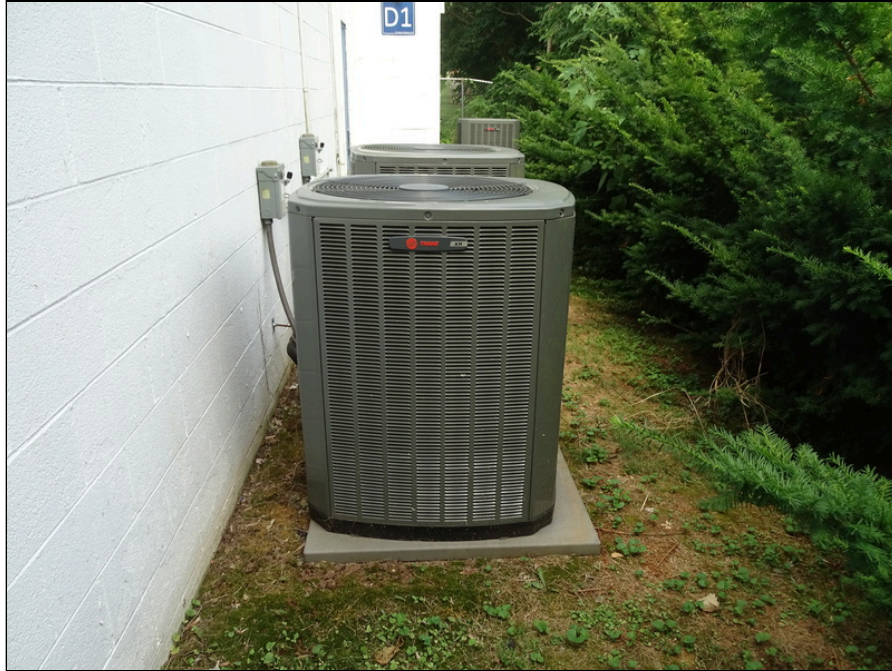
47 - Typical condenser unit at north building

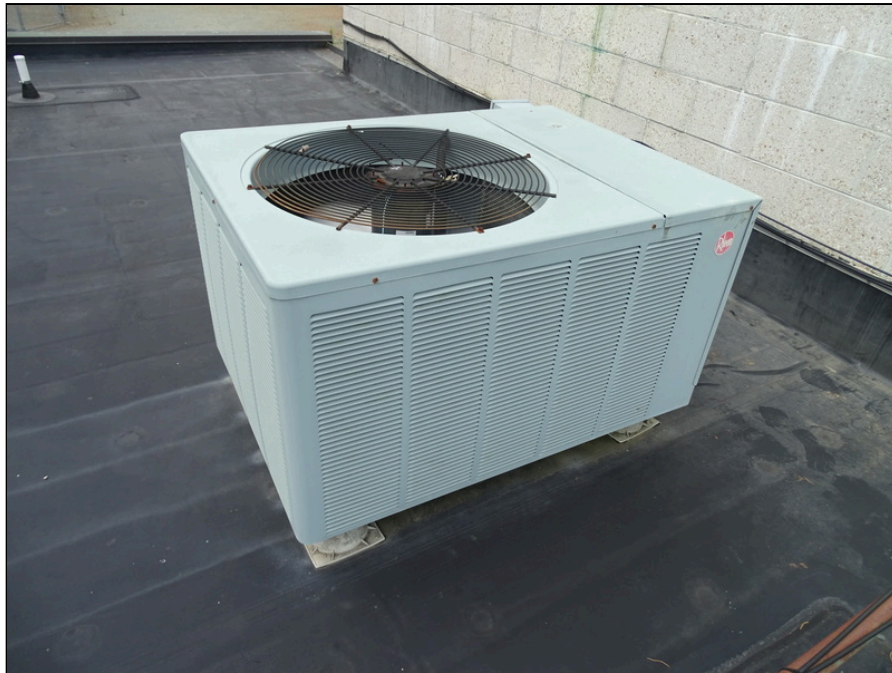
48 - Typical condensing unit

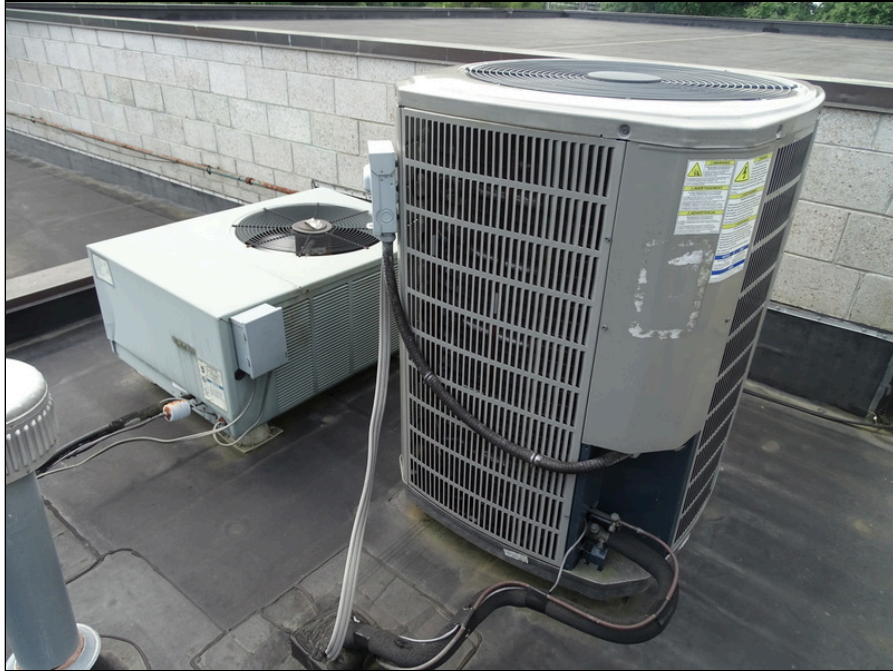
49 - Typical condensing unit

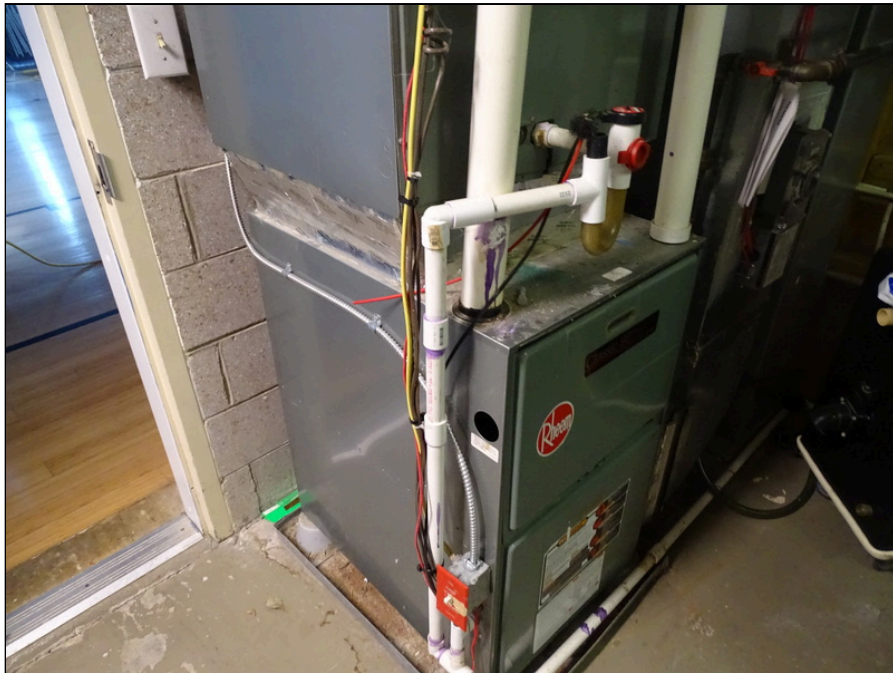
50 - Typical furnace-air handler unit at south building

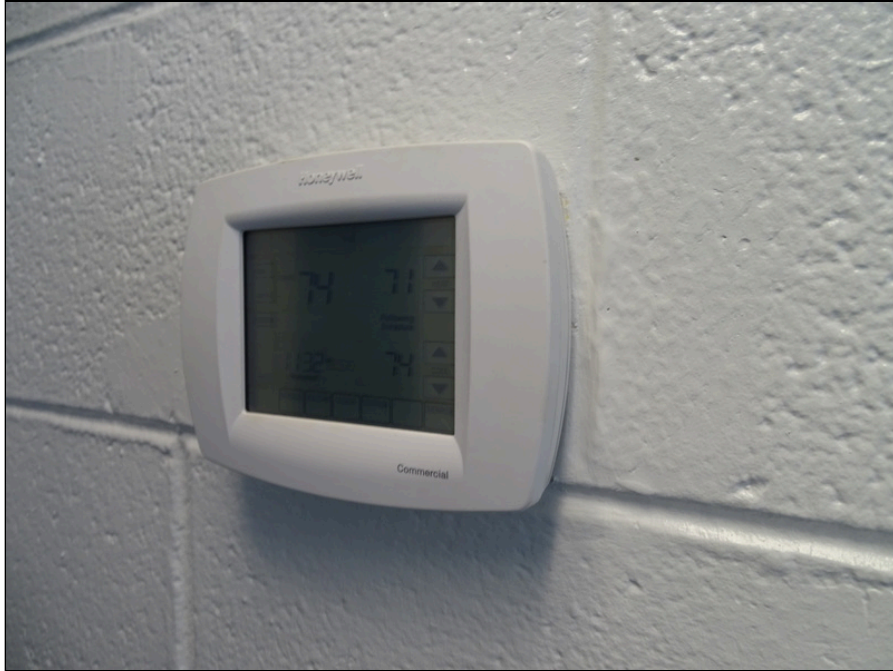
51 - Typical thermostat control

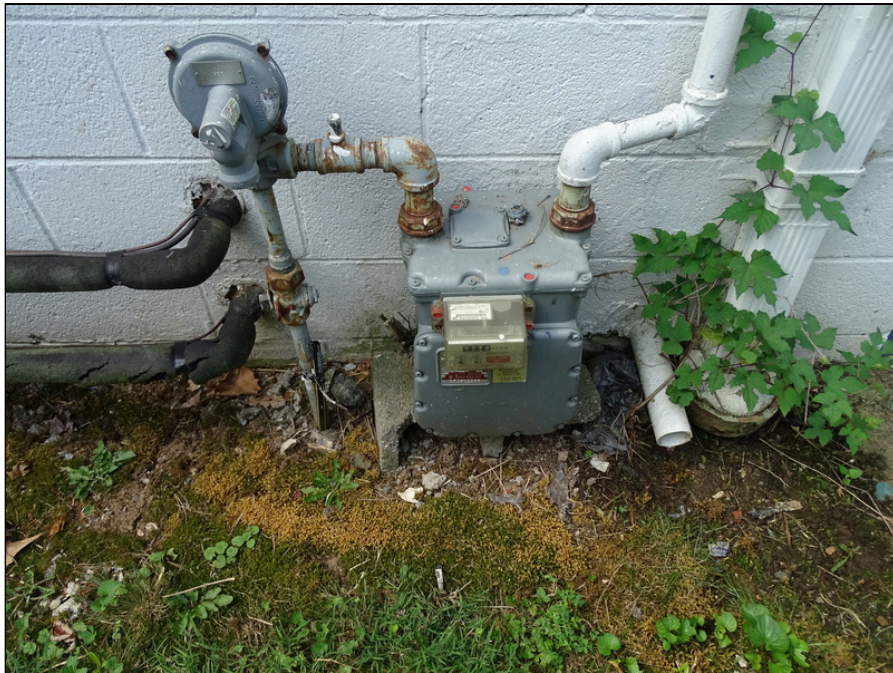
52 - Typical gas meter

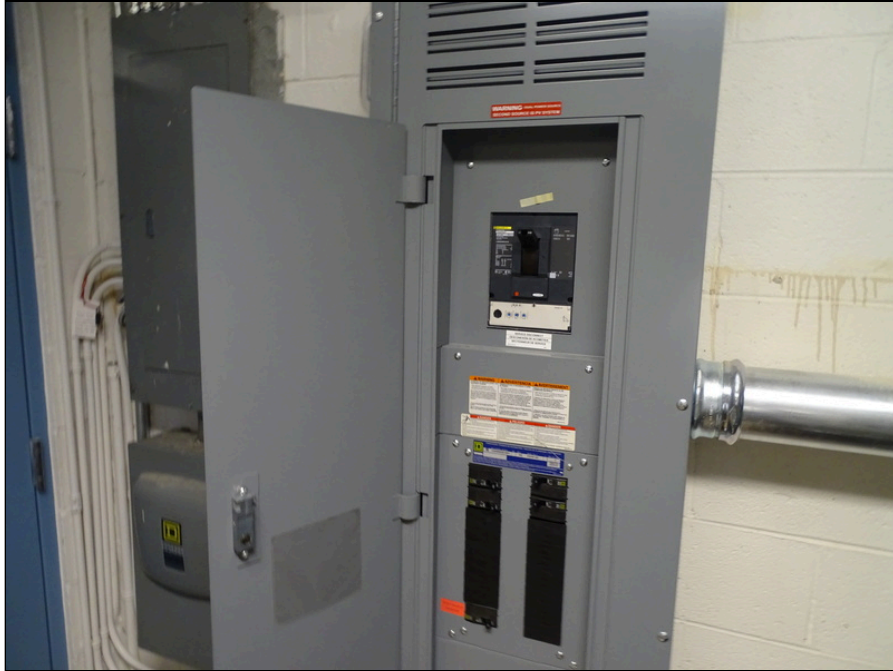
53 - Typical main electrical switchgear

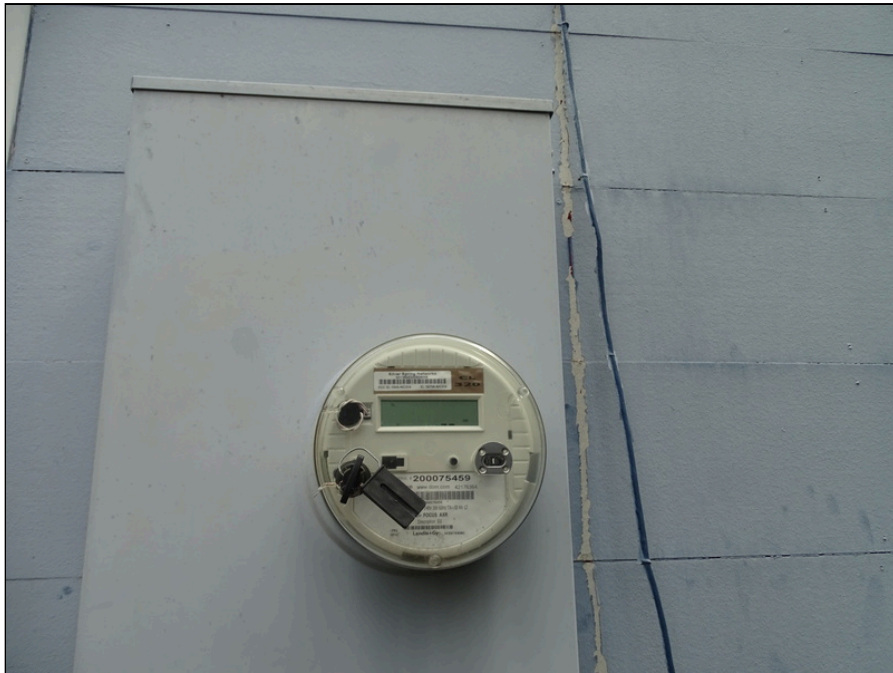
54 - Typical electrical meter

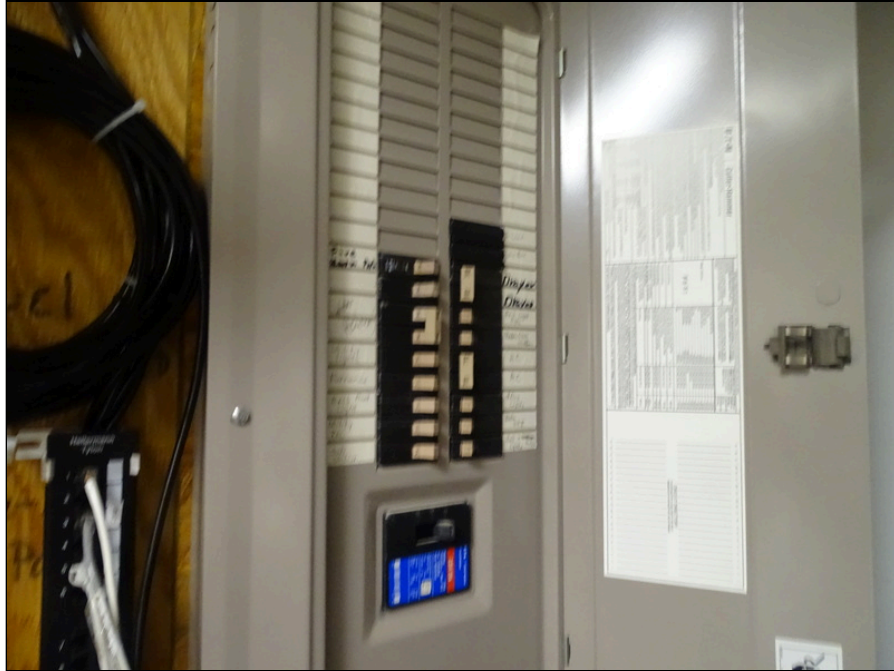
55 - Typical electrical circuit breaker panel

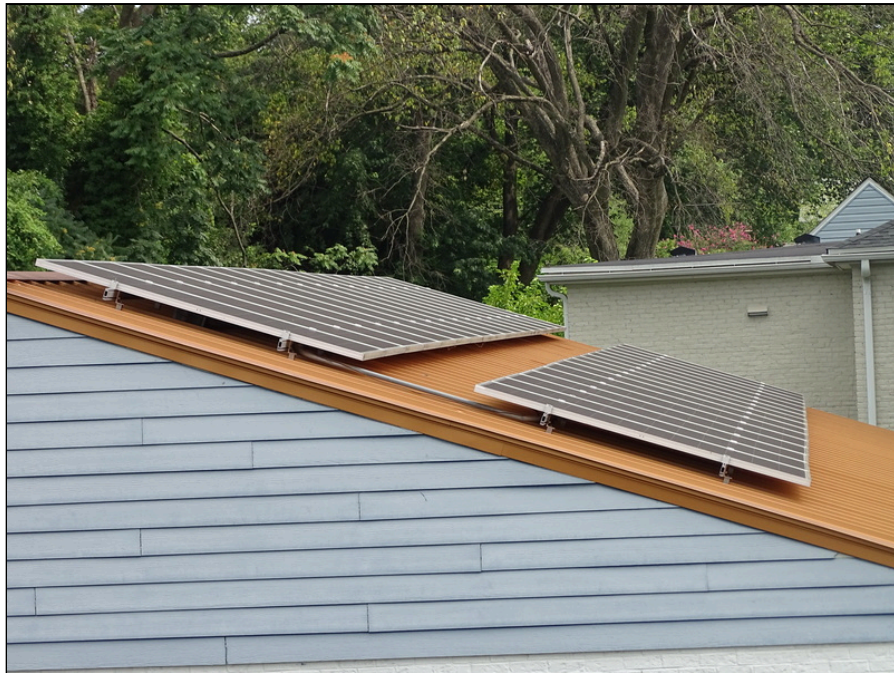
56 - Solar panels located on north building roof

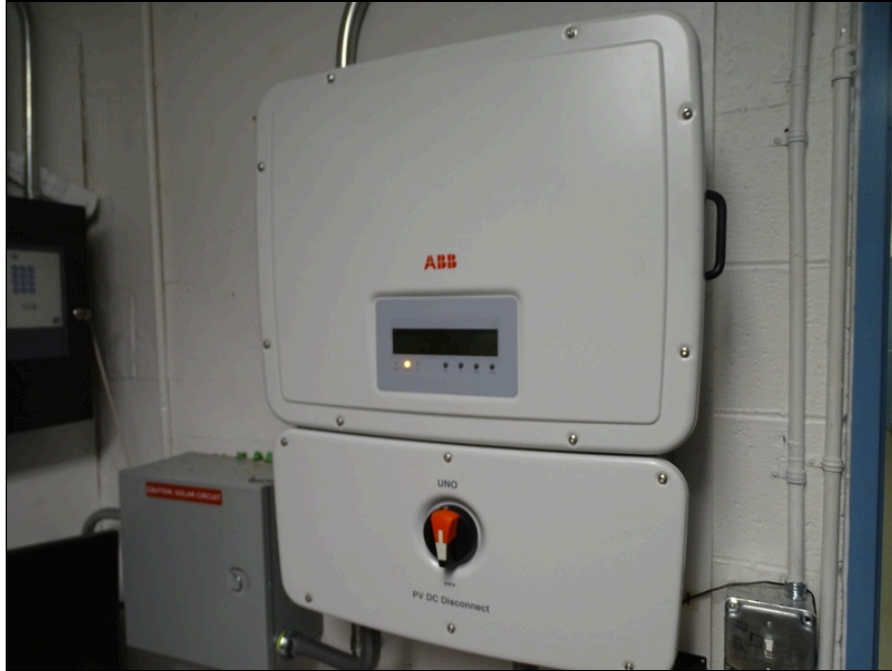
57 - Solar Power System electronic controls located in north building electrical room

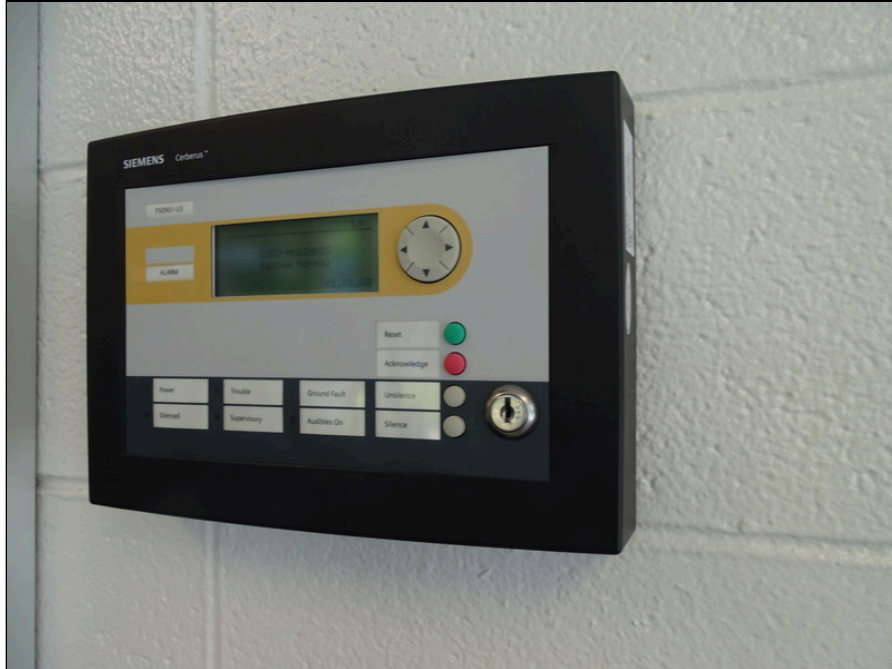
59 - Fire alarm control panel

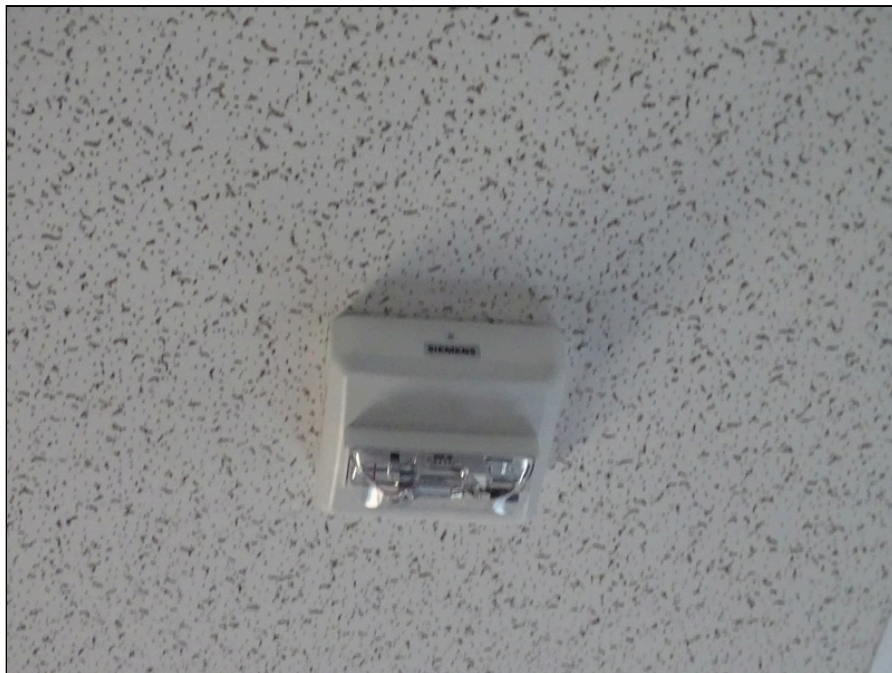
60 - Fire alarm bell and strobe

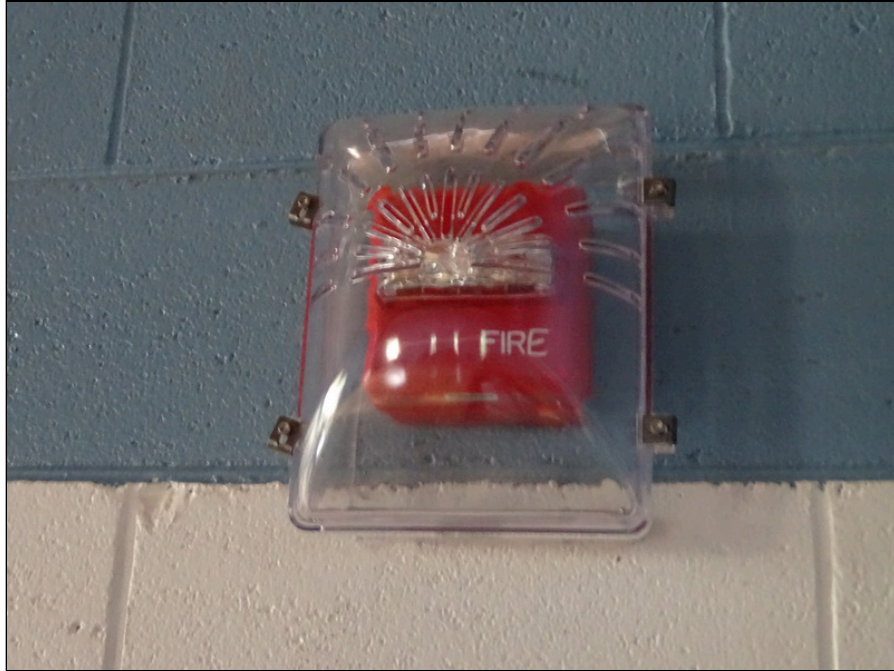
61 - Fire alarm bell and strobe

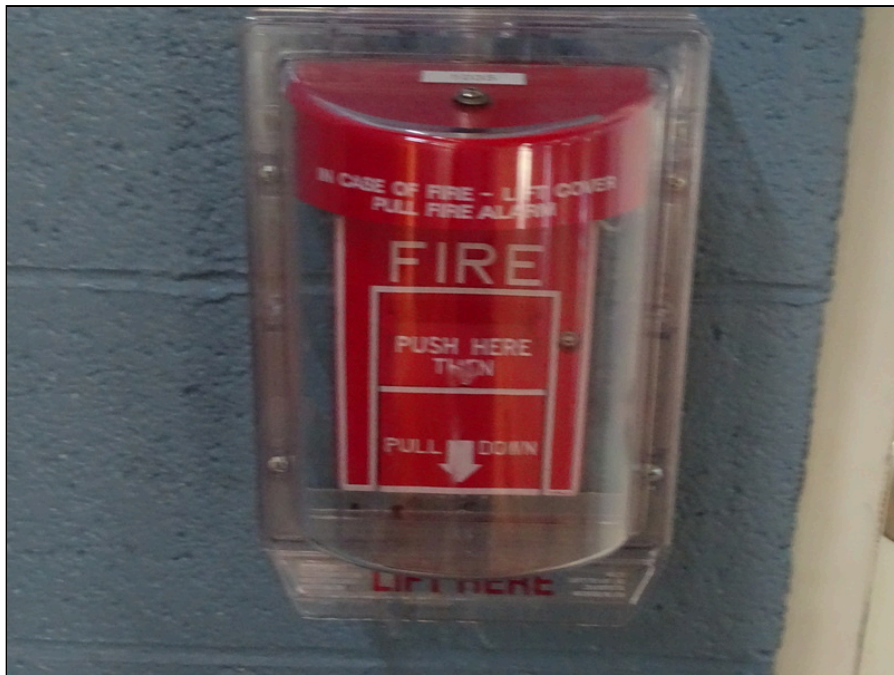
62 - Fire alarm pull down station

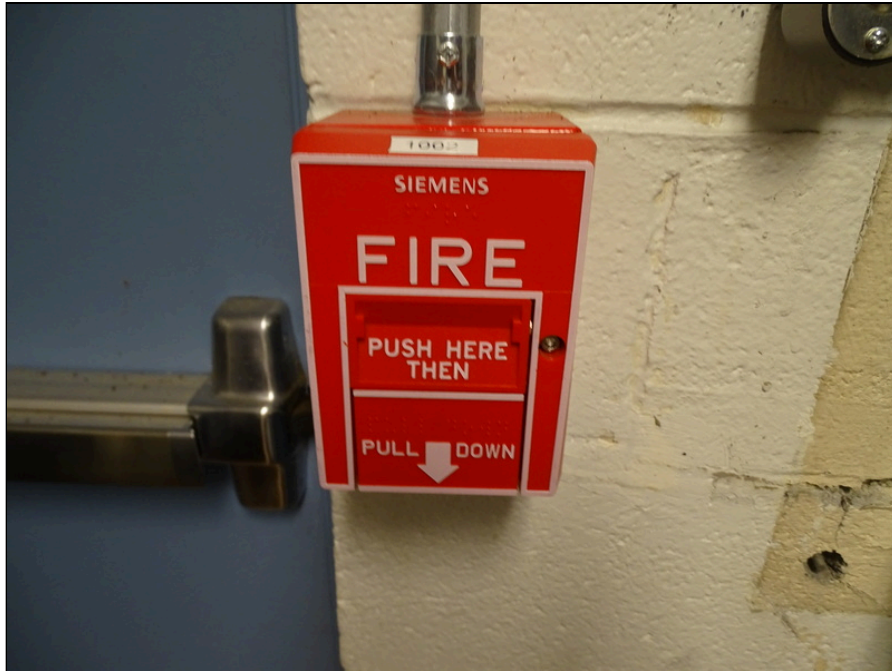
63 - Fire alarm pull down station

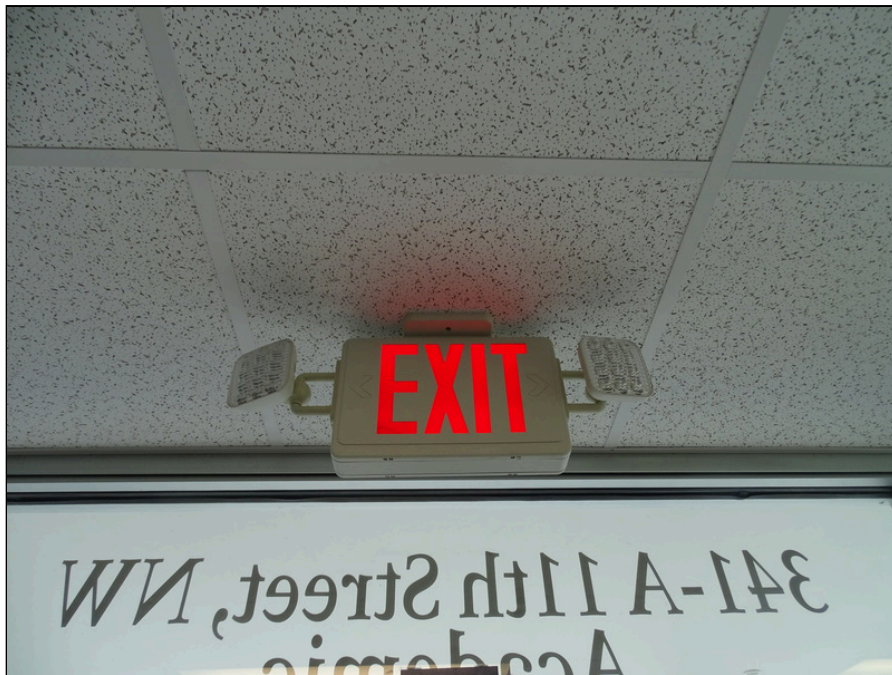
64 - Exit sign and emergency lighting

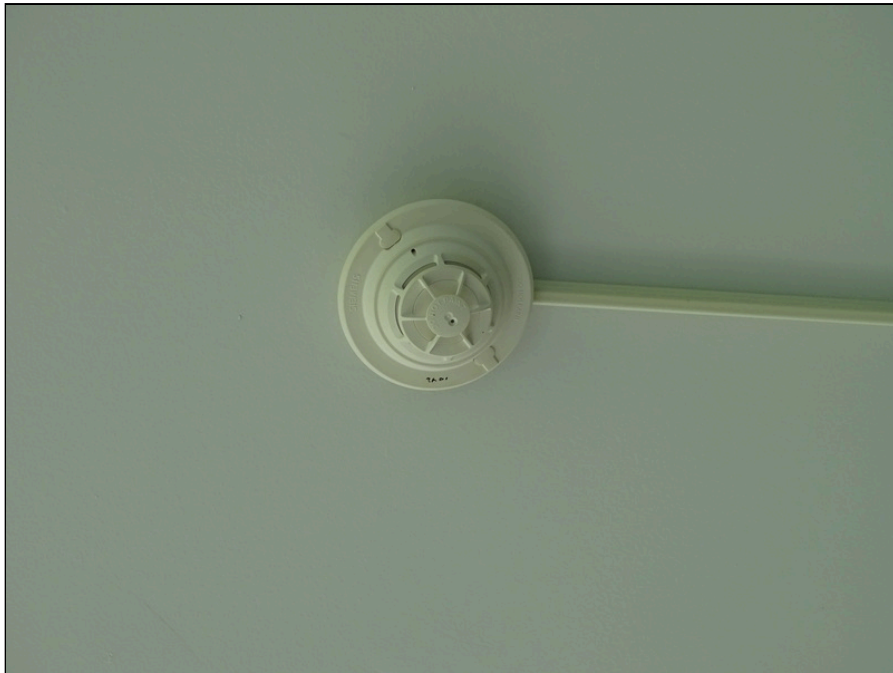
66 - Smoke detector

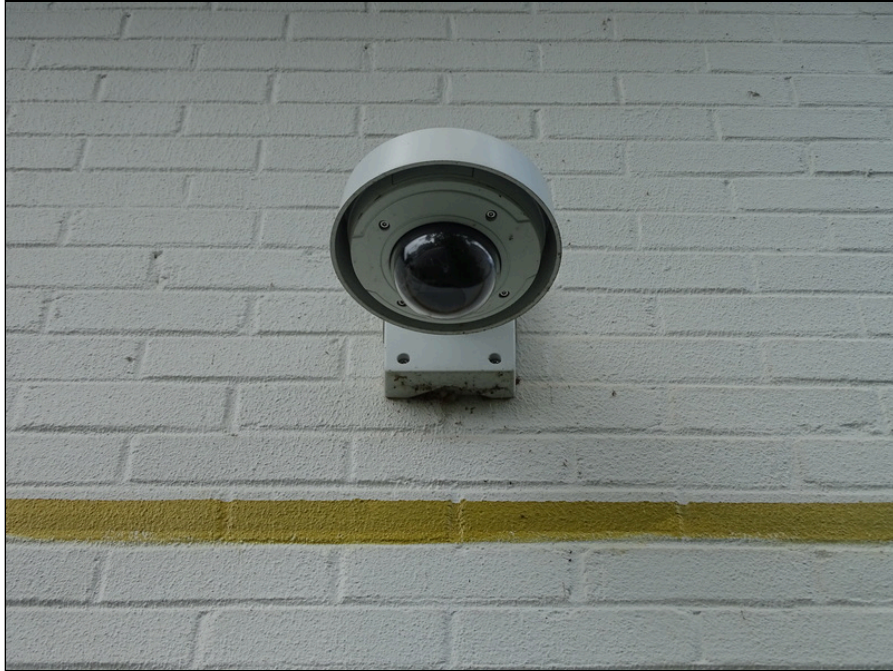
67 - Security camera

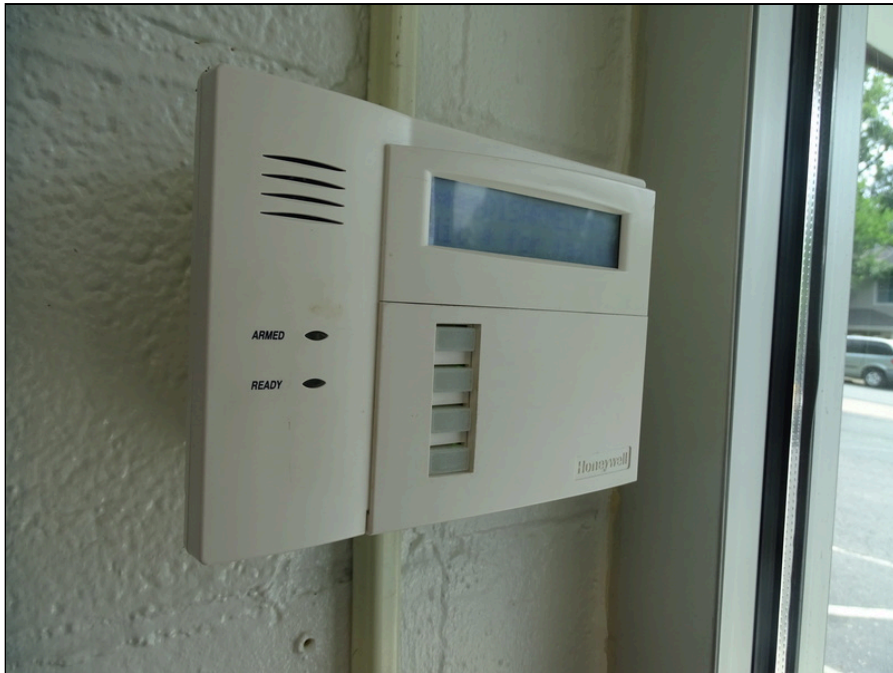
68 - Security system electronics

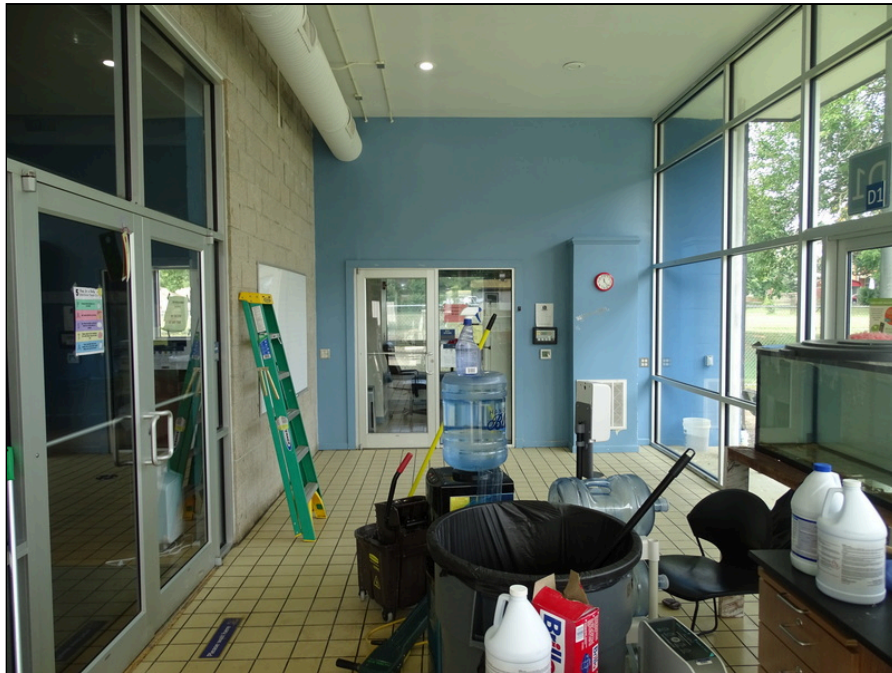
70 - Interior finishes lobby area

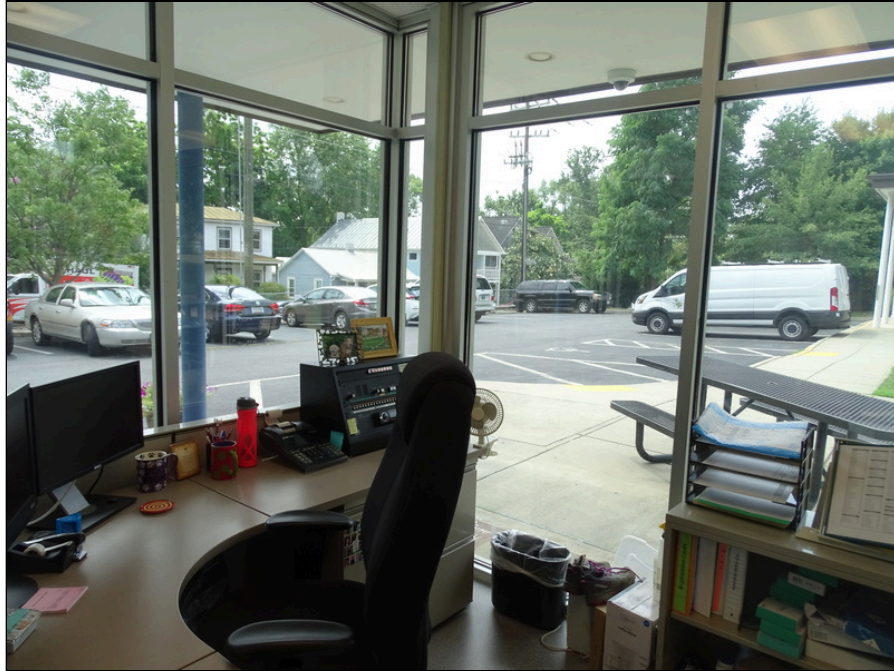
71 - Interior finishes office area

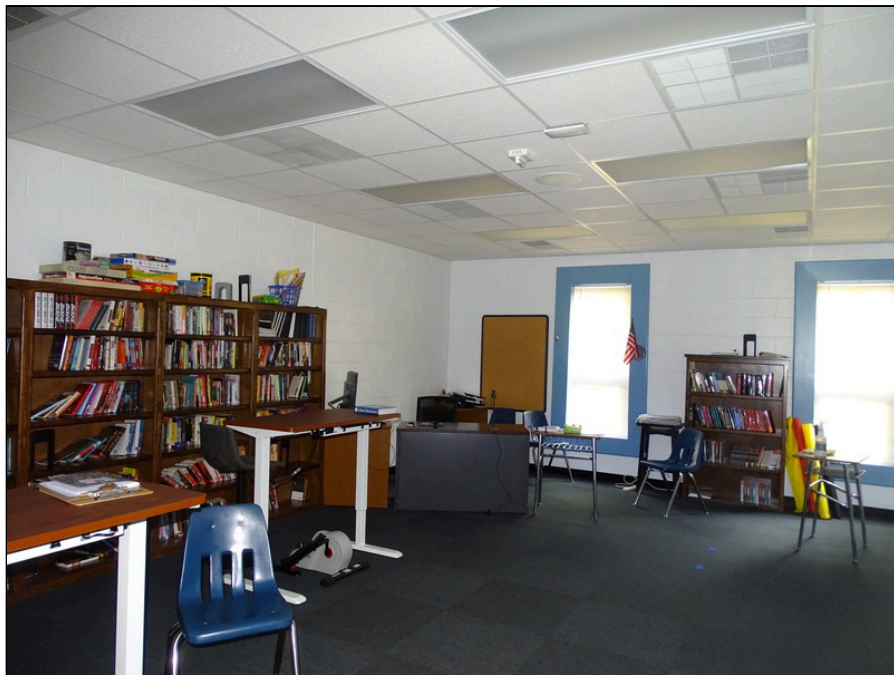
72 - Interior finishes classroom area

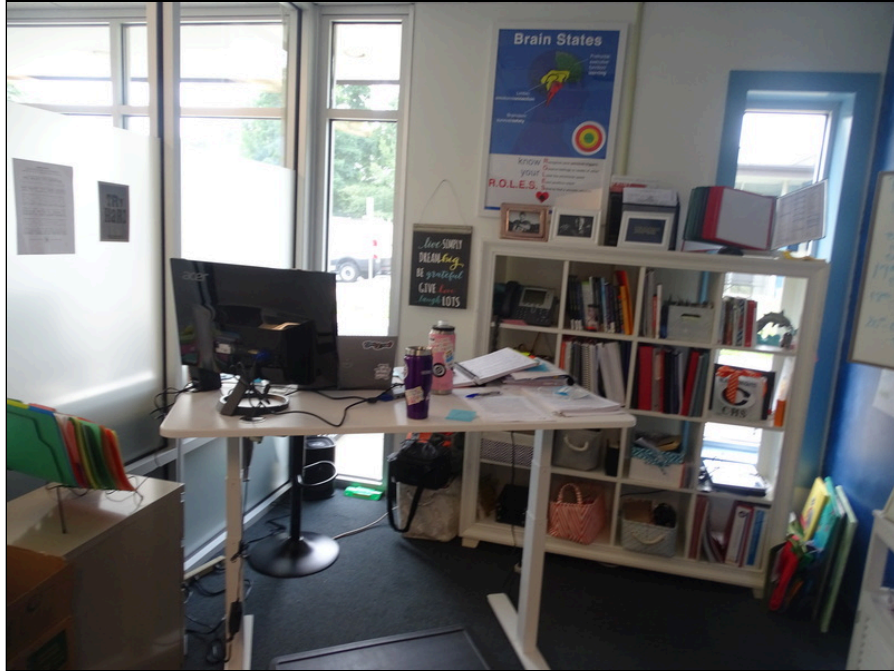
73 - Interior finishes office area

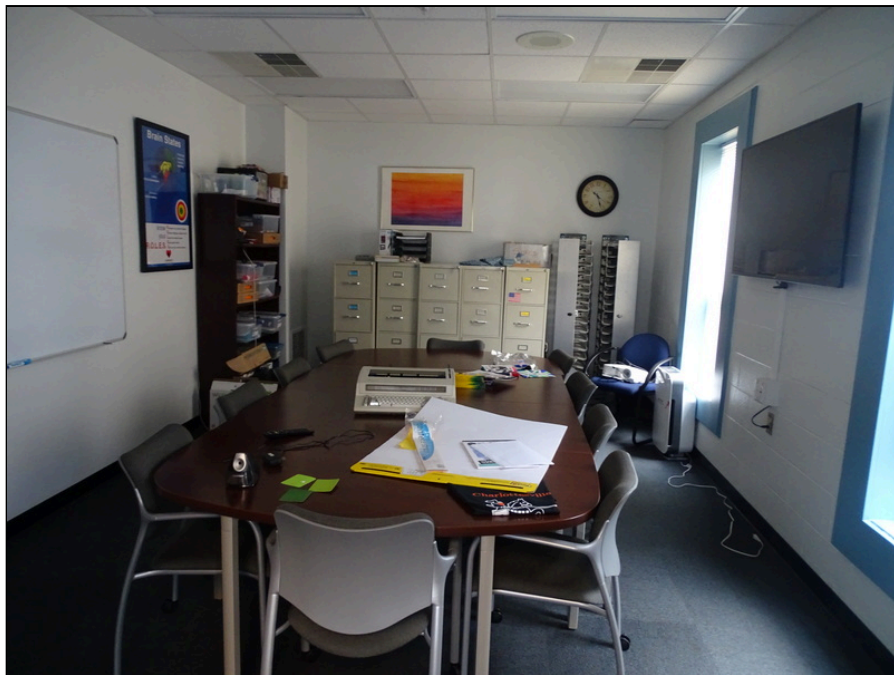
74 - Interior finishes meeting area

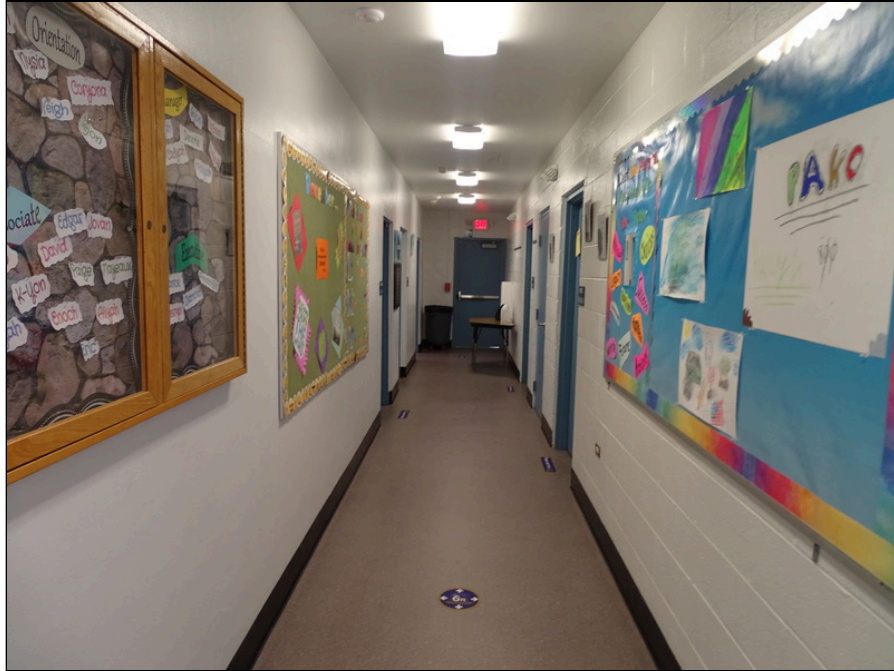
75 - Interior finishes corridor area

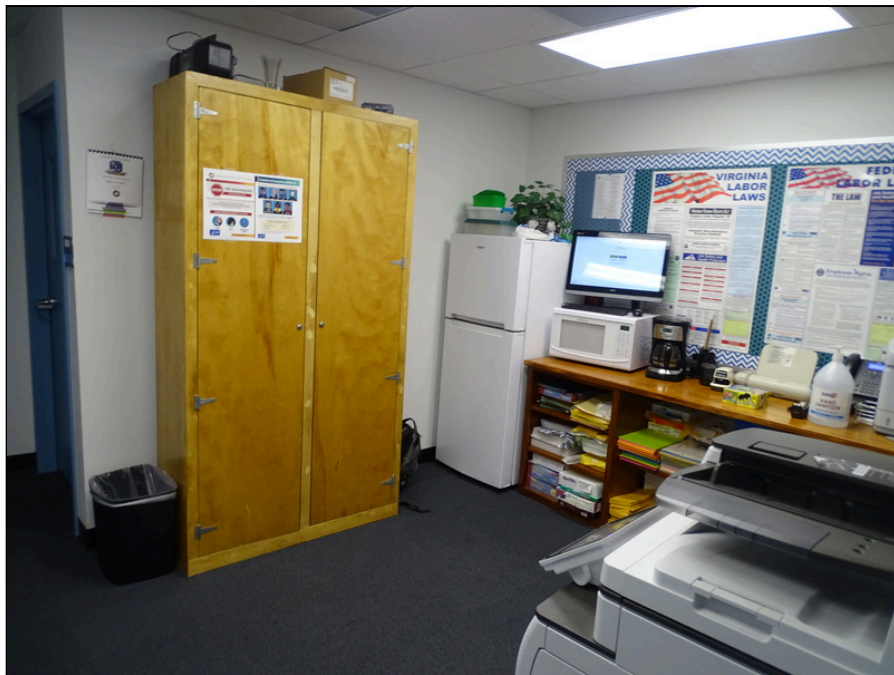
76 - Interior finishes kitchen area

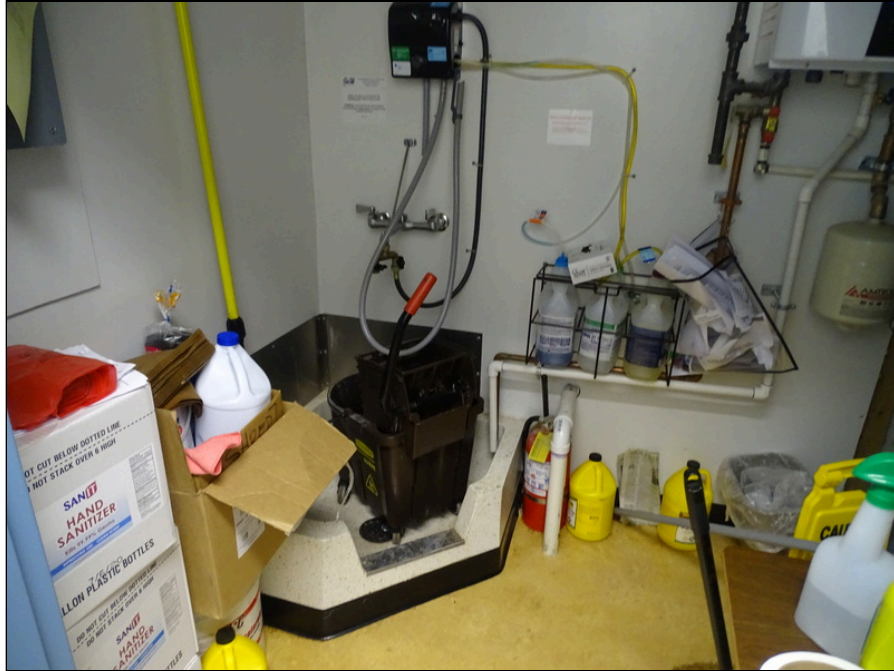
77 - Interior finishes utility room area
