LUGO MCGINNESS ACADEMY
341-(A) 11TH STREET NW
CHARLOTTESVILLE, VIRGINIA

ECS PROJECT NO. 46:6713

CITY OF CHARLOTTESVILLE - FACILITIES DEVELOPMENT

Reference: Facility Condition Assessment Report for Lugo McGinness Academy, 341-(A) 11th Street NW, Charlottesville, Virginia

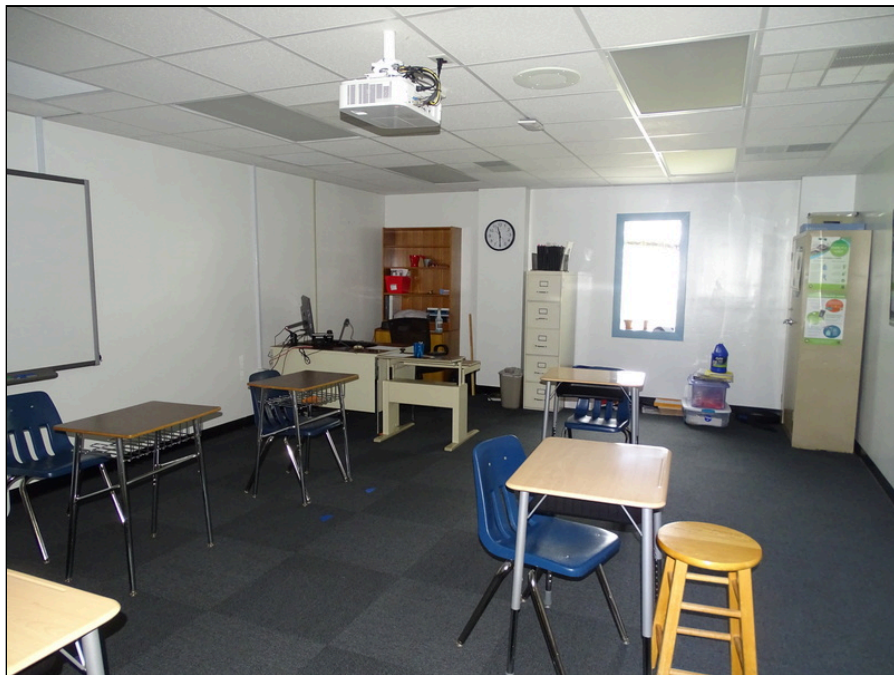
78 - Interior finishes classroom area

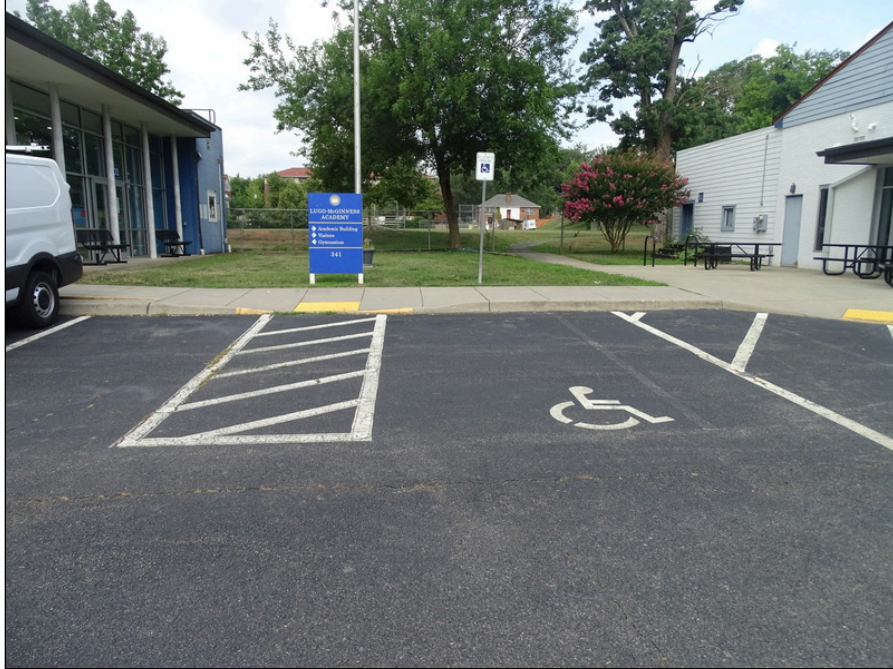
79 - Accessible parking space
