# Market Street Parking Garage Condition Assessment Report

SEPTEMBER 2021 | FINAL

Kimley-Horn and Associates, Inc.  
421 Fayetteville Street, Suite 600  
Raleigh, NC 27601

City of Charlottesville, Virginia  
305 4th Street NW  
Charlottesville, VA 22902

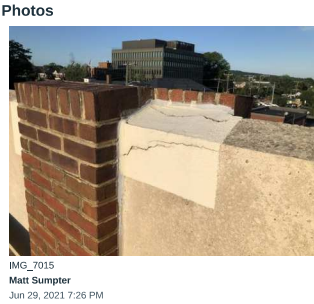
#11 Spall / Delamination / Exposed Rebar

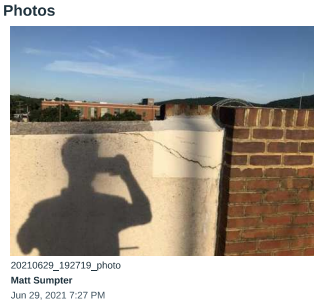
#12 Spall / Delamination / Exposed Rebar

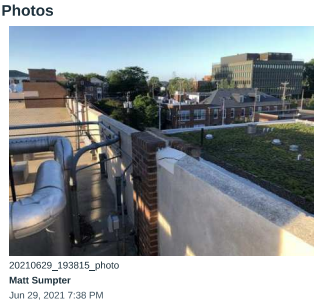
#21 Joint sealant / CJ

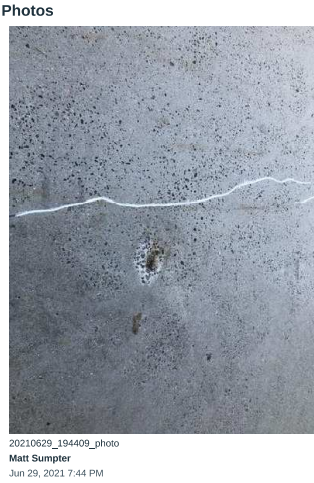
#26 Masonry

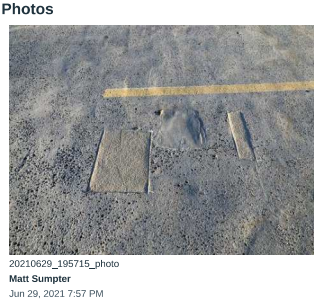
#35 Spall / Delamination / Exposed Rebar

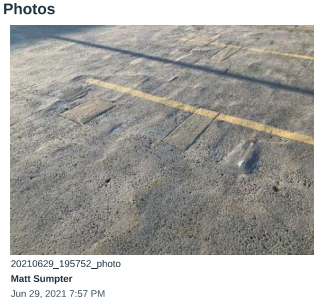
#36 Spall / Delamination / Exposed Rebar

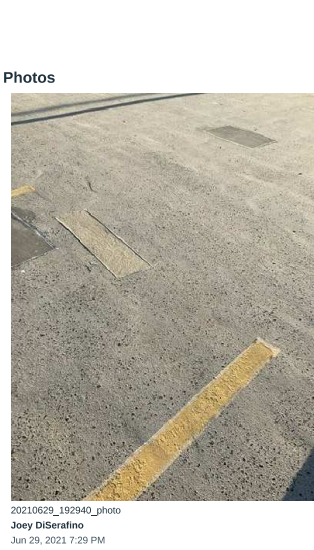
Delamination next to patch

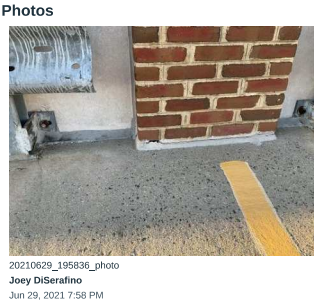
#131 Spall / Delamination / Exposed Rebar

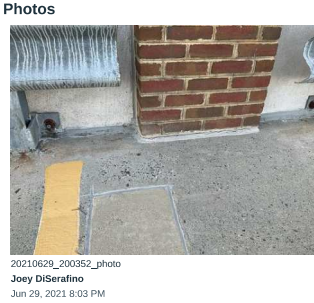
#134 Crack

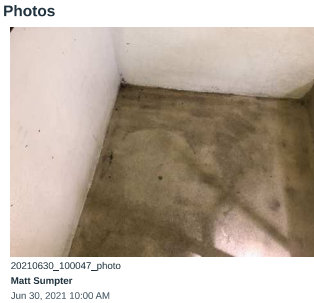
#300 Spall / Delamination / Exposed Rebar

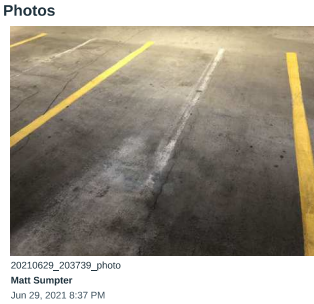
#71 Expansion joint

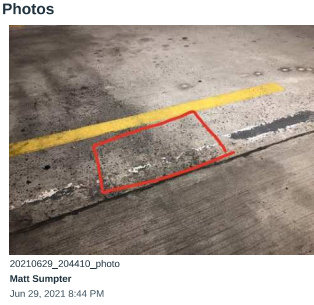
#76 Spall / Delamination / Exposed Rebar

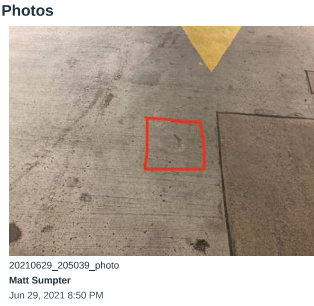
#81 Spall / Delamination / Exposed Rebar

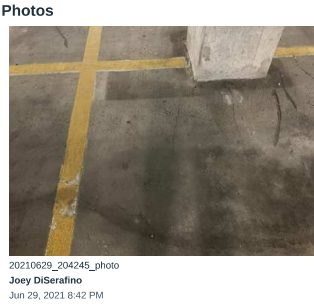
#155 Crack

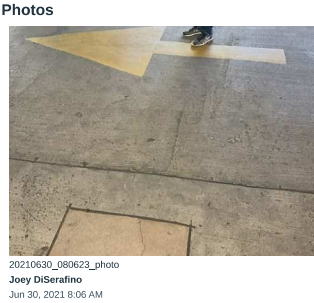
#249 Spall / Delamination / Exposed Rebar

Description  
Next to patch

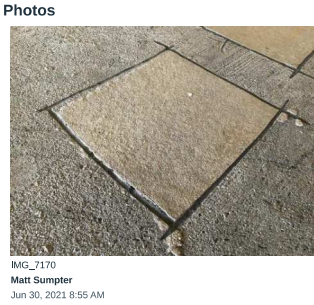
#199 Joint sealant / CJ

Description  
Old sealant in many previous spall repairs, typical

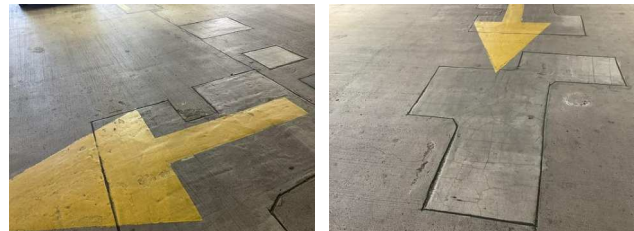
#277 Spall / Delamination / Exposed Rebar

Description  
Misc areas around patches and a couple failed patches

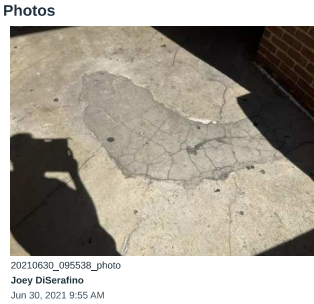
#307 Crack

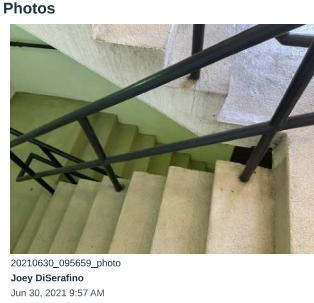
Sheet  
Level 2

#312 Spall / Delamination / Exposed Rebar

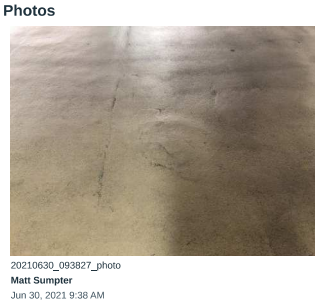
#238 Traffic coating

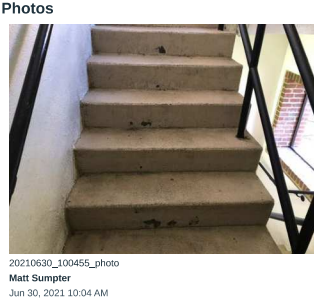
Level 1

#289 Crack

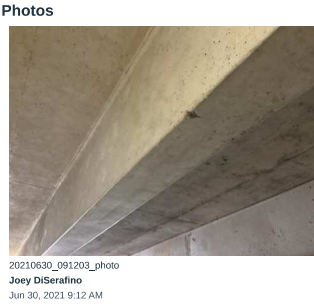
#291 Crack
