MCGUFFEY ART CENTER  
201 2ND STREET NW  
CHARLOTTESVILLE, VIRGINIA

ECS PROJECT NO. 46:6713

CITY OF CHARLOTTESVILLE - FACILITIES DEVELOPMENT

Reference: Facility Condition Assessment Report for McGuffey Art Center, 201 2ND Street NW,  
Charlottesville, Virginia

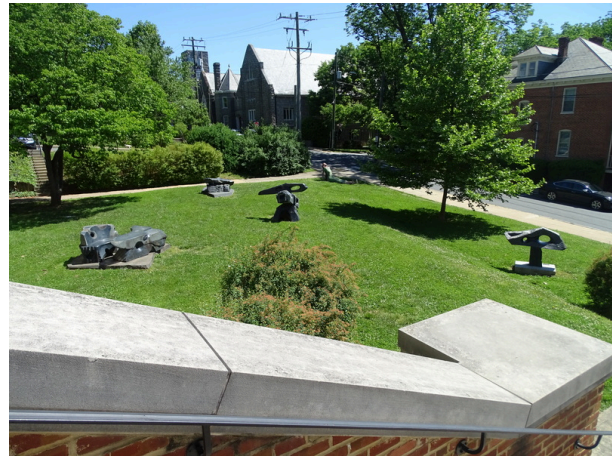
Typical landscaping

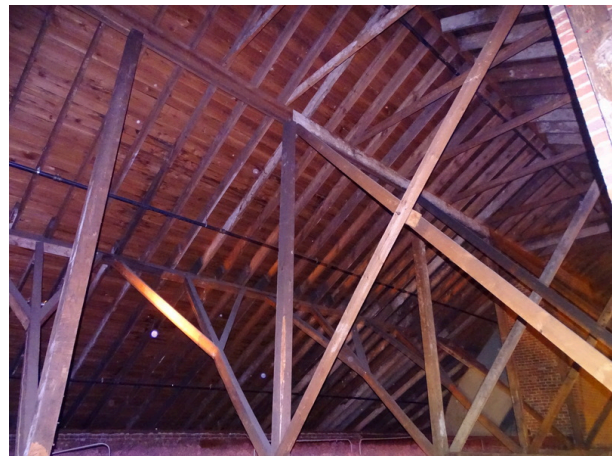
Wood roof framing

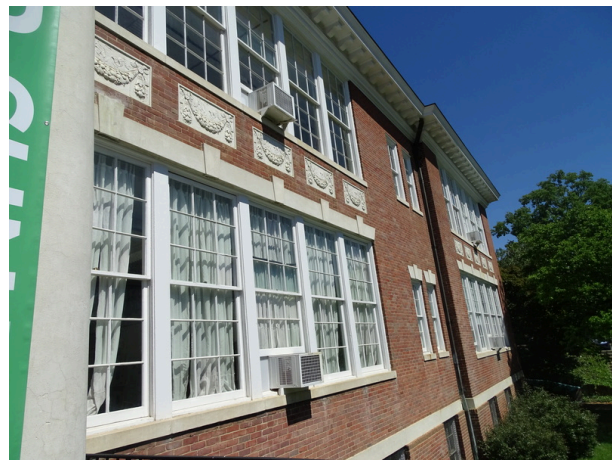
Typical exterior east side

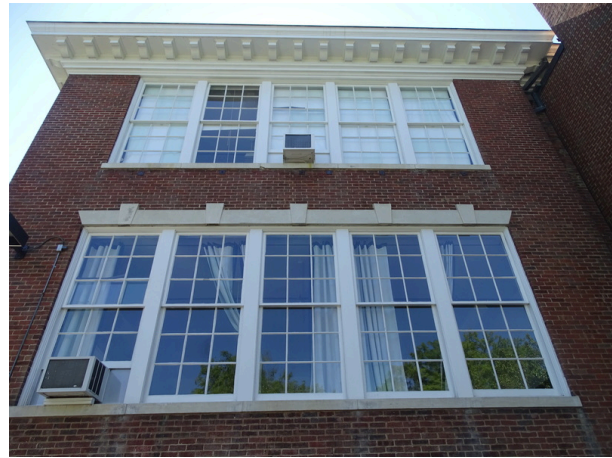
Typical exterior window units - note recent restoration

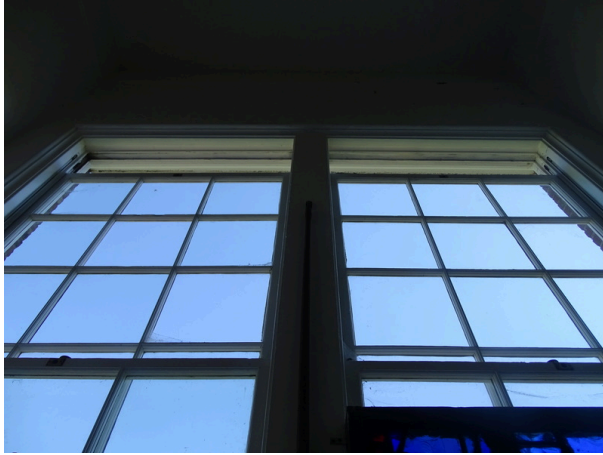
Typical exterior window units - note recent restoration

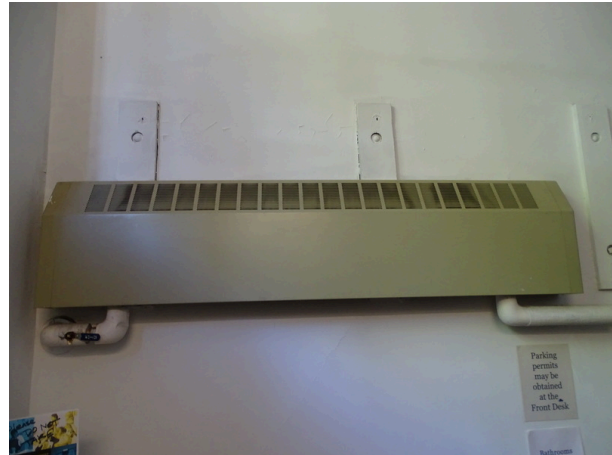
Typical radiator unit

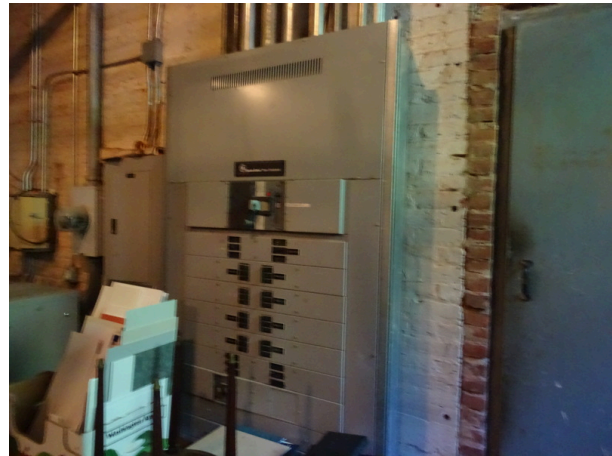
Main electrical switchgear located in the main utility room

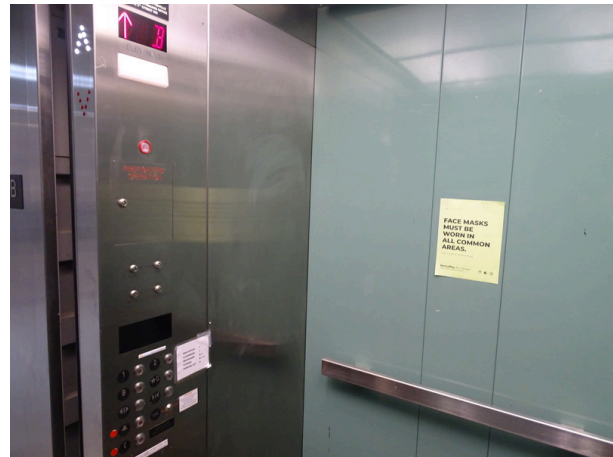
Elevator cab interior

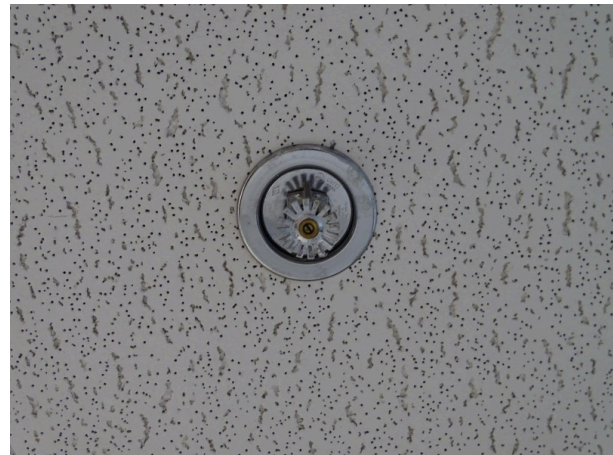
Typical sprinkler head

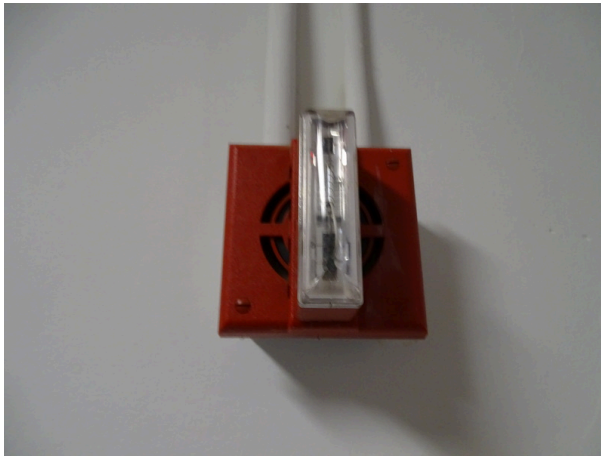
Typical fire alarm strobe and bell

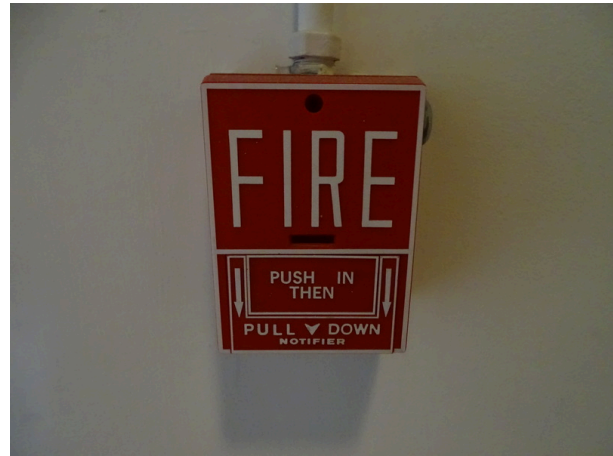
Typical fire alarm pull down station

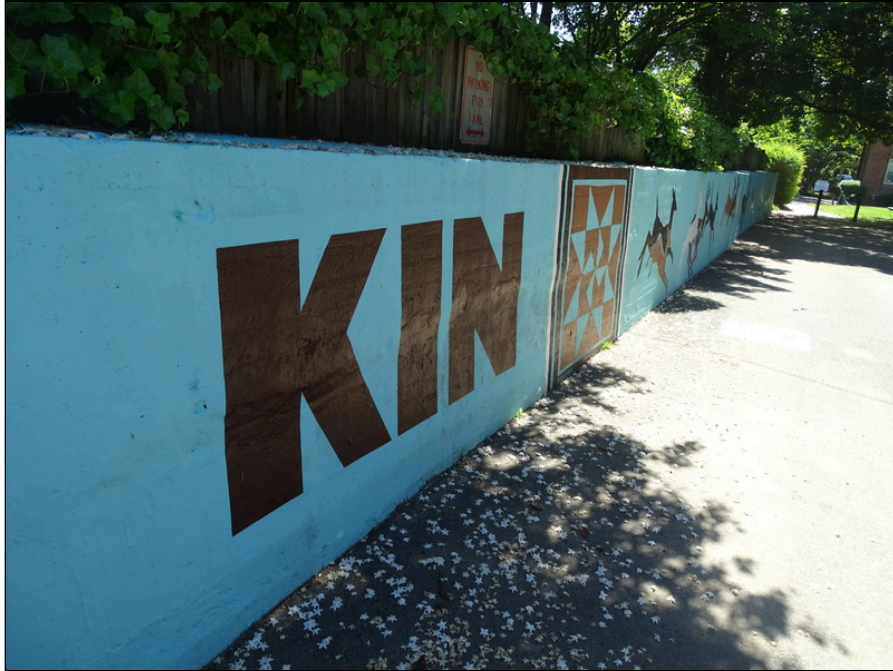
13 - Typical concrete retaining wall

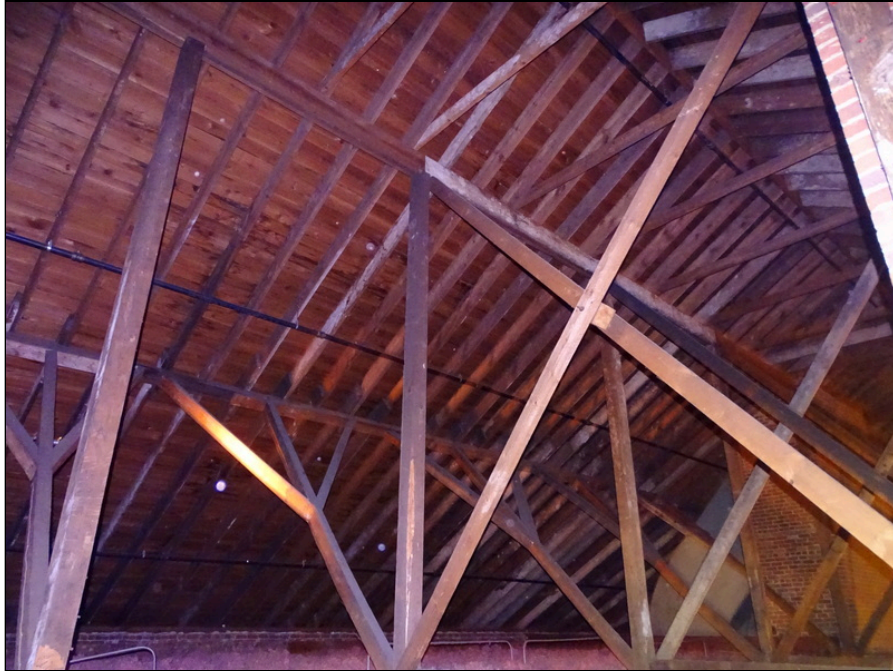
15 - Wood roof framing

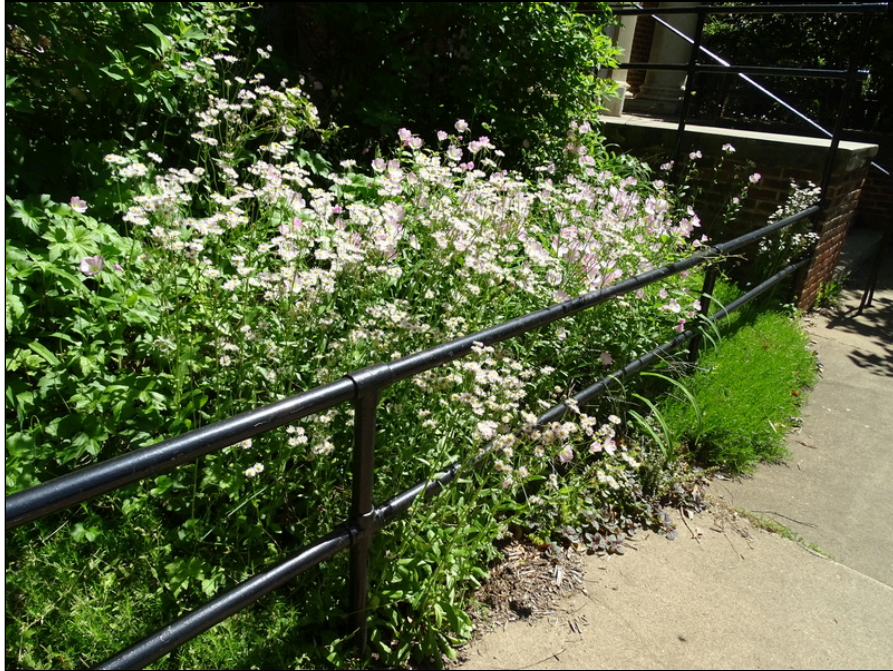
17 - Typical landscaping

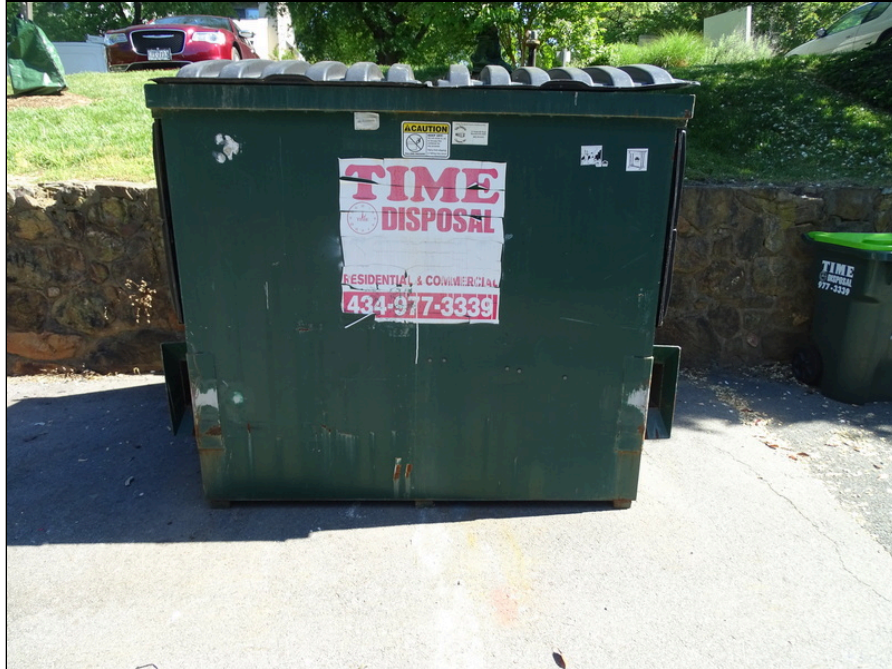
19 - Dumpster area at northwest end of the site

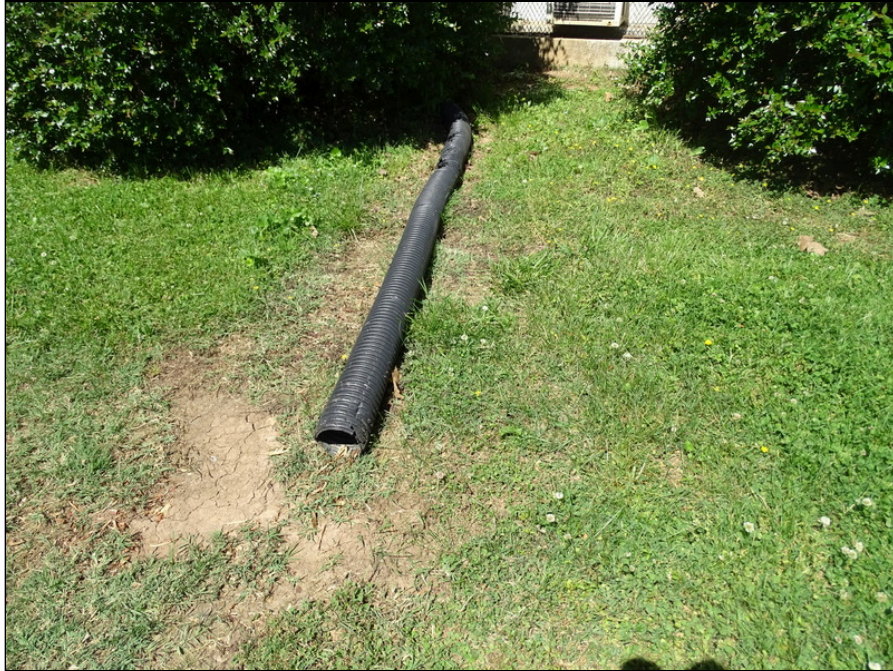
21 - Typical Typical downspouts

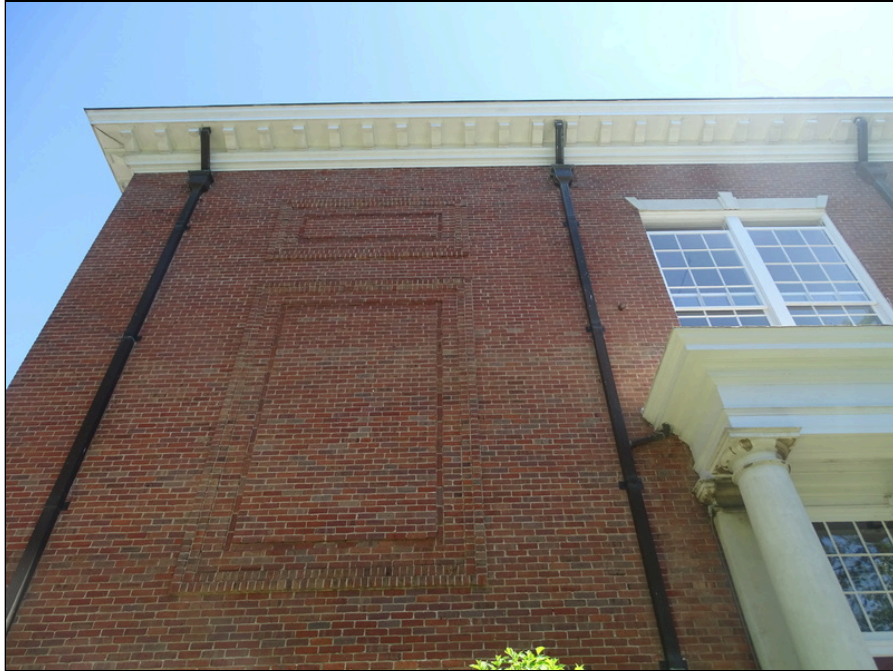
25 - Typical exterior wall

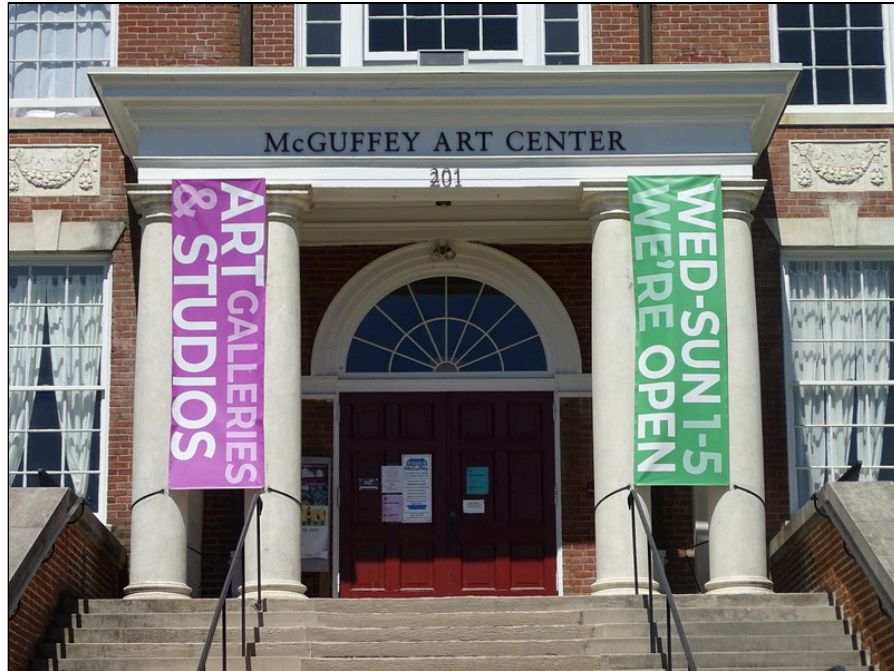
31 - Wood doors at main entrance at the east side of the building

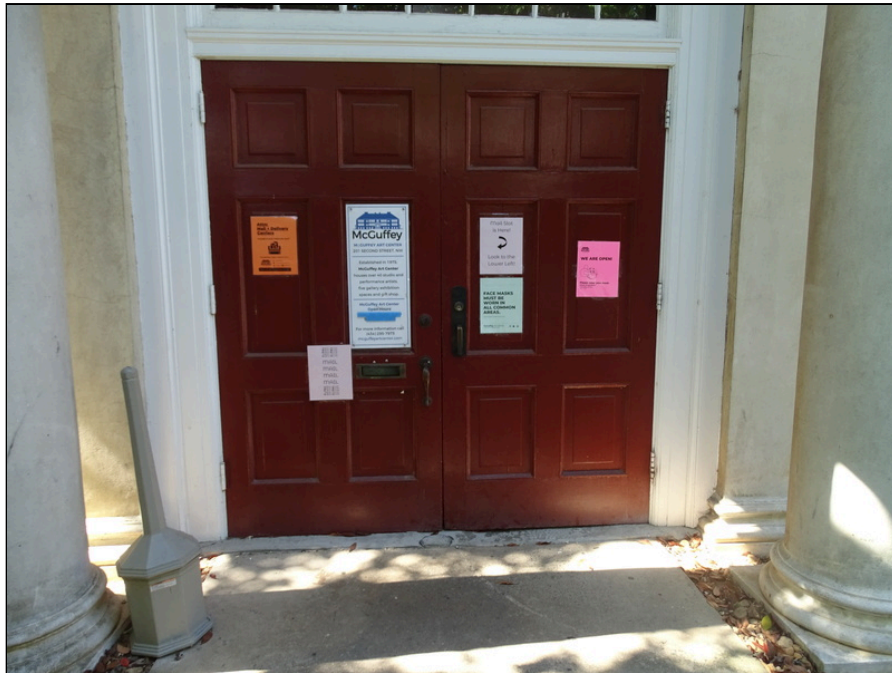
32 - Wood personnel doors at the north side of the building

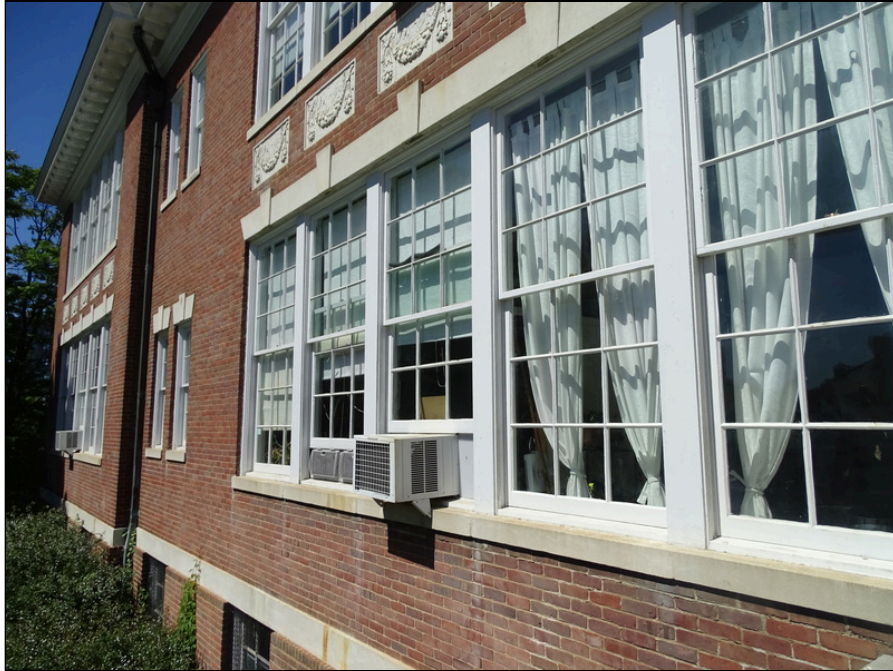
33 - Typical exterior window units - note recent restoration

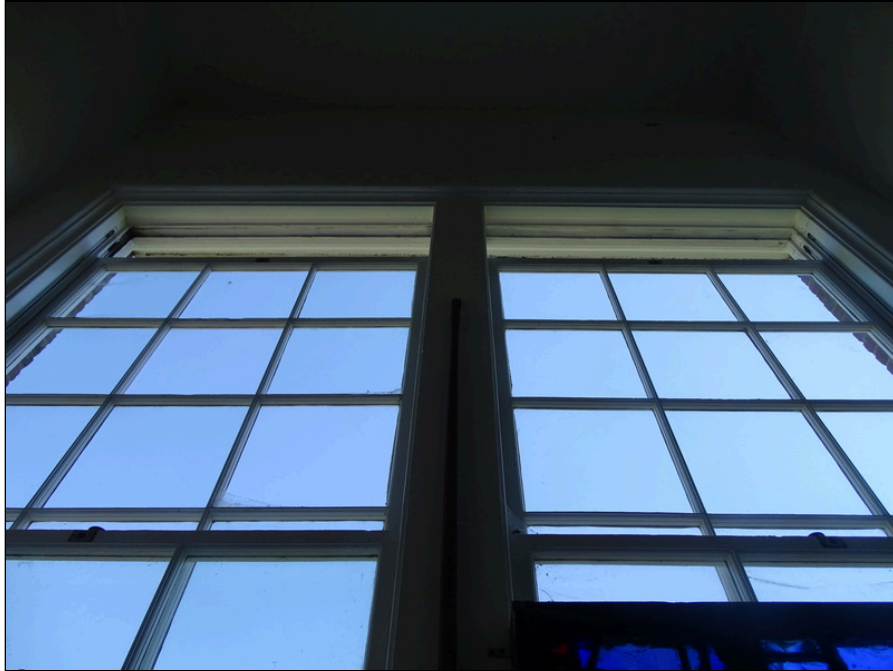
35 - Typical exterior window units - note recent restoration

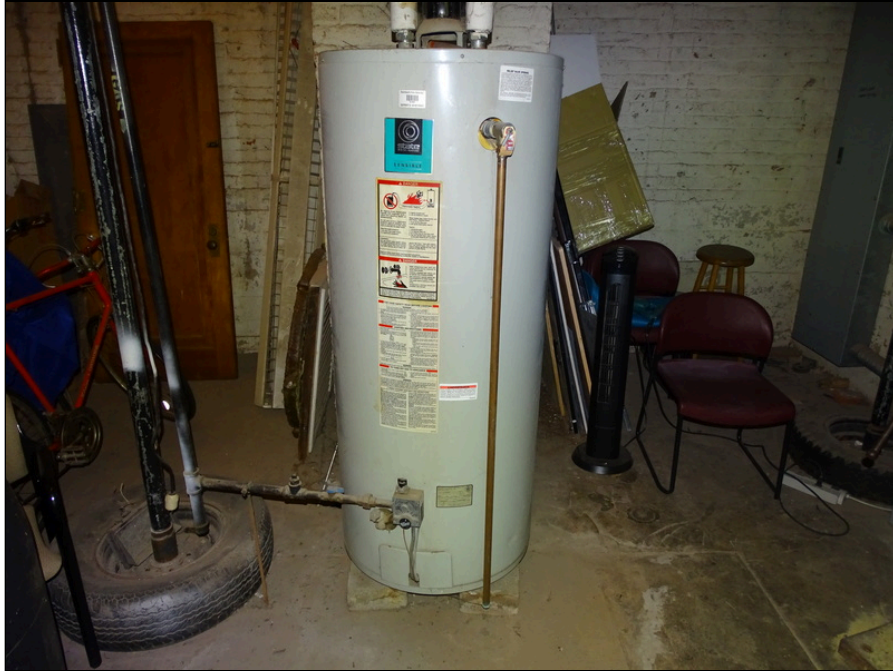
43 - Hot water storage tank

3.4.1.2 Domestic Hot Water Production																													
REPLACE WATER HEATER	12	11	1	1	EA	\$1,000.00	\$1,000	100%	\$1,000																				\$1,000

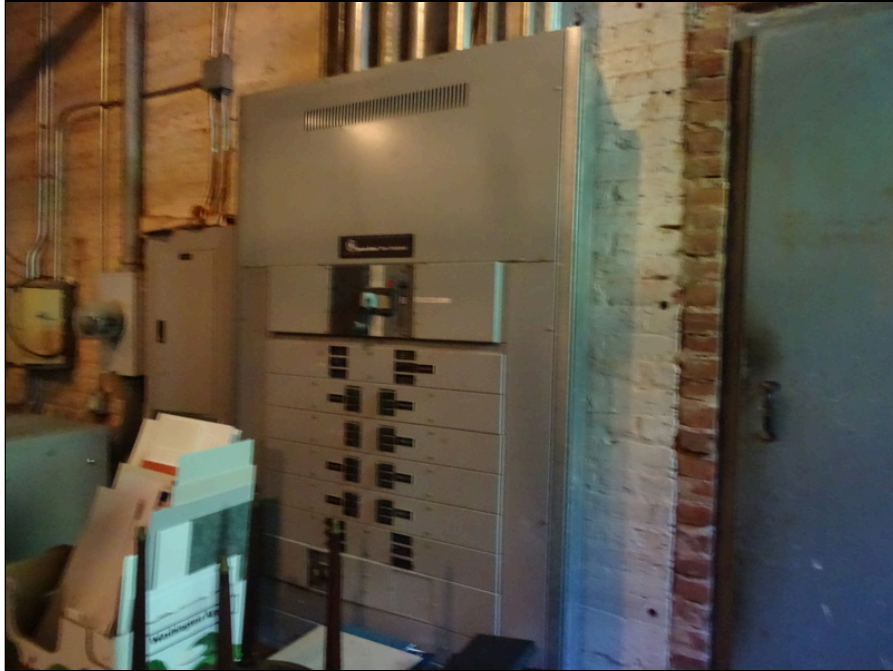
49 - Main electrical switchgear located in the main utility room

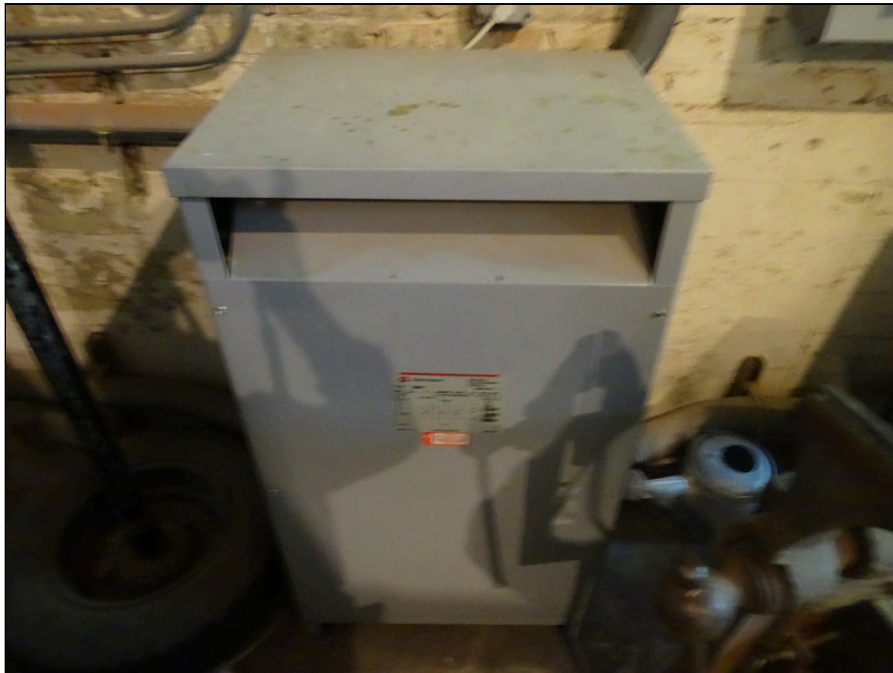
50 - Building transformer located in main utility room

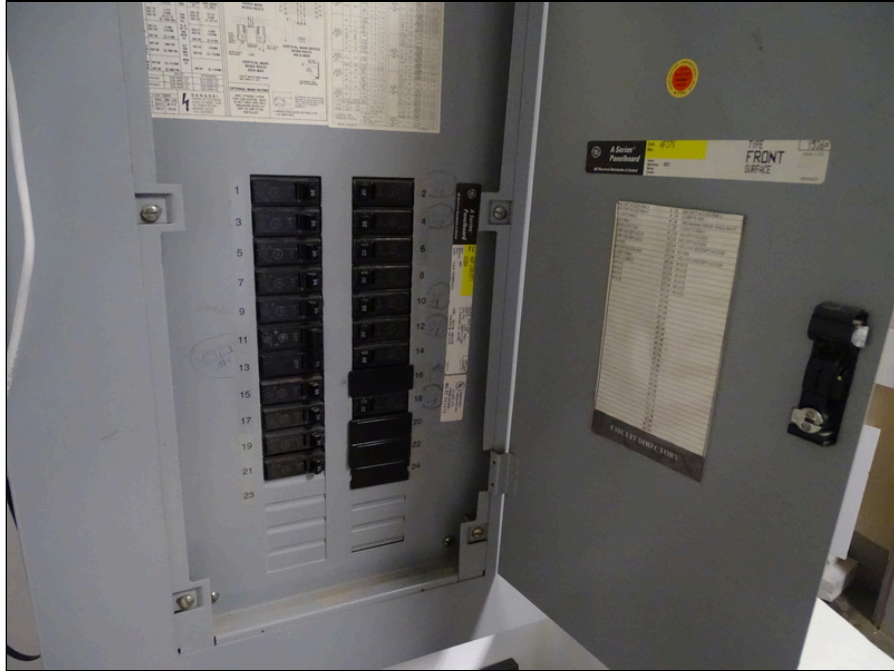
51 - Typical circuit breaker panel

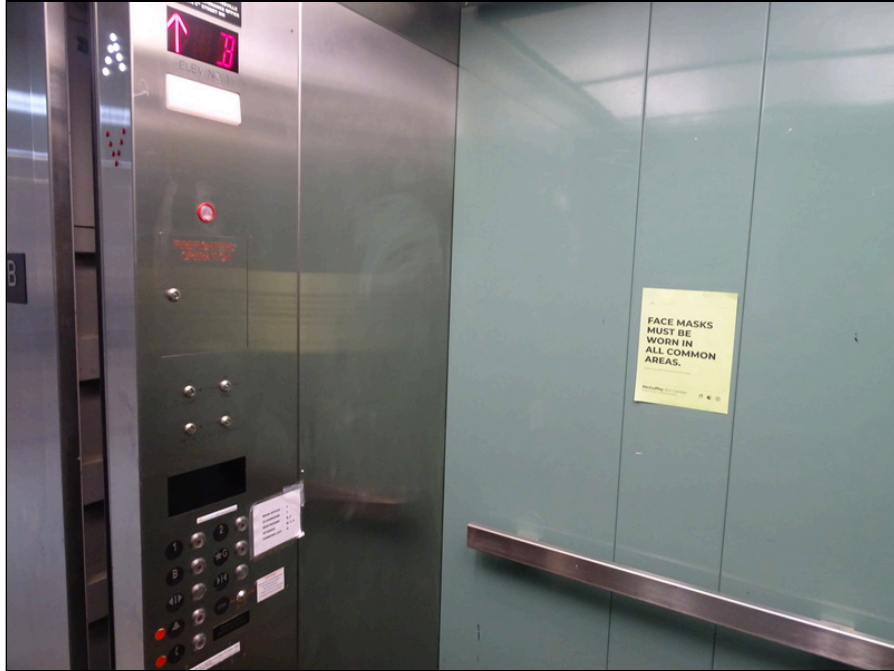
53 - Elevator cab interior

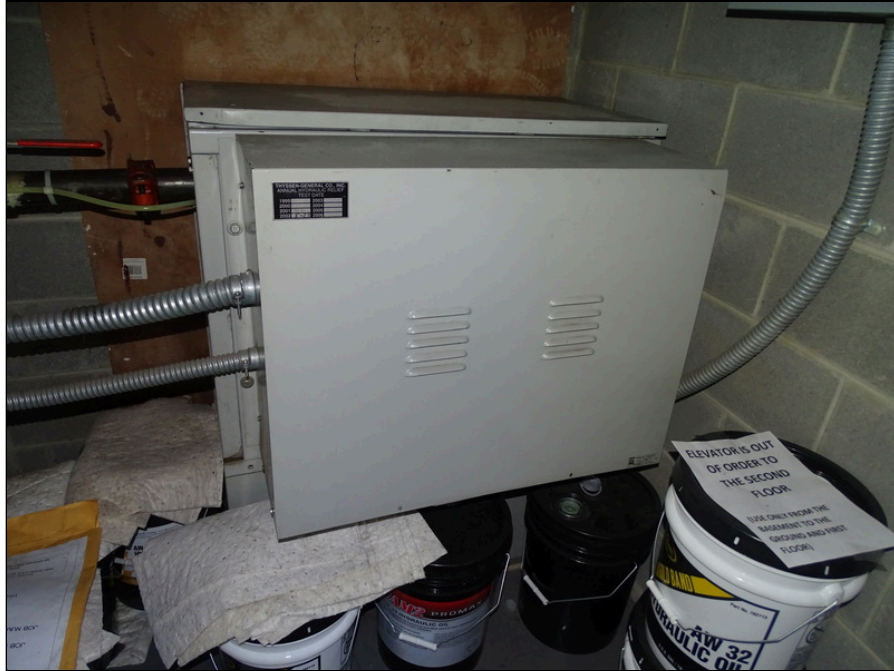
55 - Elevator machinery and controls

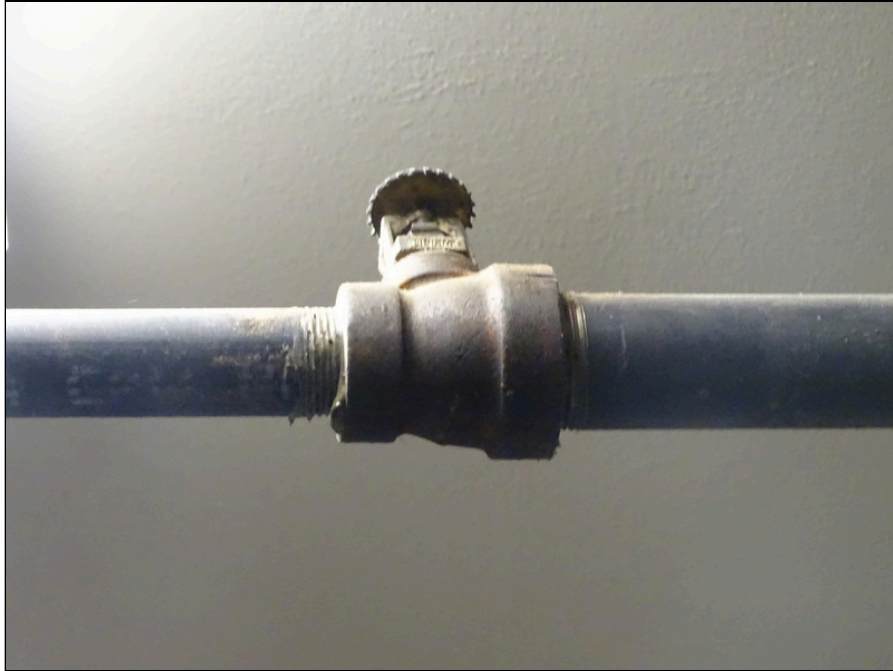
57 - Typical sprinkler pipe and sprinkler head

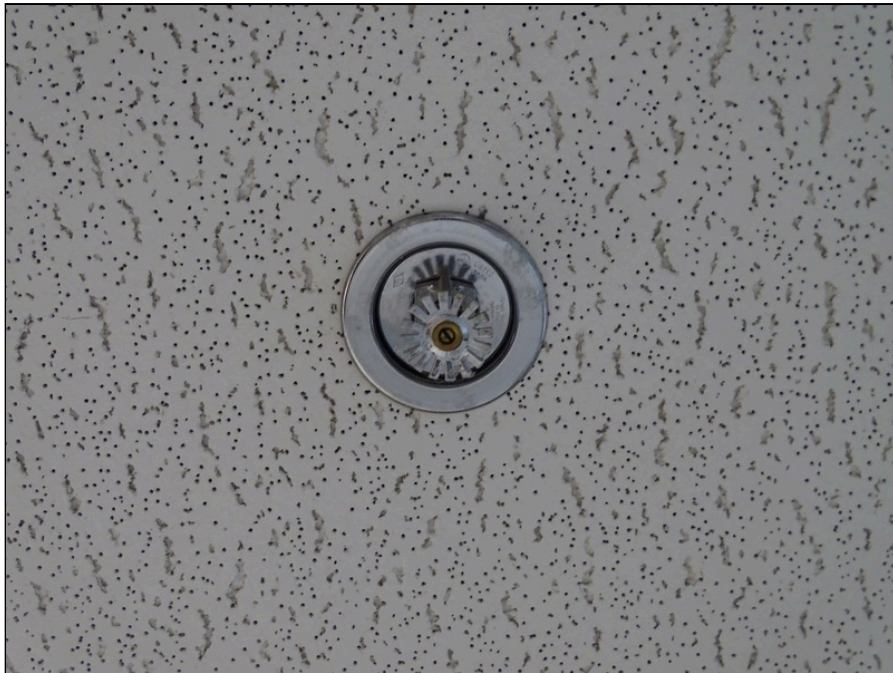
58 - Typical sprinkler head

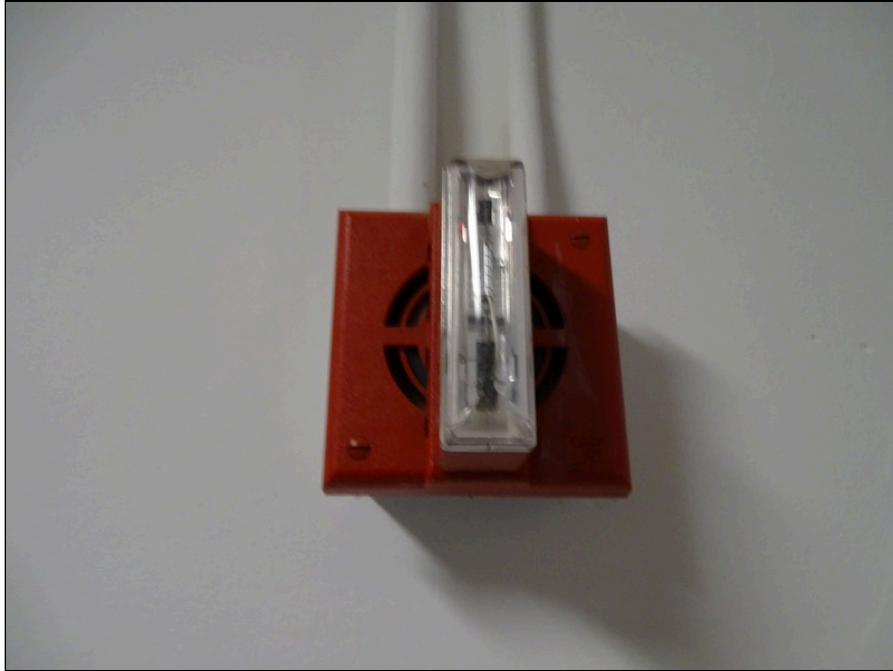
59 - Typical fire alarm strobe and bell

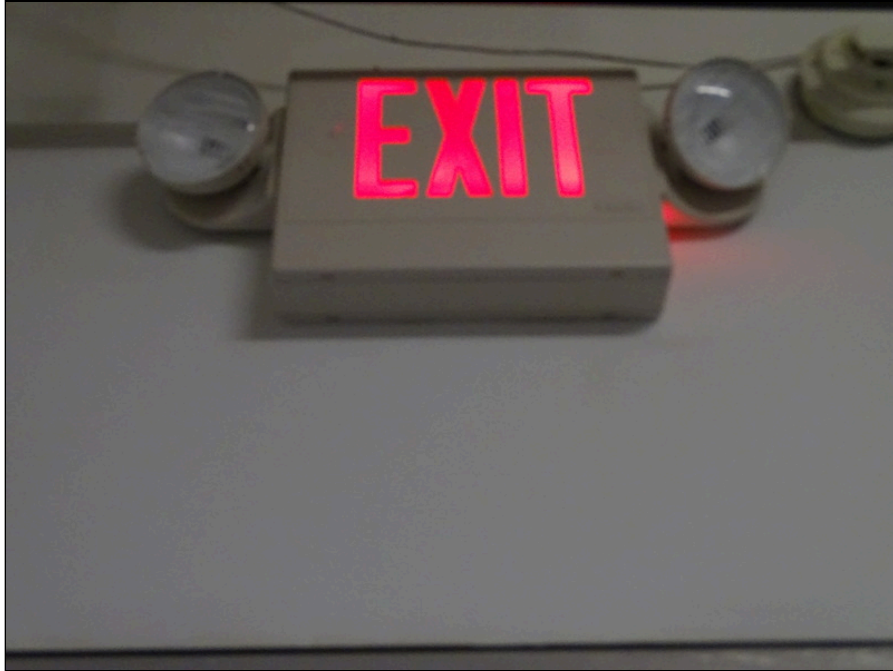
61 - Typical exit sign and emergency lighting

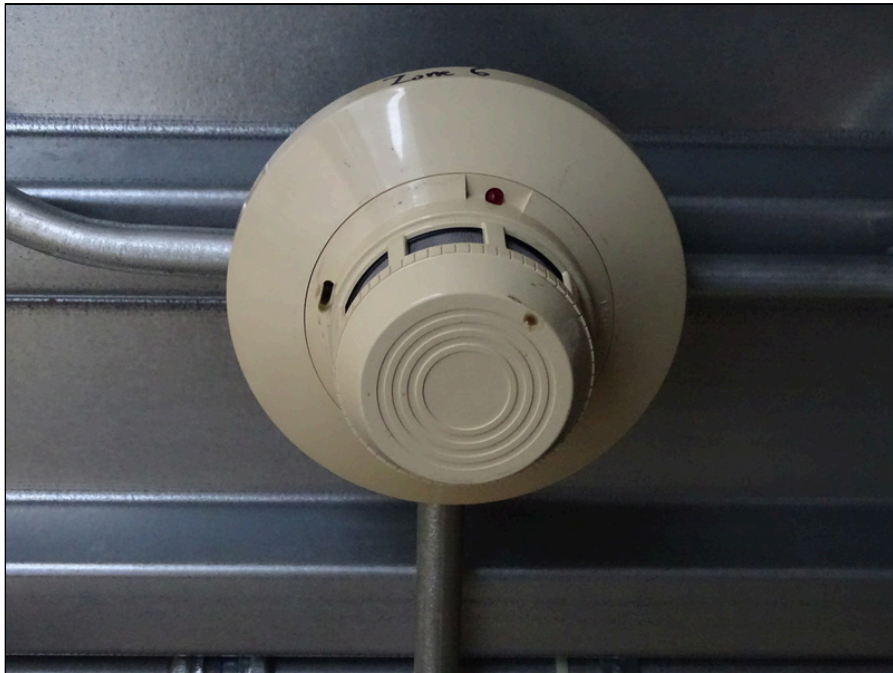
62 - Typical smoke detector
