MCINTIRE BUILDING
200 2ND STREET NE
CHARLOTTESVILLE, VIRGINIA

ECS PROJECT NO. 46:6713

CITY OF CHARLOTTESVILLE - FACILITIES DEVELOPMENT

Reference: Facility Condition Assessment Report for McIntire Building, 200 2nd Street NE,
Charlottesville, Virginia

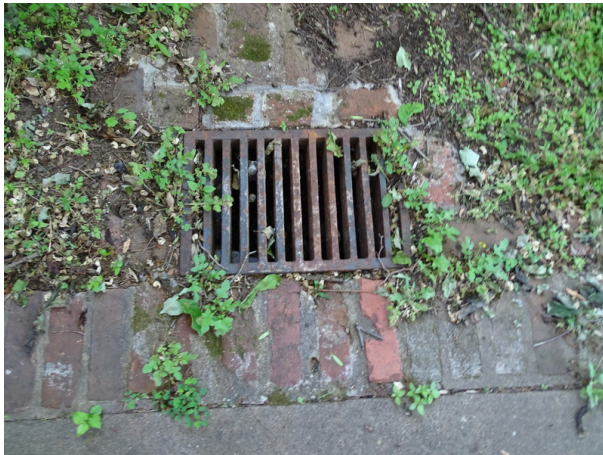
Yard inlet drainage

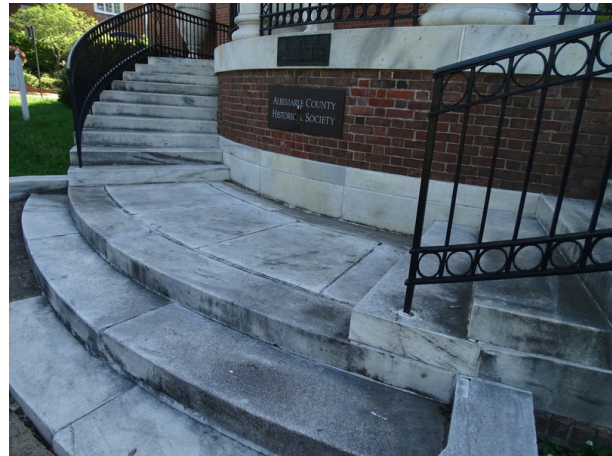
Exterior steps and ramps are located on the east and west side of the building, respectively. The steps and ramps were observed to be in generally fair condition. The handrails adjacent to the steps and ramps were observed to be in generally good condition.

Marble steps at the west entrance

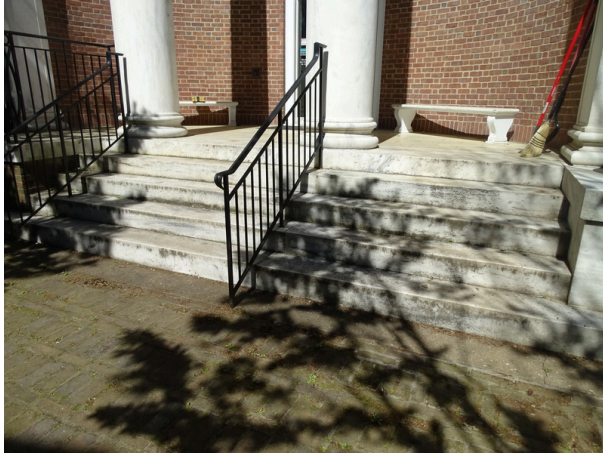
Marble steps at east entrance

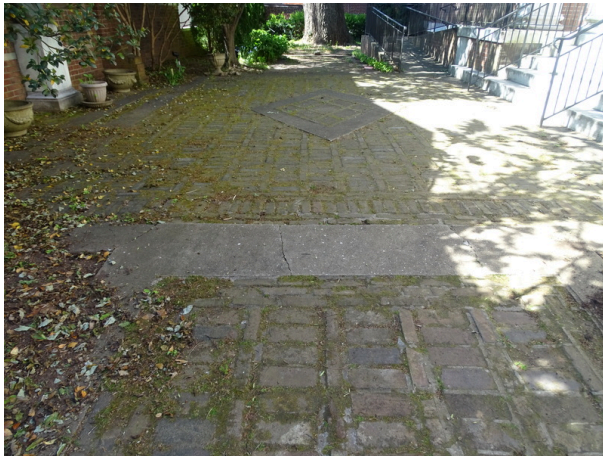
Brick pavers and concrete sidewalk

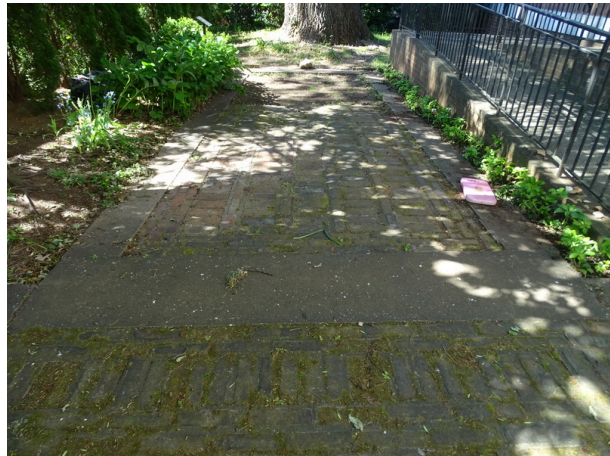
Brick pavers and concrete sidewalk

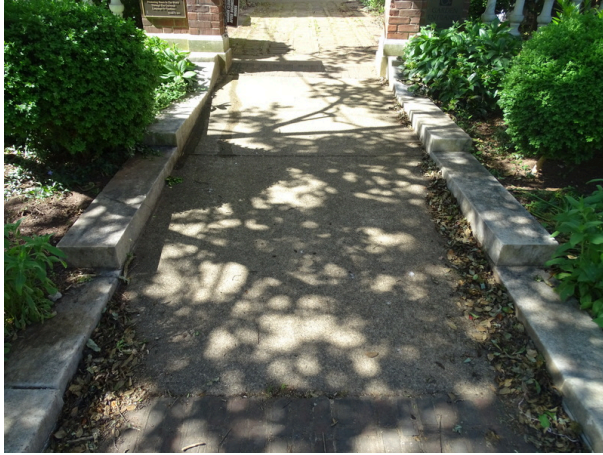
Concrete sidewalk and brick pavers at east side
of the site

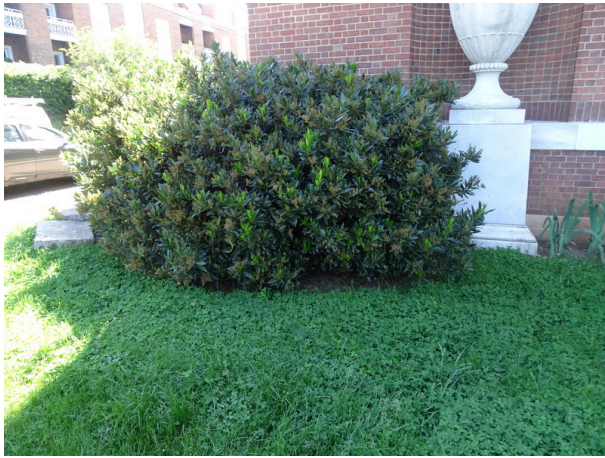
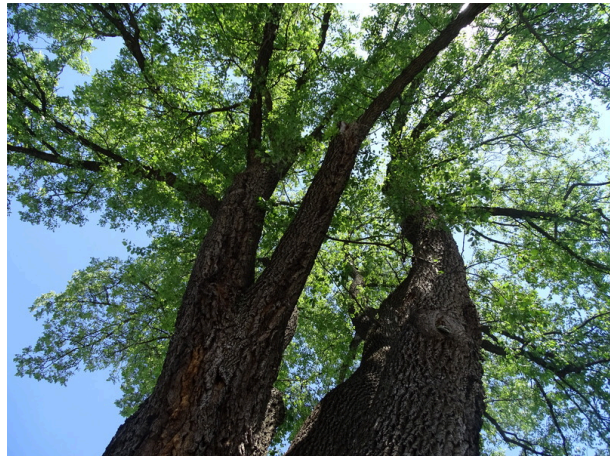
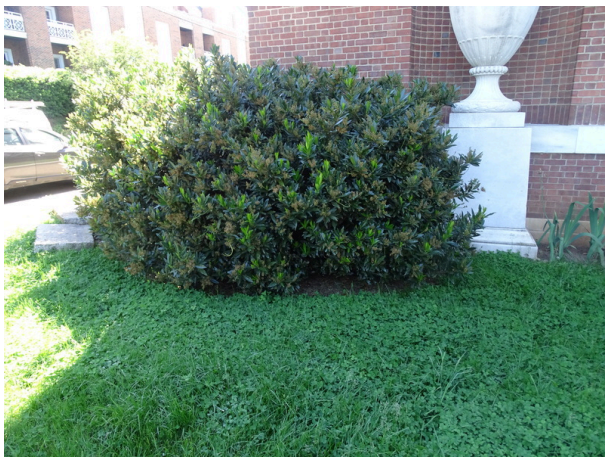
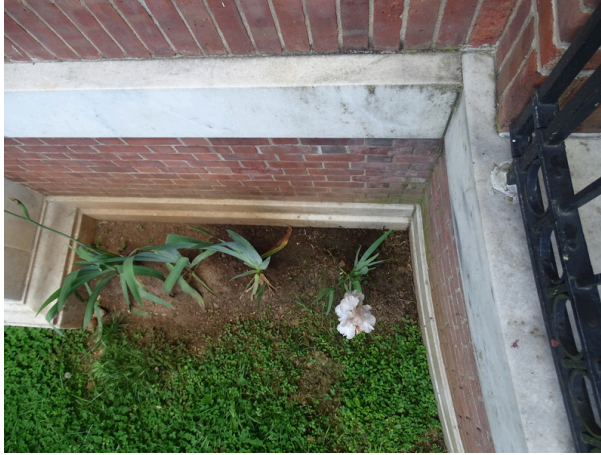
The landscaping consists generally of mature trees, and small shrubs and grassed areas around the site. The landscaping was observed to be in generally good condition.

Typical landscaping

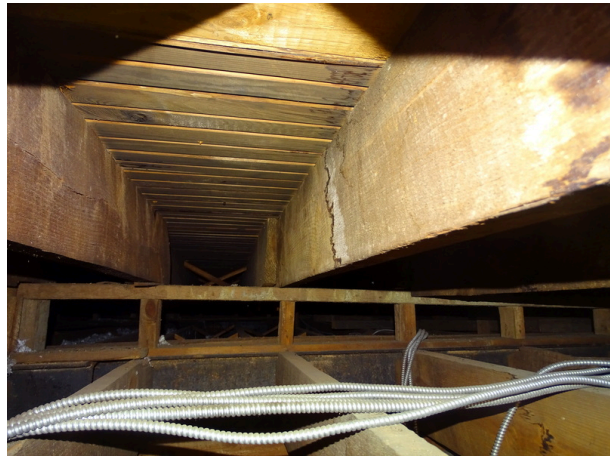
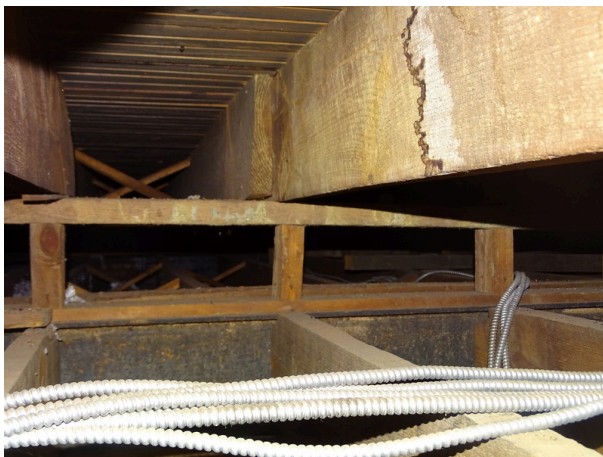
The structure of the building consists of Load bearing brick walls supported by steel beams with wood framing for partial second floor and roof. The structural frame of the building was generally in good condition.

Structure framing

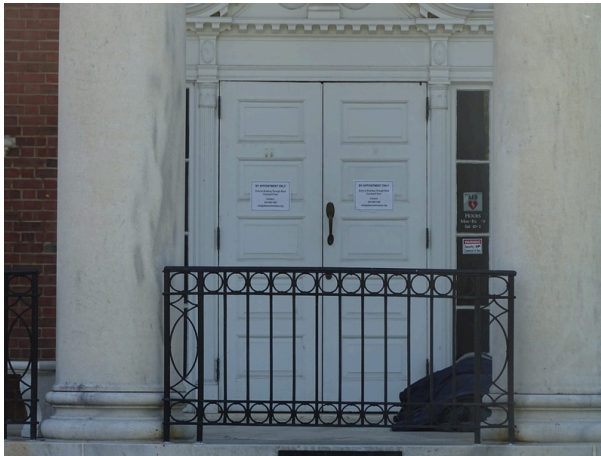
The main entrance is a Wood door. The east entrance door is a glass door. There is also a wood door on the south side of the building. The entrance doors were generally in good condition. Exterior doors typically have an expected useful life of 20 to 30 years.

Wood door at west side of the building

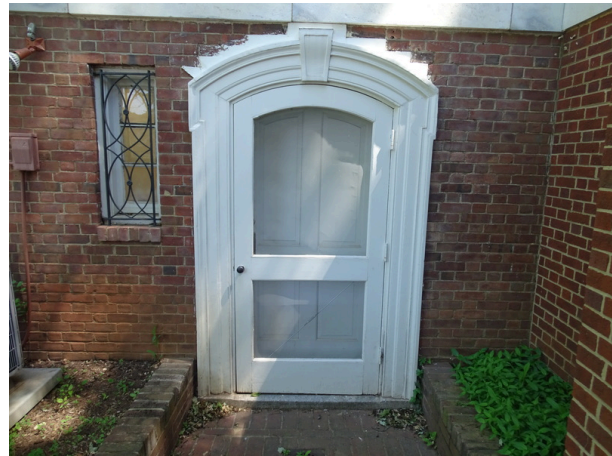
Typical exterior door

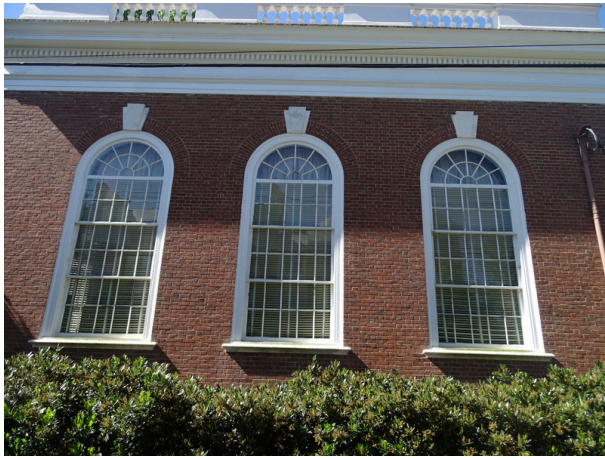
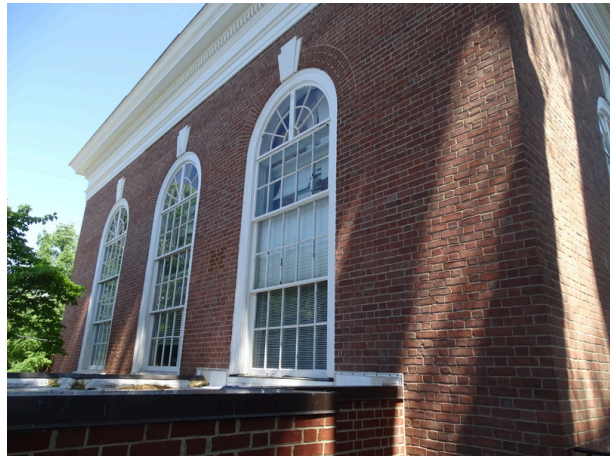
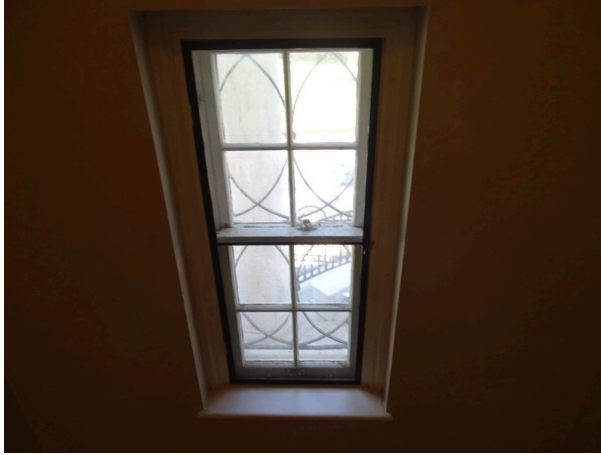
The window system for the building primarily consists of Wood-framed single-pane window units. The windows were generally in fair condition. The windows can be considered historical in nature. Based on the historical requirements, and given the similarity between the McIntire windows and those at the McGuffey Art Center, we recommend the same steam treatment as the McGuffey Art Center windows received during the 2017 renovation.

Typical exterior window

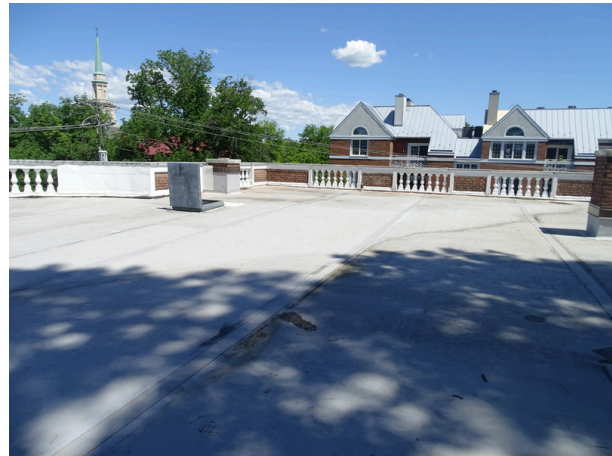
Roofing system looking south

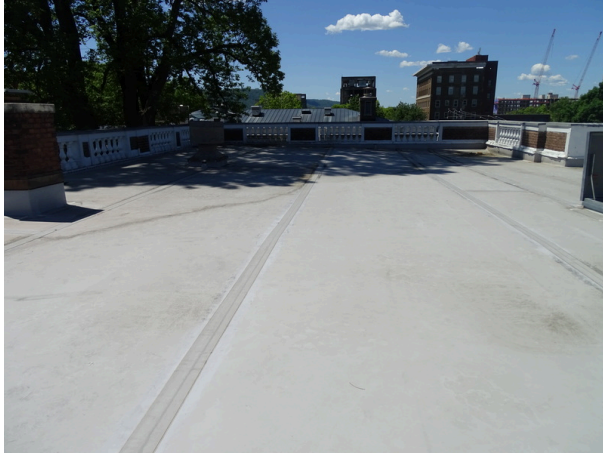
roofing system Roofing system single-ply sheet
membrane

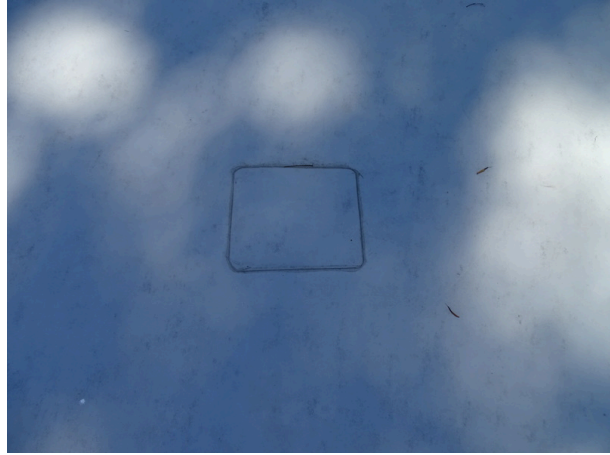
Roofing system - note patching

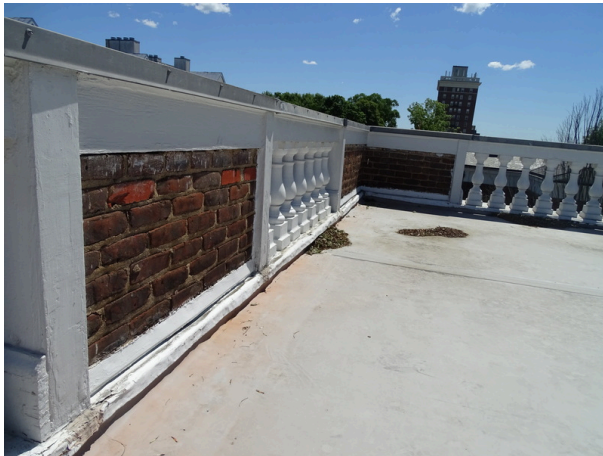
Roofing system - note needed maintenance

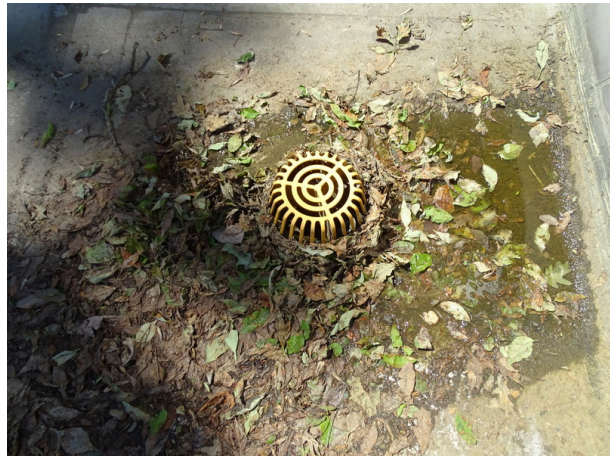
Drainage for the roofing system is provided by interior drains. The drainage was observed to be in generally fair condition. Maintenance of the drains is needed to clear fall leaves from clogging the drains. The parapet walls consist of brick with wood trim and spindles with metal flashing. The parapet walls were capped with metal coping. The parapet walls were observed to be in generally fair condition. We recommend the parapet wall flashing and capping be replaced during the next roof replacement.

Typical internal roof drain - note maintenance
needed

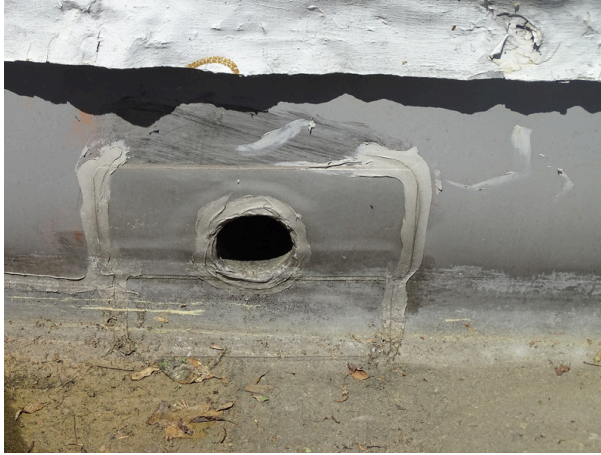
Parapet wall and through wall drain - note
patching

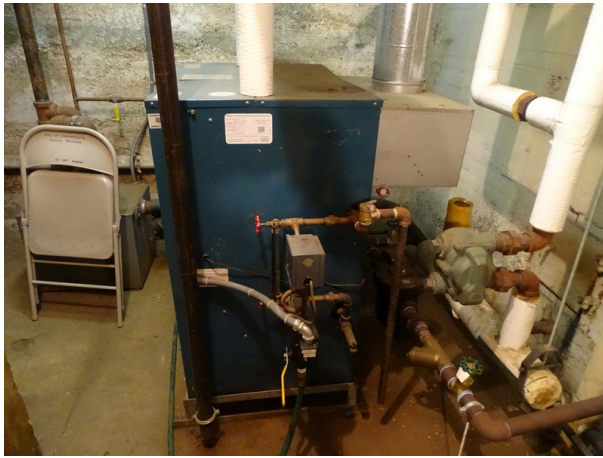
Boiler located in basement

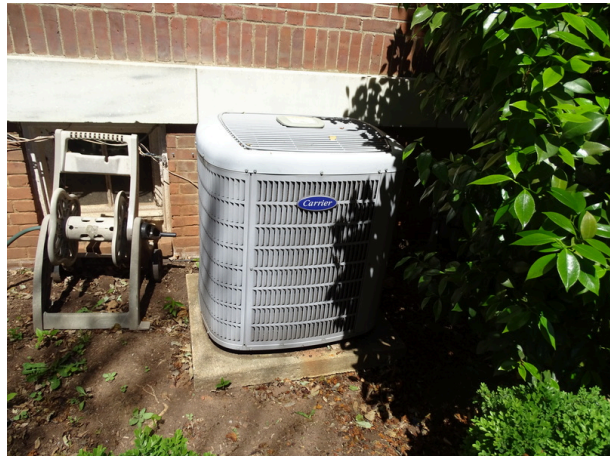
Condenser located at exterior ground level

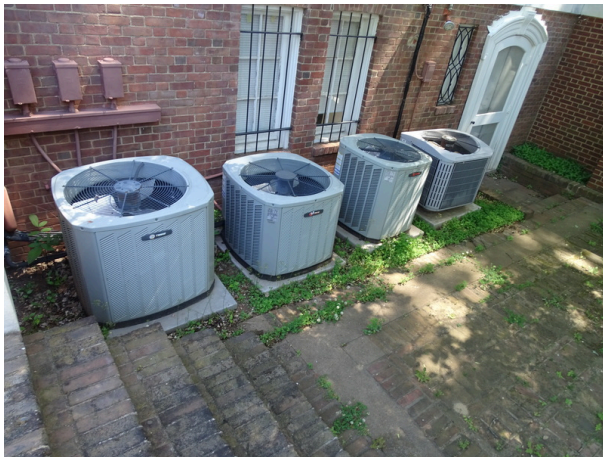
Condensers and heat pump located at exterior ground level

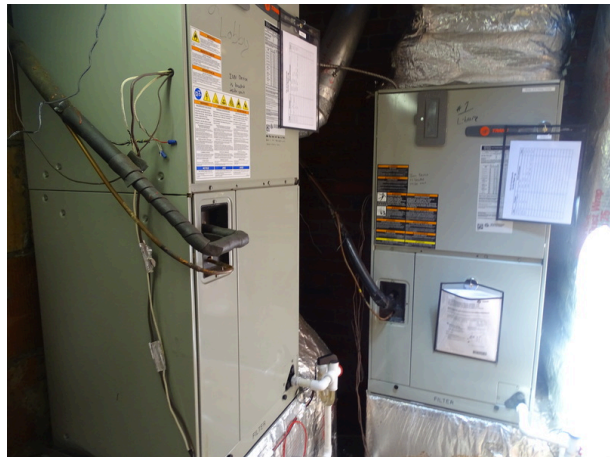
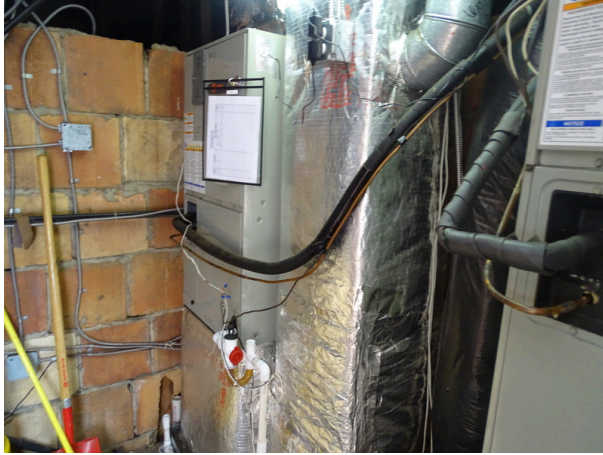
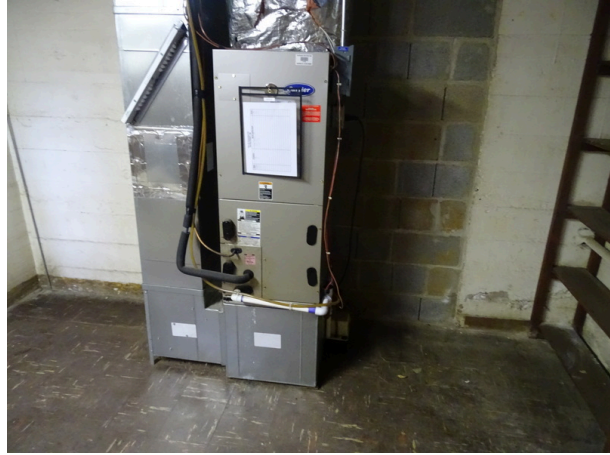
The air handlers are located in basement, mechanical room, storage room, closet room, and second floor attic space. The air handlers were manufactured by Trane and Carrier ranging from 2009 to 2011 corresponding to the exterior equipment ages. The expected useful life of a air handler is 15 years with proper maintenance. The air handlers were observed to be in good to fair condition. We recommend that the air handlers be replaced.

Typical air handler located in second level attic space

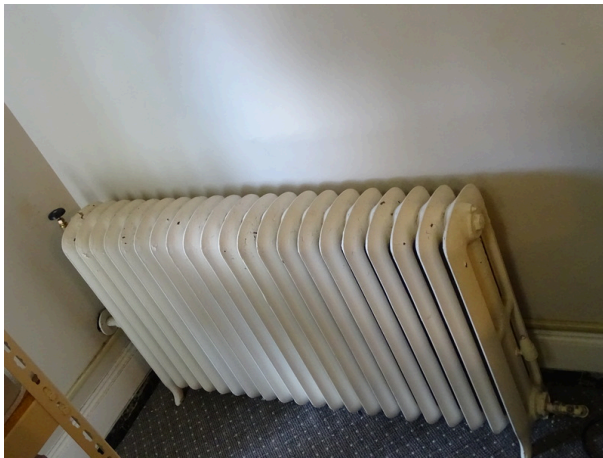
Typical radiator

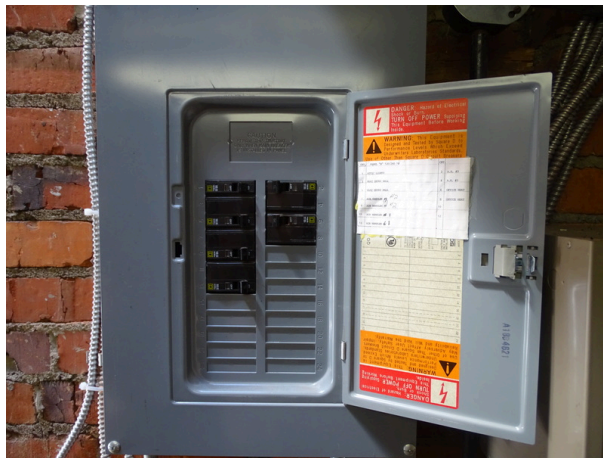
The electrical meter and service entrance are located on the north side of the building. The main service disconnect is a single-phase single-phase 120/240 - 400 amps switch. The main disconnect appeared to be recently replaced and not the original equipment from initial construction. The service disconnect was generally in good condition.

Electrical main disconnect switch

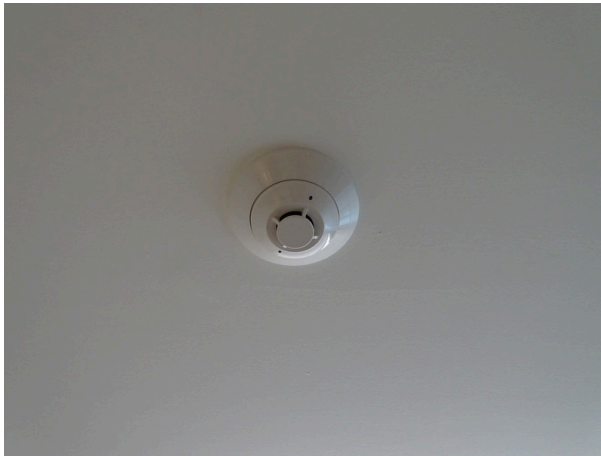
Typical smoke detector

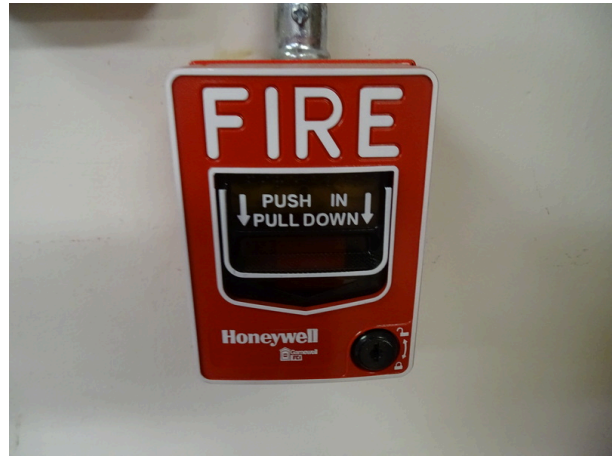
Typical fire alarm pull station

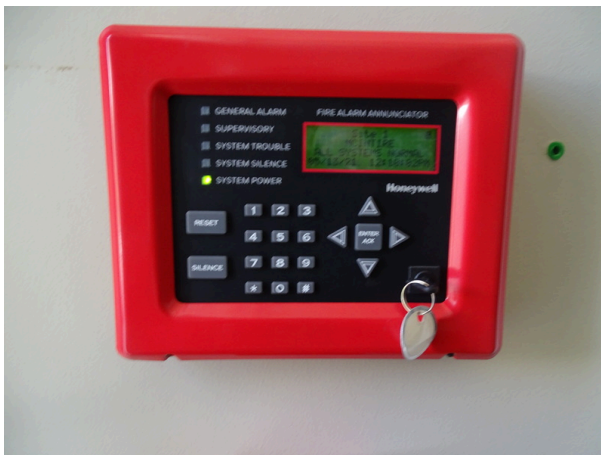
Typical fire alarm annunciator

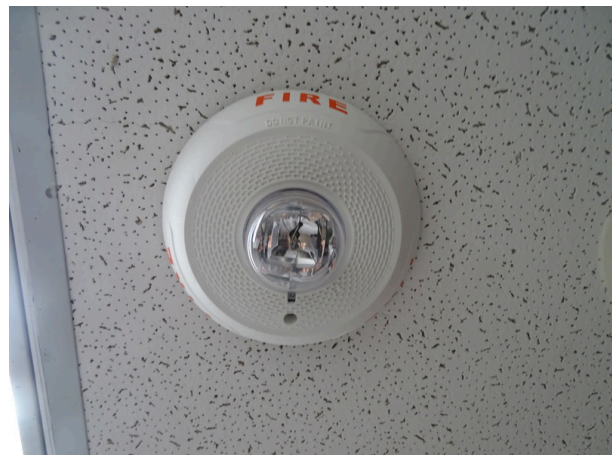
Typical fire alarm bell and strobe

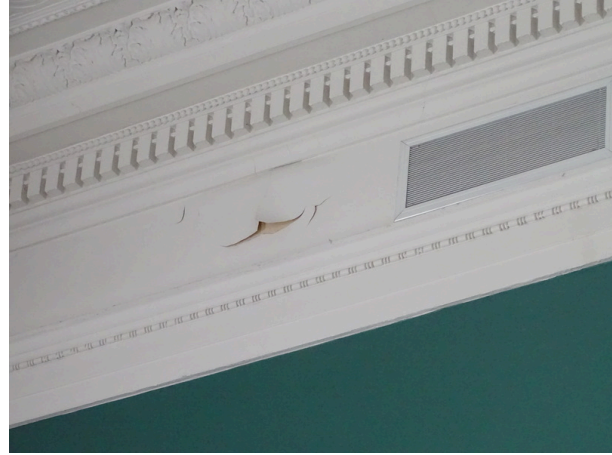
Interior ceiling - note peeling paint

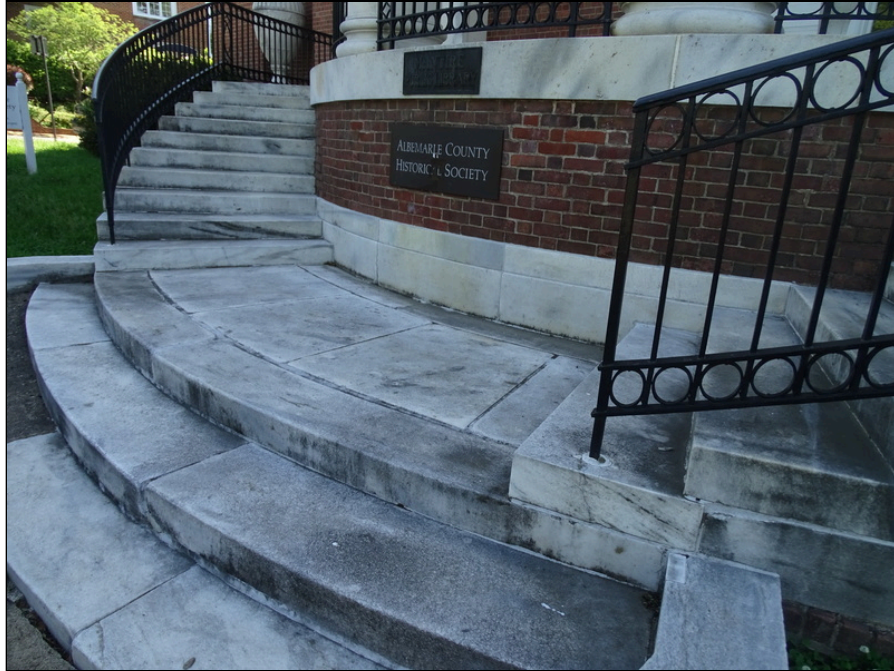
3 - Marble steps at the west entrance

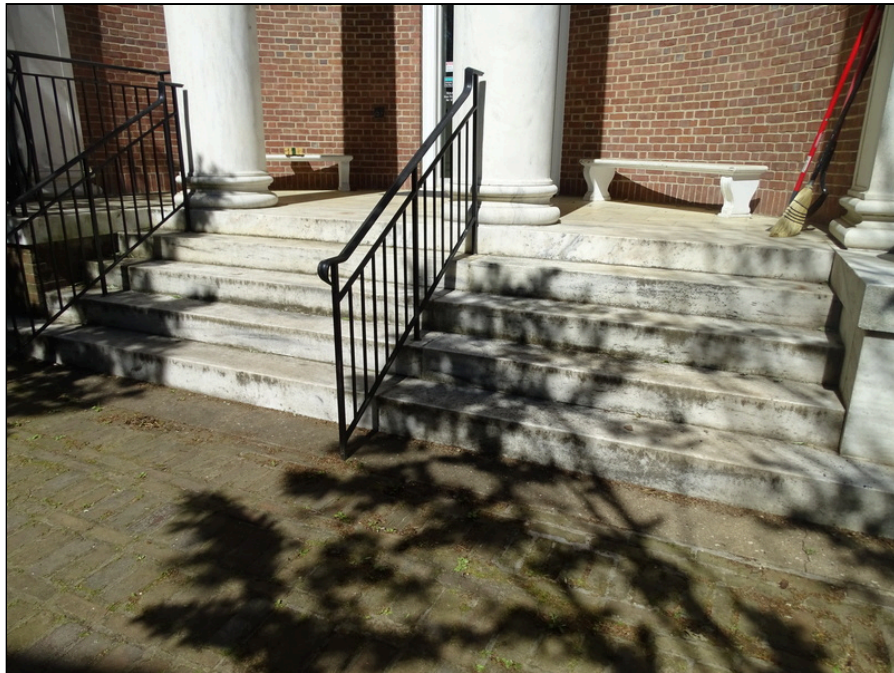
4 - Marble steps at east entrance

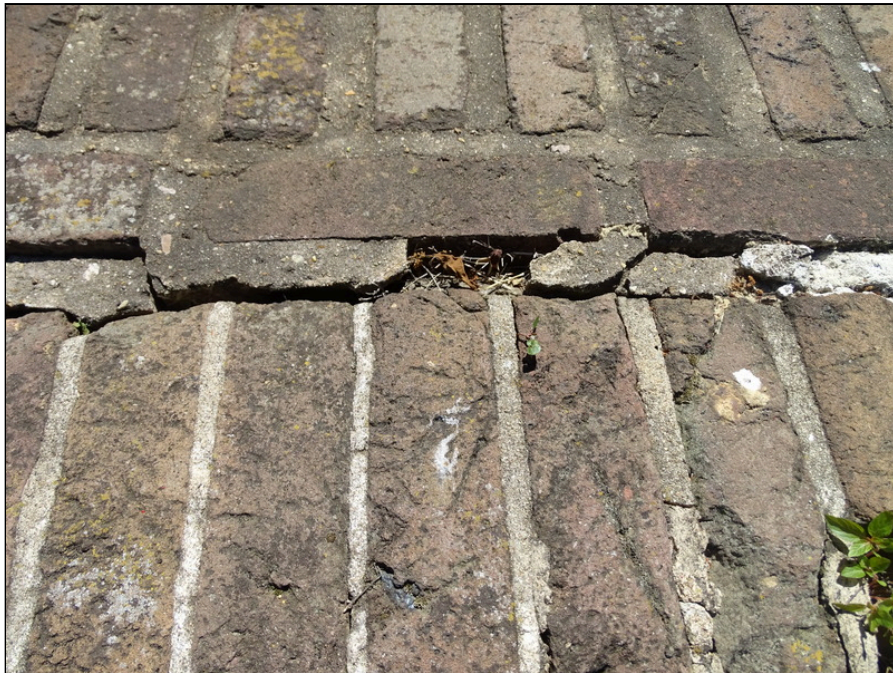
6 - Brick pavers and concrete sidewalk at east side of the site - note deterioration

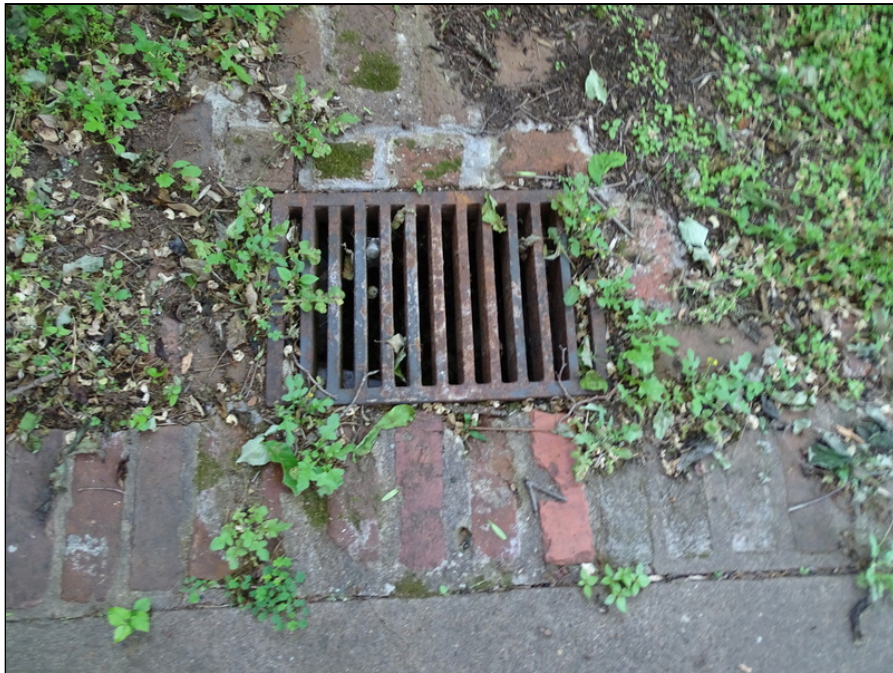
10 - Yard inlet drainage

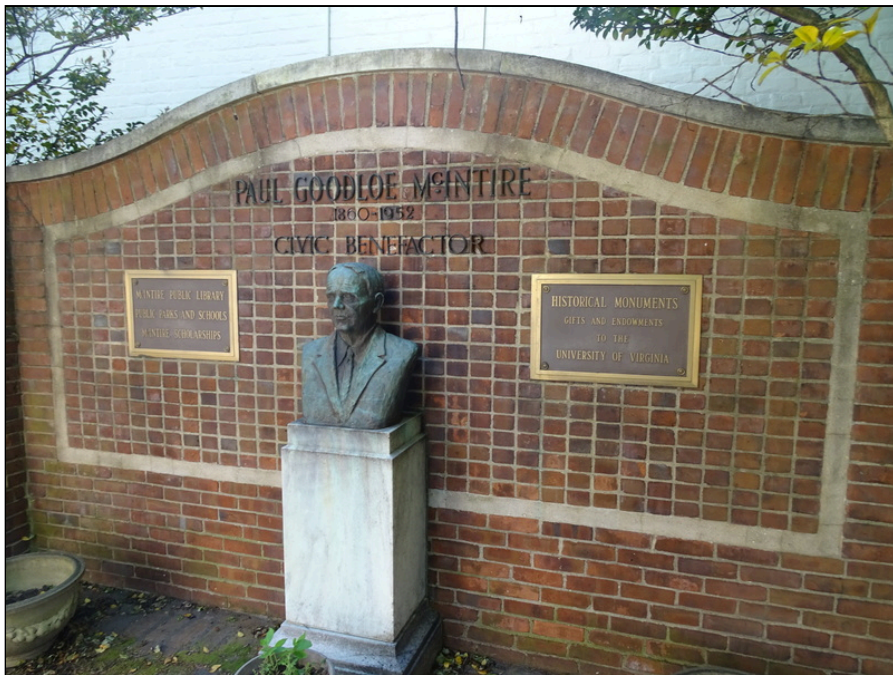
16 - Historical monument

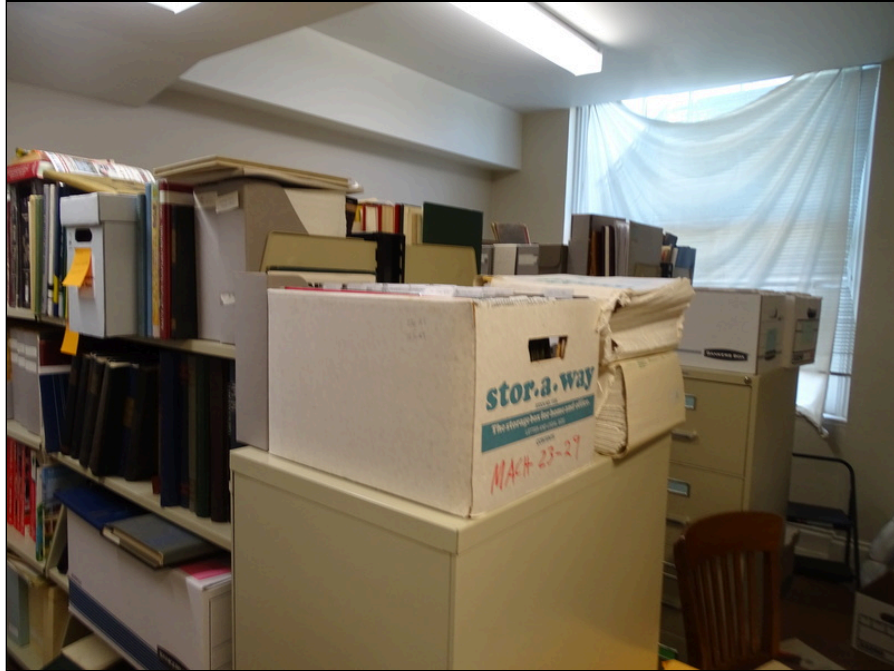
17 - Typical storage area

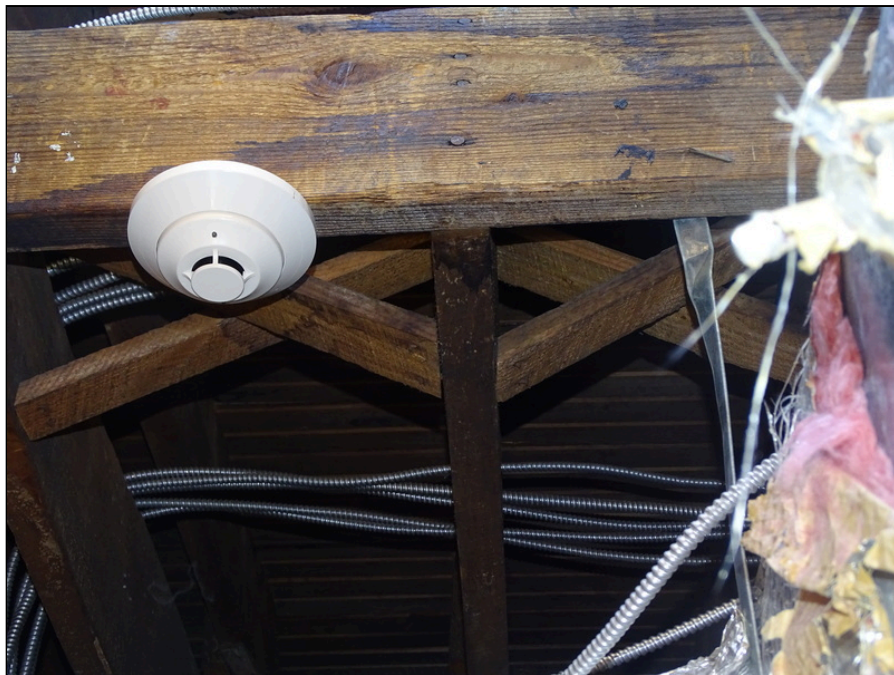
18 - Typical smoke detector

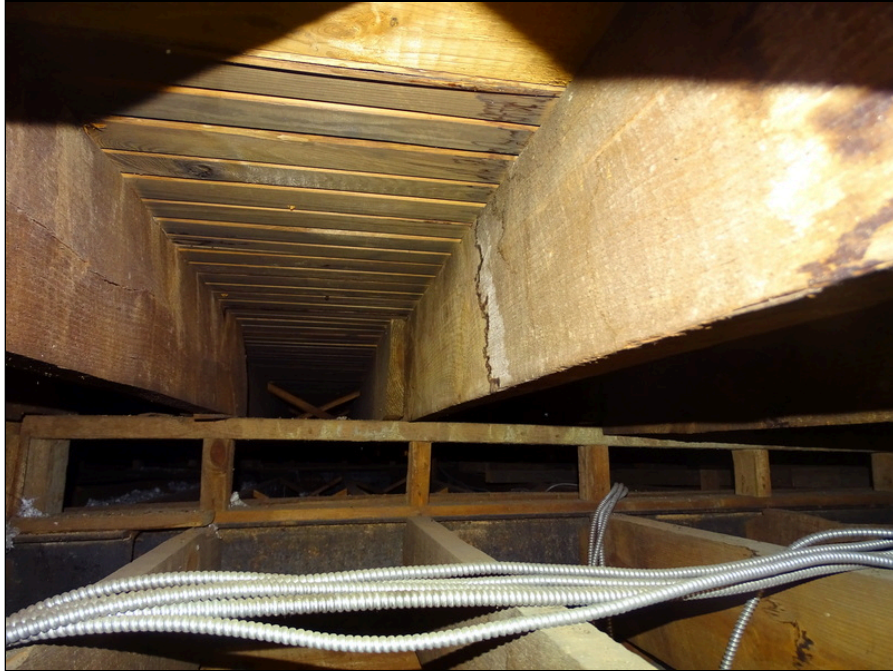
19 - Structure framing

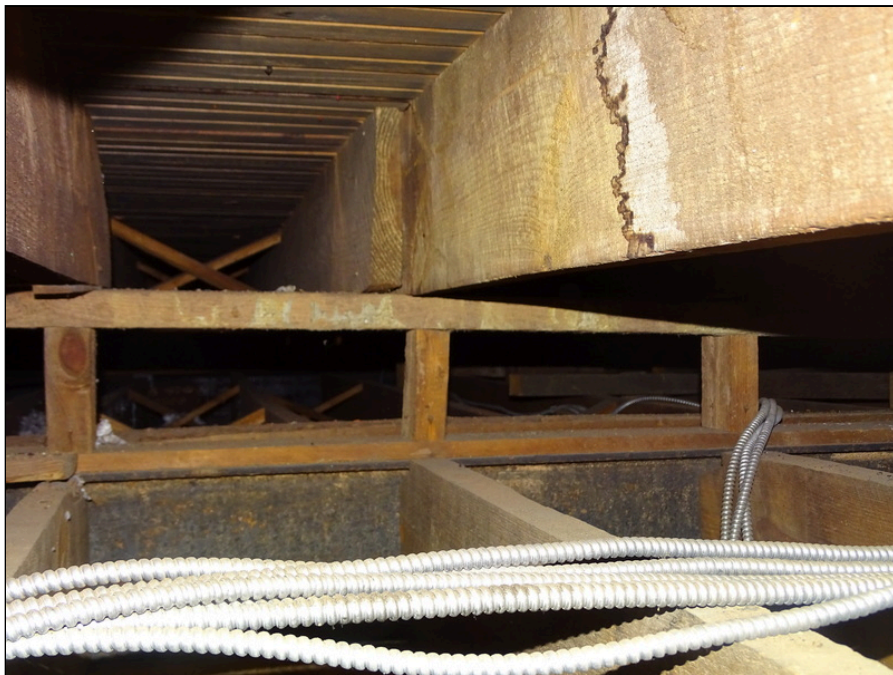
20 - Structure framing

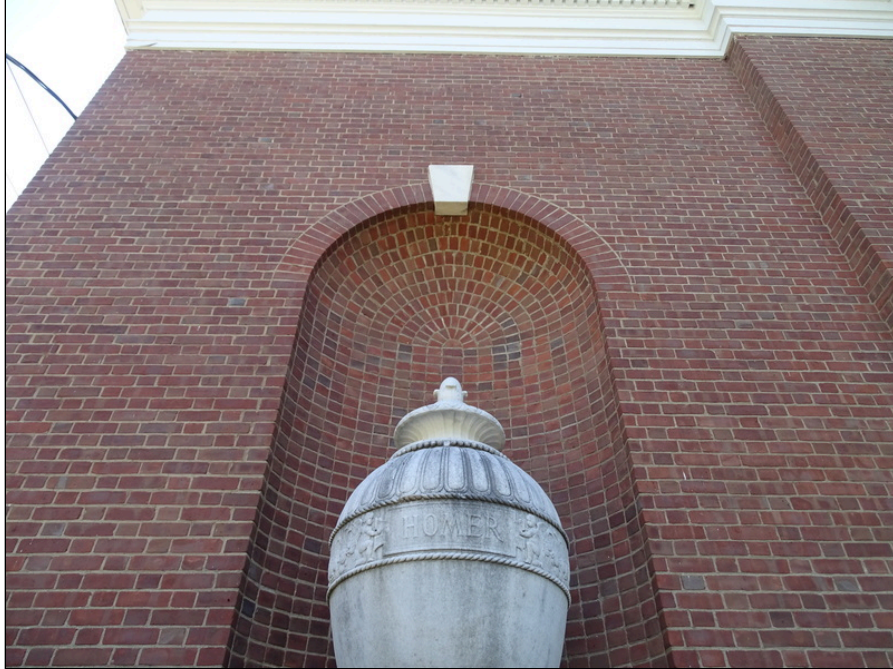
23 - Building exterior at west side

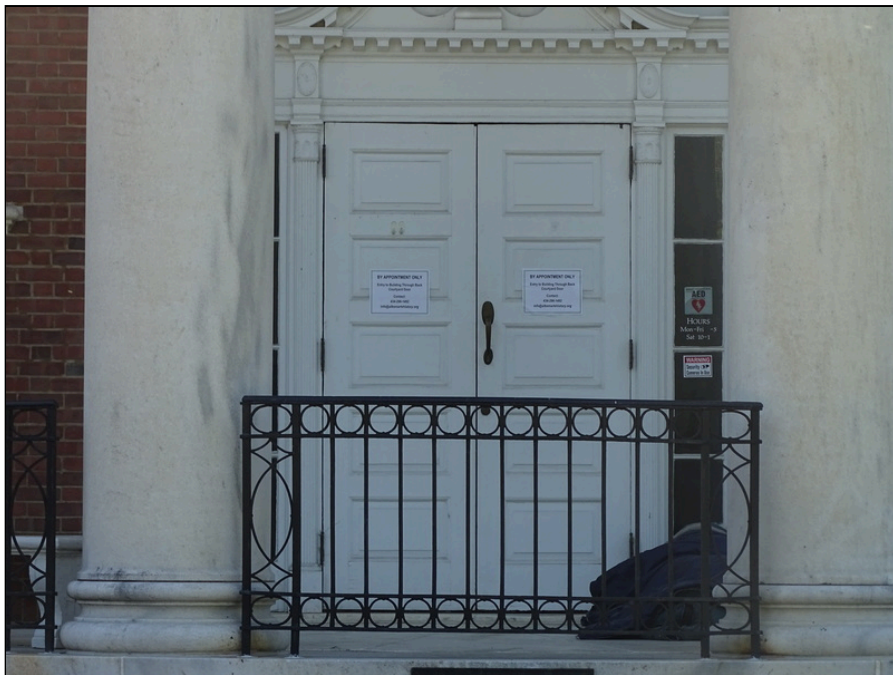
26 - Wood door at west side of the building

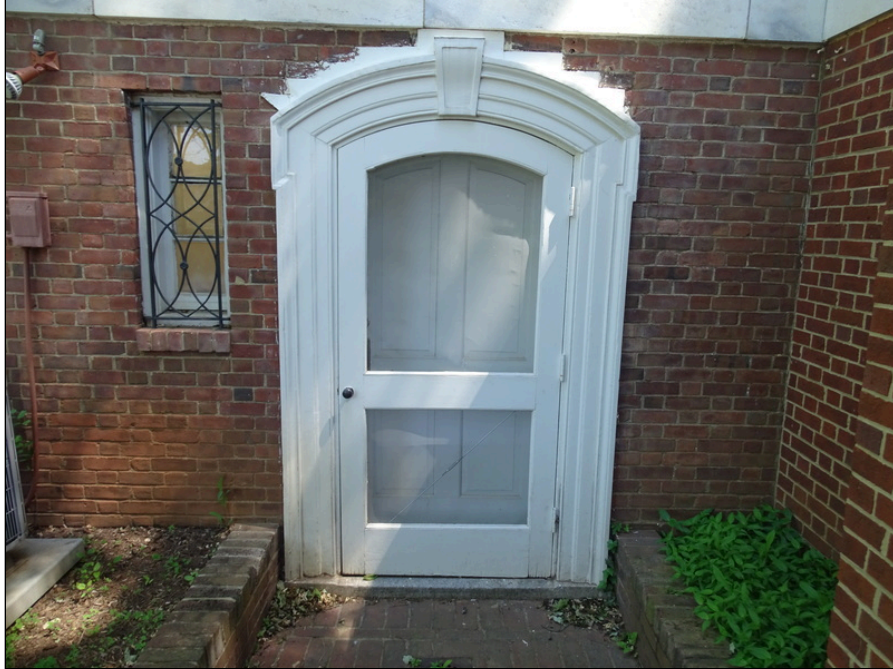
27 - Typical exterior door

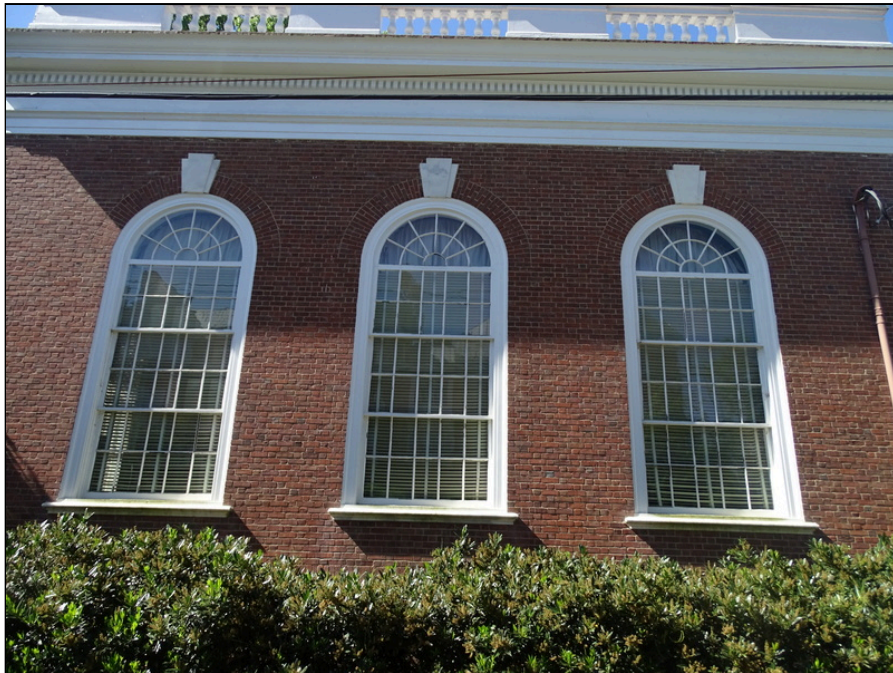
28 - Typical exterior window

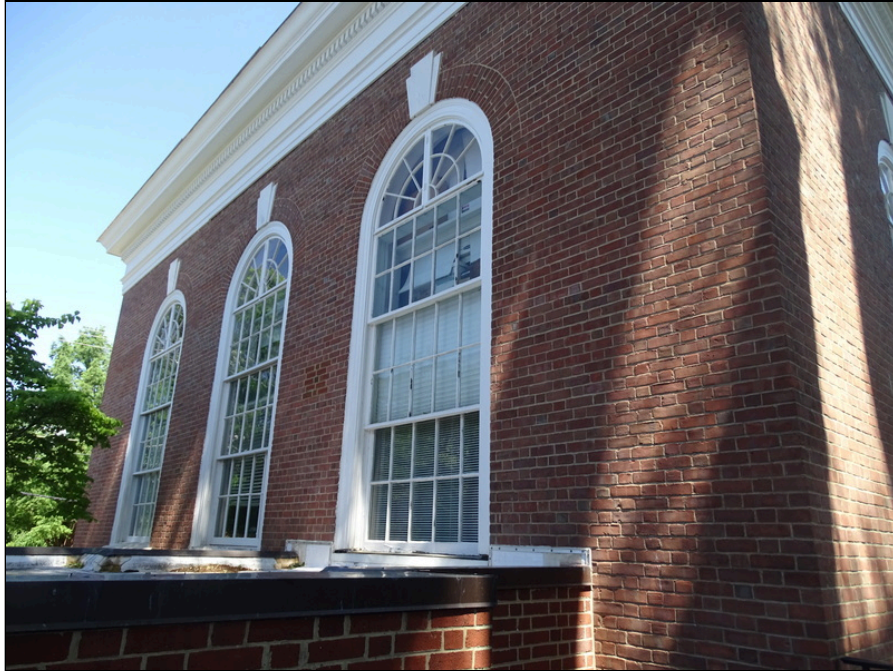
29 - Typical exterior window

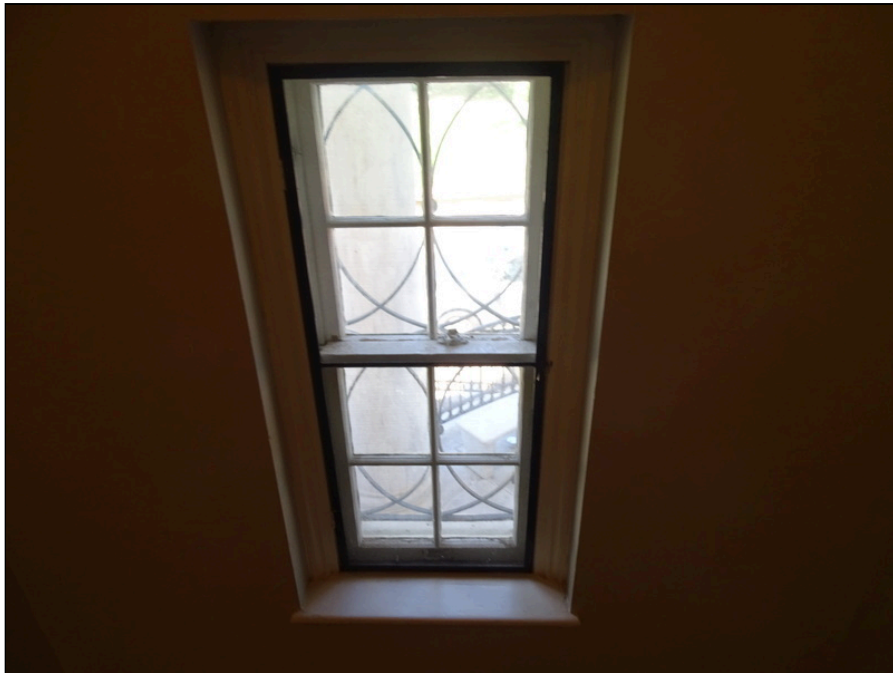
32 - Typical exterior window

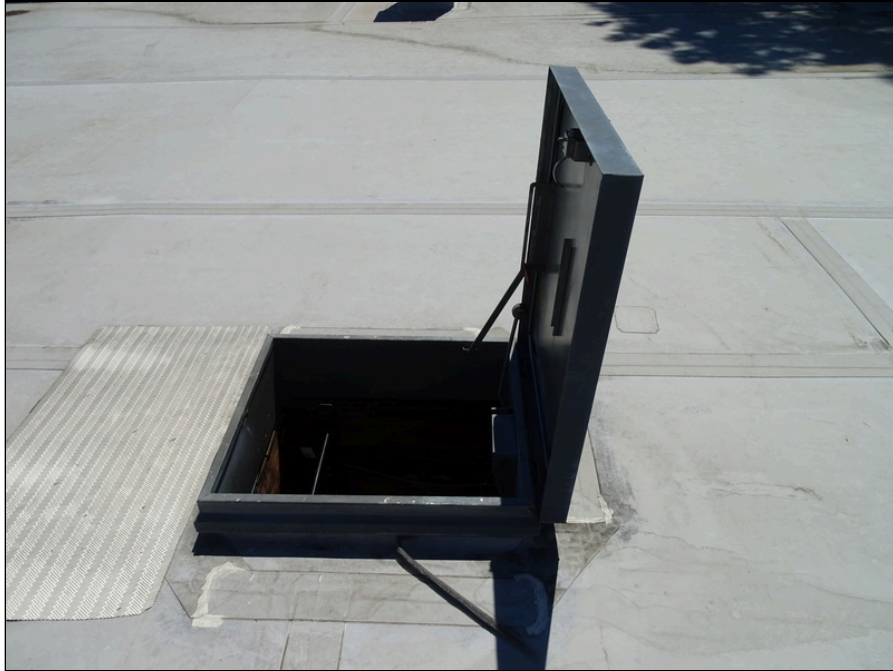
33 - Roof access

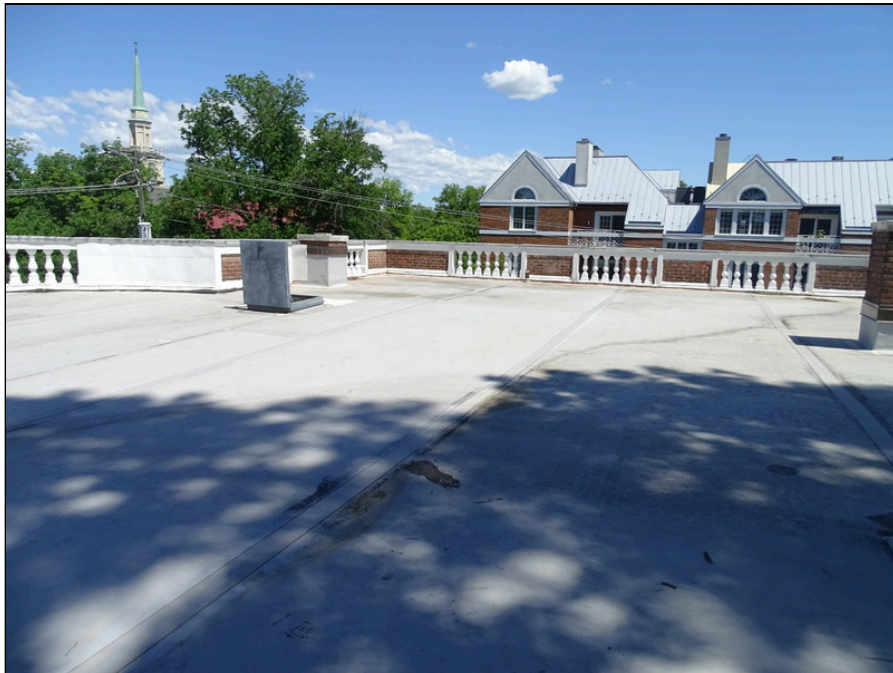
34 - Roofing system looking south

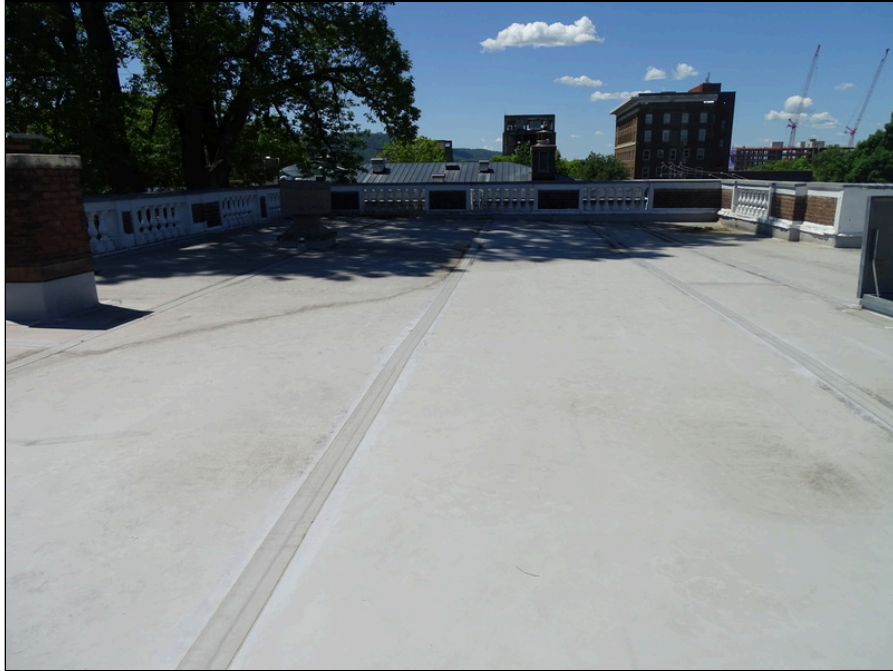
35 - roofing system Roofing system single-ply sheet membrane

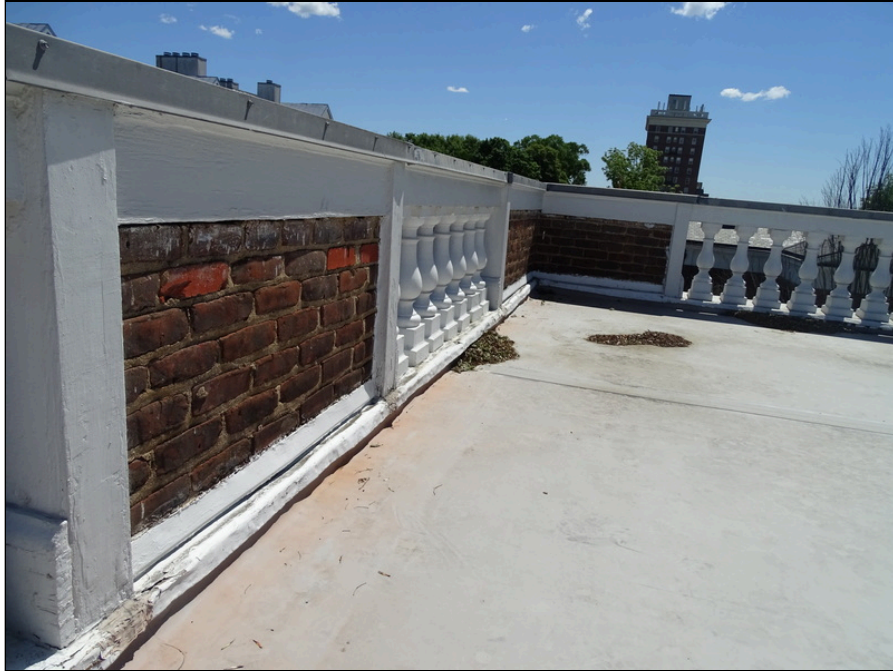
37 - Roofing system - note needed maintenance

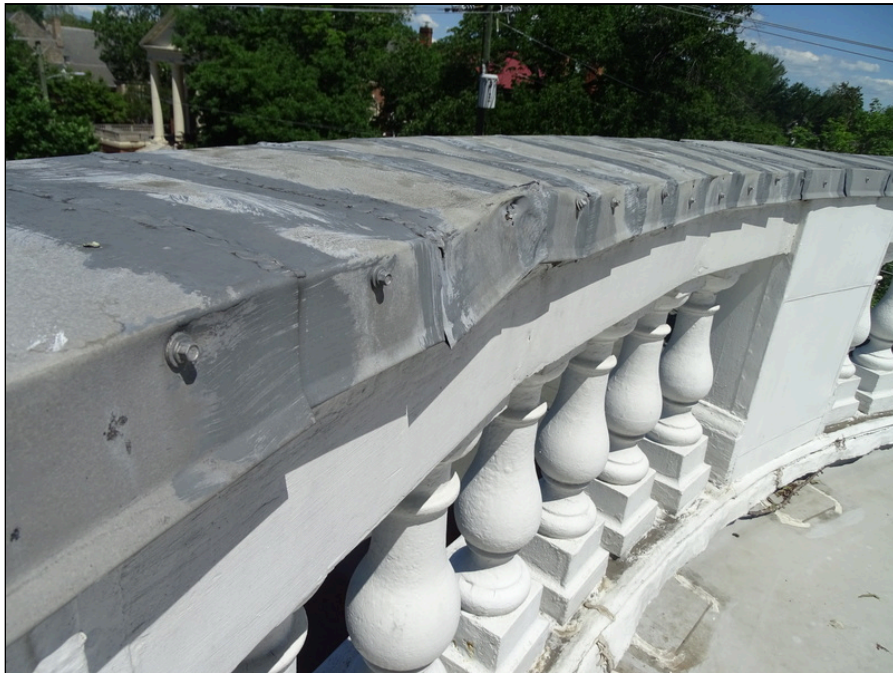
38 - Metal coping and wood parapet framing
