MCINTIRE BUILDING
200 2ND STREET NE
CHARLOTTESVILLE, VIRGINIA

ECS PROJECT NO. 46:6713

CITY OF CHARLOTTESVILLE - FACILITIES DEVELOPMENT

Reference: Facility Condition Assessment Report for McIntire Building, 200 2nd Street NE,
Charlottesville, Virginia

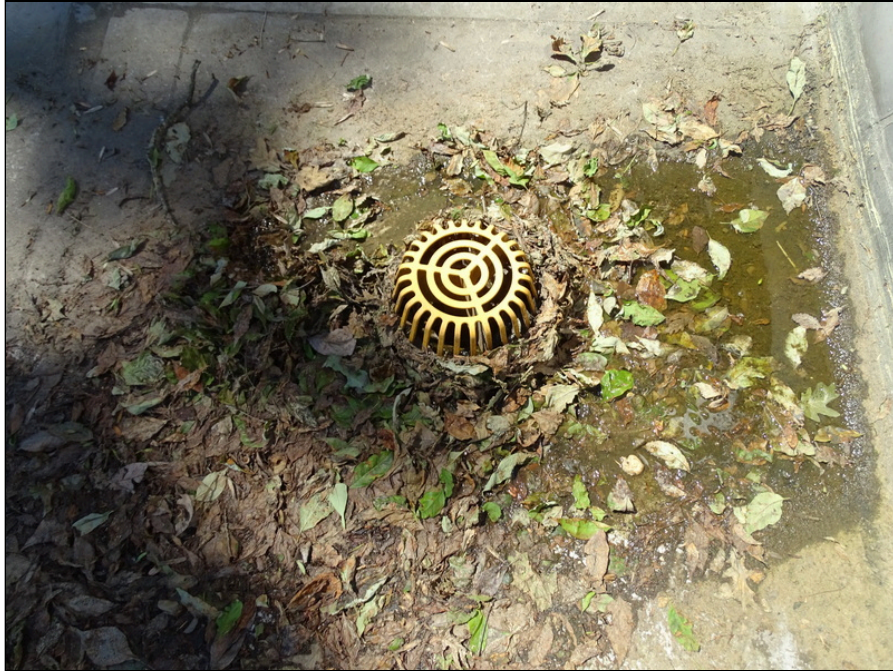
39 - Typical internal roof drain - note maintenance needed

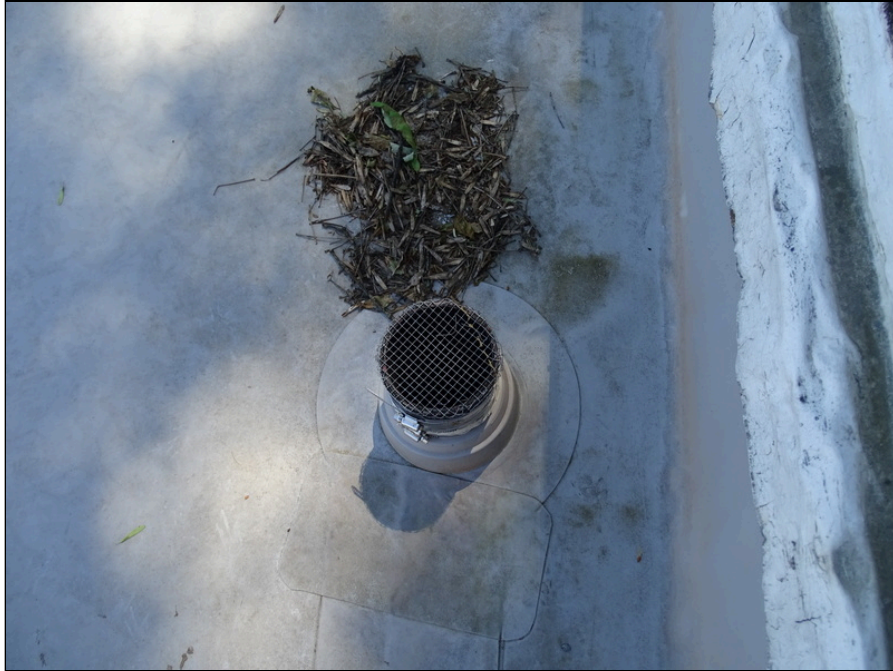
41 - Mechanical vent

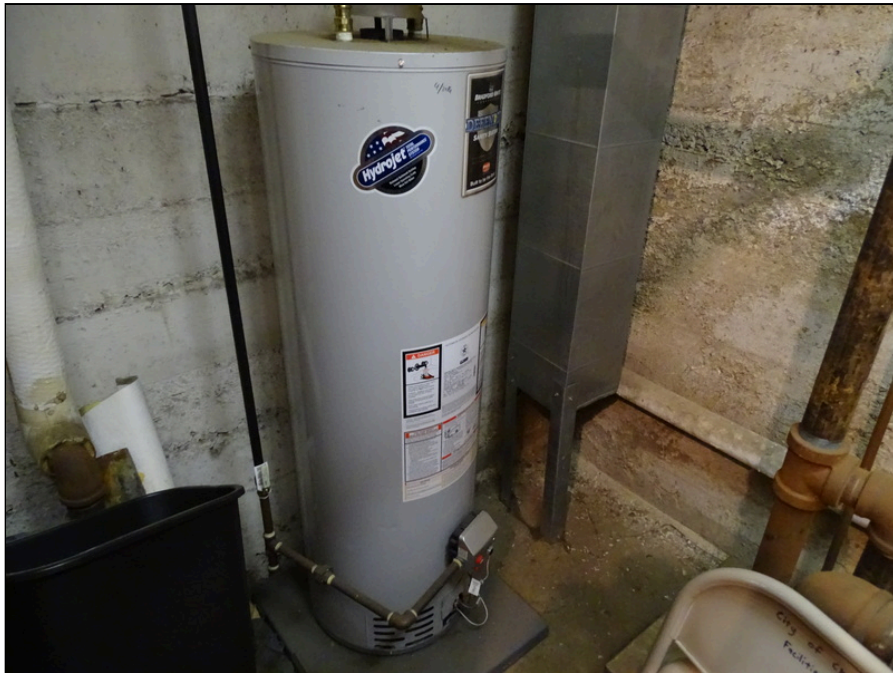
42 - Domestic water heater

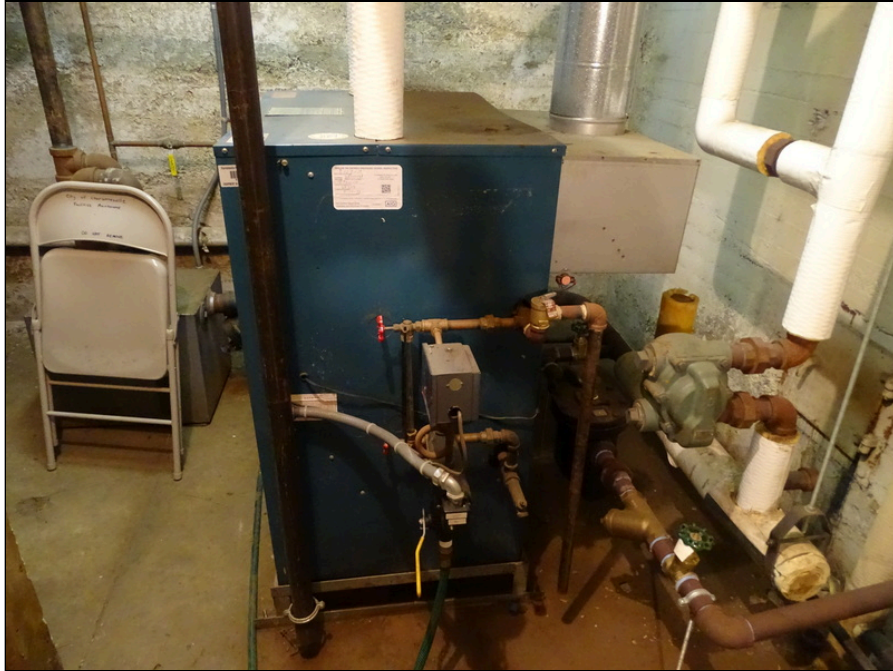
43 - Boiler located in basement

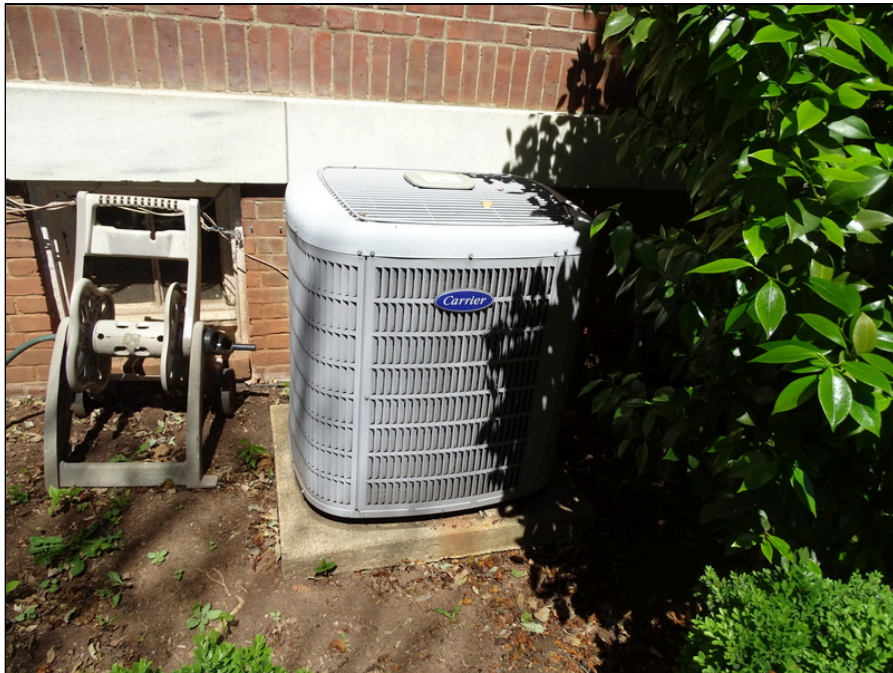
44 - Condenser located at exterior ground level

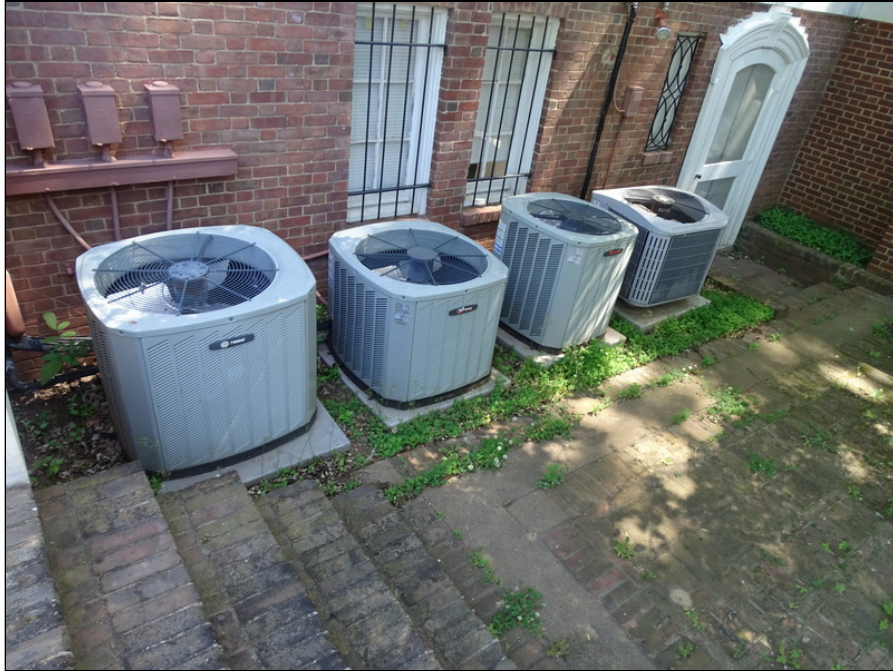
45 - Condensers and heat pump located at exterior ground level

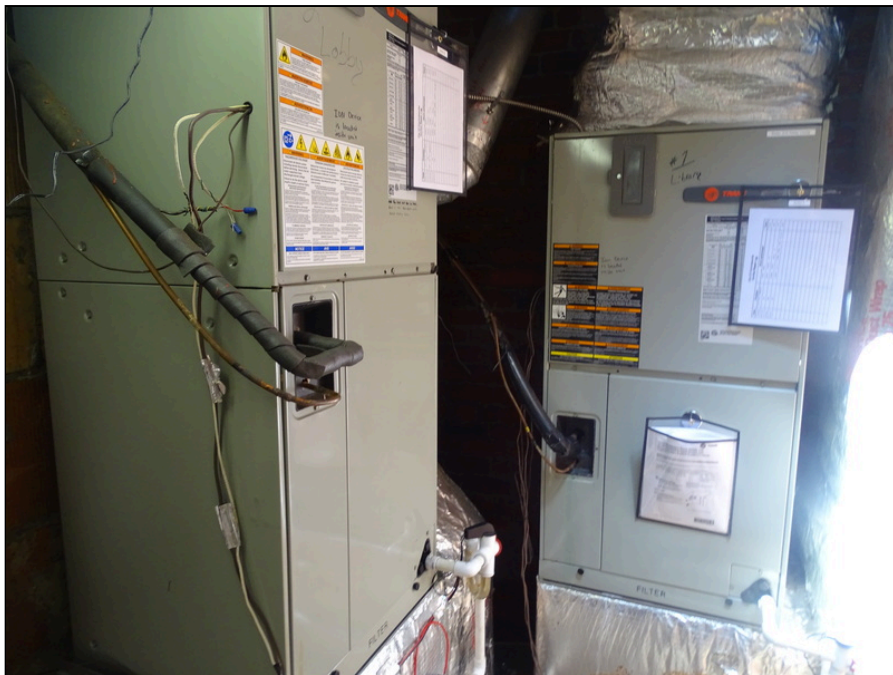
46 - Typical air handler located in second level attic space

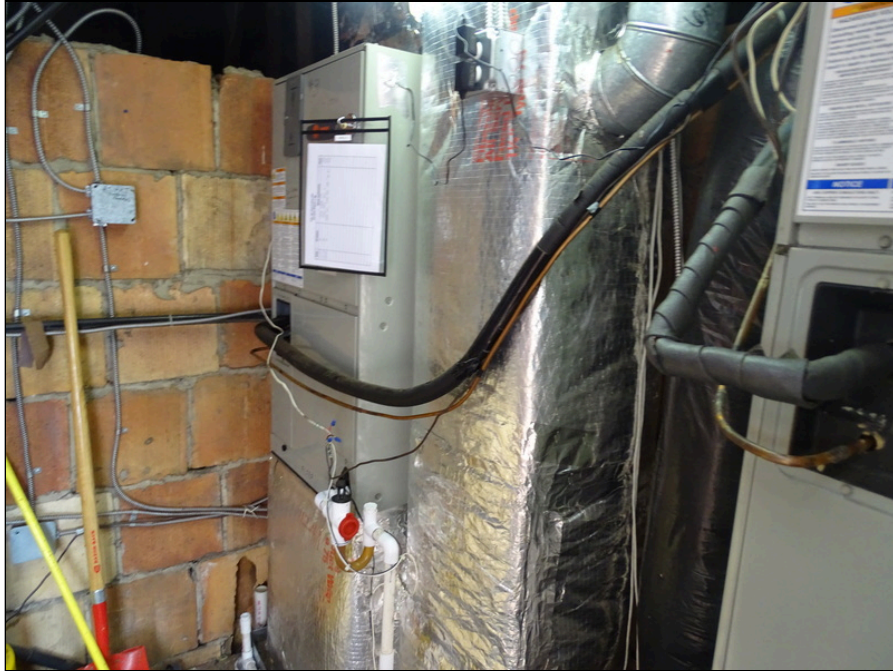
47 - Typical air handler located in second level attic space

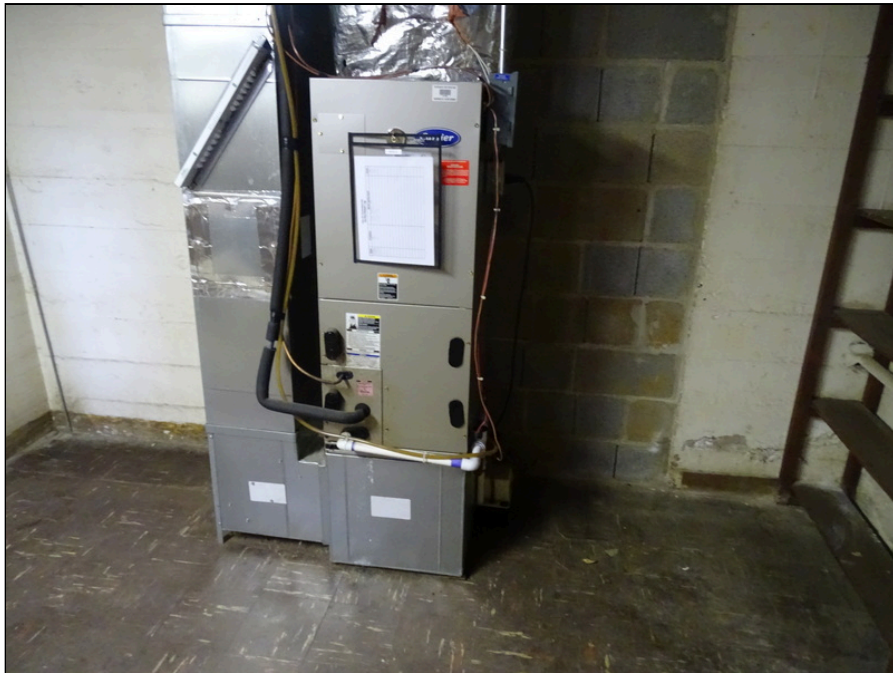
48 - Typical air handler

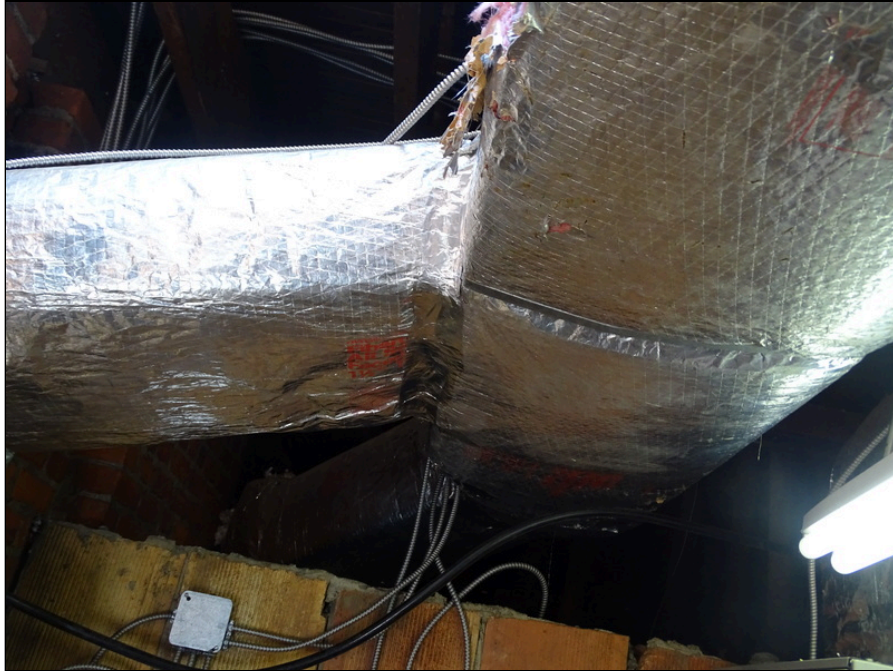
49 - Typical mechanical duct

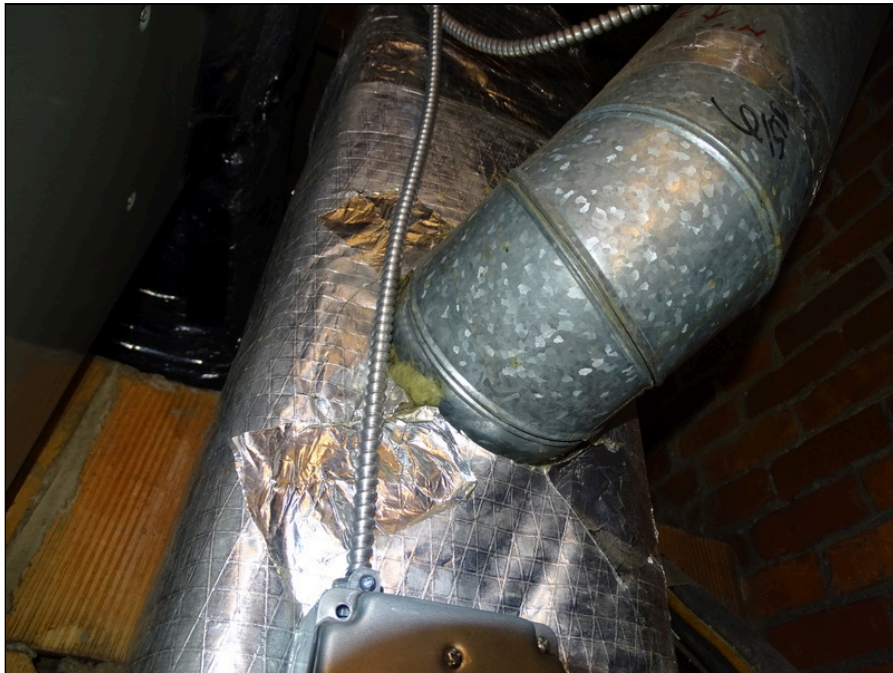
50 - Typical mechanical duct

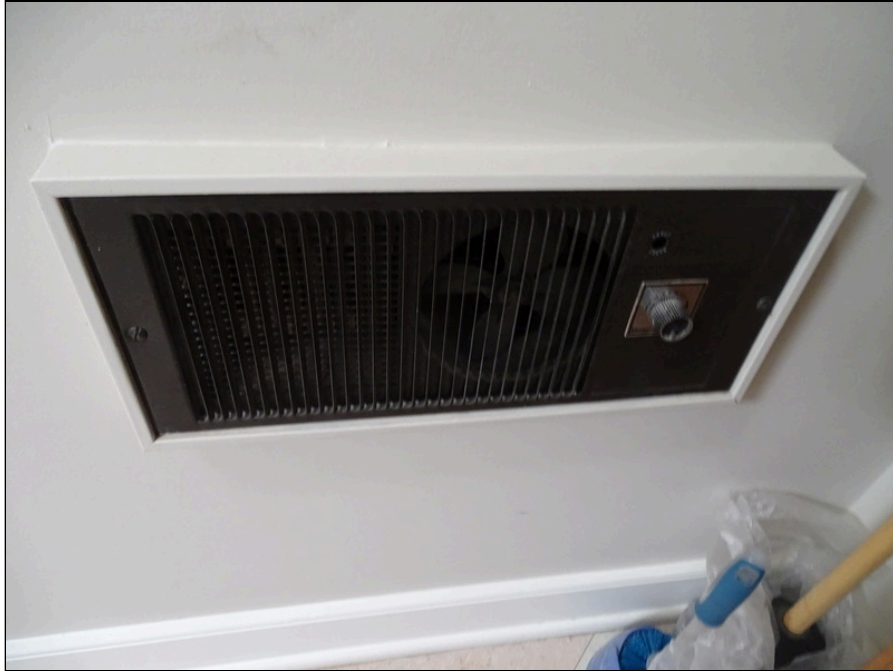
51 - Typical space heater

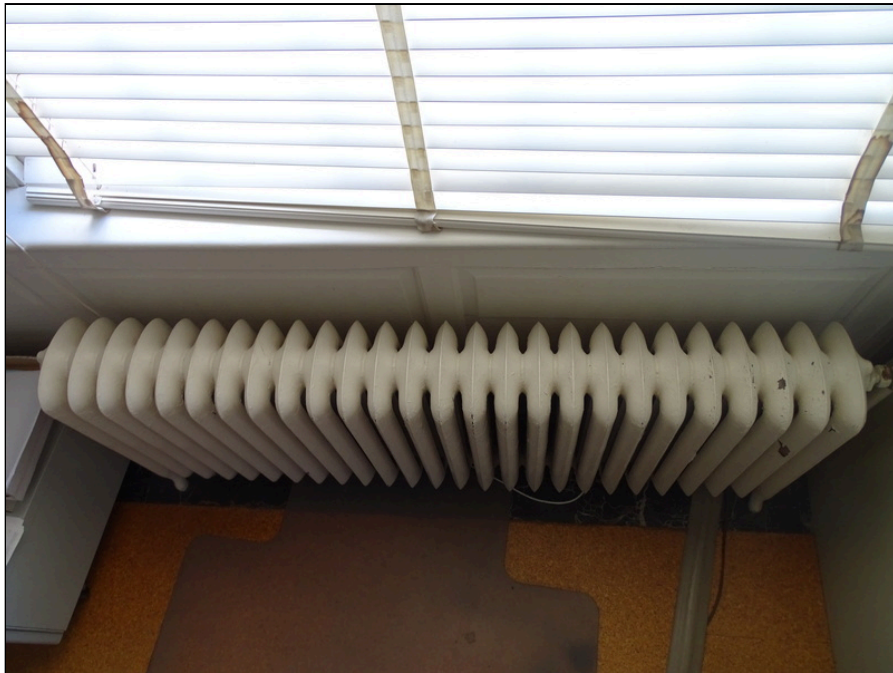
52 - Typical radiator

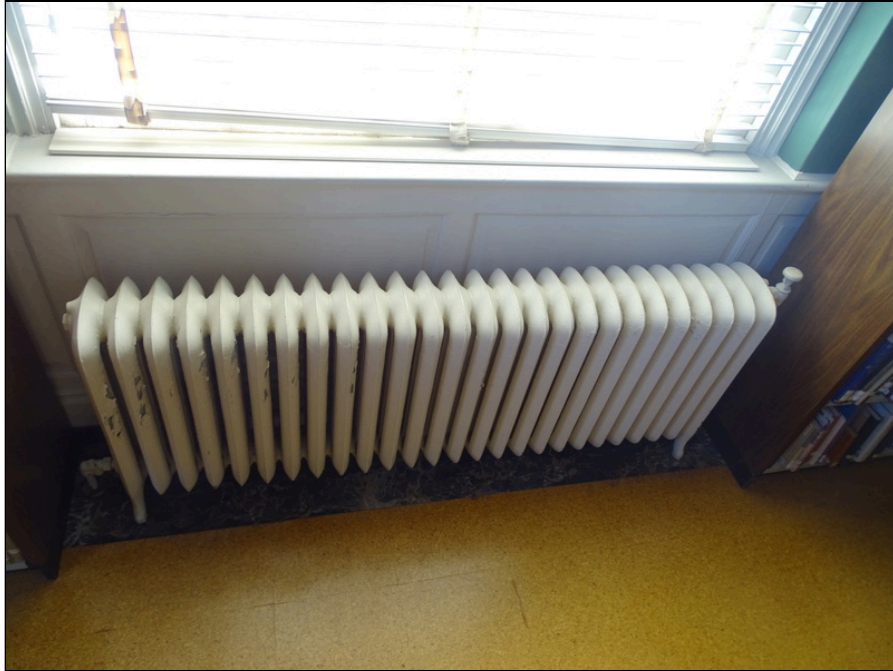
53 - Typical radiator

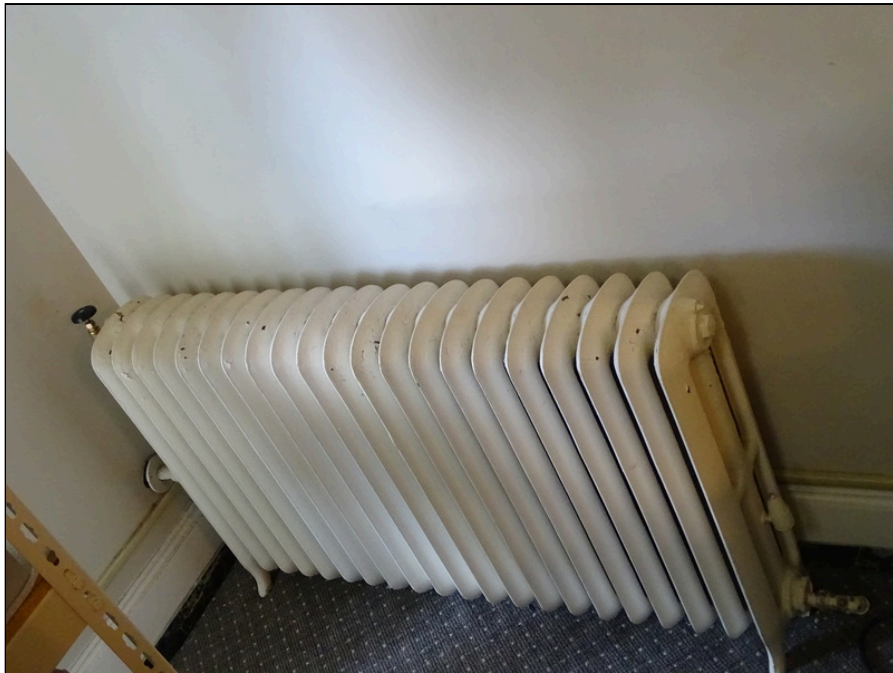
54 - Typical radiator

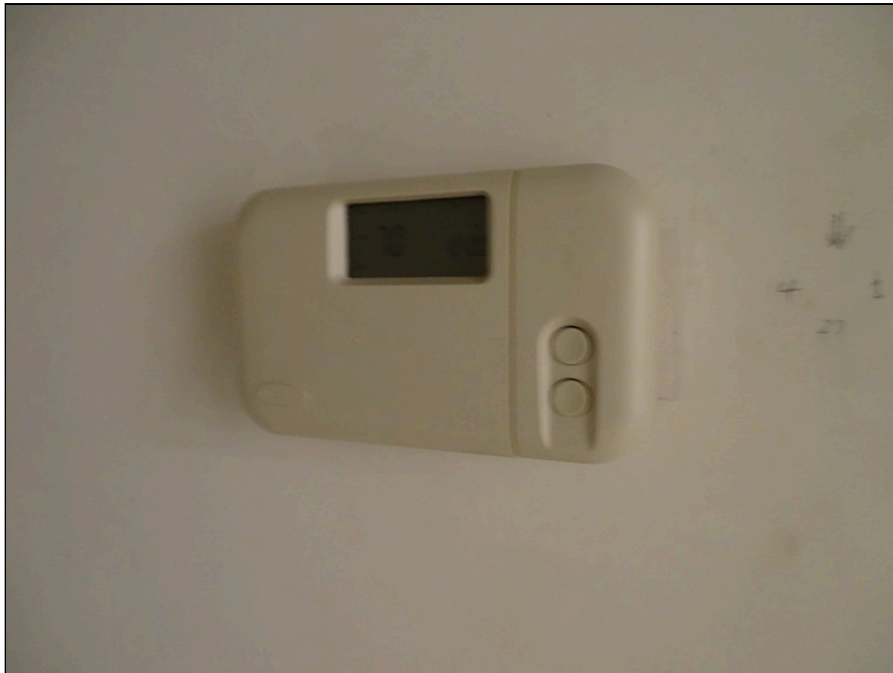
56 - Typical digital thermostat

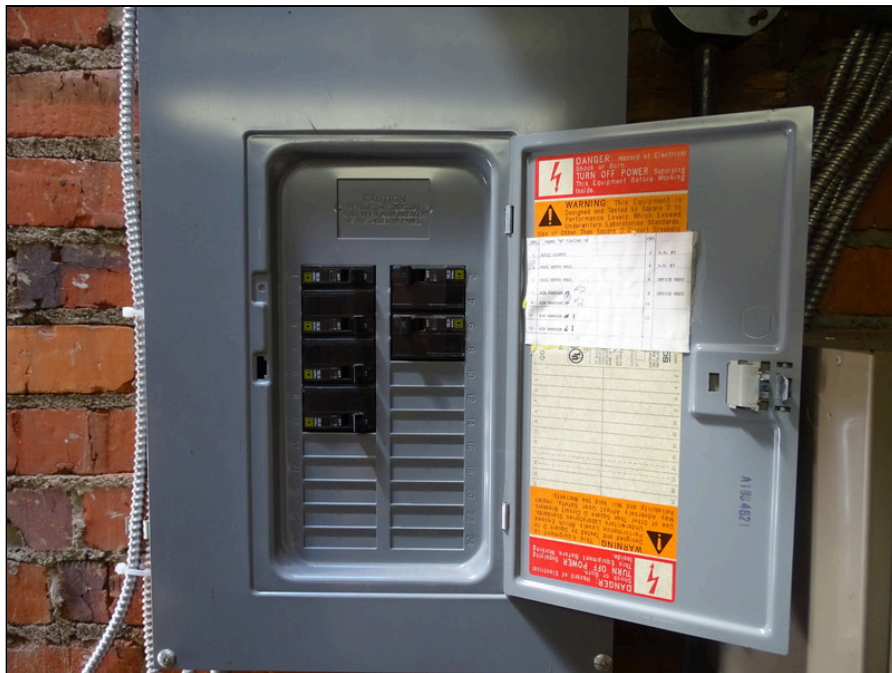
58 - Electrical main disconnect switch

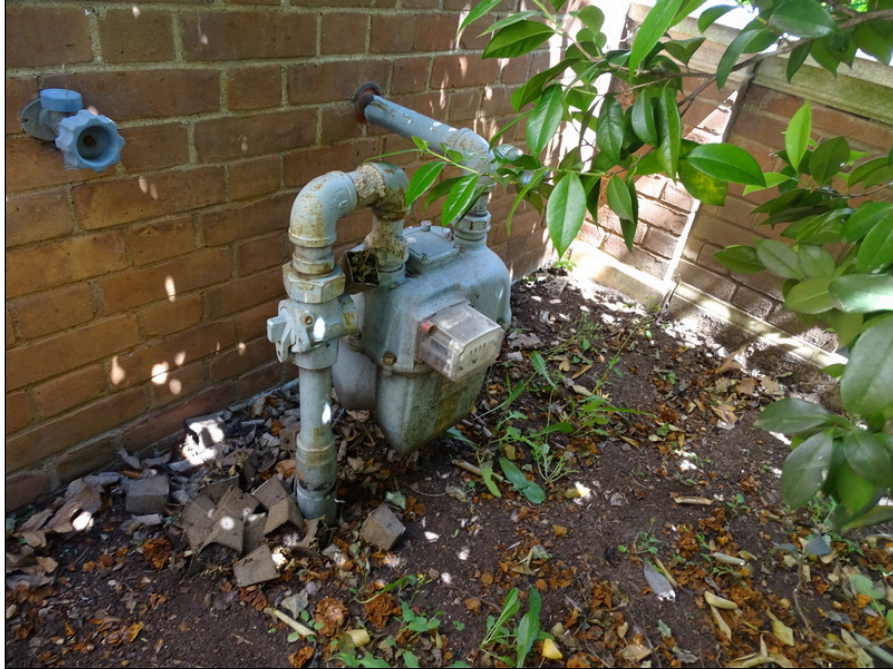
59 - Typical gas meter

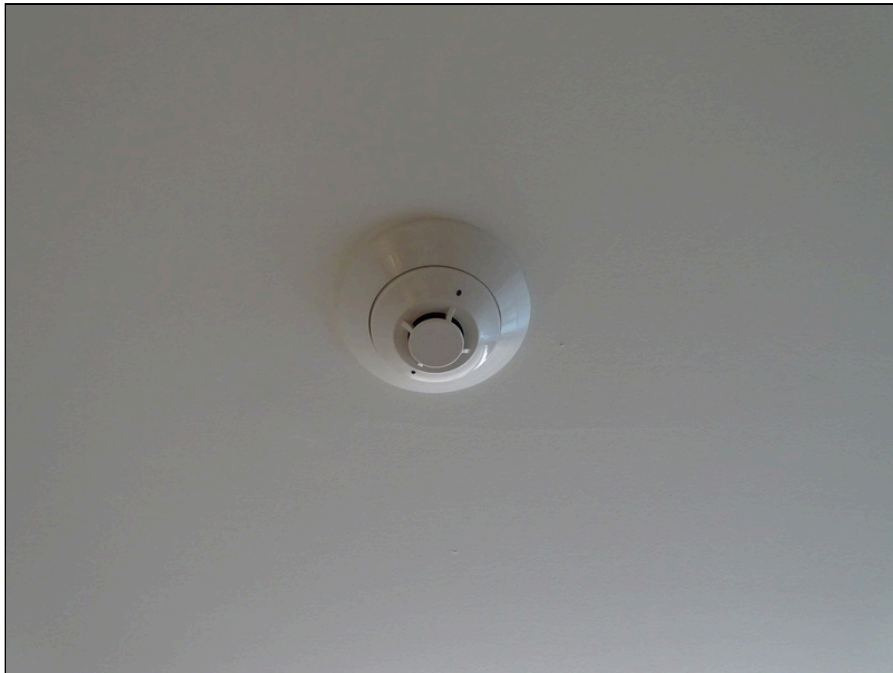
60 - Typical smoke detector

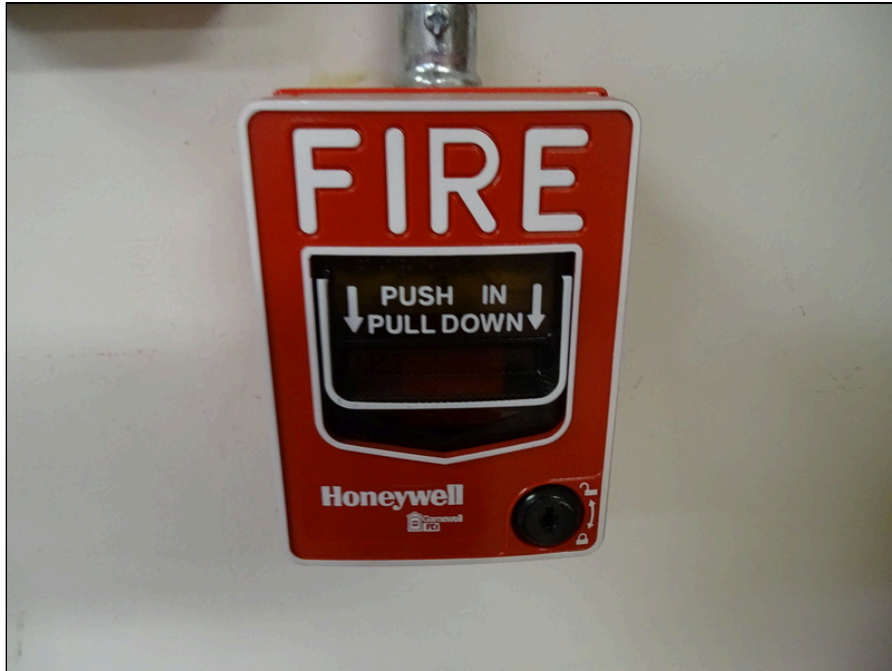
61 - Typical fire alarm pull station

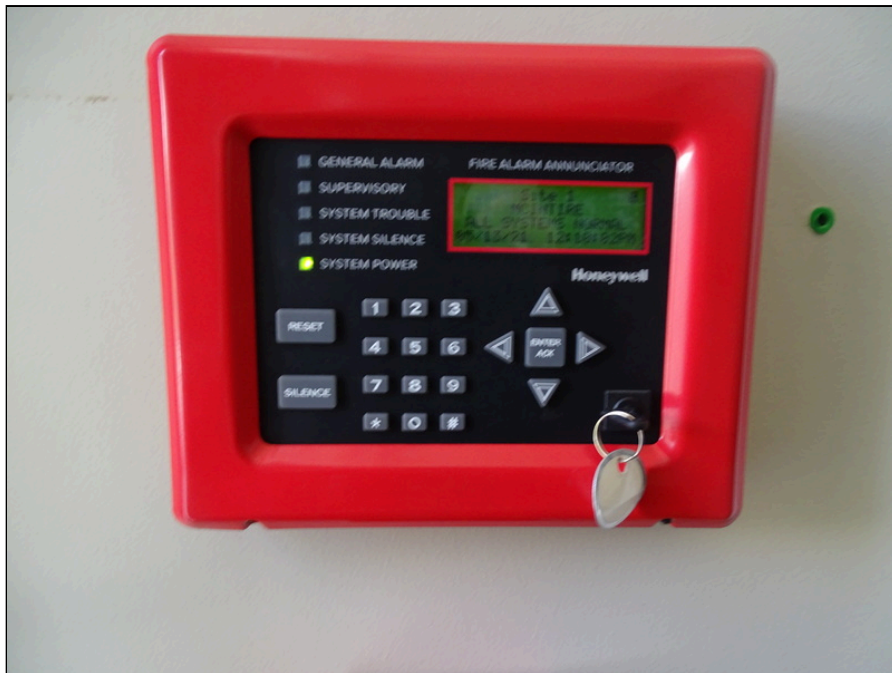
62 - Typical fire alarm annunciator

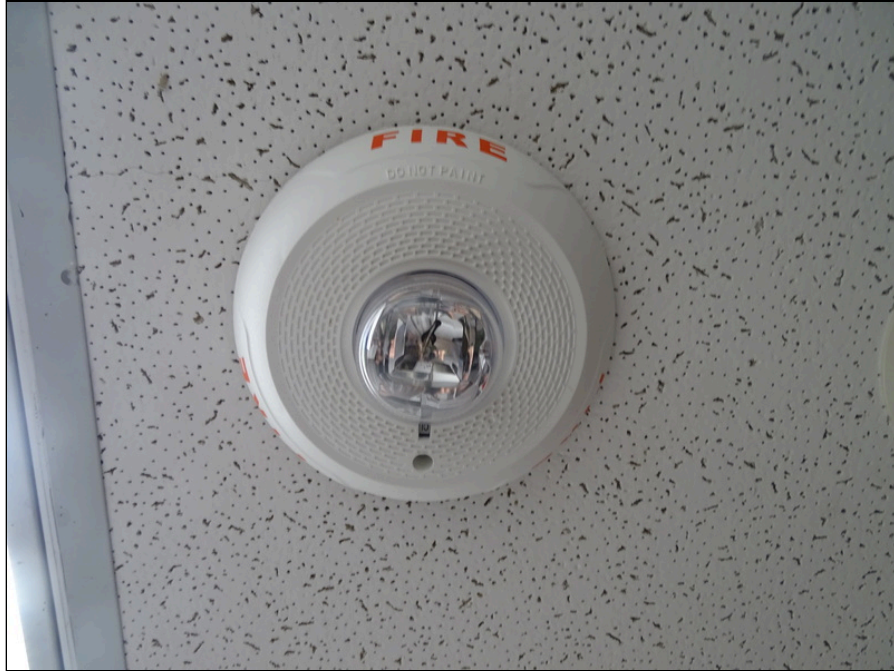
63 - Typical fire alarm bell and strobe

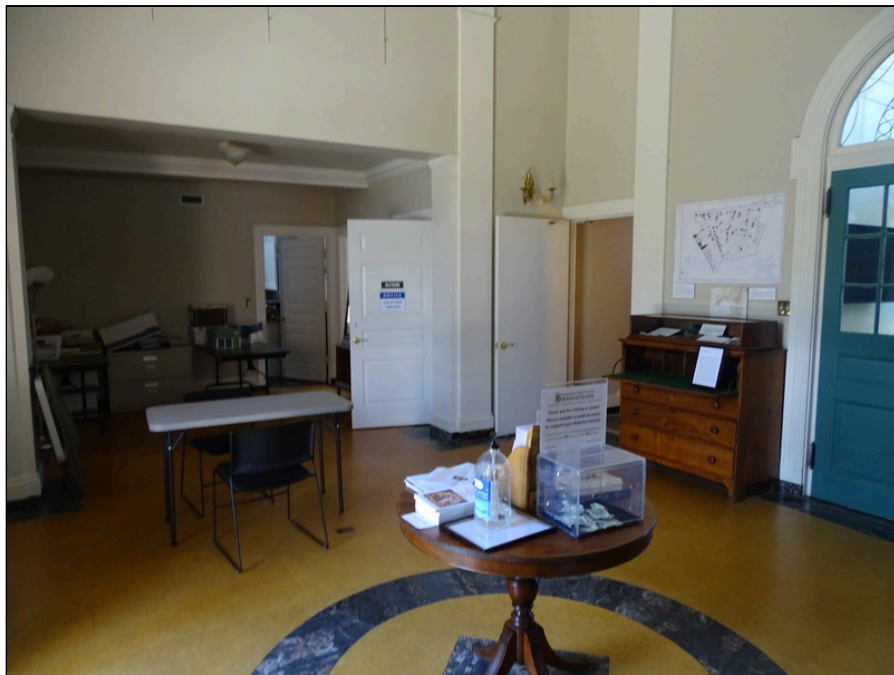
64 - First floor interiors at west entrance

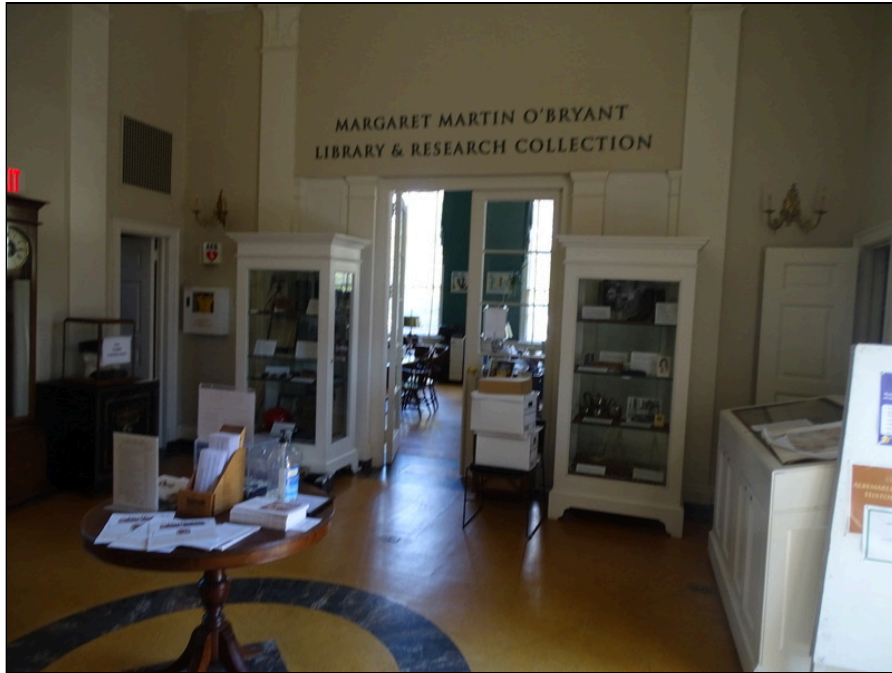
65 - First floor interiors at west entrance

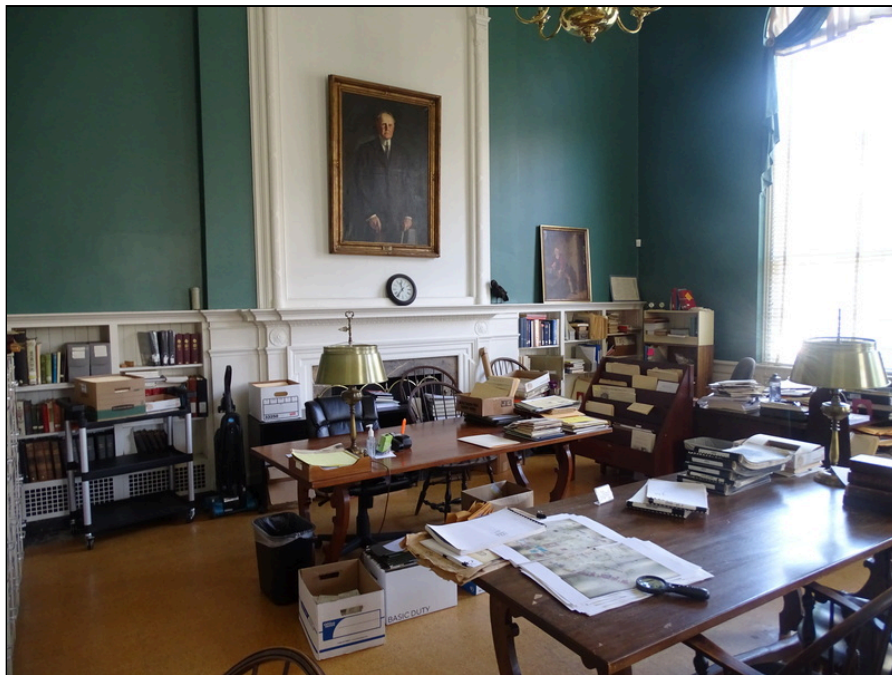
66 - First floor interiors at display area

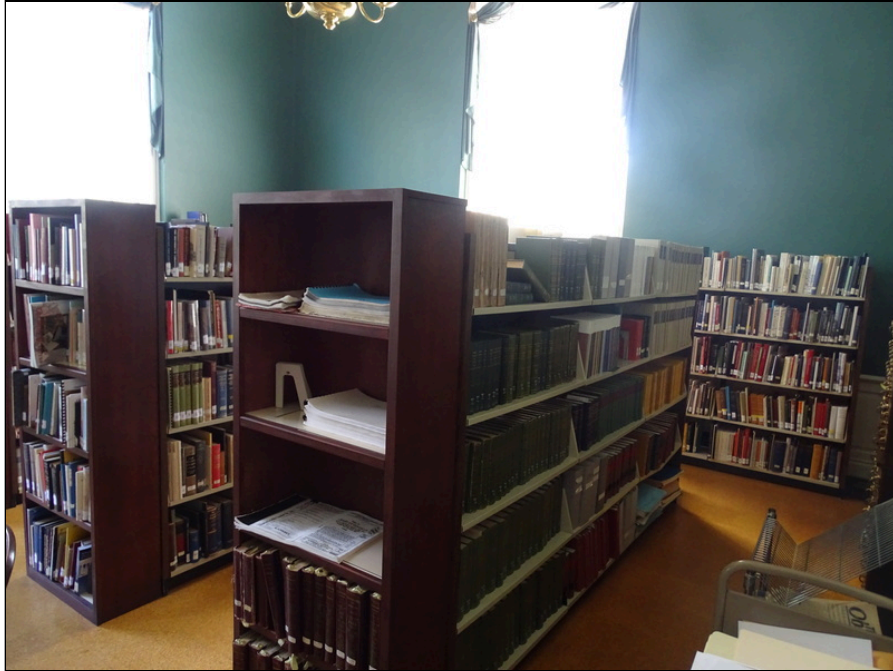
67 - First floor interiors at display area

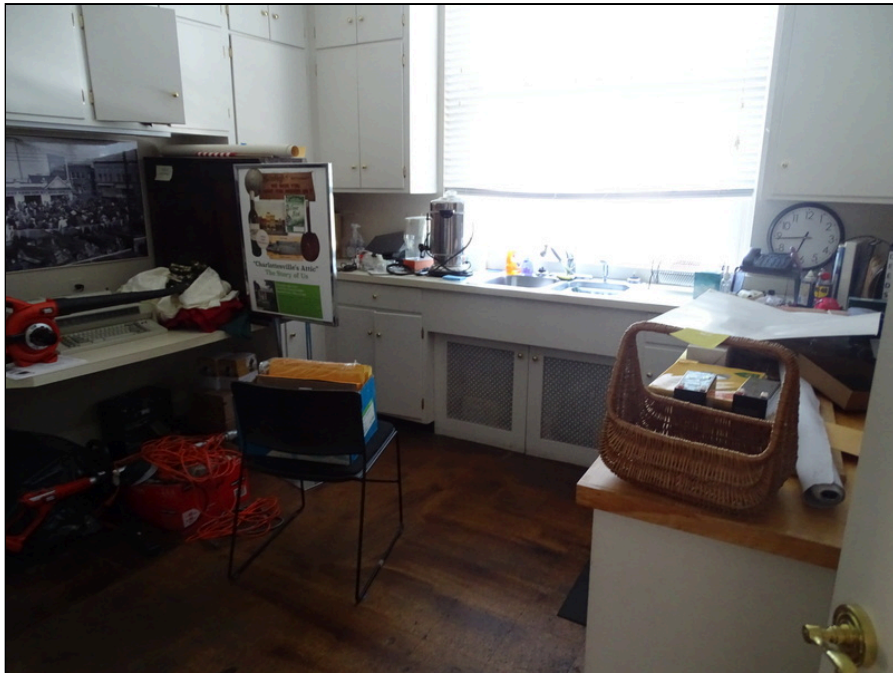
68 - First floor interiors at kitchen area

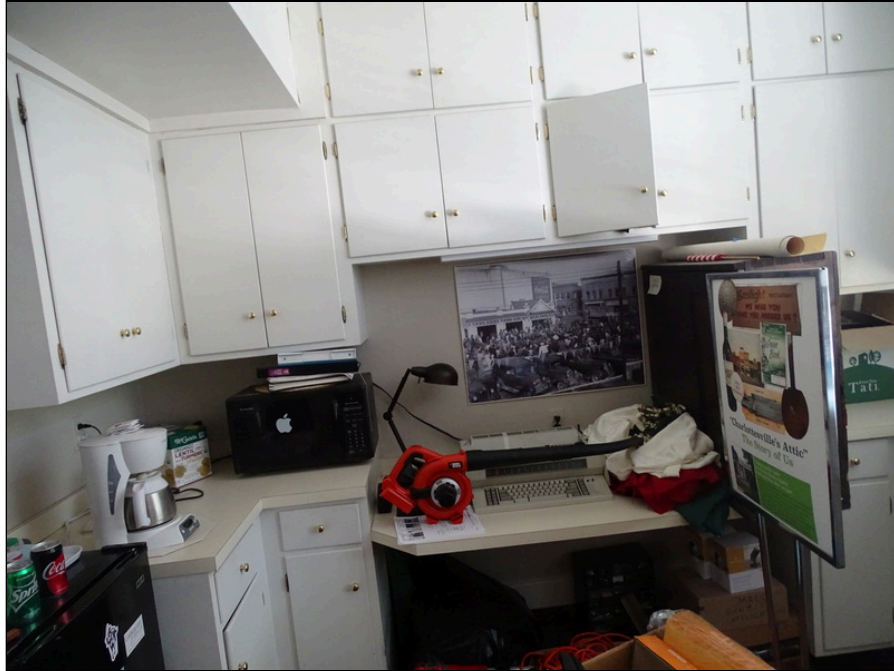
69 - First floor interiors at kitchen area

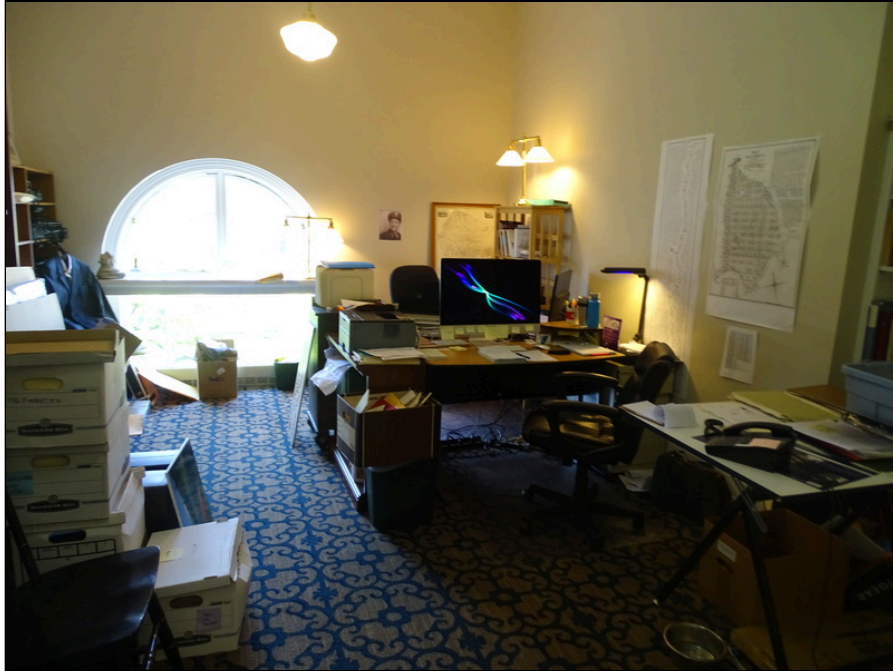
71 - Typical office area interior

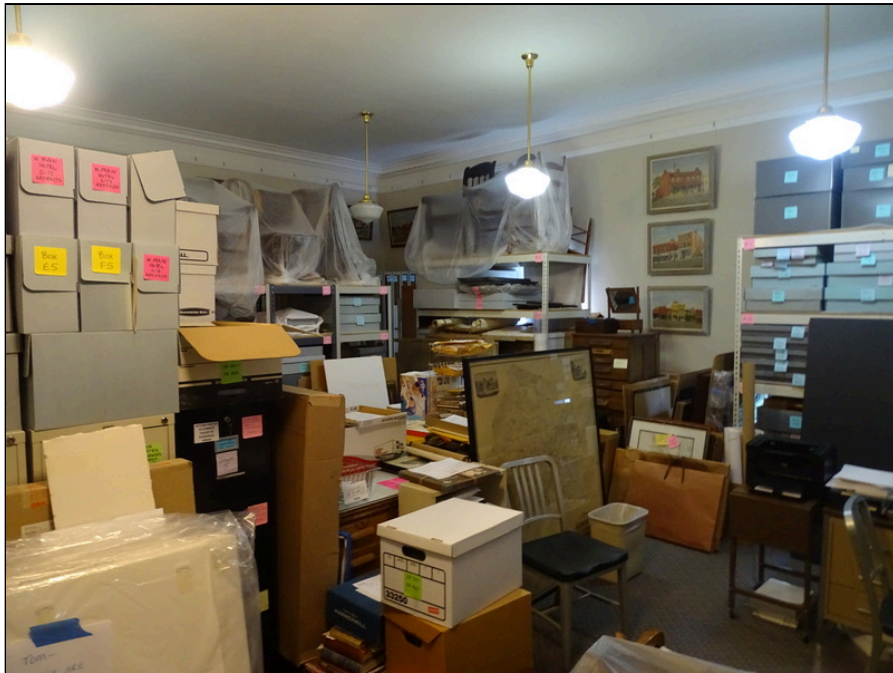
72 - Typical storage area interior

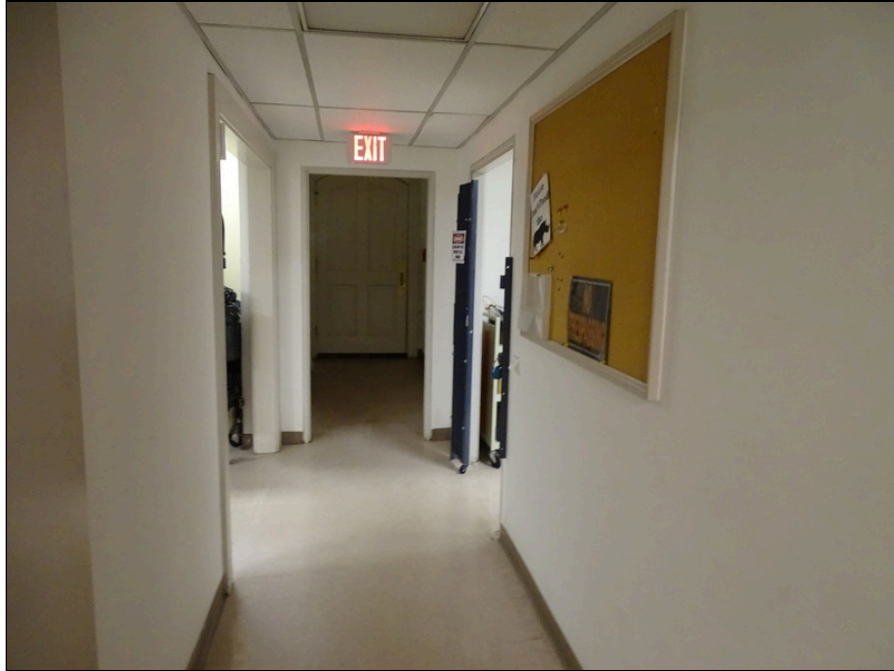
73 - Typical corridor area finishes

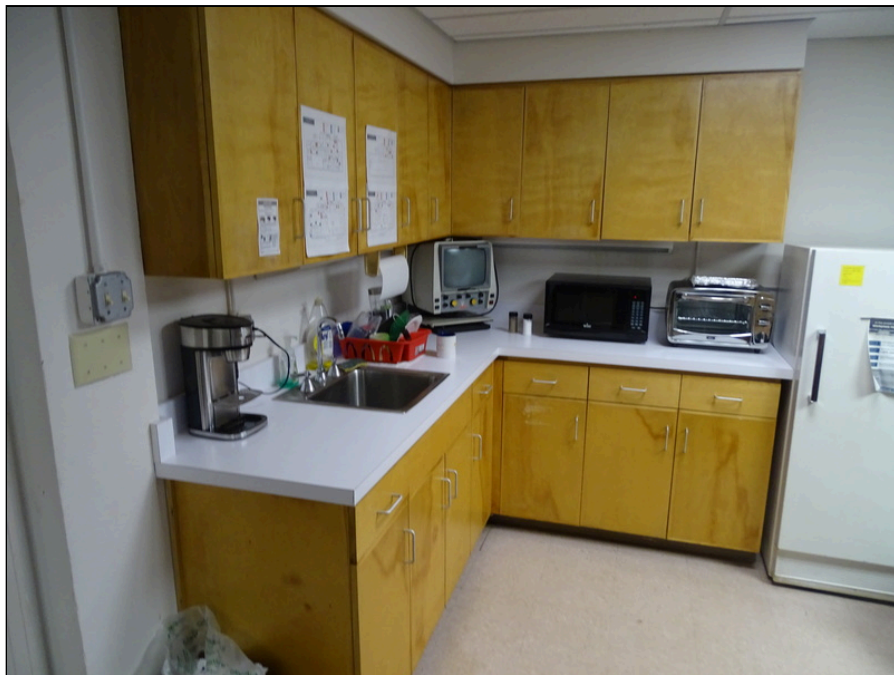
74 - Typical kitchen area finishes

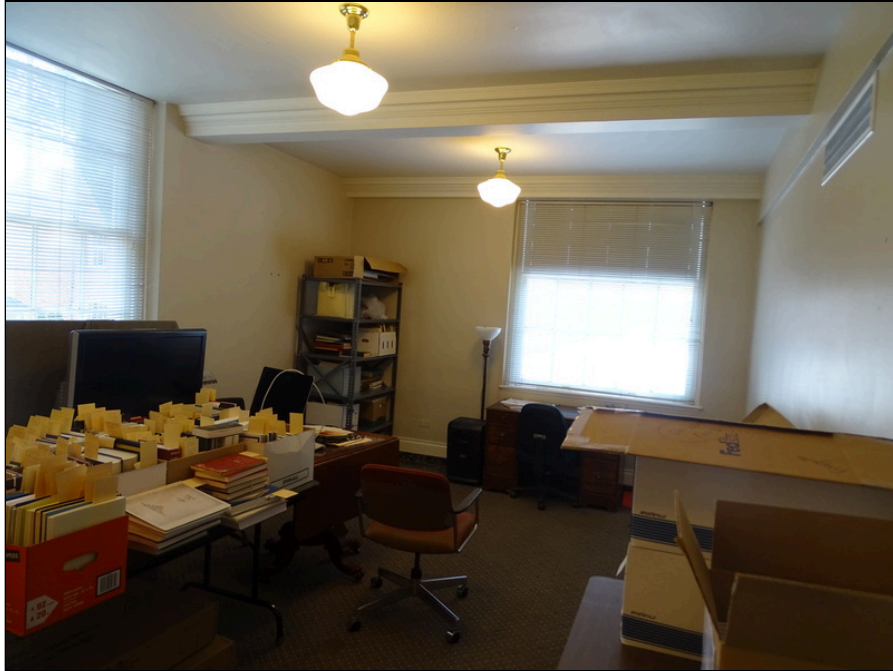
75 - Typical office area interior

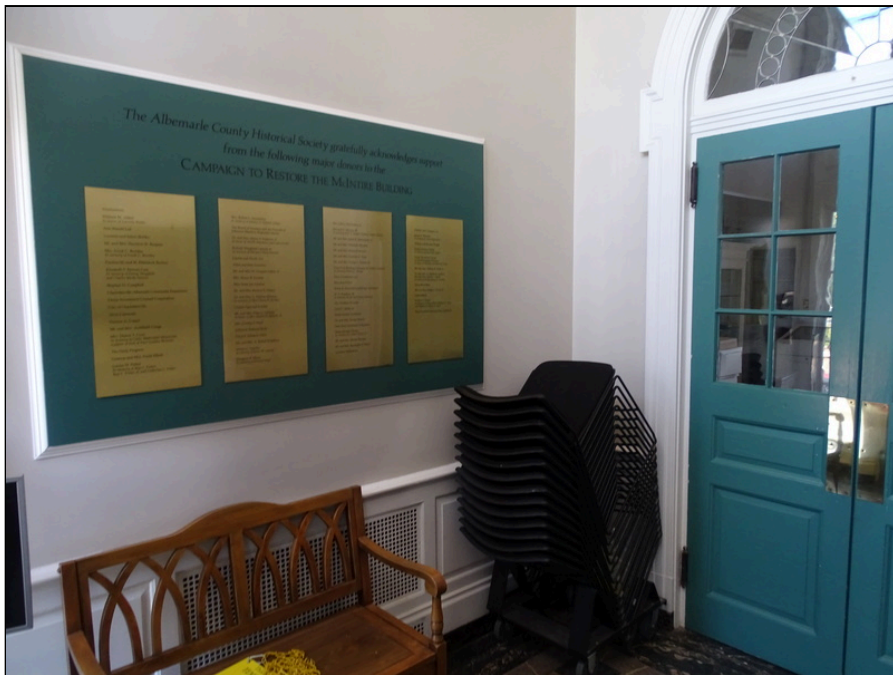
76 - Typical lobby interior

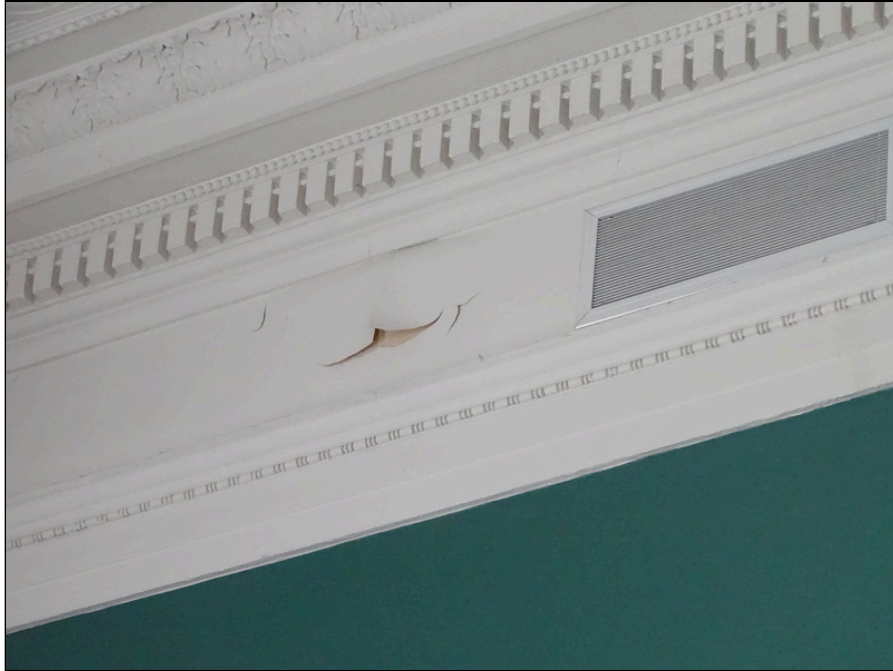
77 - Interior ceiling - note peeling paint

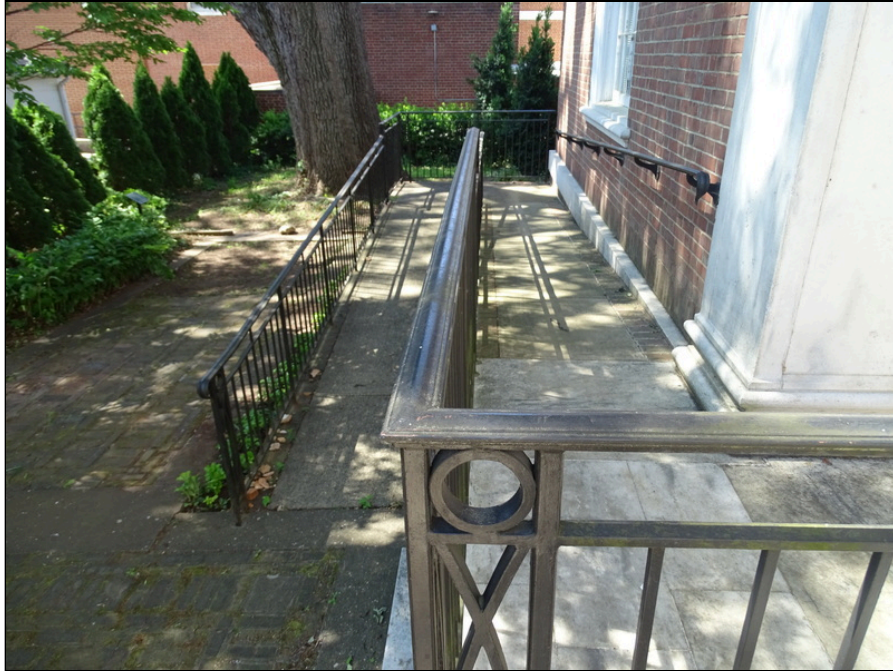
79 - Ramp at east side of the building

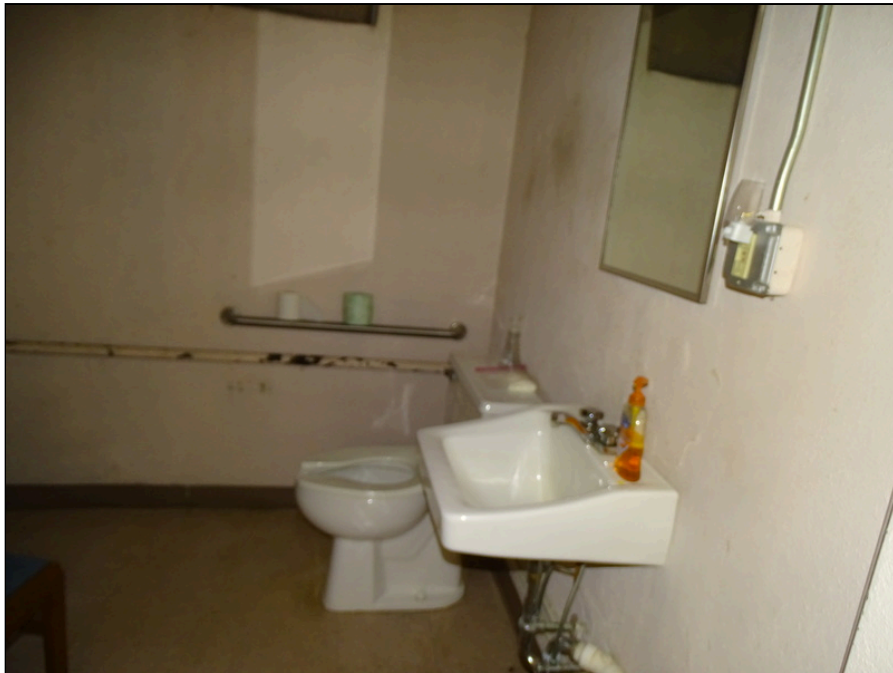
80 - Accessible restroom interior

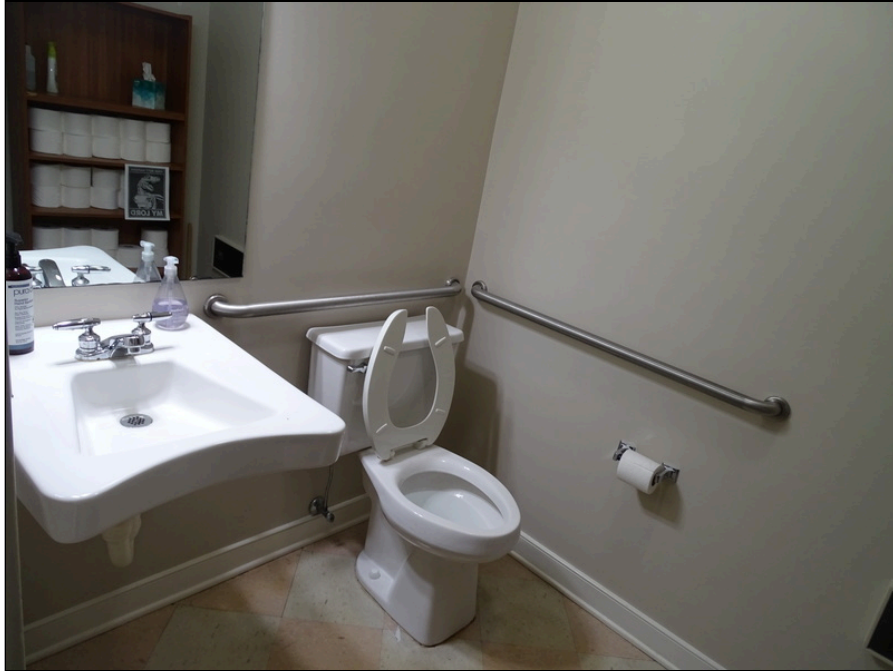
81 - First floor interiors at restroom area
