MCINTIRE BUILDING
200 2ND STREET NE
CHARLOTTESVILLE, VIRGINIA

ECS PROJECT NO. 46:6713

CITY OF CHARLOTTESVILLE - FACILITIES DEVELOPMENT

Reference: Facility Condition Assessment Report for McIntire Building, 200 2nd Street NE,
Charlottesville, Virginia

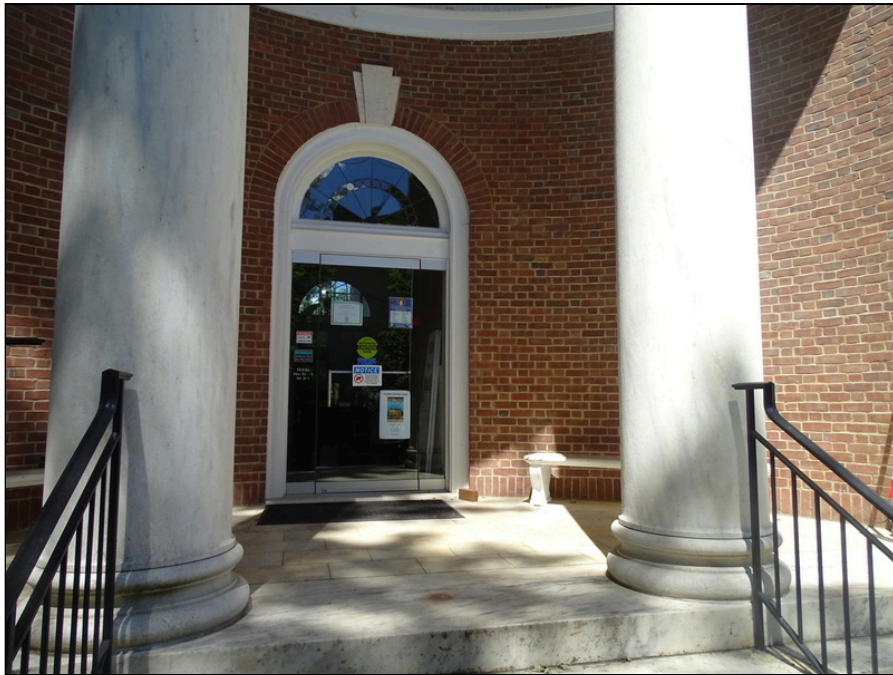
82 - Accessible door access
