MCINTIRE SKATE PARK 425 U.S. 250 BY-PASS CHARLOTTESVILLE, VIRGINIA

ECS PROJECT NO. 46:6713

CITY OF CHARLOTTESVILLE - FACILITIES DEVELOPMENT

Reference: Facility Condition Assessment Report for McIntire Skate Park, 425 U.S. 250 By-Pass, Charlottesville, Virginia

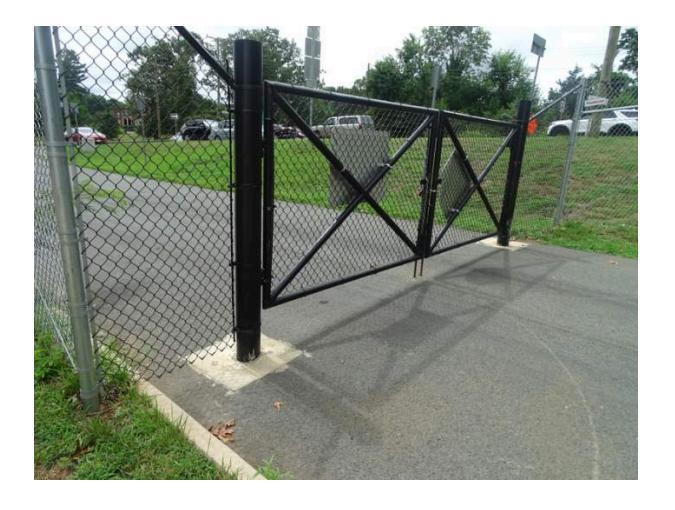
Gated entrance

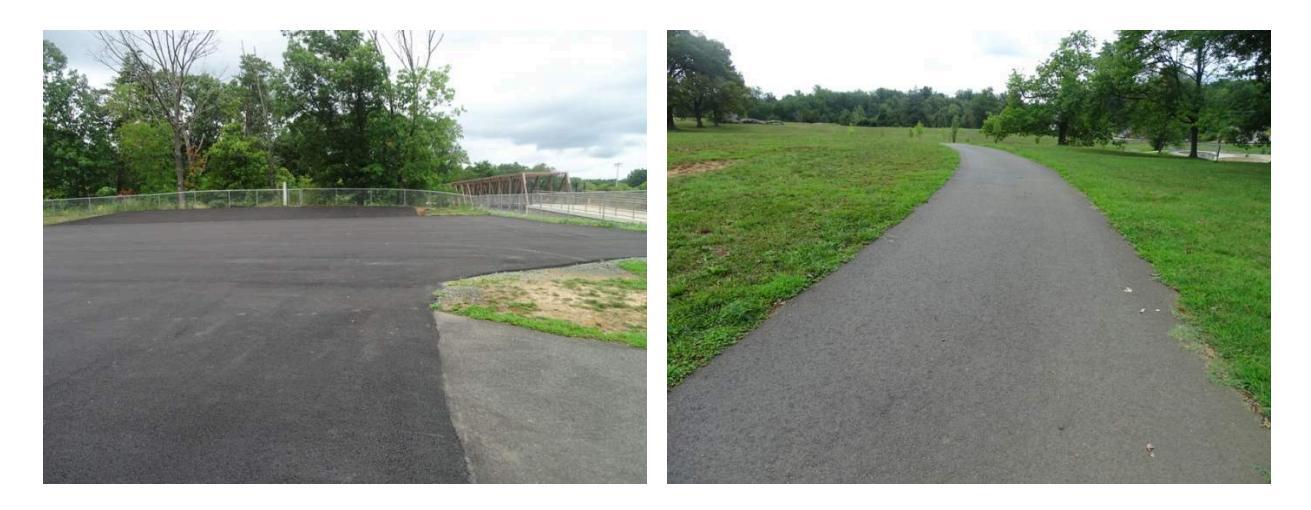
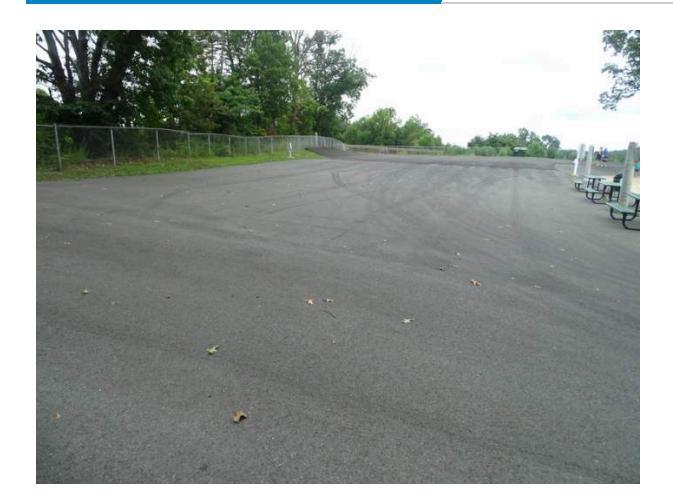
Asphalt-paved parking is available off site with pedestrian access provided by concrete and asphalt paved walking paths and a pedestrian bridge over the adjacent railroad tracks. An asphalt paved lot is located on the west side of the property with gated emergency or maintenance vehicular access only. The asphalt pavement was observed to be in generally good condition. The expected useful life of asphalt pavement is 20 years.

Asphalt pavement overview

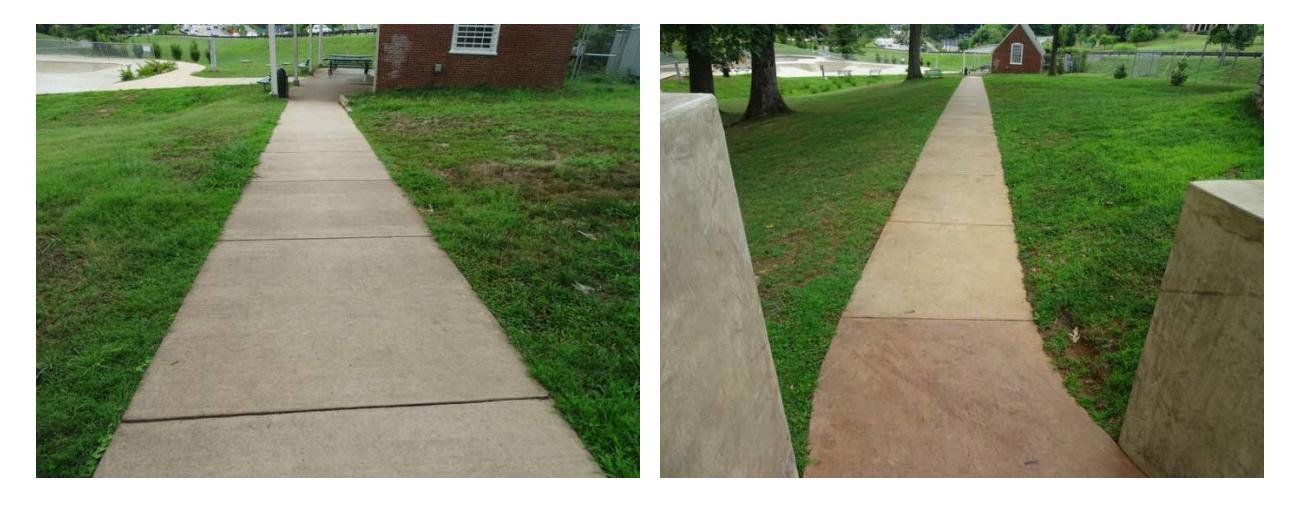
Concrete sidewalks

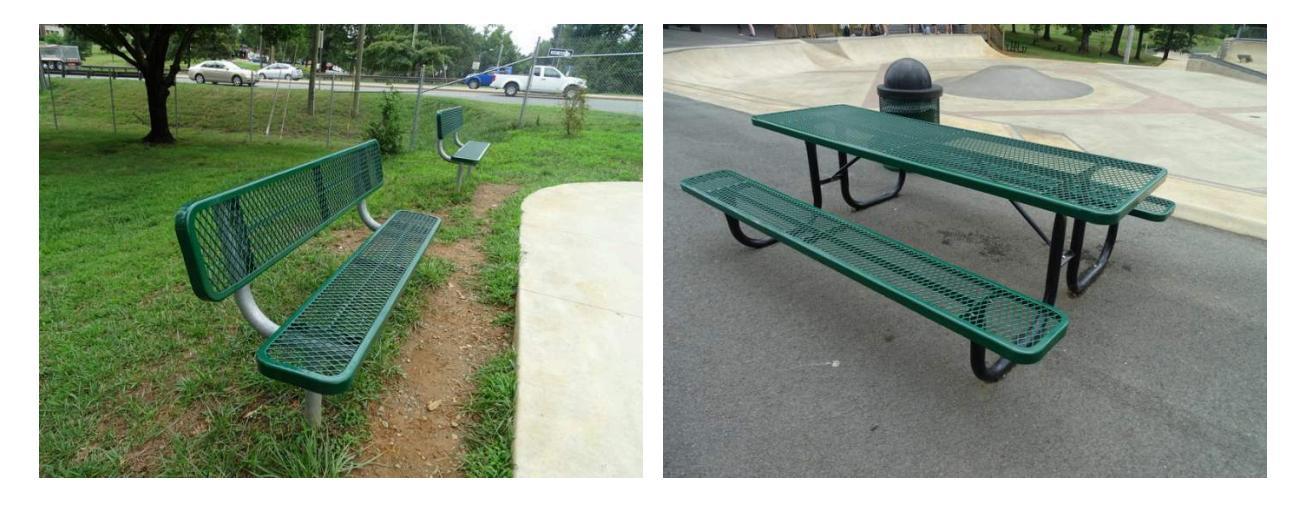
# Park Equipment

Park Equipment

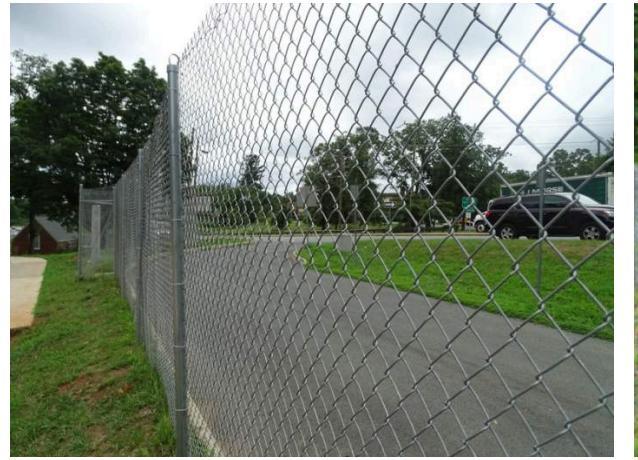
Chain-link fence

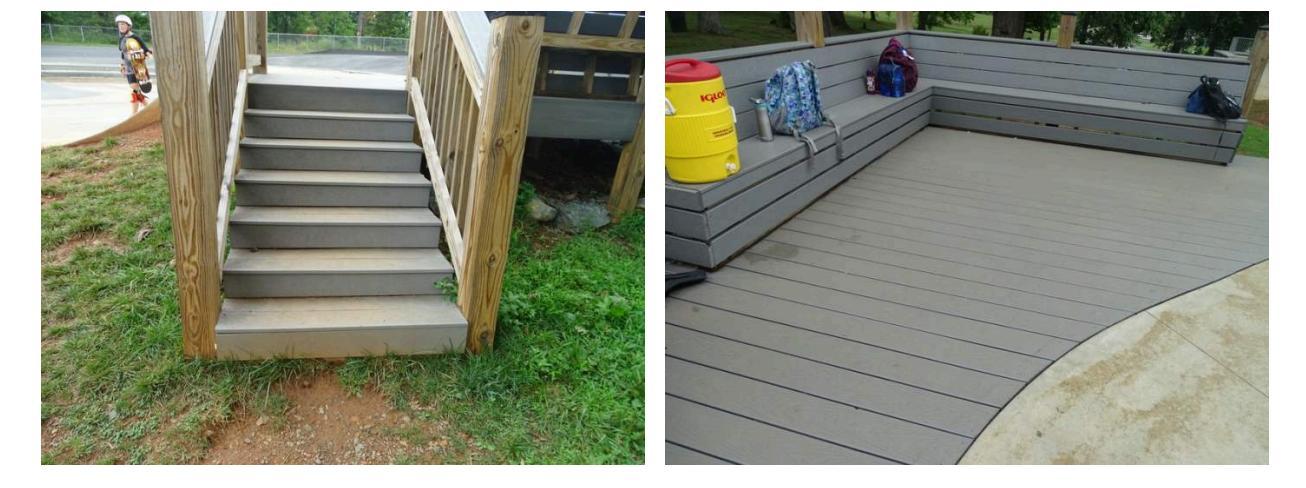
Composite exterior stairs

Composite deck

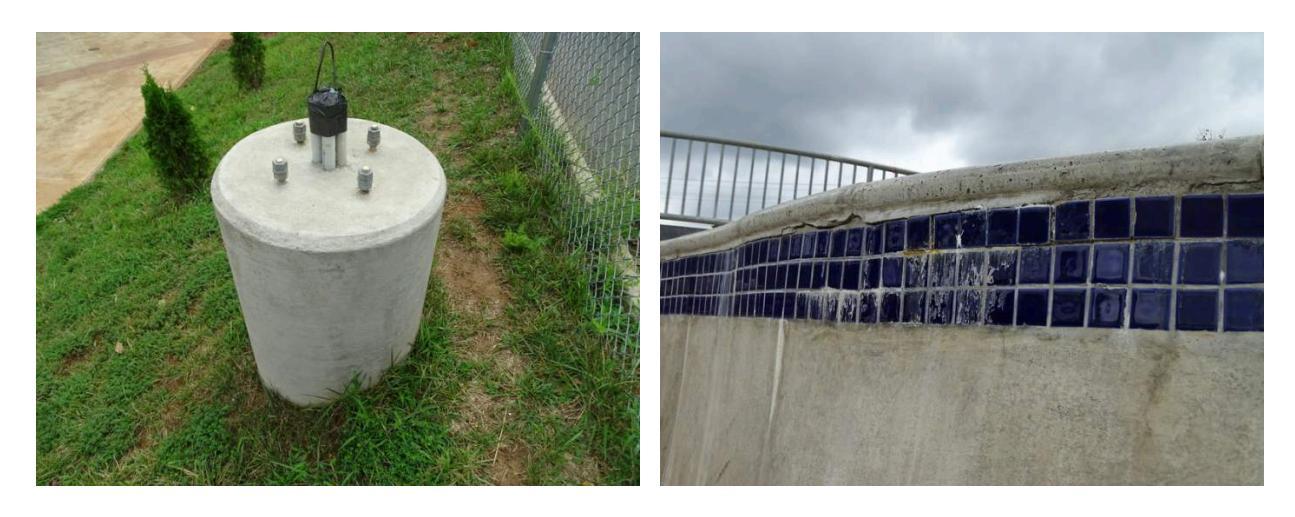
Future pole base

Pool feature tile

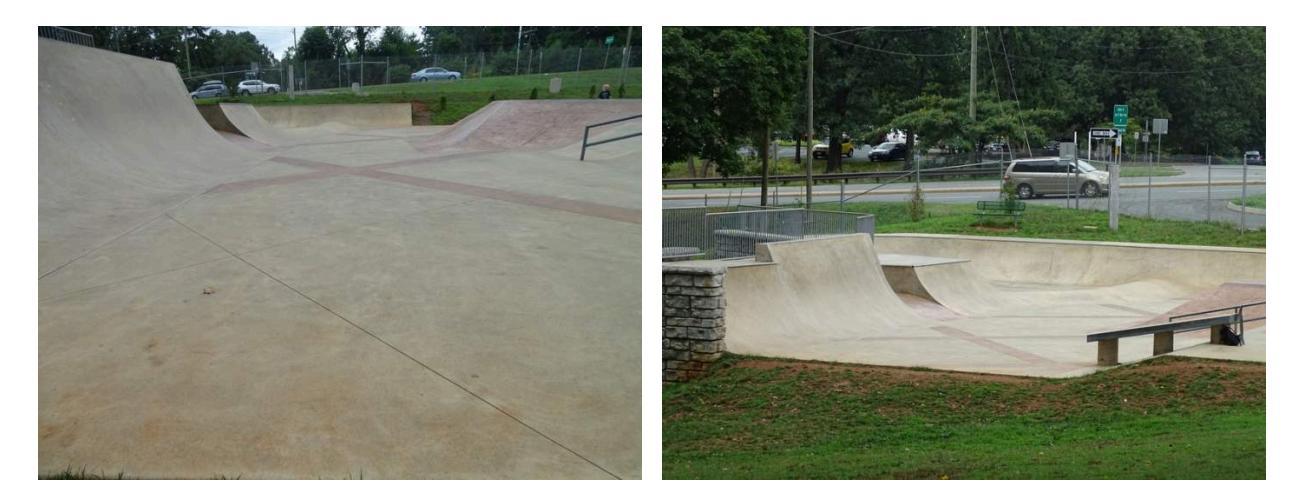
Skate features

Steel handrail

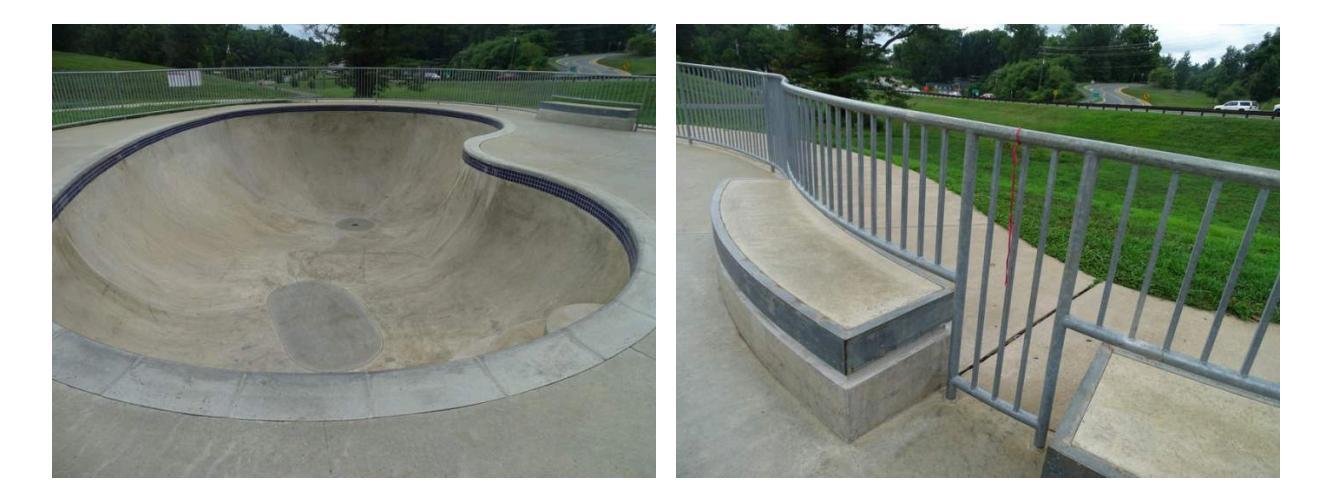
Pool feature

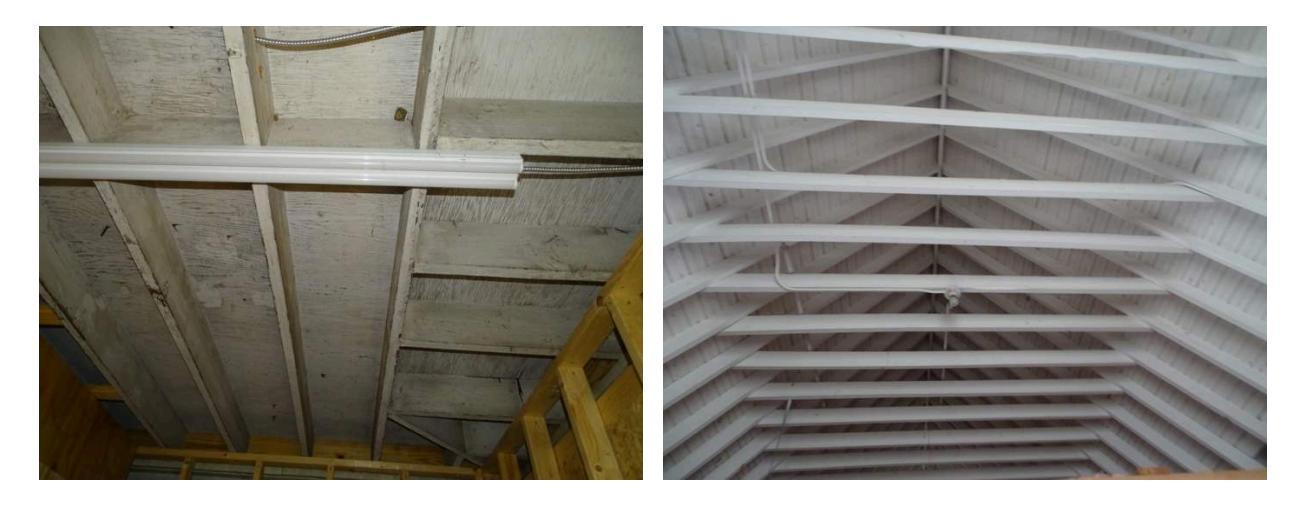
Storage roof framing

Pavilion roof framing

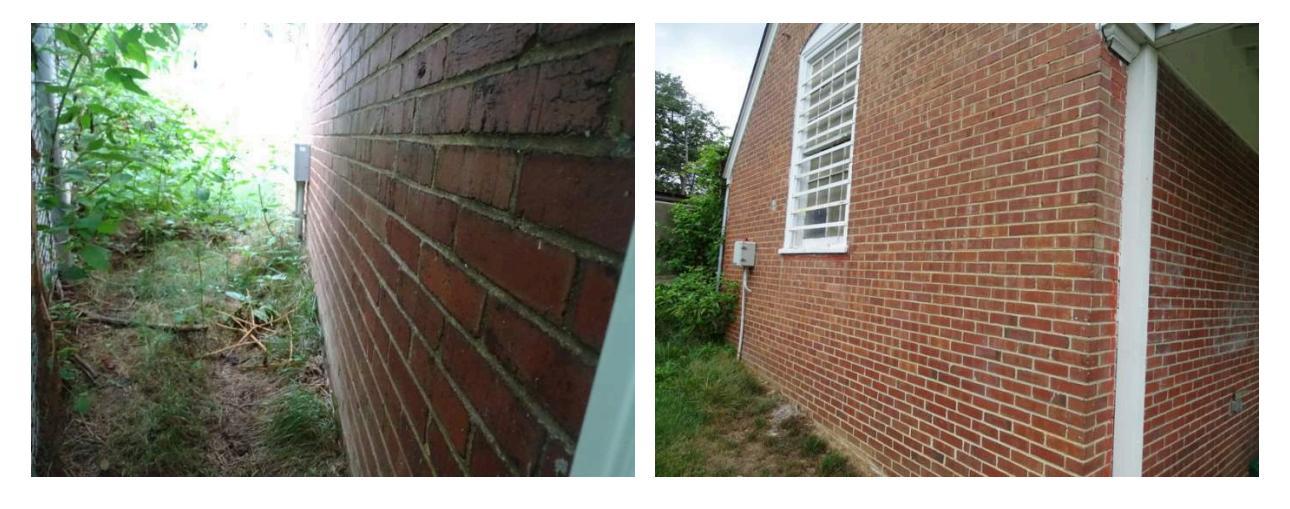
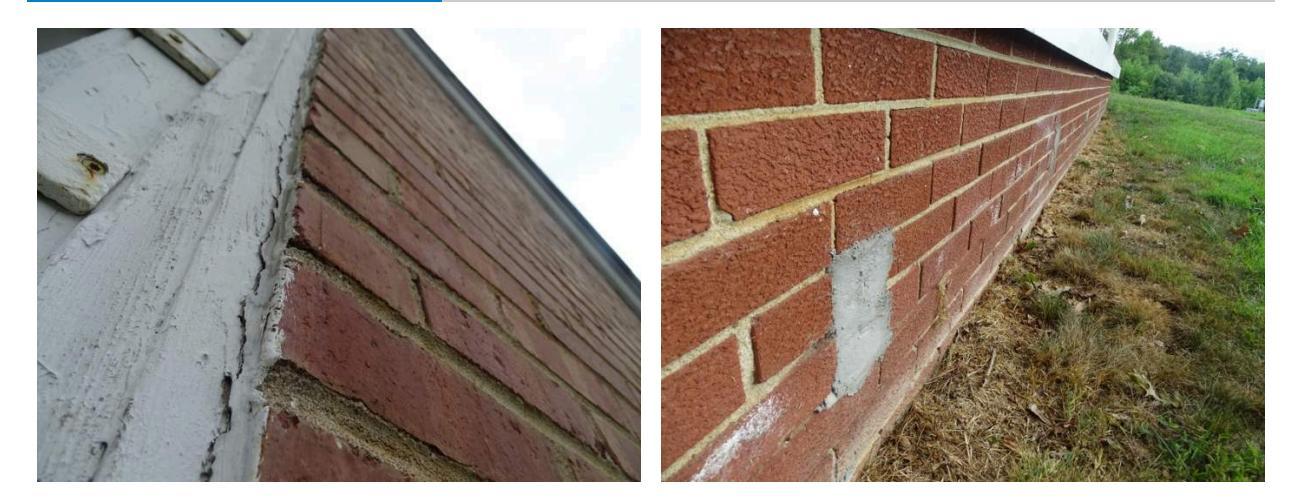
The office/storage exterior consists of brick and wood panel siding. The brick walls were generally in good to fair condition with previous repairs and areas in need of repair noted. Deterioration of the mortar joints was observed. The steel columns and beams were painted and supported the west side of the structure that was assumed to have been open at some point. Wood framed walls have been installed to close in the space for storage. The wood framed walls are flashed over the existing brick knee walls and covered with wood panel siding. Exterior sealants are located around the window and door frames and at the brick to wood transitions. The expected useful life of exterior sealants is approximately 10 to 12 years before replacement is needed. The exterior sealants were generally in fair condition. An allowance has been included to paint the exterior and replace the sealants during the study period.

Typical exterior wall

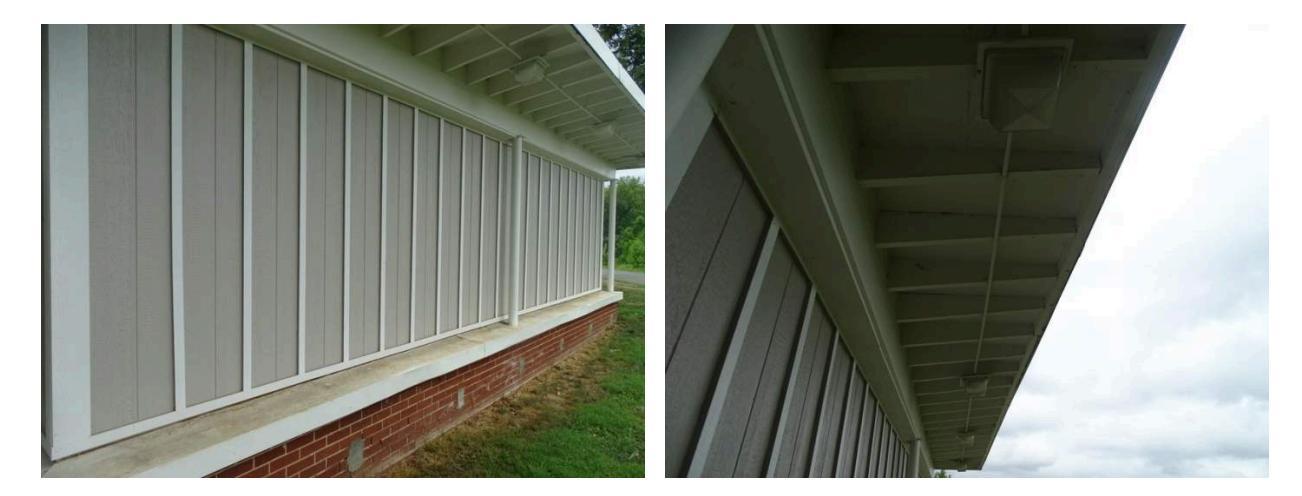
Typical wood siding

Typical overhang

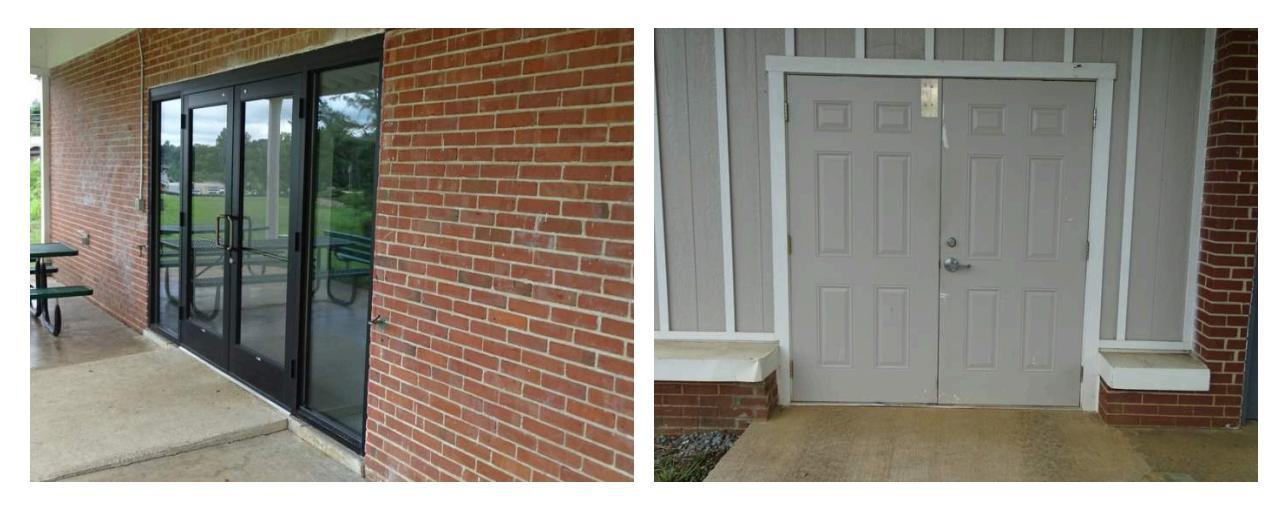
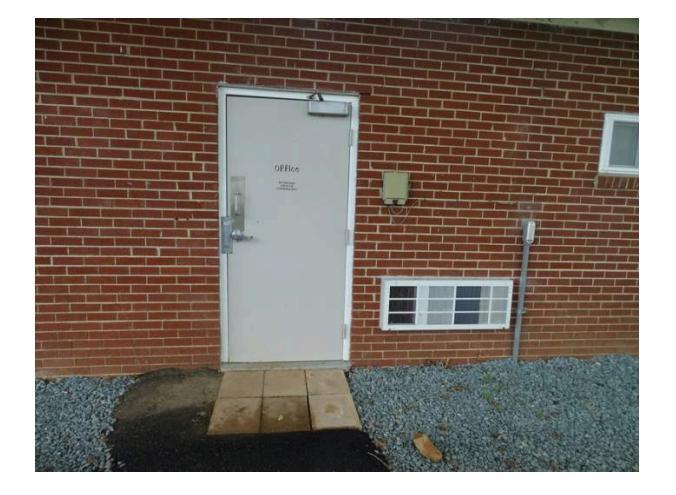
Typical main entrance

Typical entrance door

Typical personal door

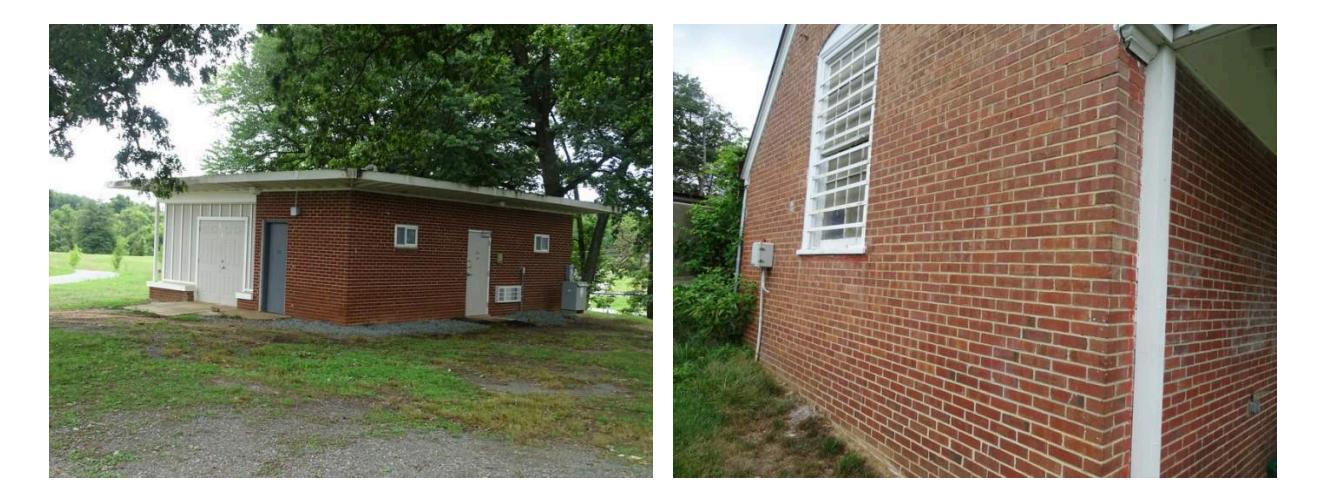
The window system for the office building consists of vinyl frame, double pane, sliding windows. The windows appeared to be in good condition.

Office/storage building

Typical exterior wall

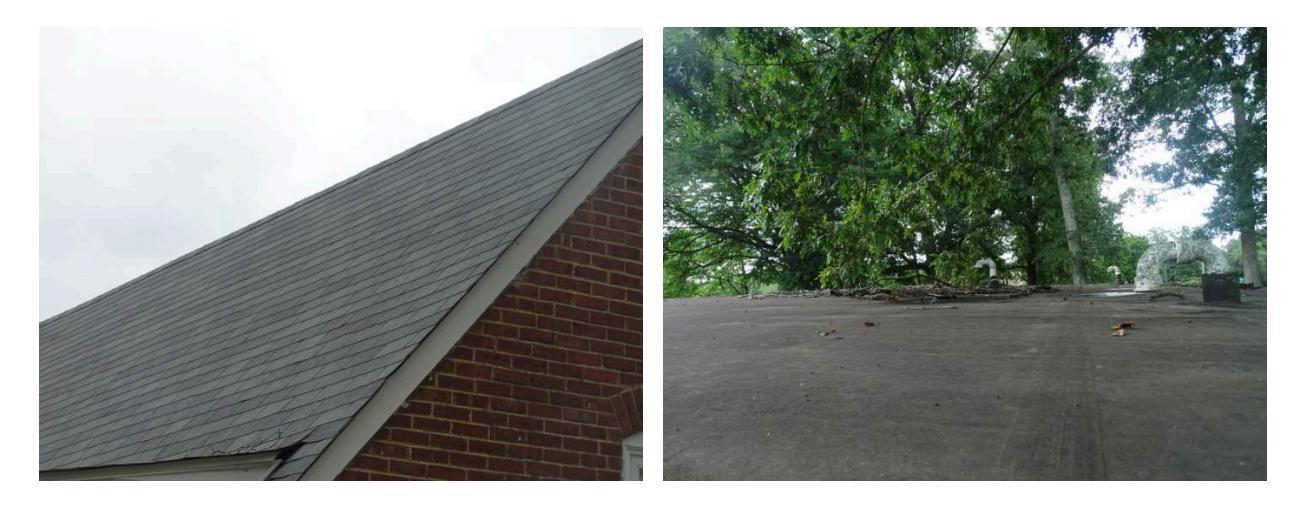
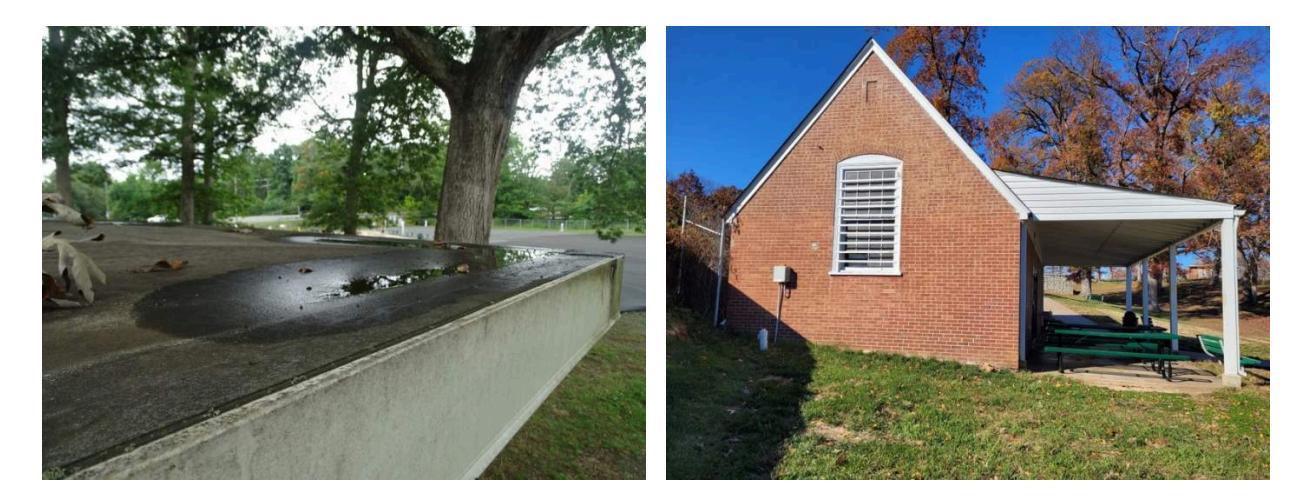
Typical roofing system

Restroom exterior

An allowance has been included to replace the roofs during the study period.

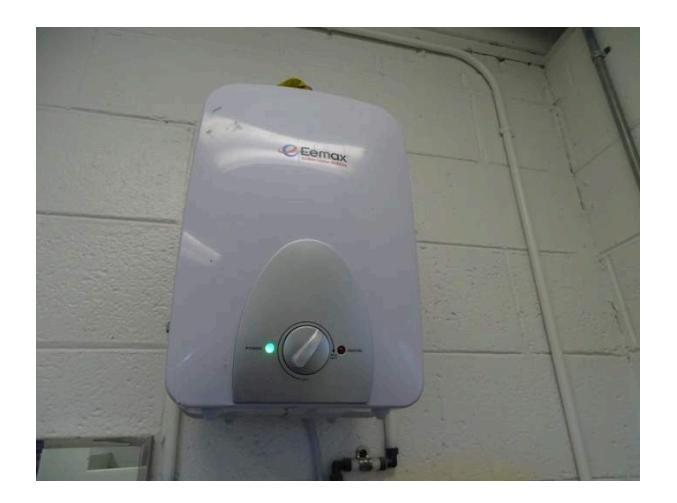
Domestic hot water is provided in the office building by a small electric point-of-use heater hung on the wall of the bathroom. The heater was in good condition. The expected useful life of an electric water heater is approximately 12 to 15 years. We recommend the water heater be replaced during the study period.

Tankless water heater

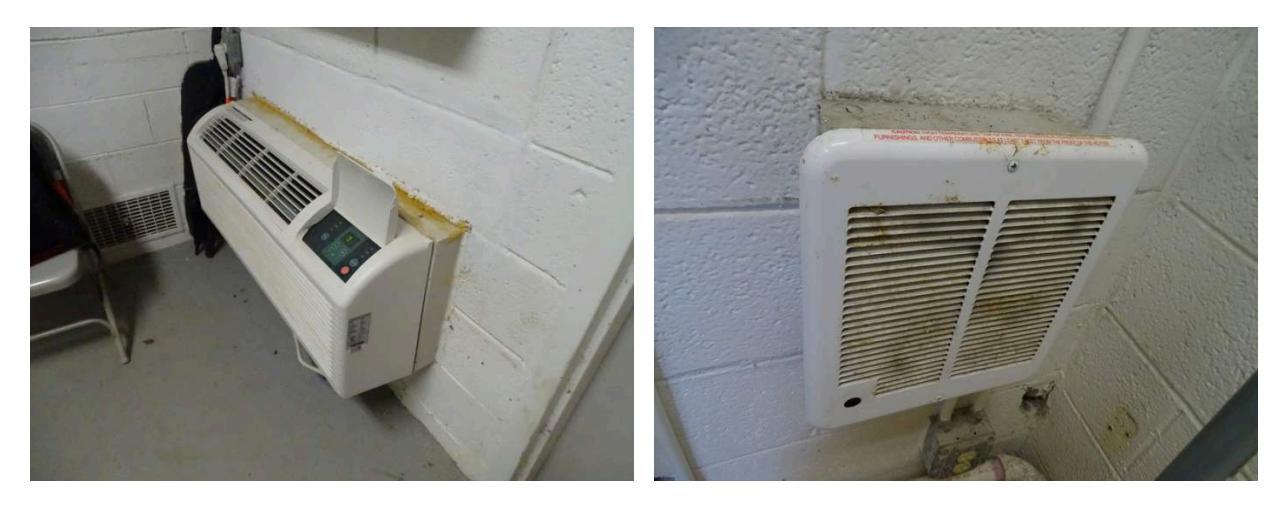
Through-wall heat pump

Unit Heater

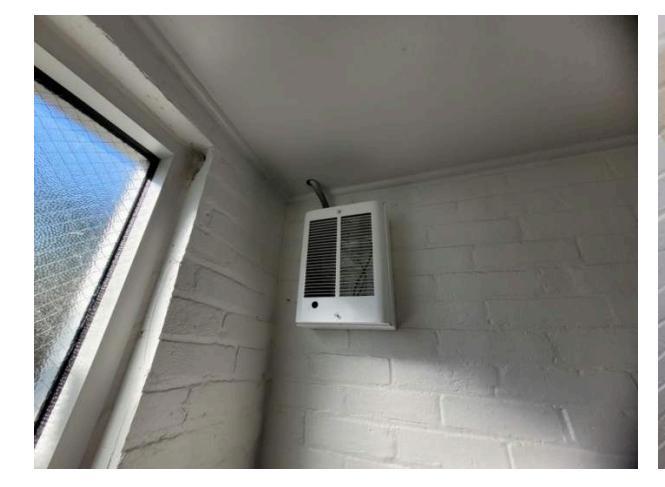
Restroom space heater

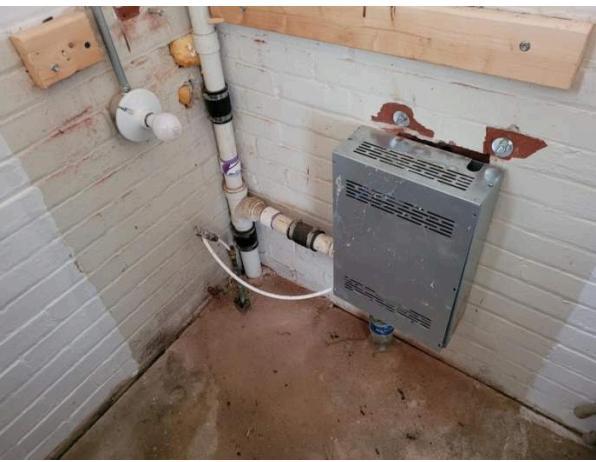
Exterior drinking fountain

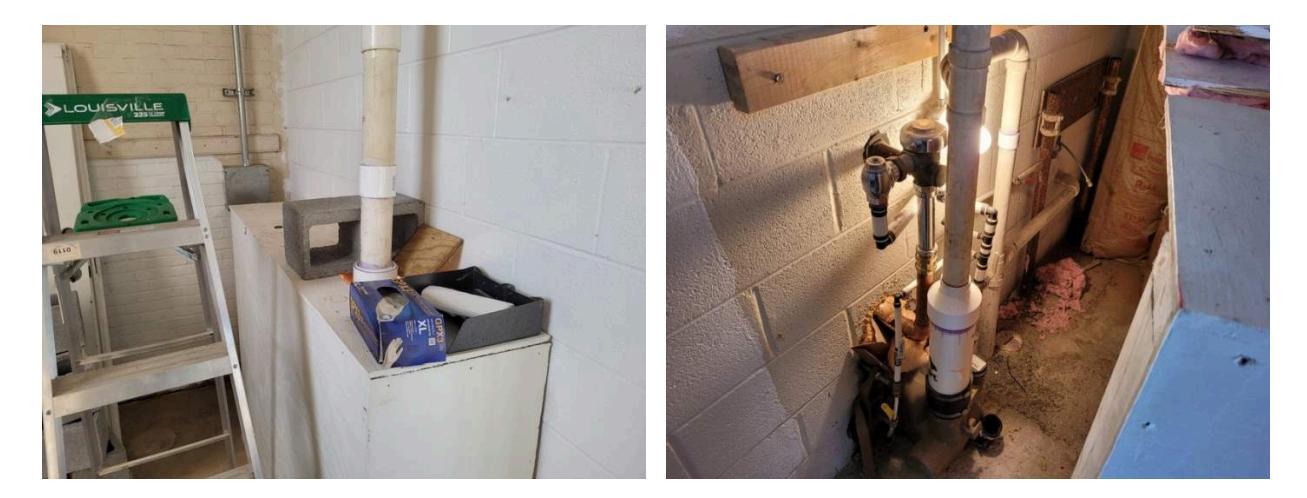
Typical plumbing cover

Restroom plumbing

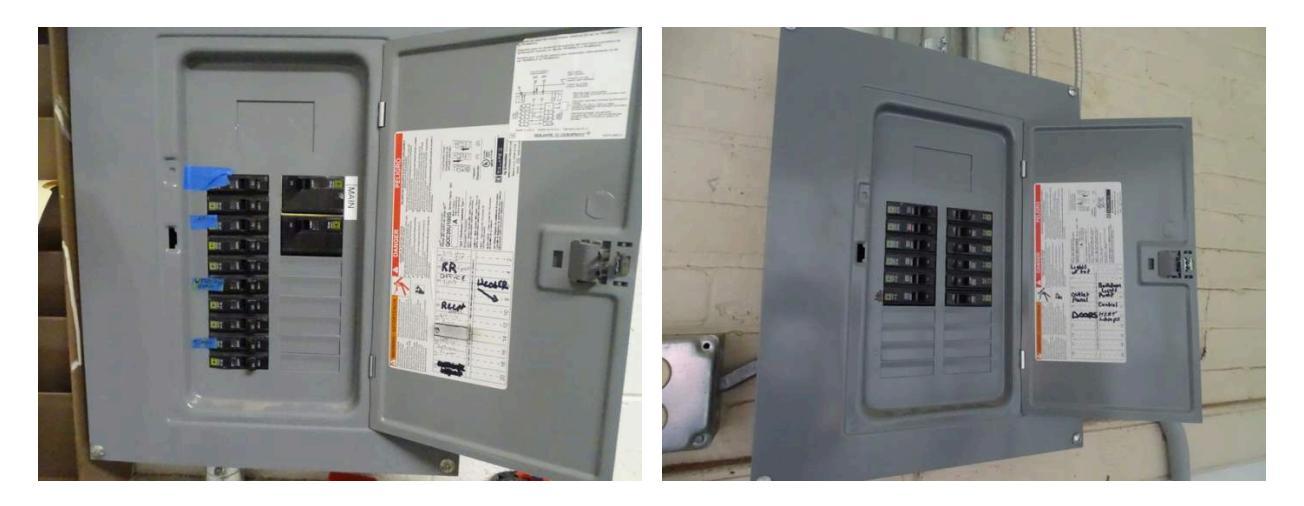
Power is distributed by copper wire from circuit breaker panels located at each of the buildings. The expected useful life of sub-panels is 50 years with proper maintenance. The circuit breaker panels were observed to be in generally good condition.

Office electrical panel

Restroom sub panel

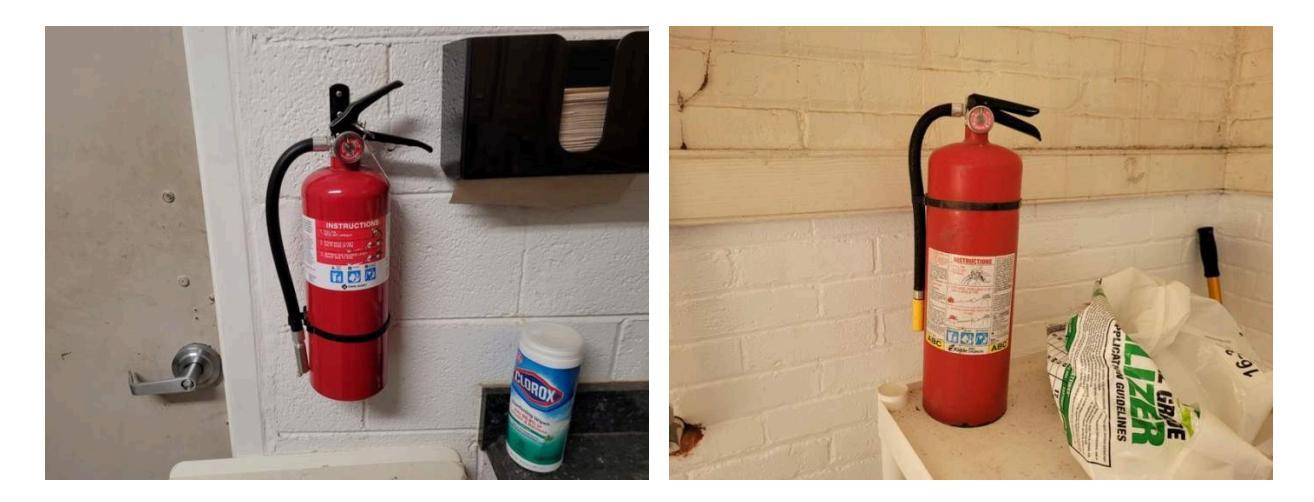
Office extinguisher

Restroom extinguisher

We recommend adding multiple fire extinguishers to both buildings and servicing these devices annually.

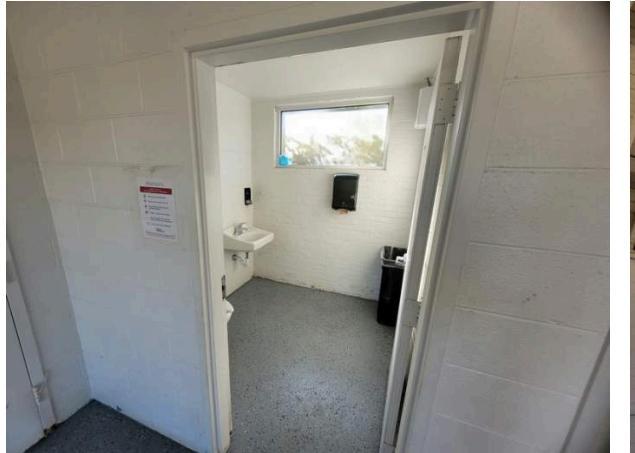
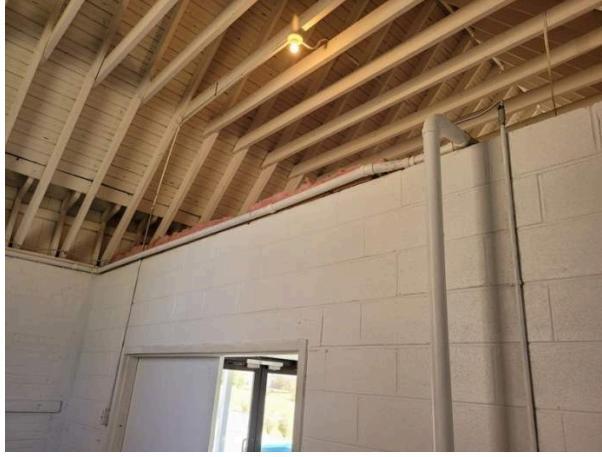
Accessible restroom

Restroom building interior

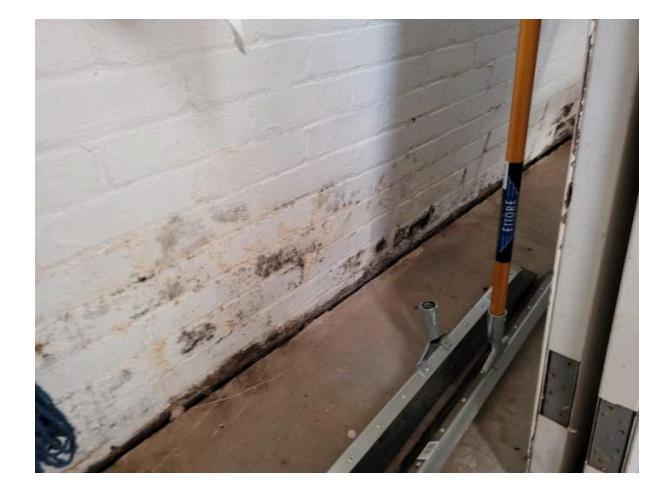
The finishes in the utility rooms include unfinished concrete floors, painted CMU and brick walls, and unfinished ceilings. The finishes in the utility rooms were observed to be in generally fair condition. A suspect substance was observed on the exterior walls. The substance may require further testing. It was noted that exterior grading maintenance was performed to resolve a water intrusion issue at the pavilion building.

Suspect substance on wall

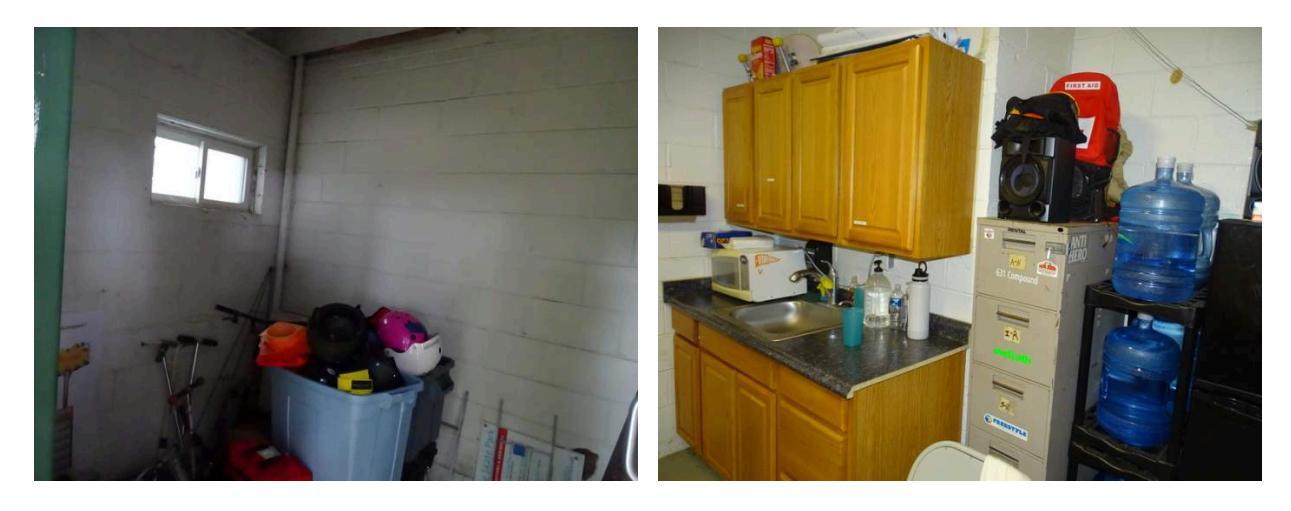
The finishes in the office building were generally in fair condition and in need of rehabilitation. An allowance for updating the finishes has been included.

Typical utility room

Typical kitchen interior

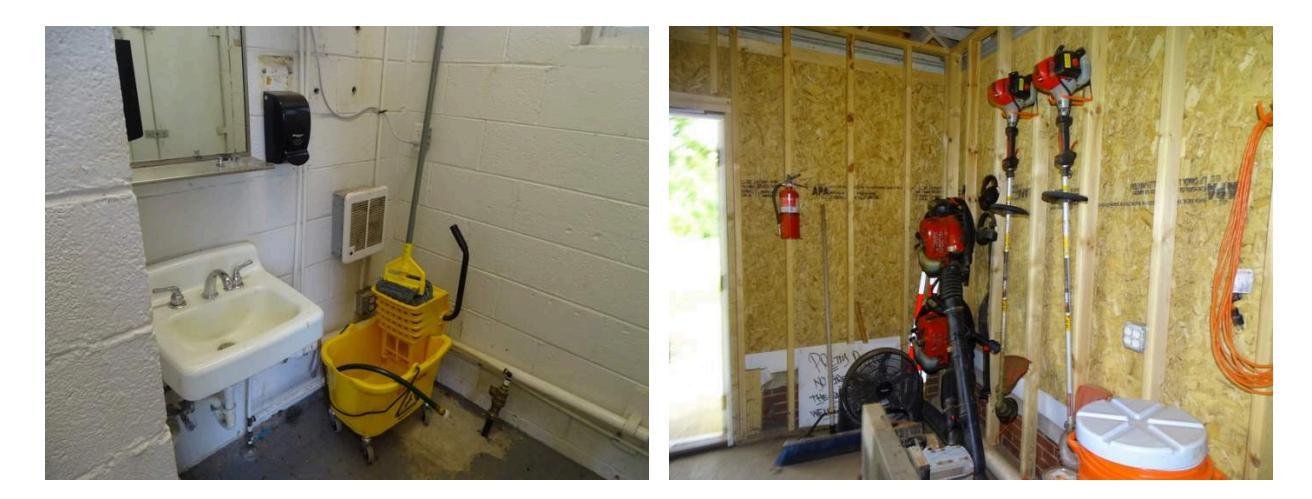
Office restroom

Storage room framing

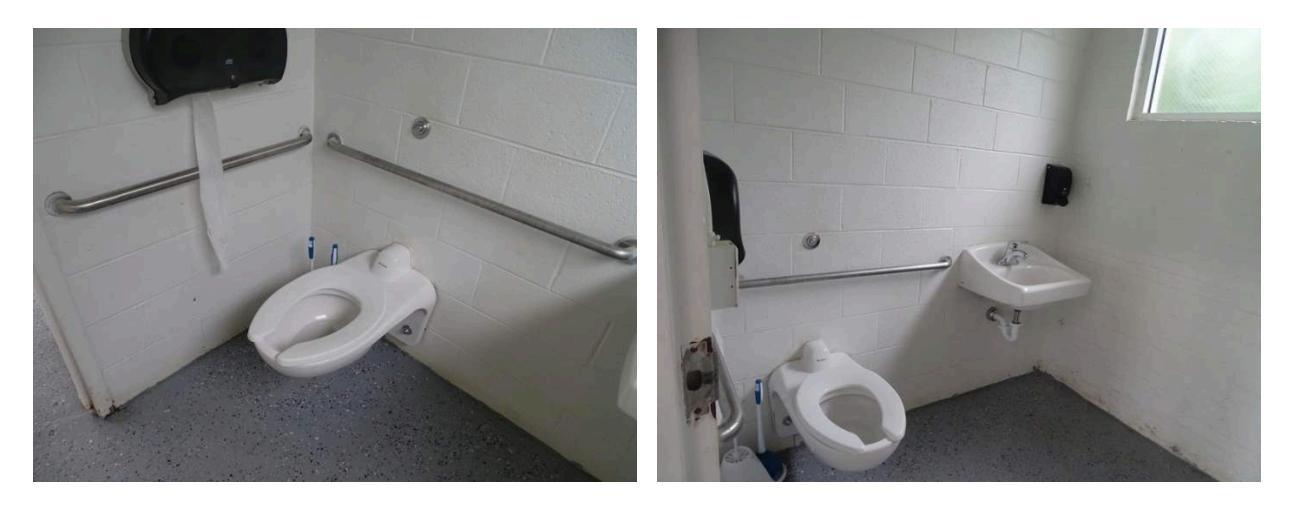
Accessible restroom

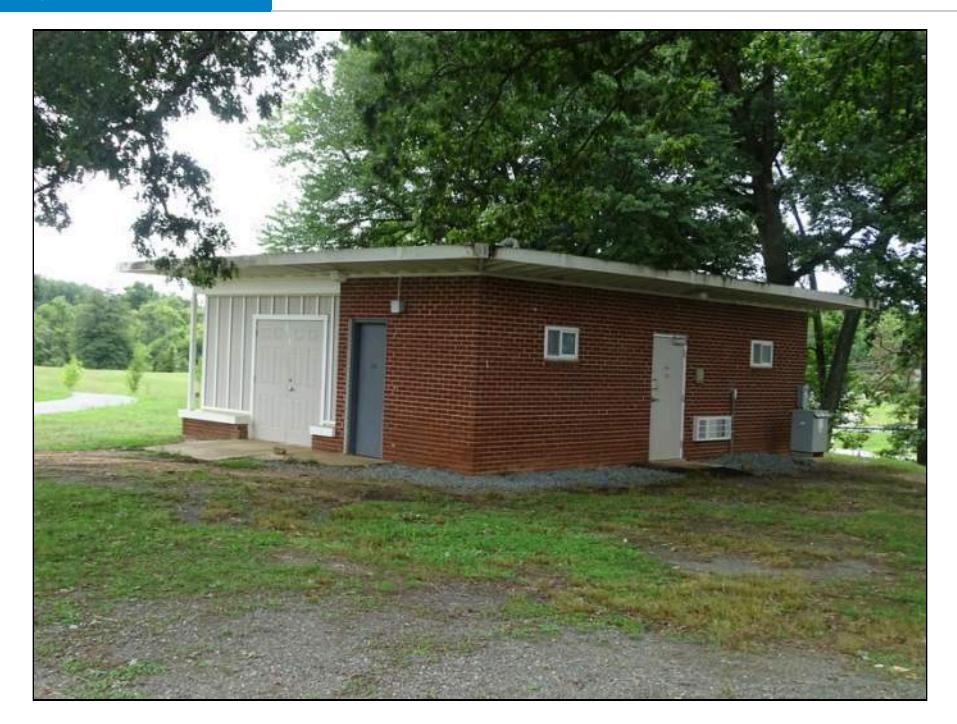
1 - Office/storage building

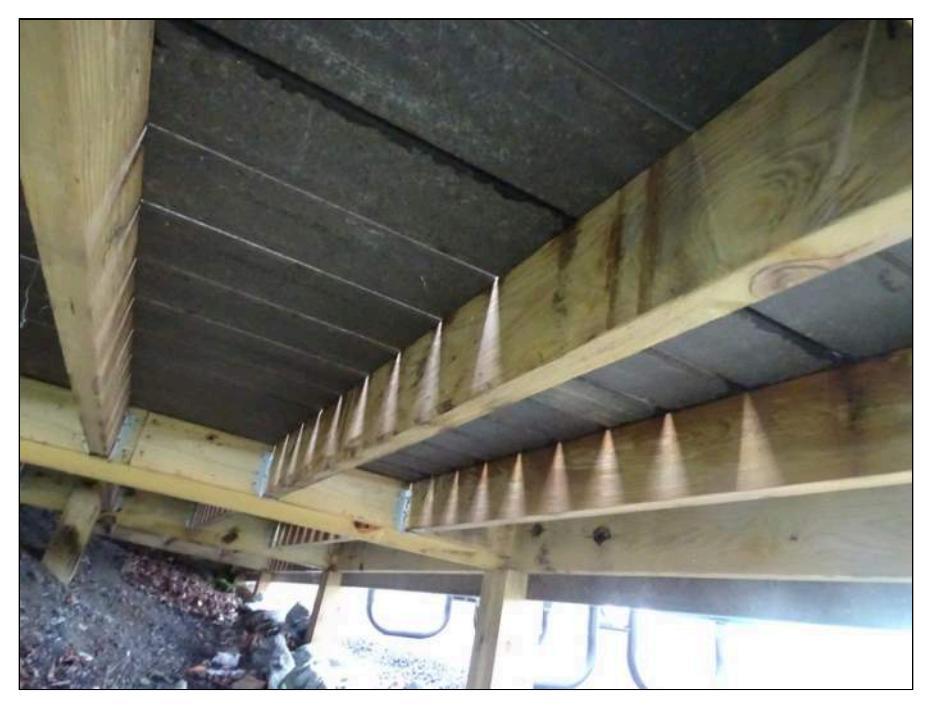
2 - Composite deck framing

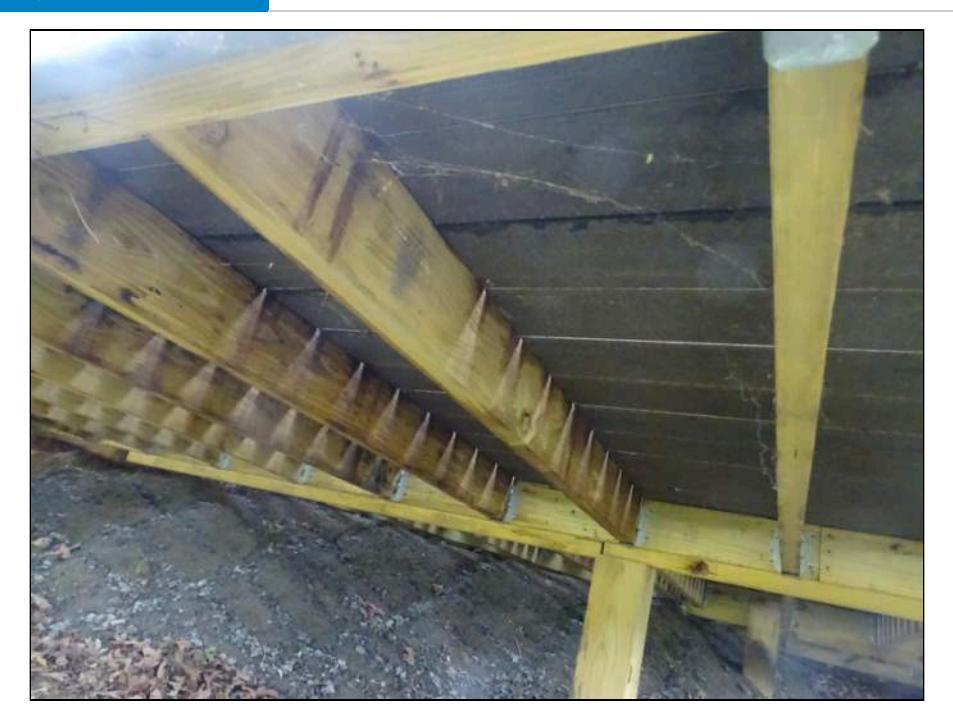
3 - Deck framing

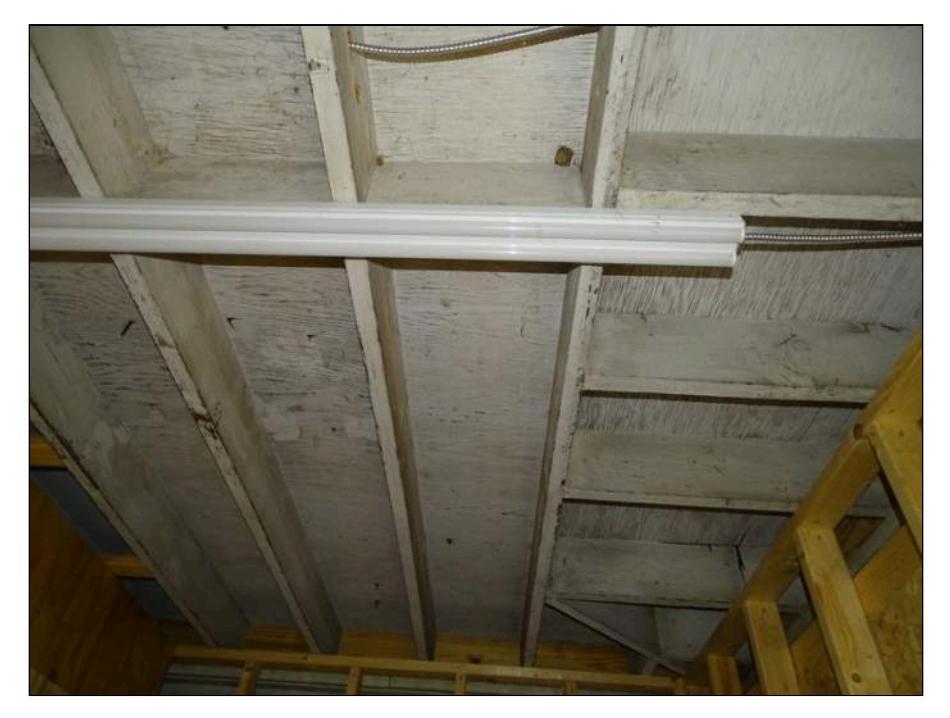
4 - Storage roof framing

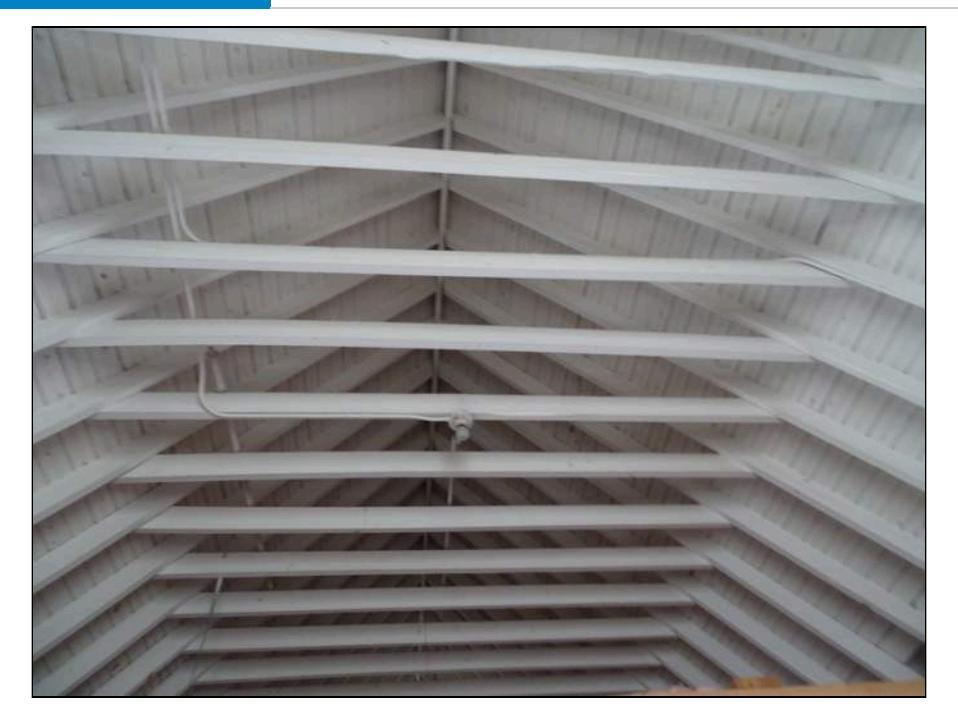
5 - Pavilion roof framing

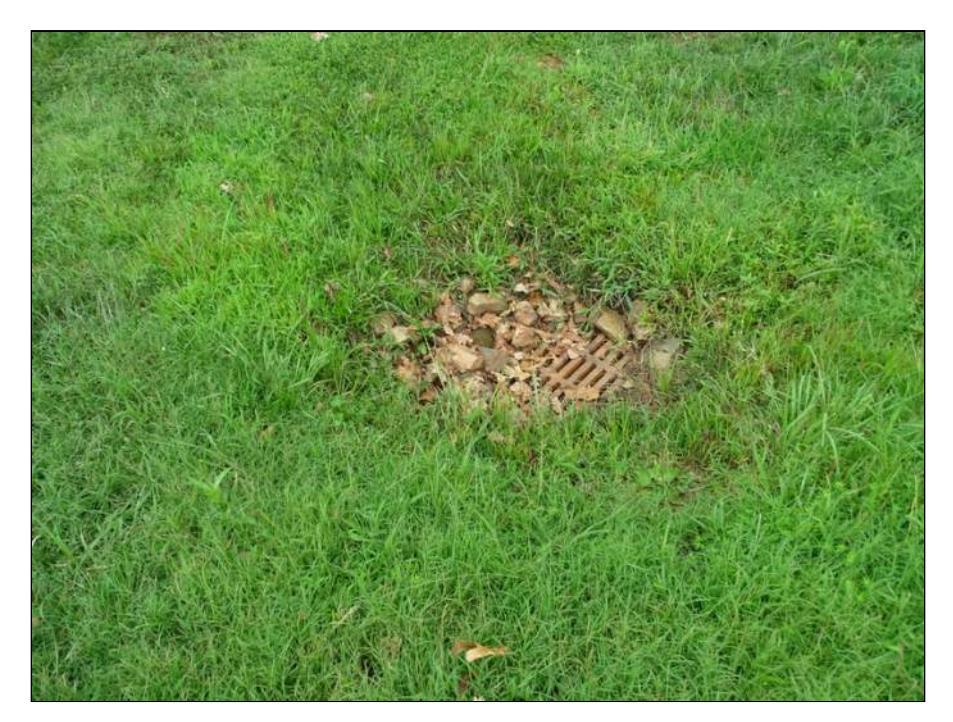
6 - Typical yard drainage
