MCINTIRE SKATE PARK 425 U.S. 250 BY-PASS CHARLOTTESVILLE, VIRGINIA

ECS PROJECT NO. 46:6713

CITY OF CHARLOTTESVILLE - FACILITIES DEVELOPMENT

Reference: Facility Condition Assessment Report for McIntire Skate Park, 425 U.S. 250 By-Pass, Charlottesville, Virginia

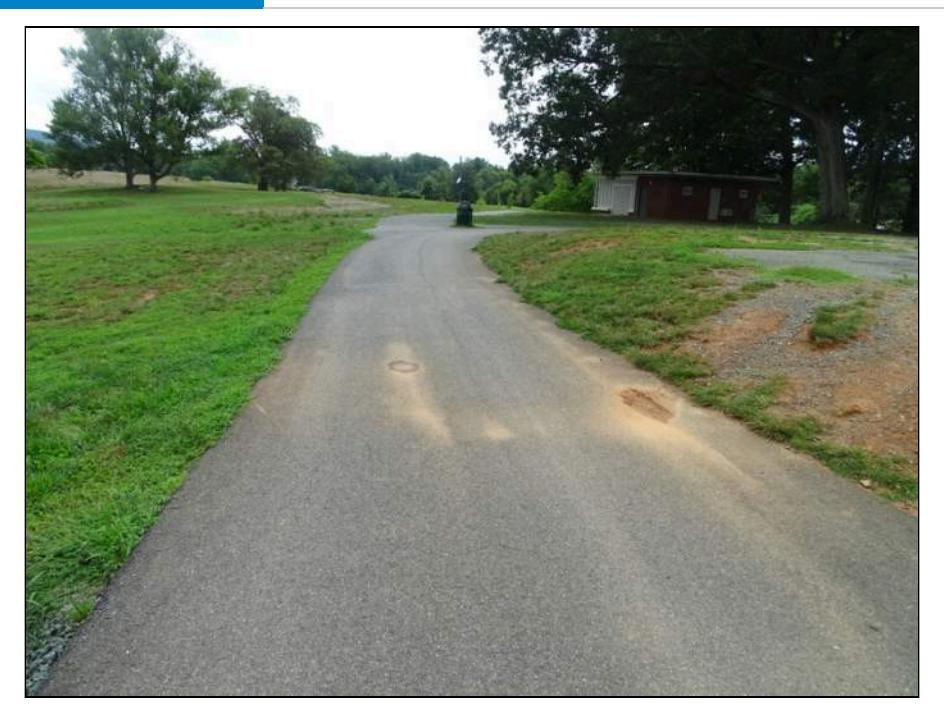
7 - General site topography

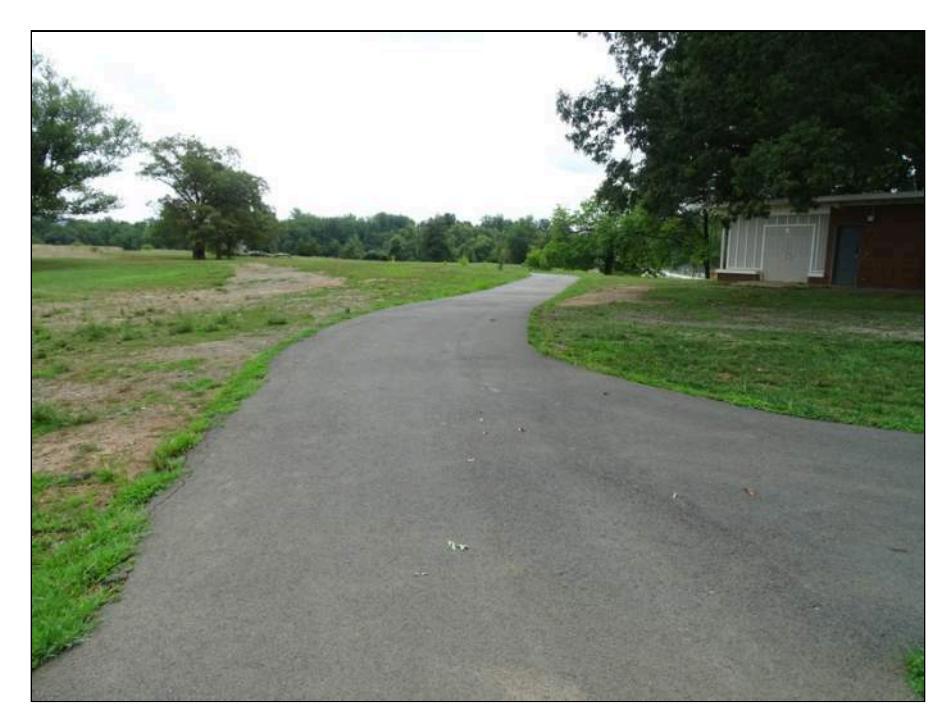
8 - General site topography

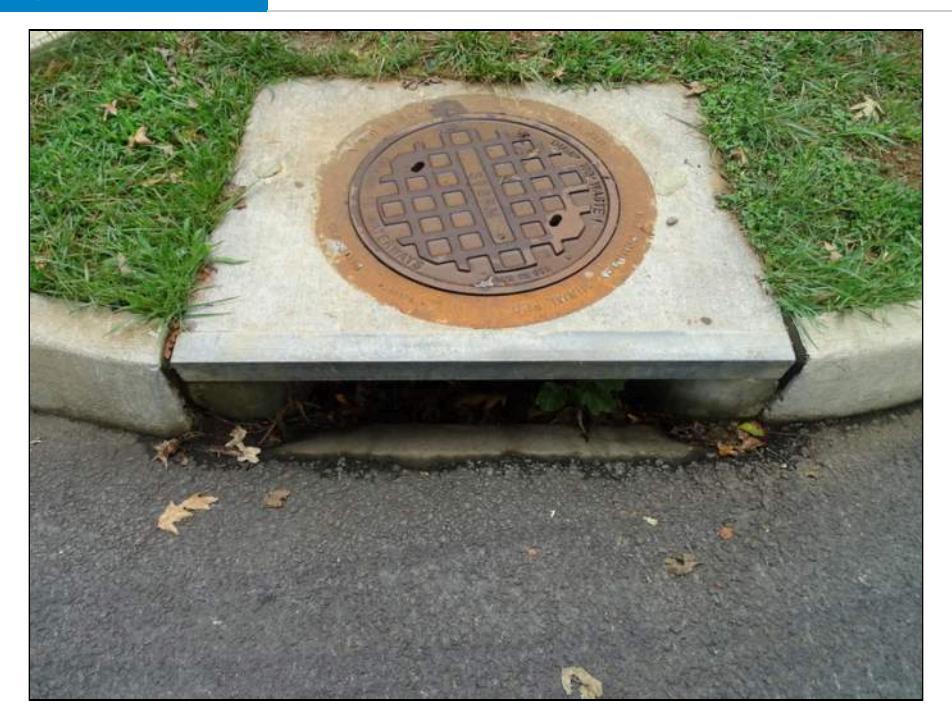
9 - Stormwater drainage

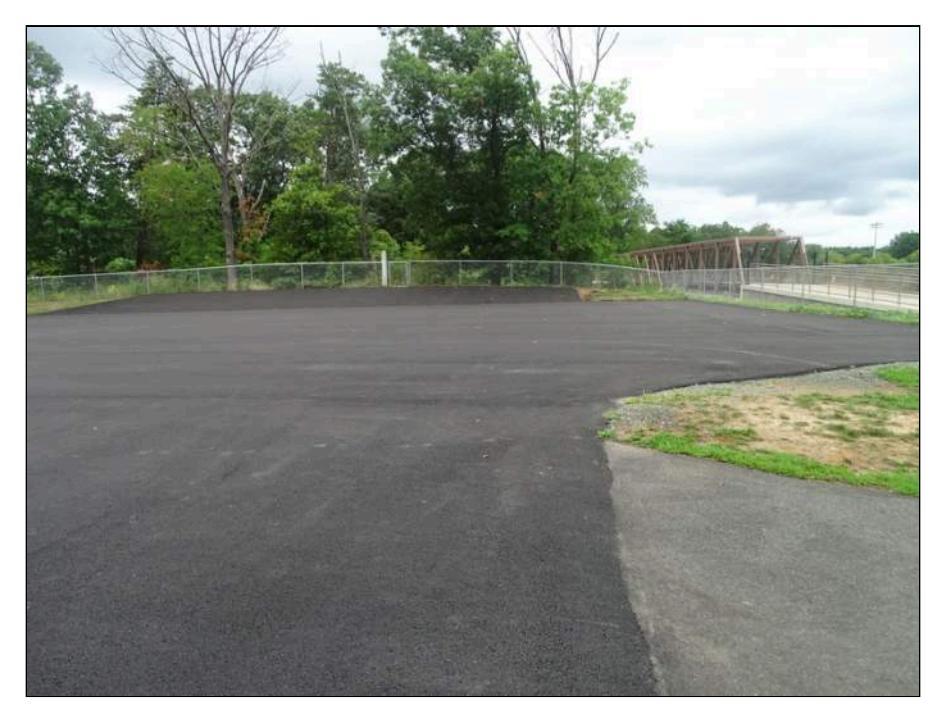
10 - Asphalt pavement overview

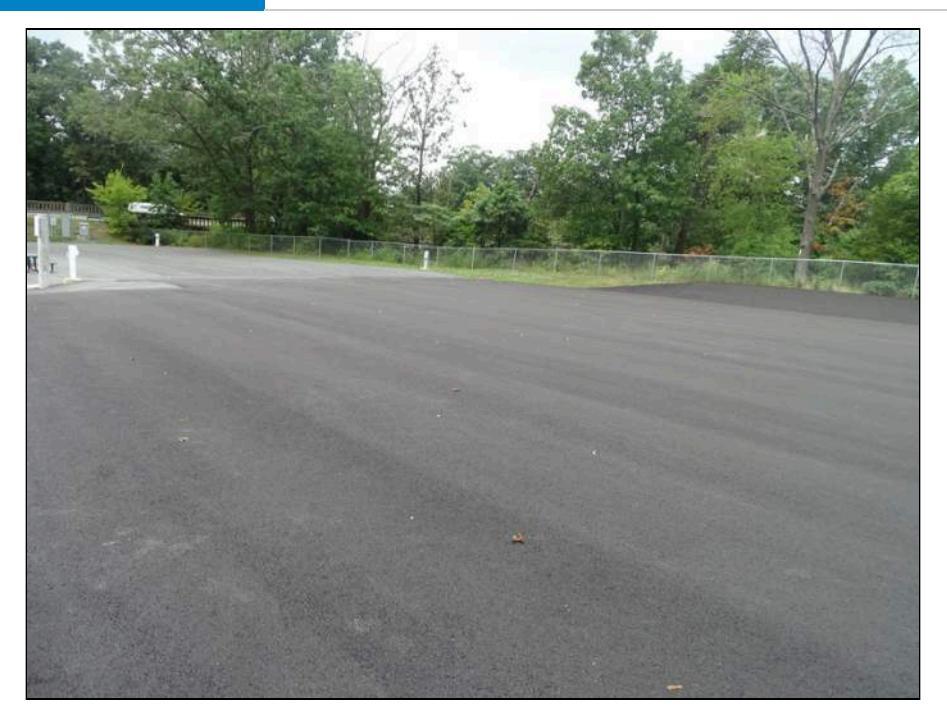
11 - Asphalt pavement overview

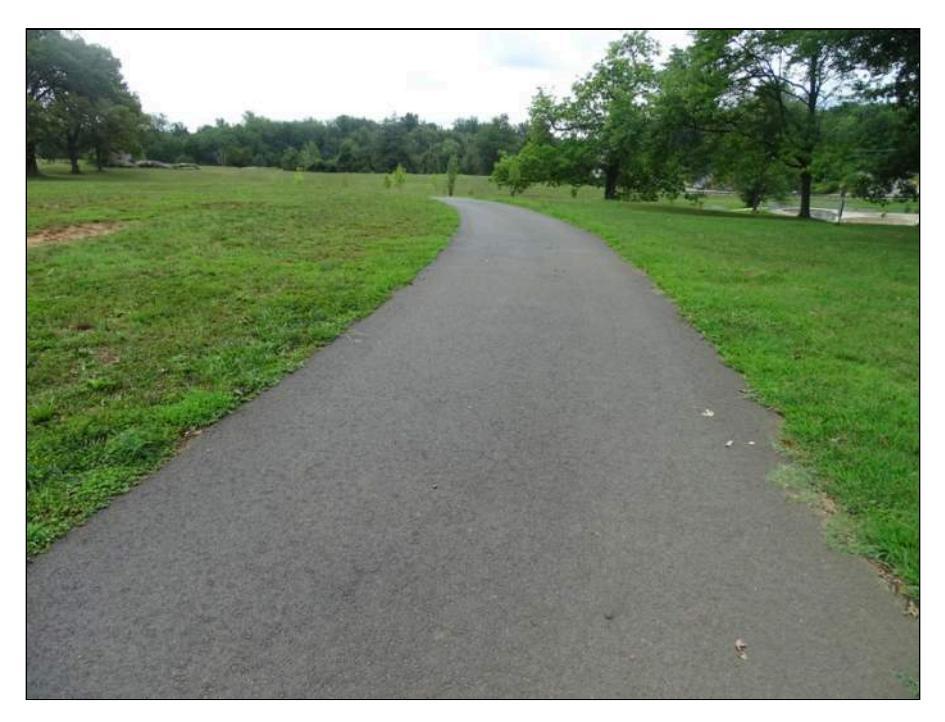
12 - Asphalt pavement overview

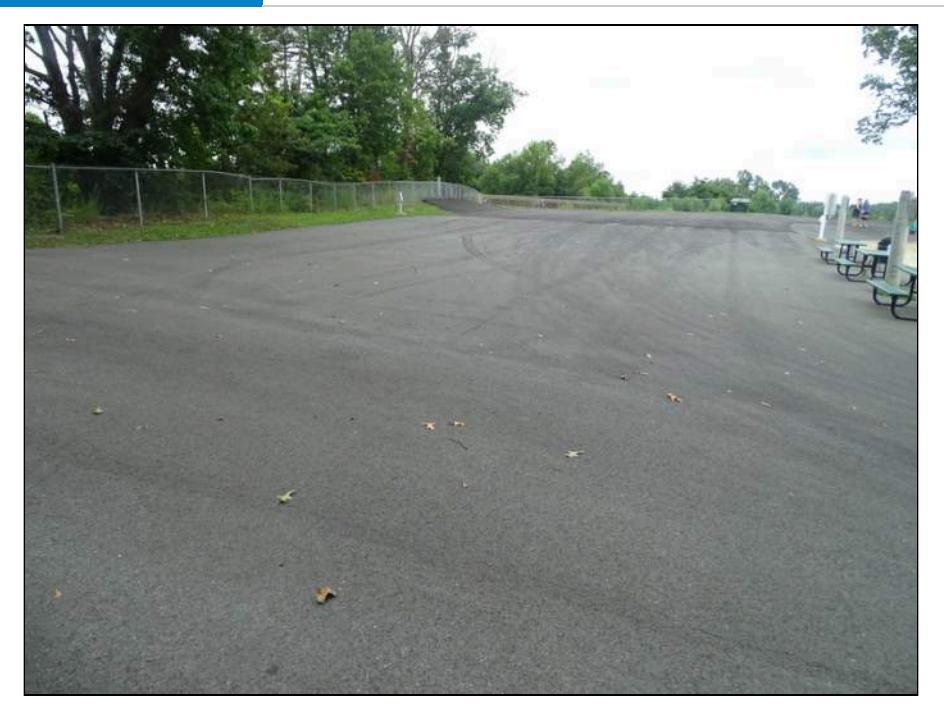
13 - Asphalt pavement overview

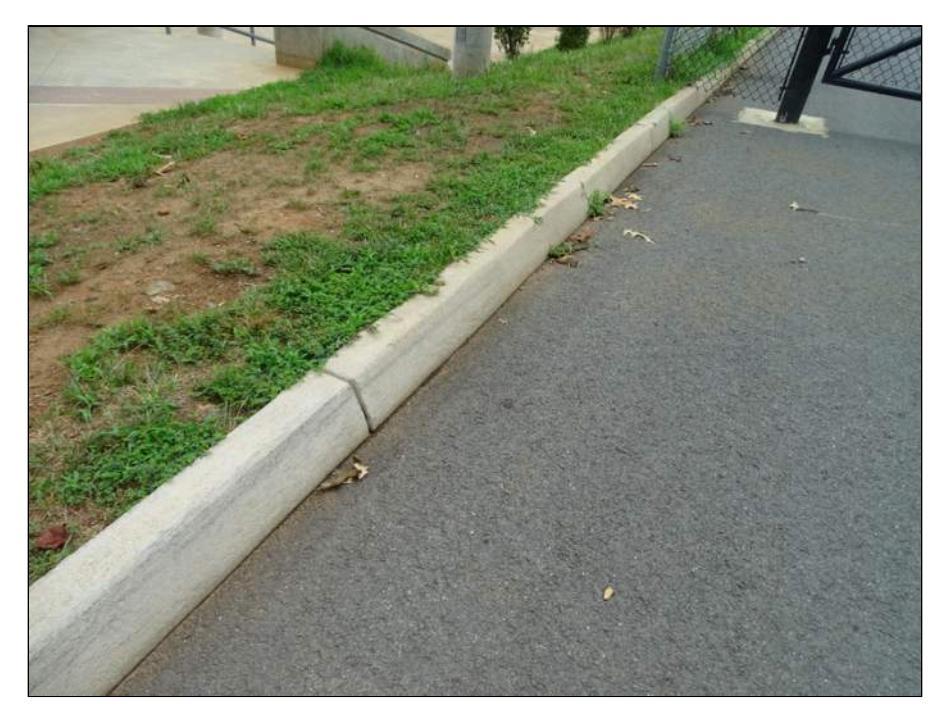
14 - Concrete curb and asphalt pavement

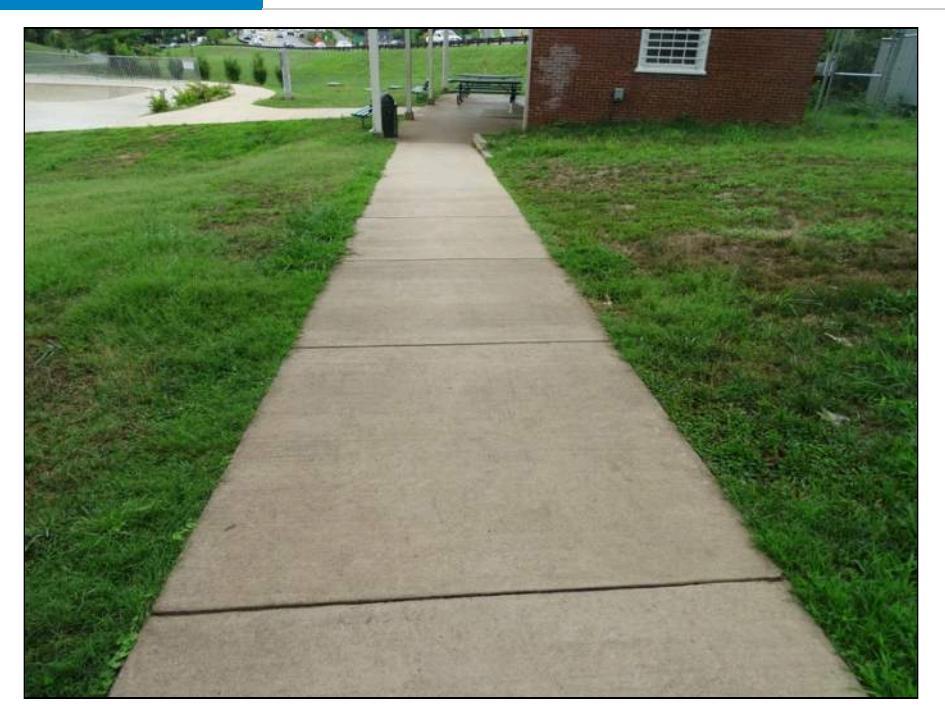
15 - Concrete sidewalks

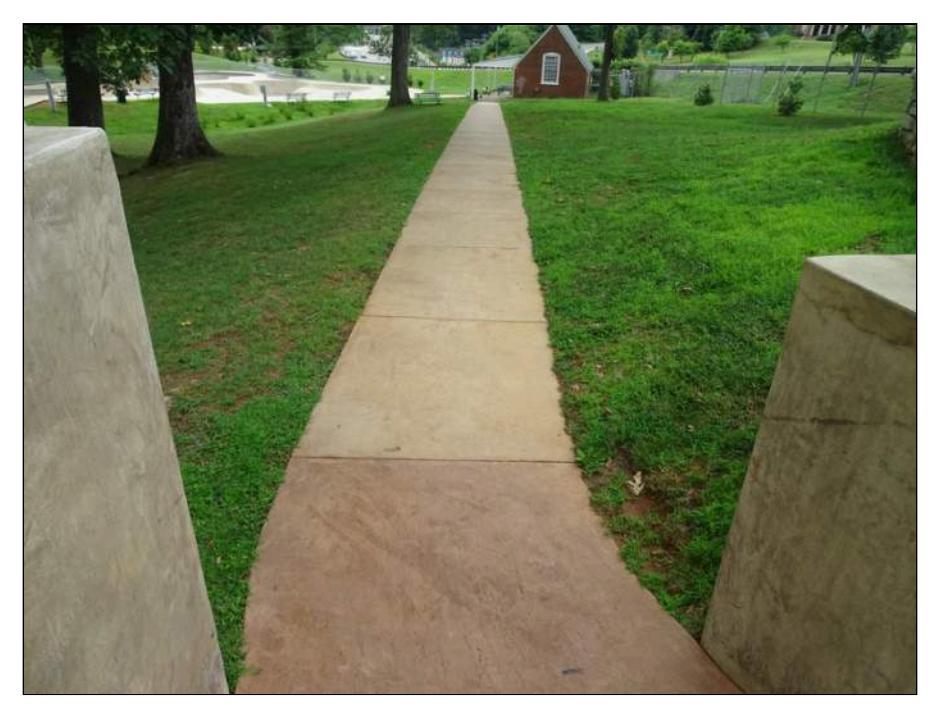
16 - Concrete sidewalks

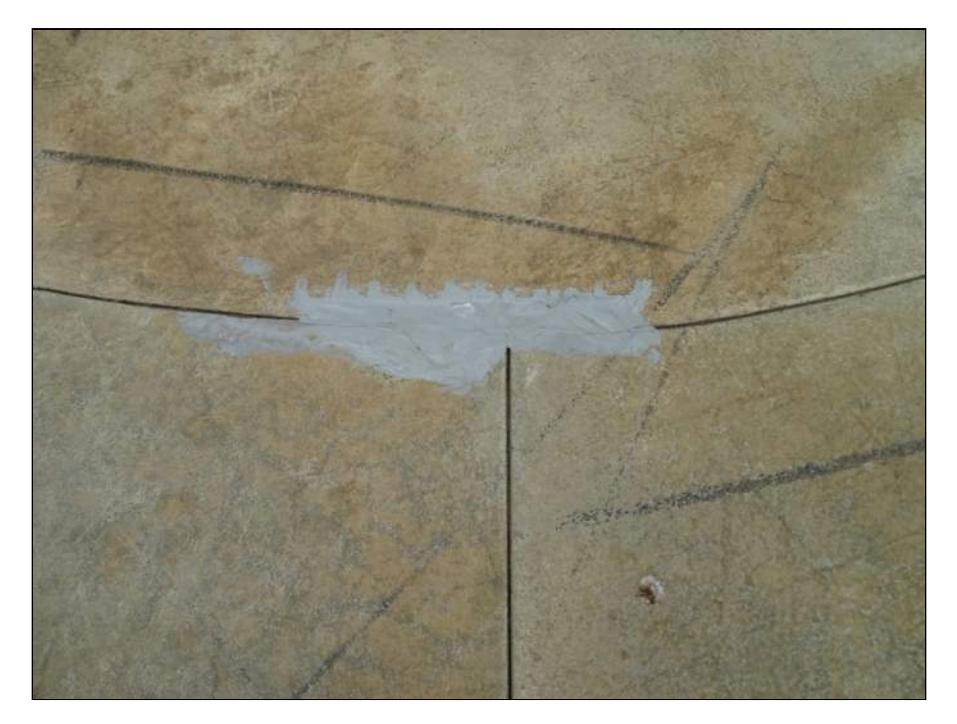
20 - Concrete pavement - note sealed

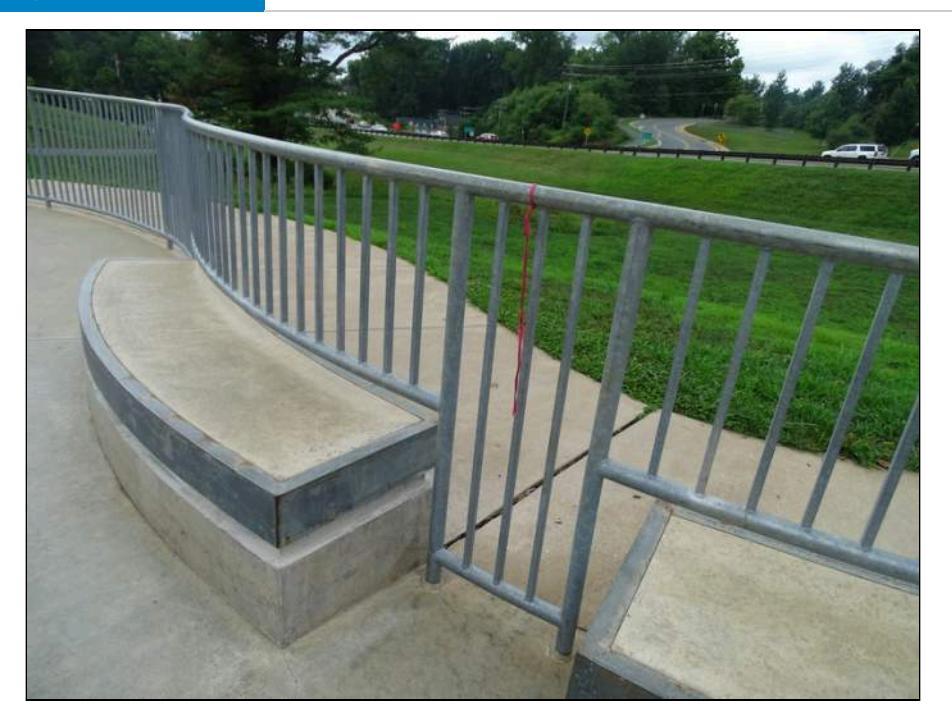
23 - Steel handrail

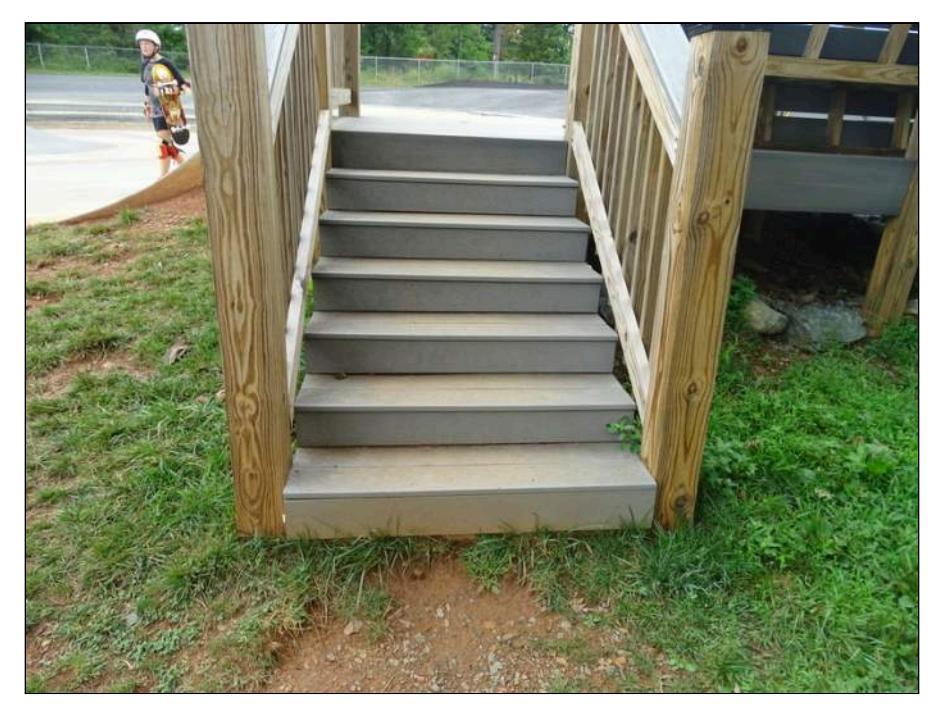
24 - Composite exterior stairs

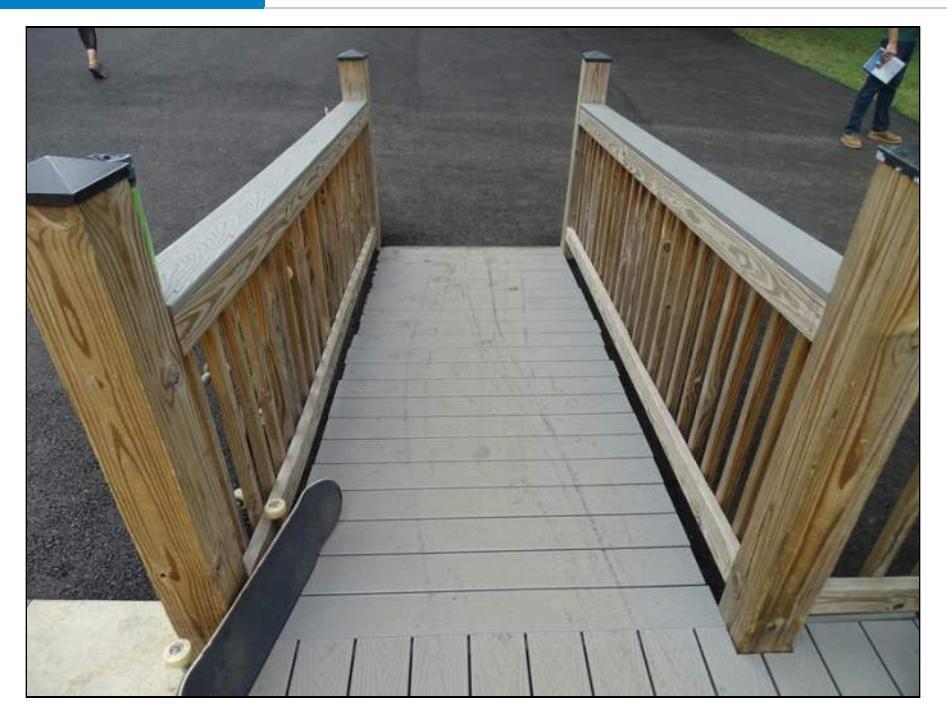
25 - Composite deck ramp

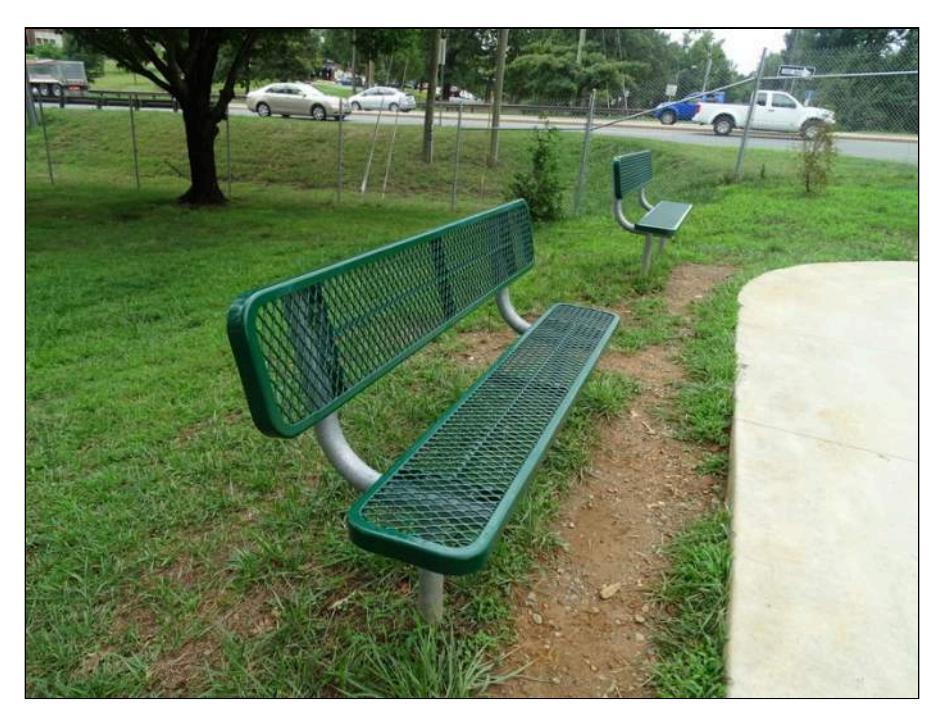
26 - Park Equipment

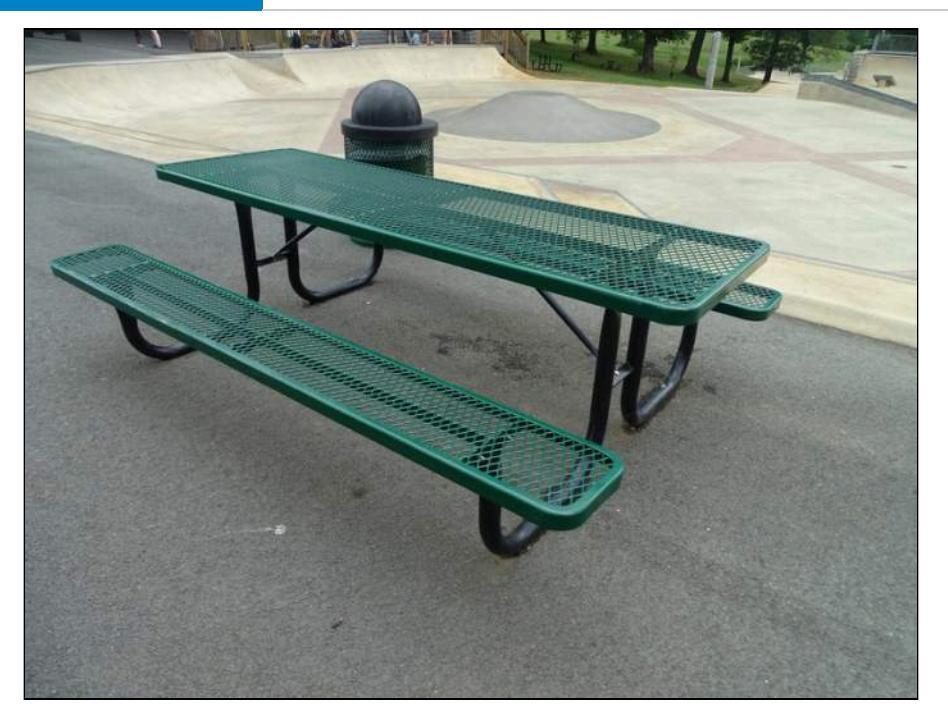
27 - Park Equipment

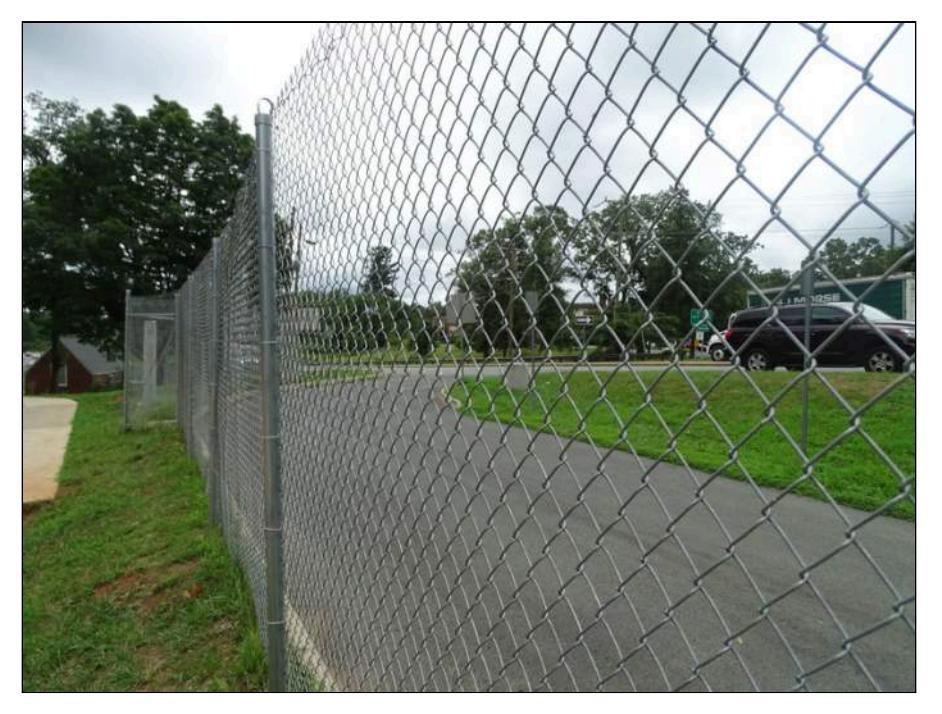
28 - Chain-link fence

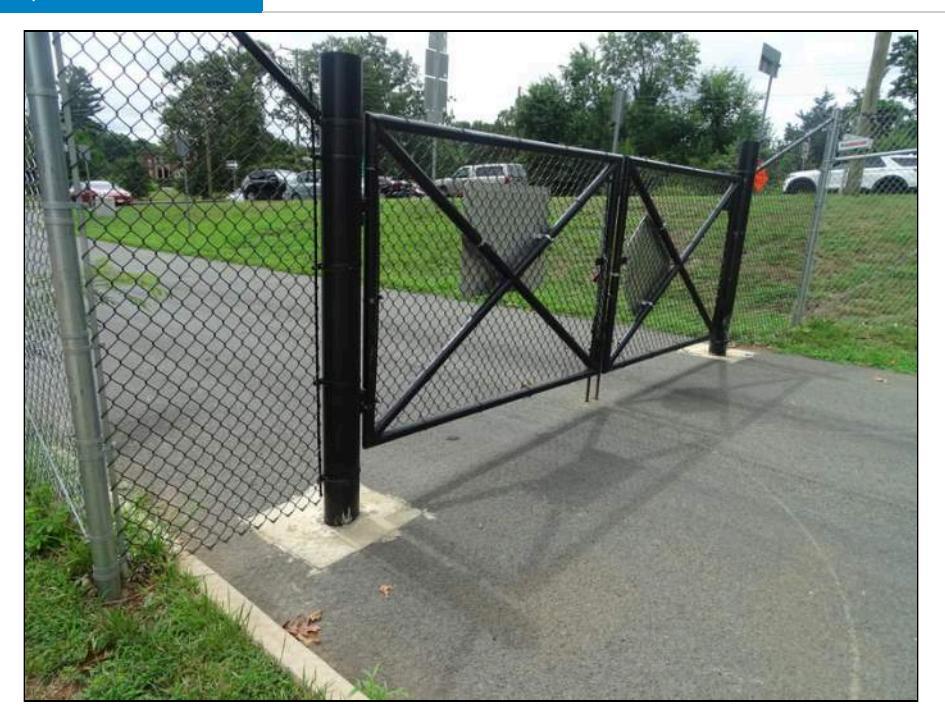
37 - Gated entrance

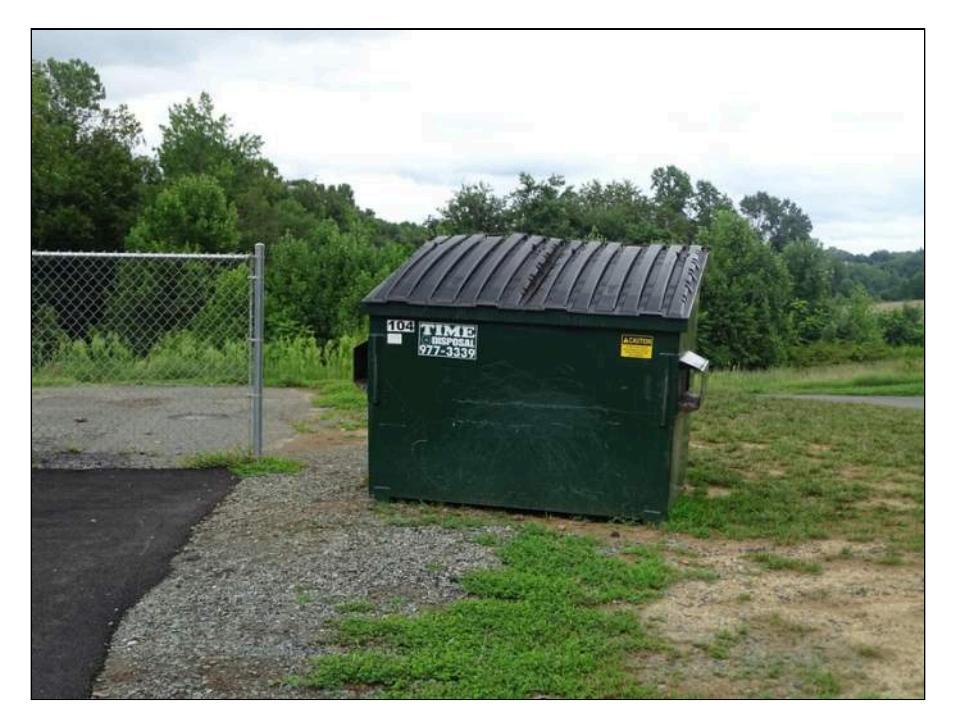
38 - Typical dumpster

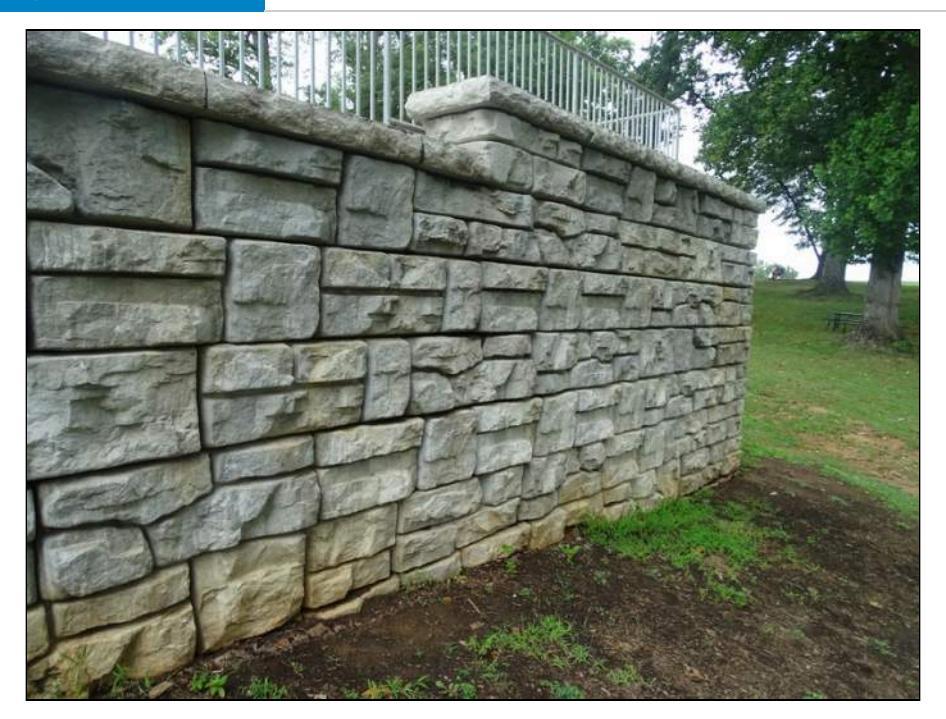
39 - Typical retaining wall

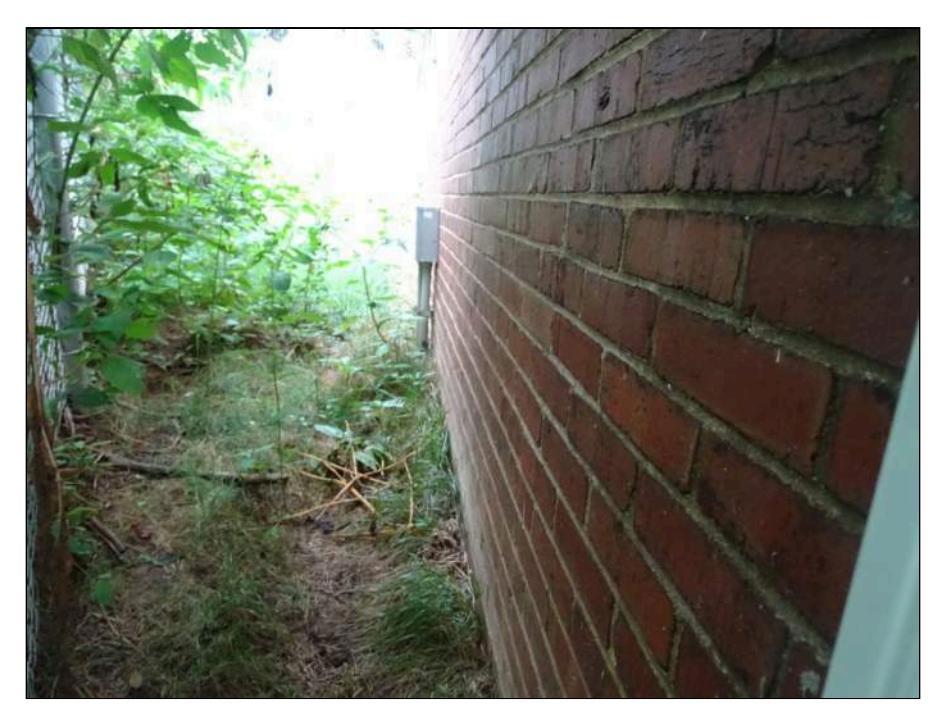
40 - Typical exterior wall

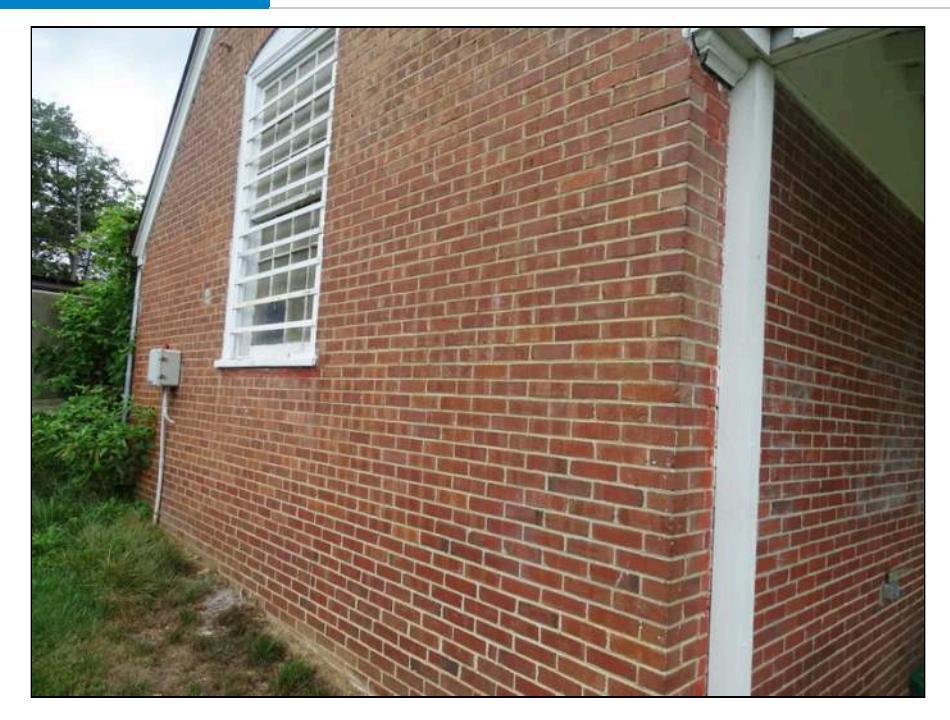
41 - Typical exterior wall

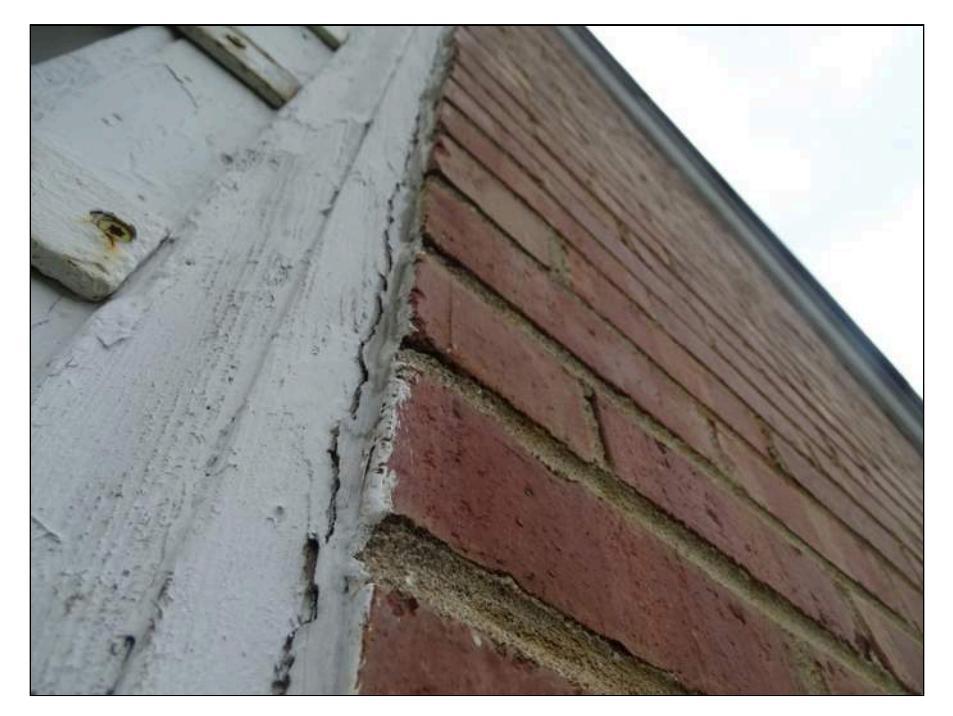
42 - Typical exterior wall

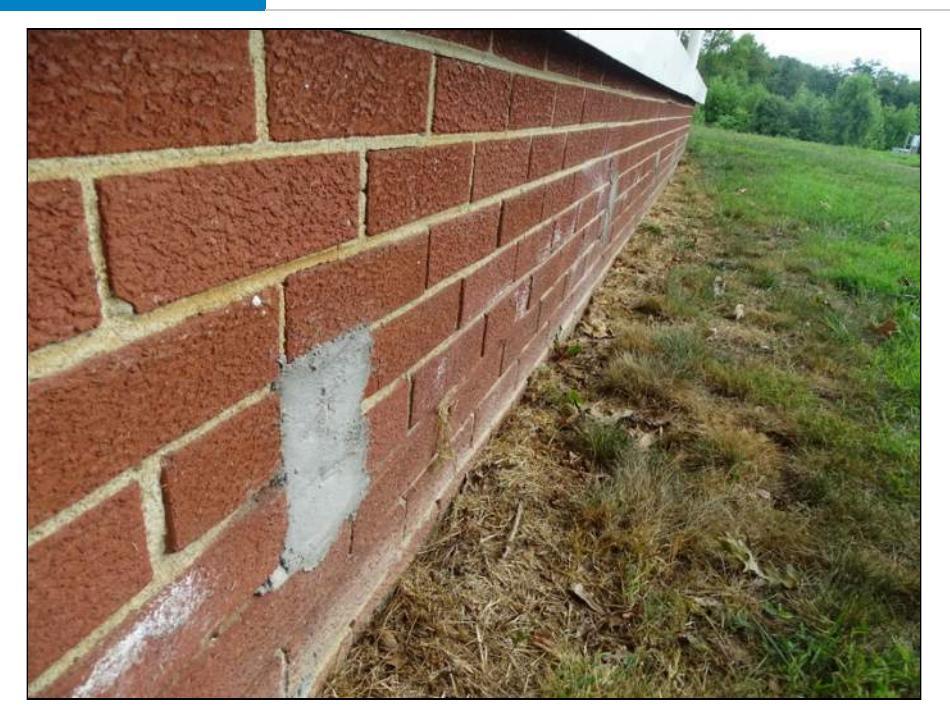
43 - Typical exterior wall

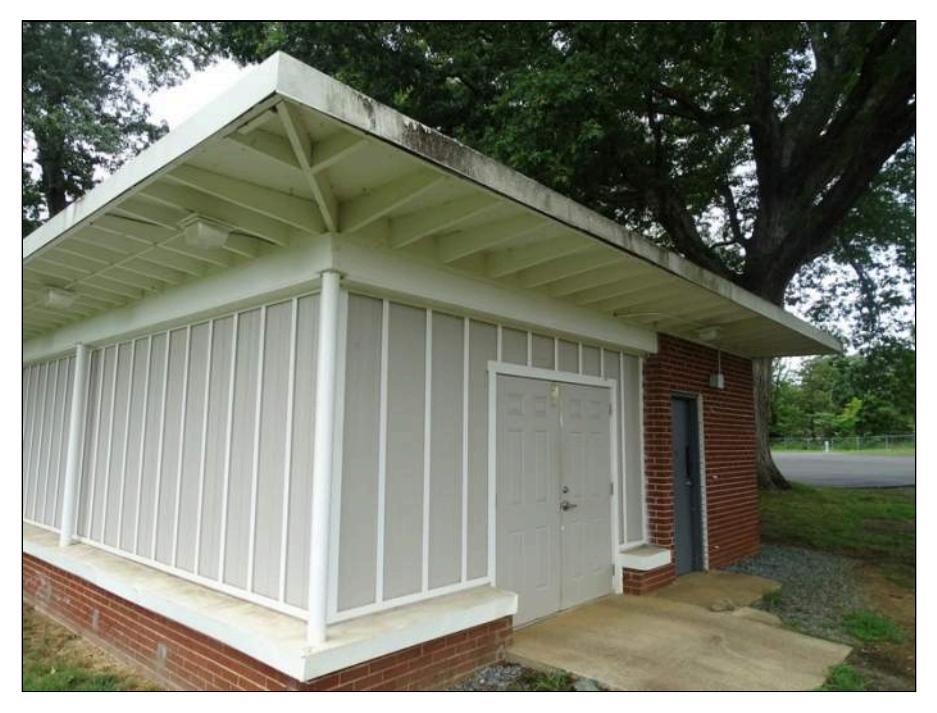
44 - Typical wood siding

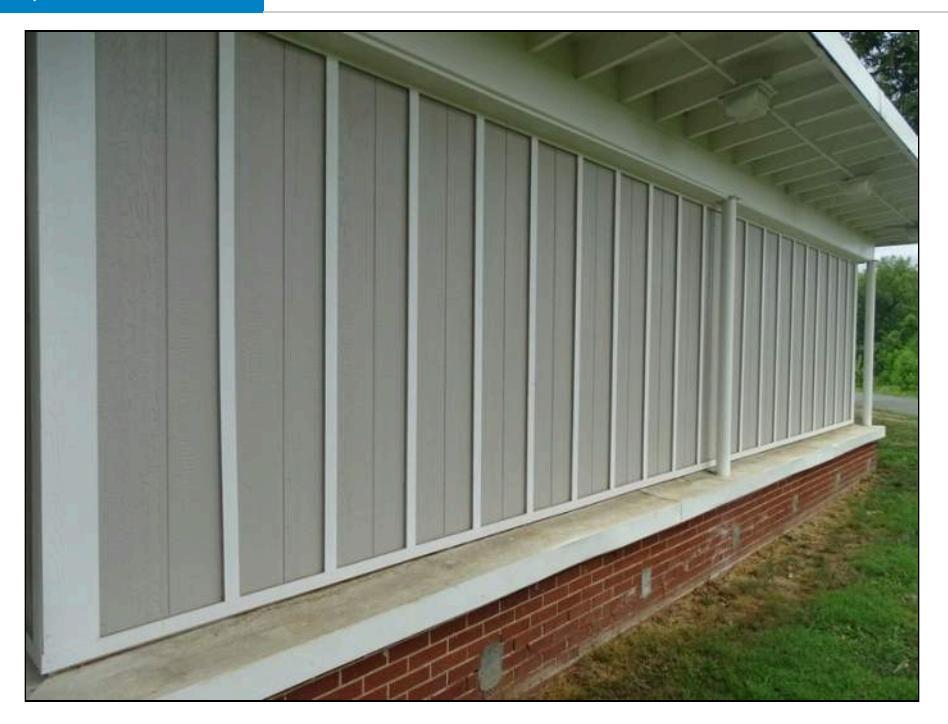
45 - Typical wood siding

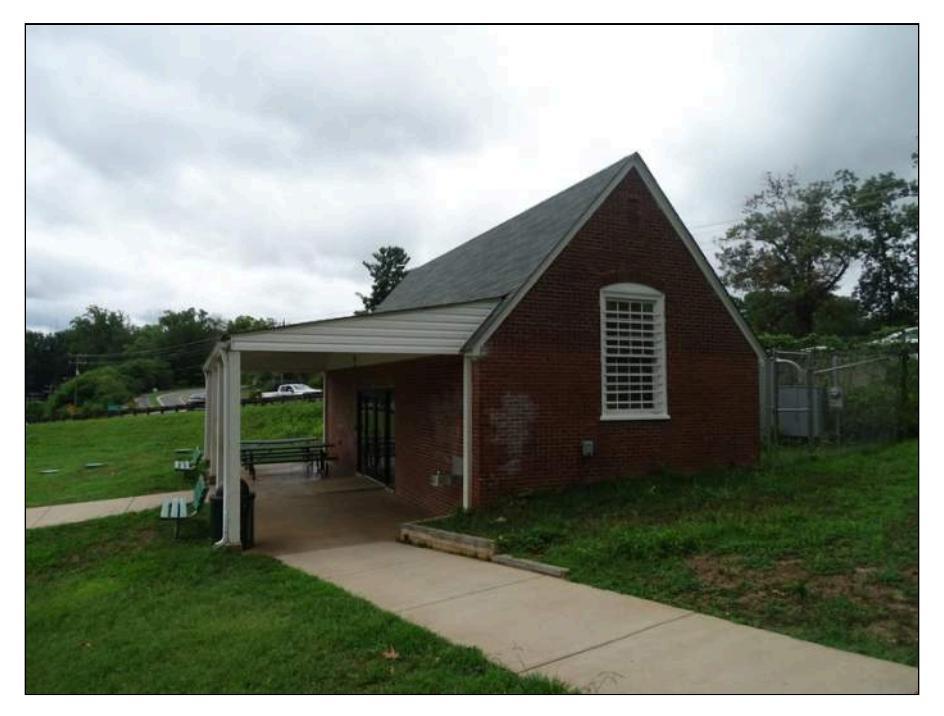
46 - Typical roofing system

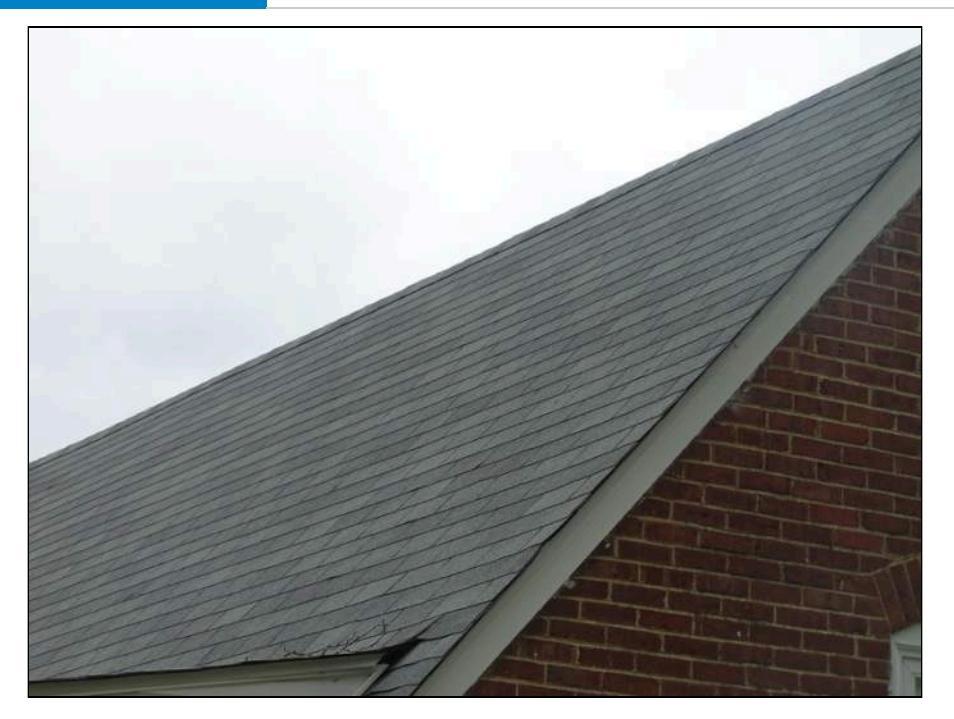
47 - Typical roofing system

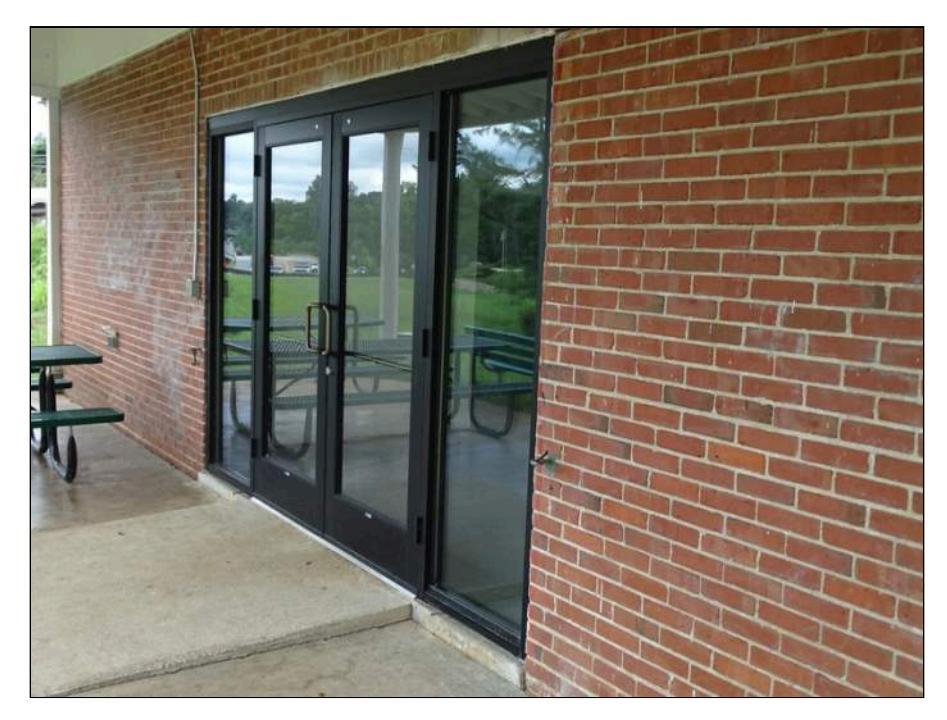
48 - Typical main entrance

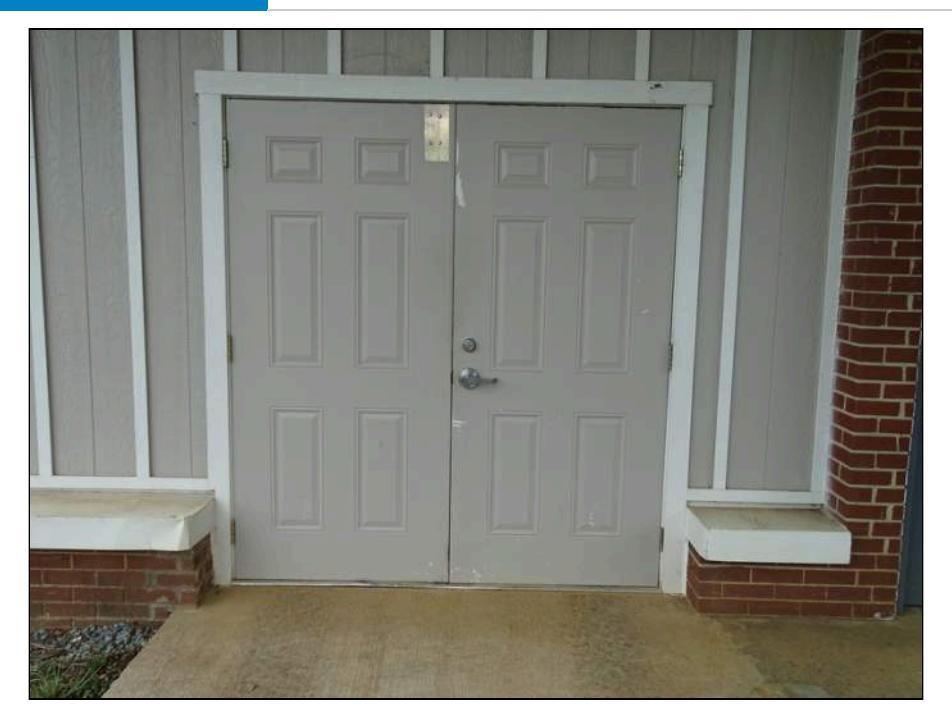
49 - Typical entrance door

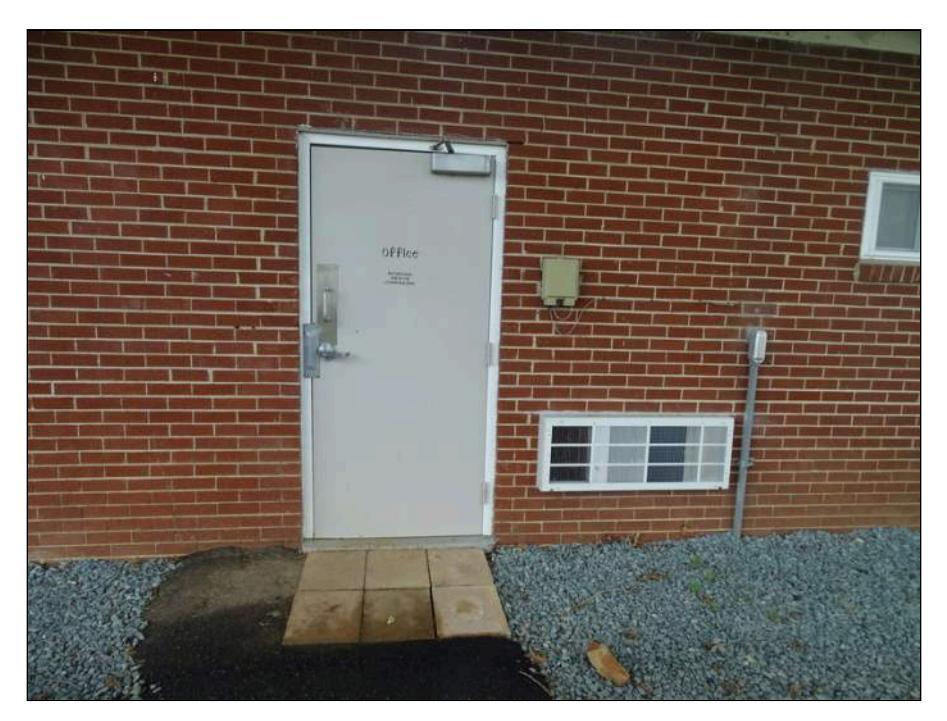
50 - Typical personal door

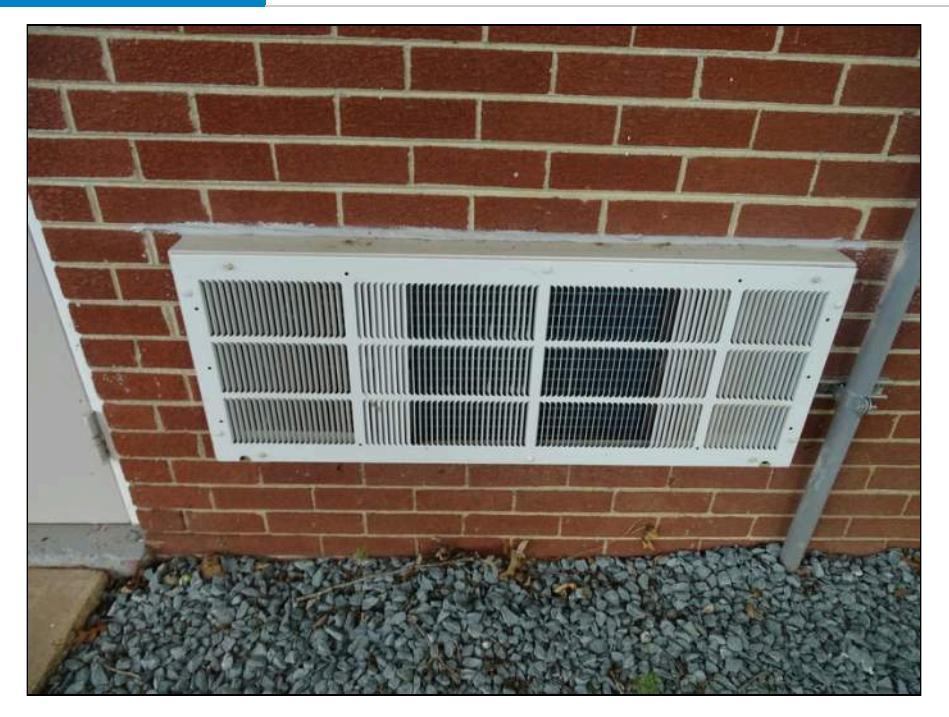
51 - Typical exterior grill

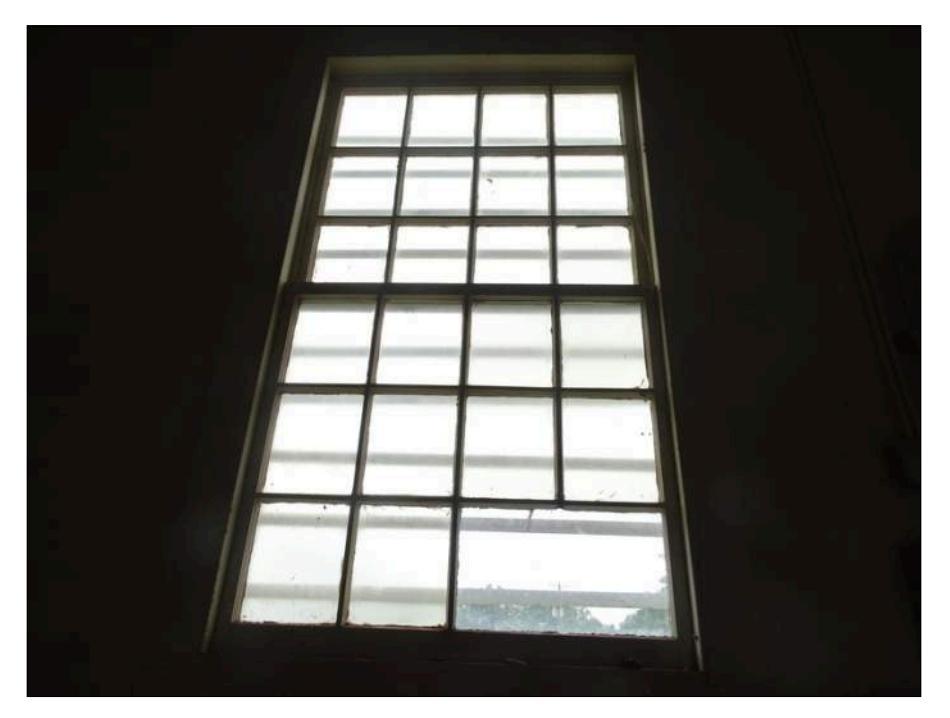
52 - Typical exterior door
