MCINTIRE SKATE PARK 425 U.S. 250 BY-PASS CHARLOTTESVILLE, VIRGINIA

ECS PROJECT NO. 46:6713

CITY OF CHARLOTTESVILLE - FACILITIES DEVELOPMENT

Reference: Facility Condition Assessment Report for McIntire Skate Park, 425 U.S. 250 By-Pass, Charlottesville, Virginia

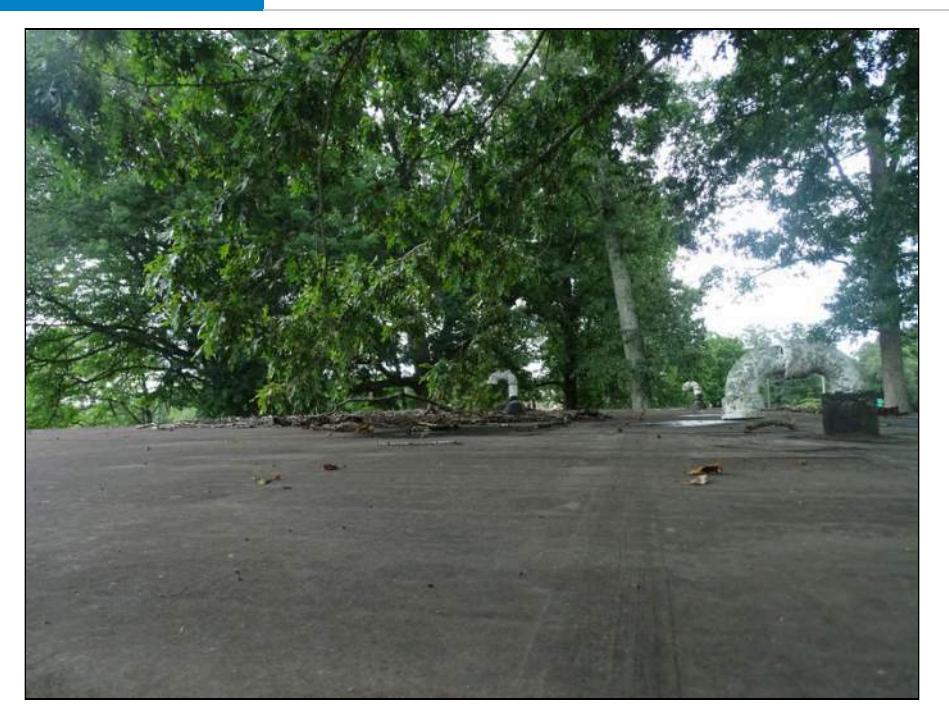
53 - Typical roofing system

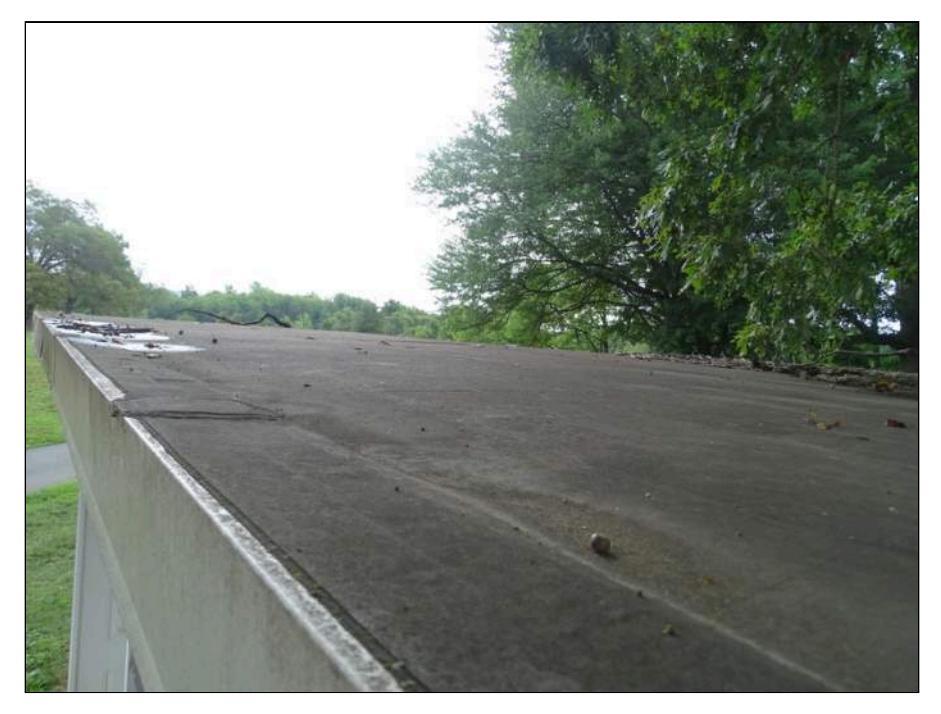
54 - Typical roofing system

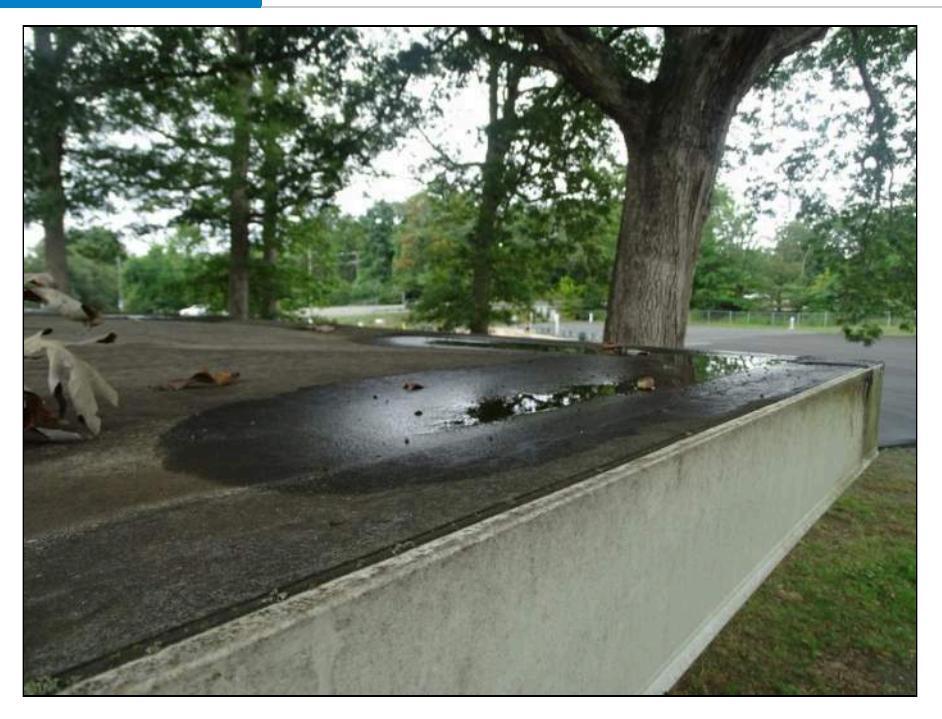
55 - Typical roofing system

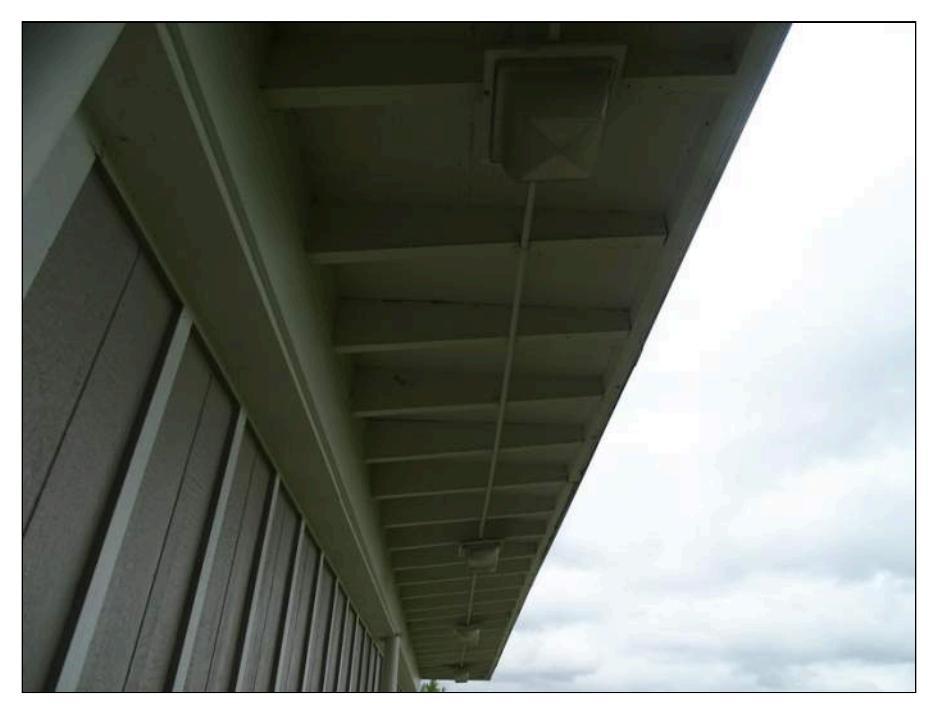
56 - Typical overhang

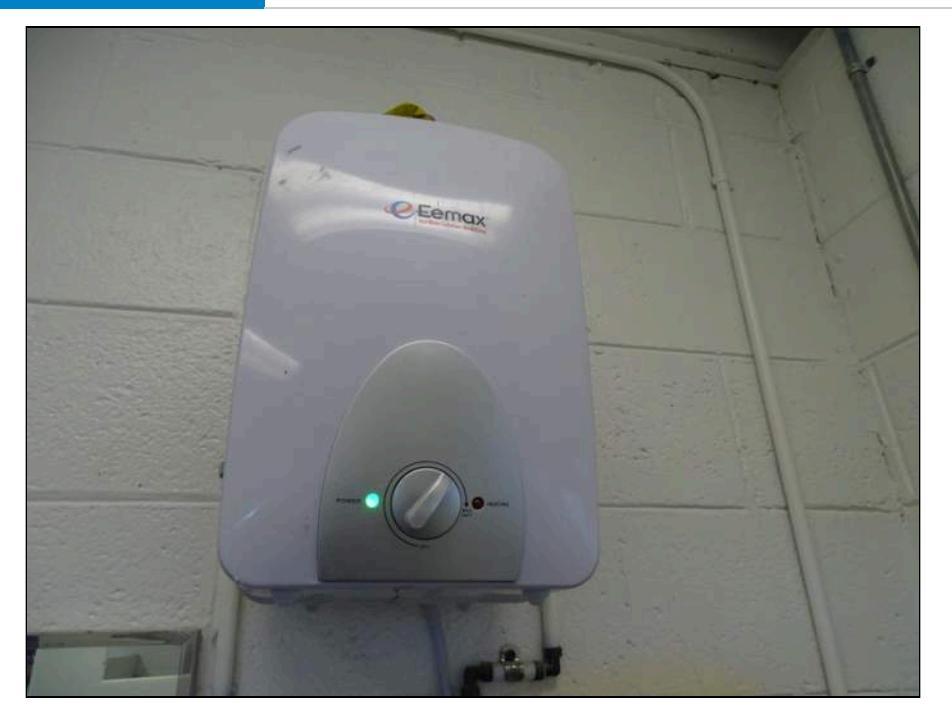
57 - Tankless water heater

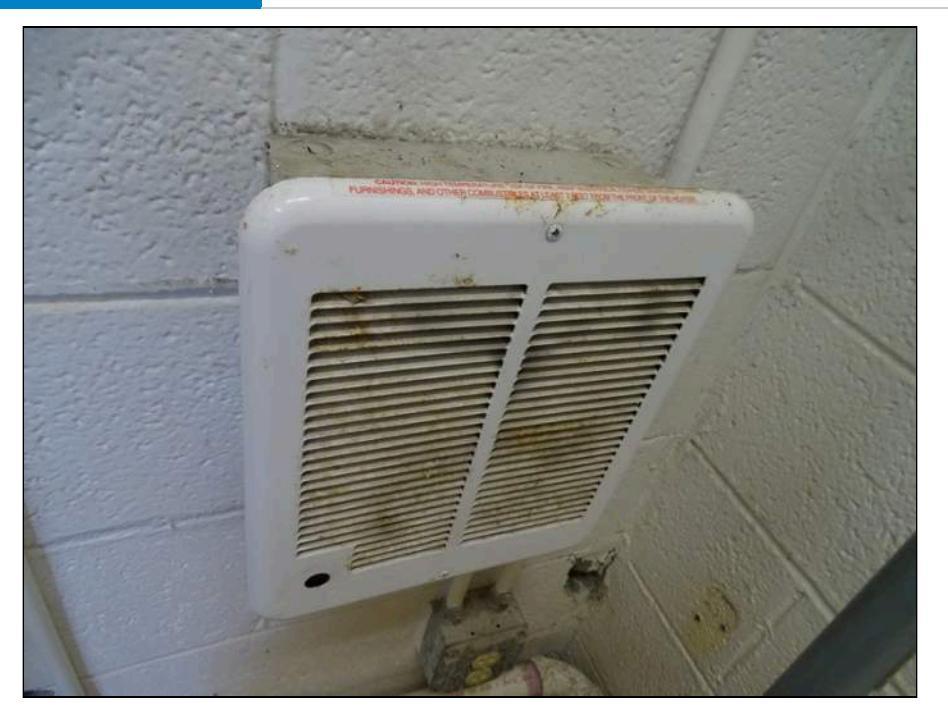
58 - Through-wall heat pump

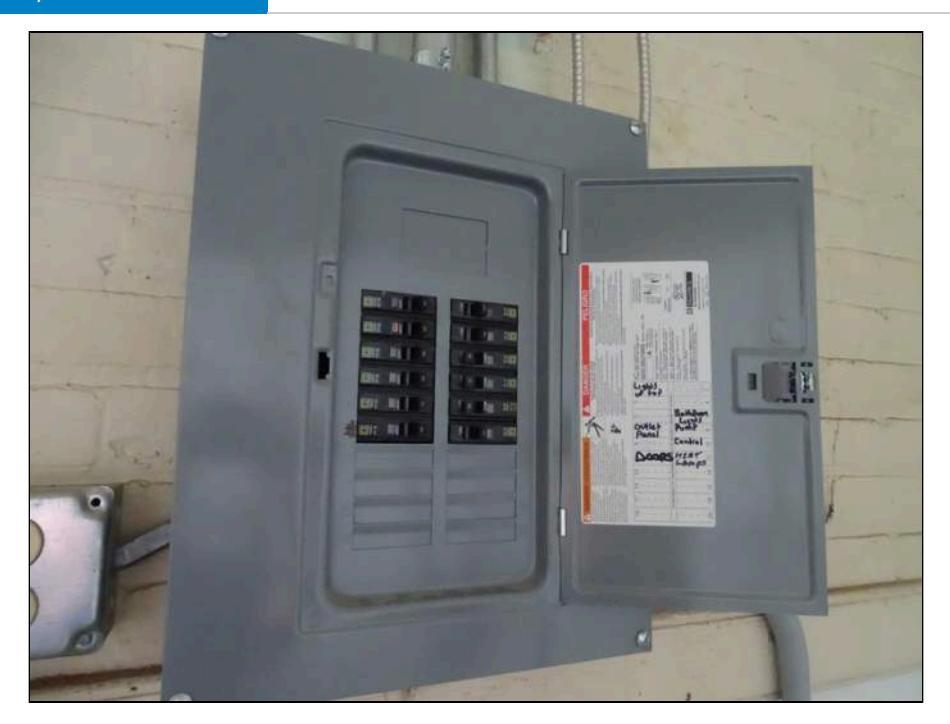
62 - Office electrical panel

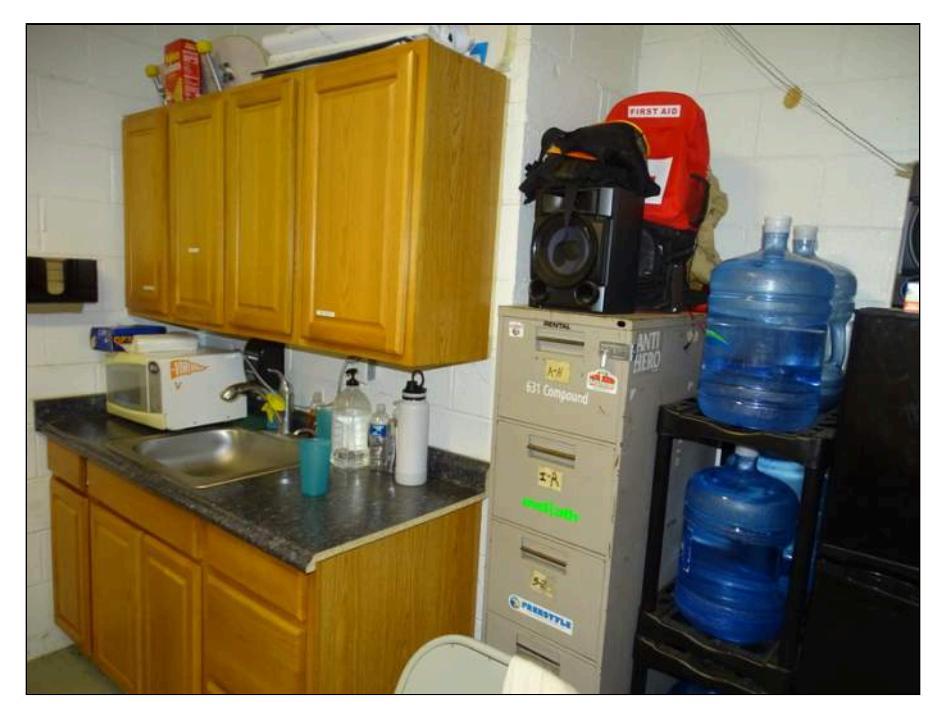
65 - Typical utility room

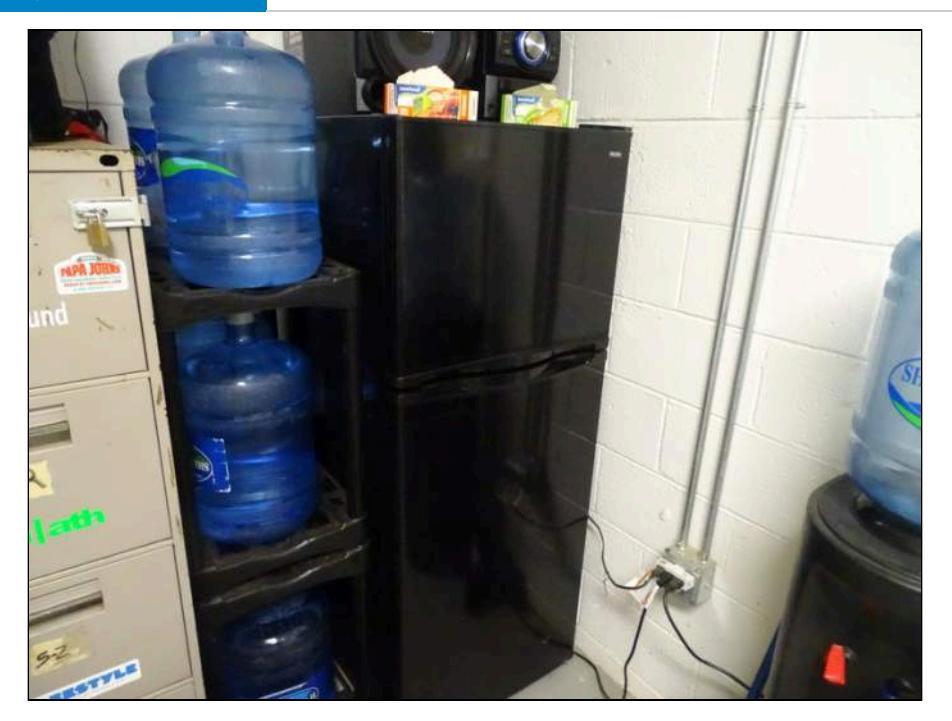
66 - Typical kitchen interior

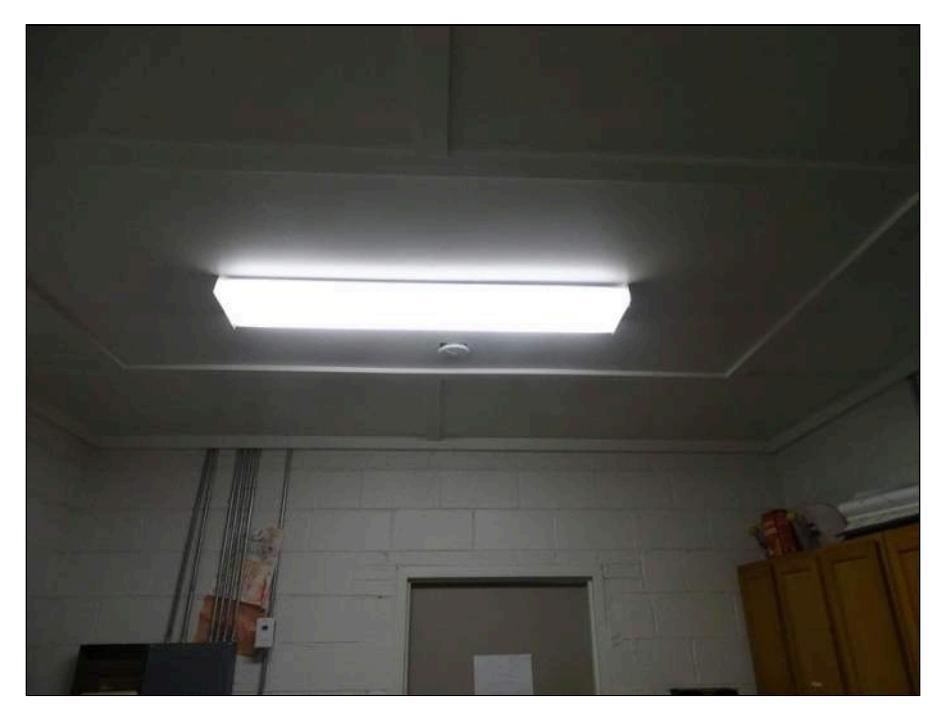
67 - Typical kitchen interior

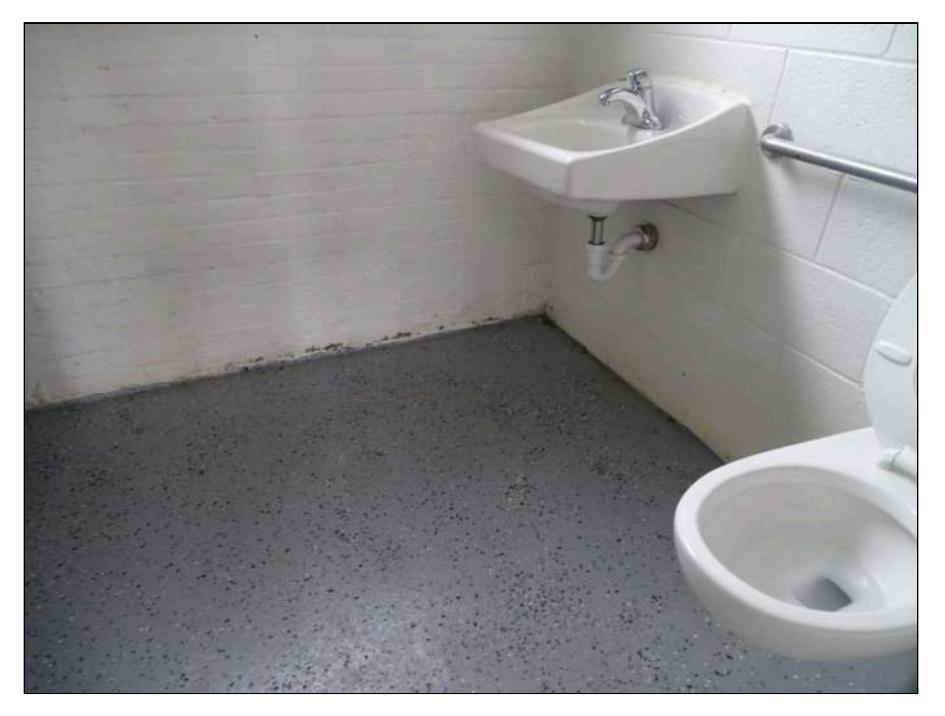
69 - Office restroom

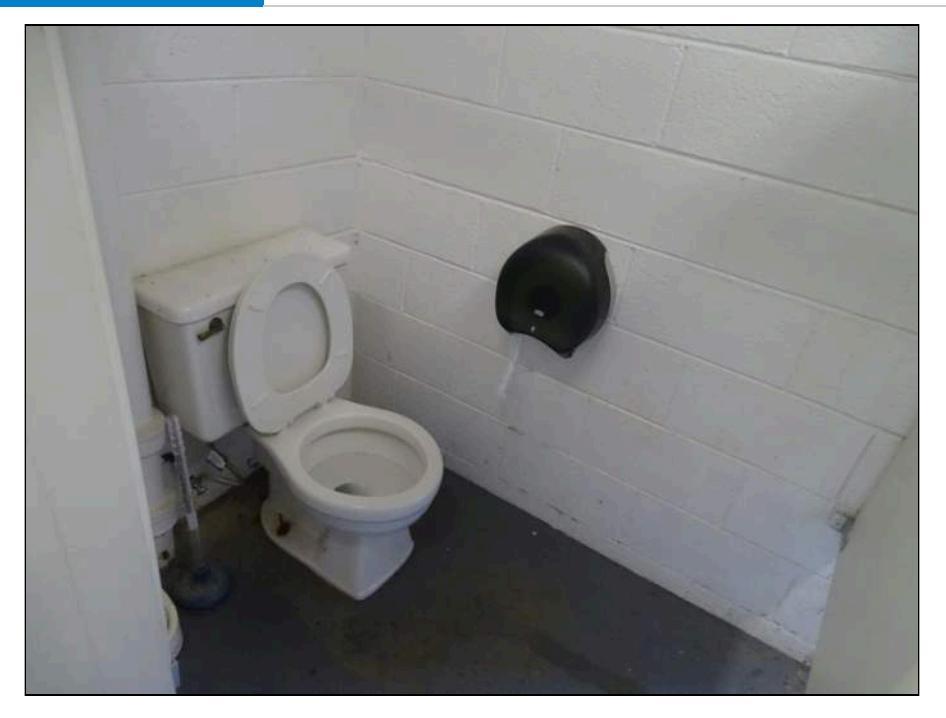
70 - Typical restroom interior

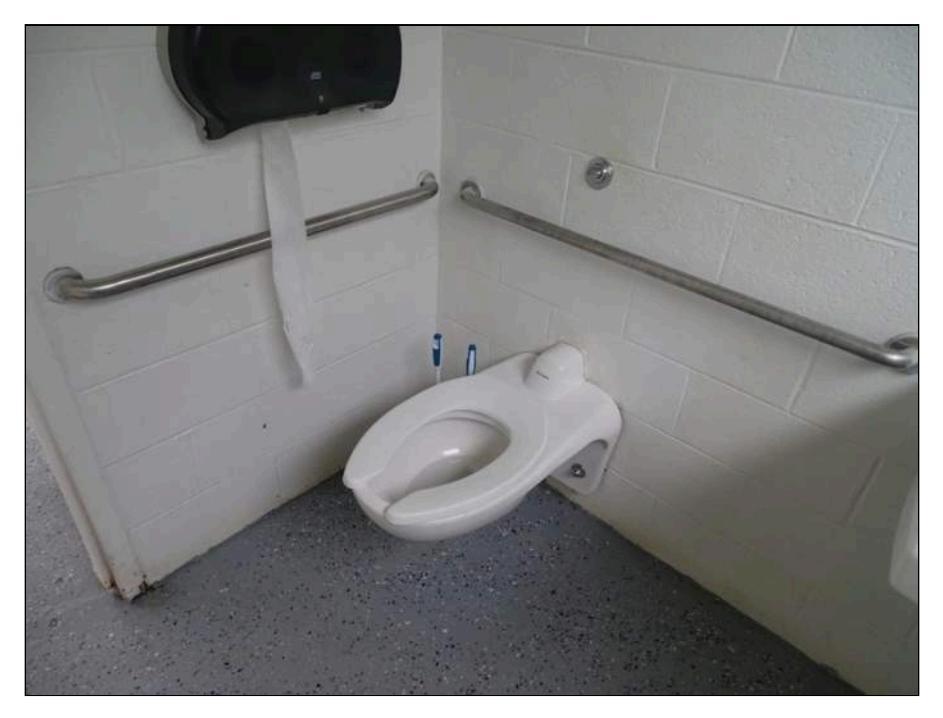
71 - Office restroom interior

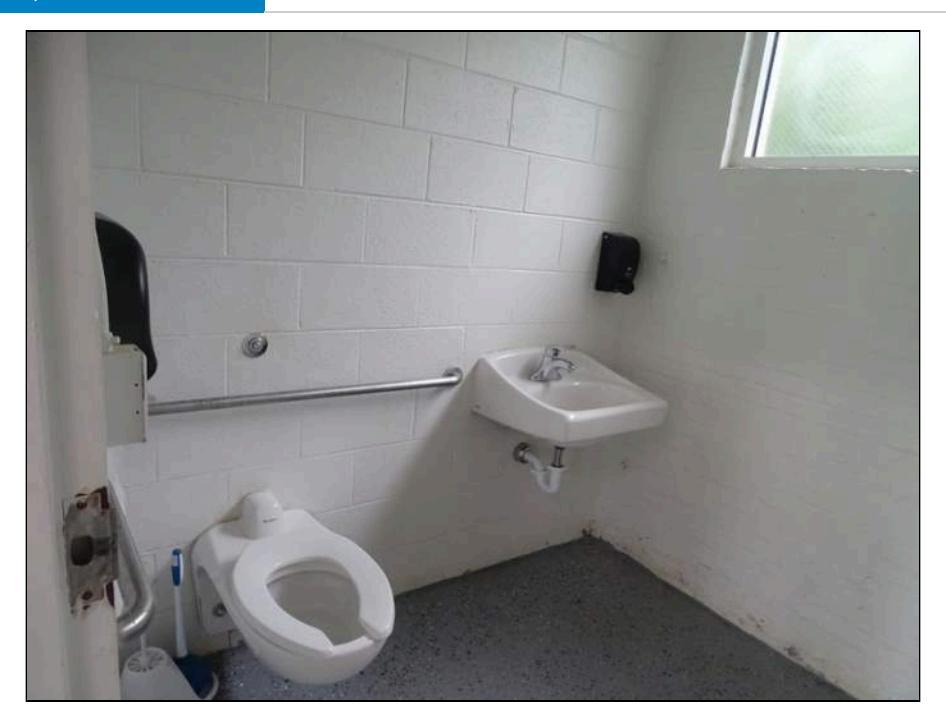
72 - Accessible restroom

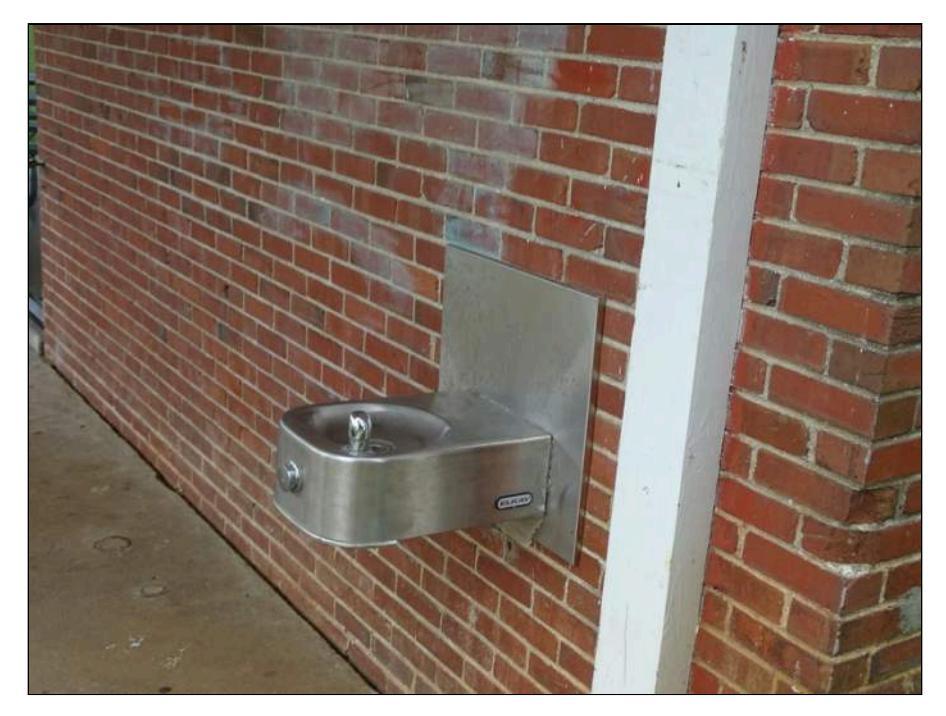
73 - Accessible restroom

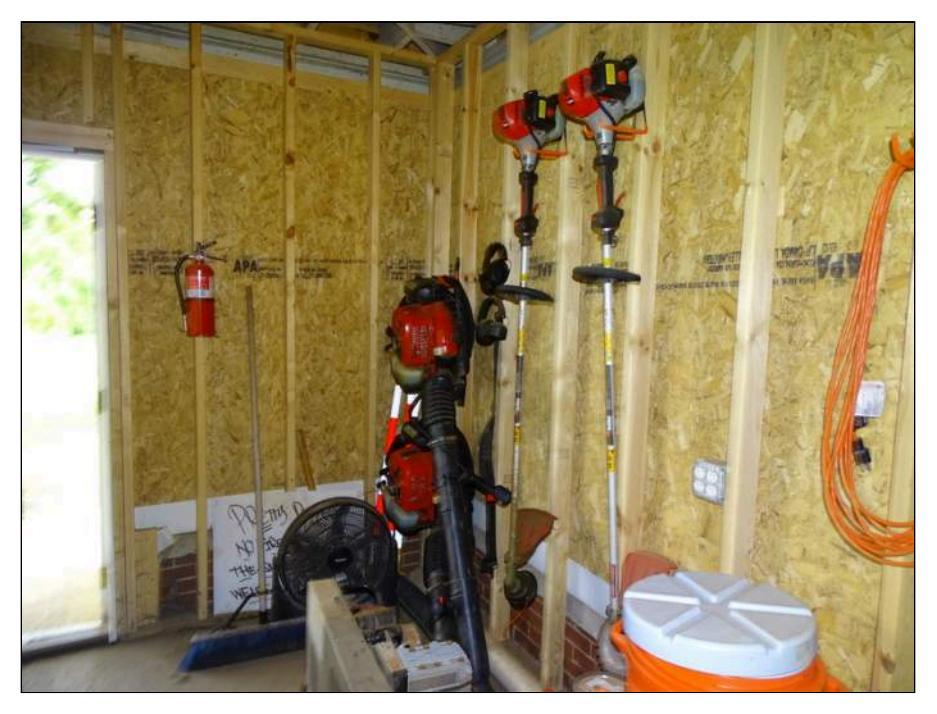
75 - Storage room

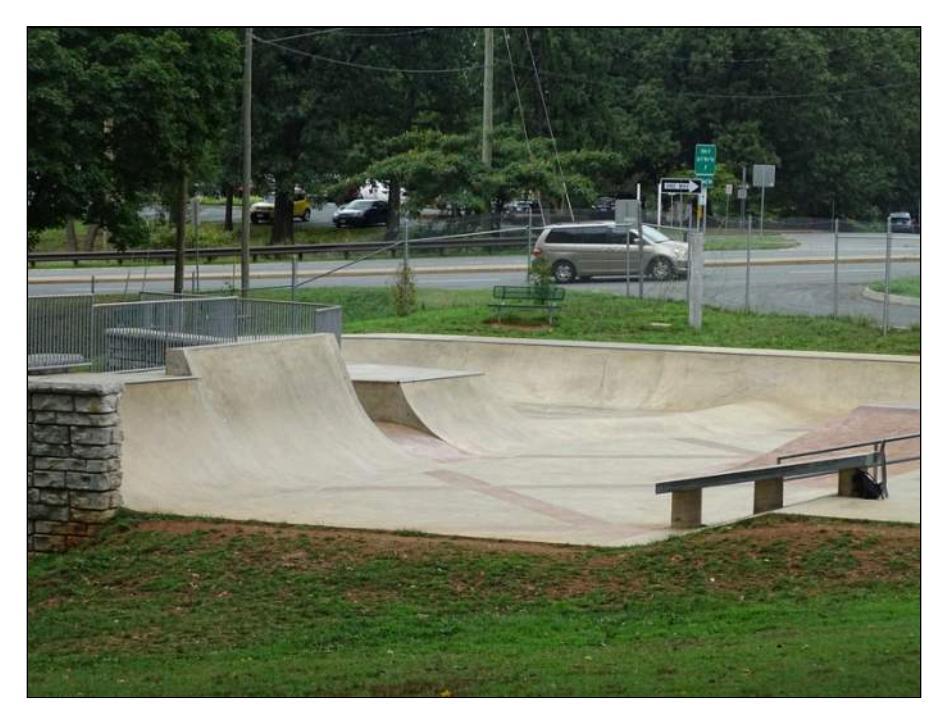
81 - Skate park

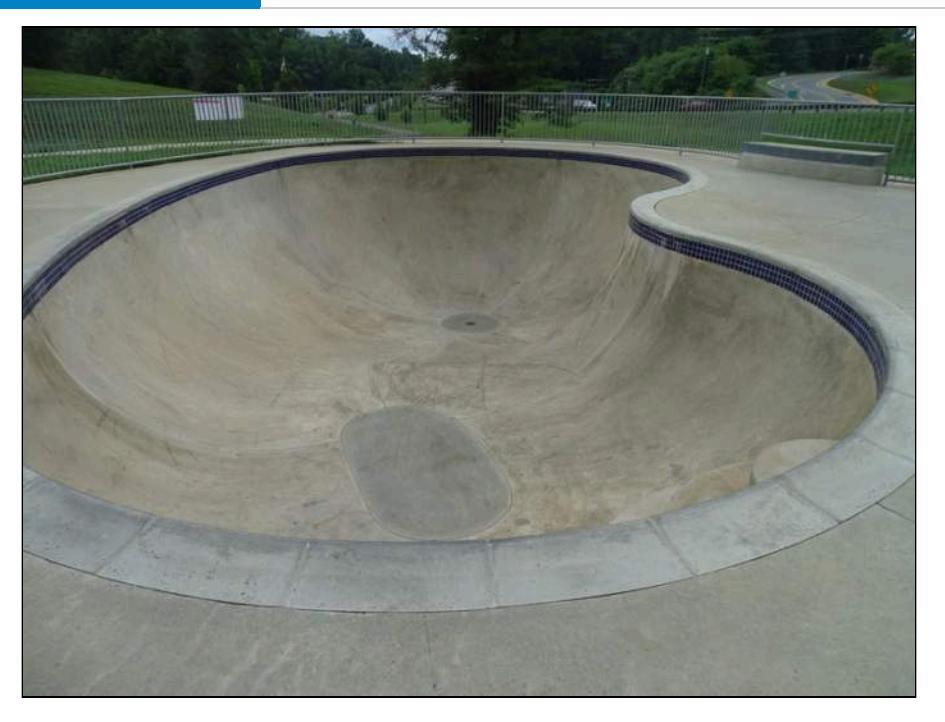
82 - Skate features

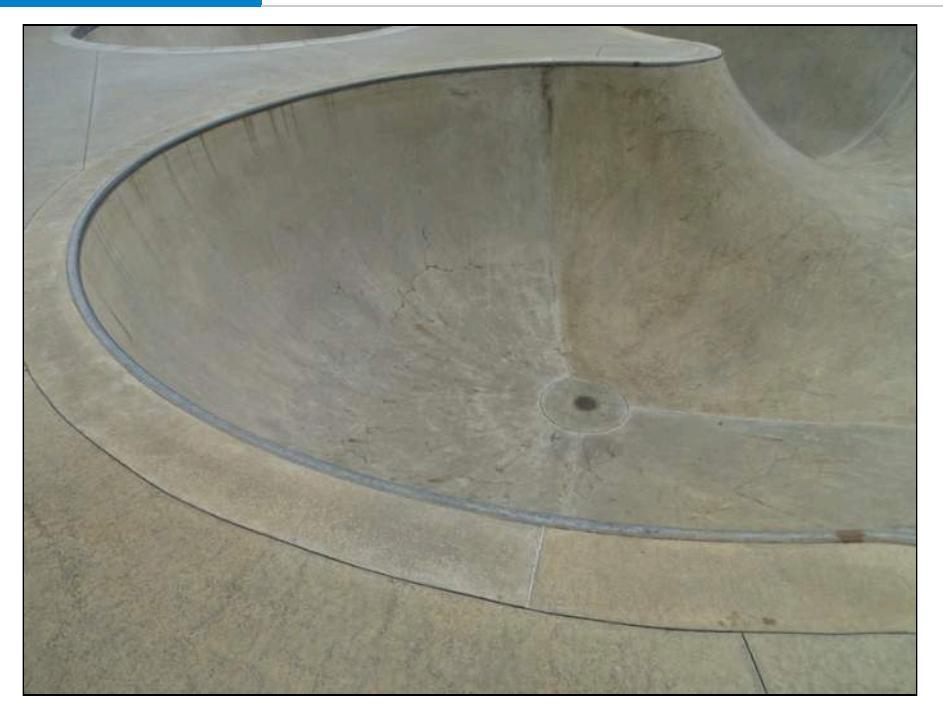
84 - Skate surface

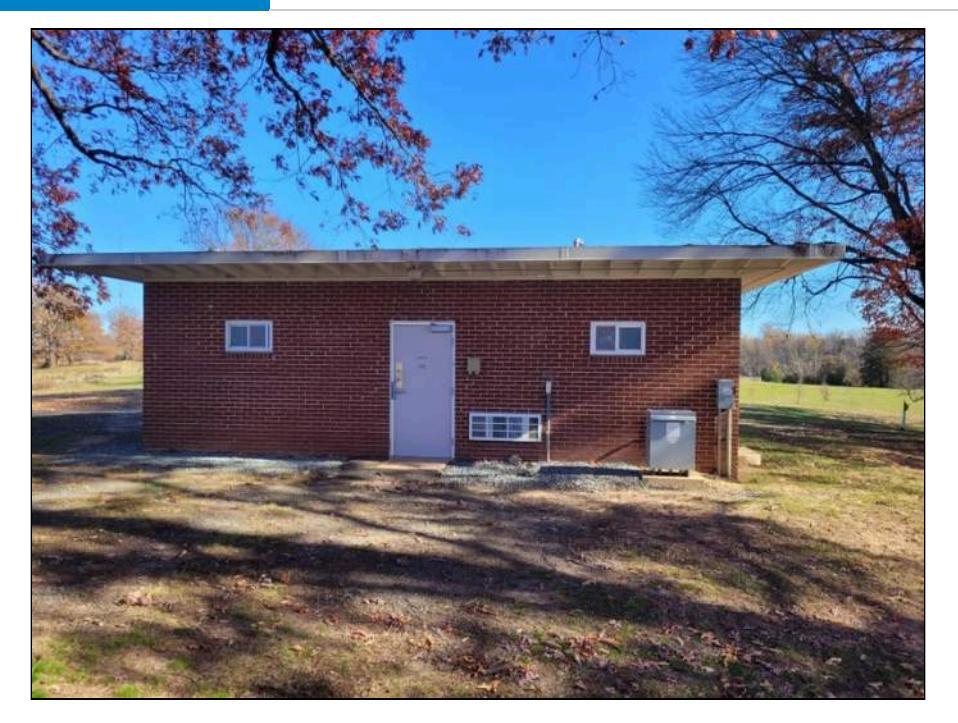
86 - Office exterior

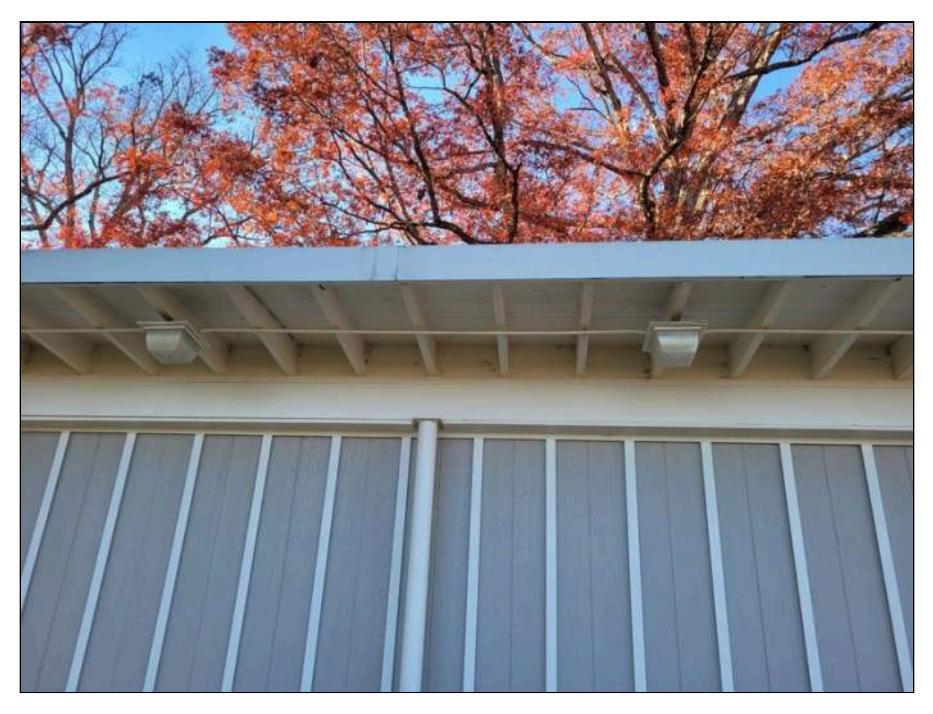
87 - Office entrance

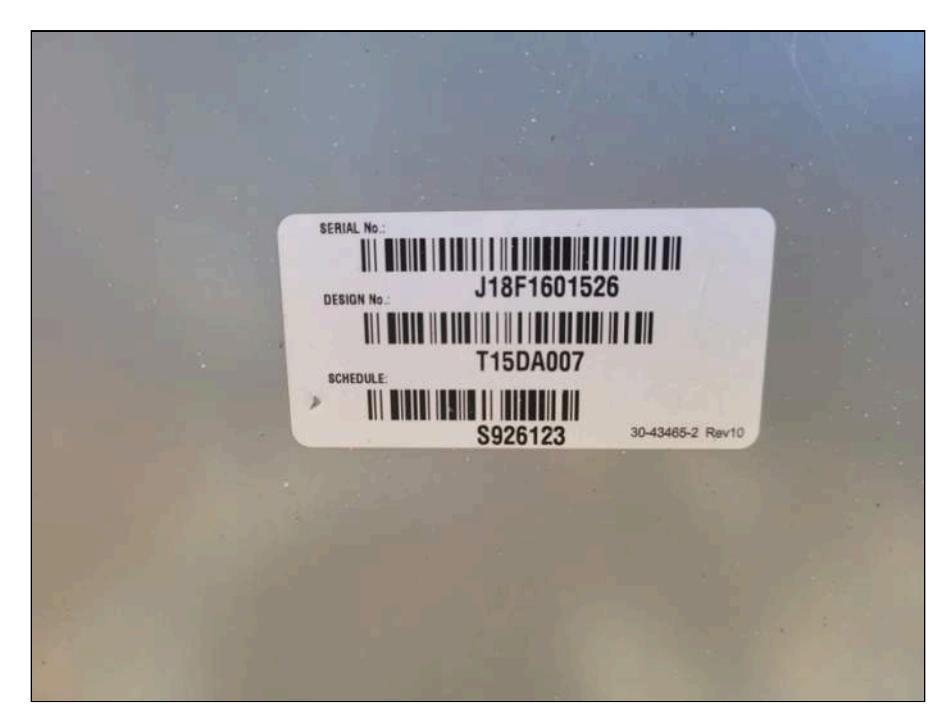
89 - Office transformer

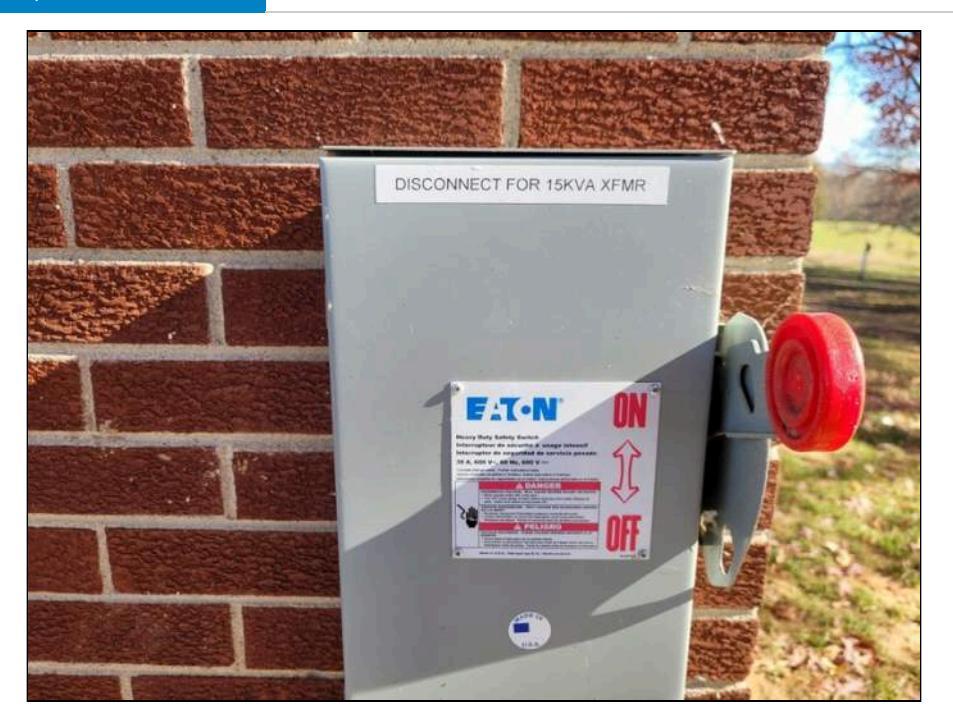
90 - Transformer label

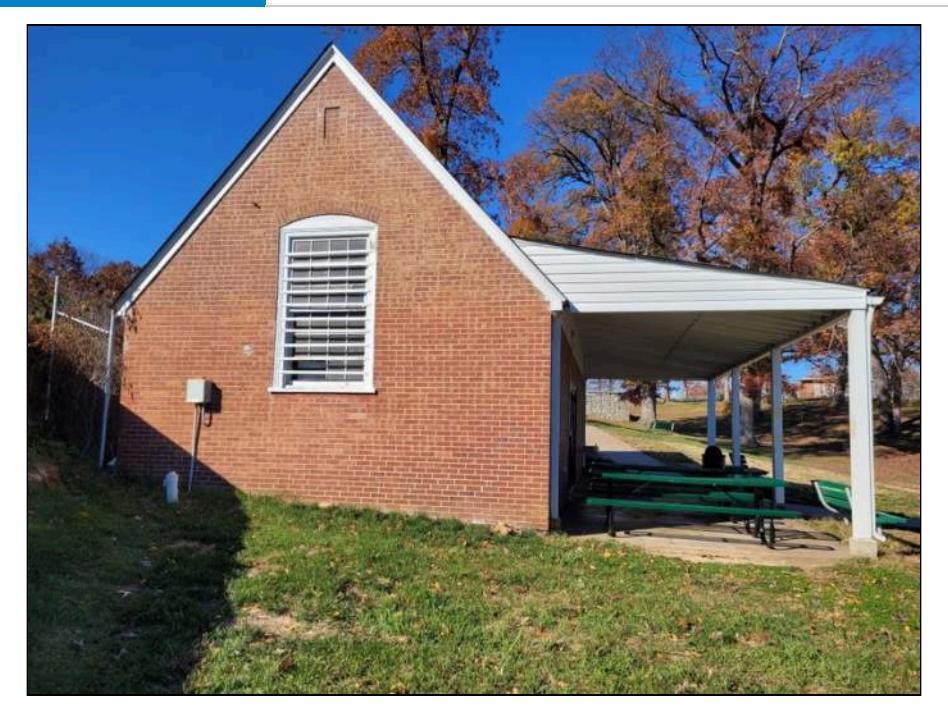
92 - Restroom entrance

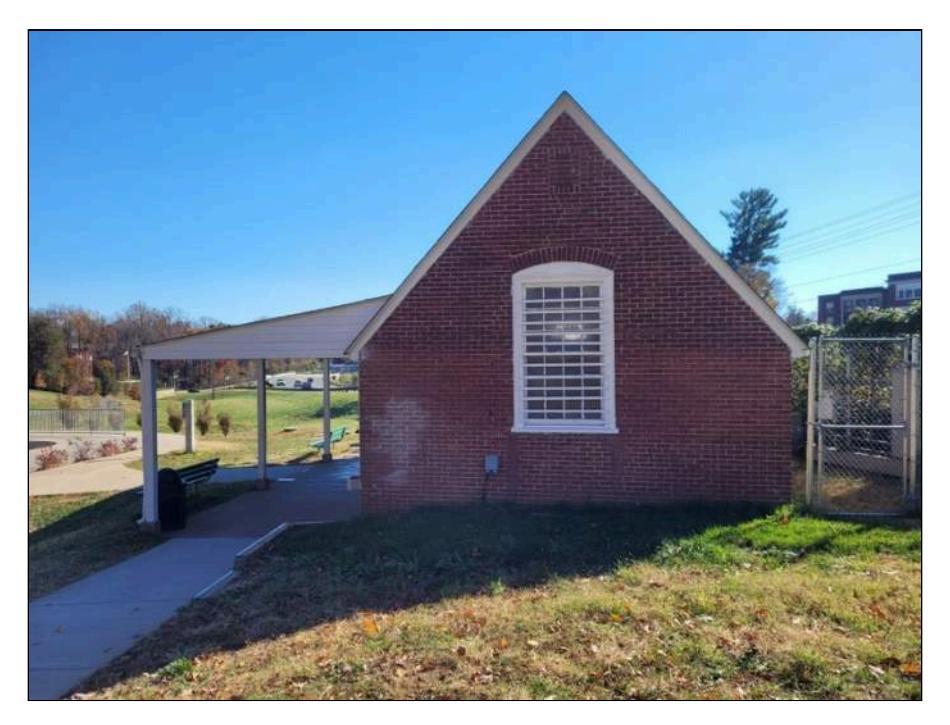
93 - Restroom exterior

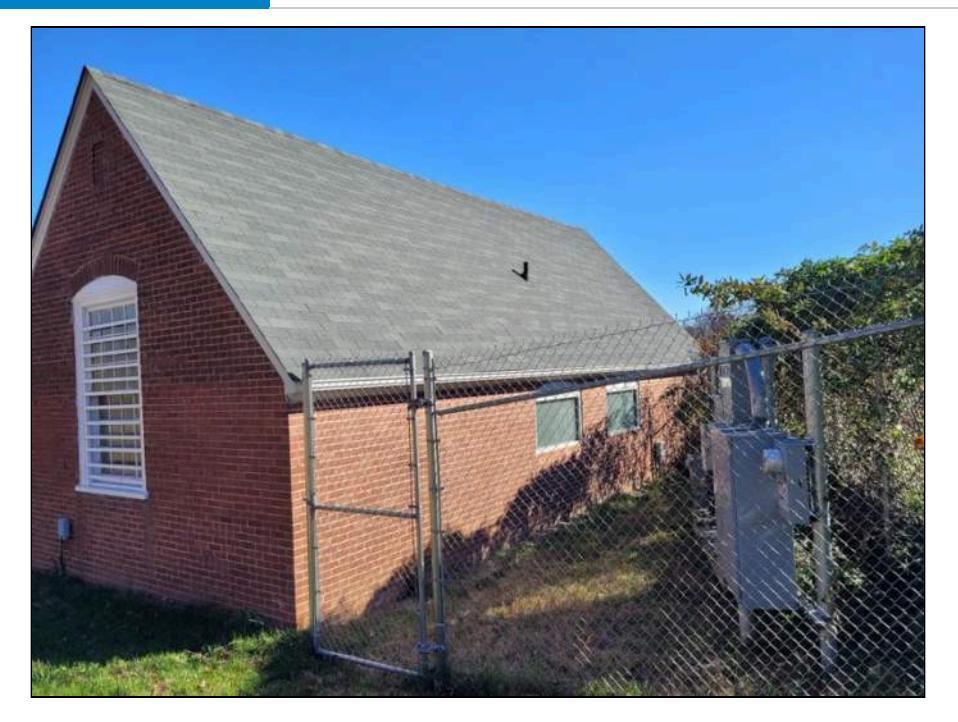
94 - Restroom exterior

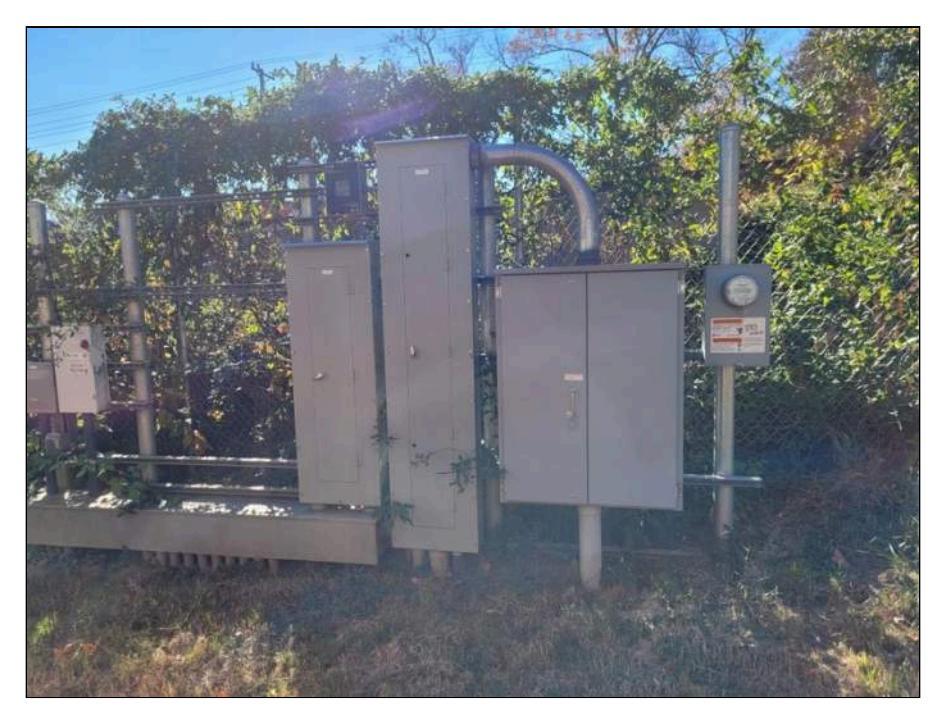
95 - Restroom exterior

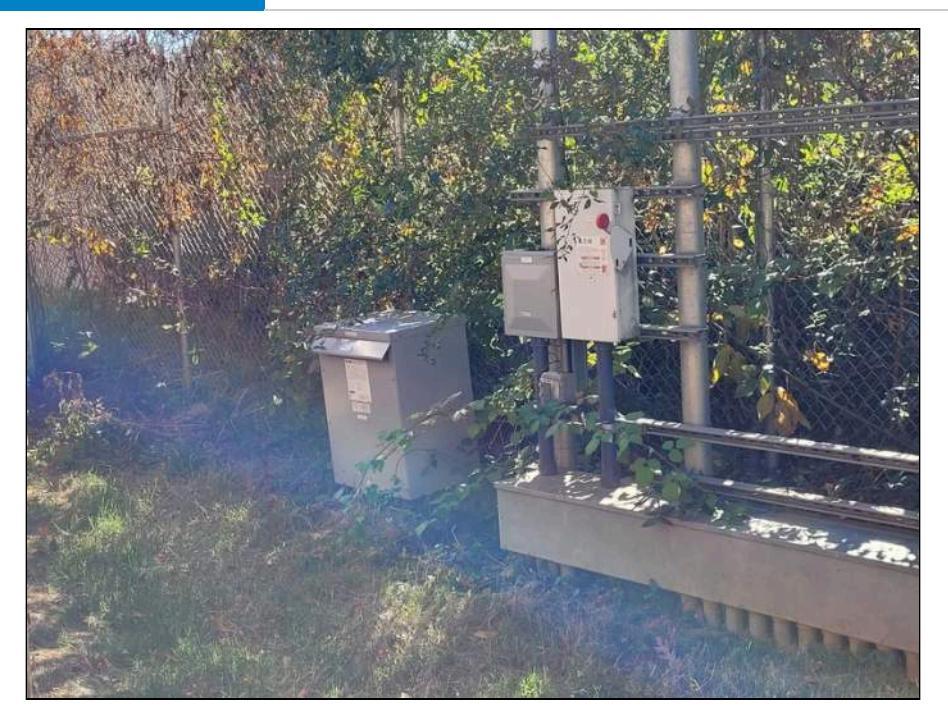
96 - Electrical service

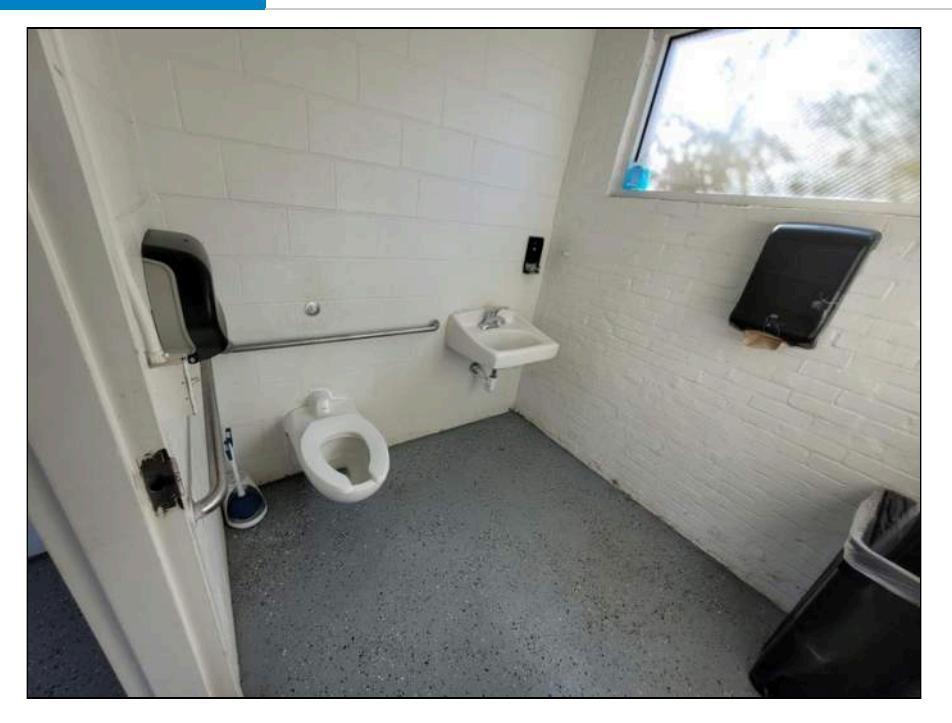
99 - Accessible restroom

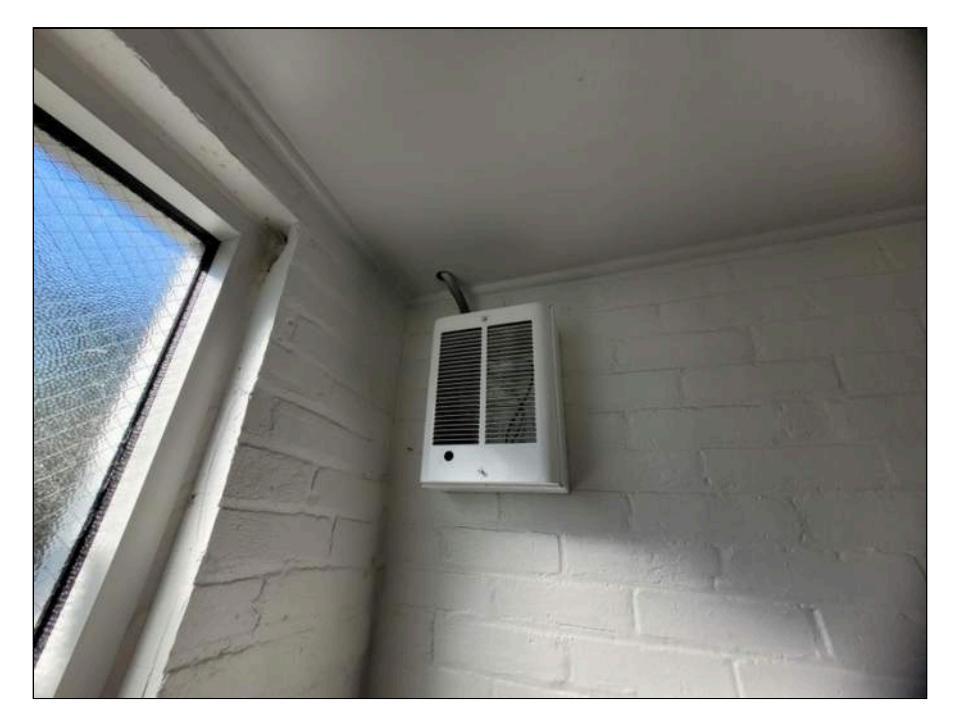
100 - Restroom space heater

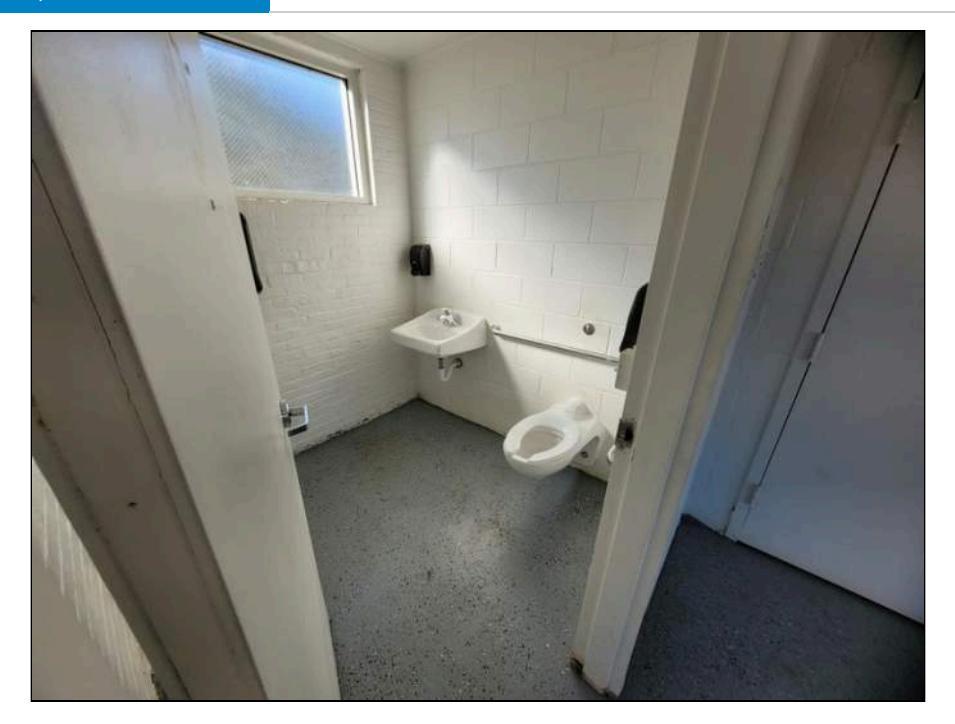
101 - Accessible restroom

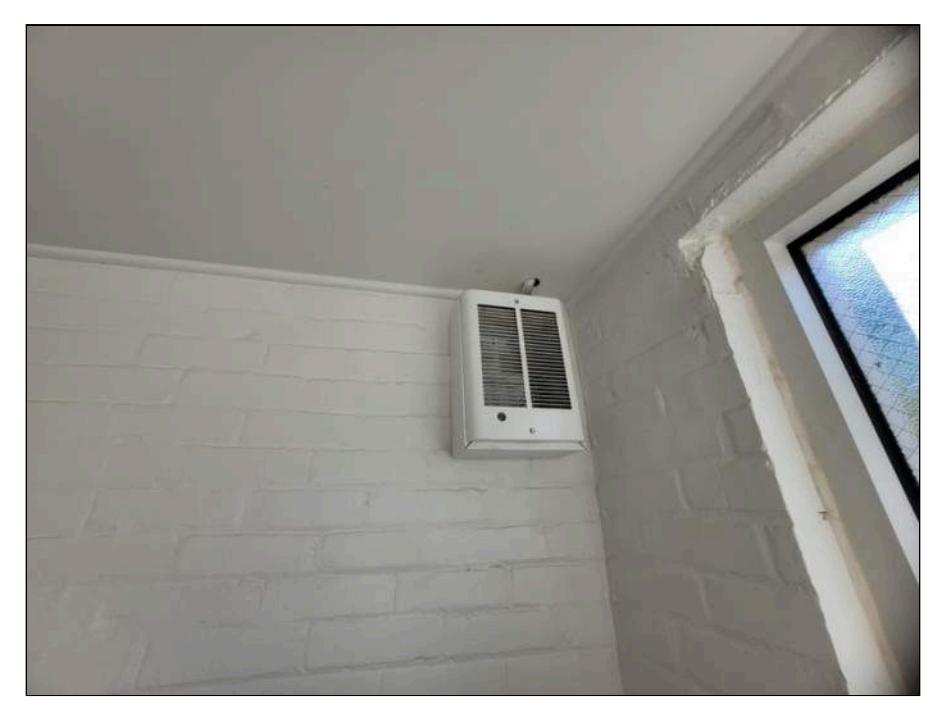
102 - Restroom space heater

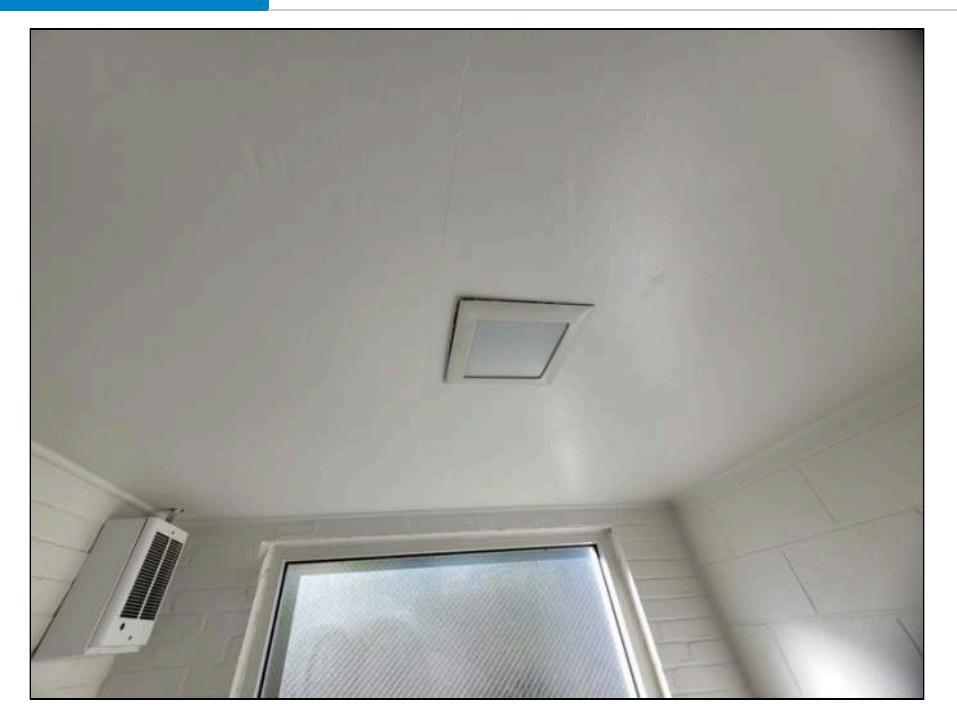
103 - Restroom ceiling
