MCINTIRE SKATE PARK 425 U.S. 250 BY-PASS CHARLOTTESVILLE, VIRGINIA

ECS PROJECT NO. 46:6713

CITY OF CHARLOTTESVILLE - FACILITIES DEVELOPMENT

Reference: Facility Condition Assessment Report for McIntire Skate Park, 425 U.S. 250 By-Pass, Charlottesville, Virginia

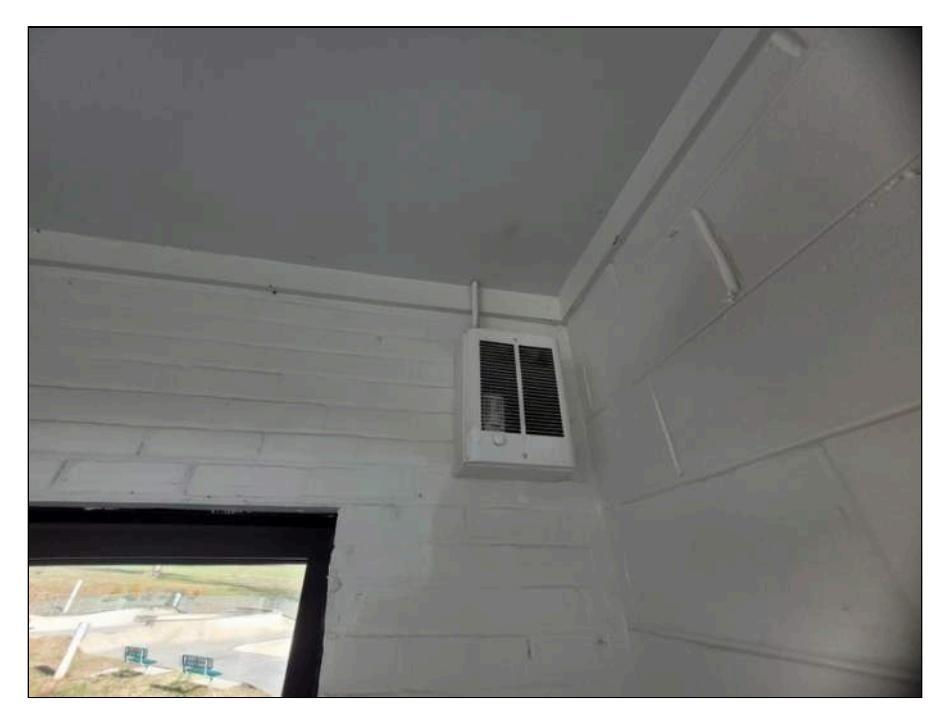
104 - Entry space heater

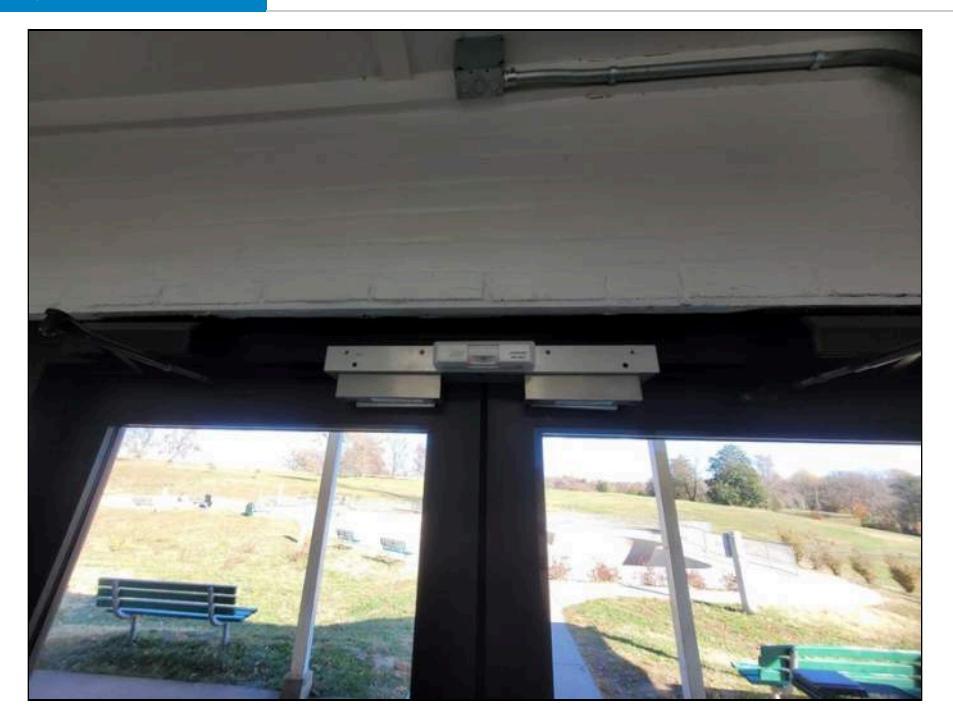
105 - Entry maglocks

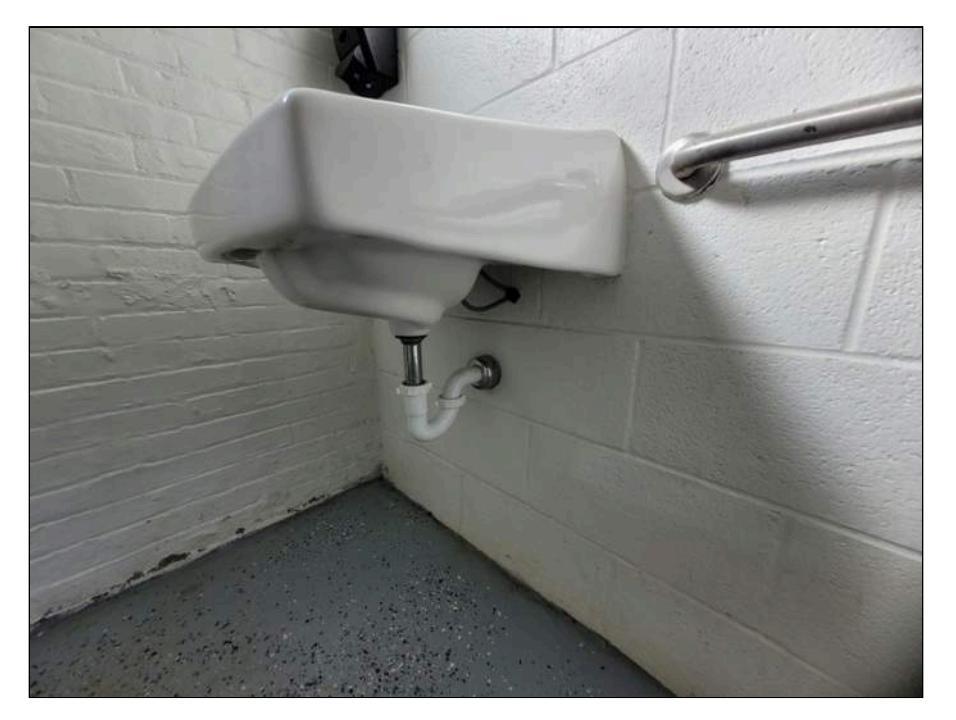
106 - Restroom plumbing

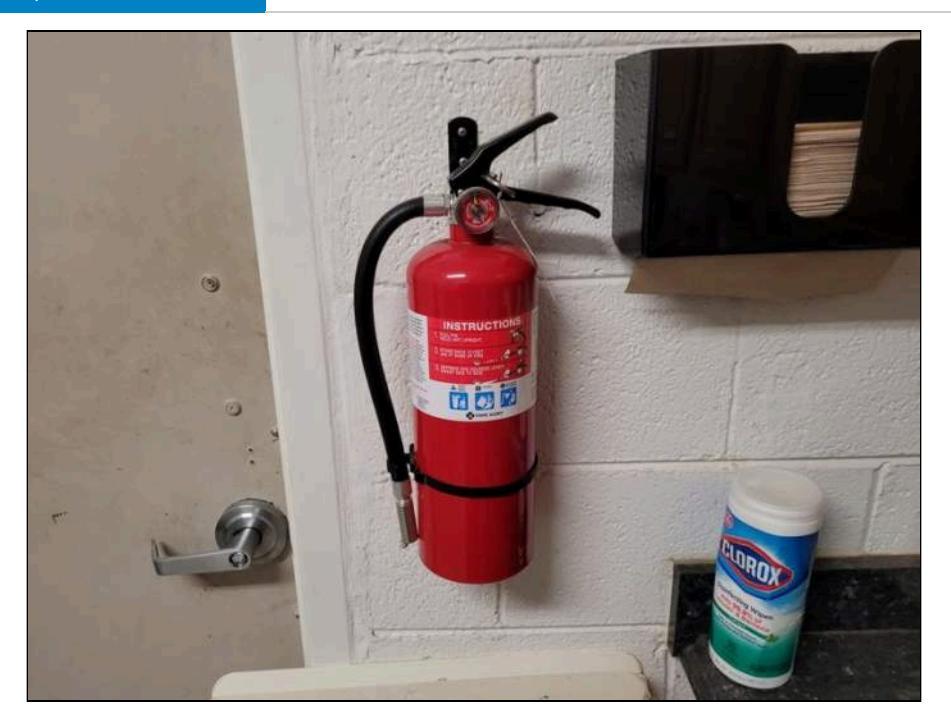
107 - Office extinguisher

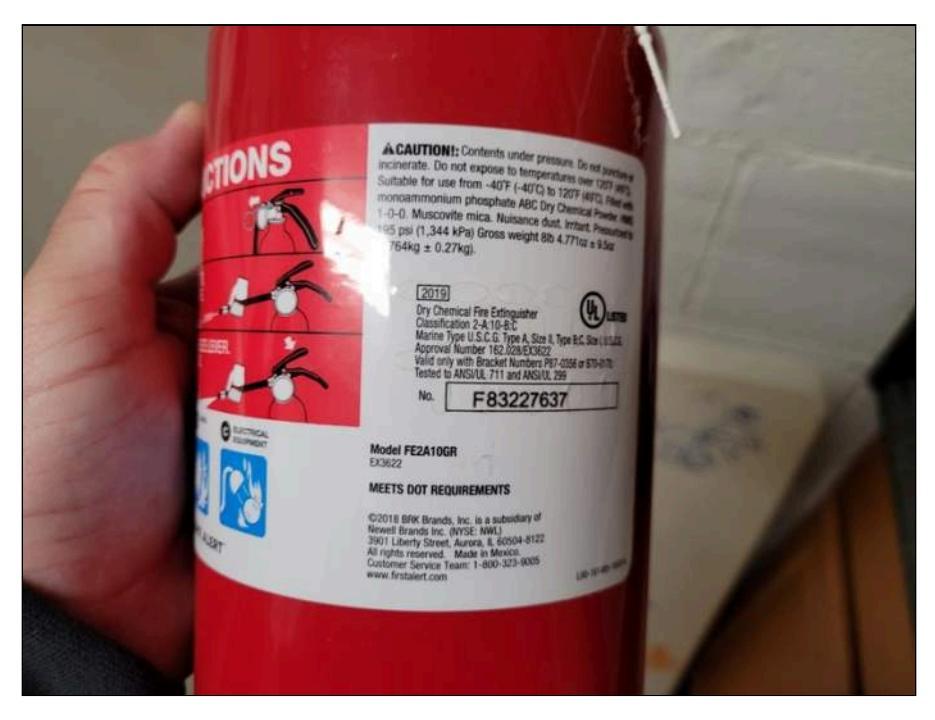
108 - Fire extinguisher

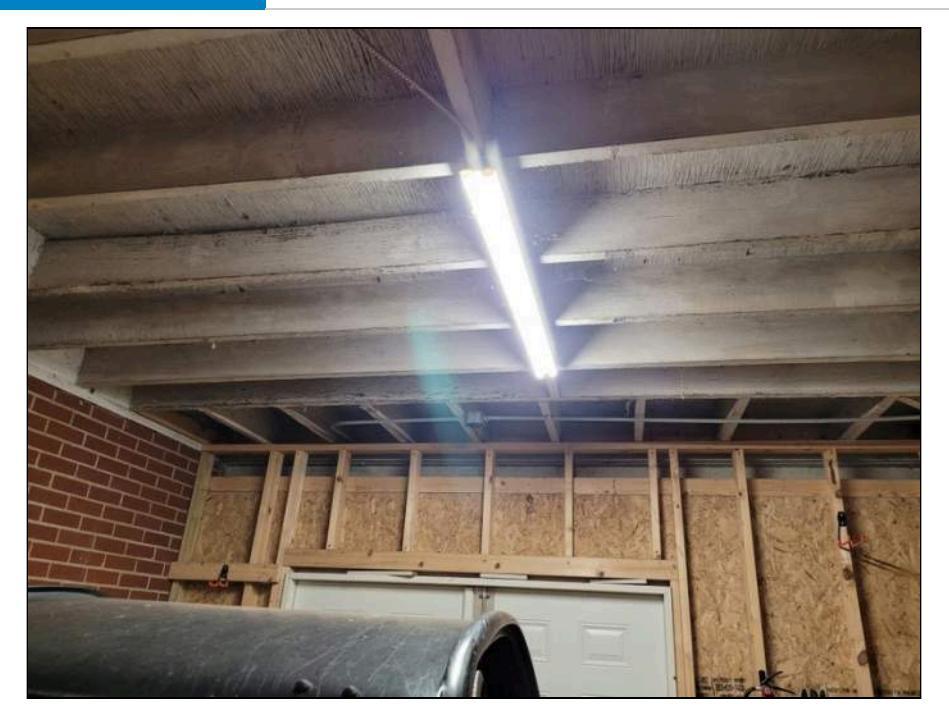
109 - Office storage framing

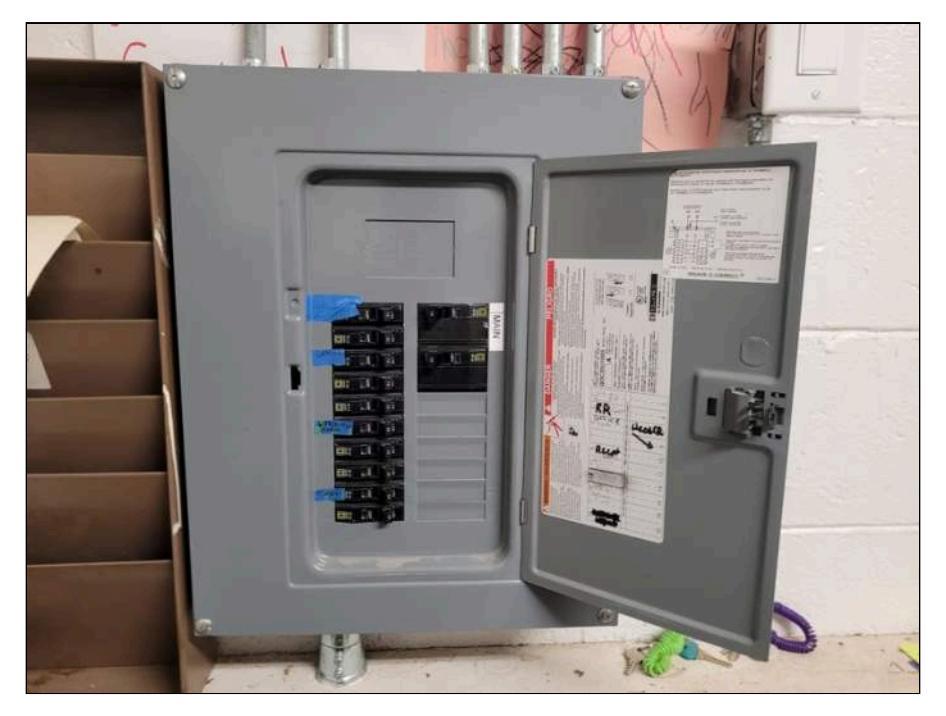
110 - Office panel

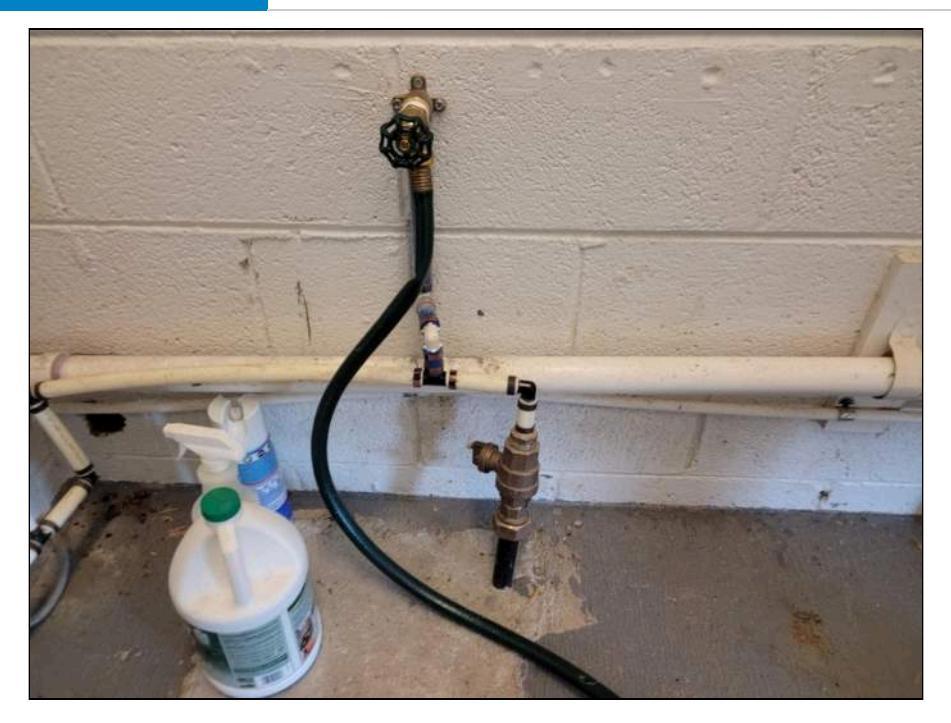
111 - Office plumbing

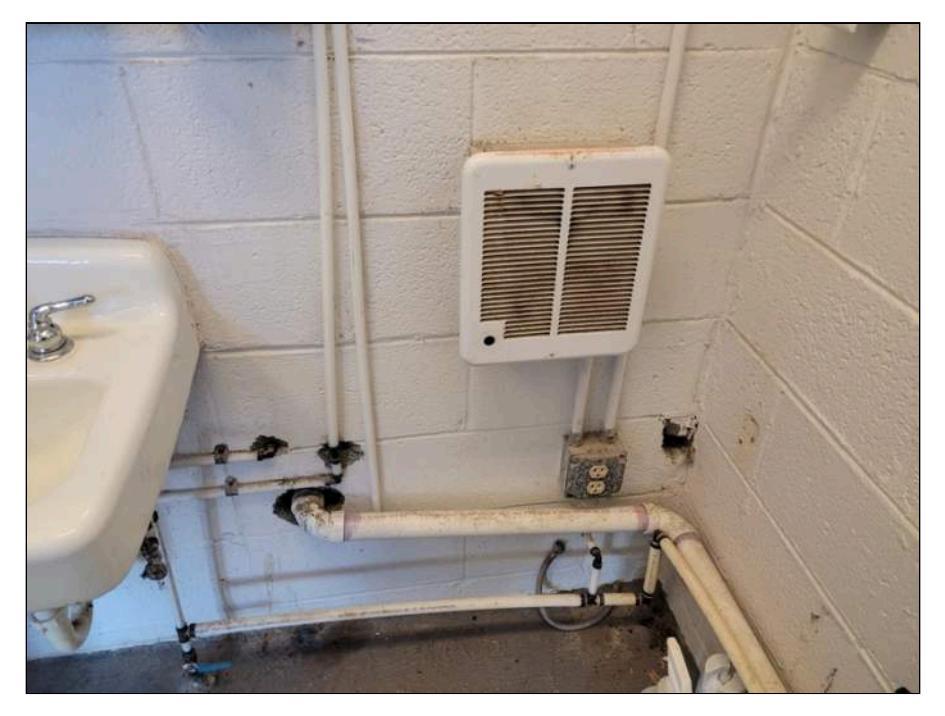
112 - Office restroom heater

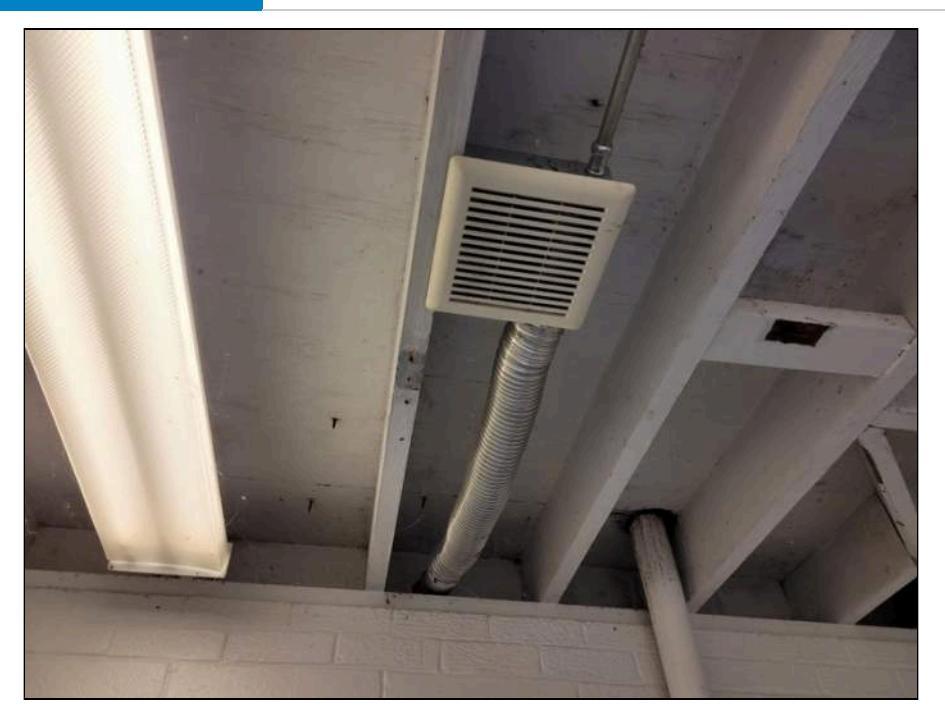
113 - Exhaust fan

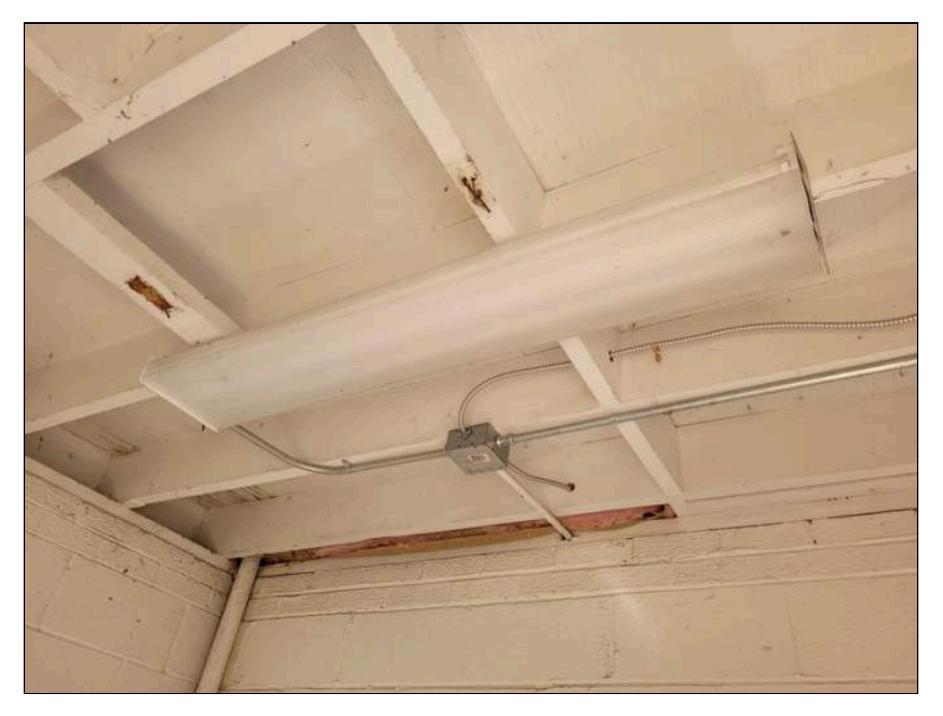
114 - Lighting

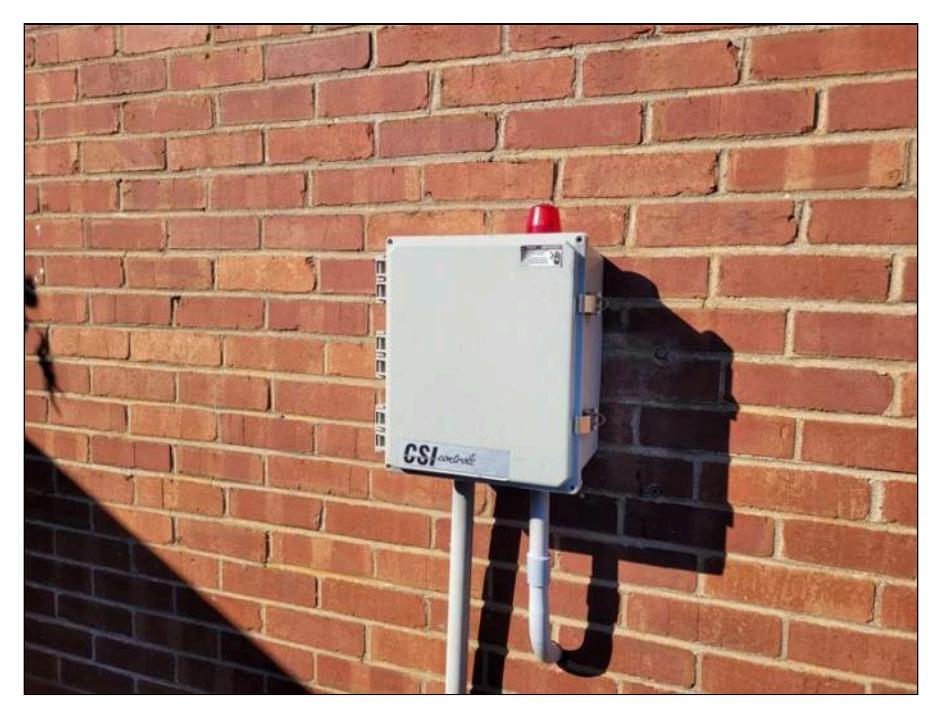
116 - Septic controls

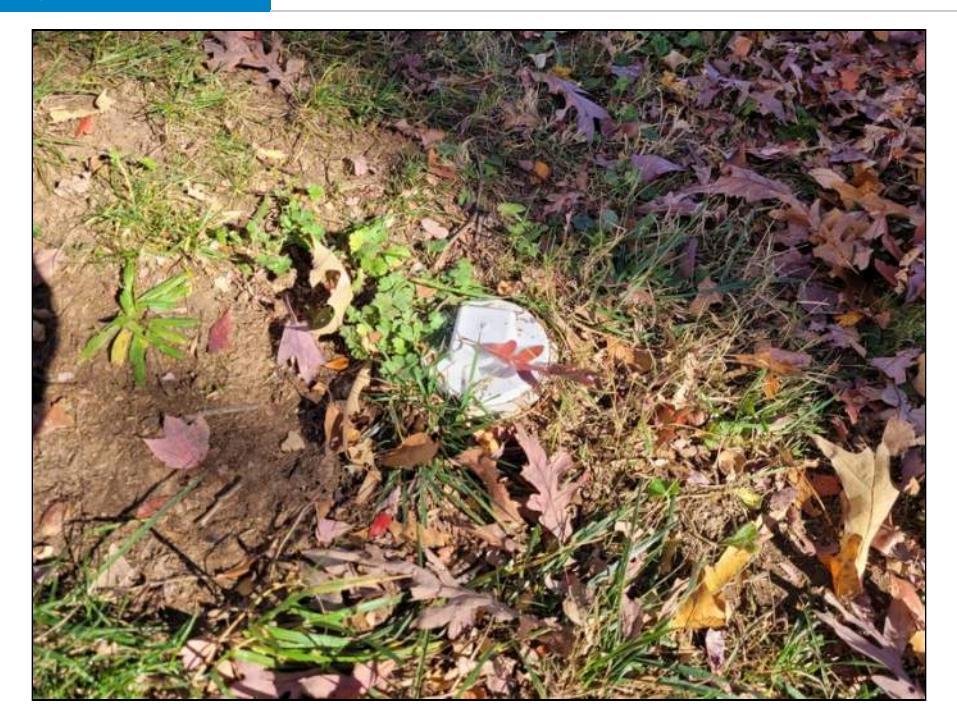
117 - Clean-out

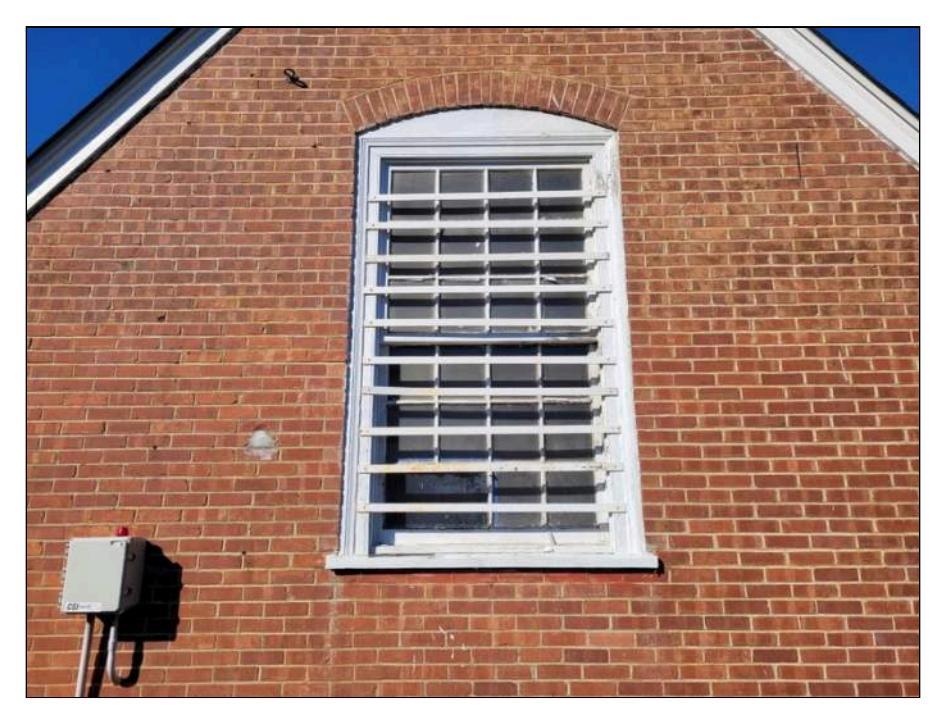
118 - Restroom window

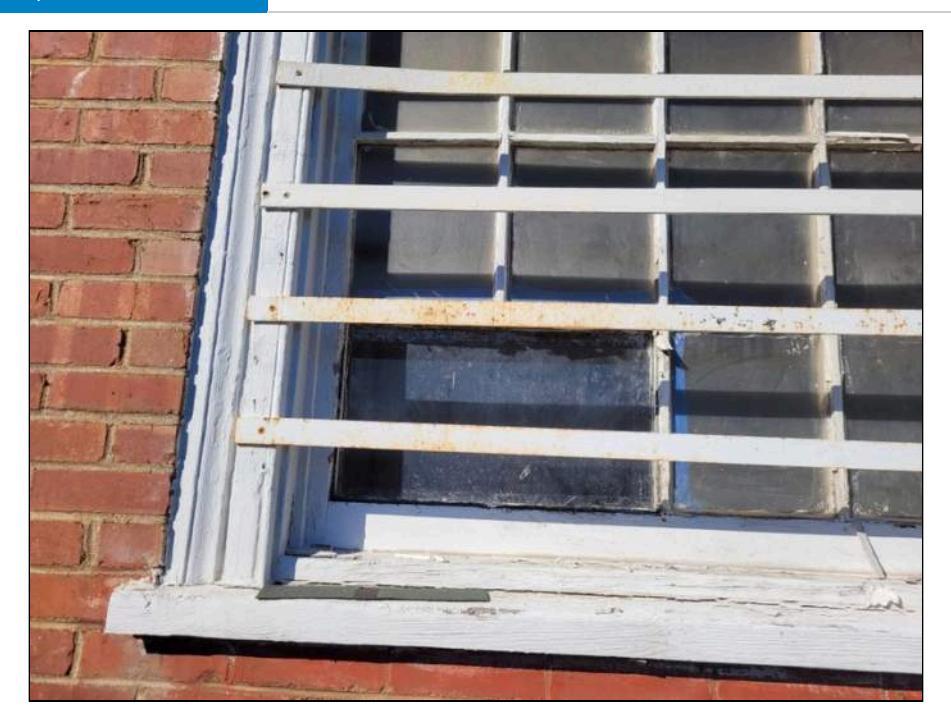
119 - Restroom window

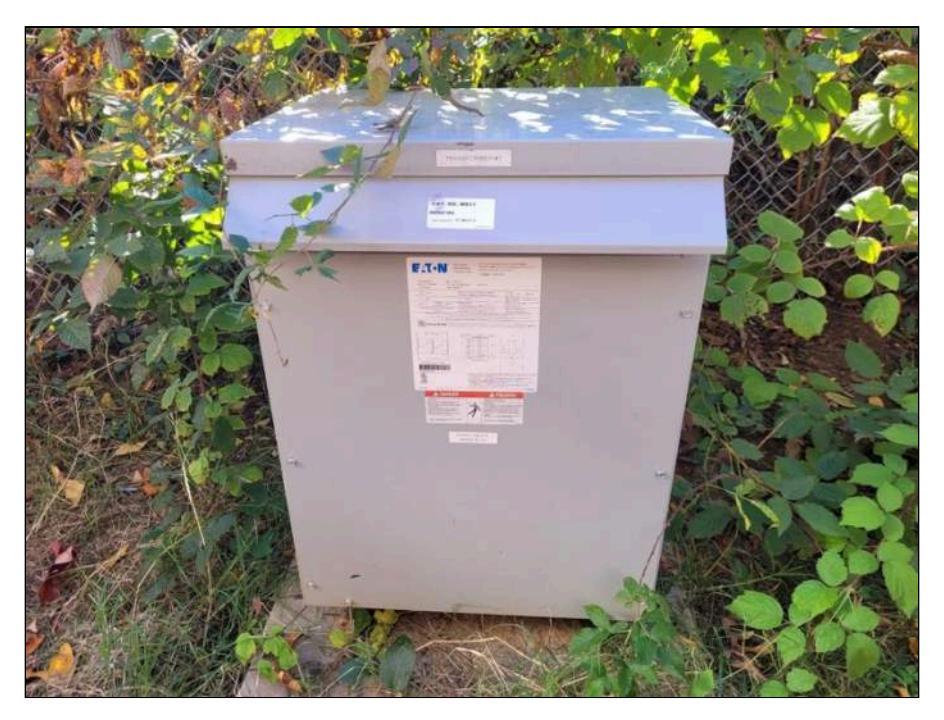
120 - Restroom transformer

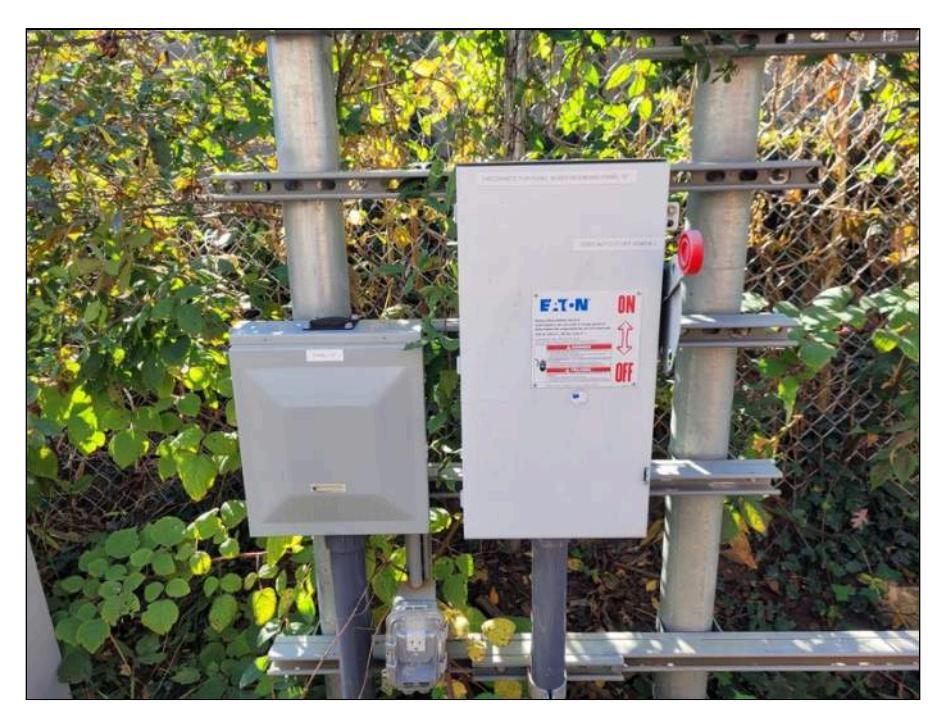
122 - Disconnect

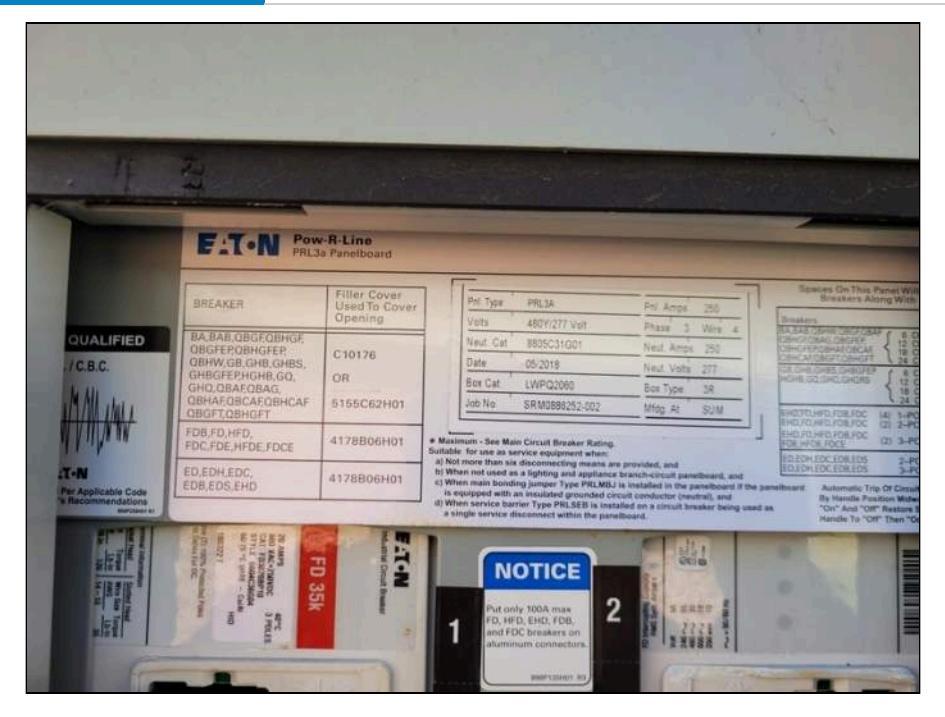
123 - Restroom panel

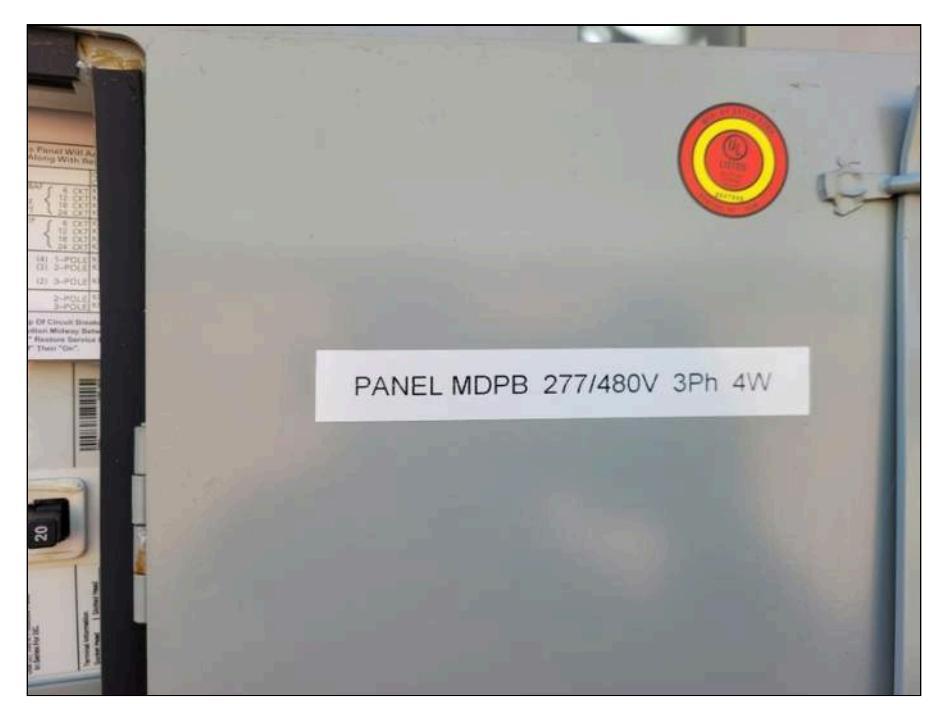
124 - Restroom service

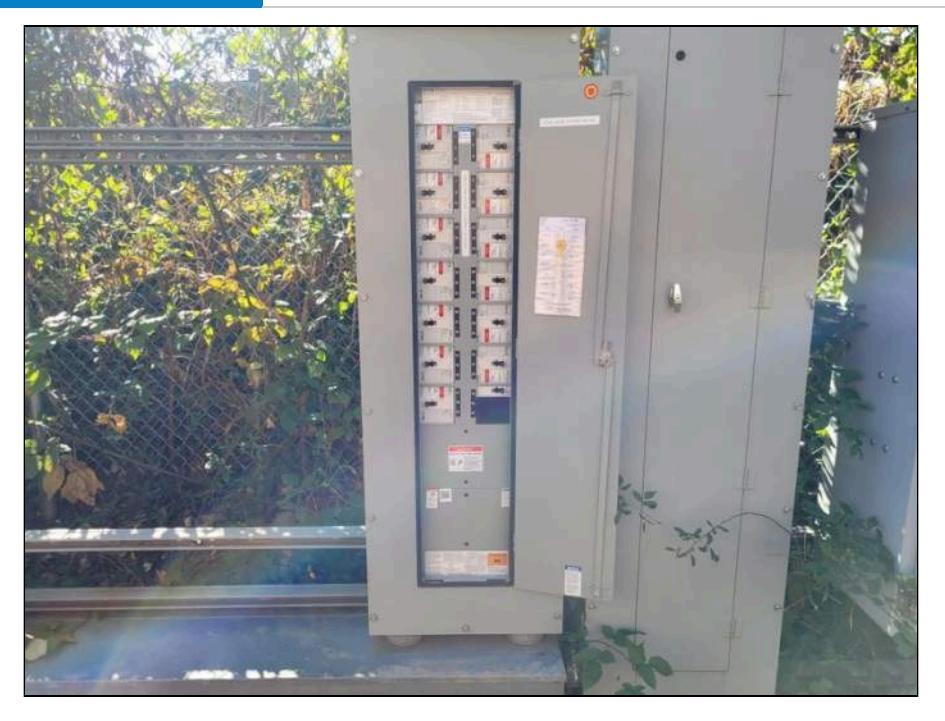
125 - Lighting panel

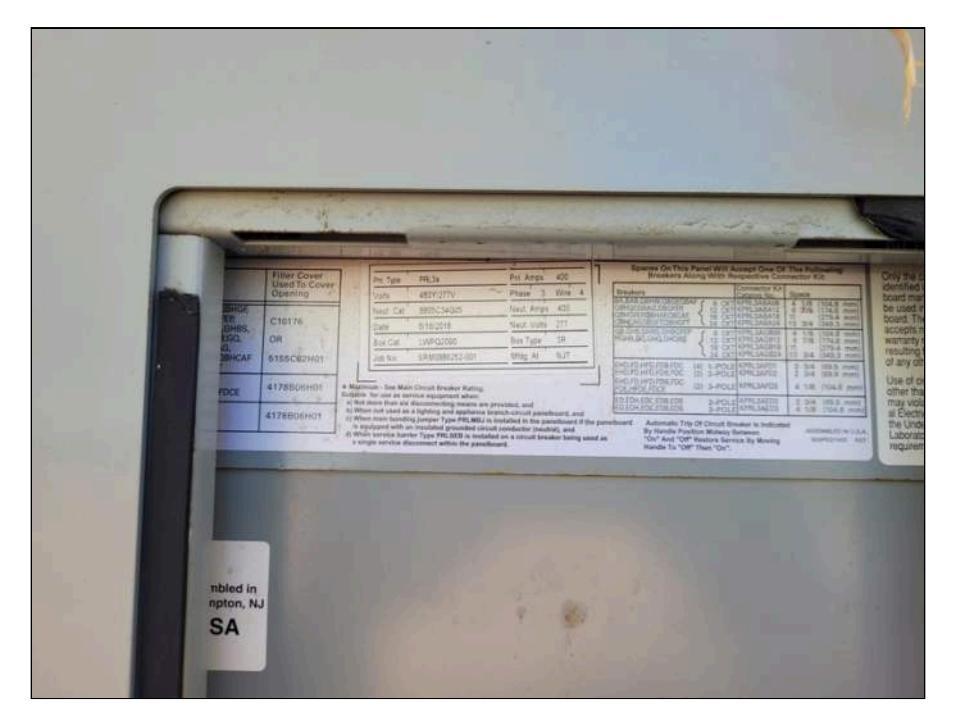
126 - Lighting panel

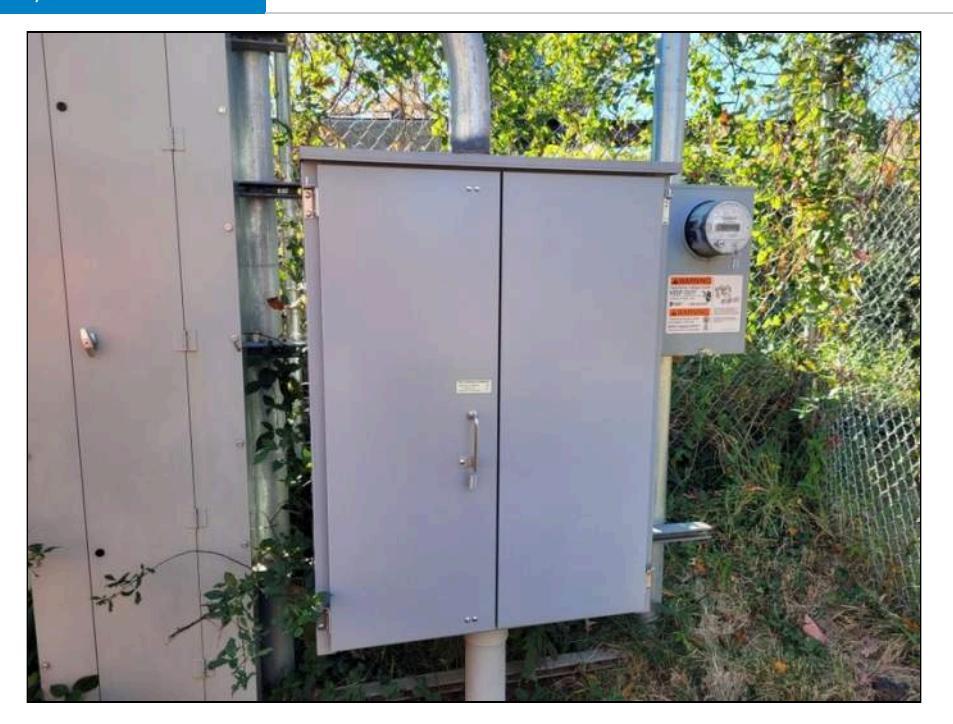
127 - CT cabinet

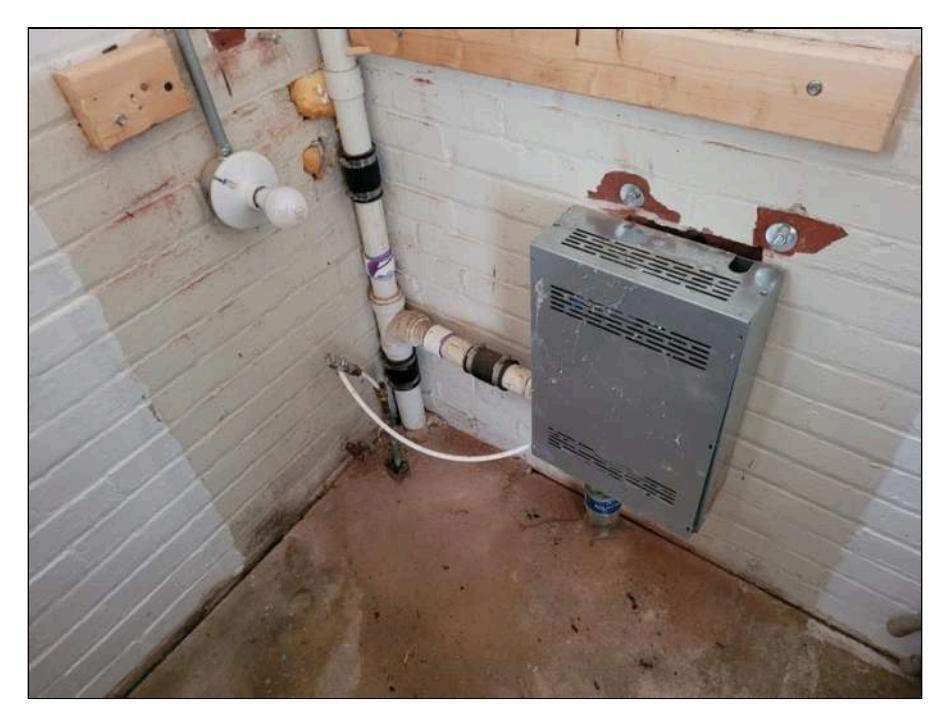
128 - Exterior drinking fountain

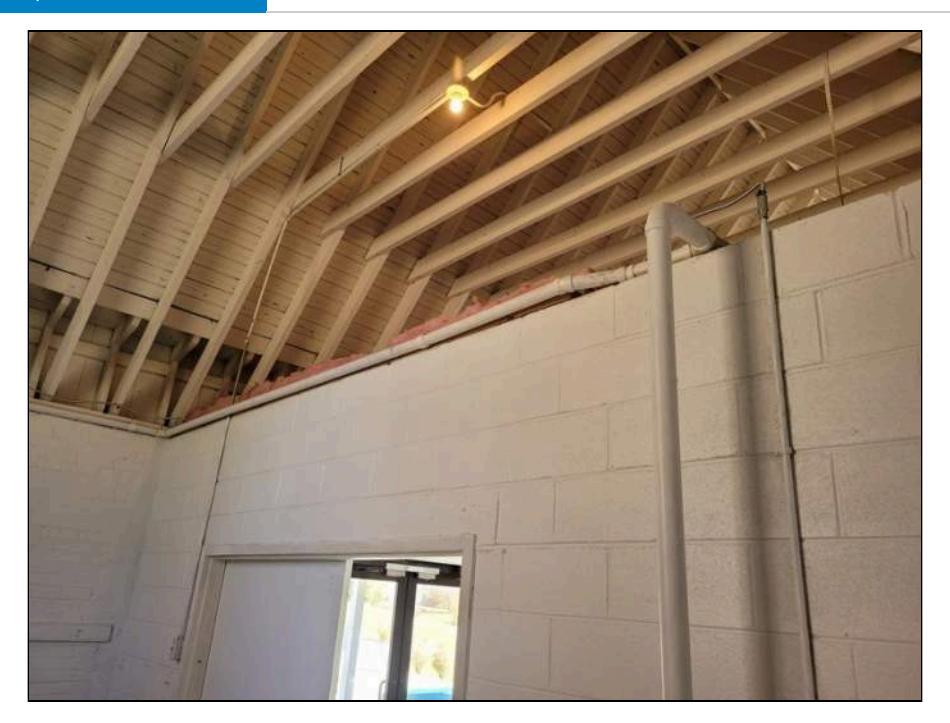
129 - Restroom building interior

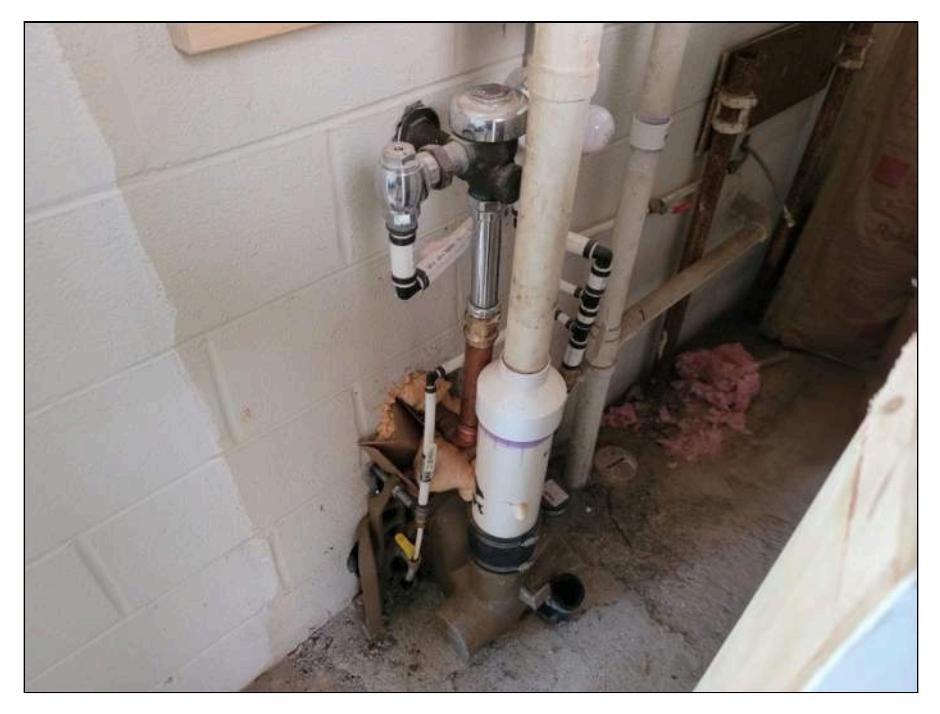
130 - Restroom plumbing

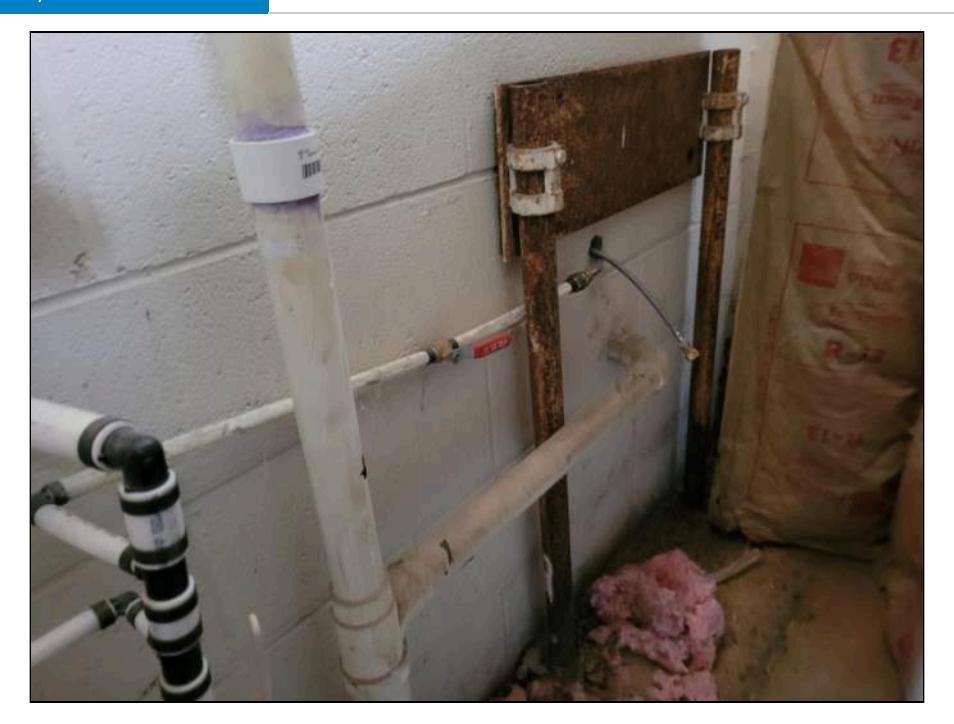
131 - Lavy carrier

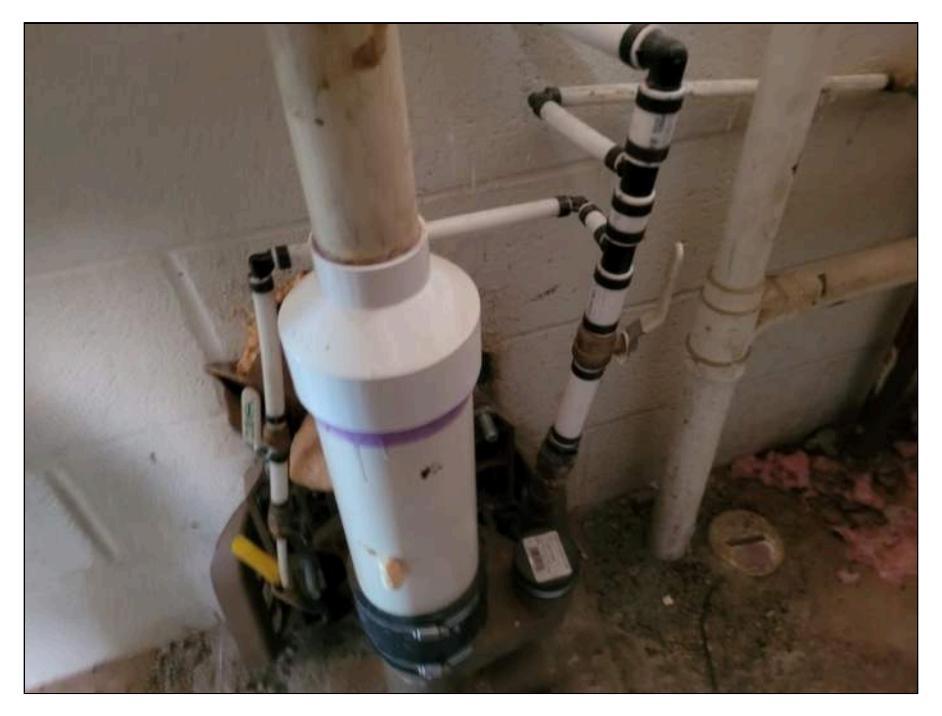
132 - Toilet carrier

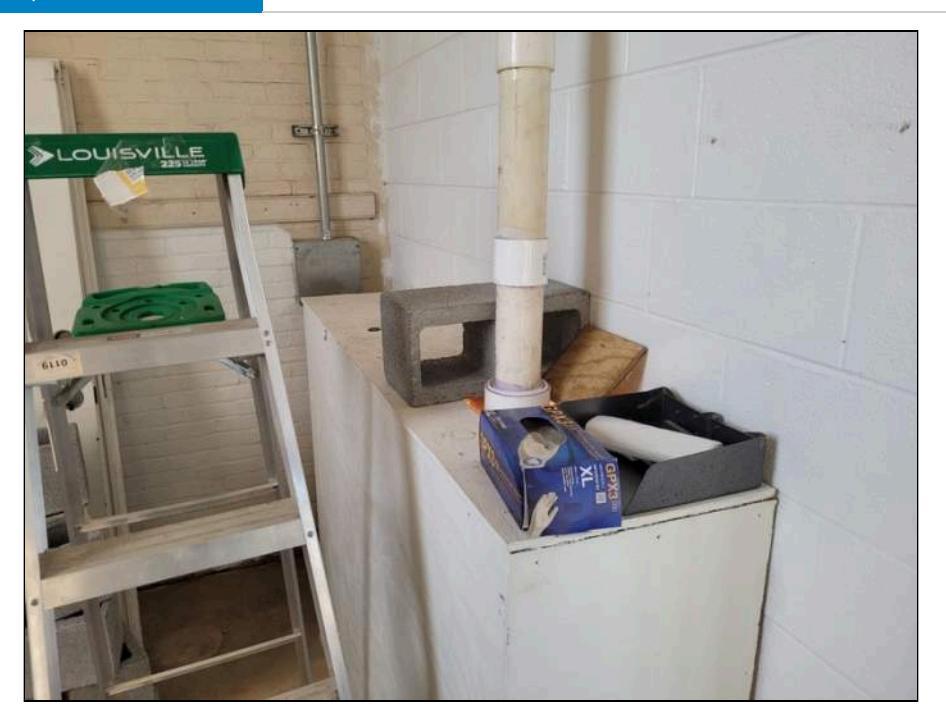
133 - Typical plumbing cover

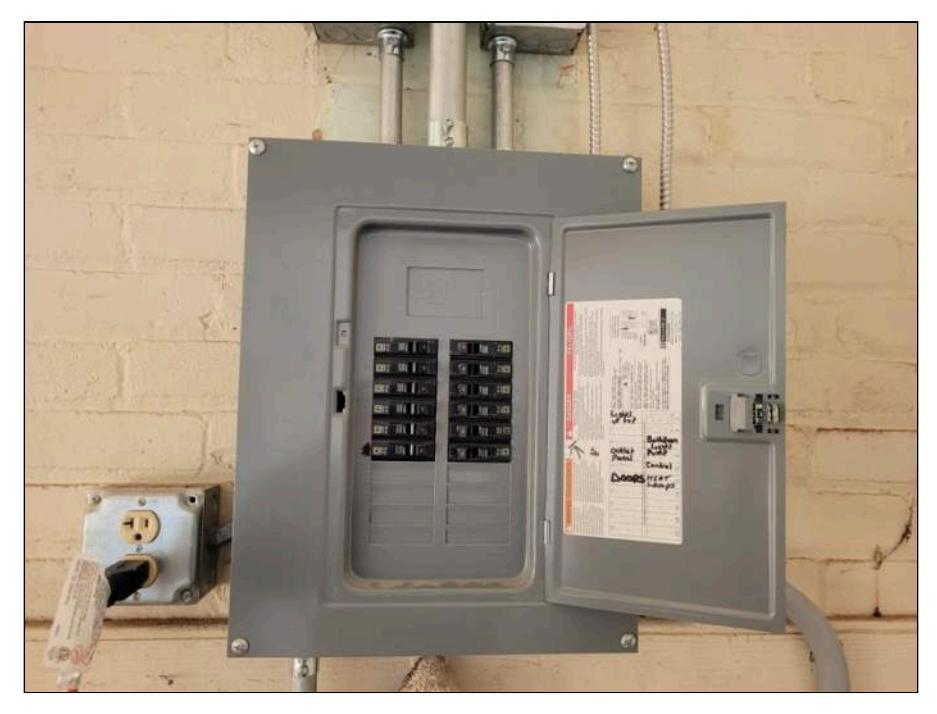
134 - Subpanel

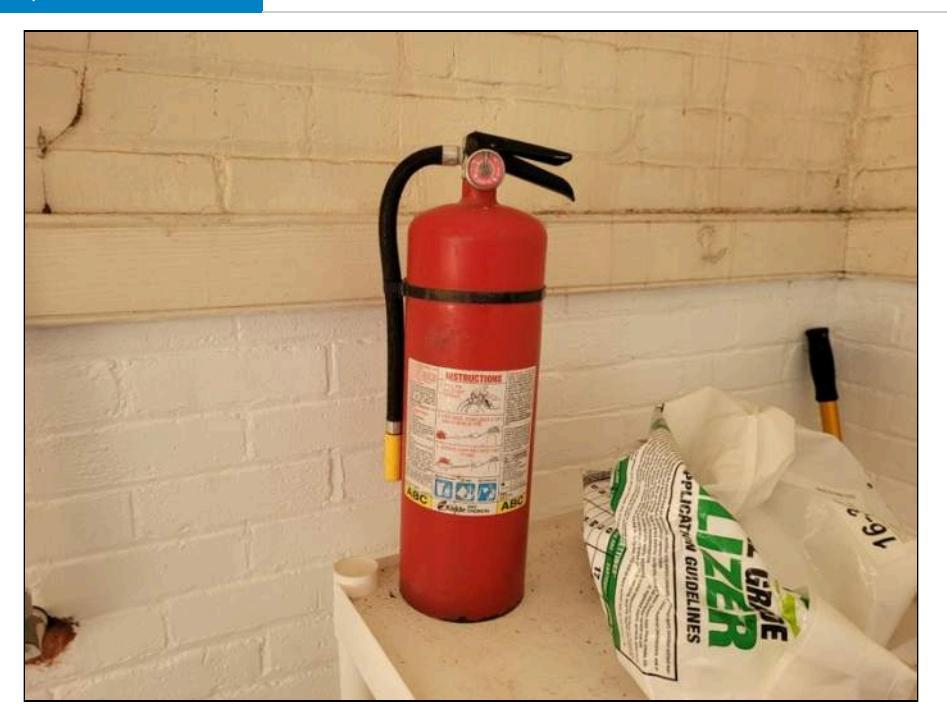
135 - Restroom extinguisher

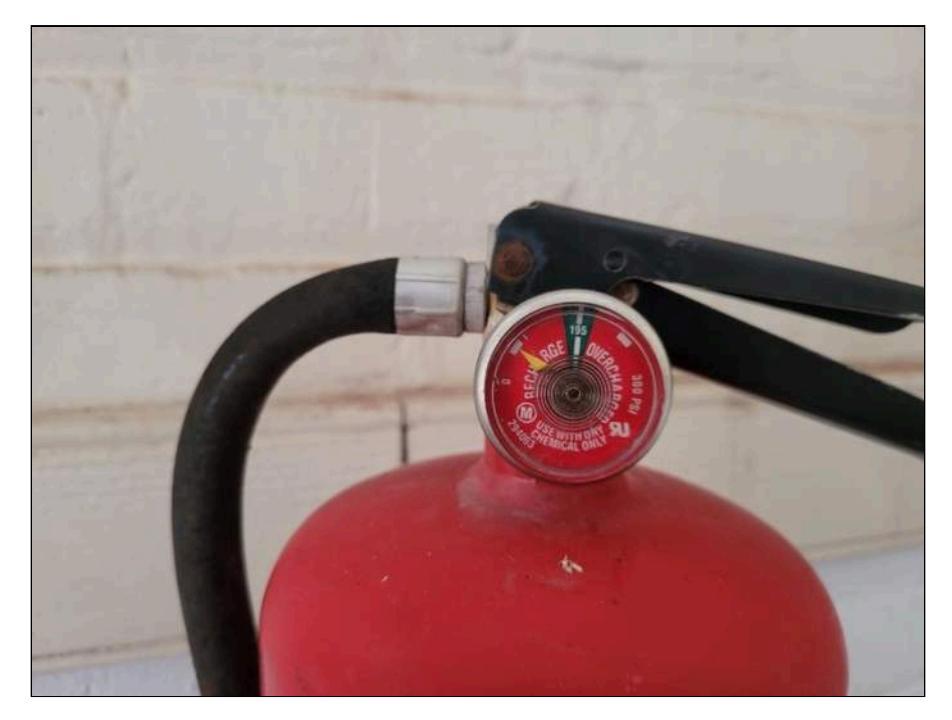
136 - Restroom extinguisher charge
### City of Charlottesville -Facilities Development ECS Project No. 46:6713 November 2, 2021

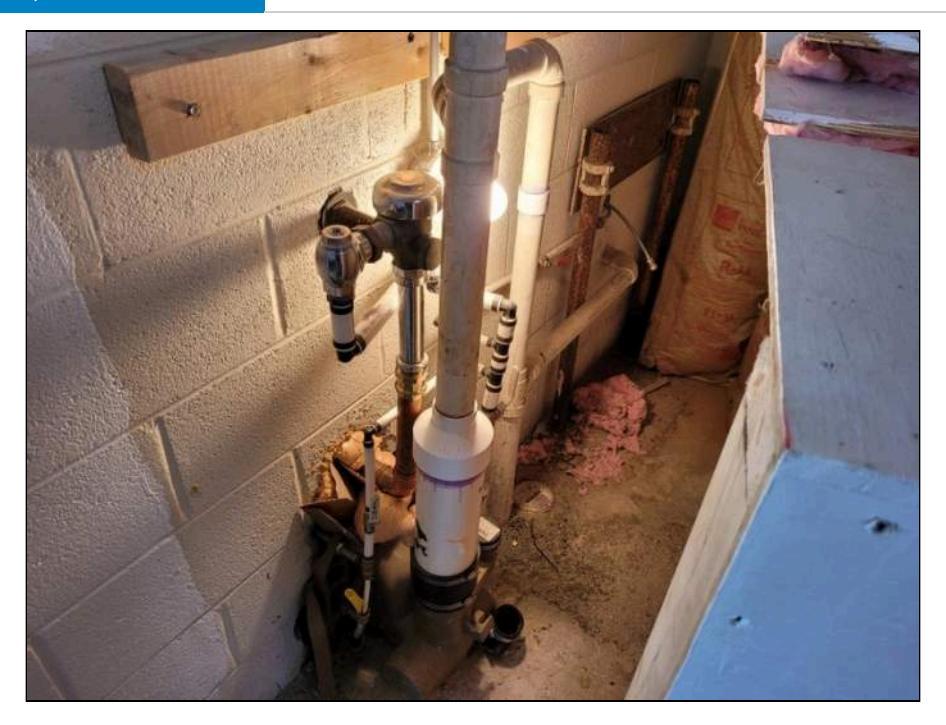
137 - Restroom plumbing

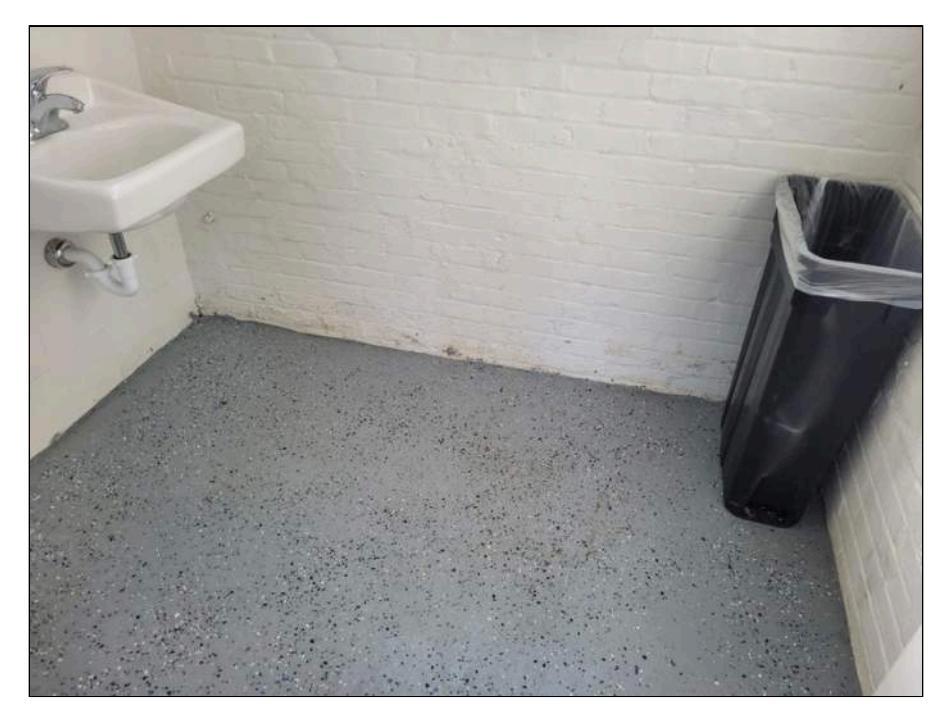
138 - Restroom
