MCINTIRE SKATE PARK 425 U.S. 250 BY-PASS CHARLOTTESVILLE, VIRGINIA

ECS PROJECT NO. 46:6713

CITY OF CHARLOTTESVILLE - FACILITIES DEVELOPMENT

Reference: Facility Condition Assessment Report for McIntire Skate Park, 425 U.S. 250 By-Pass, Charlottesville, Virginia

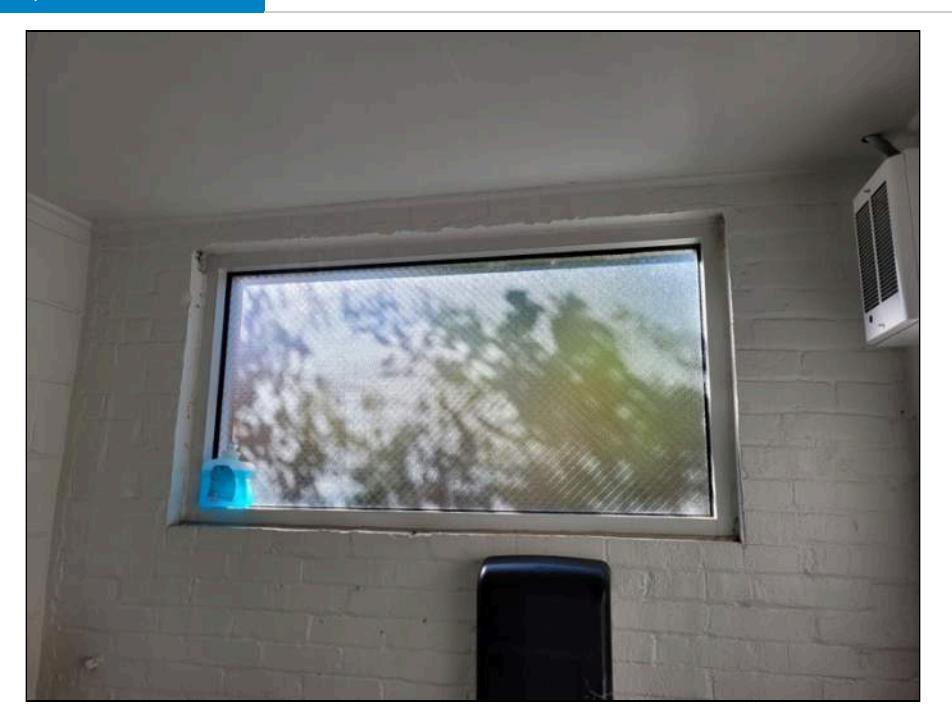
139 - Restroom window

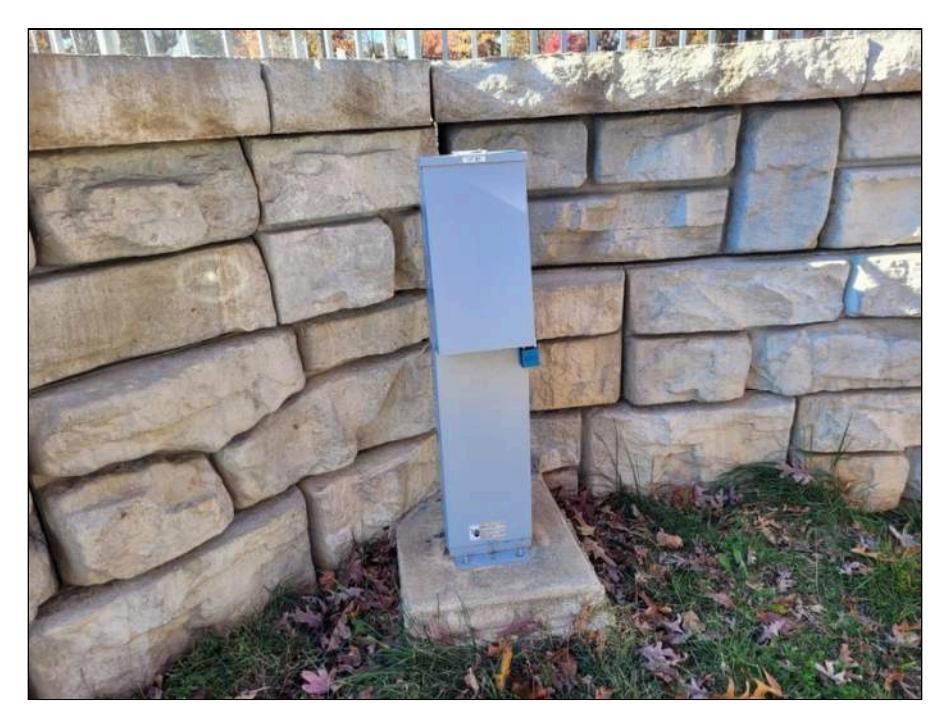
140 - Power pedestal

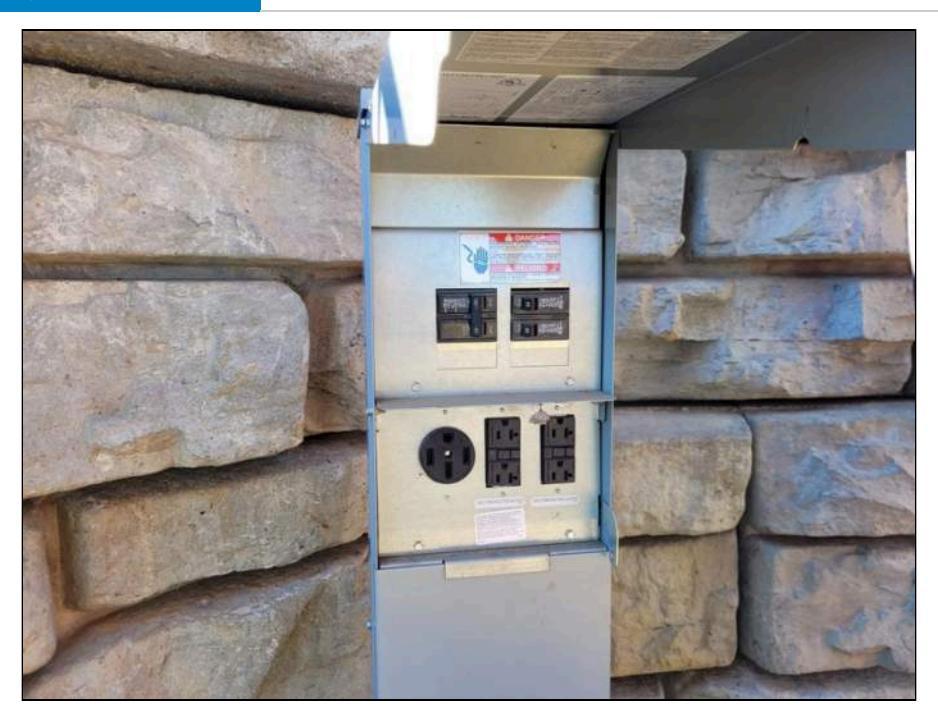
141 - power pedestal
