MEADE PARK BATH HOUSE AND MECHANICAL BUILDING
300 MEADE AVENUE
CHARLOTTESVILLE, VIRGINIA

ECS PROJECT NO. 46:6713

CITY OF CHARLOTTESVILLE - FACILITIES DEVELOPMENT

Reference: Facility Condition Assessment Report for Meade Park Bath House and Mechanical Building, 300 Meade Avenue, Charlottesville, Virginia

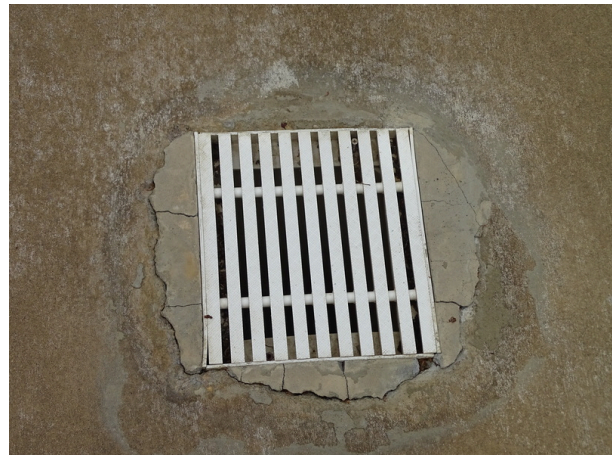
Stormwater drainage

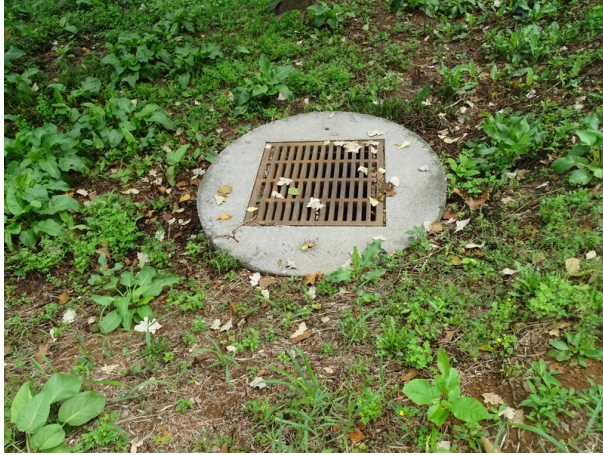
Stormwater drainage

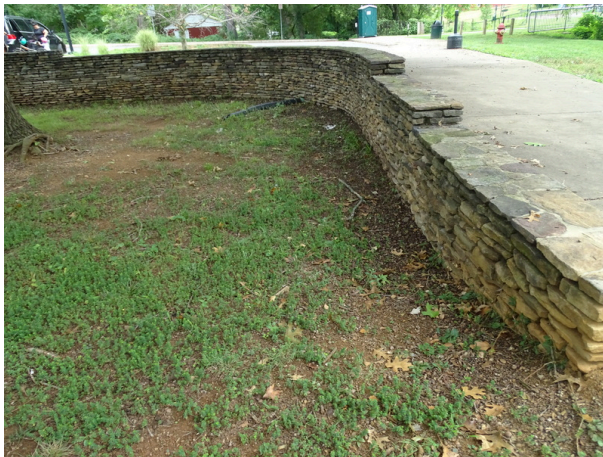
Typical retaining wall - note efflorescence

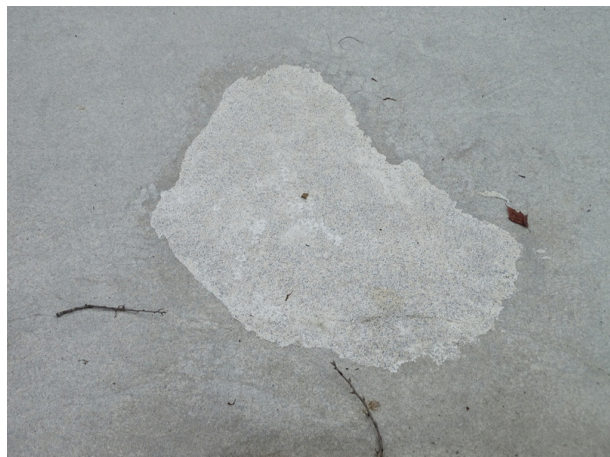
Repaired pool deck area

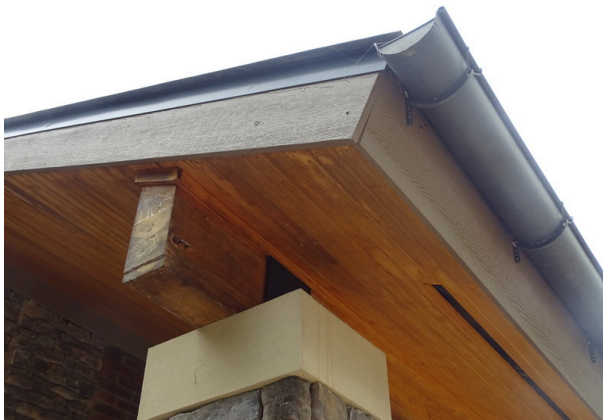
The structure of both buildings consists of wood roof framing with steel exterior columns and load bearing CMU walls. The structural frame of the buildings was generally in good condition.

Wood roof framing and steel columns

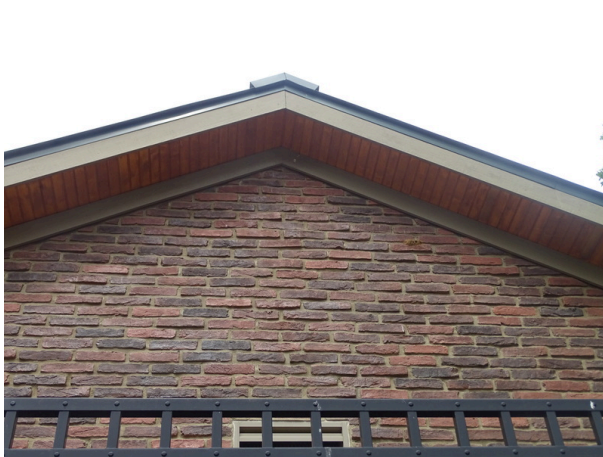
Brick joints and sealant at exterior

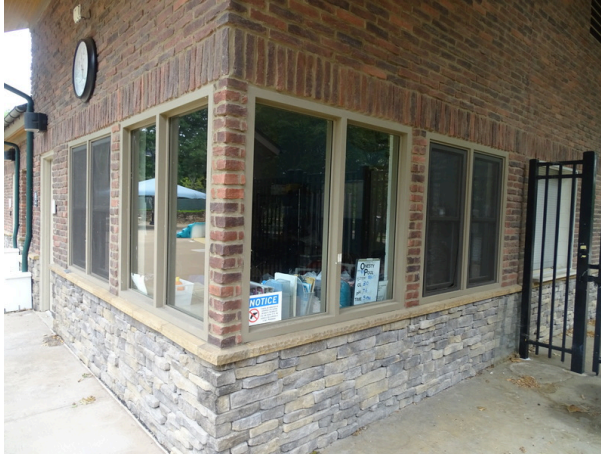
Two exterior display cabinets with glass inserts were installed on the south wall of the bath house. One of the glass panels was broken out. We recommend replacing this glass panel.

Bath house overview

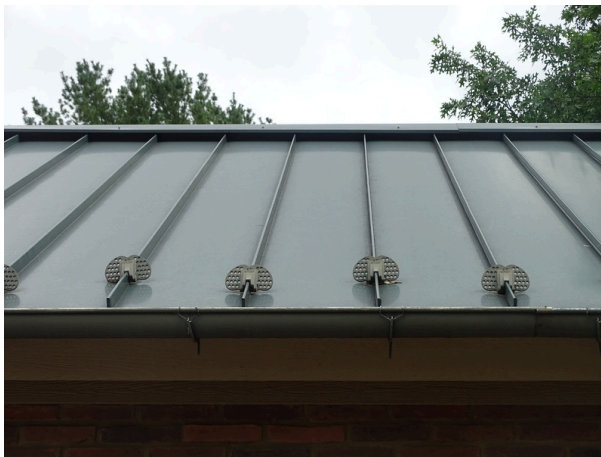
The roofing system for both the Bath house and Mechanical room structures consist of standing seam metal roofing systems. The roofing was in good condition. The expected useful life of the metal roofing systems is generally 50 years. Metal roofs should be painted or a protective coating should be applied every 25 years to protect the metal roof.

Metal roof overview

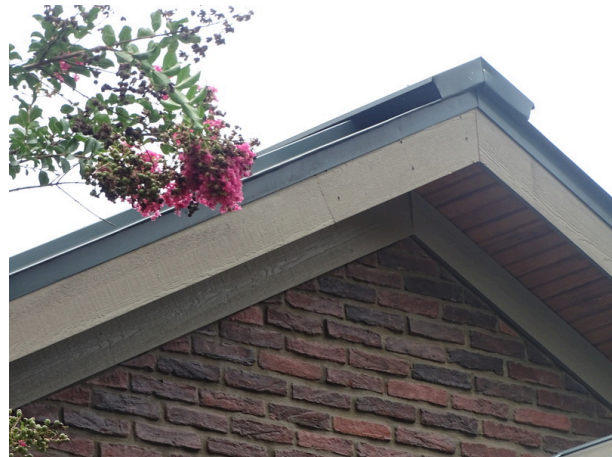
Squirrel nests were observed in the soffit vent of the building. We recommend removing the squirrels and nesting material and installing screening over the soffit vent as a maintenance item.

Typical wooden soffit overview

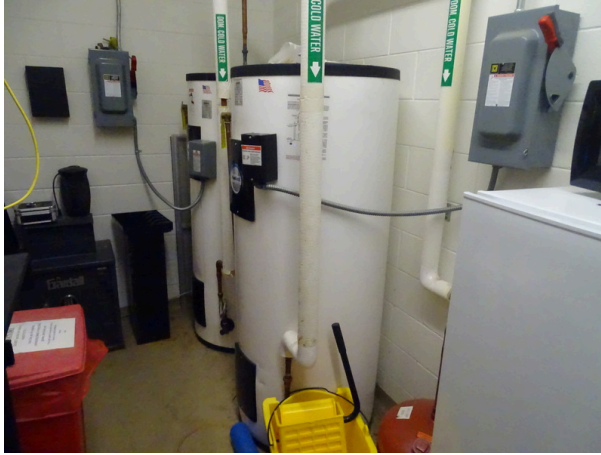
Bath house water heater

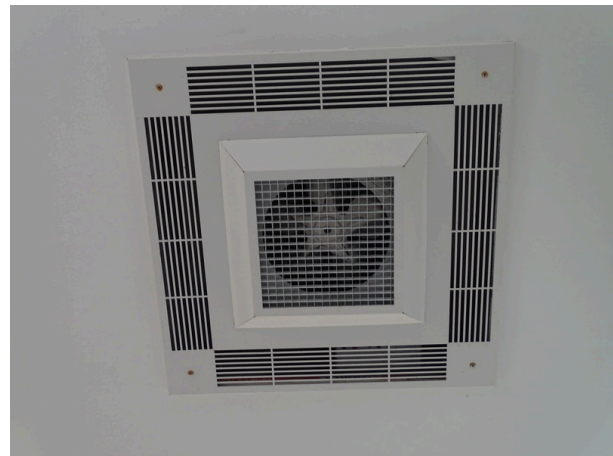
Unit heater and exhaust fan

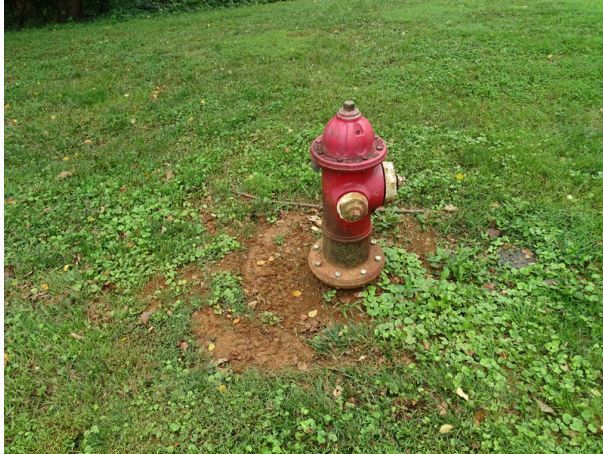
A fire hydrant was observed at the east side of the site near the parking lot. The fire hydrant was observed to be in good condition.

Typical water hydrant

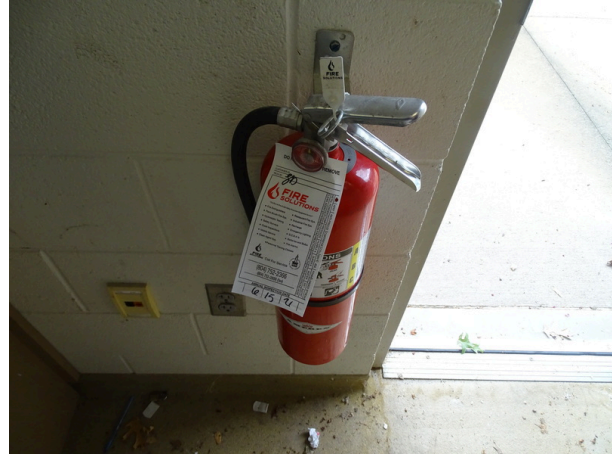
Fire extinguisher in the mechanical building

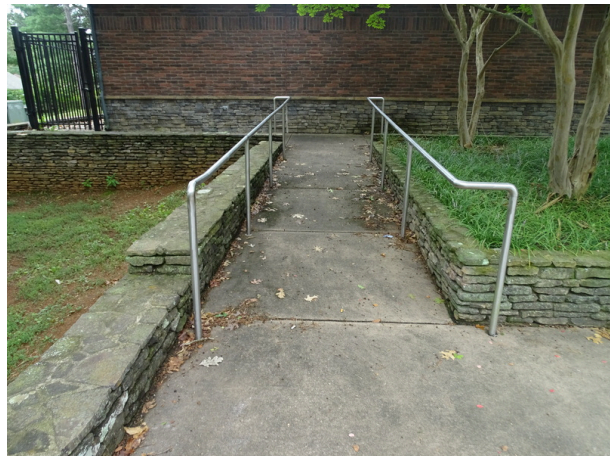
Accessible ramp

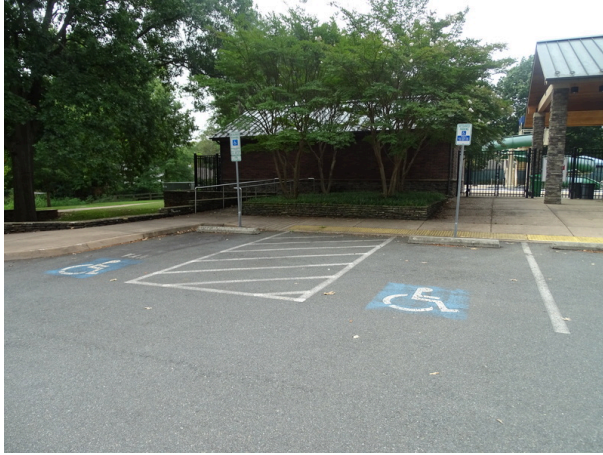
Accessible parking

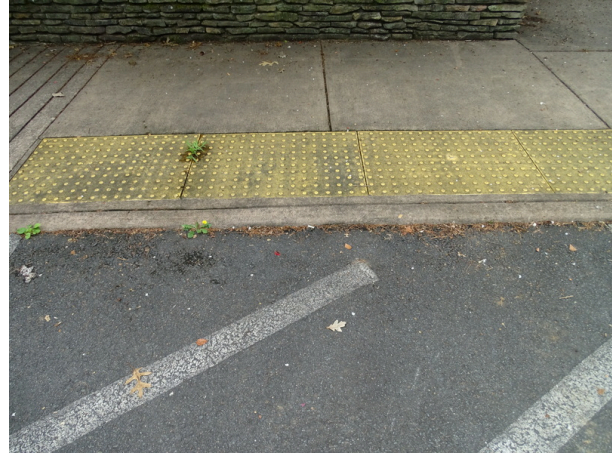
Truncated domes at curb ramp from parking lot

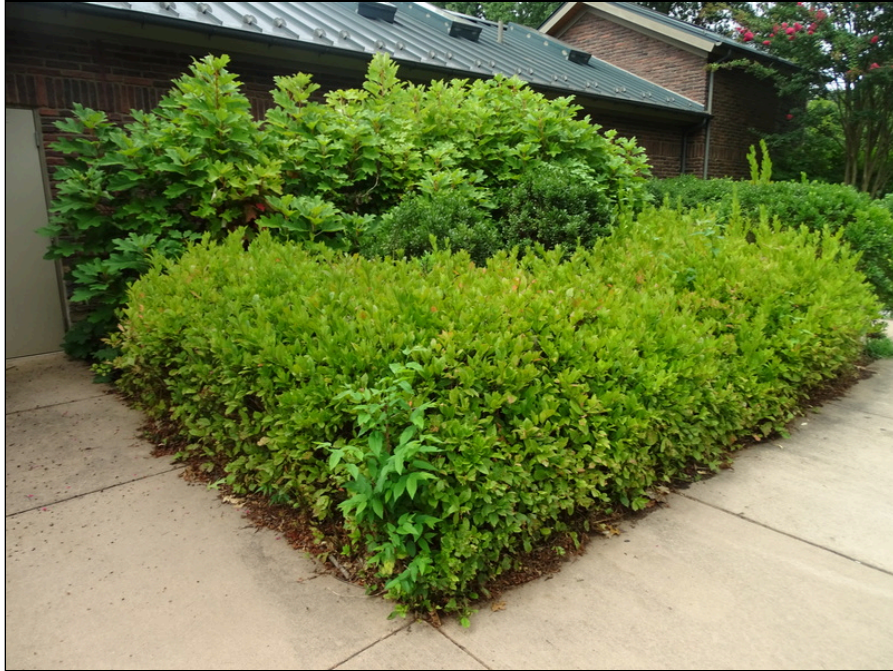
1 - Meade Park Bath House

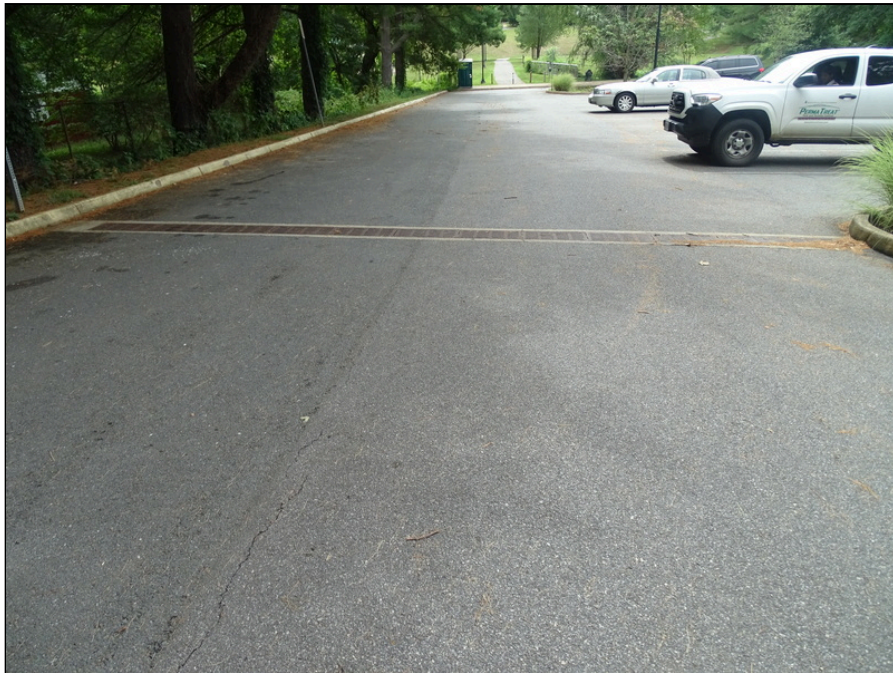
2 - Stormwater drainage and asphalt pavement - note cracking

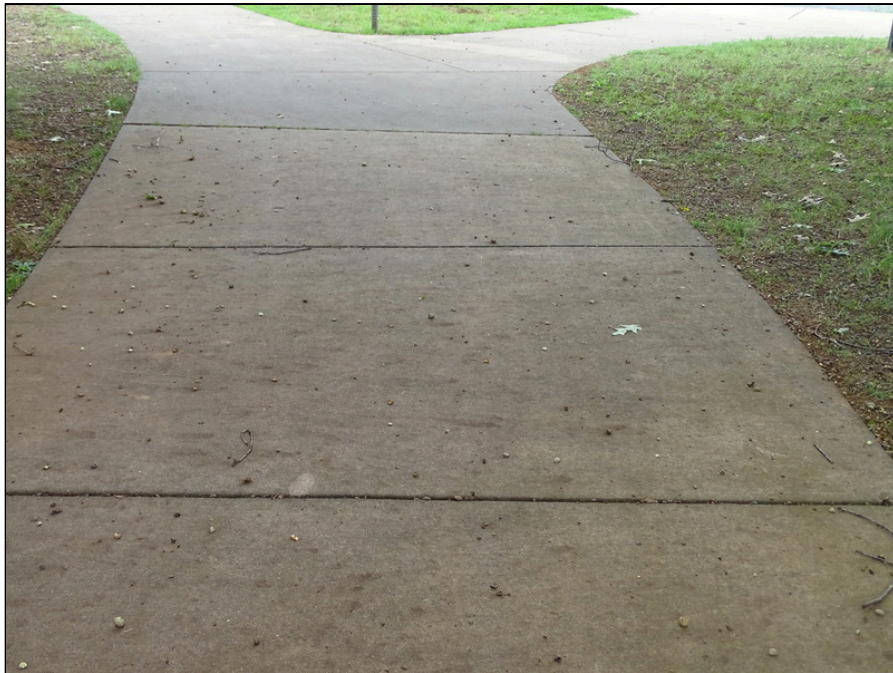
4 - Typical concrete sidewalk

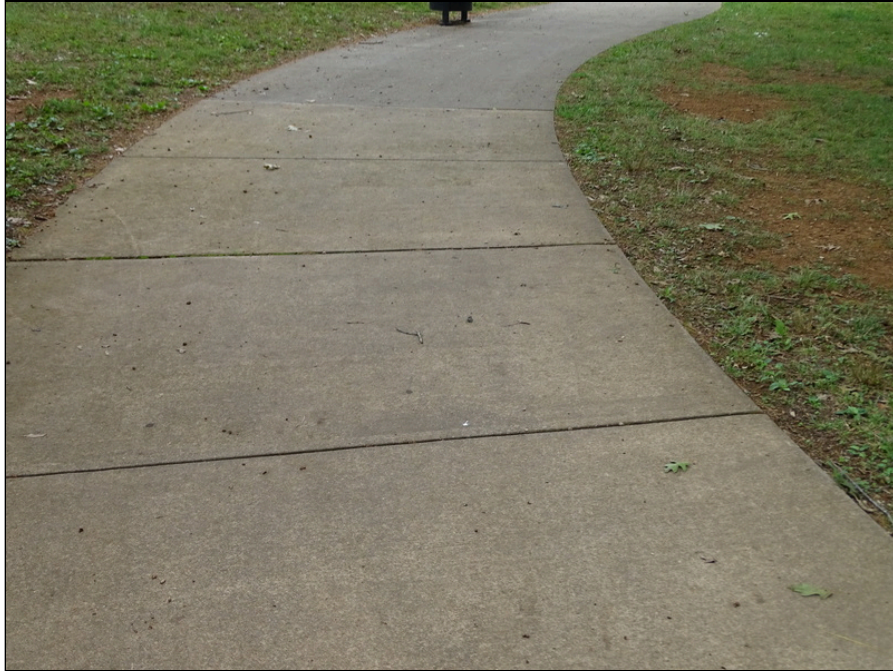
5 - Typical concrete sidewalk

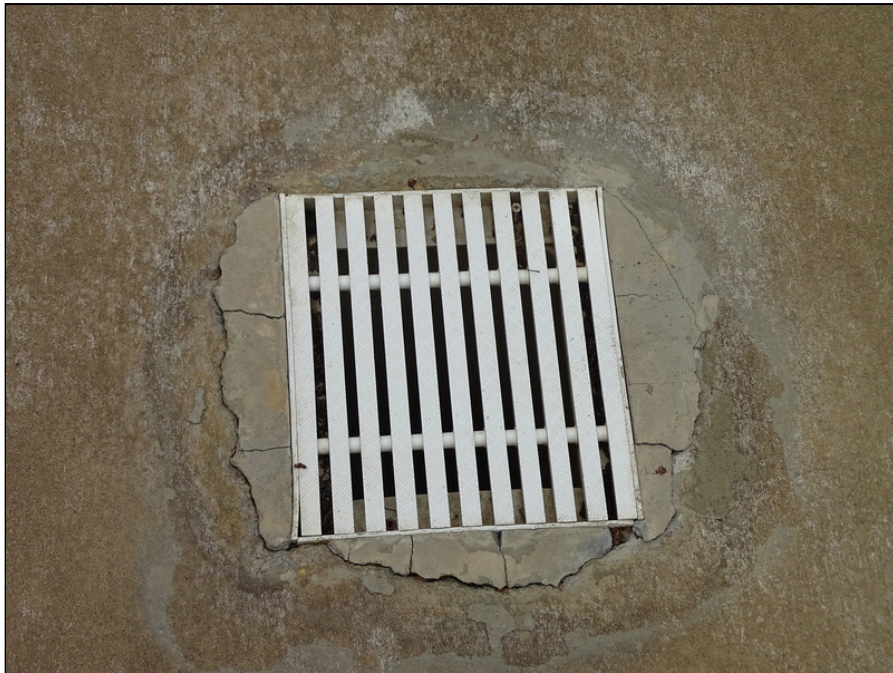
10 - Stormwater drainage

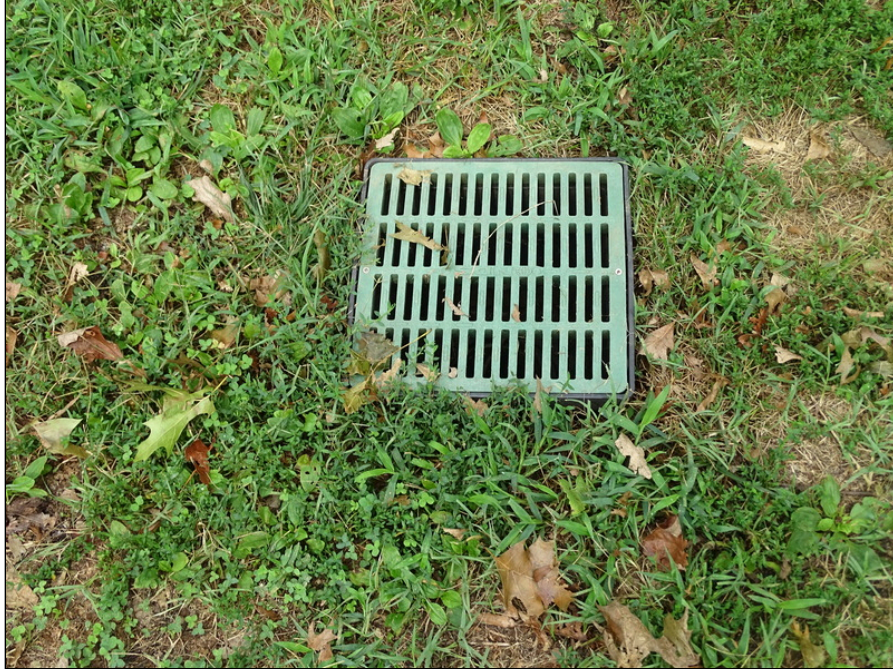
11 - Stormwater drainage

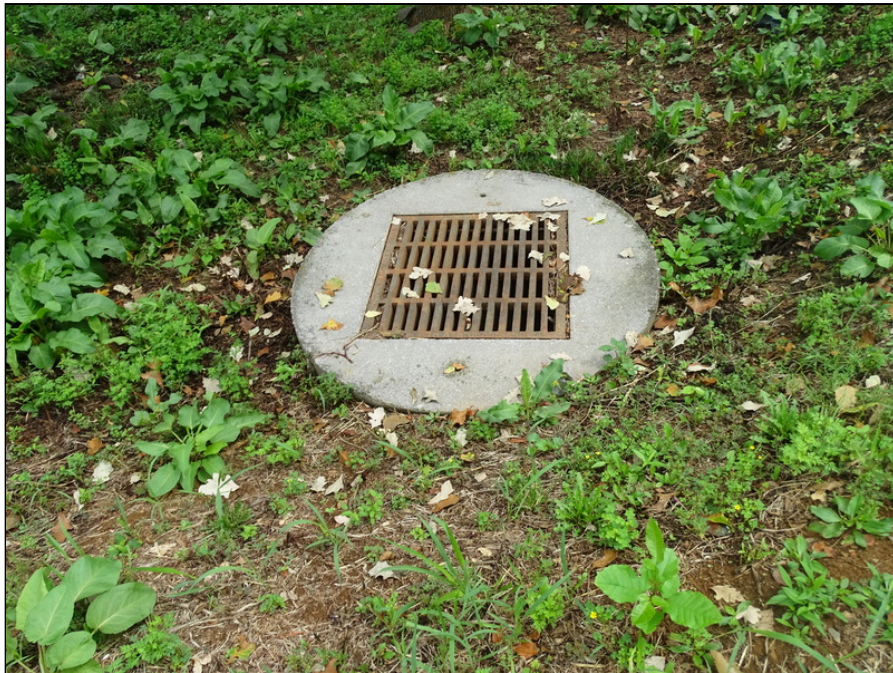
12 - Stormwater drainage

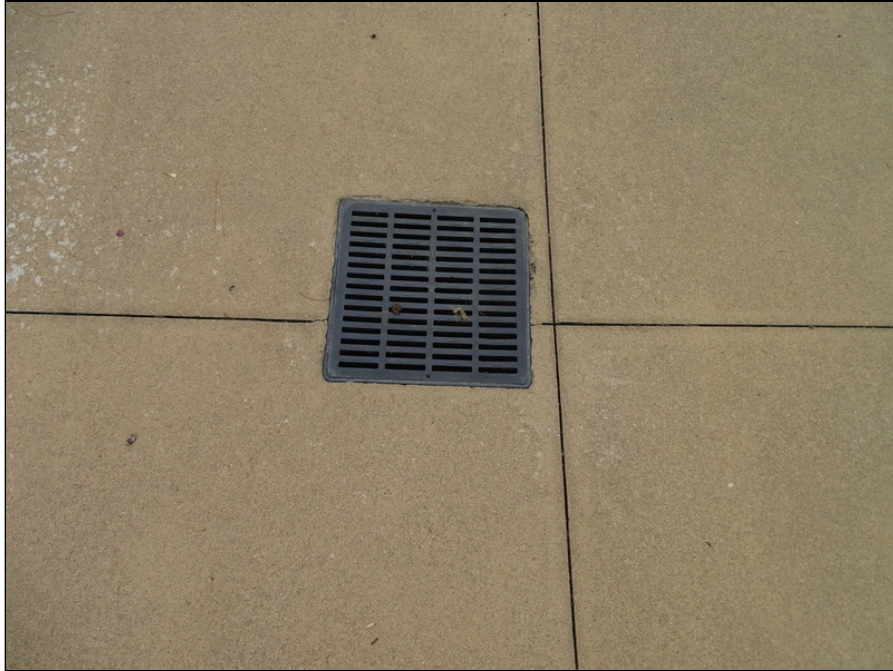
13 - Stormwater drainage

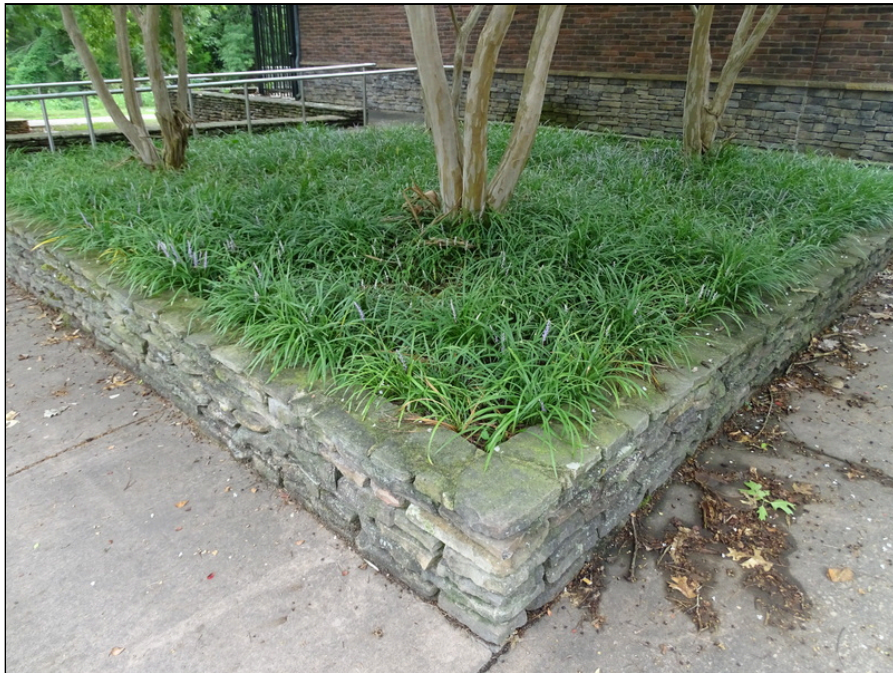
14 - Typical landscape

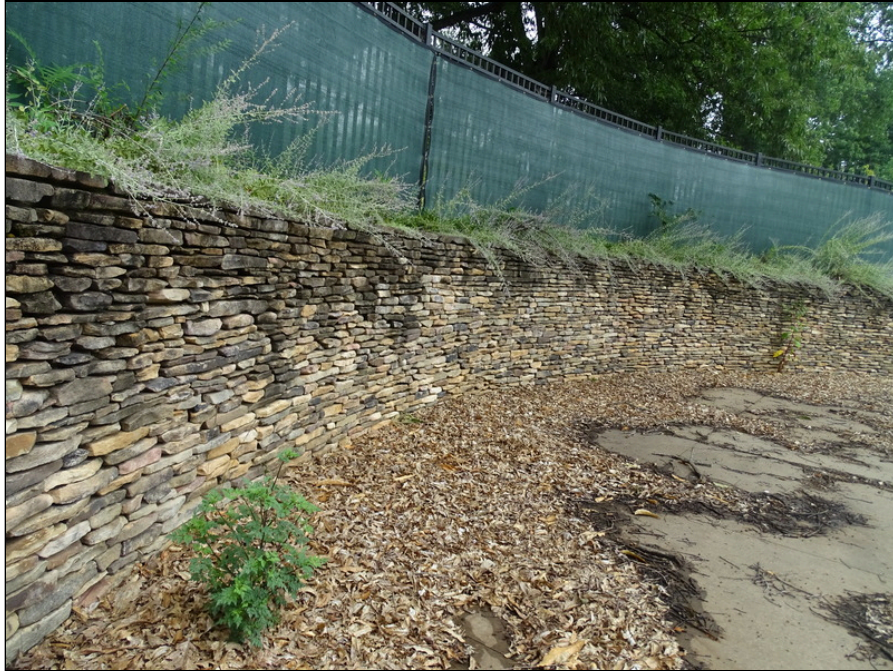
15 - Landscaping and metal fencing

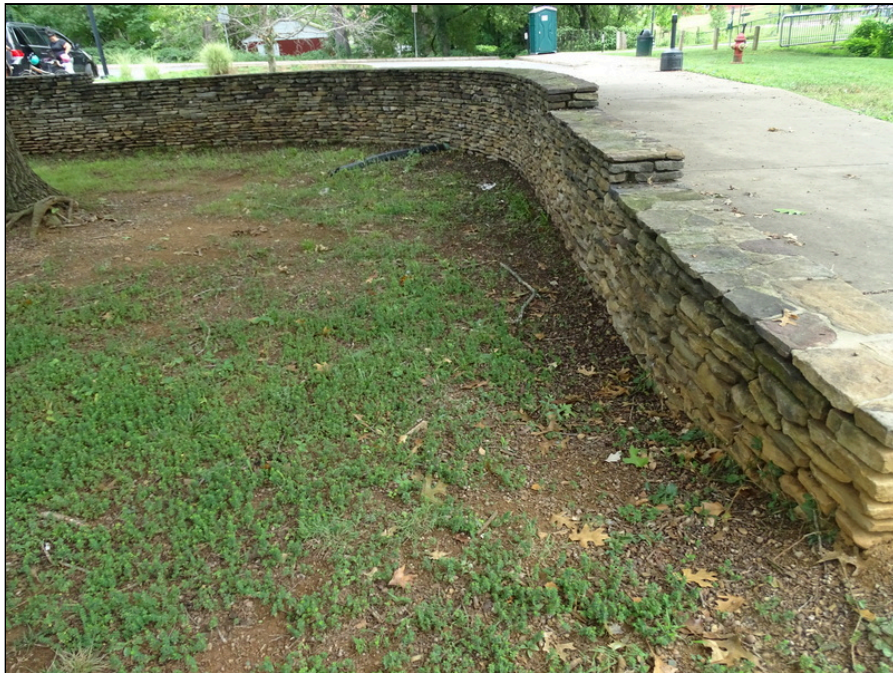
16 - Typical retaining wall - note efflorescence

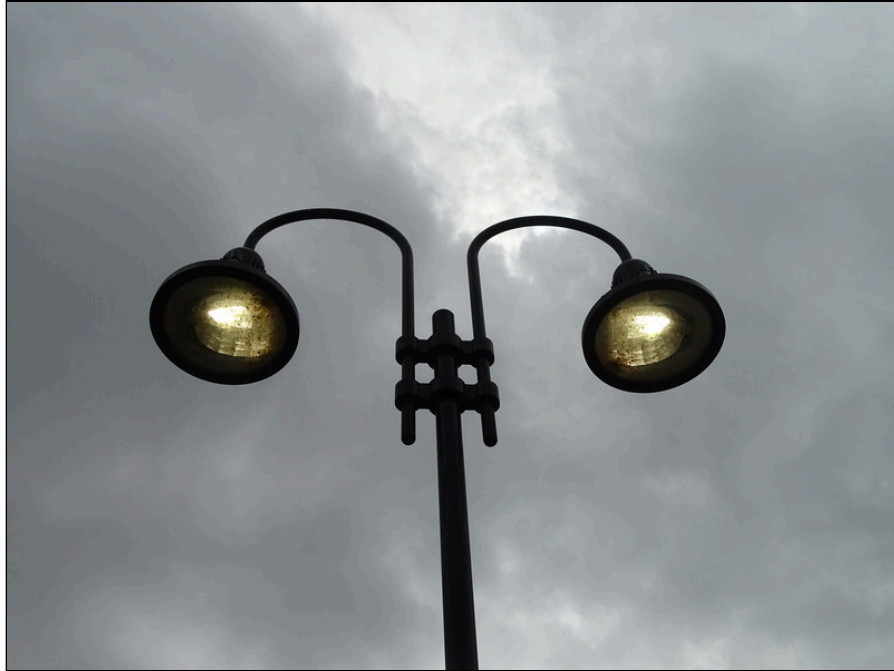
17 - Typical pole mounted lights

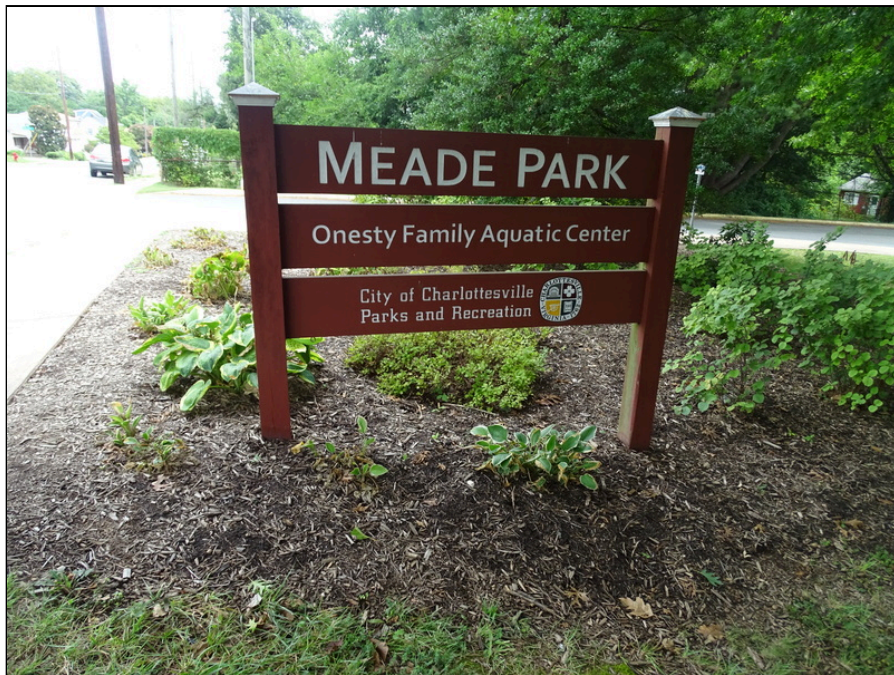
18 - Monuments sign

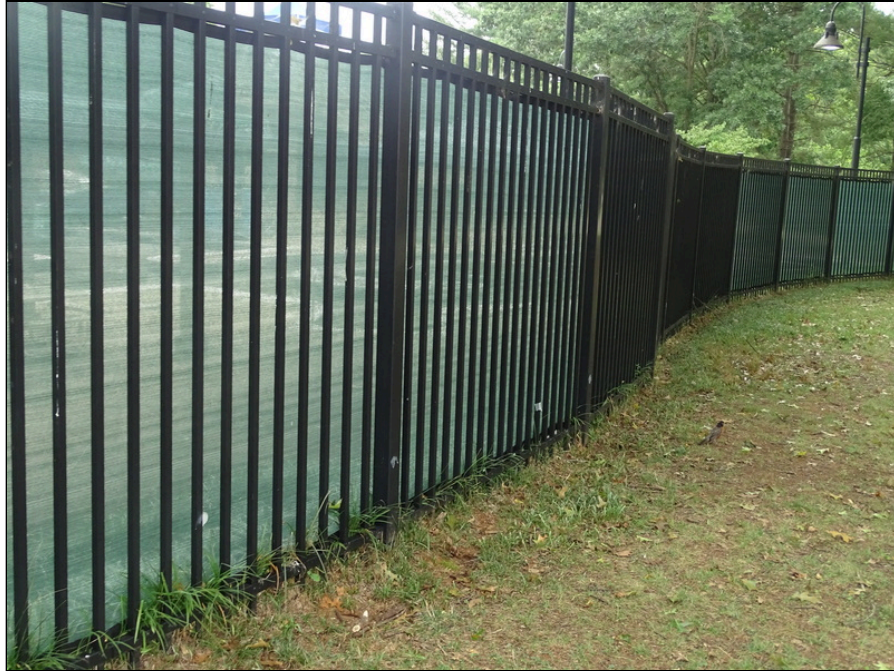
19 - Landscaping and metal fencing

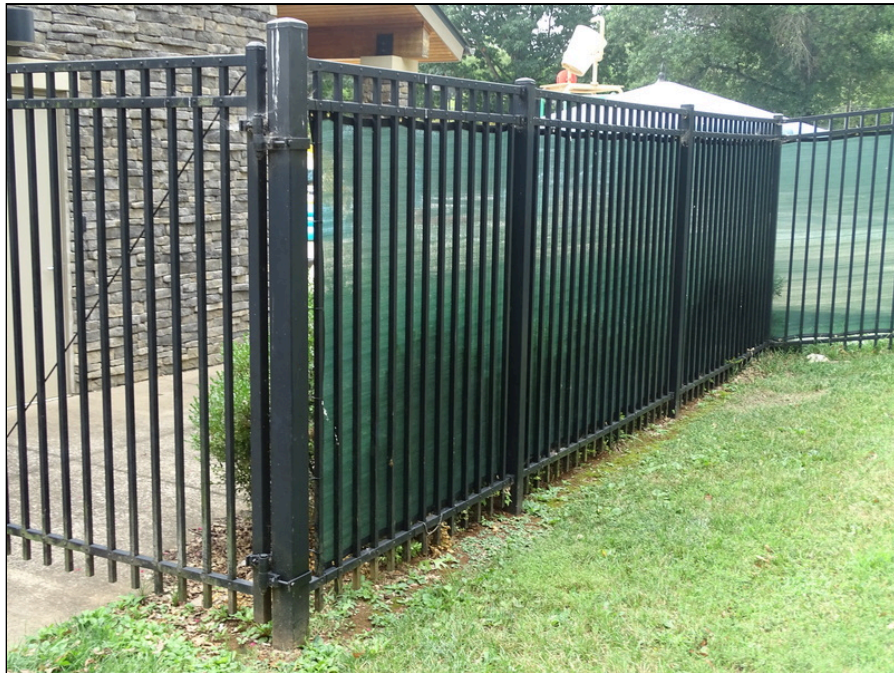
20 - Landscaping and metal fencing

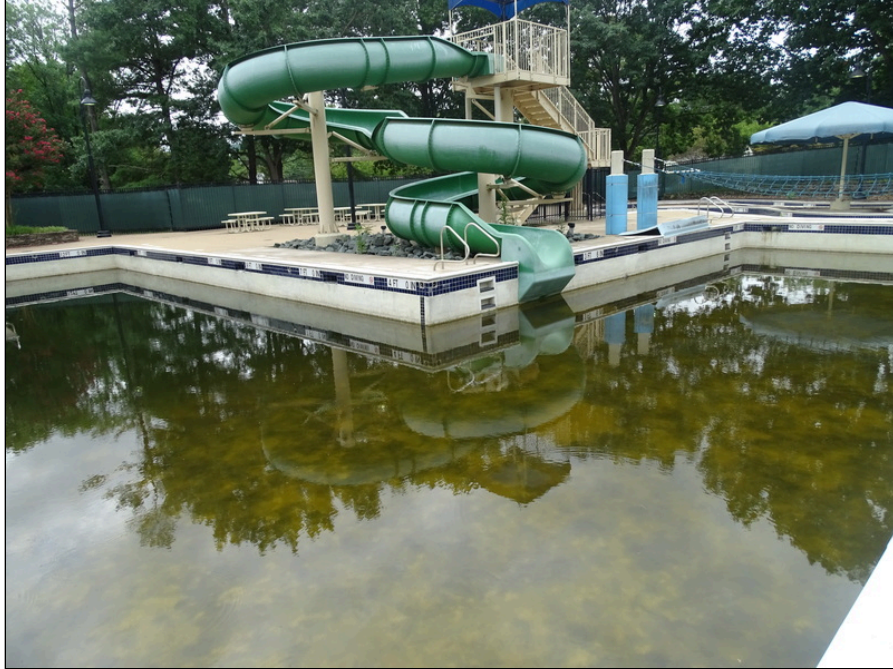
21 - Pool overview

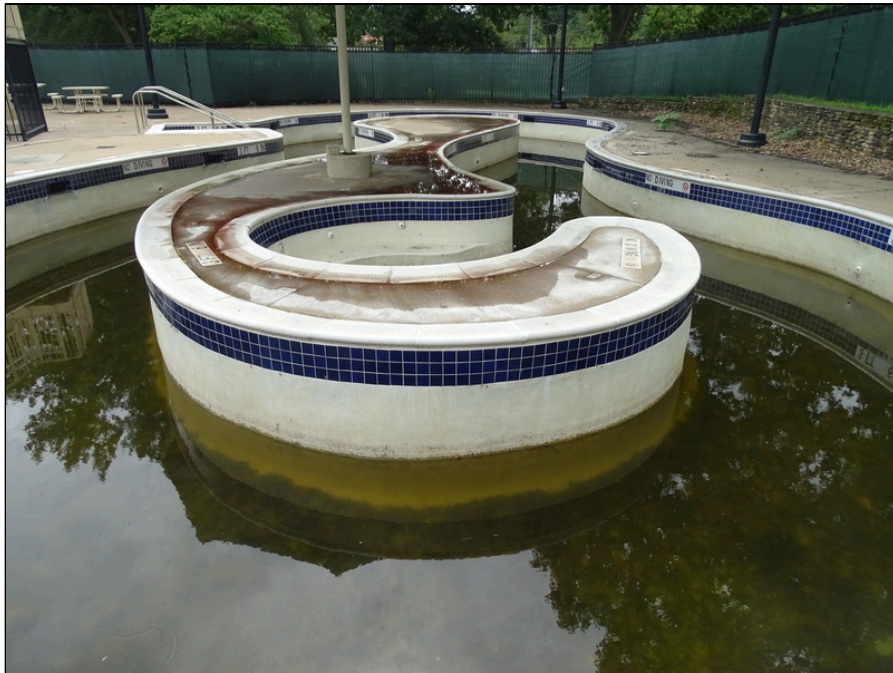
22 - Pool deck

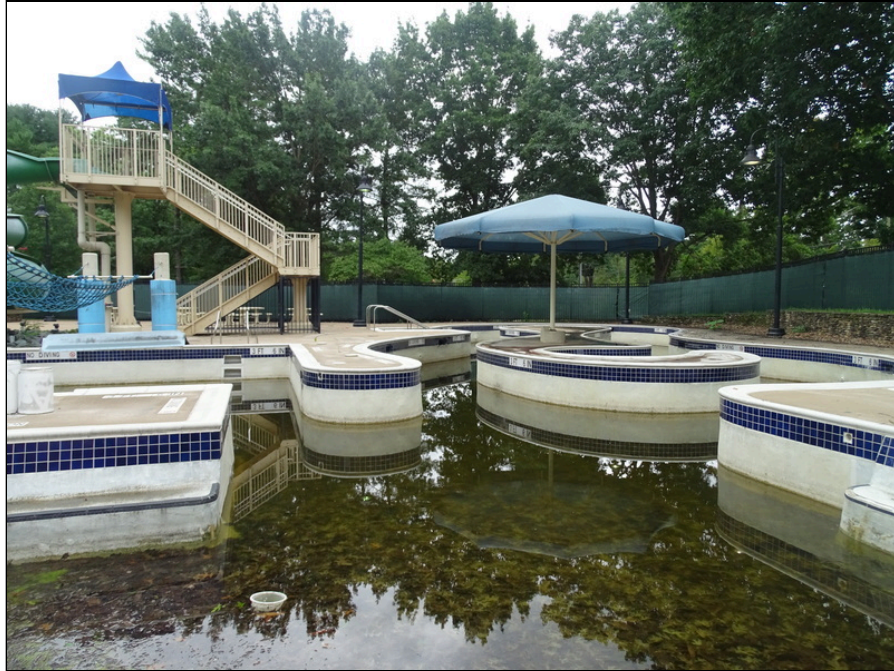
23 - Pool overview

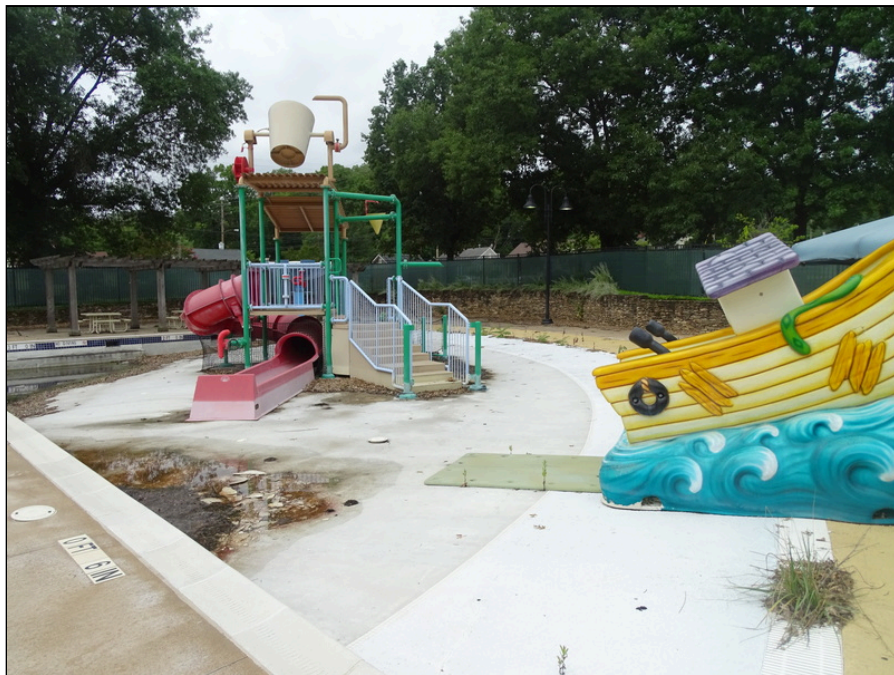
24 - Pool equipment's

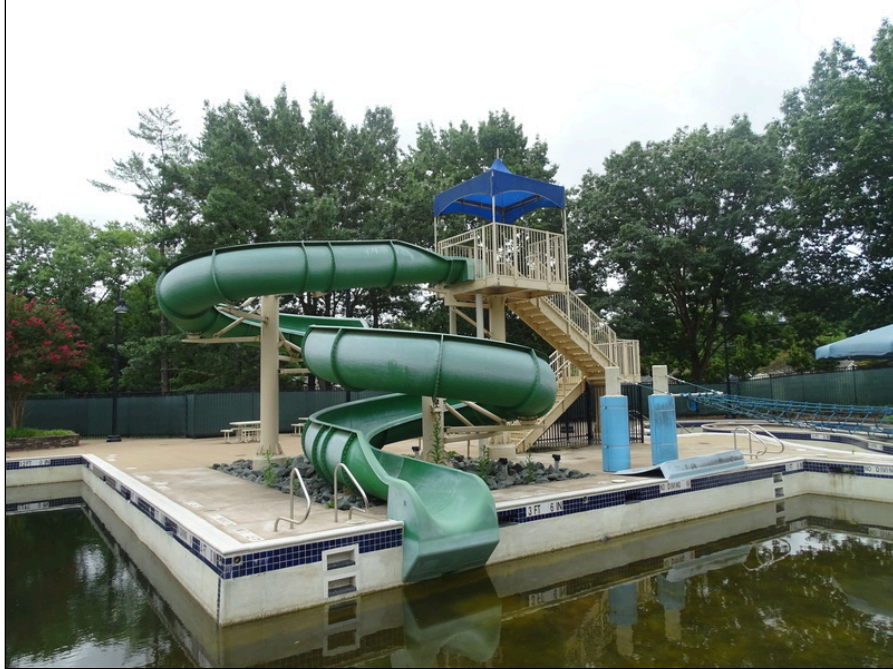
25 - Pool equipment's

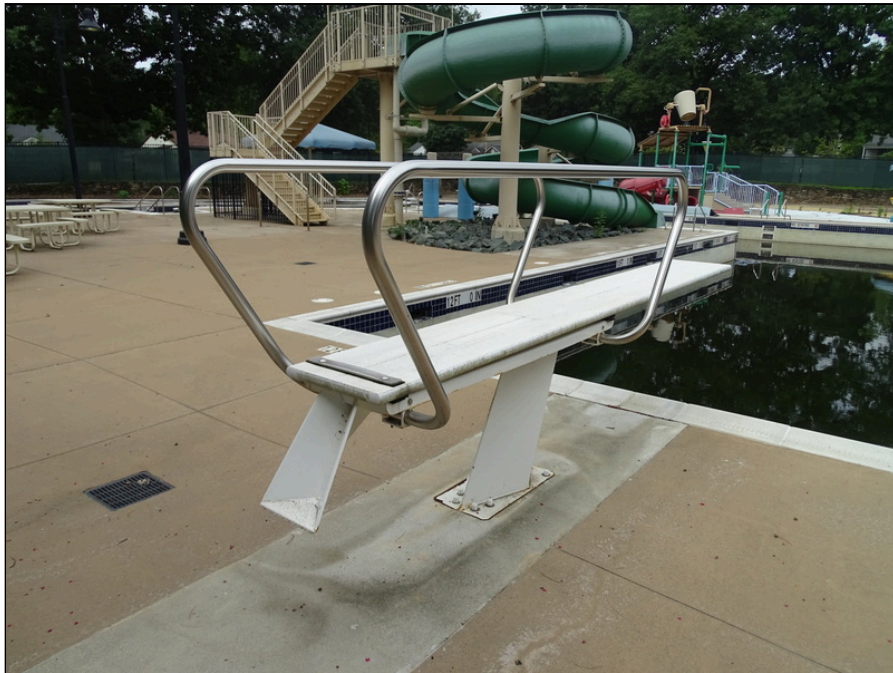
26 - Pool equipment's

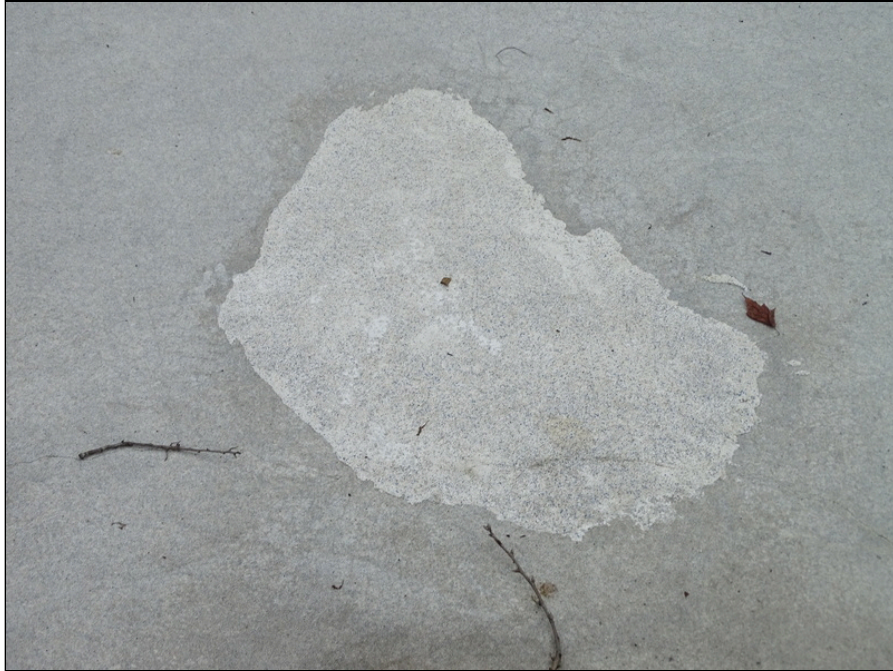
27 - Repaired pool deck area

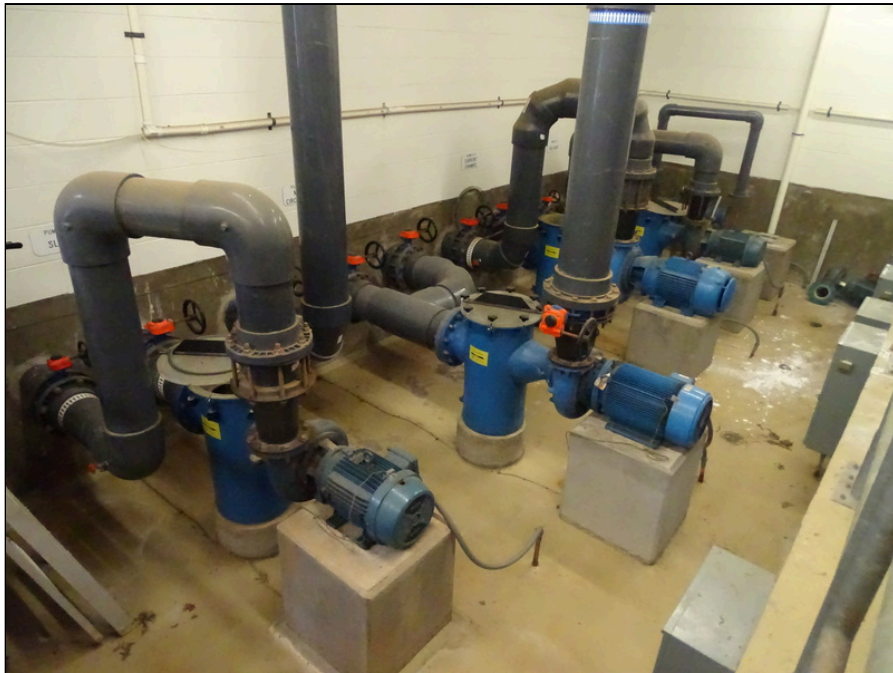
32 - Pool equipment

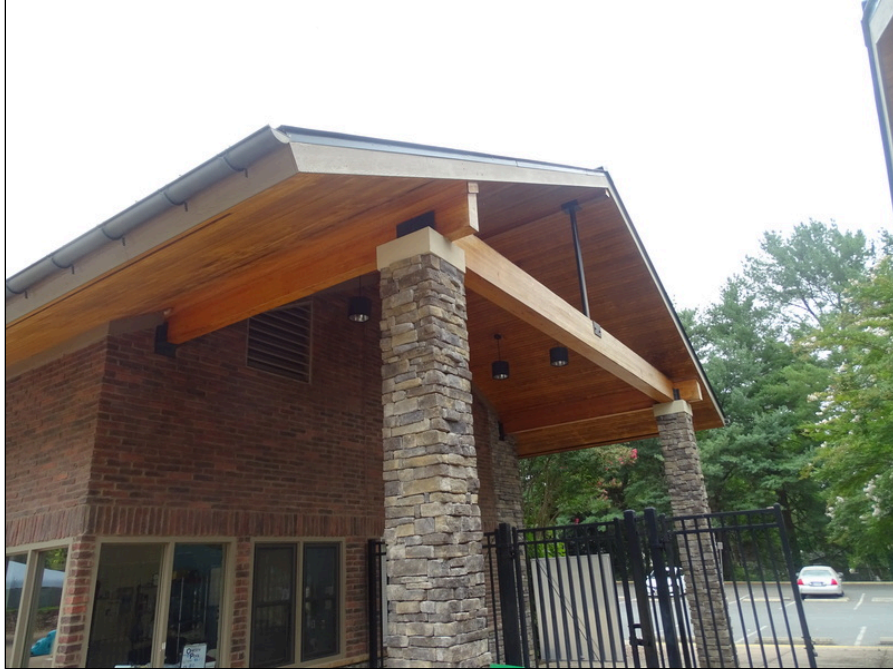
33 - Wood roof framing and steel columns

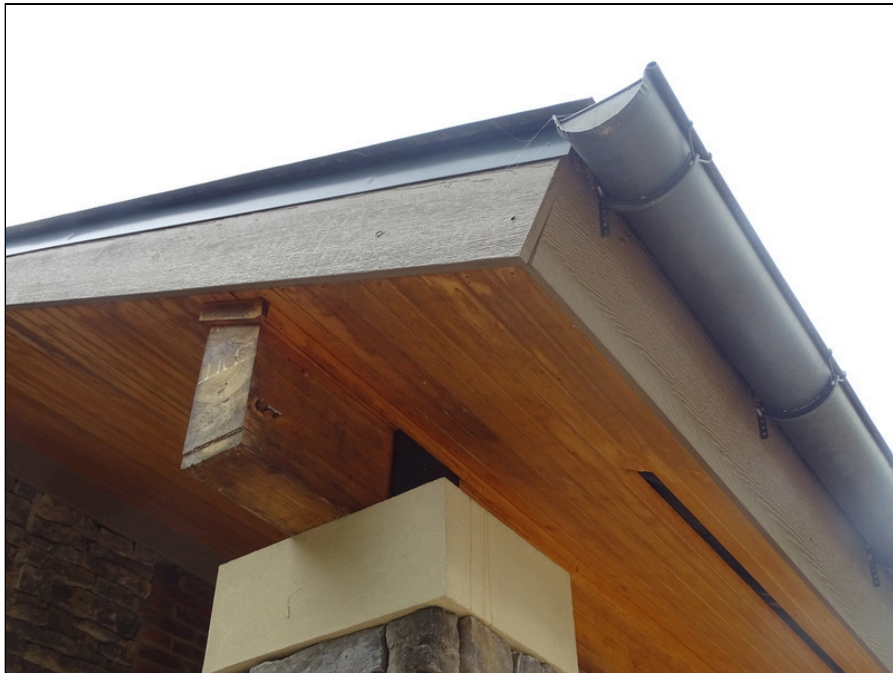
34 - Wood roof framing and steel columns

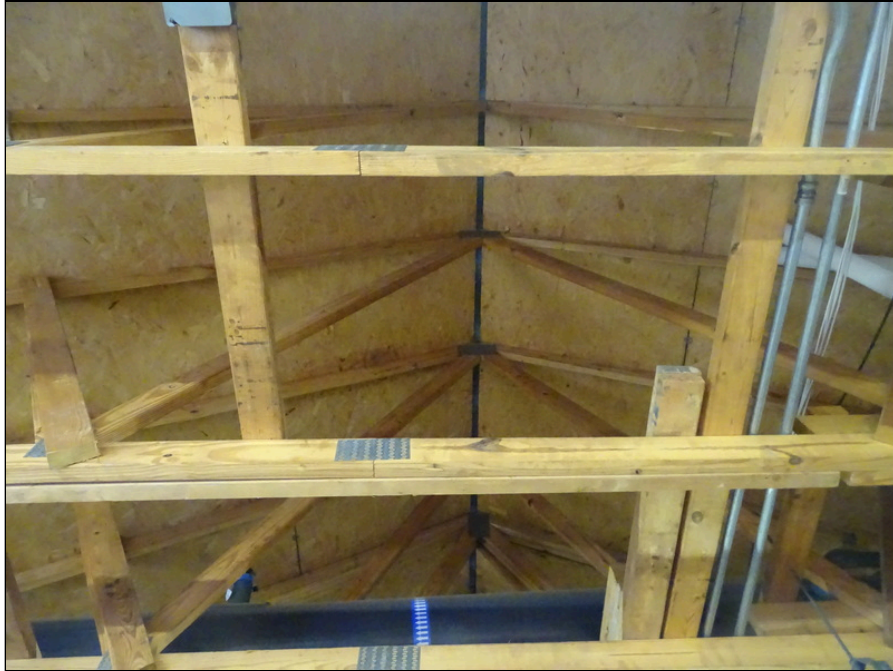
35 - Wood roof framing

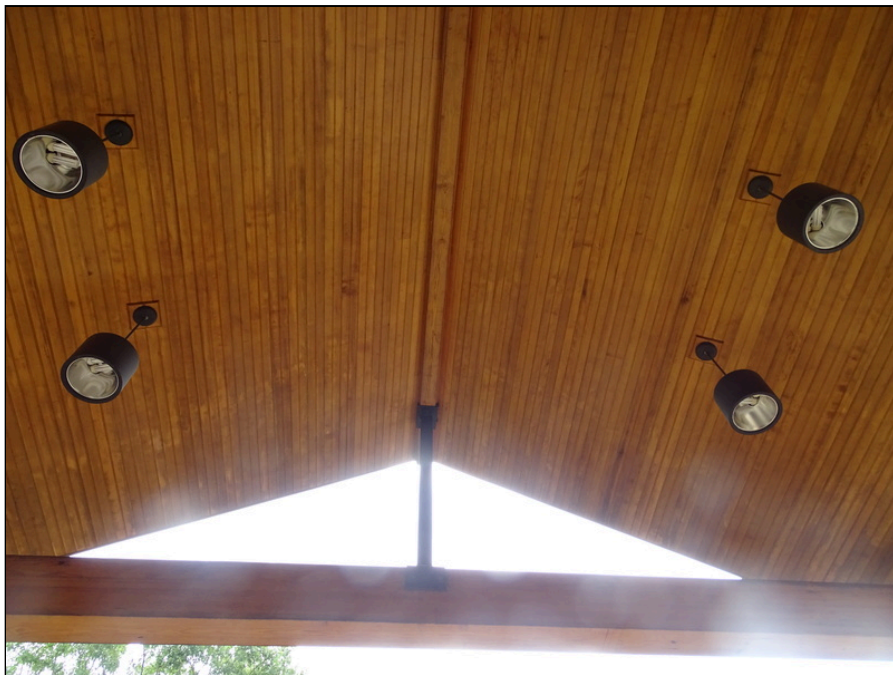
36 - Wood roof framing

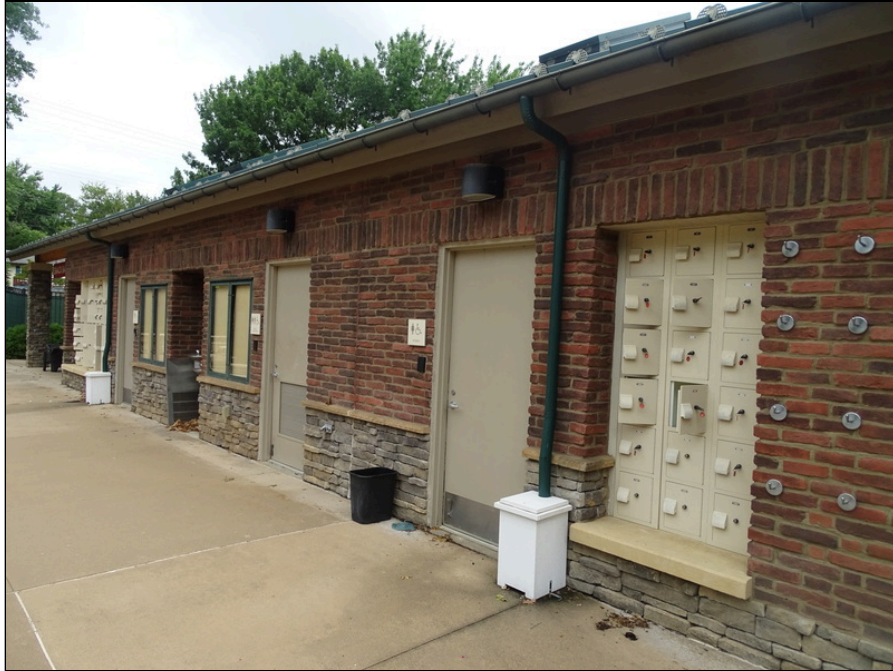
37 - Bath house overview

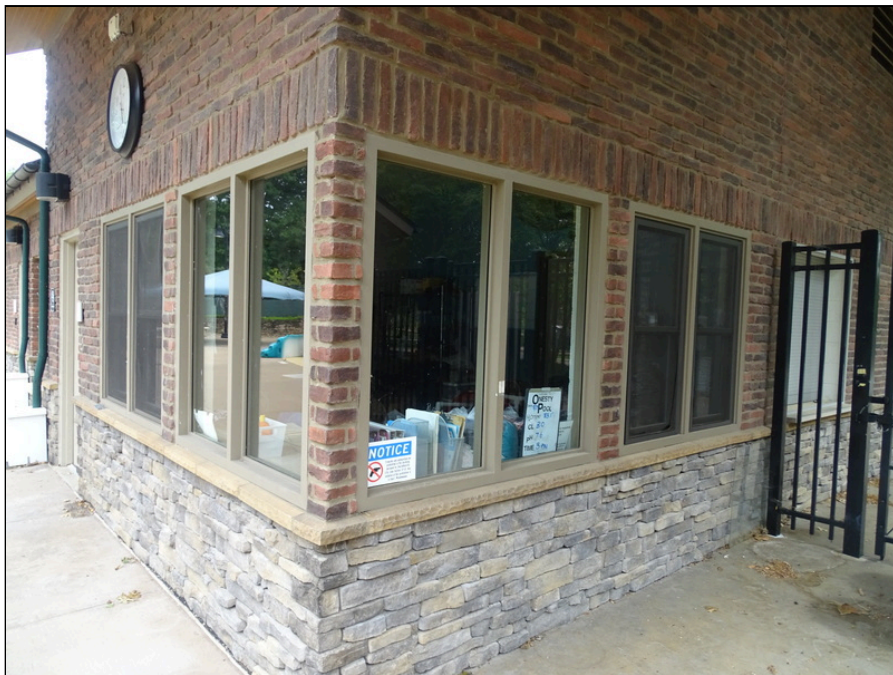
38 - Bath house overview

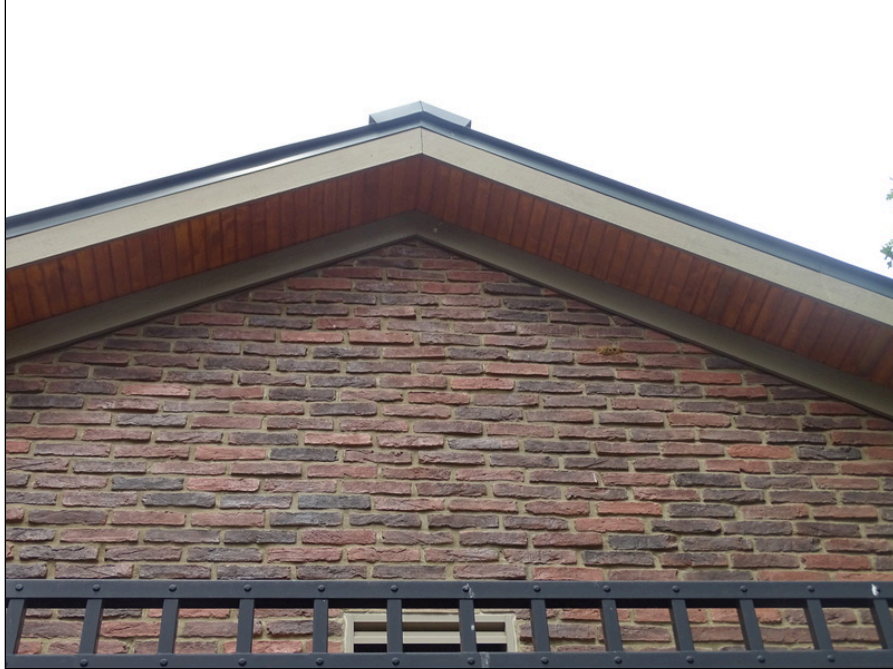
39 - Brick joints and sealant at exterior
