MEADE PARK BATH HOUSE AND MECHANICAL BUILDING
300 MEADE AVENUE
CHARLOTTESVILLE, VIRGINIA

ECS PROJECT NO. 46:6713

CITY OF CHARLOTTESVILLE - FACILITIES DEVELOPMENT

Reference: Facility Condition Assessment Report for Meade Park Bath House and Mechanical Building, 300 Meade Avenue, Charlottesville, Virginia

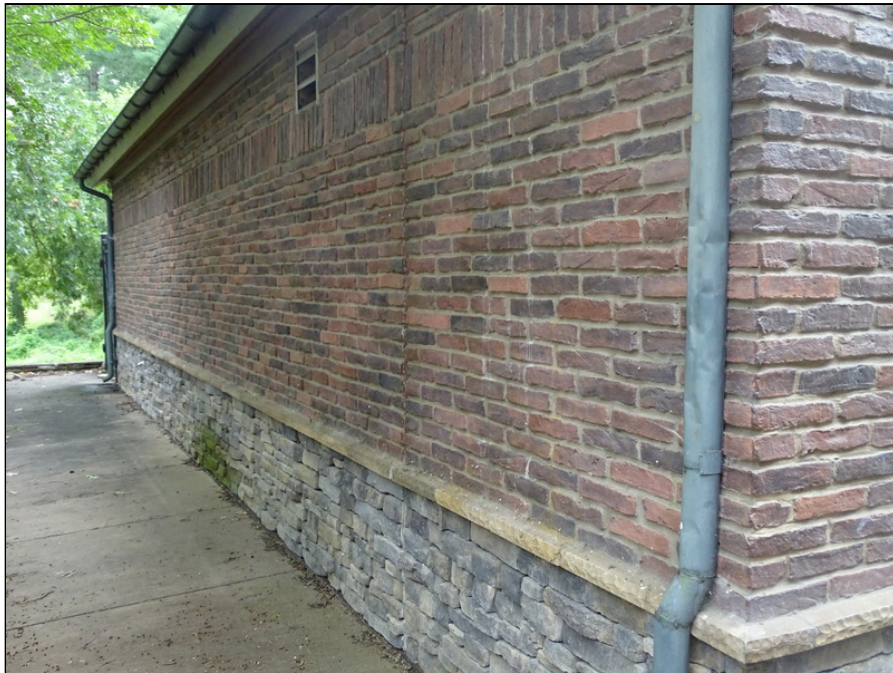
40 - Typical exterior building overview

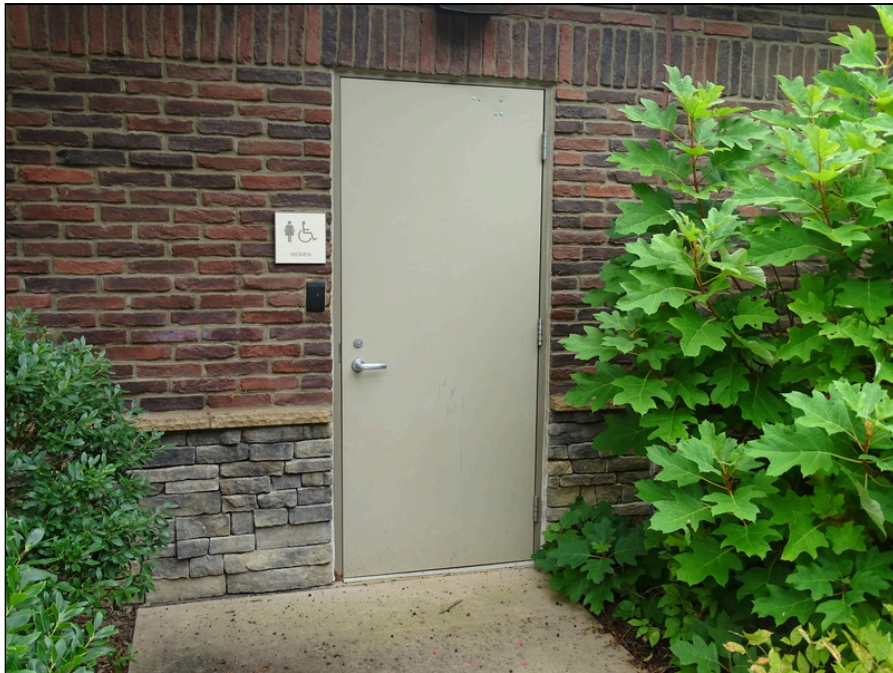
42 - Exterior personal door

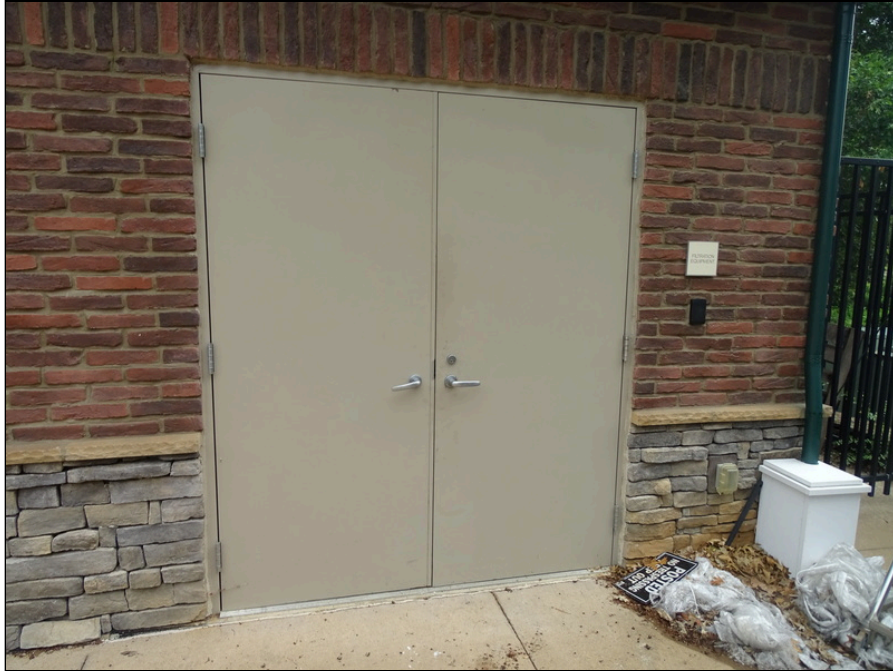
43 - Exterior door

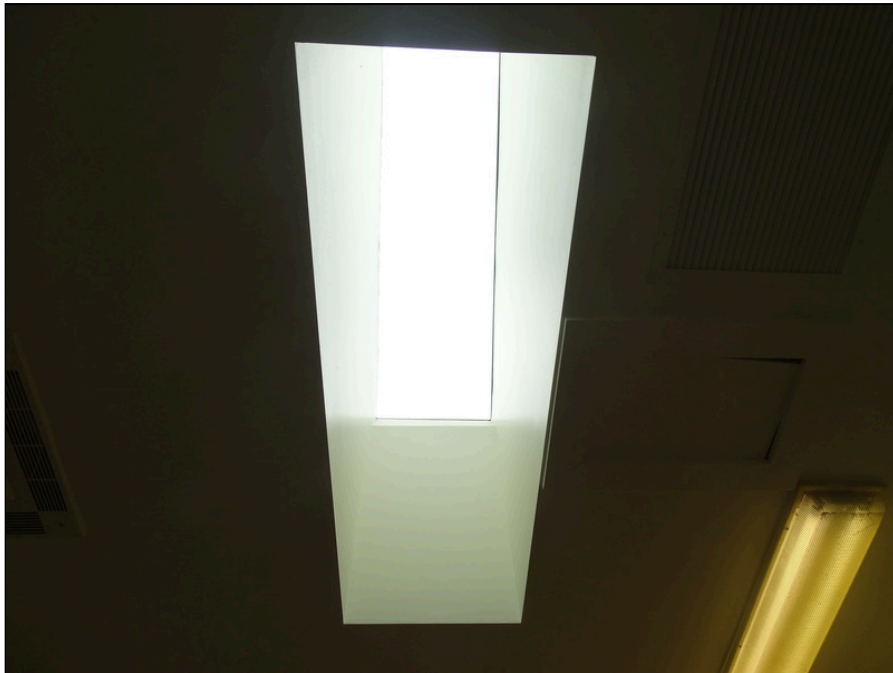
46 - Typical skylight

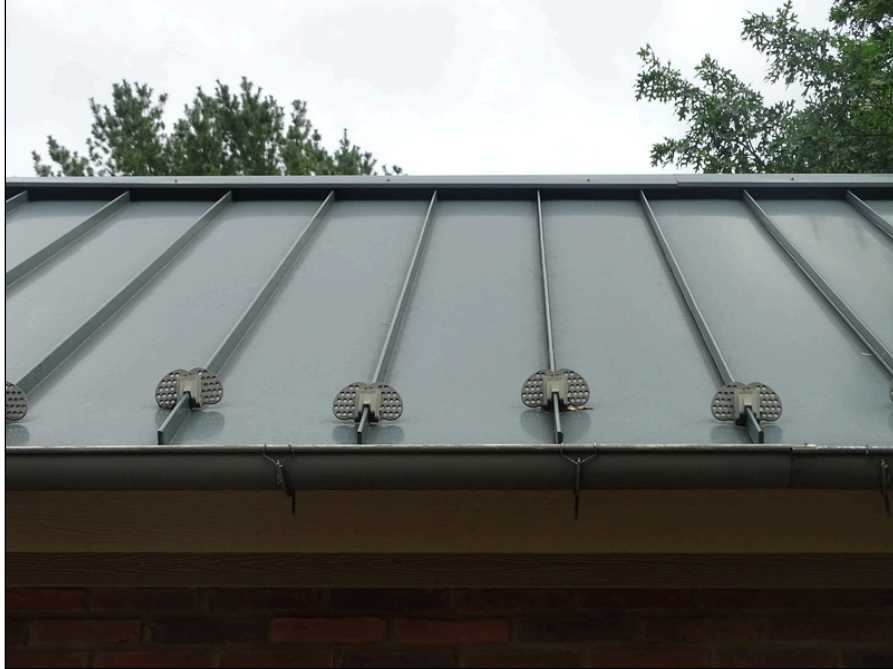
47 - Metal roof overview

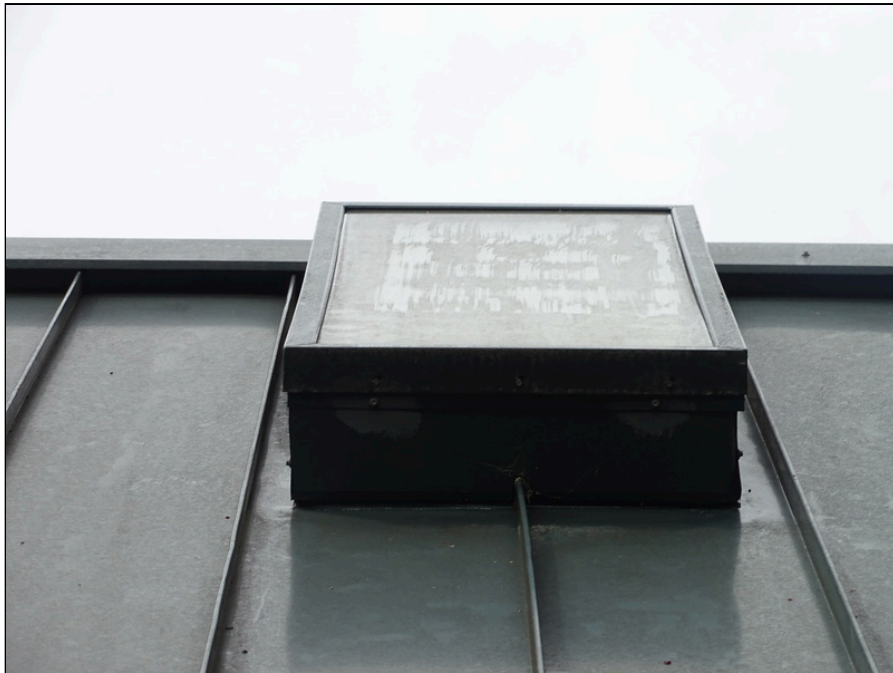
48 - Typical skylight on top of roof

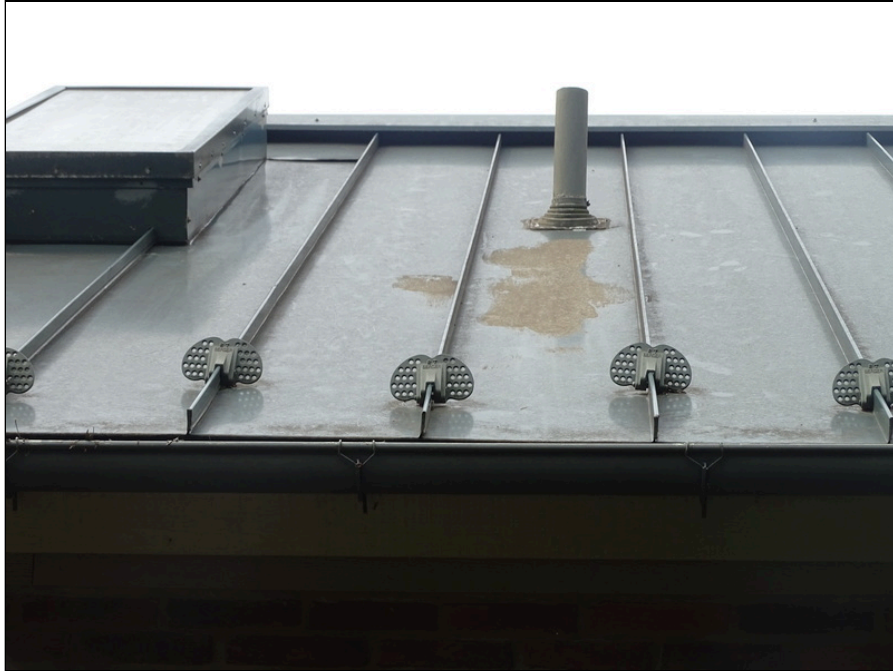
49 - Typical plumbing penetration

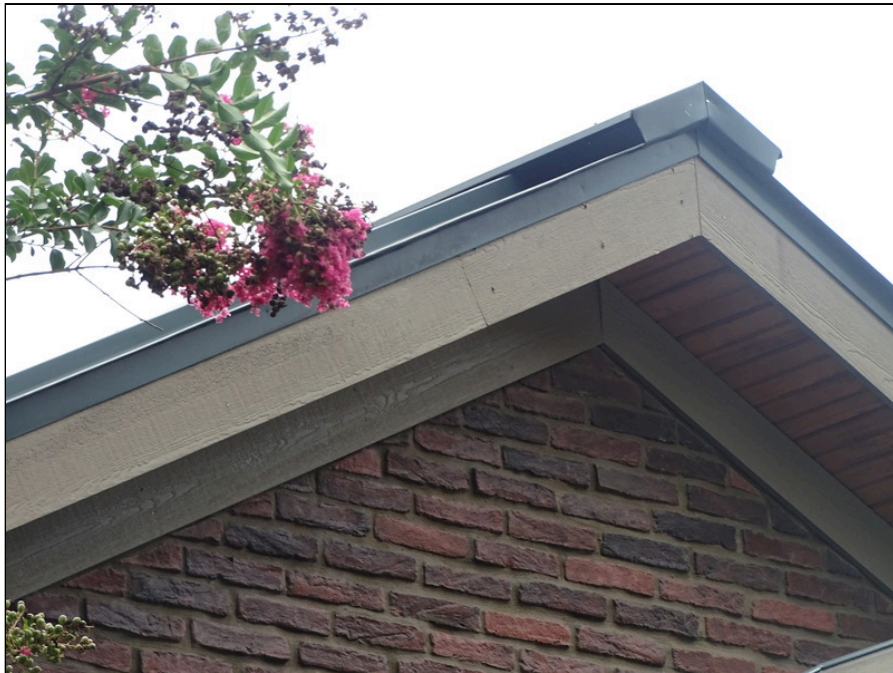
50 - Typical wooden soffit overview

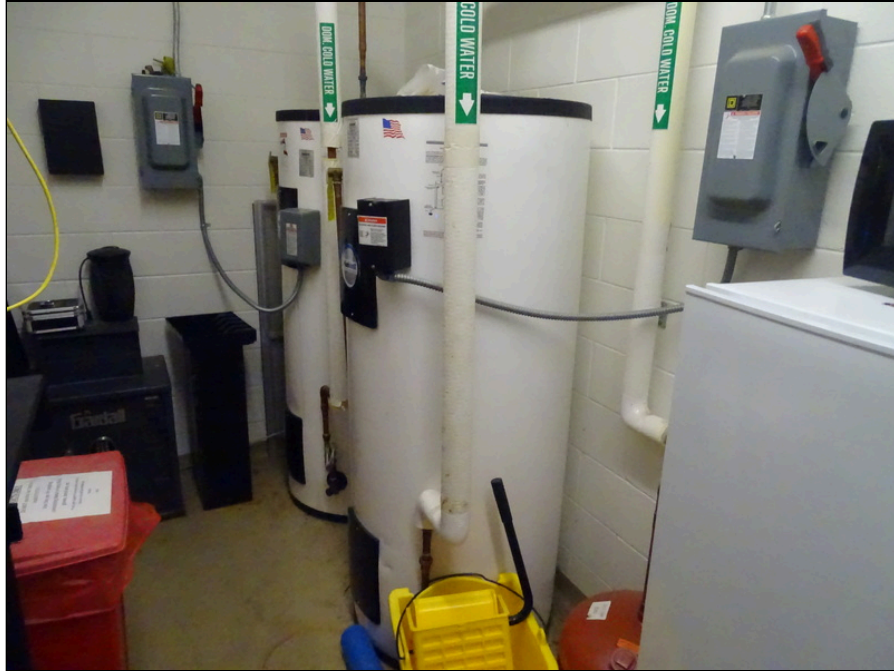
51 - Bath house water heater

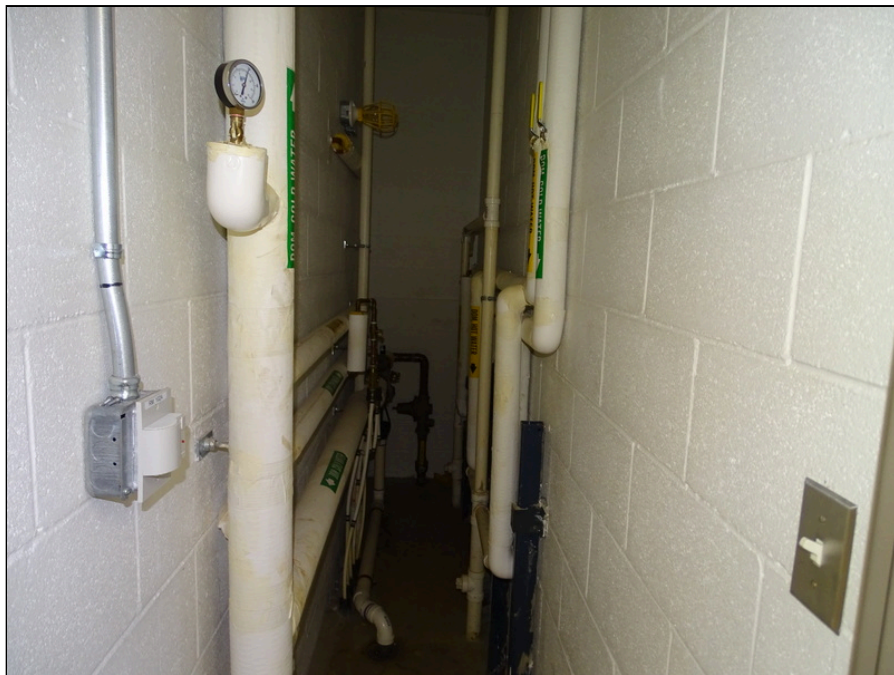
52 - Typical water lines

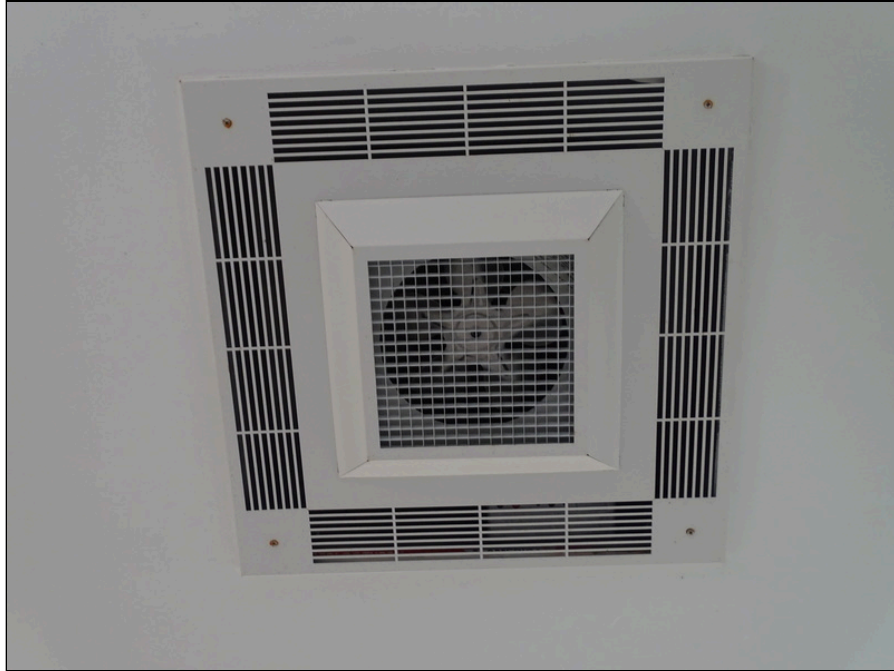
53 - Unit heater and exhaust fan

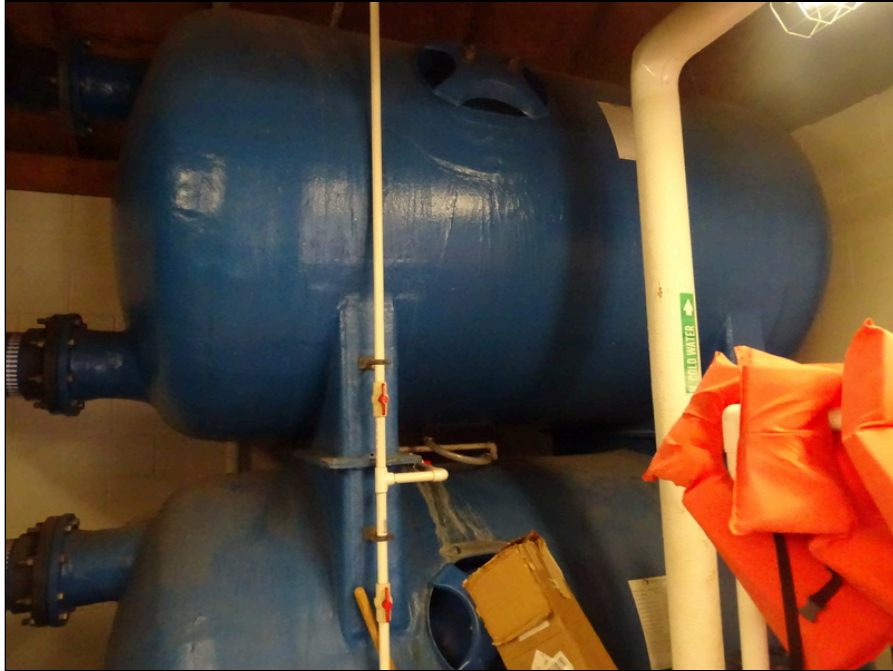
55 - Mechanical building pump room overview

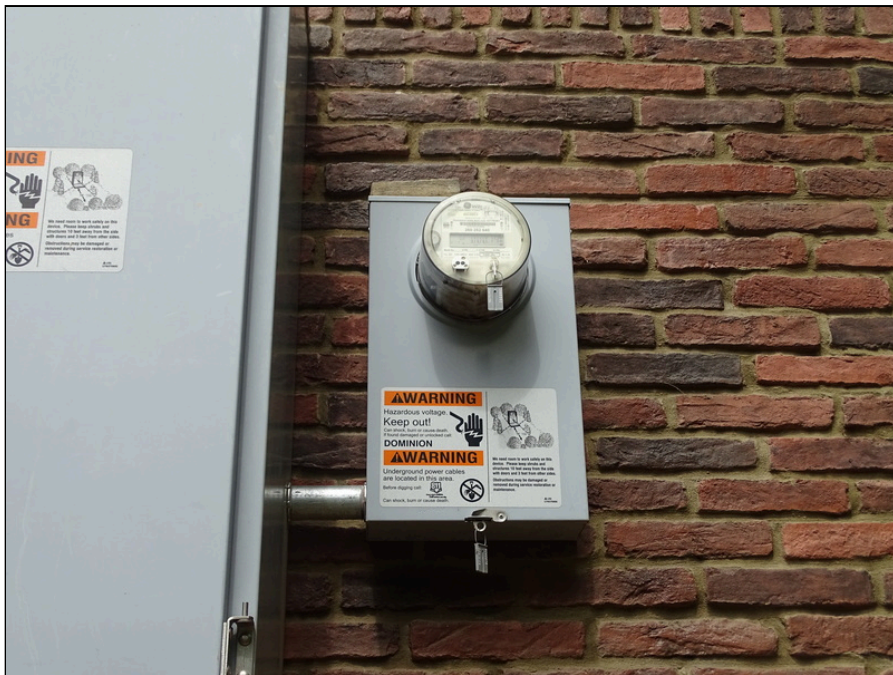
56 - Typical electric meter

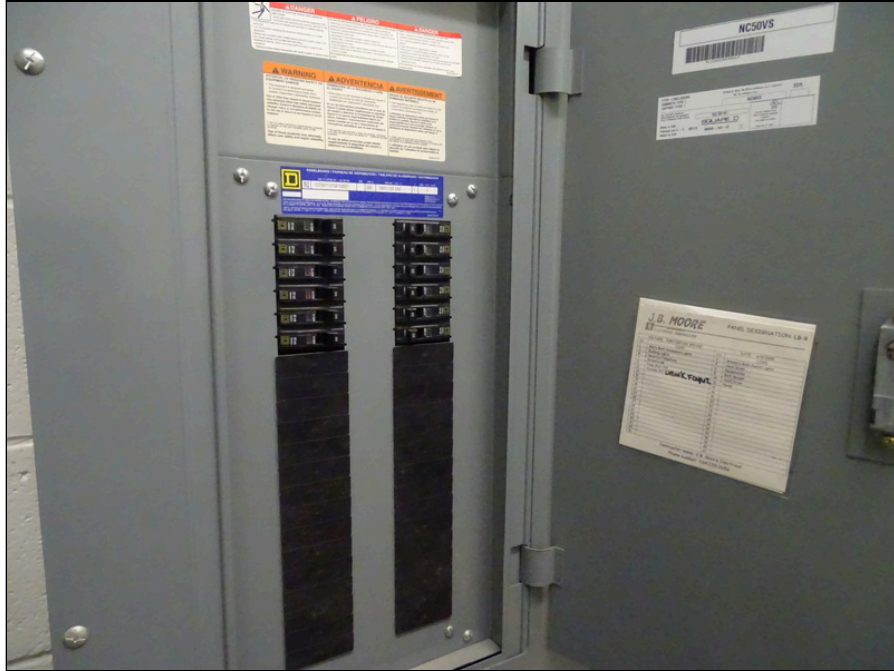
57 - Bath house electrical panel

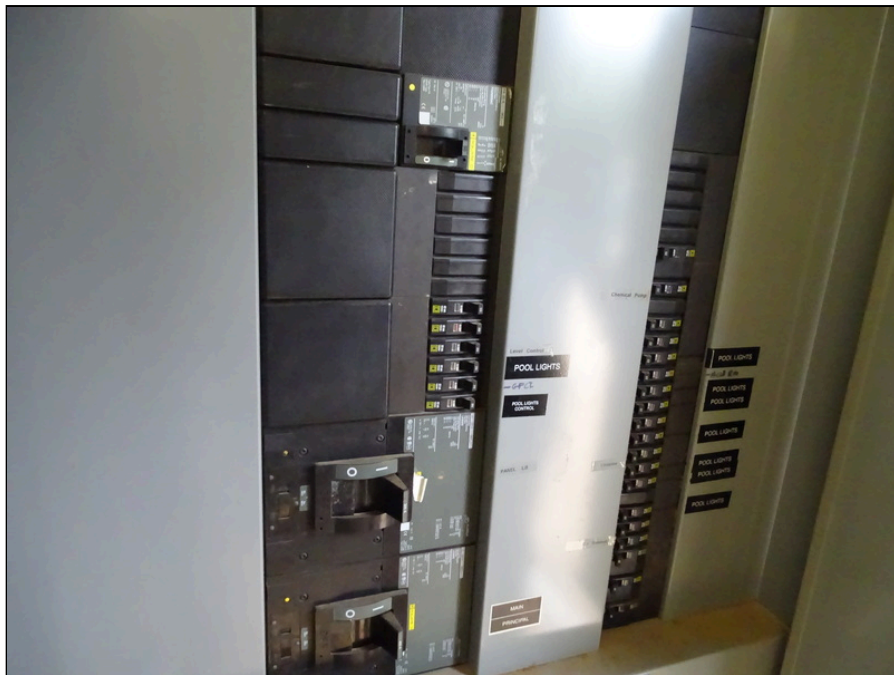
58 - Mechanical building electrical panel

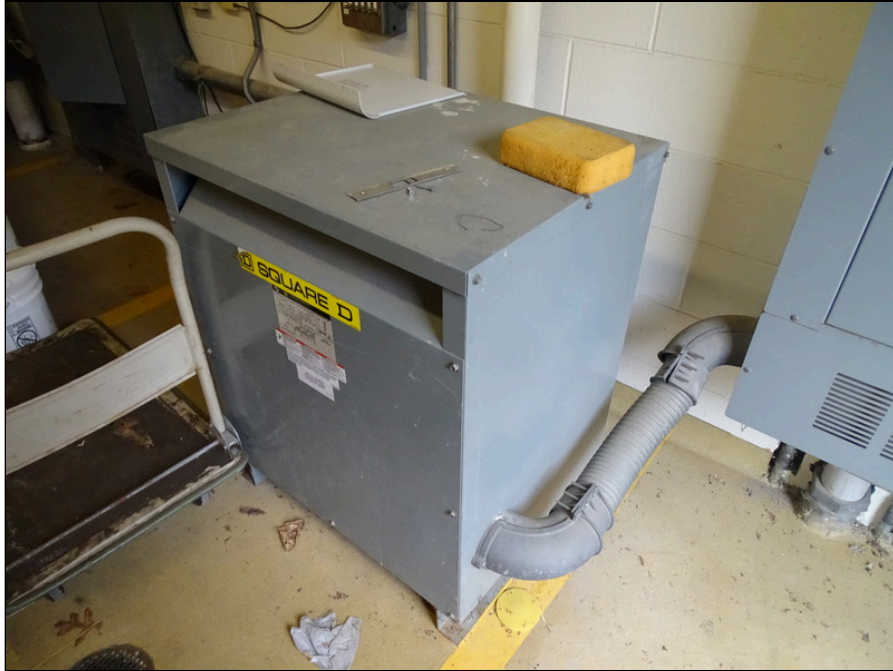
59 - Mechanical building transformer

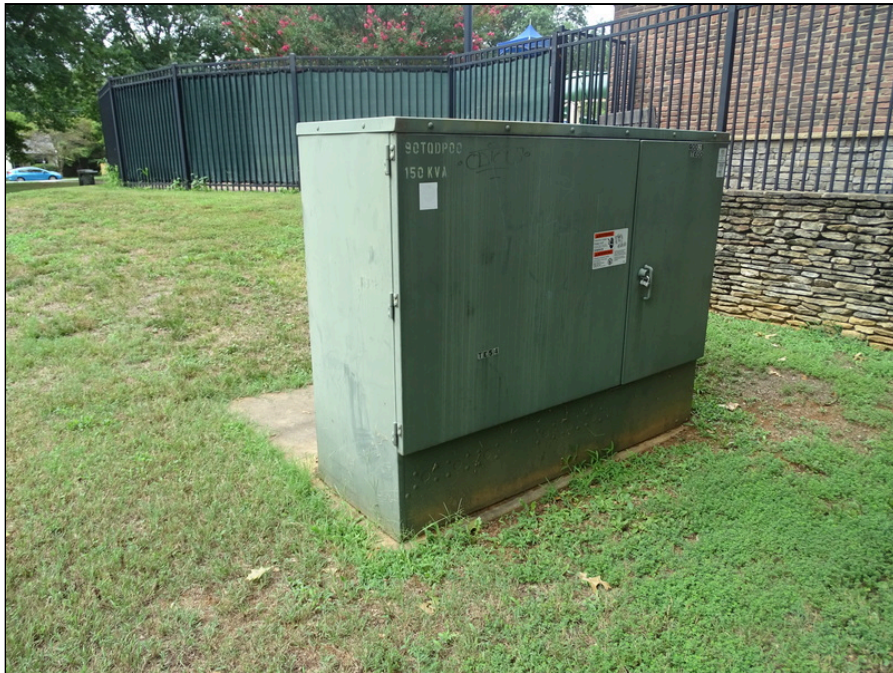
60 - Typical transformer

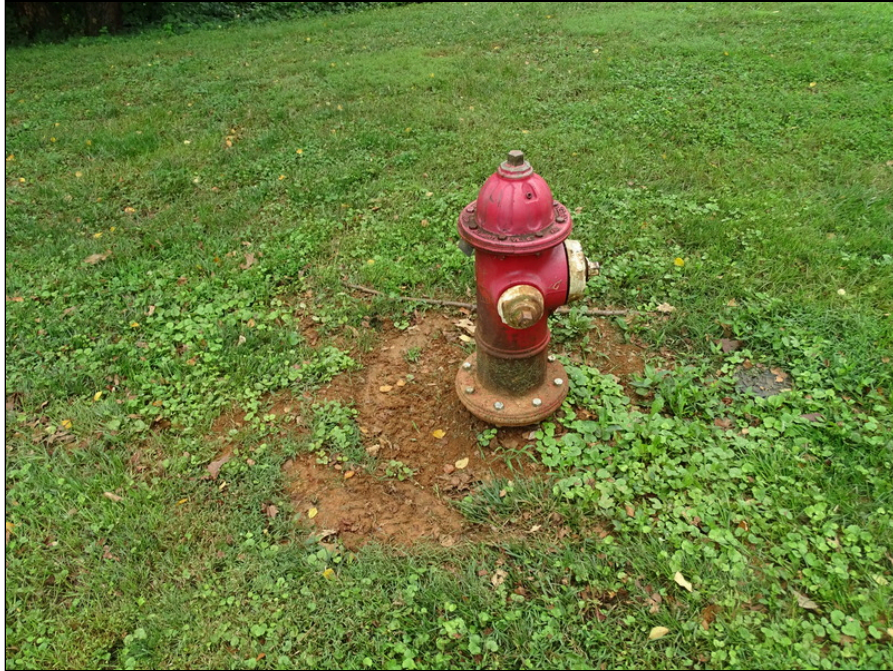
61 - Typical water hydrant

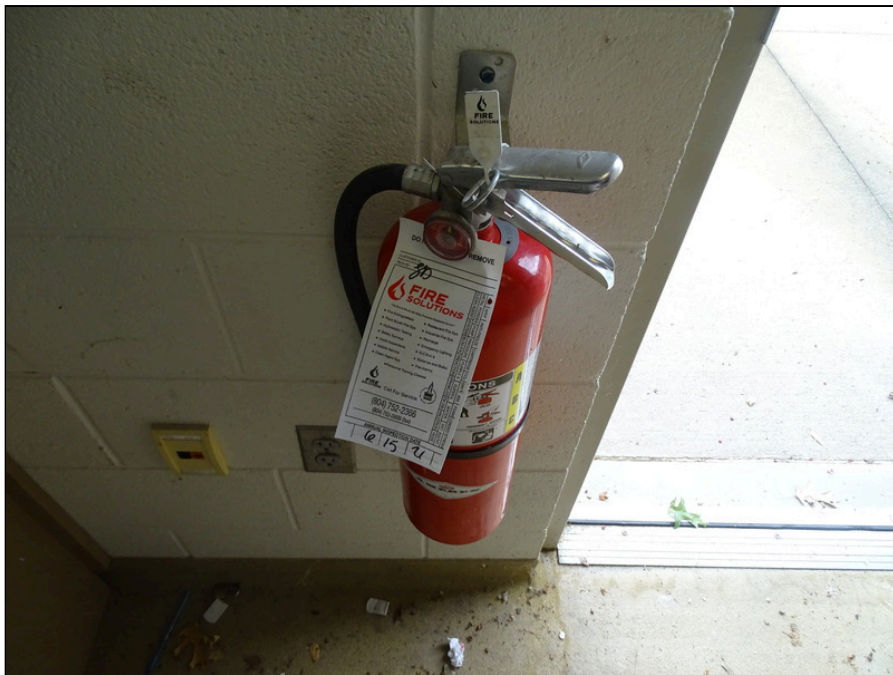
62 - Fire extinguisher in the mechanical building

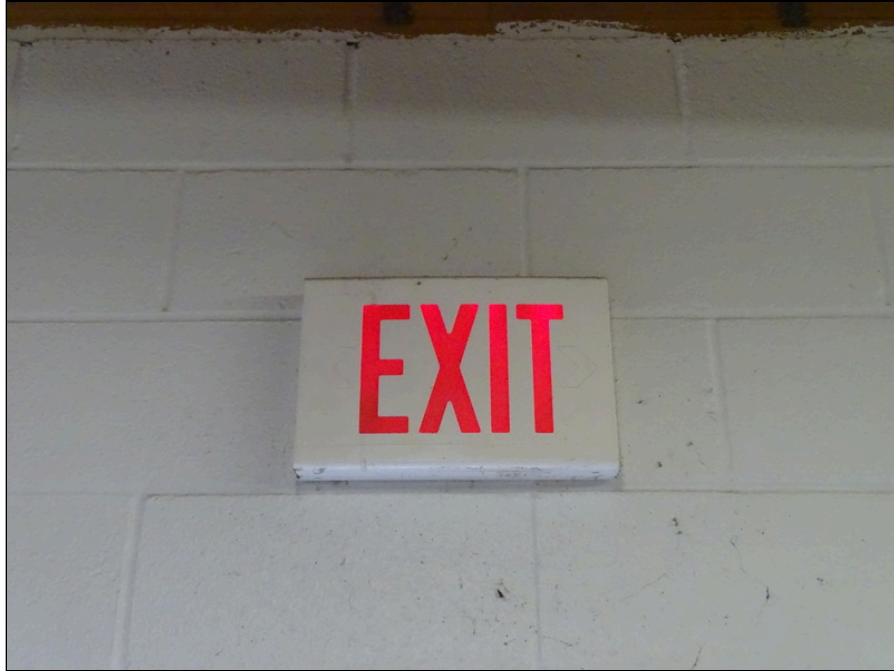
63 - Typical exit sign

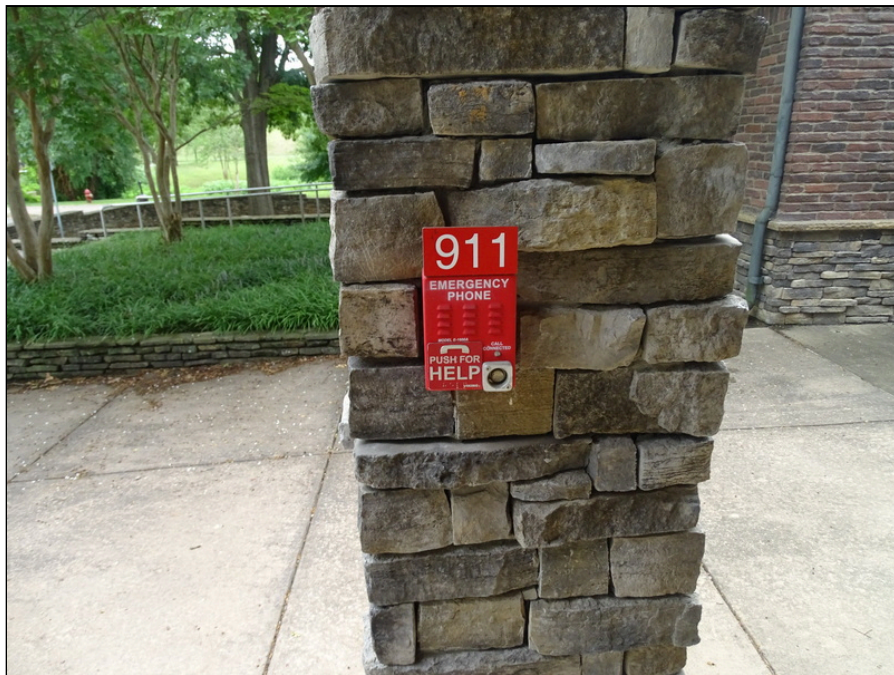
64 - Call button located at the exterior of the Bath house

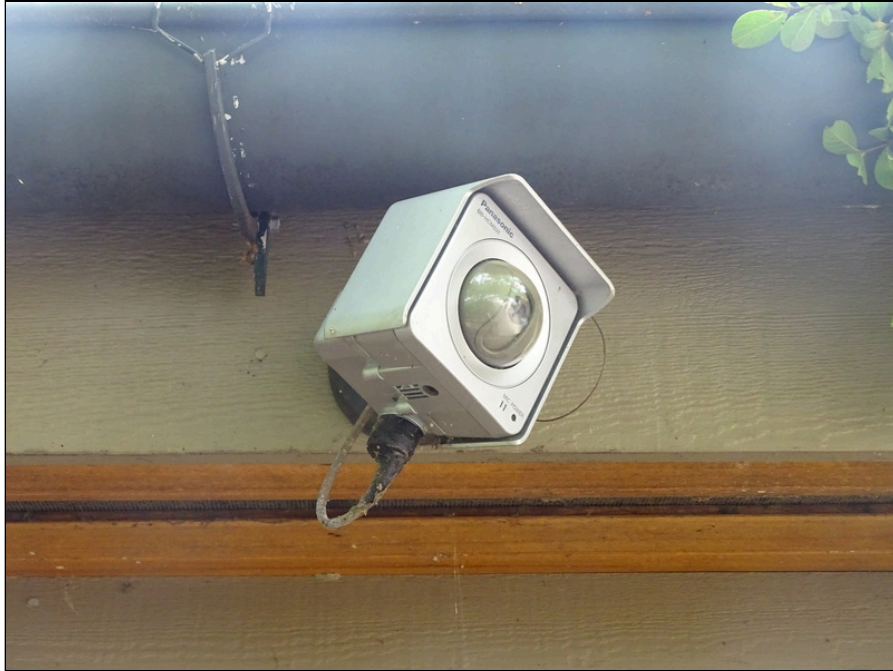
65 - Security camera

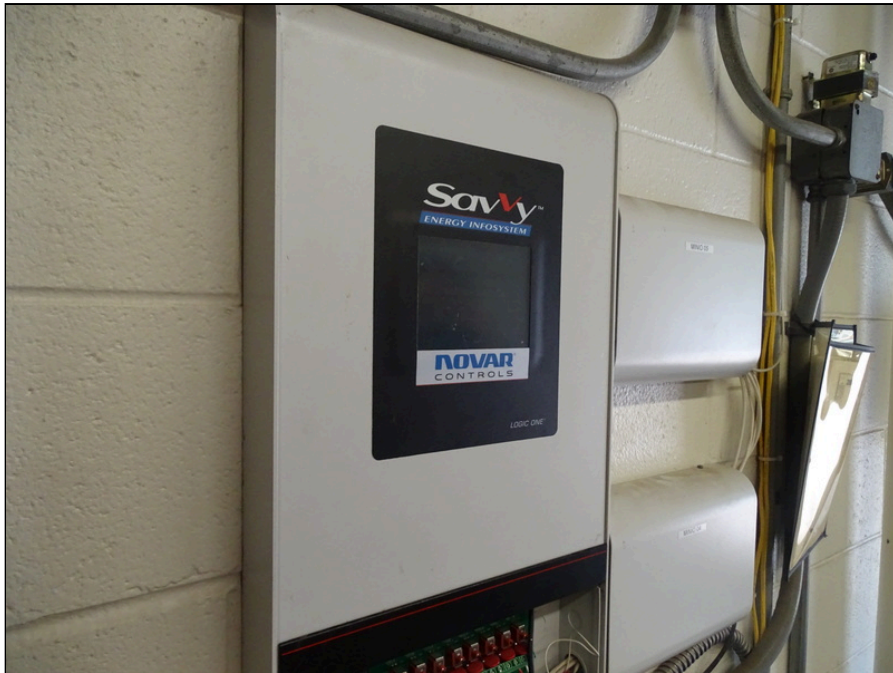
66 - Novar system

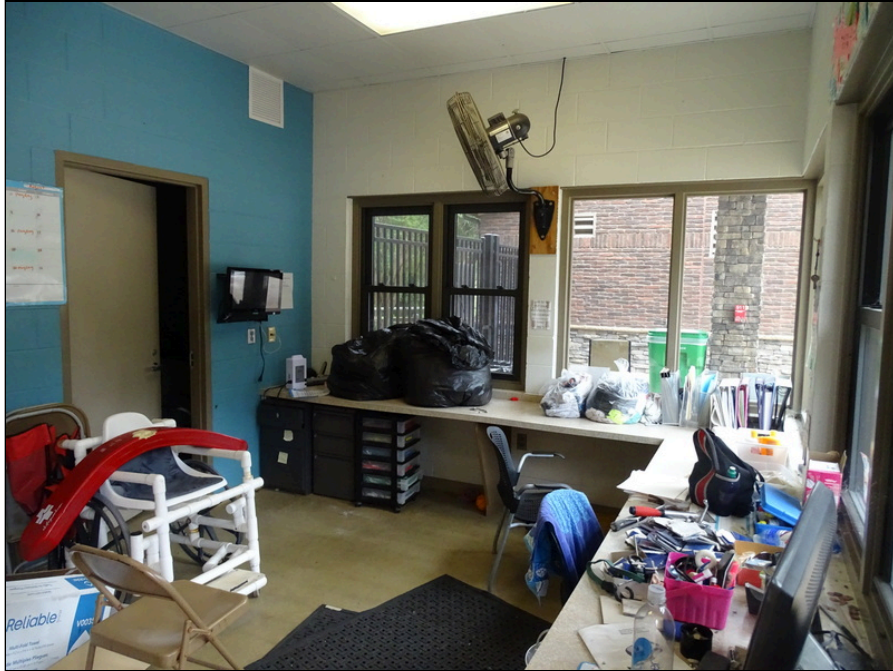
67 - Guard's office

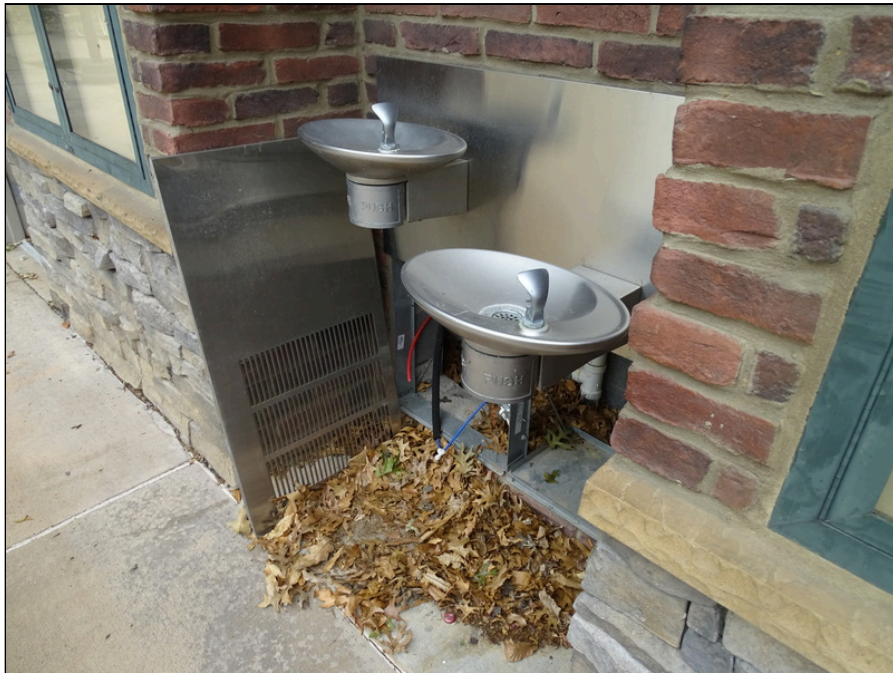
68 - Drinking fountains

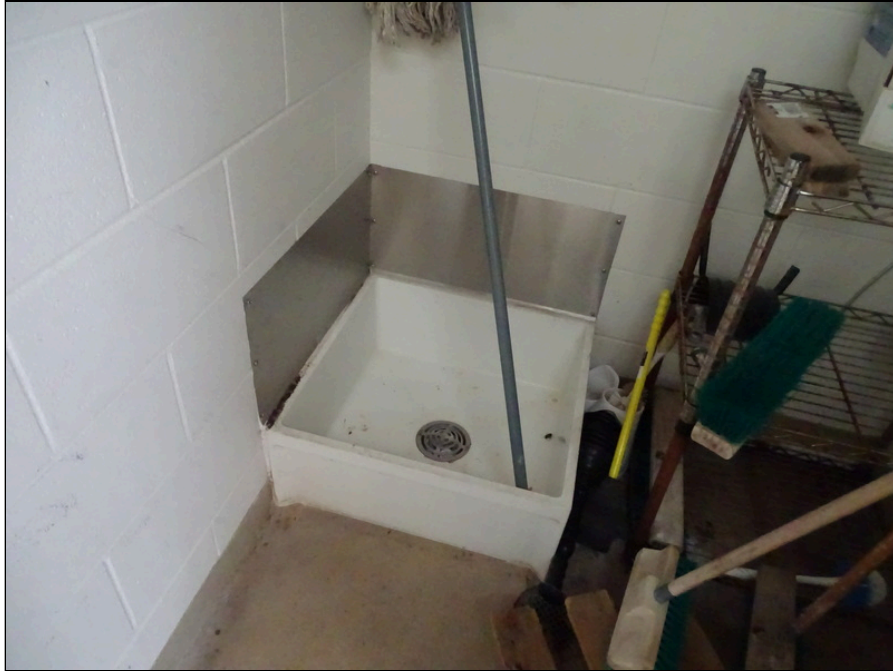
69 - Utility room

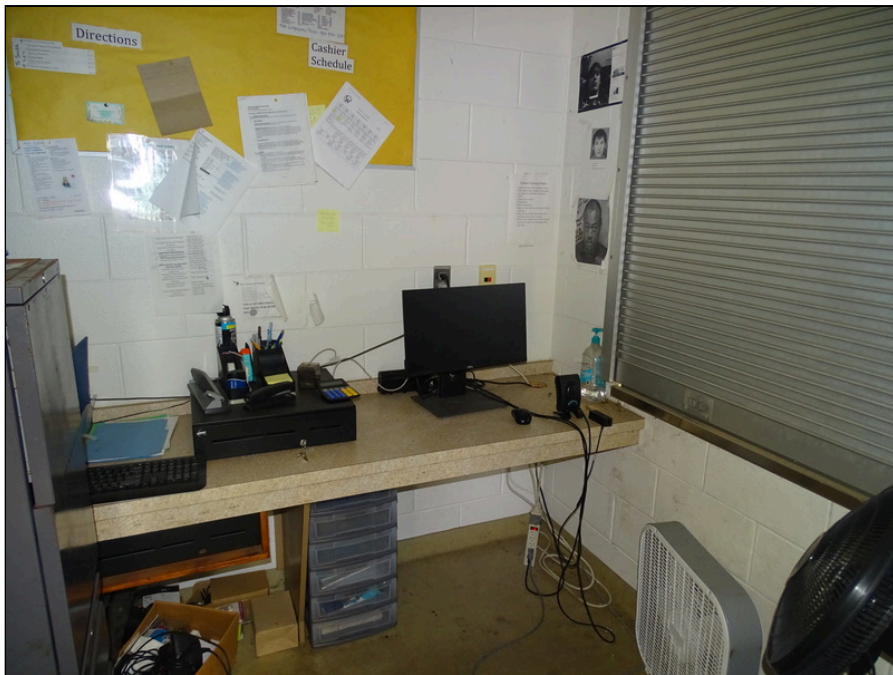
70 - Typical office

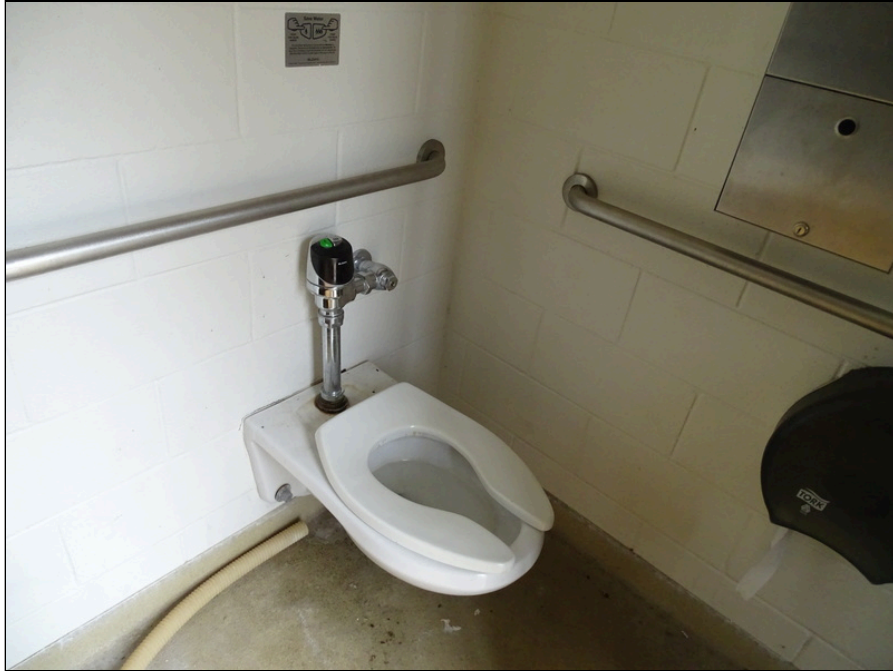
71 - Typical accessible restroom

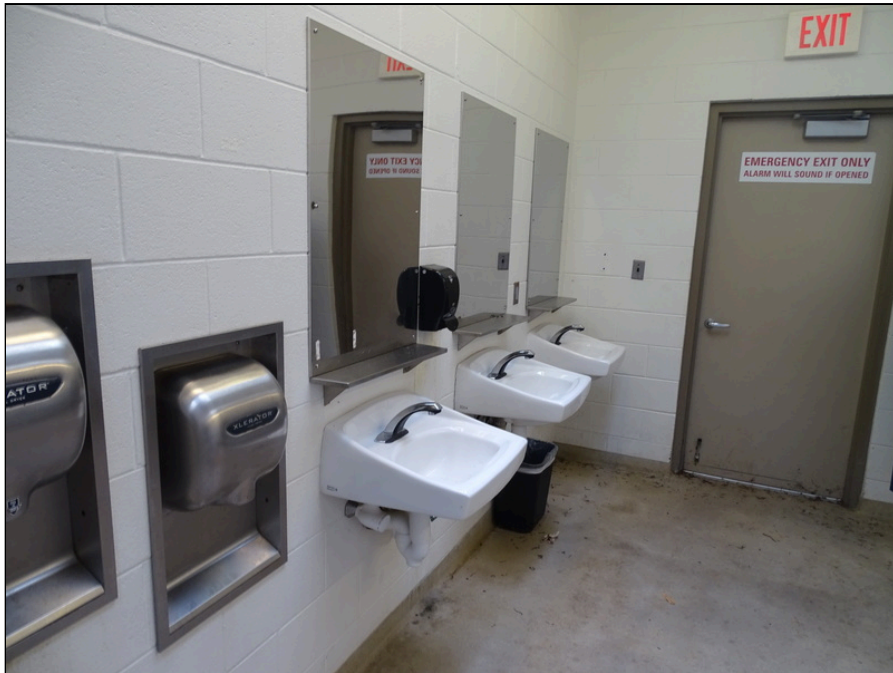
72 - Typical restroom

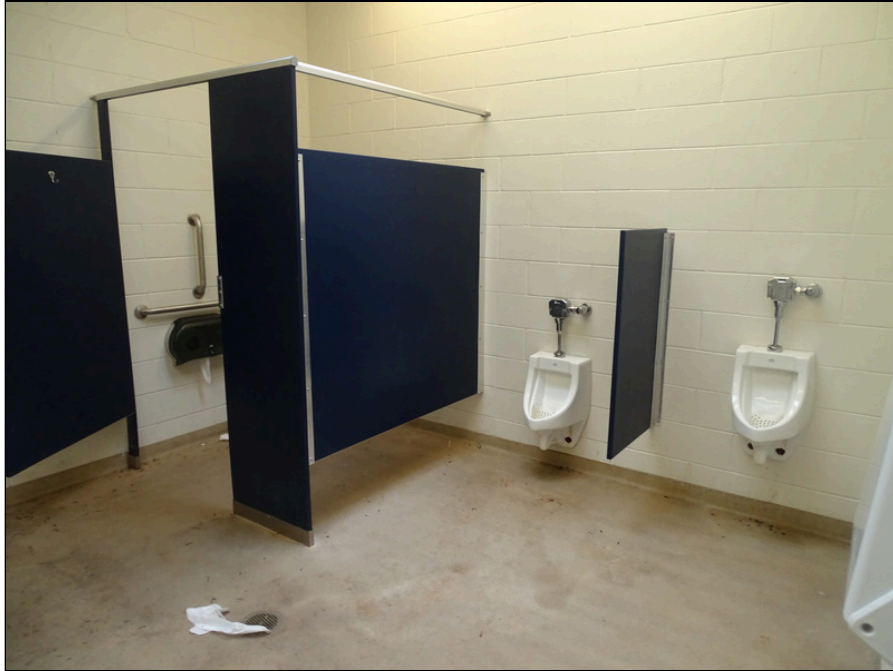
73 - Typical restroom

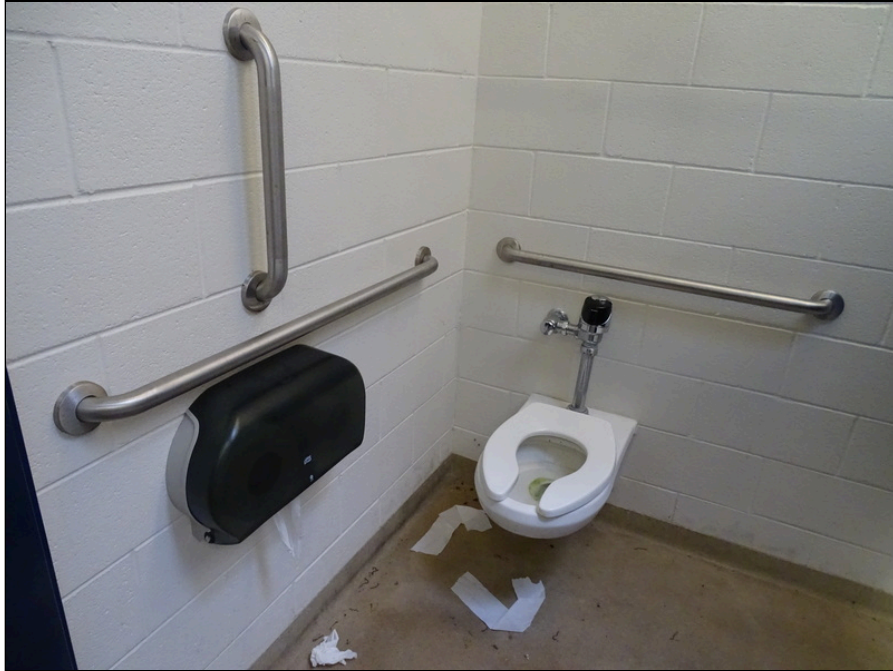
75 - Typical accessible restroom

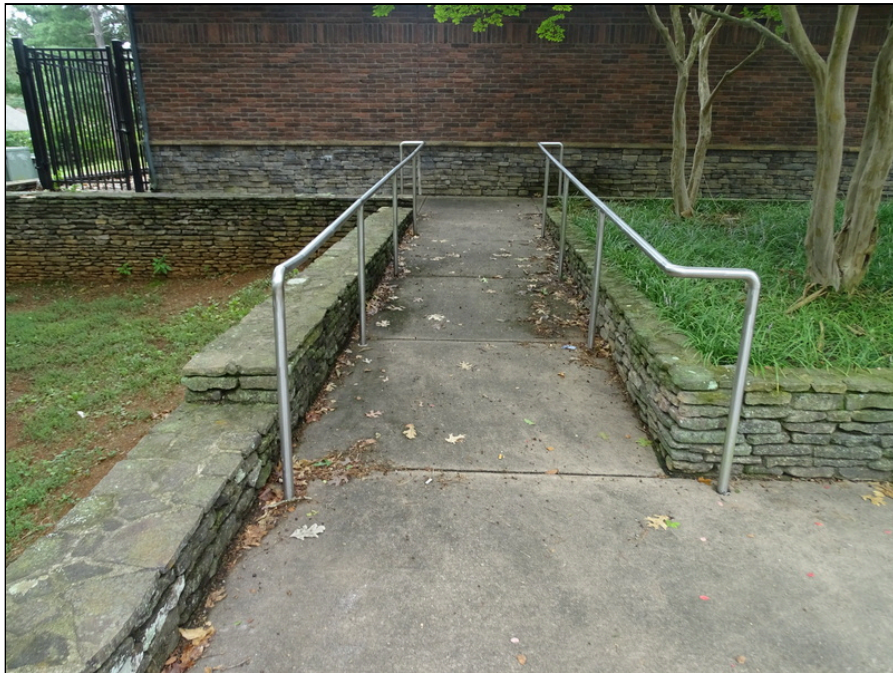
76 - Accessible ramp

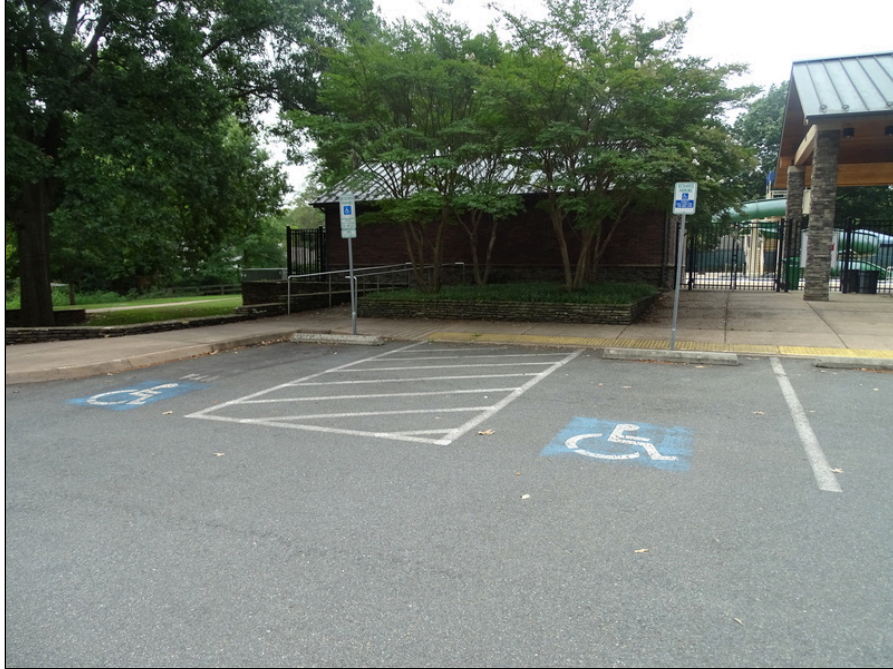
77 - Accessible parking

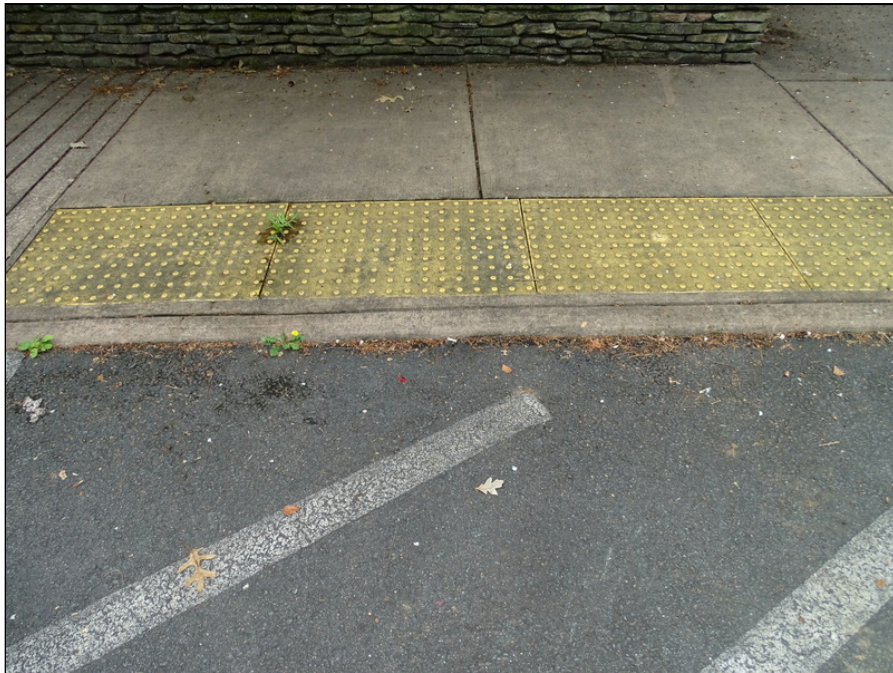
78 - Truncated domes at curb ramp from parking lot
