MEADOWCREEK GOLF COMPLEX  
1400 PEN PARK ROAD  
CHARLOTTESVILLE, VIRGINIA

ECS PROJECT NO. 46:6713

CITY OF CHARLOTTESVILLE - FACILITIES DEVELOPMENT

Reference: Facility Condition Assessment Report for Meadowcreek Golf Complex, 1400 Pen Park Road, Charlottesville, Virginia

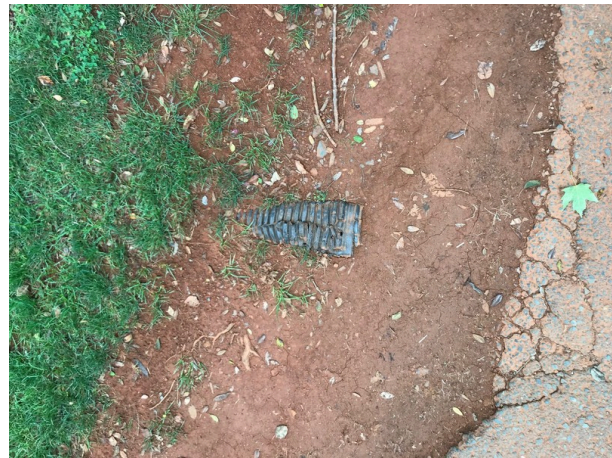
Crushed Downspout Drainage

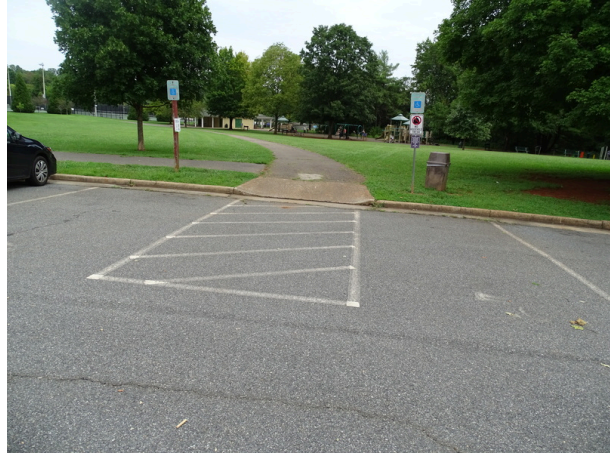
Assessible parking

The parking area serving the property has a total of approximately 10 parking spaces. Of the parking spaces, 3 are accessible with none being marked as van accessible. Accessibility requires that 1 accessible parking spaces be provided in parking areas with a total of 1 to 25 spaces. One in six of the accessible parking spaces are required to be van accessible. A minimum of a 60-inch wide access aisle is required to be provided for every two accessible parking spaces. Accessible aisles were not observed to be provided, however, the orientation of the parking spaces provided adequate access aisles to the spaces. The number of parking spaces provided meets accessibility requirements.

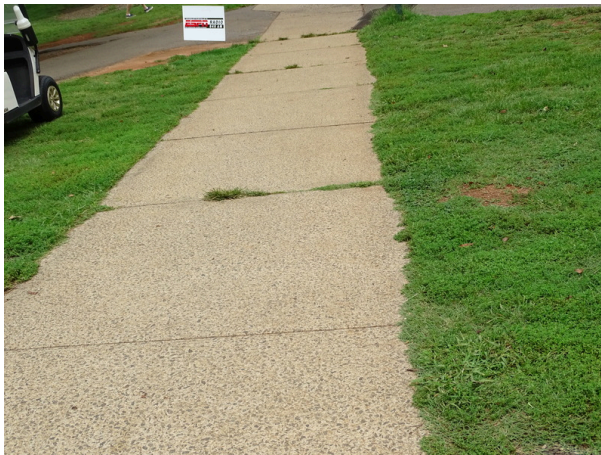
Concrete sidewalk

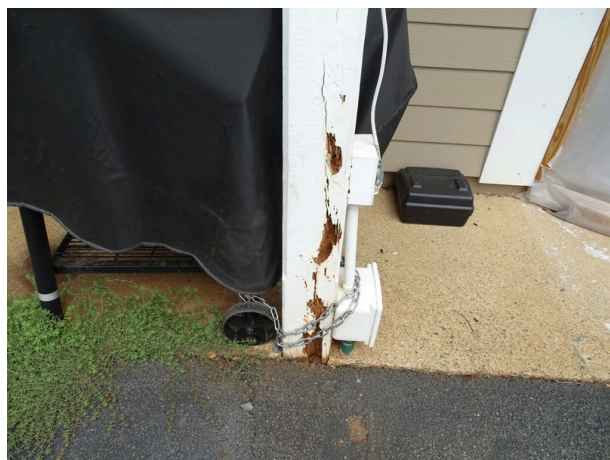
Clubhouse wood column rotten at base

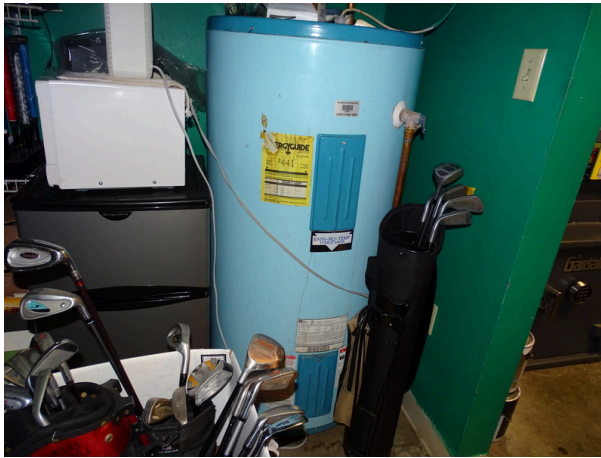
Clubhouse water heater

3.4.1.2 Domestic Hot Water Production																													
REPLACE WATER HEATER	12	11	1	1	EA	\$1,500.00	\$1,500	200%	\$1,500												\$1,500								\$3,000

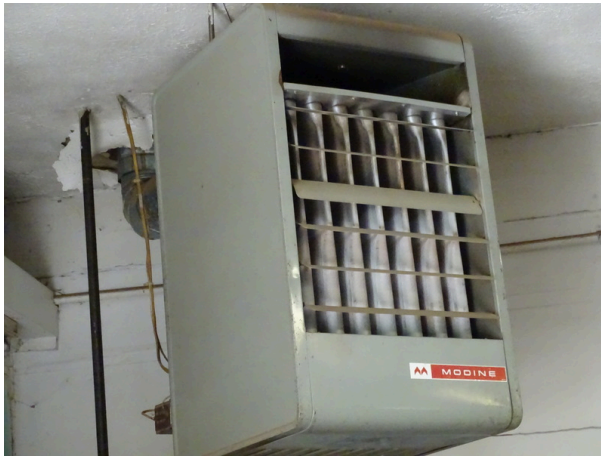
Maintenance Shop unit heater

3.4.2.1 Equipment																													
REPLACE CLUBHOUSE HEAT PUMP & CONDENSER	15	14	1	1	EA	\$9,500.00	\$9,500	200%	\$9,500															\$9,500					\$19,000
REPLACE UNIT HEATER IN MAINTENANCE SHOP	20	19	1	2	EA	\$1,500.00	\$3,000	100%	\$3,000																				\$3,000
Total (Uninflated)									\$101,300.00	\$0.00	\$0.00	\$0.00	\$22,500.00	\$0.00	\$0.00	\$22,500.00	\$0.00	\$0.00	\$0.00	\$0.00	\$1,500.00	\$0.00	\$22,500.00	\$9,500.00	\$0.00	\$0.00	\$0.00	\$0.00	\$179,800.00

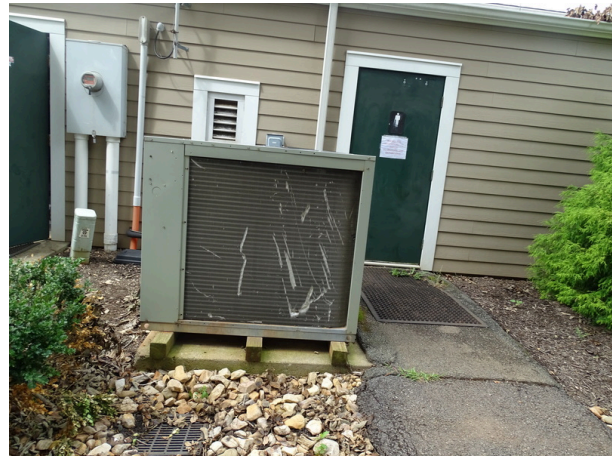
Clubhouse heat pump condenser

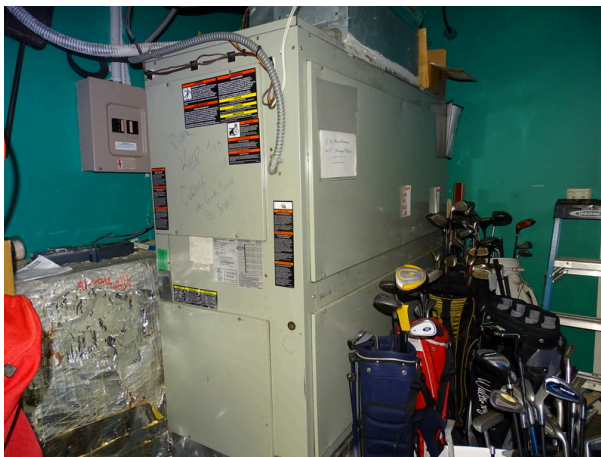
Clubhouse heat pump

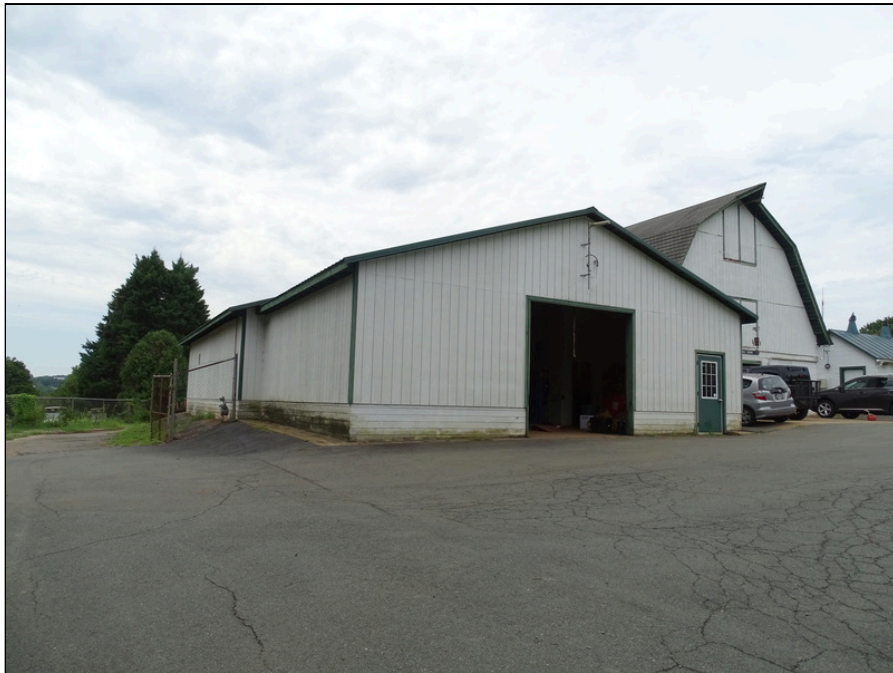
4 - Maintenance Shop, note staining at north side of building

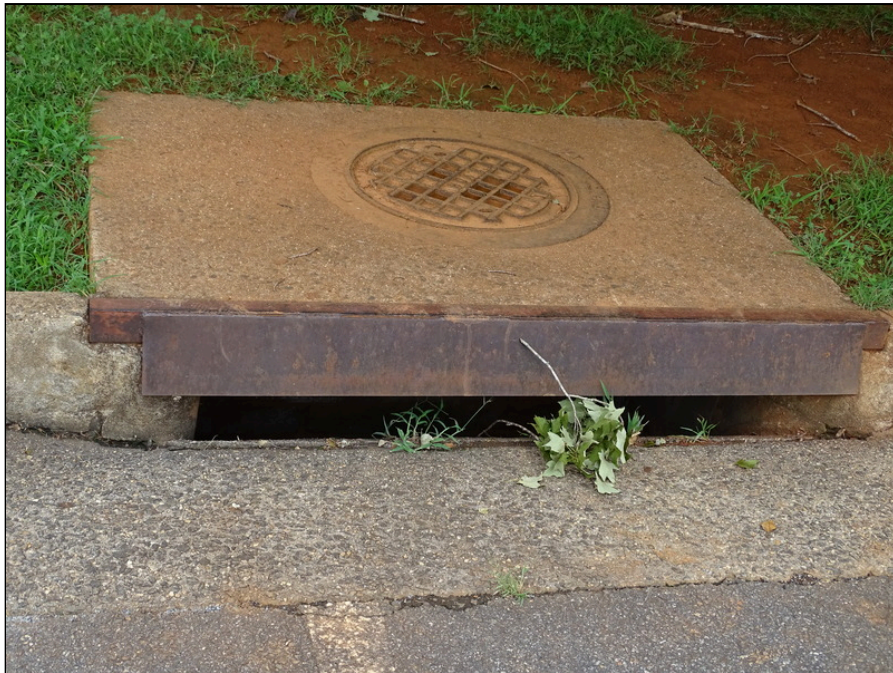
8 - Stormwater drainage at parking lot

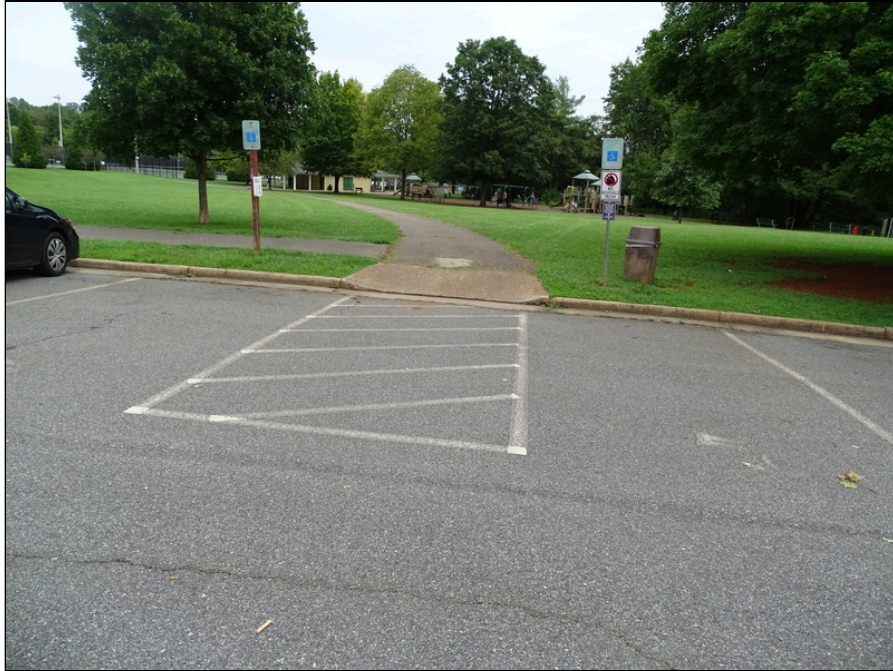
9 - Assessible parking

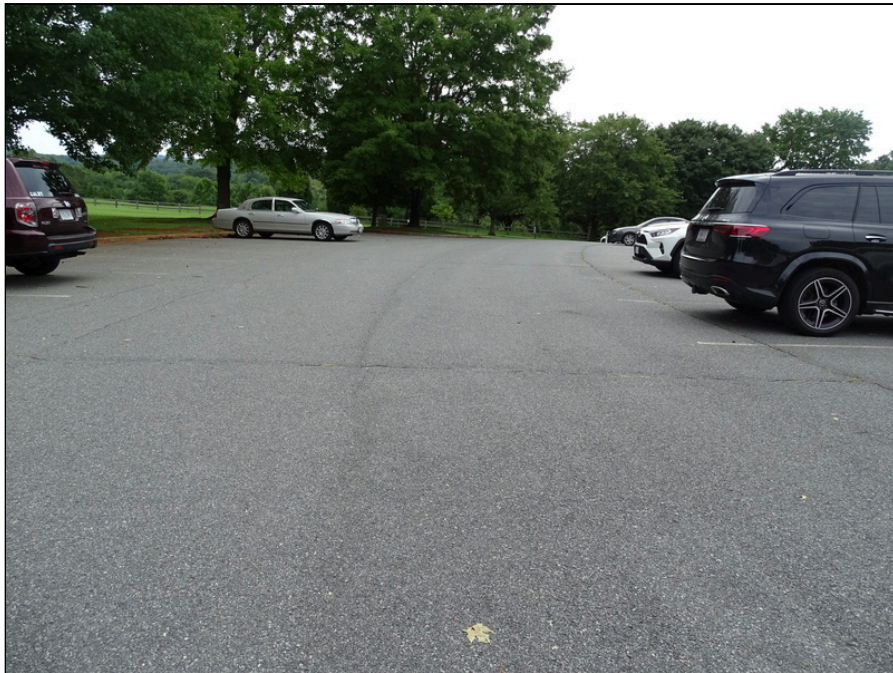
10 - Asphalt parking pavement

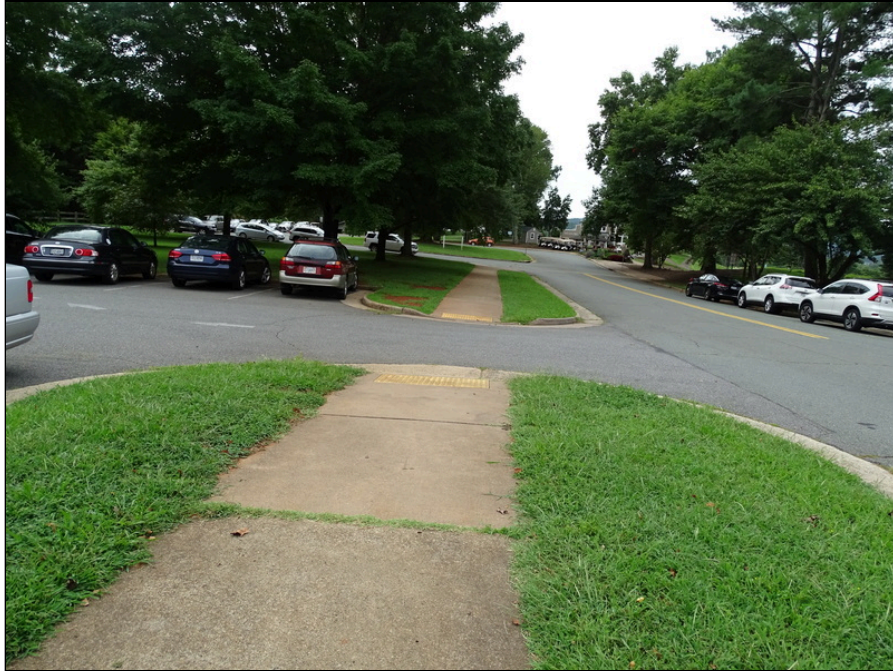
19 - Concrete walkways and ramp

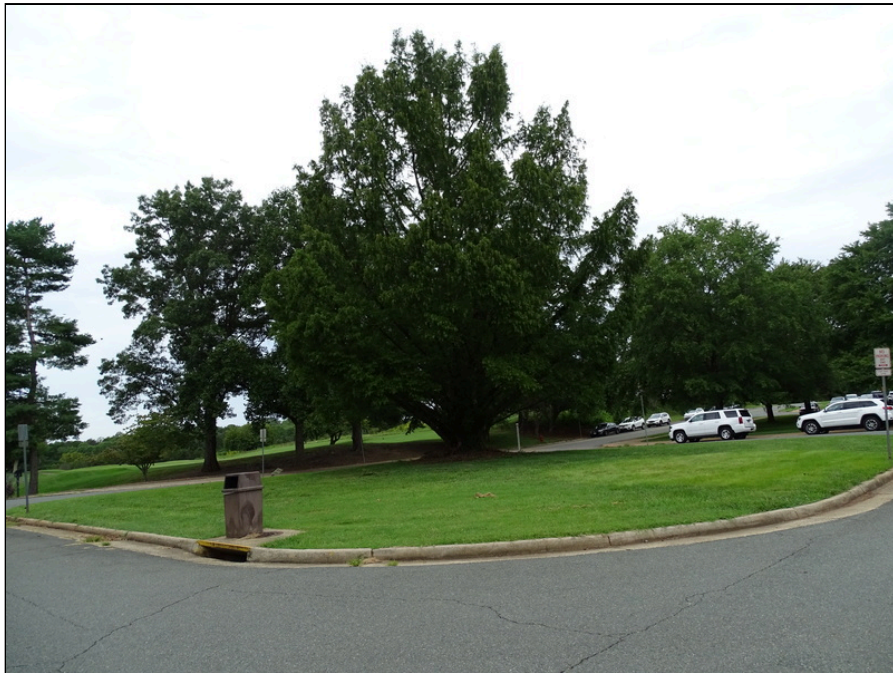
22 - Typical landscape

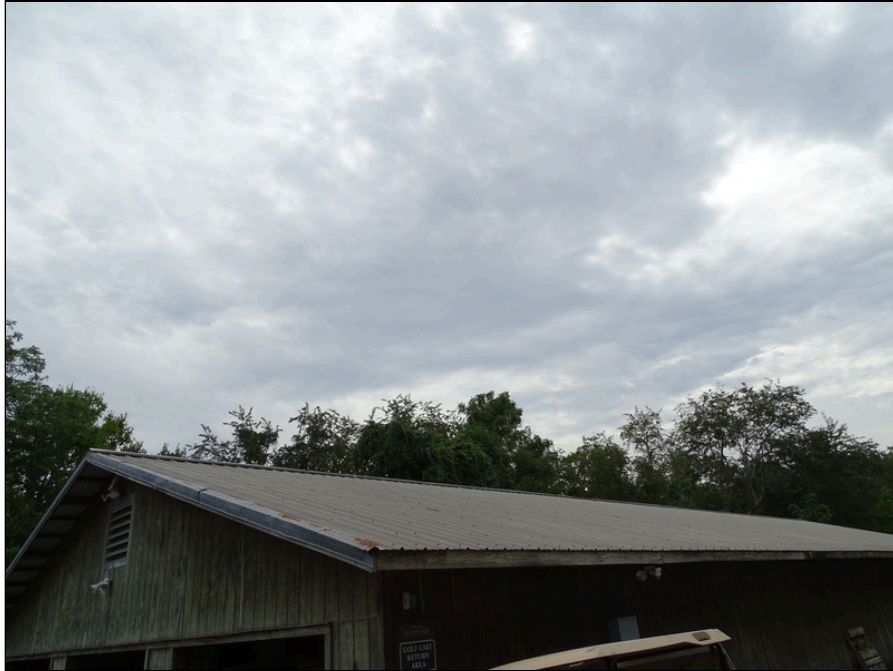
25 - Golf Cart Shed roof

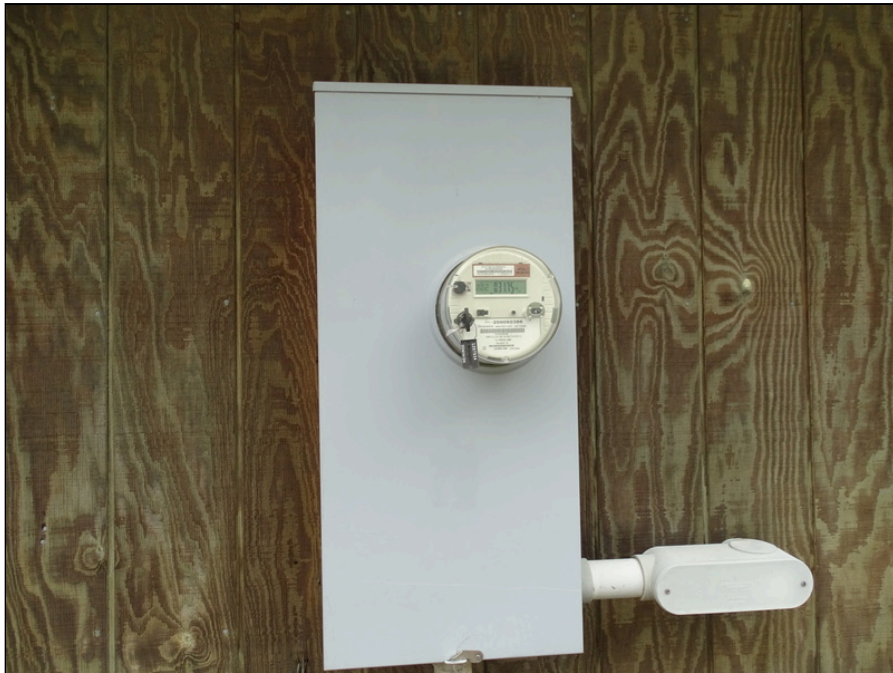
26 - Golf Cart Shed electrical entrance

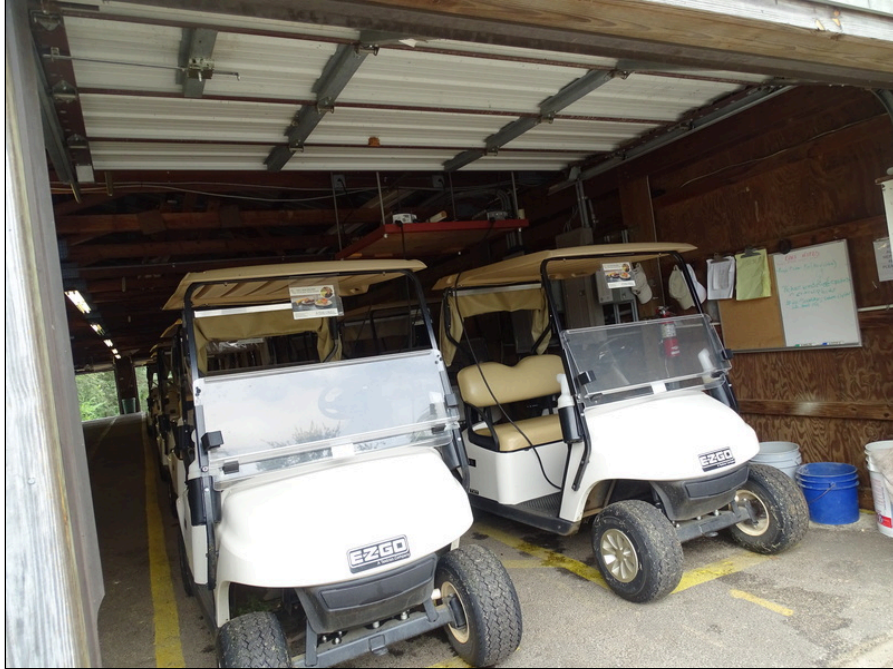
27 - Golf cart shed overhead door

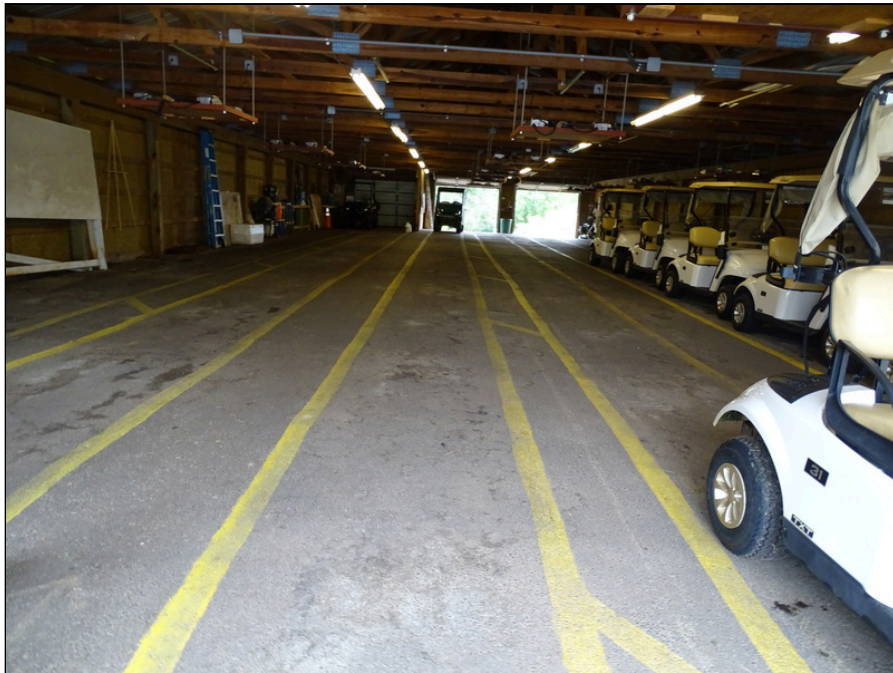
28 - Golf cart shed framing

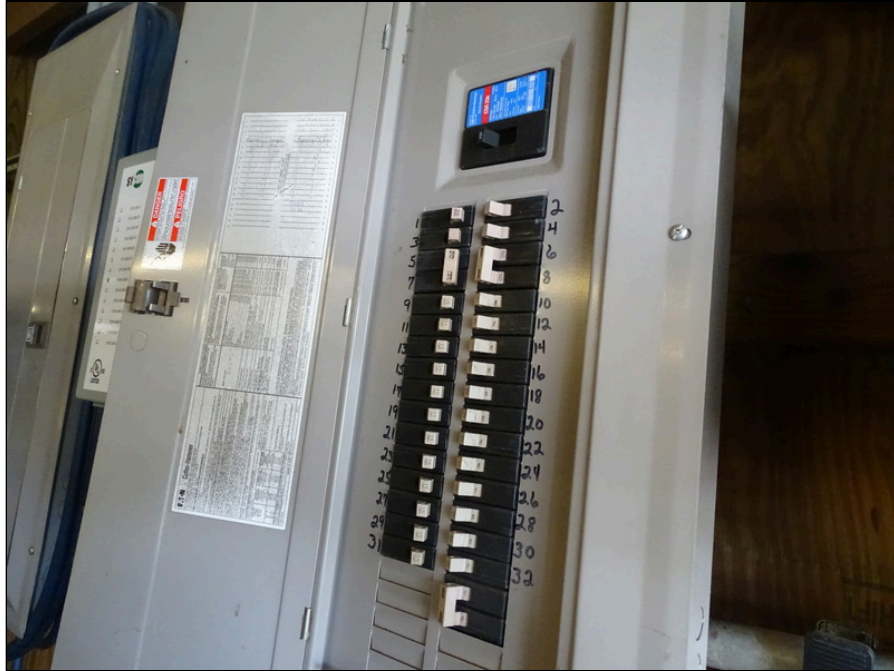
29 - Golf Cart Shed circuit breaker panel

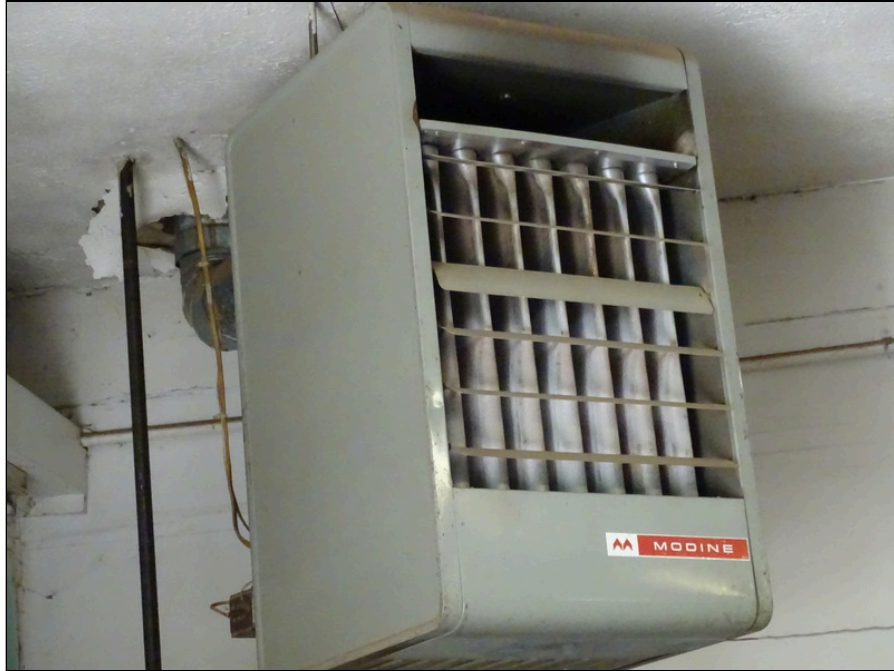
31 - Maintenance Shop unit heater

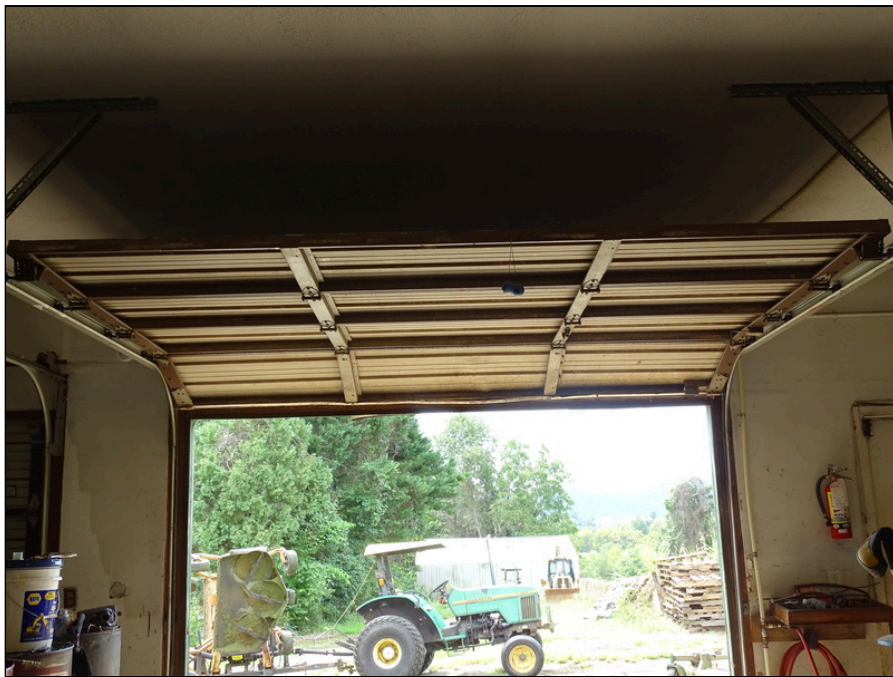
34 - Maintenance overhead door

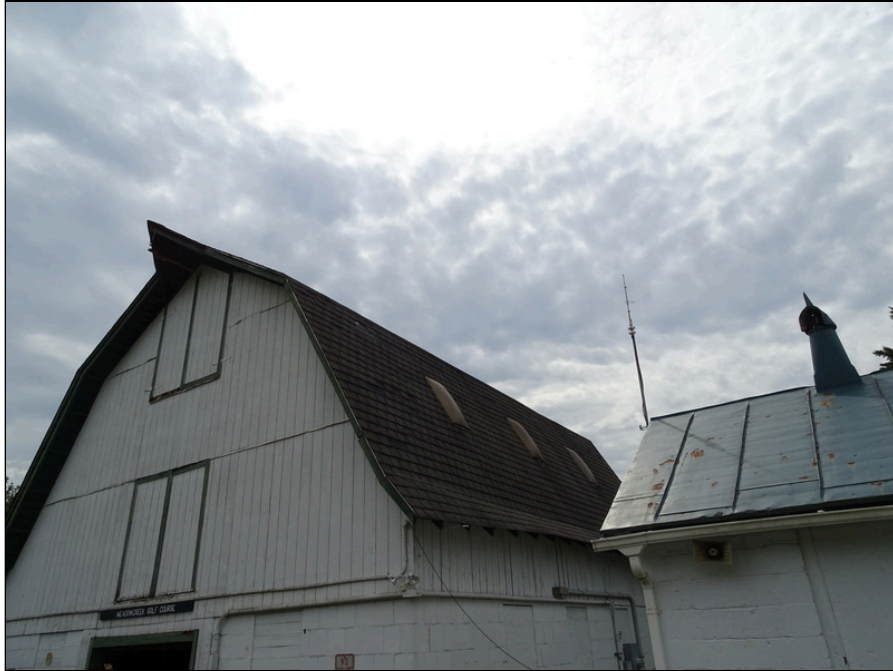
35 - Storage building roof

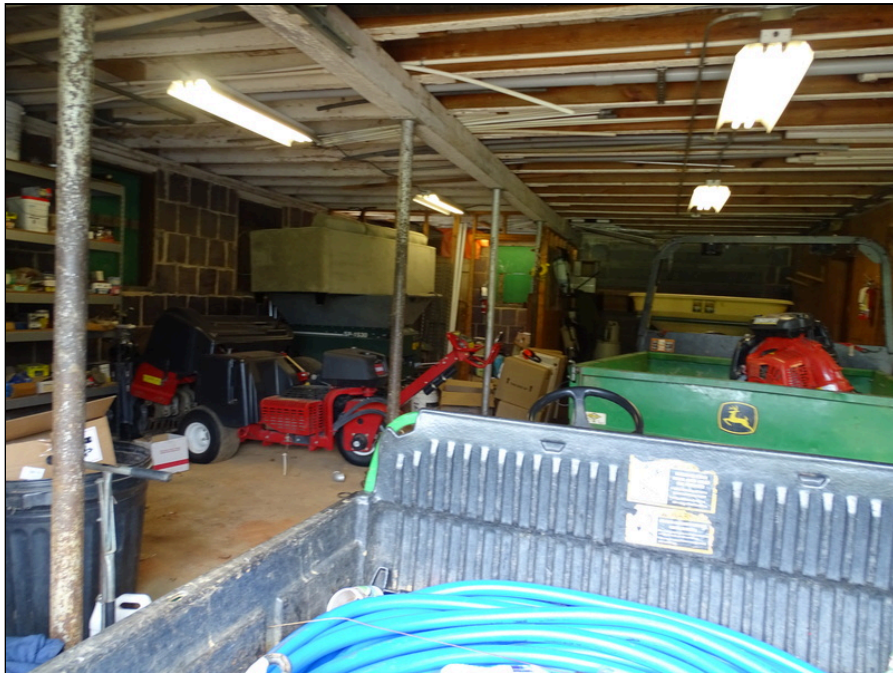
40 - Storage building framing

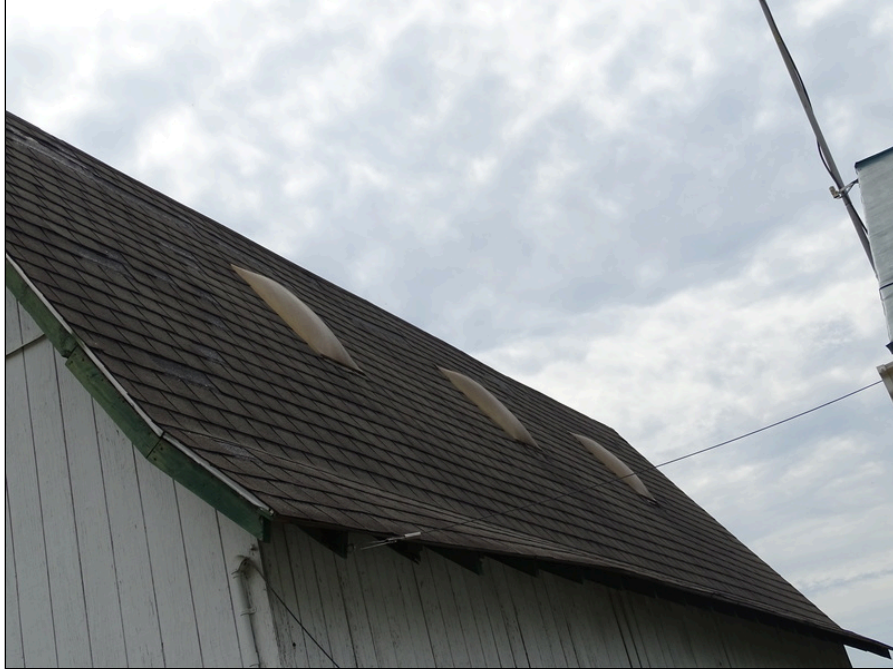
41 - Storage building skylight

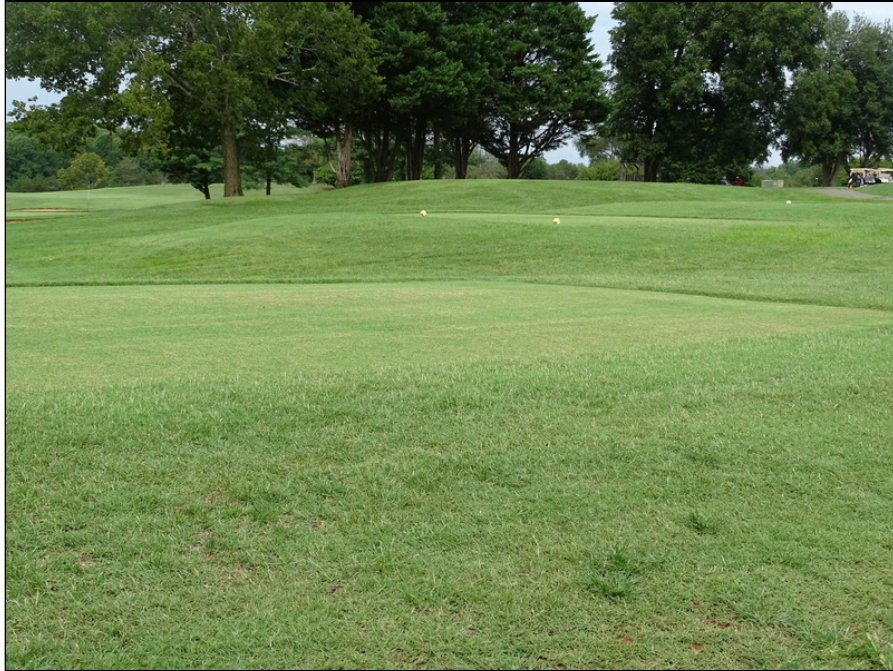
43 - Typical landscape of golf area

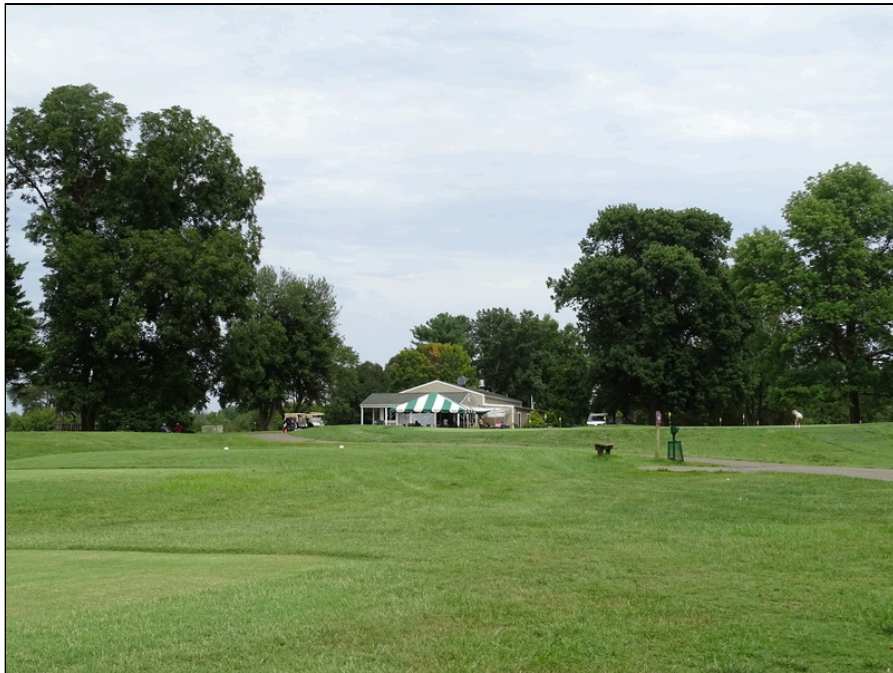
44 - Typical landscape of golf area

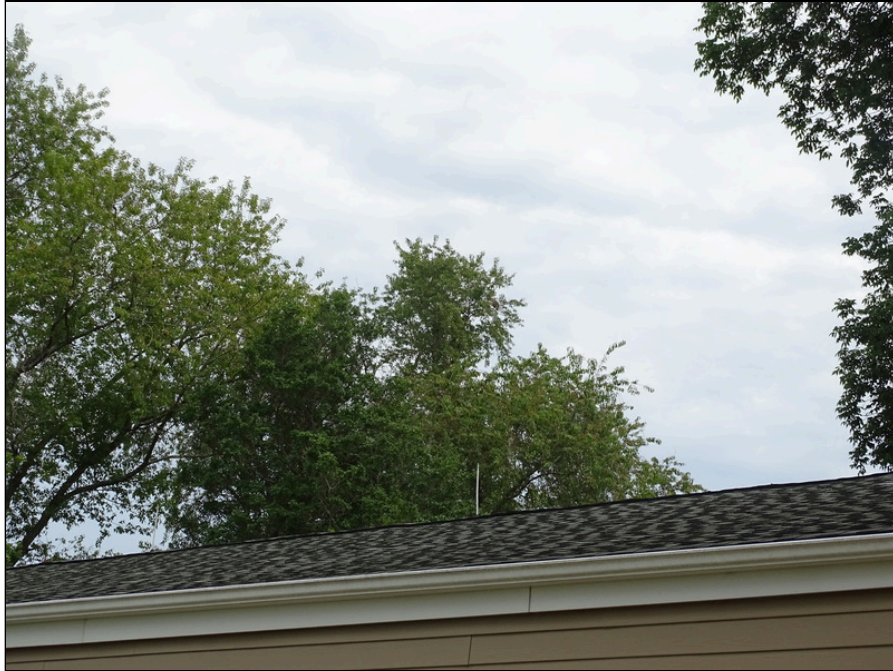
47 - Clubhouse shingle roof

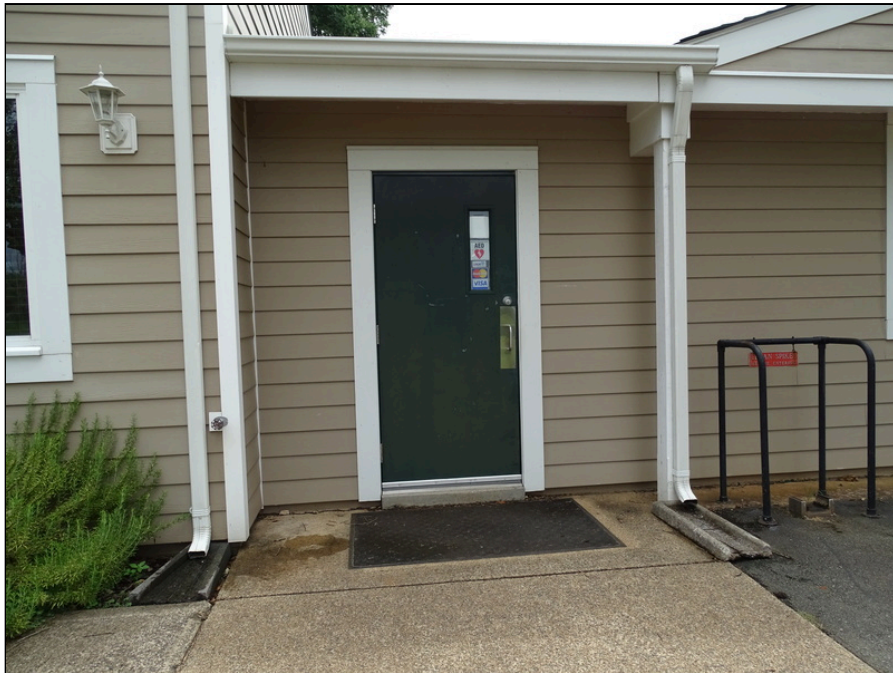
48 - Clubhouse steel personal door

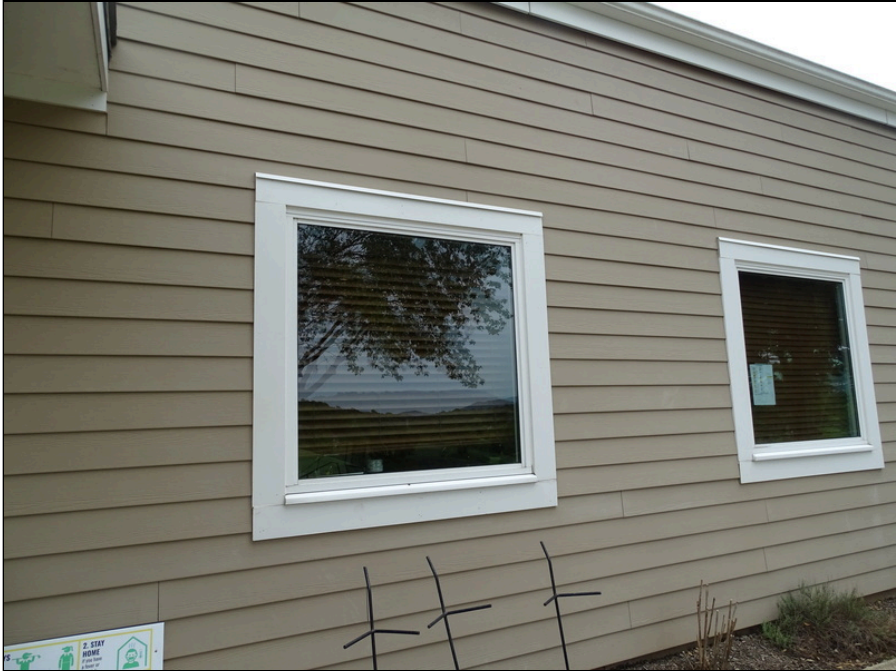
49 - Typical exterior window

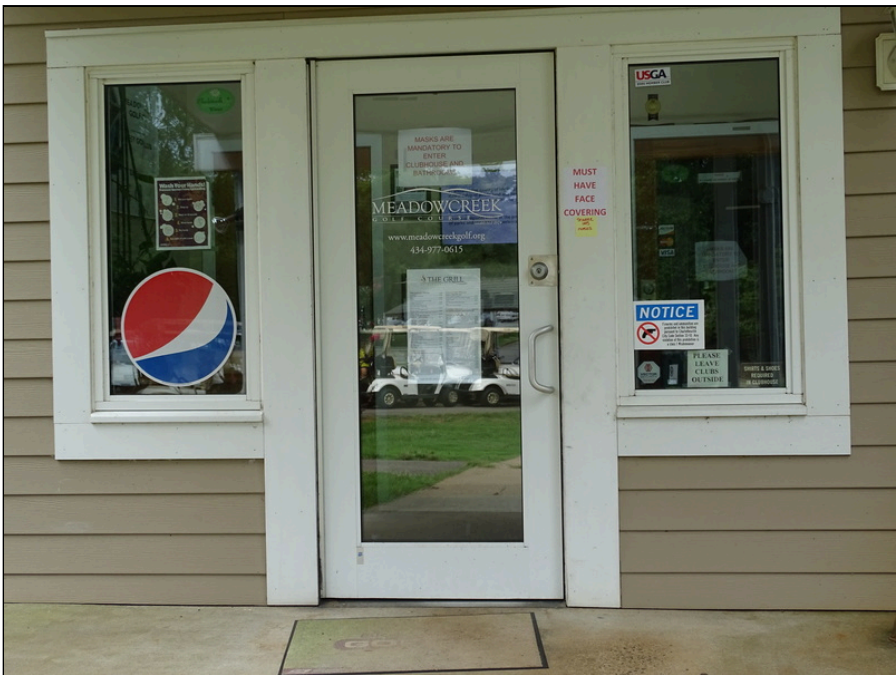
50 - Clubhouse storefront door

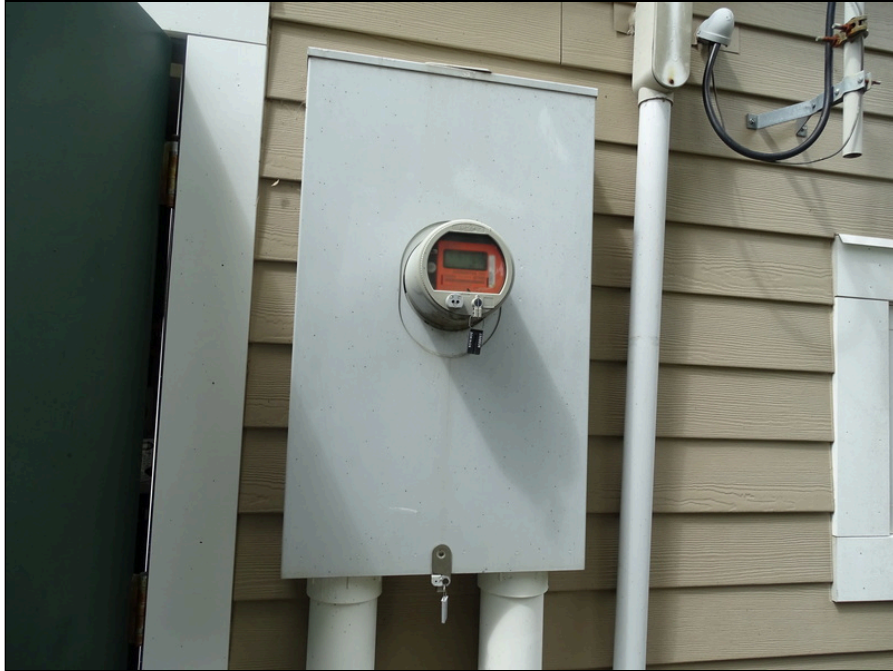
51 - Clubhouse service panel

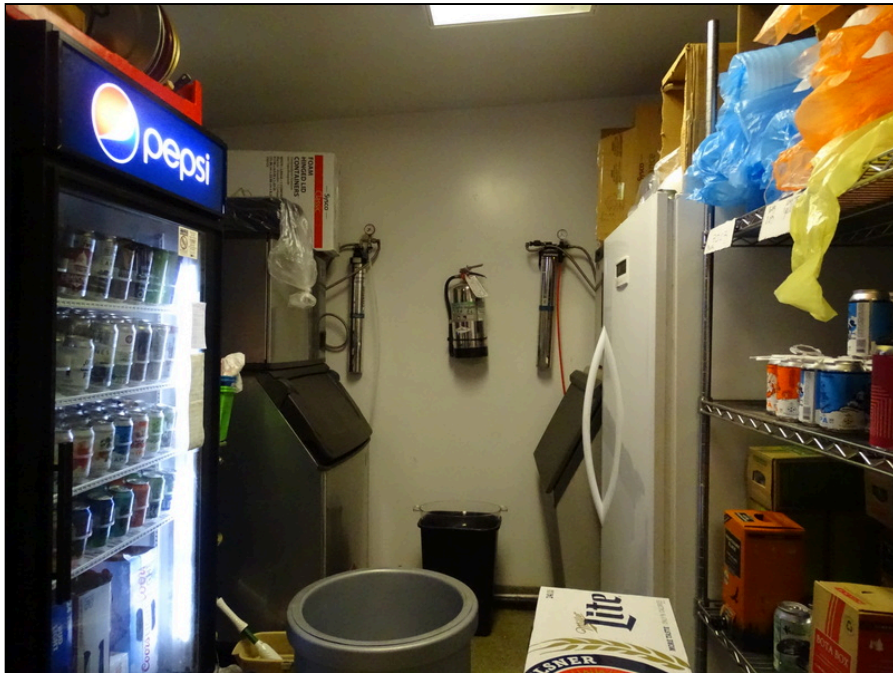
52 - Clubhouse Kitchen area

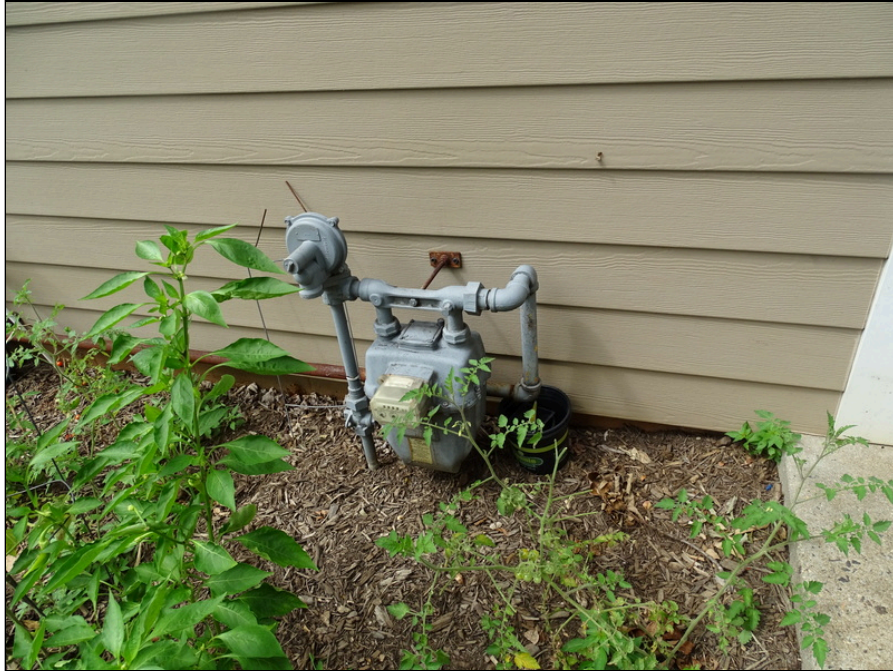
53 - Clubhouse gas meter

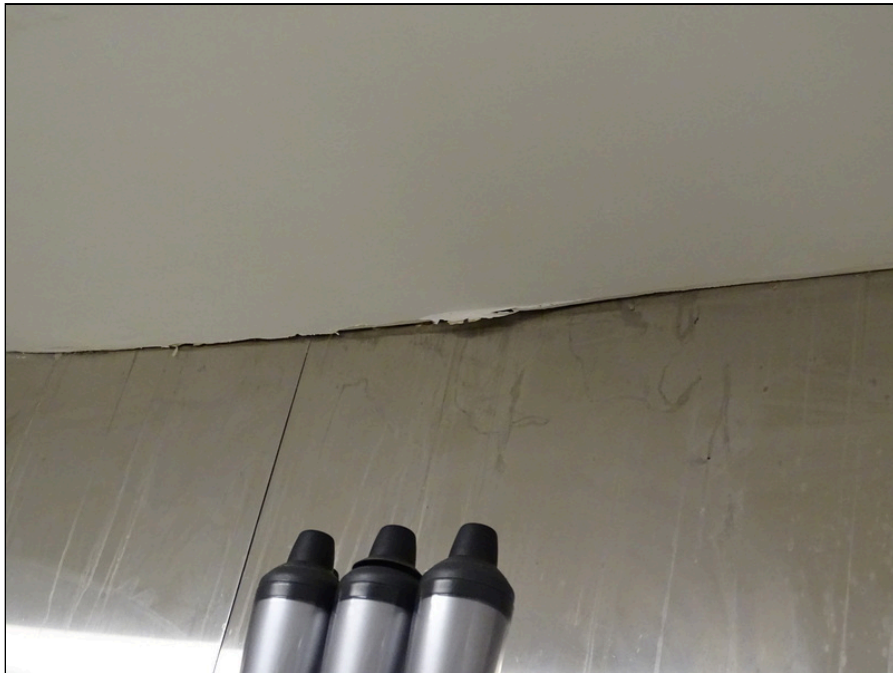
54 - Clubhouse ceiling condition

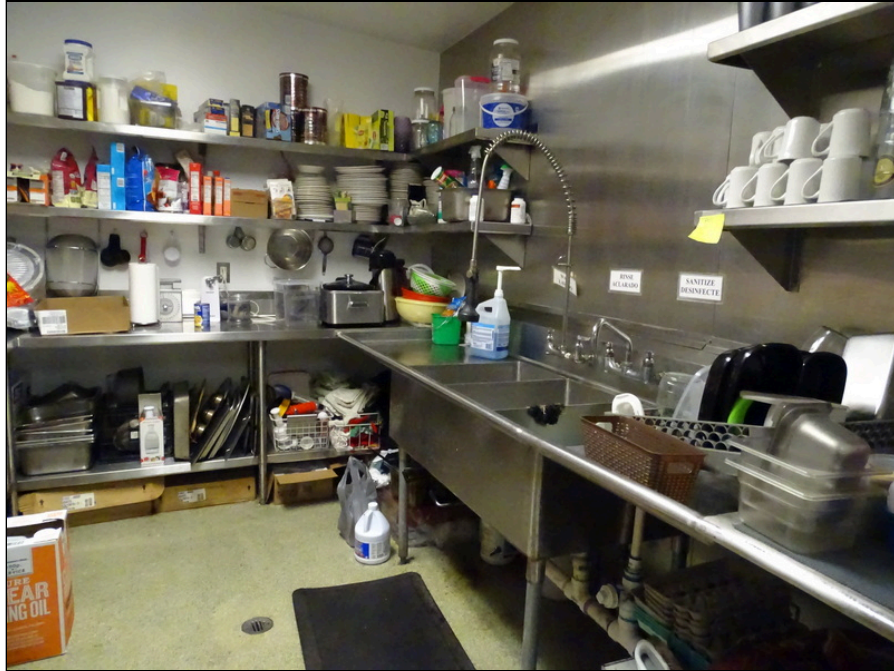
55 - Clubhouse Kitchen area

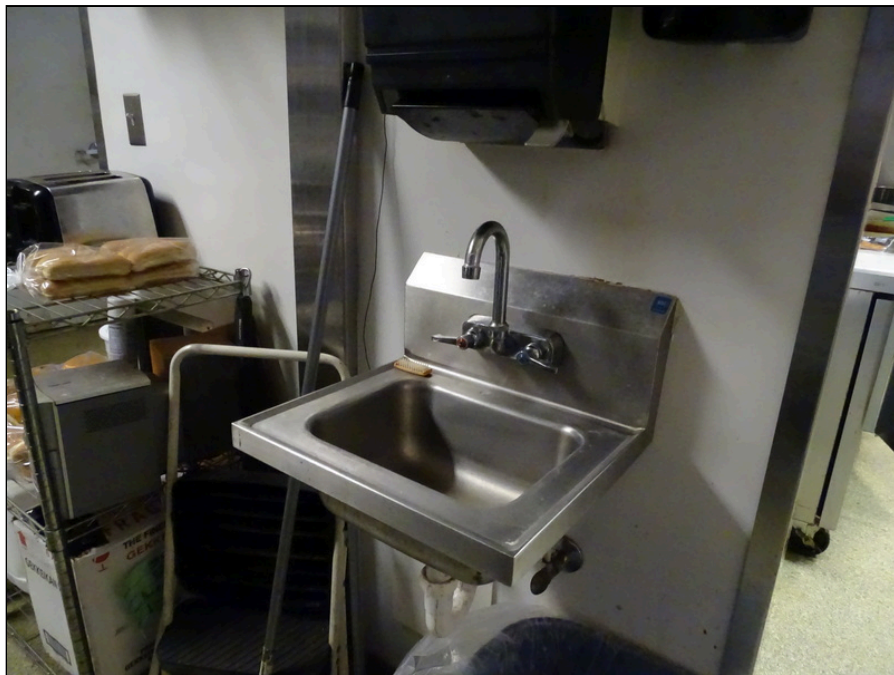
56 - Clubhouse Kitchen area

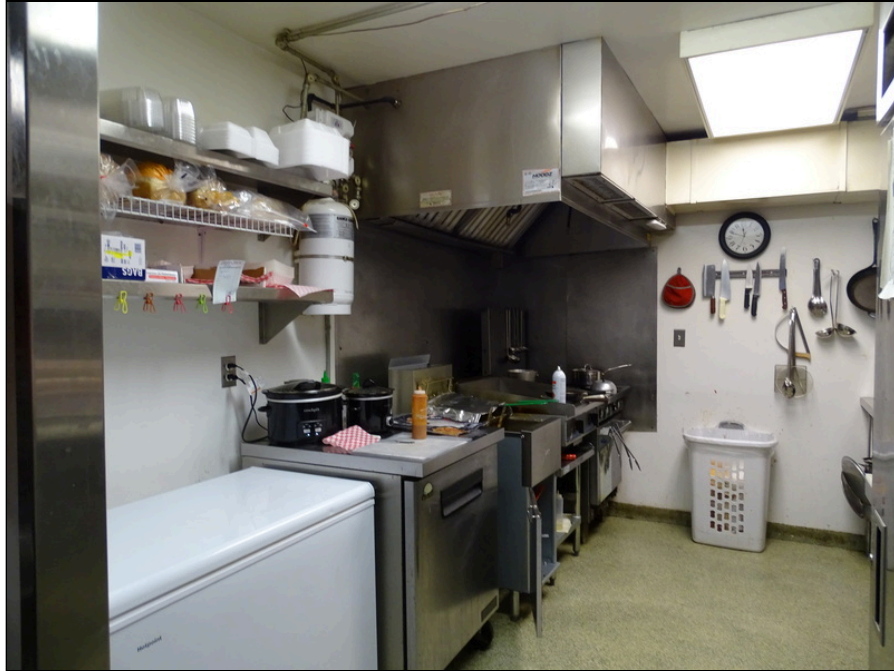
57 - Clubhouse Kitchen area

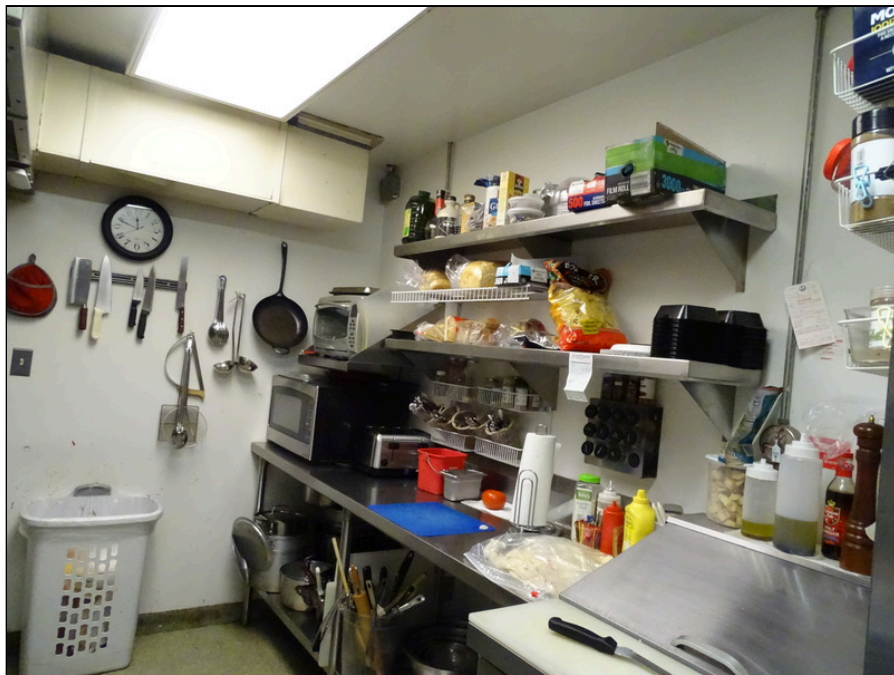
58 - Clubhouse Kitchen area

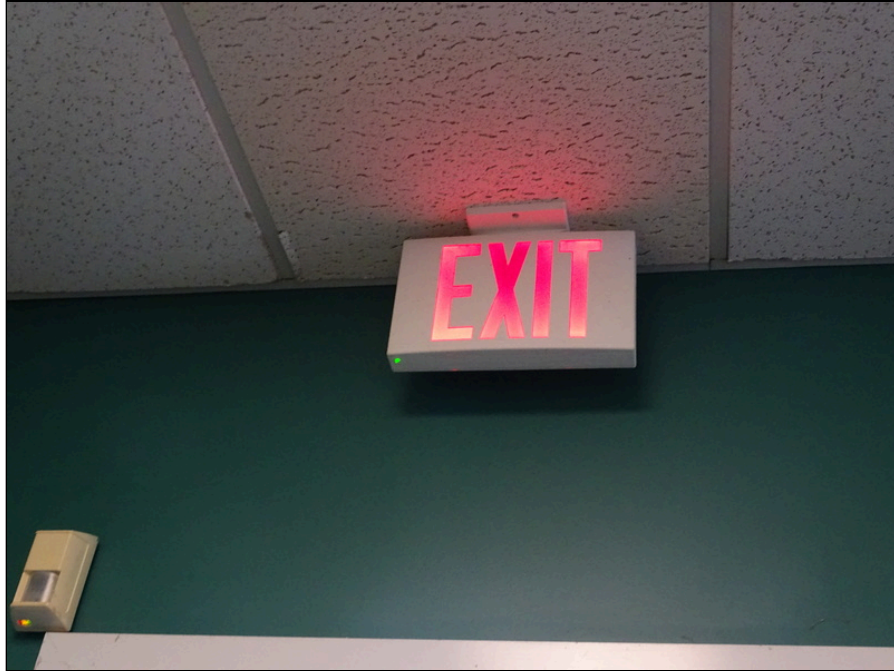
59 - Clubhouse exit sign

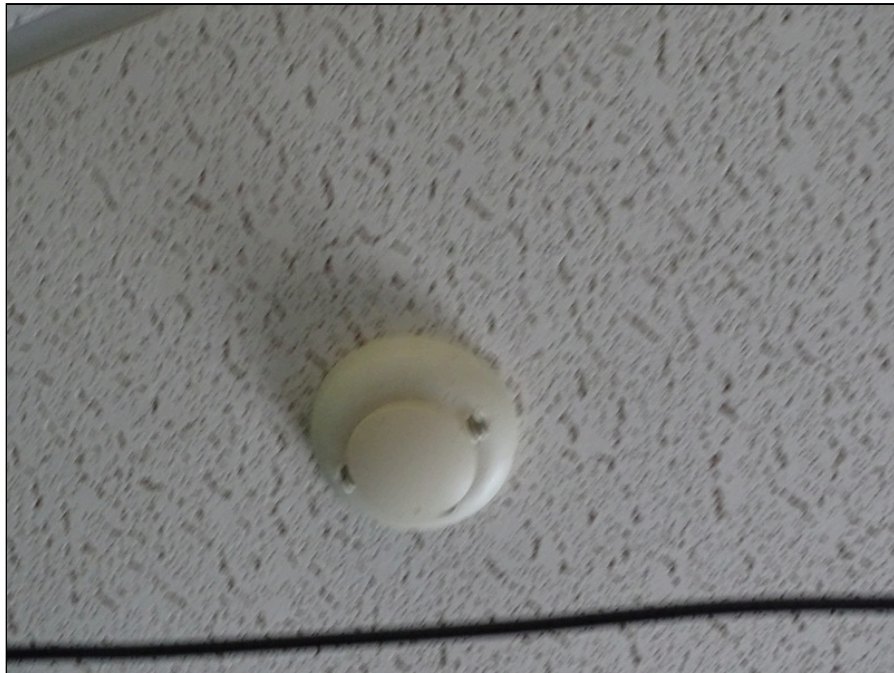
60 - Clubhouse smoke detector

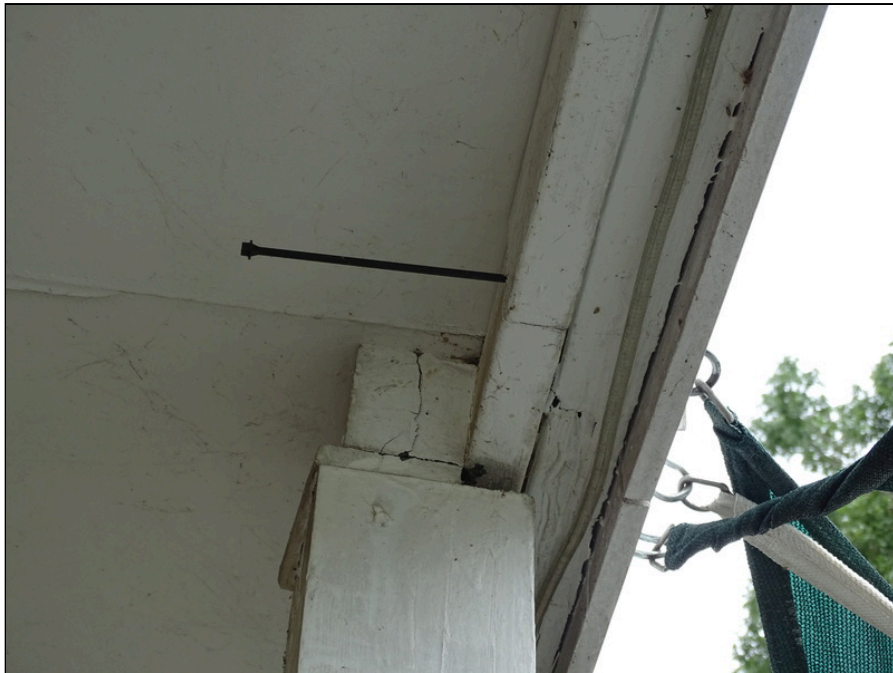
62 - Clubhouse wood column rotten at top
