MEADOWCREEK GOLF COMPLEX  
1400 PEN PARK ROAD  
CHARLOTTESVILLE, VIRGINIA

ECS PROJECT NO. 46:6713

CITY OF CHARLOTTESVILLE - FACILITIES DEVELOPMENT

Reference: Facility Condition Assessment Report for Meadowcreek Golf Complex, 1400 Pen Park Road, Charlottesville, Virginia

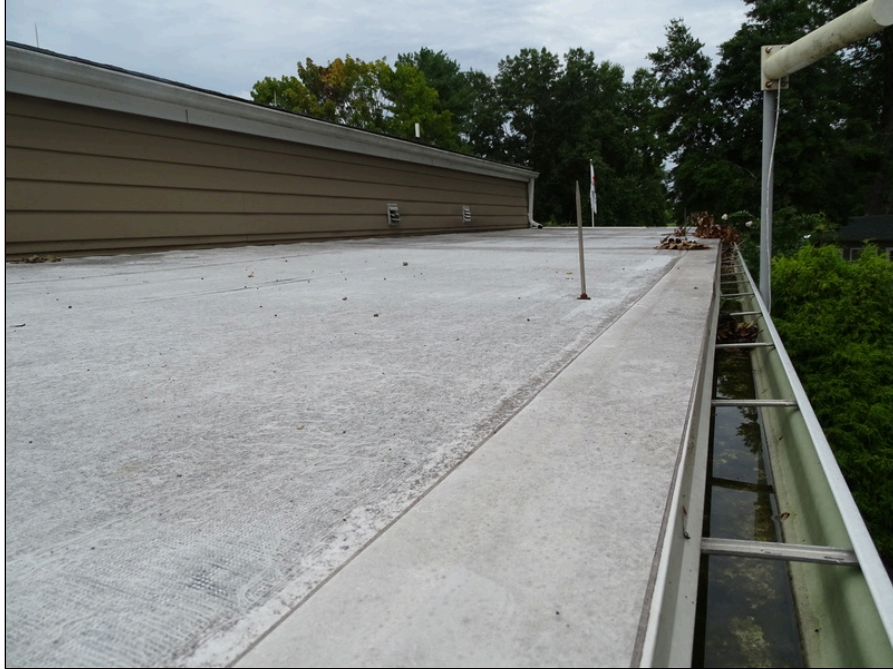
63 - Clubhouse single-ply roof and gutter

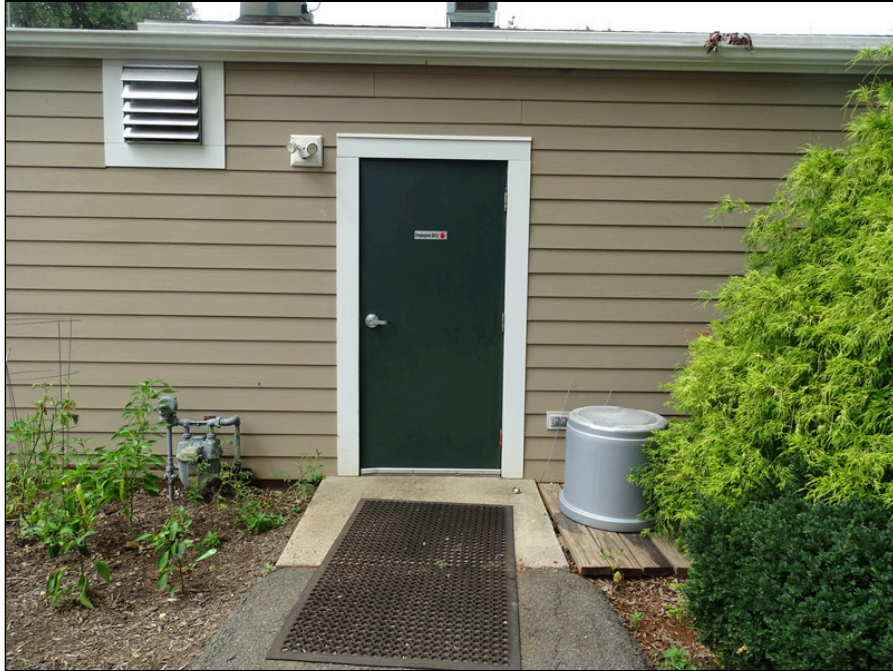
65 - Clubhouse employee door

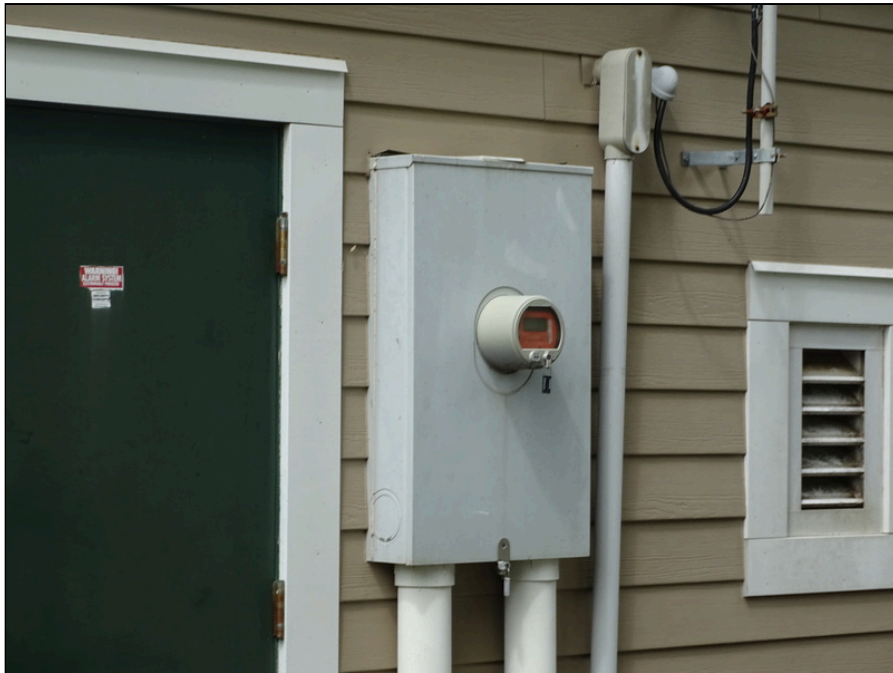
66 - Clubhouse electrical entrance

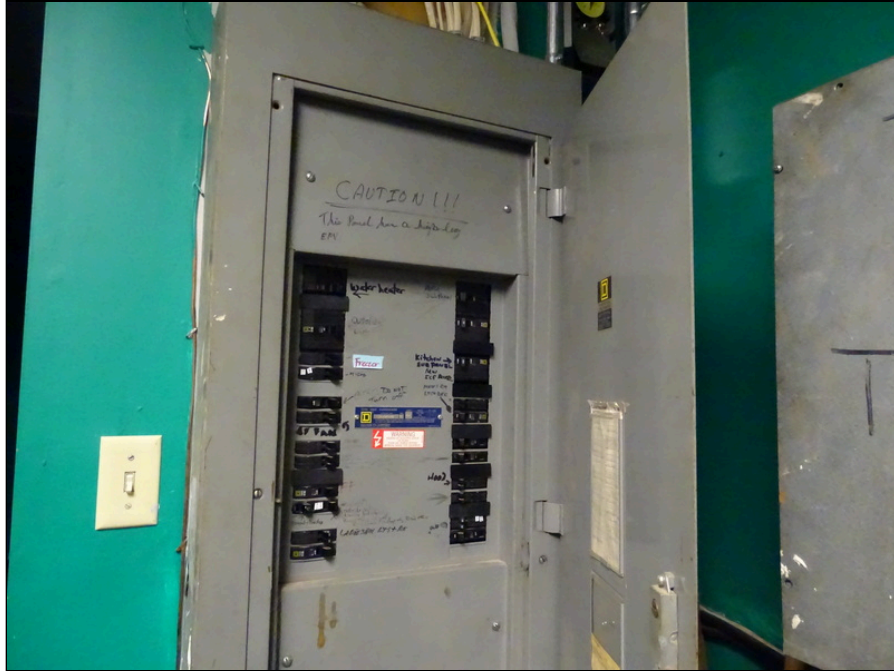
67 - Clubhouse circuit breaker panel

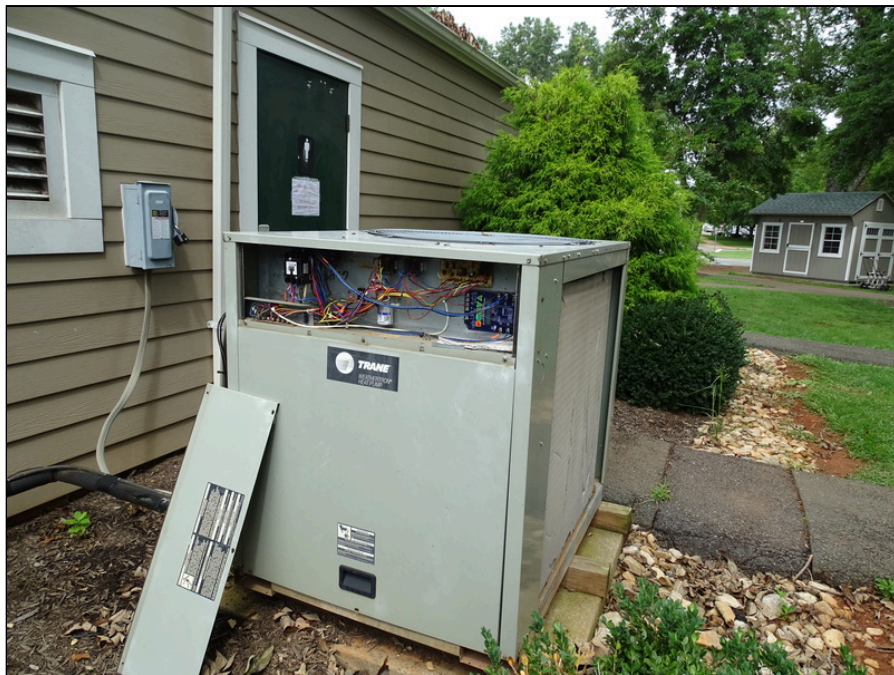
68 - Clubhouse heat pump condenser

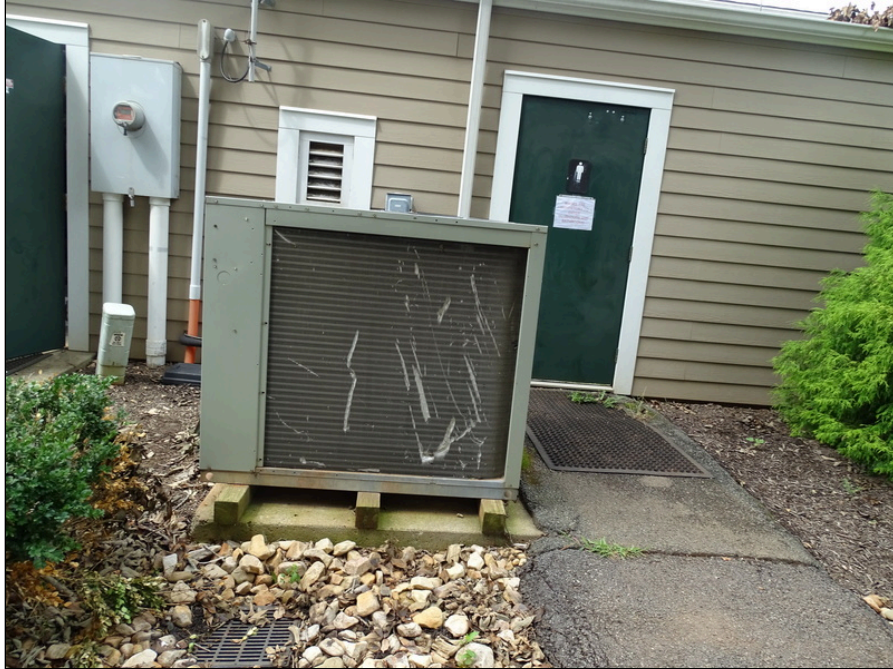
69 - Clubhouse heat pump condenser

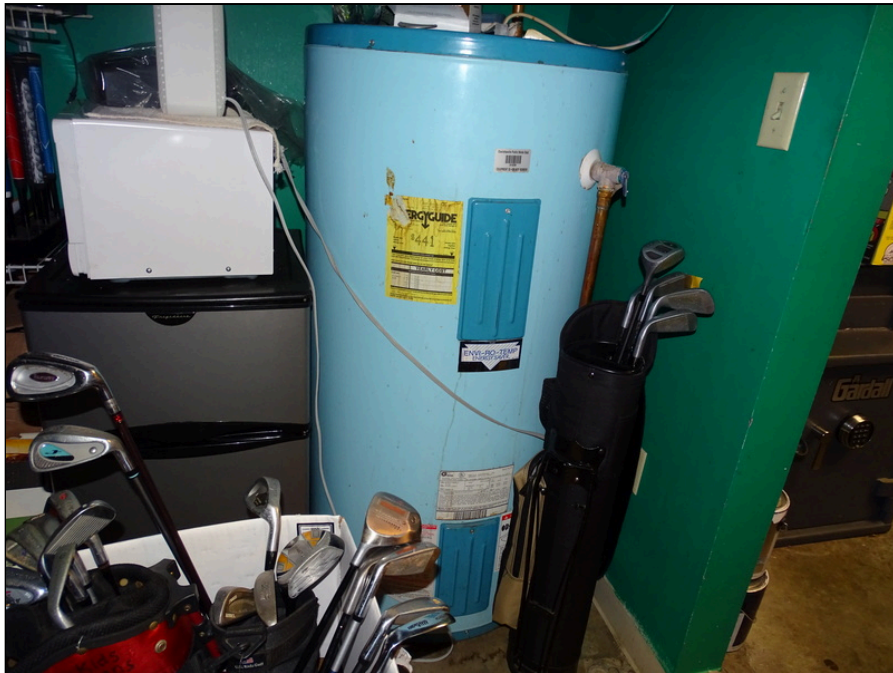
70 - Clubhouse water heater

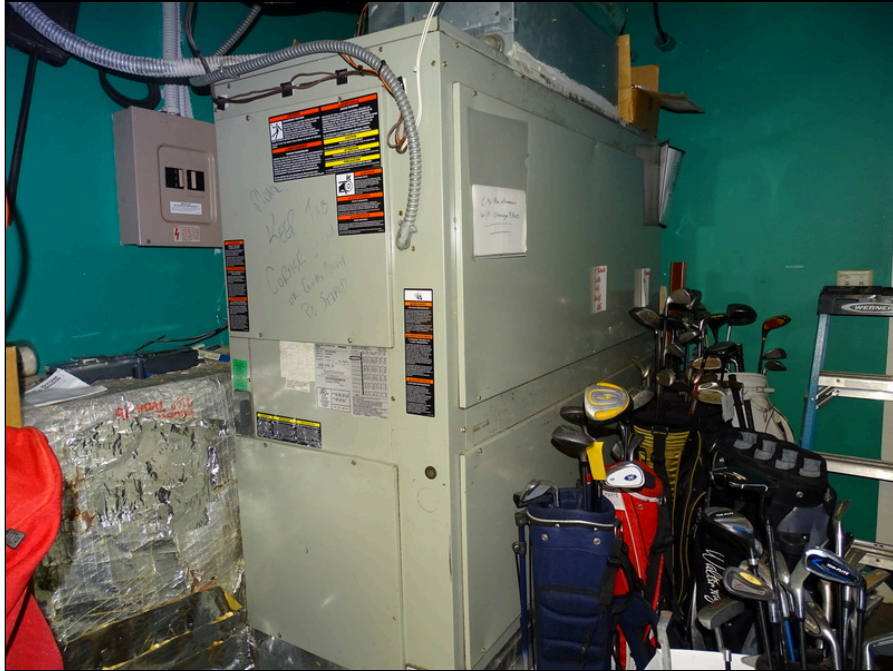
71 - Clubhouse heat pump

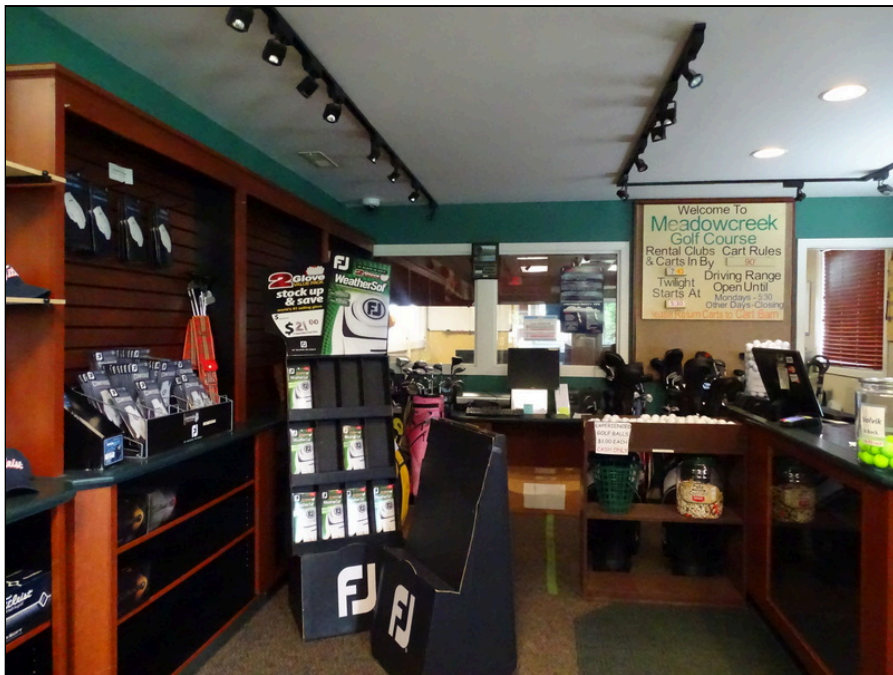
72 - Clubhouse shop

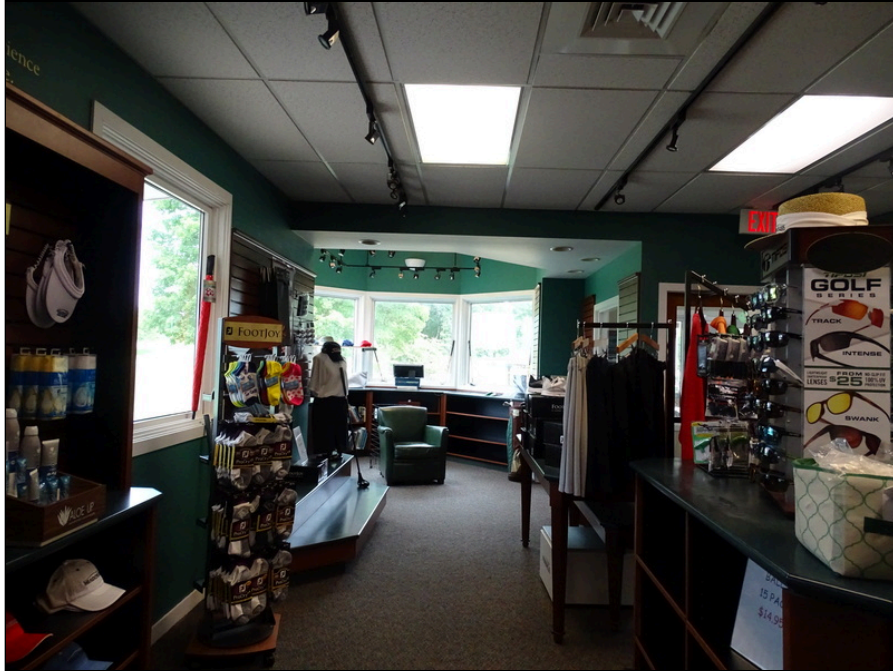
73 - Clubhouse shop

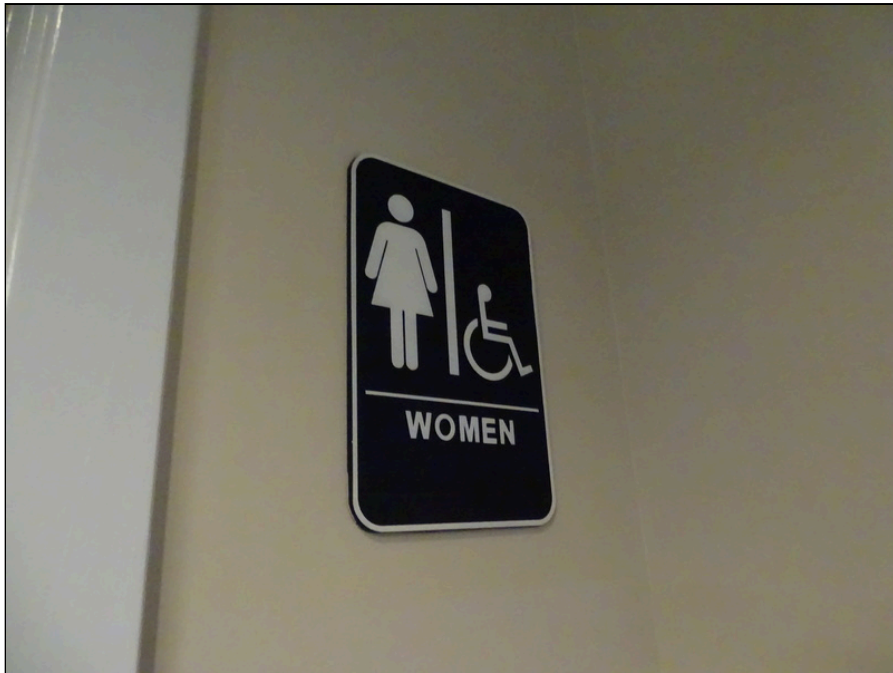
74 - Accessible restroom sign in clubhouse

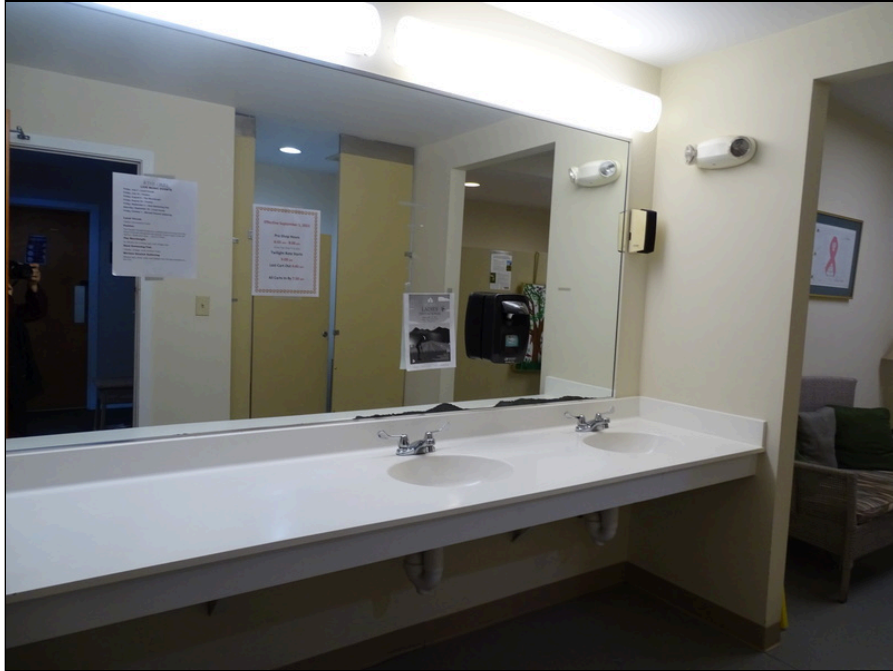
75 - Clubhouse restroom

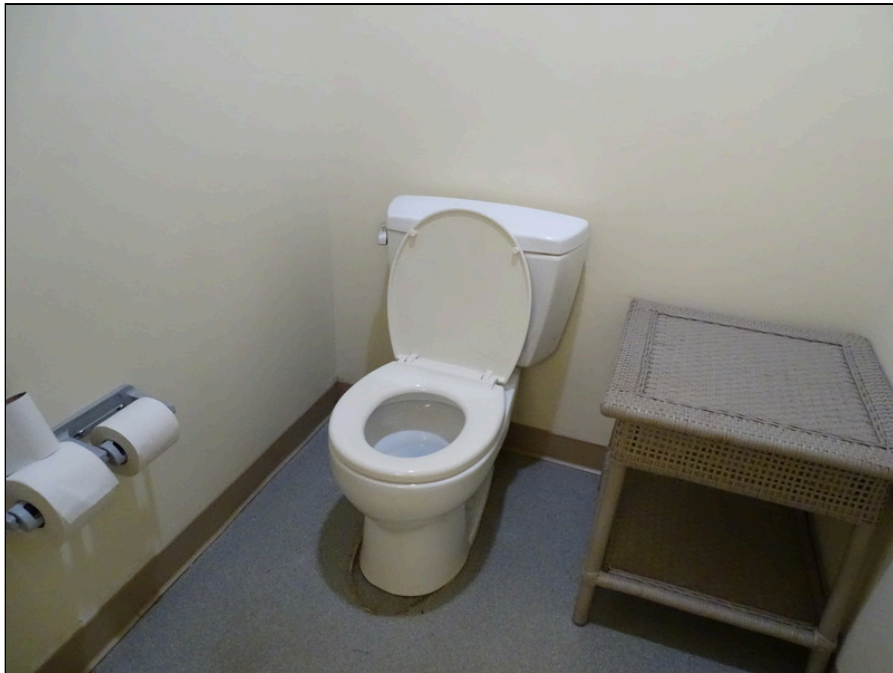
76 - Clubhouse restroom

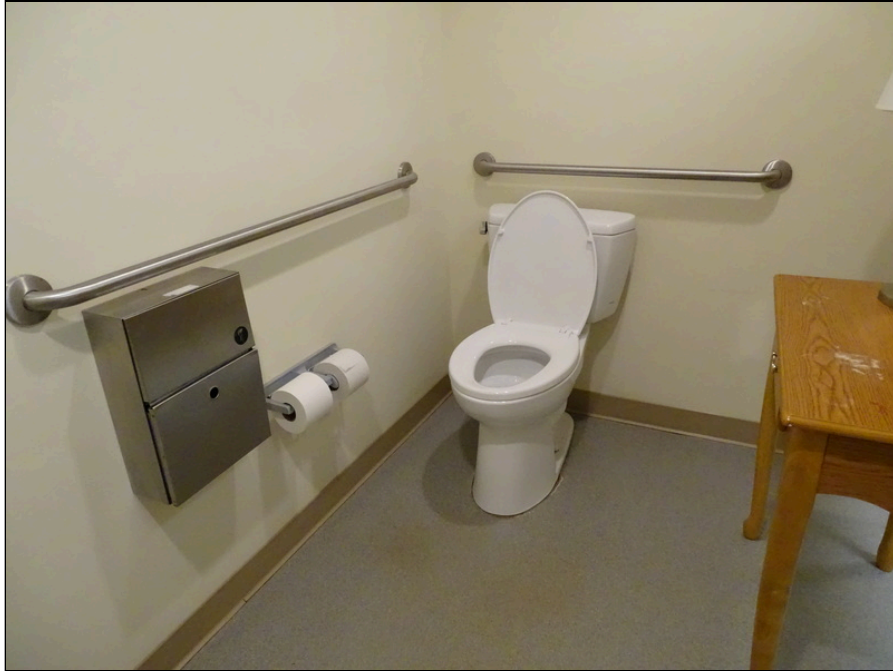
77 - Clubhouse restroom

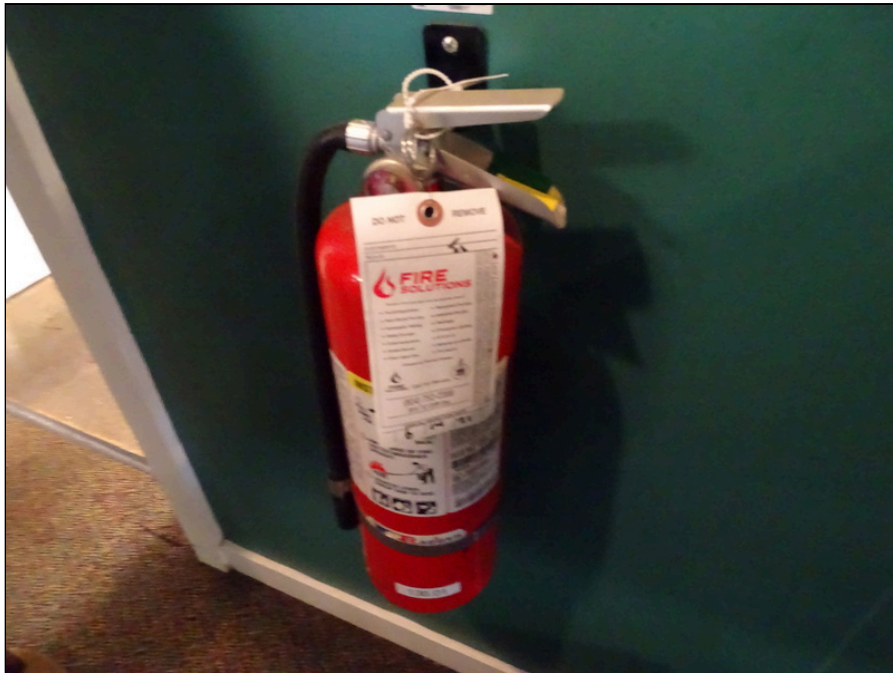
78 - Clubhouse fire extinguisher

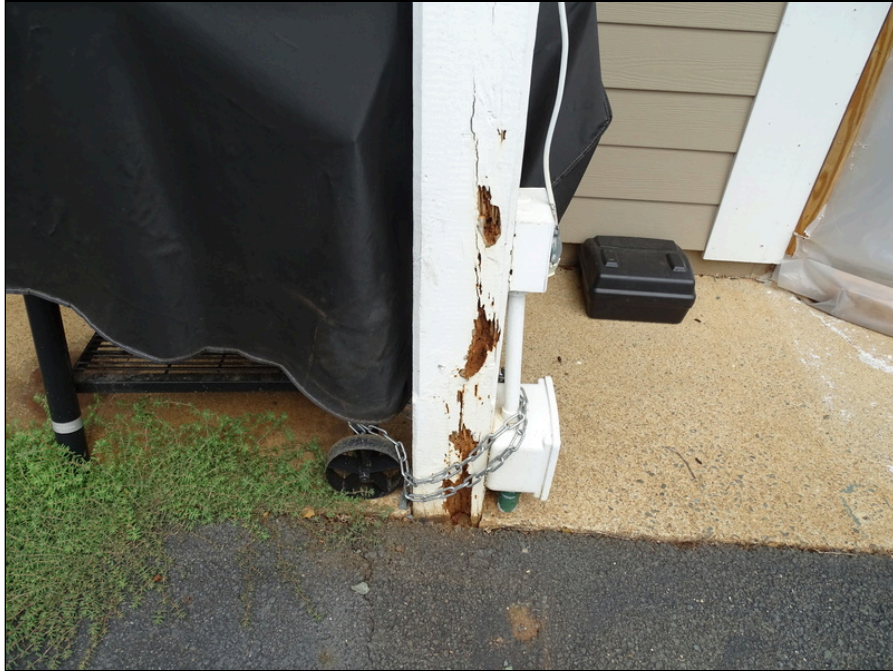
79 - Clubhouse wood column rotten at base

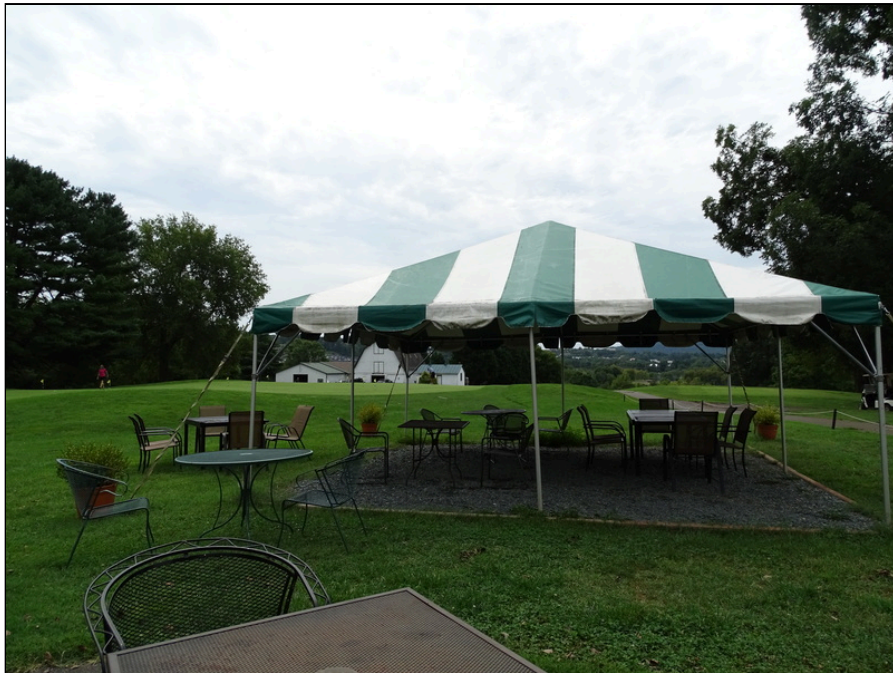
80 - Clubhouse landscape
