MICHIE BUILDING
610 EAST MARKET STREET
CHARLOTTESVILLE, VIRGINIA

ECS PROJECT NO. 46:6713

OCTOBER 26, 2021

Reference: Facility Condition Assessment Report for Michie Building, 610 East Market Street,
Charlottesville, Virginia

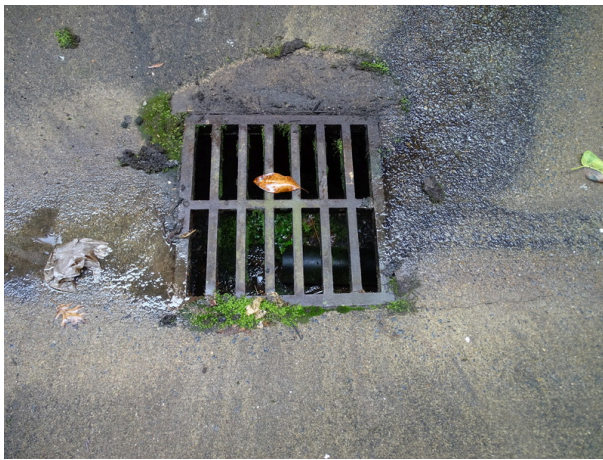
Typical stormwater drainage

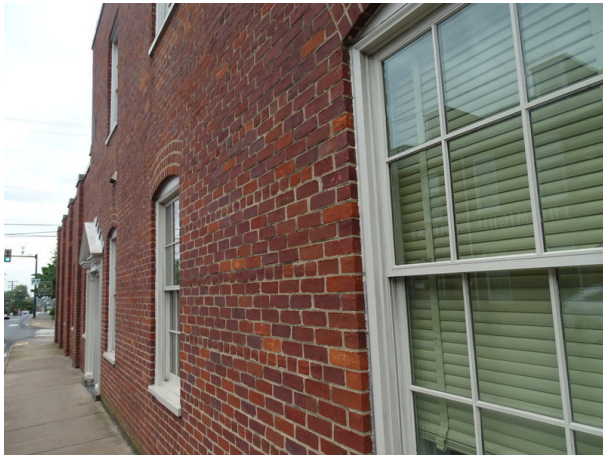
North elevation of the building

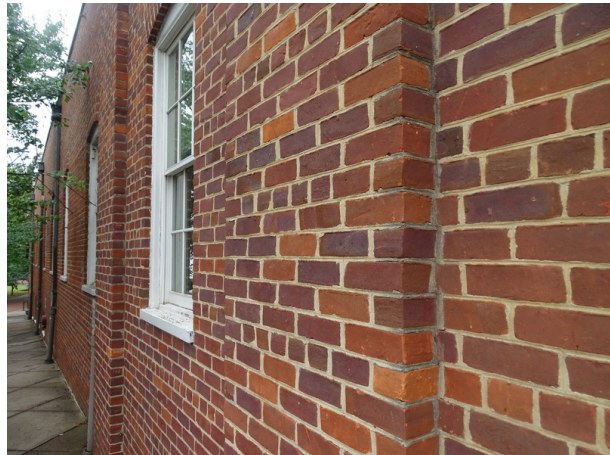
East elevation of the building

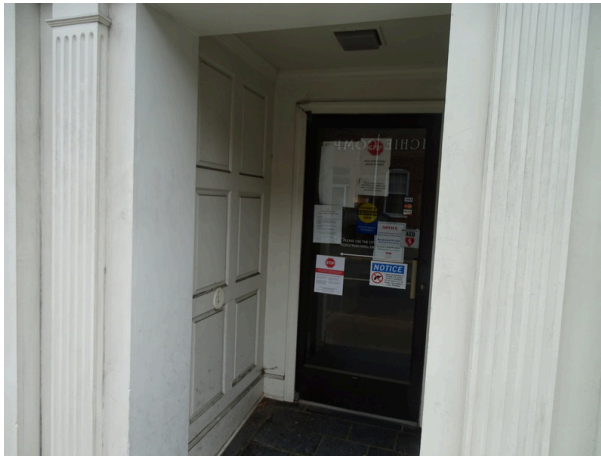
The main entrance is a Metal door with glass. The main entrance door was generally in good condition.

Metal door with glass at north entrance

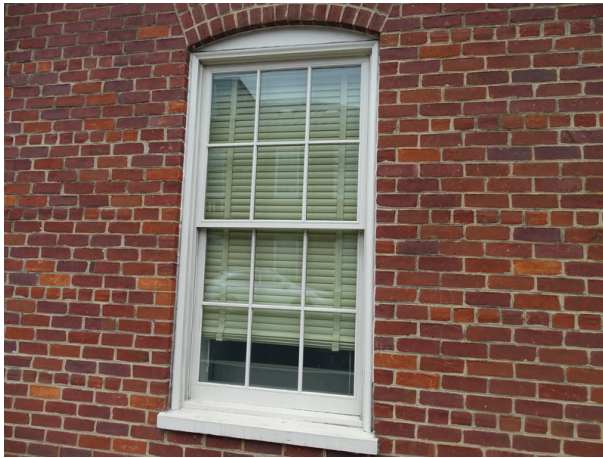
The window system for the building primarily consists of Wood-framed single-pane operable window units. The windows were generally in fair condition. The expected useful life of window units is typically 30 years. There was reported leakage of window units on the east side of the building. We recommend the windows be replaced.

Typical exterior window

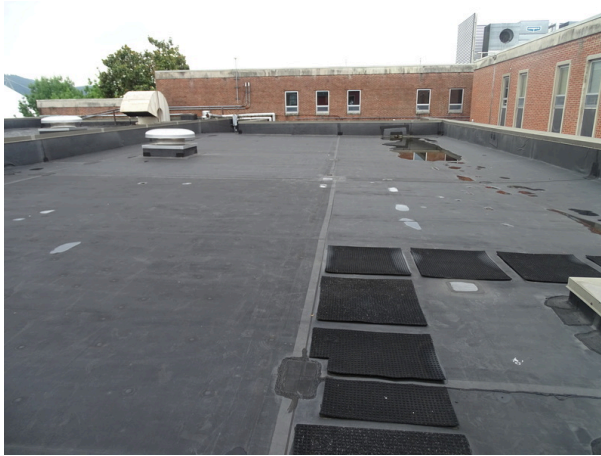
Single-ply membrane roofing system looking north

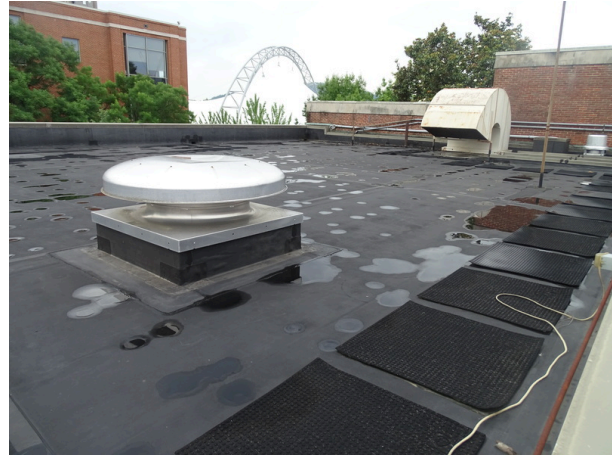
Single-ply membrane roofing system looking north

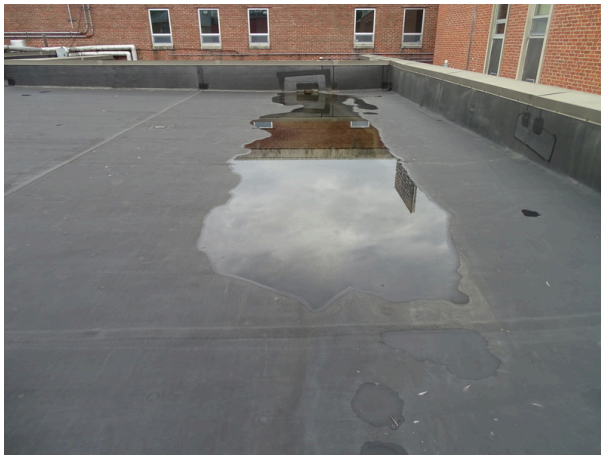
Drainage for the roofing system is provided by through wall scupper drains with downspouts and gutters with downspouts. The drainage was observed to be in generally fair condition with areas of ponding observed. The parapet walls consisted of single-ply membrane and were capped with metal coping. The parapet walls were observed to be in generally fair condition. We recommend the parapet wall flashing and capping be replaced with the above noted roofing replacement.

Single-ply membrane roofing system looking south - note ponding

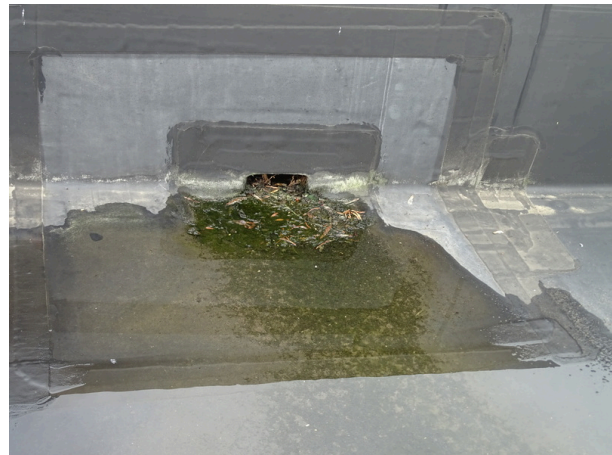
Typical through wall scupper drain - note ponding

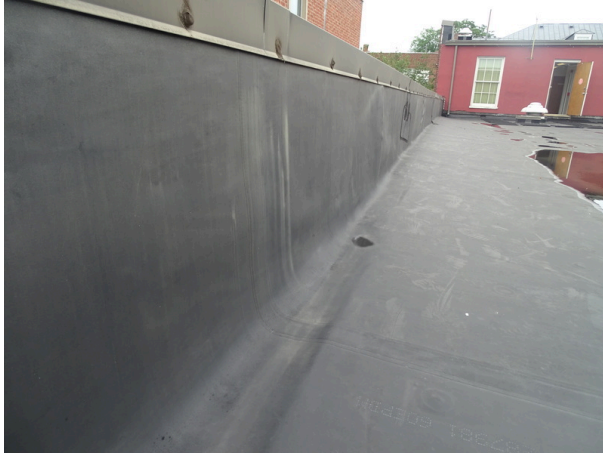
Typical parapet wall

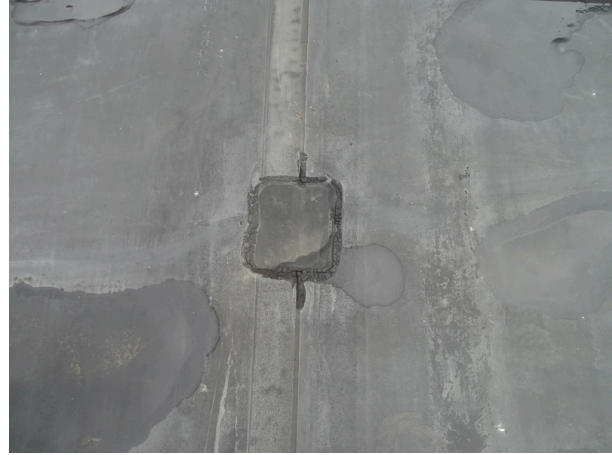
Single-ply membrane roofing system - note patching

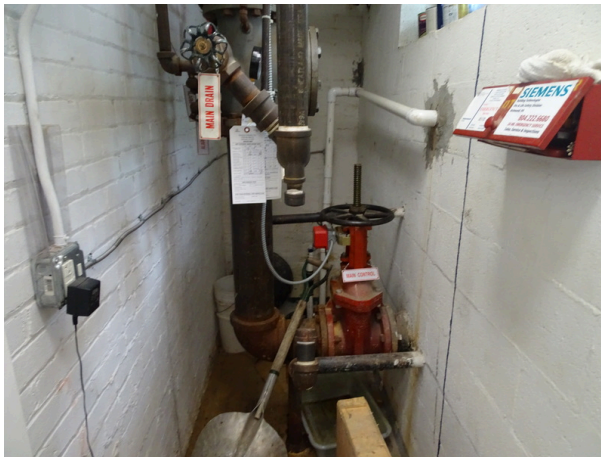
Fire sprinkler system

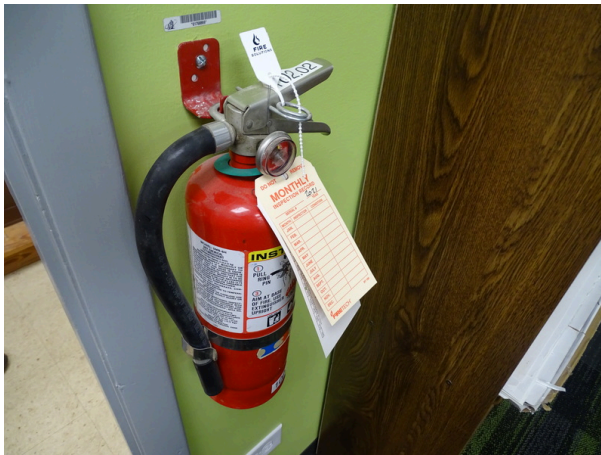
Typical fire extinguisher

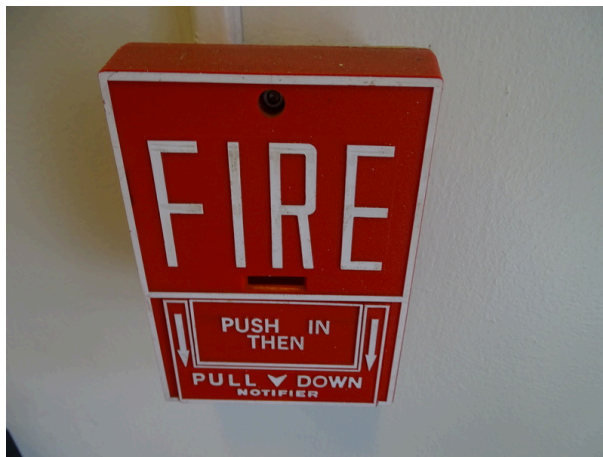
Typical fire alarm pull station

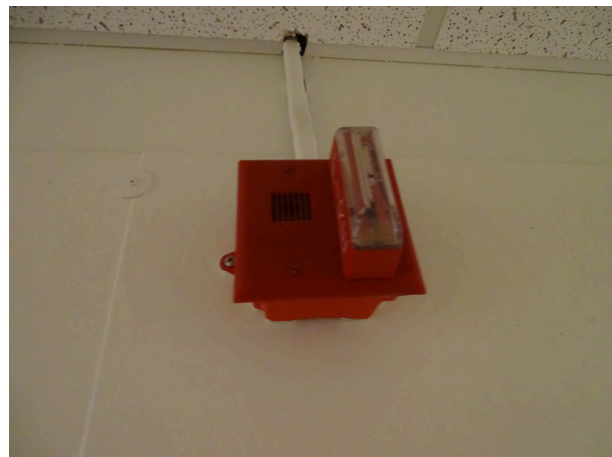
Typical fire alarm bell and strobe

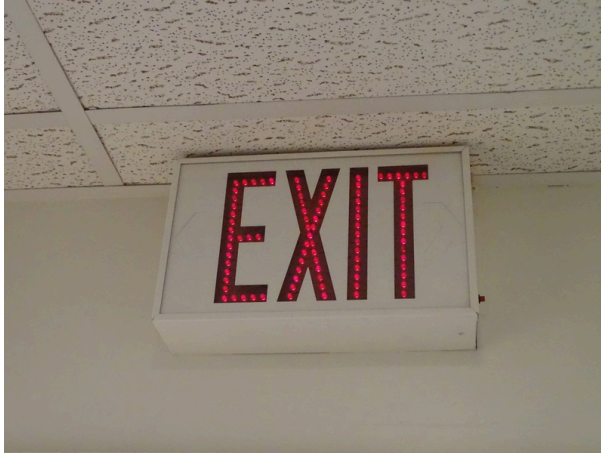
Typical exit sign

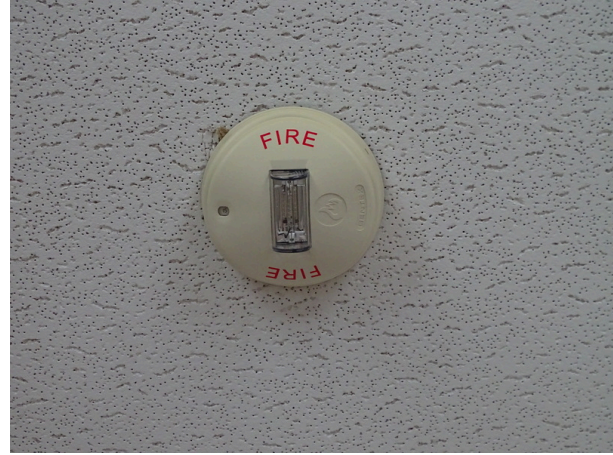
Typical smoke detector

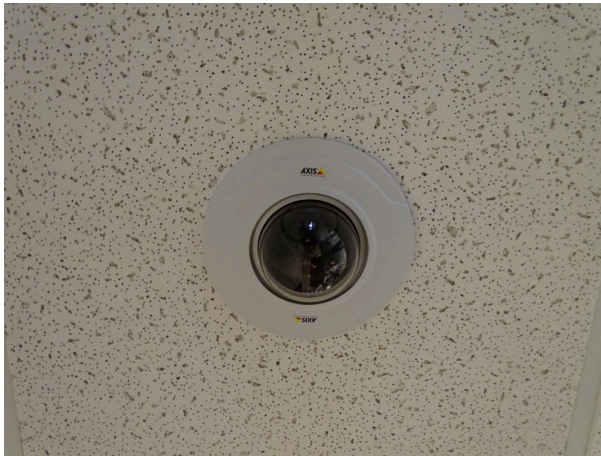
Typical security camera

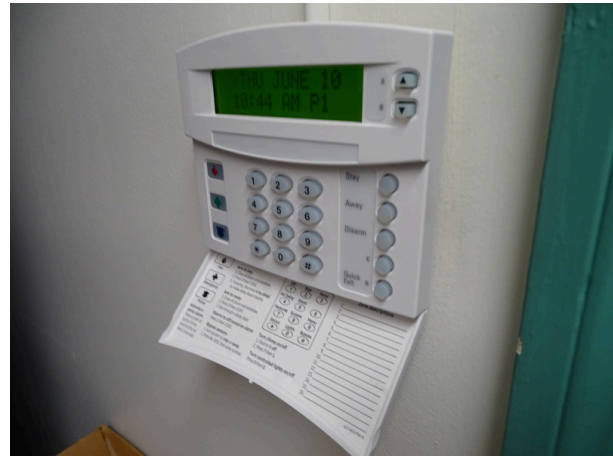
Security control

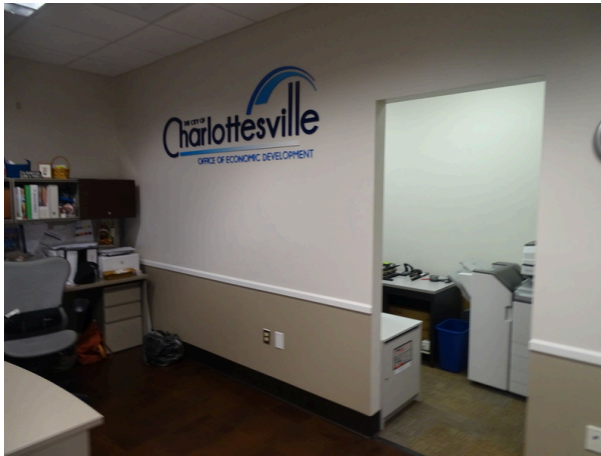
Interior finishes at entrance area

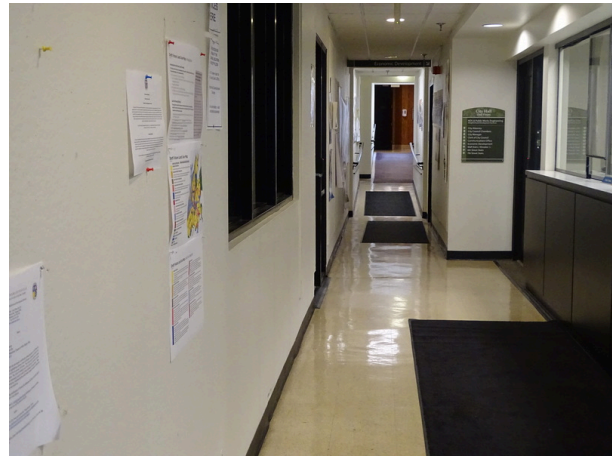
Interior finishes at corridor area

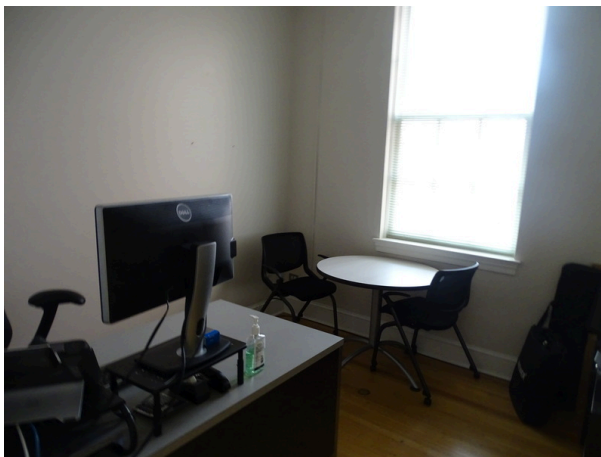
Interior finishes at typical office area

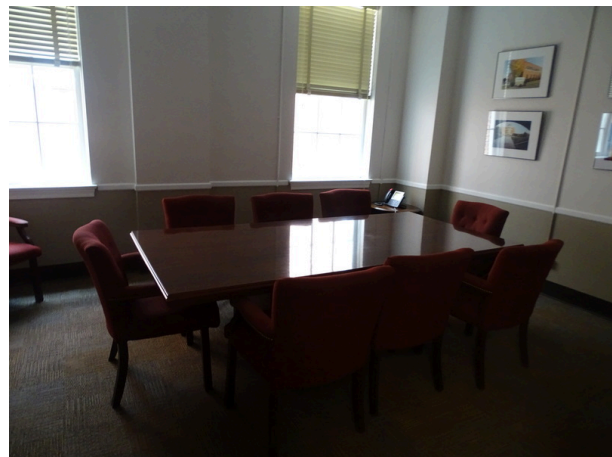
Interior finishes at typical meeting room area

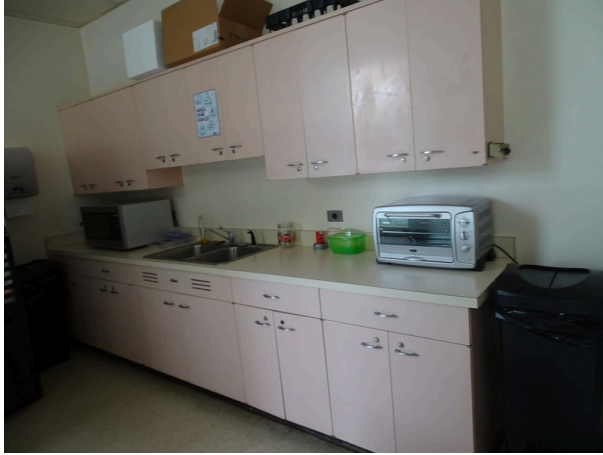
Interior finishes at kitchen area

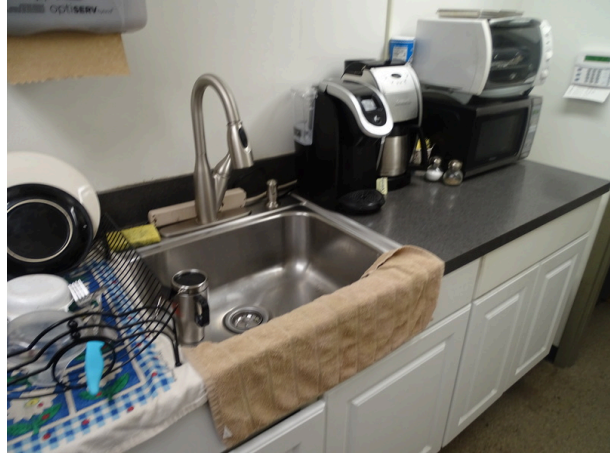
Interior finishes at kitchen area

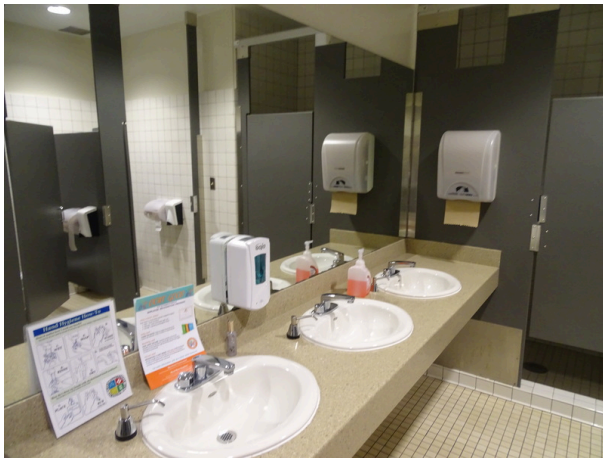
Interior finishes at typical restroom area

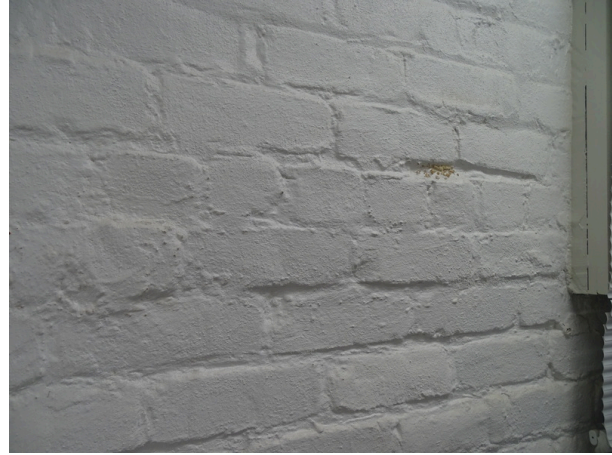
Typical wall - note efflorescence

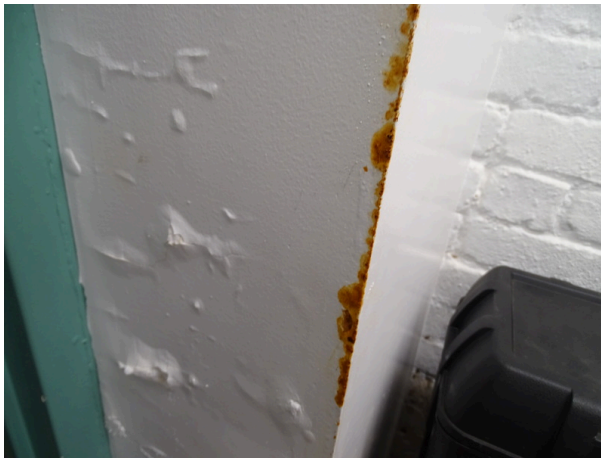
Typical wall - note efflorescence

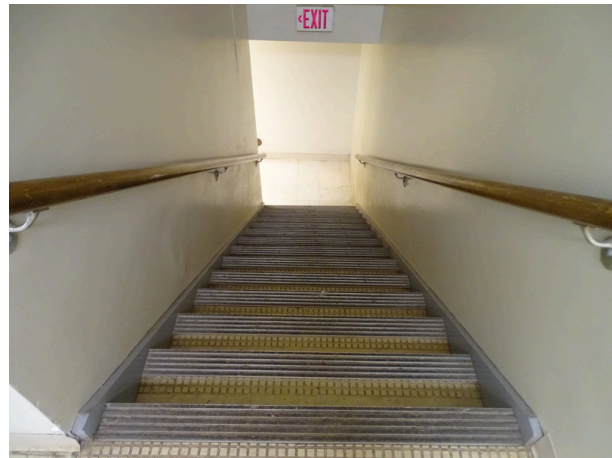
Interior finishes at typical stairs

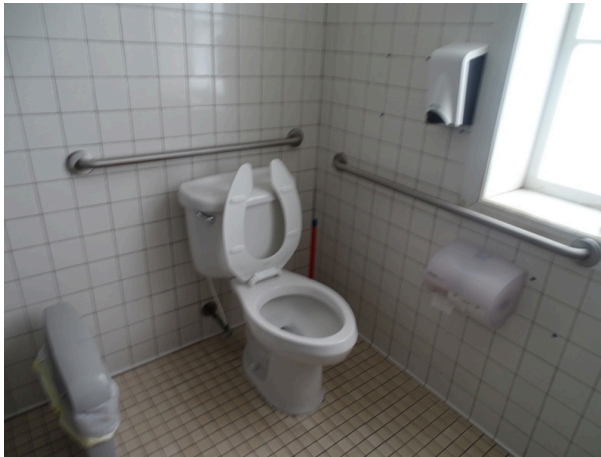
Accessible restroom

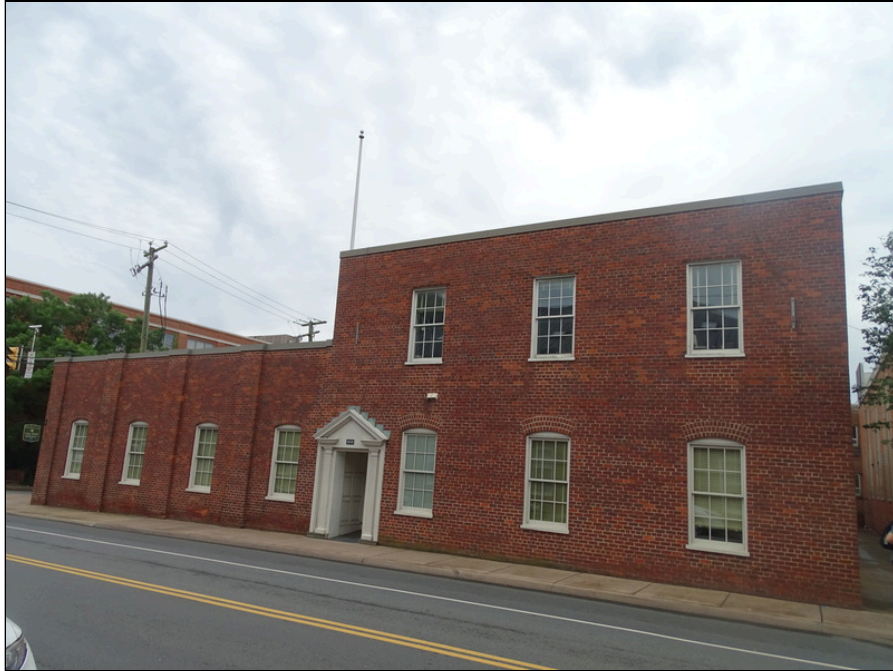
1 - Michie Building

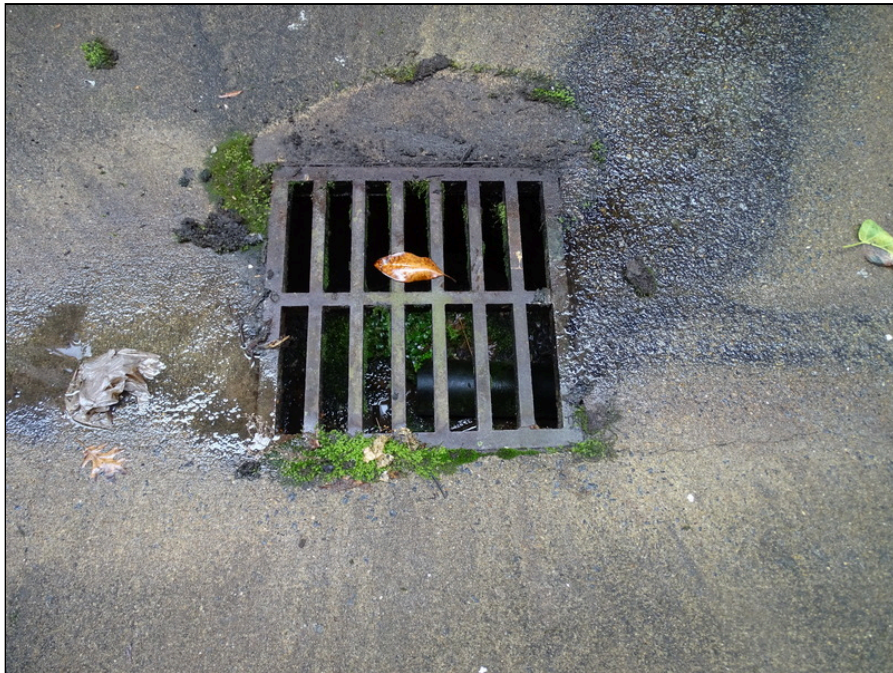
2 - Typical stormwater drainage

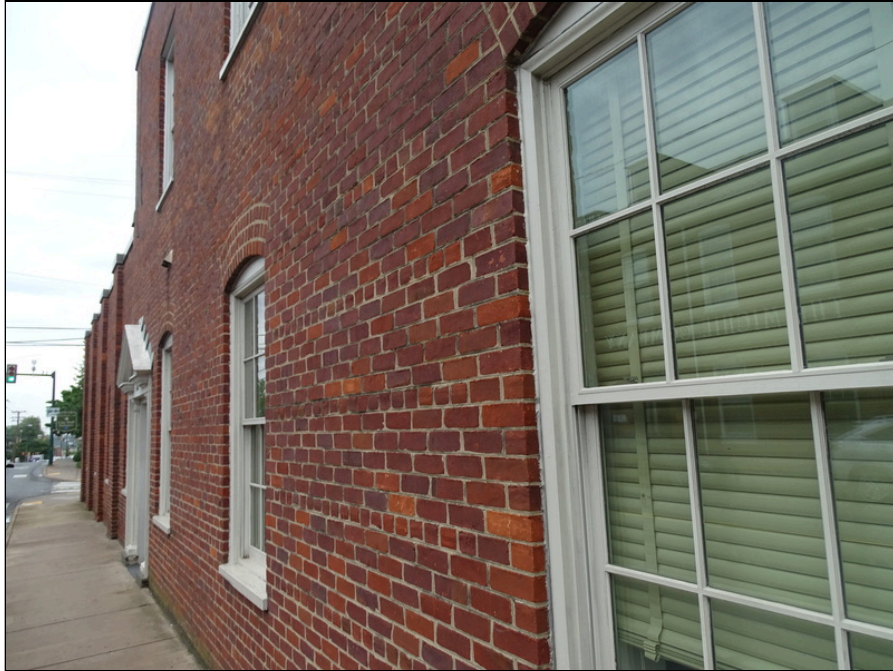
3 - North elevation of the building

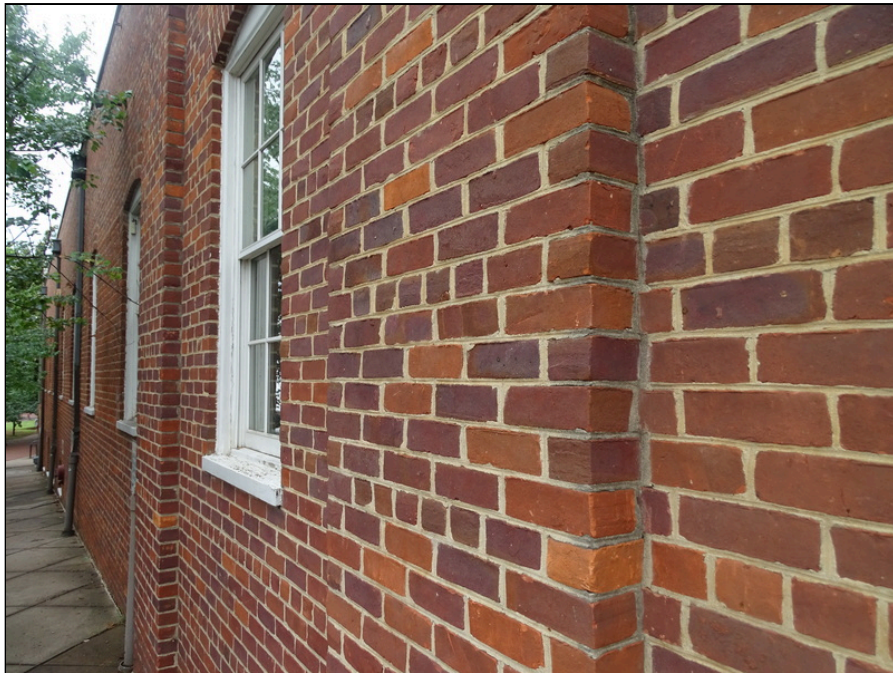
4 - East elevation of the building

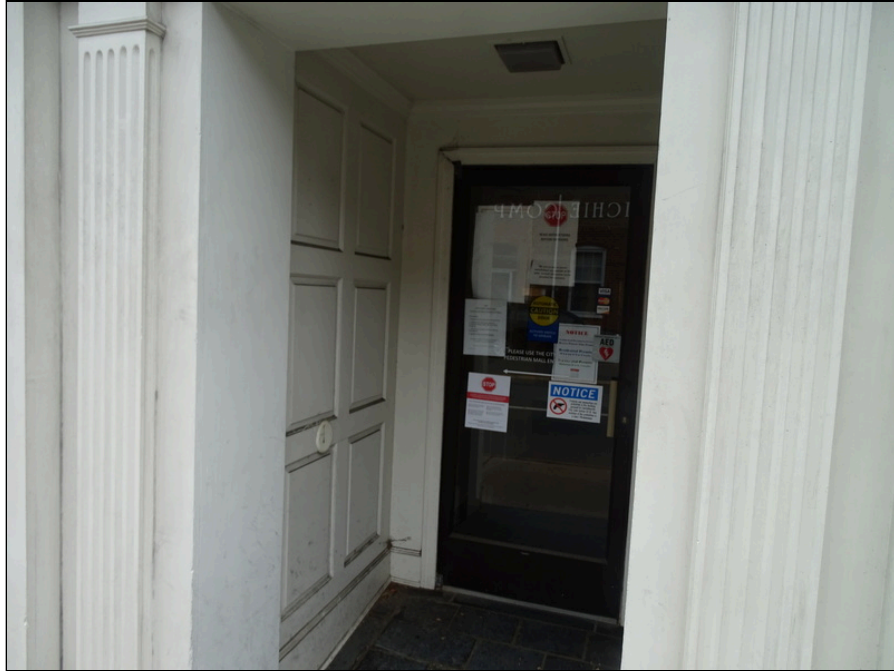
13 - Metal door with glass at north entrance

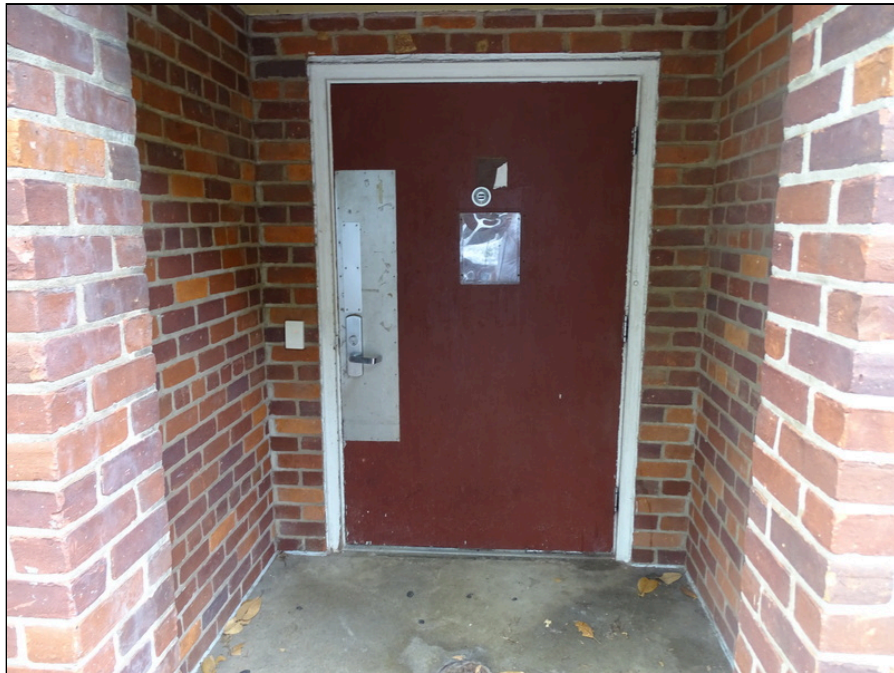
14 - Typical steel personal door

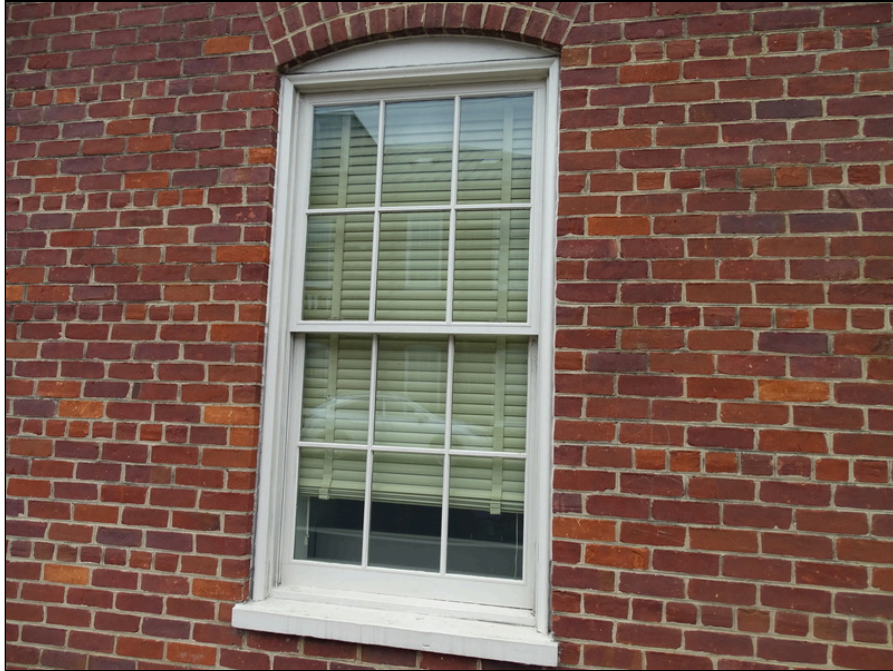
17 - Typical exterior window

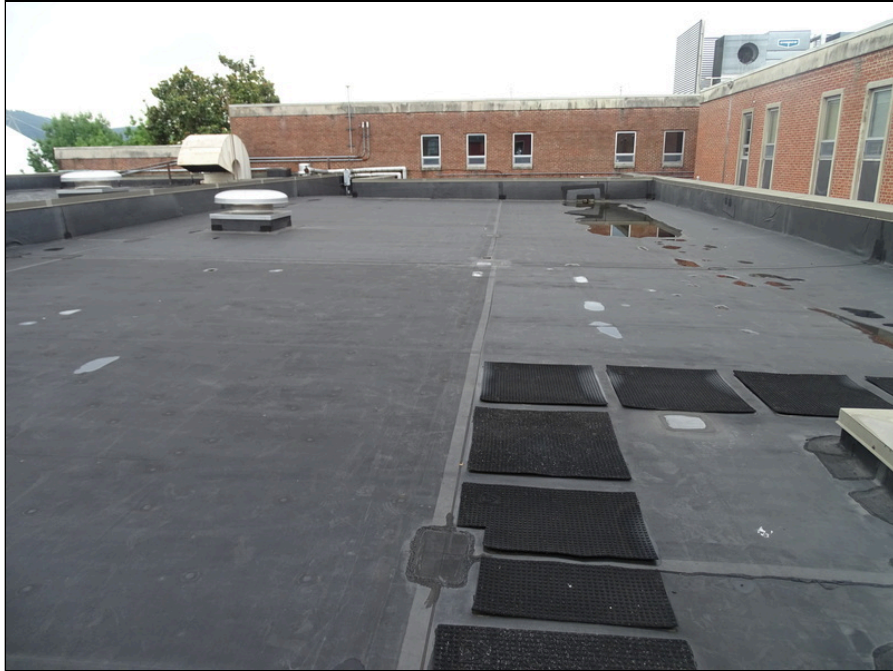
21 - Single-ply membrane roofing system looking north

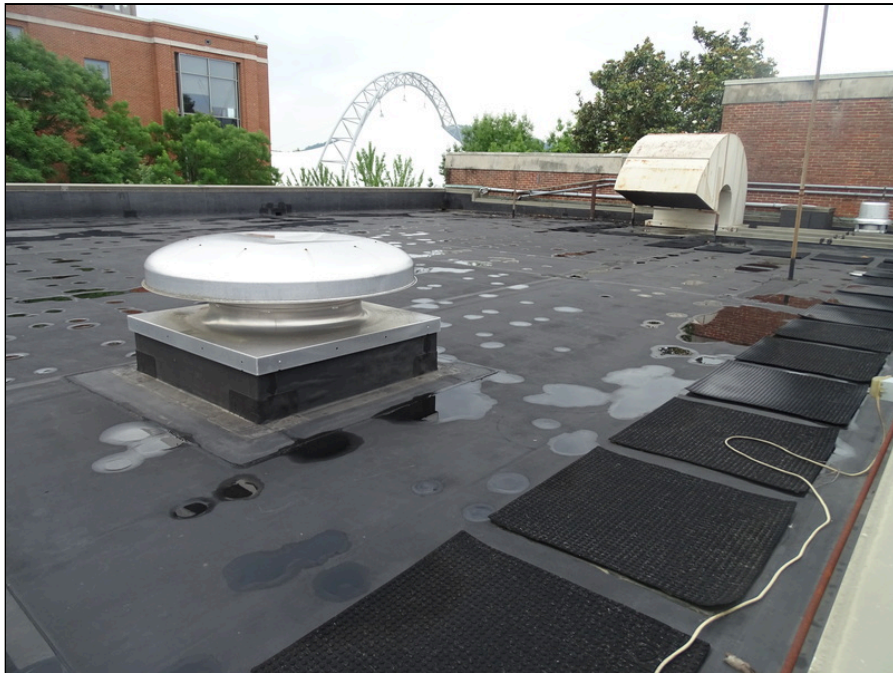
22 - Single-ply membrane roofing system looking north

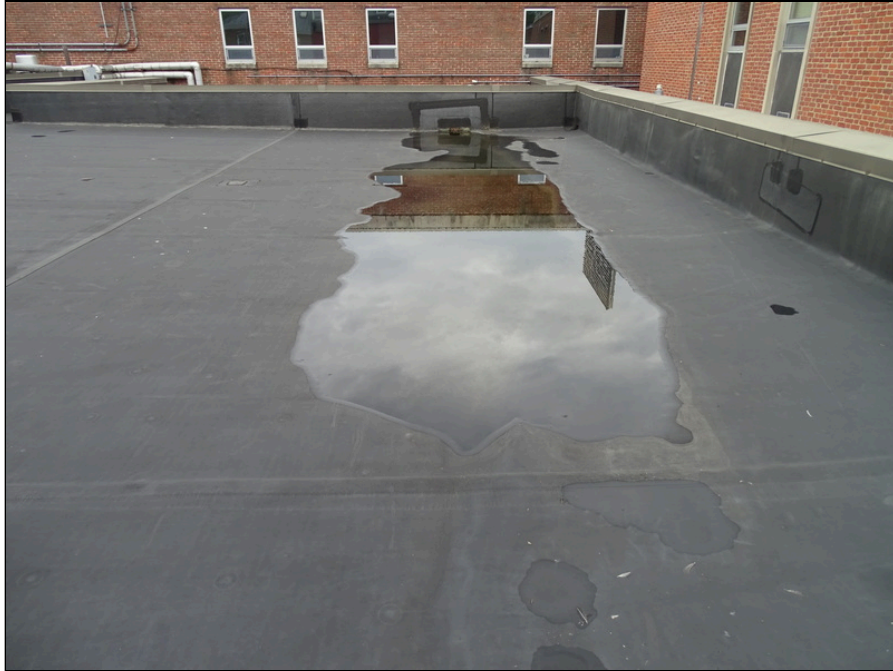
23 - Single-ply membrane roofing system looking south - note ponding

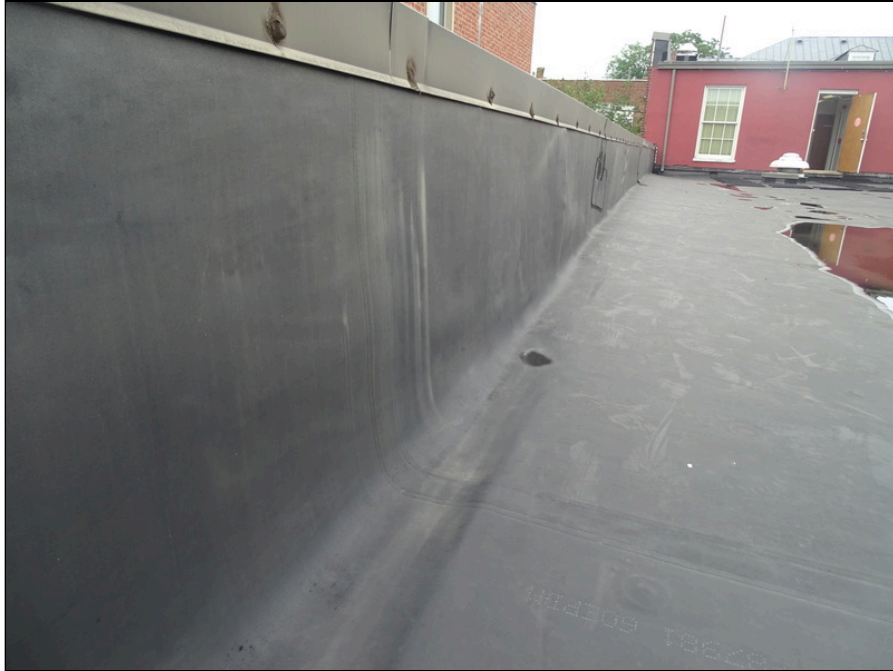
25 - Typical parapet wall

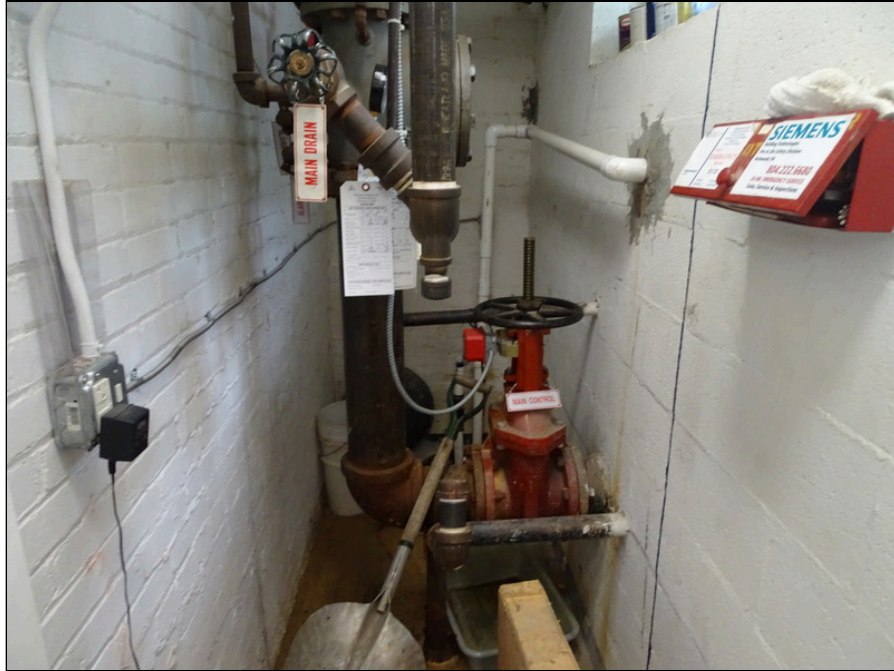
33 - Fire sprinkler system

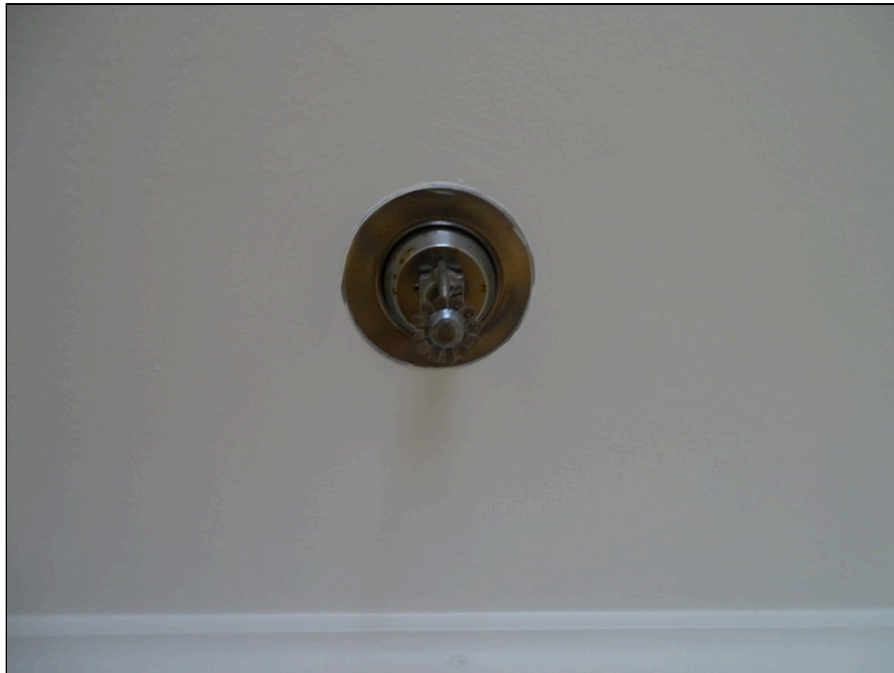
34 - Typical sprinkler head

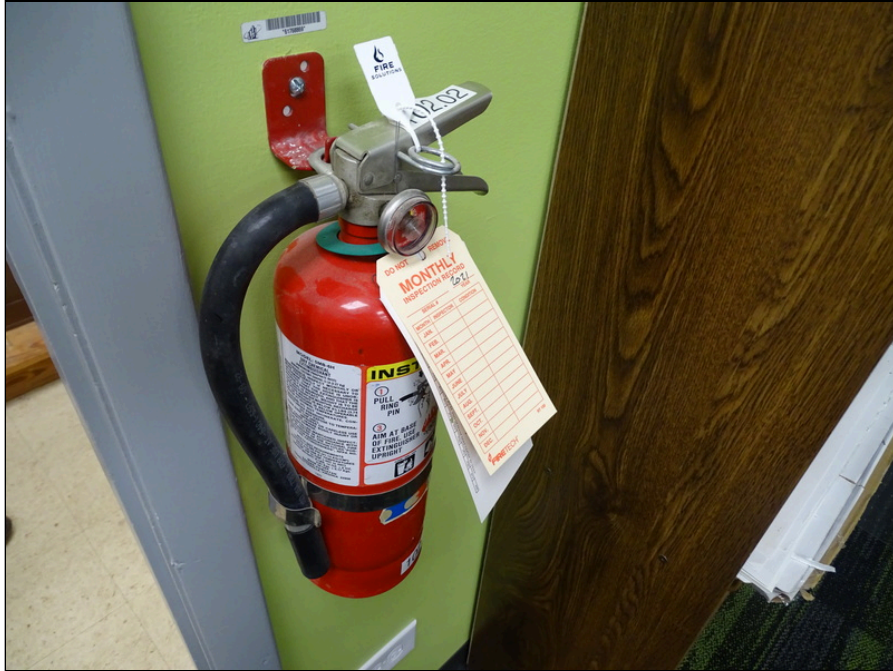
35 - Typical fire extinguisher

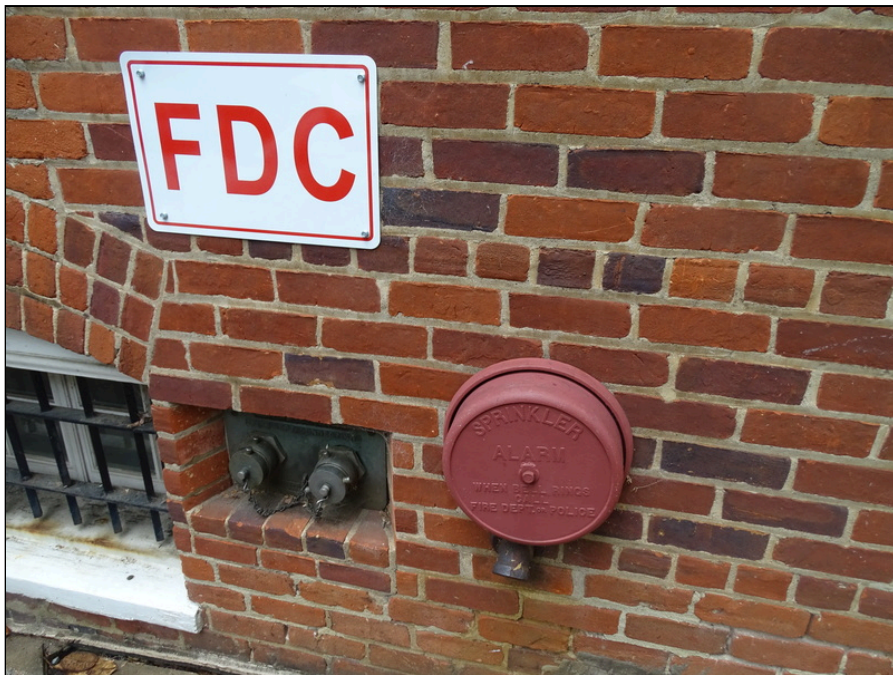
36 - Fire Department connections

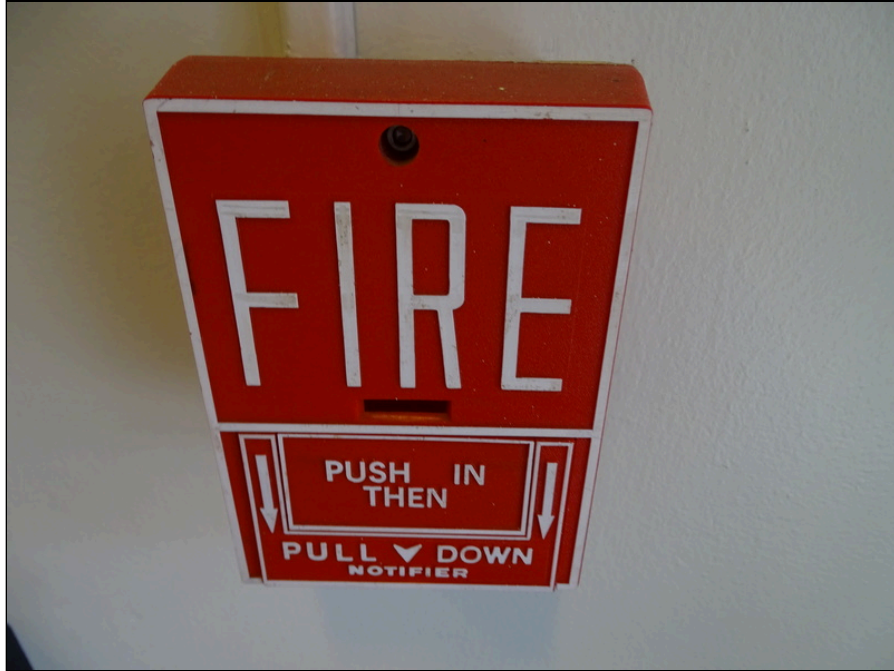
37 - Typical fire alarm pull station

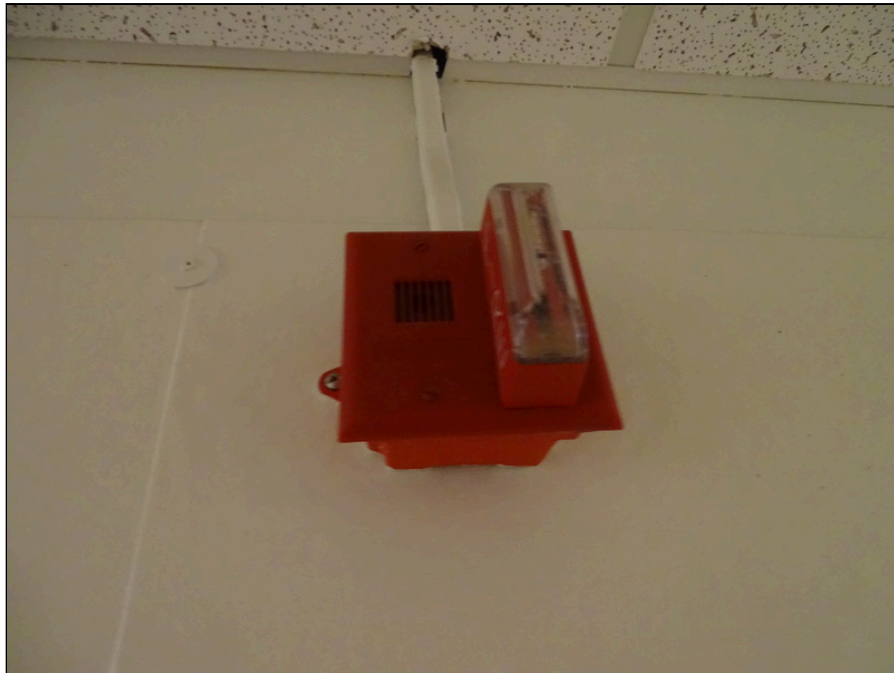
38 - Typical fire alarm bell and strobe

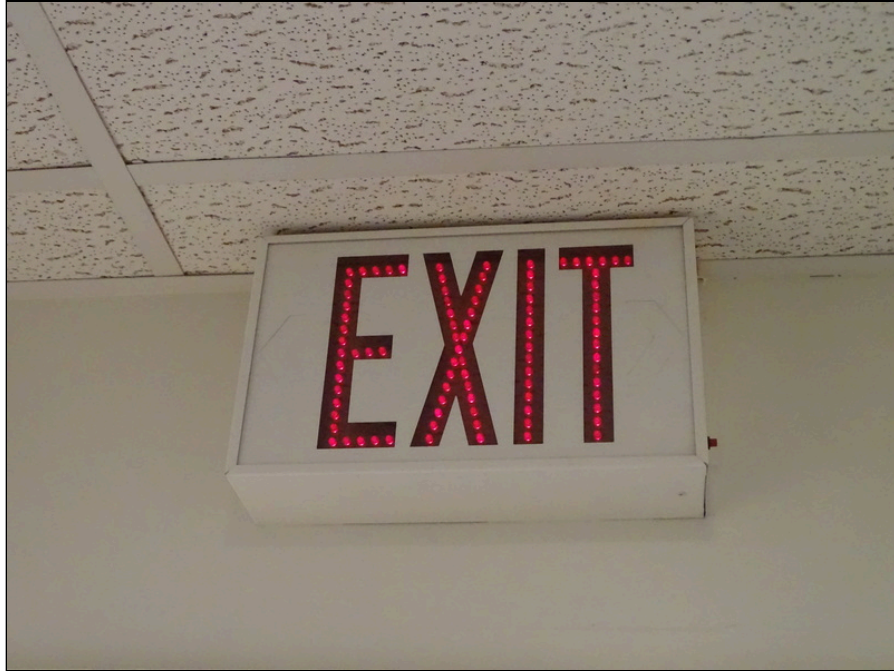
39 - Typical exit sign

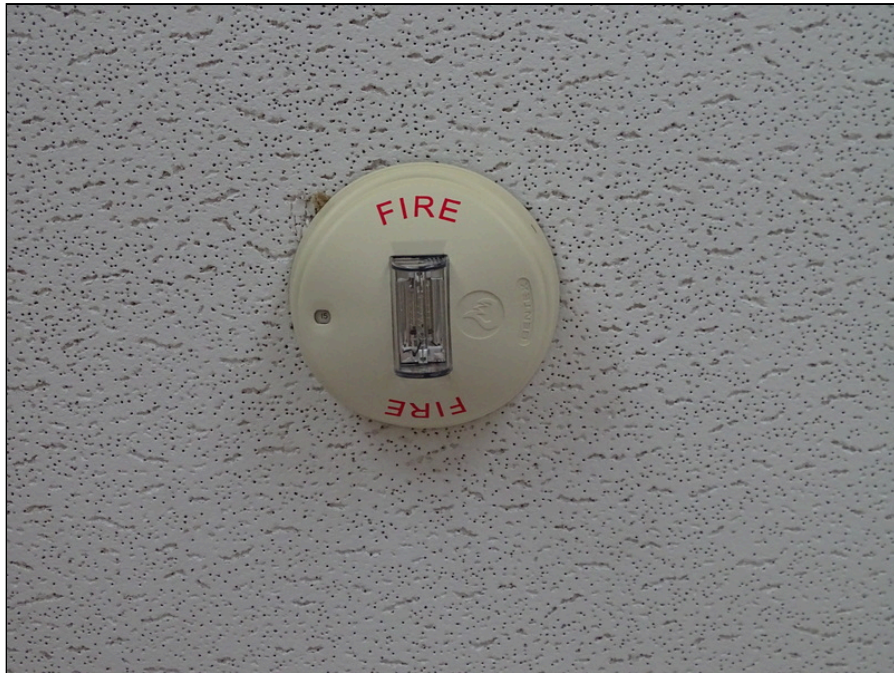
40 - Typical smoke detector

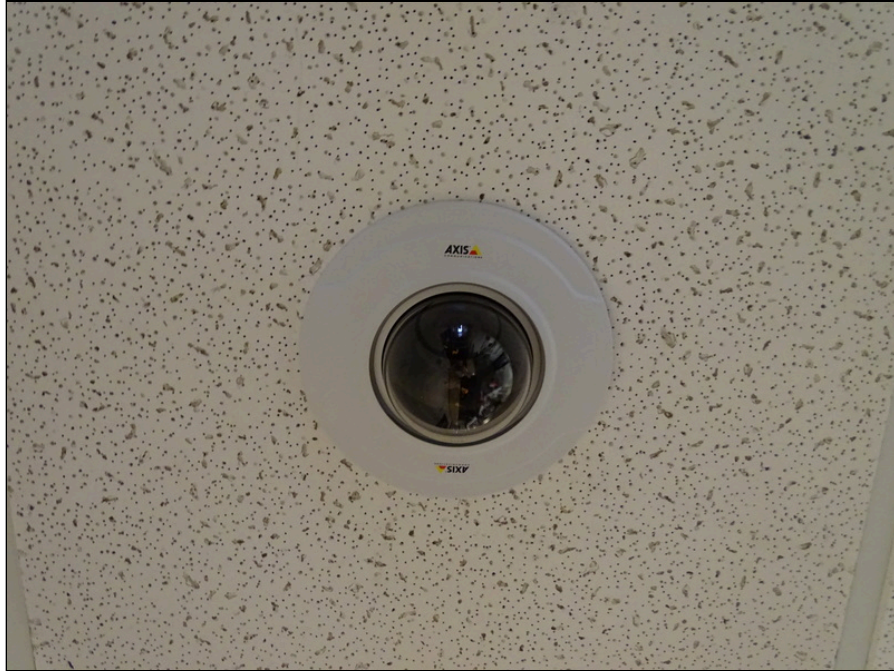
41 - Typical security camera

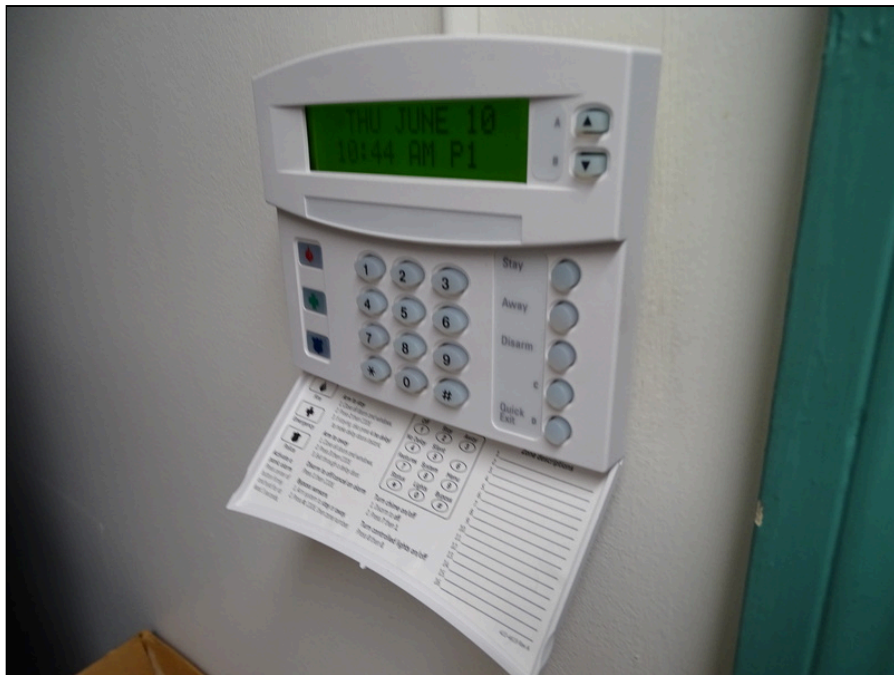
42 - Security control

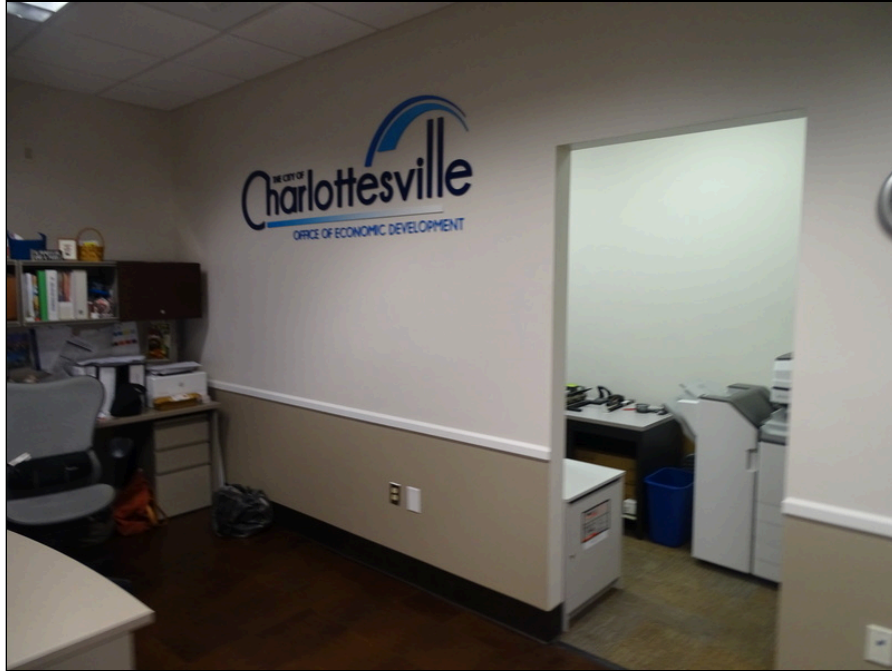
43 - Interior finishes at entrance area

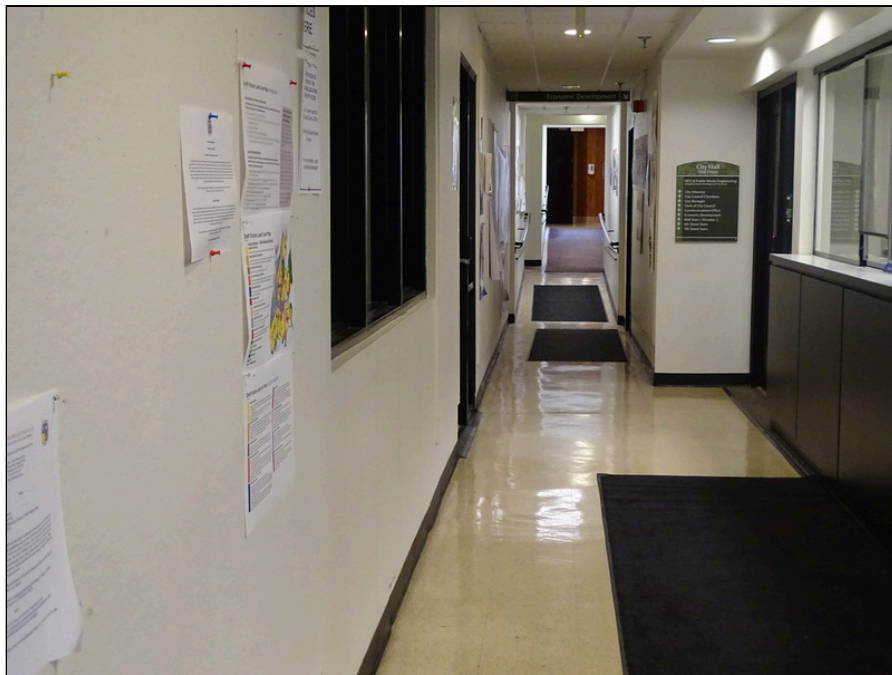
44 - Interior finishes at corridor area
