MICHIE BUILDING
610 EAST MARKET STREET
CHARLOTTESVILLE, VIRGINIA

ECS PROJECT NO. 46:6713

OCTOBER 26, 2021

Reference: Facility Condition Assessment Report for Michie Building, 610 East Market Street,
Charlottesville, Virginia

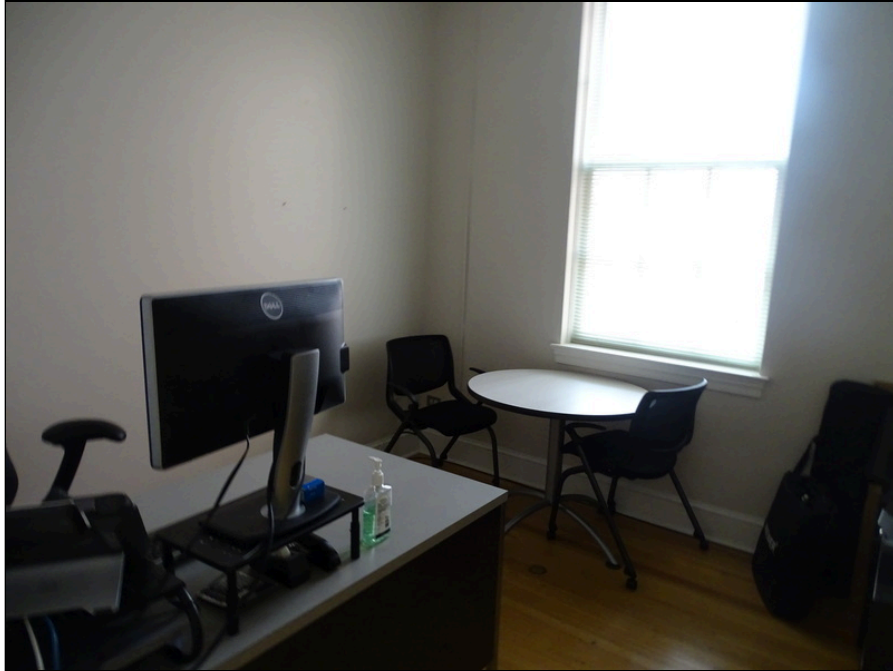
45 - Interior finishes at typical office area

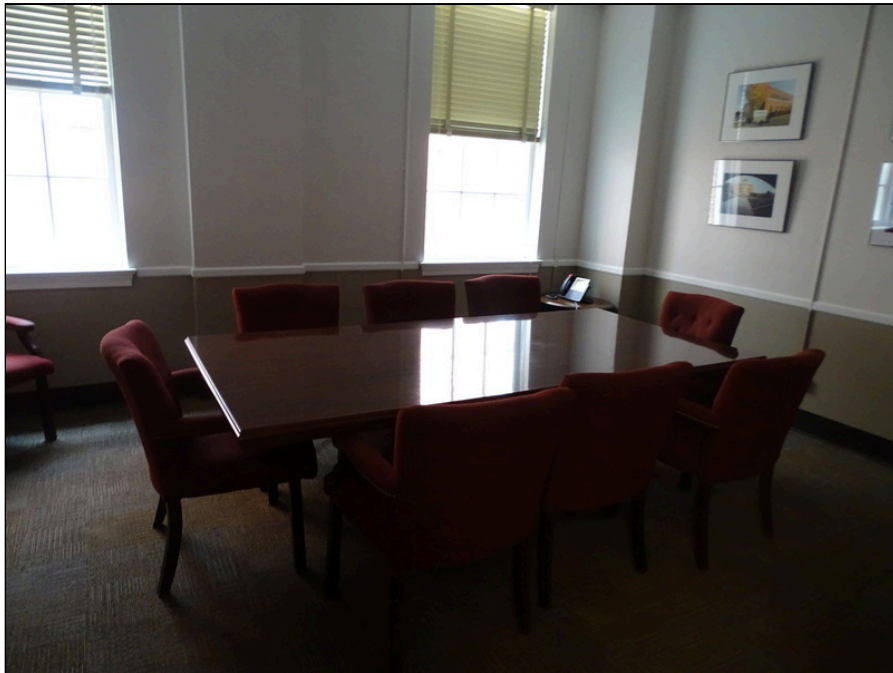
46 - Interior finishes at typical meeting room area

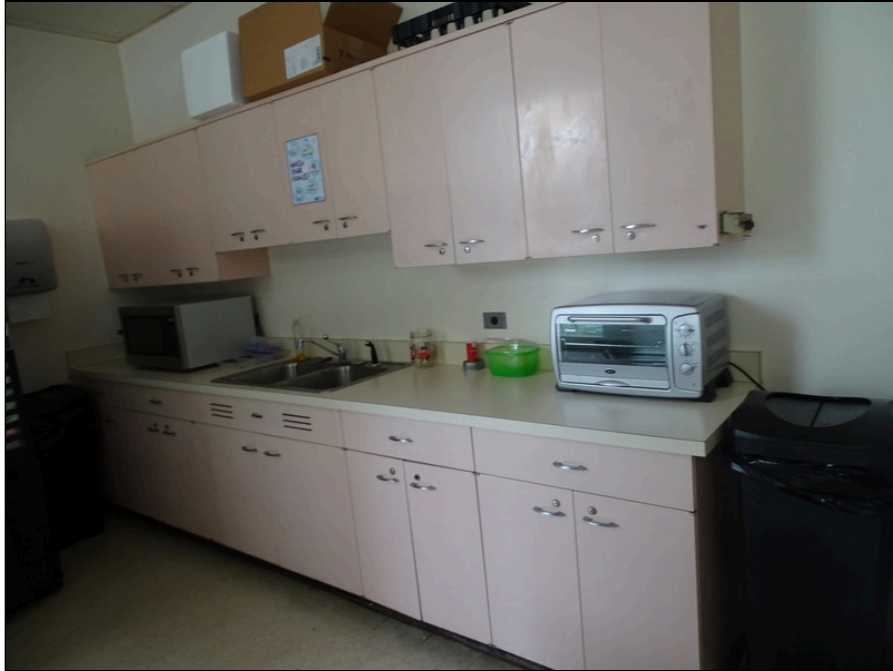
47 - Interior finishes at kitchen area

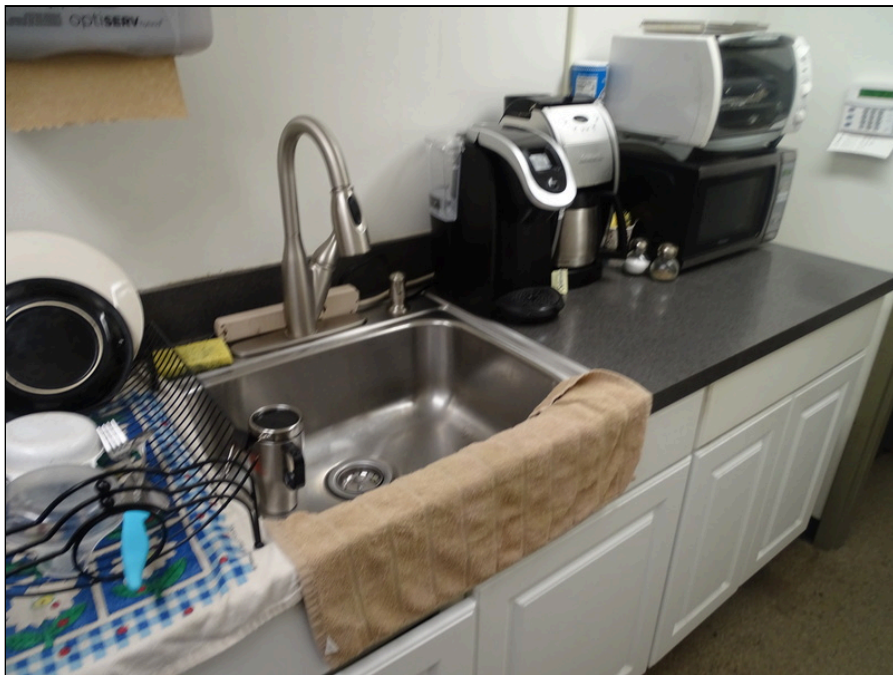
48 - Interior finishes at kitchen area

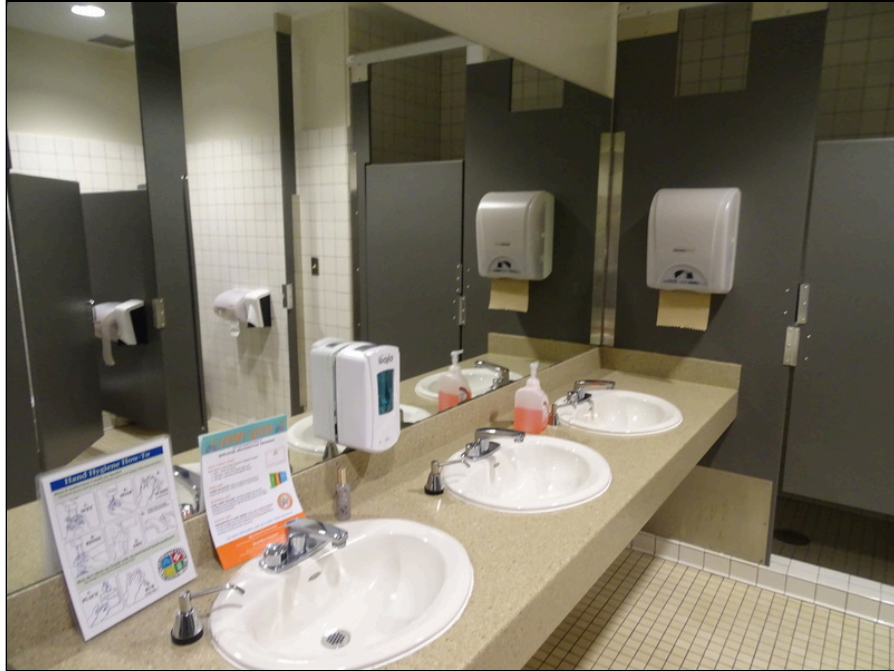
49 - Interior finishes at typical restroom area

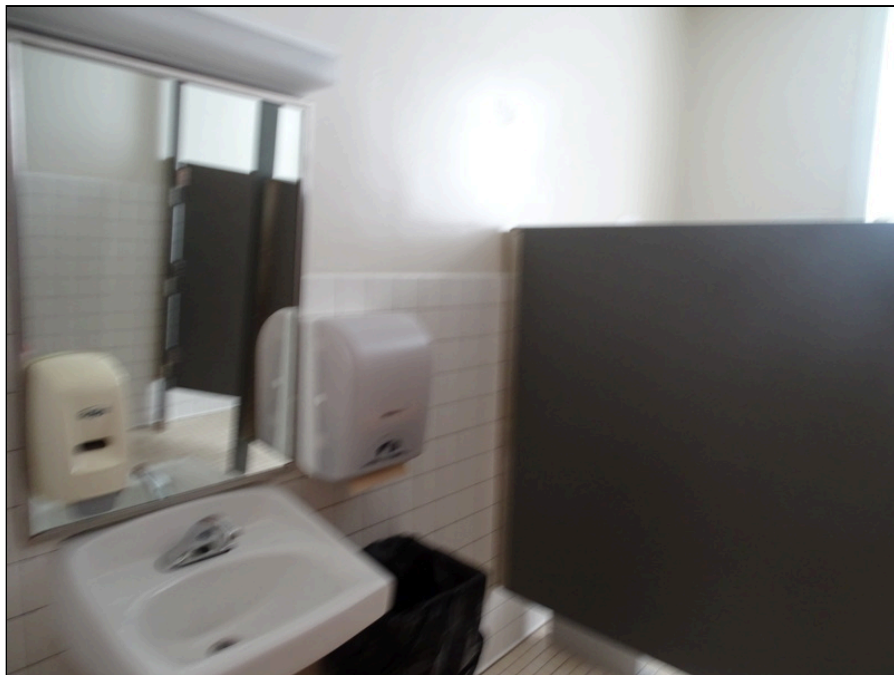
50 - Interior finishes at typical restroom area

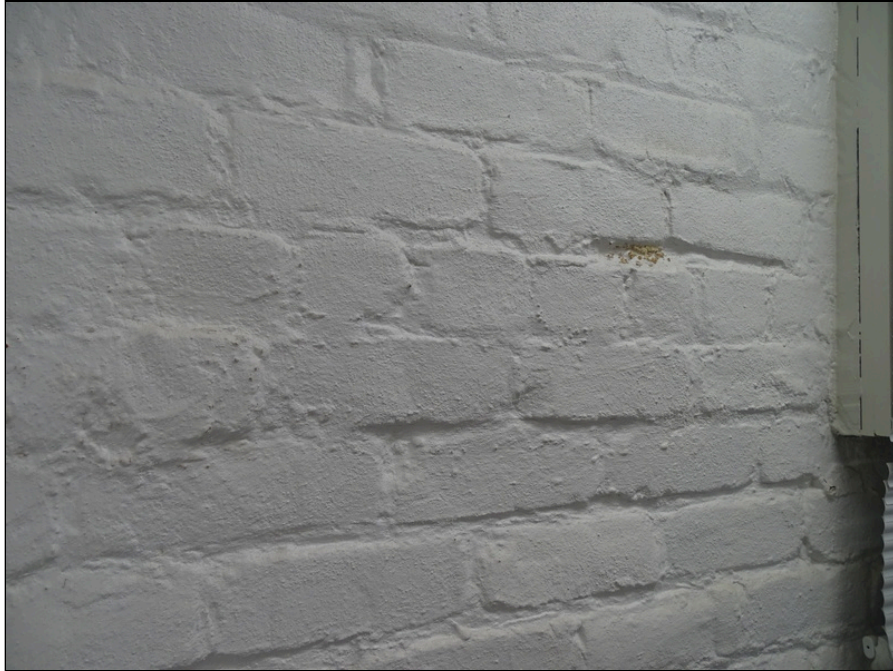
53 - Typical wall - note efflorescence

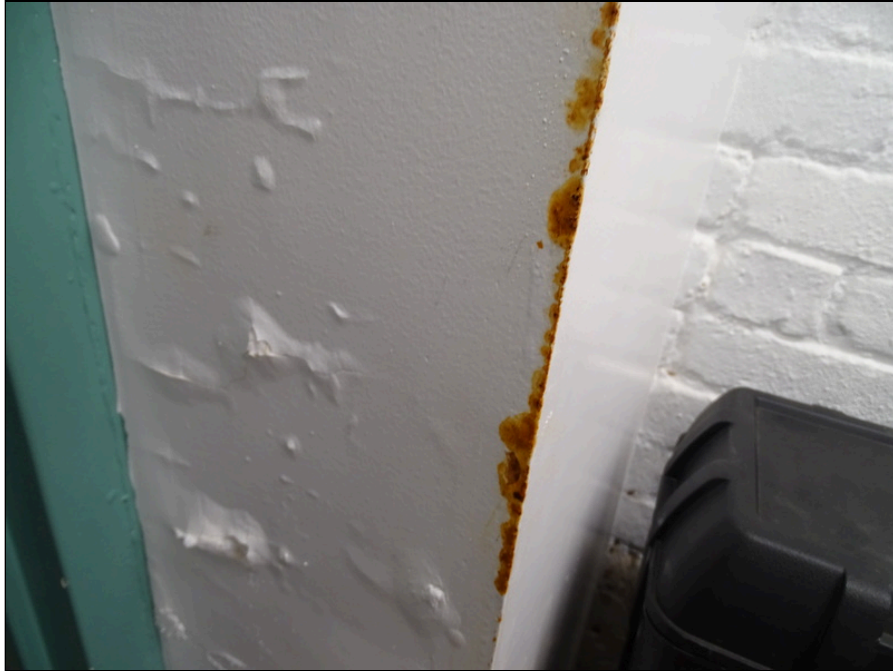
55 - Typical wall - note efflorescence

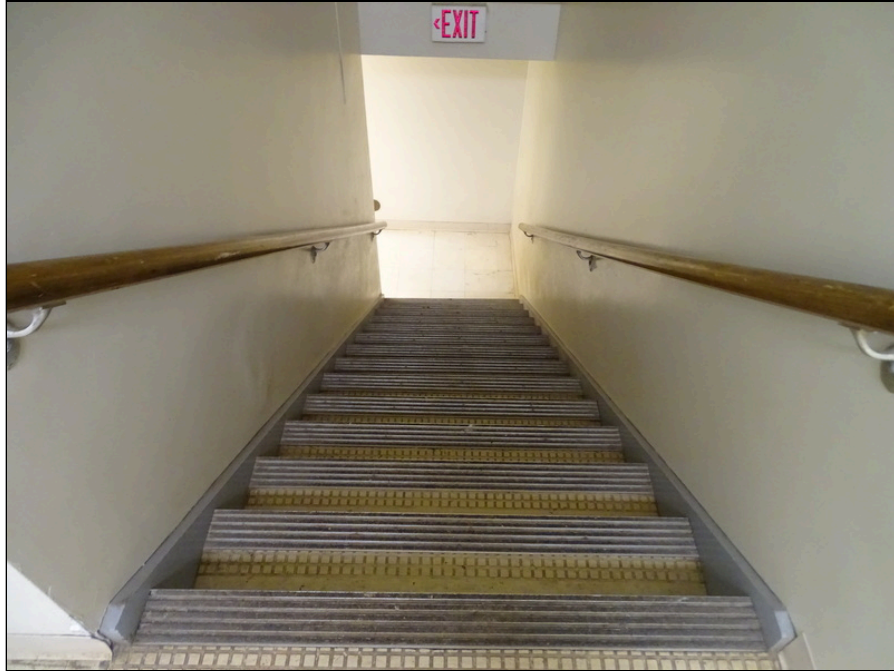
57 - Interior finishes at typical stairs

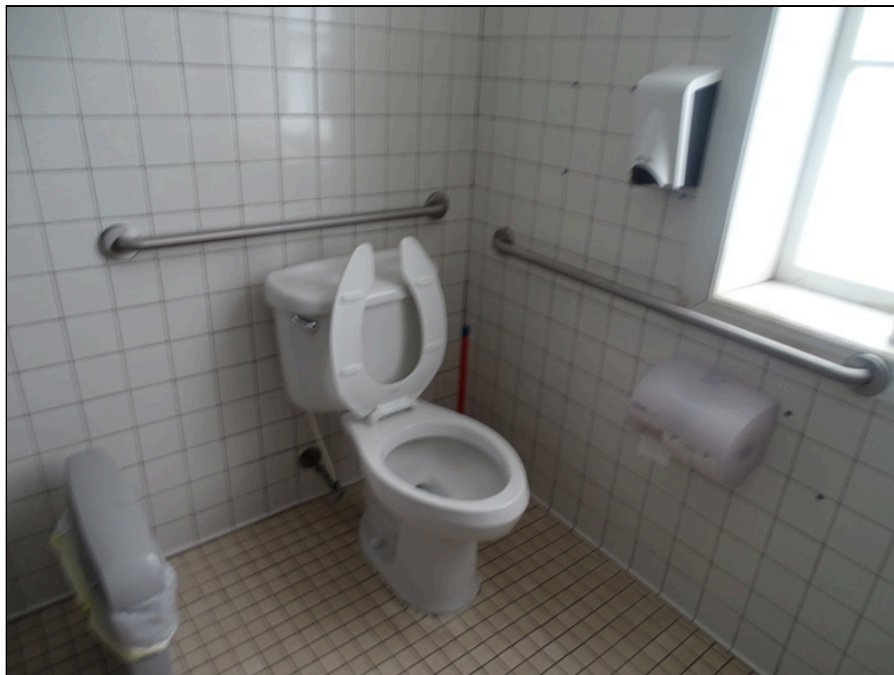
58 - Accessible restroom
