PEN PARK COMPLEX
1300 PEN PARK ROAD
CHARLOTTESVILLE, VIRGINIA

ECS PROJECT NO. 46:6713

CITY OF CHARLOTTESVILLE - FACILITIES DEVELOPMENT

Reference: Facility Condition Assessment Report for Pen Park Complex, 1300 Pen Park Road,
Charlottesville, Virginia

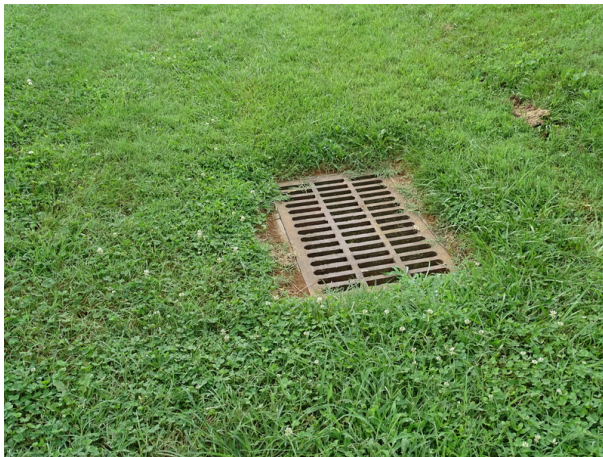
Stormwater drainage

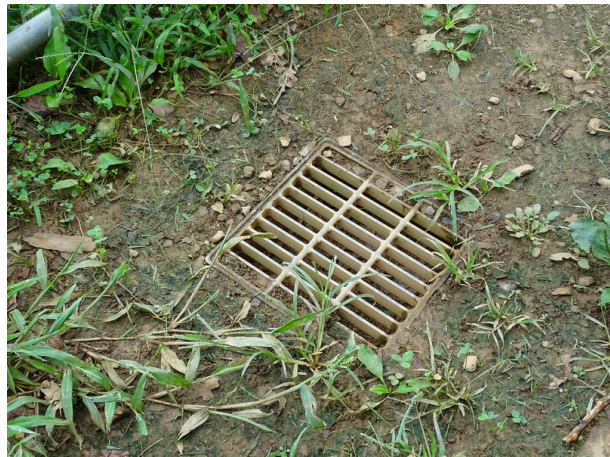
Stormwater drainage

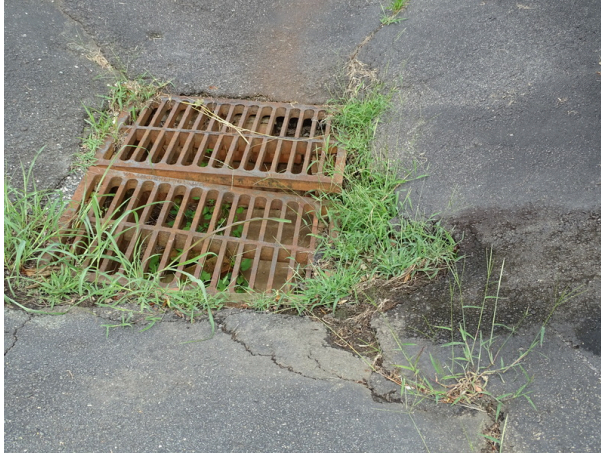
Stormwater drainage

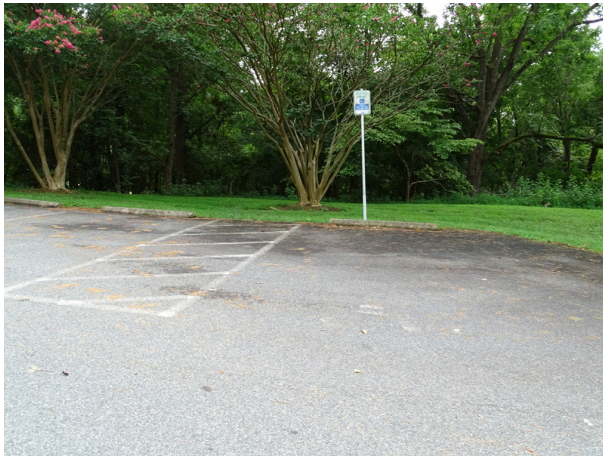
An asphalt-paved drive lane and parking area are located on the west side of the site and are accessed from Pen Road. Additional asphalt paved areas were provided throughout the complex adjacent to the buildings. The asphalt pavement was observed to be in generally fair condition. We observed areas of cracking in the drive lanes and parking spaces, although there were repairs completed in 2013 at the worst areas. The line striping was generally in fair condition. The expected useful life of asphalt pavement is 20 years. We are providing allowances to complete full depth repairs, as needed, throughout the study period.

Accessible Asphalt parking area

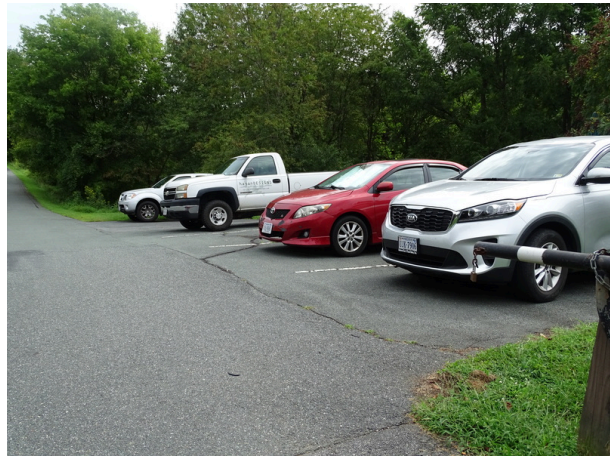
Asphalt parking area and site entrance

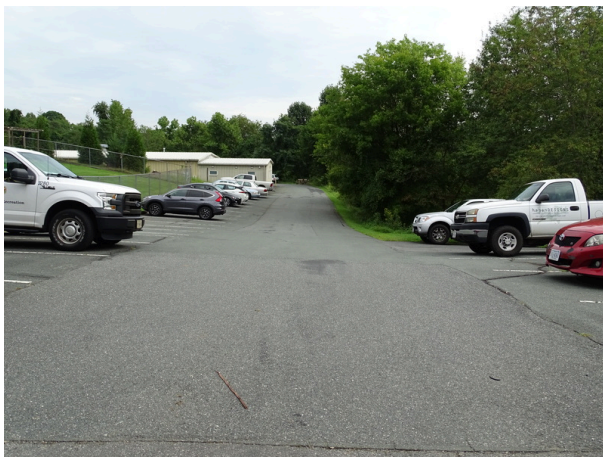
Asphalt parking area

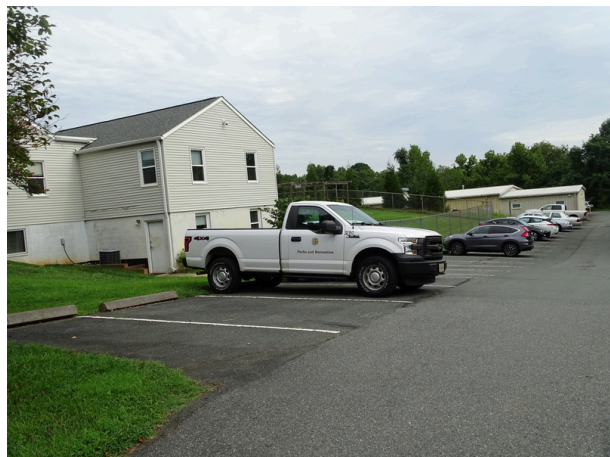
Asphalt parking area

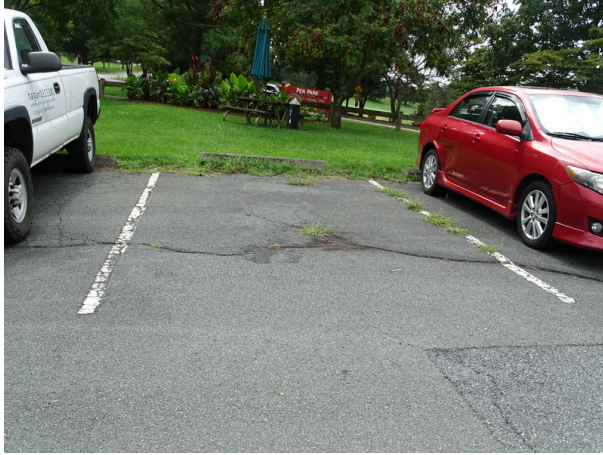
Asphalt parking area

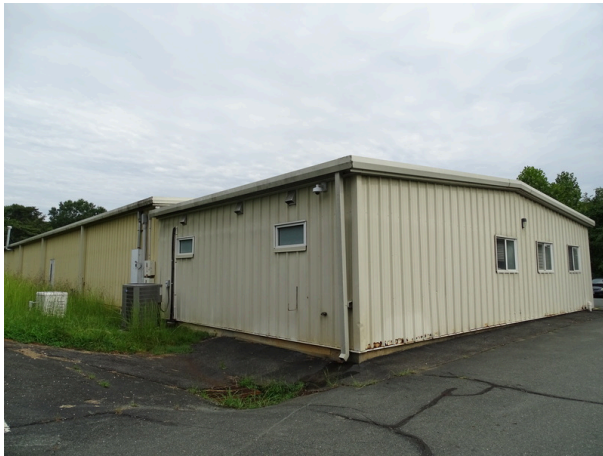
Parks Shop exterior overview

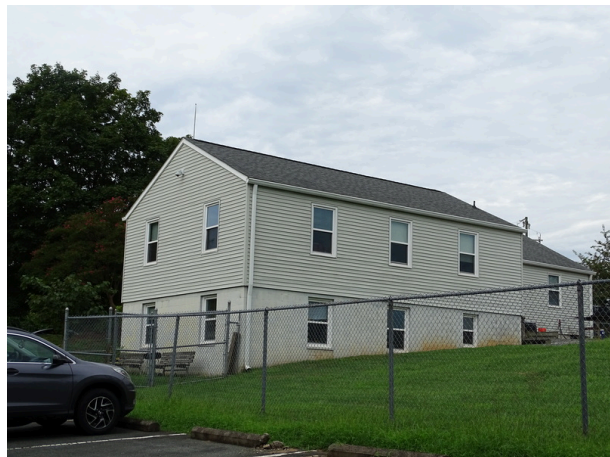
Division office exterior and windows

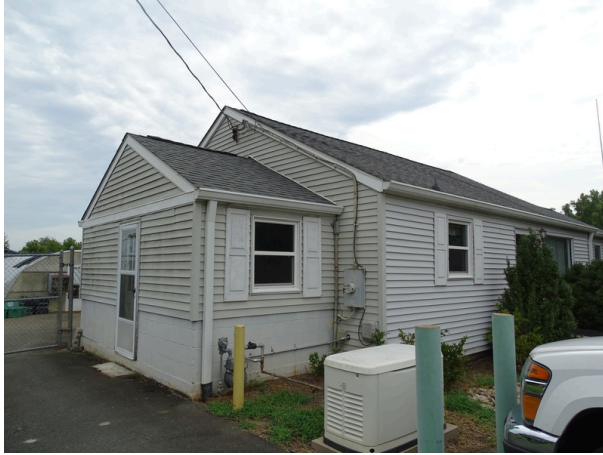
Division office exterior and windows

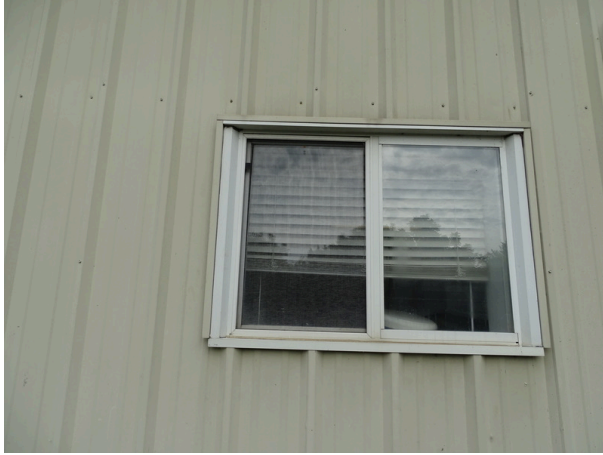
Park shop typical window

3.3.5 Exterior Windows																															
REPLACE WINDOWS AT PARKS SHOP	25	18	7	8	EA	\$1,000.00	\$8,000	100%							\$8,000															\$8,000

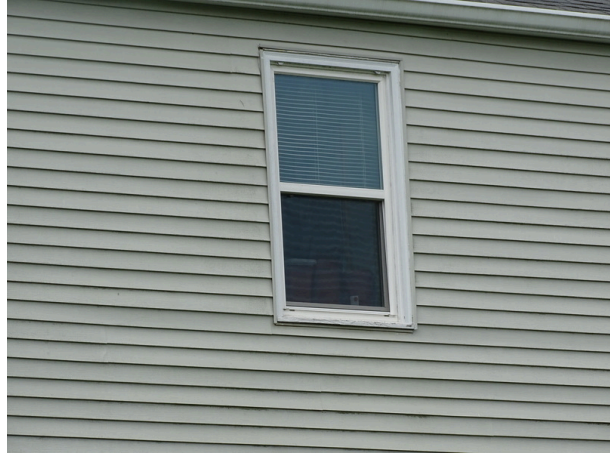
Division office typical window

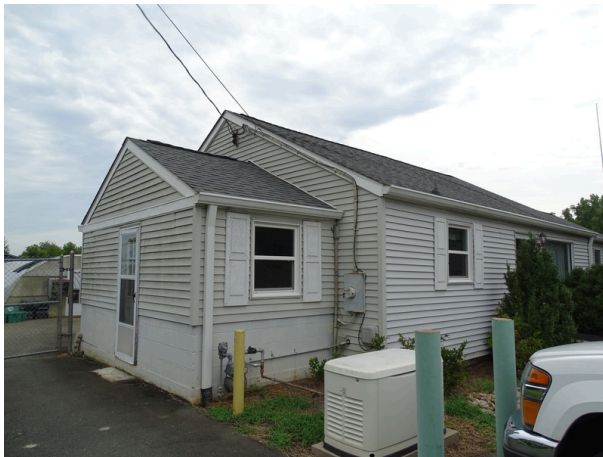
Division office exterior and windows

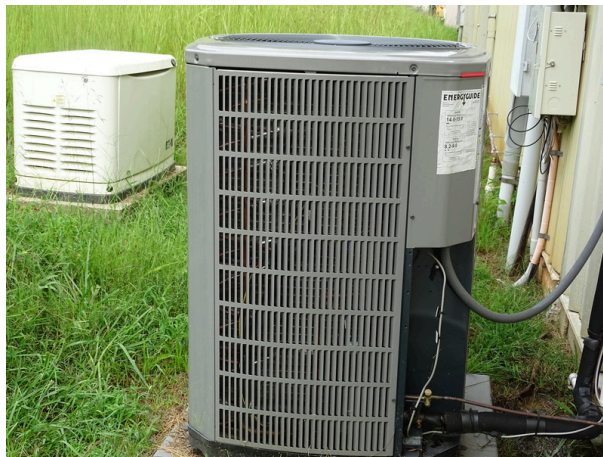
Parks Shop Condenser

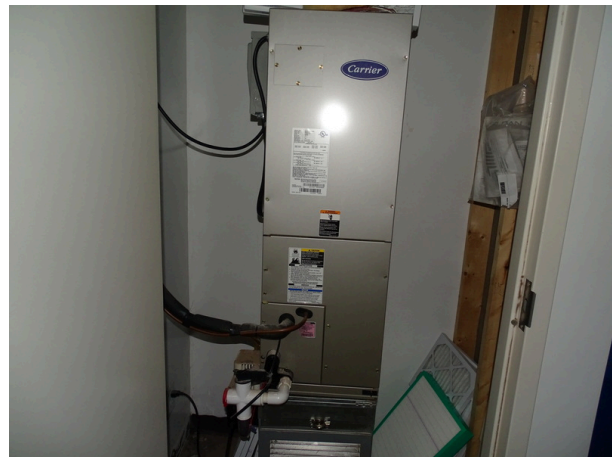
Division Office heat pump

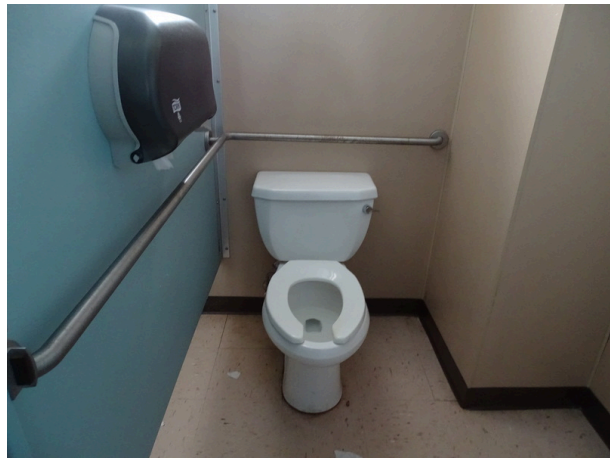
Parks Shop accessible restroom

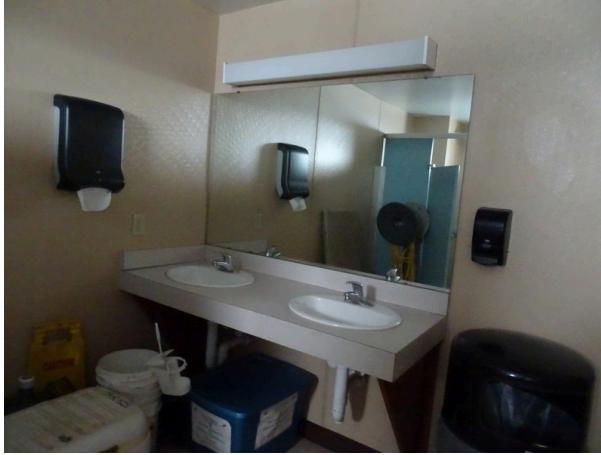
PVC waste lines

Cost Recommendation	EUL	EFF AGE	RUL	Year	Cost
PROVIDE VAN ACCESSIBLE SPACES	10	10	0	Immediate	\$500
INSULATE EXPOSED PIPES UNDER SINKS	10	10	0	Immediate	\$100
INSTALL HANDRAILS AT ENTRANCE RAMP	25	25	0	Immediate	\$5,000
INSTALL VERTICAL GRAB BAR IN RESTROOM	10	10	0	Immediate	\$150
Total					\$5,750

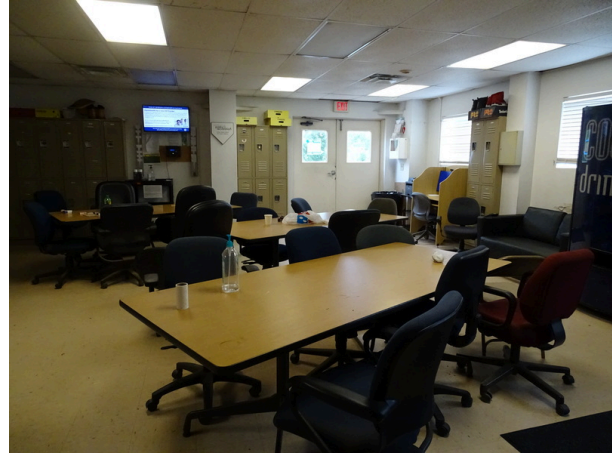
Parks Shop breakroom

Cost Recommendation	EUL	EFF AGE	RUL	Year	Cost
RENOVATE PARKS SHOP BREAK ROOM AND KITCHEN	20	19	1	1	\$15,000
Total					\$15,000

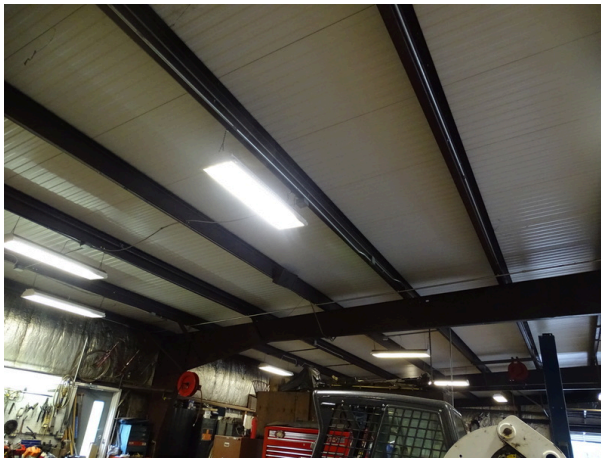
Parks Shop framing

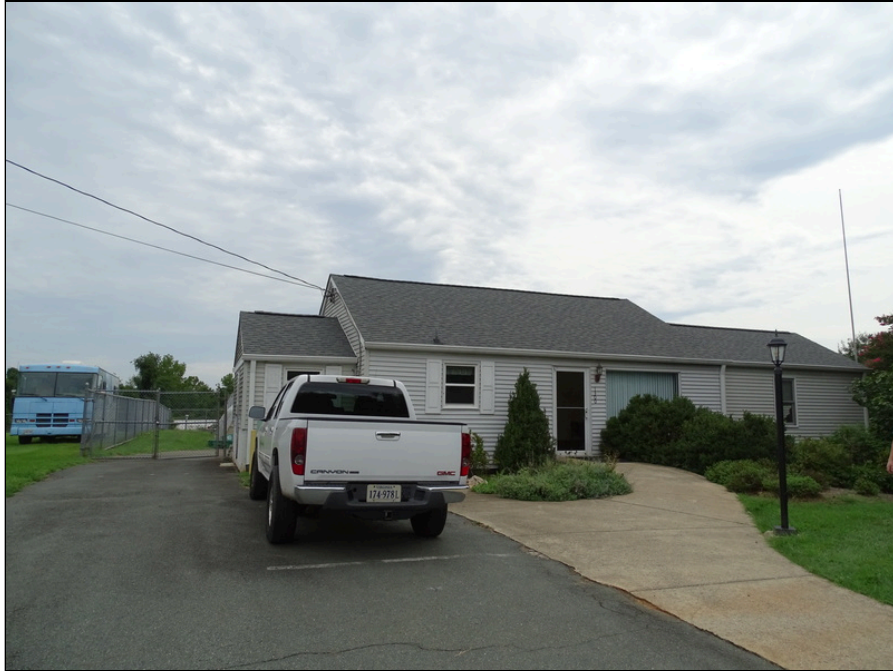
1 - Office overview

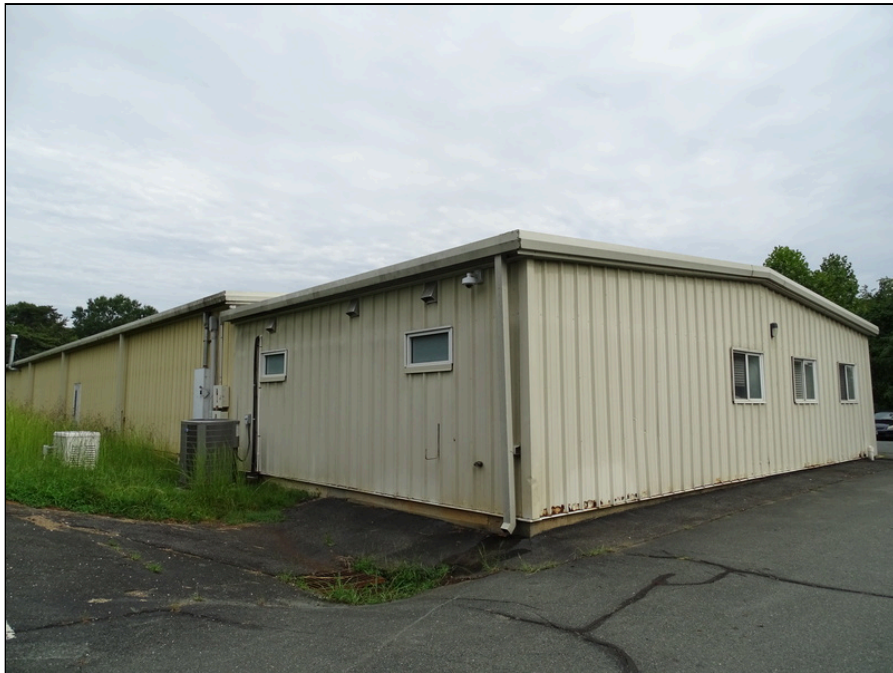
2 - Parks Shop exterior overview

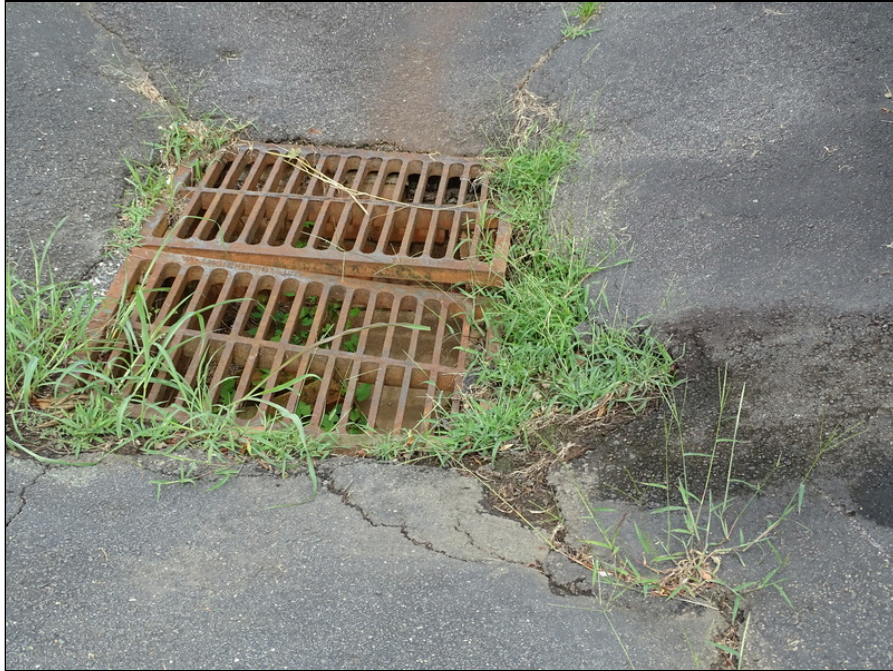
3 - Stormwater drainage

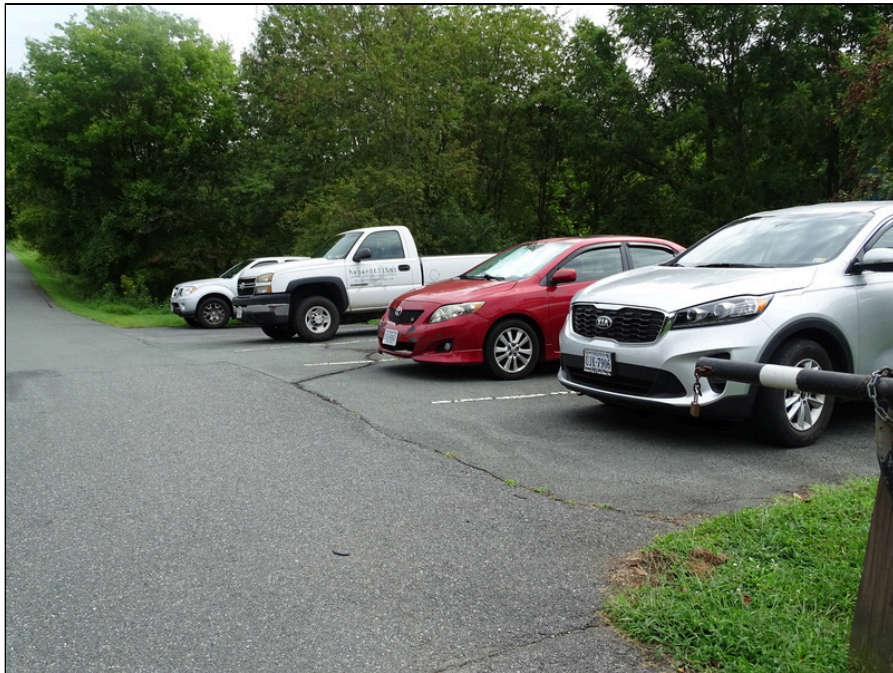
4 - Asphalt parking area and site entrance

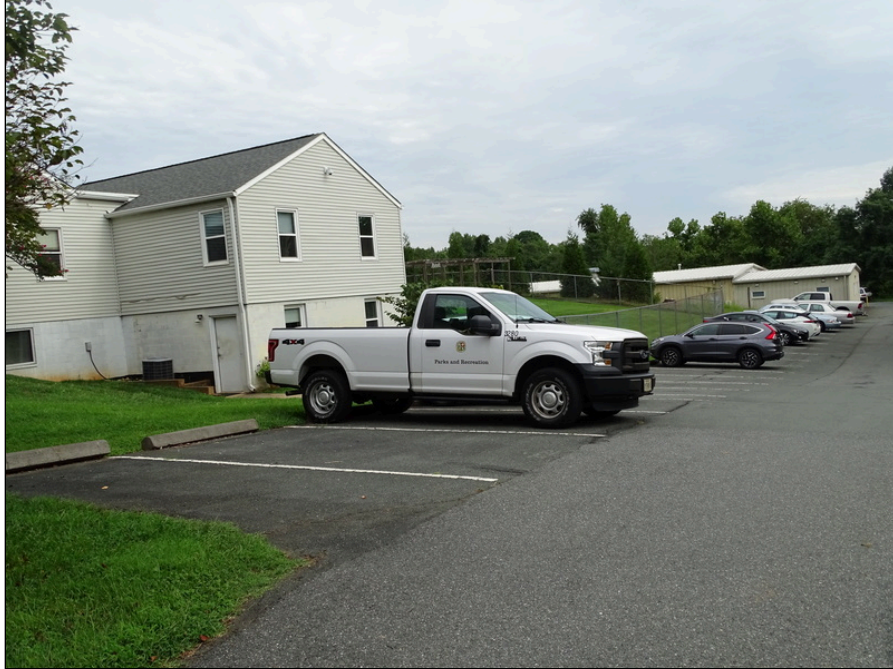
5 - Asphalt parking area

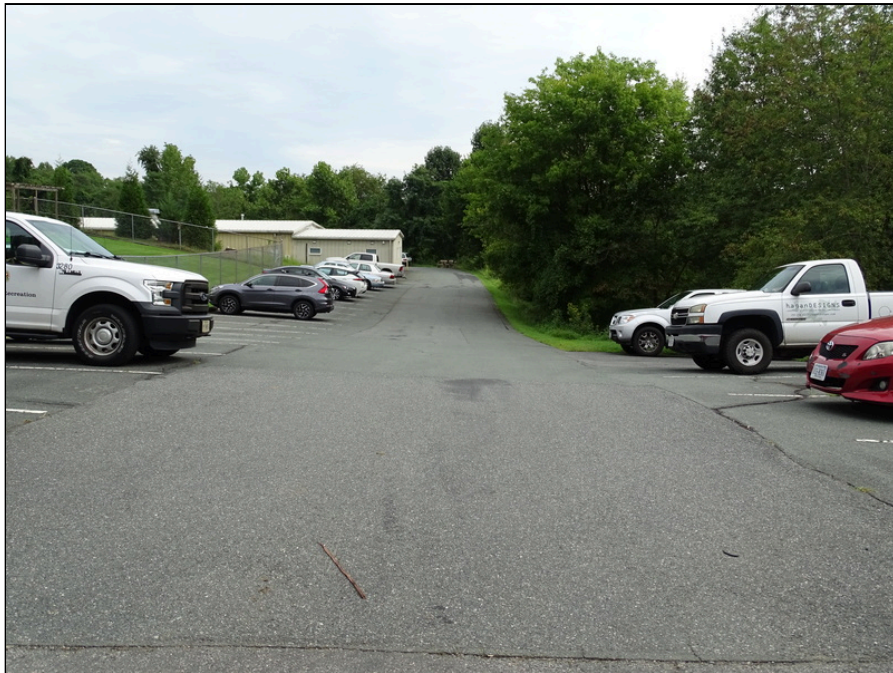
6 - Asphalt parking area

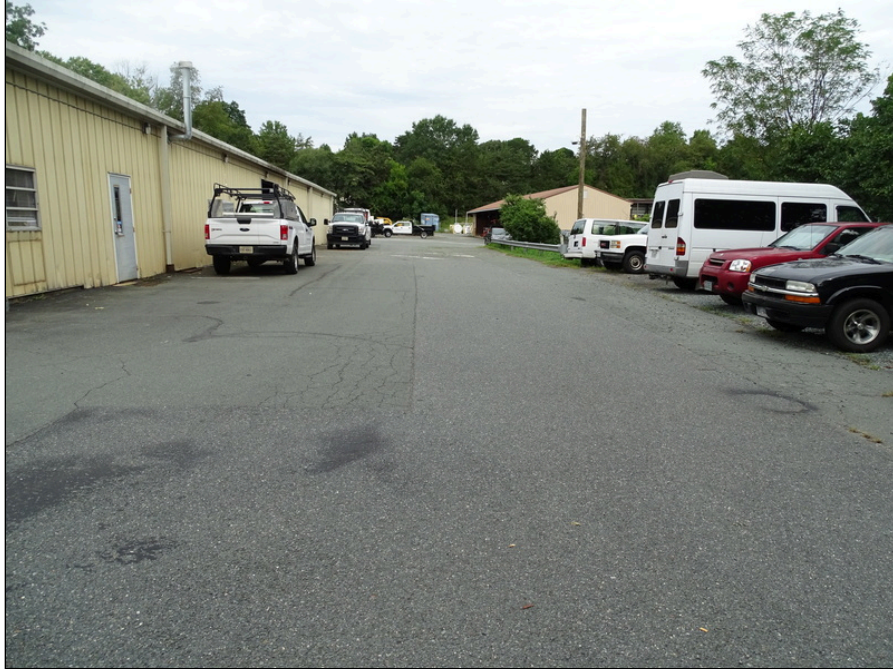
7 - General site asphalt in front of Parks Shop

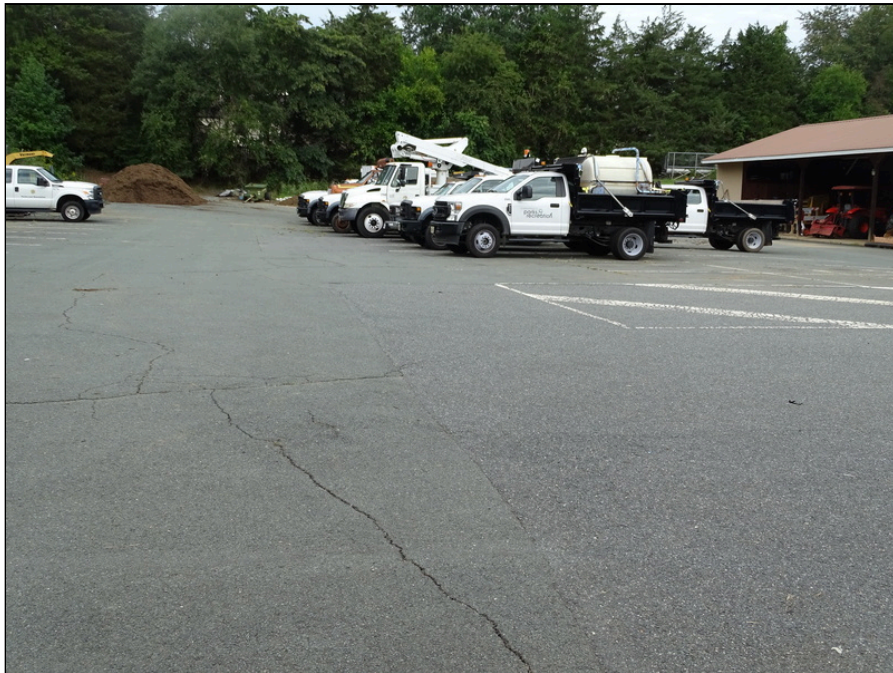
8 - General site asphalt

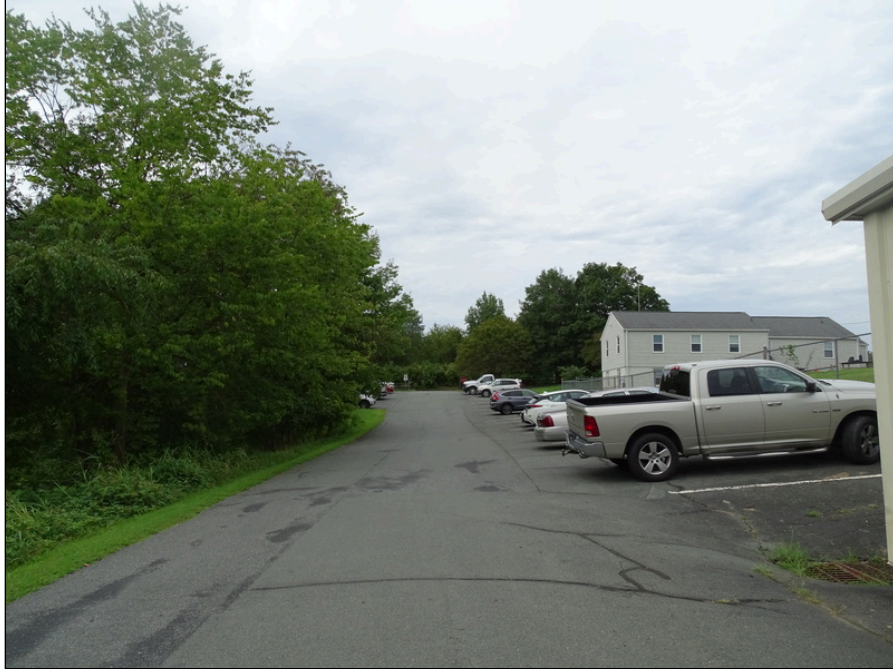
9 - Asphalt parking area

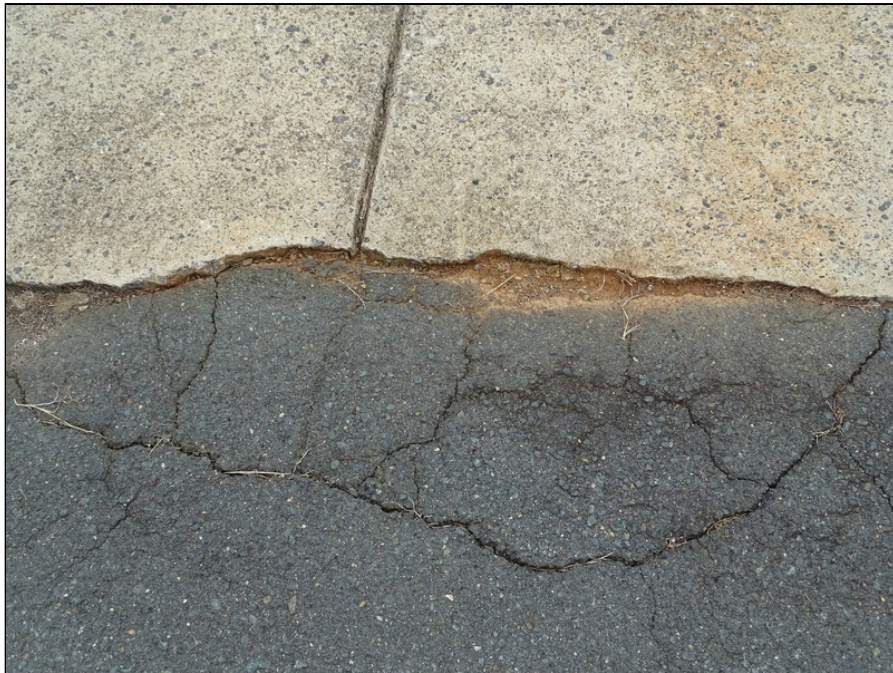
10 - Asphalt condition in front of Division office

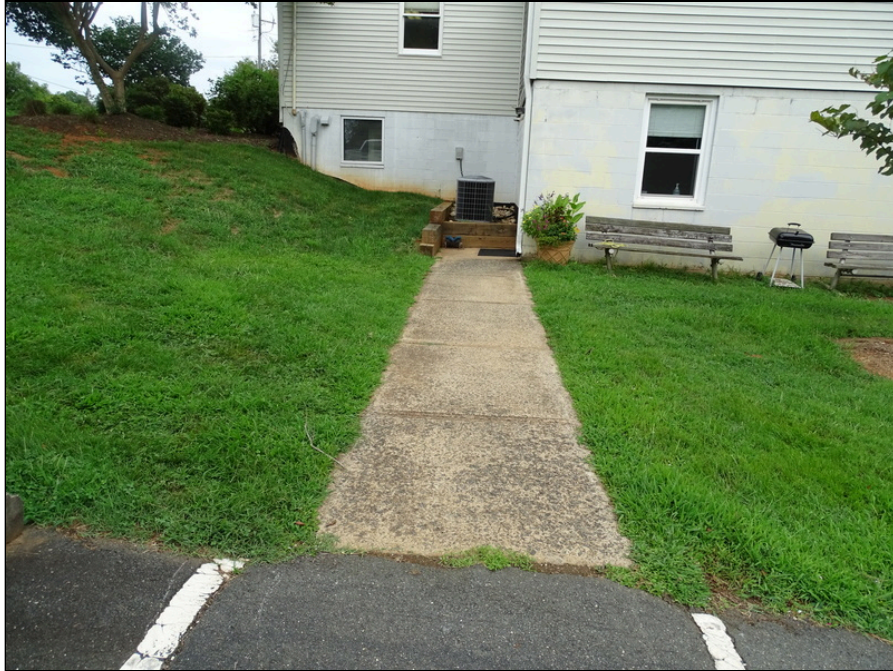
11 - Division office landscape

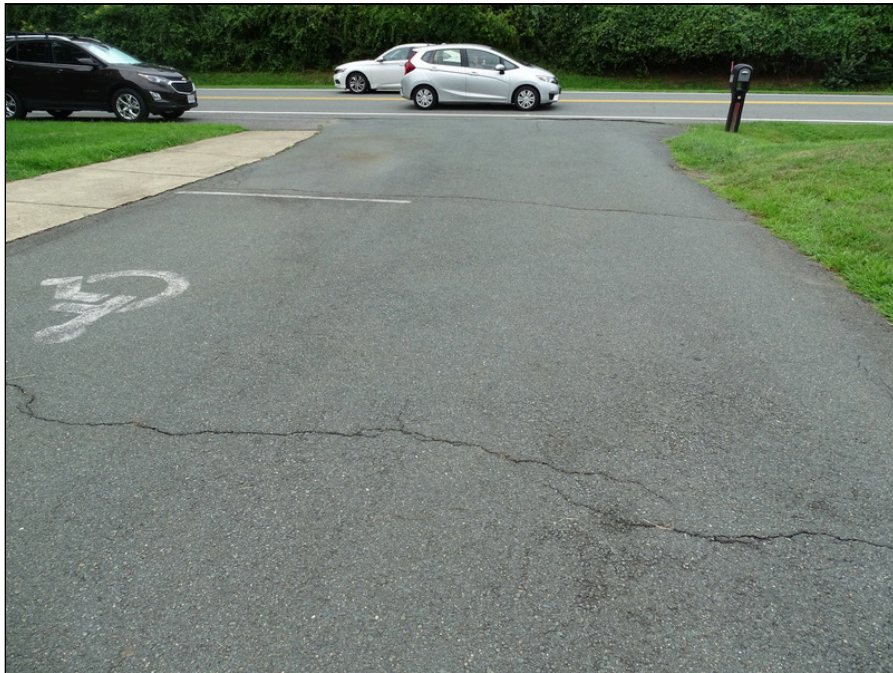
12 - Division office site entrance apron

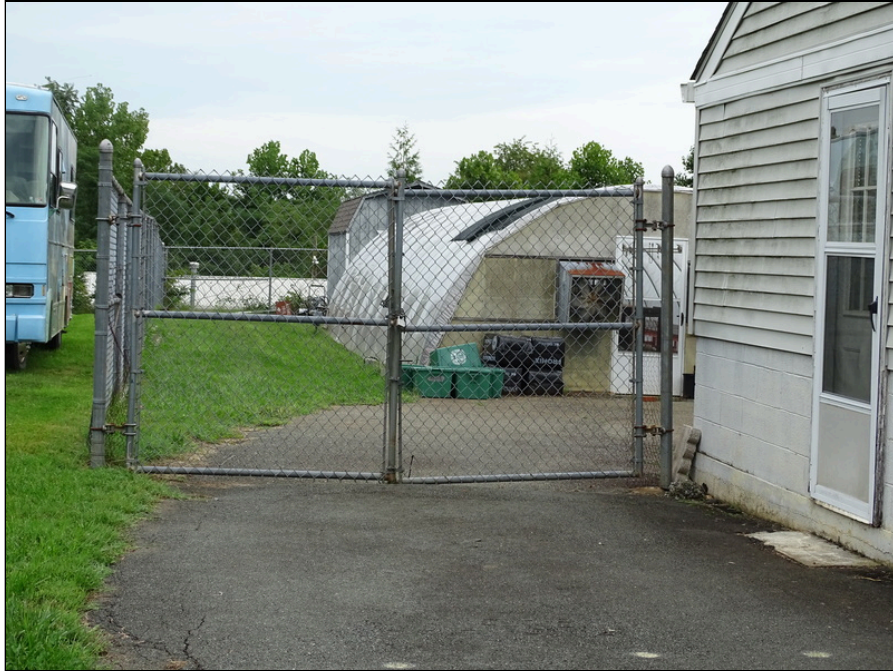
13 - Chain link fencing along the Division office

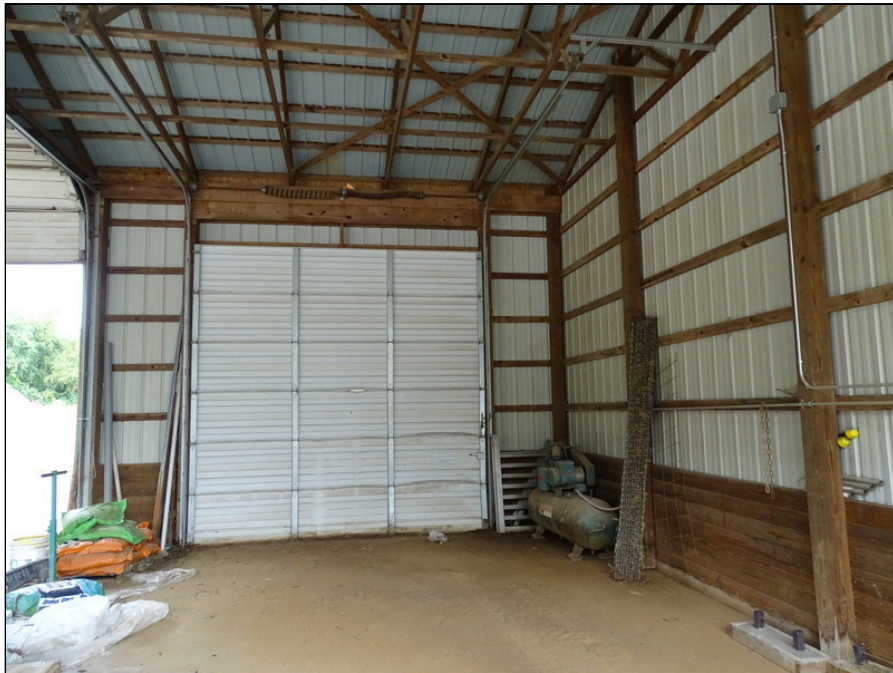
14 - Pole Barn slab on-grade

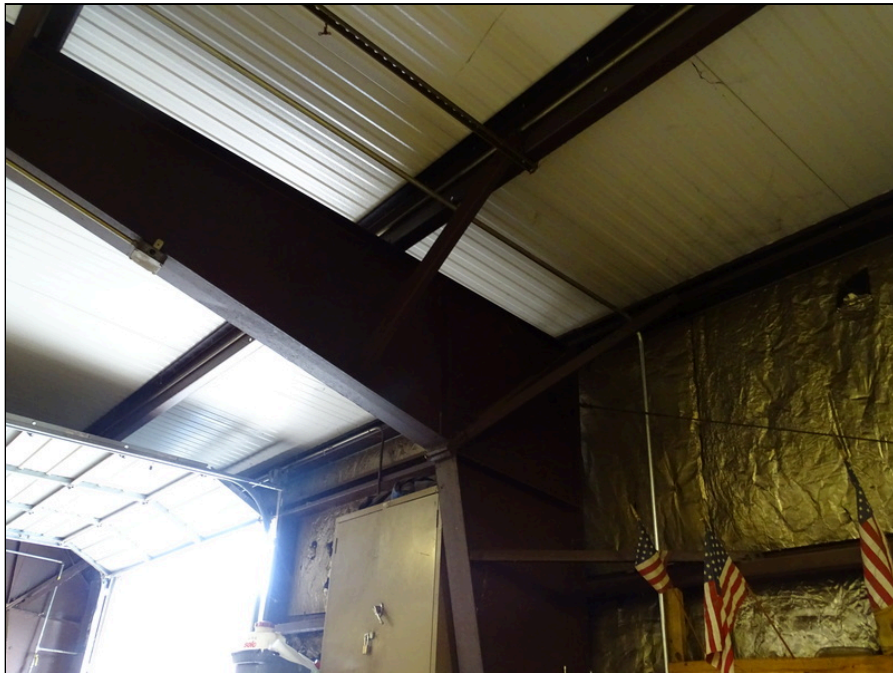
16 - Parks Shop framing

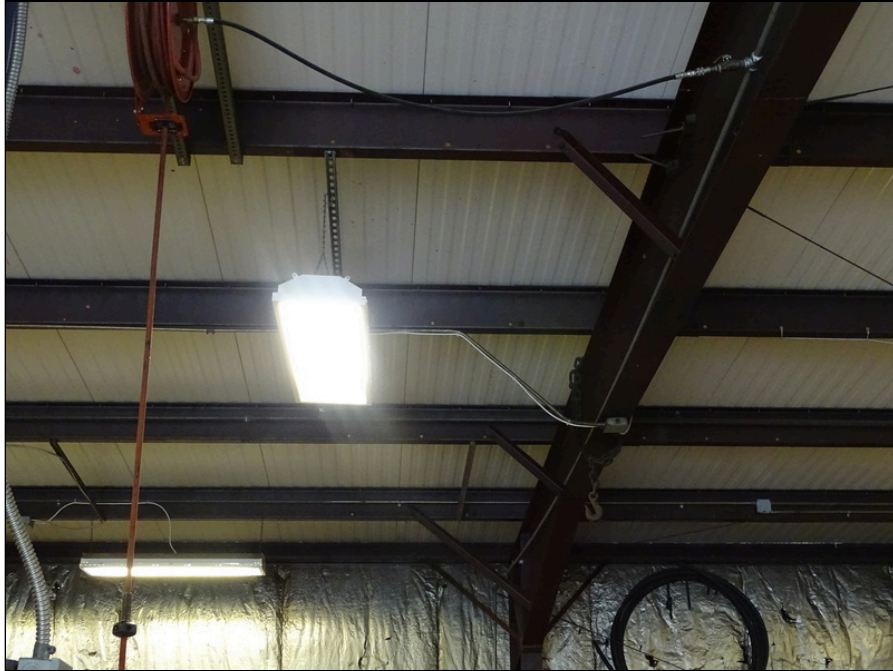
17 - Parks shop building frame

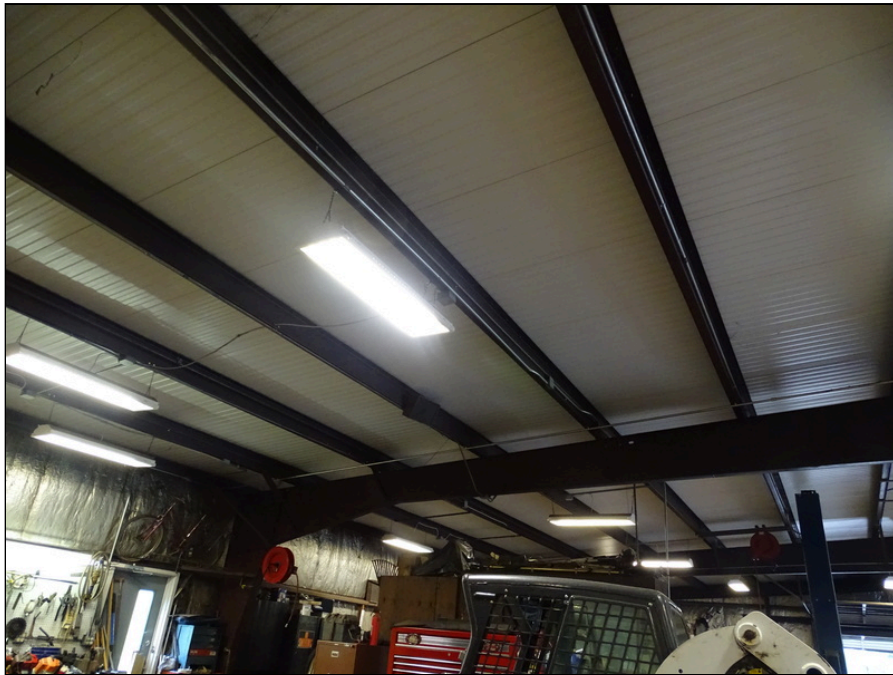
18 - Parks Shop framing

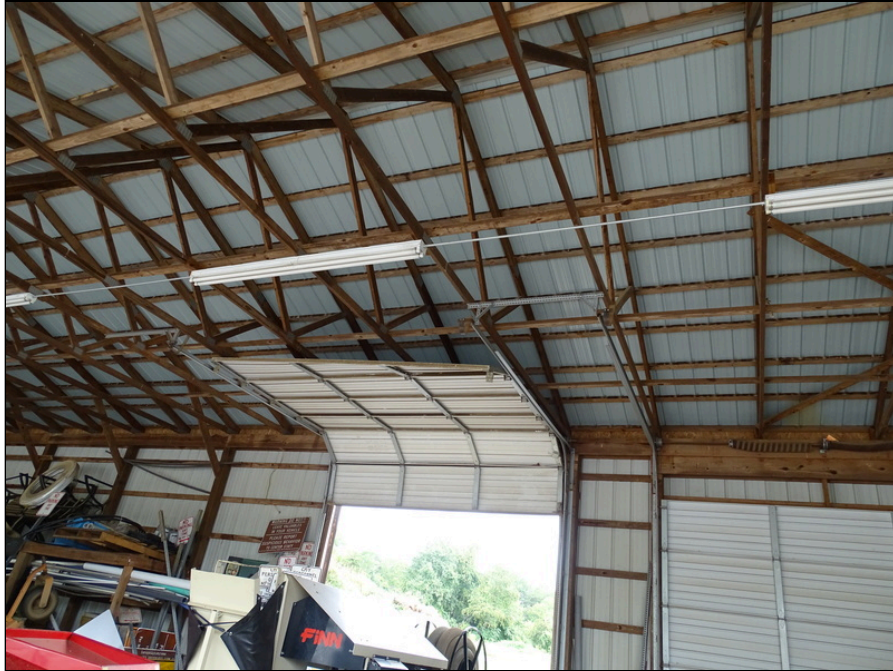
19 - Pole Barn framing

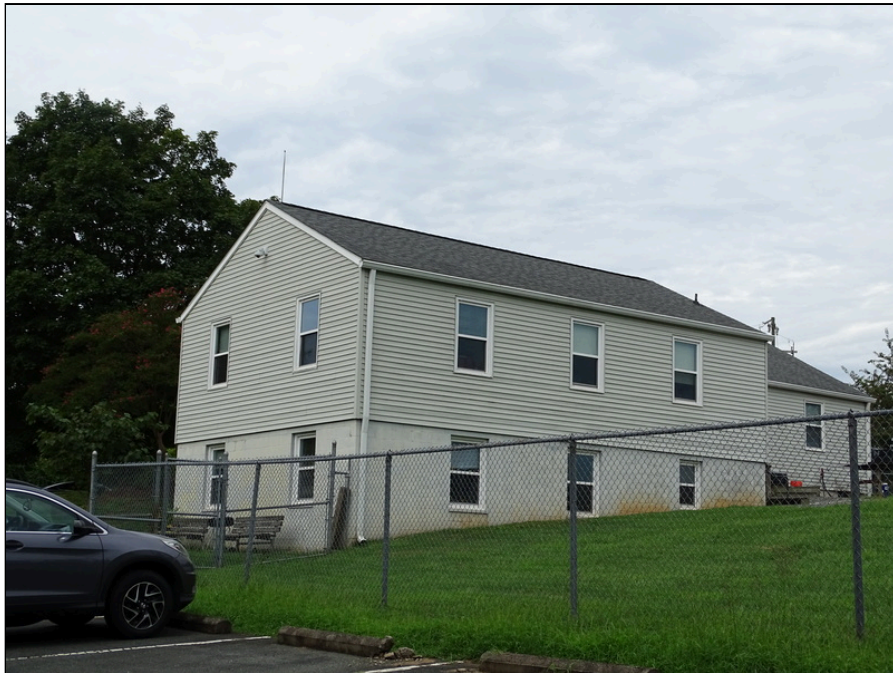
20 - Division office exterior and windows

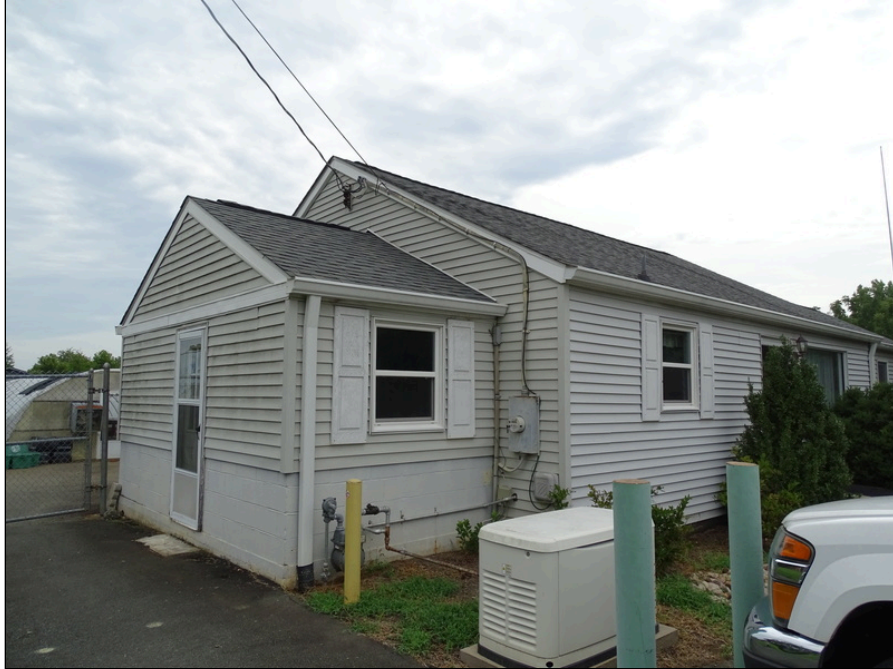
21 - Division office exterior and windows

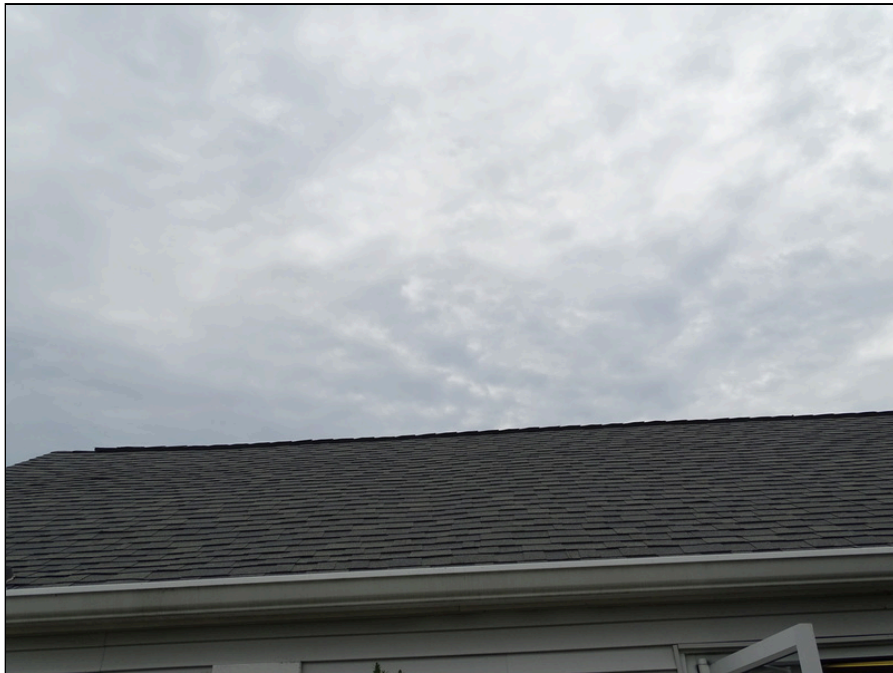
24 - Division office asphalt shingle roofing system

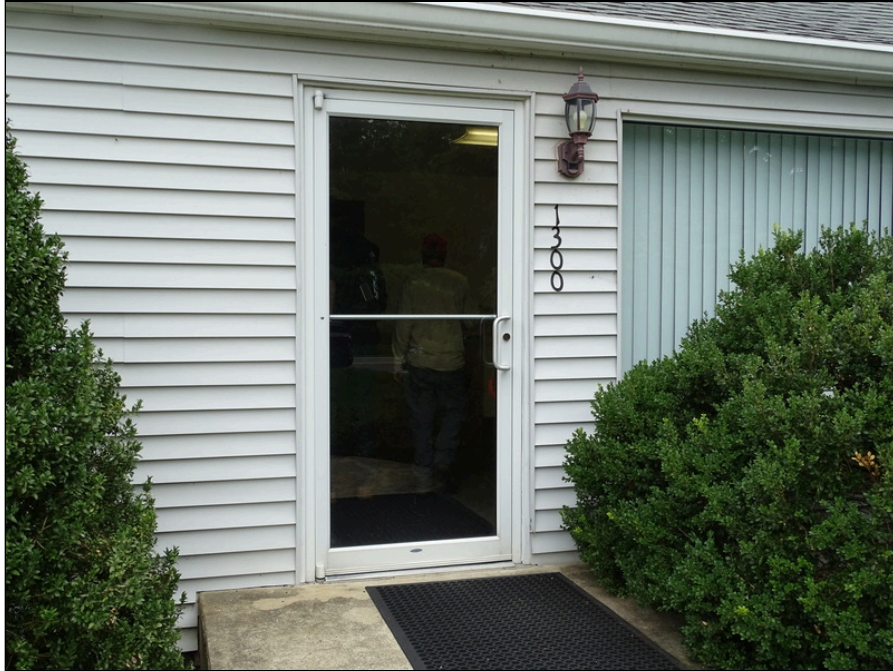
25 - Division office storefront door

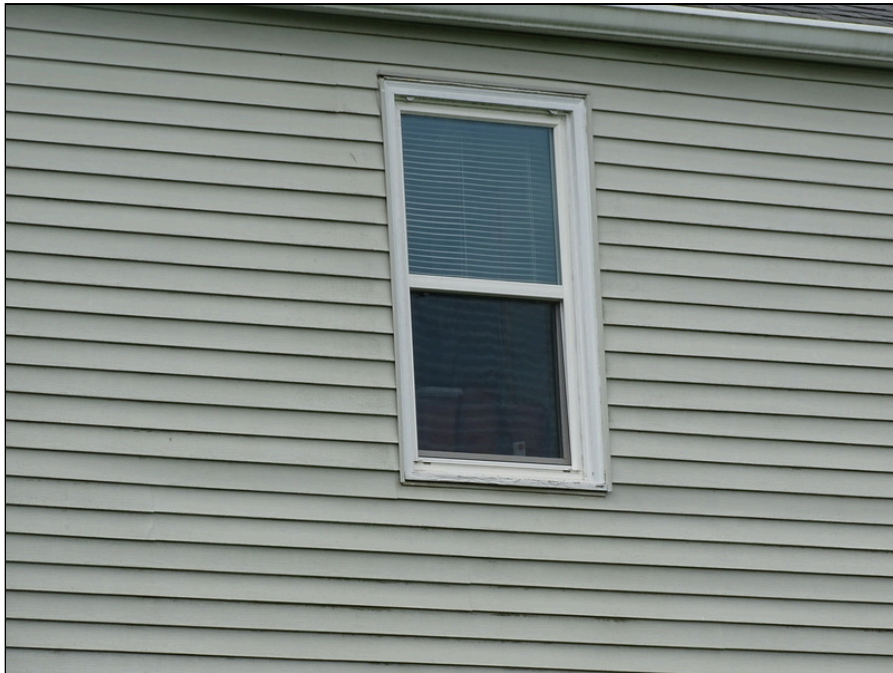
26 - Division office typical window

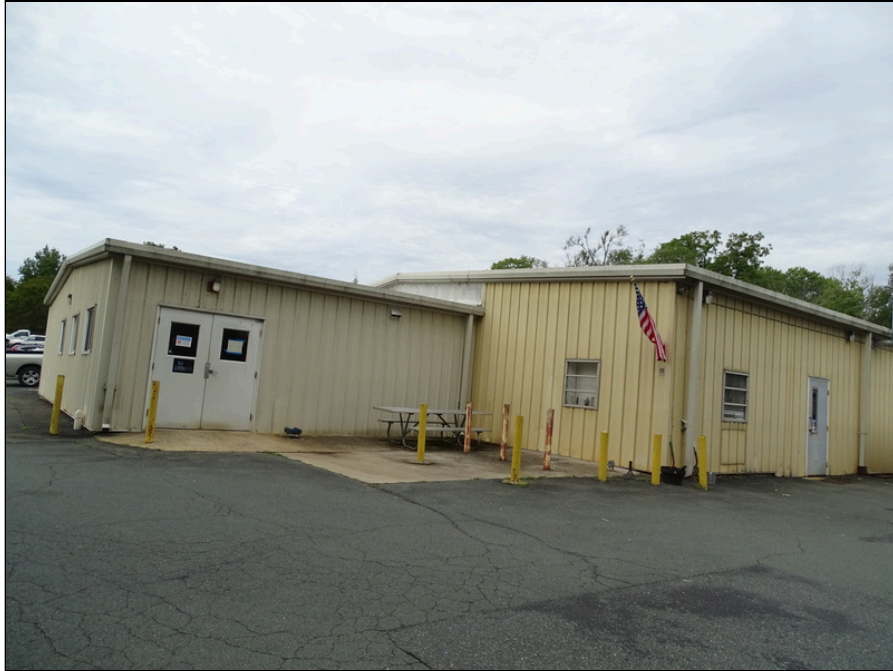
27 - Parks Shop exterior and doors

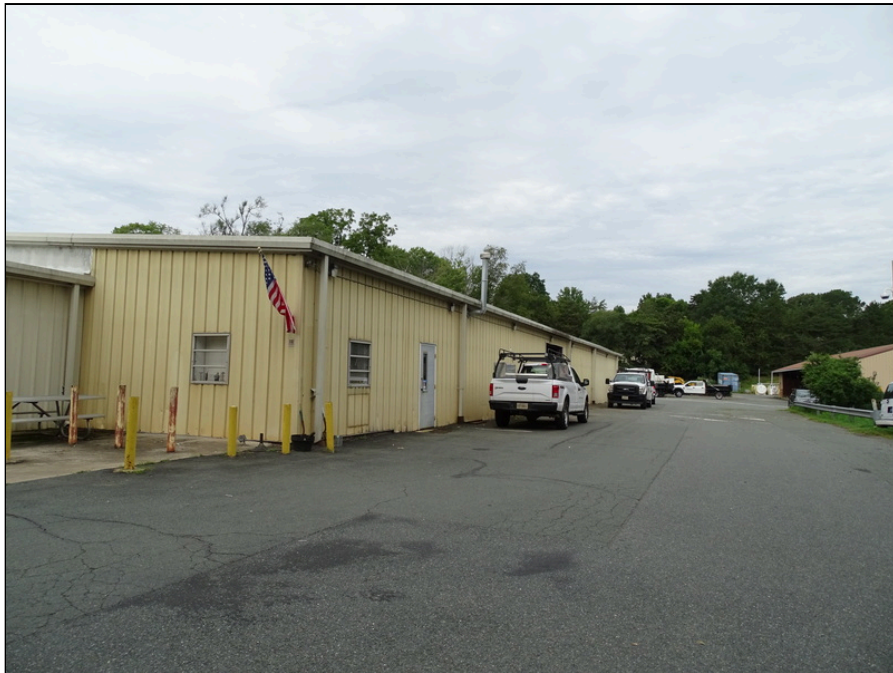
28 - General site asphalt in front of Parks Shop

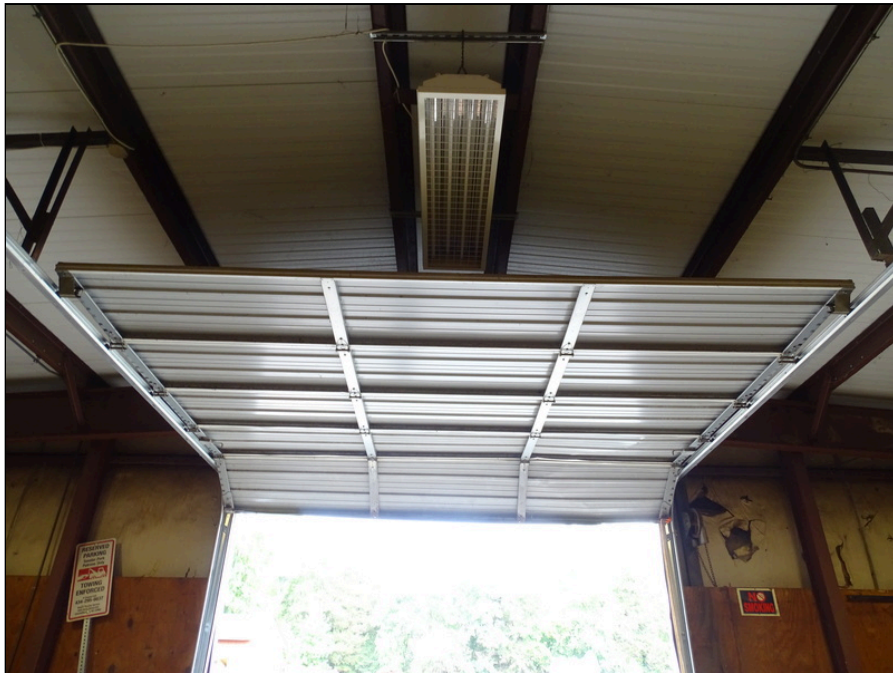
32 - Parks Shop overhead door

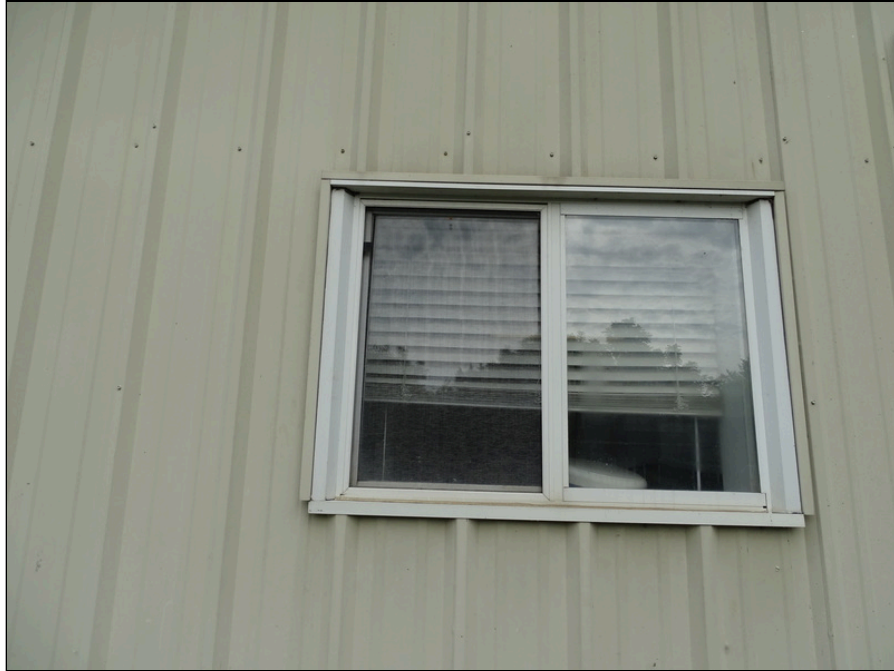
33 - Park shop typical window

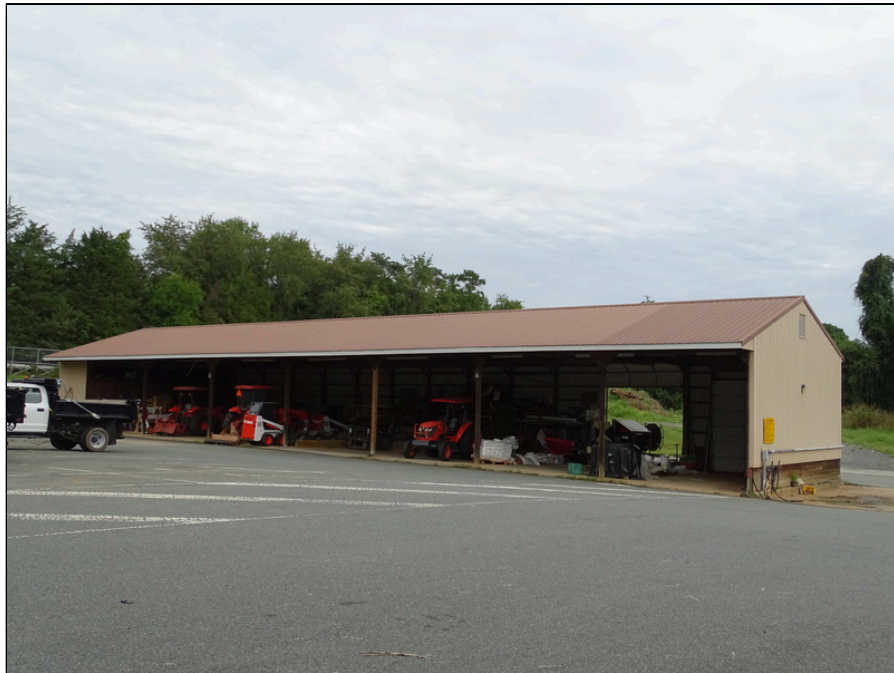
34 - Pole Barn exterior
