PEN PARK COMPLEX
1300 PEN PARK ROAD
CHARLOTTESVILLE, VIRGINIA

ECS PROJECT NO. 46:6713

CITY OF CHARLOTTESVILLE - FACILITIES DEVELOPMENT

Reference: Facility Condition Assessment Report for Pen Park Complex, 1300 Pen Park Road,
Charlottesville, Virginia

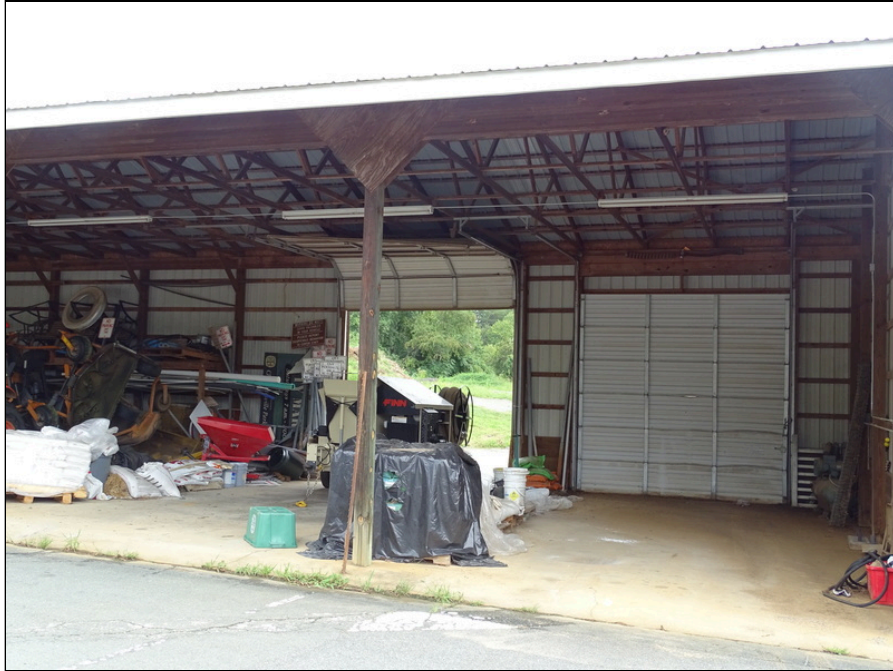
35 - Pole Barn overhead doors

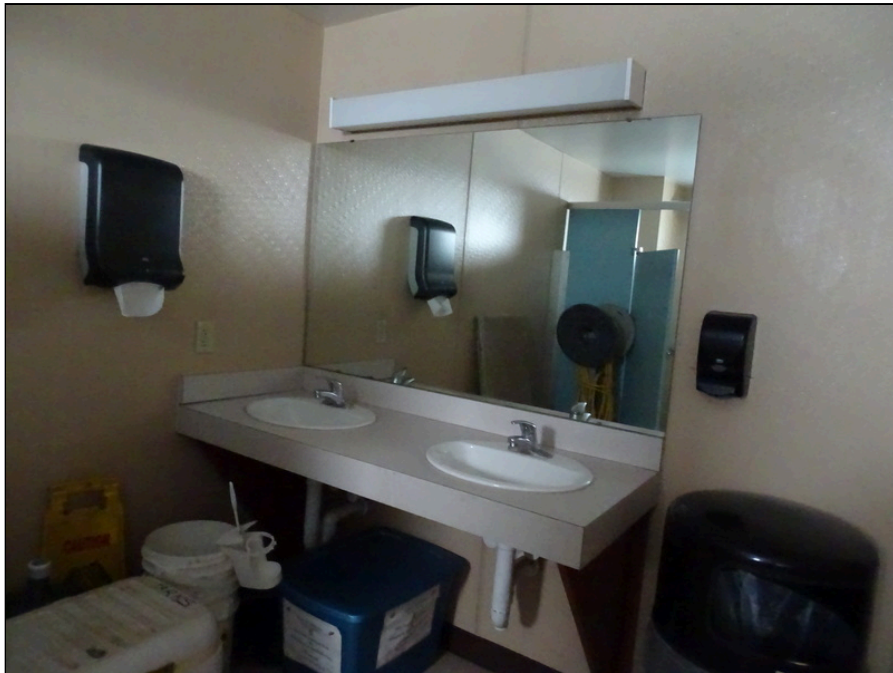
36 - PVC waste lines

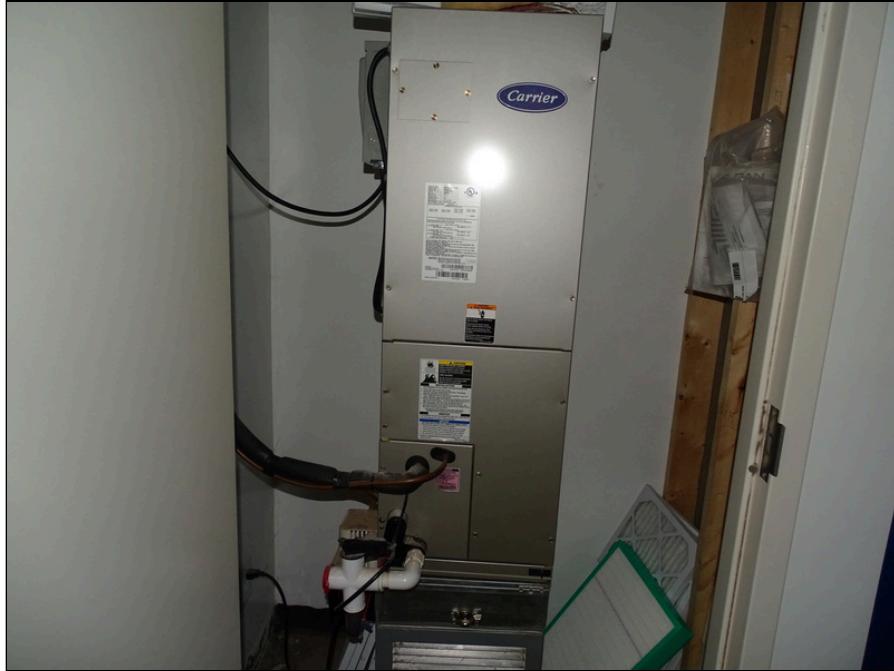
37 - Division Office heat pump

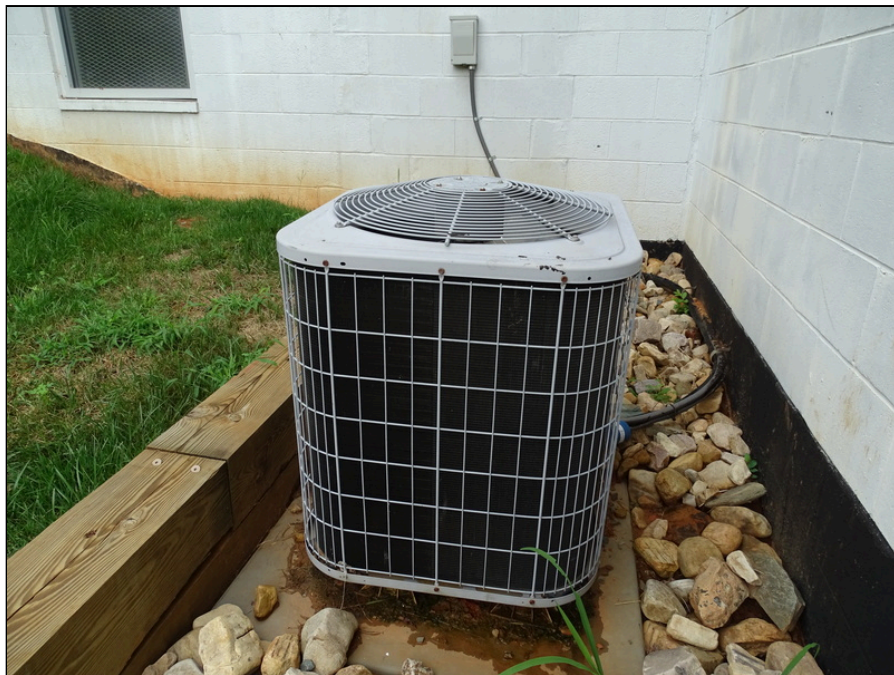
38 - Division office condenser

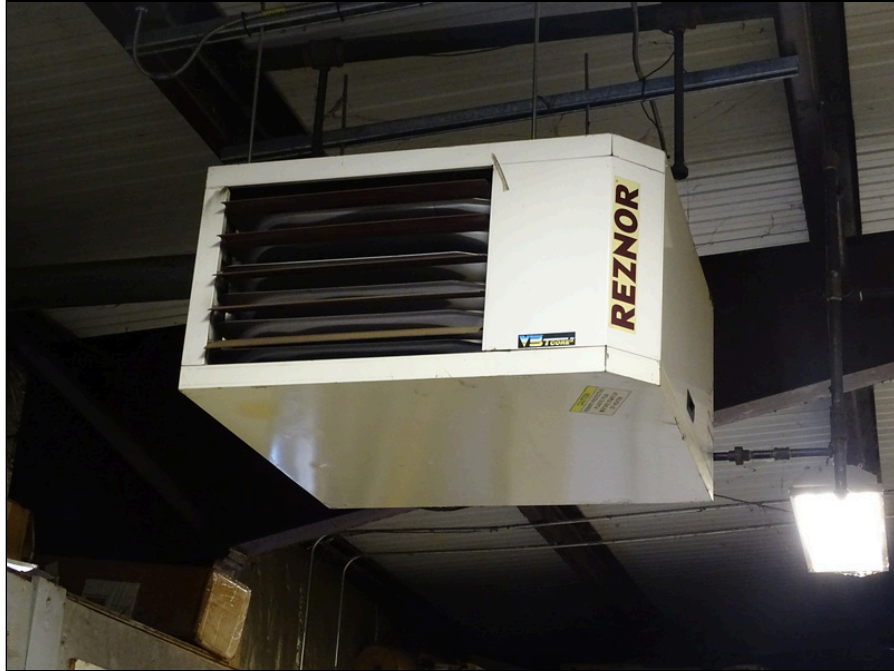
39 - Parks shop space heater

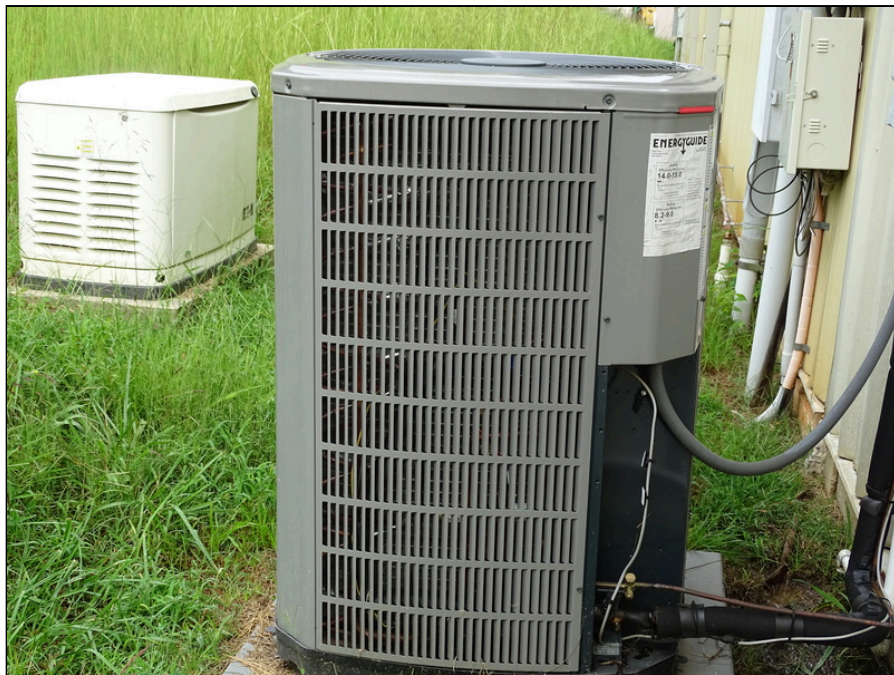
40 - Parks Shop Condenser

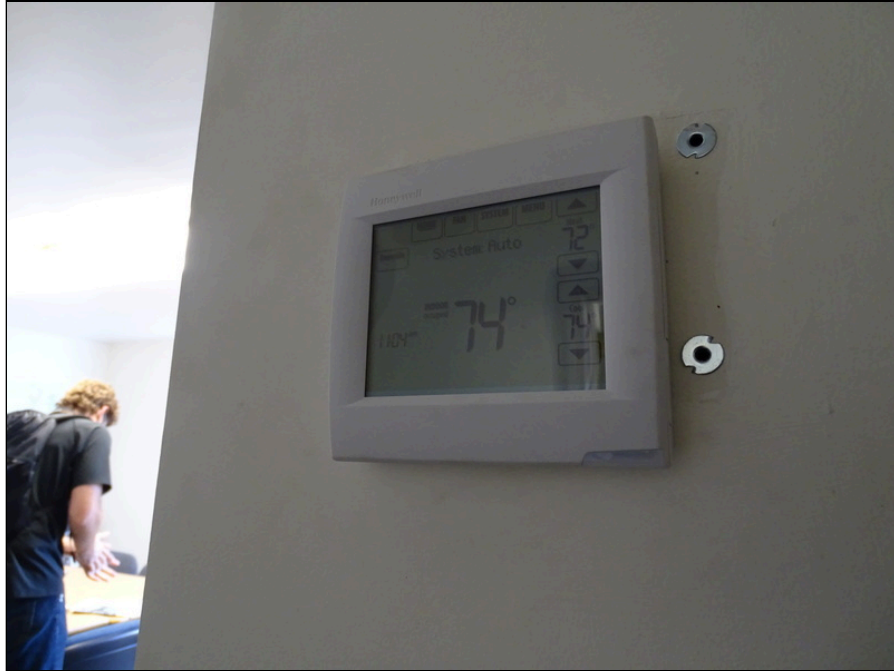
41 - Division office typical thermostat

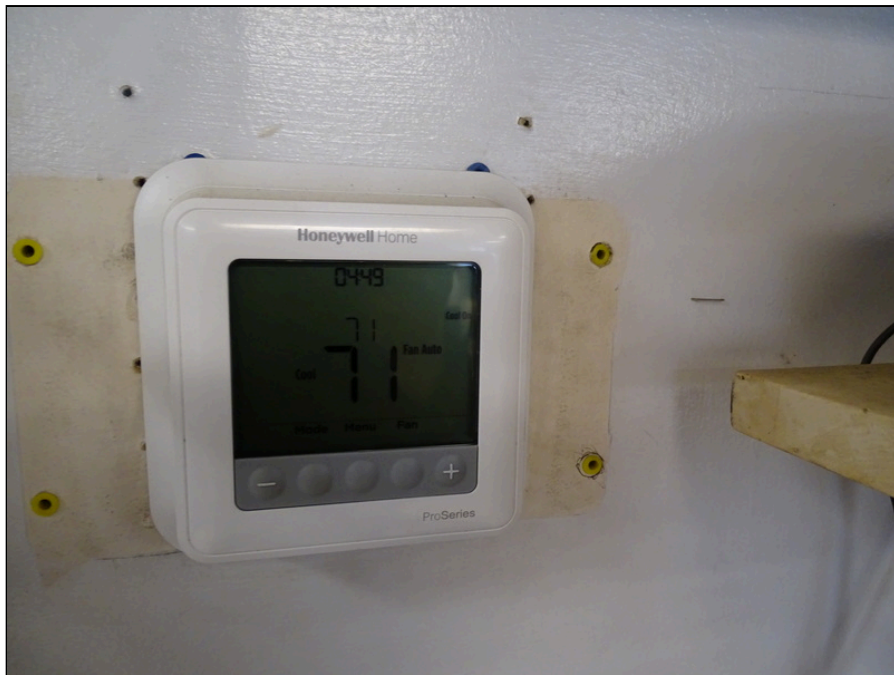
42 - Parks Shop thermostat

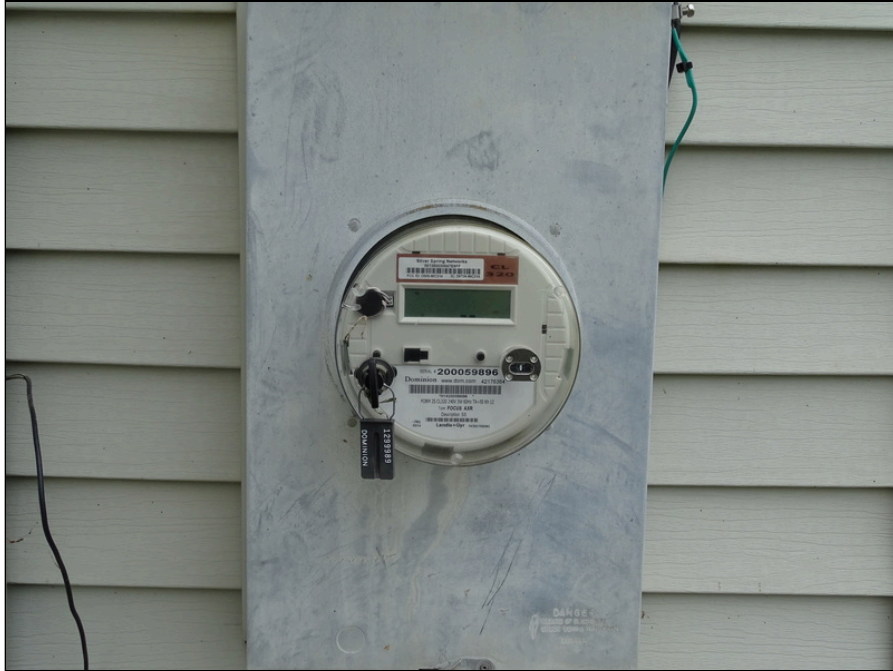
43 - Division office electrical entrance

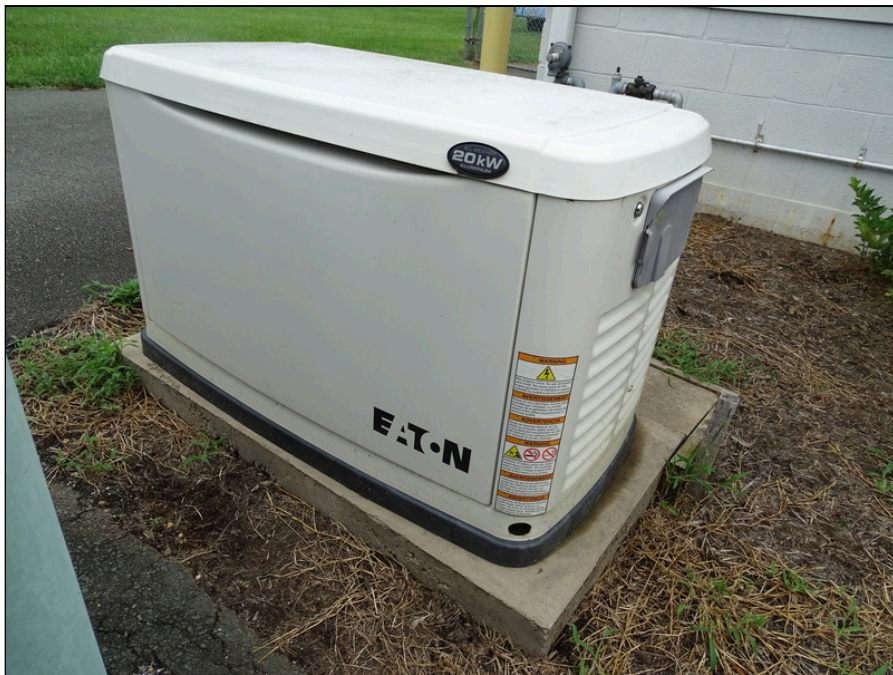
44 - Emergency generator at the Division Office

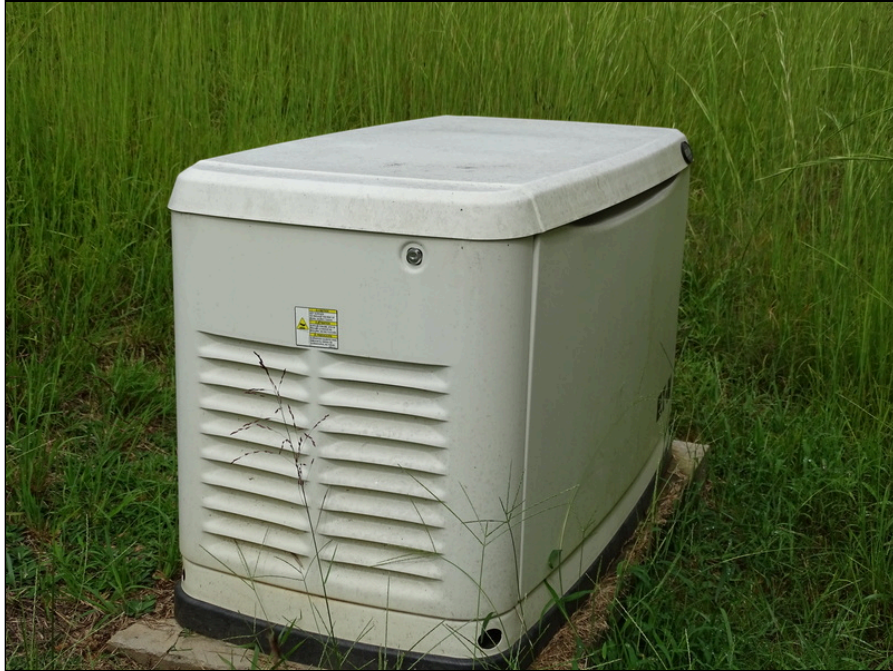
45 - Emergency generator at the Parks Shop

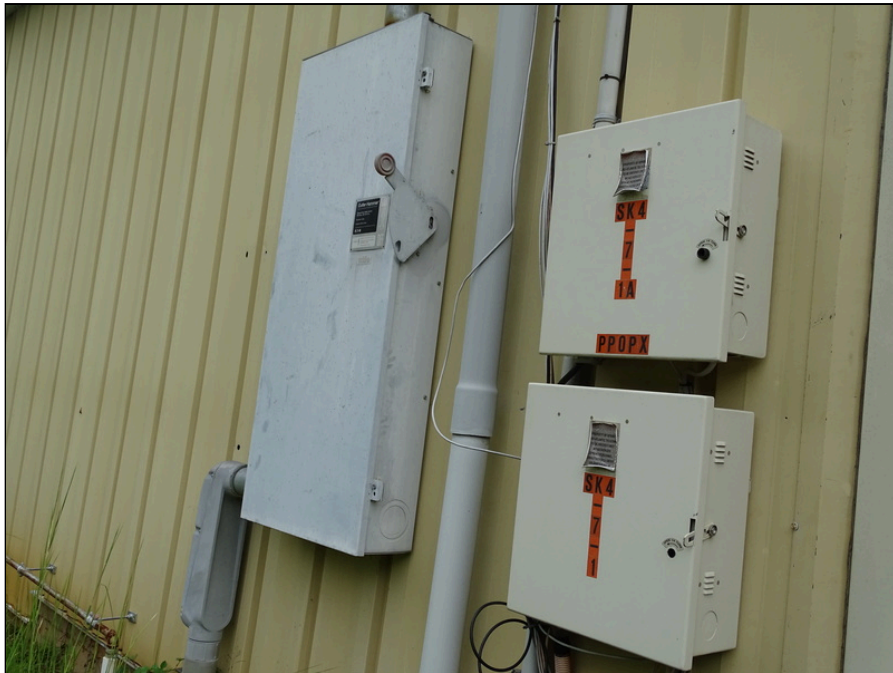
46 - Parks Shop main electrical entrance

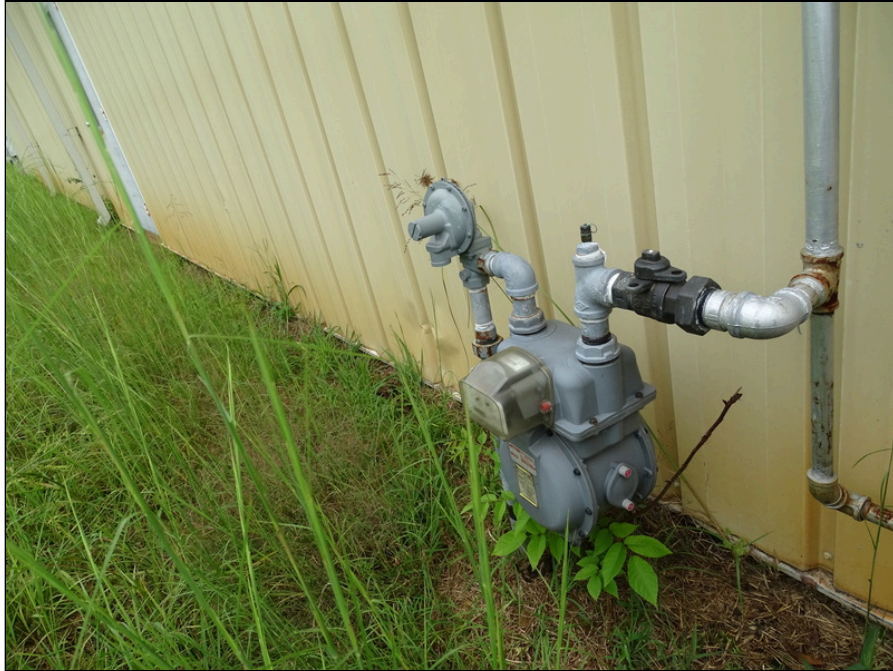
73 - Parks Shop gas meter

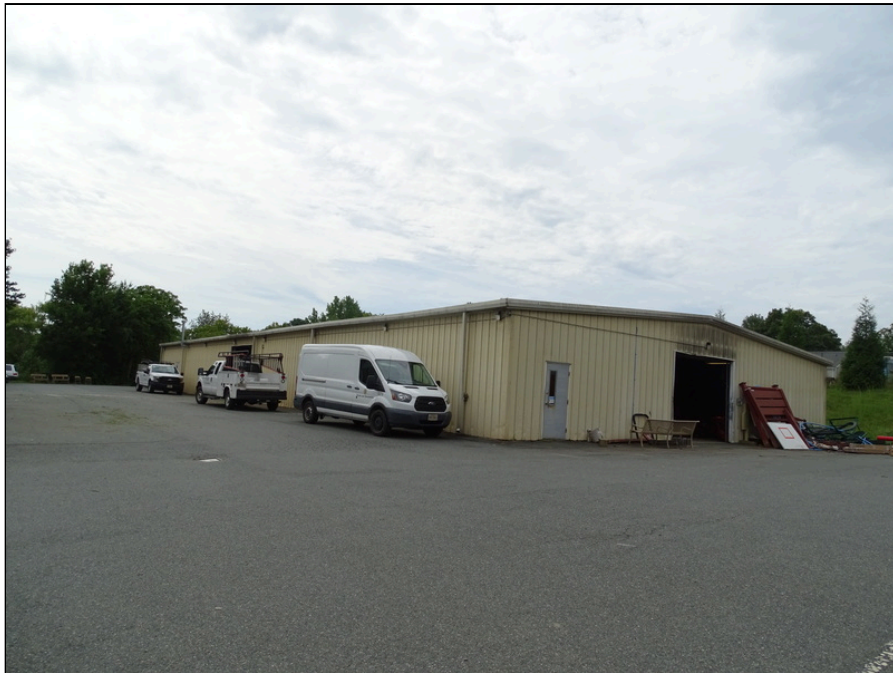
74 - General site asphalt

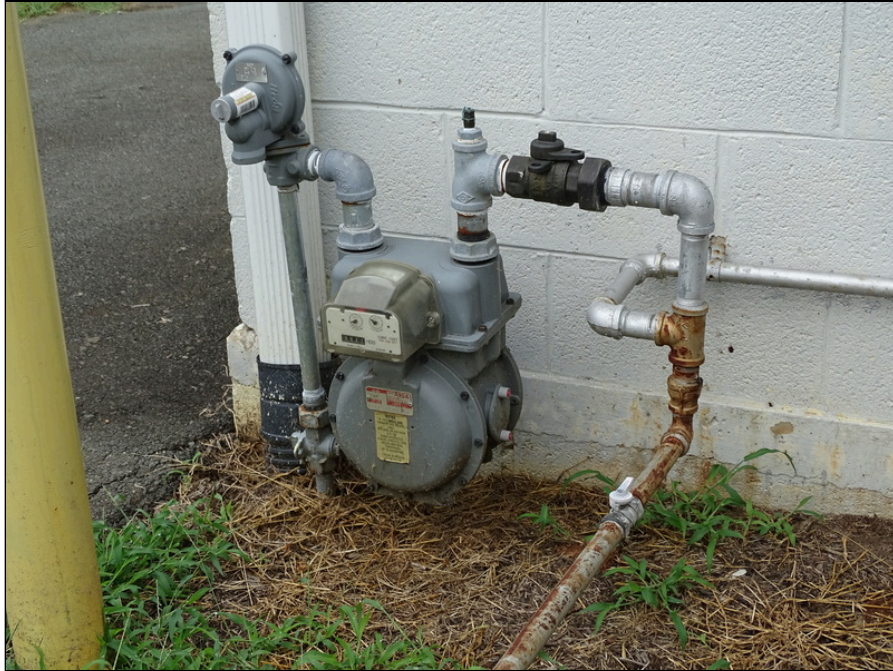
79 - Typical gas meter

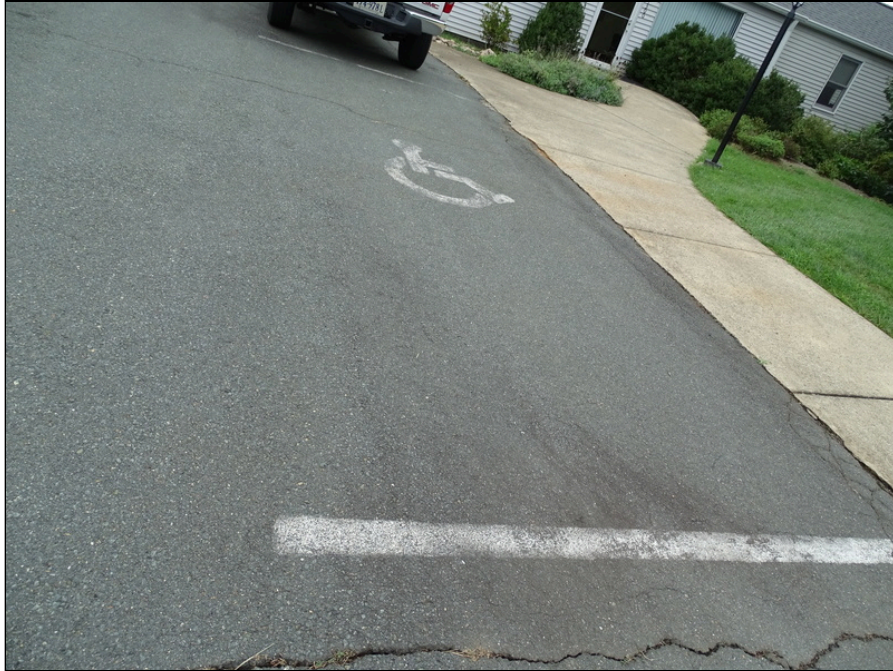
81 - Accessible Asphalt parking area
