PRESTON MORRIS BUILDING
407 EAST HIGH STREET
CHARLOTTESVILLE, VIRGINIA

ECS PROJECT NO. 46:6713

CITY OF CHARLOTTESVILLE - FACILITIES DEVELOPMENT

Reference: Facility Condition Assessment Report for Preston Morris Building, 407 East High Street, Charlottesville, Virginia

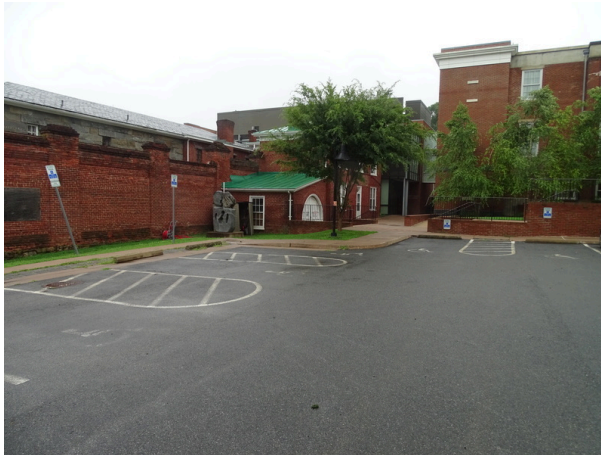
Accessible parking

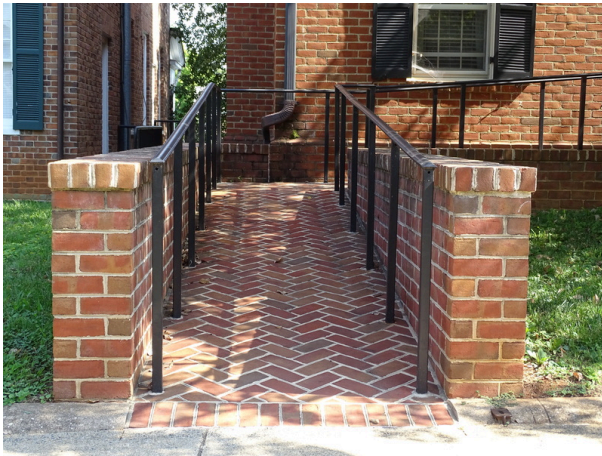
Brick ramp at southwest side of the building

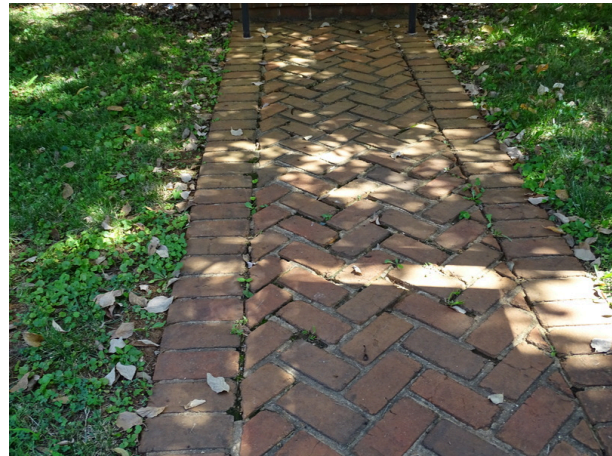
Brick sidewalk south side of the building

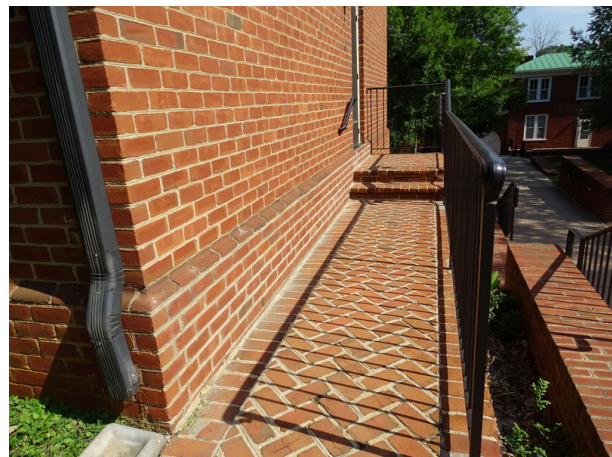
Building exterior southeast side of the building

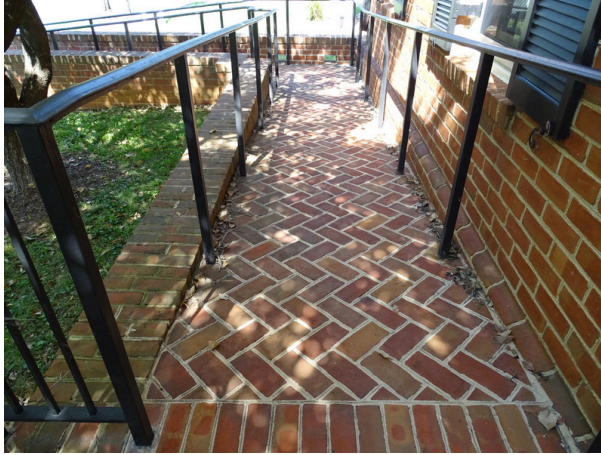
Accessible brick ramp at southwest side of the building

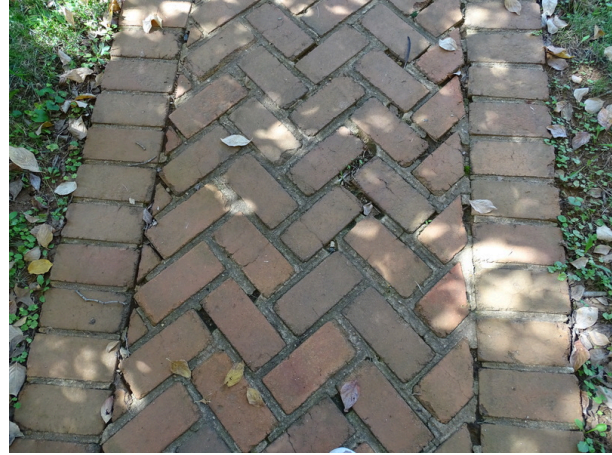
Brick ramp at southwest side of the building

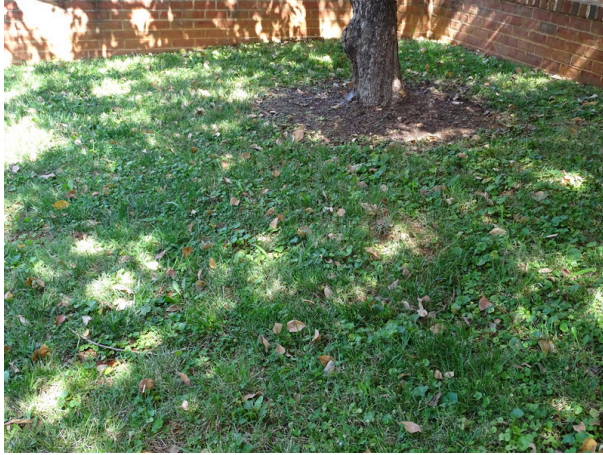
The landscaping consists generally of a two trees and grassed area at the south side of the site. The landscaping was observed to be in generally good condition.

Landscape area

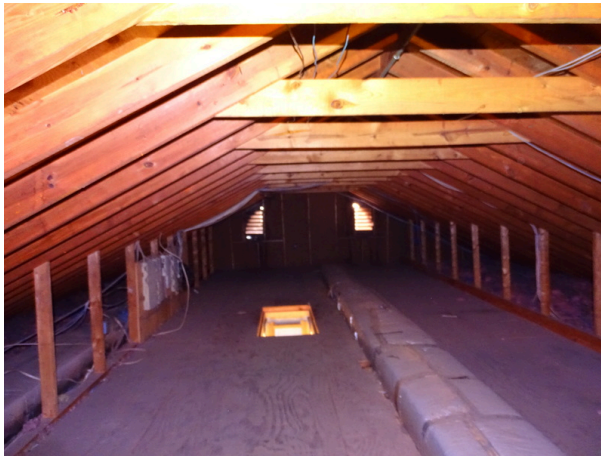
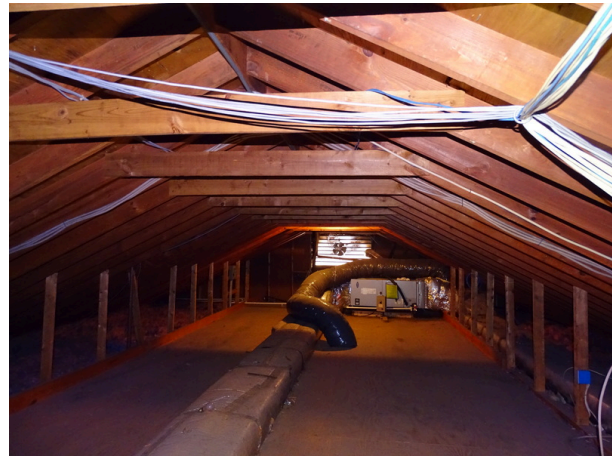
The structure of the building consists of Wood framing with brick masonry bearing exterior walls with brick masonry columns. The structural frame of the building was generally in good condition.

Structural framing

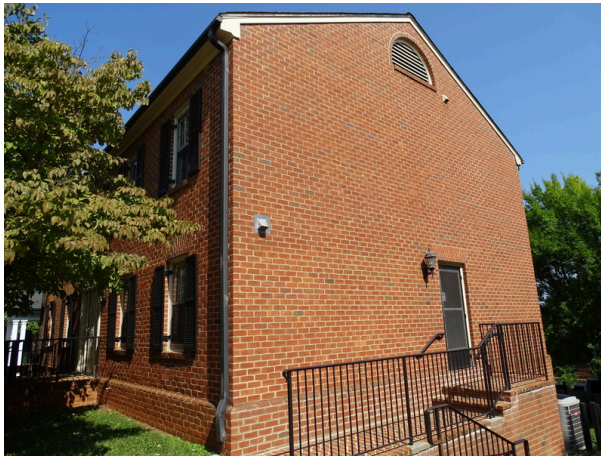
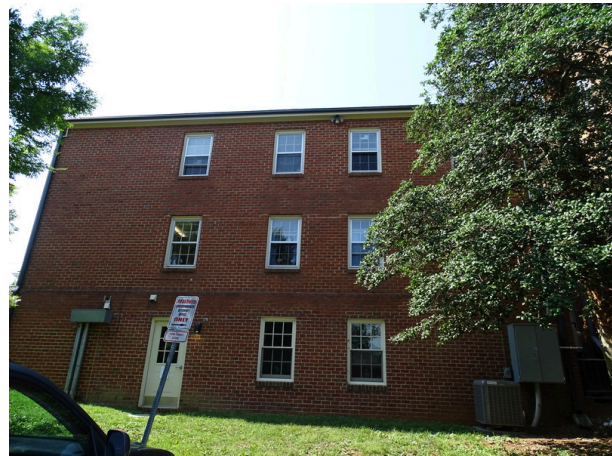
The wood trim and wood covered soffits are painted. The paint was generally in good condition with renovations completed in 2006. Painting of exterior components is typically recommended every 5 to 7 years. We recommend the wood trim and soffits be painted during the report period.

Building exterior southeast side of the building

Building exterior north side of the building

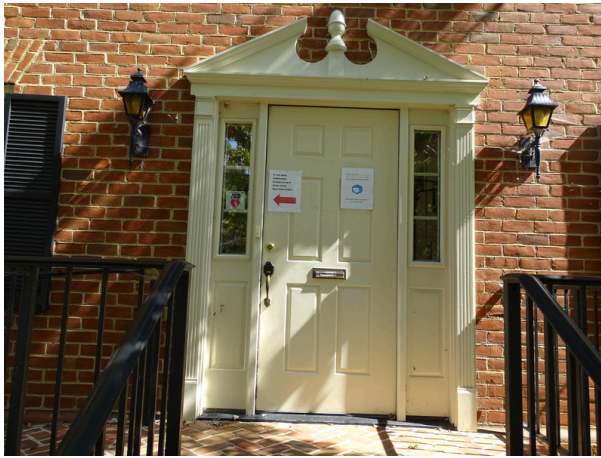
The main entrance is a Wood door. The main entrance door was generally in good condition. Exterior doors typically have an expected useful life of 20 to 30 years.

Main entrance door

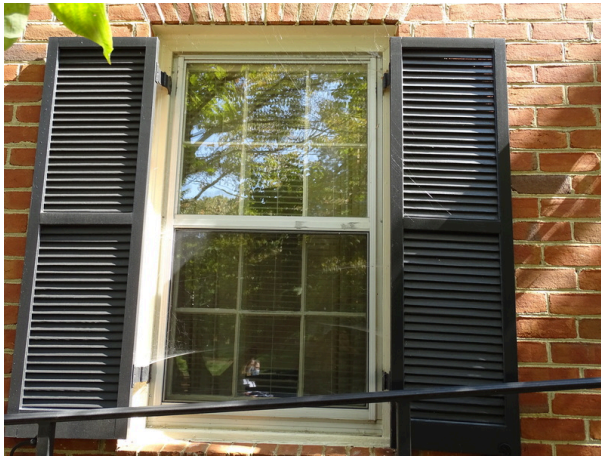
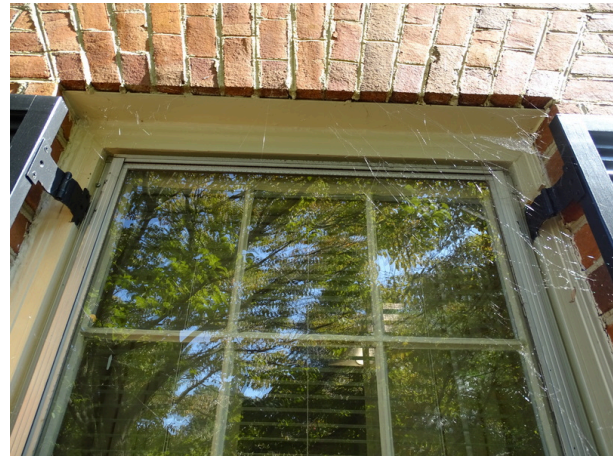
The window system for the building primarily consists of Vinyl frame double pane - operable window units. The expected useful life of windows is typically 30 years. The window units were in generally in good condition.

Typical exterior window

Typical exterior window condition

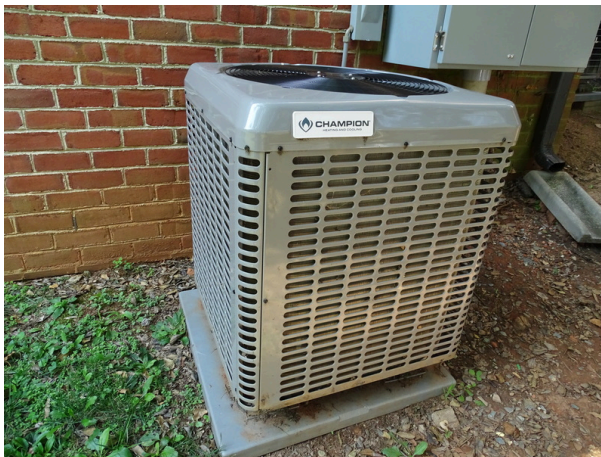
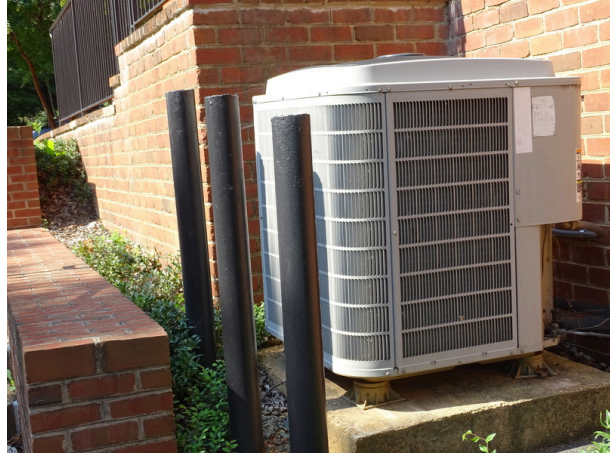
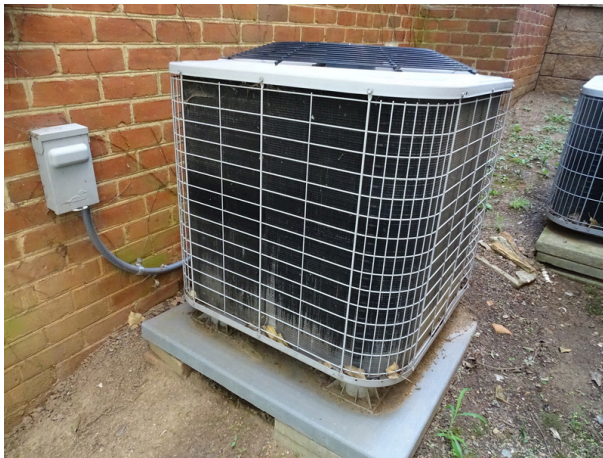
Condenser Unit

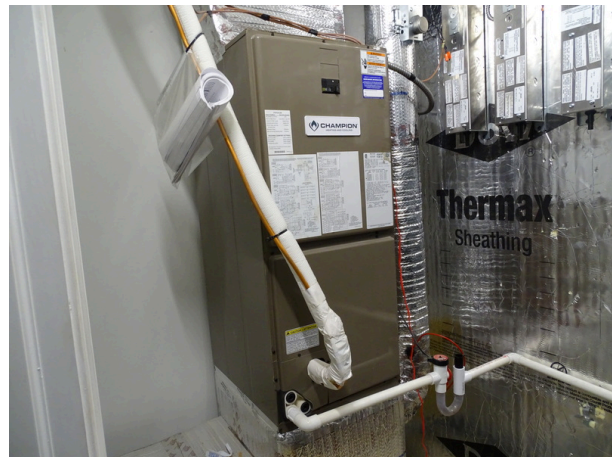
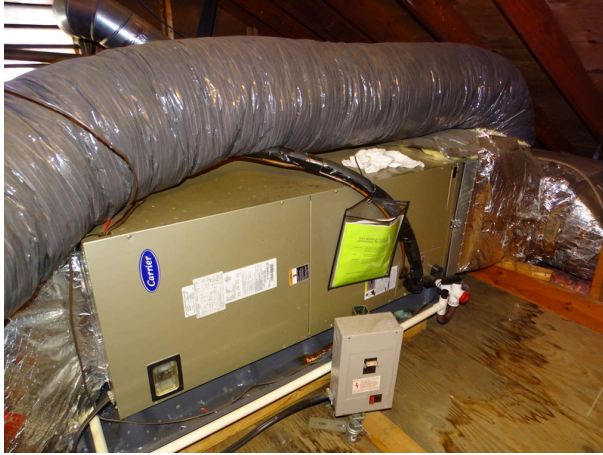
Two heat pump air handler units were located in the lower level and one in the attic. The air handlers were manufactured by Bryant, Champion, and Carrier in various ages. The expected useful life of an air handler is 15 years with proper maintenance. The air handlers were observed to be in good to fair condition. We recommend that the air handlers be replaced during the report period.

Air Handler Unit

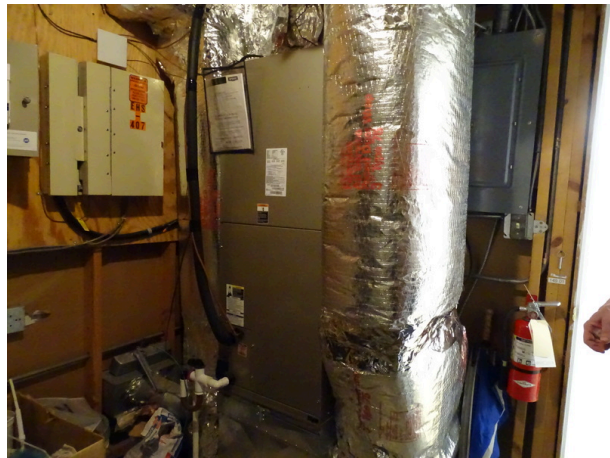
Typical mechanical duct

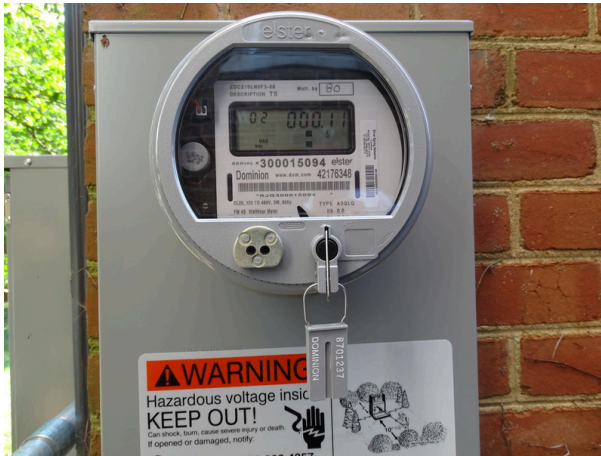
Digital electric meter

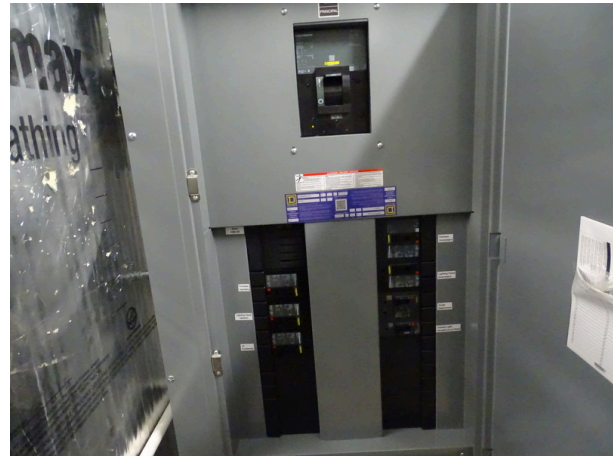
Main electrical disconnect

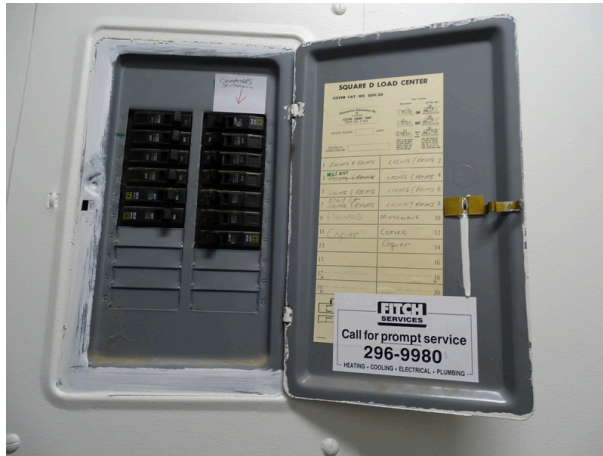
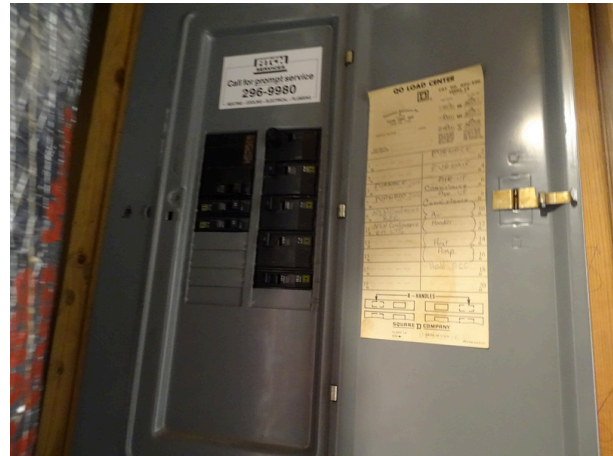
Power is distributed by copper wire from smaller circuit breaker panels manufactured by Square D located throughout the building. The Square D panels are in generally good condition.

Electrical panel

Typical circuit breaker panel manufactured by
Square D

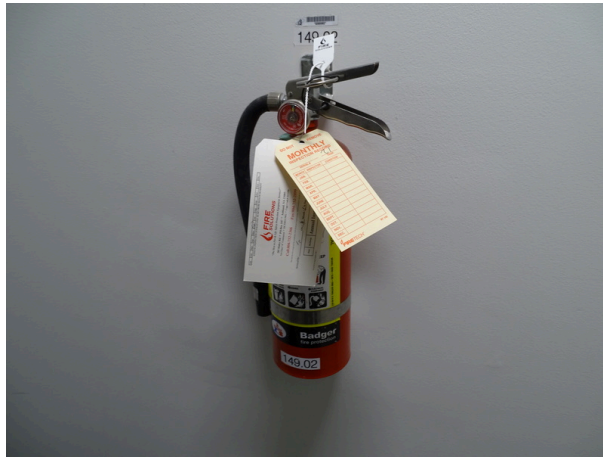
The fire suppression system consists of Fire extinguishers. The fire suppression system was observed but not tested. Fire extinguishers were observed throughout the building. The fire extinguishers were observed to have inspection tags issued by Fire Solutions in June 2021. These devices are required to be inspected annually.

Fire extinguisher

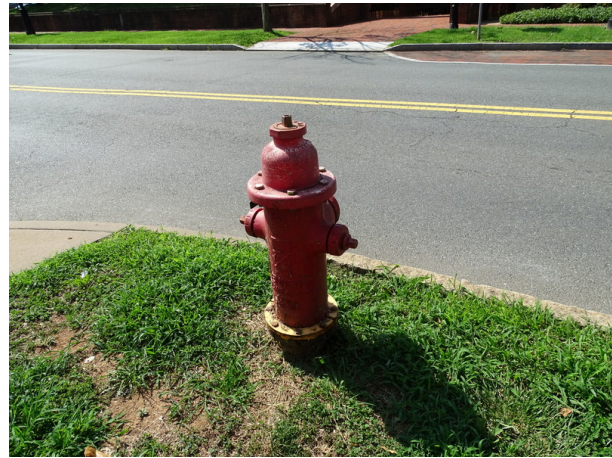
Fire hydrant

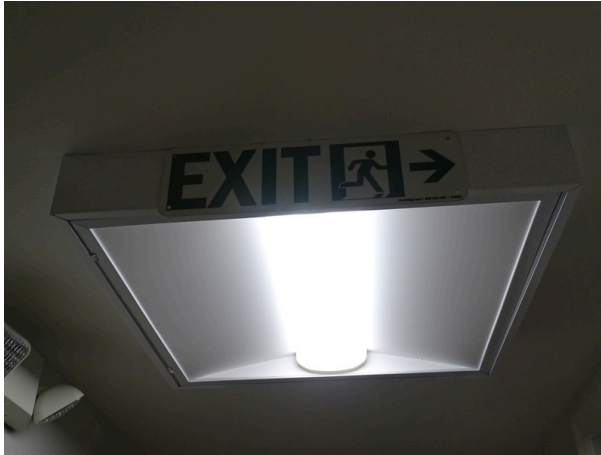
The smoke alarm system was observed but not tested. Smoke detectors, exit signs, and emergency lighting are located throughout the building. The fire alarm systems were generally in good condition.

Typical exit sign

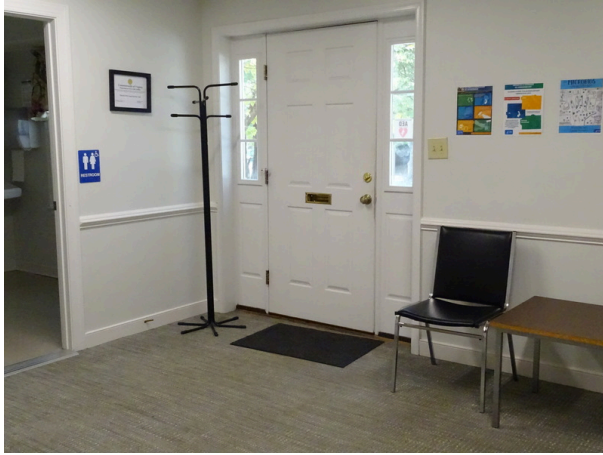
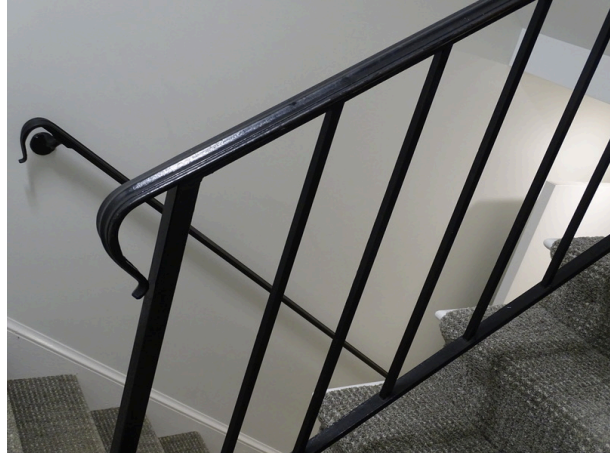
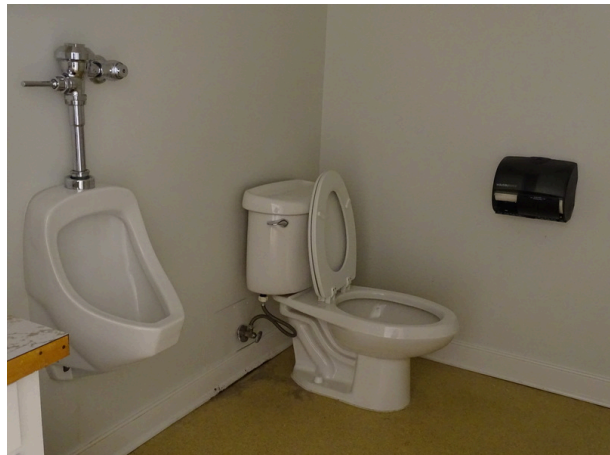
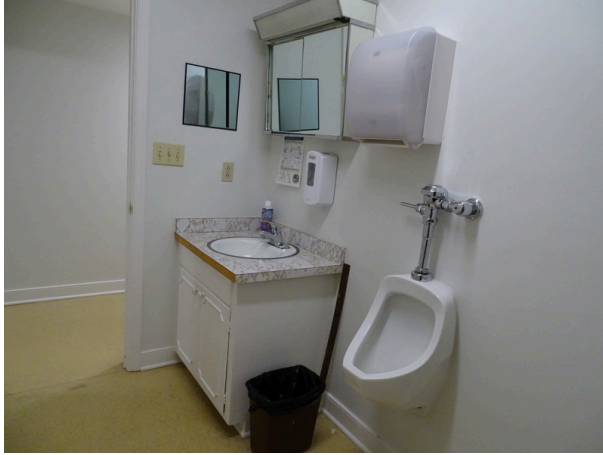
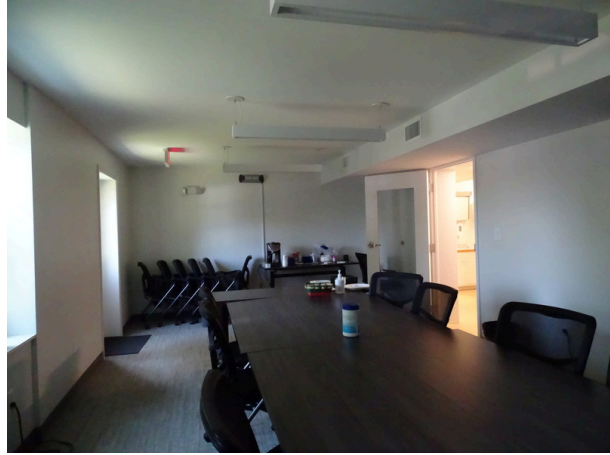
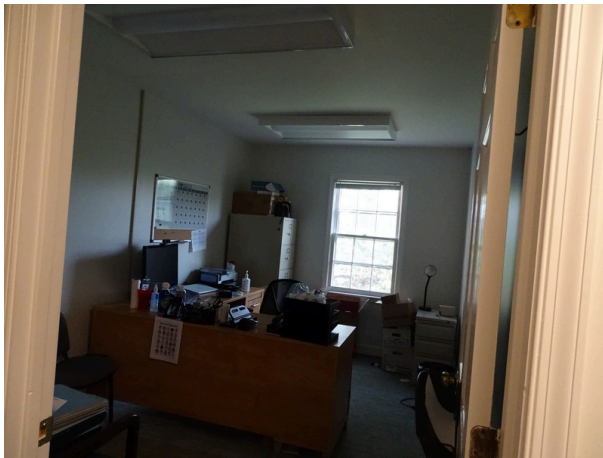
The finishes in the corridor areas include ceramic tile floors, and painted r gypsum board walls and painted gypsum board ceilings. The finishes in the corridor areas were observed to be in generally good condition.

Interior finishes entrance area

Typical handrail stair

Typical stair

Typical men's restroom

Typical meeting room

Typical office interior

Typical corridor interior

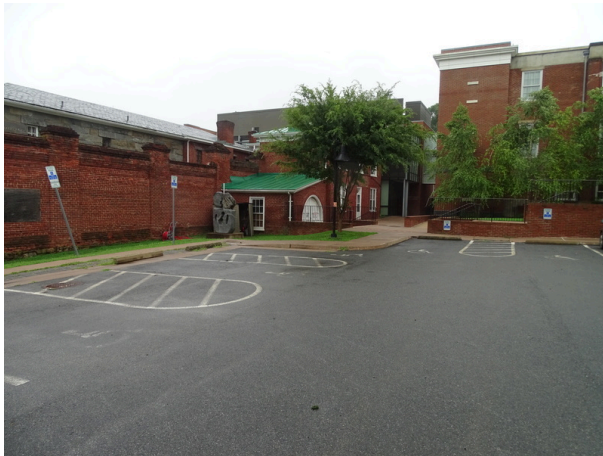
Accessible parking

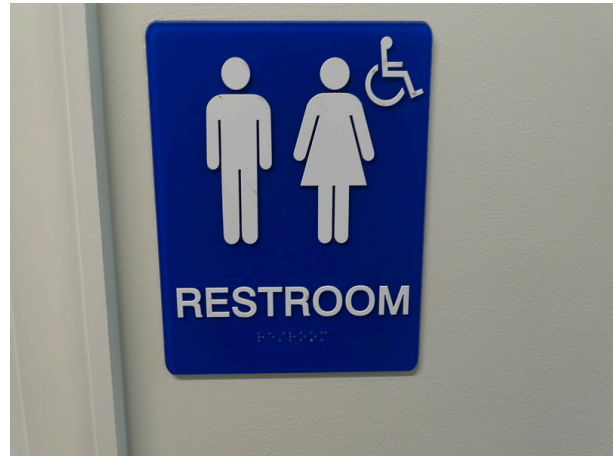
Accessible restroom sign

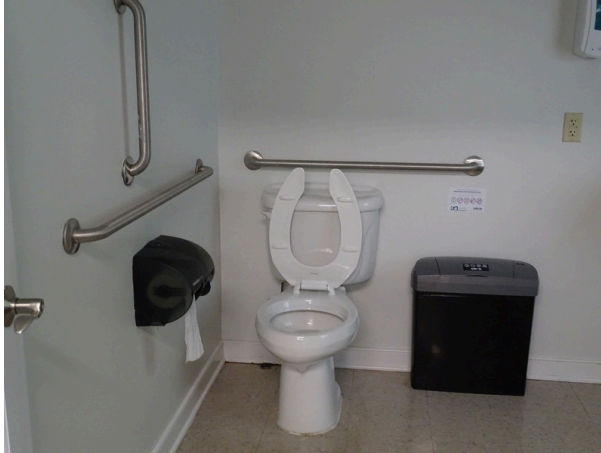
The building contains accessible toilets.

Accessible restroom

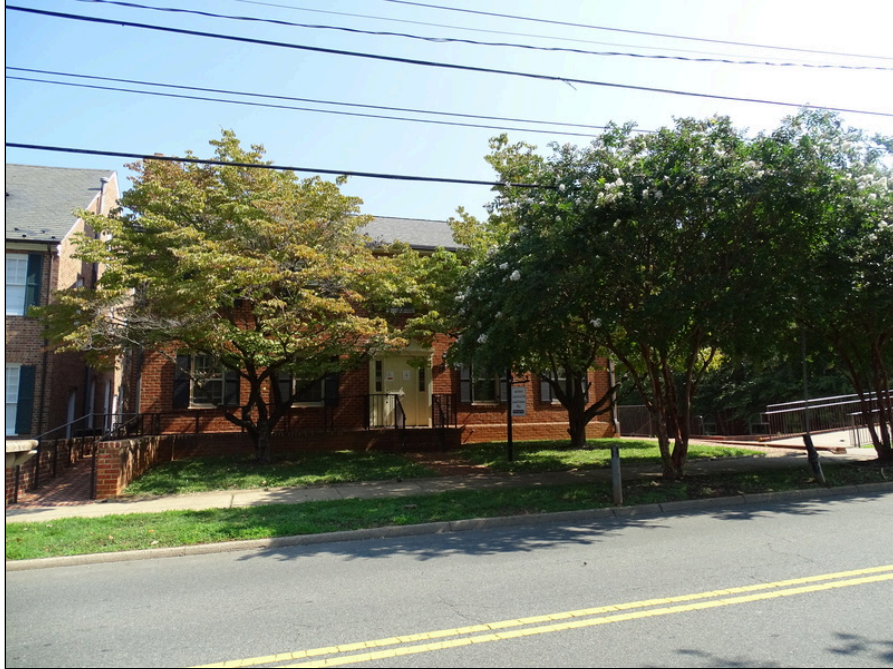
1 - Preston Morris Building

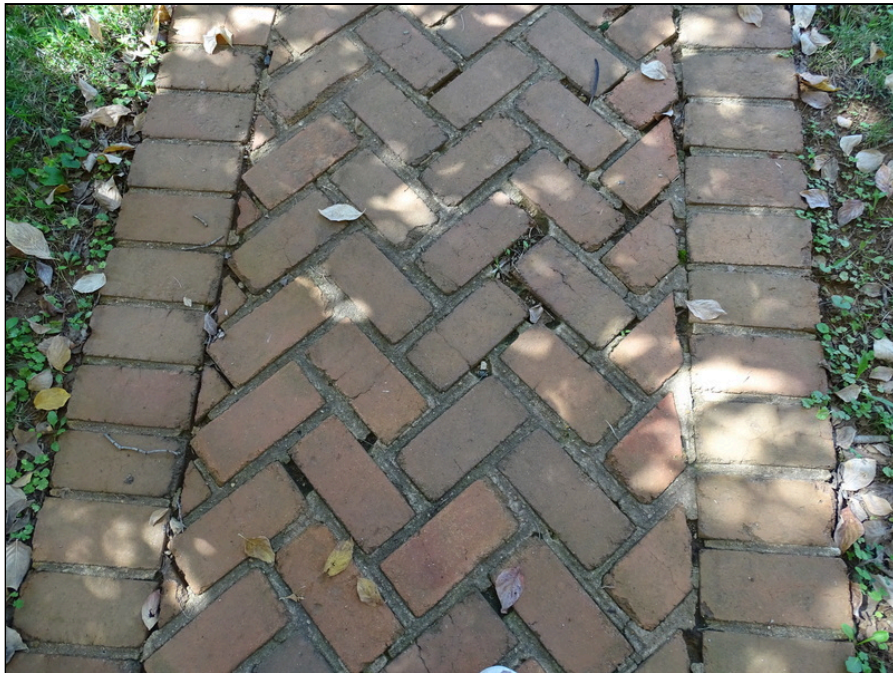
2 - Brick ramp at southwest side of the building

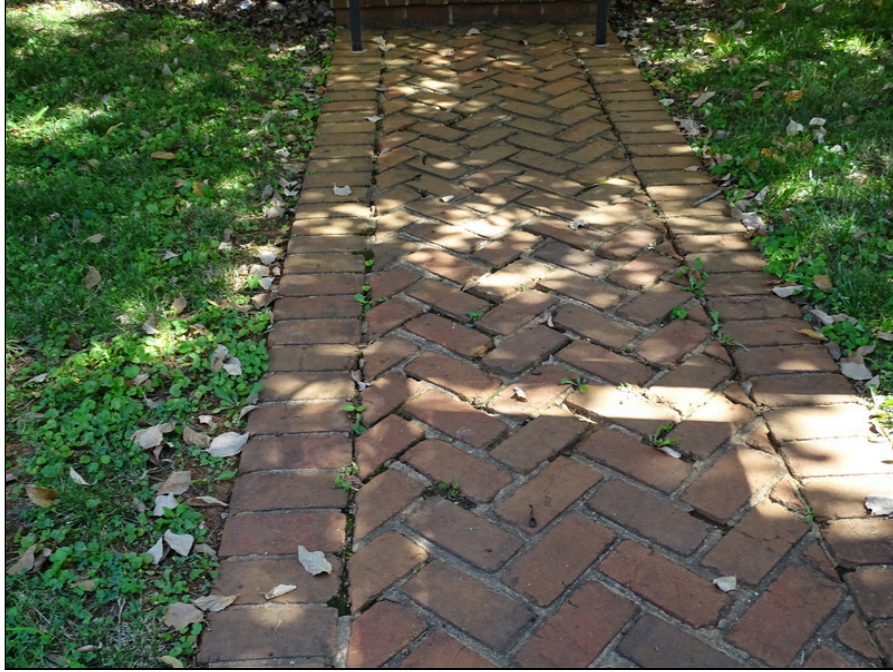
3 - Brick sidewalk south side of the building

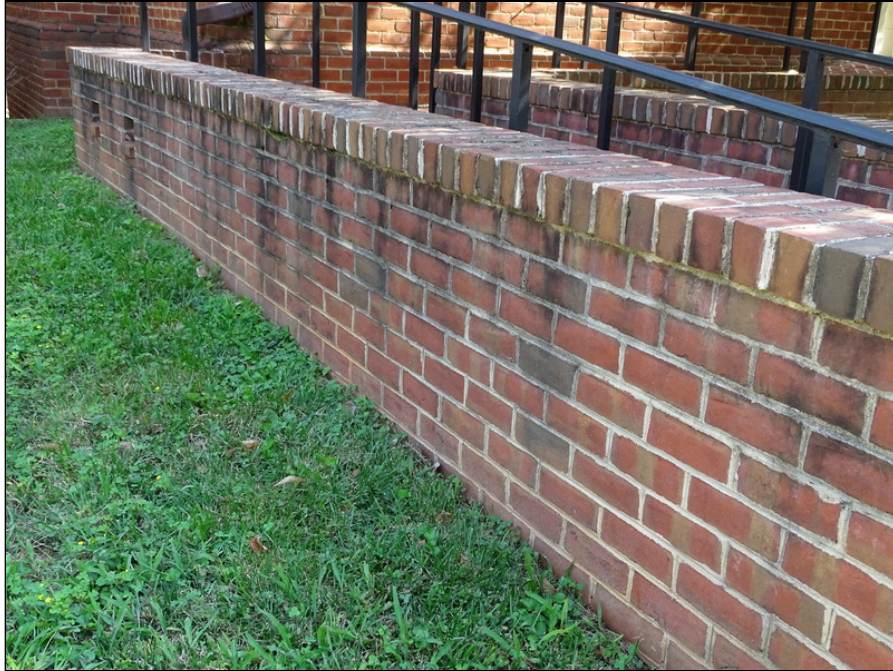
5 - Brick work retaining wall condition

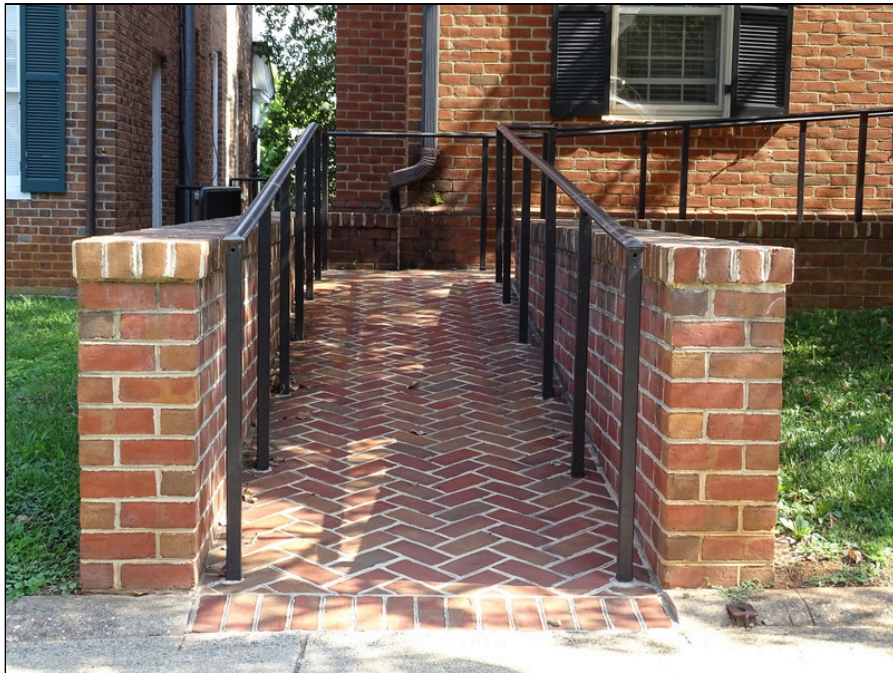
6 - Brick ramp at southwest side of the building

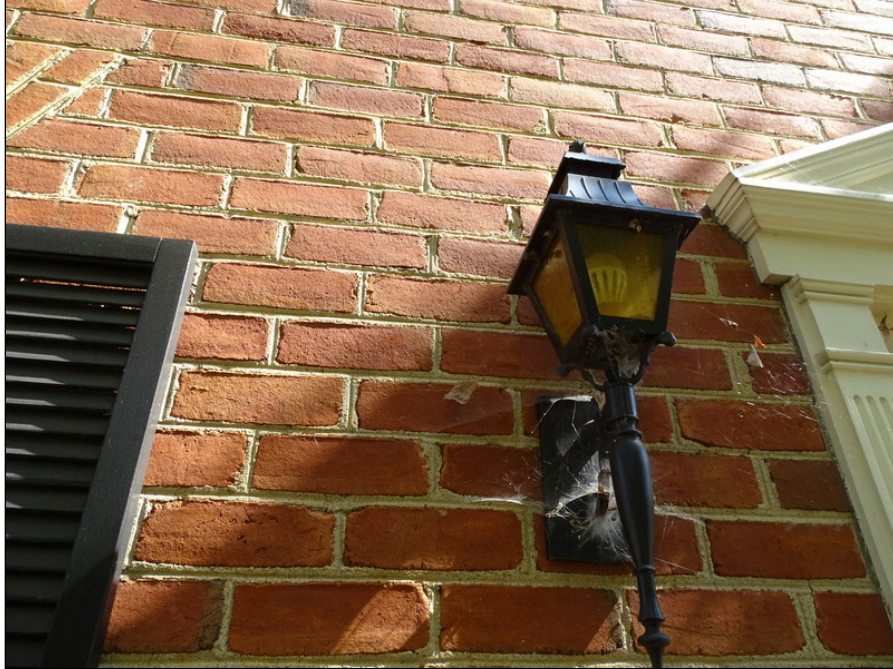
9 - Building mounted light

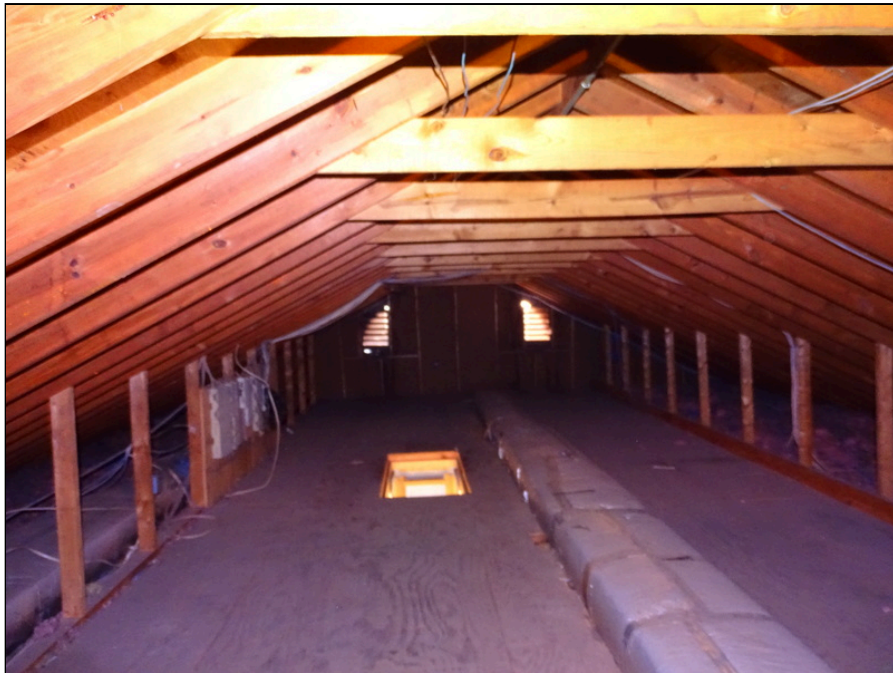
12 - Structural framing

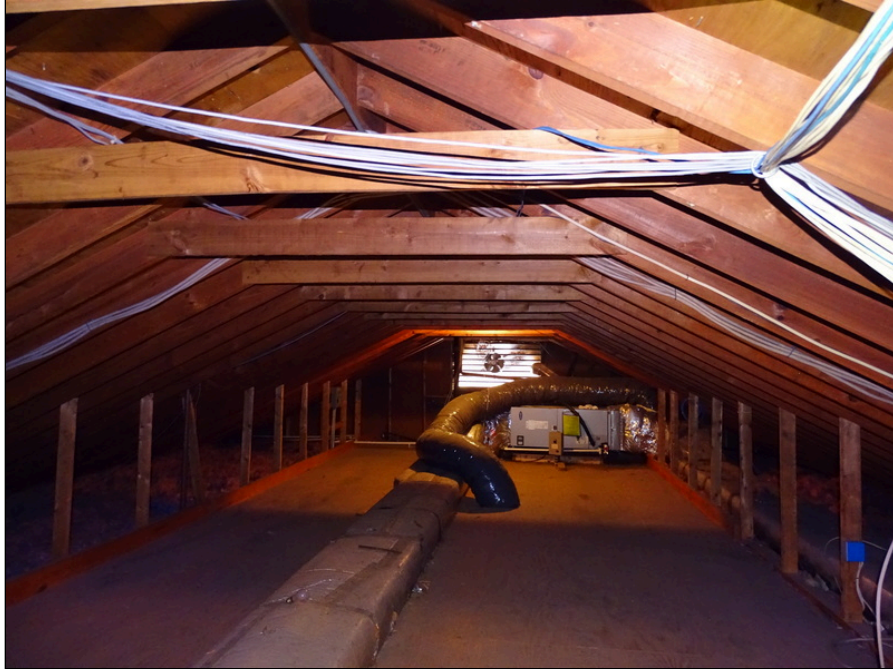
13 - Structural framing

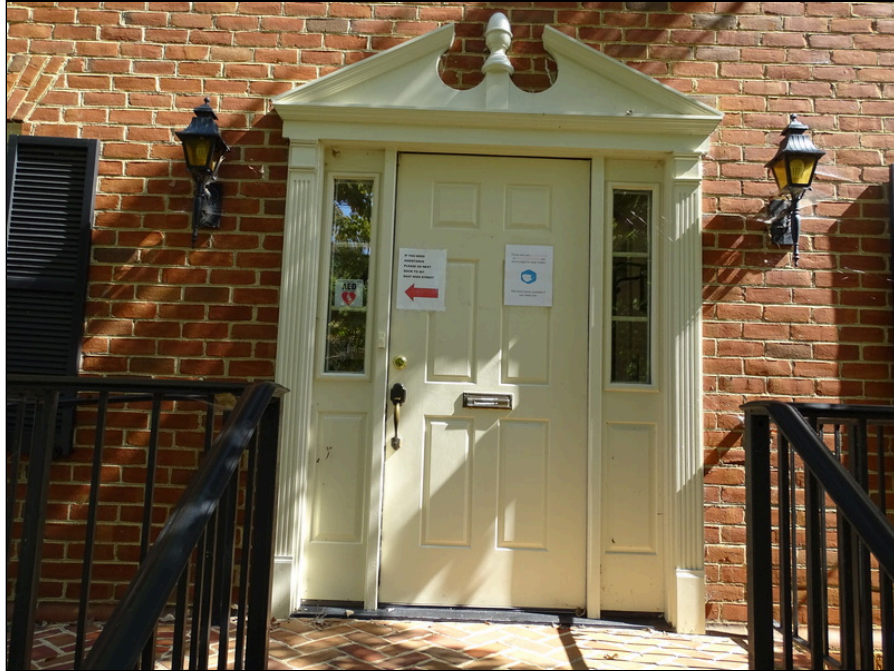
19 - Main entrance door

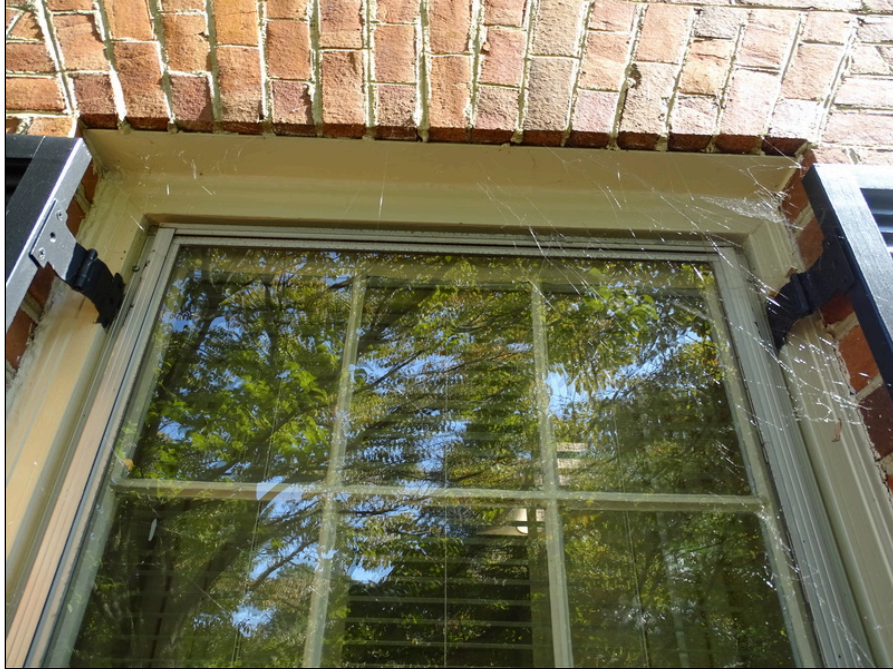
23 - Typical exterior window condition

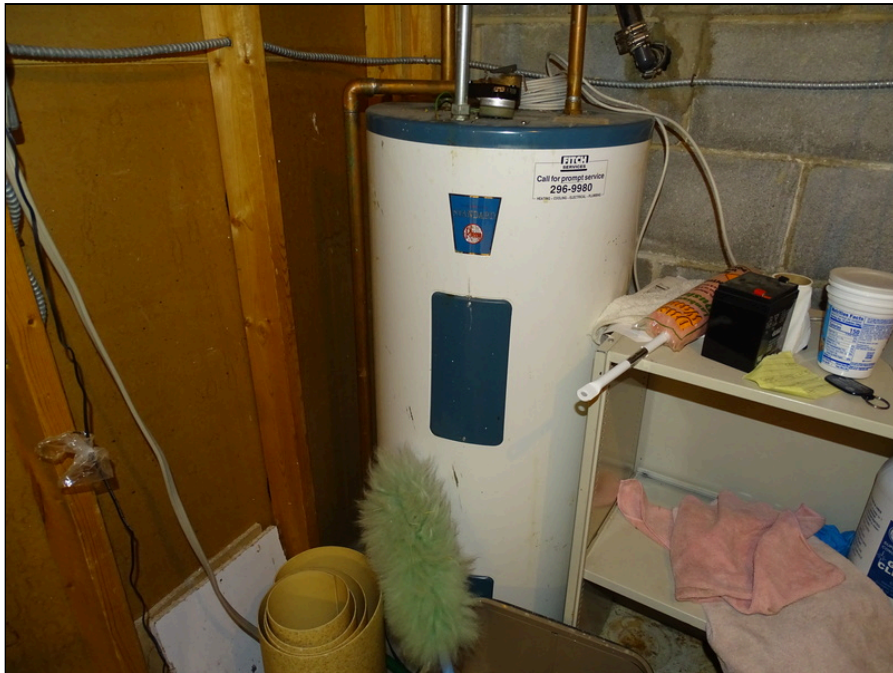
24 - Electric domestic water heater

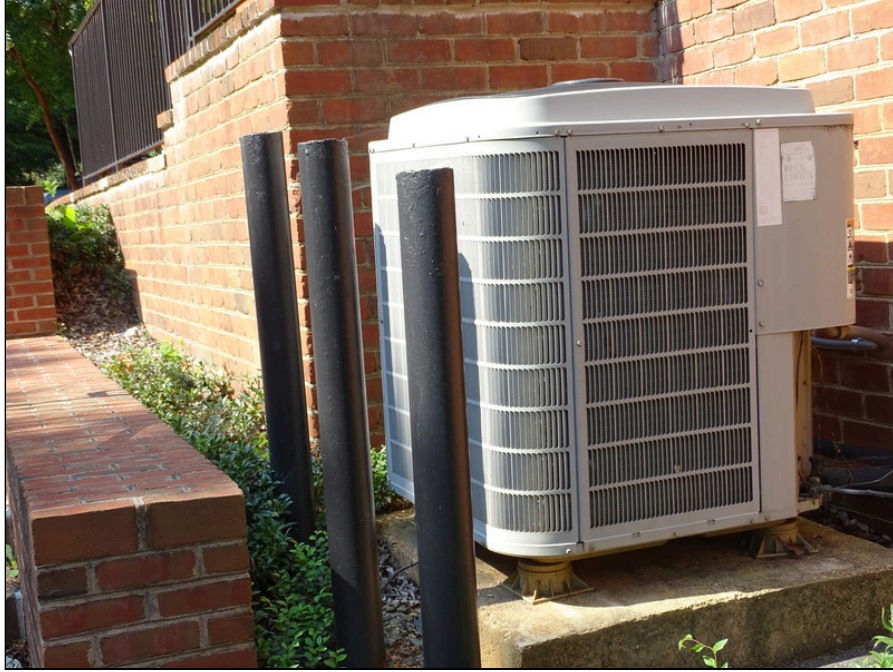
25 - Condenser Unit

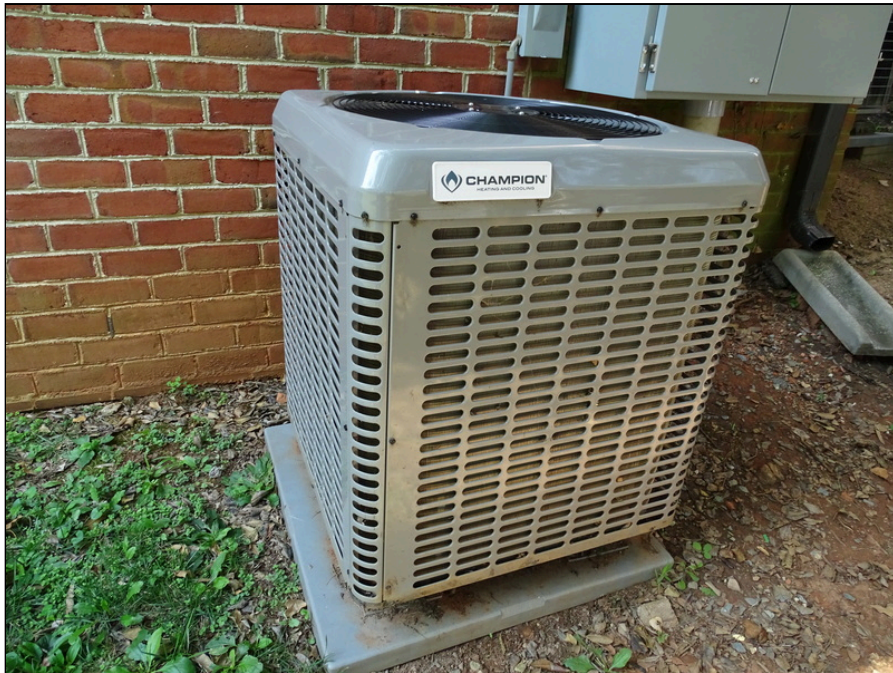
26 - Condenser Unit

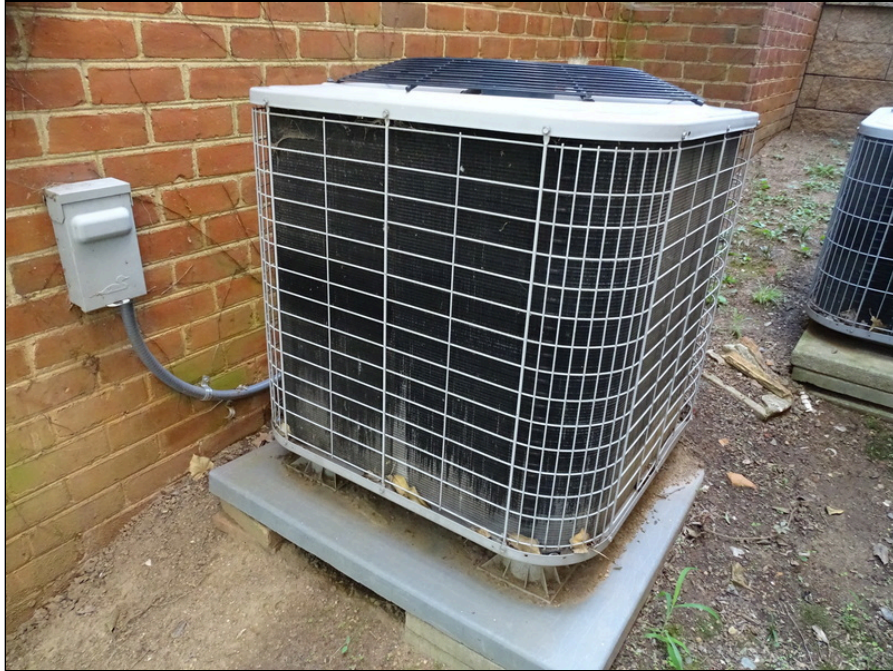
27 - Condenser Unit

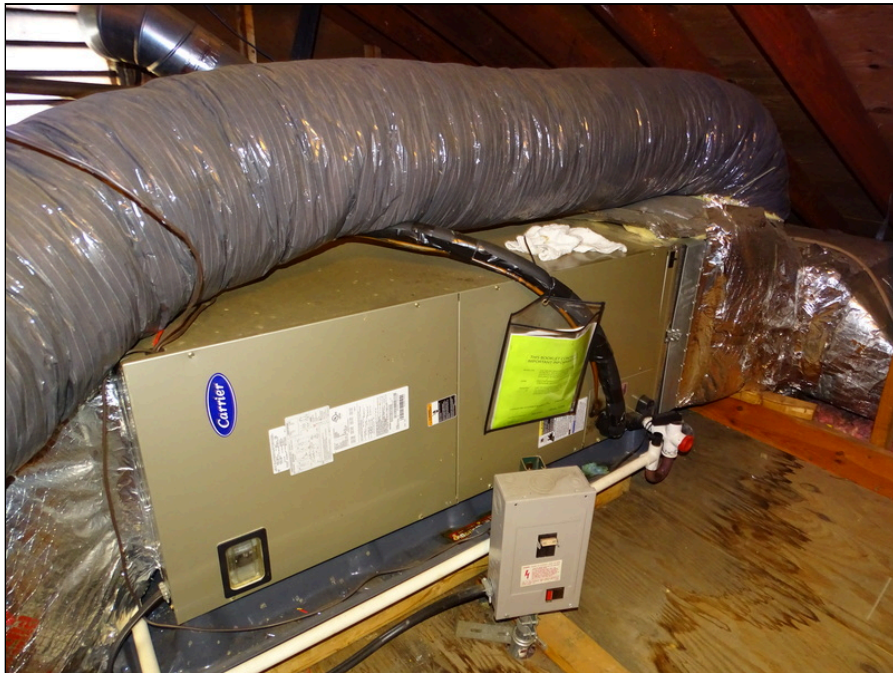
28 - Air Handler Unit

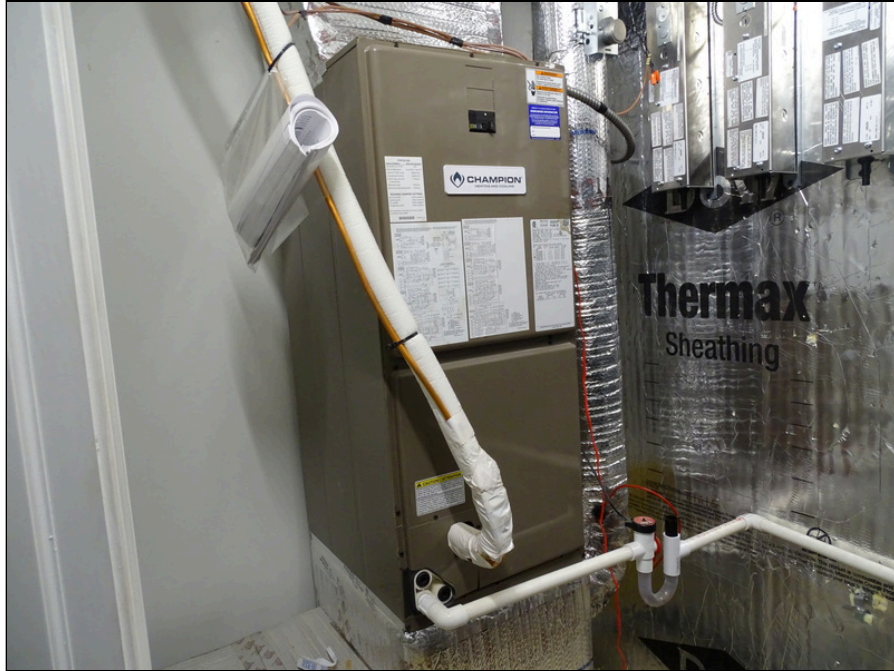
29 - Air Handler Unit

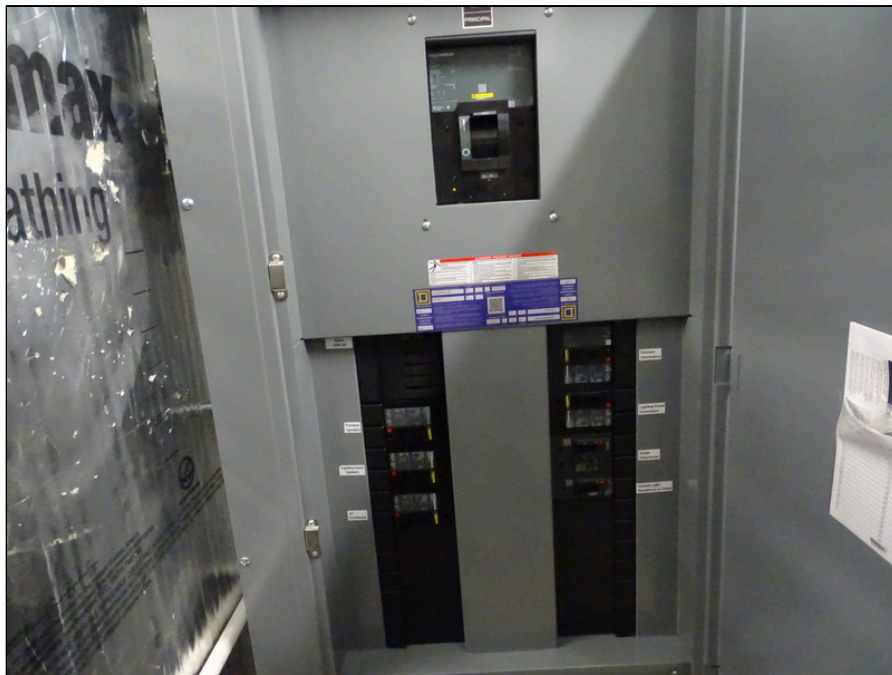
34 - Main electrical disconnect

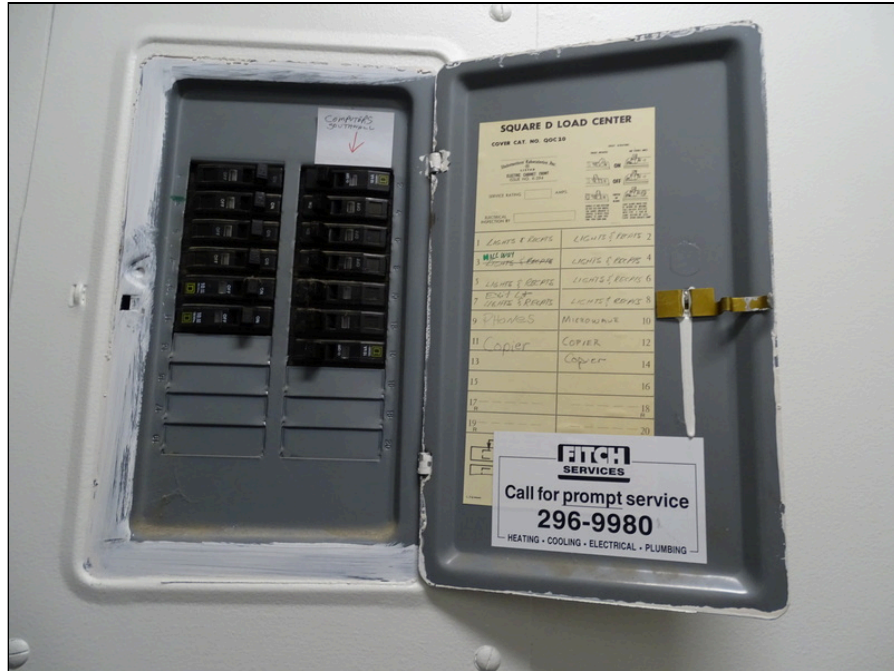
35 - Electrical panel

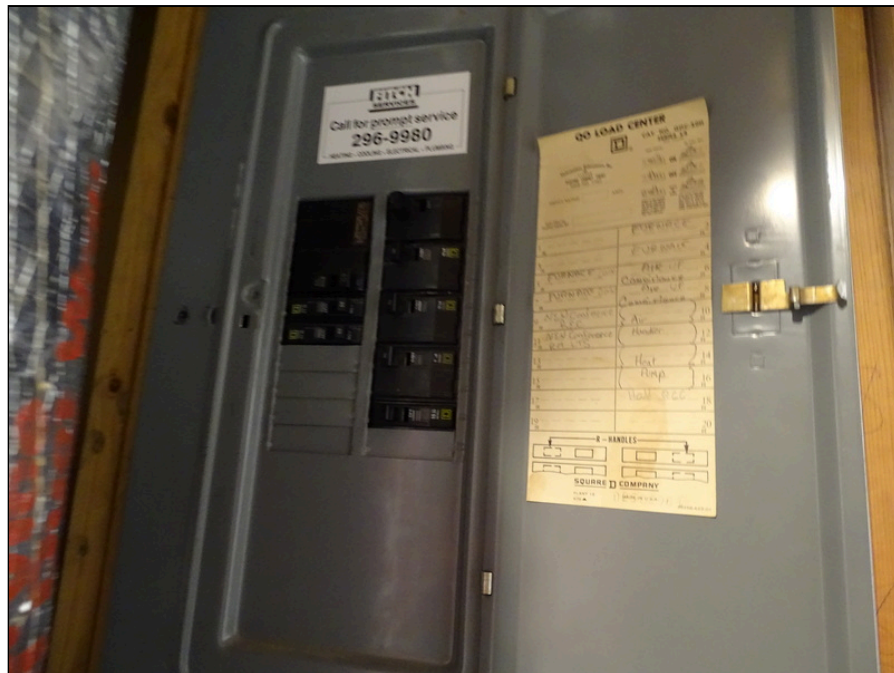
36 - Typical circuit breaker panel manufactured by Square D

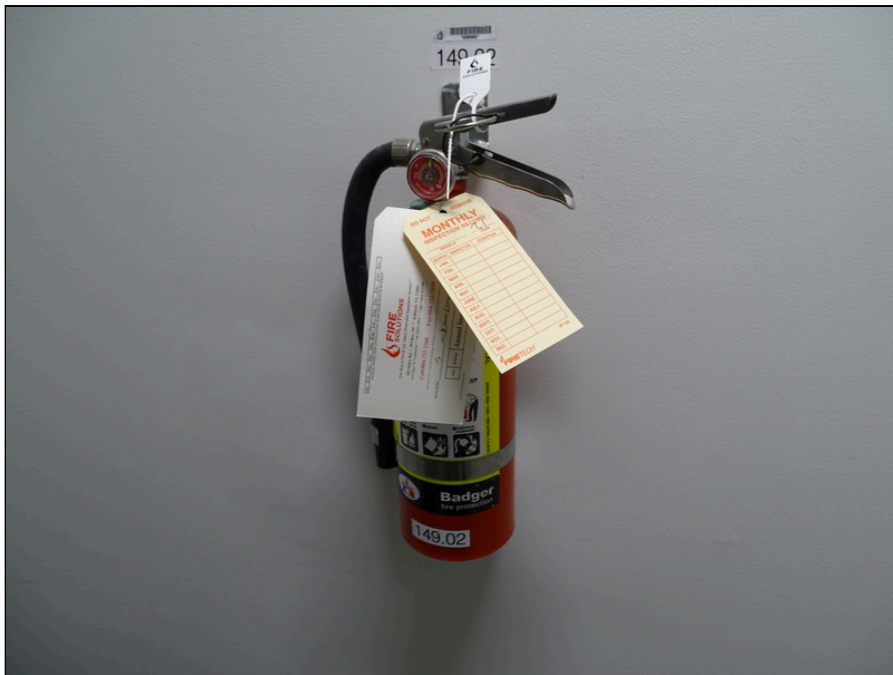
38 - Fire extinguisher
