PRESTON MORRIS BUILDING
407 EAST HIGH STREET
CHARLOTTESVILLE, VIRGINIA

ECS PROJECT NO. 46:6713

CITY OF CHARLOTTESVILLE - FACILITIES DEVELOPMENT

Reference: Facility Condition Assessment Report for Preston Morris Building, 407 East High Street, Charlottesville, Virginia

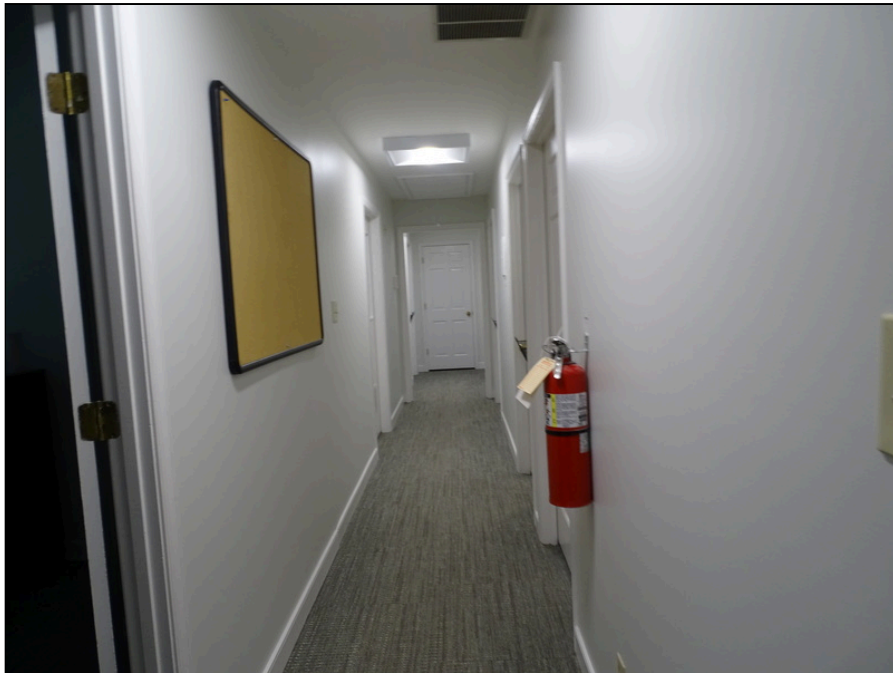
44 - Typical corridor interior

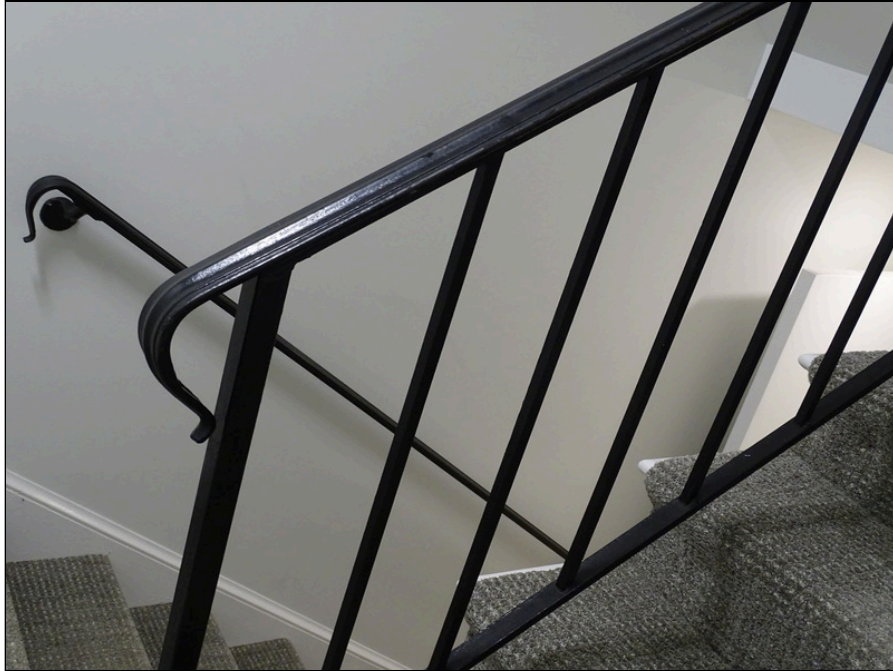
45 - Typical handrail stair

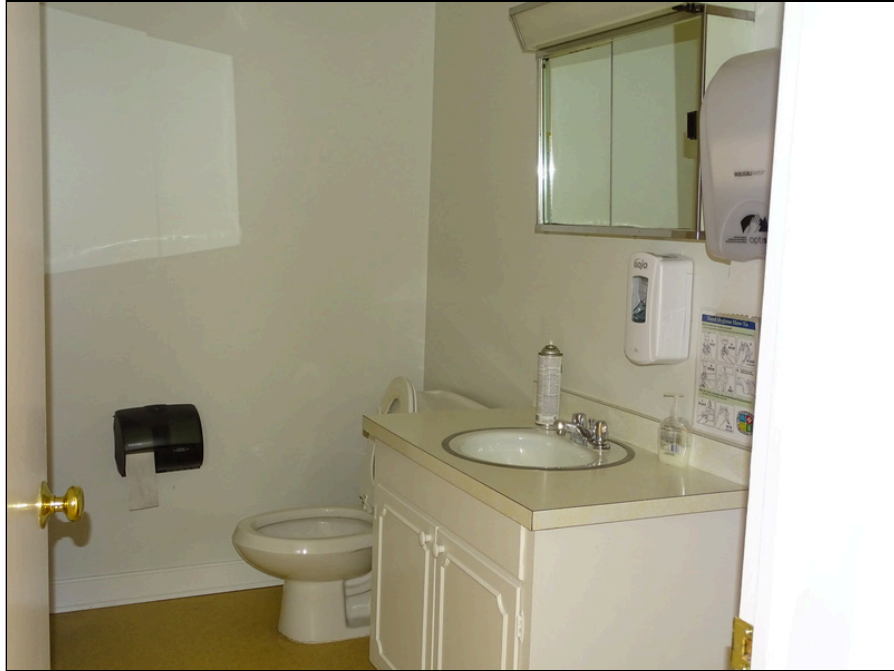
47 - Typical restroom interior

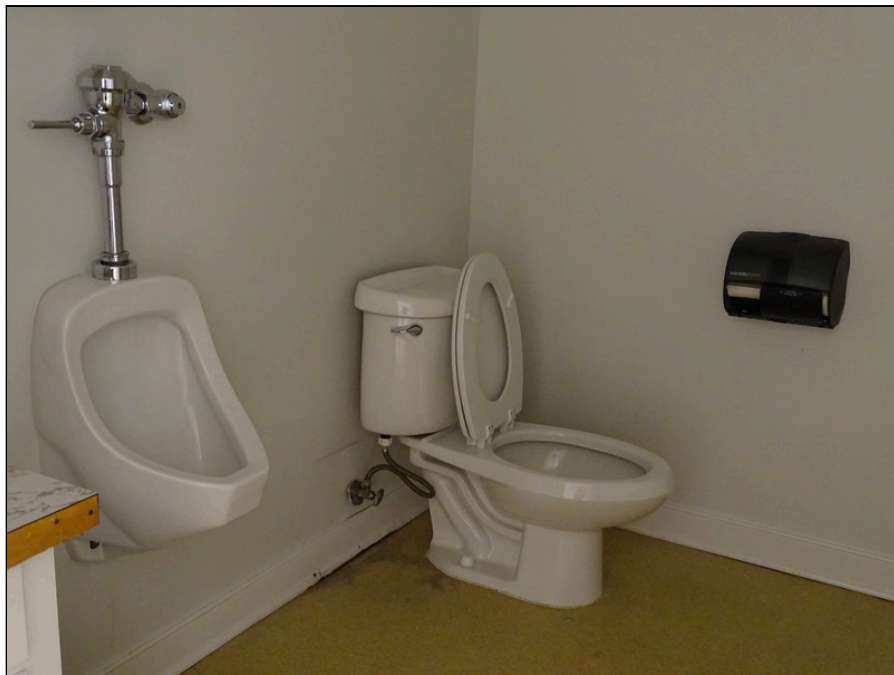
48 - Typical men's restroom

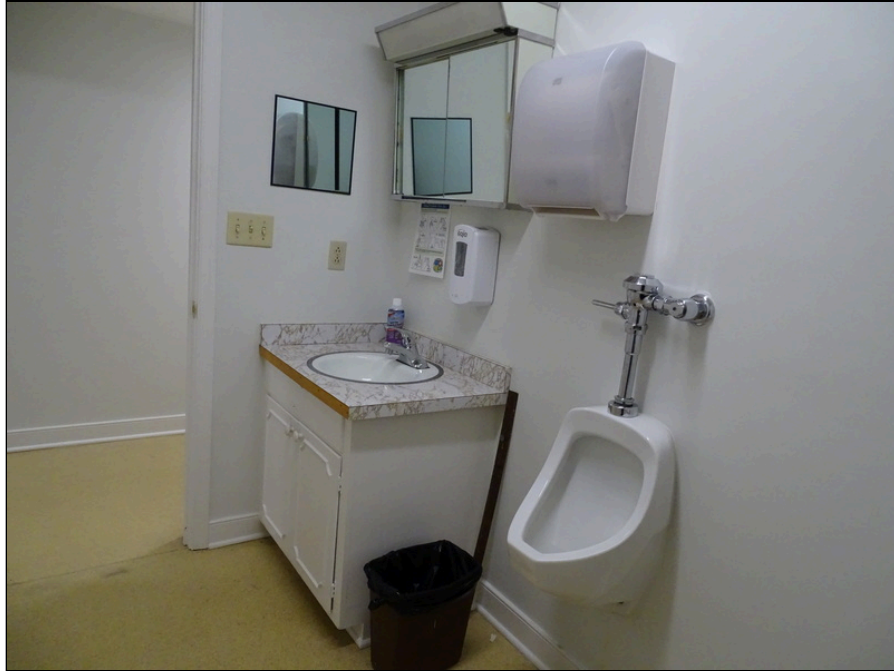
49 - Typical men's restroom

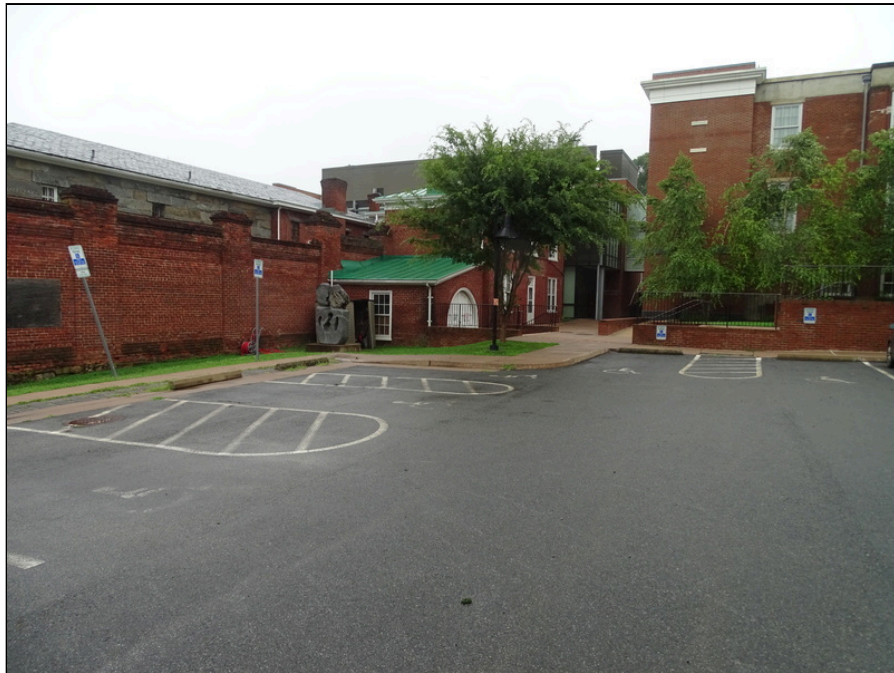
50 - Accessible parking

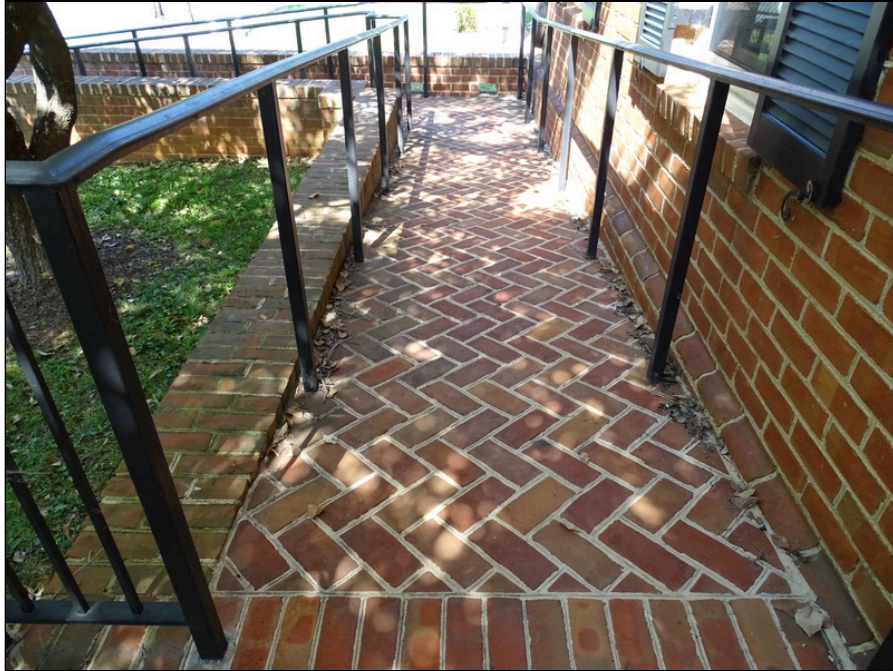
51 - Accessible brick ramp at southwest side of the building

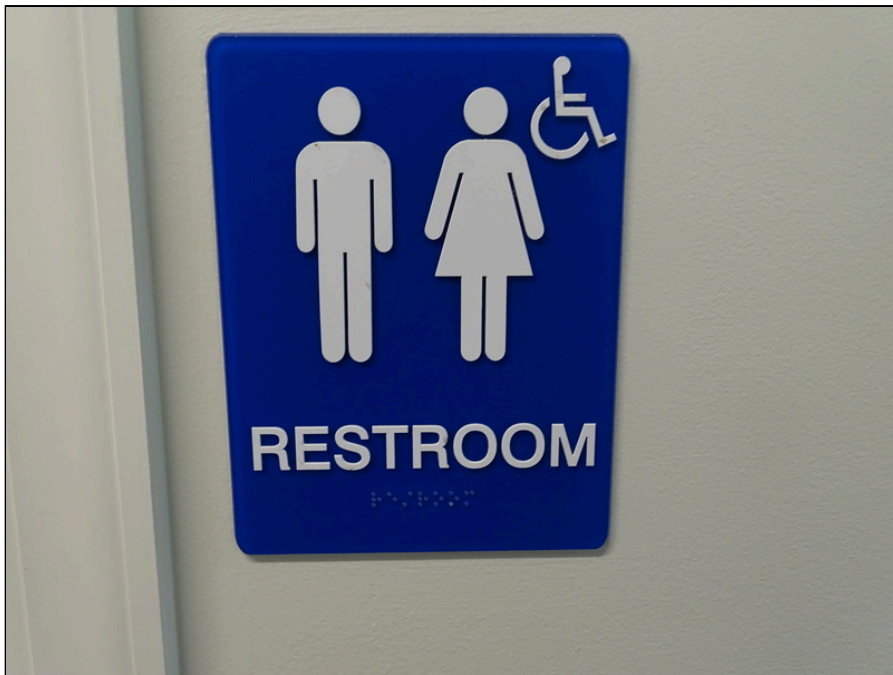
52 - Accessible restroom sign

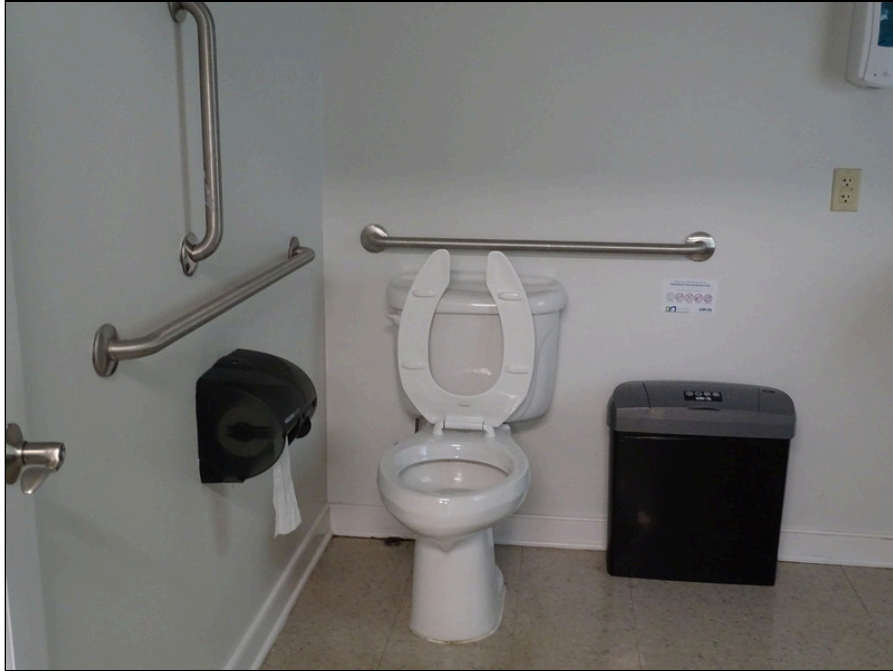
53 - Accessible restroom
