PUBLIC WORKS ADMINISTRATION BUILDING
305 4TH STREET NW
CHARLOTTESVILLE, VIRGINIA

ECS PROJECT NO. 46:6713

CITY OF CHARLOTTESVILLE - FACILITIES DEVELOPMENT

Reference: Facility Condition Assessment Report for Public Works Administration Building, 305 4th Street NW, Charlottesville, Virginia

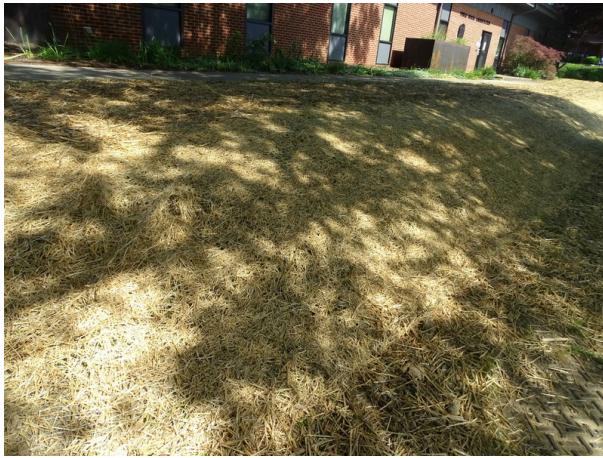
Topography

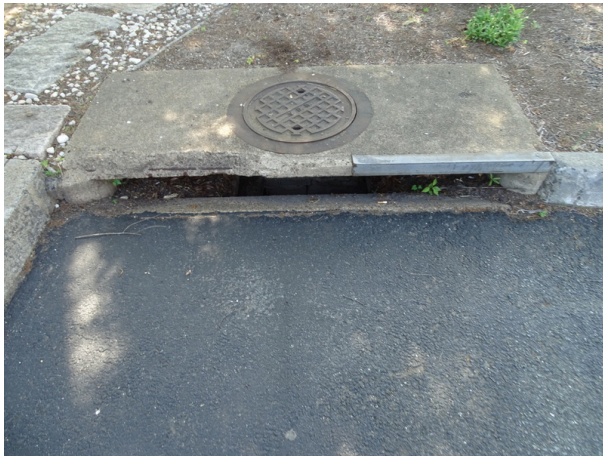
Typical drainage

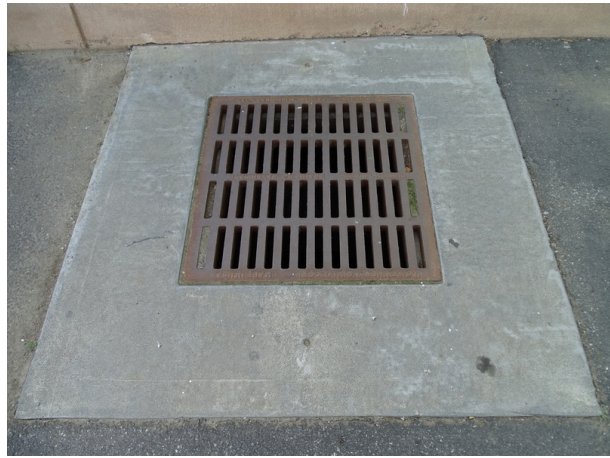
Typical drainage

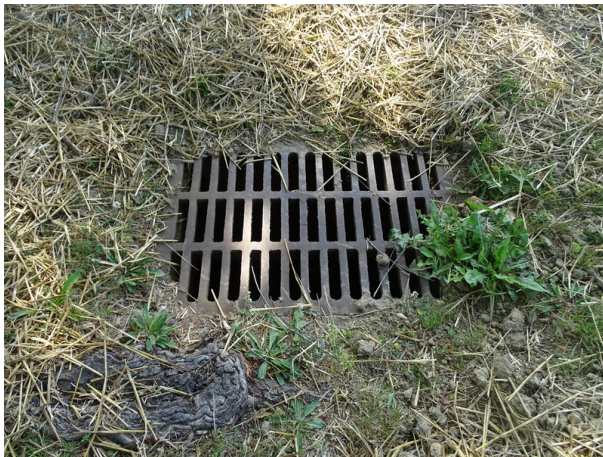
Typical yard inlet drainage

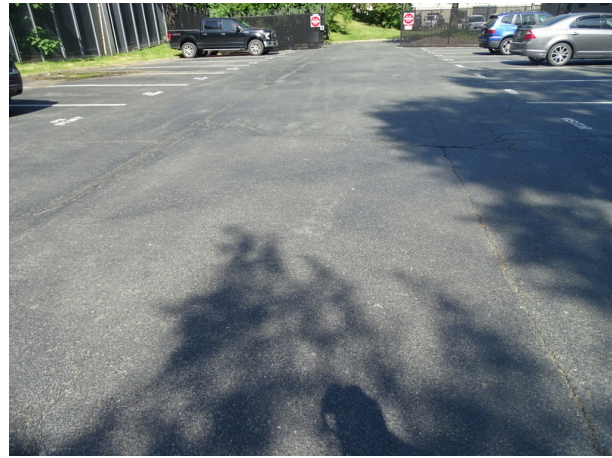
Asphalt pavement drive lane

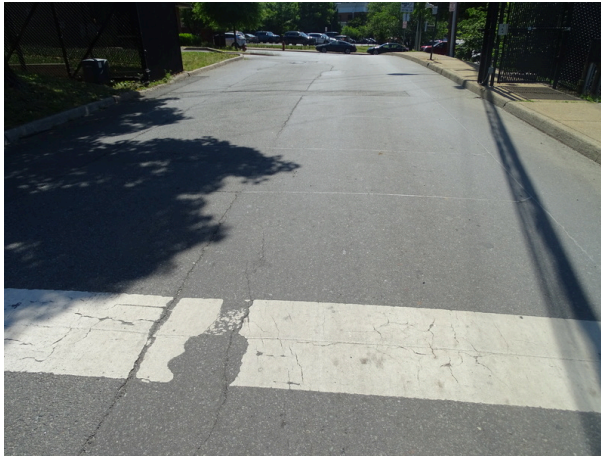
Asphalt pavement drive lane

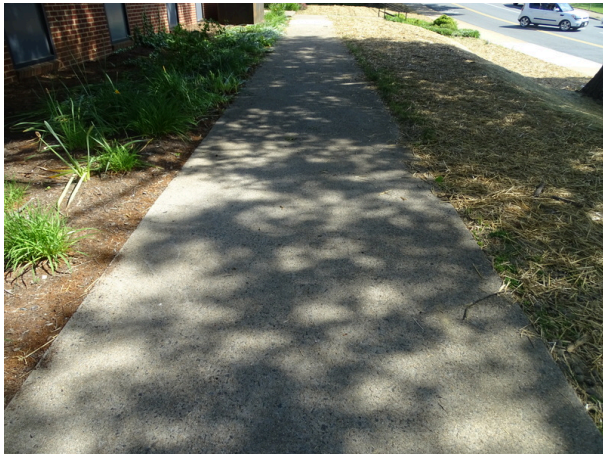
Concrete sidewalk east side of the building

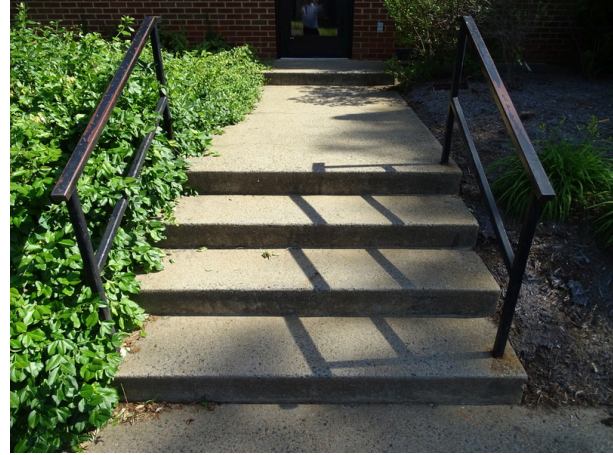
Painted steel handrails were provided at the exterior stairs. The paint was observed in fair condition with peeling and chipping noted. We recommend repainting the railings as a maintenance item.

Concrete steps south side of the building

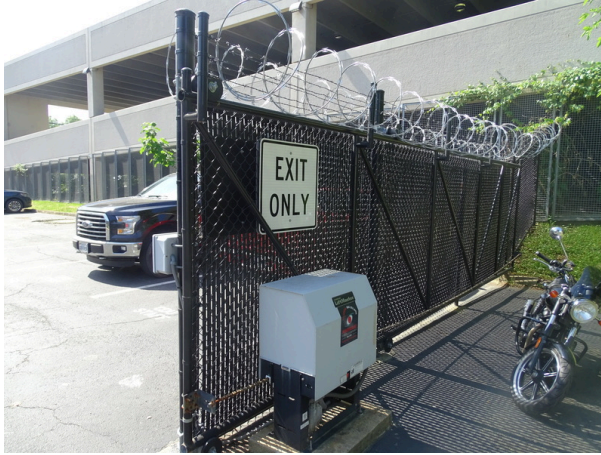
A chain link fence and electric operated gate are located on the south side of the building. The chain link fence and gate were generally in good condition.

Chain link fence and gate on the south side of the building

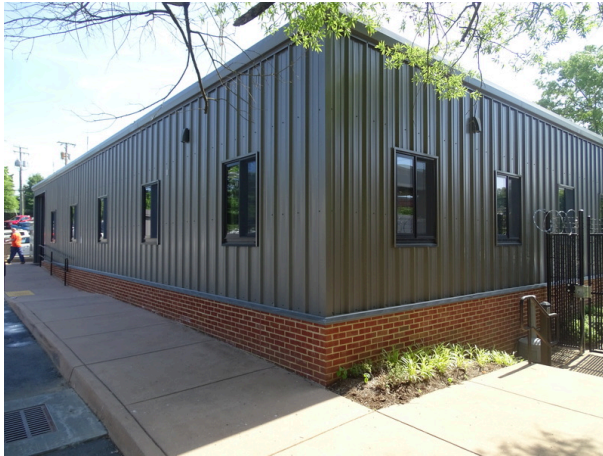
Building exterior west side of the building

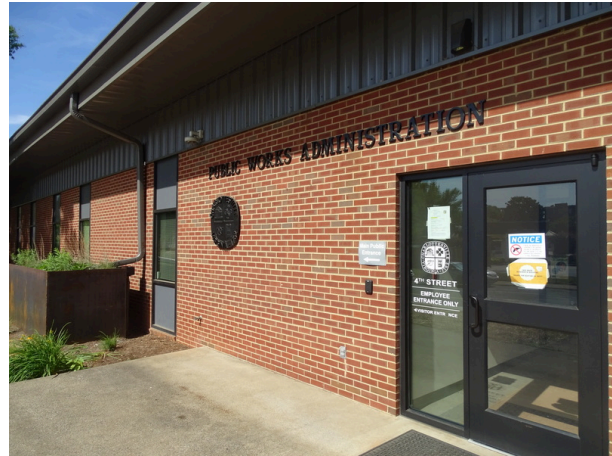
Typical building exterior

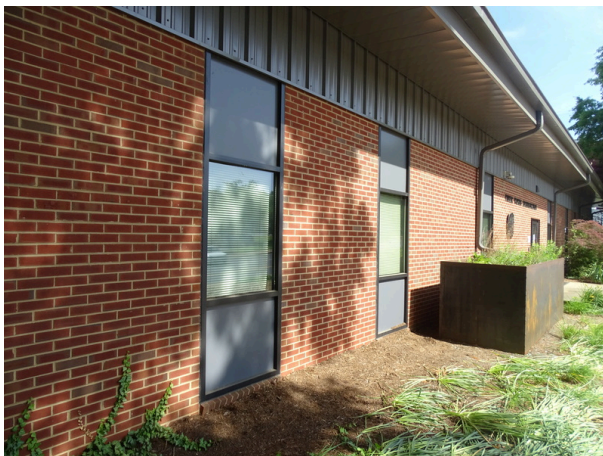
Typical building exterior

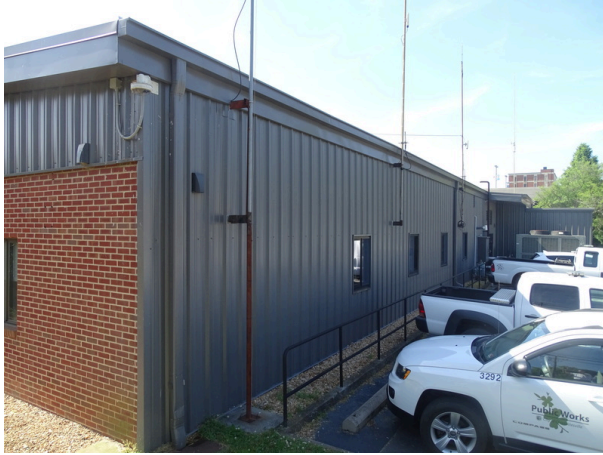
Building exterior west side of the building

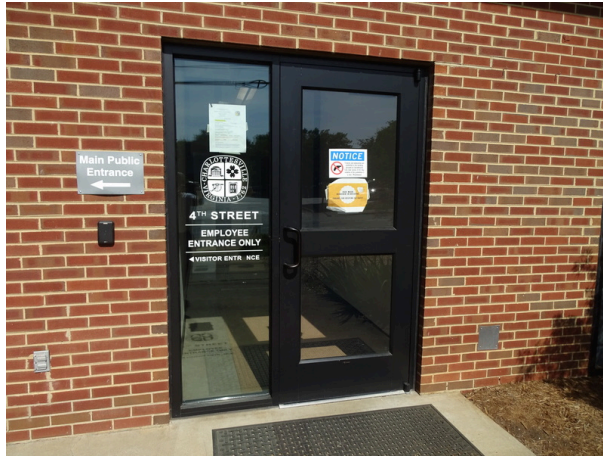
The main entrances are Storefront entrances. The main entrance doors were generally in good condition. Personnel doors are located at around the building. The personnel doors were generally in good condition. Exterior doors typically have an expected useful life of 20 to 30 years.

Storefront entrance east side of the building

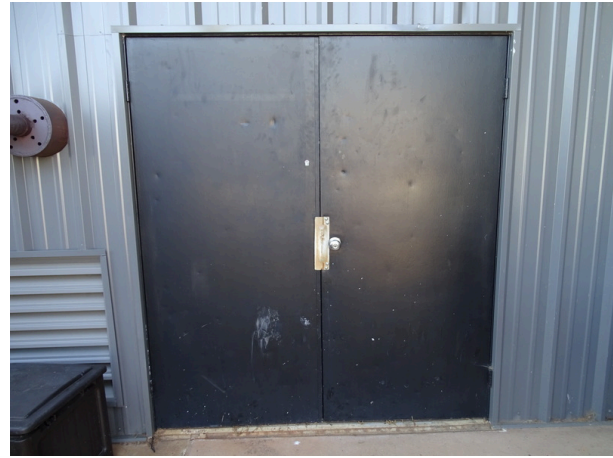
Typical personnel doors

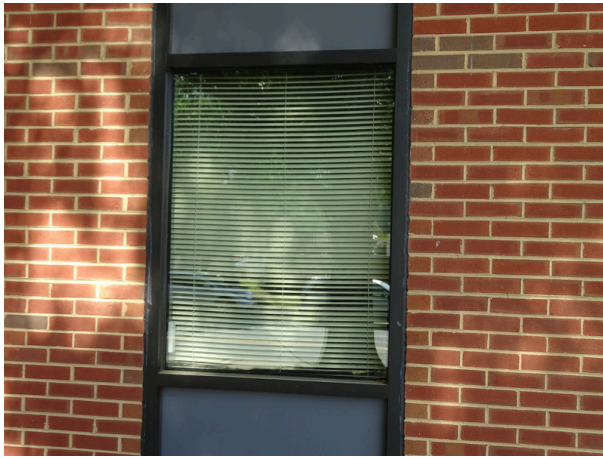
The window system for the building primarily consists of Aluminum frame double pane window units. The gaskets in the windows were generally in good condition. The expected useful life of gaskets is typically 20 years.

Typical exterior window

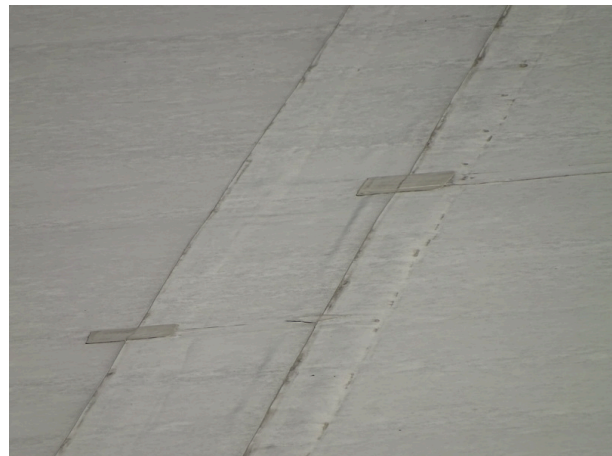
Typical patching

3.3.6 Roofing Systems																																
REPLACE SINGLE-PLY ROOFING SYSTEM	15	5	10	15,250	SF	\$14.00	\$213,500	100%										\$213,500												\$213,500

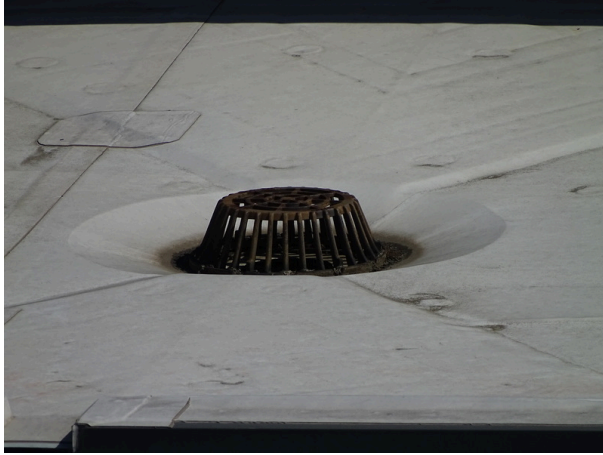
Typical internal drain

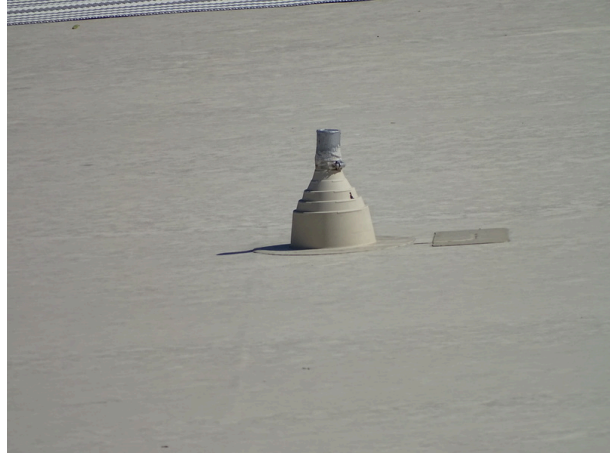
Typical plumbing penetration

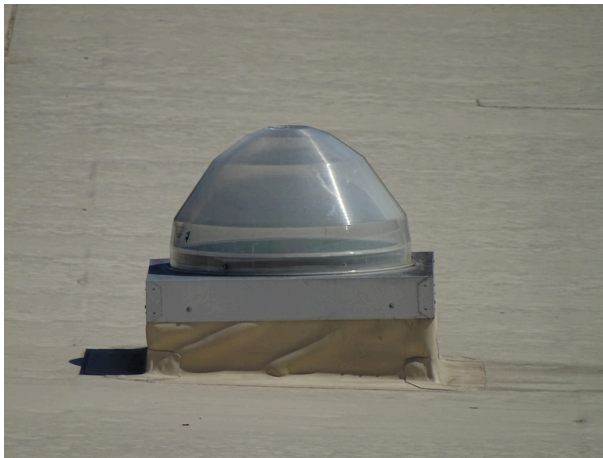
Typical skylight

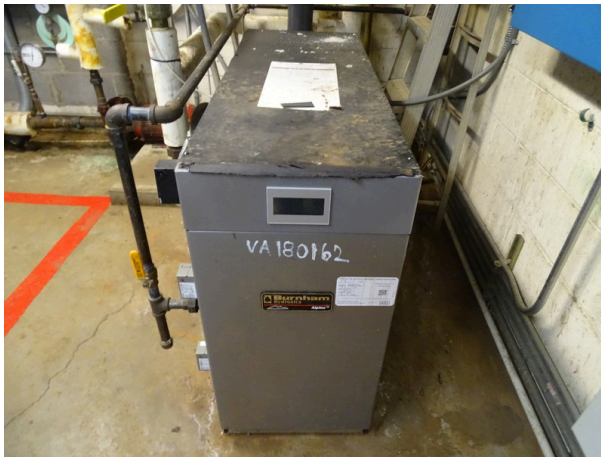
Boiler located in main utility room

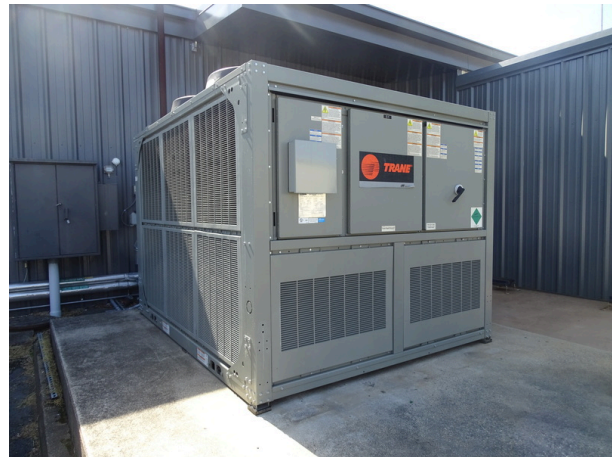
Chiller located at west side of the building

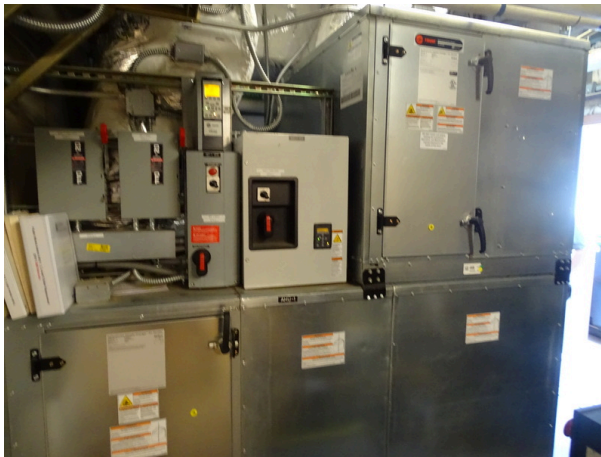
Air Handler Unit located in main utility room

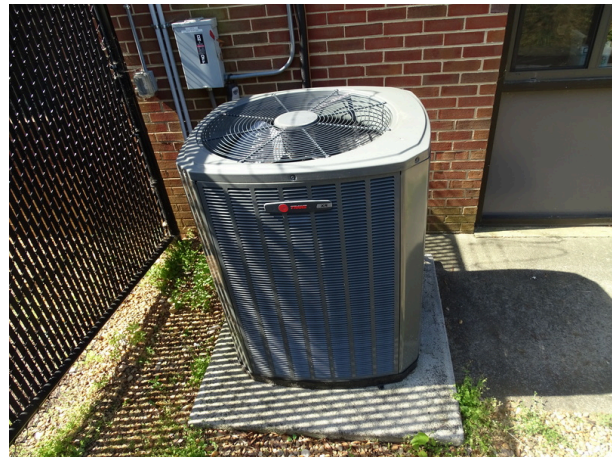
Condensers manufactured by Trane are located on the north side and south side of the building with installation dates of 2004 and 2015, respectively. Condensers have an expected useful life of 15 years and should be replaced during the study period based on their age.

Condenser located at north side of the building

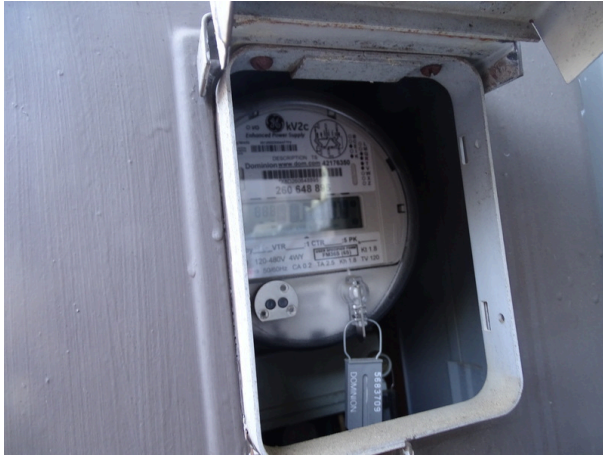
Typical electrical meter

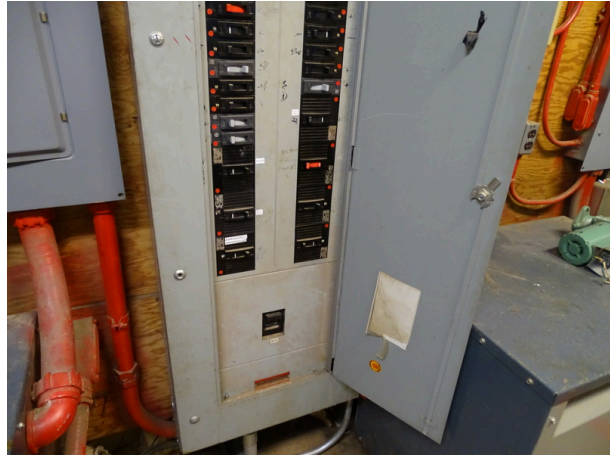
Main electrical switchgear

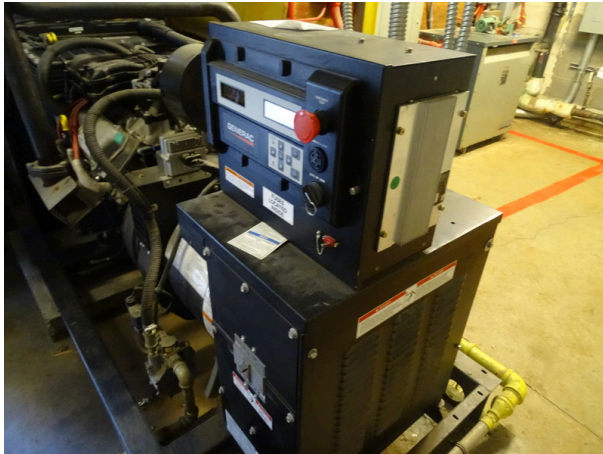
An emergency generator manufactured by Generac was reportedly installed in 2010 and is located in the main utility room. The emergency generator is reportedly tested on a weekly basis. The expected useful life of an emergency generator is 25 years with proper maintenance. The emergency generator was observed to be in fair condition. Based on the age of the generator, we recommend replacement during the report period.

Emergency power generator

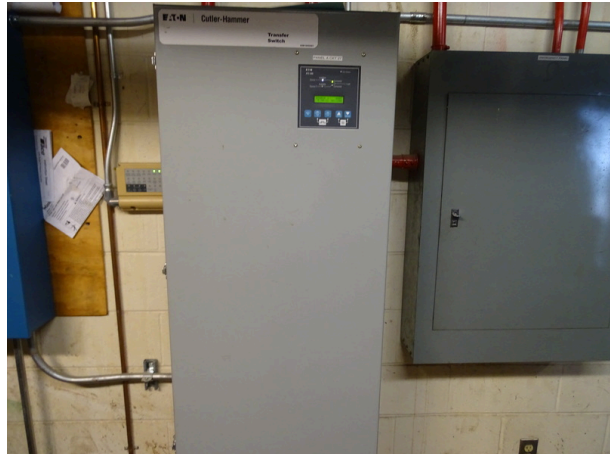
Emergency power transfer switch

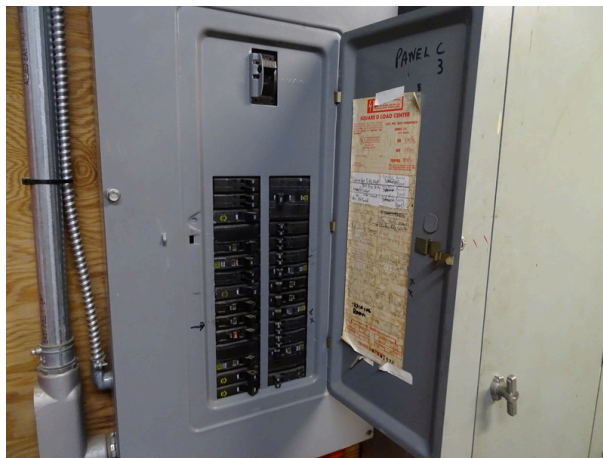
Power is distributed by copper wire from circuit breaker panels located throughout the building. The expected useful life of sub-panels is 50 years with proper maintenance. The circuit breaker panels were observed to be in generally good condition.

Typical circuit breaker panel

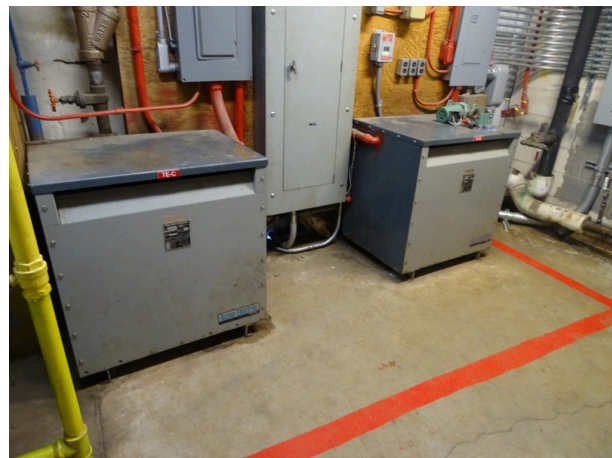
Typical building transformer

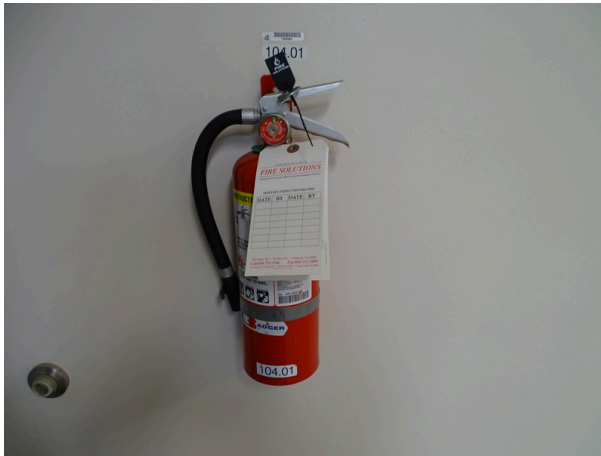
The fire suppression system includes fire extinguishers and a wet chemical system for the kitchen range hood. The fire suppression system was observed but not tested. The fire extinguishers were observed to have recent inspection tags issued June 2021. These devices are required to be inspected annually. Replacement of the fire extinguishers is considered routine maintenance.

Typical fire extinguisher

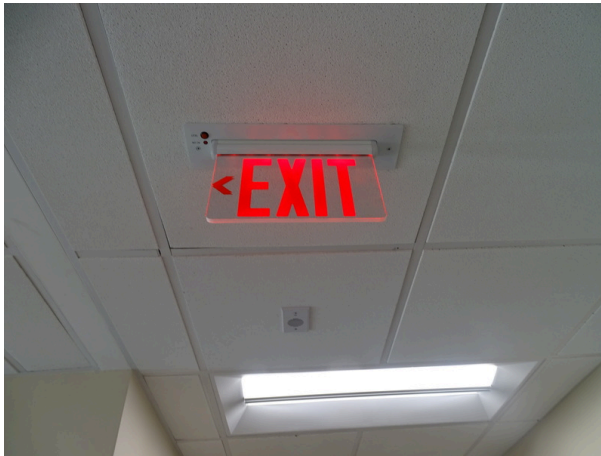
Emergency exit signs, emergency lighting, and fire extinguishers, are located throughout the building.

Typical exit sign

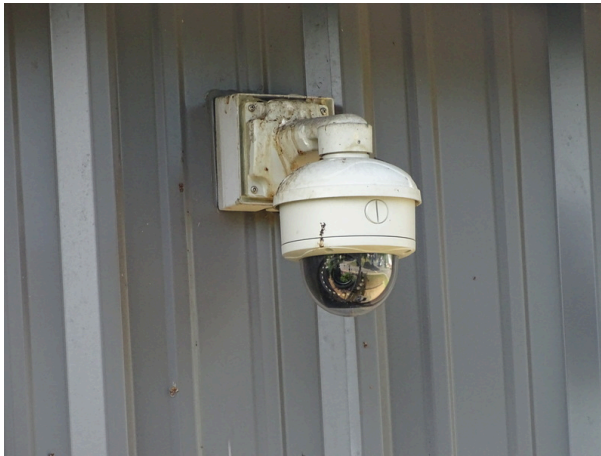
The building is monitored by a motion sensor security system, with security cameras, that is activated after-hours. The security system was generally in good condition.

Typical security camera

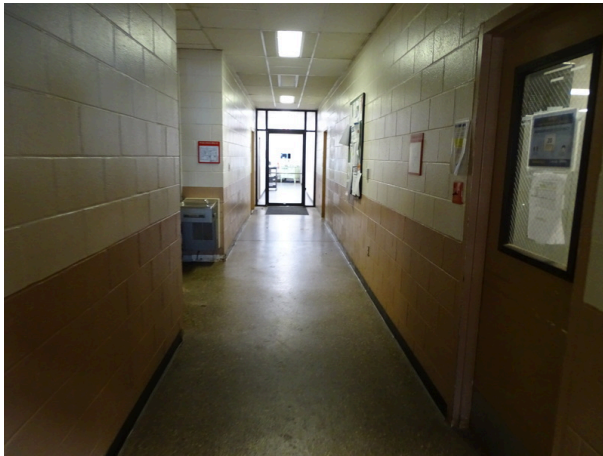
The finishes in the corridors include terrazzo tile floors, painted gypsum walls, and suspended acoustical tile ceilings. The finishes in the corridors were observed to be in generally good condition.

Interior finishes of corridor area

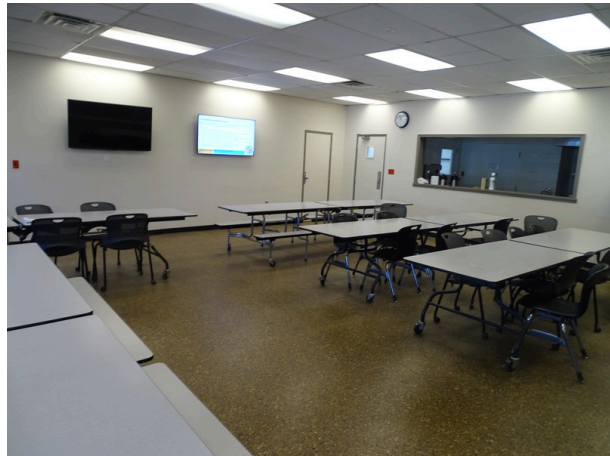
The finishes in the kitchens include terrazzo floors, painted gypsum walls, and suspended acoustical tile ceilings. The finishes in the kitchens were observed to be in generally good condition.

Interior finishes of kitchen area

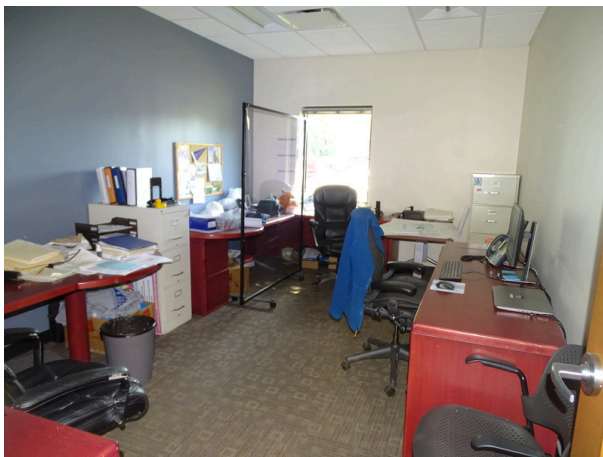
The finishes in the offices and meeting rooms include carpet floors, painted gypsum walls, and suspended acoustical tile ceilings. The finishes in the offices and meeting rooms were observed to be in generally good condition.

Interior finishes of office area

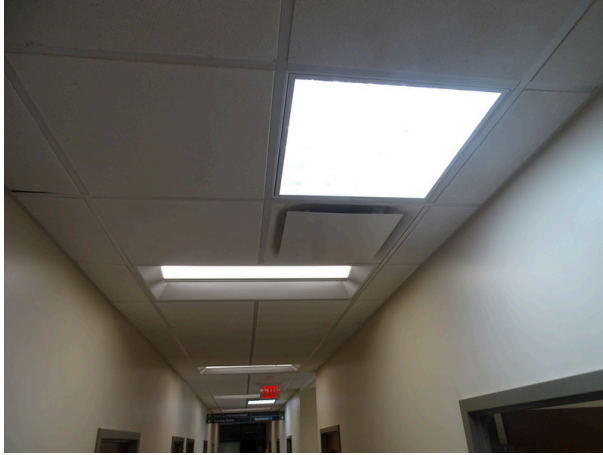
Interior finishes of corridor area ceiling

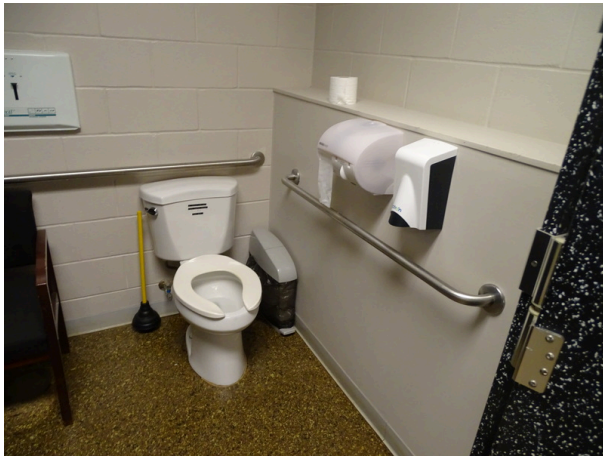
Accessible toilet

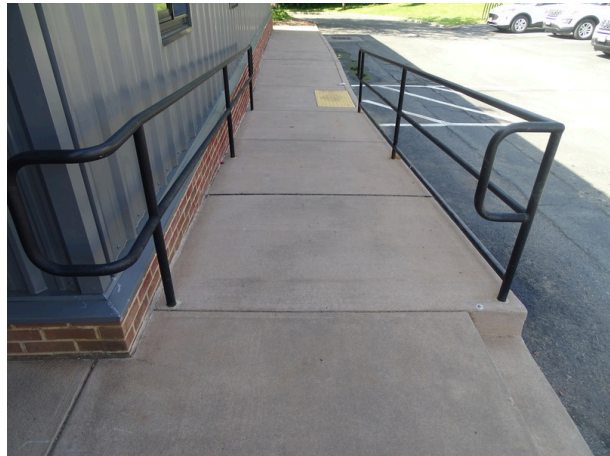
Accessible ramp

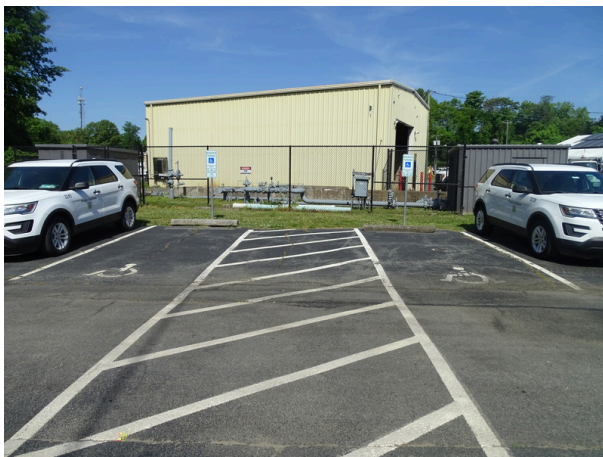
The parking area serving the property has a total of approximately 42 parking spaces. Of the parking spaces, Two are accessible with Two being van accessible. Accessibility requires that two accessible parking spaces be provided in parking areas with a total of one to 50 spaces. One in six of the accessible parking spaces are required to be van accessible. A minimum of a 60-inch wide access aisle is required to be provided for every two accessible parking spaces. Accessible aisles were observed to be provided. The number of parking spaces provided meets accessibility requirements.

Accessible parking spaces

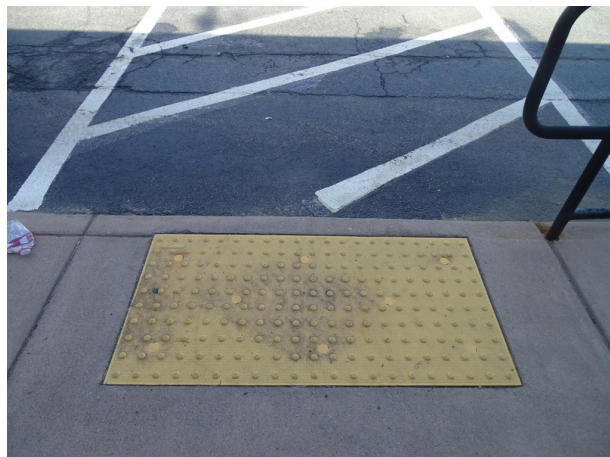
Accessible curb ramp with truncated domes

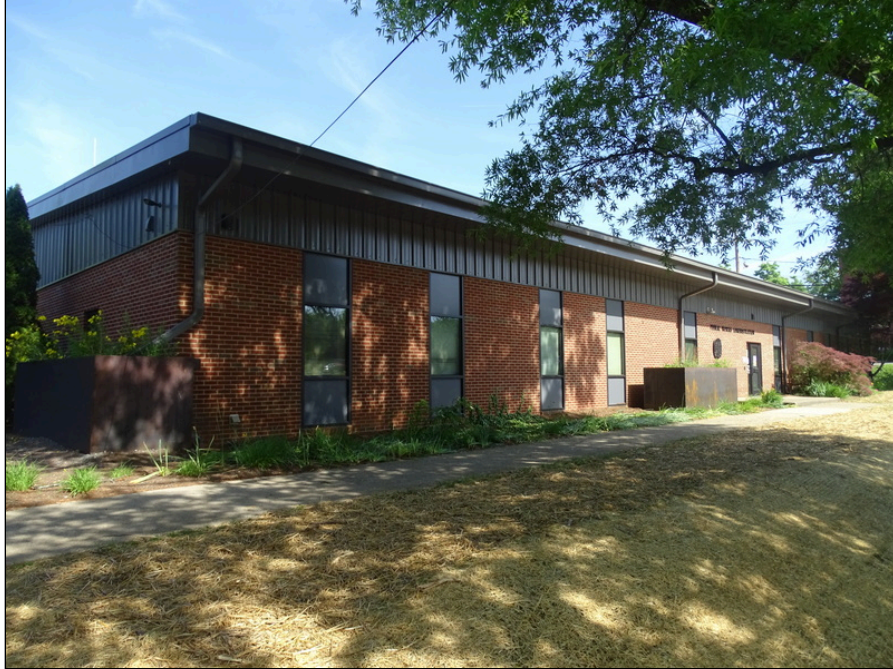
1 - Public Works Administration Building - building exterior northeast side of the building

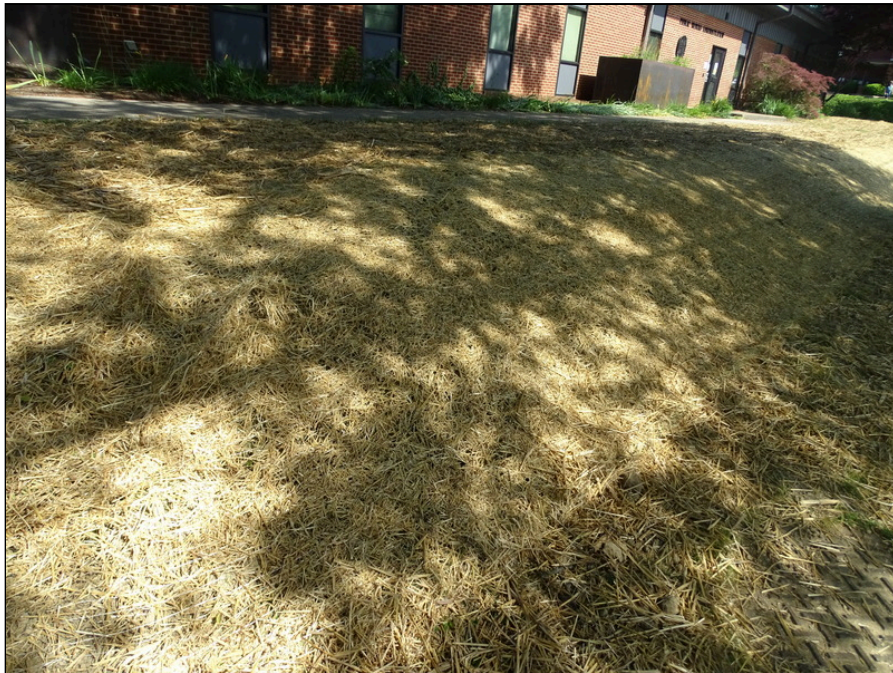
2 - Topography

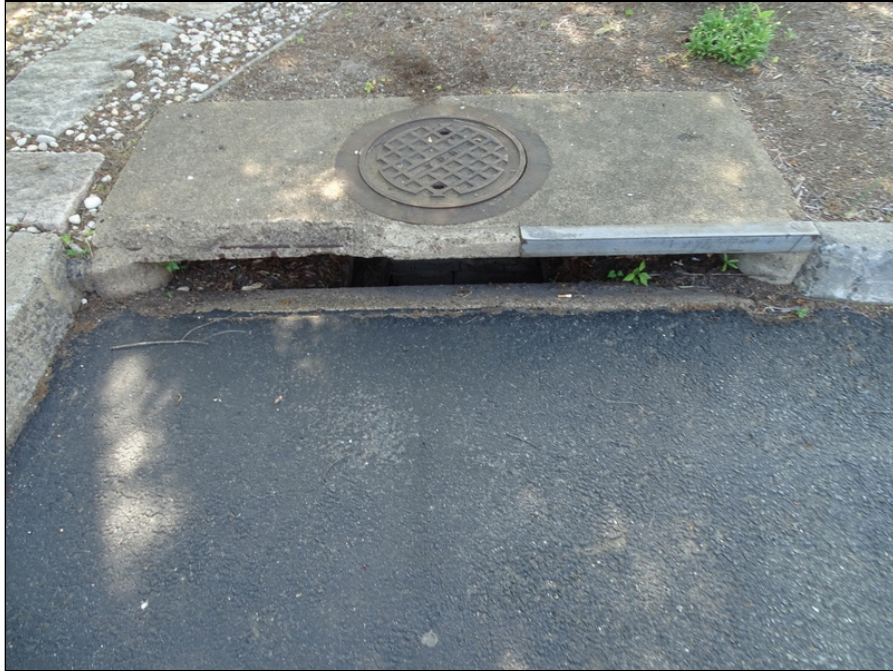
3 - Typical drainage

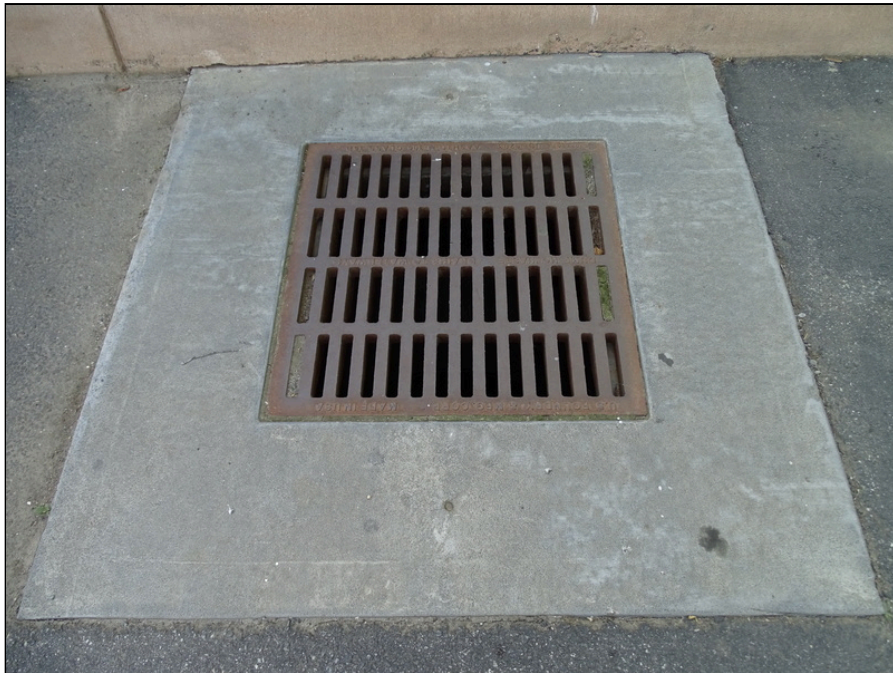
4 - Typical drainage

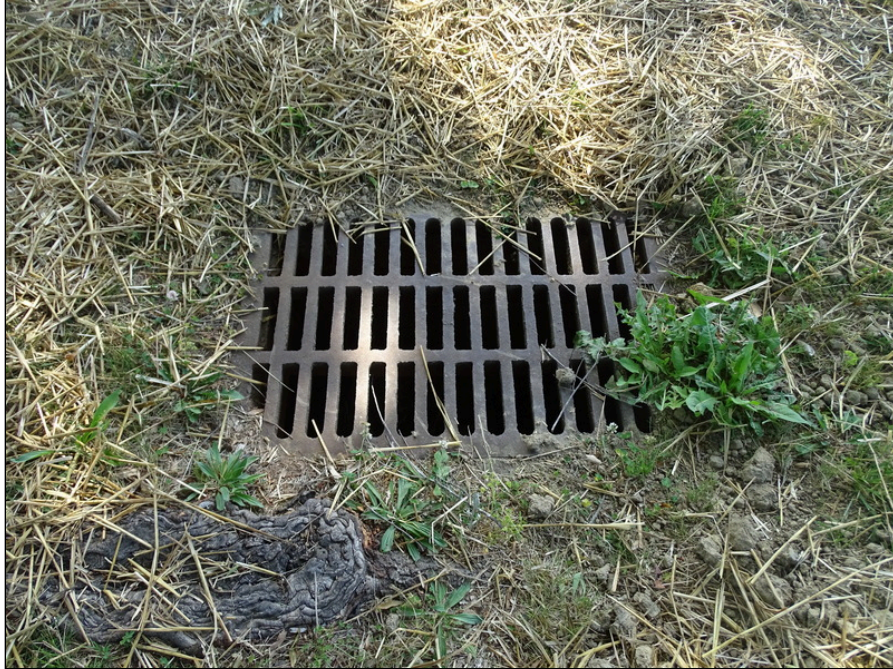
5 - Typical yard inlet drainage

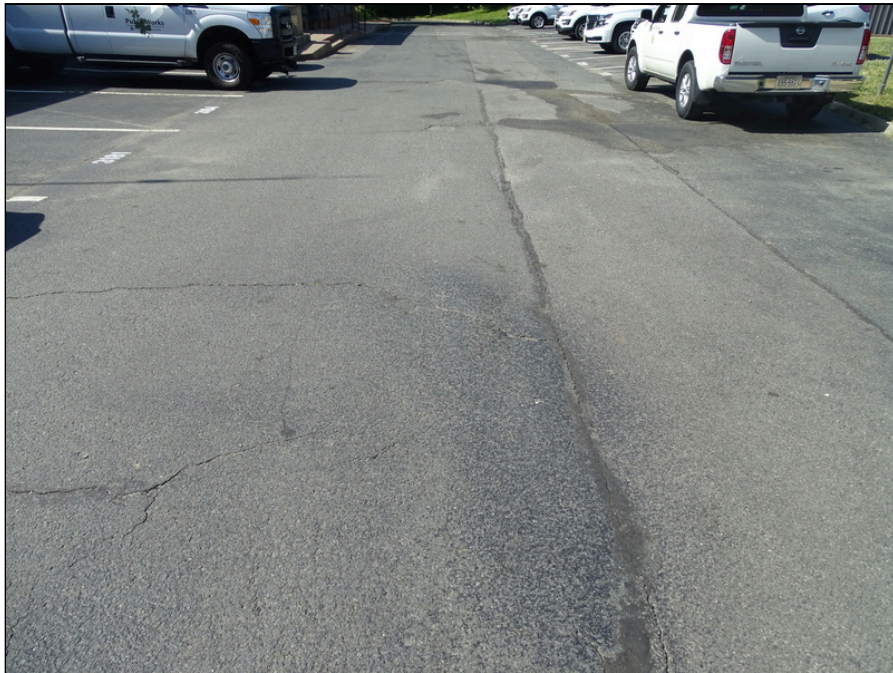
6 - Asphalt pavement drive lane and parking west side of the building

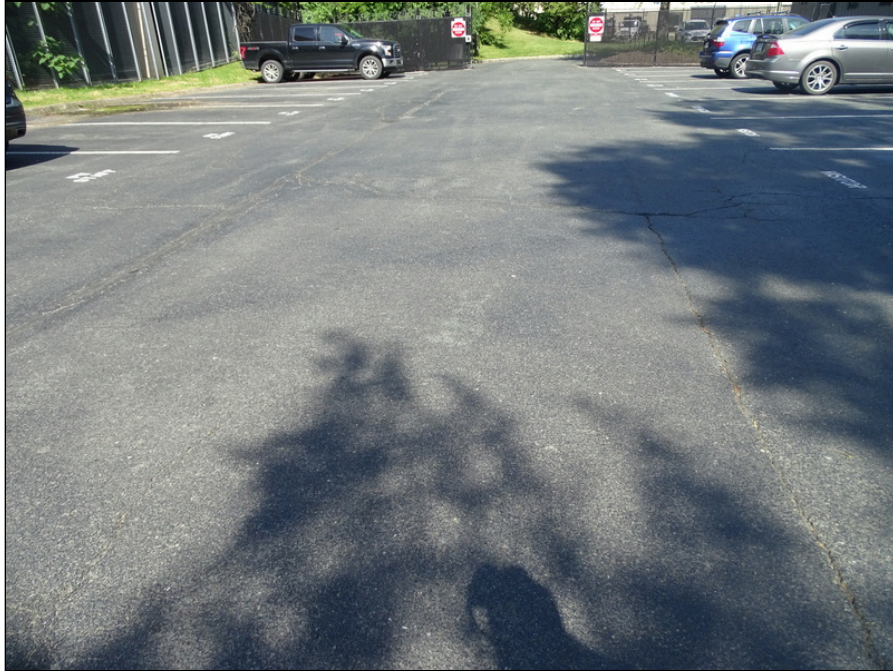
7 - Asphalt pavement drive lane

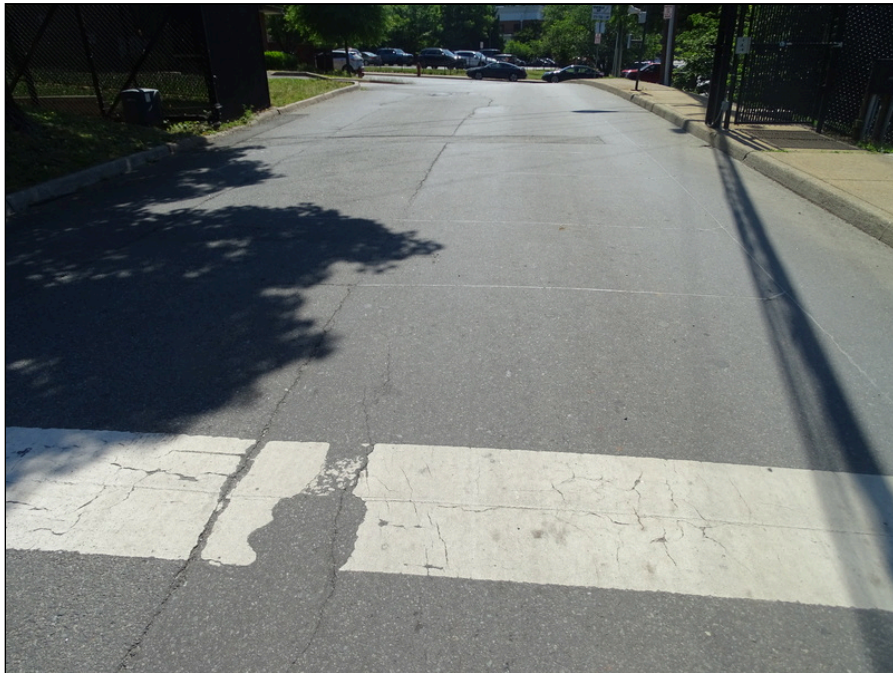
8 - Asphalt pavement drive lane

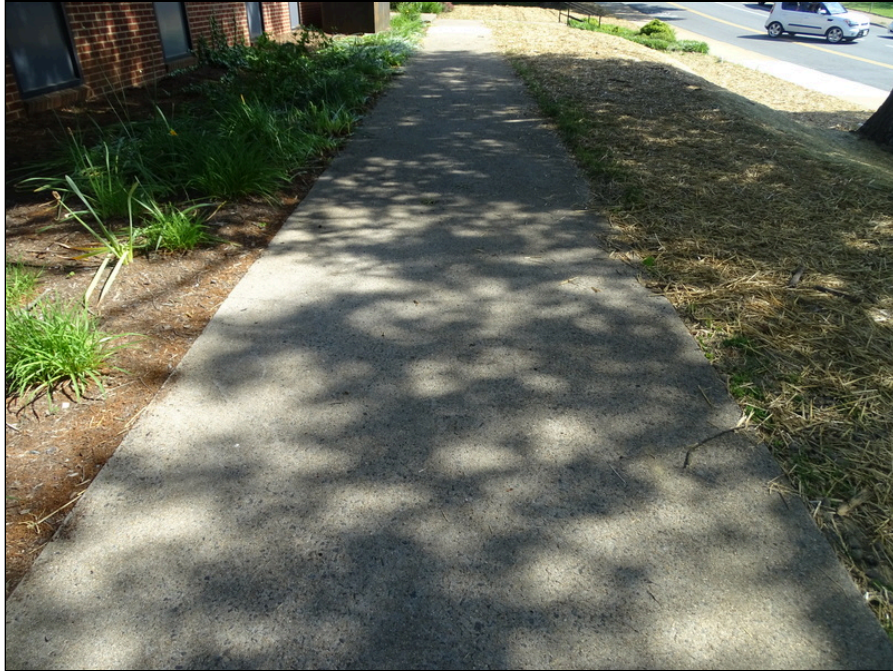
9 - Concrete sidewalk east side of the building

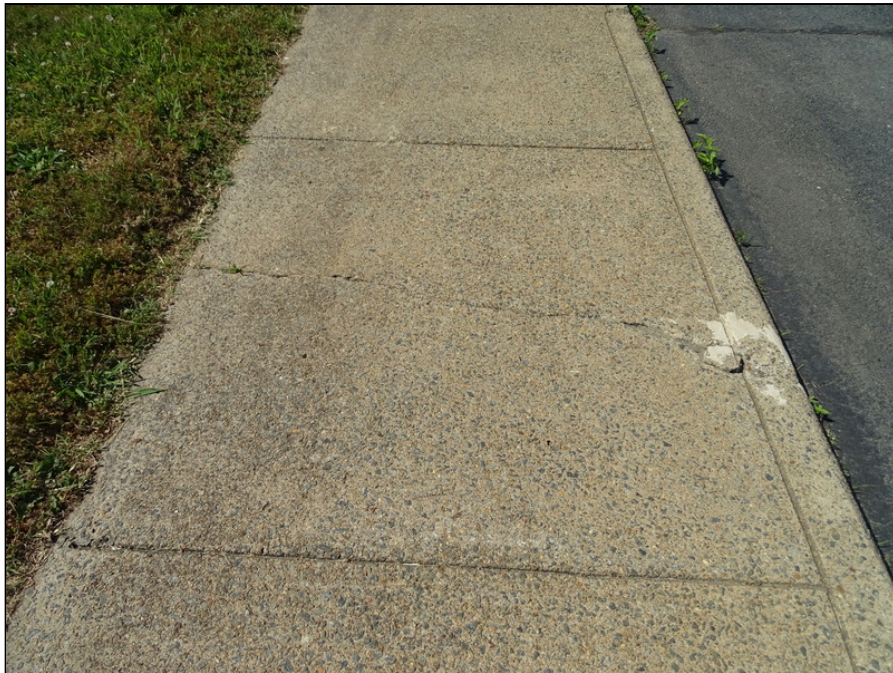
10 - Typical concrete sidewalk - note cracking

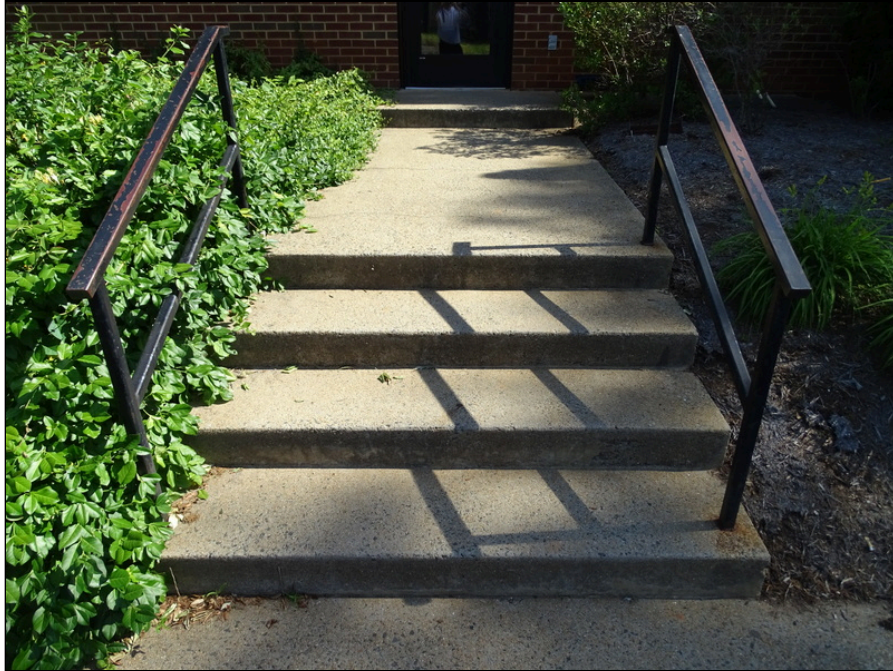
13 - Concrete steps south side of the building

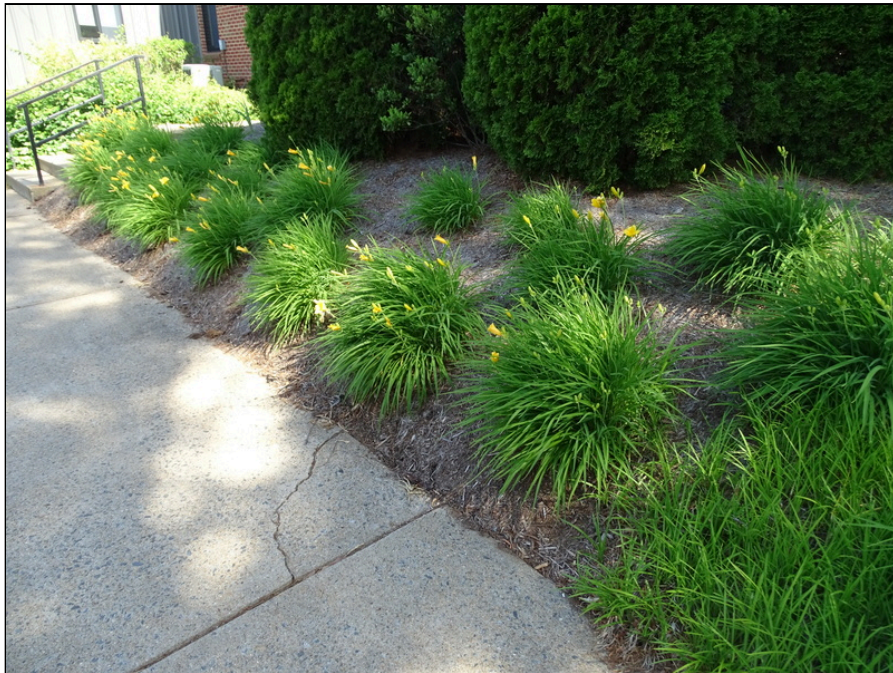
14 - Typical concrete side walk and landscaping

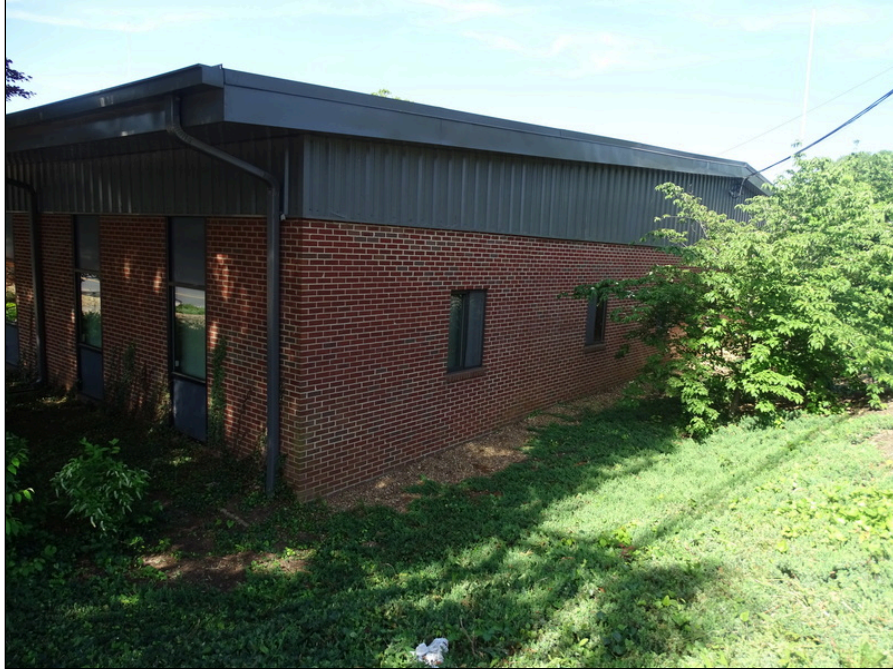
15 - Typical landscaping

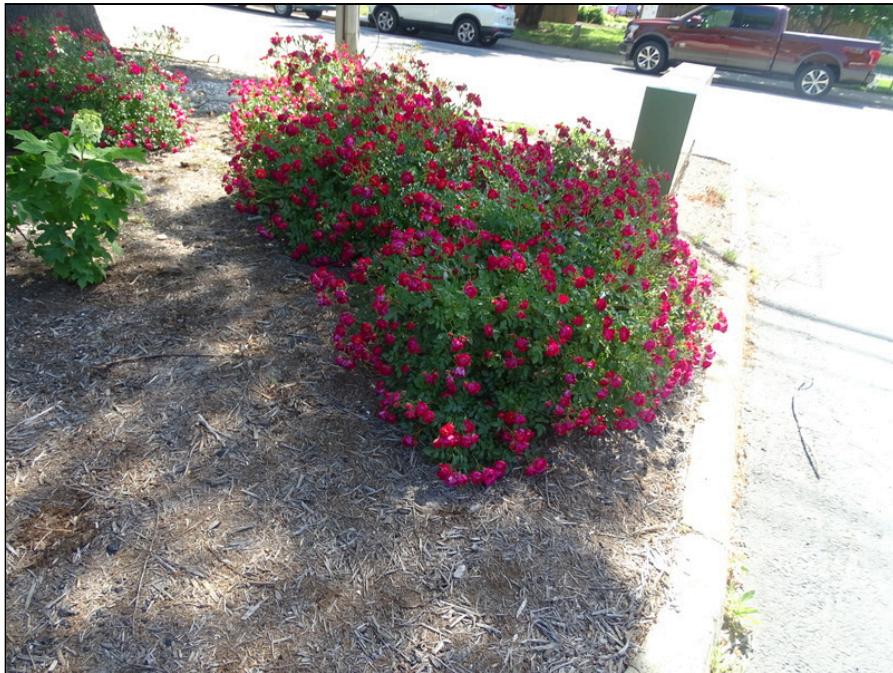
16 - Typical landscaping

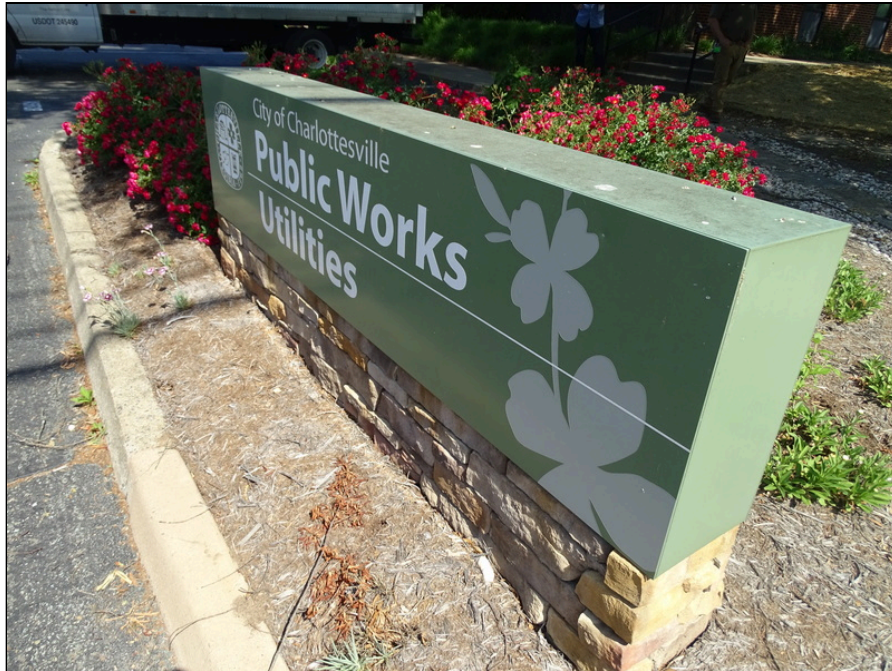
17 - Typical monuments sign

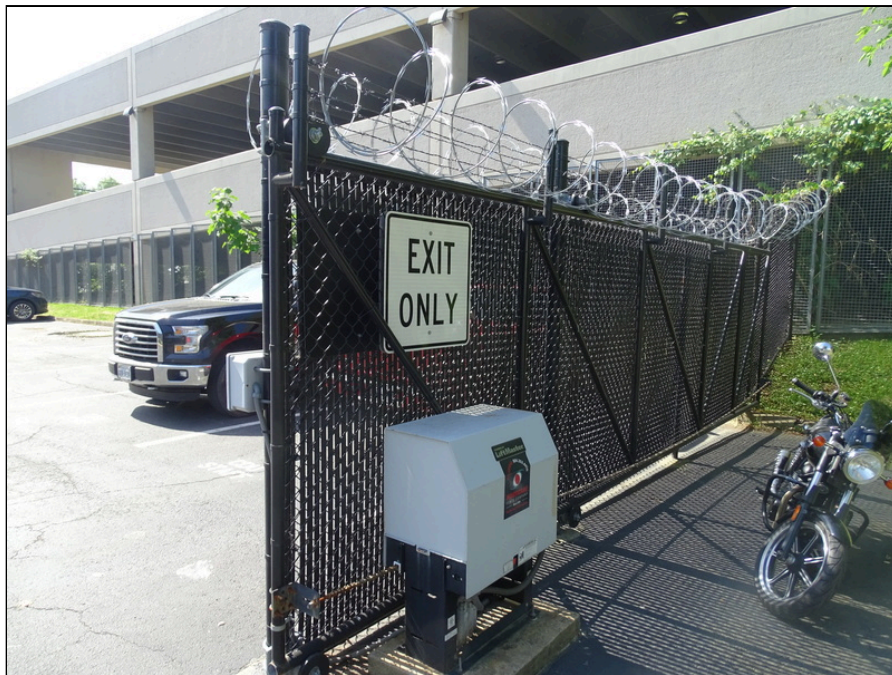
18 - Chain link fence and gate on the south side of the building

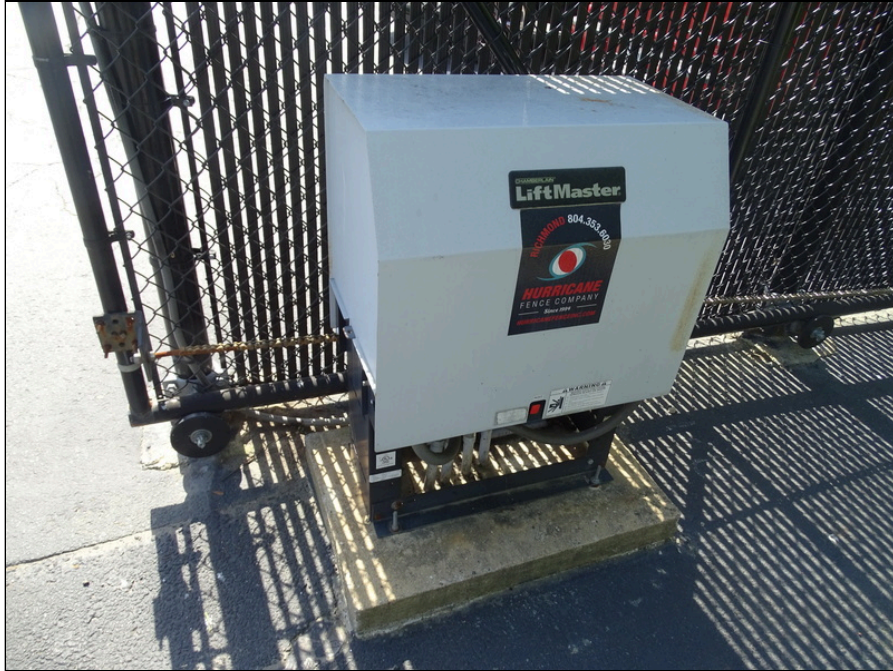
19 - Typical fences controller system
