PUBLIC WORKS ADMINISTRATION BUILDING
305 4TH STREET NW
CHARLOTTESVILLE, VIRGINIA

ECS PROJECT NO. 46:6713

CITY OF CHARLOTTESVILLE - FACILITIES DEVELOPMENT

Reference: Facility Condition Assessment Report for Public Works Administration Building, 305 4th Street NW, Charlottesville, Virginia

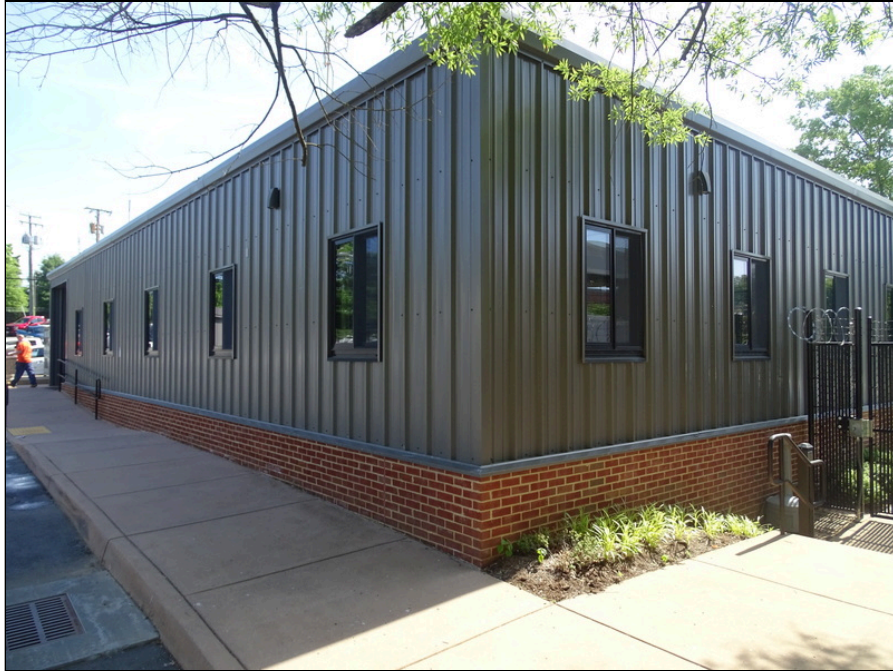
21 - Building exterior west side of the building

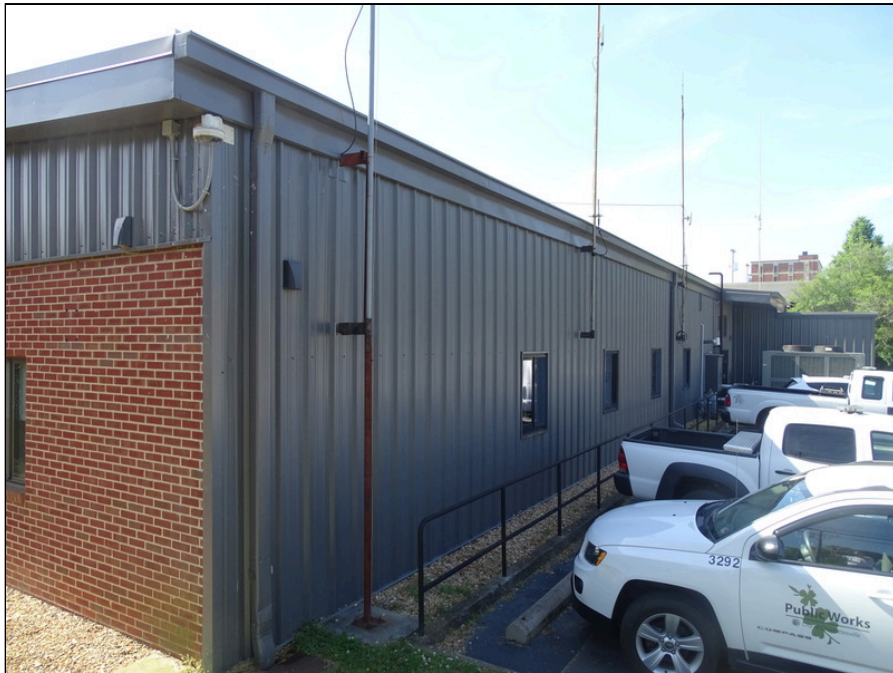
22 - Building exterior west side of the building

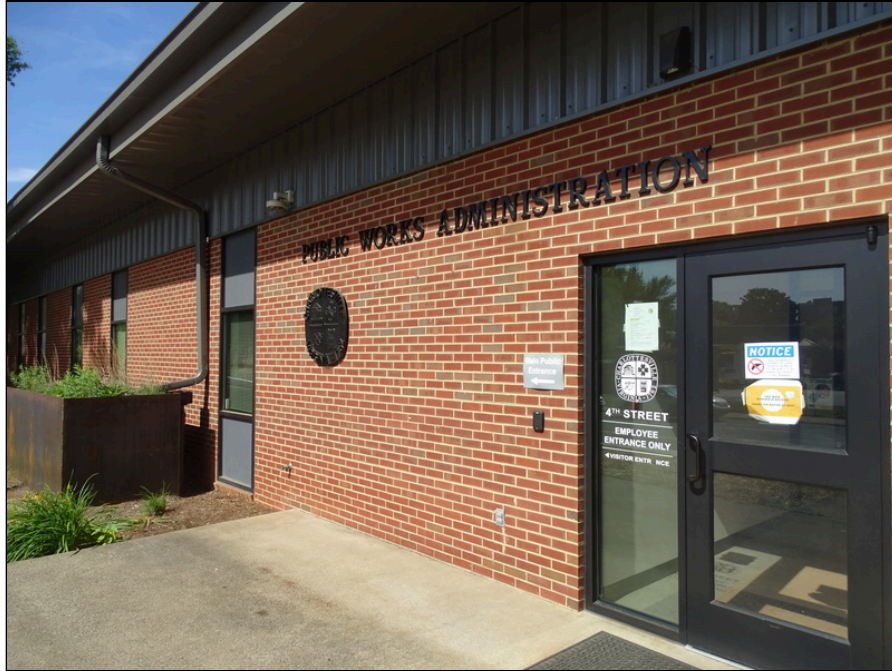
23 - Typical building exterior

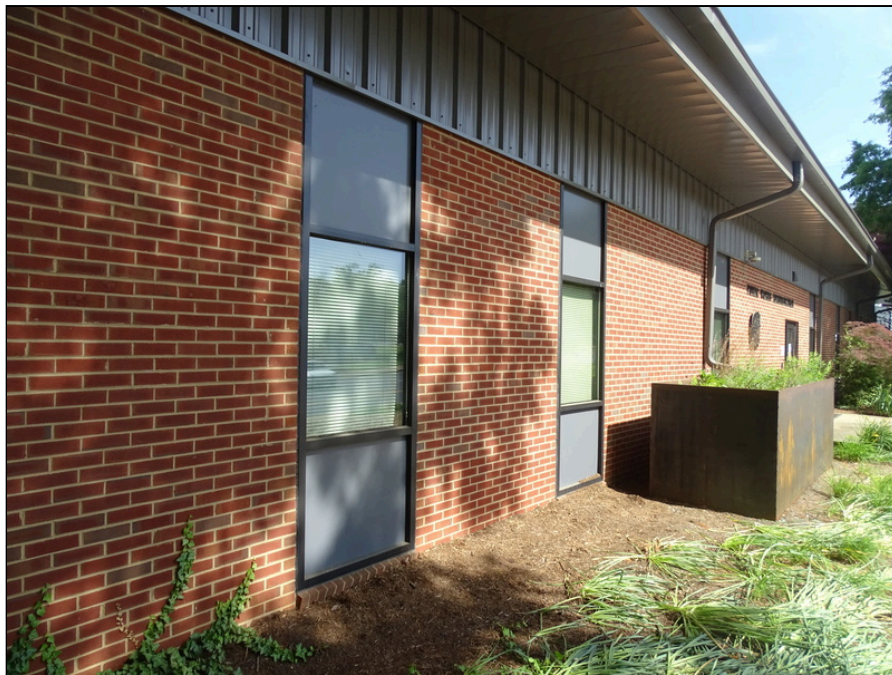
24 - Typical building exterior

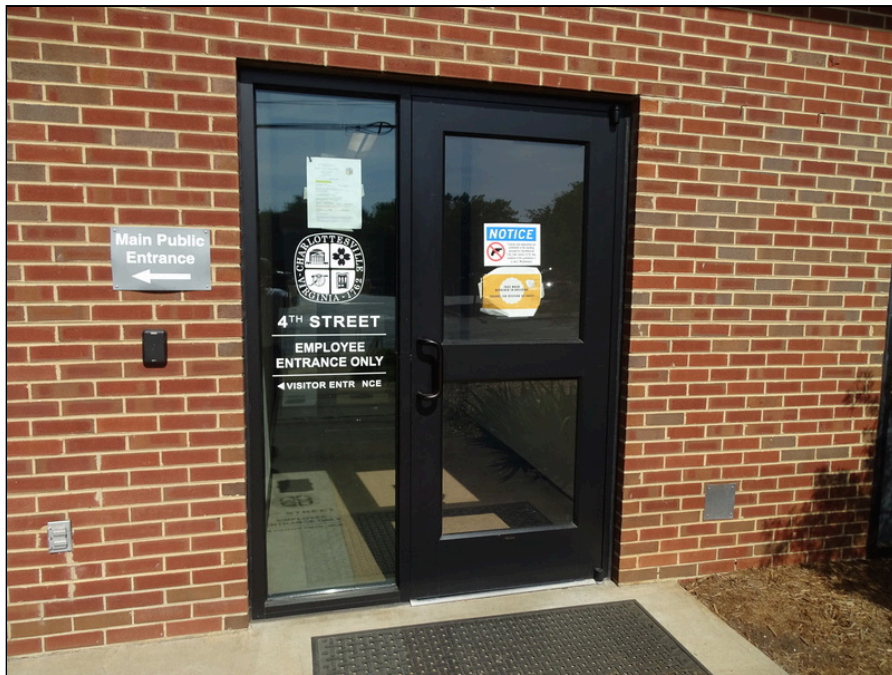
26 - Storefront entrance east side of the building

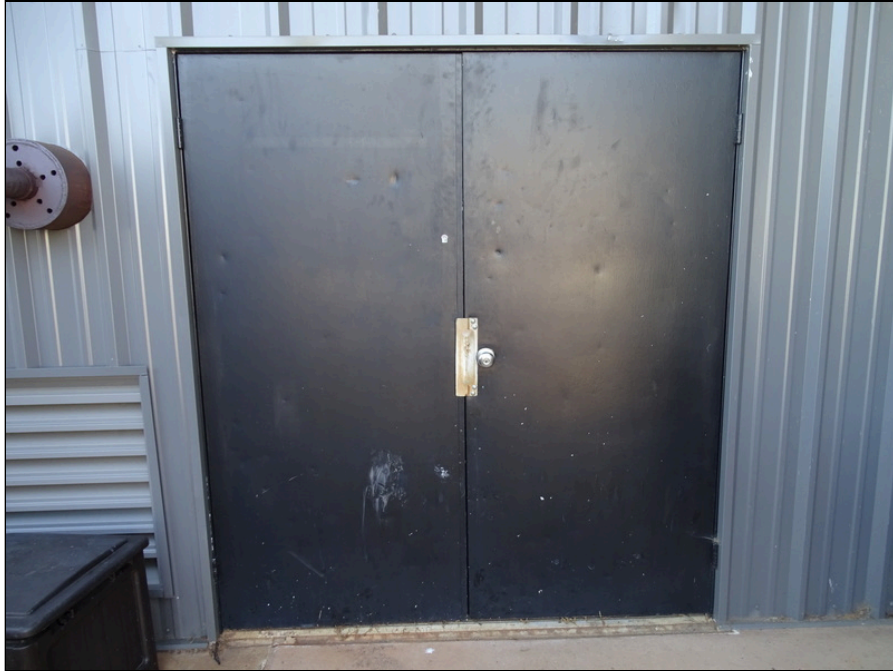
27 - Typical personnel doors

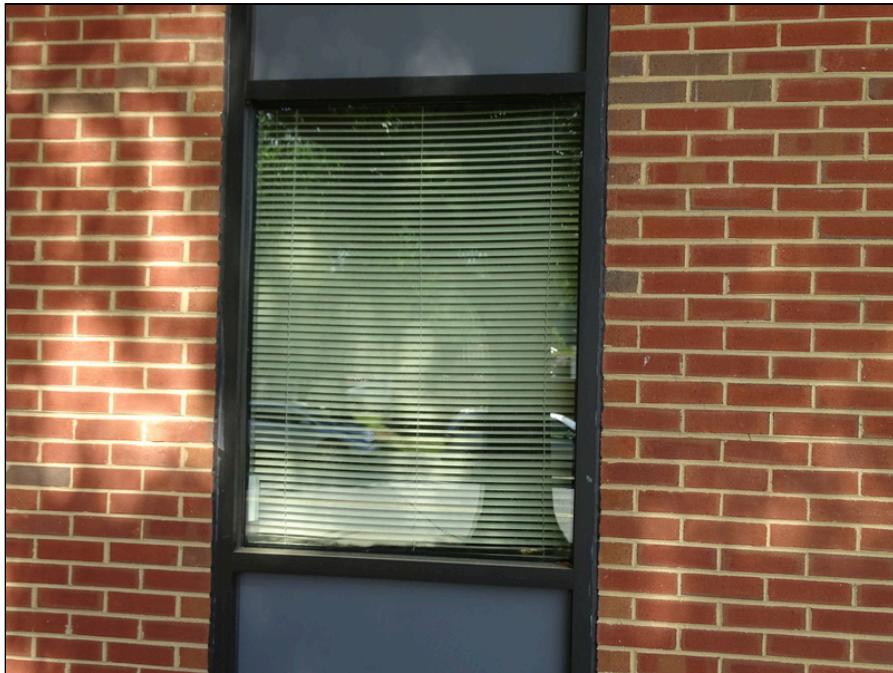
28 - Typical exterior window

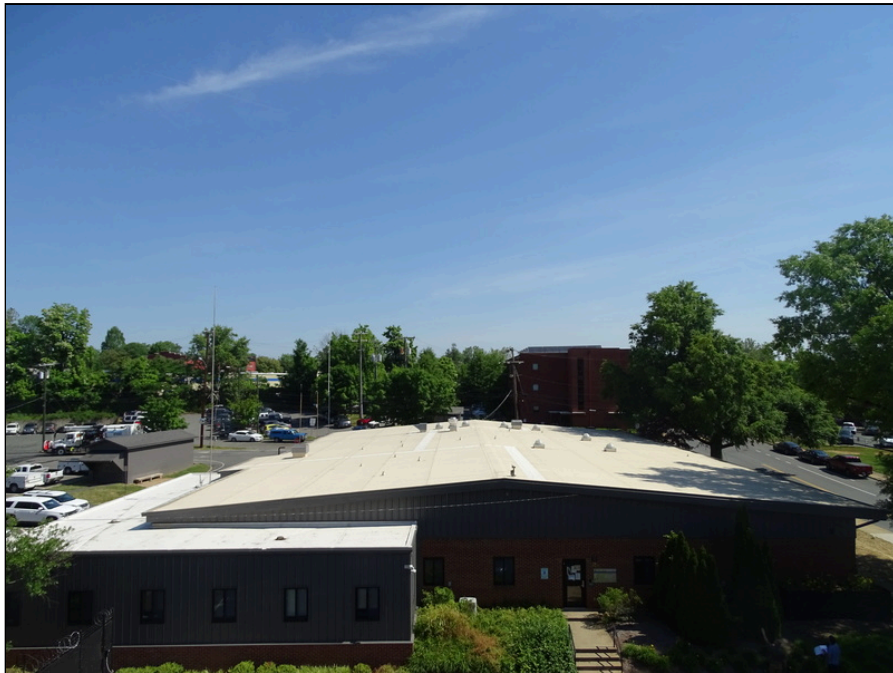
30 - Roofing system east and west side of the building looking north

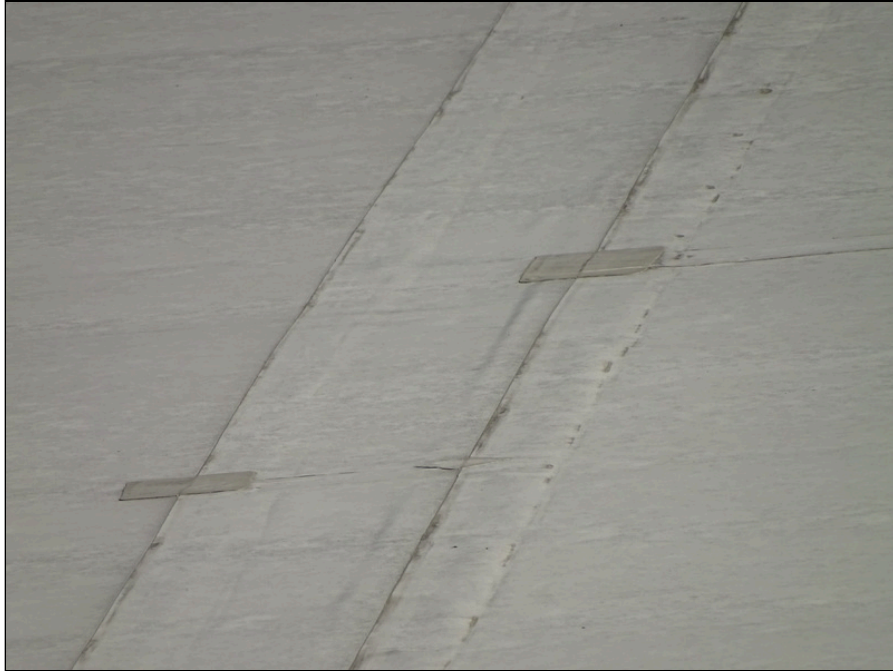
31 - Typical patching

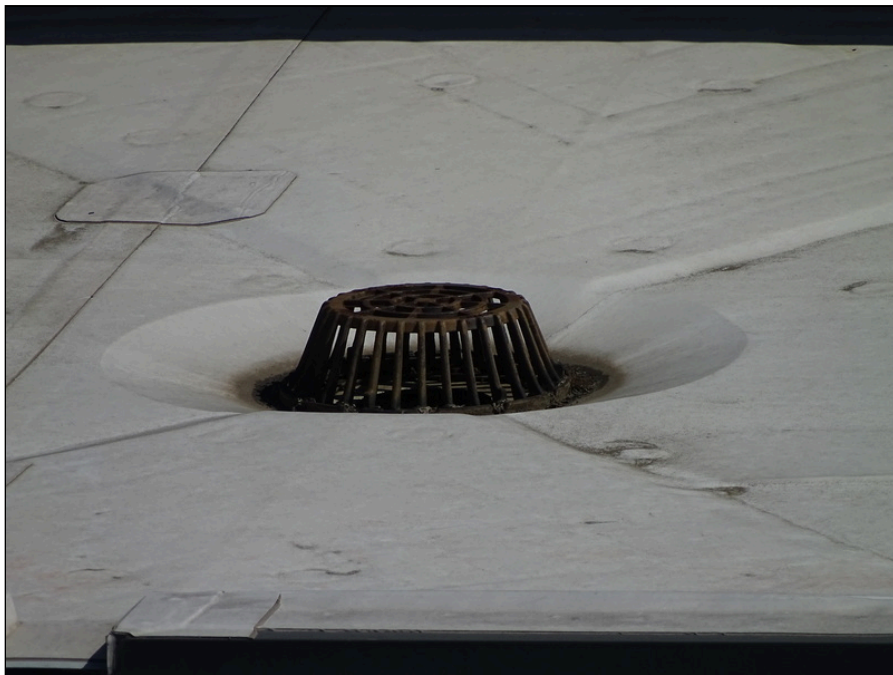
32 - Typical internal drain

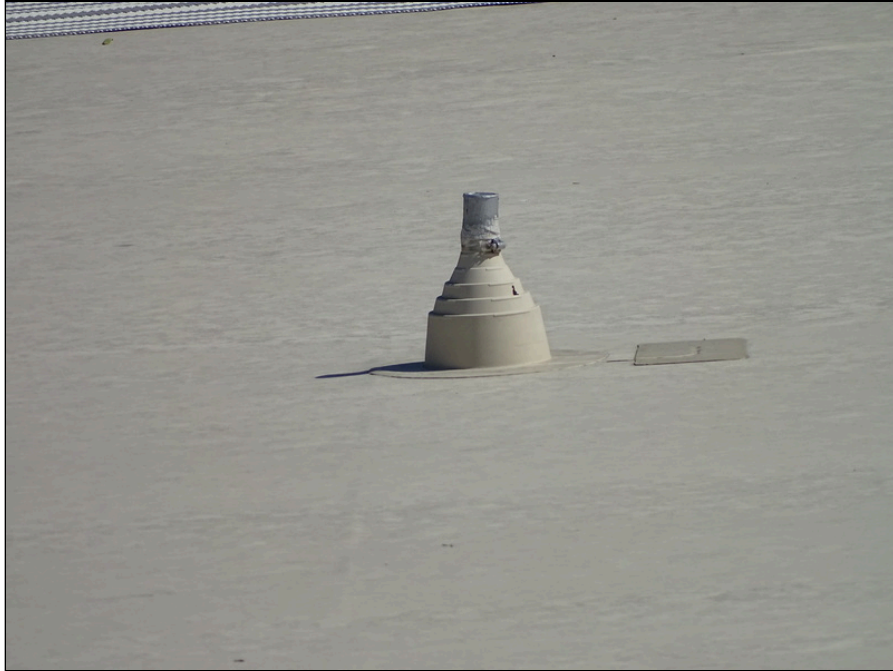
33 - Typical plumbing penetration

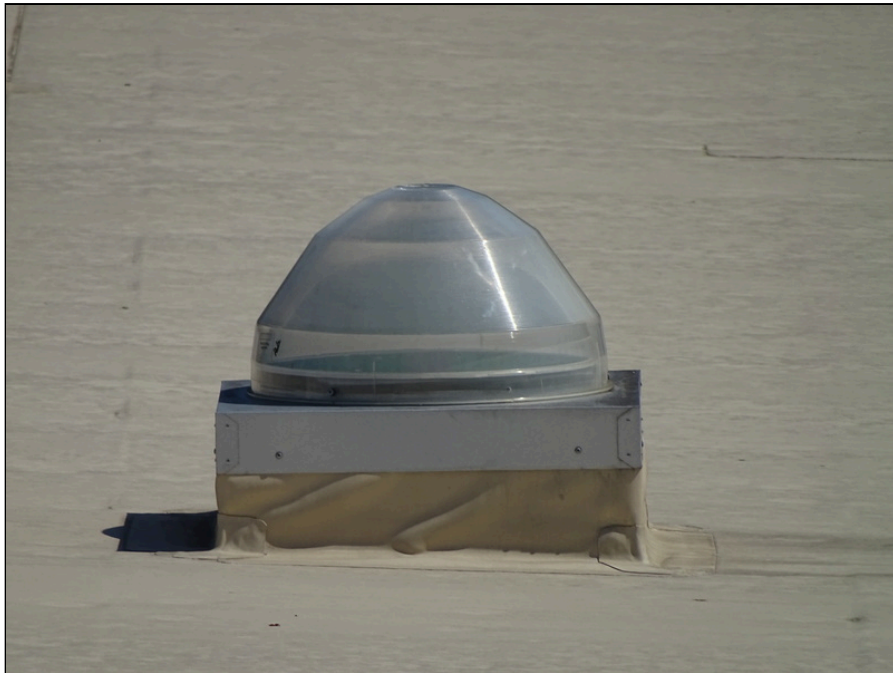
34 - Typical skylight

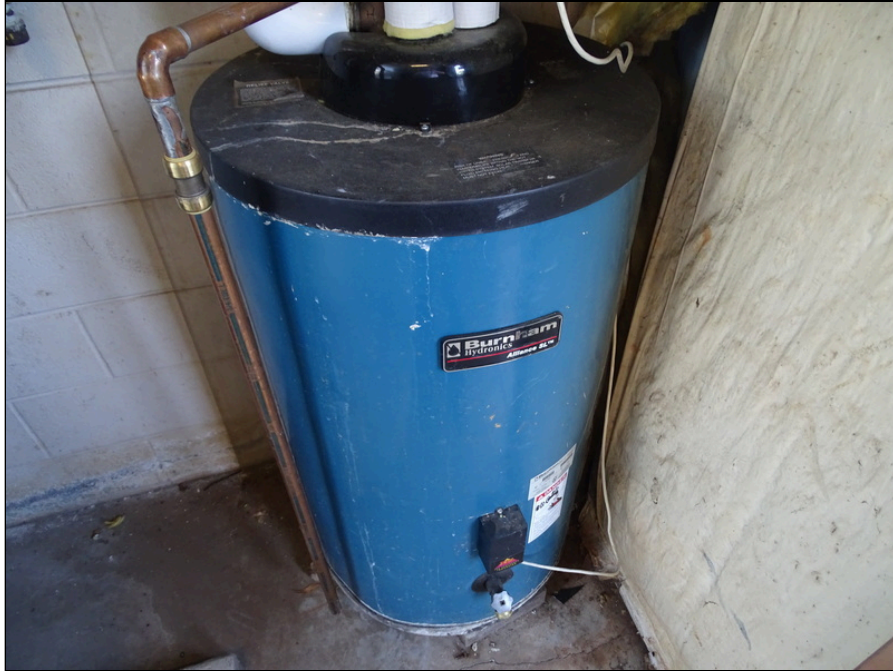
35 - Boiler system domestic hot water supply

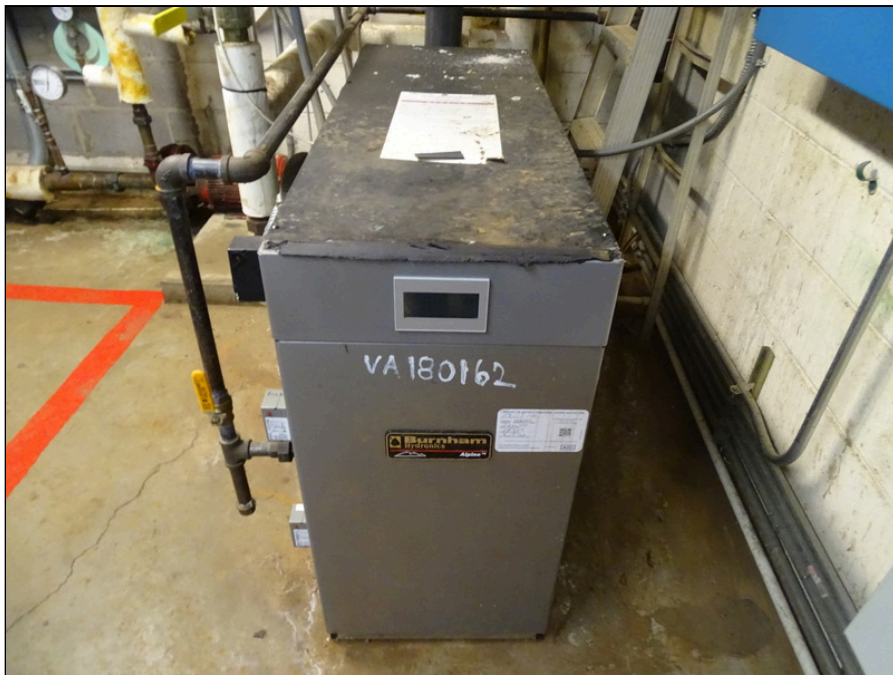
36 - Boiler located in main utility room

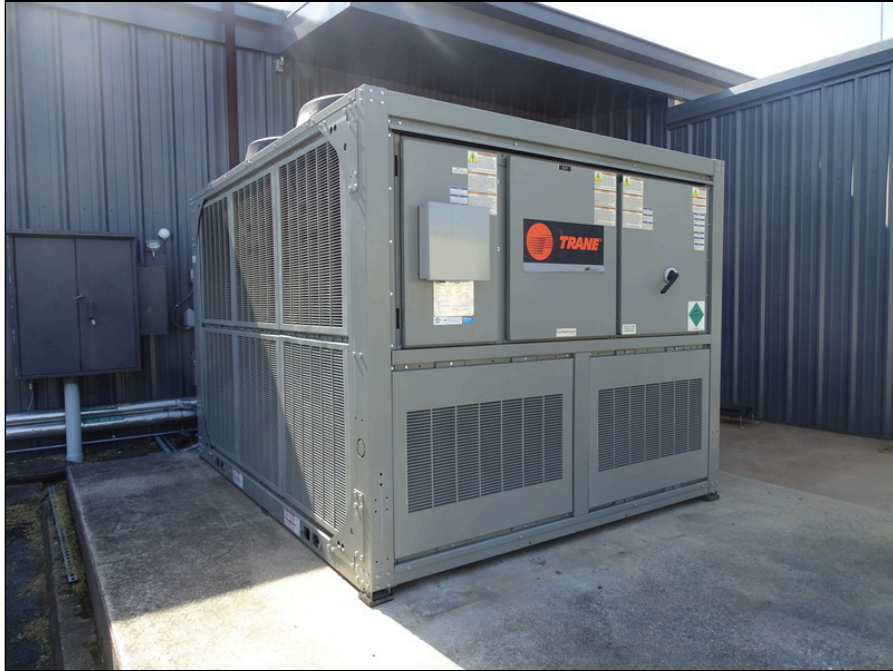
37 - Chiller located at west side of the building

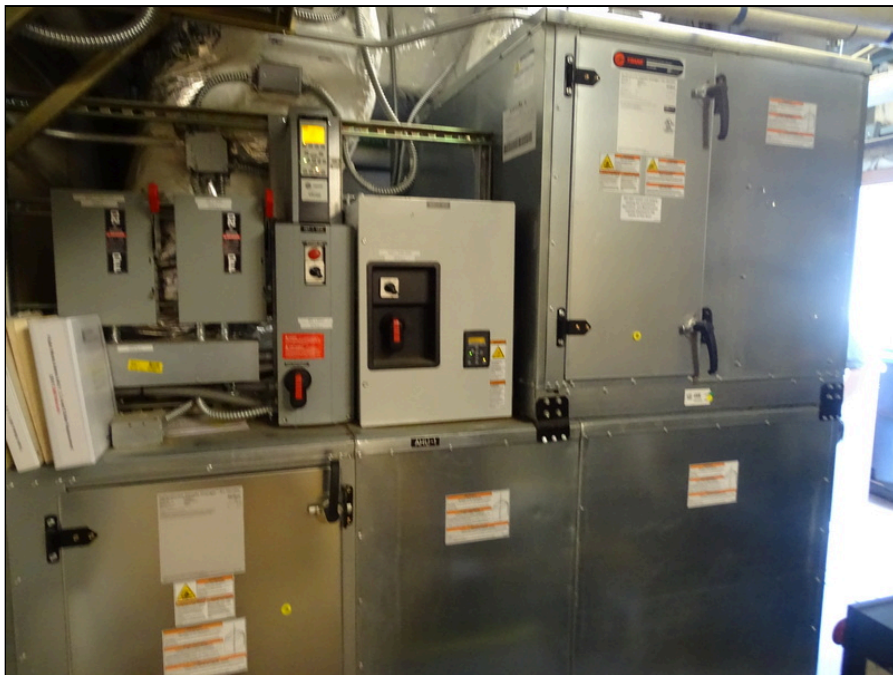
38 - Air Handler Unit located in main utility room

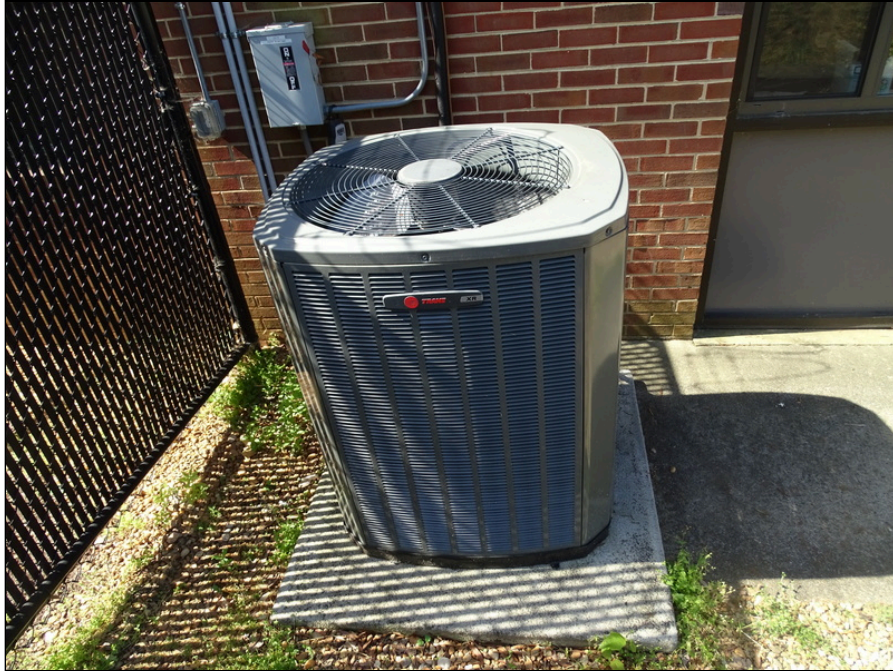
39 - Condenser located at north side of the building

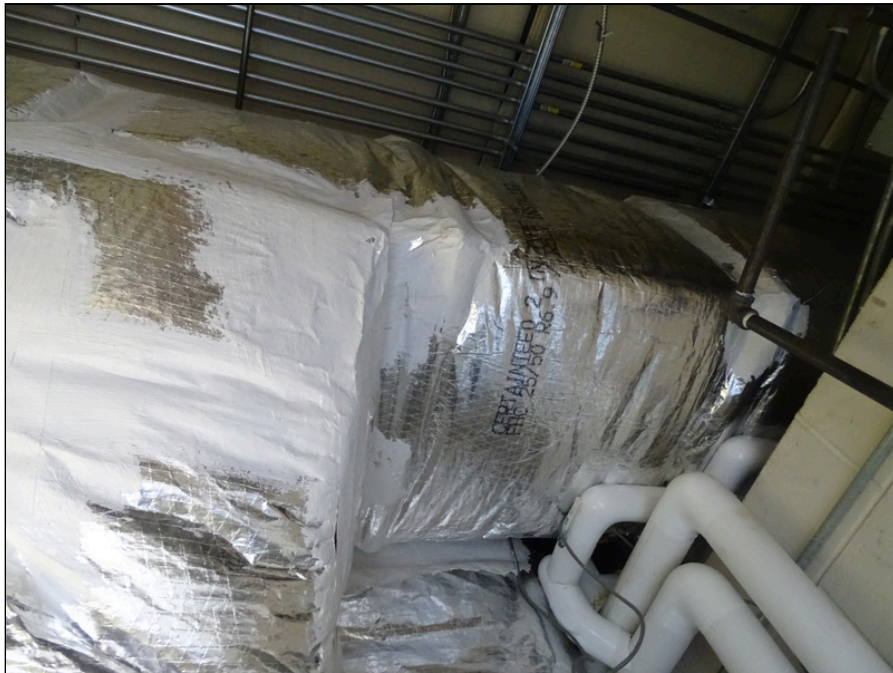
40 - Typical mechanical duct

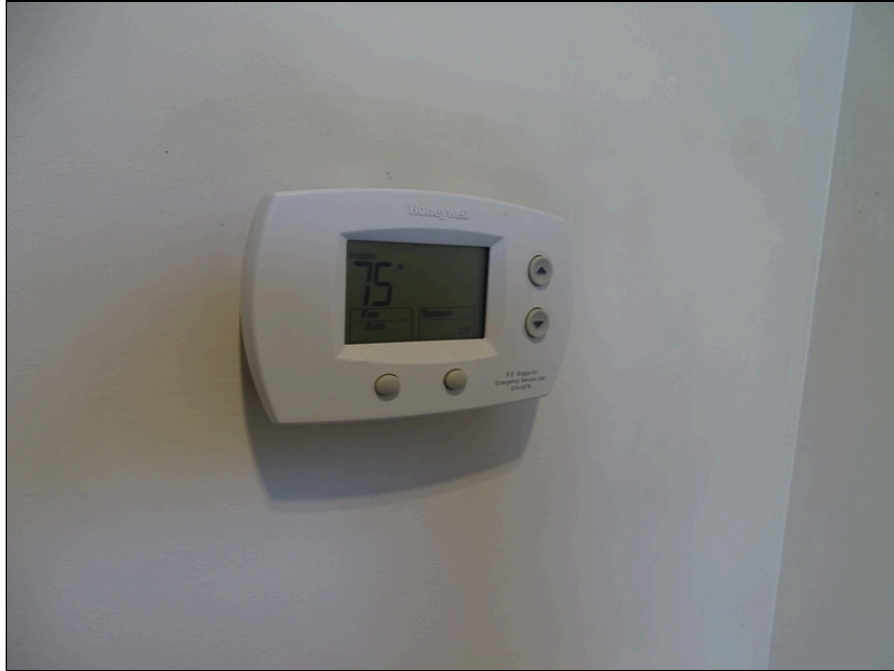
41 - Typical thermostat

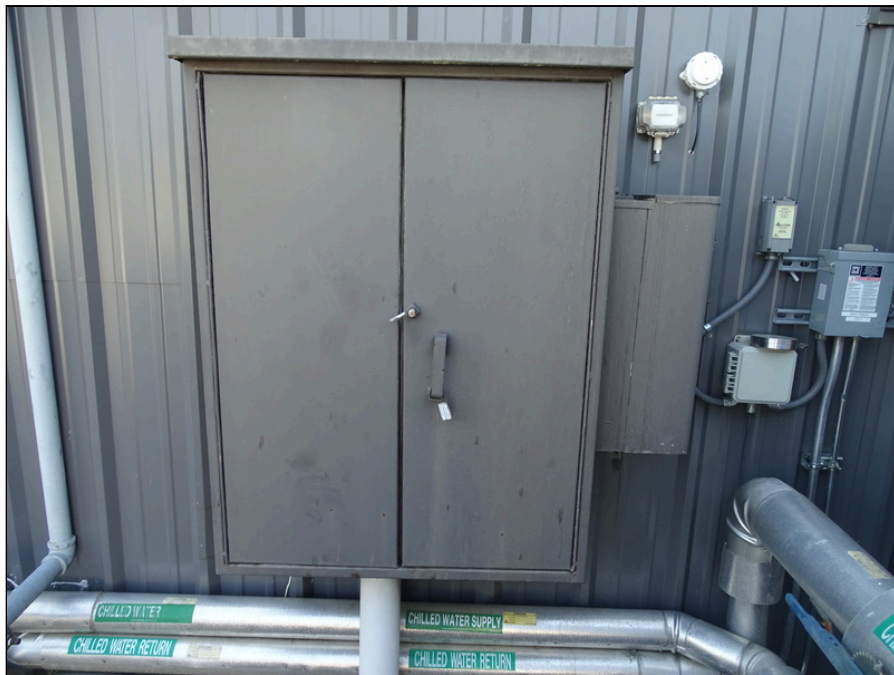
42 - Main electrical service and utility meter

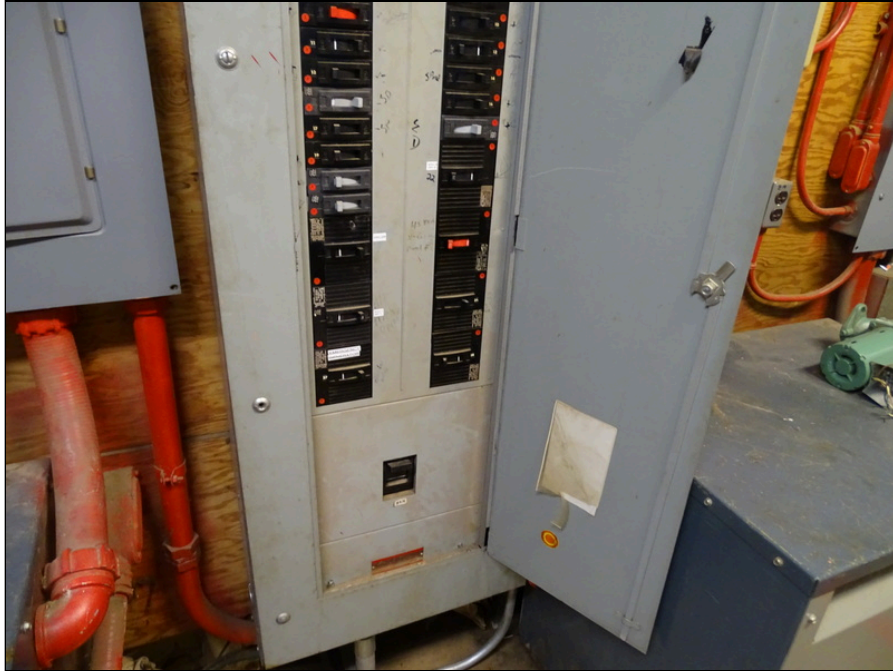
43 - Main electrical switchgear

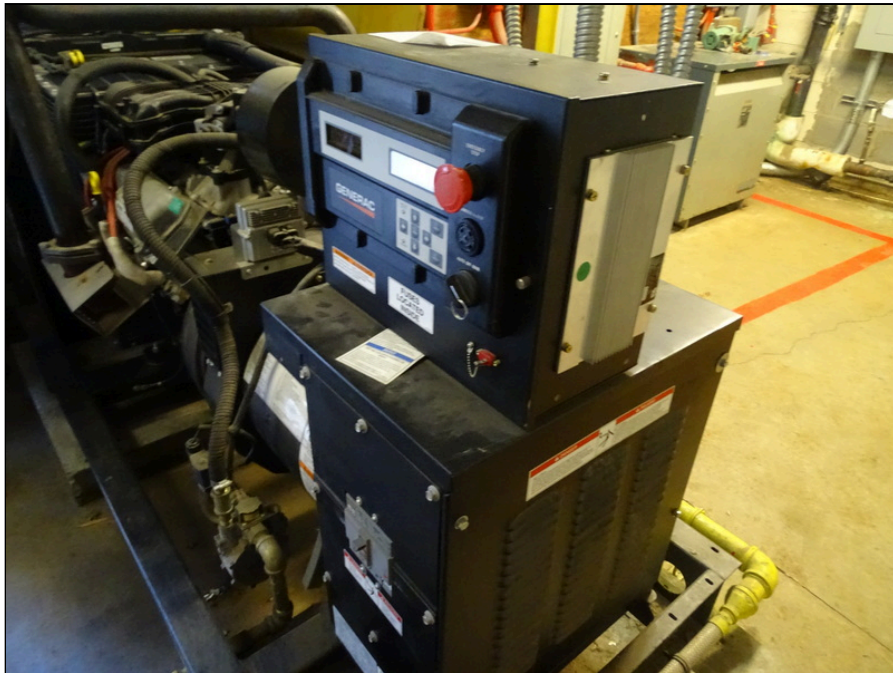
44 - Emergency power generator

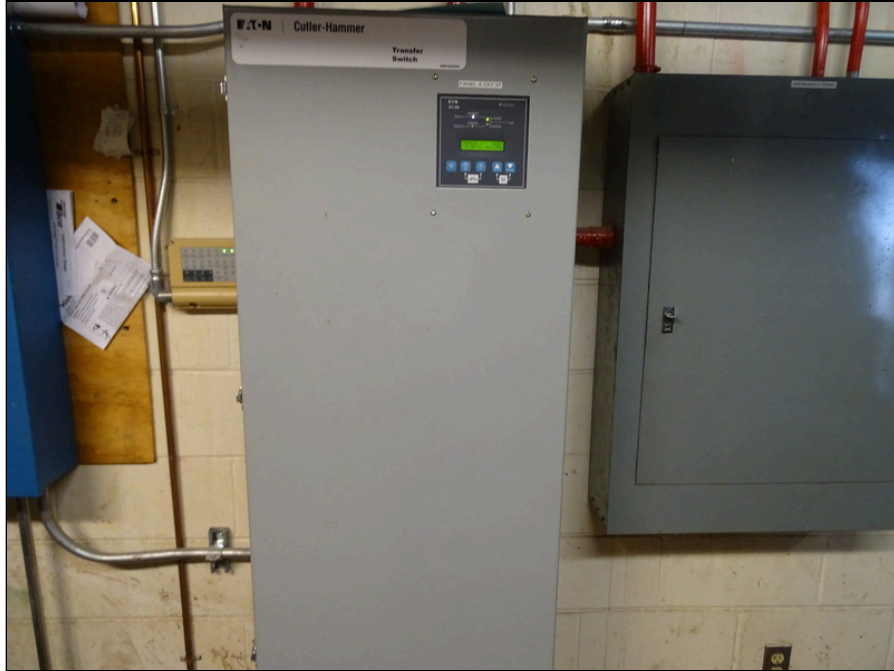
45 - Emergency power transfer switch

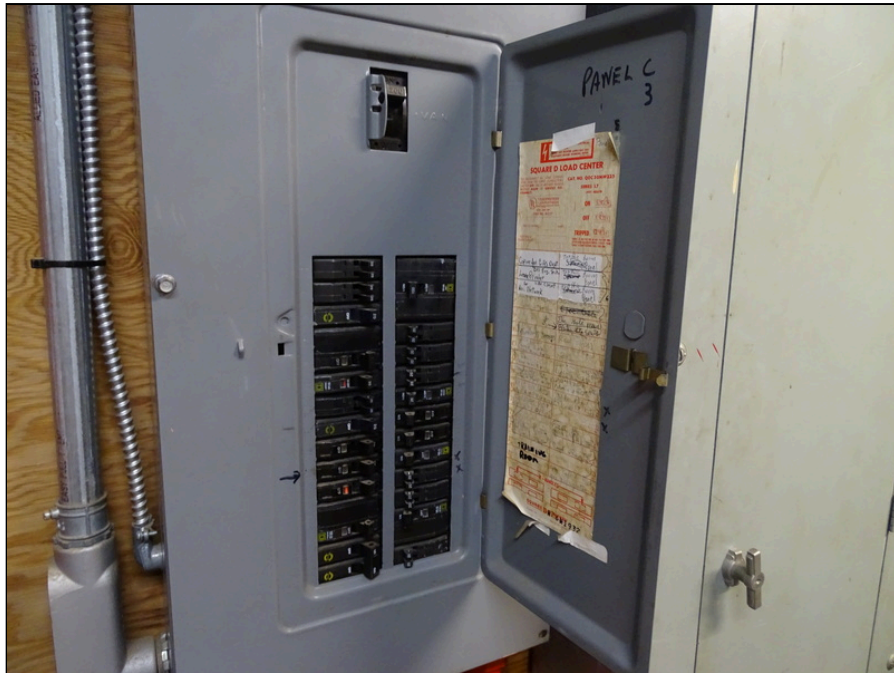
46 - Typical circuit breaker panel

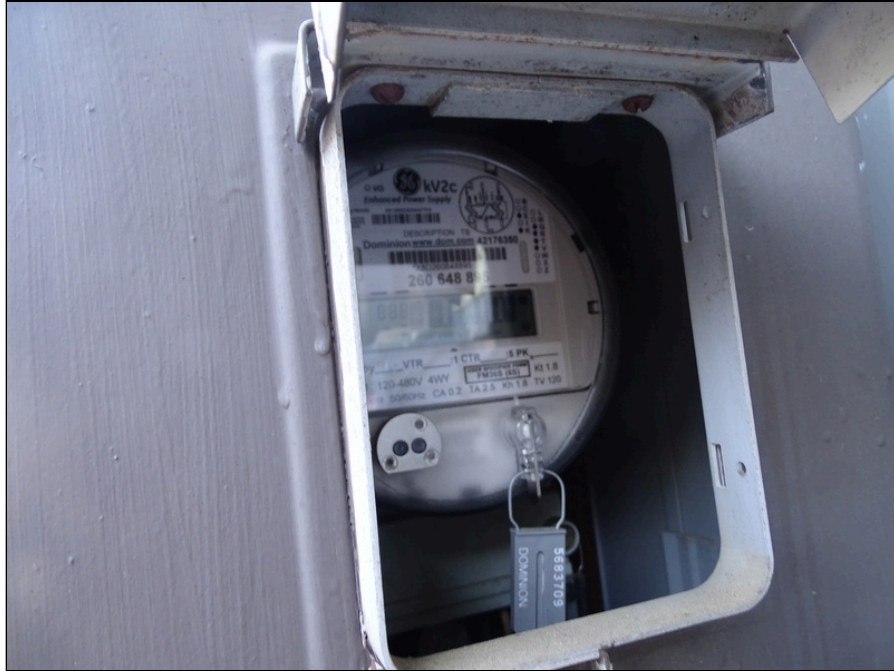
47 - Typical electrical meter

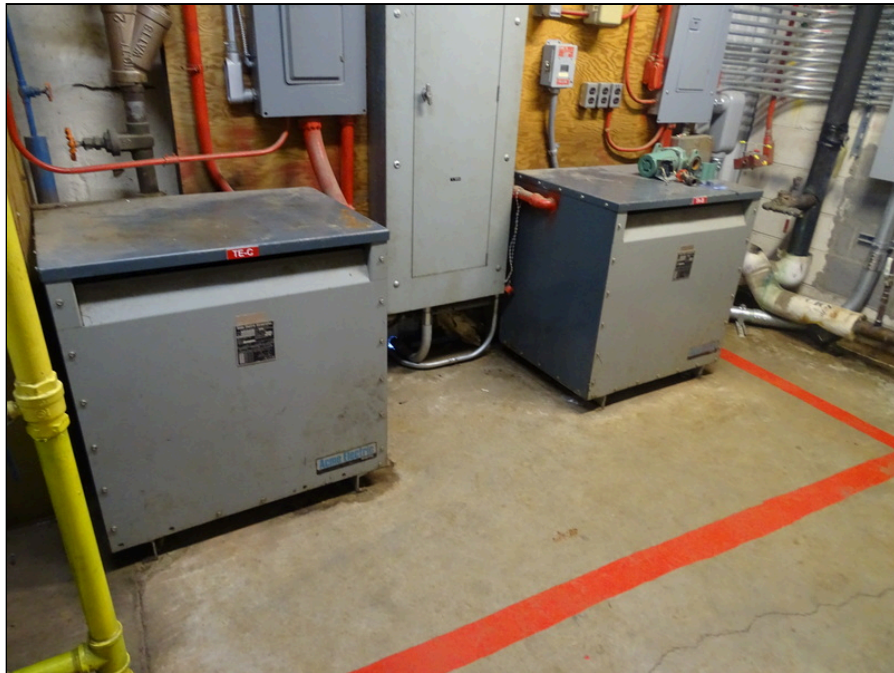
48 - Typical building transformer

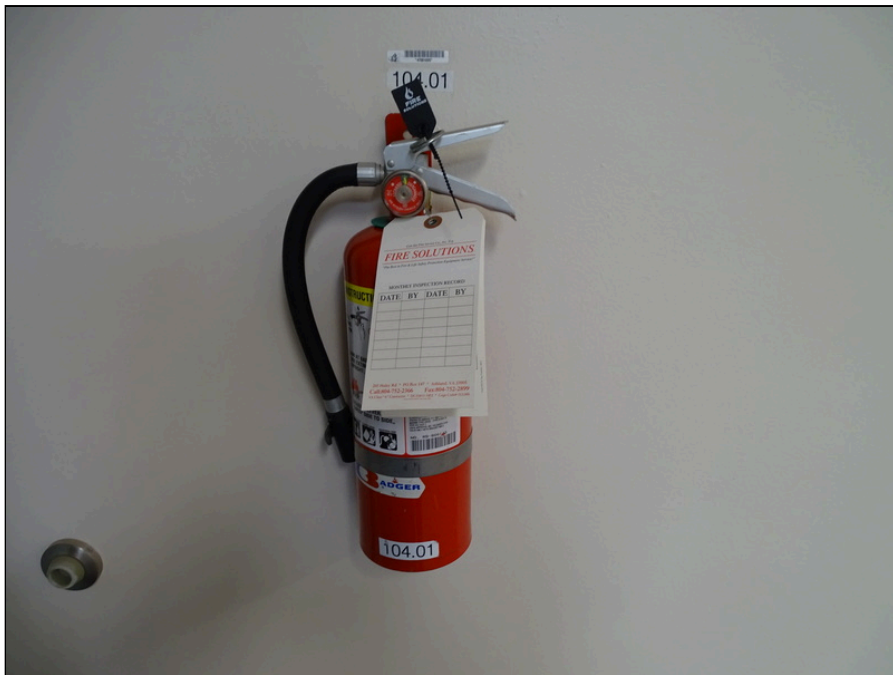
50 - Typical fire extinguisher

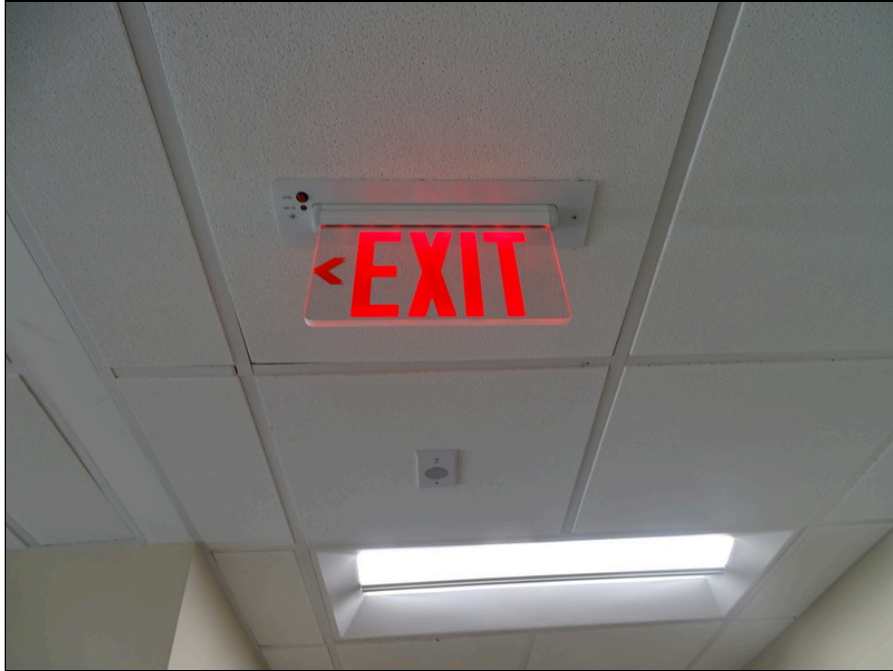
51 - Typical exit sign

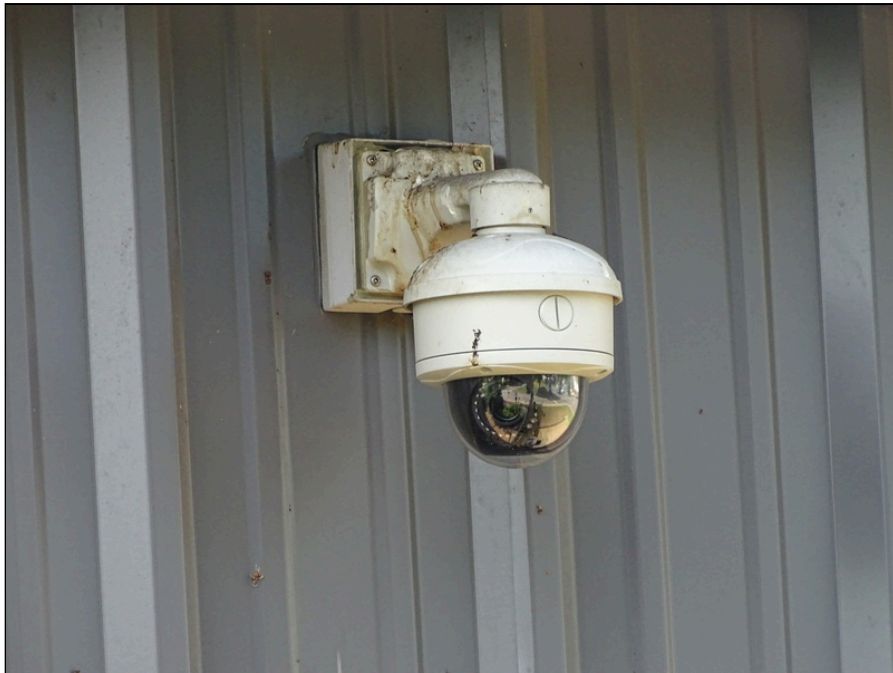
52 - Typical security camera

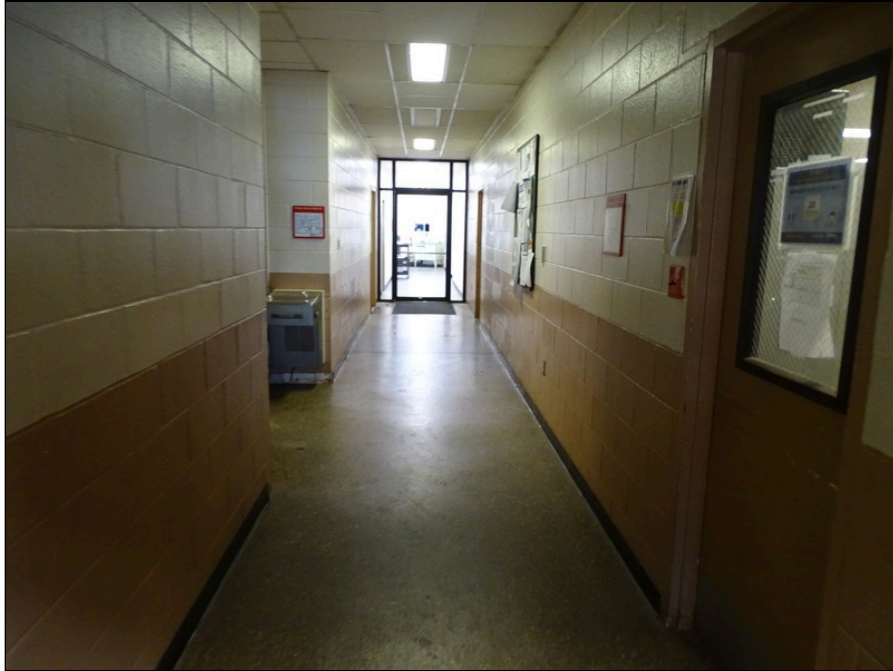
53 - Interior finishes of corridor area

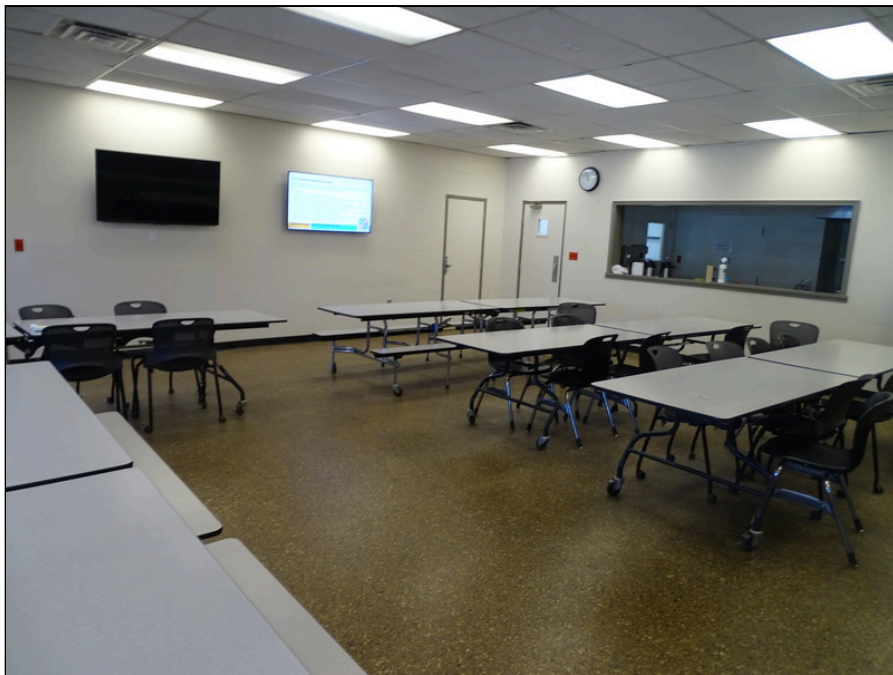
54 - Interior finishes of kitchen area

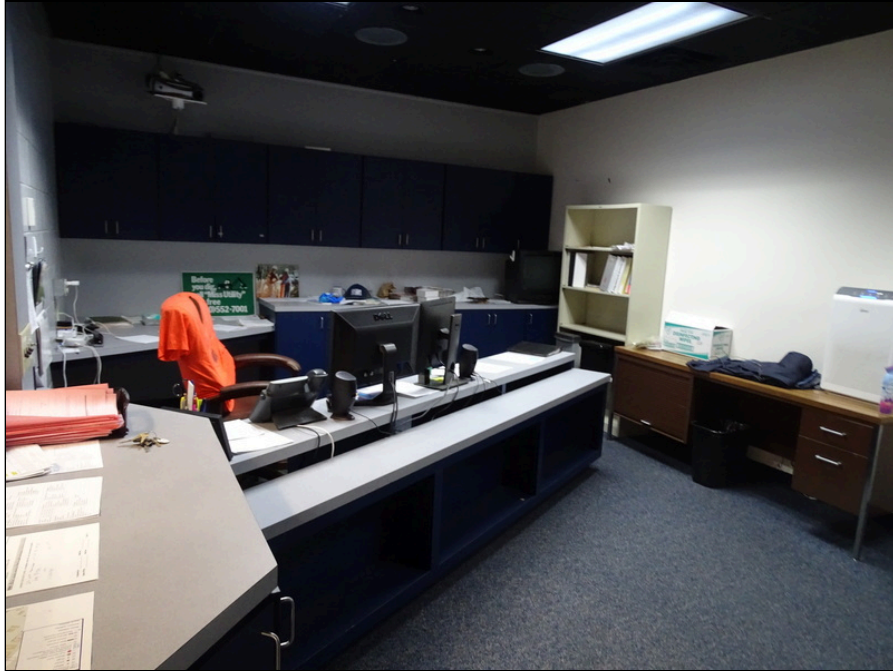
55 - Interior finishes of office area

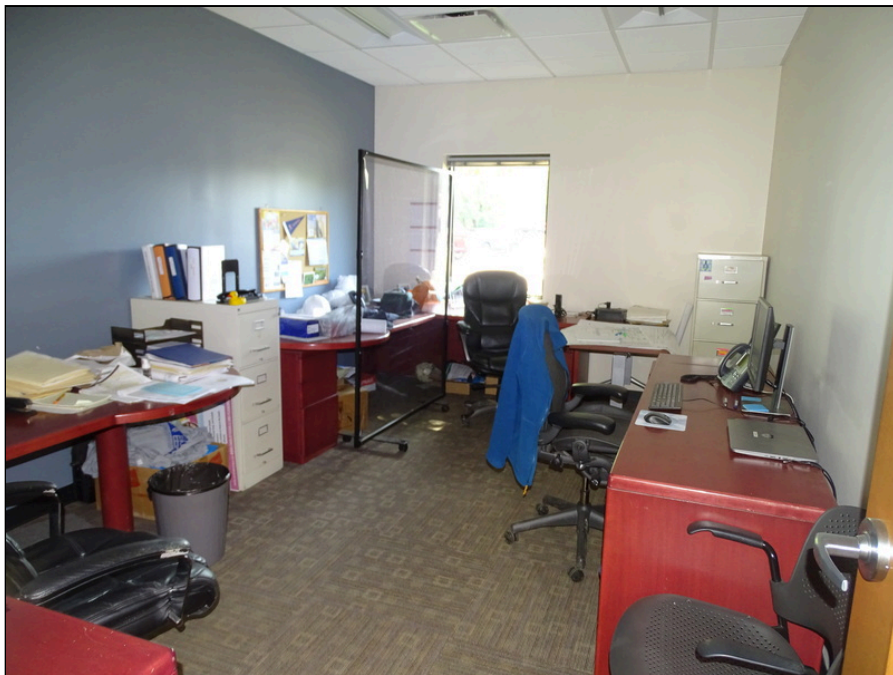
56 - Interior finishes of office area

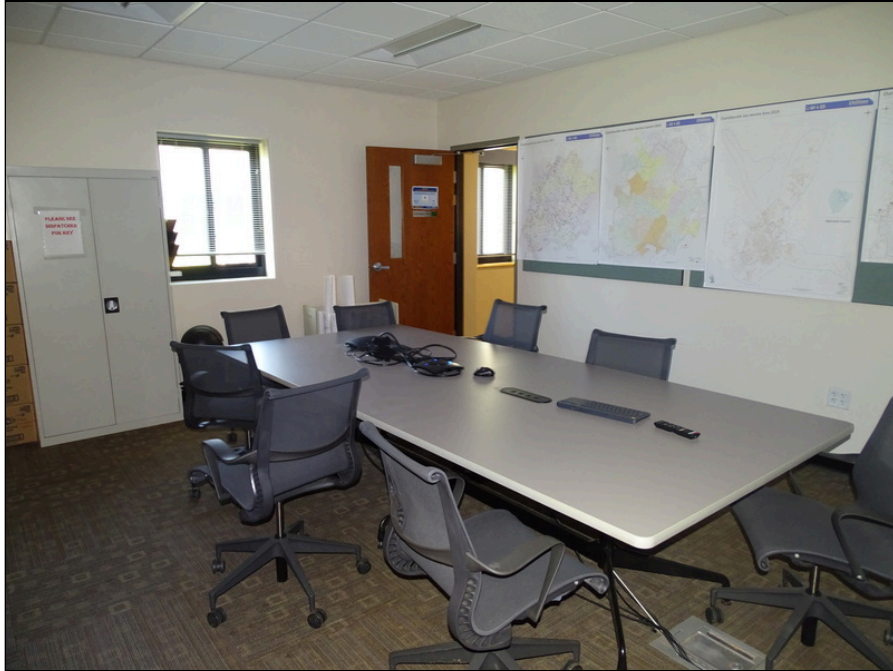
57 - Interior finishes of meeting room area

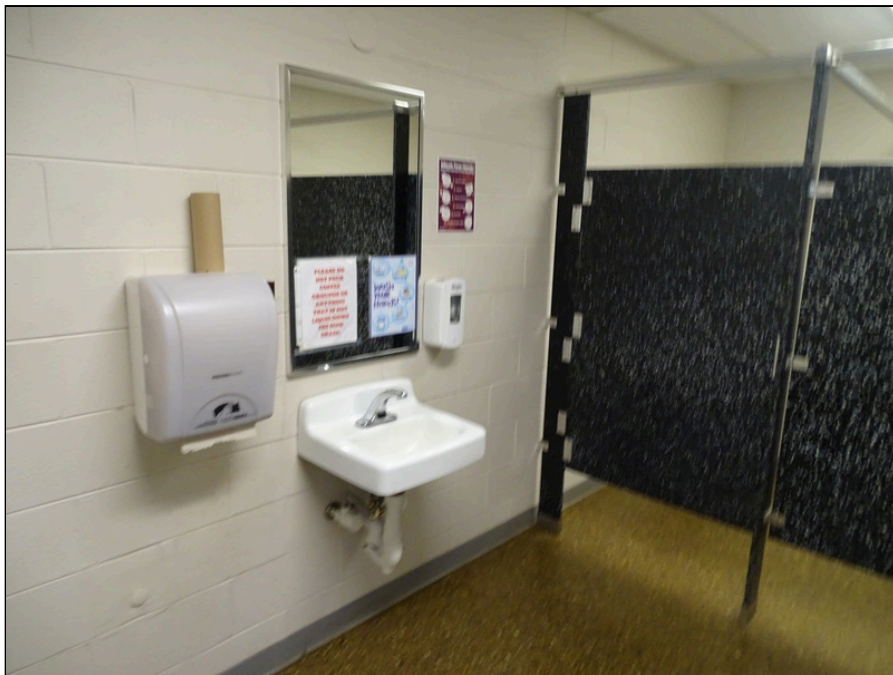
58 - Interior finishes of restroom area

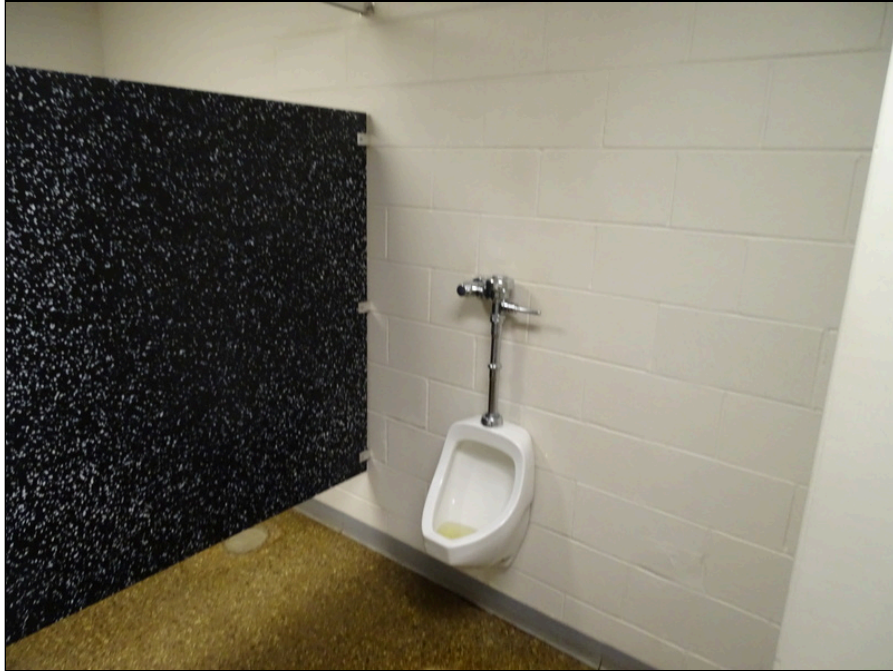
59 - Interior finishes of restroom area

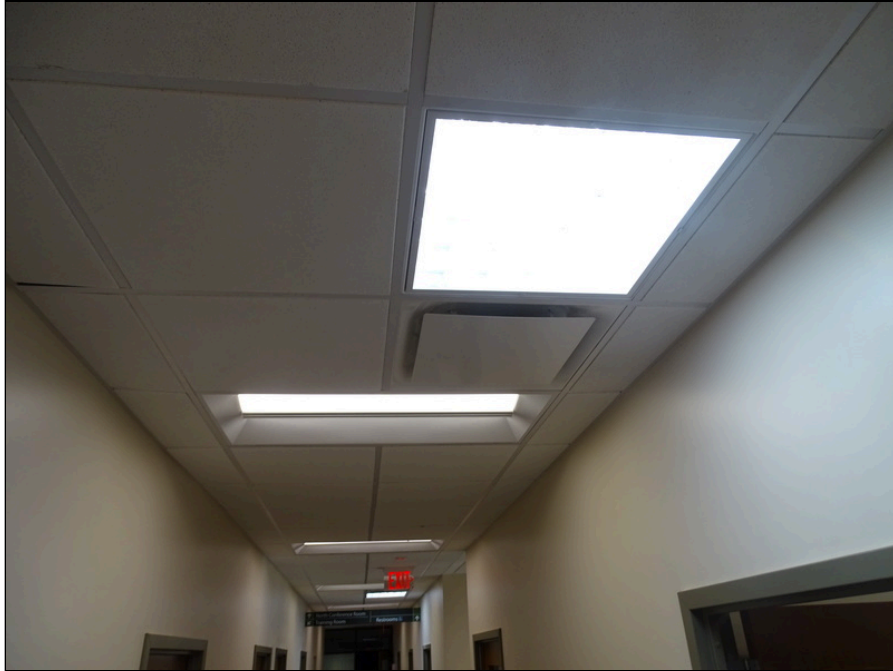
61 - Interior finishes of corridor area ceiling

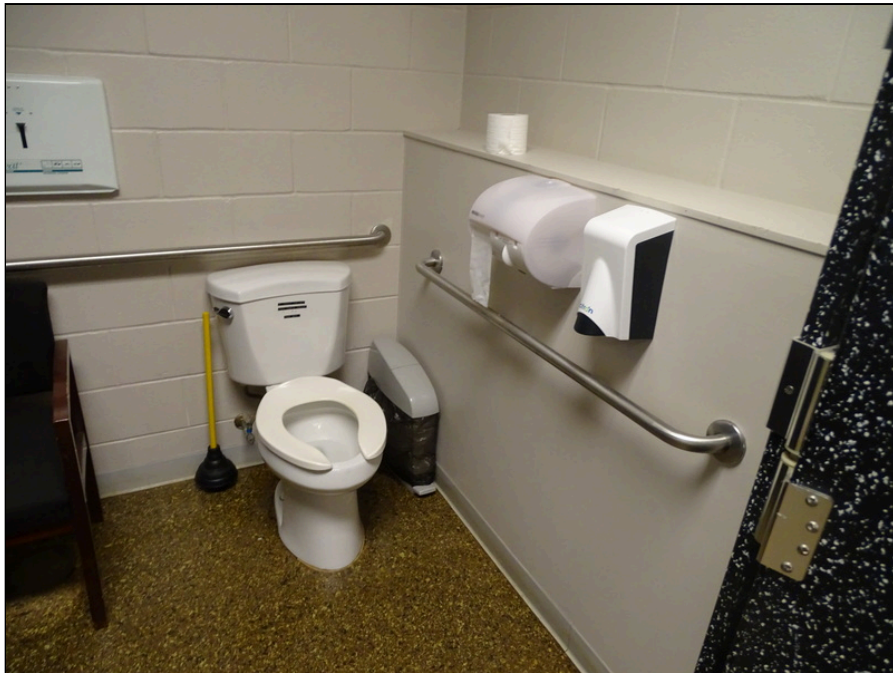
62 - Accessible toilet
