PUBLIC WORKS ADMINISTRATION BUILDING
305 4TH STREET NW
CHARLOTTESVILLE, VIRGINIA

ECS PROJECT NO. 46:6713

CITY OF CHARLOTTESVILLE - FACILITIES DEVELOPMENT

Reference: Facility Condition Assessment Report for Public Works Administration Building, 305 4th Street NW, Charlottesville, Virginia

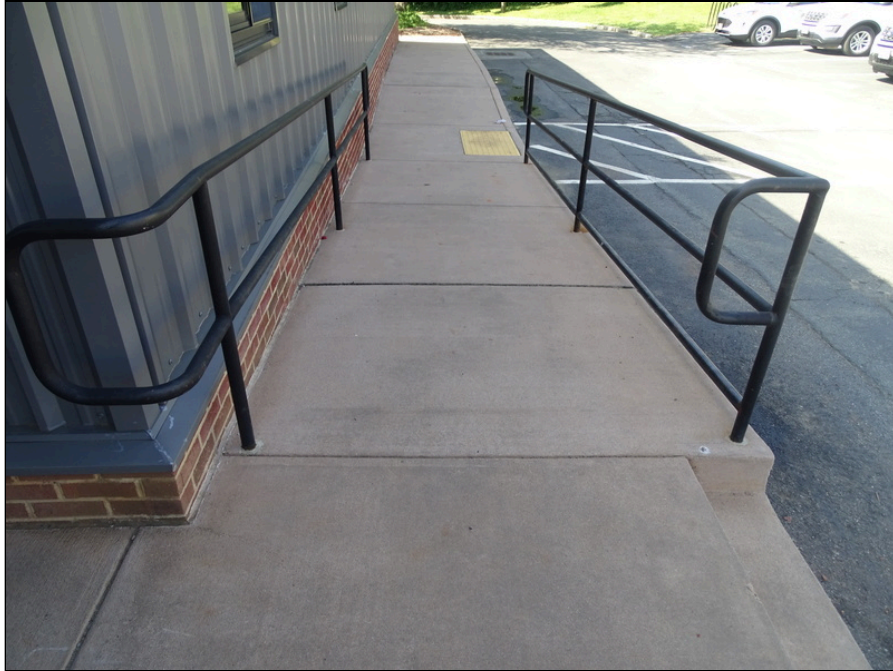
63 - Accessible ramp

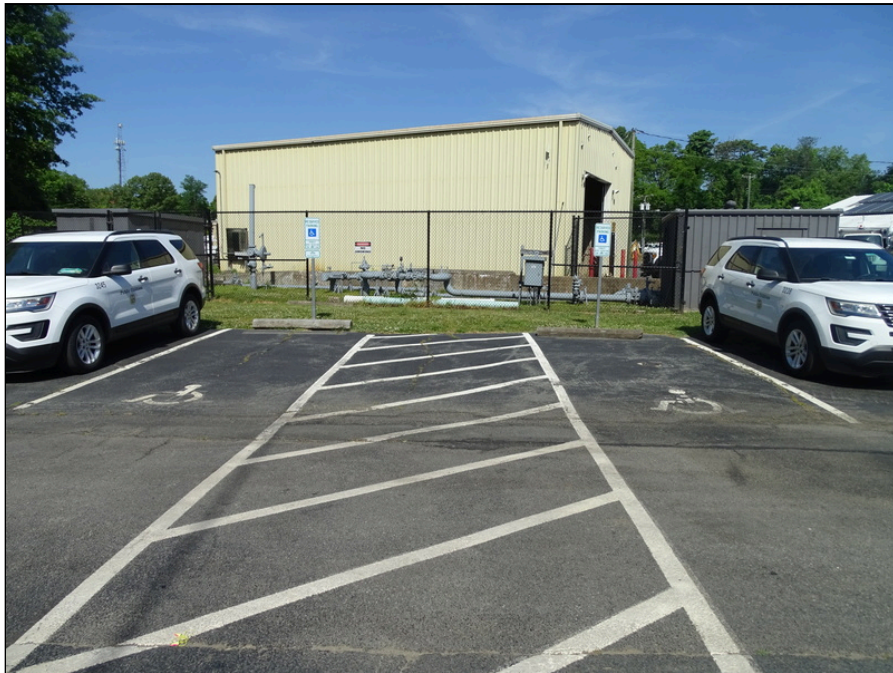
64 - Accessible parking spaces

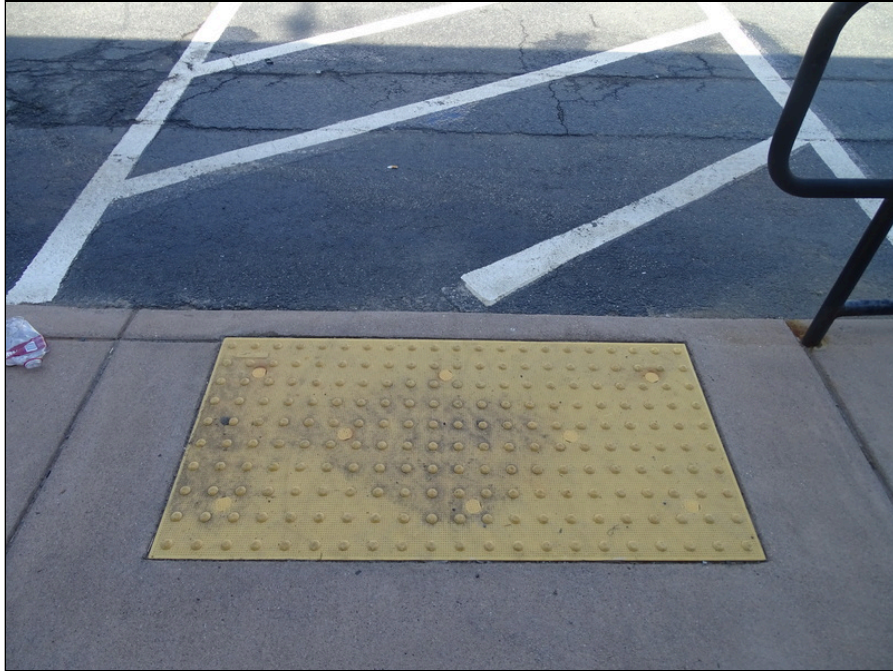
65 - Curb ramp with truncated domes
