SCHOOL BUS YARD & FUEL STATION
1505 AVON STREET EXT
CHARLOTTESVILLE, VIRGINIA

ECS PROJECT NO. 46:6713

CITY OF CHARLOTTESVILLE - FACILITIES DEVELOPMENT

Reference: Facility Condition Assessment Report for School Bus Yard & Fuel Station, 1505 Avon Street Ext, Charlottesville, Virginia

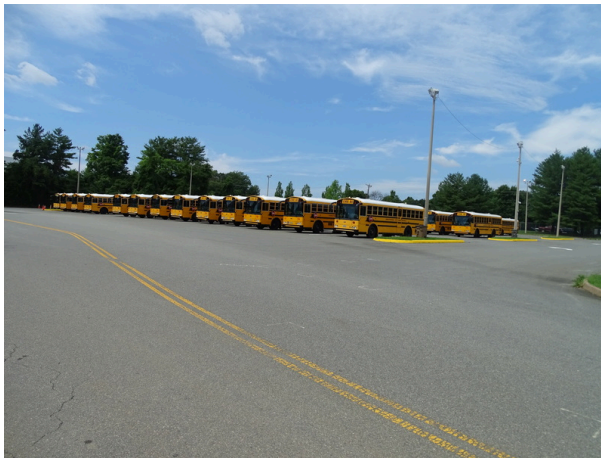
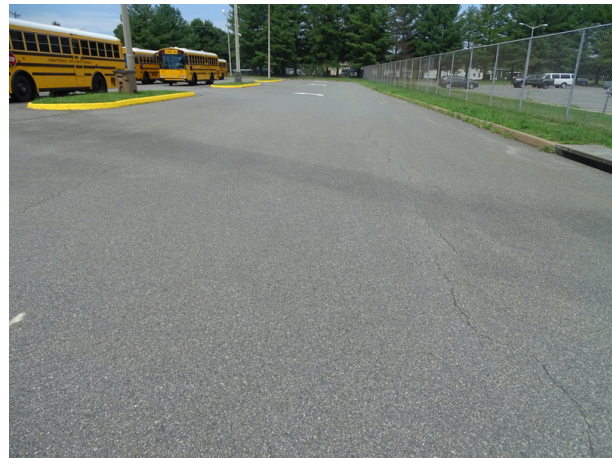
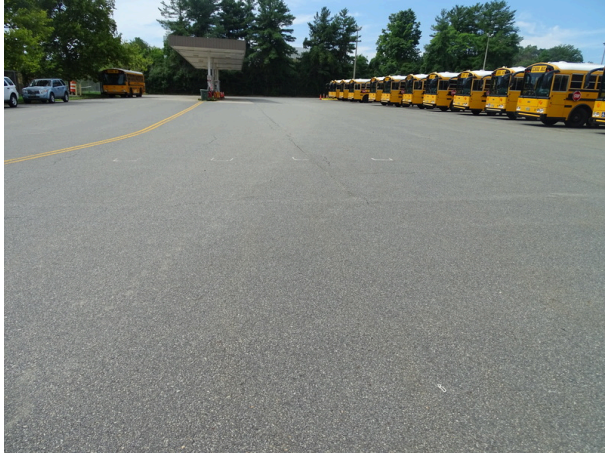
The concrete curbs surrounding the parking areas were generally in fair condition, with cracking and vegetation growth noted. We recommend removing the growth, monitoring the cracking, and replace as needed along with the sidewalk repairs noted later in the report.

Bus lot overview

Lot and curb overview

Bus lot and Fuel station overview

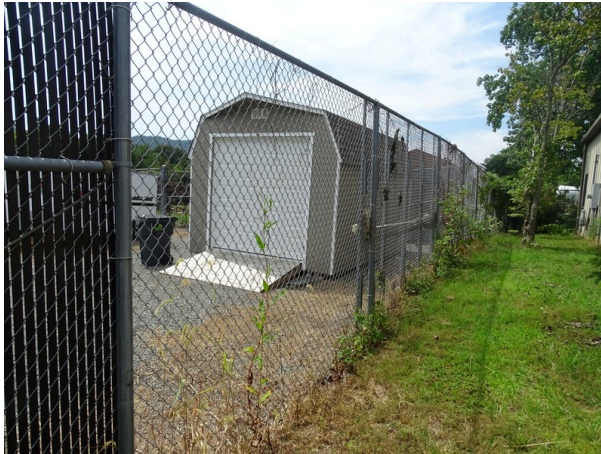
the fence had been replaced over the years, although some of the fence was original. The fence on the south side of the property was beginning to deteriorate and was detached in many locations. We recommend replacing the fence on the south side of the property during the report period.

Typical fence overview

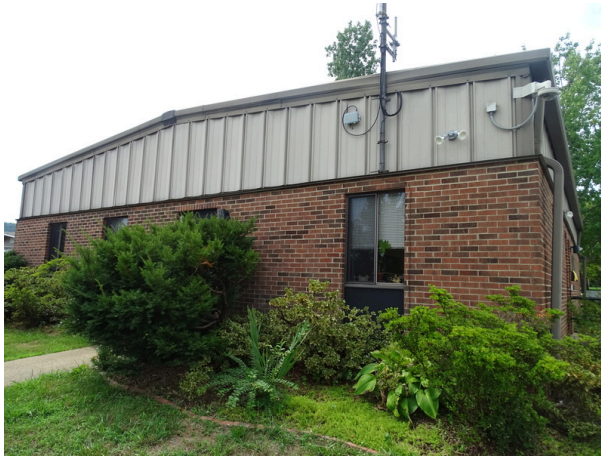
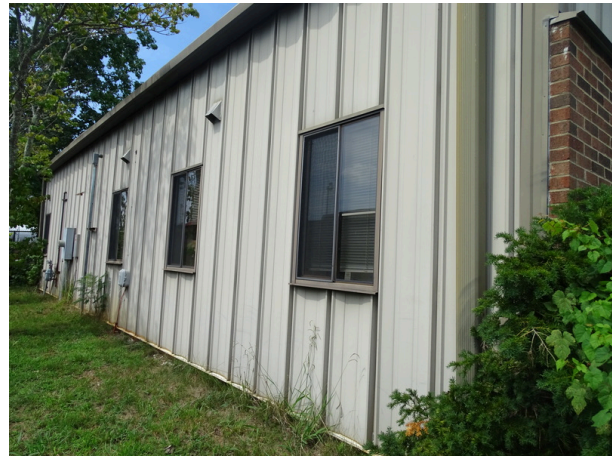
North building elevation

East building elevation

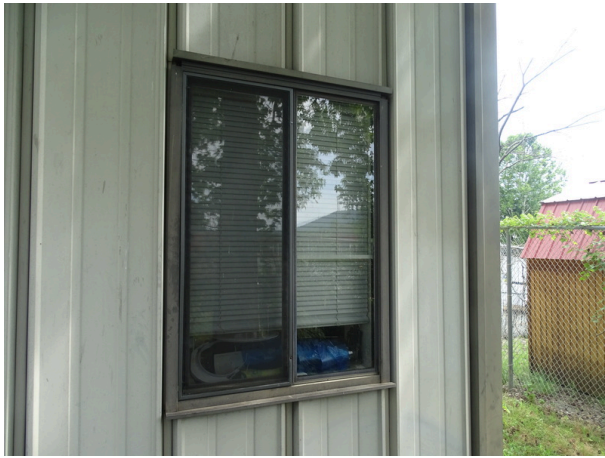
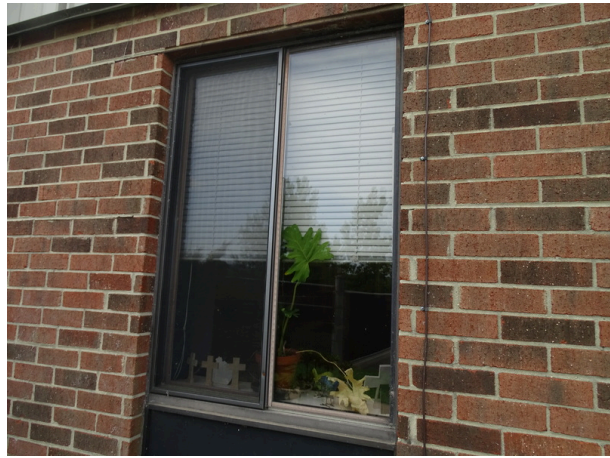
The window system for the building primarily consists of Aluminum frame single pane - operable window units. The gaskets in the windows were generally in fair condition. The expected useful life of single pane windows is typically 30 years. The screens and glass were in sound condition, however, it was reported that the windows were difficult to operate and they were drafty in the wintertime. The windows are nearing their expected useful lives and should be replaced during the report period.

Exterior window

Typical exterior window overview

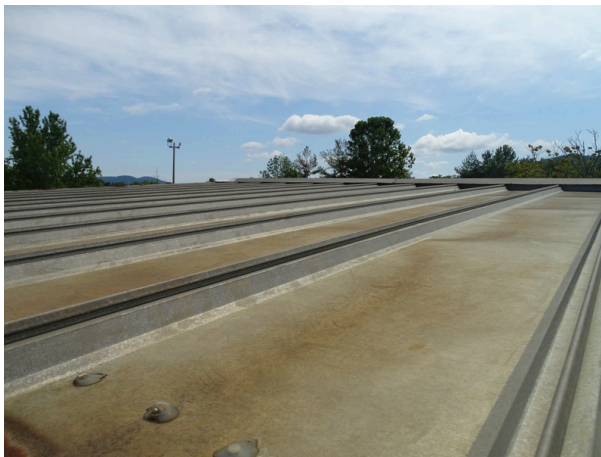
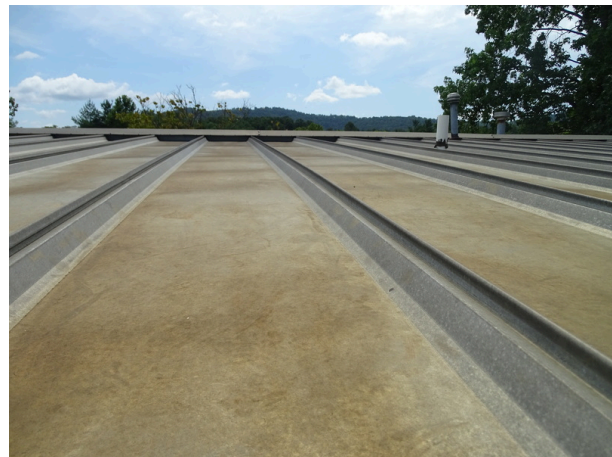
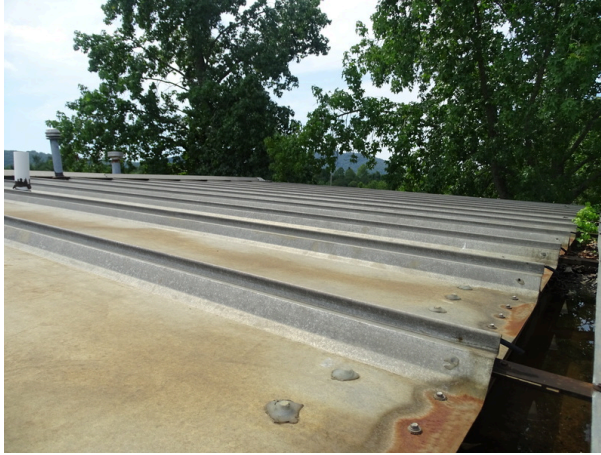
Vegetative growth was observed in the gutters. We recommend regular maintenance and cleaning of the gutters.

Metal panel roofing system overview

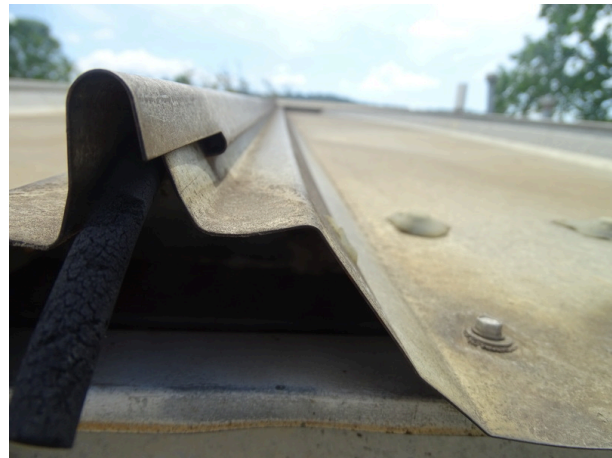
Metal roof condition

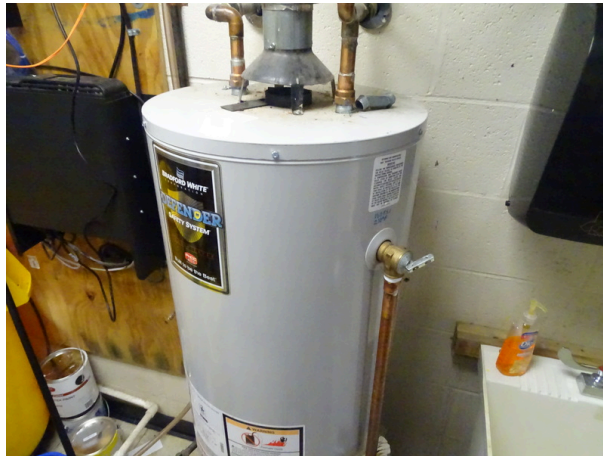
Domestic hot water to the building is provided by Gas domestic water heater located in the janitor's closet. The 40 gallon Gas domestic water heater was manufactured by Bradford White in 2013 and was in good condition. The expected useful life of a Gas domestic water heater is approximately 12 to 15 years. We recommend the Gas domestic water heater be replaced during the report period.

Typical gas domestic water heater

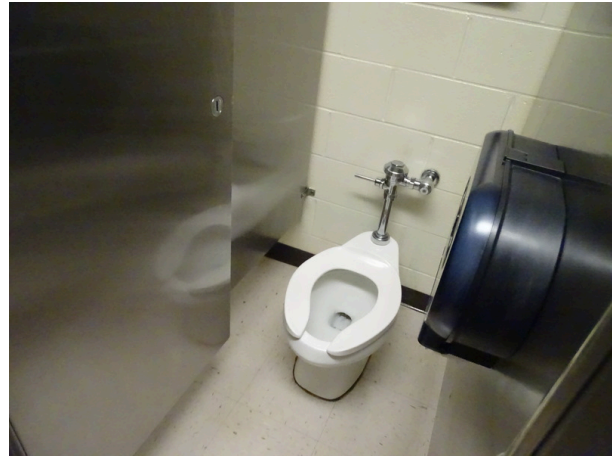
Typical Accessible restroom

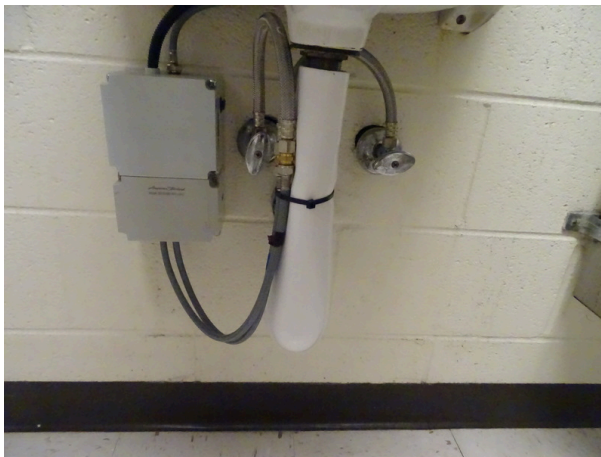
Typical restroom

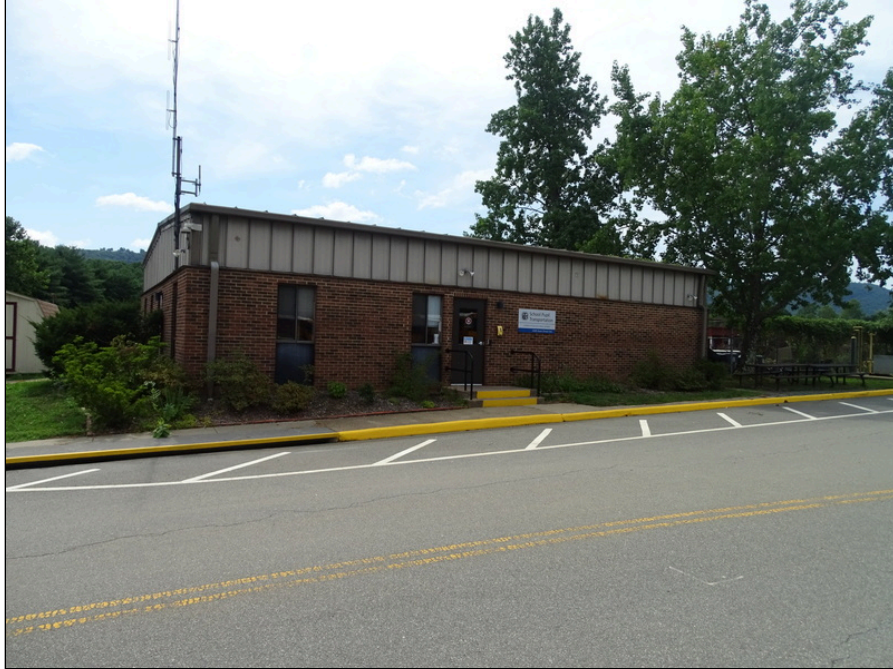
1 - Building overview

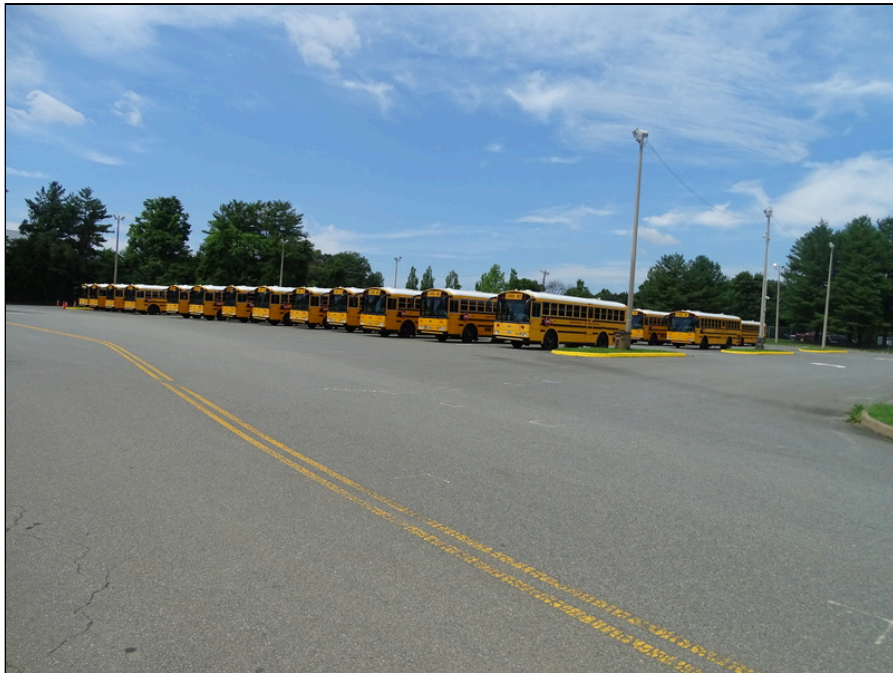
2 - Bus lot overview

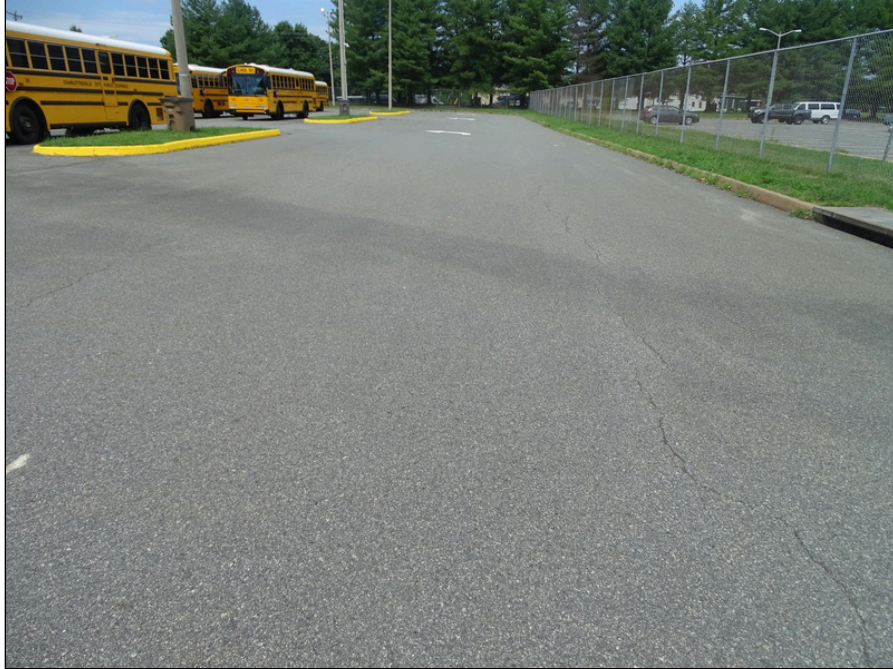
3 - Bus lot and commuter lot overview

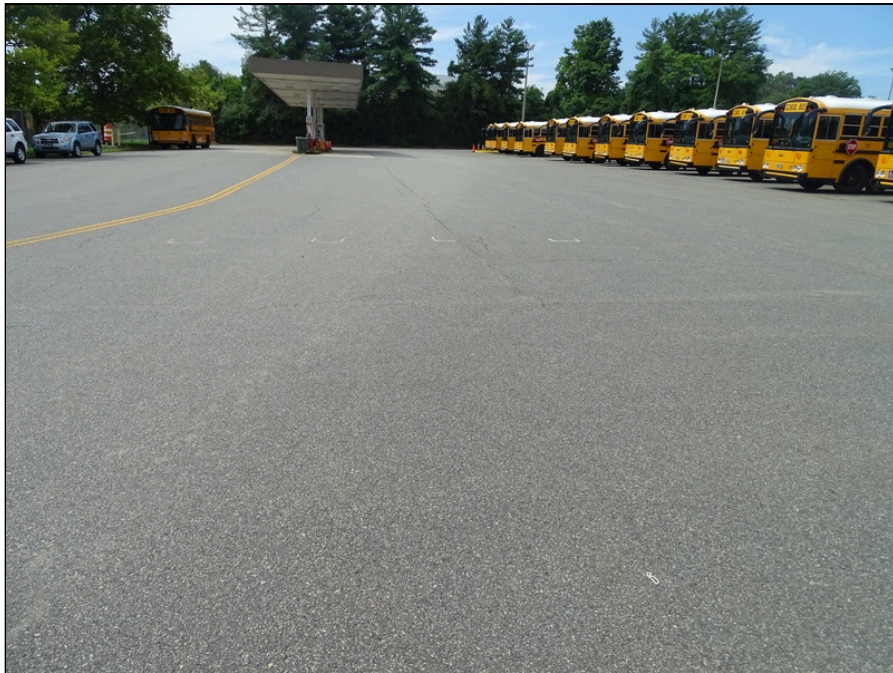
4 - Bus lot and Fuel station overview

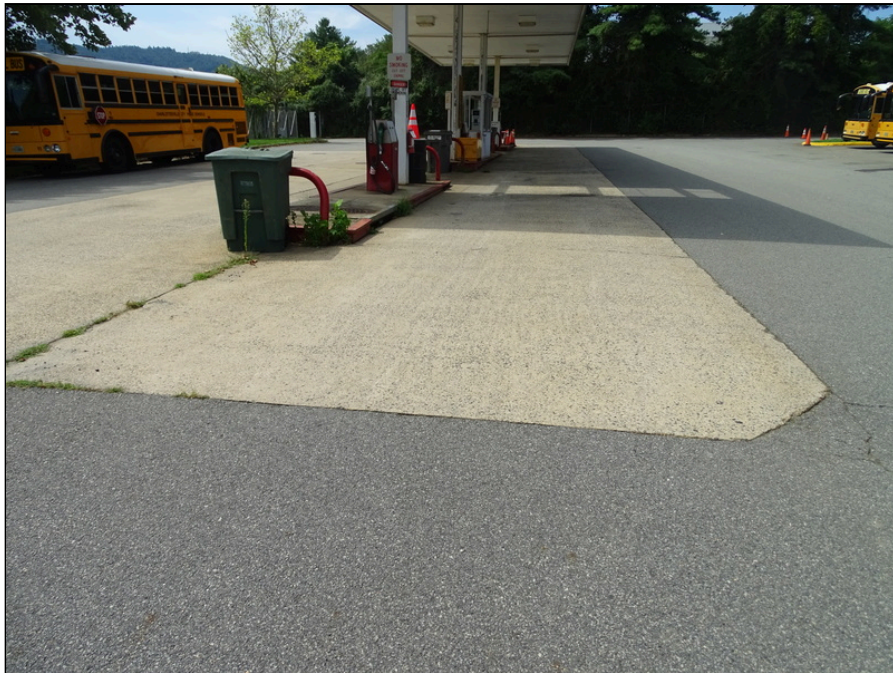
6 - Fuel station

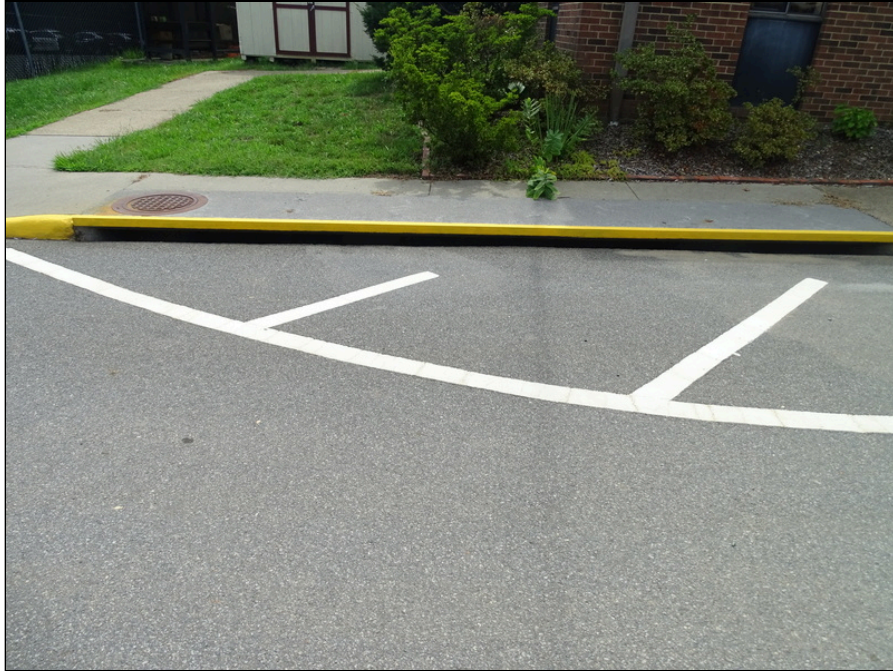
7 - Site drainage

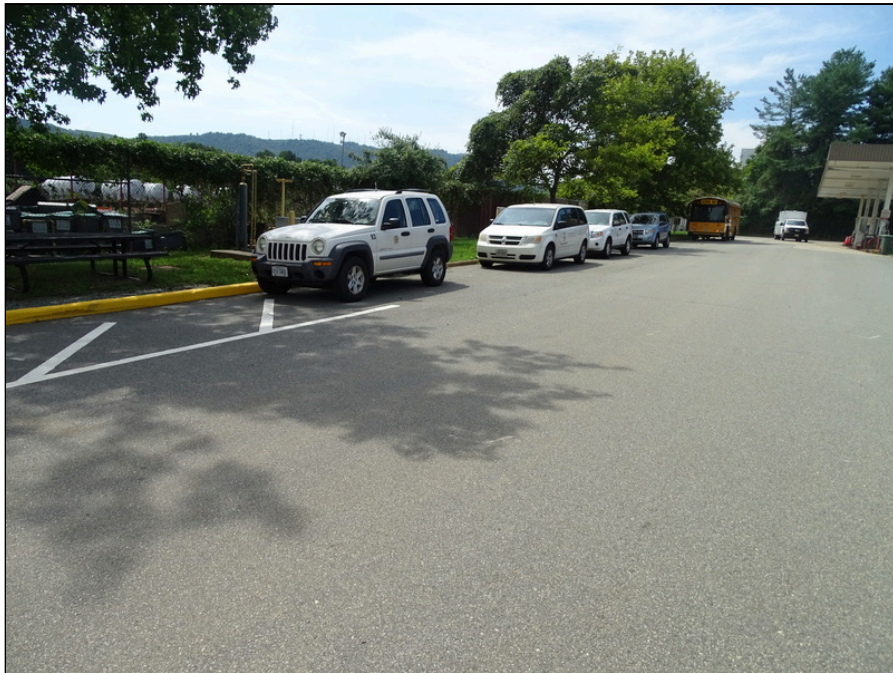
14 - Entrance overview

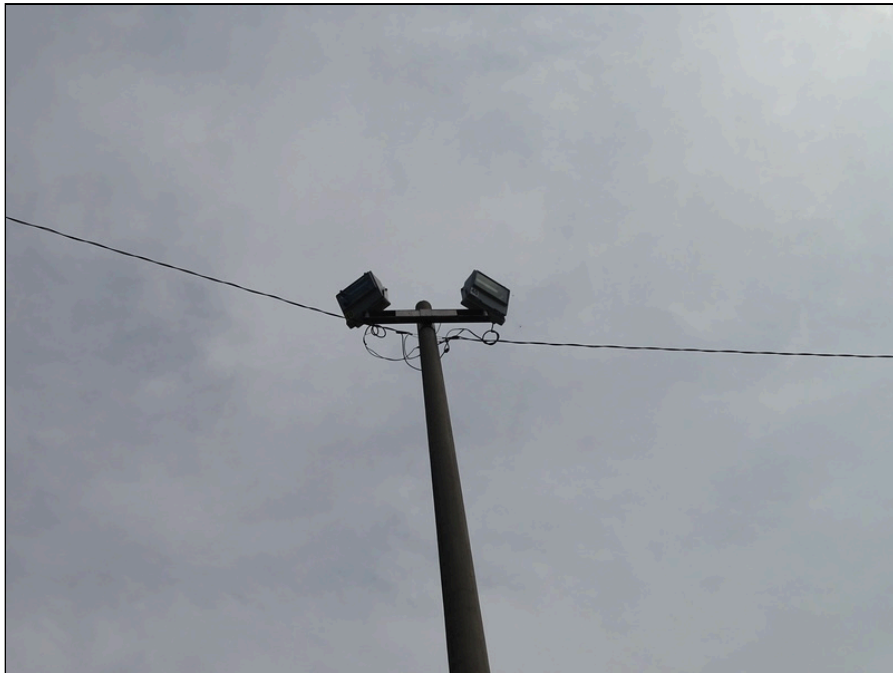
18 - Pole mounted lights

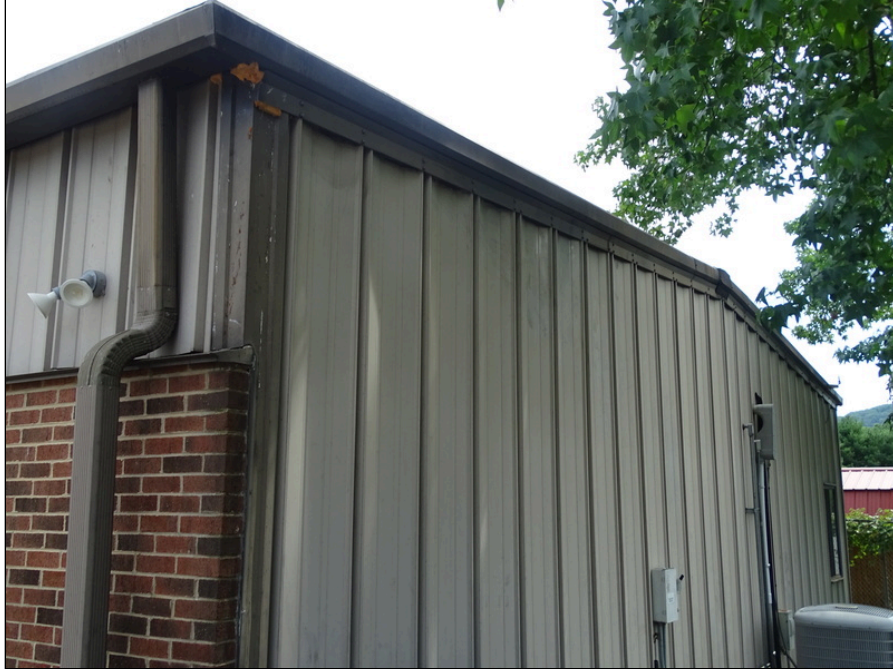
19 - Typical downspout overview

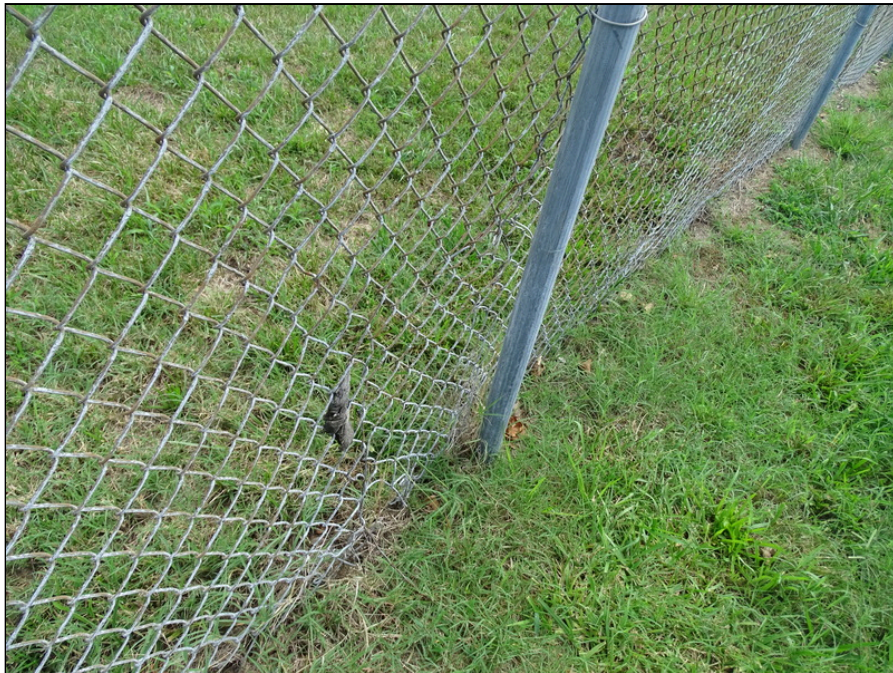
20 - Fence overview

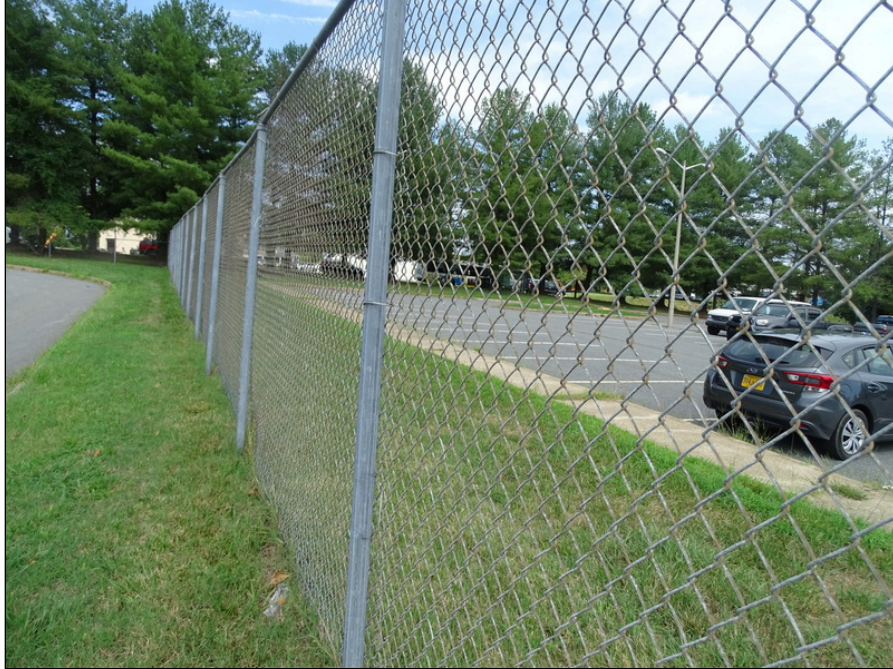
21 - Commuter lot and fence overview

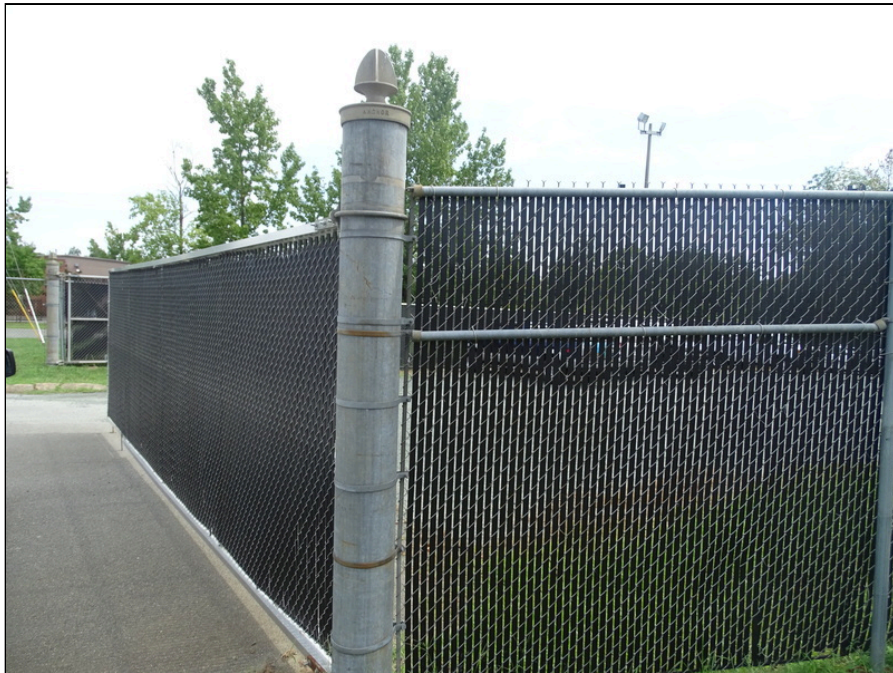
22 - Typical fence overview

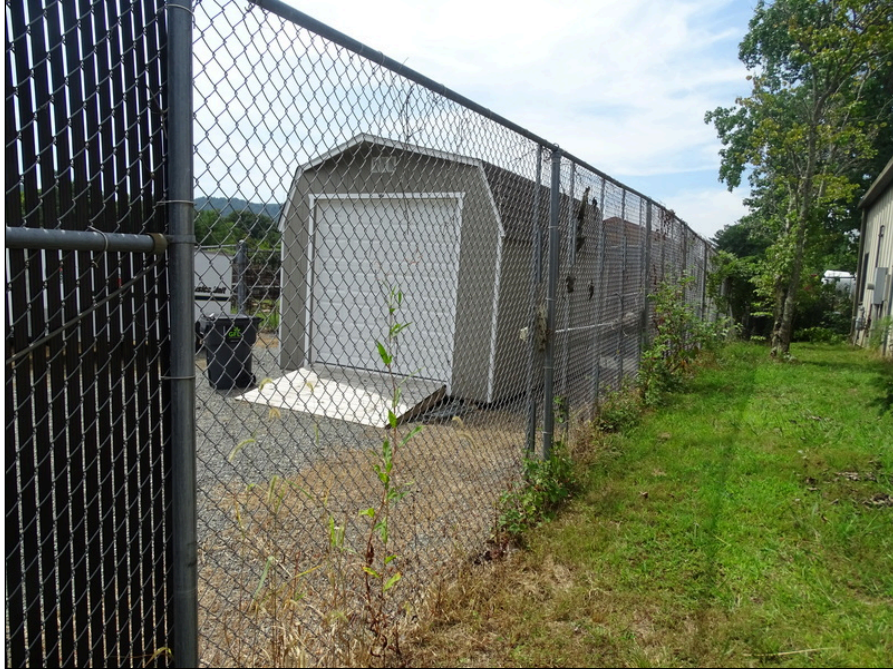
23 - Typical fence overview

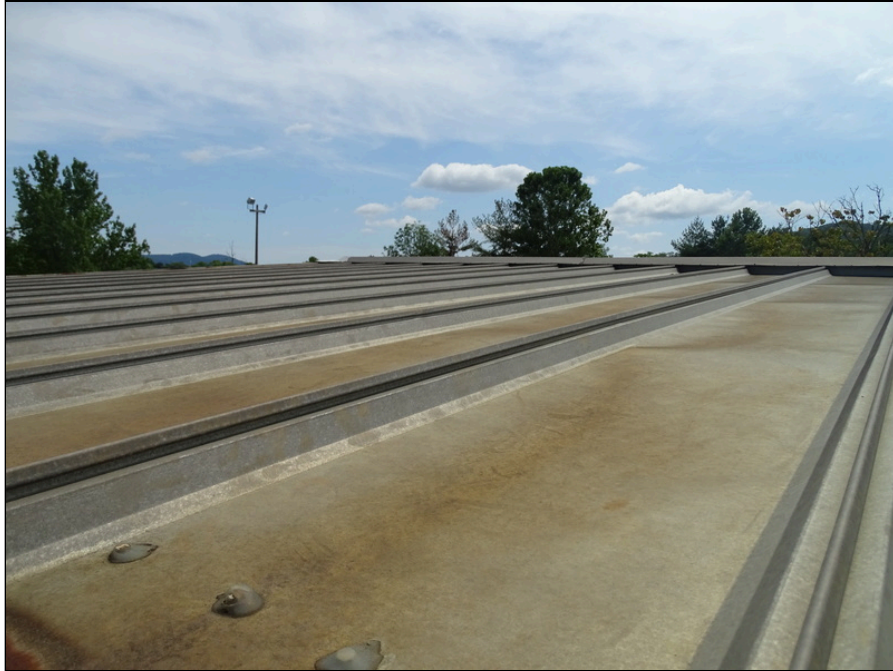
25 - Metal panel roofing system overview

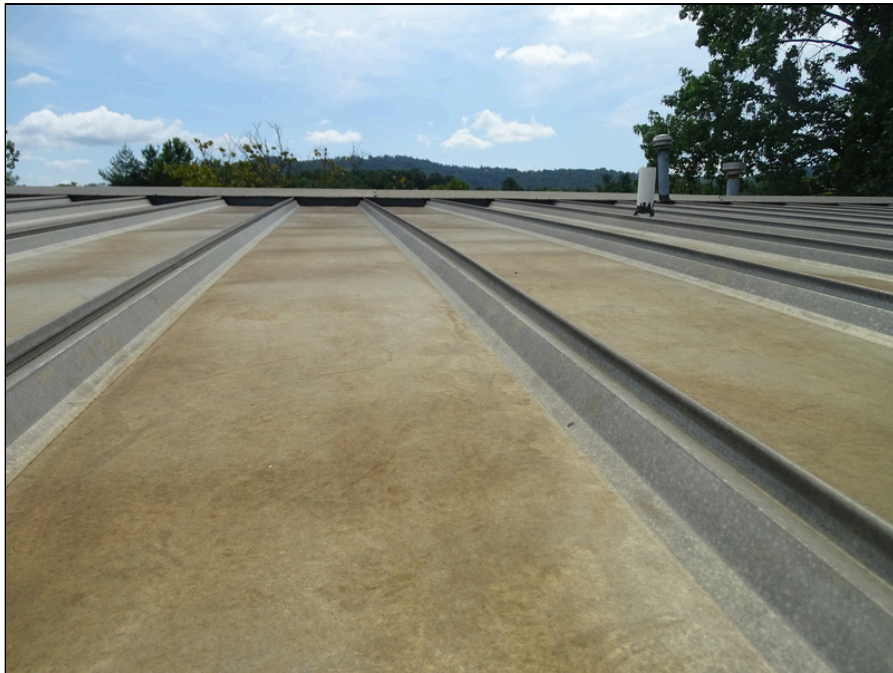
26 - Metal panel roofing system overview

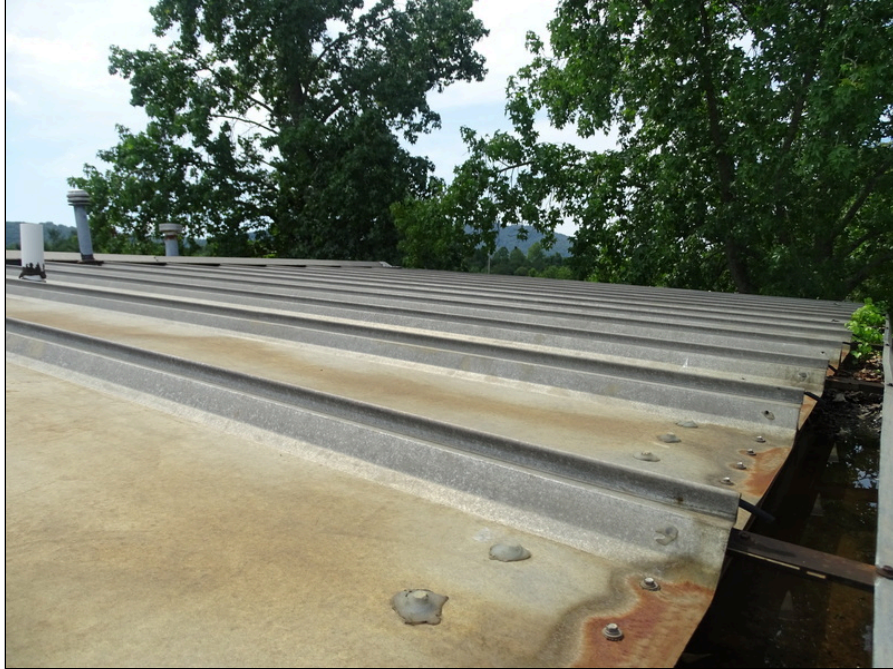
27 - Metal panel roofing system overview

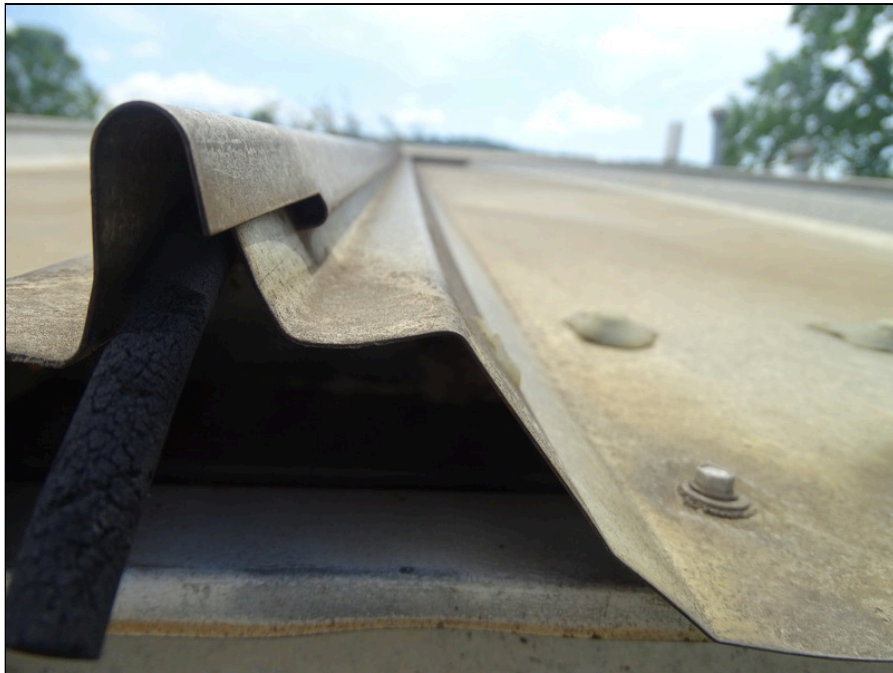
30 - Metal roof condition

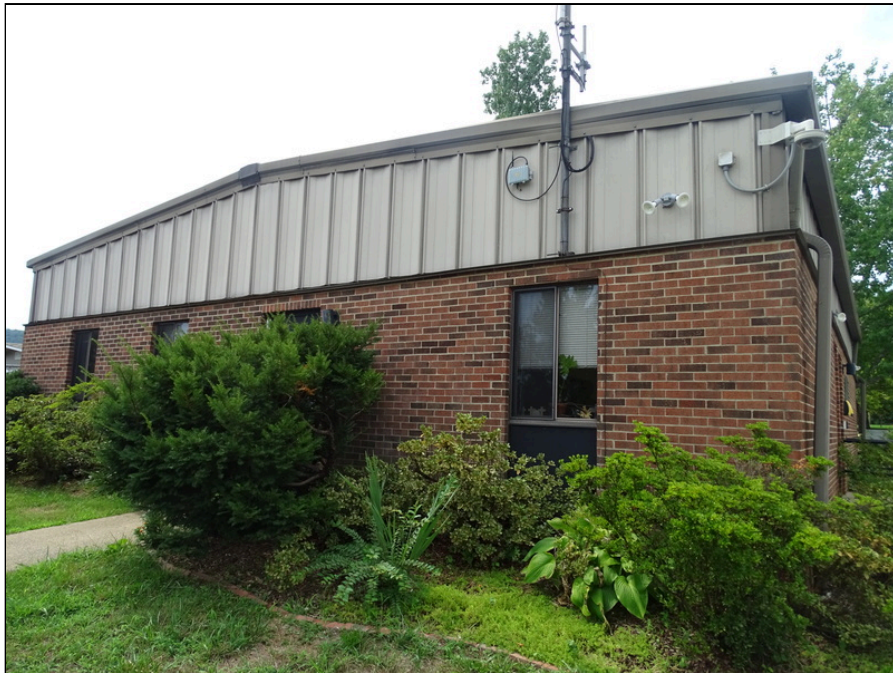
32 - North building elevation

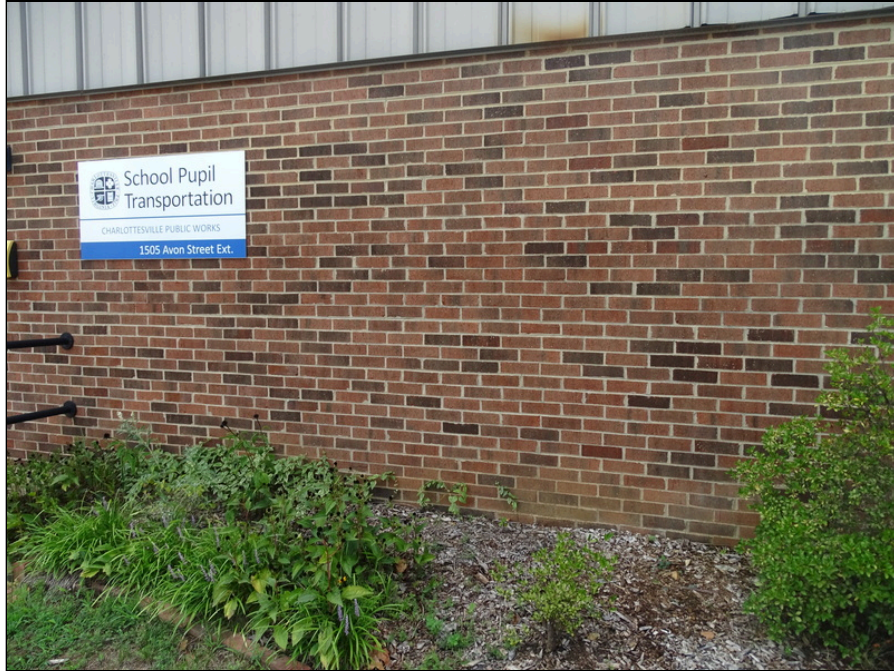
33 - Brick veneer wall and signage

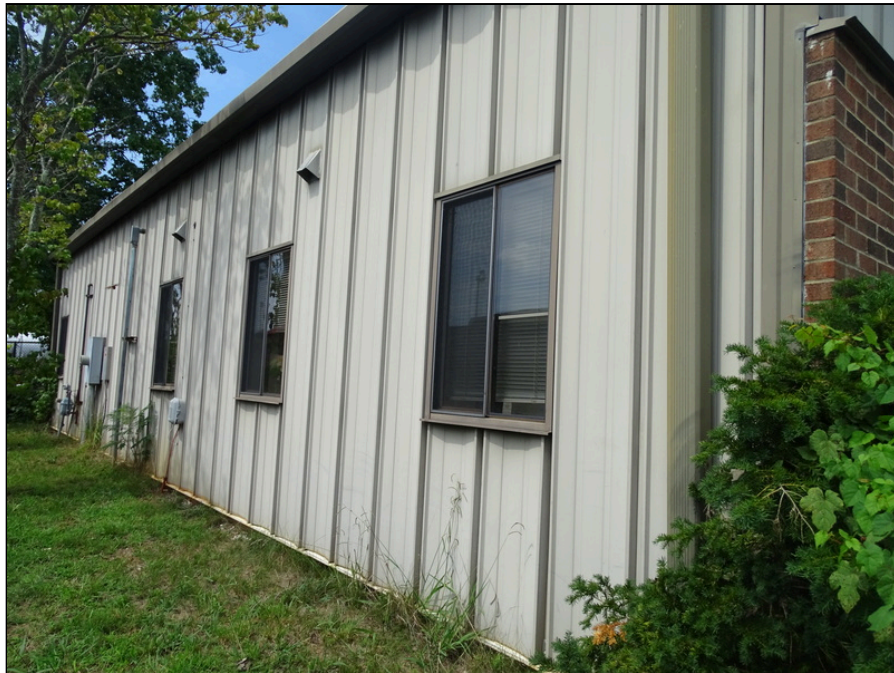
34 - East building elevation

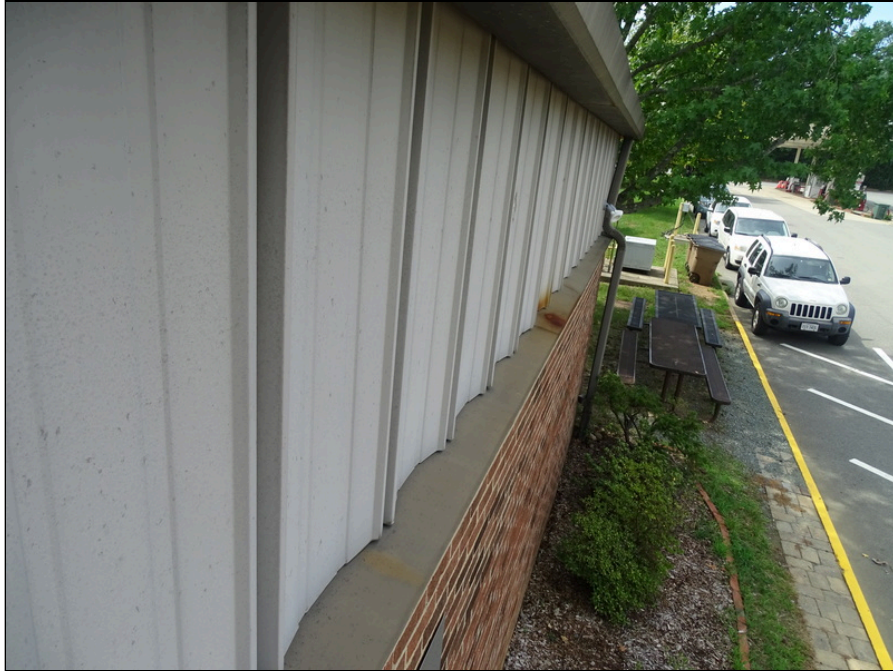
35 - Metal siding overview

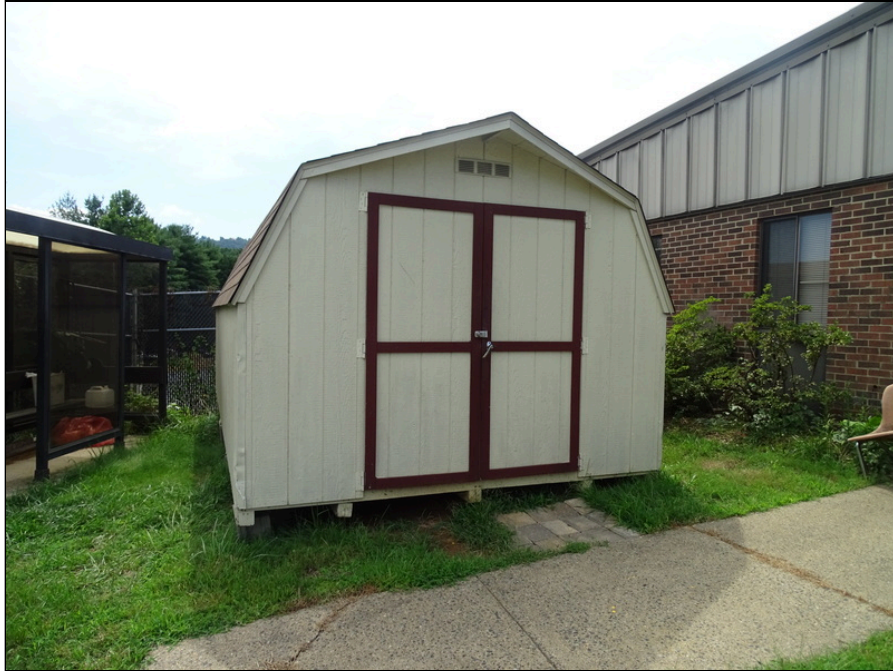
37 - Storage shed

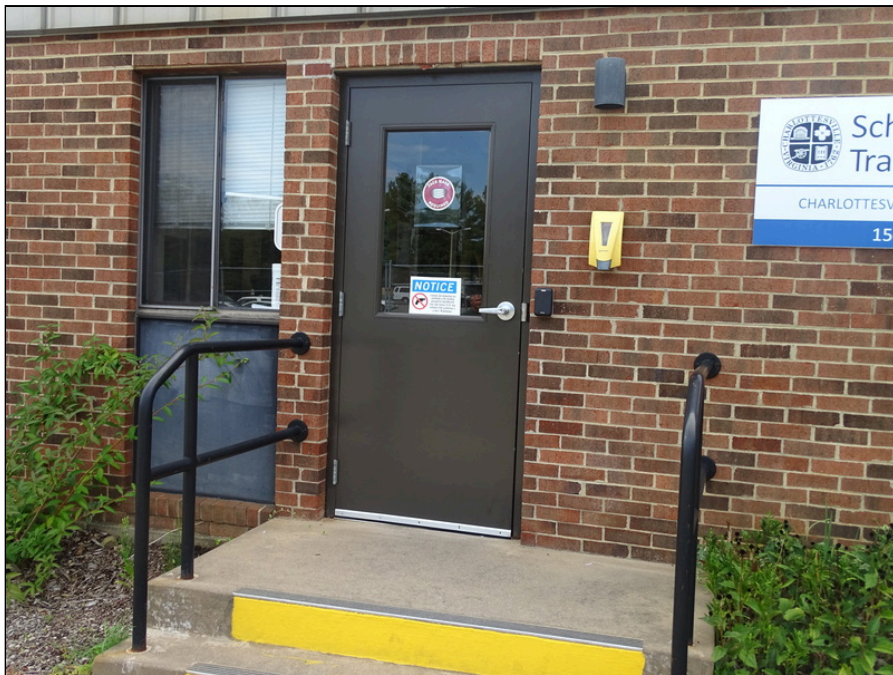
38 - Main entrance

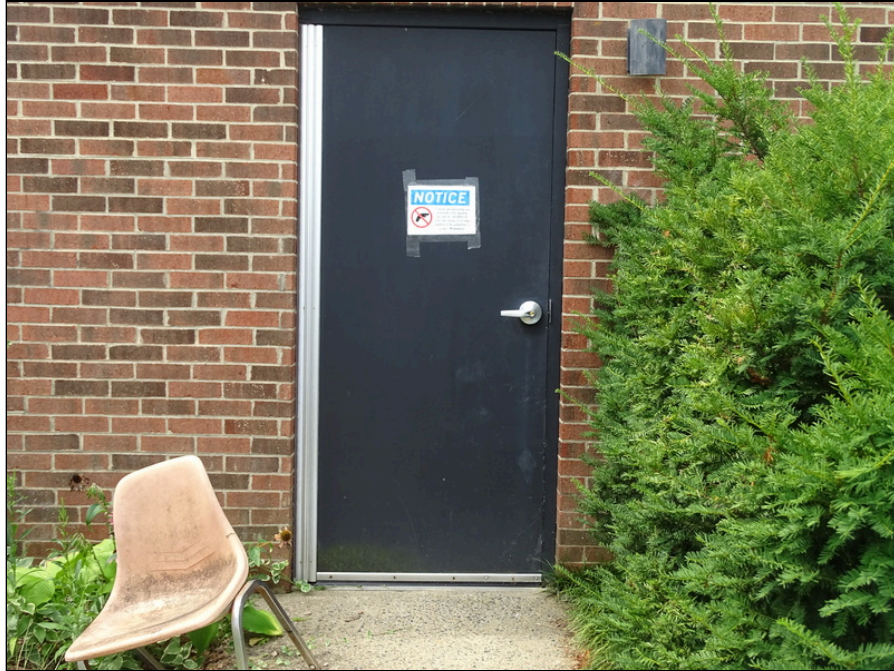
39 - Typical exterior single steel door

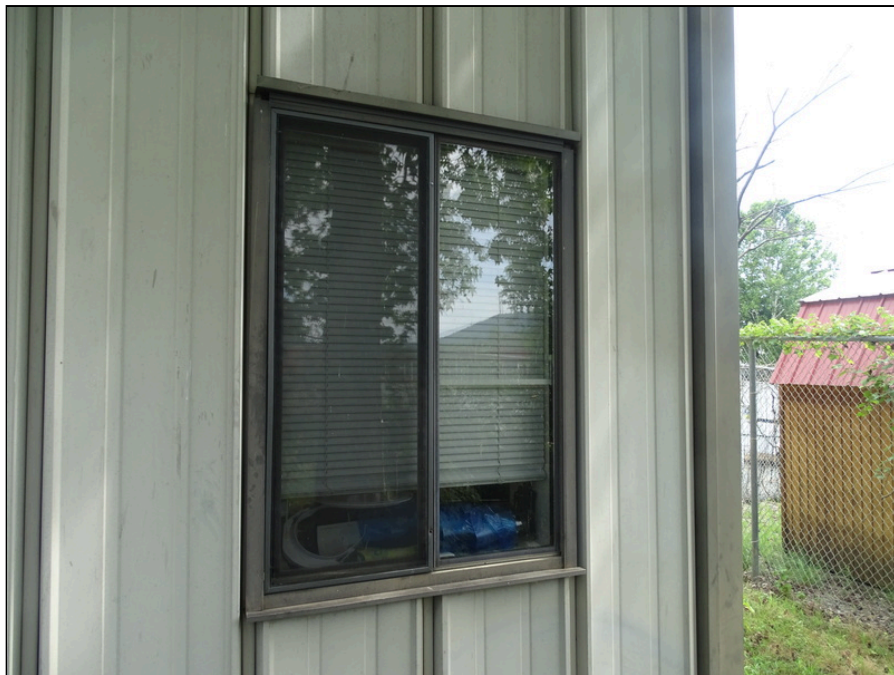
40 - Exterior window

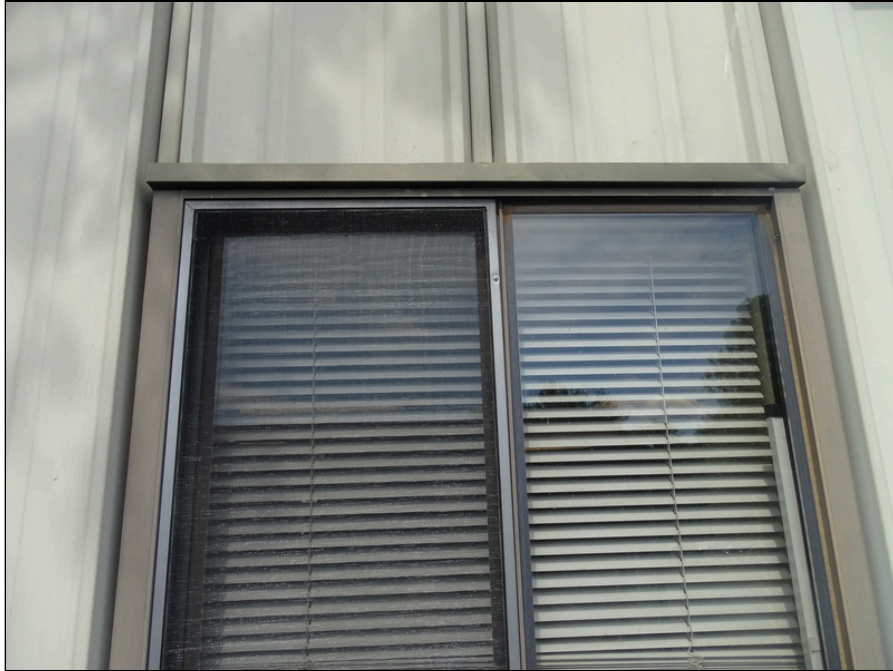
41 - Typical window exterior

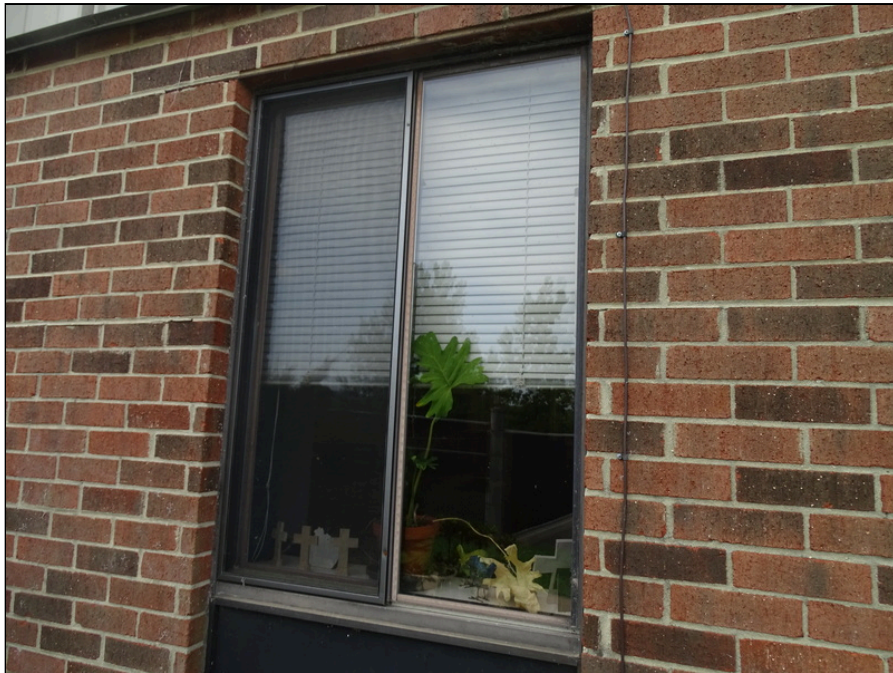
42 - Typical exterior window overview

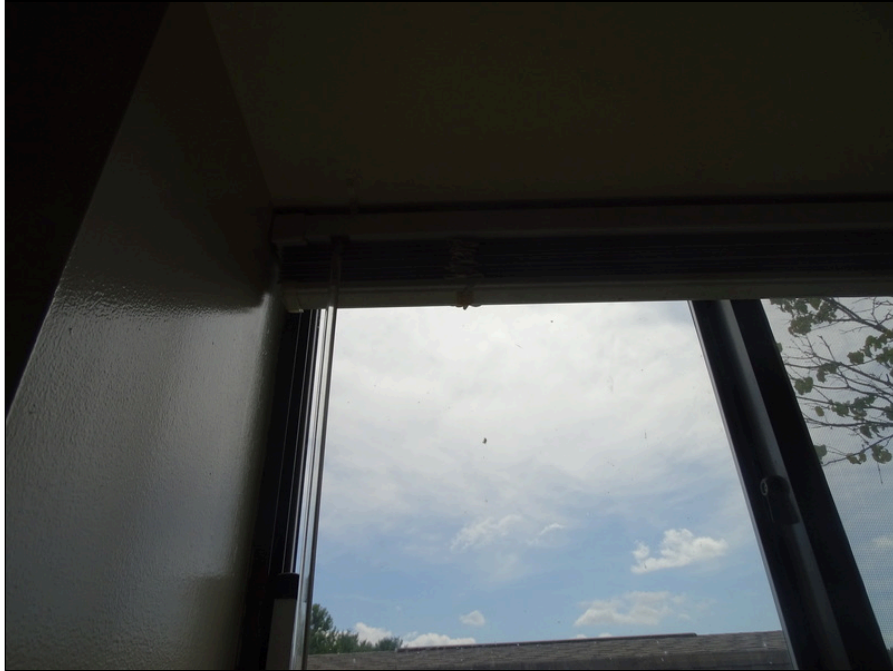
43 - Typical window interior

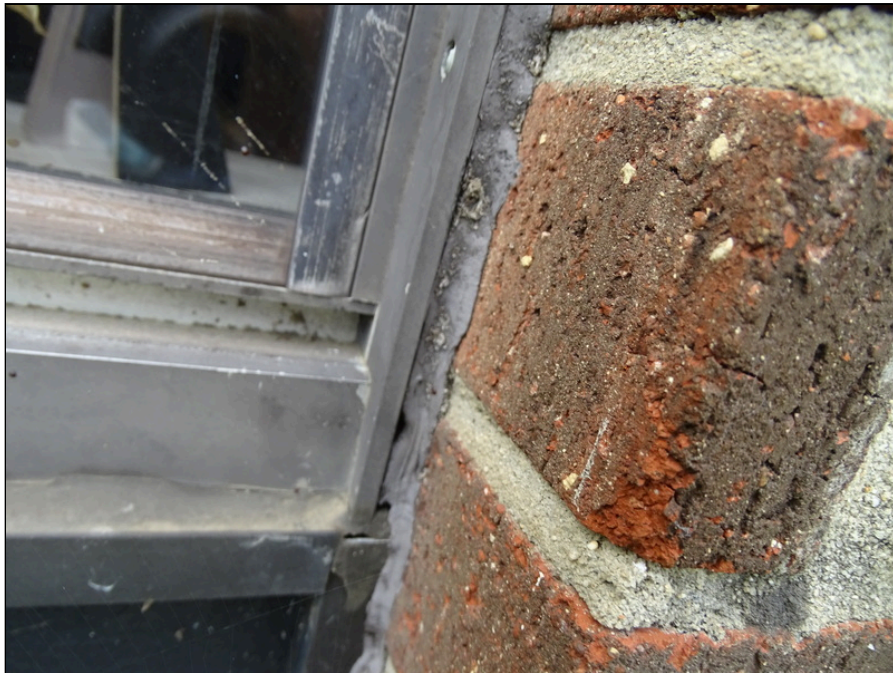
44 - Sealant around window

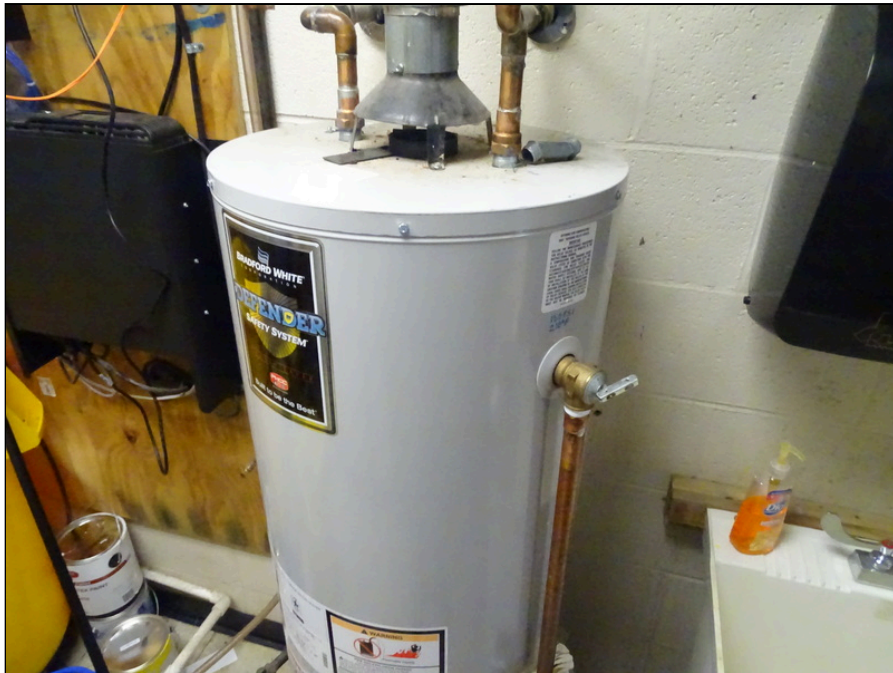
46 - Typical domestic water heater
