SCHOOL BUS YARD & FUEL STATION
1505 AVON STREET EXT
CHARLOTTESVILLE, VIRGINIA

ECS PROJECT NO. 46:6713

CITY OF CHARLOTTESVILLE - FACILITIES DEVELOPMENT

Reference: Facility Condition Assessment Report for School Bus Yard & Fuel Station, 1505 Avon Street Ext, Charlottesville, Virginia

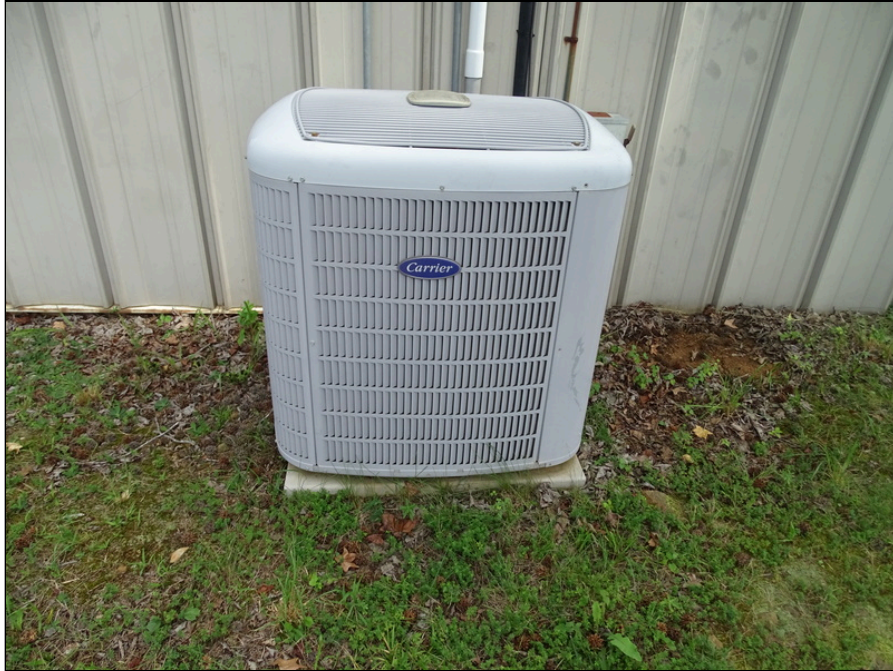
47 - Condenser

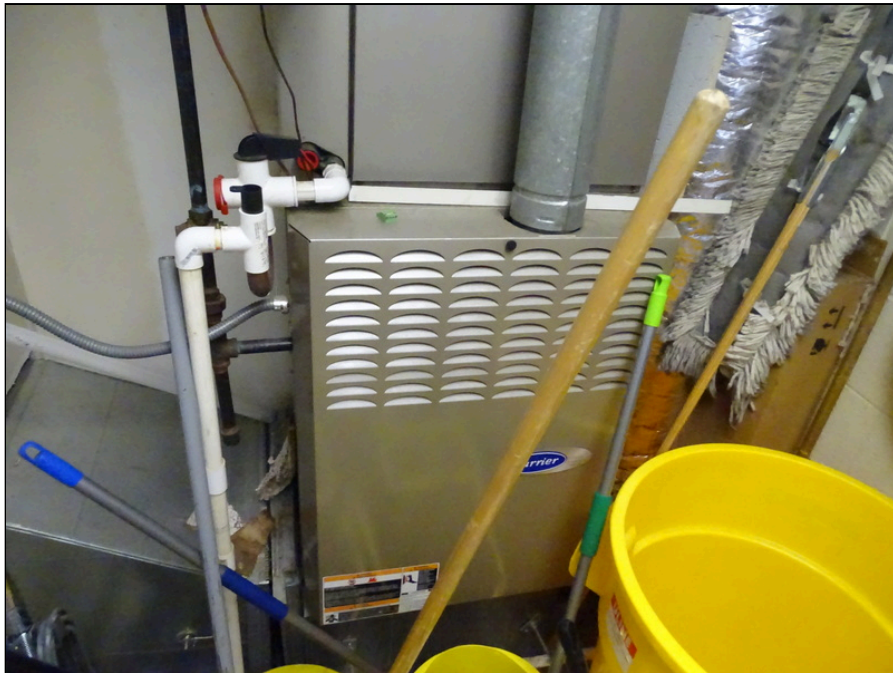
48 - HVAC system and ductwork

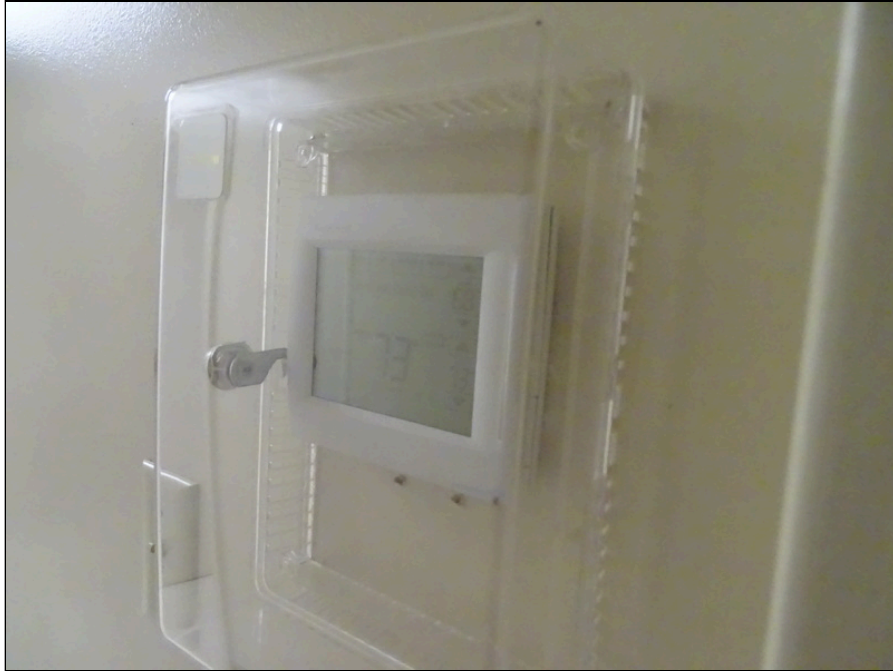
49 - Typical thermostat

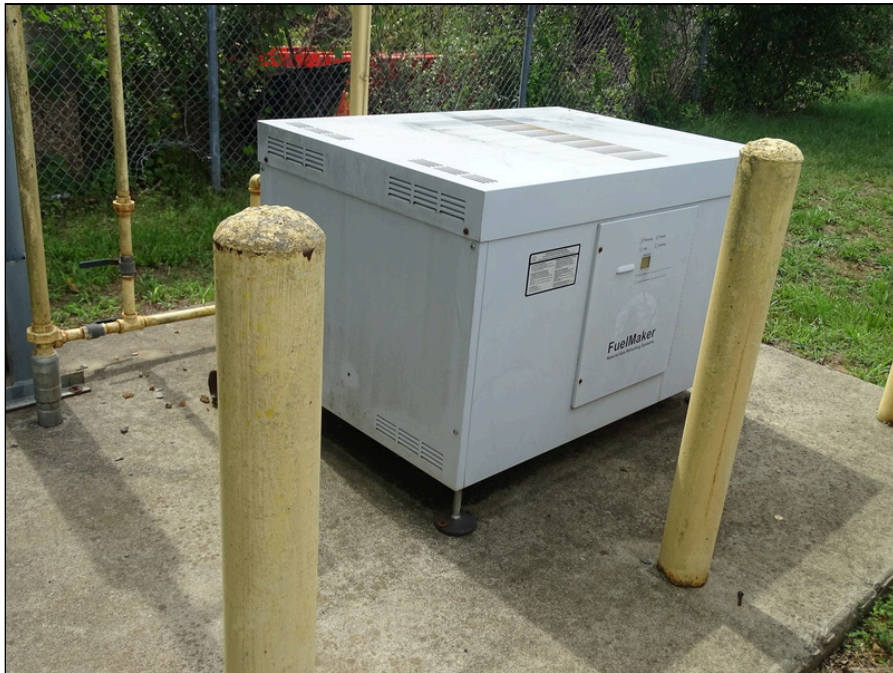
50 - Typical Condenser

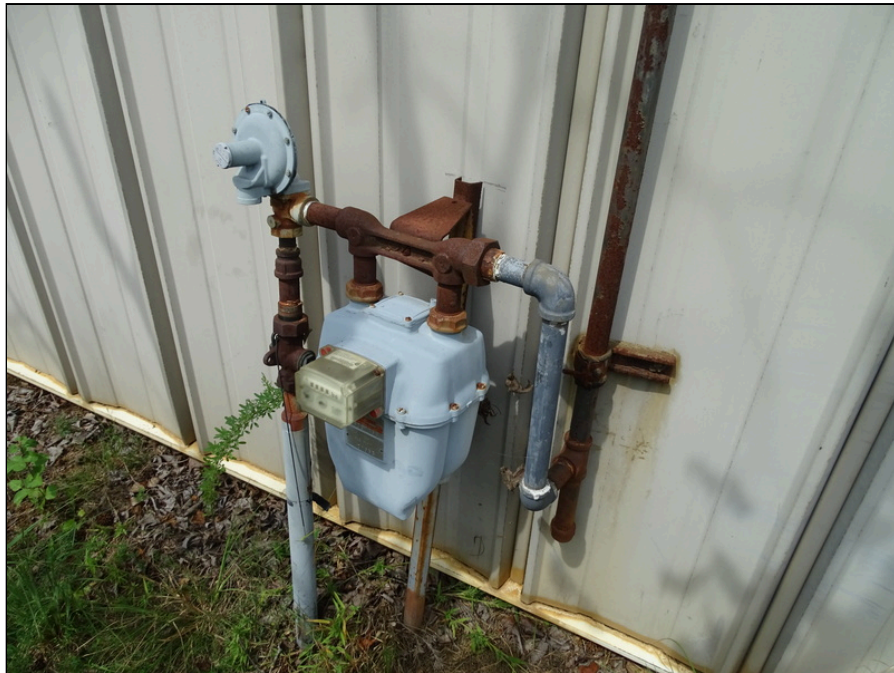
51 - Typical gas meter

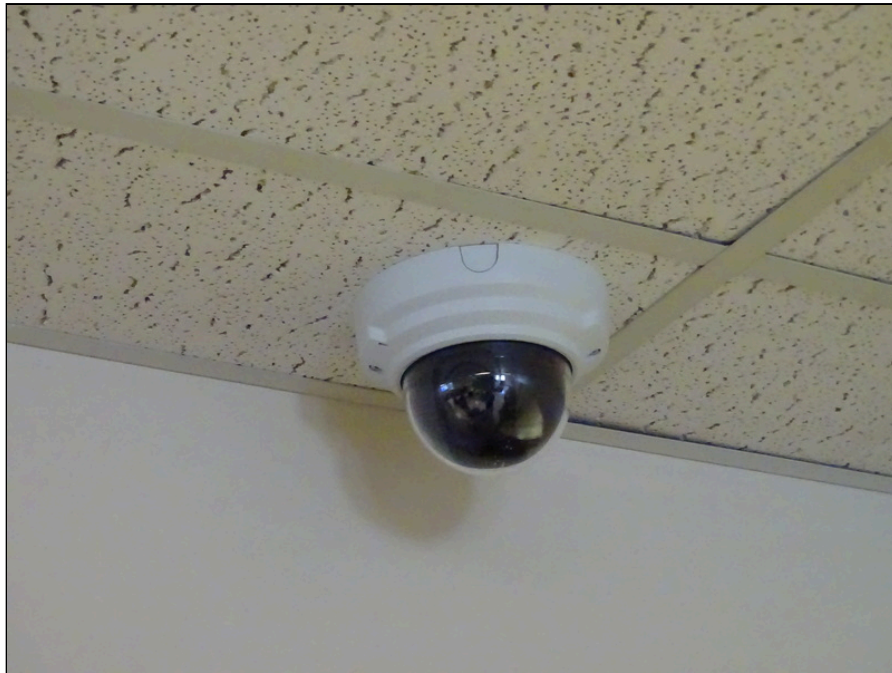
59 - Security alarm system

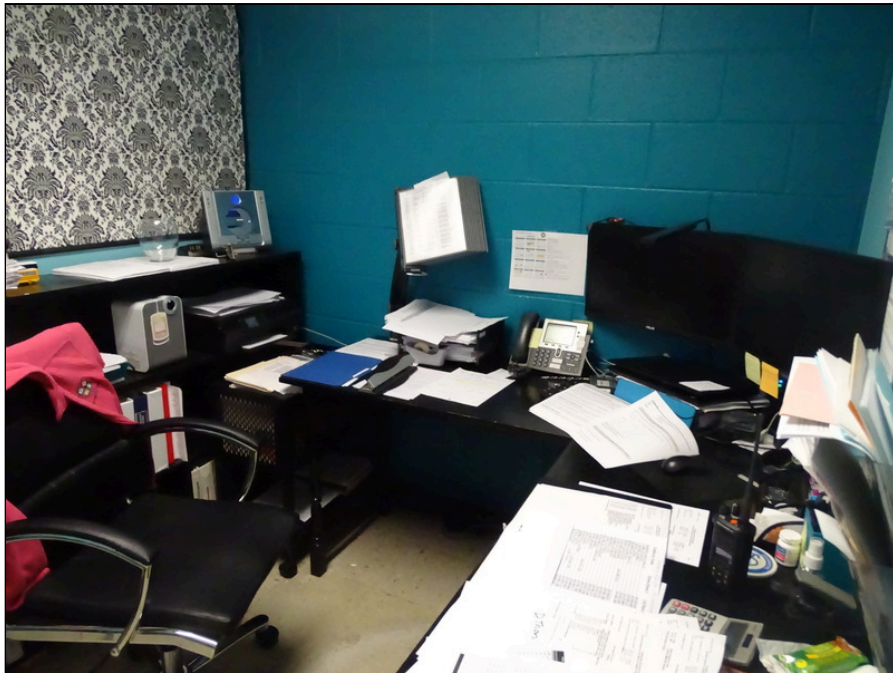
67 - Typical office

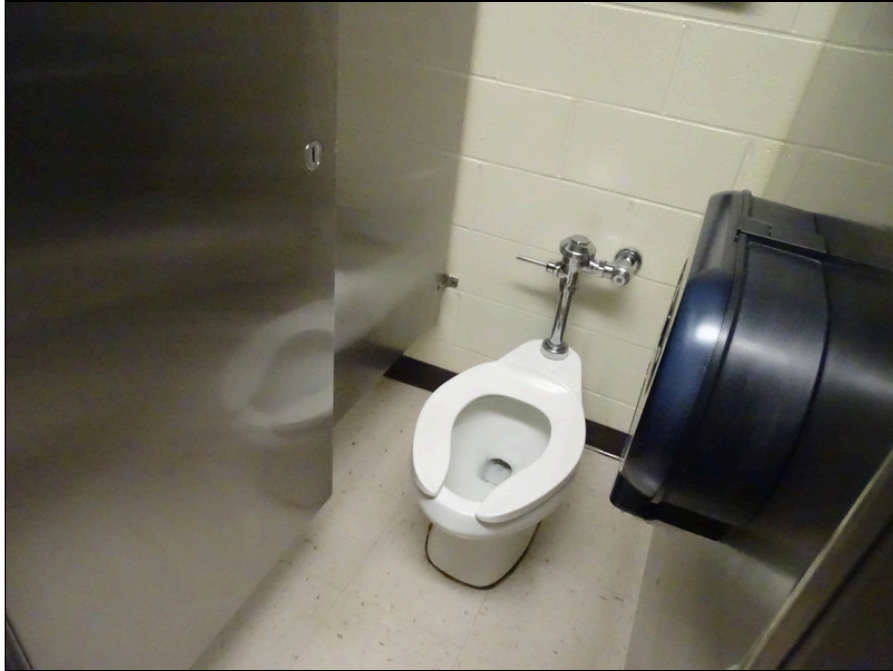
70 - Restroom

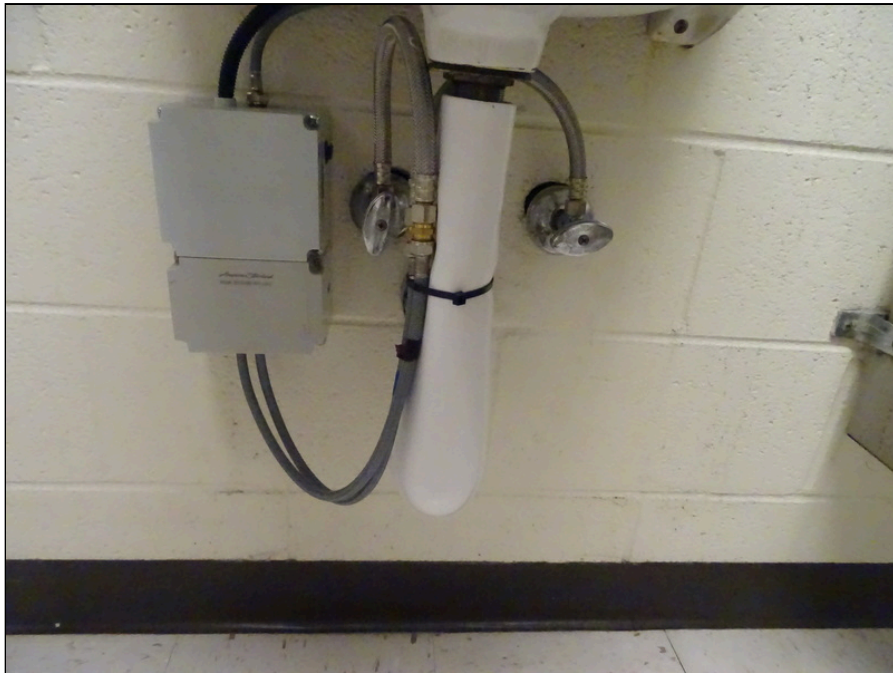
71 - Typical restroom

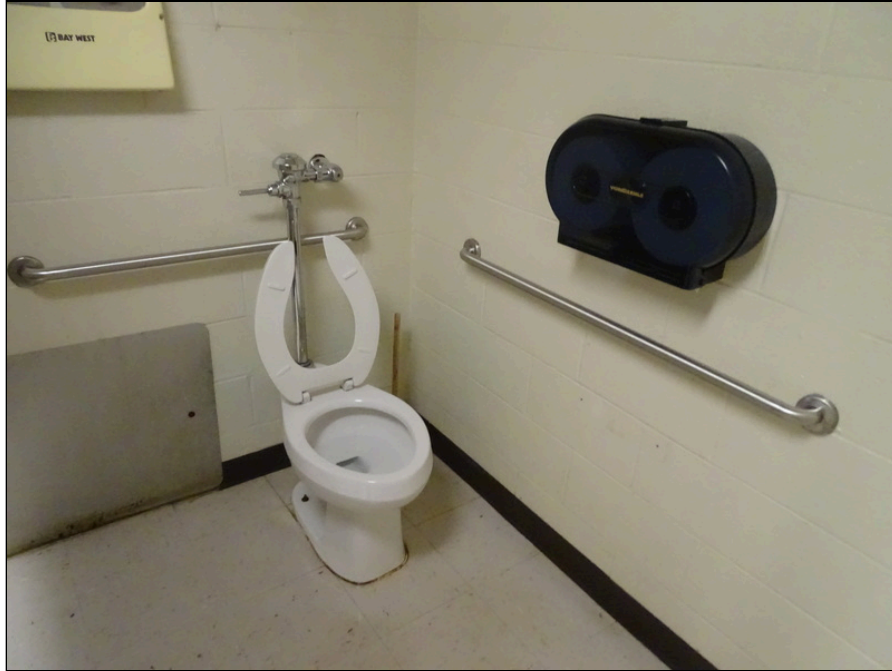
72 - Restroom
