SCHOOLS CENTRAL OFFICE  
1562 DAIRY ROAD  
CHARLOTTESVILLE, VIRGINIA

ECS PROJECT NO. 46:6713

CITY OF CHARLOTTESVILLE - FACILITIES DEVELOPMENT

Reference: Facility Condition Assessment Report for Schools Central Office, 1562 Dairy Road,  
Charlottesville, Virginia

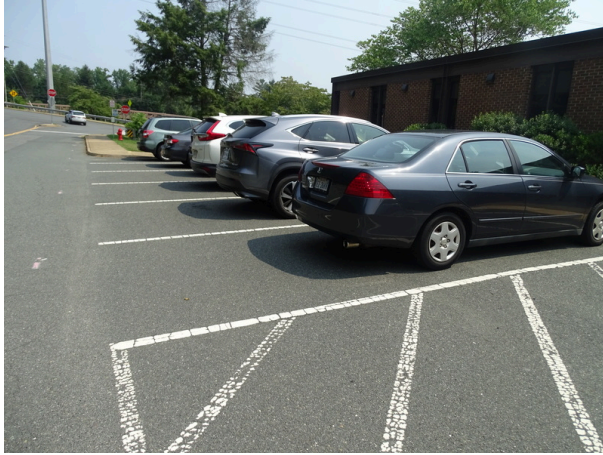
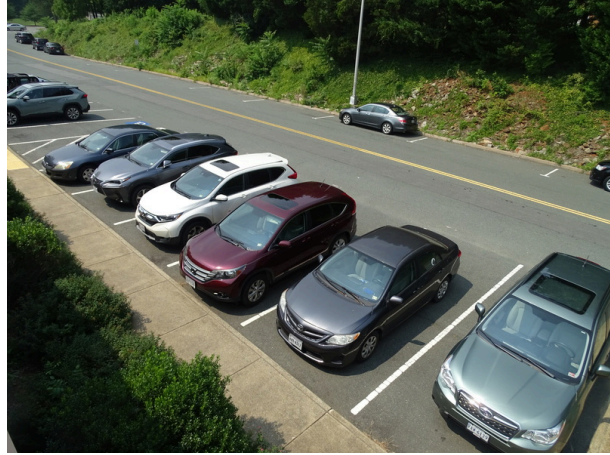
Asphalt-paved drive lanes are located on the west side of the site. The asphalt pavement was observed to be in generally good condition although the line striping was cracked in some areas. The expected useful life of asphalt pavement is 20 years. We recommend repairing areas of asphalt pavement on an as-needed basis and have provided an allowance to overlay the asphalt pavement later in the report period.

Parking lot overview

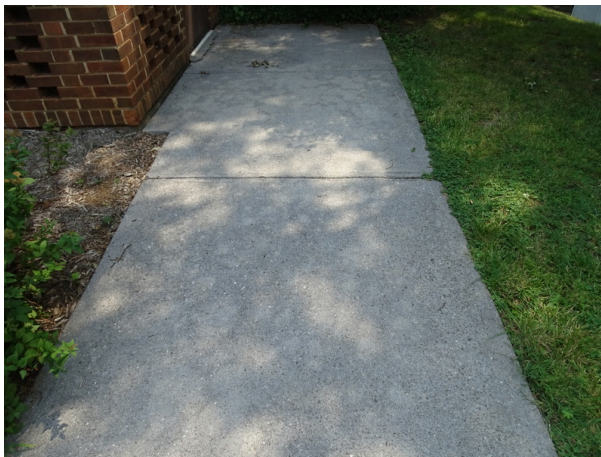
The site contains concrete sidewalks of undetermined thickness. Regularly spaced control joints were observed. Some of the sections of the concrete sidewalks were observed to have been recently replaced and the sidewalks were in overall good condition. We recommend that the settled and cracked sections of concrete sidewalks be replaced on an as-needed basis during the study period.

Concrete sidewalks

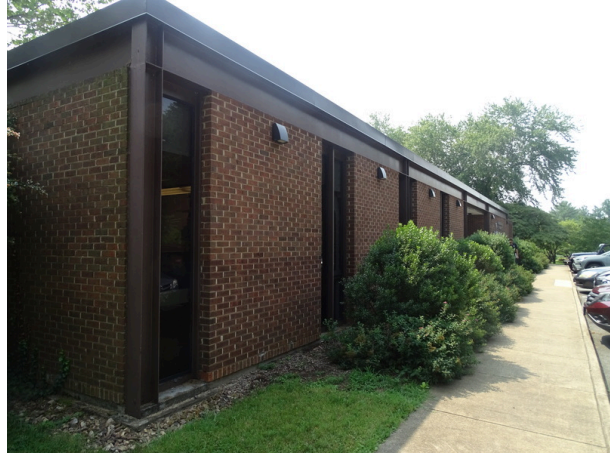
Typical concrete sidewalk and landscape

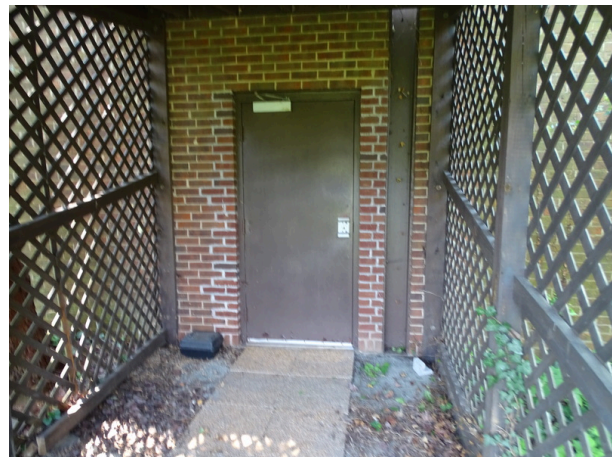
The main entrances are Storefront entrance. The main entrance doors were generally in good condition. Steel personnel doors are located at each building face. The personnel doors were generally in good condition, however, personnel doors had twist action hardware. Exterior doors typically have an expected useful life of 20 to 30 years.

Personnel door

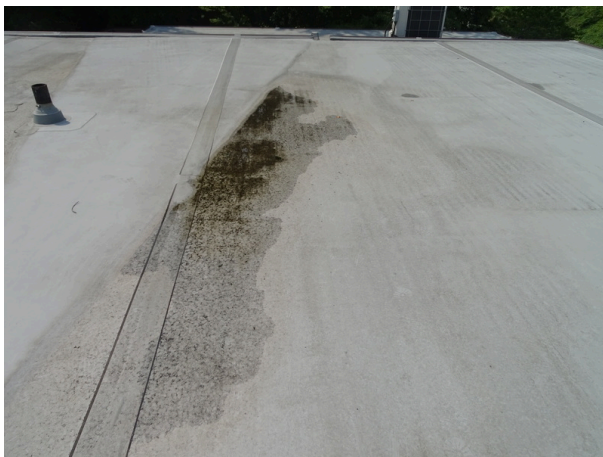
Roof overview - note ponding

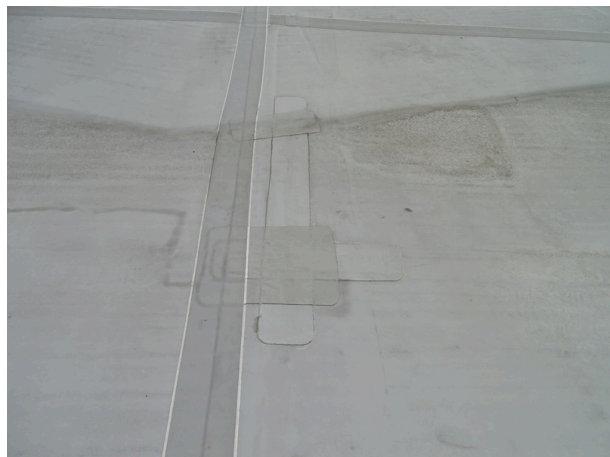
Roof overview - note patching

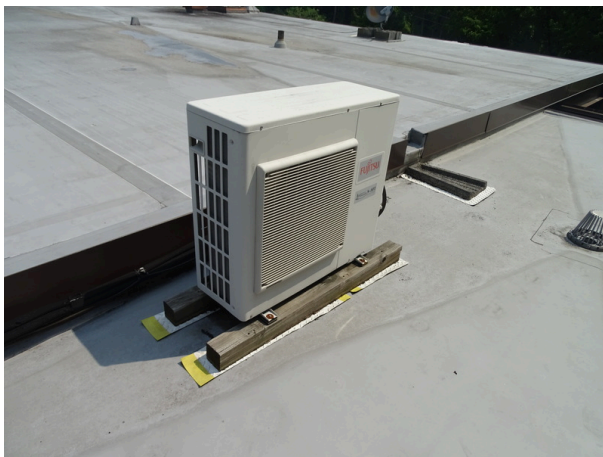
The split system located on the roof is in fair condition. Split systems have an expected useful life of 15 years and should be replaced during the study period.

Split system

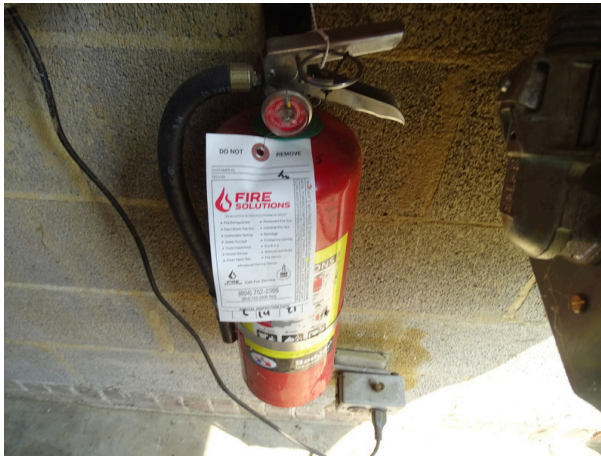
The fire suppression system consists of fire extinguishers located throughout the building. The fire extinguishers were observed to have recent inspection tags issued in June 2021. These devices are required to be inspected annually. Replacement of the fire extinguishers is considered routine maintenance.

Fire extinguisher

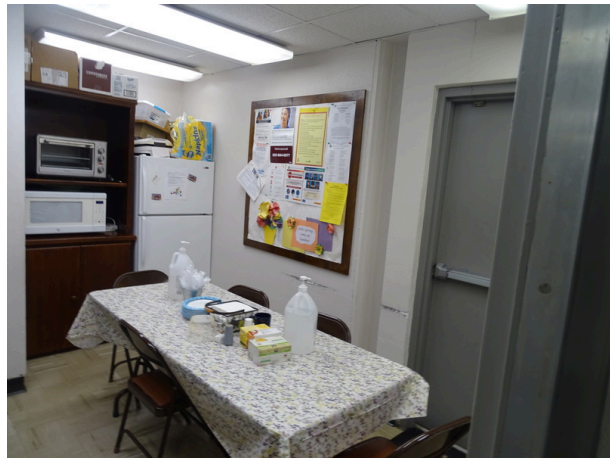
Typical kitchen area finishes

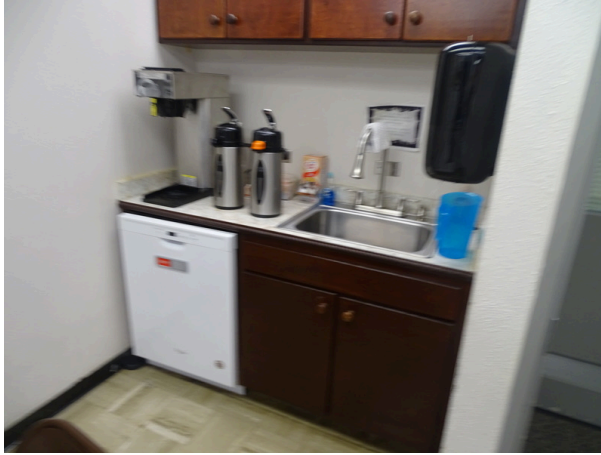
Typical kitchen area finishes

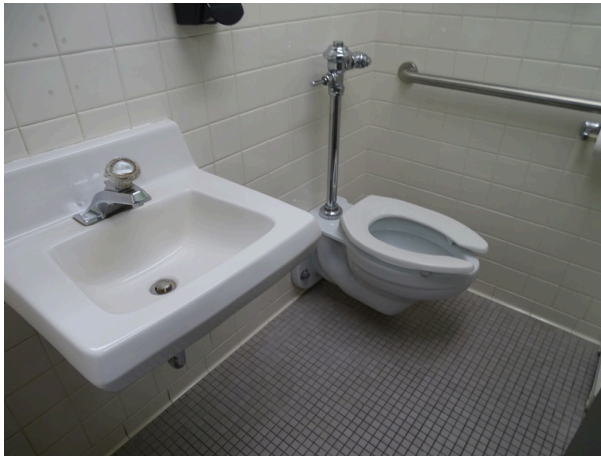
Accessible restroom

1.	Do publicly-accessible toilet rooms appear to have a minimum compliant floor area?	No	Rework recommended
2.	Does the lavatory appear to be mounted at a compliant height and with compliant knee area?	Yes

3.	Does the lavatory faucet have compliant handles?	No	Rework recommended
4.	Is the plumbing piping under lavatories configured to protect against contact?	No	Rework recommended

5.	Are grab bars provided at compliant locations around the toilet?	No	Rework recommended
6.	Do toilet stall doors appear to provide the minimum compliant clear width?	N/A

7.	Do toilet stalls appear to provide the minimum compliant clear floor area?	No	Rework recommended
8.	Do urinals appear to be mounted at a compliant height and with compliant approach width?	N/A

Cost Recommendation	EUL	EFF AGE	RUL	Year	Cost
RECONFIGURE RESTROOM TO PROVIDE COMPLIANT FLOOR AREA	-	-	-	Immediate	\$15,000
Total					\$15,000

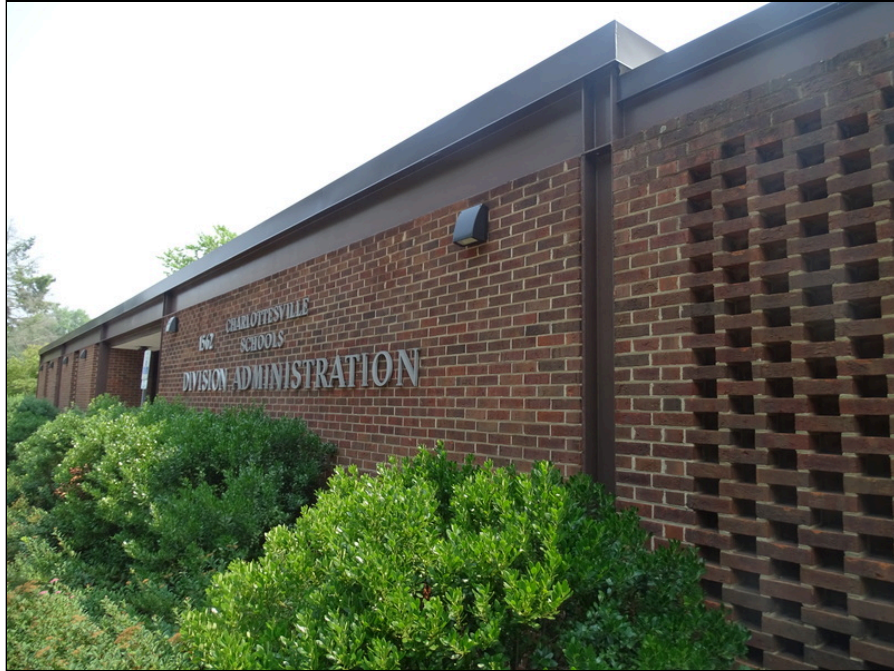
1 - Building overview

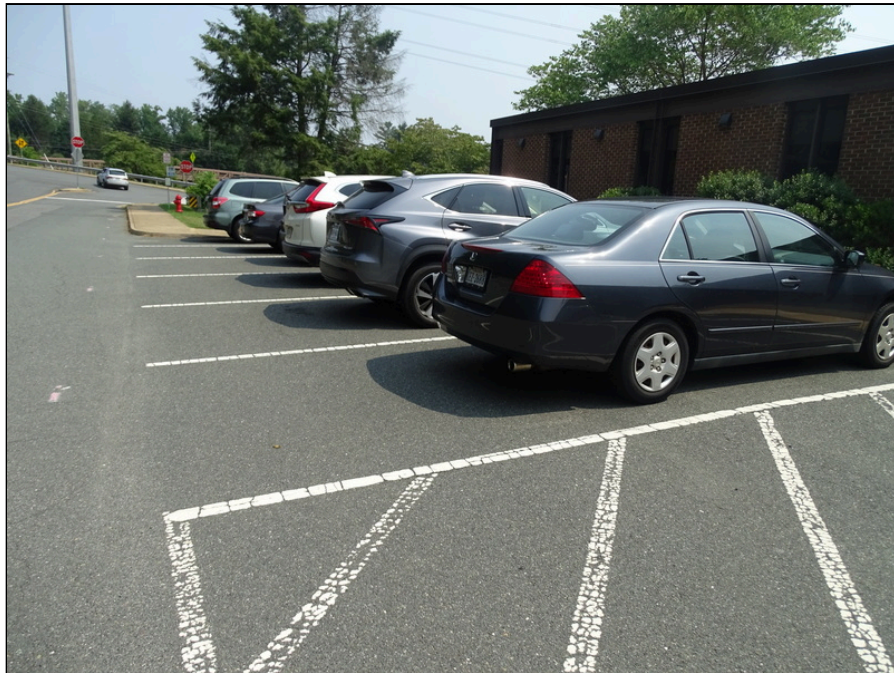
2 - Parking lot overview

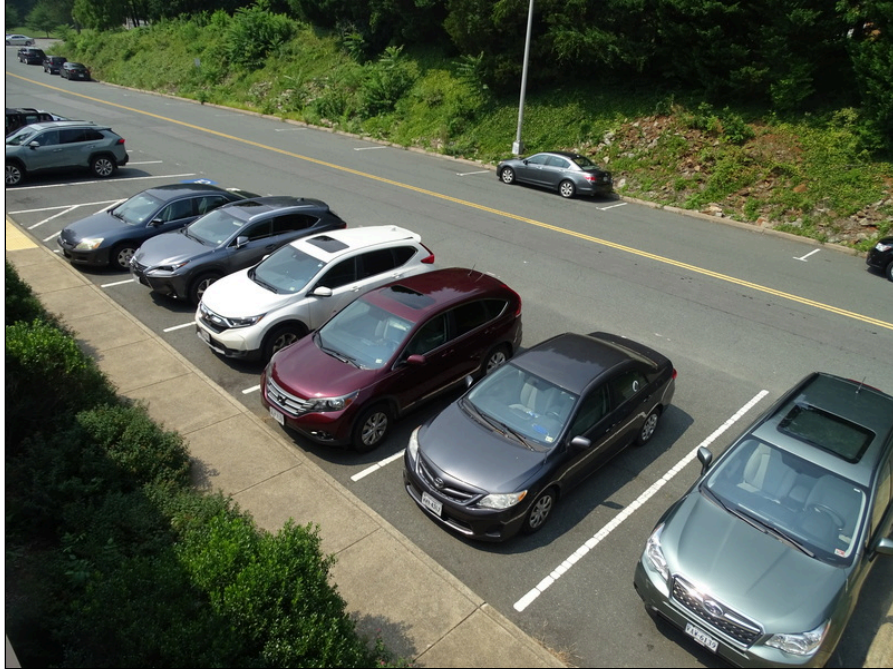
3 - Parking lot overview

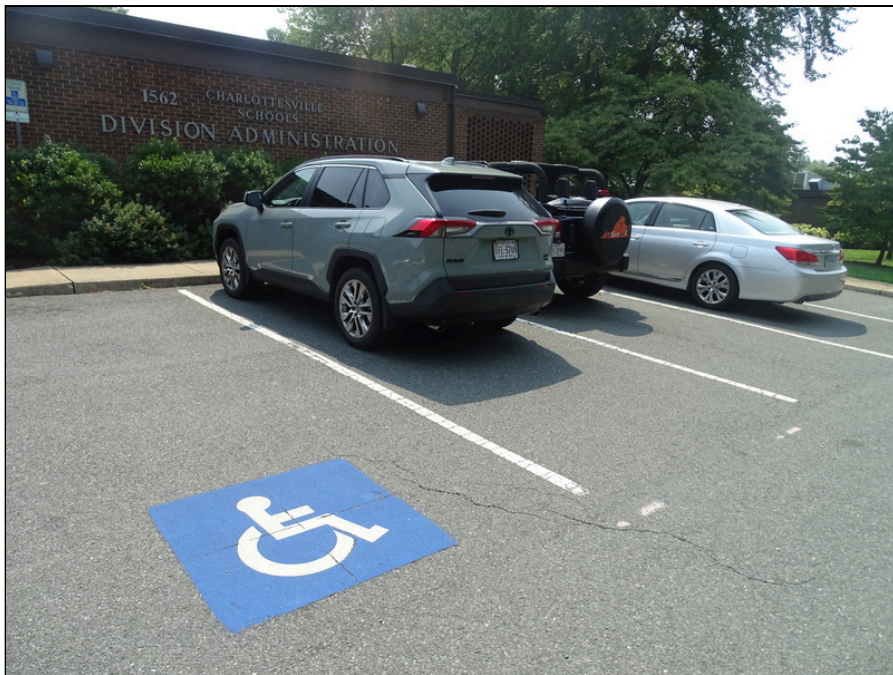
4 - Parking lot overview

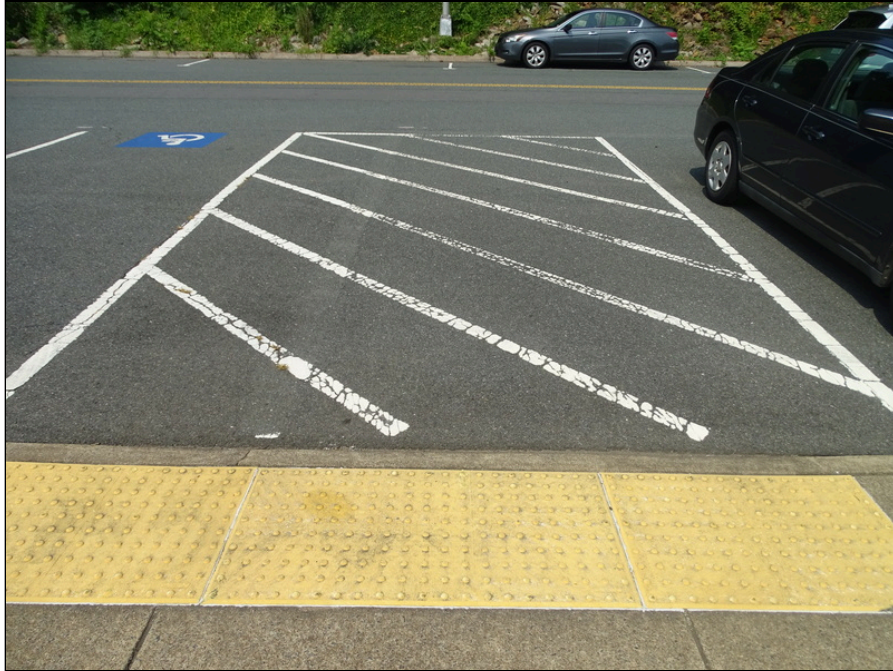
5 - Curb ramp with truncated domes

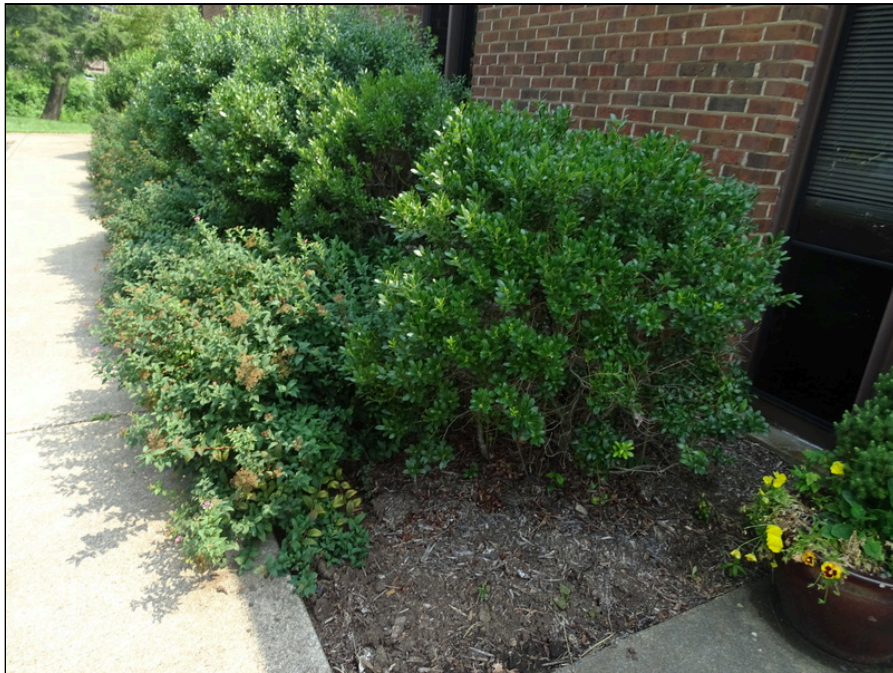
6 - Typical landscape

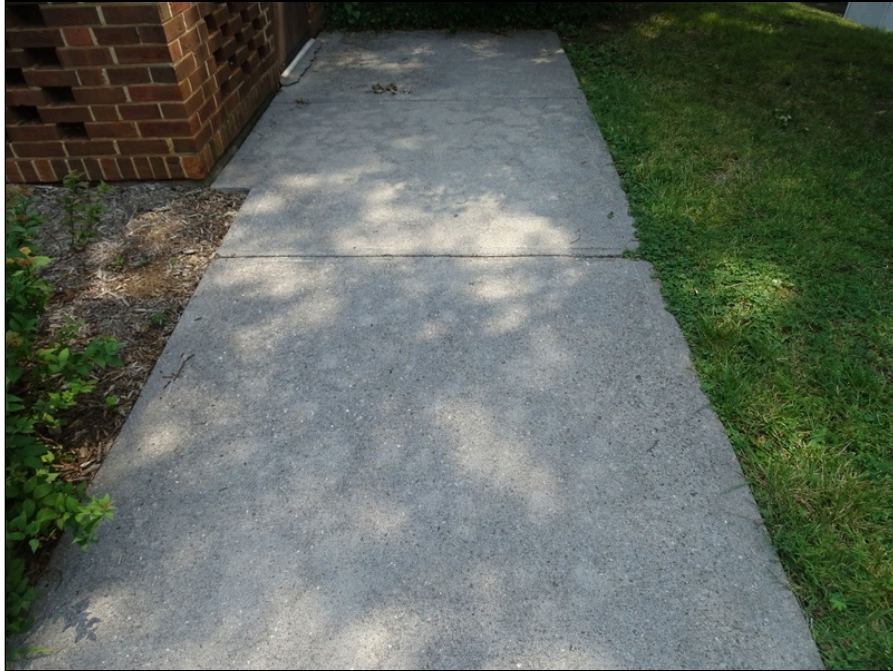
7 - Concrete sidewalks

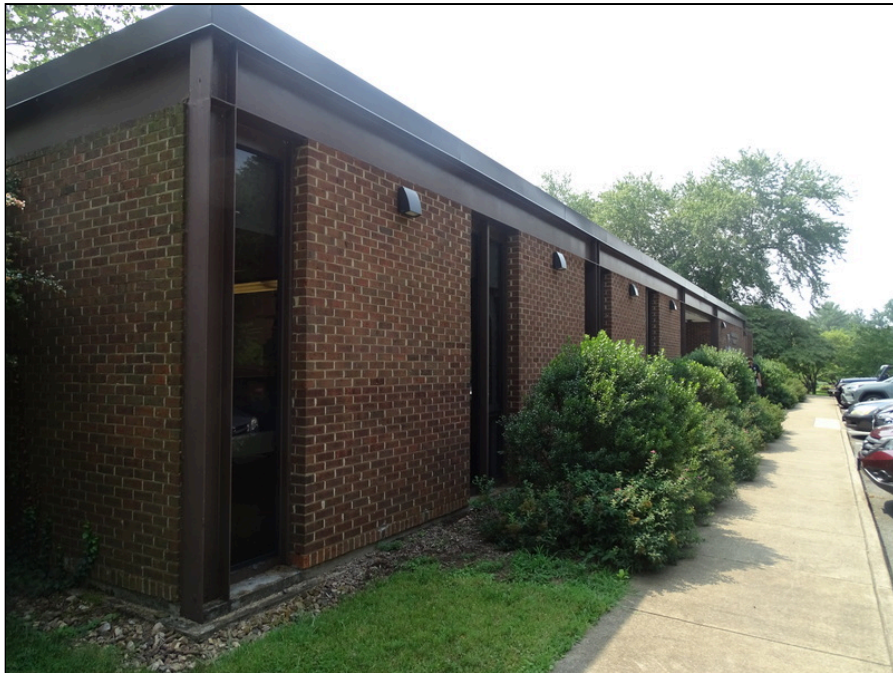
8 - Typical concrete sidewalk and landscape

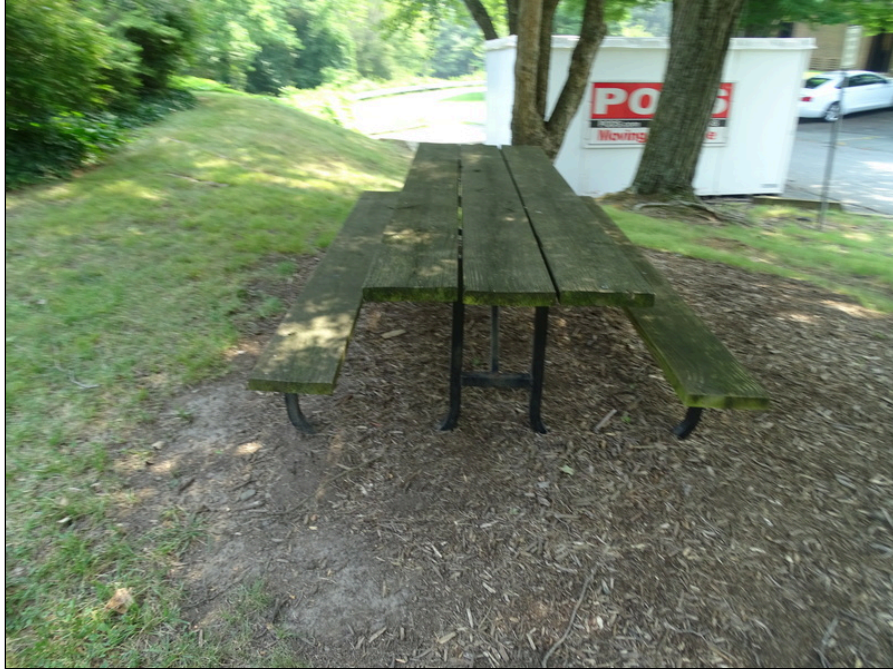
9 - Typical landscape

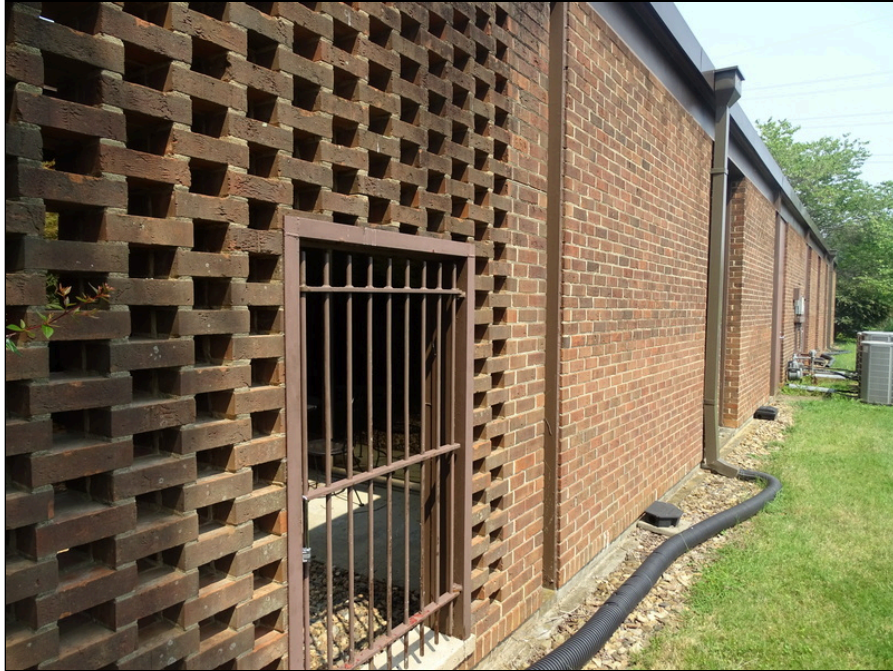
11 - Typical downspout

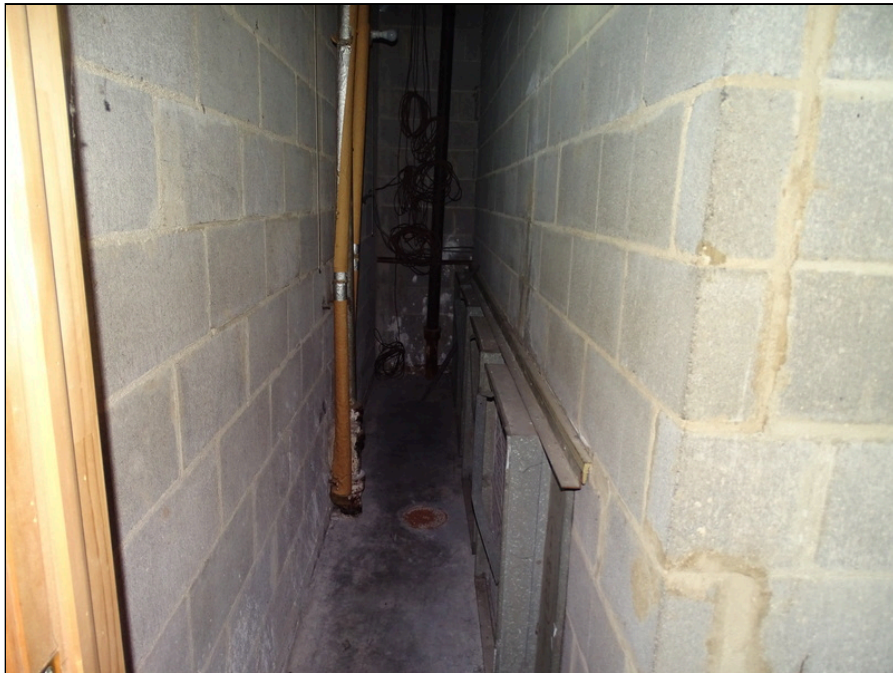
12 - Structure framing

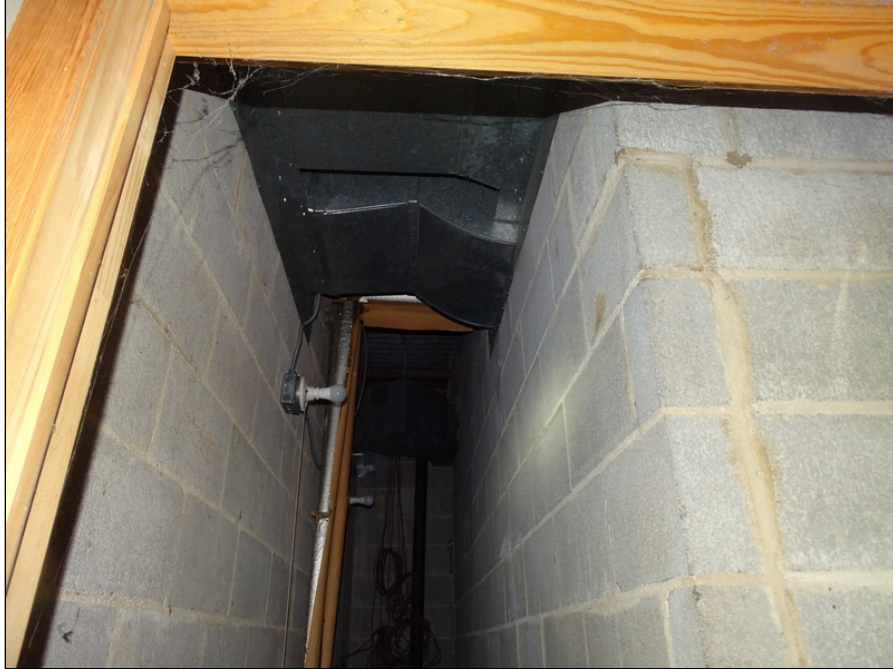
13 - Structure framing

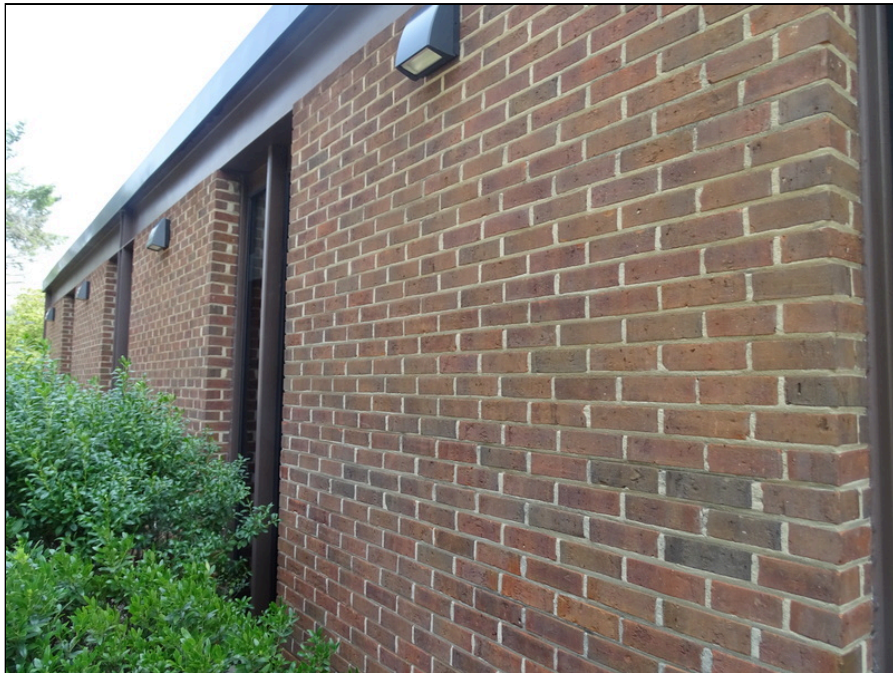
14 - Building exterior overview

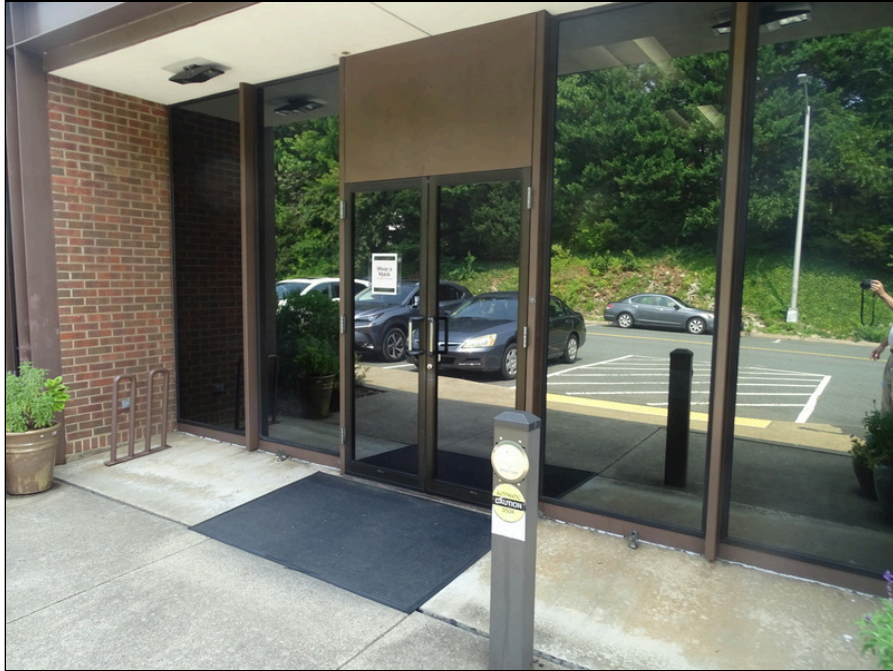
17 - Main entrance doors

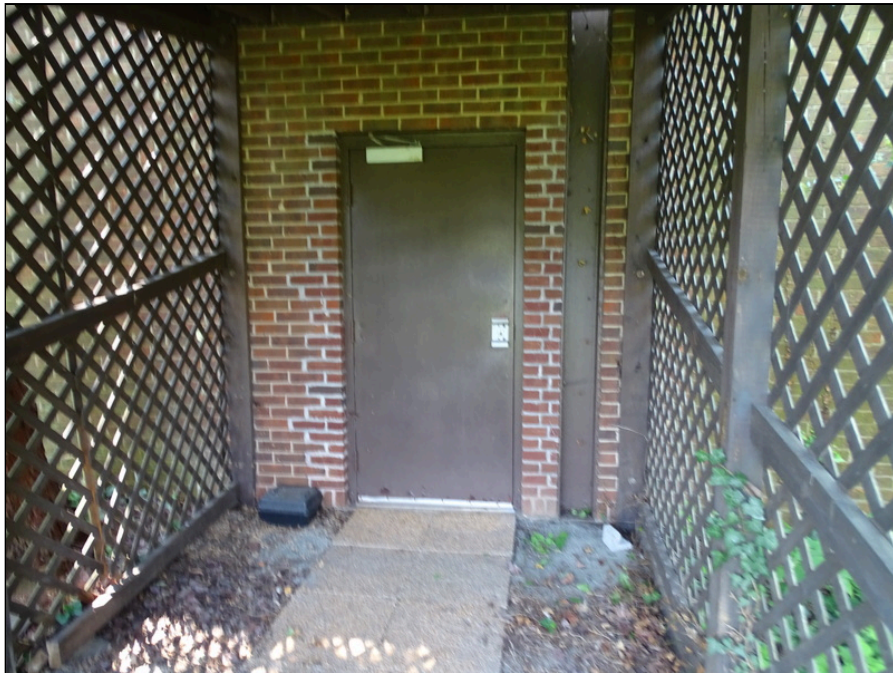
18 - Personnel door

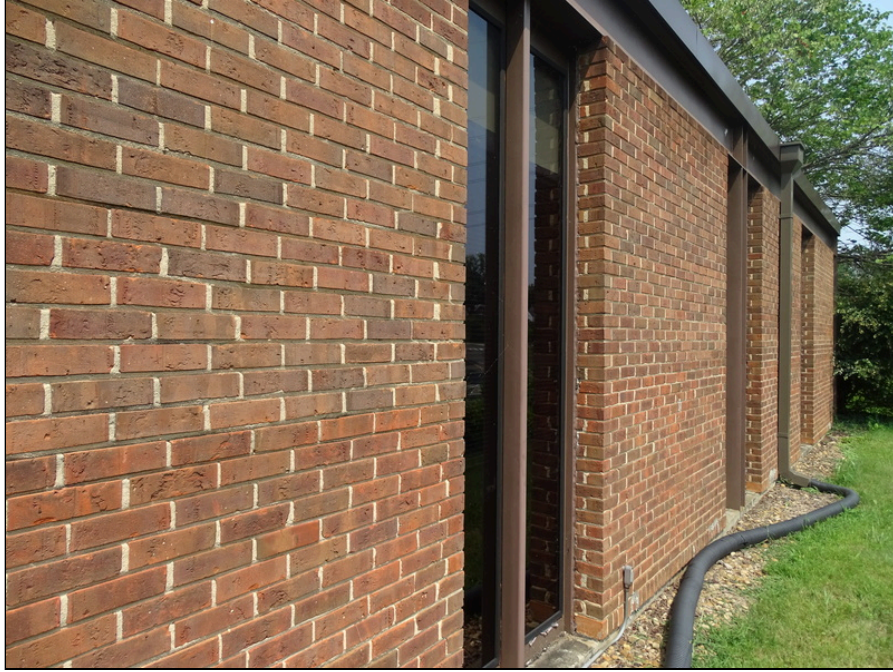
19 - Typical windows

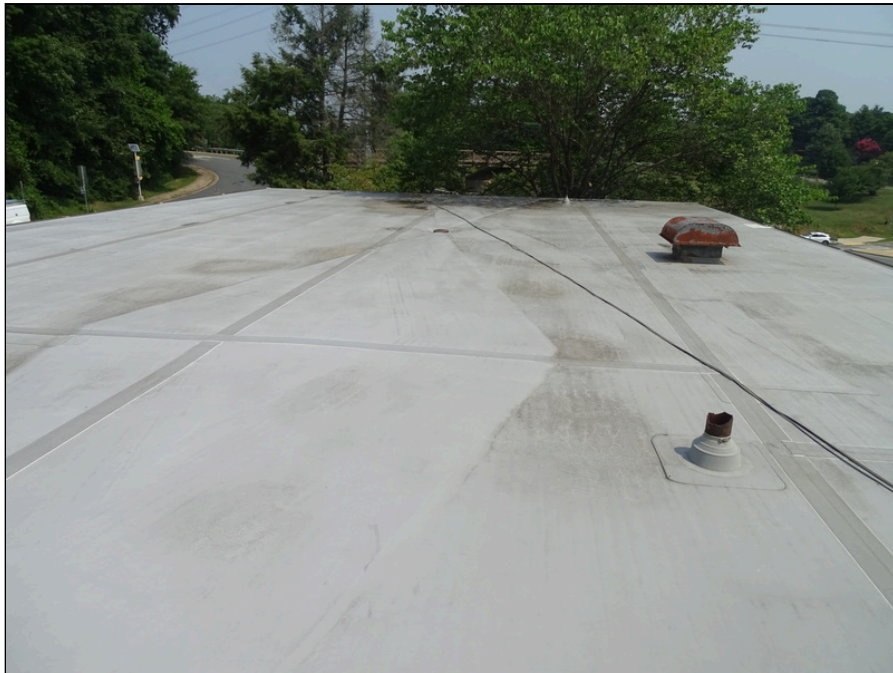
20 - Roof overview

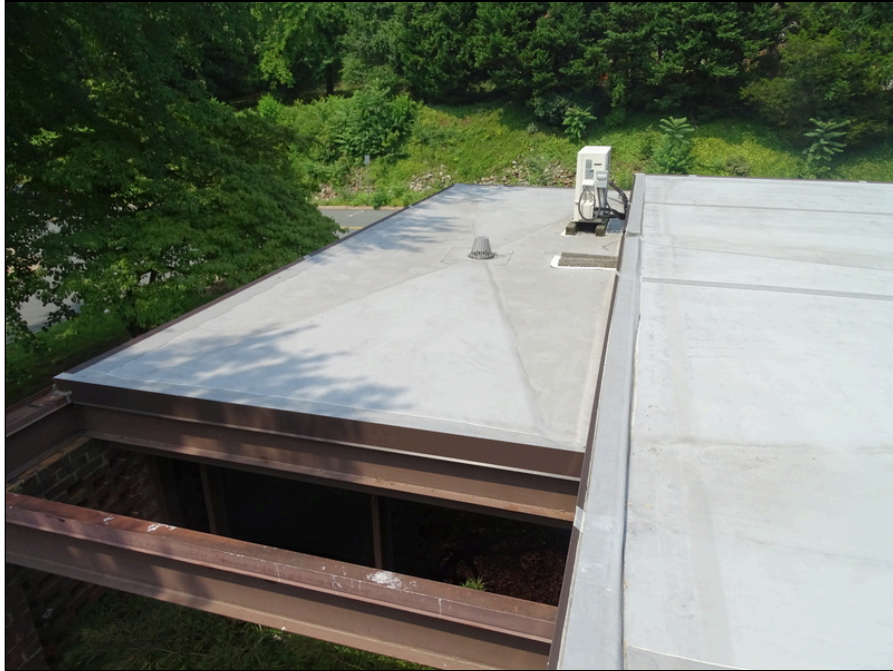
21 - Roof overview

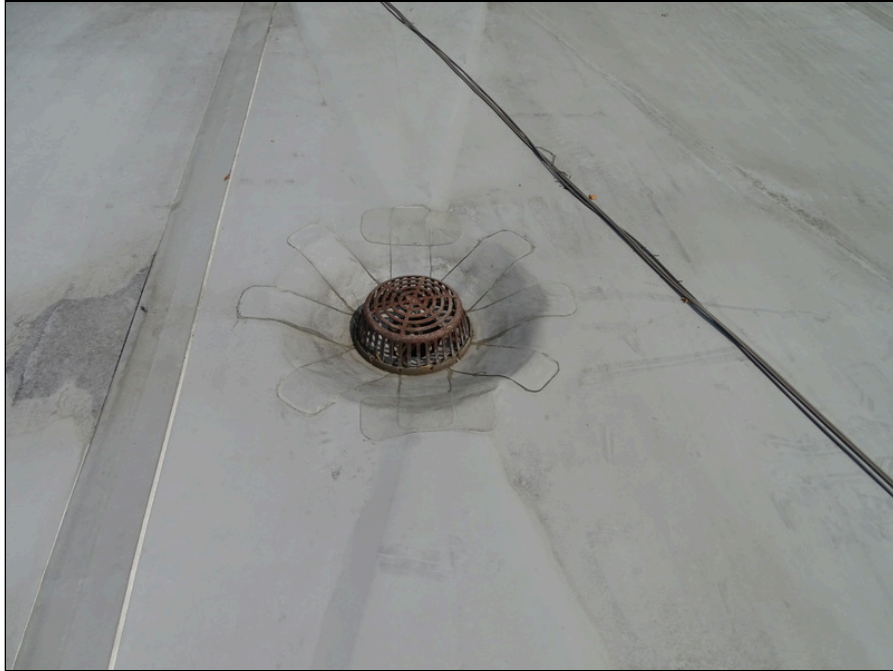
25 - Roof internal drain

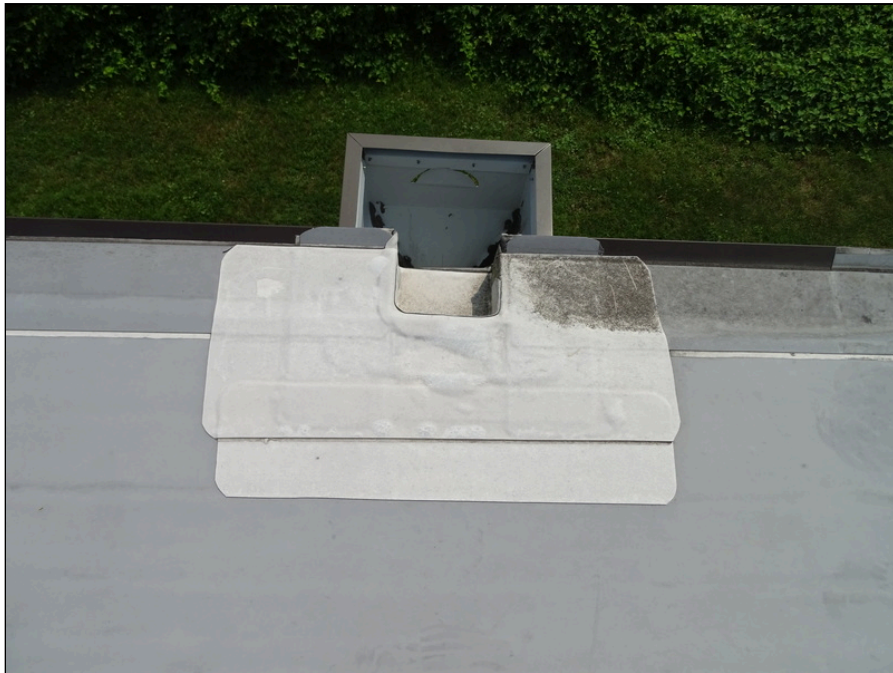
26 - Roof downspout

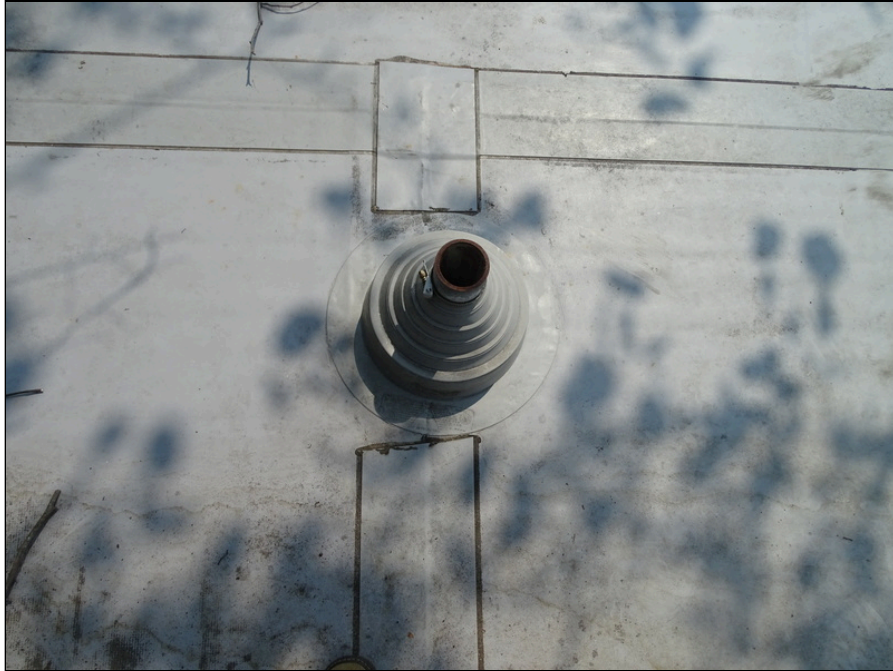
27 - Typical plumbing penetration

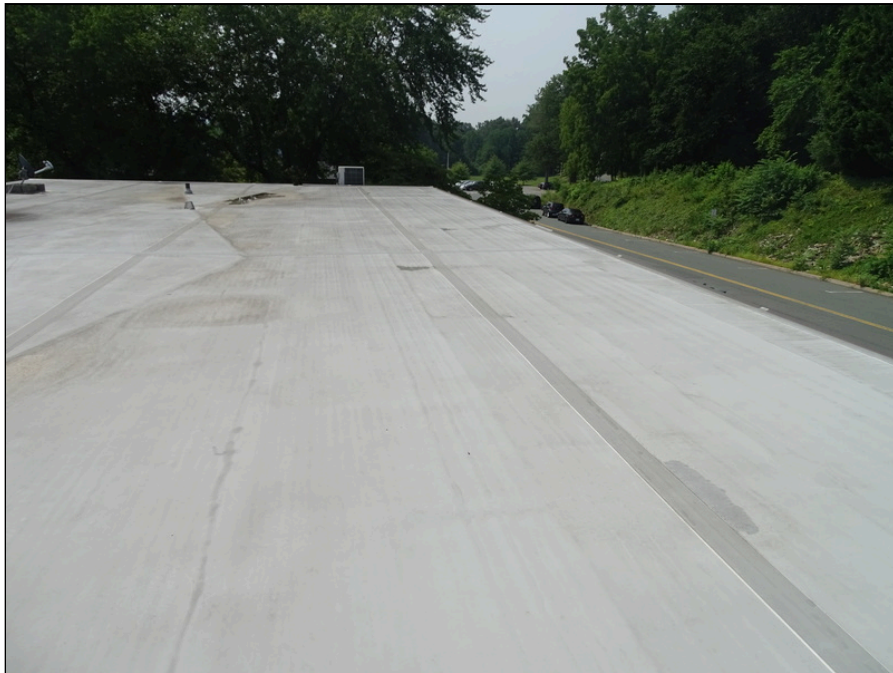
28 - Roof overview

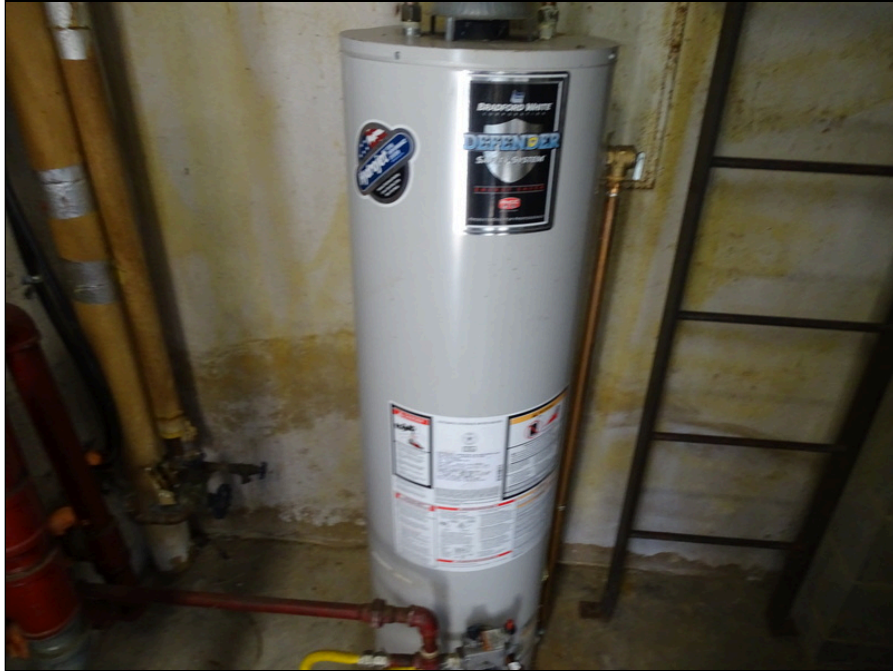
29 - Water heater and supply lines

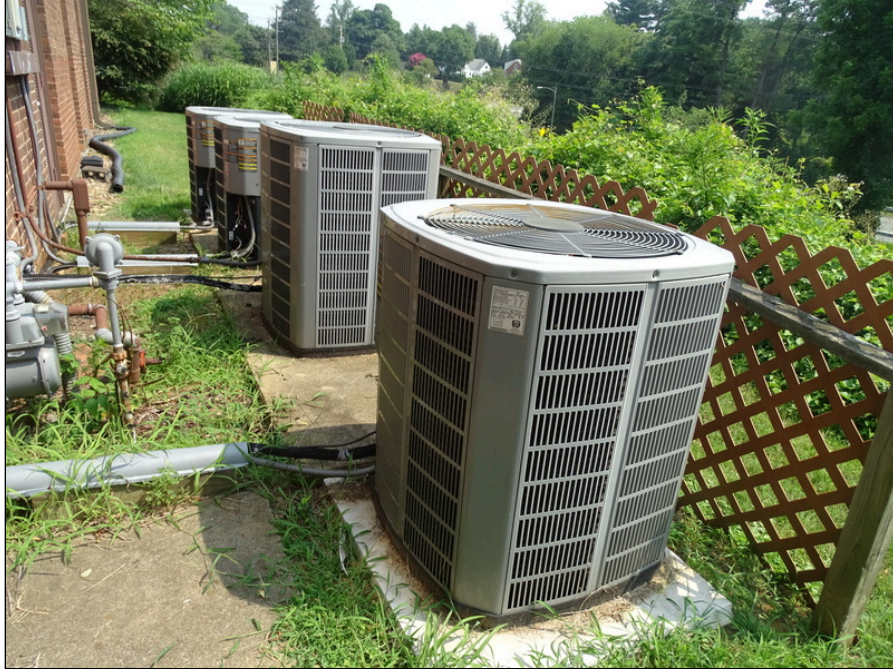
31 - Condensers

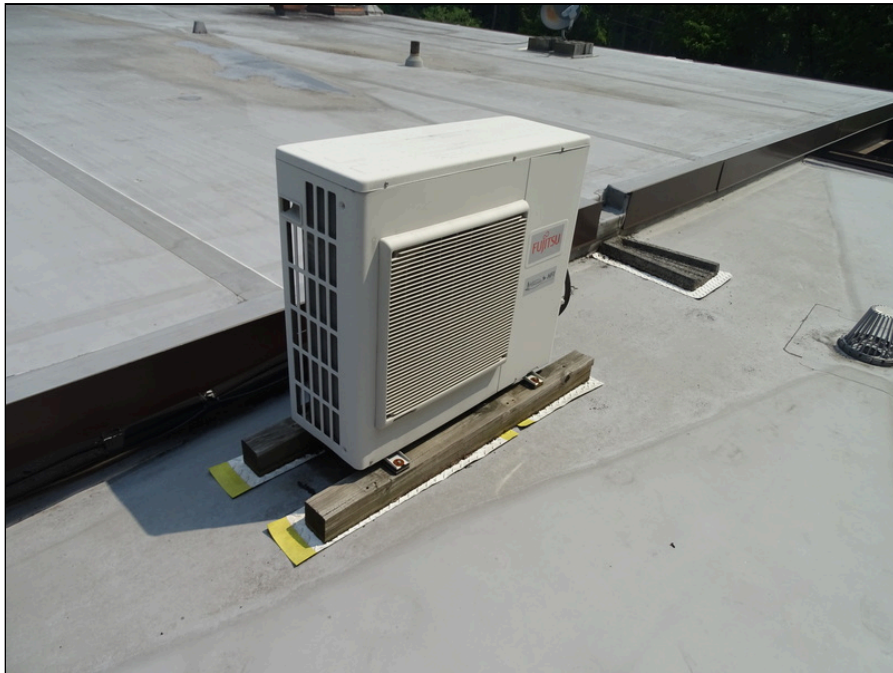
32 - Split system

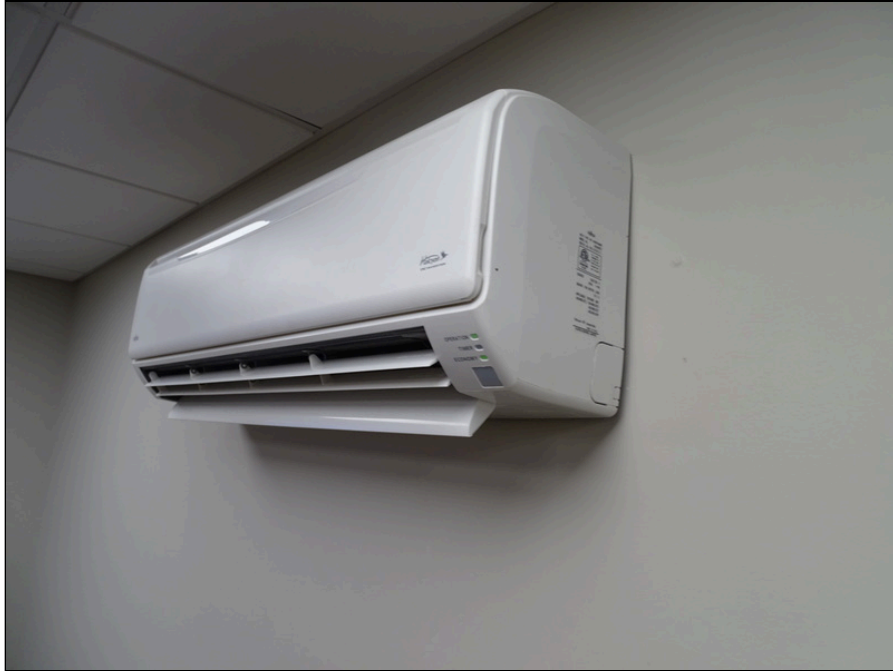
33 - Split system

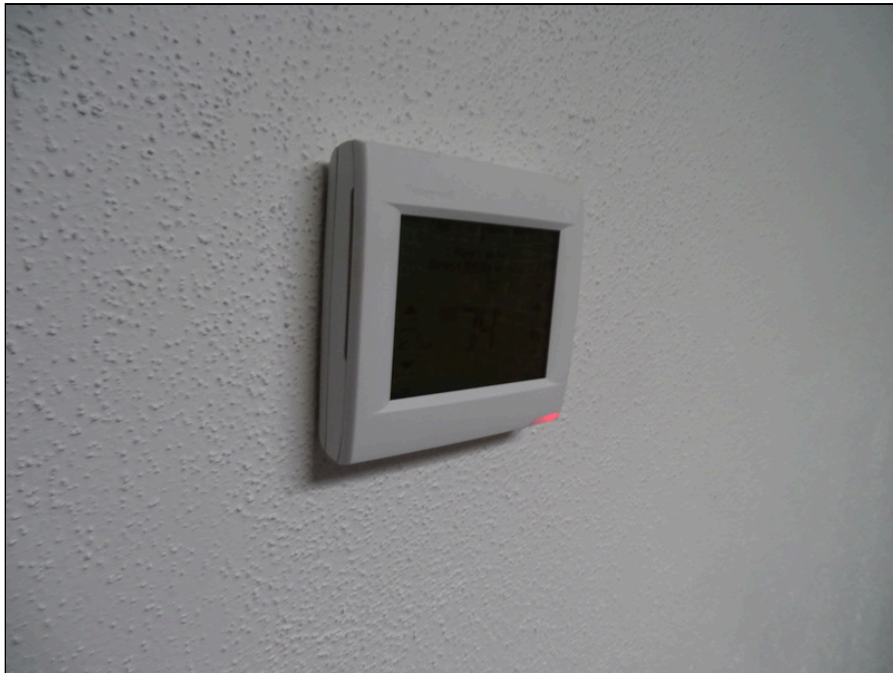
34 - Thermostat

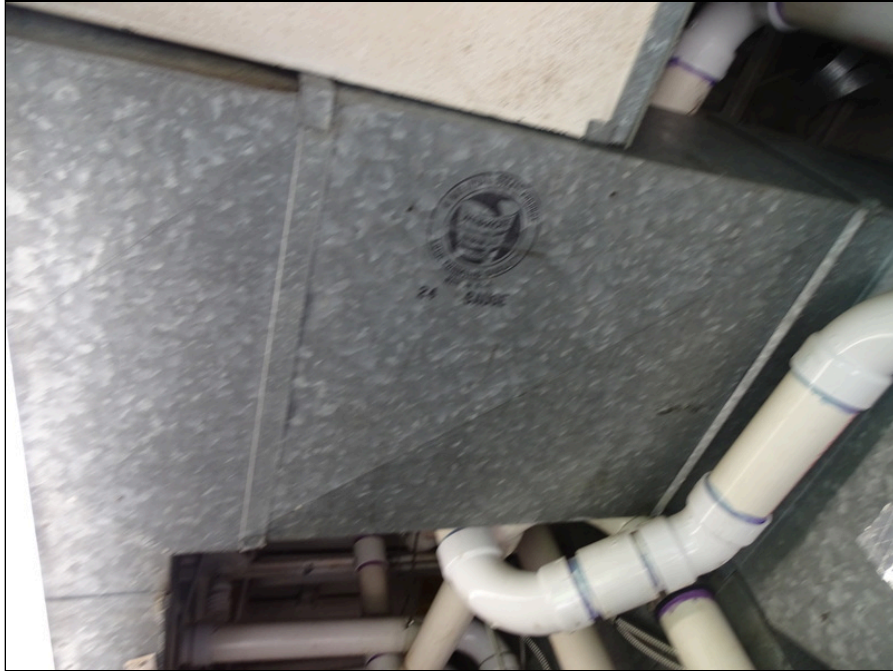
35 - Typical mechanical duct

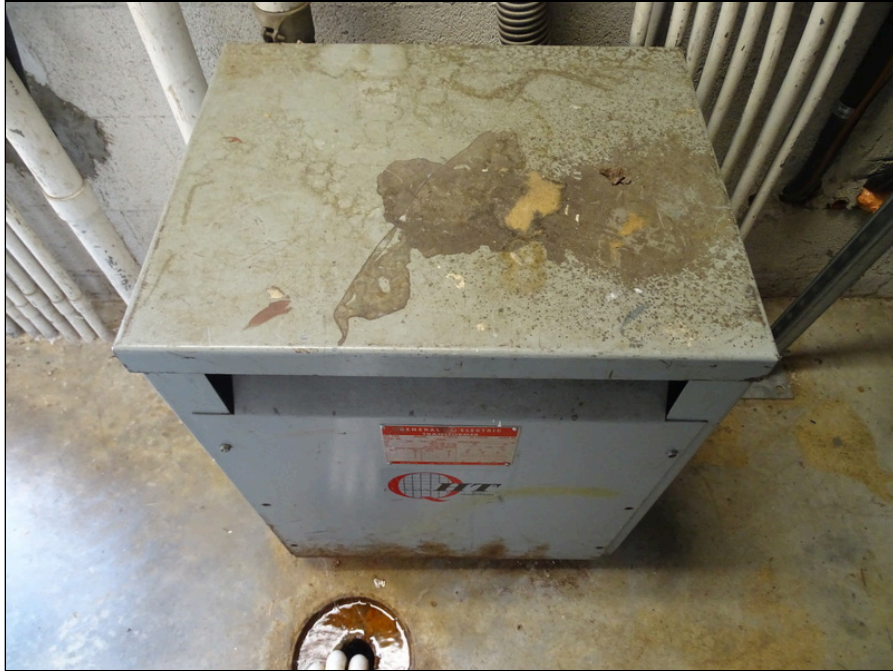
37 - Transformer

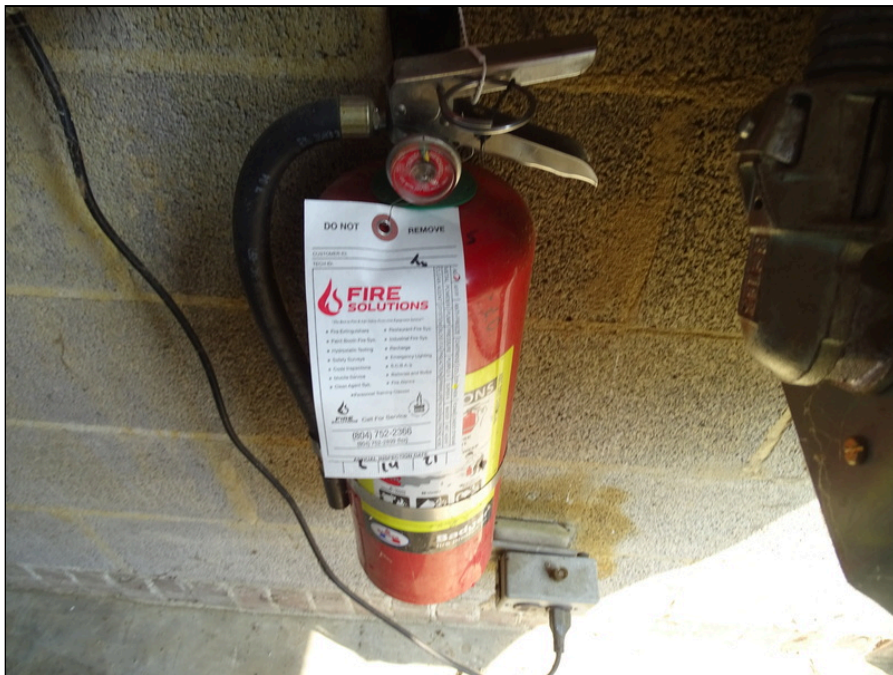
38 - Fire extinguisher

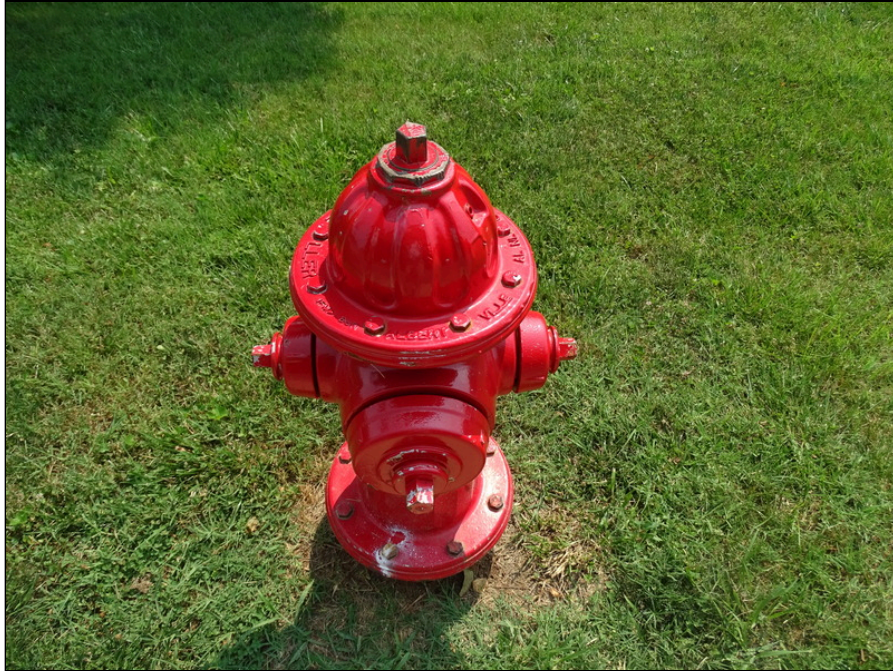
39 - Fire hydrant
