SCHOOLS CENTRAL OFFICE  
1562 DAIRY ROAD  
CHARLOTTESVILLE, VIRGINIA

ECS PROJECT NO. 46:6713

CITY OF CHARLOTTESVILLE - FACILITIES DEVELOPMENT

Reference: Facility Condition Assessment Report for Schools Central Office, 1562 Dairy Road,  
Charlottesville, Virginia

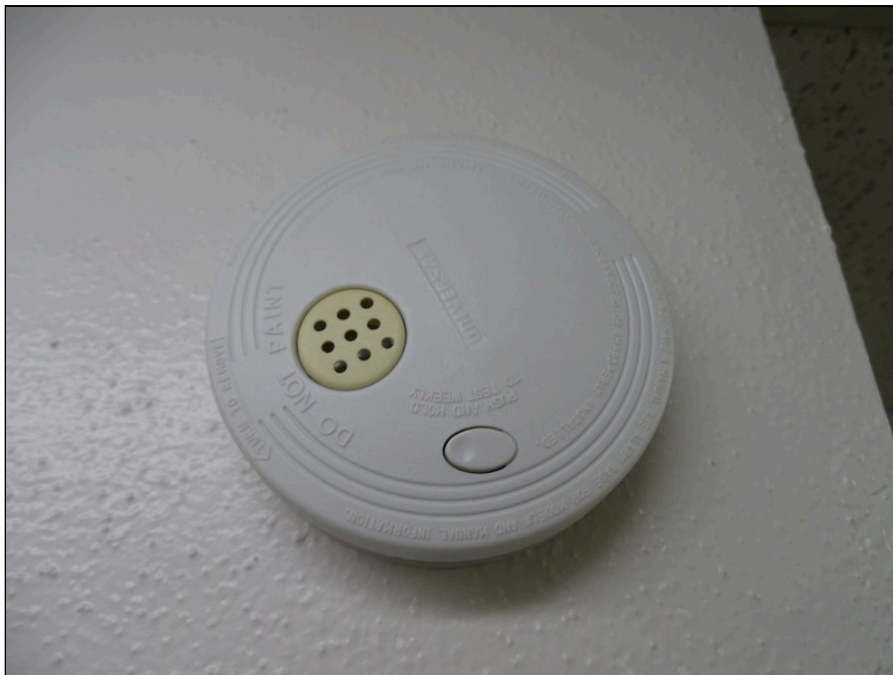
40 - Smoke detector

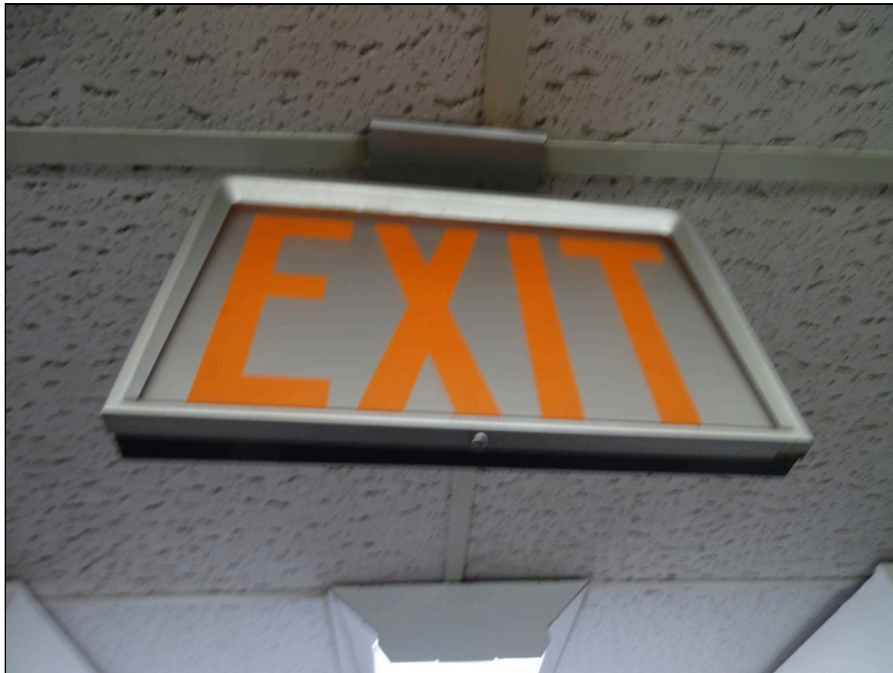
41 - Emergency lights
