THE ENERGY HOUSE
608 RIDGE STREET
CHARLOTTESVILLE, VIRGINIA

ECS PROJECT NO. 46:6713

CITY OF CHARLOTTESVILLE - FACILITIES DEVELOPMENT

Reference: Facility Condition Assessment Report for The Energy House, 608 Ridge Street,
Charlottesville, Virginia

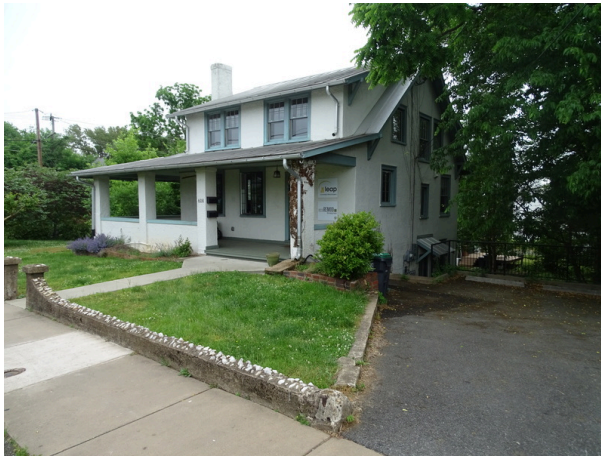
The Energy House

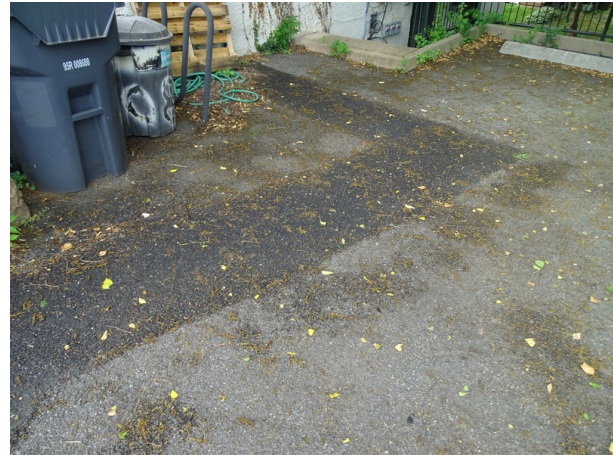
Asphalt parking area

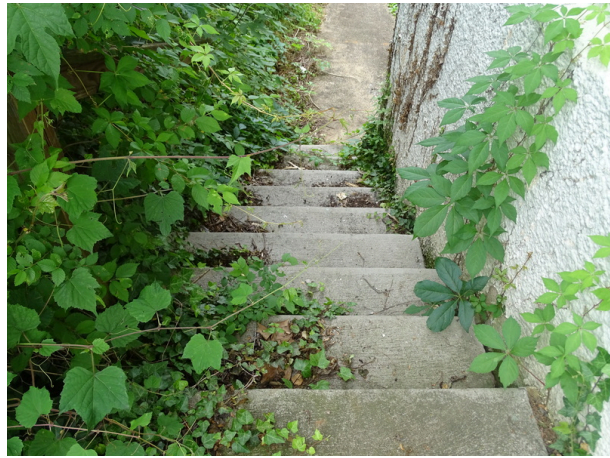
Concrete steps

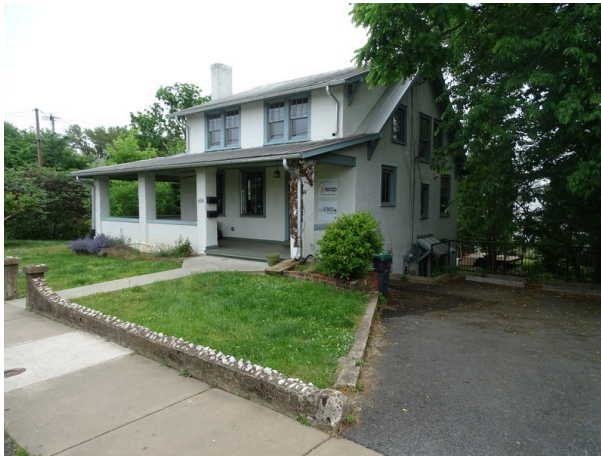
Typical landscaping

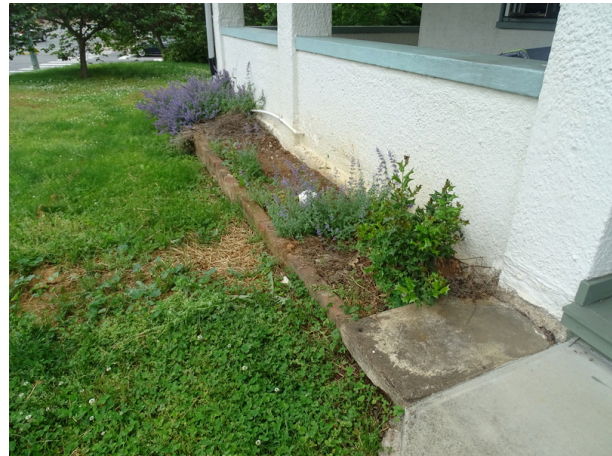
Typical landscaping

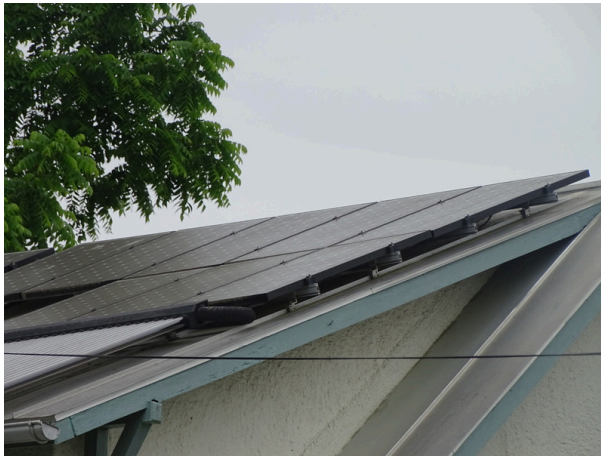
Solar panels located on northeast roof area

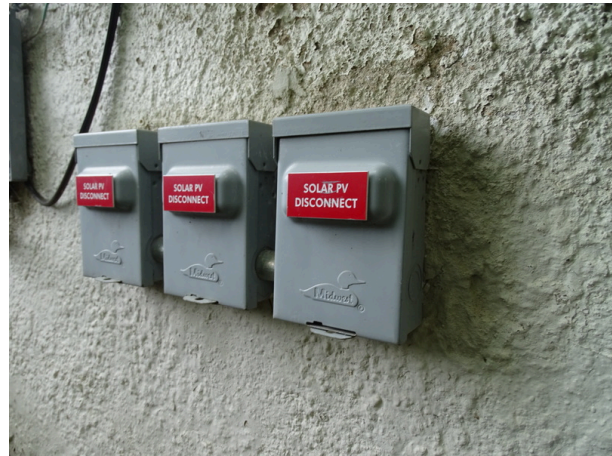
Solar service disconnect

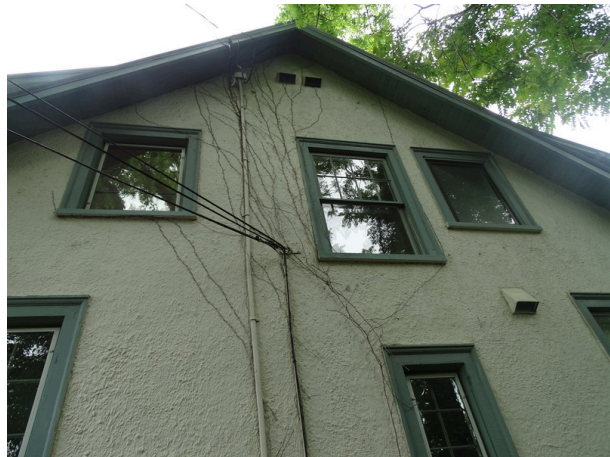
Building exterior at south side of the building

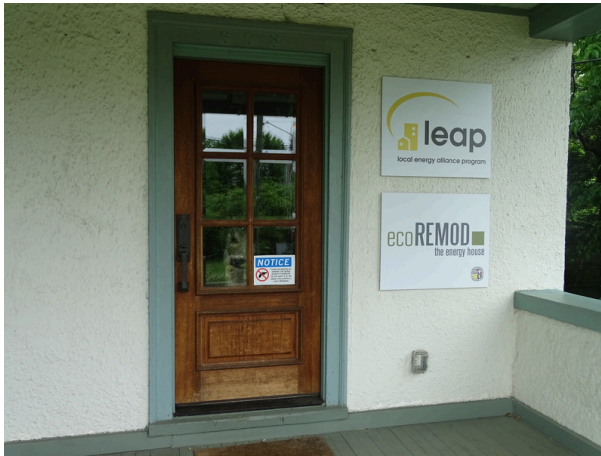
The main entrance is a Wood door with glass. The main entrance door was generally in good condition. Exterior doors typically have an expected useful life of 20 to 30 years.

Main entrance door

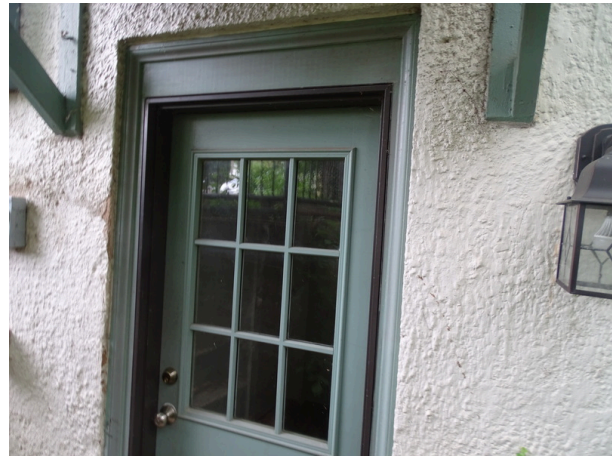
Typical exterior door

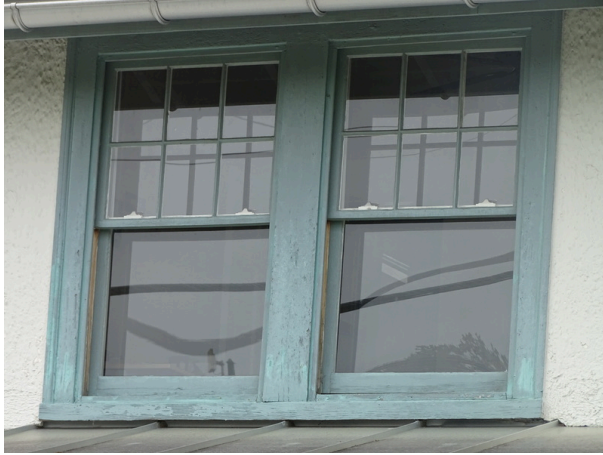
The window system for the building primarily consists of Wood frame double pane - operable window units. The window units were recently installed in addition to older exterior windows for energy conservation purposes. The condition of the window units was generally good. The expected useful life of windows is typically 30 years.

Typical exterior window units

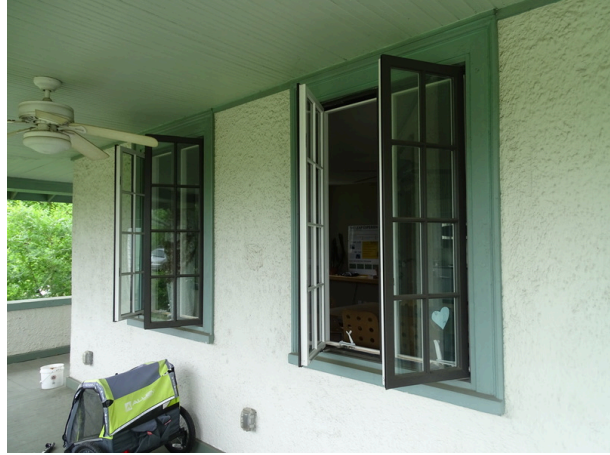
Typical exterior window units

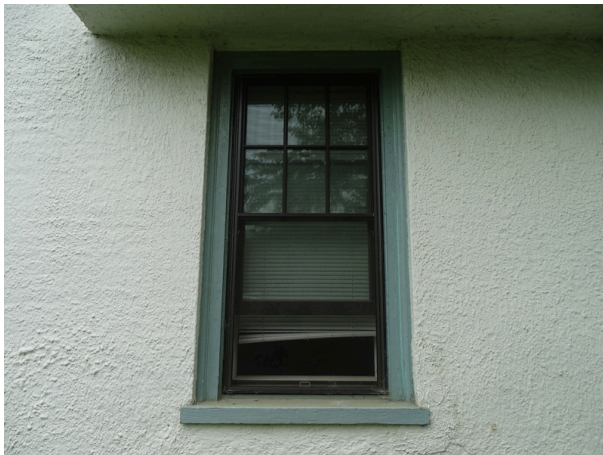
Exterior window

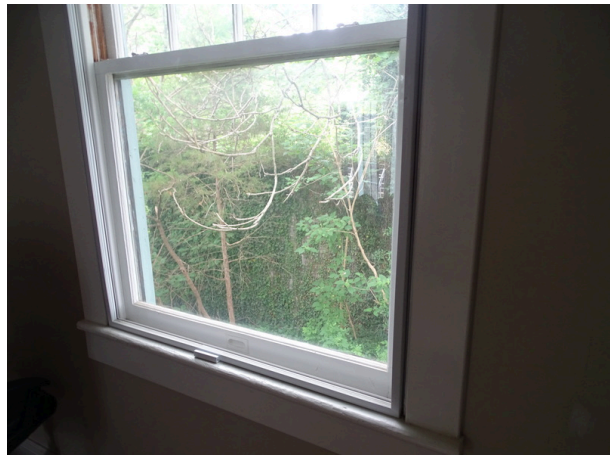
Additional window units installed for energy conservation

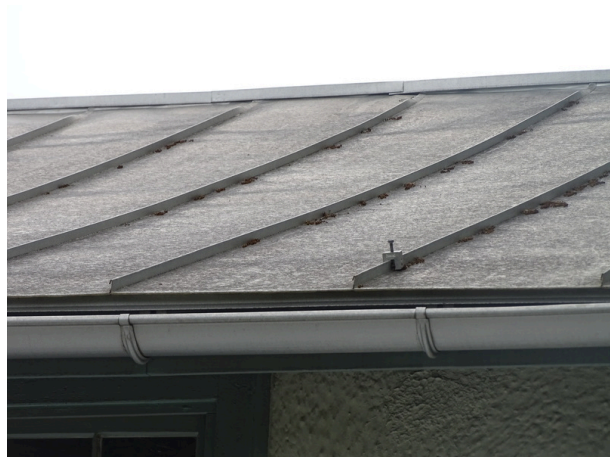
Metal roofing system south side of the building

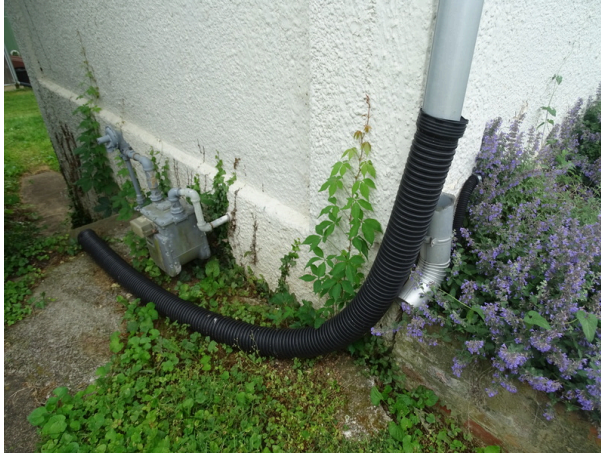
Typical downspout

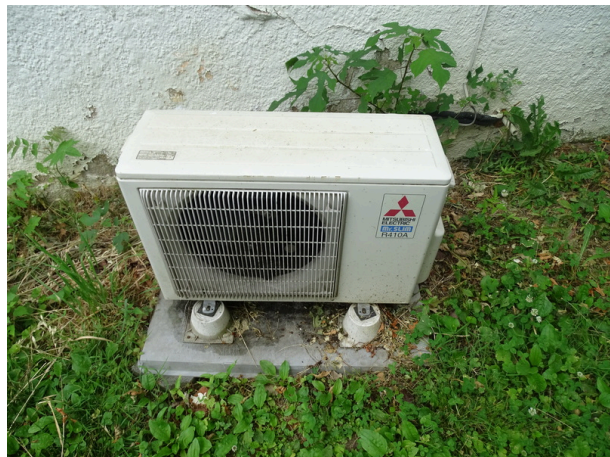
Typical split system

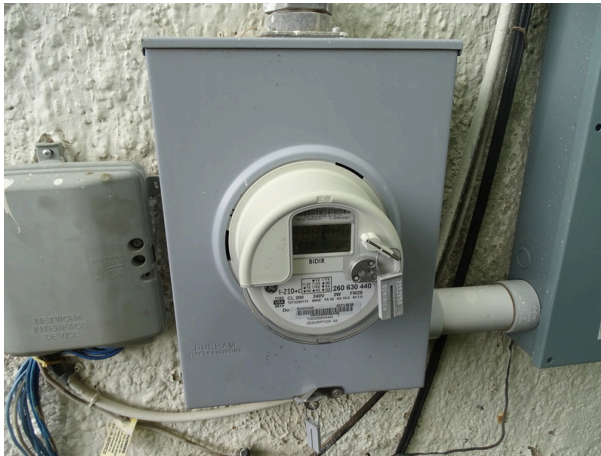
Electrical utility meter

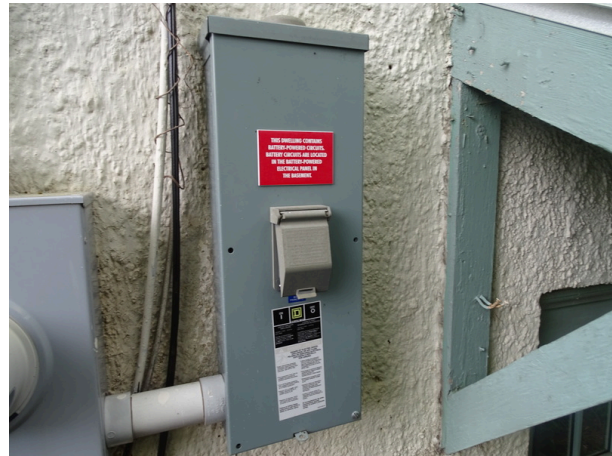
Main service disconnect

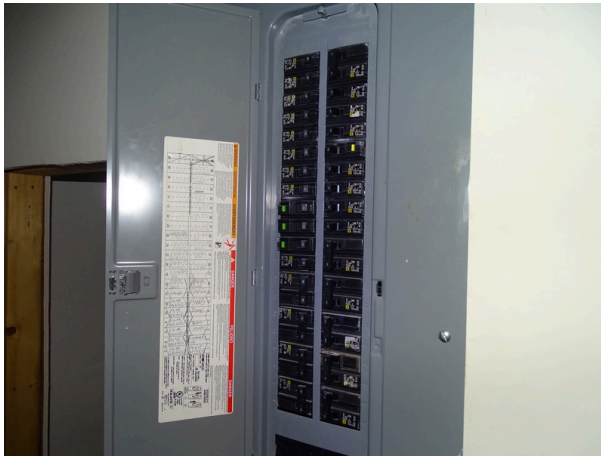
Power is distributed by copper wire from circuit breaker panels located throughout the building. Older circuit breaker panels were reportedly recently replaced during renovations and the new circuit breaker panels are in generally in good condition.

Typical circuit breaker panel

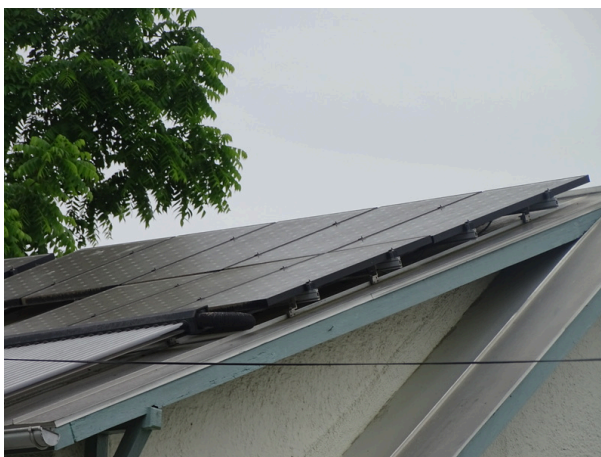
The solar power system consists of electronic controls located in the basement area. The Solar Power System was generally in good condition.

Solar panels located on northeast roof area

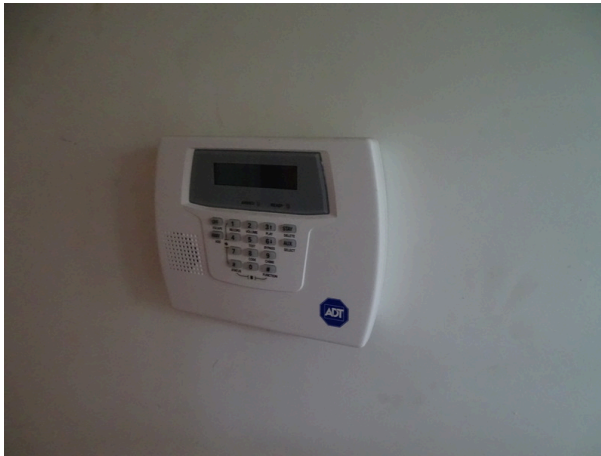
The building has secure access with hardware locks and an electronic security system with motion detection. The security system was generally in good condition.

Security system electronics

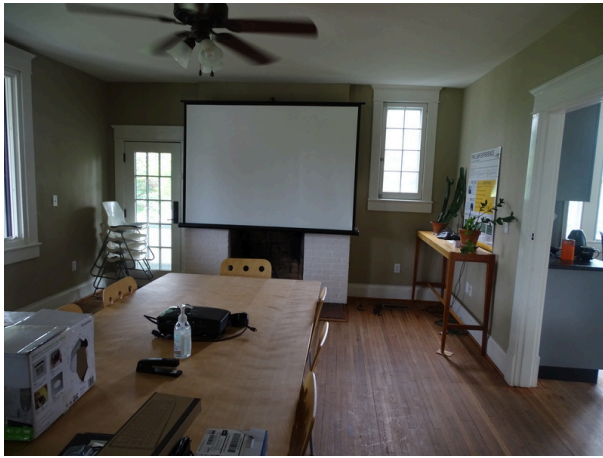
Interior finishes meeting room area

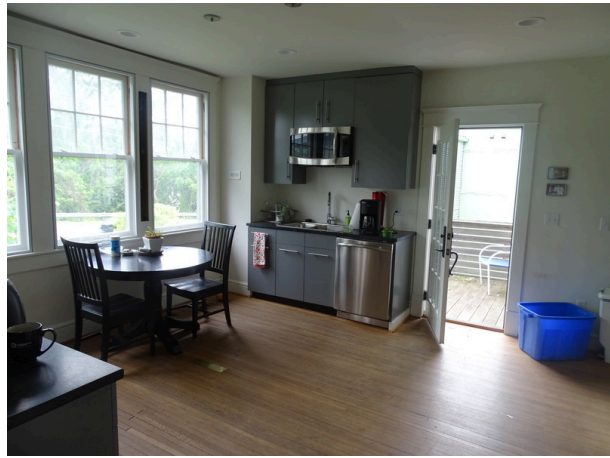
The finishes in the kitchens include wood floors, painted plaster and/ or gypsum board walls and painted plaster and/or gypsum board ceilings. The finishes in the kitchens were observed to be in generally good condition.

Interior finishes kitchen area

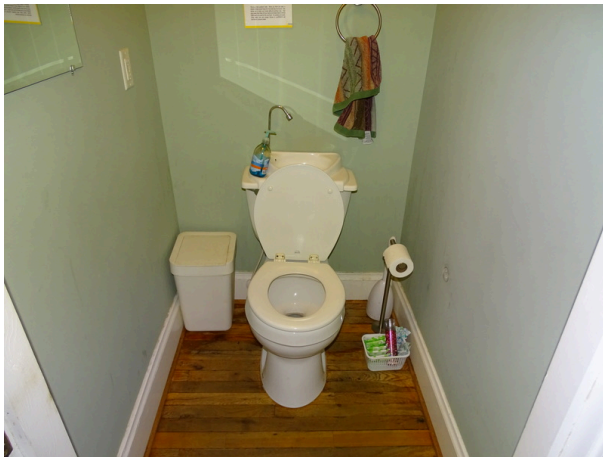
Typical restroom

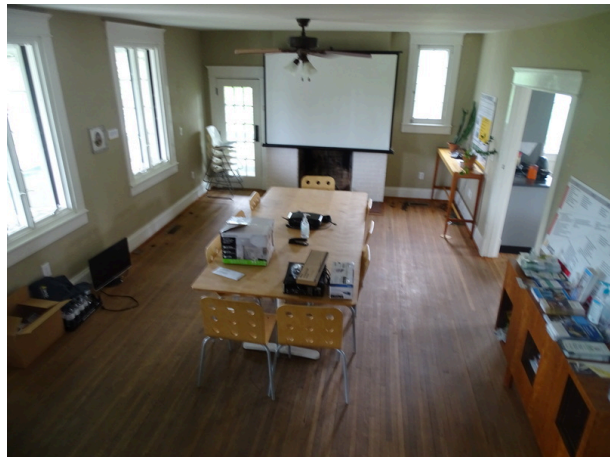
Interior finishes meeting room area

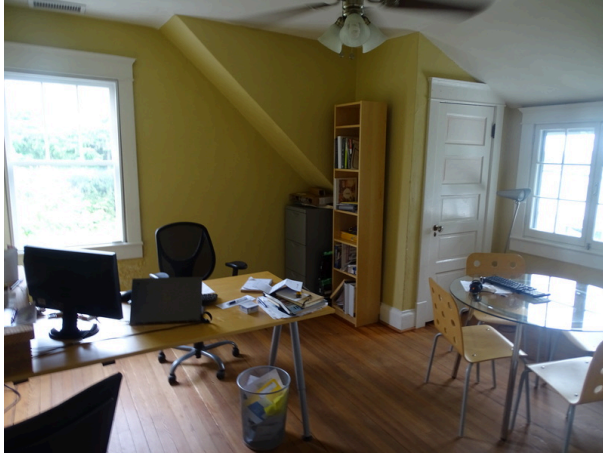
Interior finishes entrance area

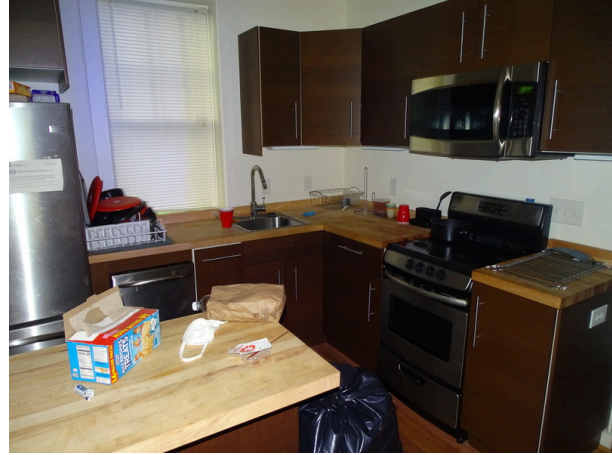
Interior finishes kitchen area

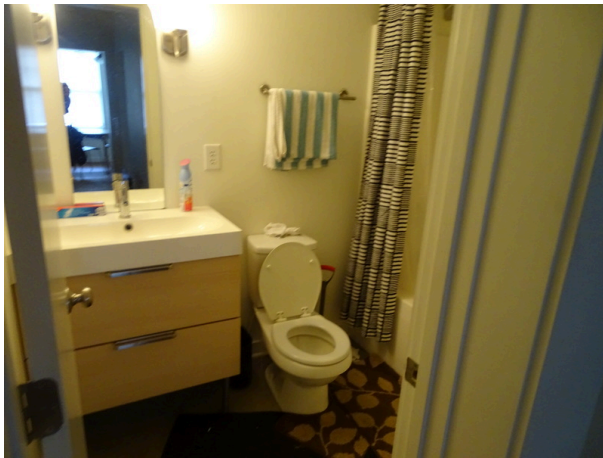
Interior finishes restroom area

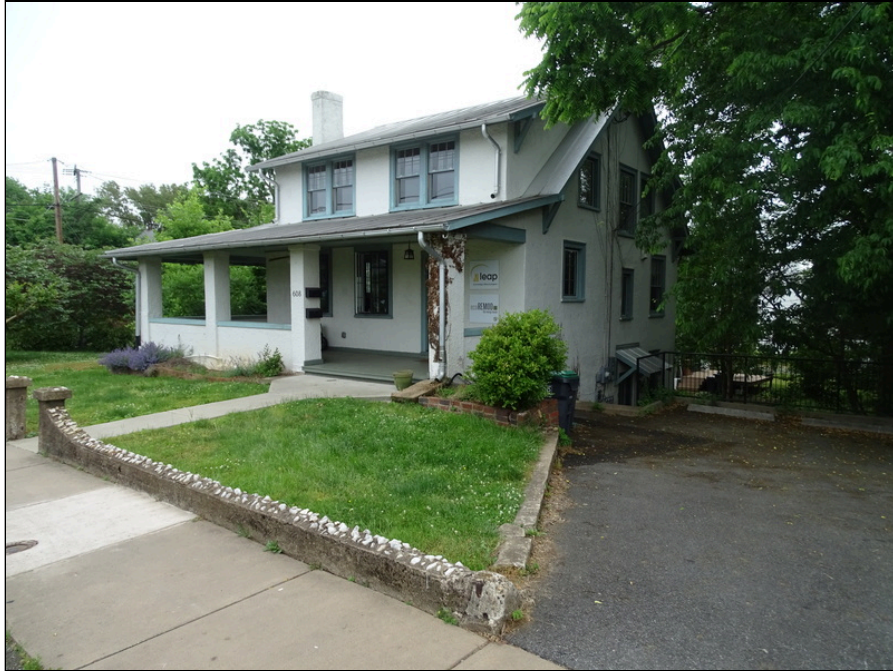
1 - The Energy House

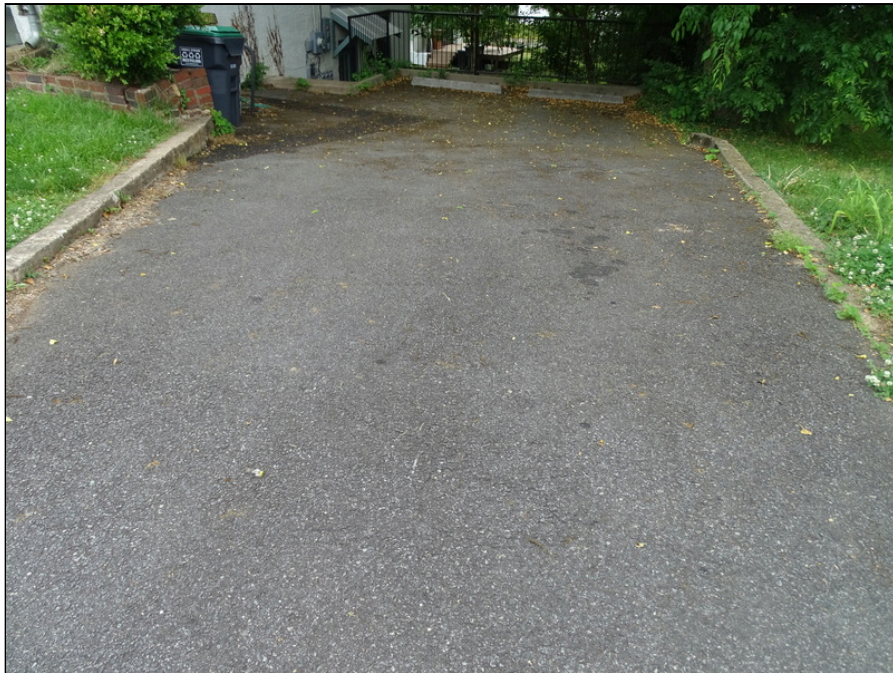
2 - Asphalt parking area

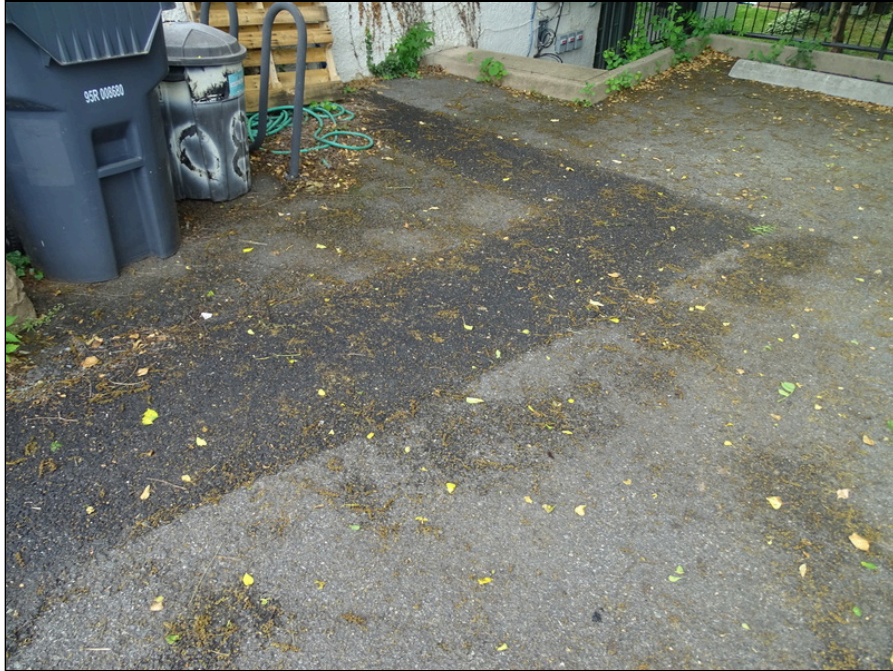
3 - Asphalt parking area

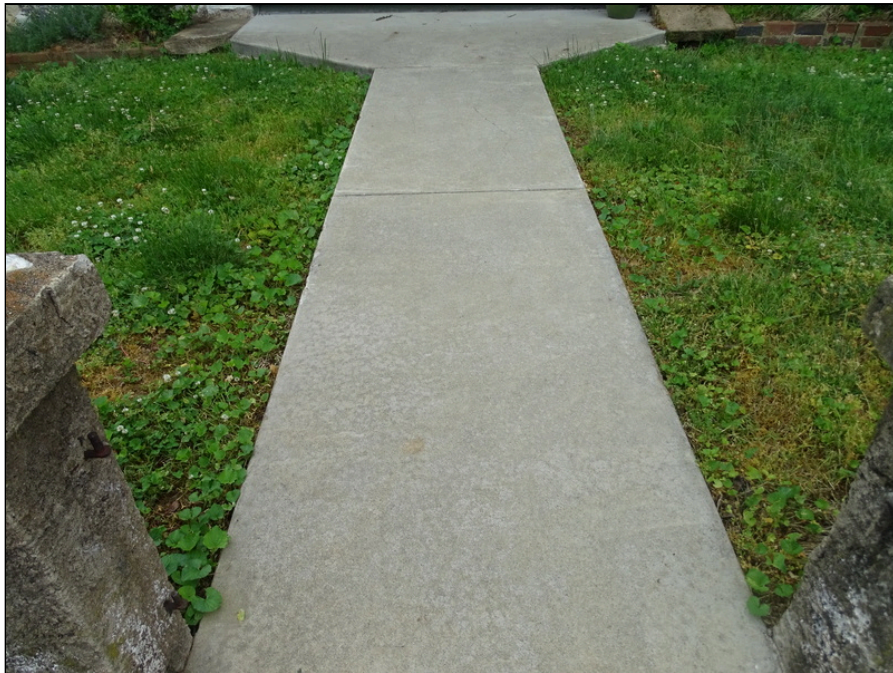
4 - Concreted sidewalk

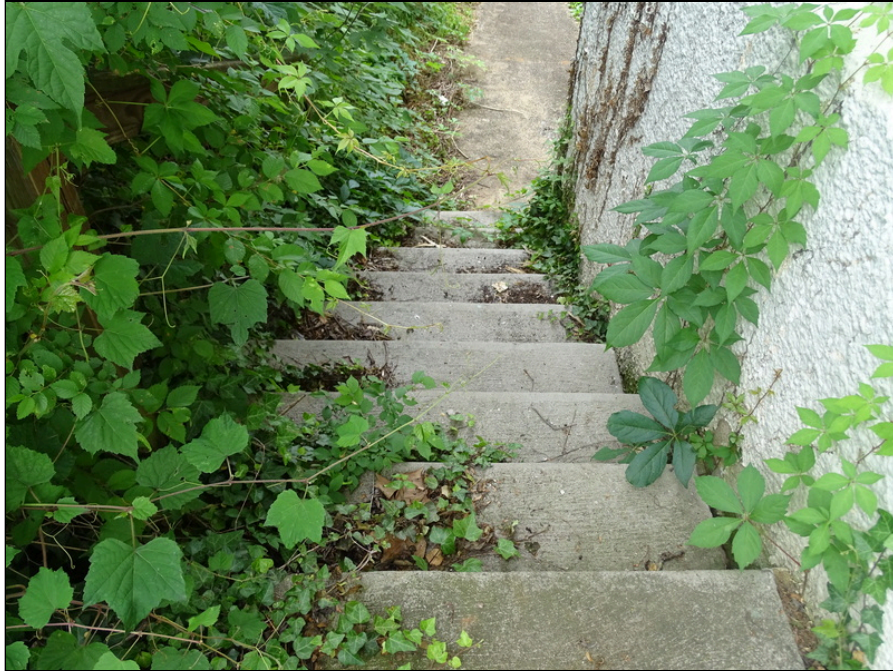
5 - Concrete steps

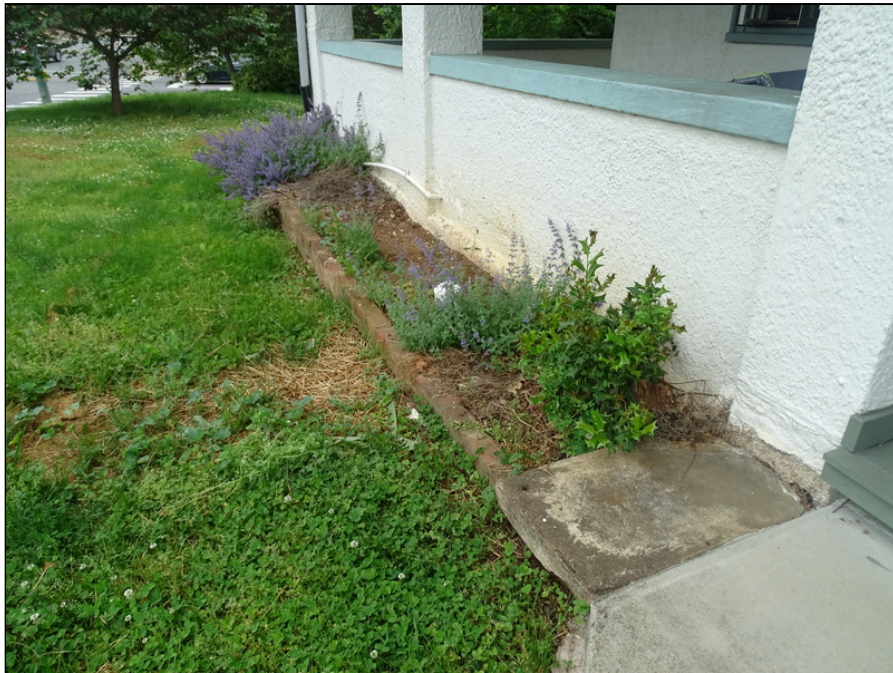
6 - Typical landscaping

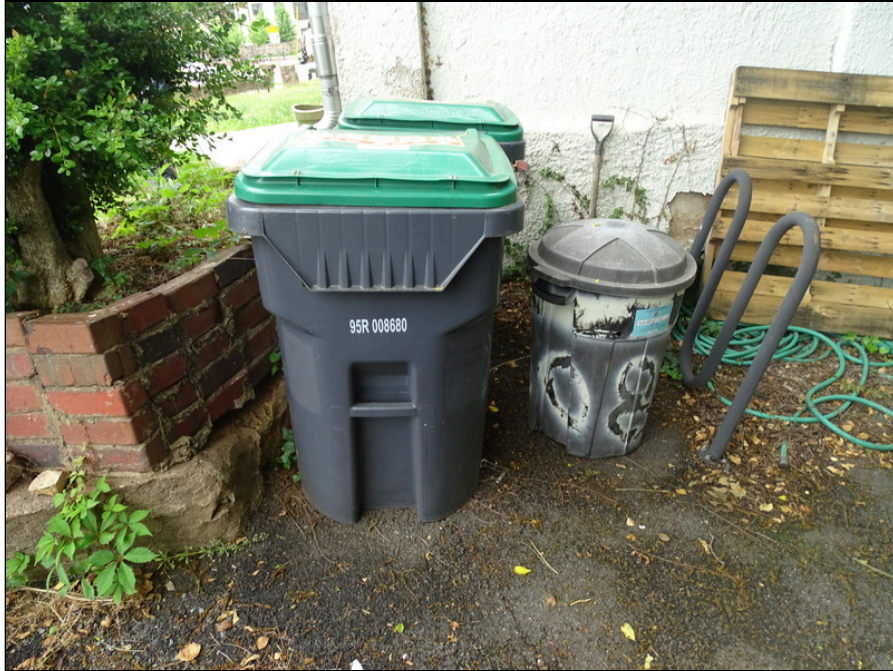
7 - Trash container at south side of the building

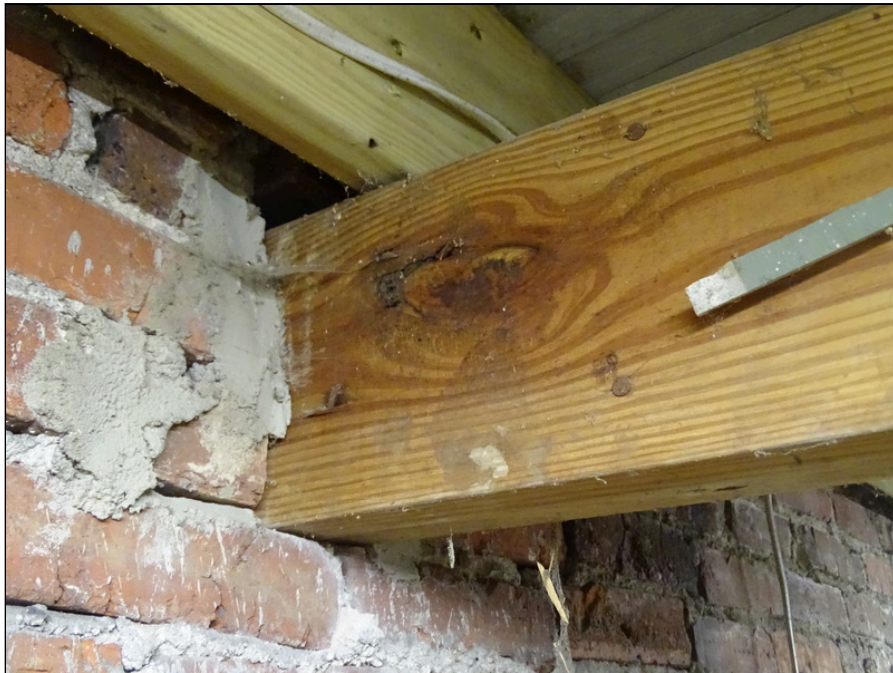
8 - Structural framing

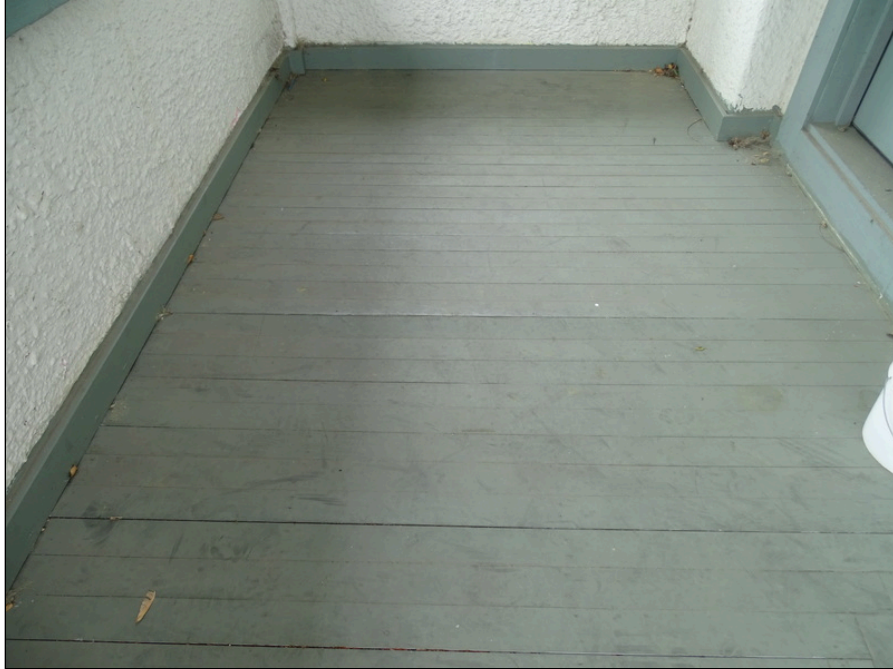
9 - Porch area overview

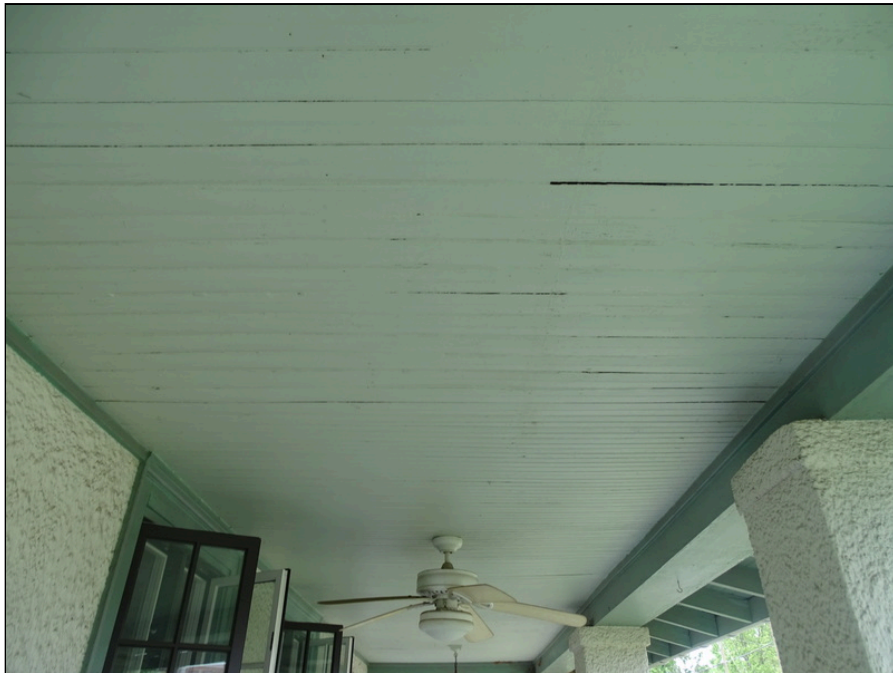
10 - Exterior soffit at west side of the building

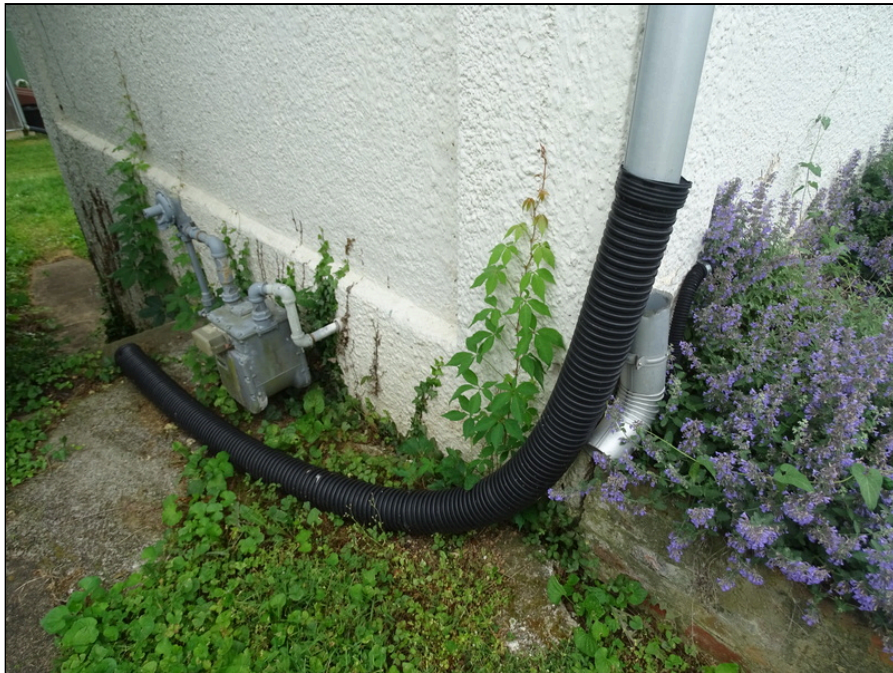
12 - Typical downspout

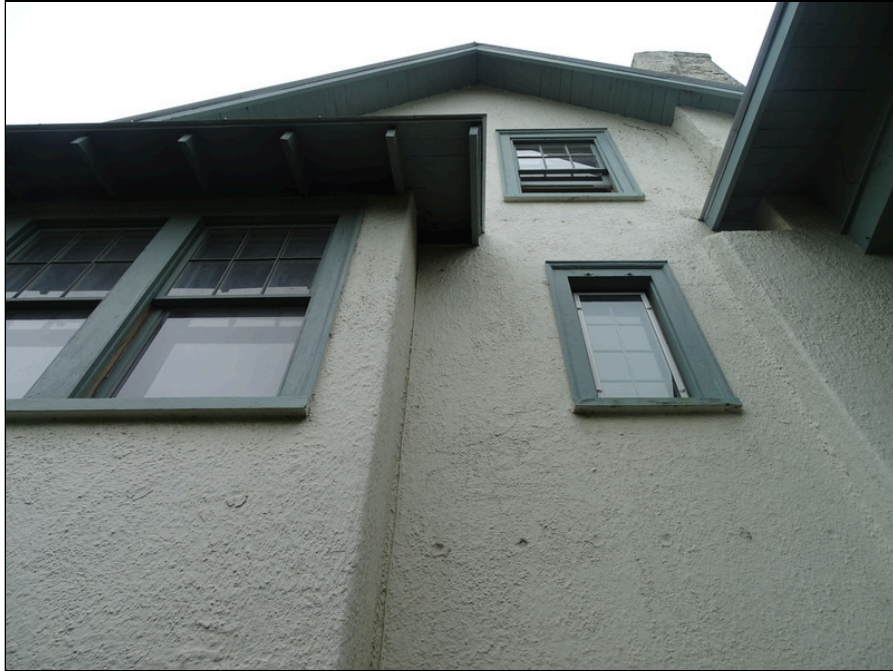
13 - Building exteriors

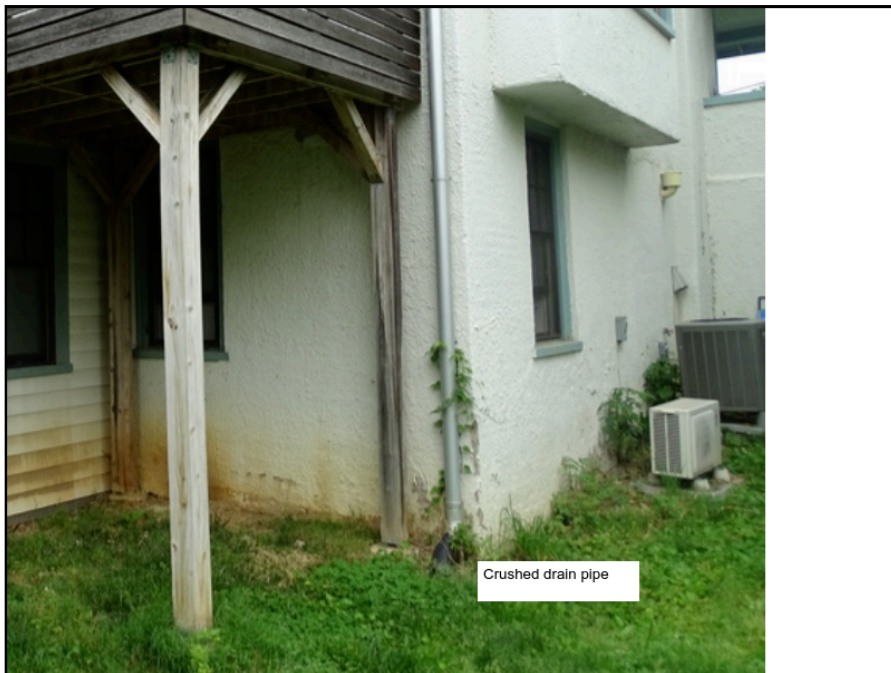
14 - Building exterior at northeast side of the building

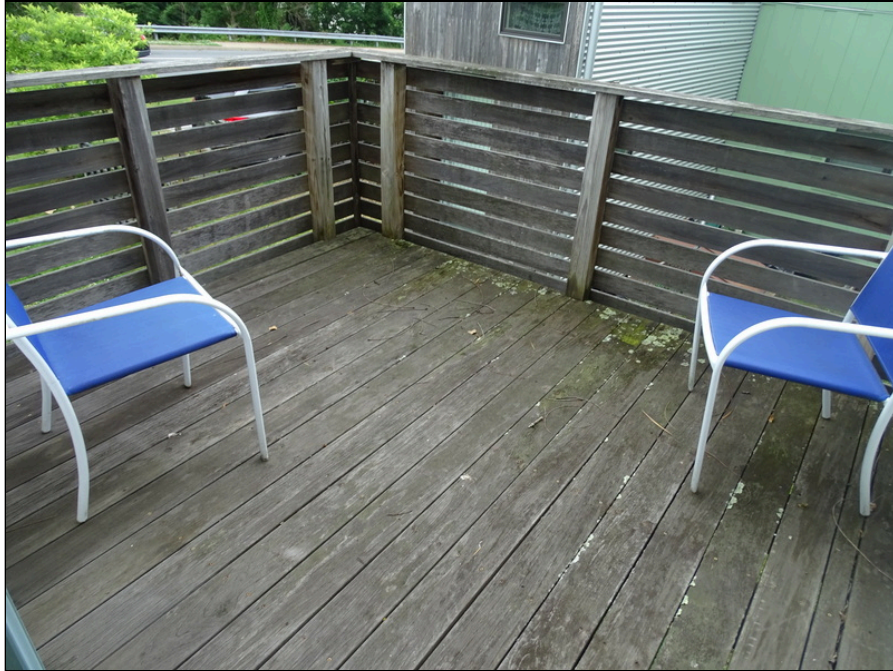
15 - Wood Deck

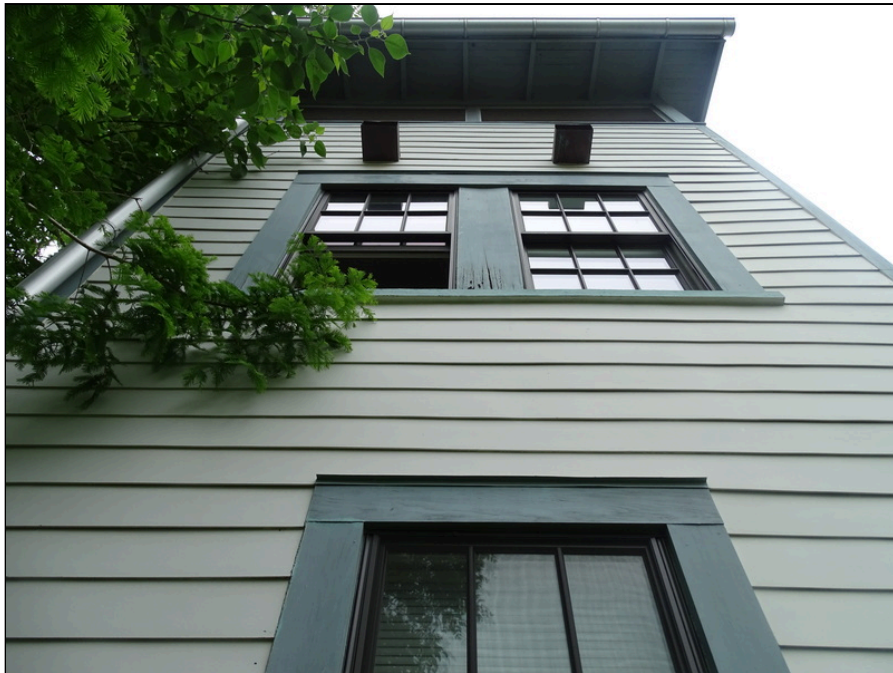
16 - Building exterior at east side of the building

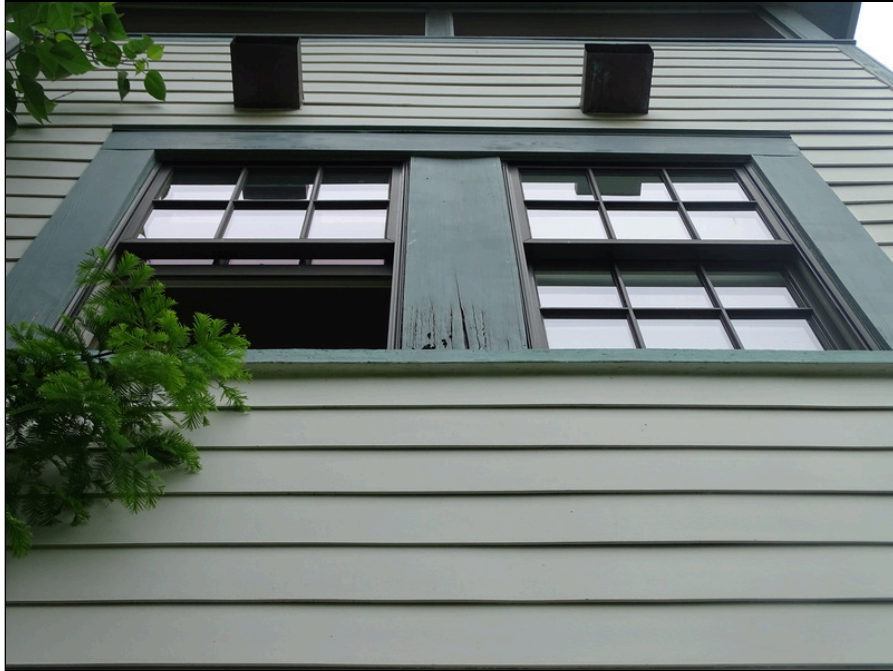
17 - Exterior window condition at east side of the building

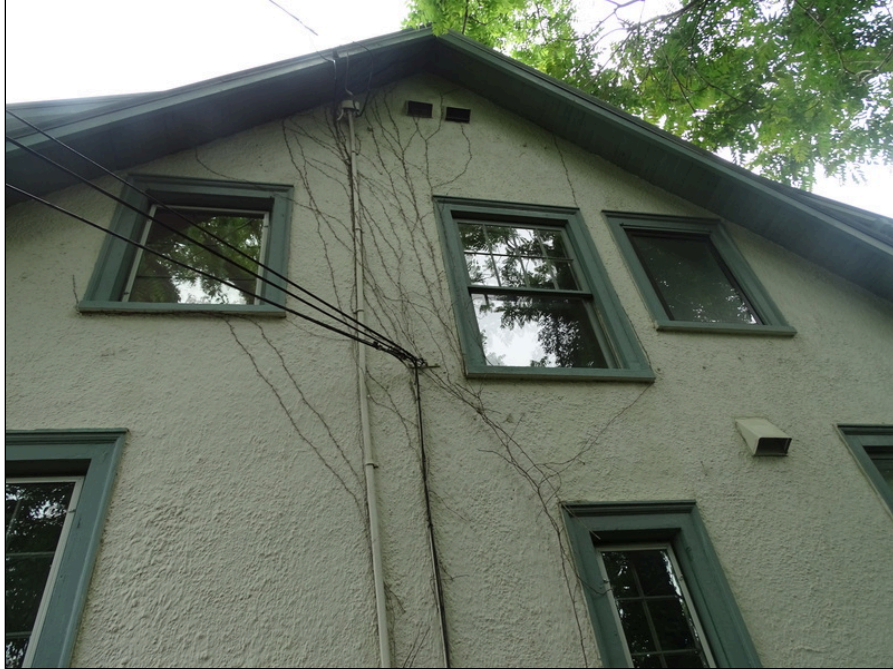
21 - Building exterior at south side of the building

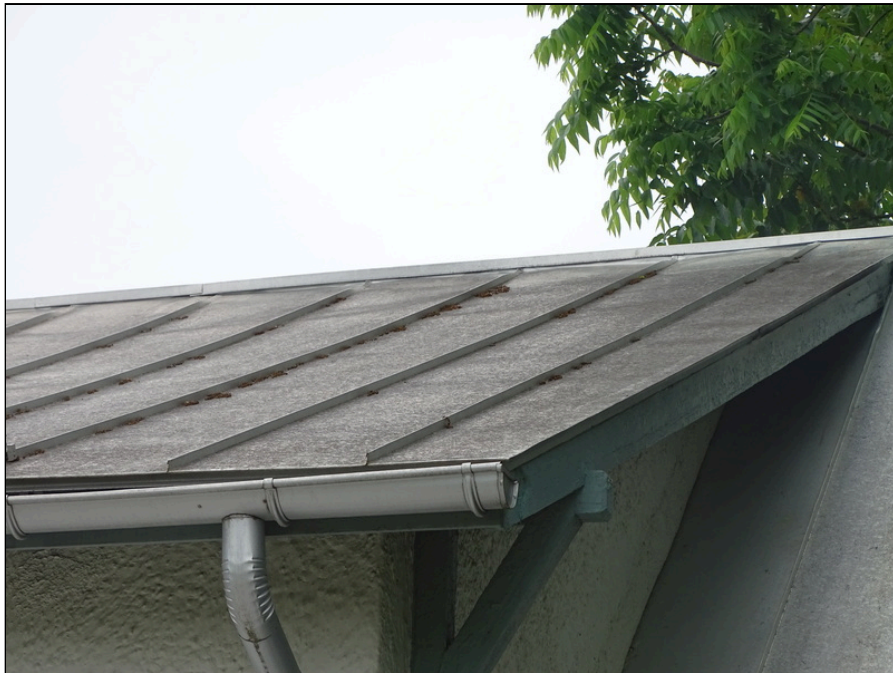
22 - Metal roofing system south side of the building

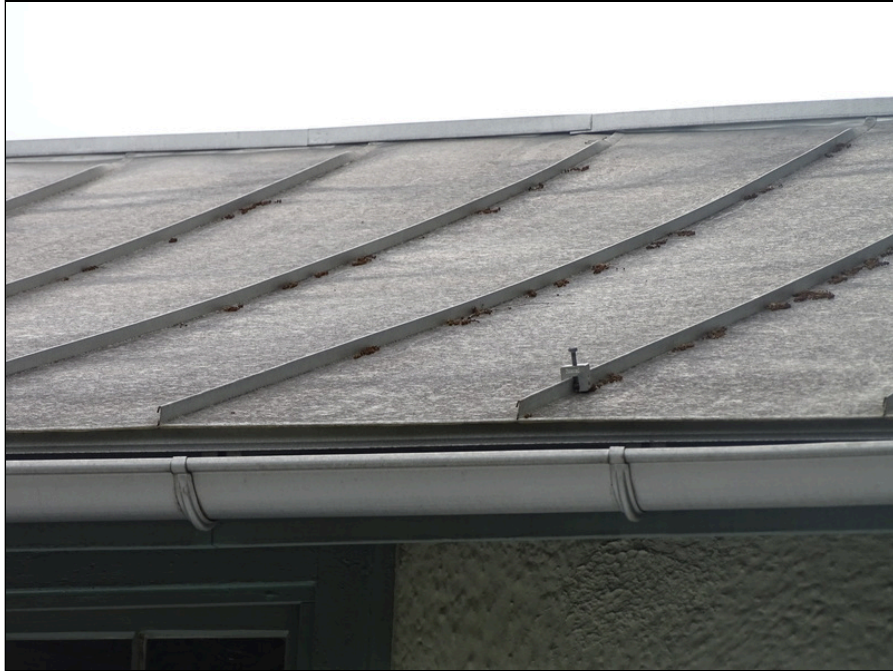
23 - Metal roofing system south side of the building

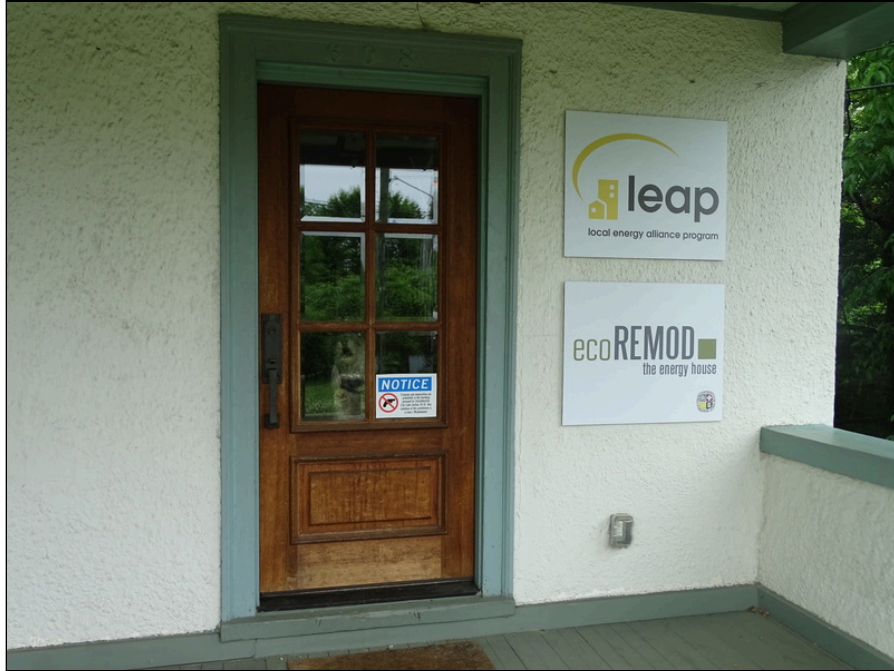
25 - Main entrance door

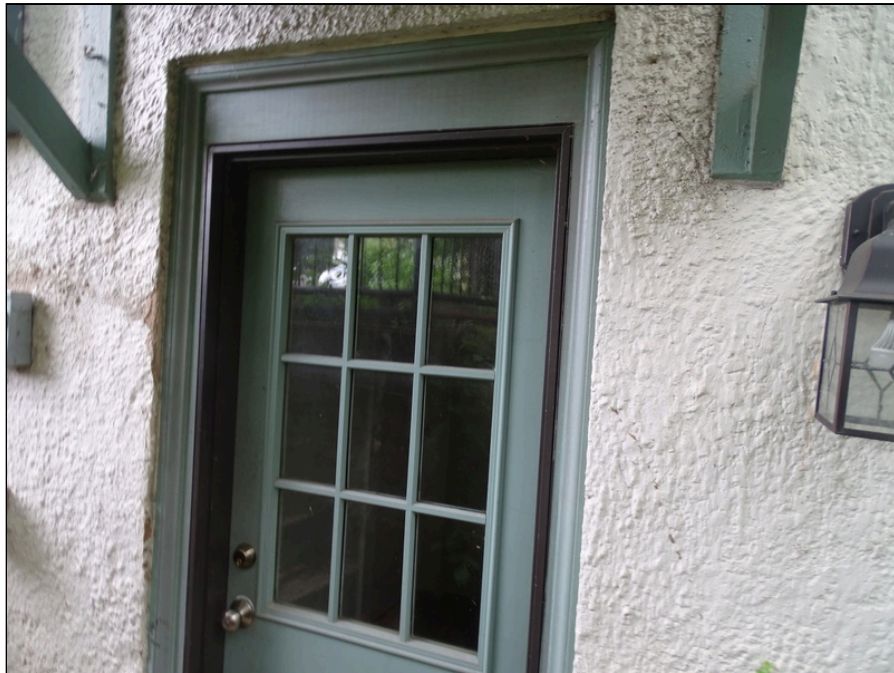
26 - Typical exterior door

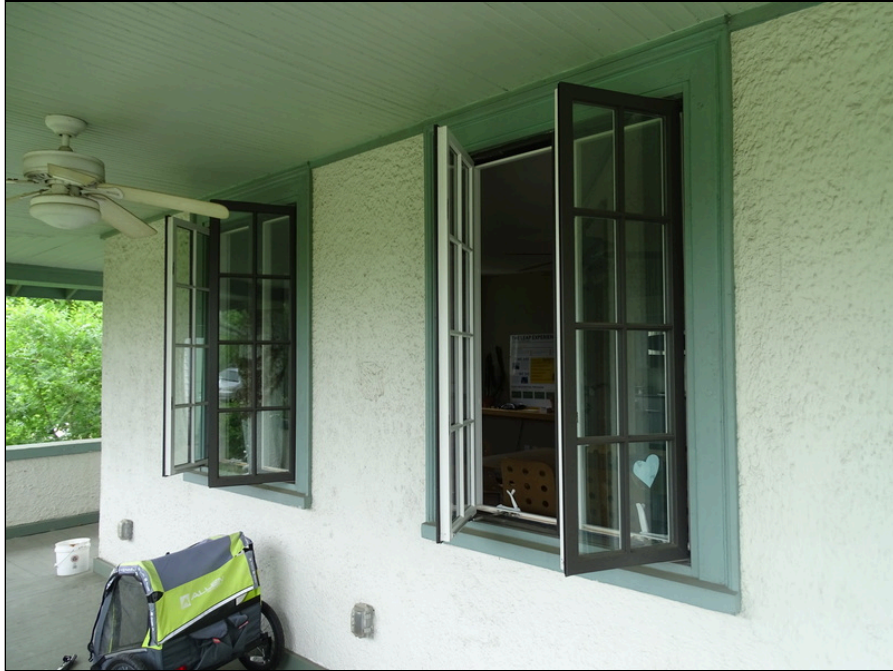
27 - Typical exterior window units

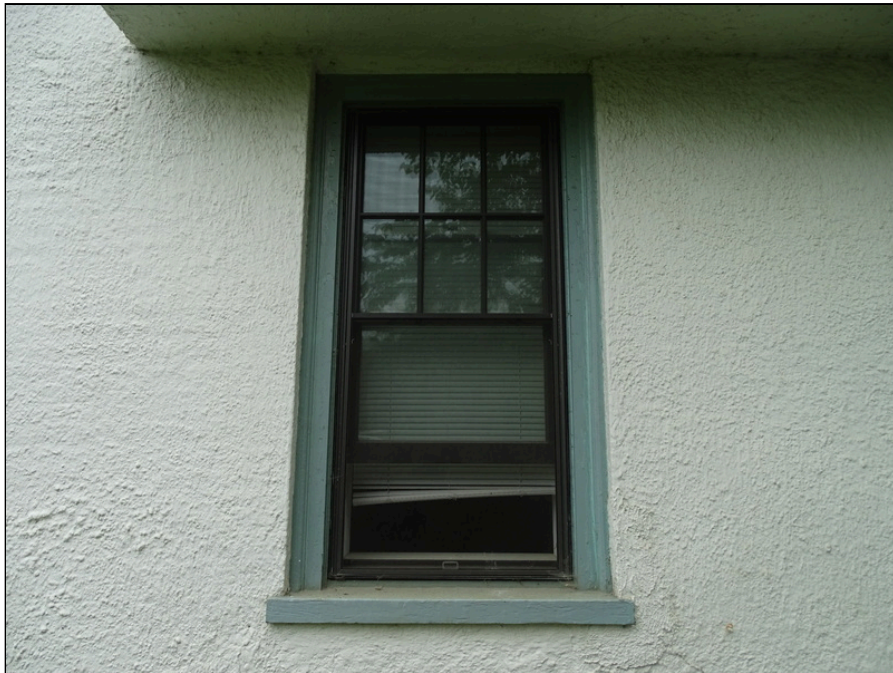
28 - Typical exterior window

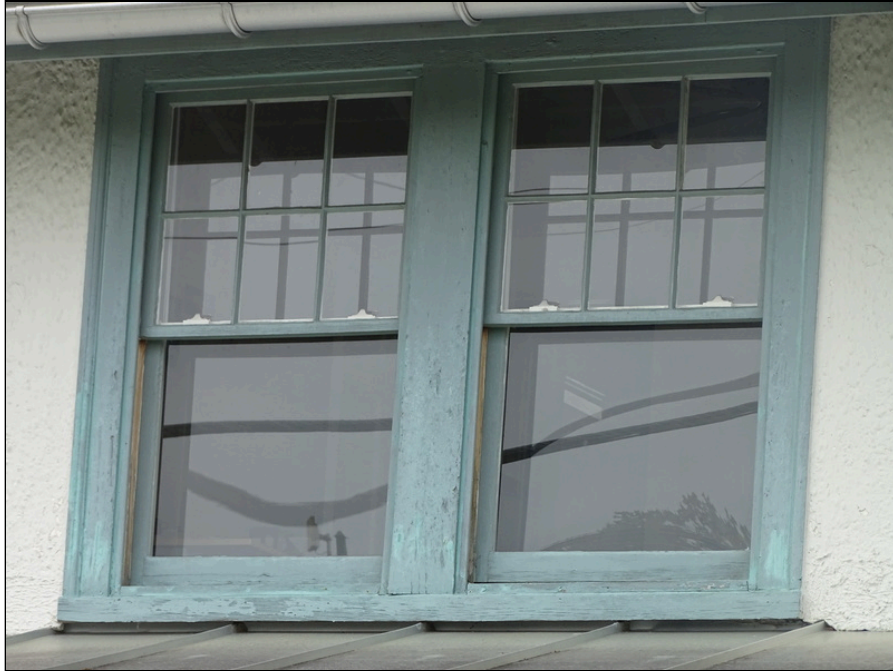
29 - Typical exterior window units
