THE ENERGY HOUSE
608 RIDGE STREET
CHARLOTTESVILLE, VIRGINIA

ECS PROJECT NO. 46:6713

CITY OF CHARLOTTESVILLE - FACILITIES DEVELOPMENT

Reference: Facility Condition Assessment Report for The Energy House, 608 Ridge Street,
Charlottesville, Virginia

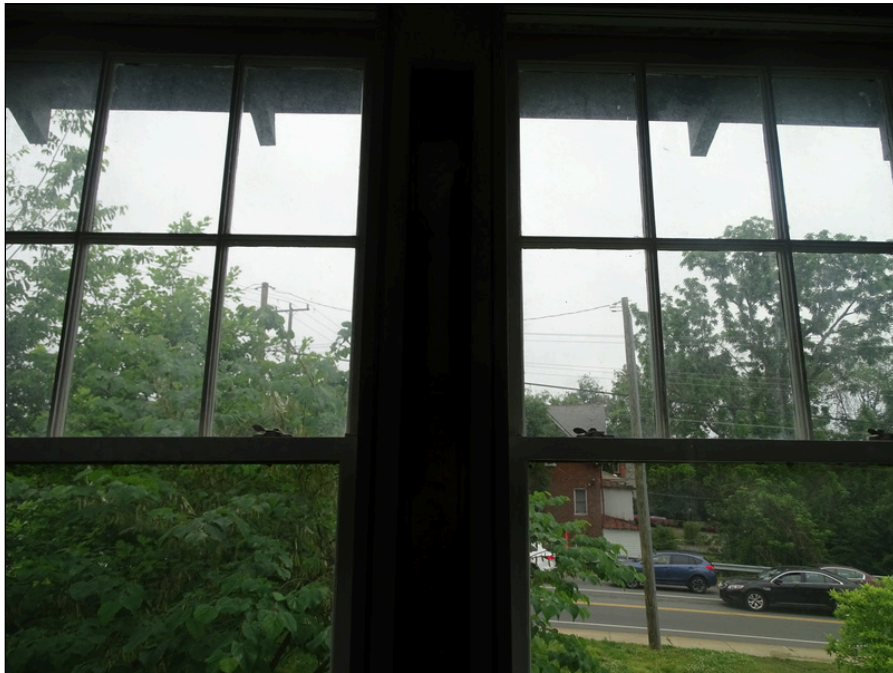
30 - Typical window

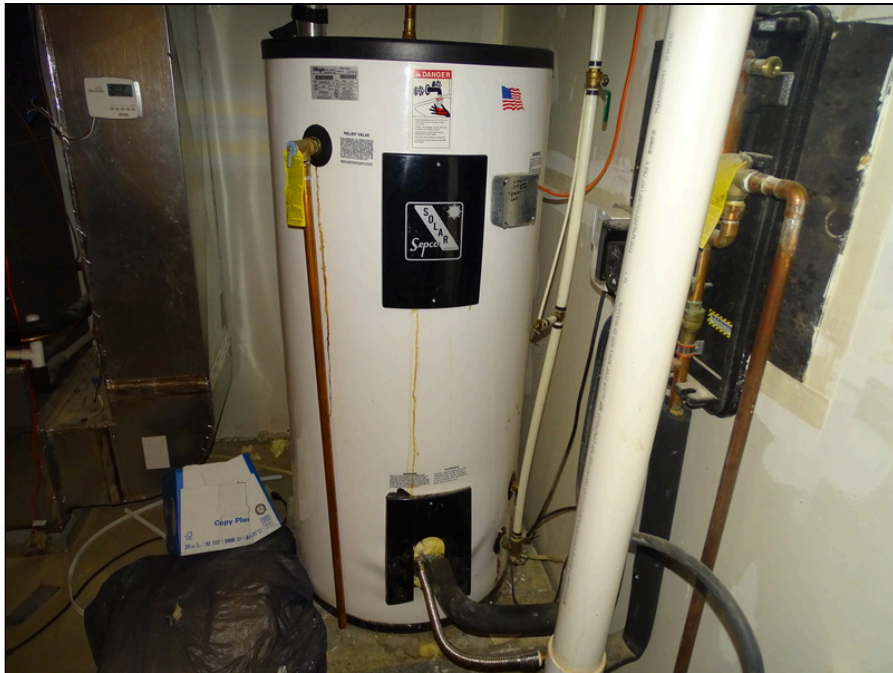
32 - Solar thermal water heater

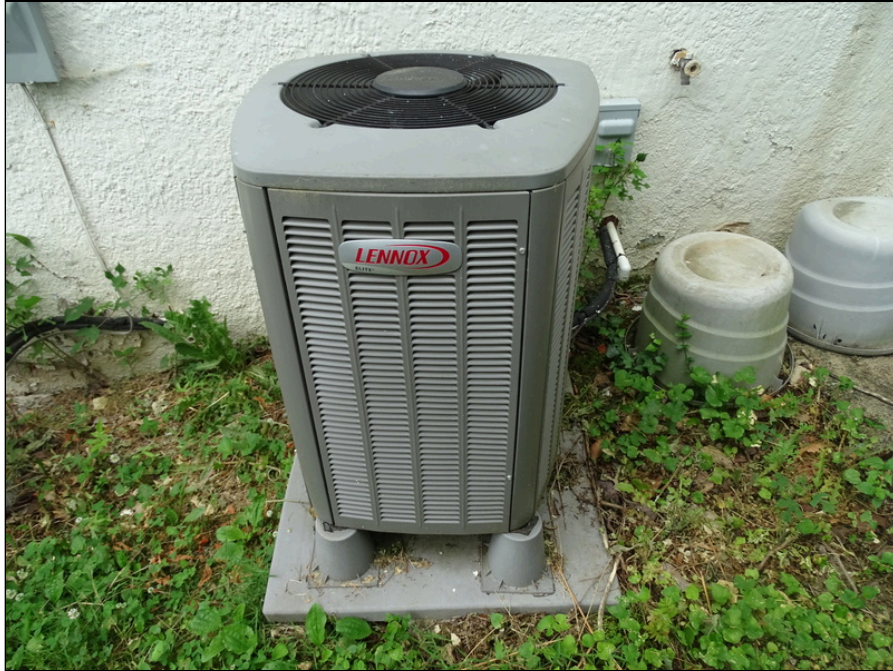
33 - Heat Pump

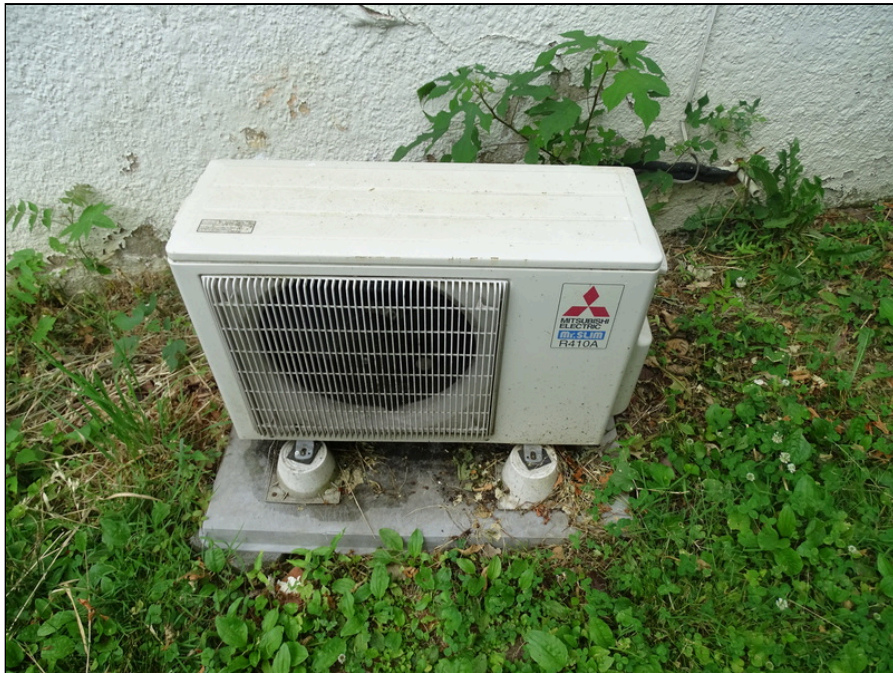
34 - Typical split system

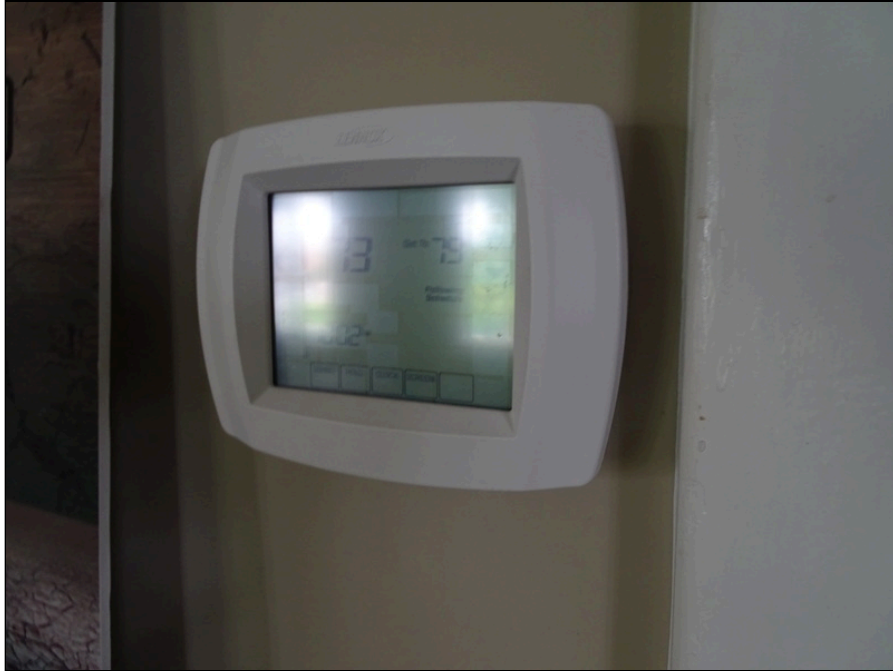
35 - Typical digital thermostat

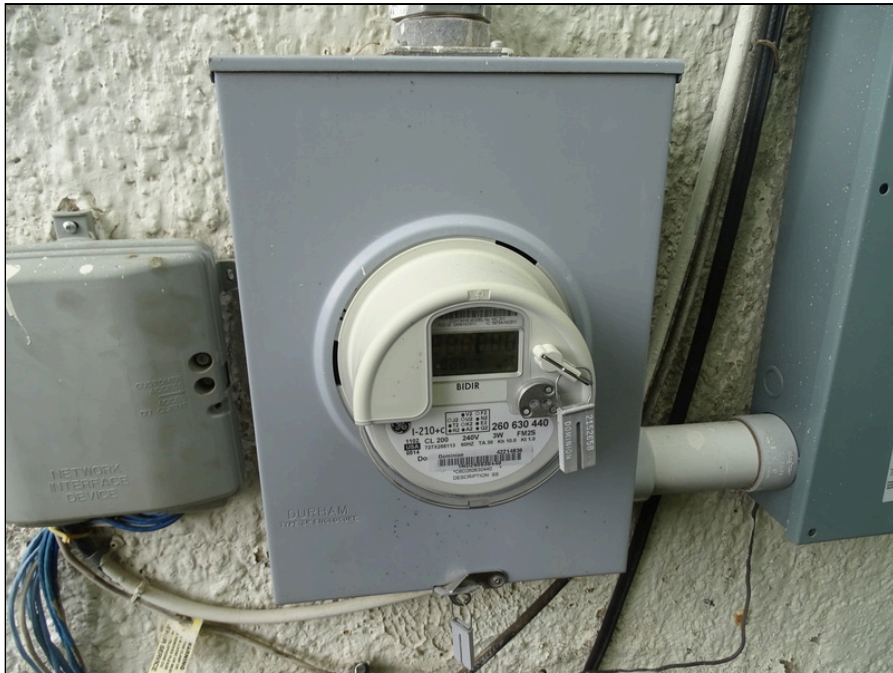
36 - Electrical utility meter

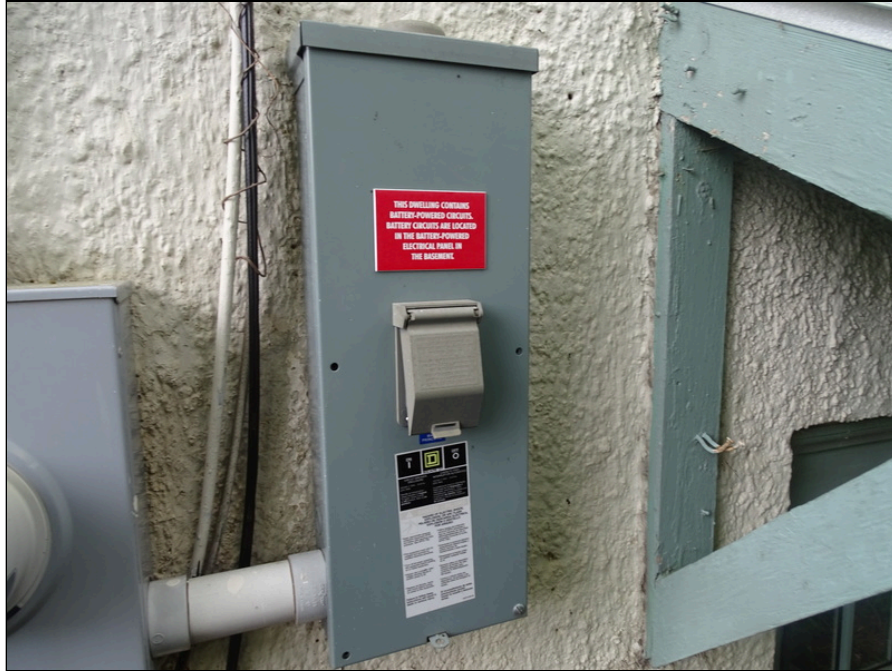
37 - Main service disconnect

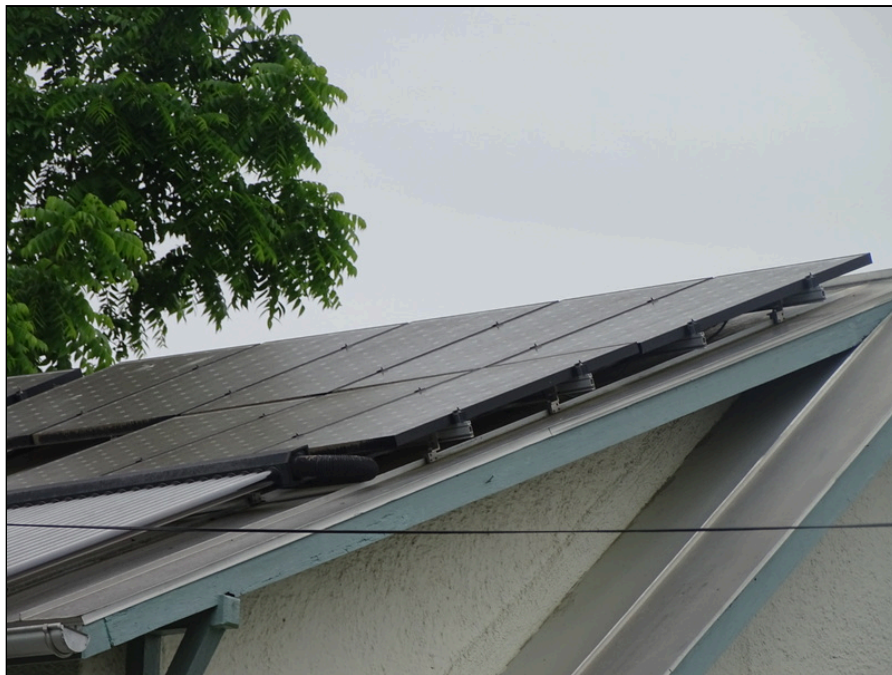
38 - Solar panels located on northeast roof area

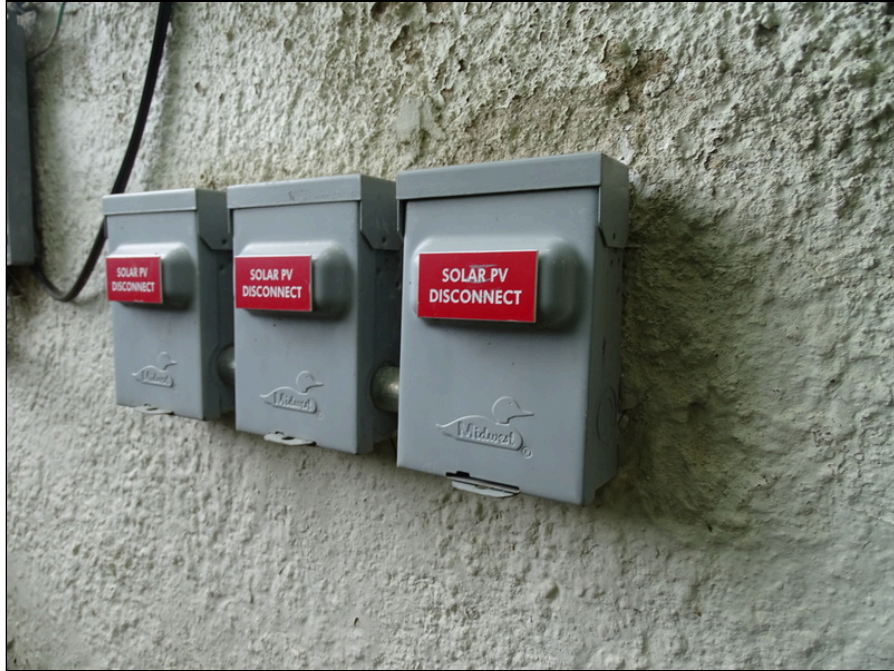
39 - Solar service disconnect

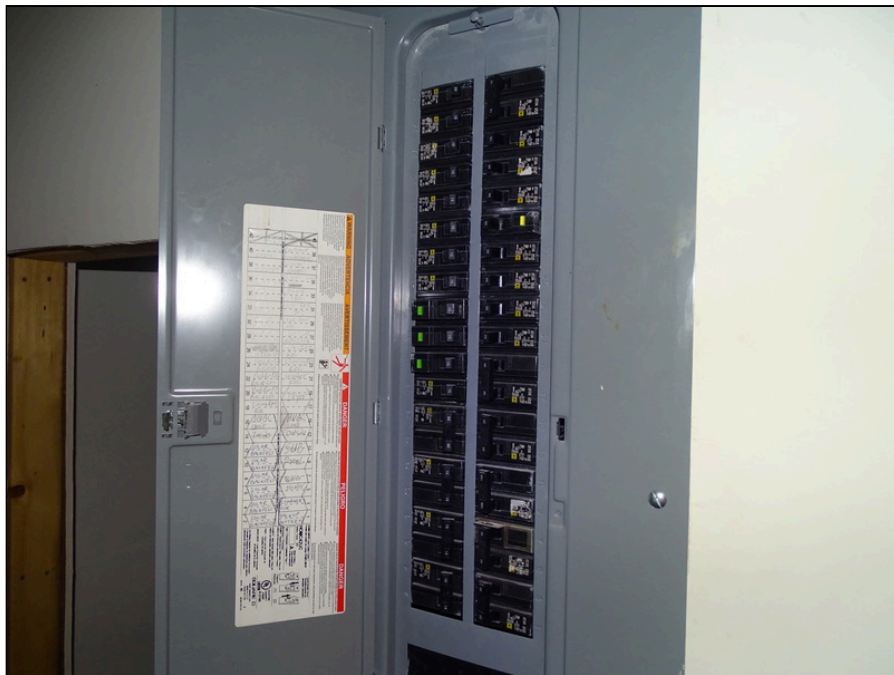
40 - Typical circuit breaker panel

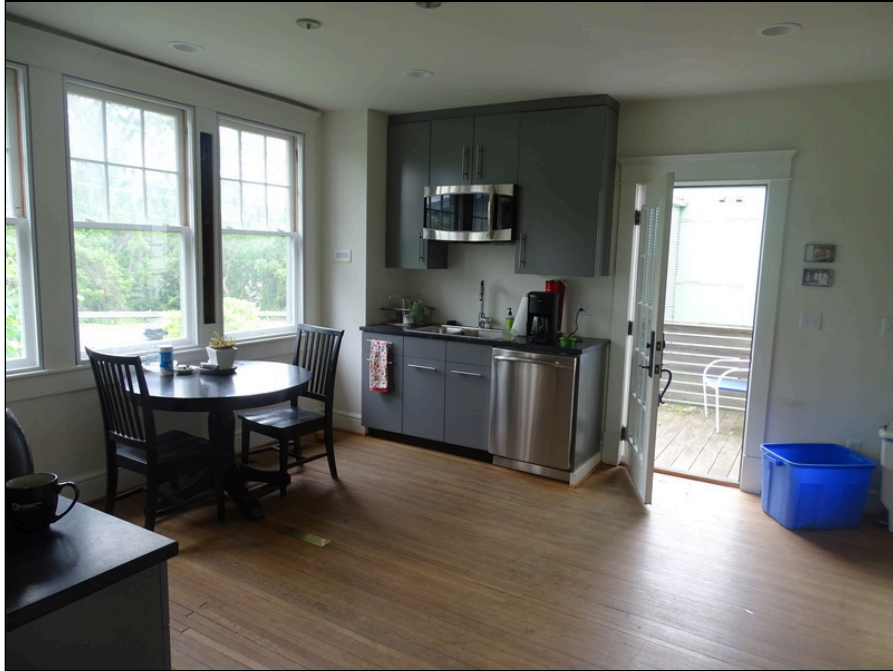
41 - Interior finishes kitchen area

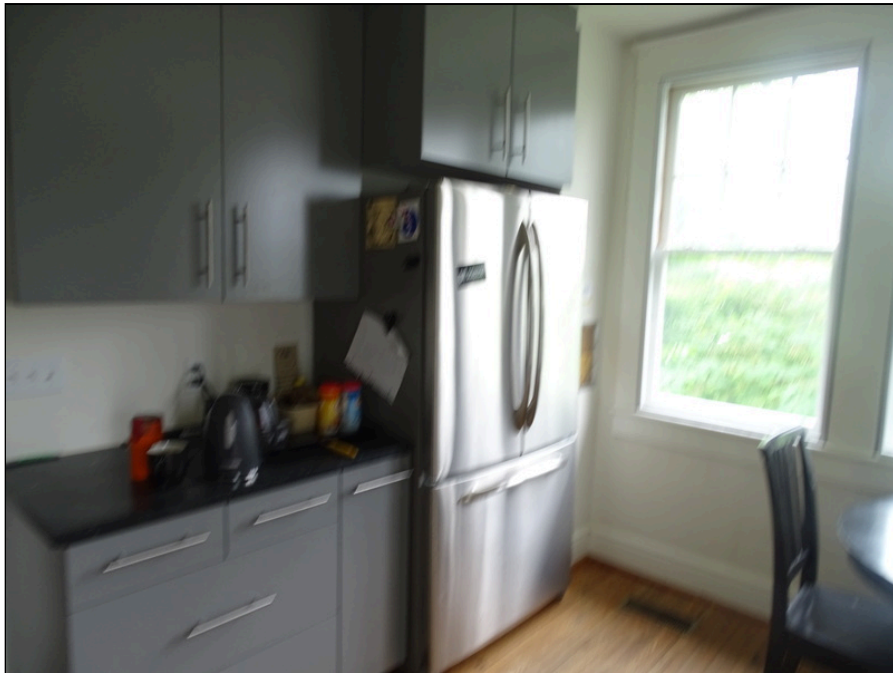
42 - Interior finishes kitchen area

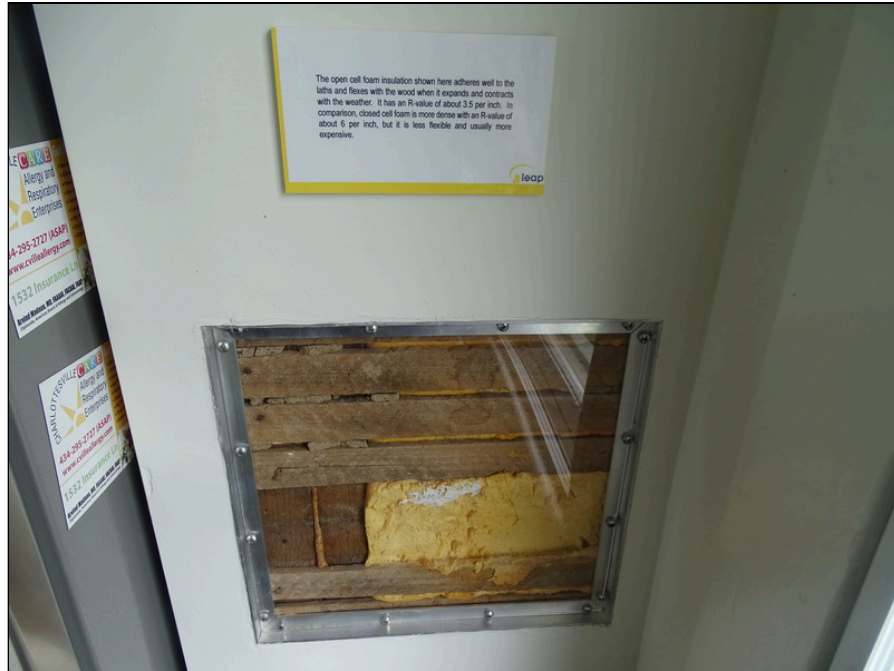
43 - Interior wall condition

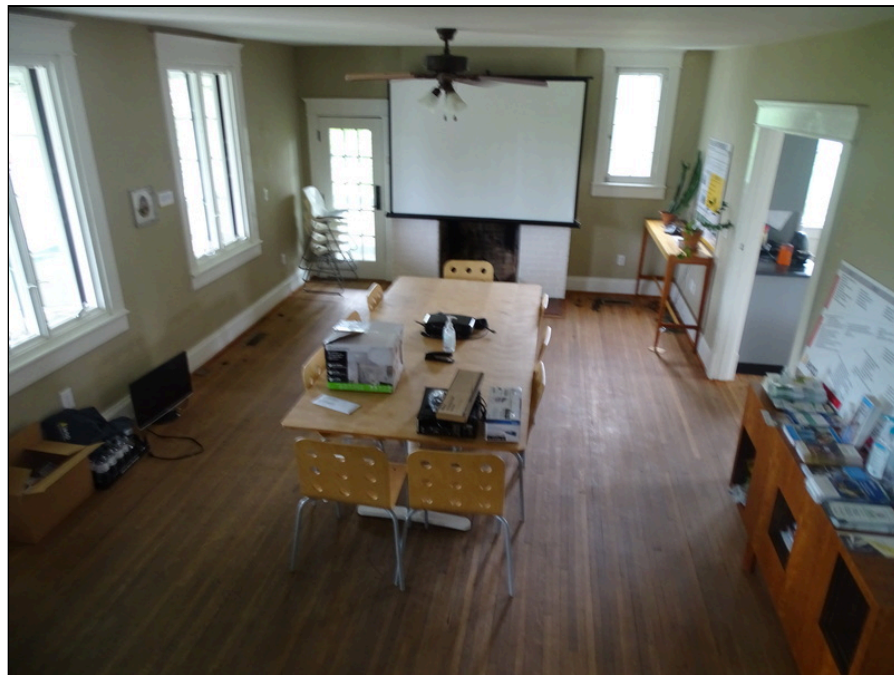
44 - Interior finishes meeting room area

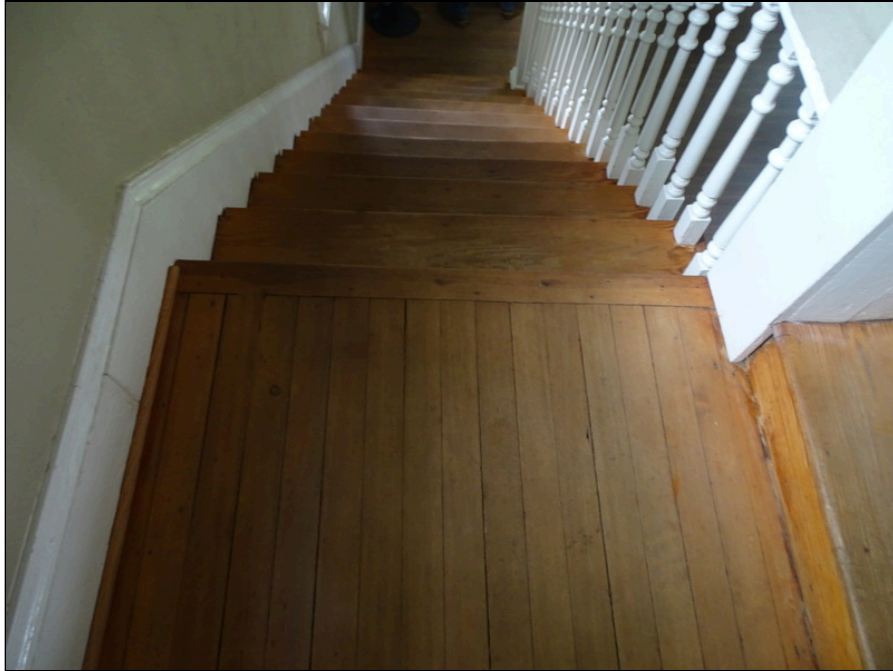
45 - Interior stair overview

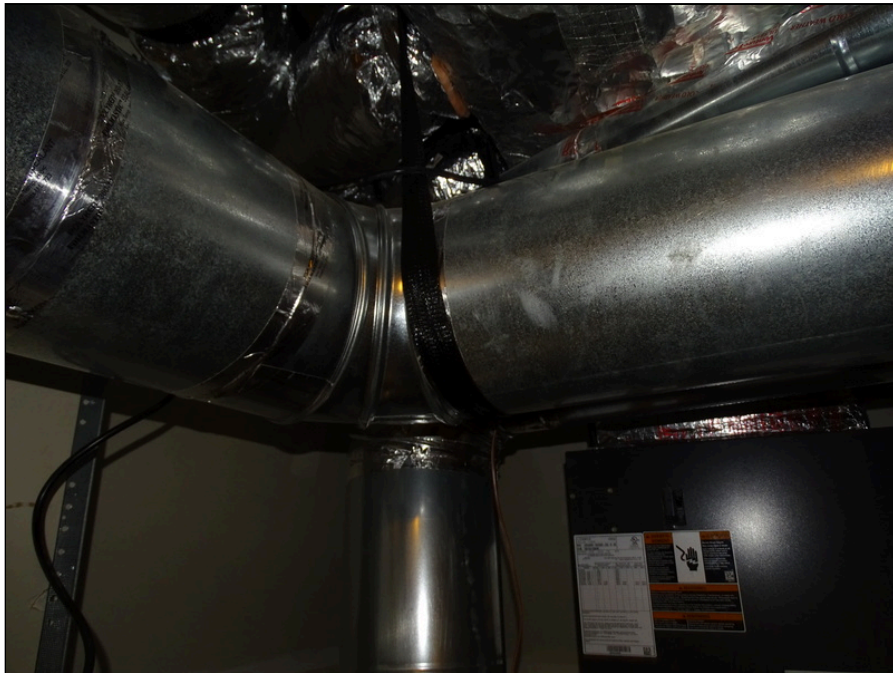
46 - Typical mechanical duct

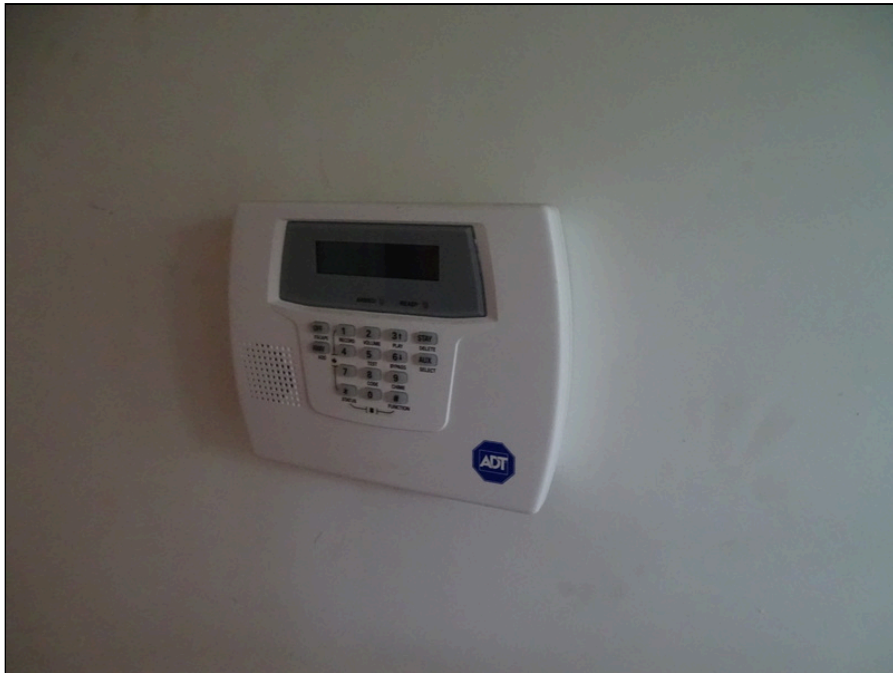
48 - Security system electronics

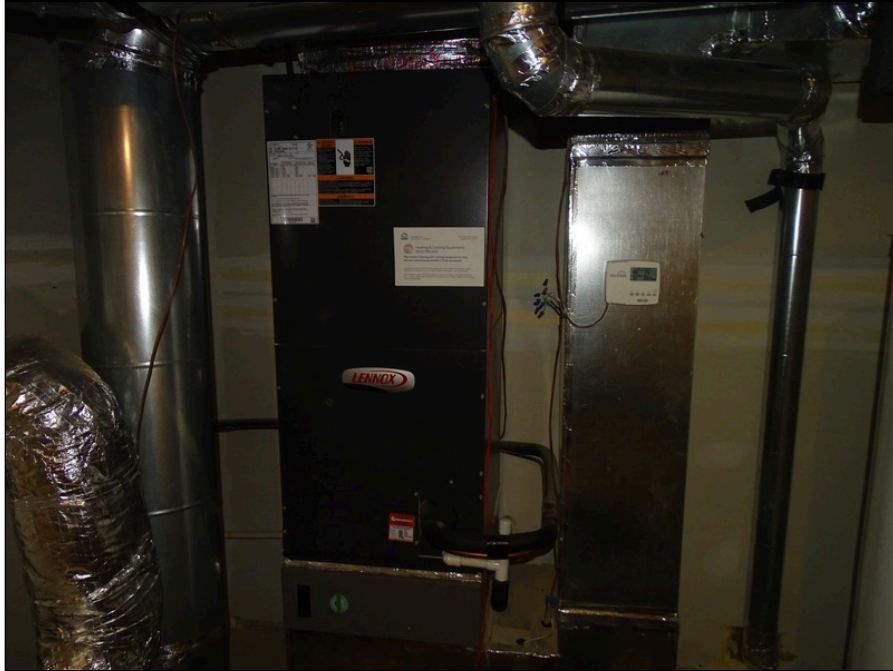
49 - Air Handler Unit

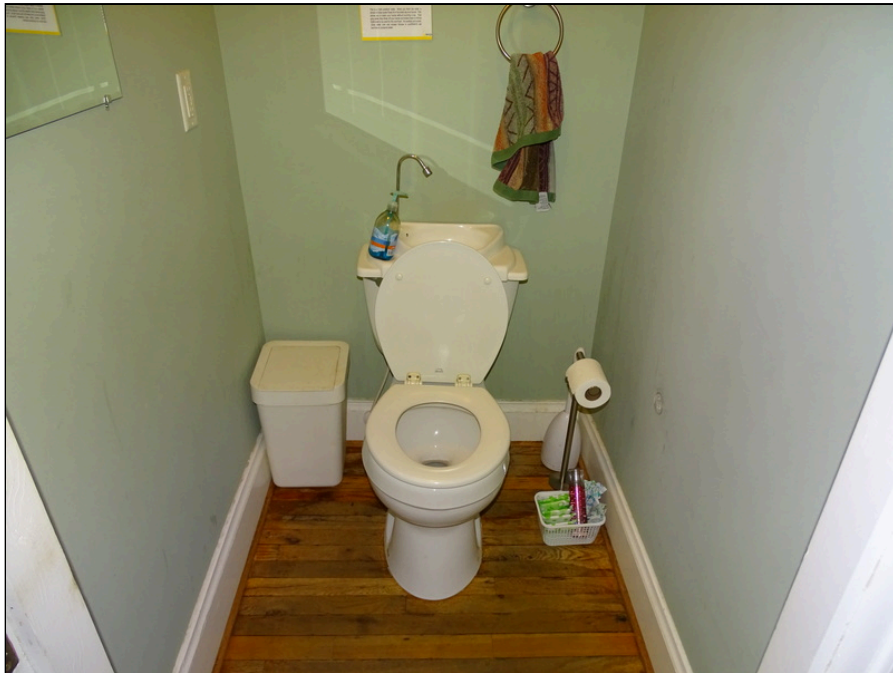
50 - Typical restroom

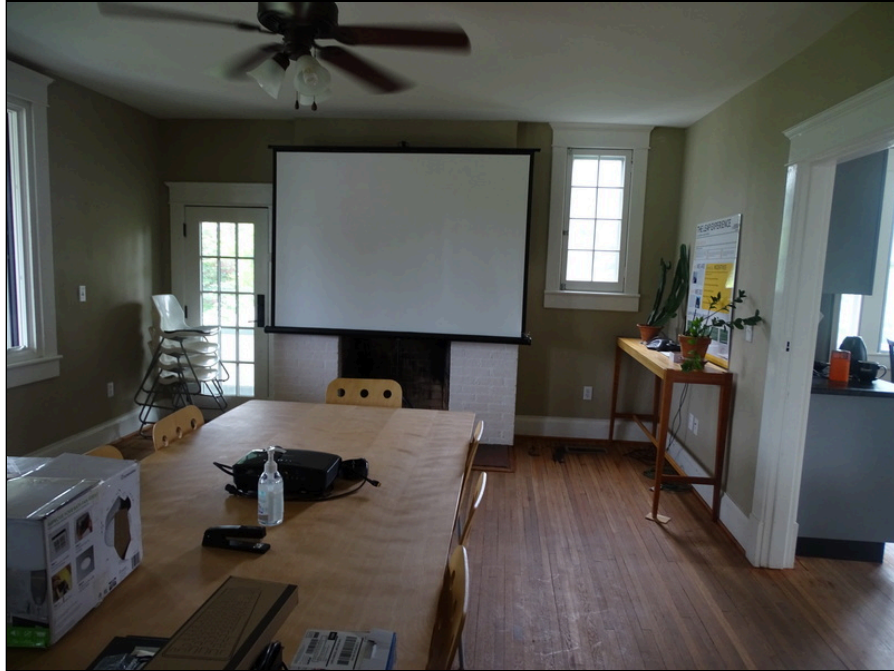
51 - Interior finishes meeting room area

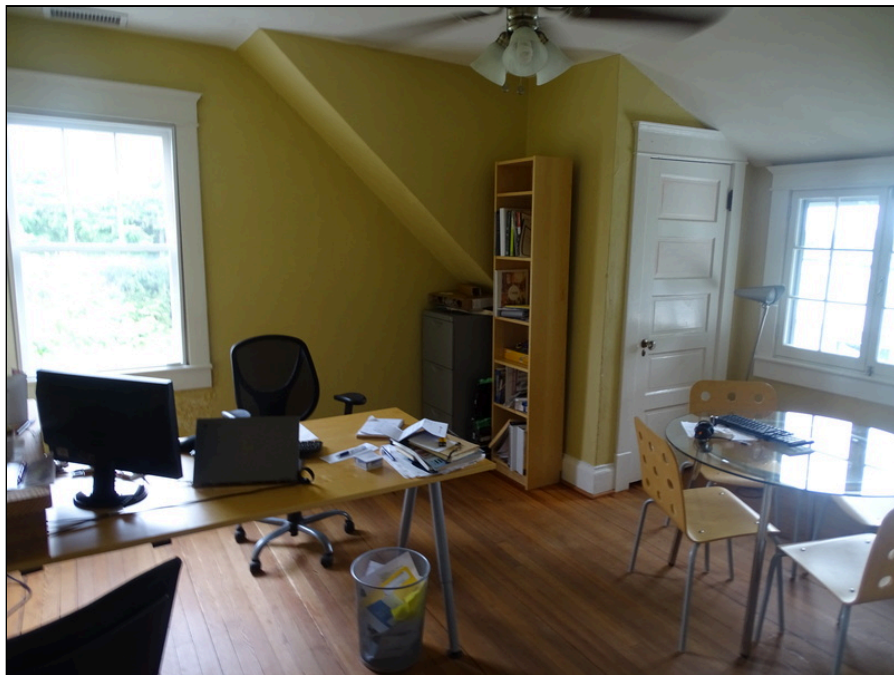
52 - Interior finishes entrance area

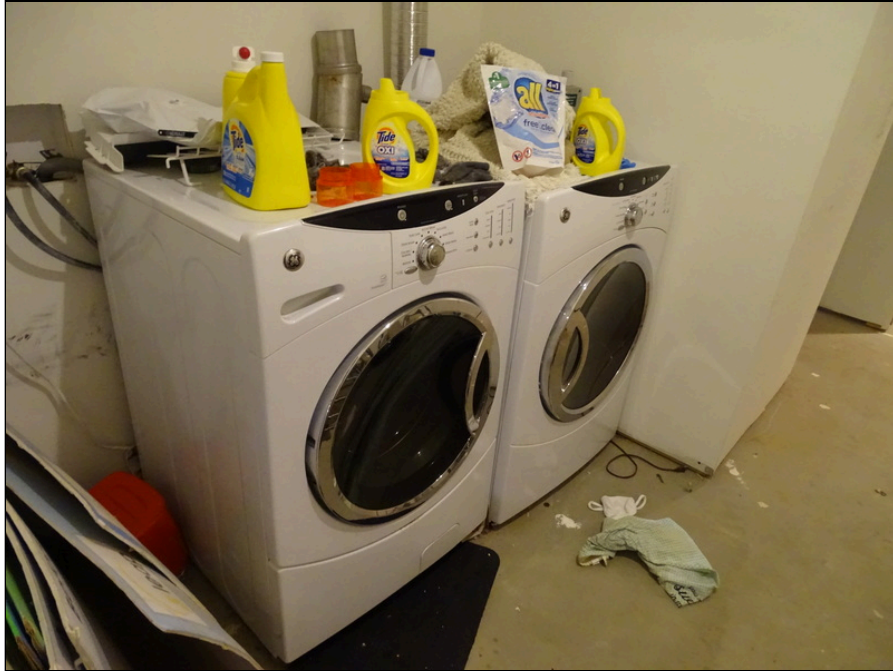
53 - Laundry area interior

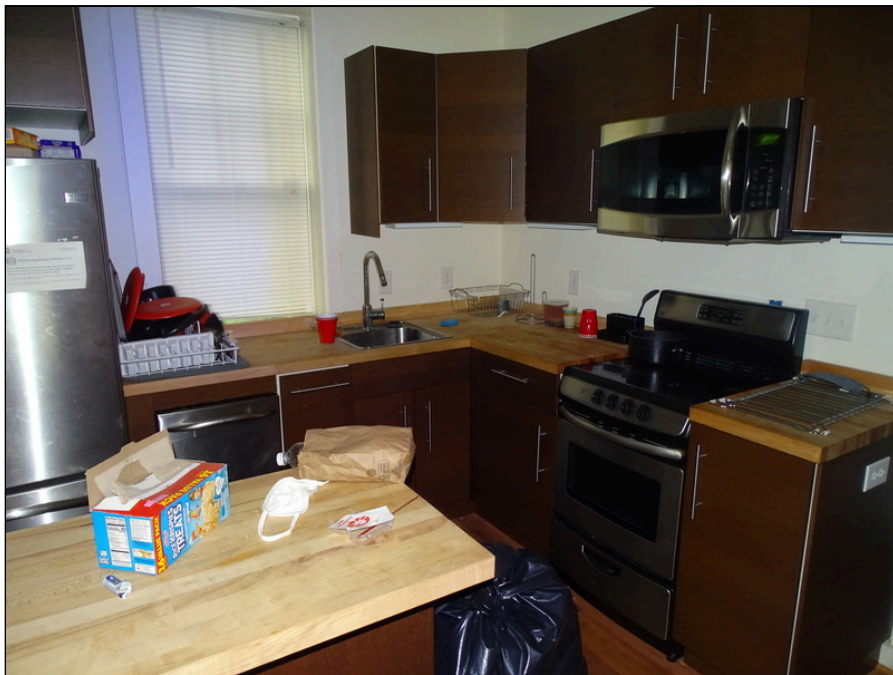
54 - Interior finishes kitchen area

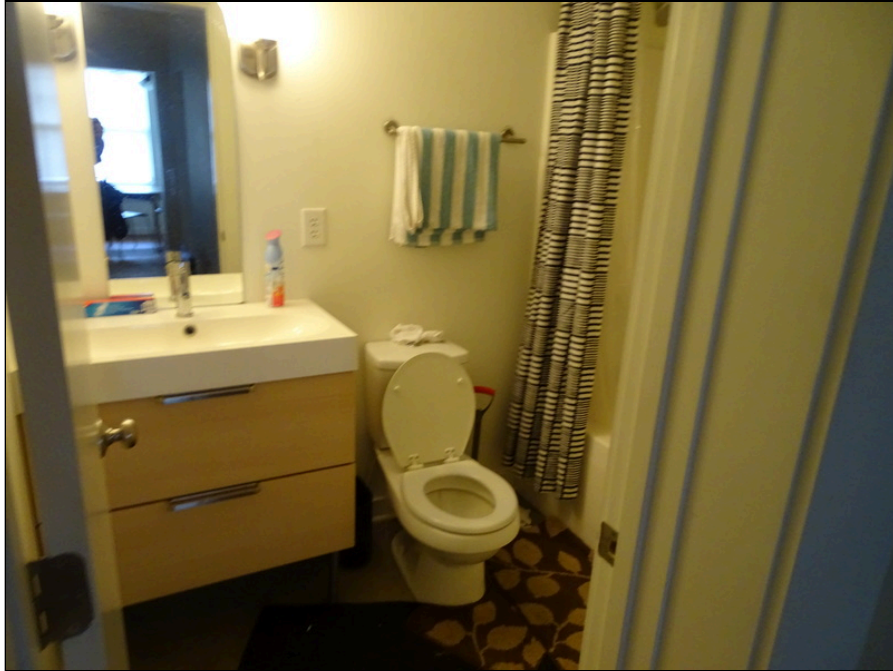
55 - Interior finishes restroom area
