VENABLE ELEMENTARY SCHOOL
406 14TH STREET NW
CHARLOTTESVILLE, VIRGINIA

ECS PROJECT NO. 46:6713

CITY OF CHARLOTTESVILLE - FACILITIES DEVELOPMENT

Reference: Facility Condition Assessment Report for Venable Elementary School, 406 14th Street NW, Charlottesville, Virginia

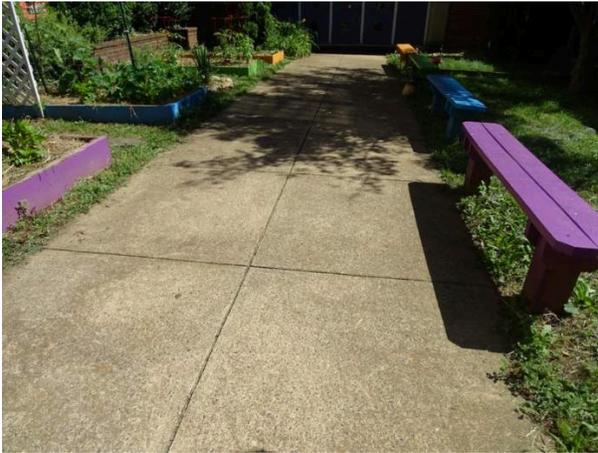
Typical concrete sidewalk

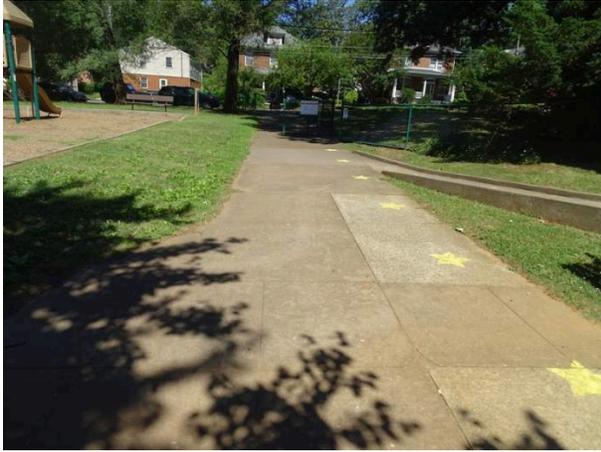
Typical concrete sidewalk

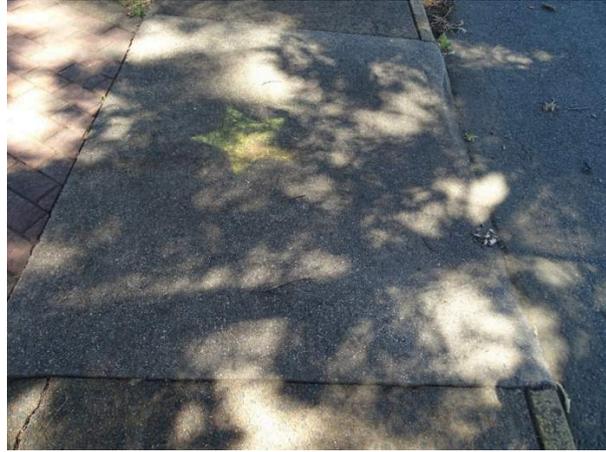
Curb ramp

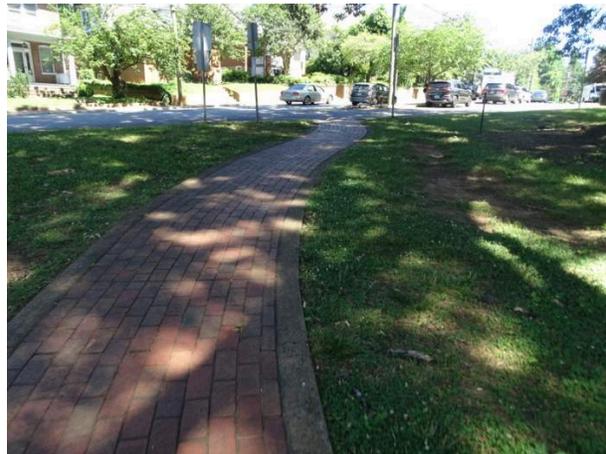
A brick paver sidewalk is located on the southwest side of the site. The brick paver sidewalk was in good condition.

Brick paver sidewalk

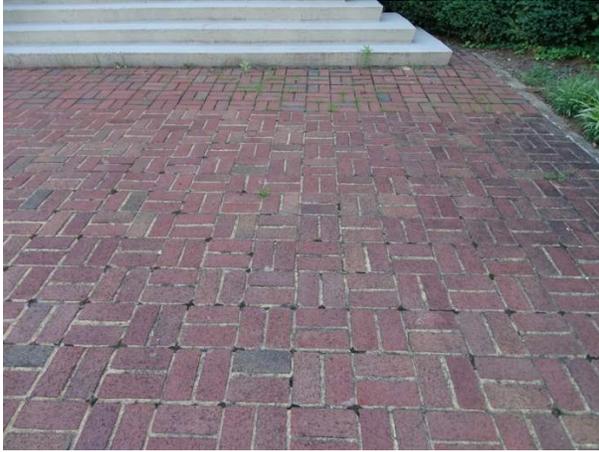
Brick paver sidewalk

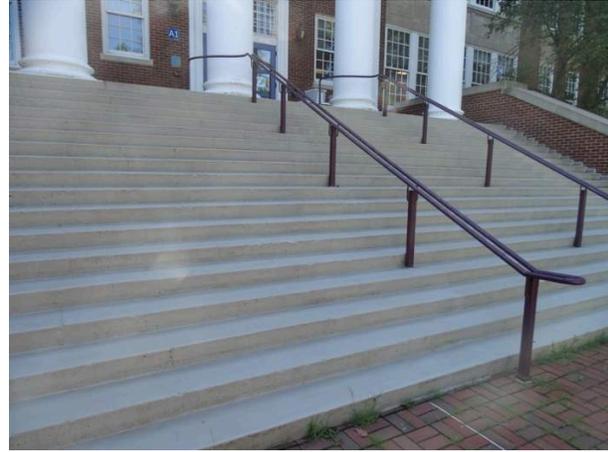
Concrete stairs at the west side of the building

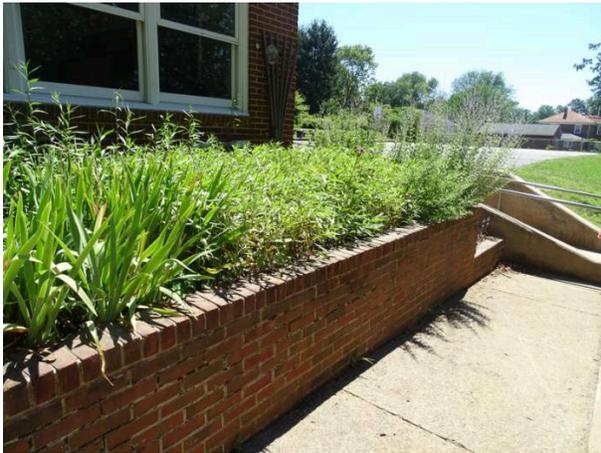
Typical landscaping

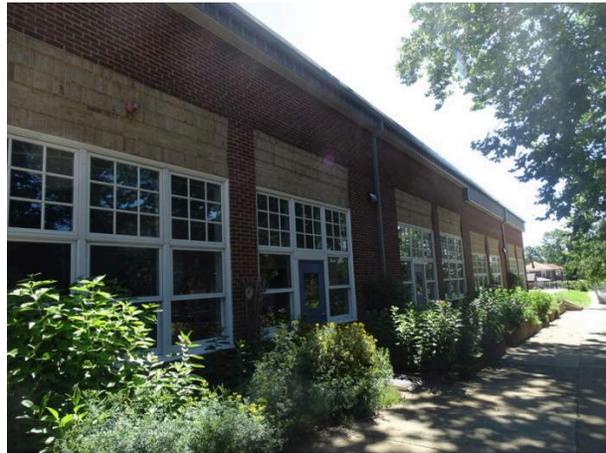
Typical landscape

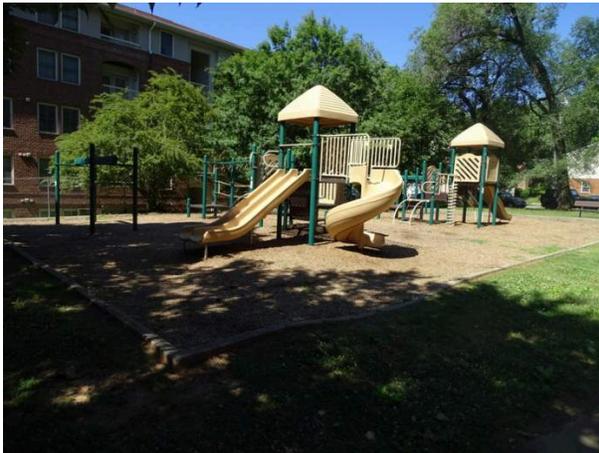
Playground at south end of site

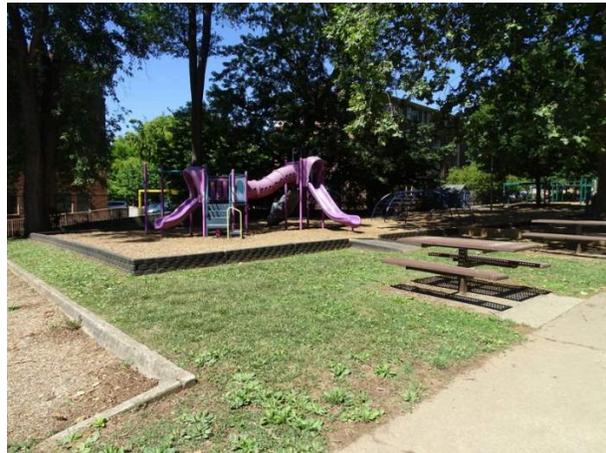
Playground at northeast end of site

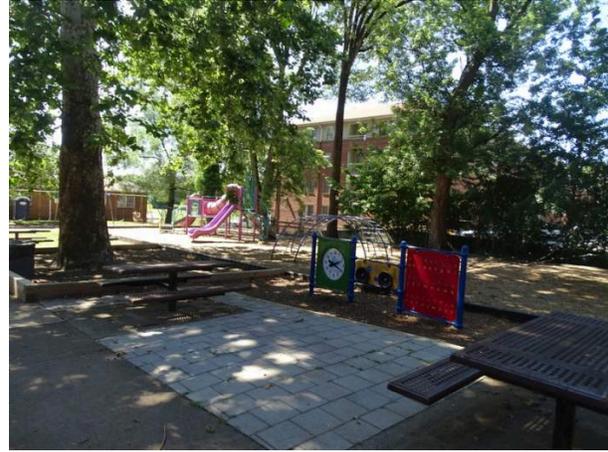
An asphalt play surface is located at the southeast side of the property. The surface was in generally fair condition with cracking and vegetative growth noted. We recommend the play surface is resurfaced during the report period.

Playground at southeast end of site

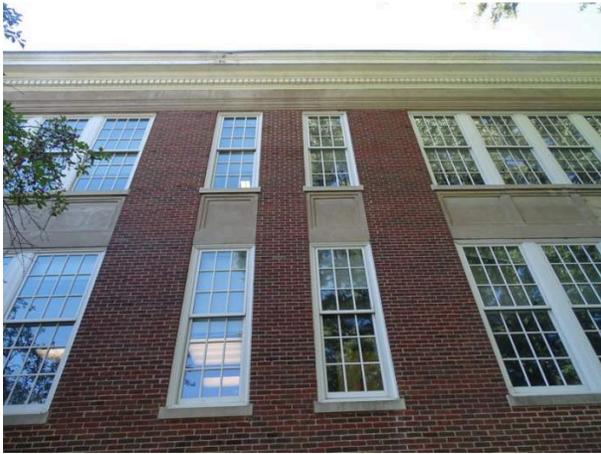
Building exterior west side of the building

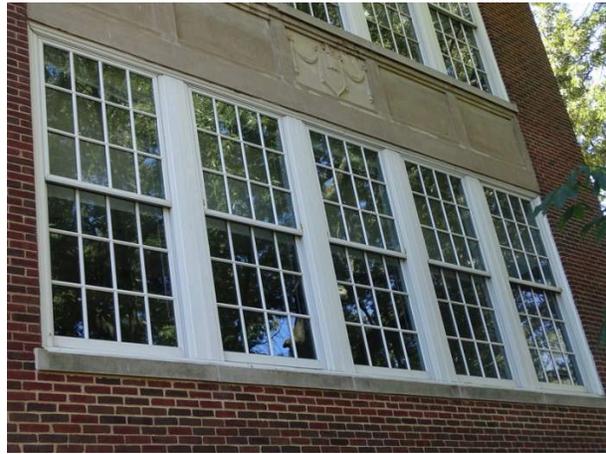
Building exterior south side of the building

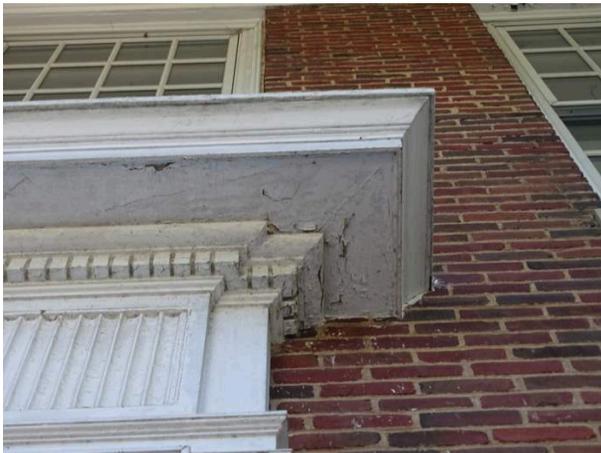
Building exterior - note rotten through cornice work

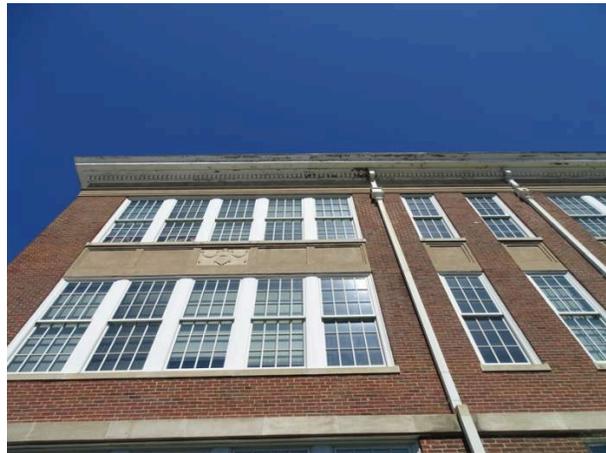
Building exterior - note rotten through cornice work

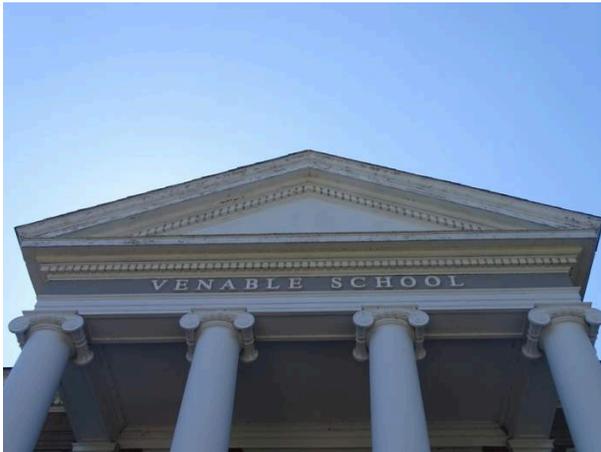
Building exterior - note peeling paint

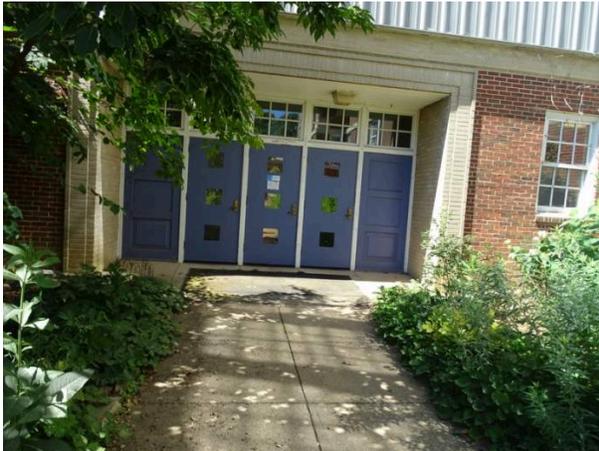
Main entrance doors at west side of the building

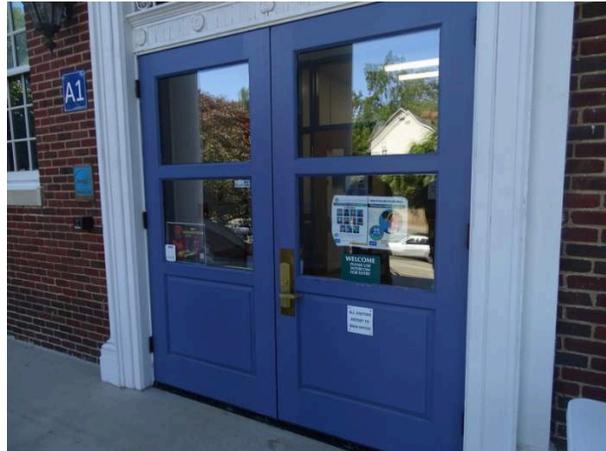
Entrance doors at north side of the building

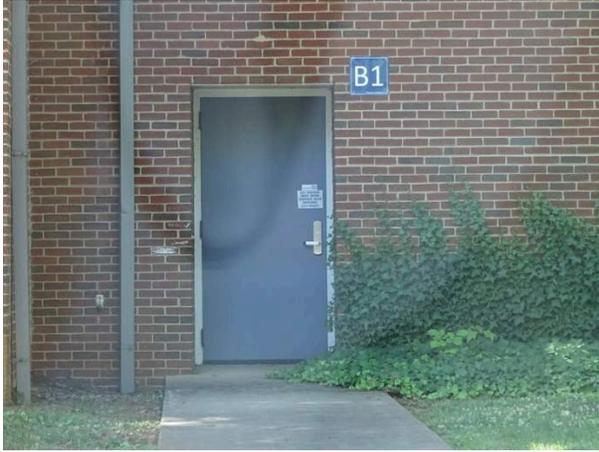
Typical personnel door

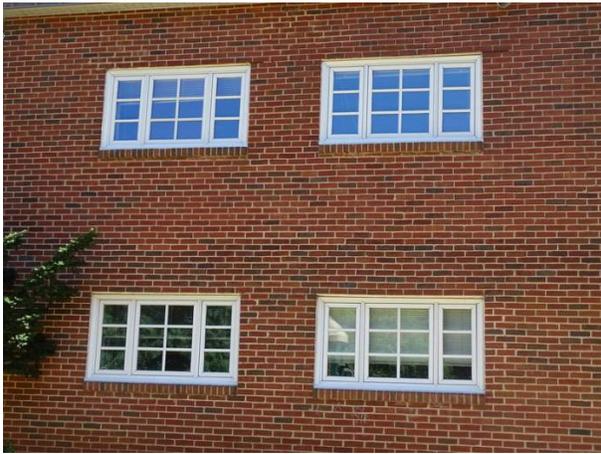
Typical exterior window

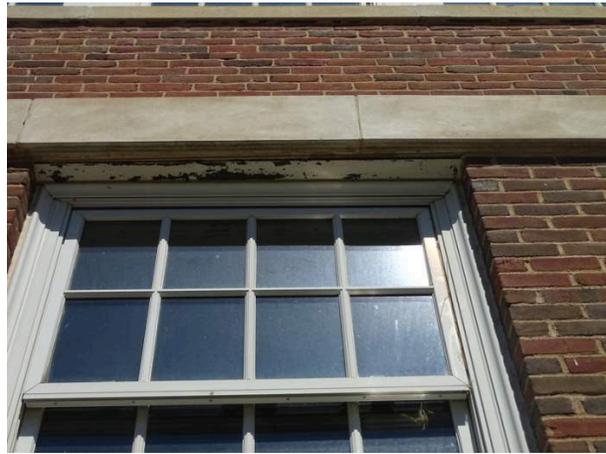
It was noted that the paint on the steel lintels was cracking and peeling. The steel lintels should be repainted with the wood trim noted above.

Typical exterior window - note peeling paint

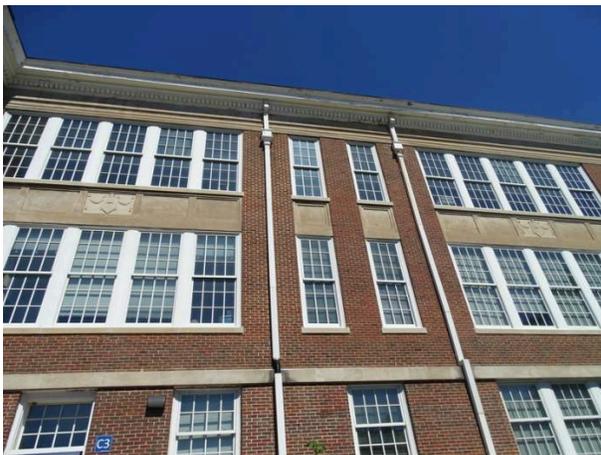
Typical exterior windows

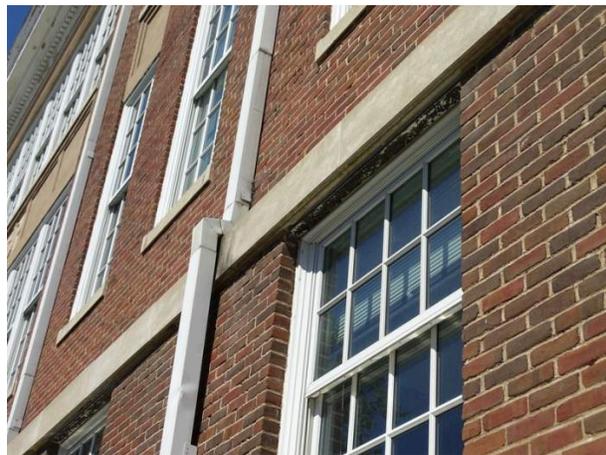
Typical exterior window - note peeling paint

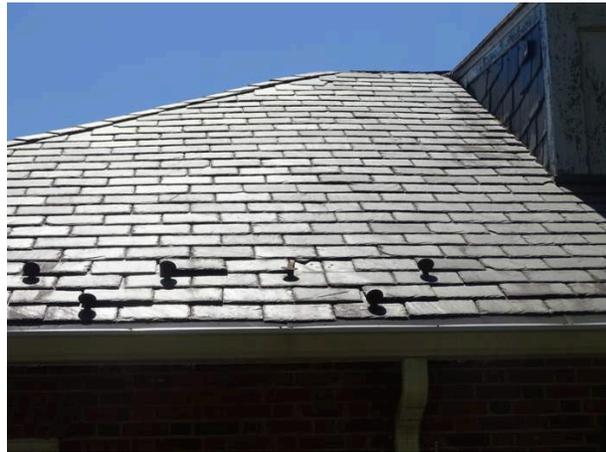
Slate shingle roofing system

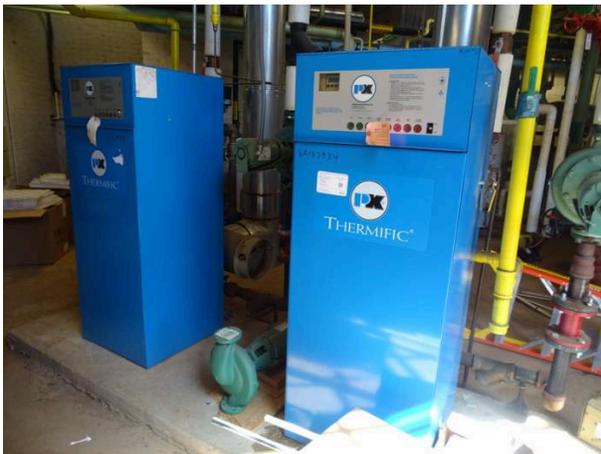
Boilers located in main utility room

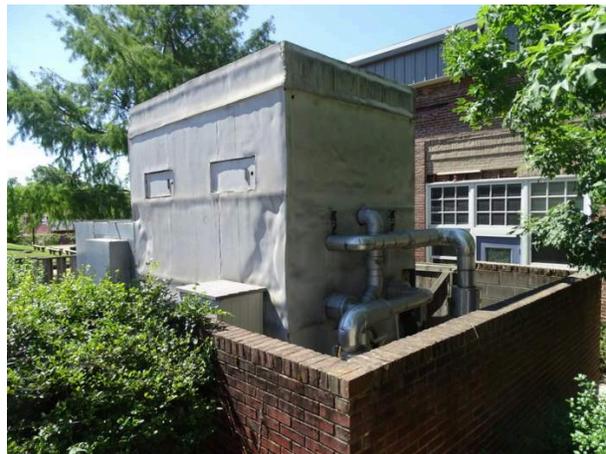
Cooling tower located on east side of the building

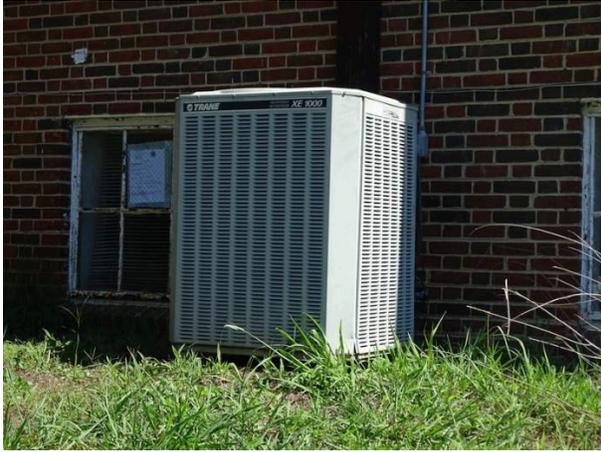
Condenser unit at annex

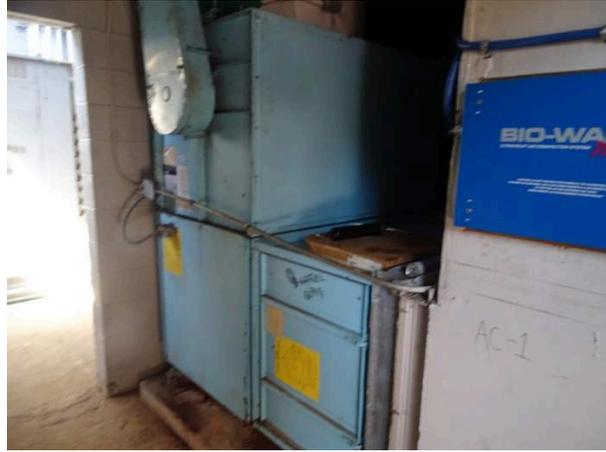
Air Handler Unit located in main utility room

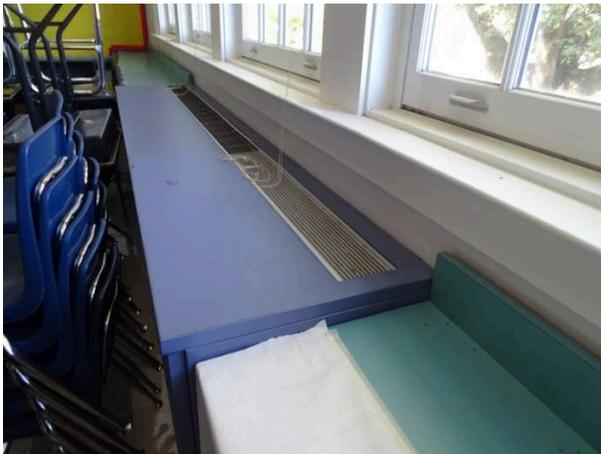
Typical older Water Source Heat Pump

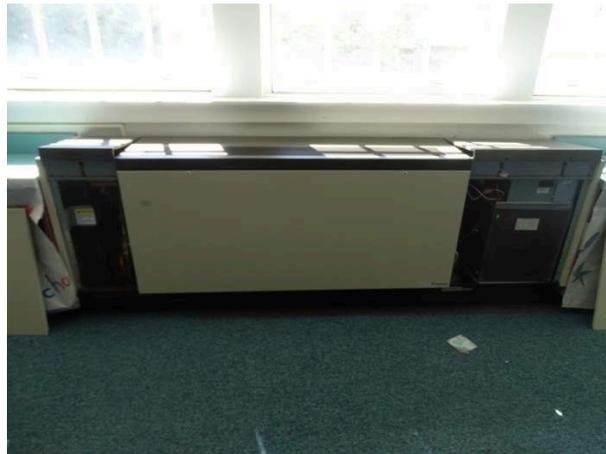
Typical newer Water Source Heat Pump

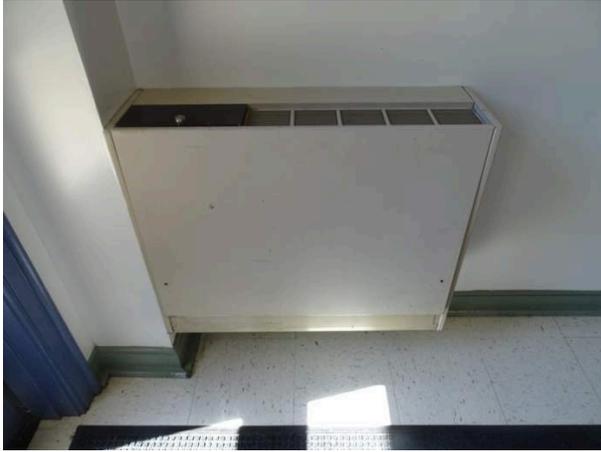
Typical newer Water Source Heat Pump

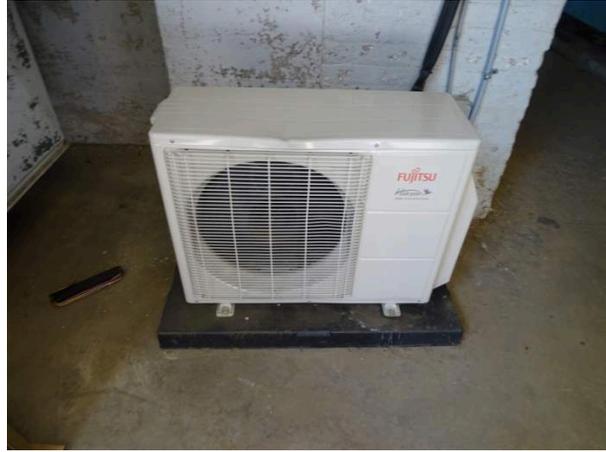
Split system located in main utility room

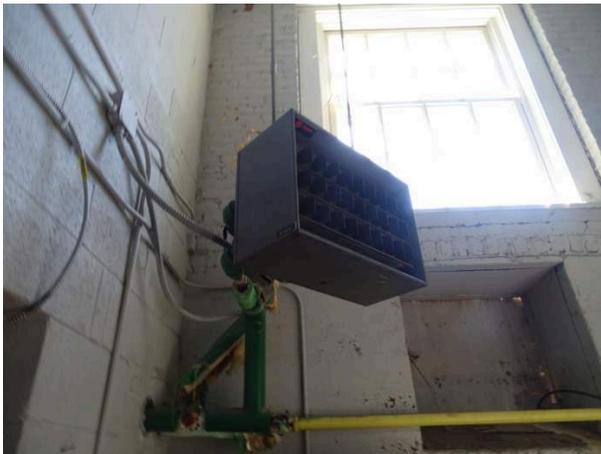
Space heater located in main utility room

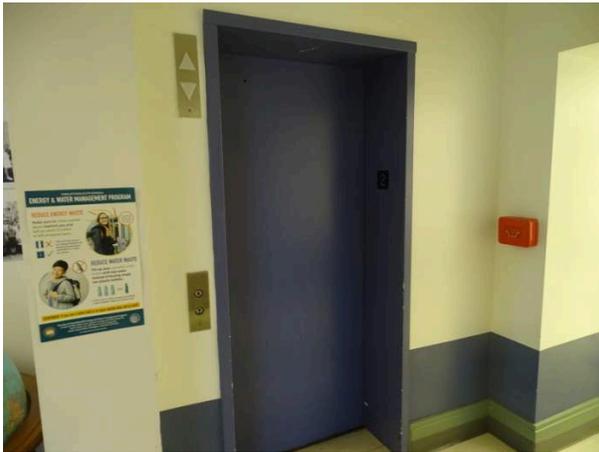
Elevator located at center of building

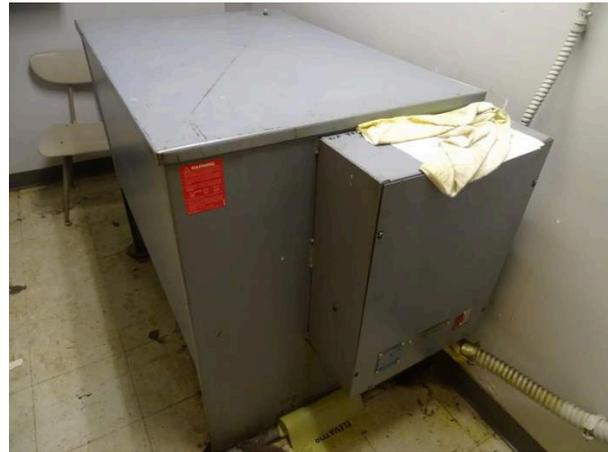
Elevator machine and controls

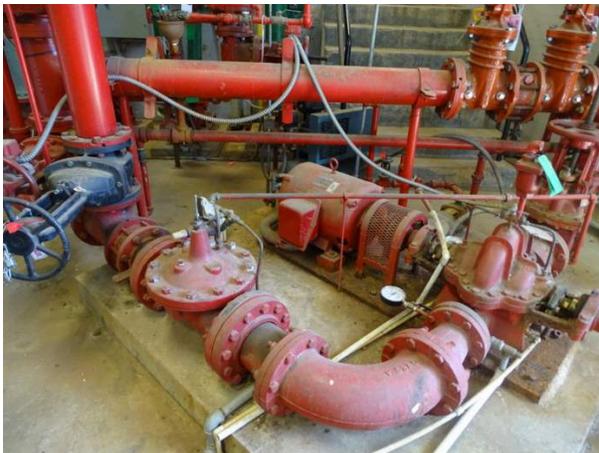
Fire sprinkler system

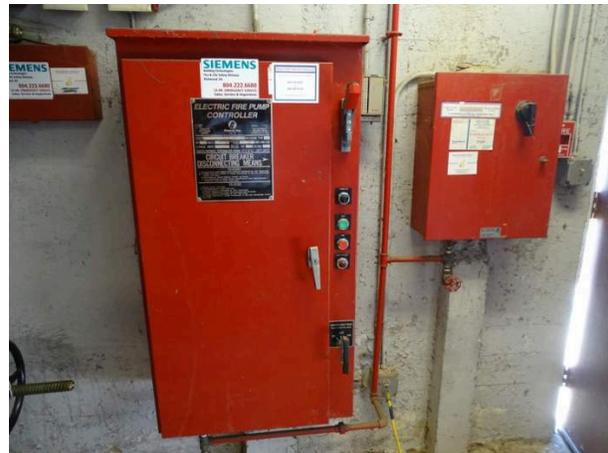
Fire sprinkler pump controller

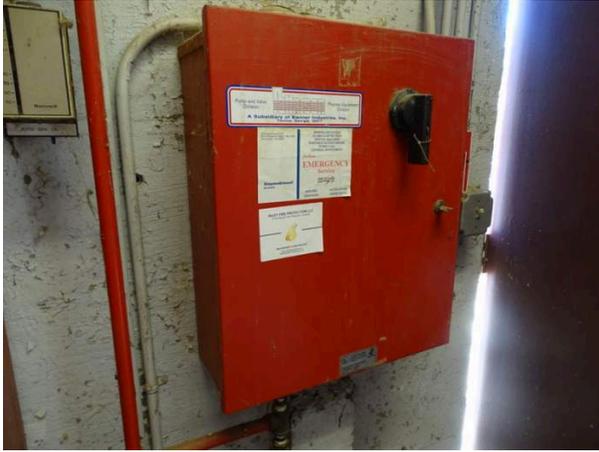
Fire sprinkler pump controller

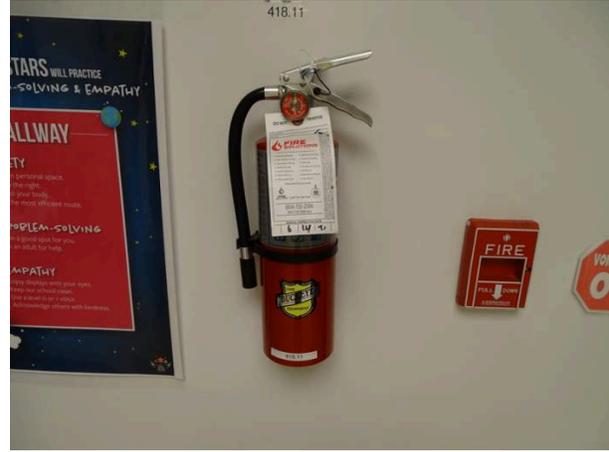
Typical fire extinguisher

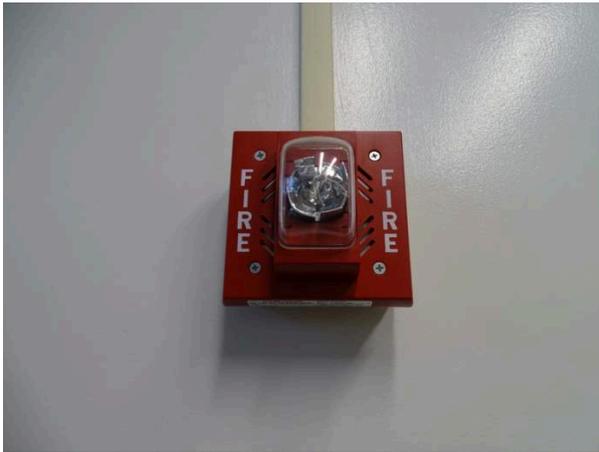
Typical fire alarm bell and strobe

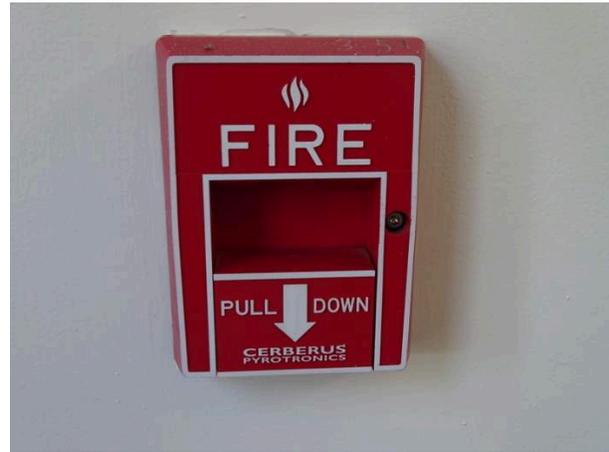
Typical fire alarm pull station

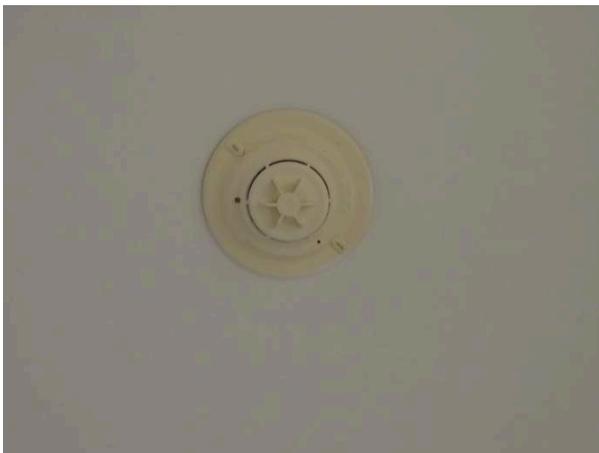
Typical smoke detector

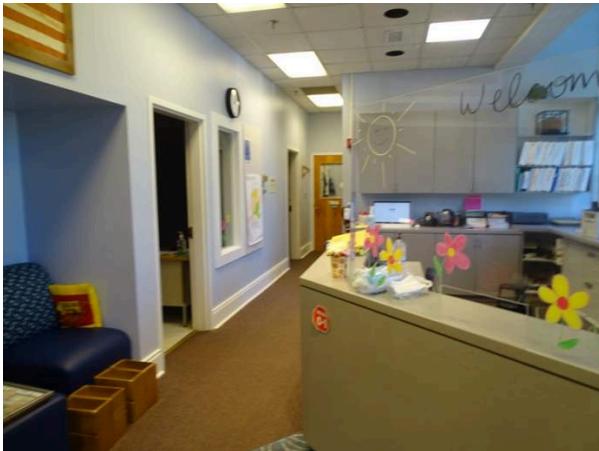
Interior finishes main office area

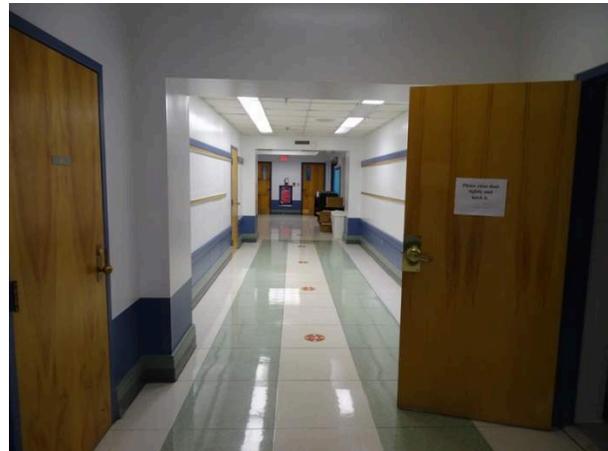
Interior finishes corridor area

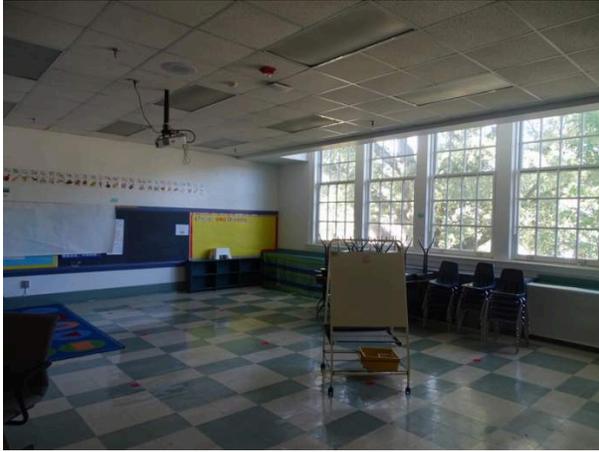
Interior finishes classroom area

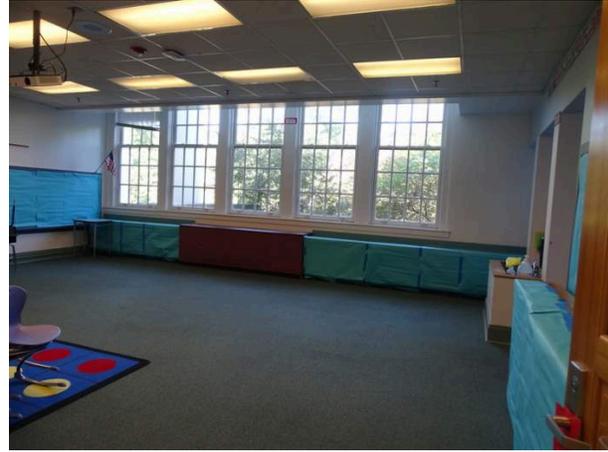
Interior finishes classroom area

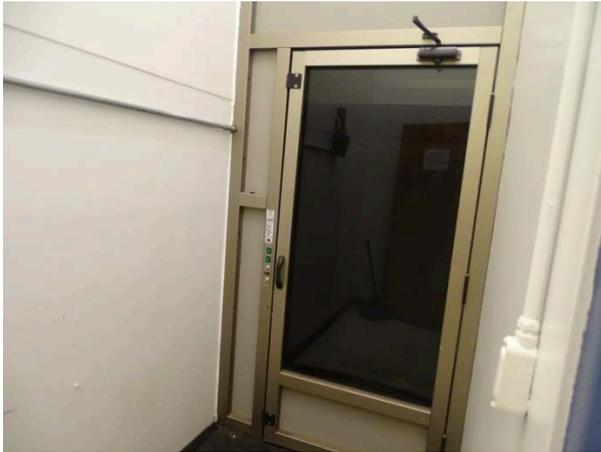
Accessible lift

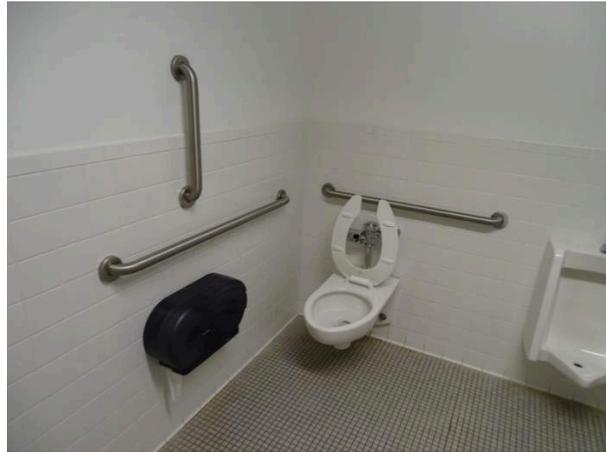
Accessible restroom

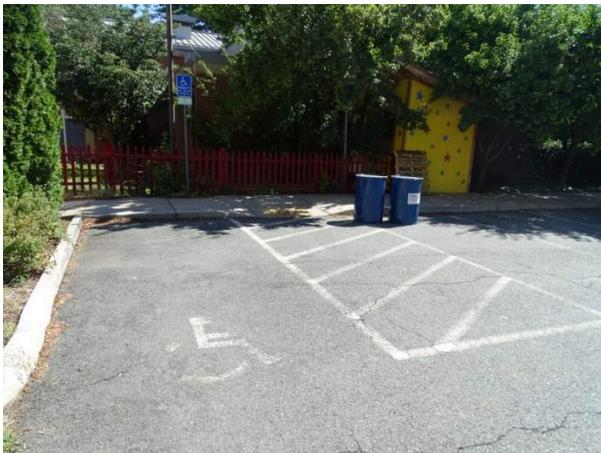
Accessible parking space

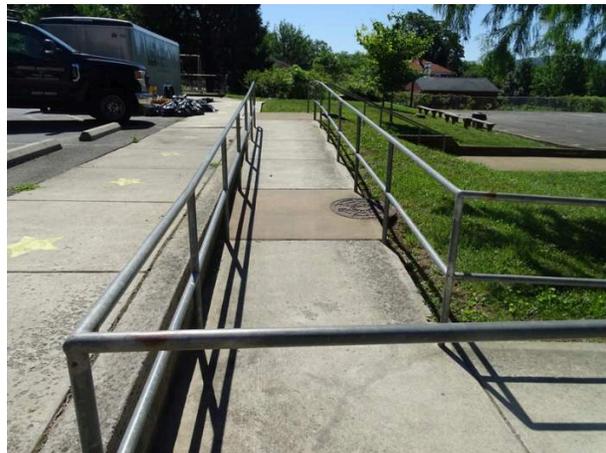
Accessible ramp at south end the site

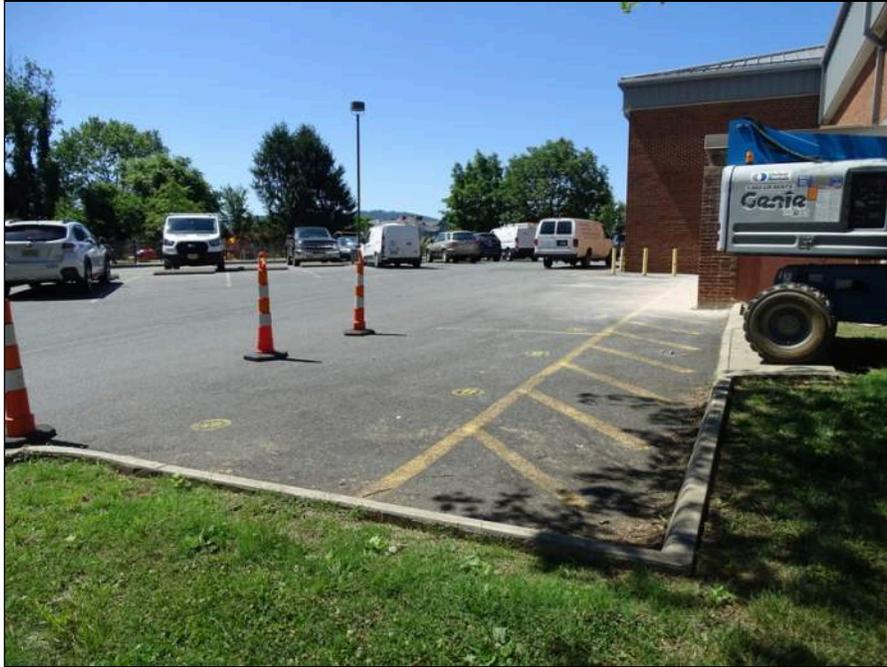
3 - Asphalt pavement west side looking south

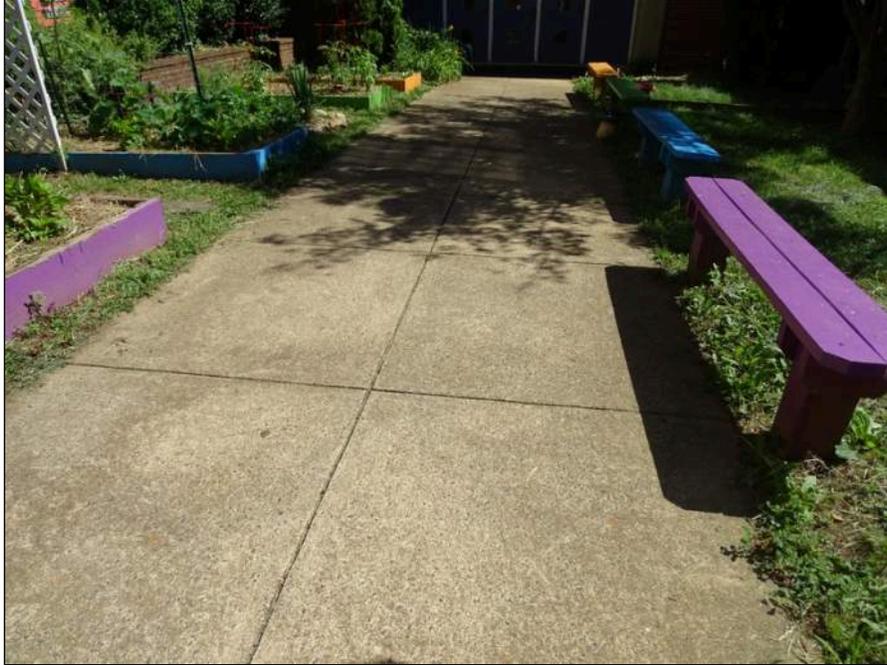
7 - Typical concrete sidewalk

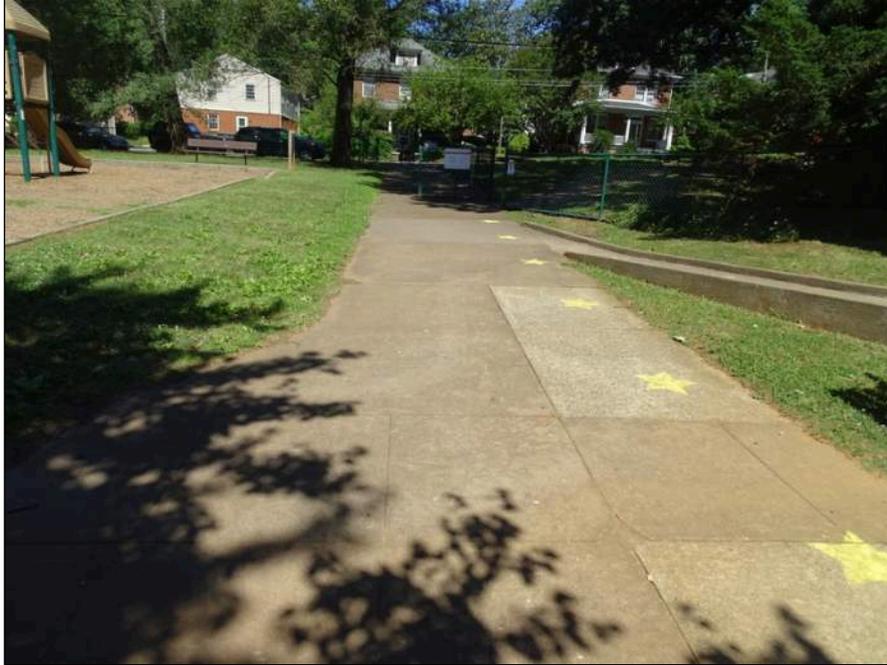
9 - Typical concrete sidewalk

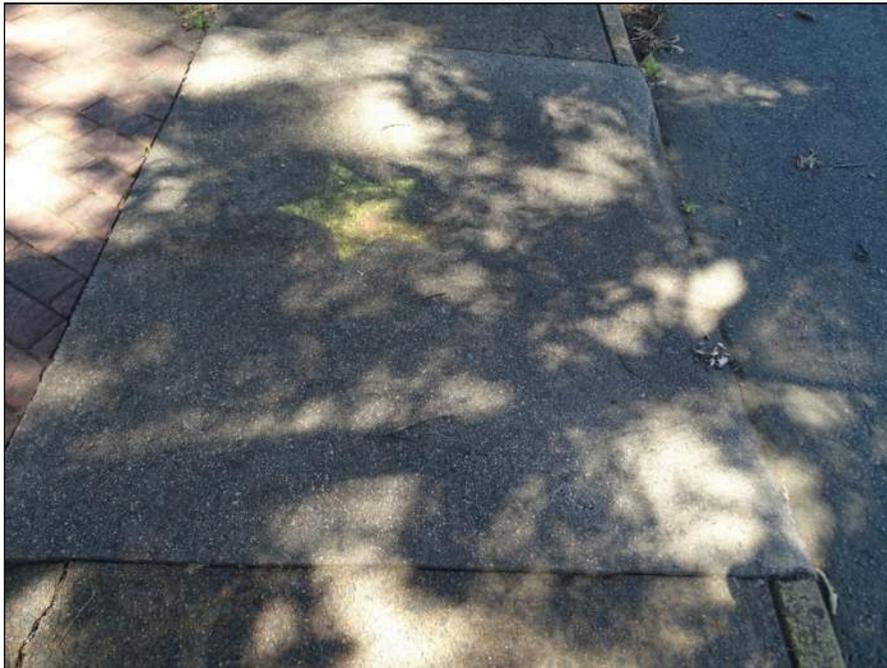
10 - Curb ramp

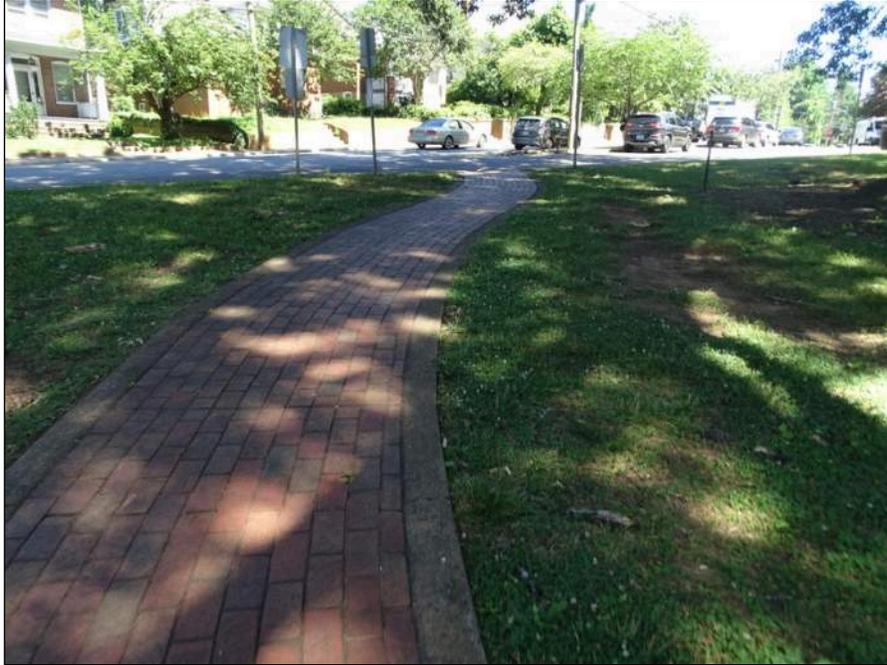
13 - Brick paver sidewalk

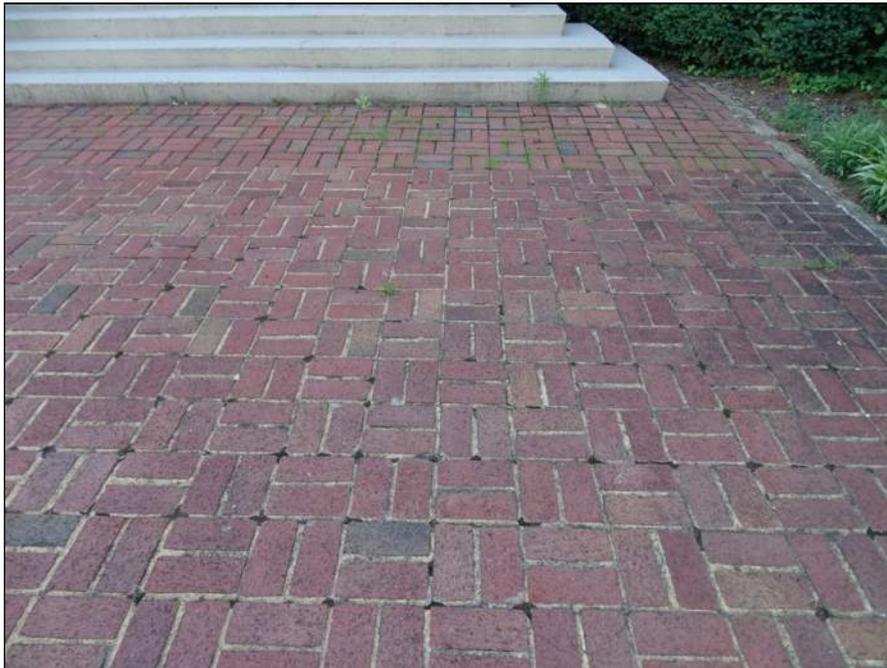
14 - Brick paver sidewalk

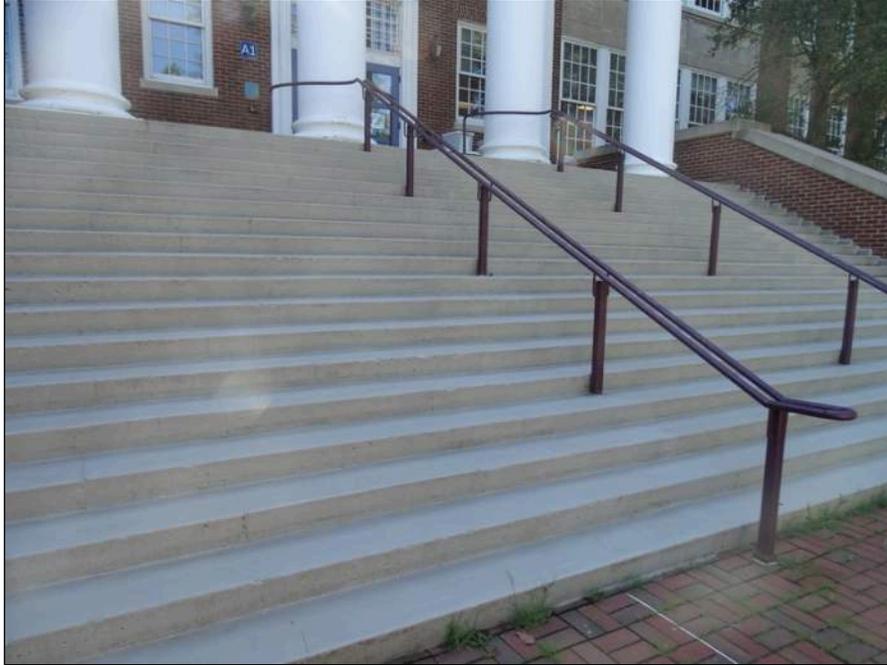
15 - Concrete stairs at the west side of the building

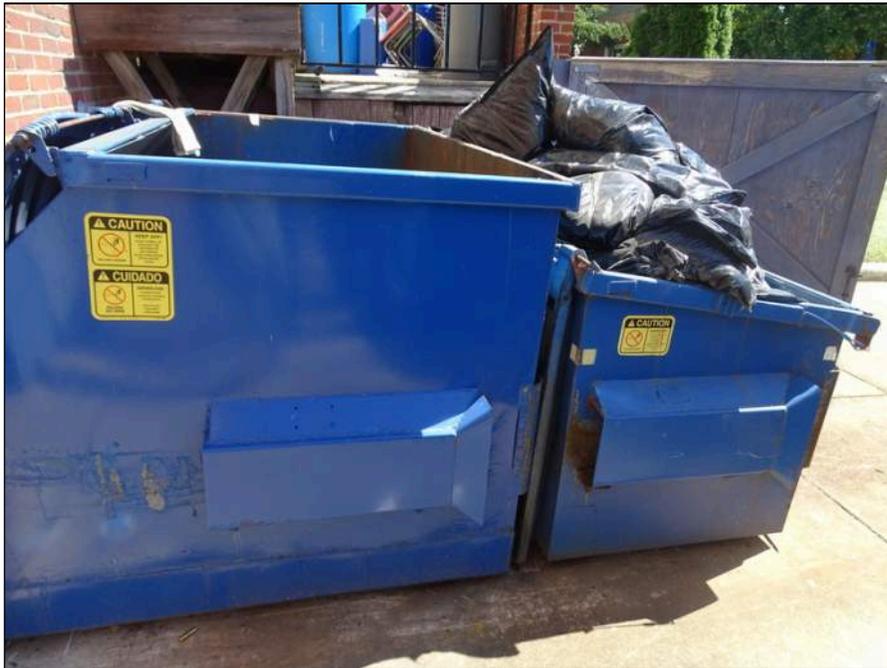
18 - Dumpster area

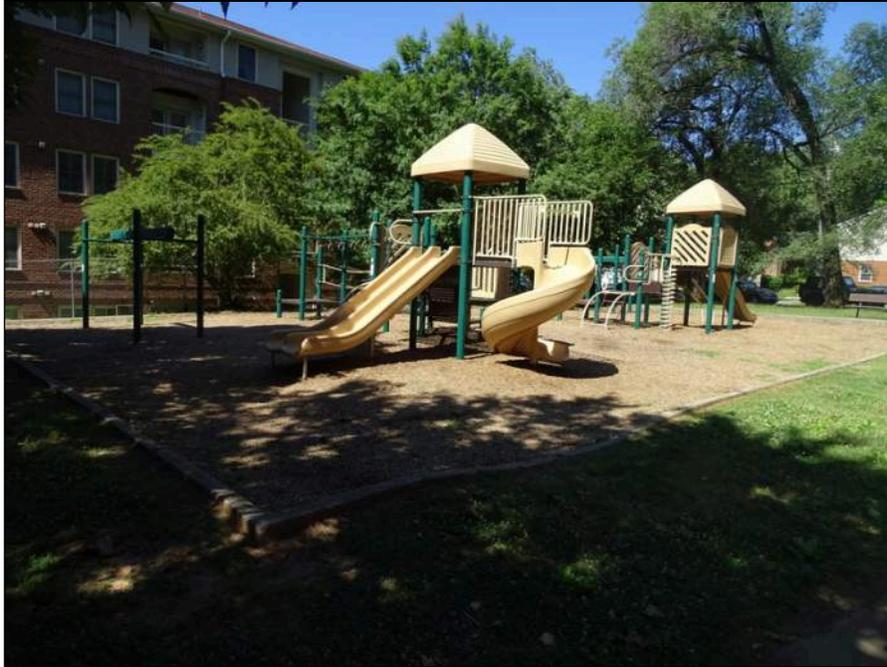
19 - Playground at south end of site

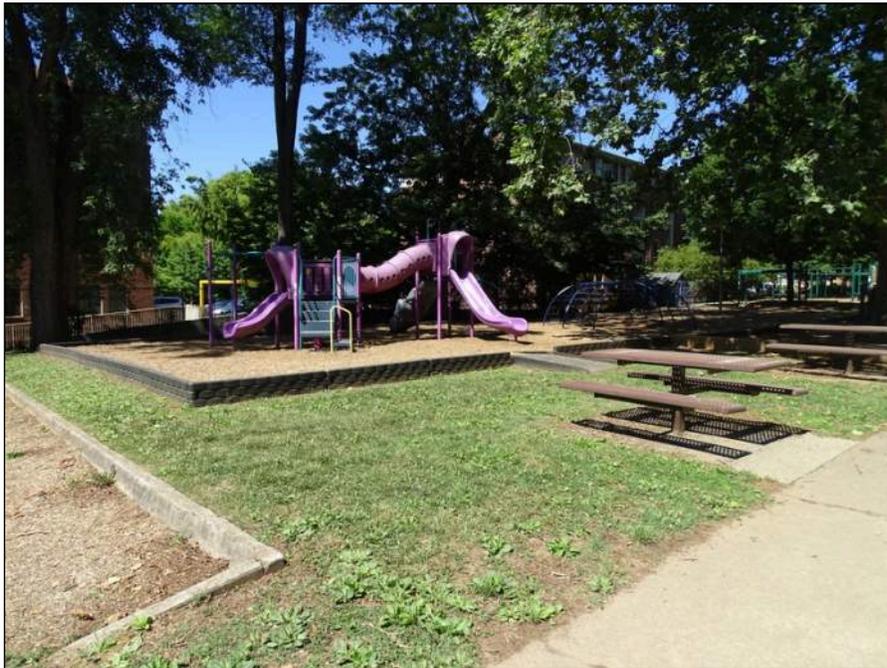
20 - Playground at northeast end of site

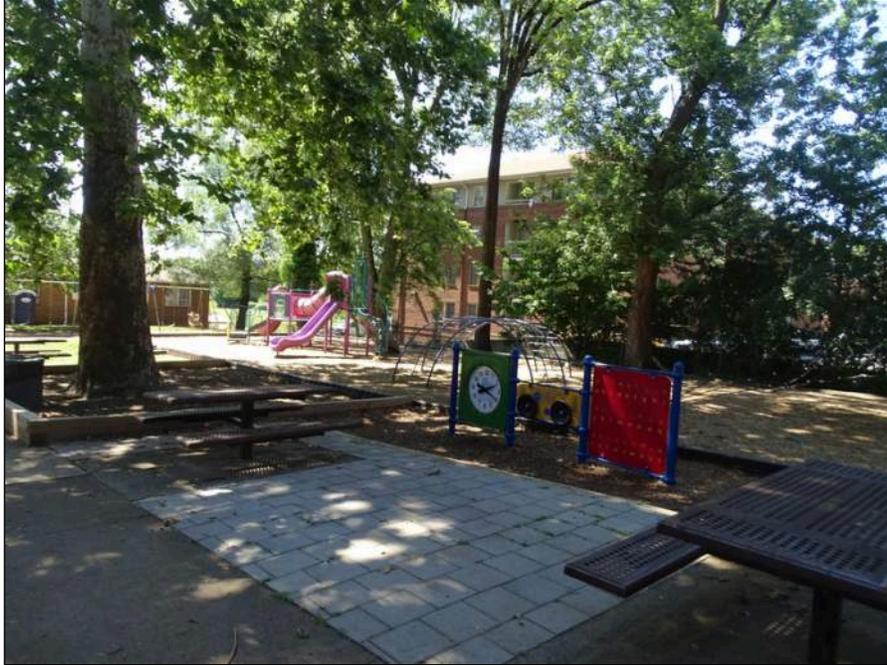
21 - Playground at southeast end of site

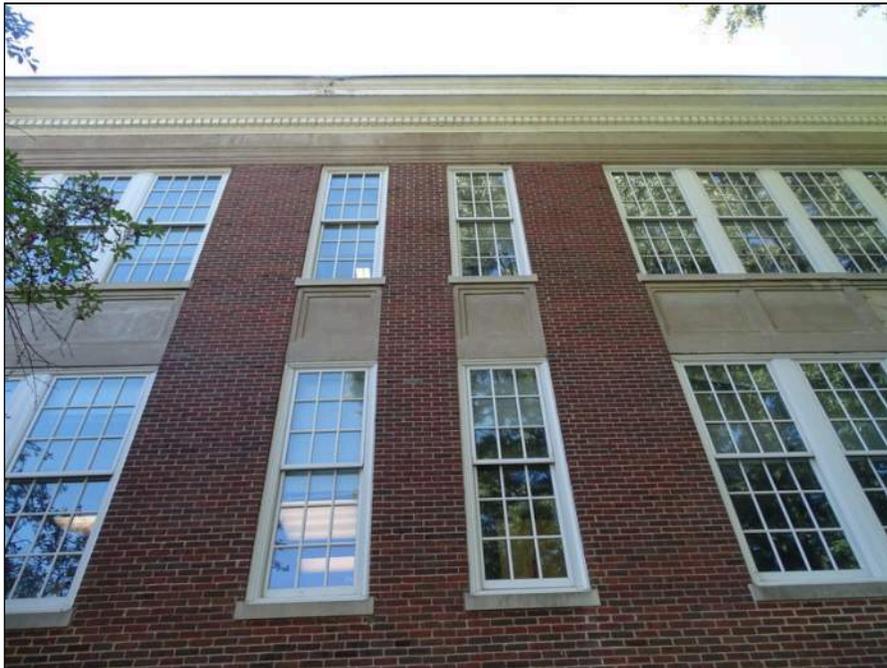
22 - Building exterior west side of the building

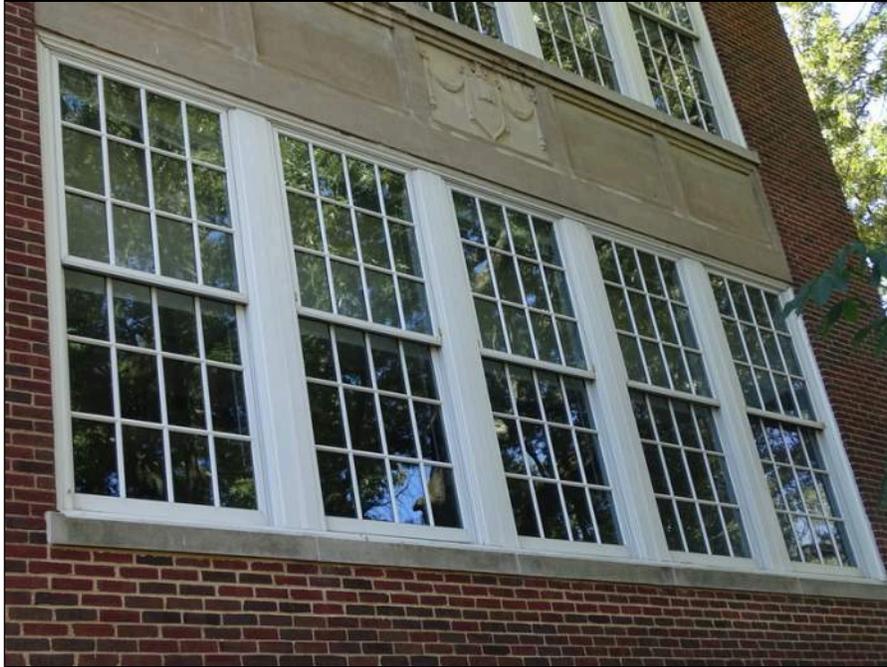
23 - Building exterior south side of the building

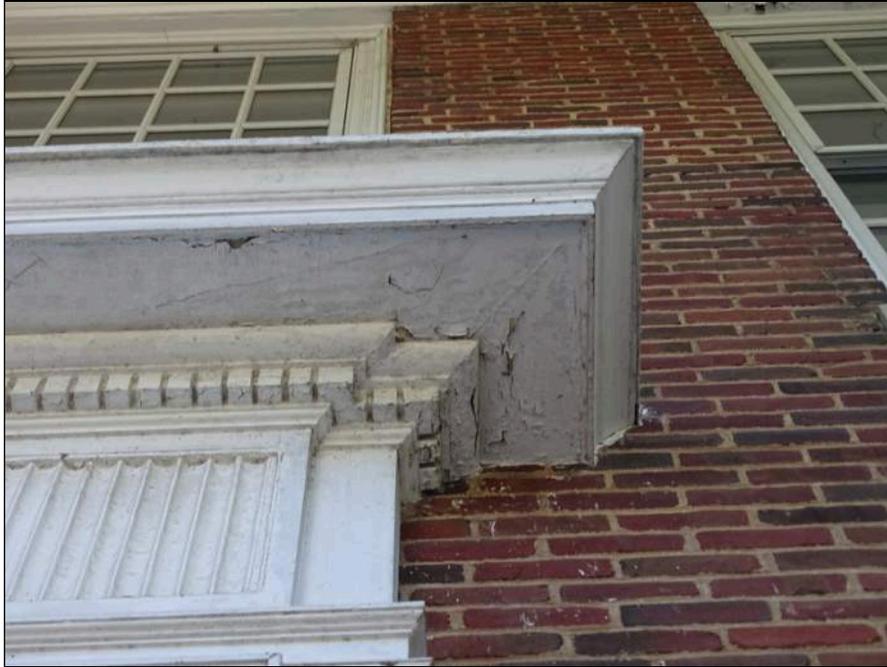
25 - Building exterior - note rotten through cornice work

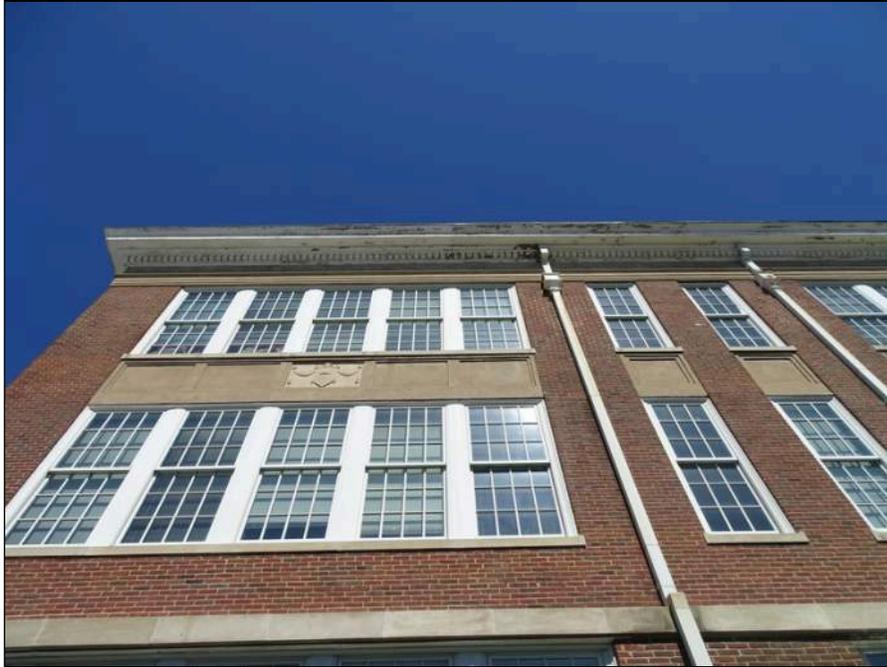
29 - Building exterior - note rotten through cornice work
