VENABLE ELEMENTARY SCHOOL
406 14TH STREET NW
CHARLOTTESVILLE, VIRGINIA

ECS PROJECT NO. 46:6713

CITY OF CHARLOTTESVILLE - FACILITIES DEVELOPMENT

Reference: Facility Condition Assessment Report for Venable Elementary School, 406 14th Street NW, Charlottesville, Virginia

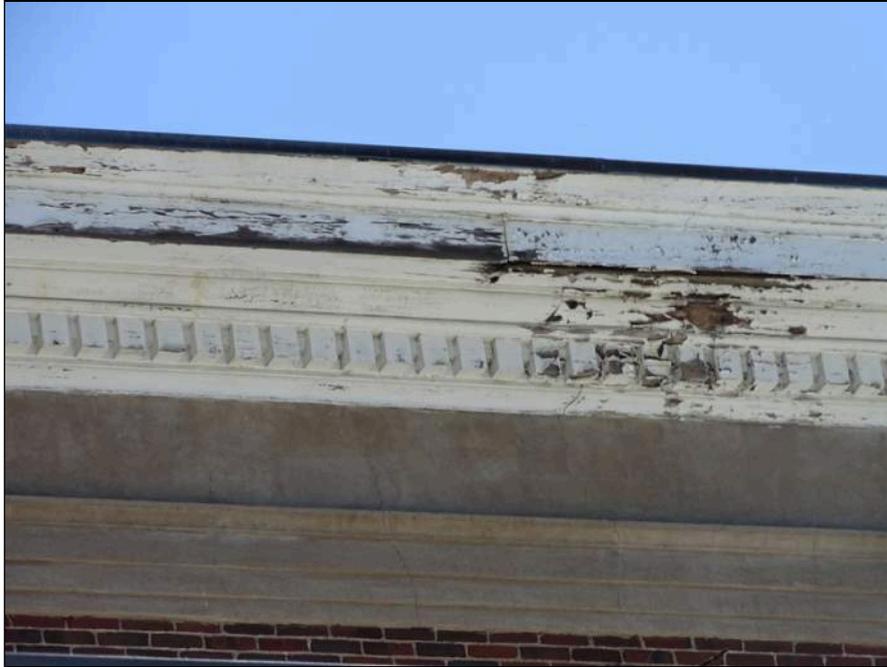
33 - Building exterior - note rotten through cornice work

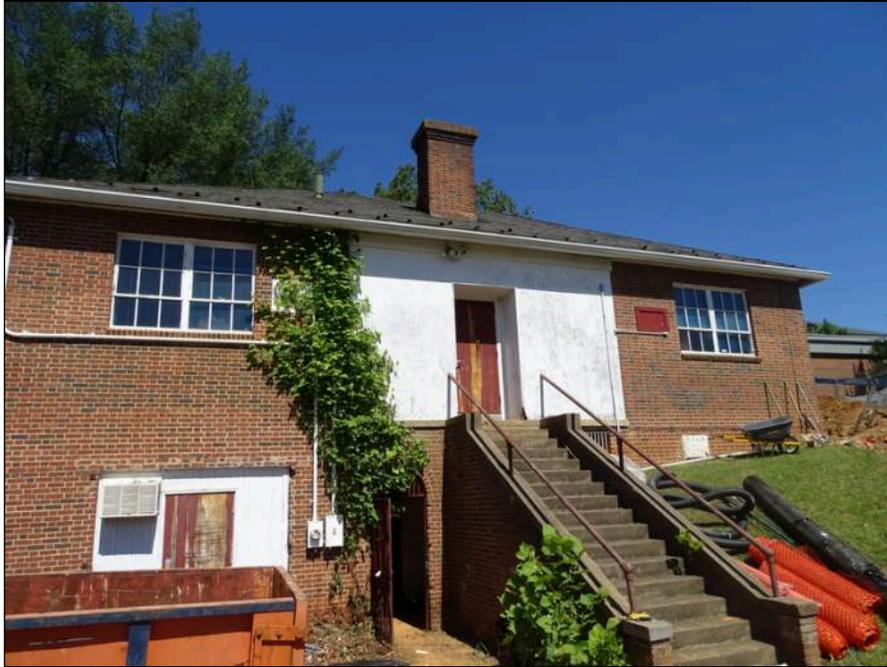
35 - Venable annex building exterior

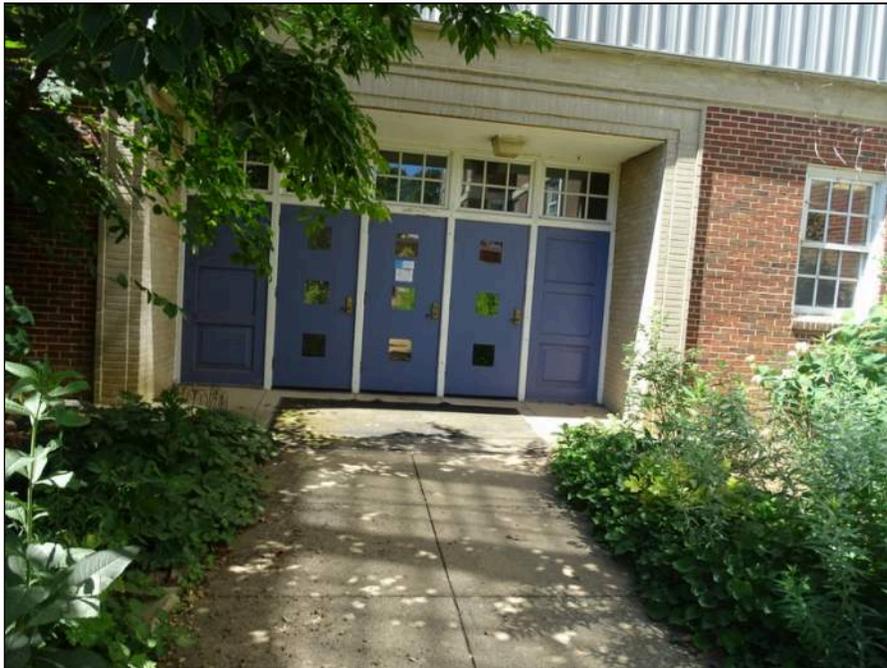
36 - Main entrance doors at west side of the building

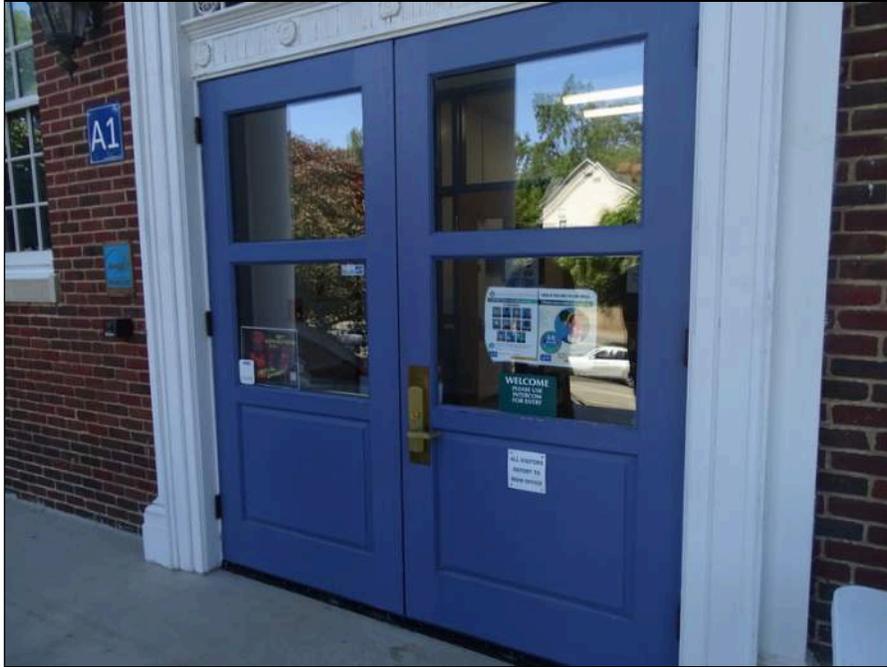
37 - Entrance doors at north side of the building

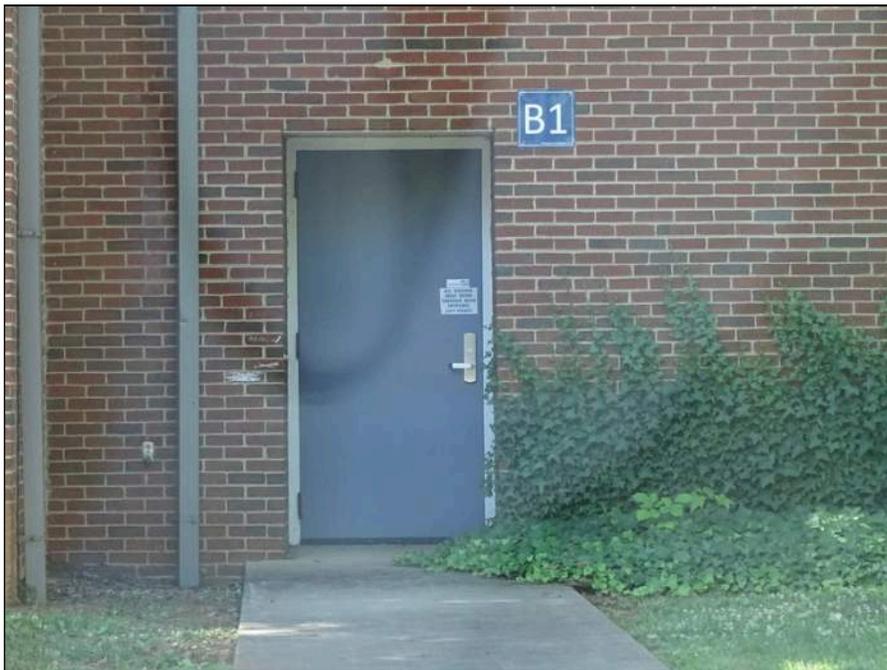
38 - Typical personnel door

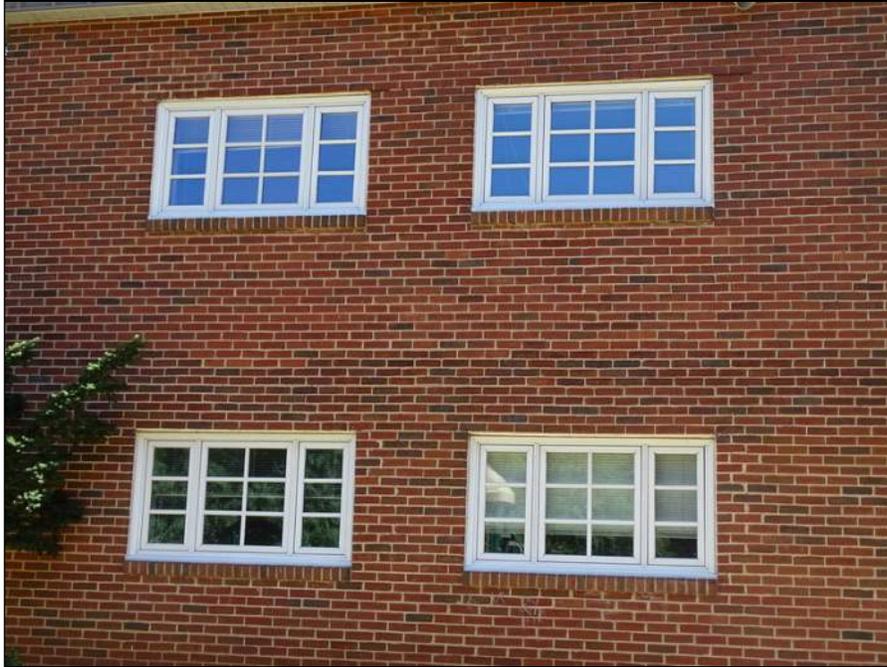
39 - Typical exterior window

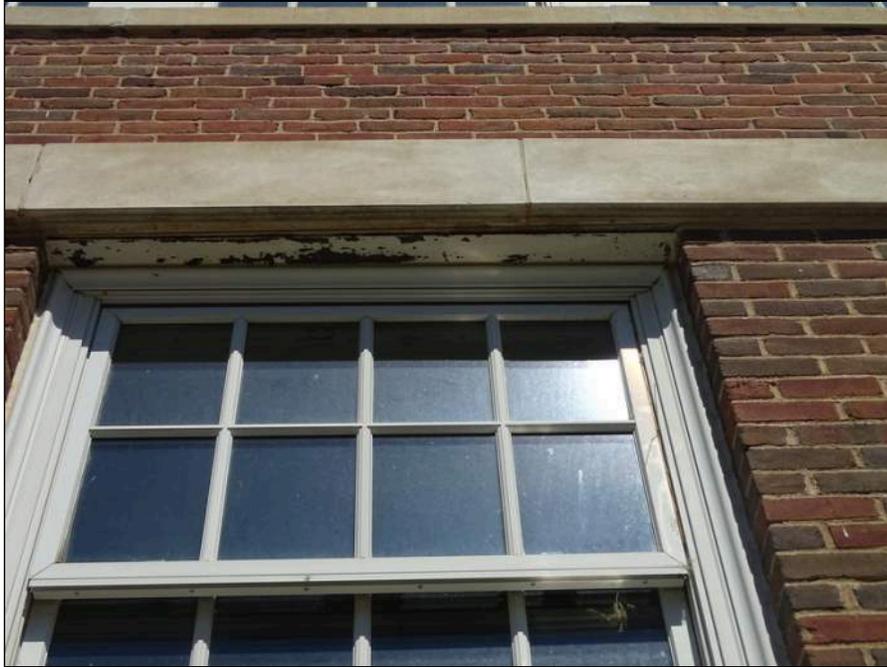
41 - Typical exterior window - note peeling paint

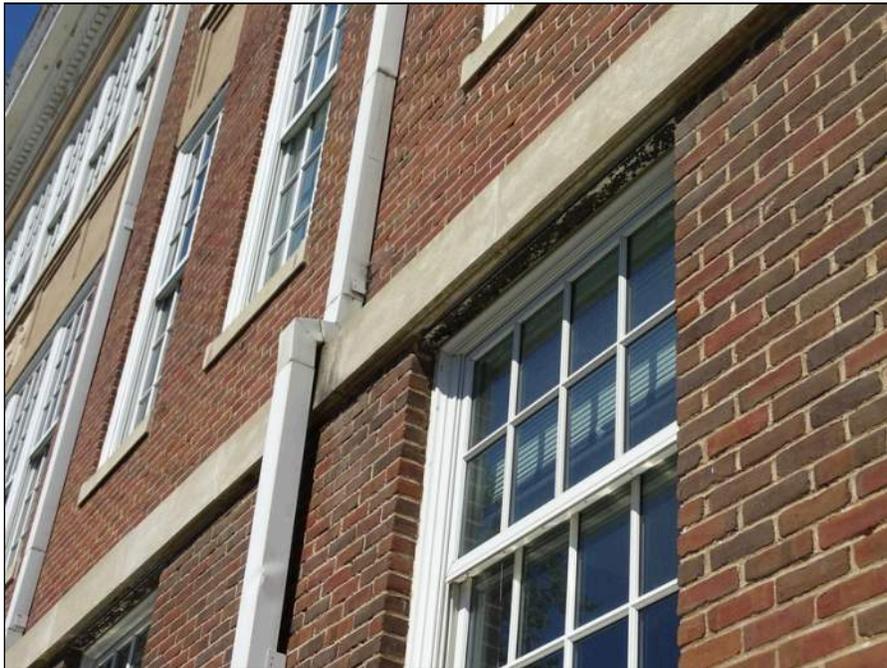
42 - Typical exterior window - note peeling paint

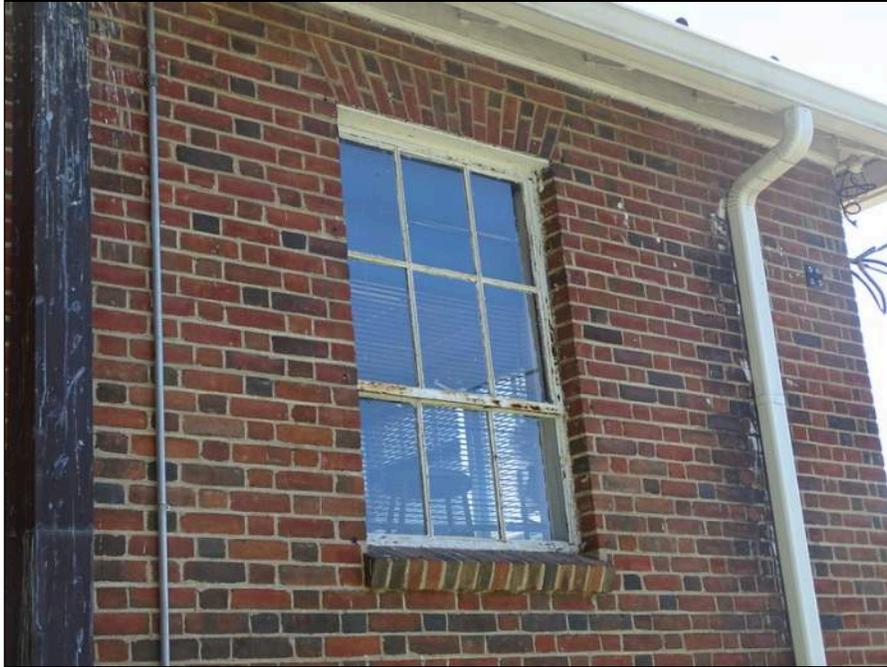
43 - Typical exterior window - note peeling paint

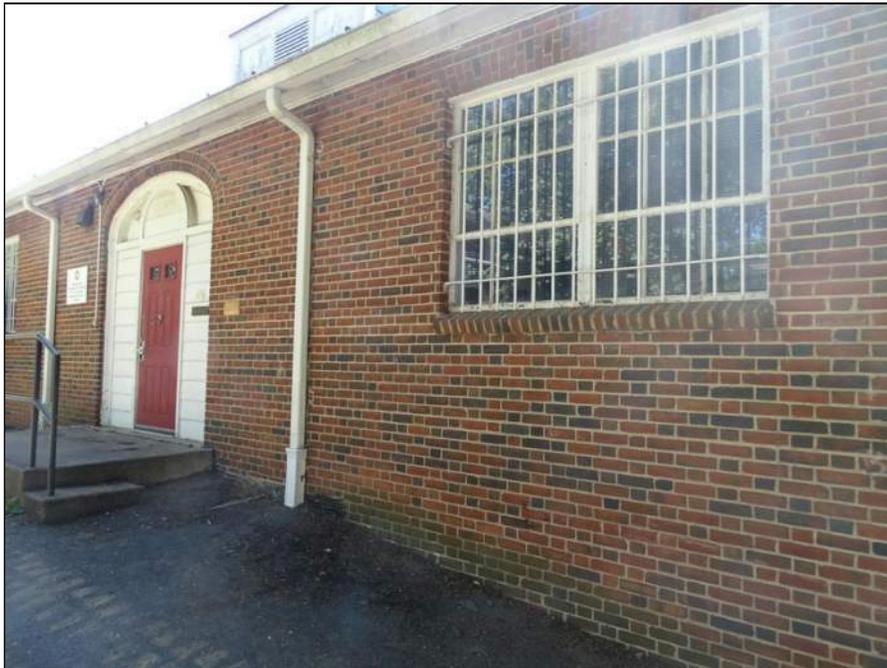
44 - Typical exterior window security fence - note peeling paint

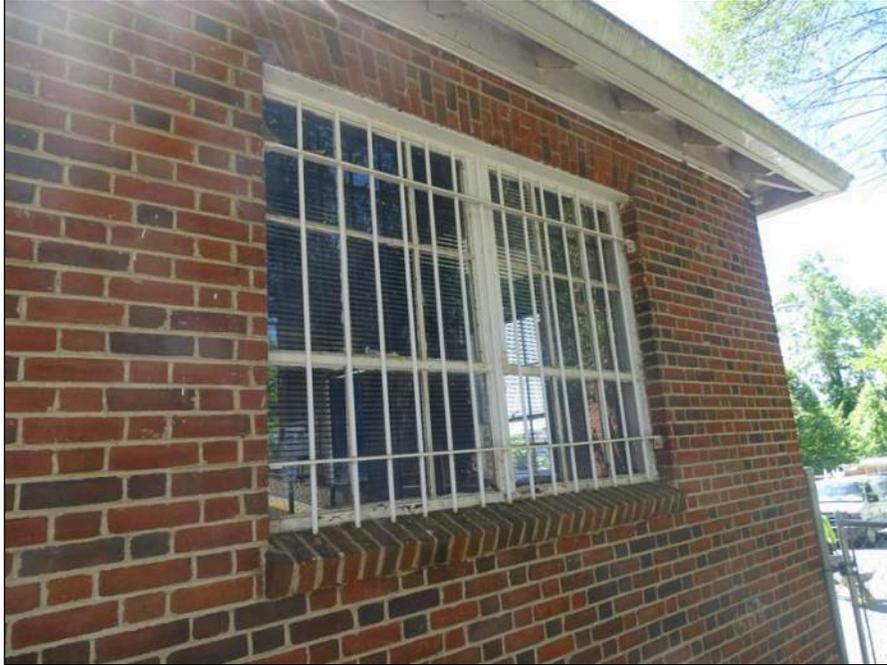
45 - Typical exterior window security fence - note peeling paint

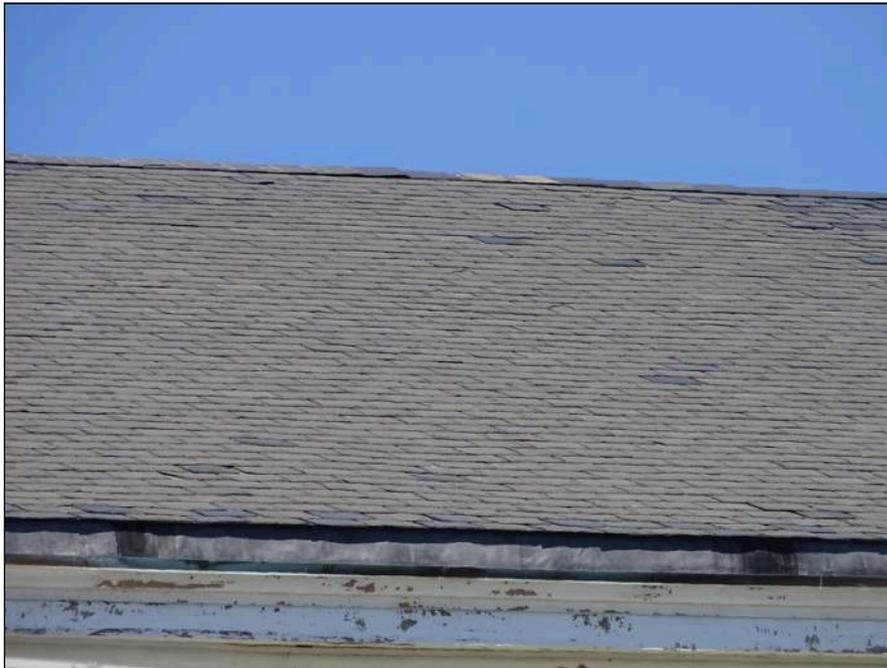
46 - Slate shingle roofing system

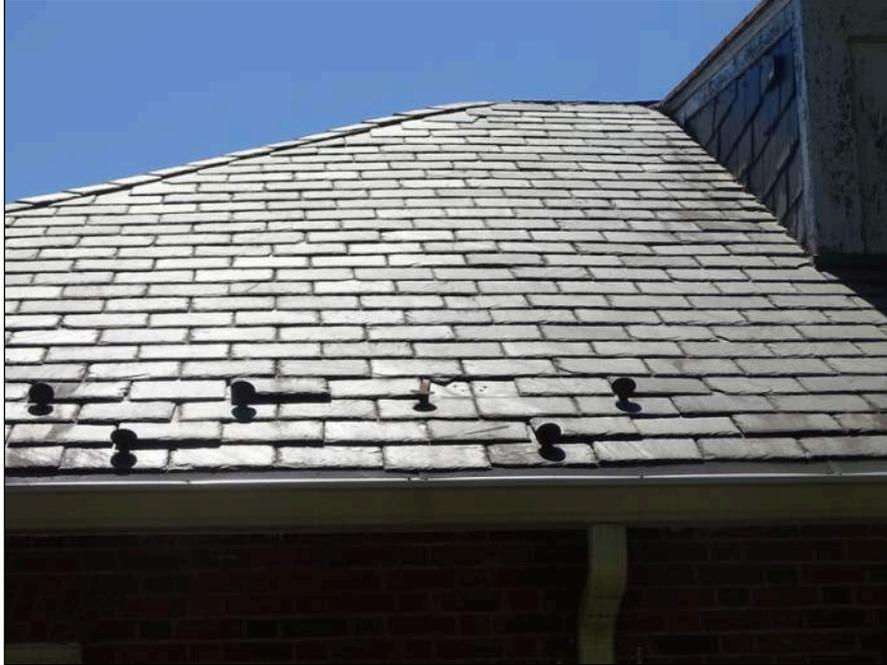
47 - Slate shingle roofing system

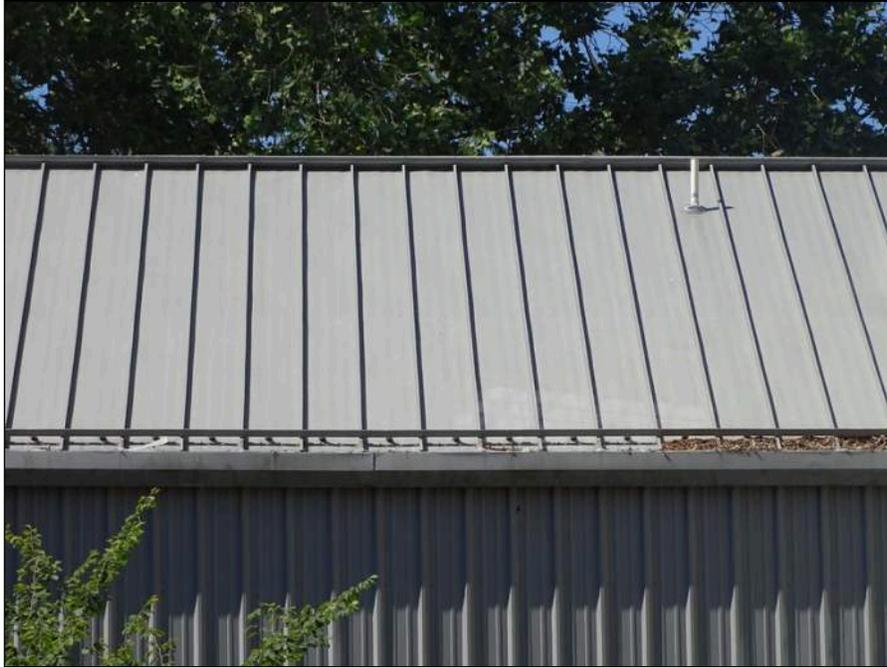
49 - Metal roofing system - south addition

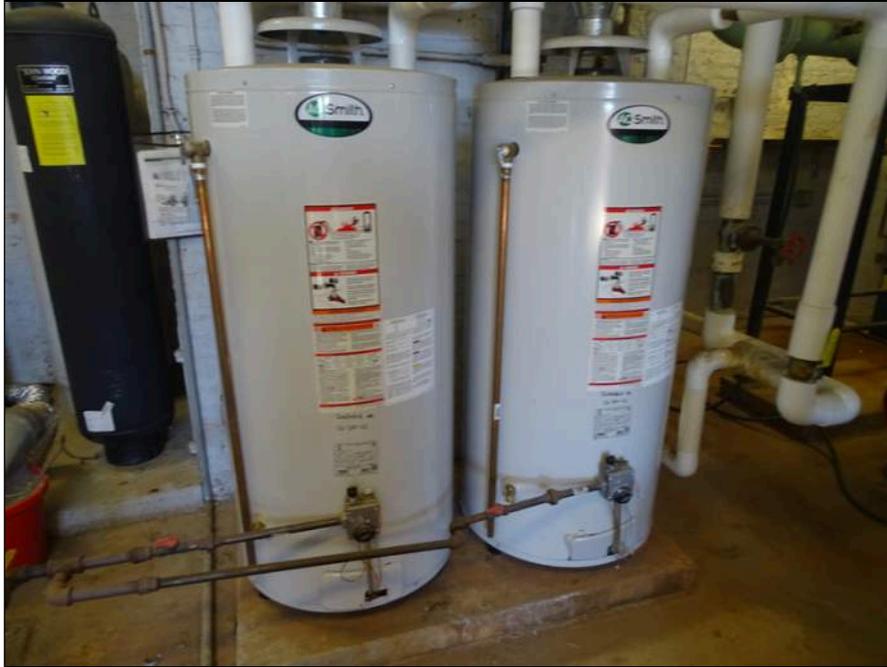
51 - Gas domestic water heaters

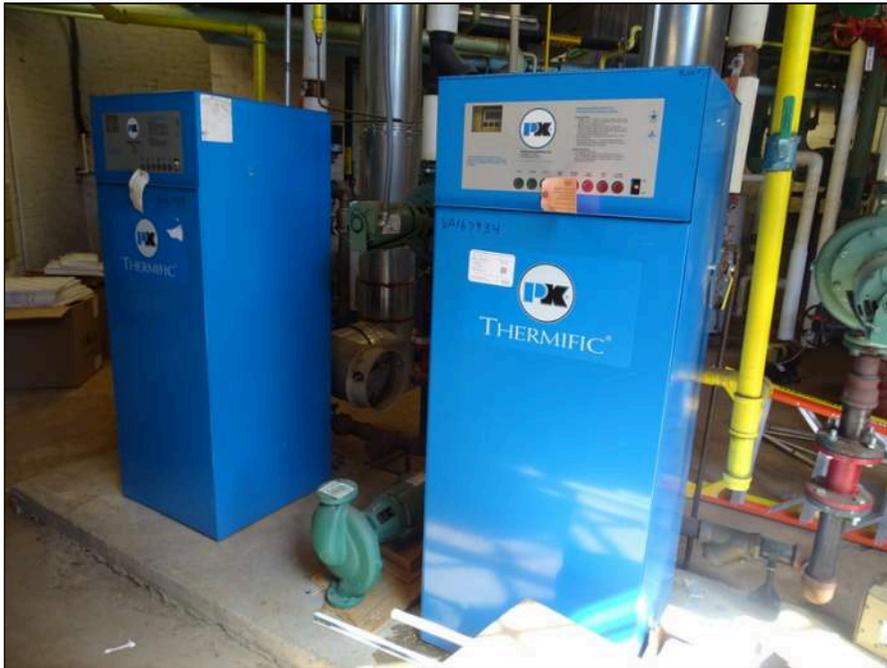
52 - Boilers located in main utility room

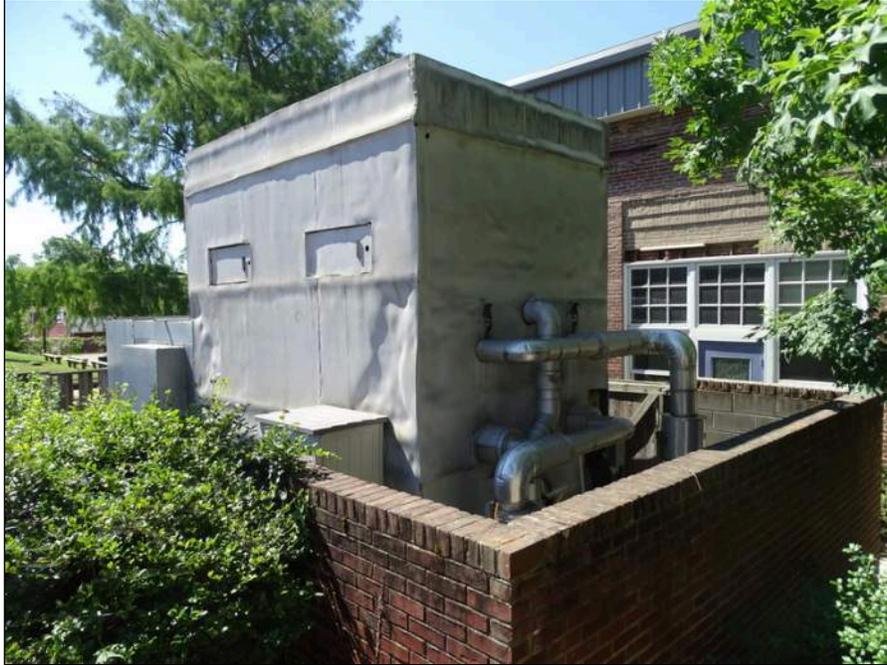
53 - Cooling tower located on east side of the building

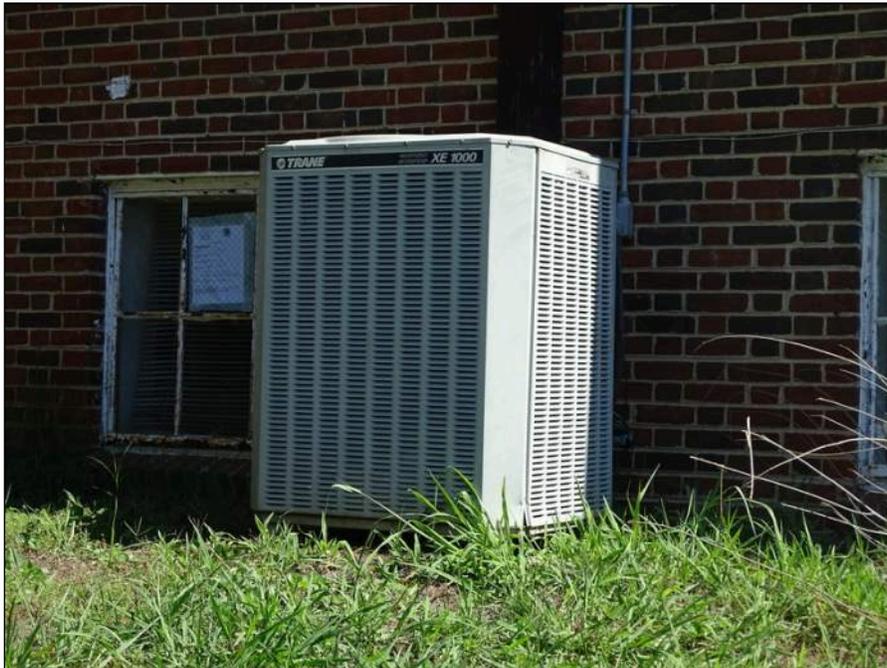
54 - Condenser unit at annex

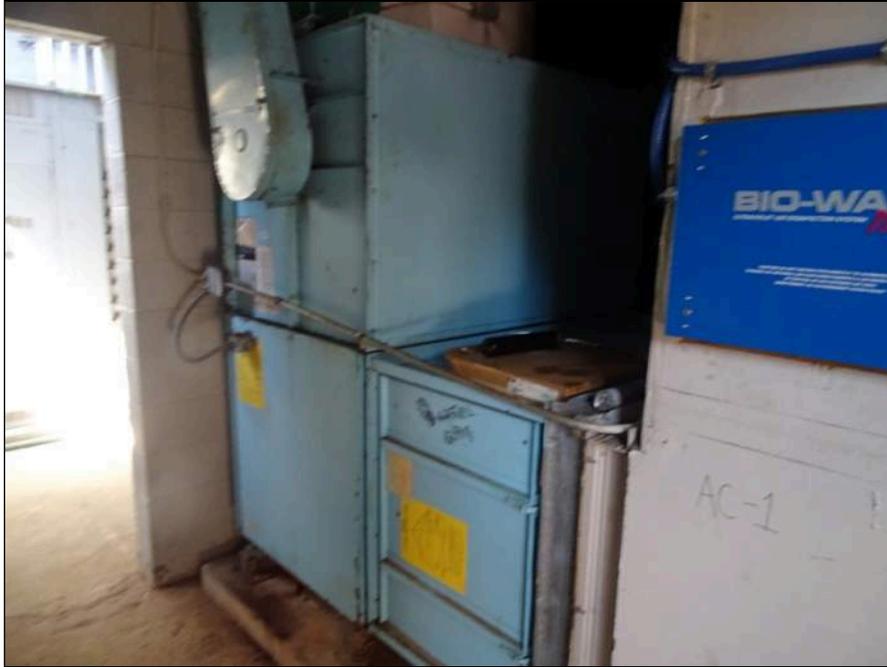
55 - Air Handler Unit located in main utility room

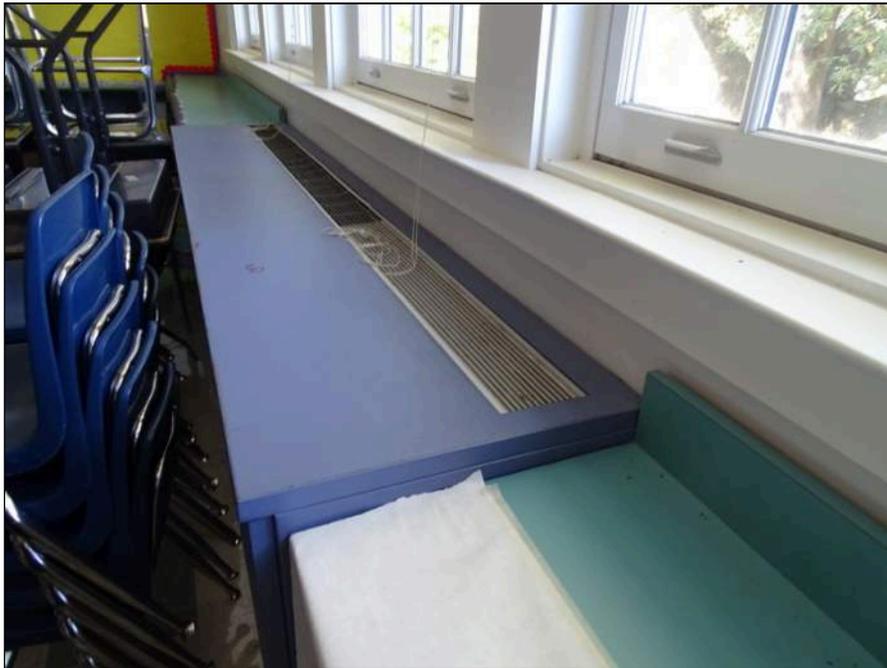
56 - Typical older Water Source Heat Pump

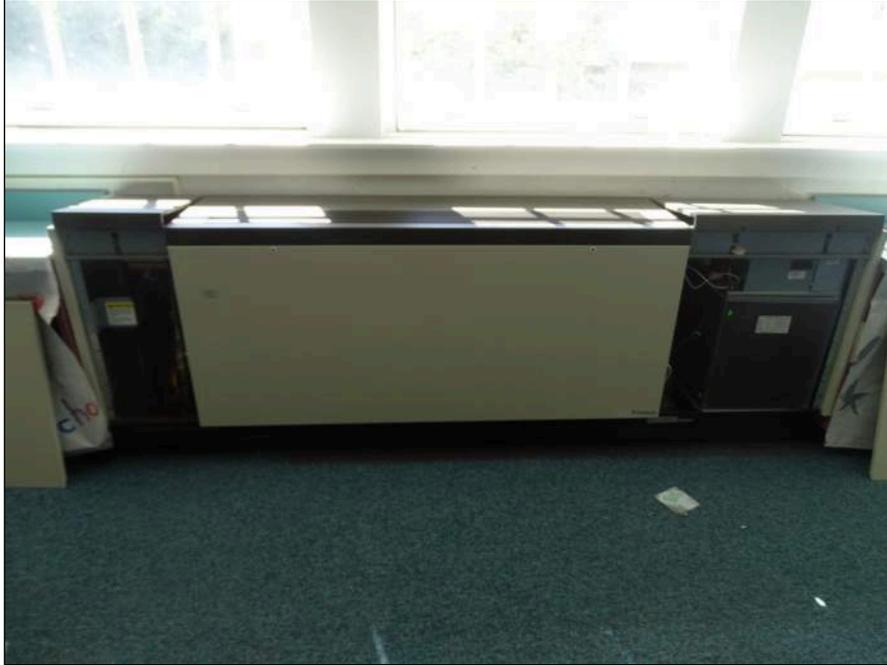
57 - Typical newer Water Source Heat Pump

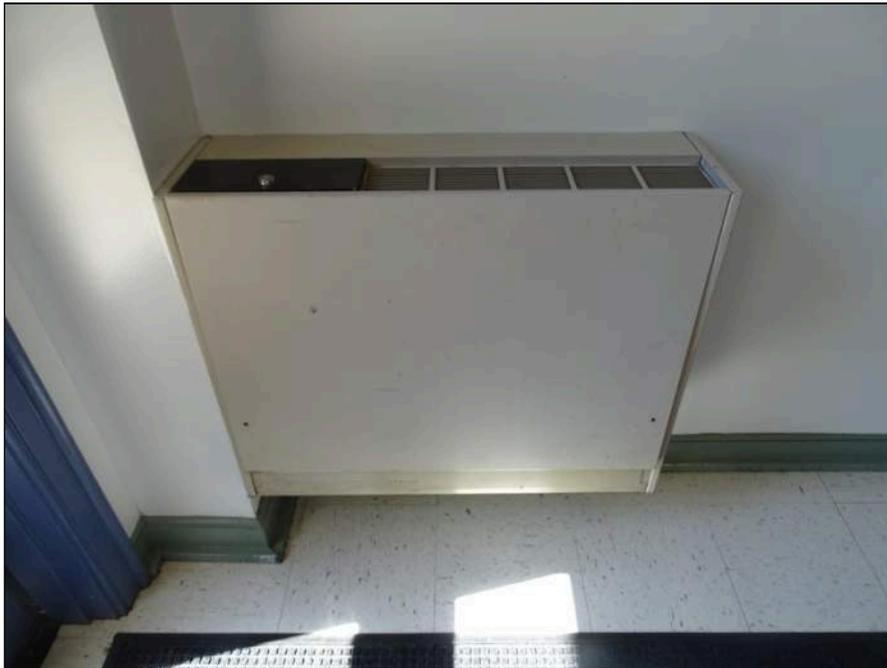
58 - Typical newer Water Source Heat Pump

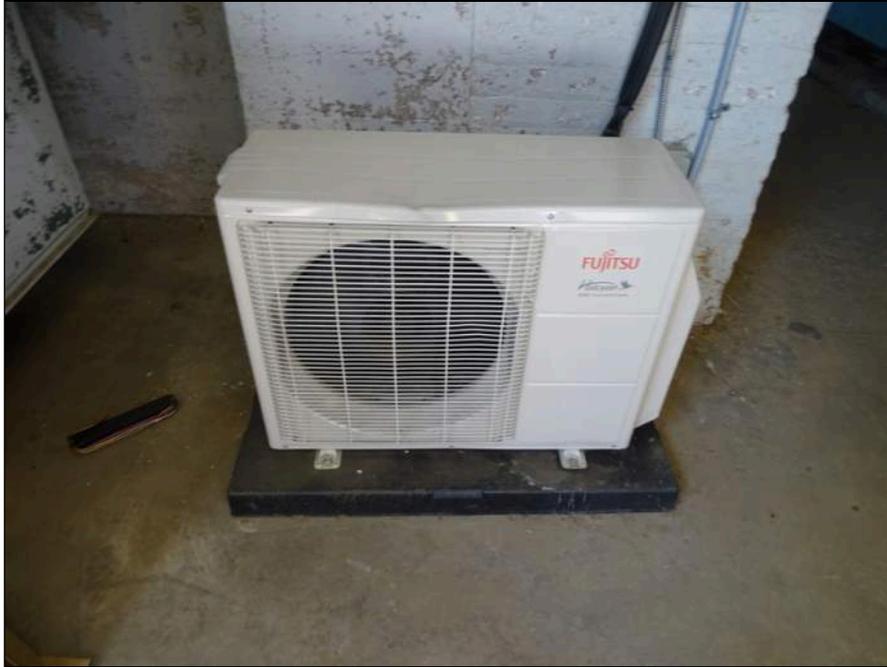
59 - Split system located in main utility room

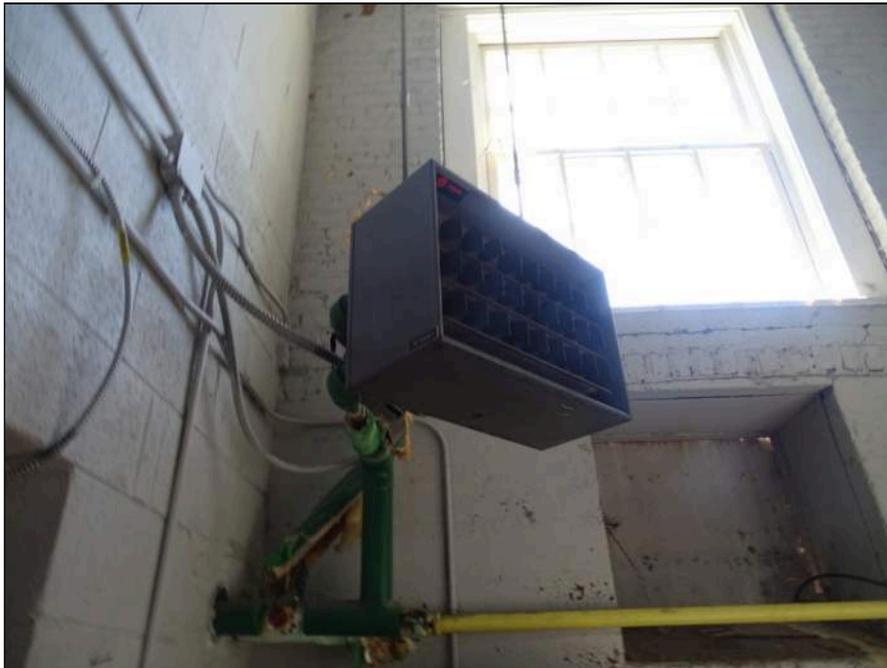
60 - Space heater located in main utility room

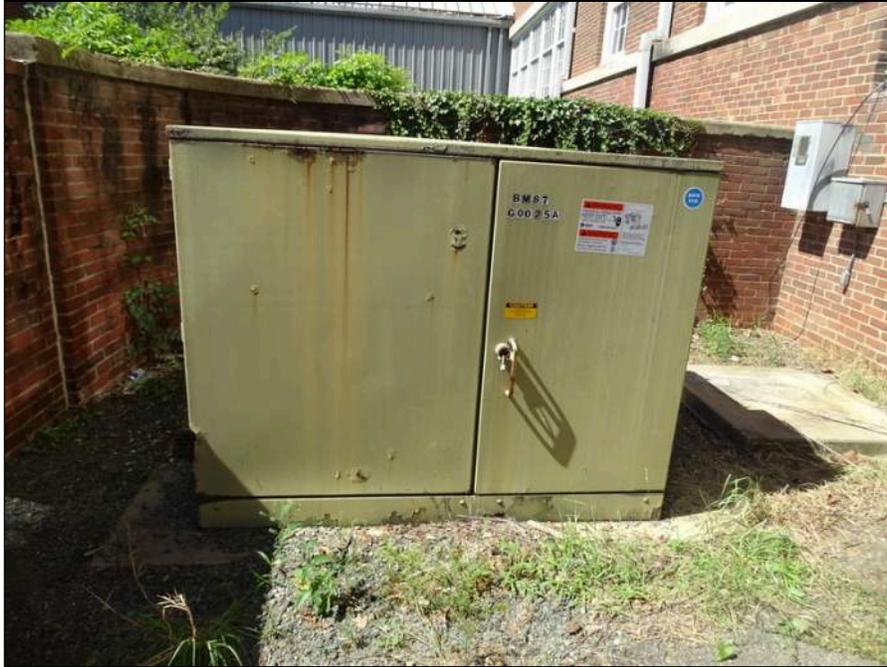
61 - Electric utility transformer

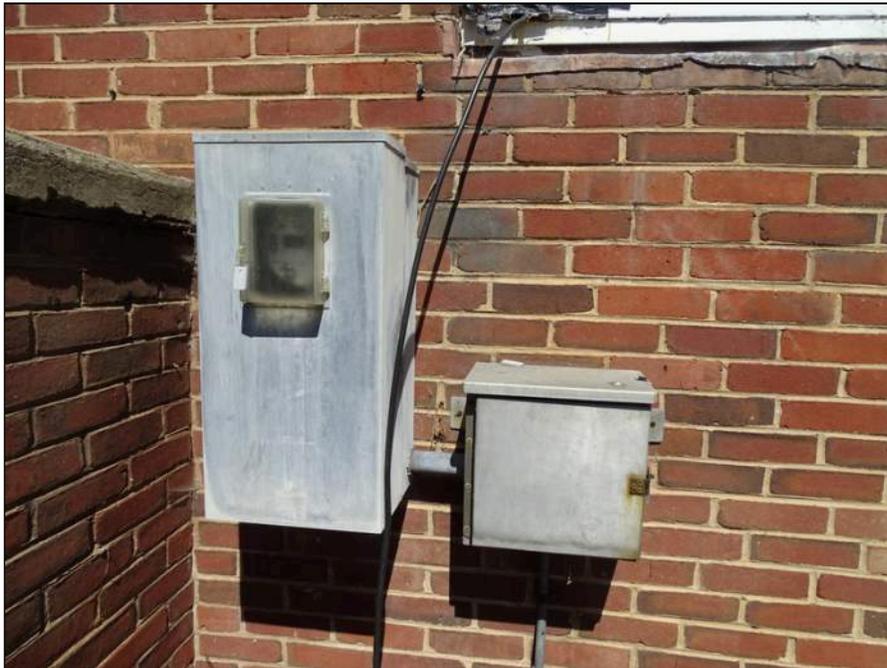
62 - Electric utility meter

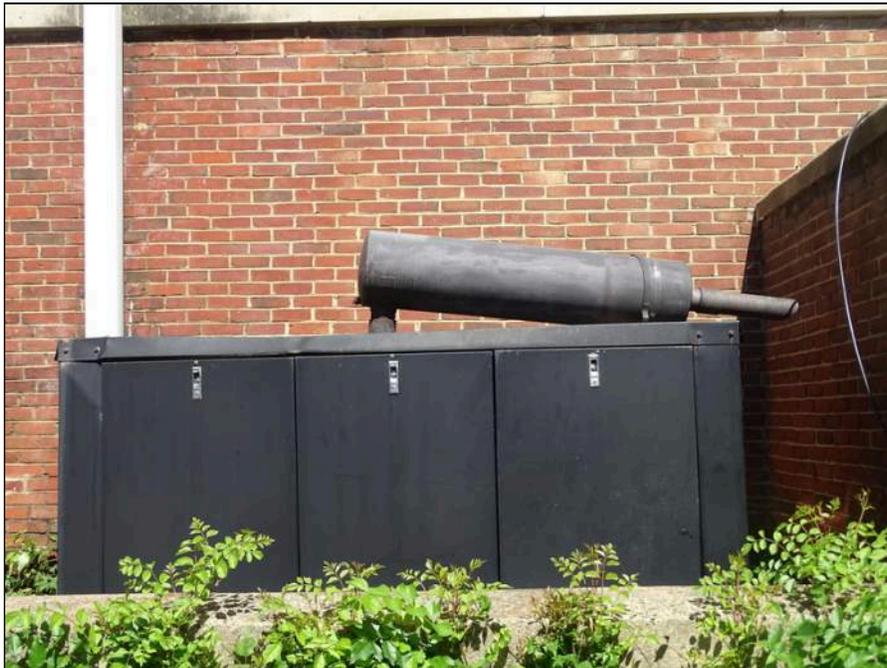
64 - Emergency power generator

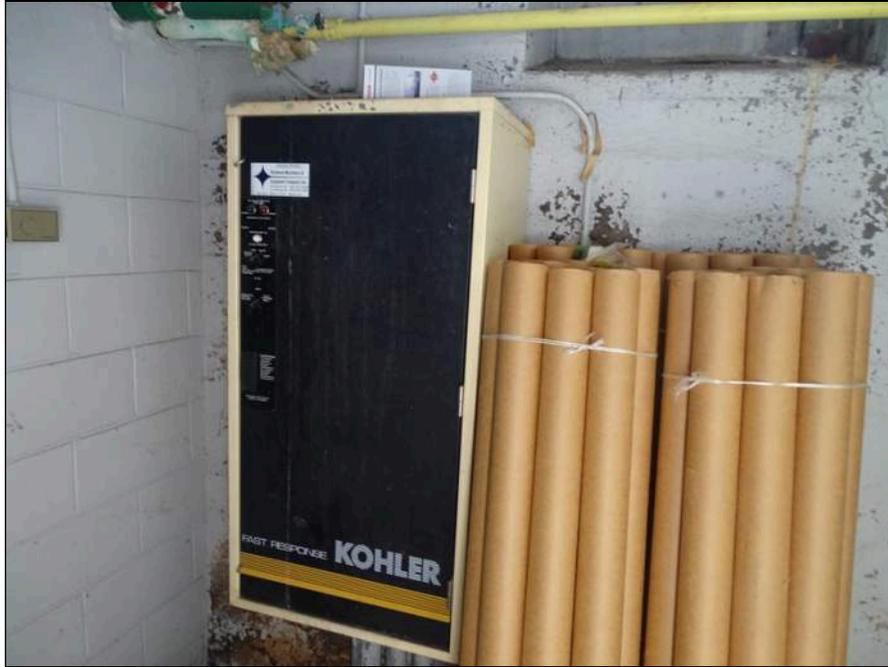
65 - Emergency power transfer switch

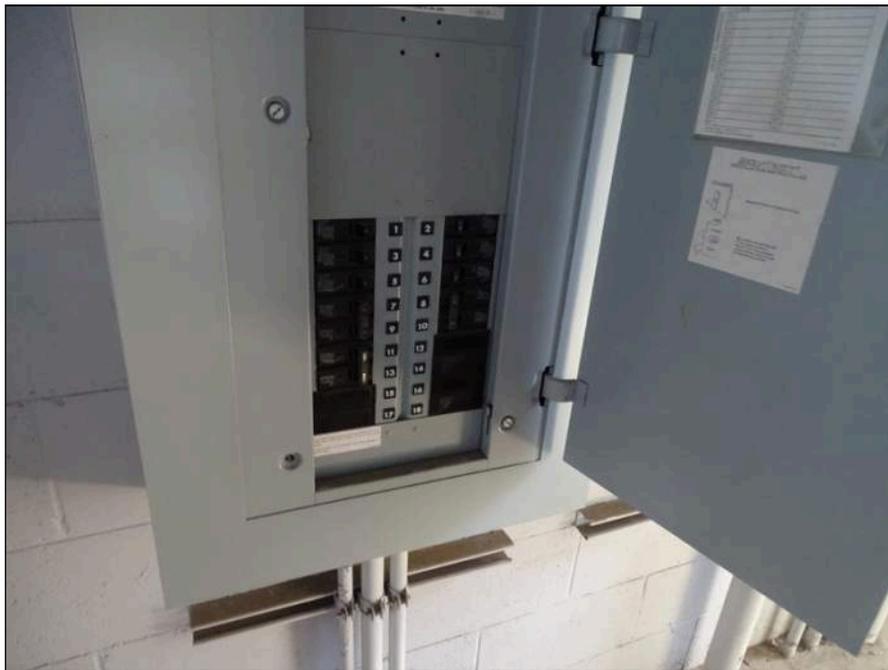
66 - Typical electric circuit breaker panel

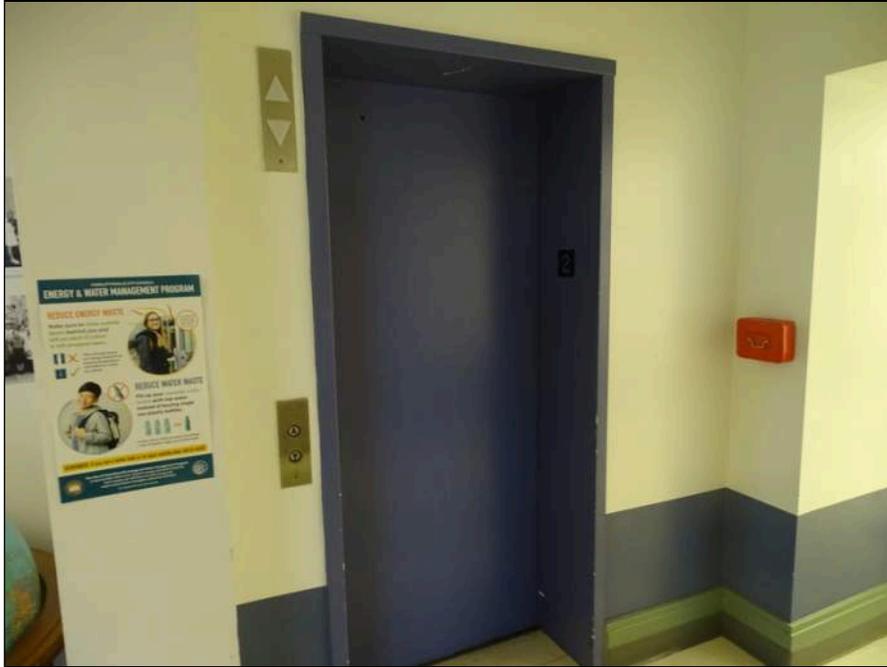
67 - Elevator located at center of building

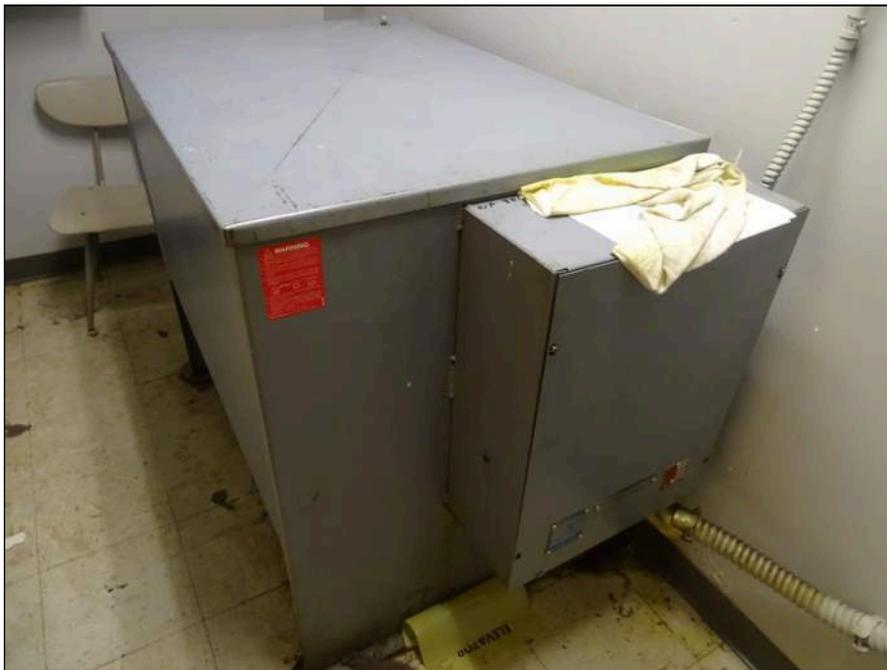
68 - Elevator machine and controls

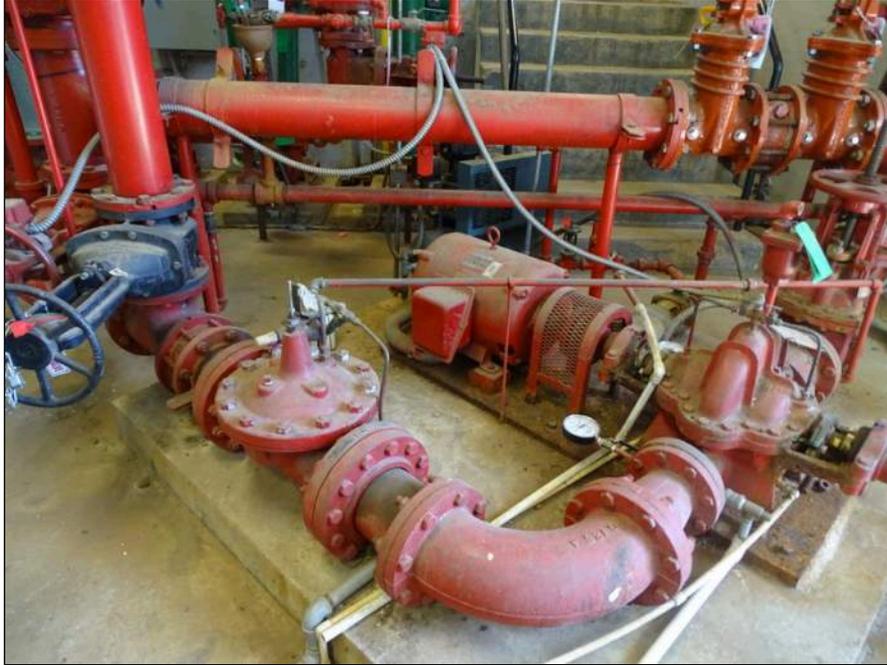
69 - Fire sprinkler system

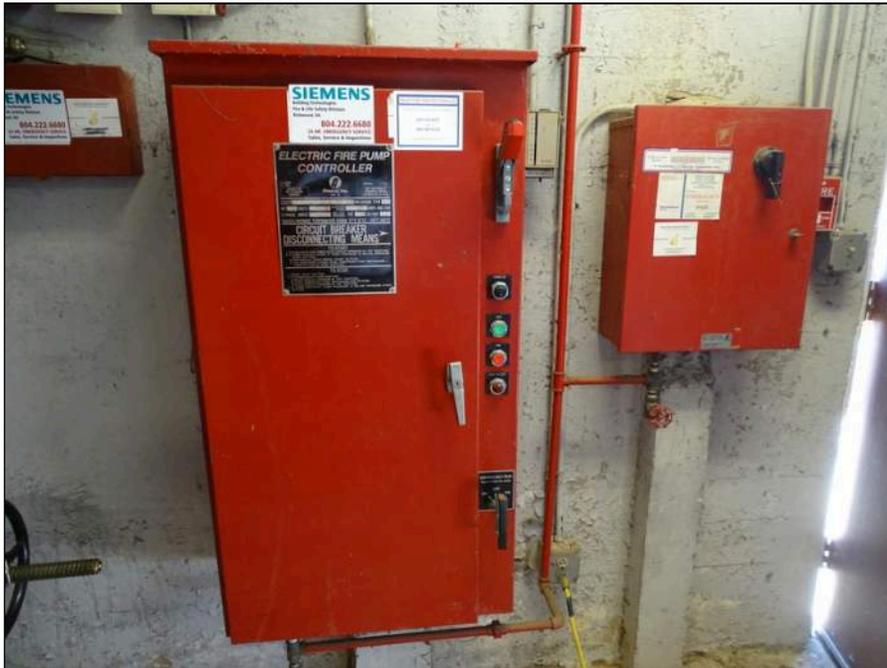
70 - Fire sprinkler pump controller

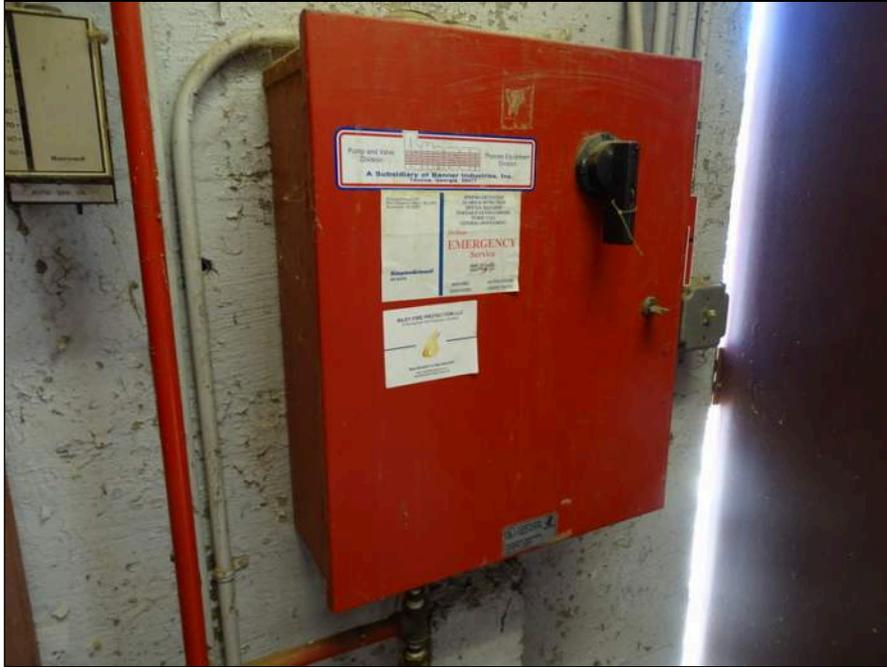
71 - Fire sprinkler pump controller

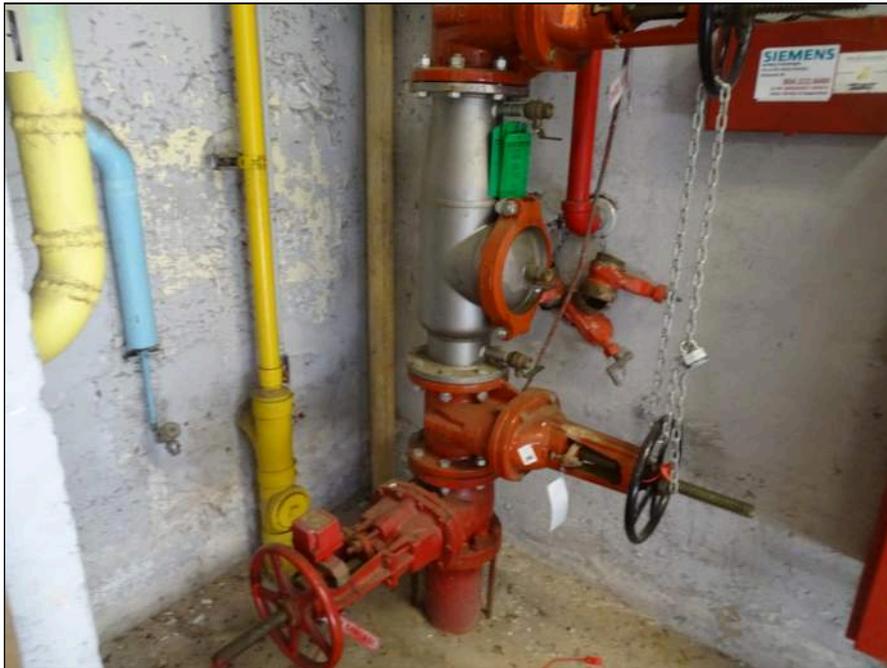
72 - Fire sprinkler supply

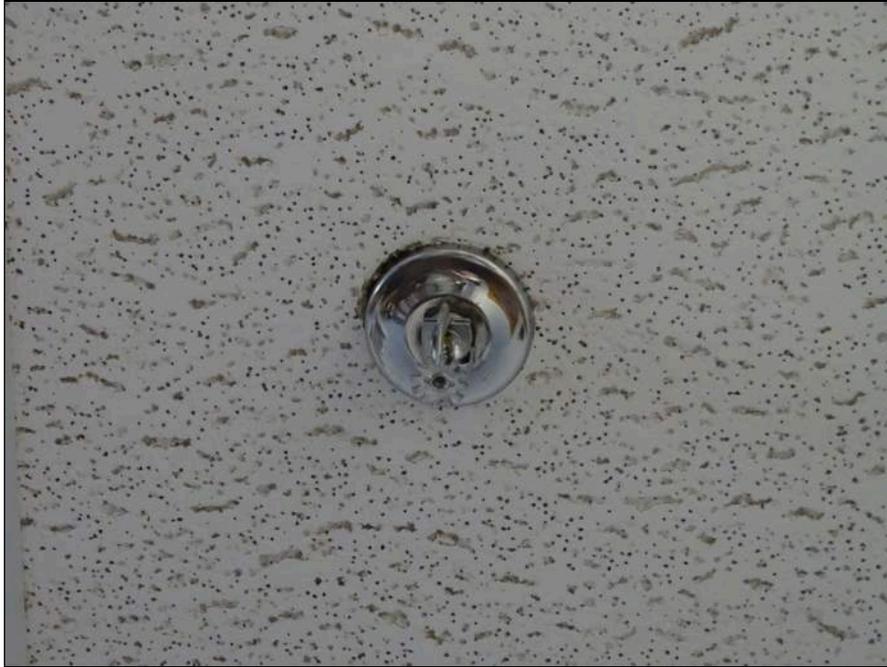
73 - Typical fire sprinkler head

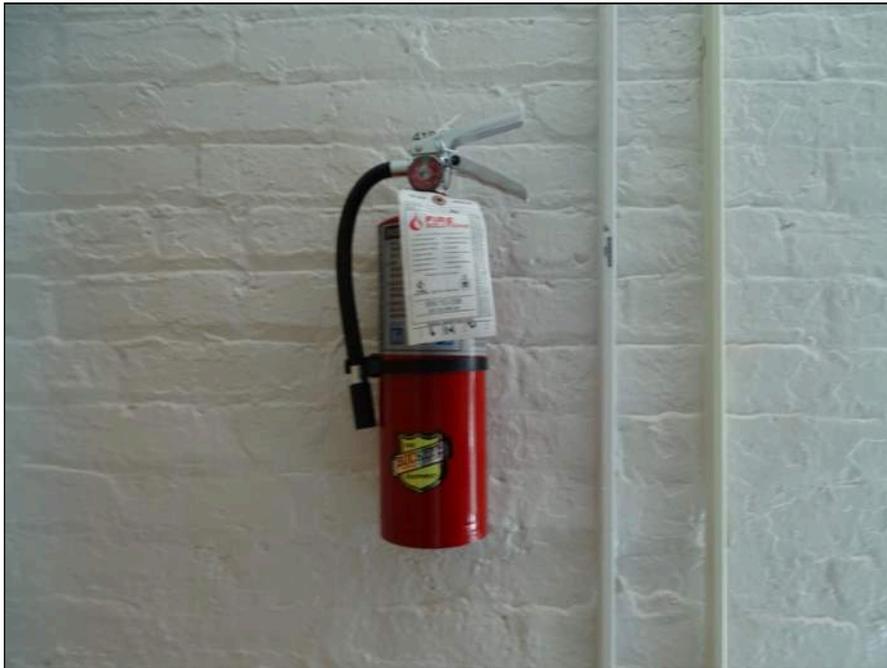
74 - Typical fire extinguisher

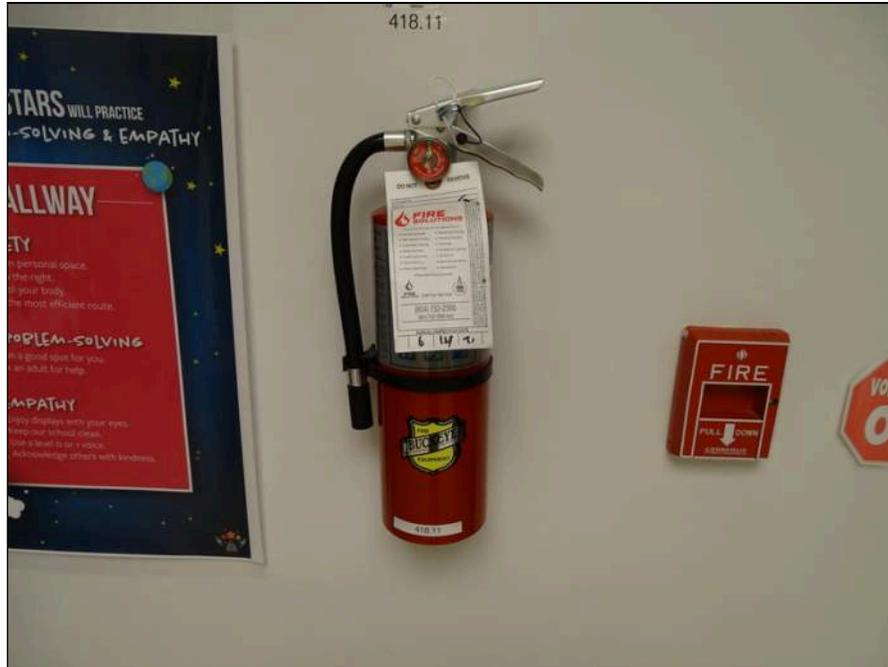
75 - Typical fire extinguisher
