VENABLE ELEMENTARY SCHOOL
406 14TH STREET NW
CHARLOTTESVILLE, VIRGINIA

ECS PROJECT NO. 46:6713

CITY OF CHARLOTTESVILLE - FACILITIES DEVELOPMENT

Reference: Facility Condition Assessment Report for Venable Elementary School, 406 14th Street NW, Charlottesville, Virginia

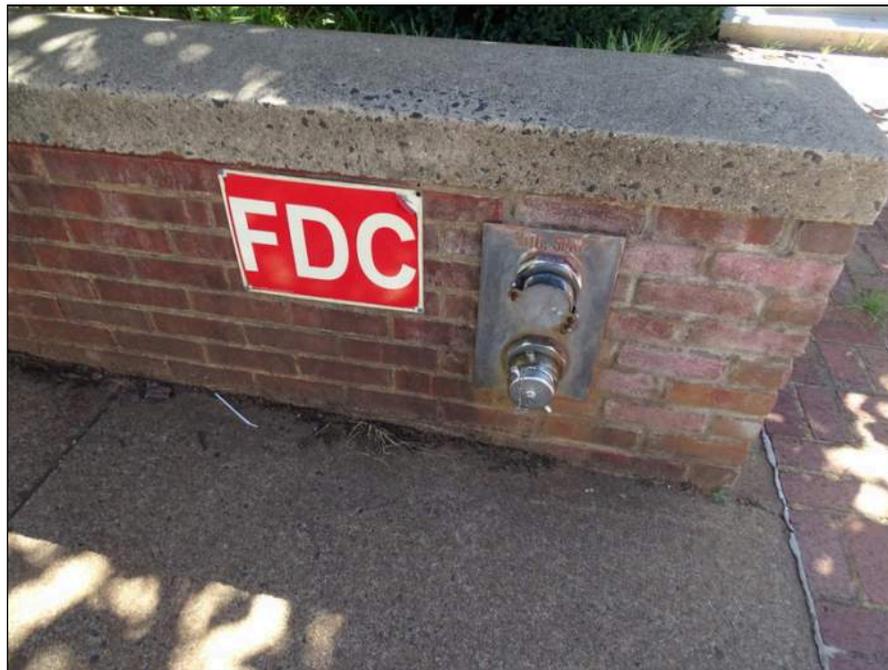
76 - Fire Department Connection

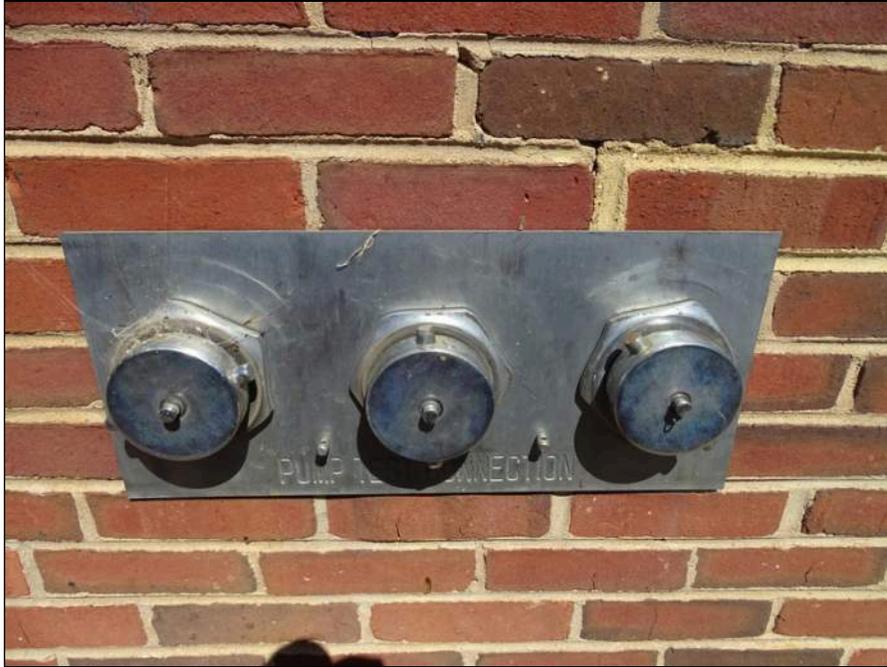
77 - Fire Pump Test Connection

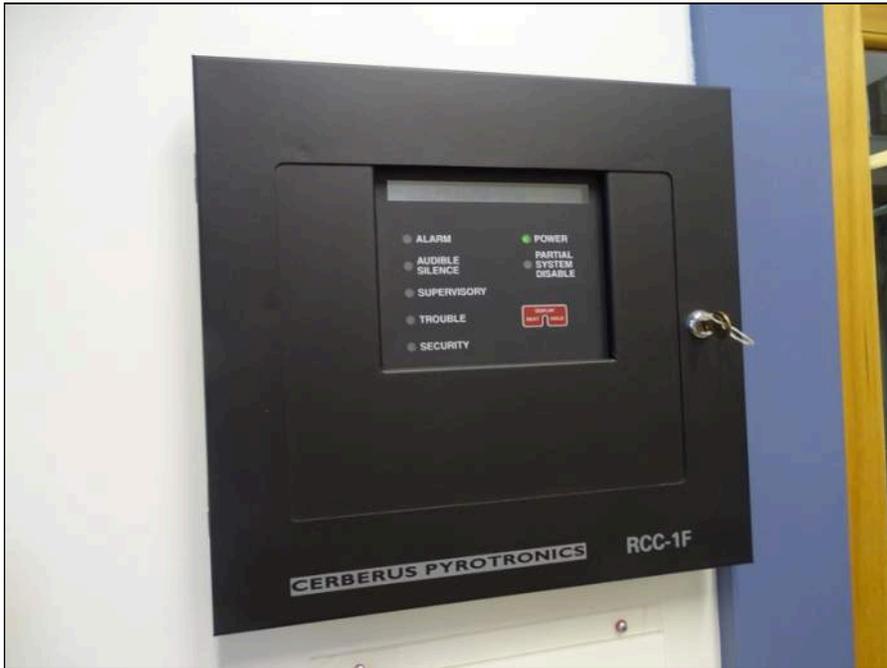
78 - Fire alarm control panel

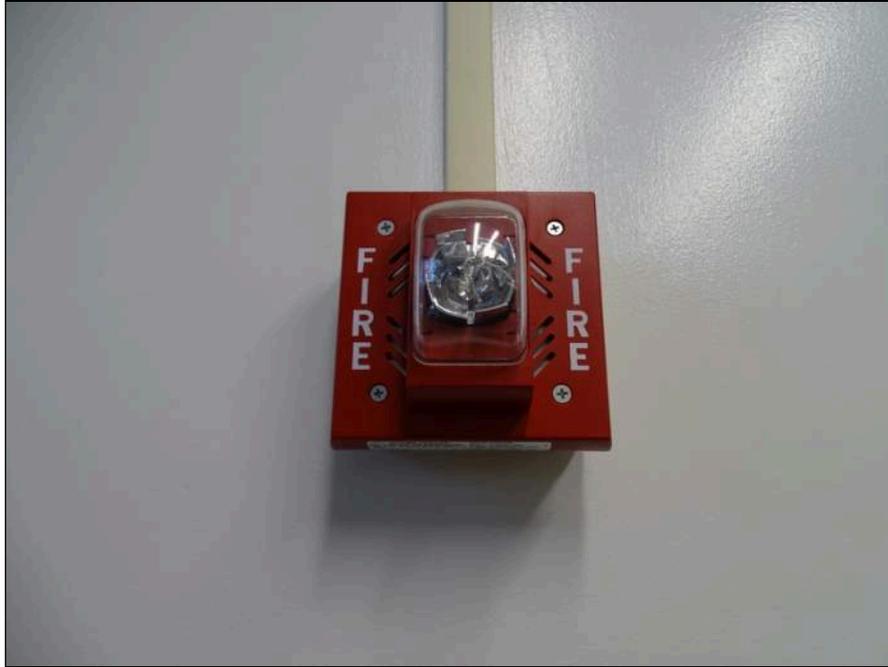
79 - Typical fire alarm bell and strobe

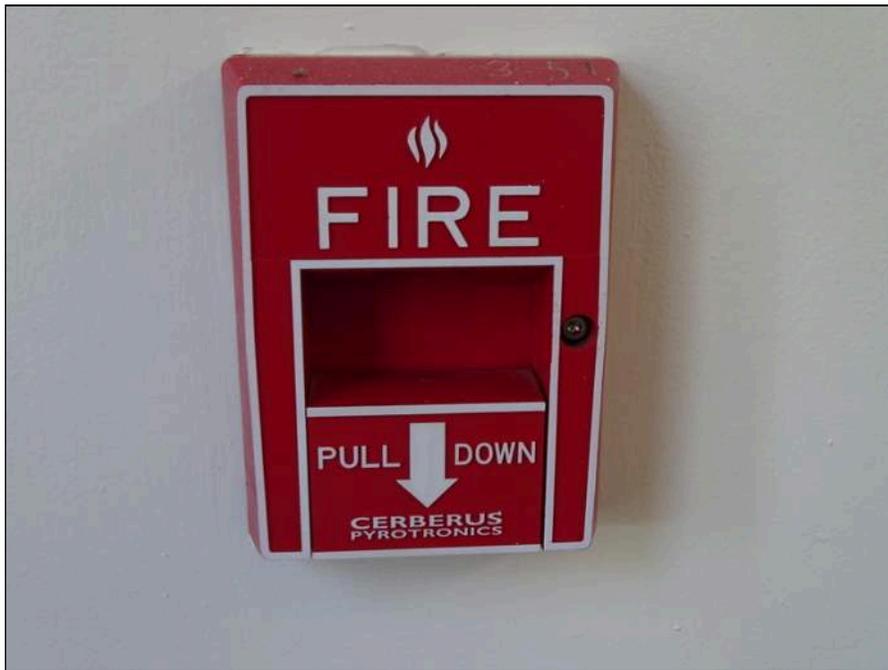
80 - Typical fire alarm pull station

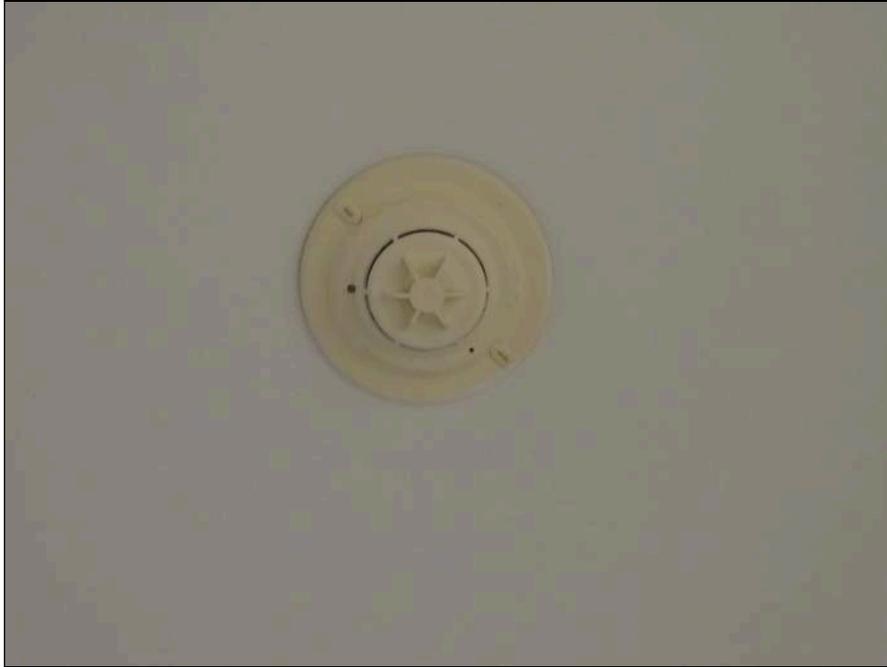
81 - Typical smoke detector

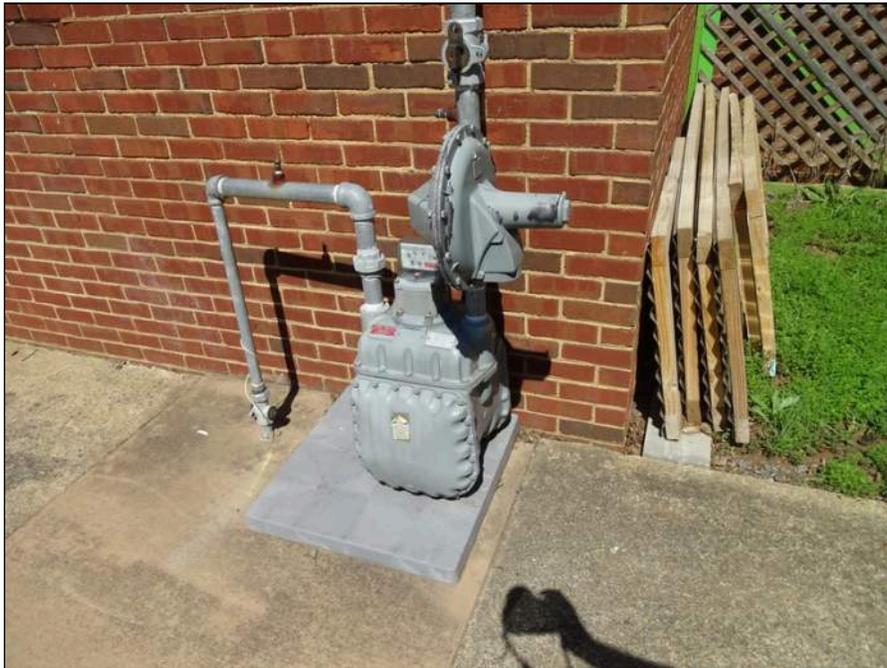
82 - Typical gas meter

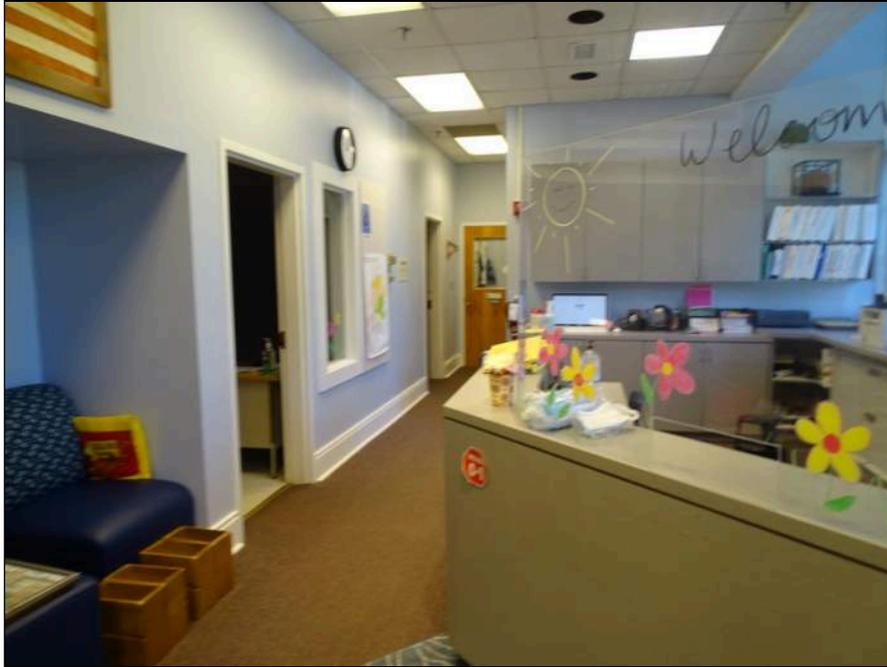
83 - Interior finishes main office area

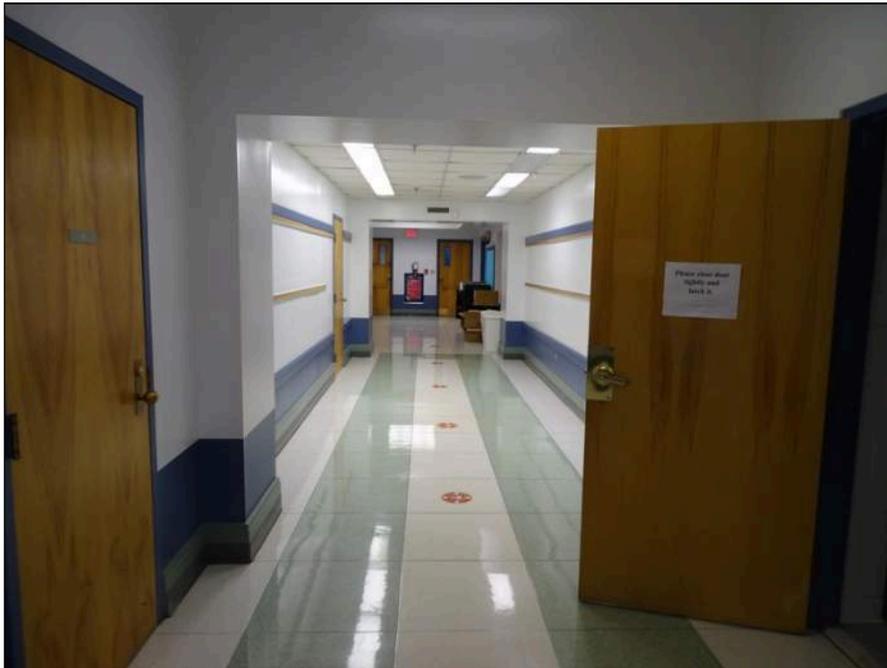
84 - Interior finishes corridor area

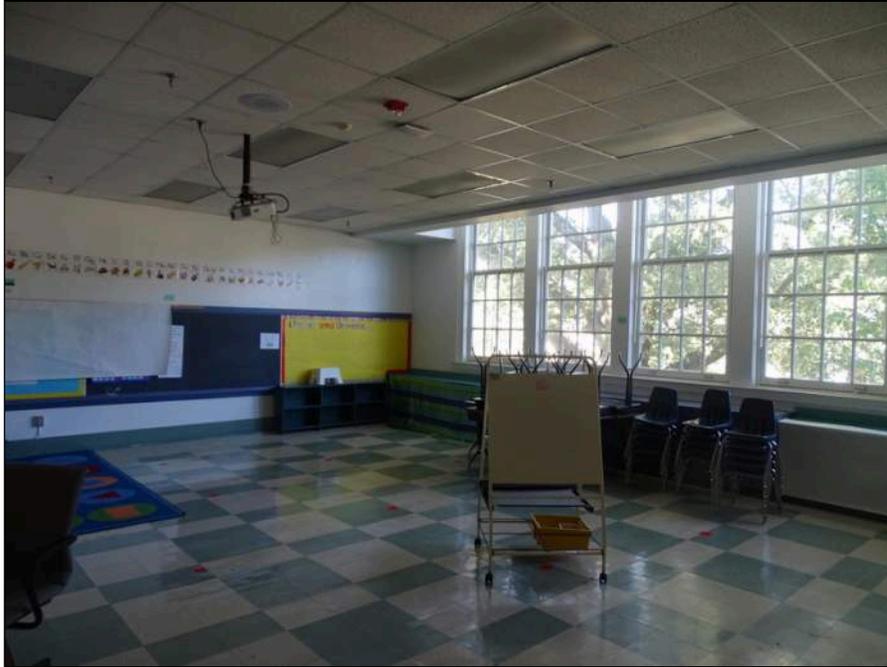
85 - Interior finishes classroom area

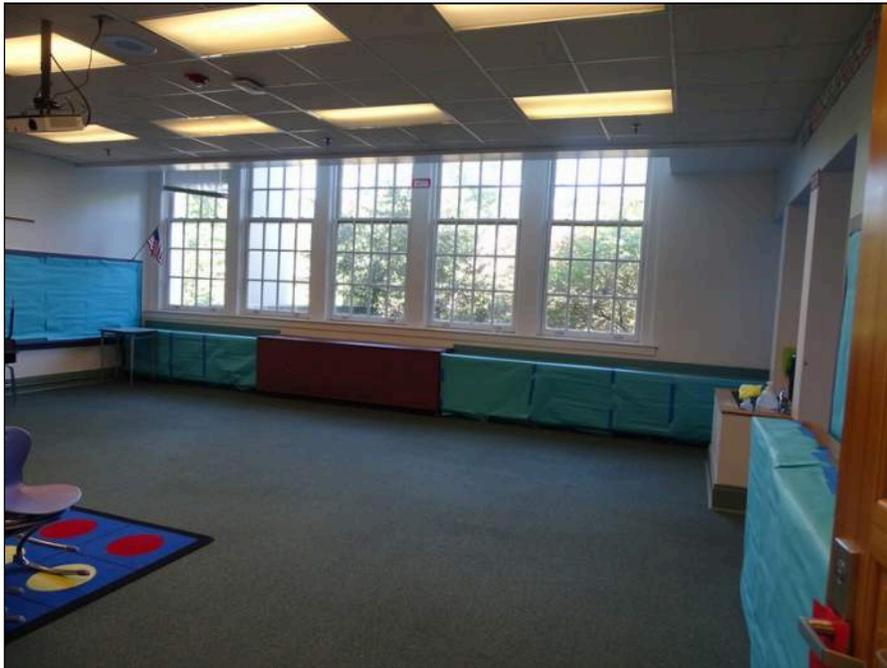
86 - Interior finishes classroom area

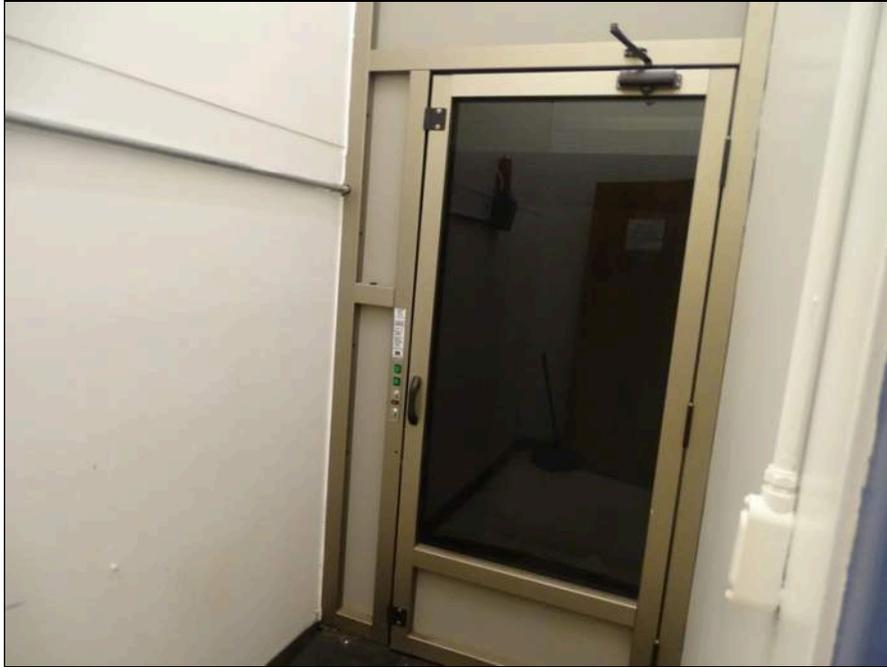
87 - Accessible lift

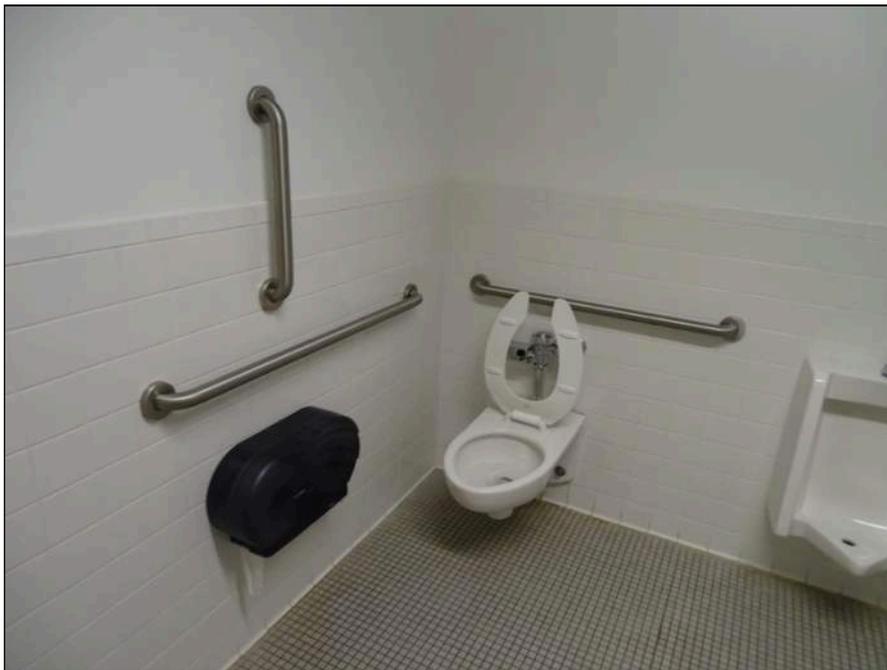
88 - Accessible restroom

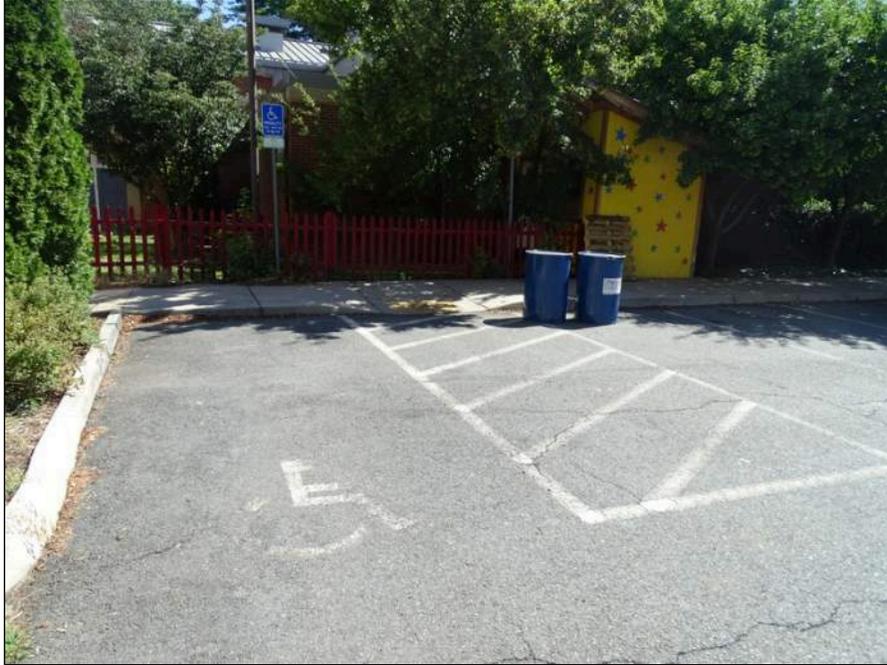
89 - Accessible parking space

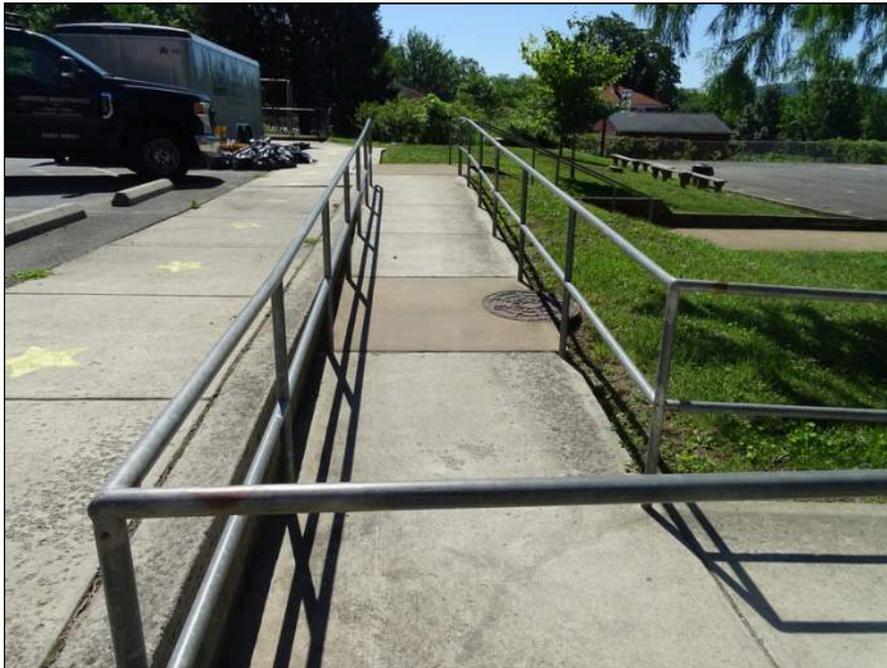
90 - Accessible ramp at south end the site
