WALKER UPPER ELEMENTARY SCHOOL
1564 DAIRY ROAD
CHARLOTTESVILLE, VIRGINIA

ECS PROJECT NO. 46:6713

CITY OF CHARLOTTESVILLE - FACILITIES DEVELOPMENT

Reference: Facility Condition Assessment Report for Walker Upper Elementary School, 1564 Dairy Road, Charlottesville, Virginia

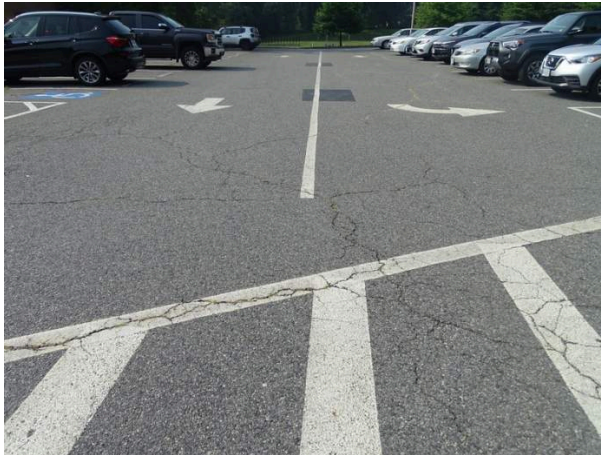
Asphalt-paved drive lanes and parking areas are located on the north, east, and west side of the site which also provides access to the site. The asphalt pavement was observed to be in generally fair condition with extensive cracks observed on the pavement. Striping was in fair condition. The expected useful life of asphalt pavement is 20 years. Based on the extensive cracking, we recommend milling and overlaying the cracked areas of asphalt pavement.

Asphalt parking at west side of the site - note cracking

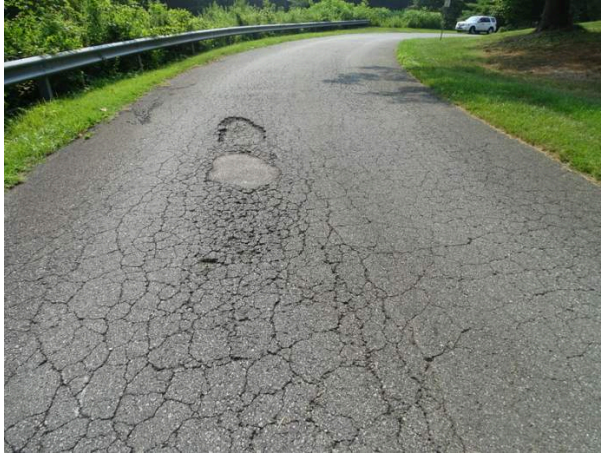
Asphalt drive lane east side of the site - note cracking

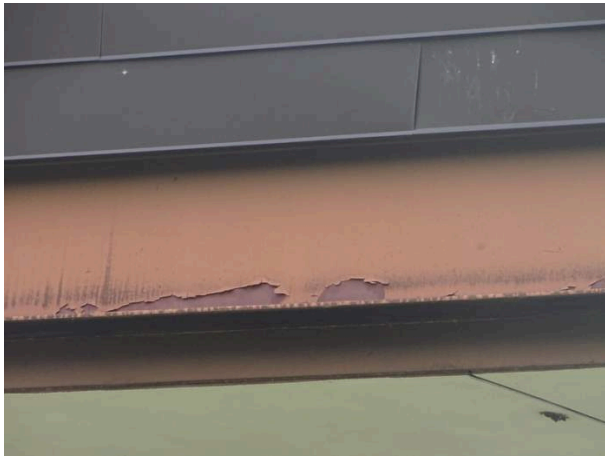
Various awning structures are located at the over entrance doors throughout the building. The awnings consist of a concrete deck with metal columns. The underside of the concrete and the metal columns were painted. The paint was observed to be peeling at the underside of the awning at various entrances. The awnings should be painted in conjunction with the exposed concrete beams and columns painting project.

Building exterior - note peeling paint

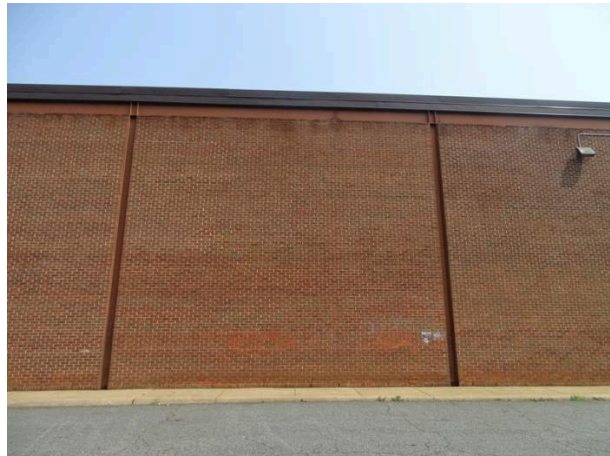
Building exterior of main building efflorescence

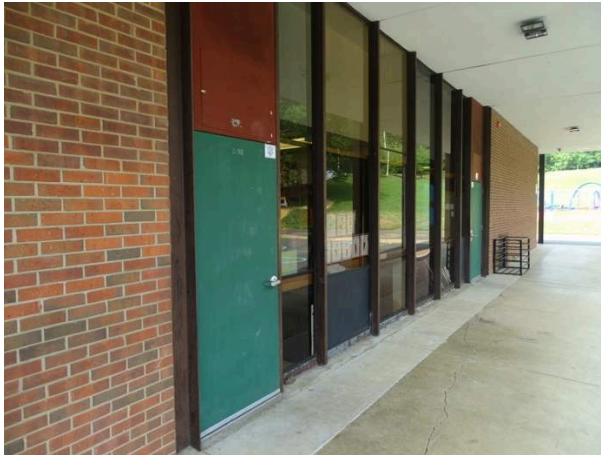
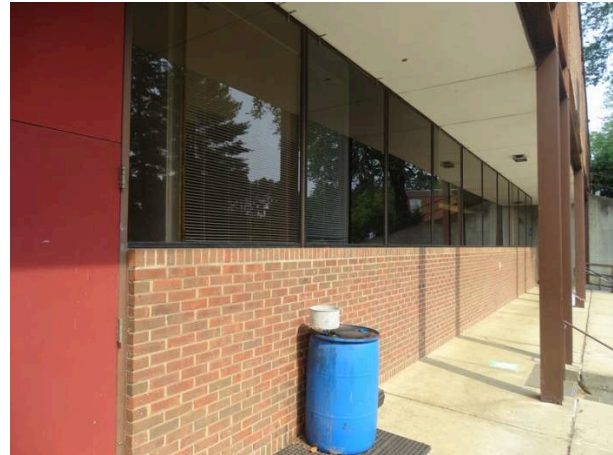
The window system for the building primarily consists of metal frame single pane and/or double pane window units. It was reported that the windows were replaced when damaged as needed. Metal frame single-pane windows have a typical expected useful life of 25 years. There administrative offices on the north side of the main building were reportedly subject to wide temperature fluctuations due to the windows. Replacement of windows has been included in the study period.

Typical exterior windows

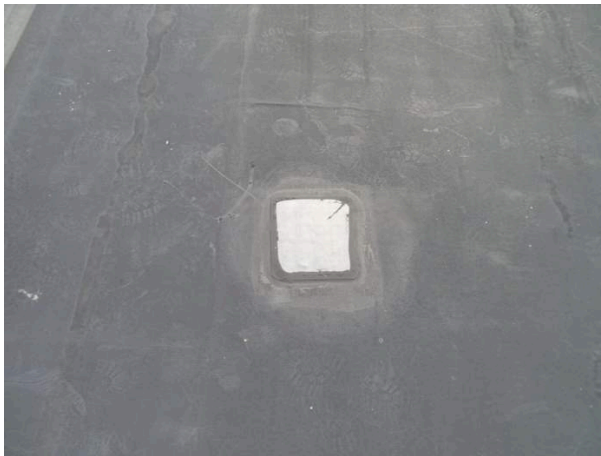
Single-ply membrane roofing system - note patching

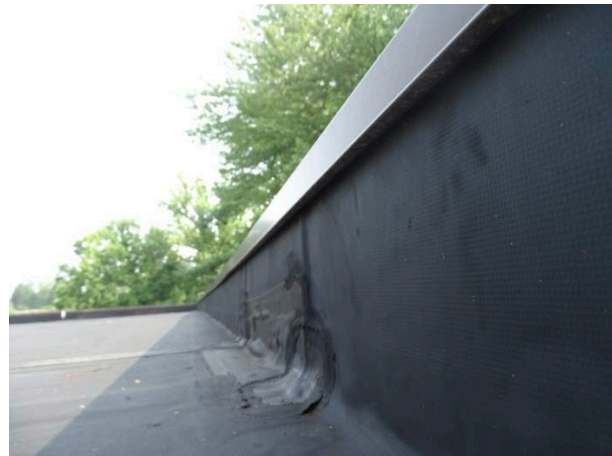
Single-ply membrane roofing system - note patching

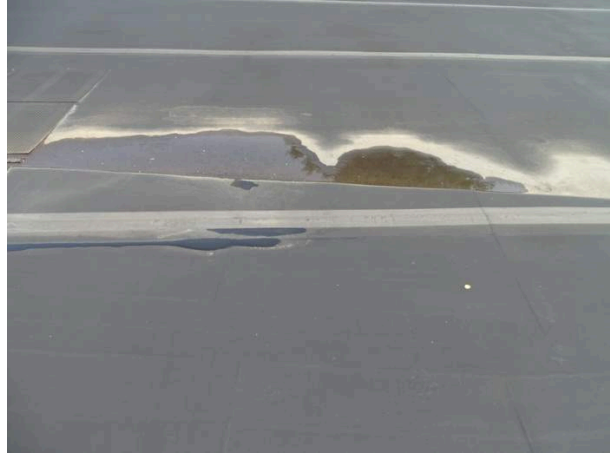
Single-ply membrane roofing system - note ponding

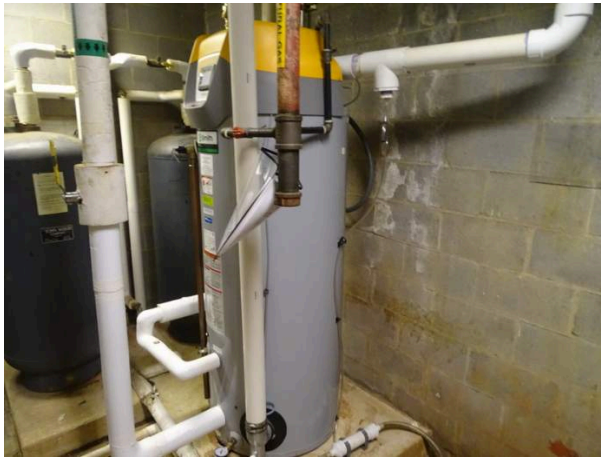
The expected useful life of water heaters is approximately 15 years with proper maintenance. We recommend the water heaters be replaced during the study period.

Gas domestic water heater located in main building

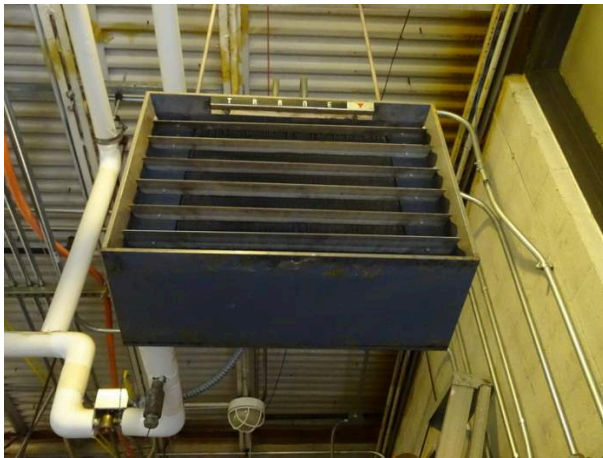
Ceiling mounted space heaters are located in the main utility room. The expected useful life of ceiling mounted space heaters is 15 years with proper maintenance. We recommend that ceiling mounted space heaters be replaced during the report period.

Typical space heater

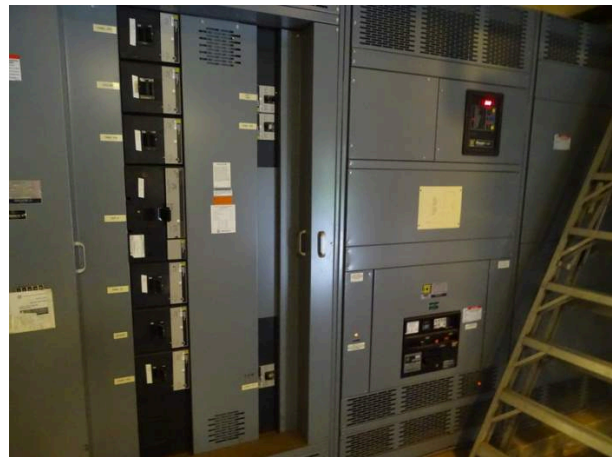
Main electrical switchgear

Power is distributed by copper wire from circuit breaker panels located throughout the building. The expected useful life of sub-panels is 50 years with proper maintenance. Some of the the circuit breaker panels were reportedly recently replaced. Older circuit breaker panels were observed with some rusting. The circuit breaker panels were observed to be in generally good to fair condition. We recommend replacing the remainder of the older circuit breaker panels.

Cost Recommendation	EUL	EFF AGE	RUL	Year	Cost
REPLACE OLDER CIRCUIT BREAKER PANELS	50	49	1	1	\$10,000
Total					\$10,000

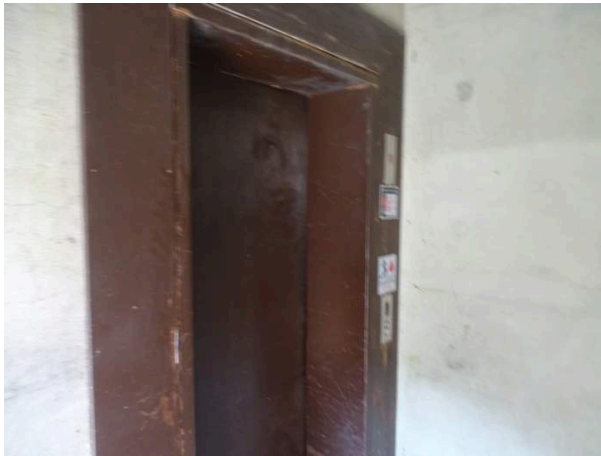
Elevator cab

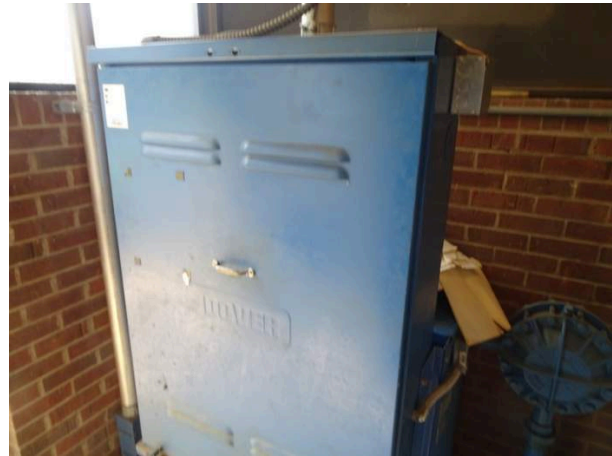
Elevator controls

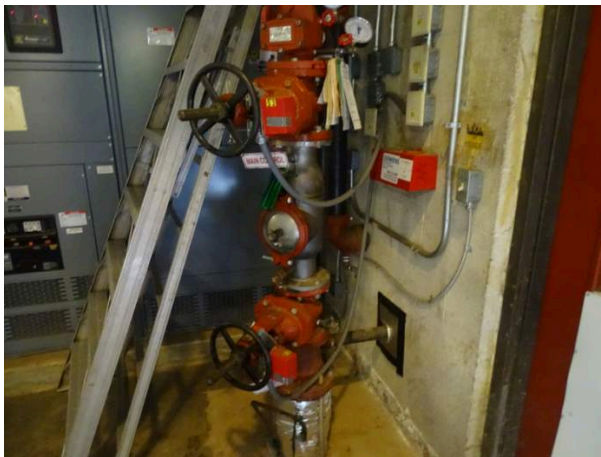
Fire sprinkler system

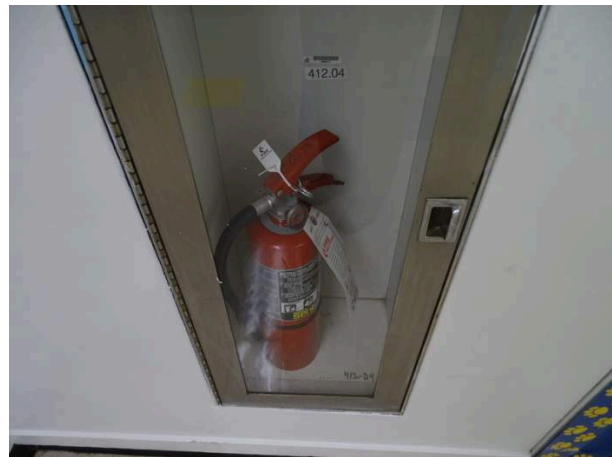
Fire extinguishers were observed throughout the building including in mechanical rooms. The fire extinguishers were observed to have recent inspection tags issued July 2021. These devices are required to be inspected annually. Replacement of the fire extinguishers is considered routine maintenance.

Typical Fire Extinguisher

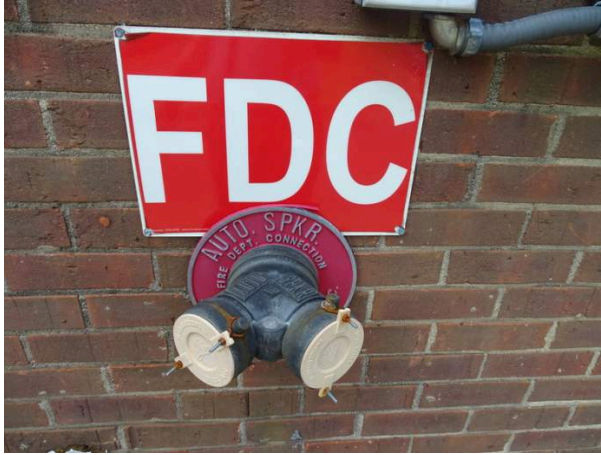
Fire Department Connections

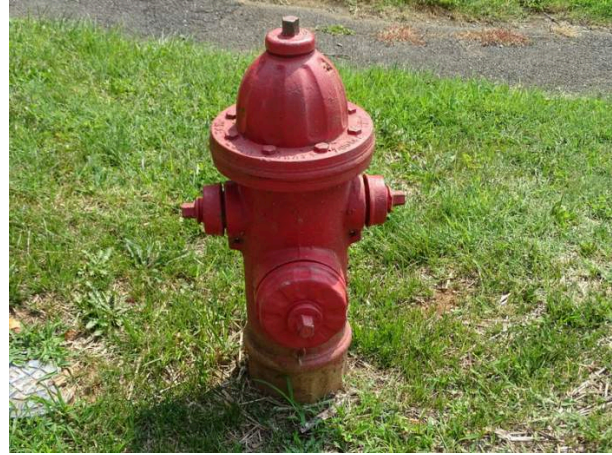
Fire hydrants are located at the building exterior. The fire hydrants were observed to be in good condition.

Typical fire hydrant

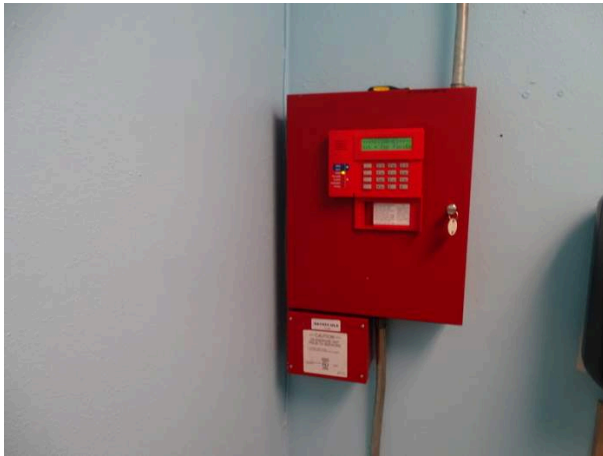
Fire alarm annunciator panel

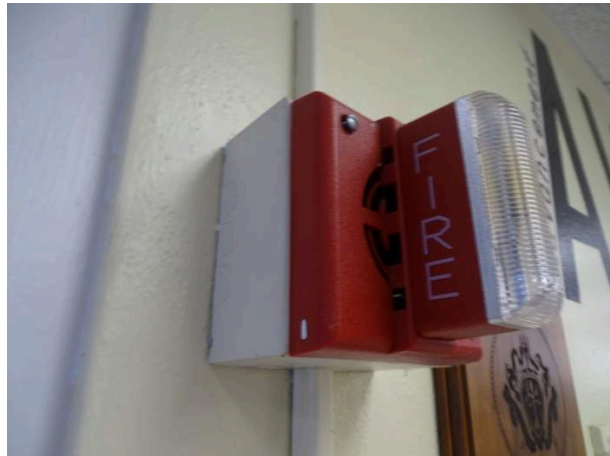
Typical fire alarm bell and strobe

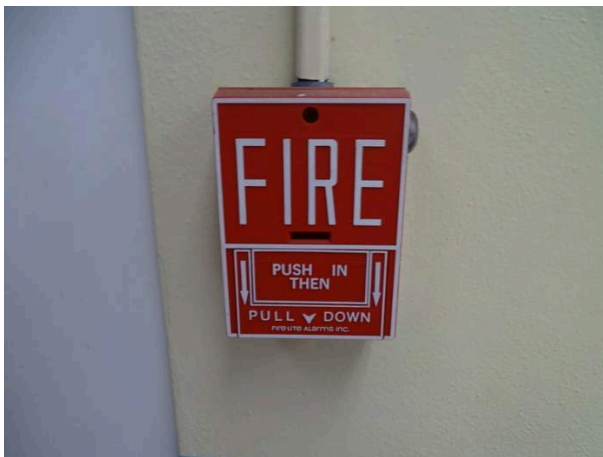
Typical fire alarm pull station

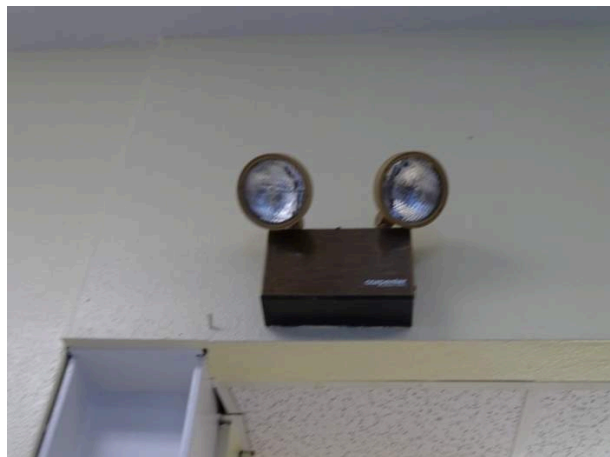
Typical emergency lighting

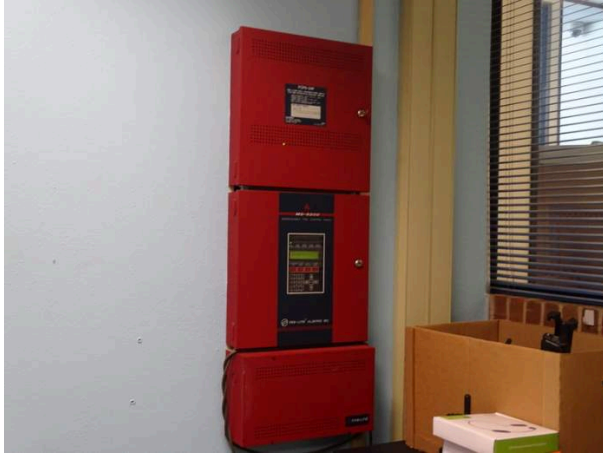
The fire alarm system was observed but not tested. A fire control panel is located in the Main Office. The fire control panel was observed to be in good condition. Emergency exit signs and lighting, pull stations, fire extinguishers, smoke detectors, and alarm bells and strobes are located throughout the building.

Fire alarm control panel

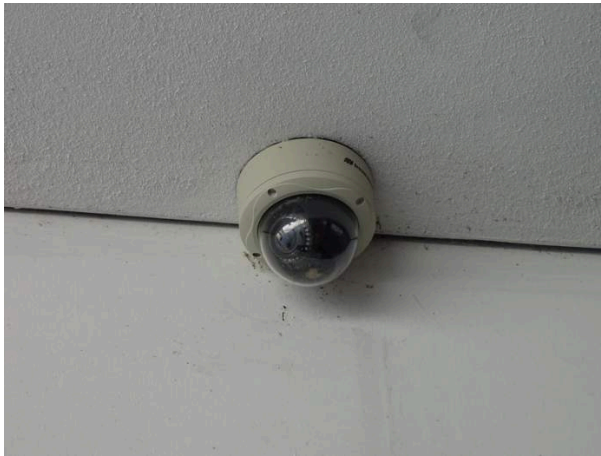
Typical security camera

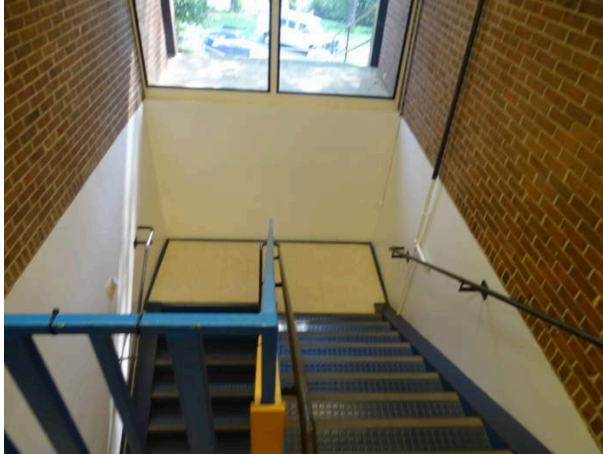
Interior finishes of stair area

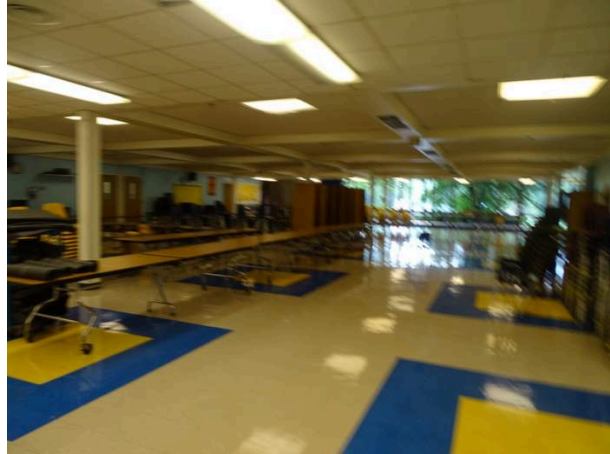
Interior finishes of cafeteria area

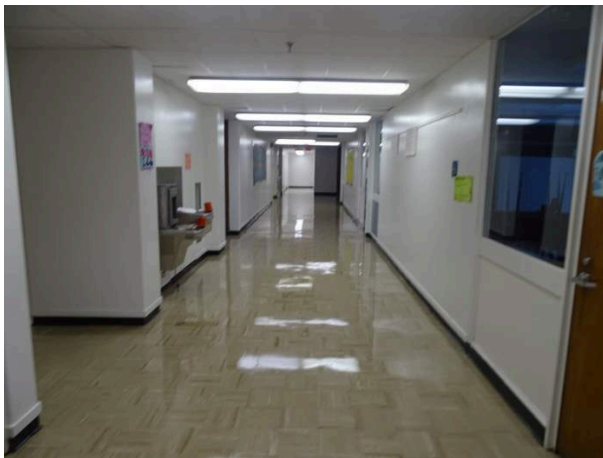
Interior finishes of corridor area

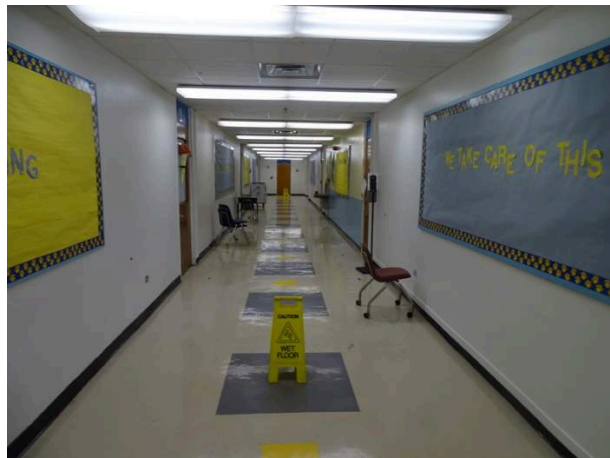
Interior finishes of corridor area

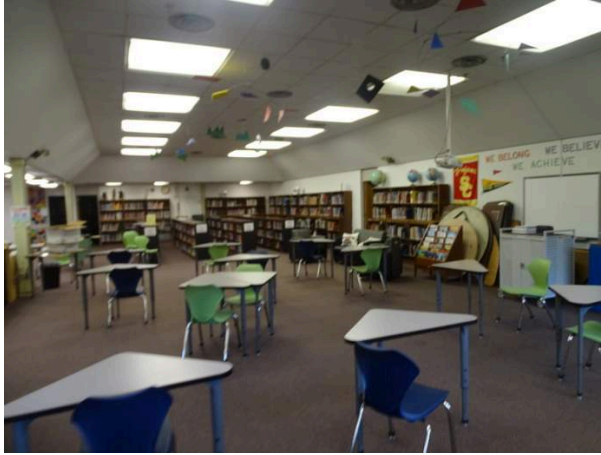
Interior finishes of library area

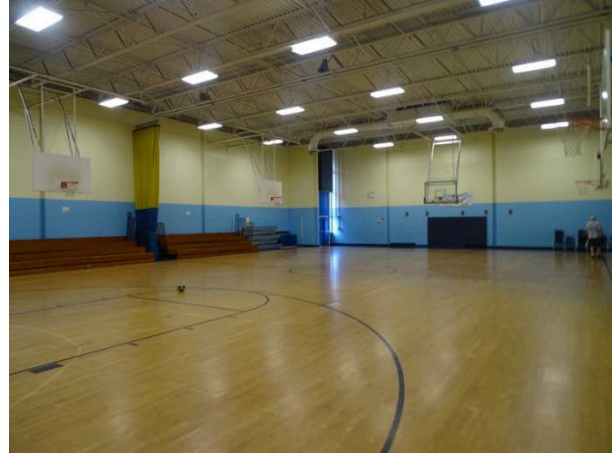
The finishes in the gym consist of wood flooring, painted CMU and painted gypsum board walls, and unfinished ceilings. The finishes in the gym were generally in good condition.

Interior finishes of gym area

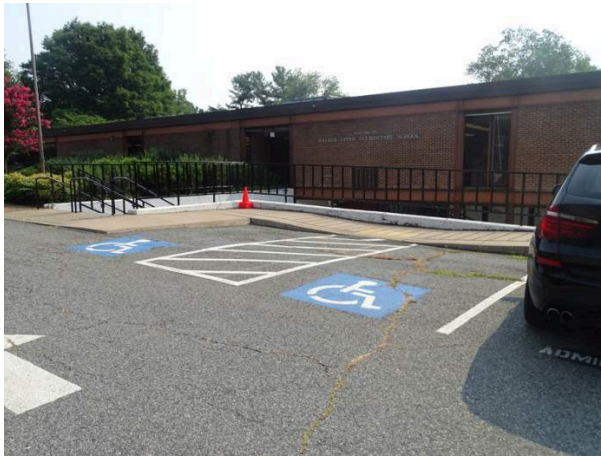
The parking area serving the property has a total of approximately 49 parking spaces. Of the parking spaces, Two are accessible with Two being van accessible. Accessibility requires that two accessible parking spaces be provided in parking areas with a total of 26 to 50 spaces. One in six of the accessible parking spaces are required to be van accessible. A minimum of a 60-inch wide access aisle is required to be provided for every two accessible parking spaces. Accessible aisles were observed to be provided. The number of parking spaces does meet accessibility requirements.

Accessible parking spaces

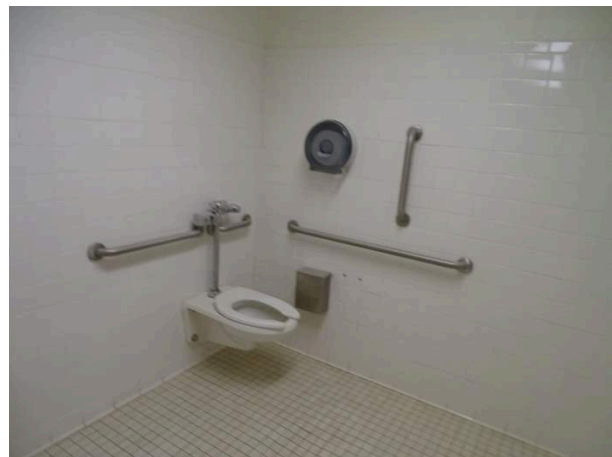
Accessible interior finishes of restroom area

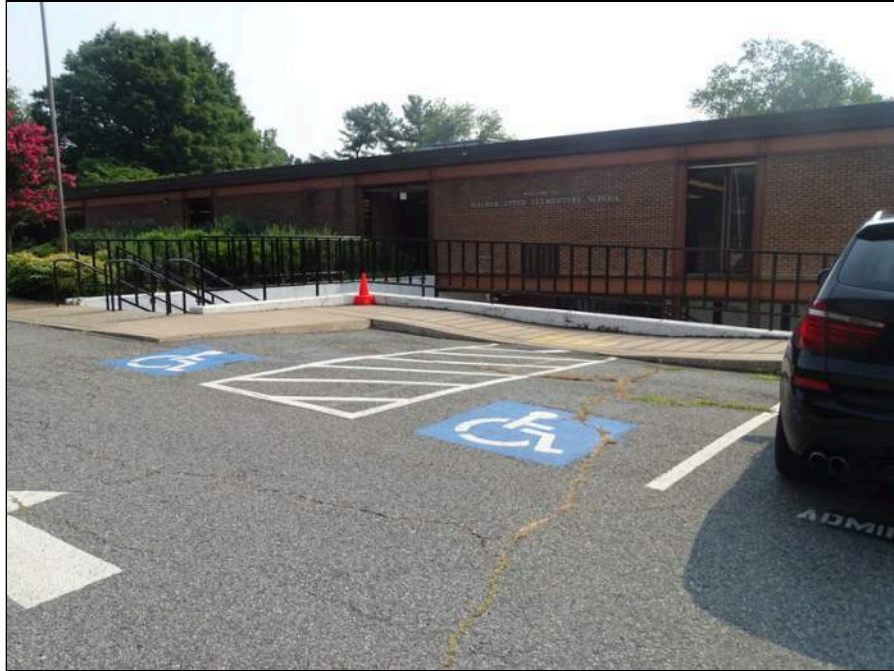
1 - Walker Upper Elementary School

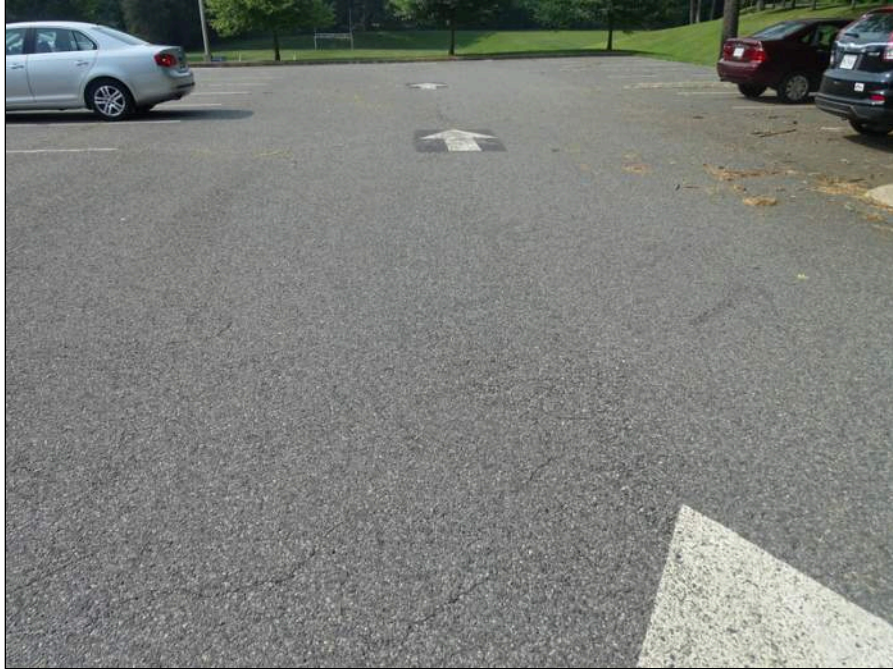
5 - Asphalt pavement parking

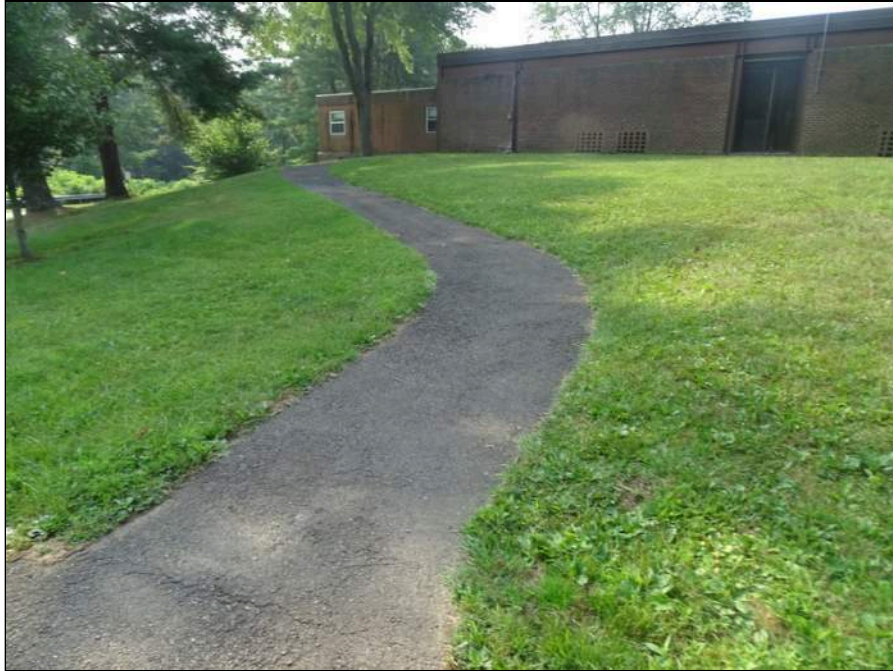
7 - Asphalt sidewalk at south end of the site

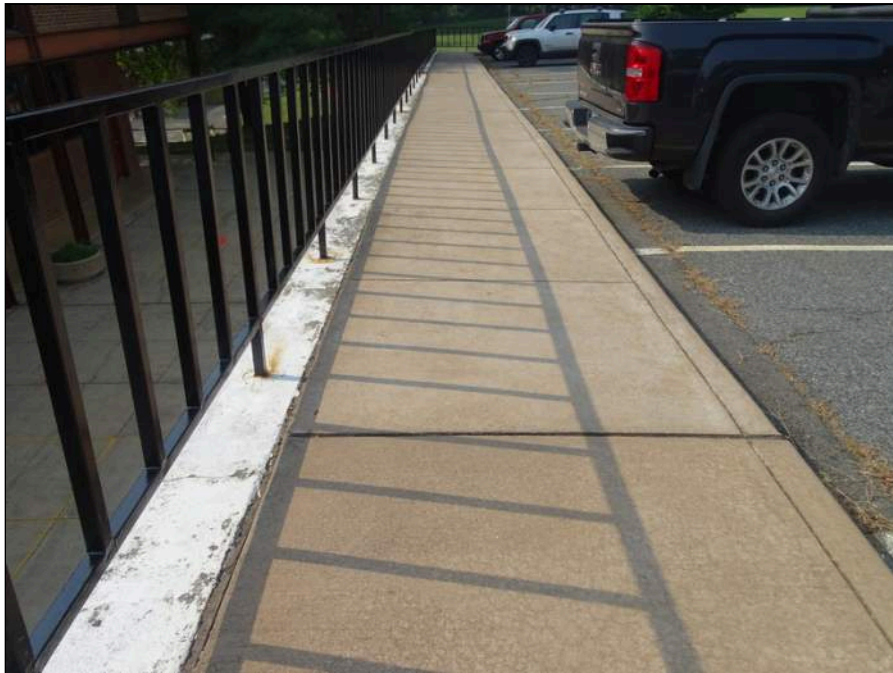
8 - Typical concrete sidewalk

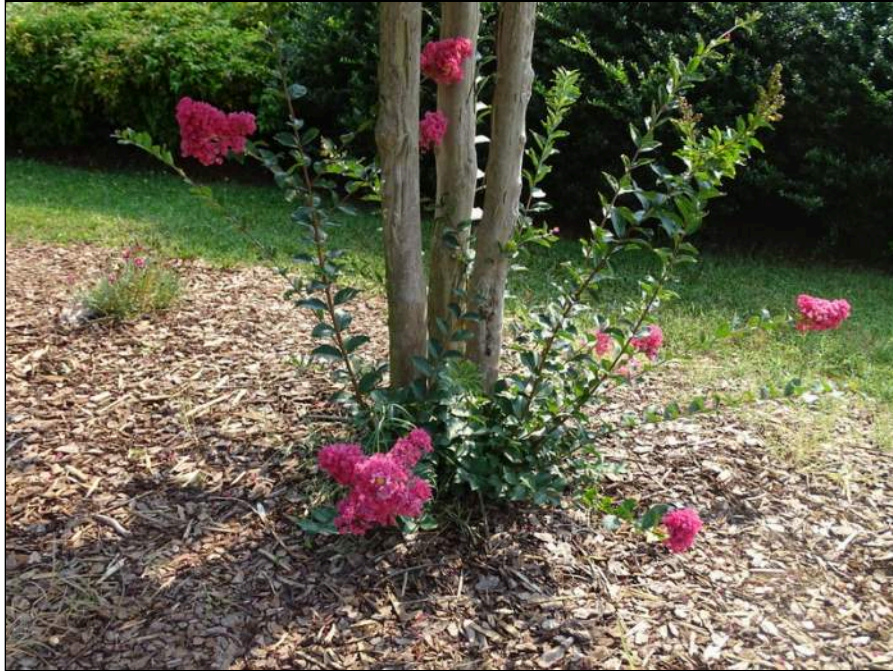
17 - Typical landscaping

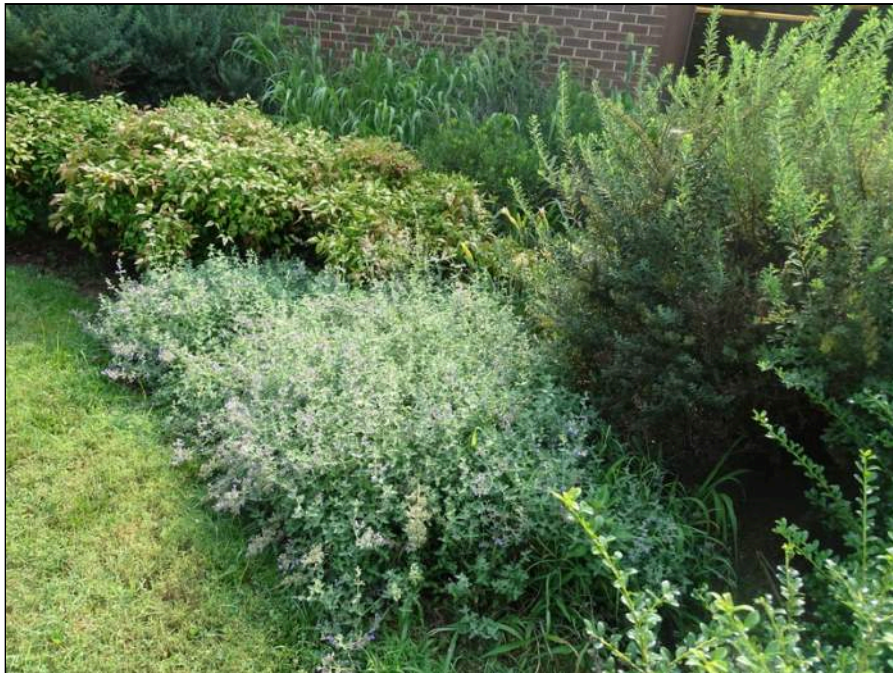
18 - Typical landscaping

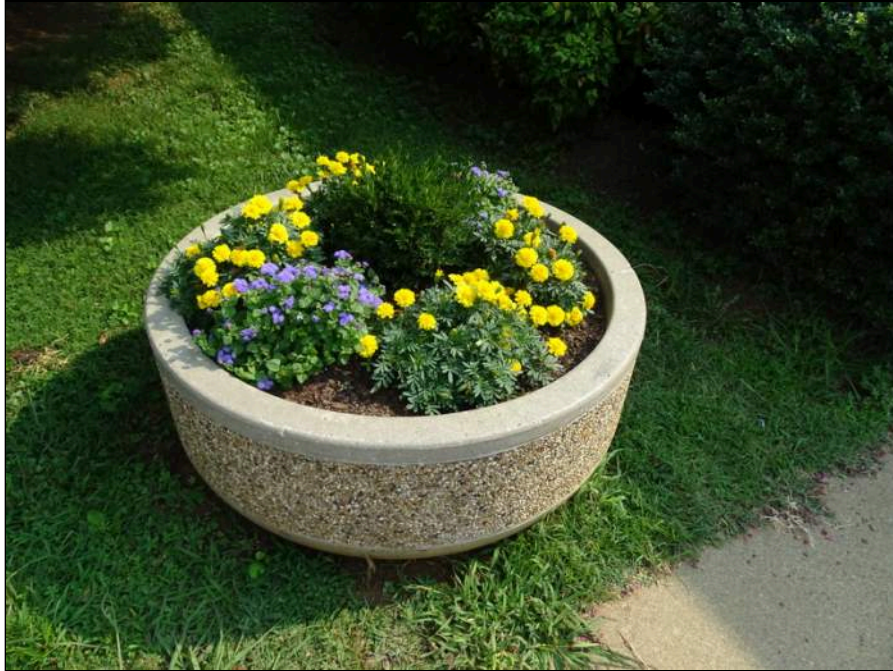
19 - Typical landscaping

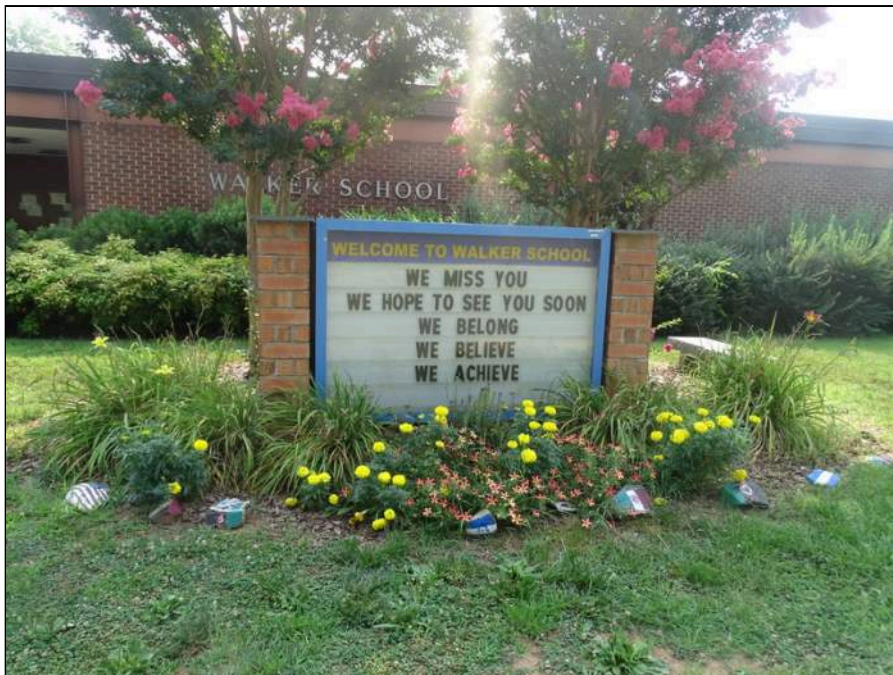
20 - Monument sign at west end of the site

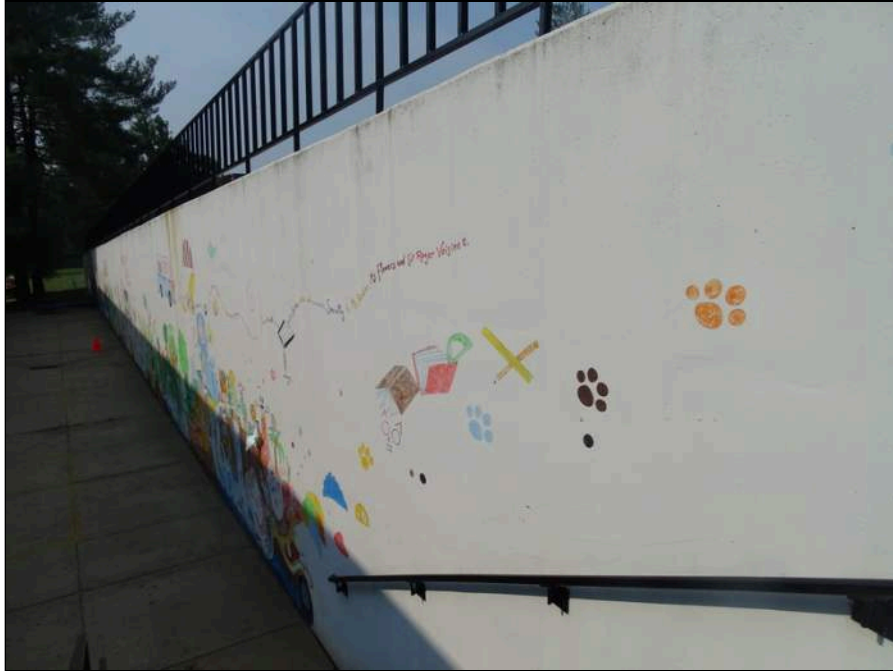
21 - Cast in place concrete retaining wall between main building and west parking area

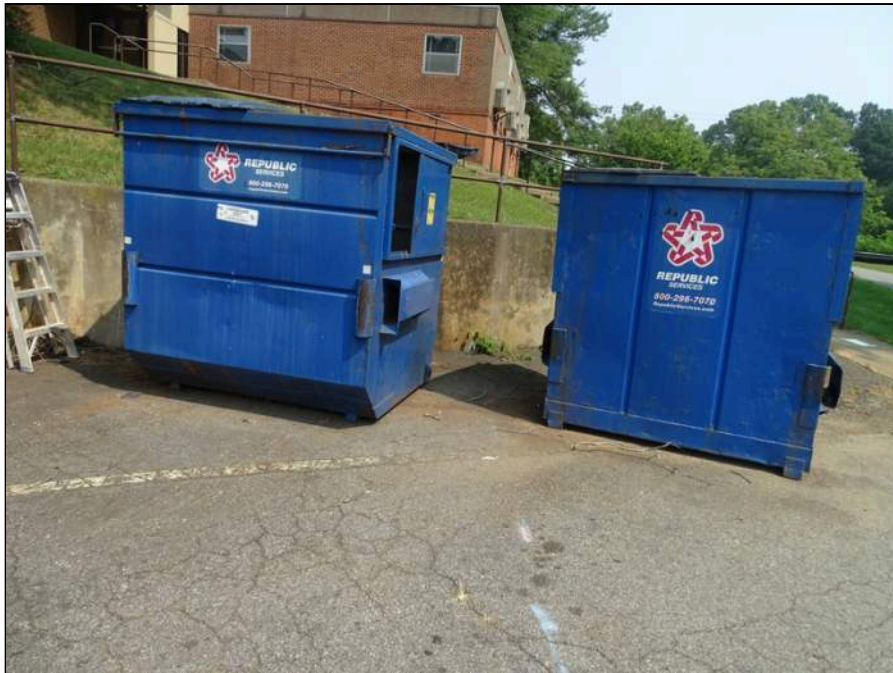
22 - Dumpster area at east end of the site

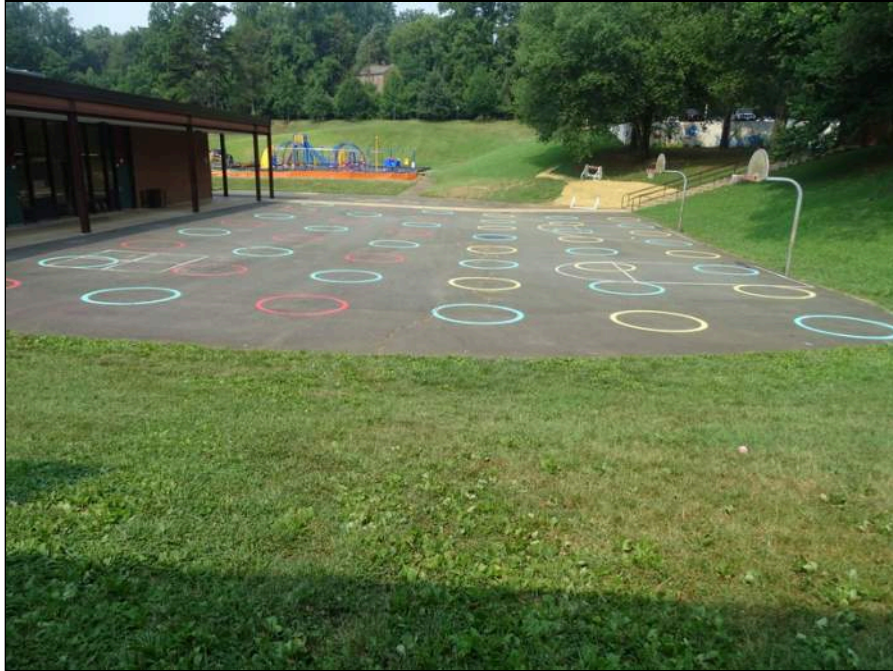
23 - Basketball court located between main building and gym

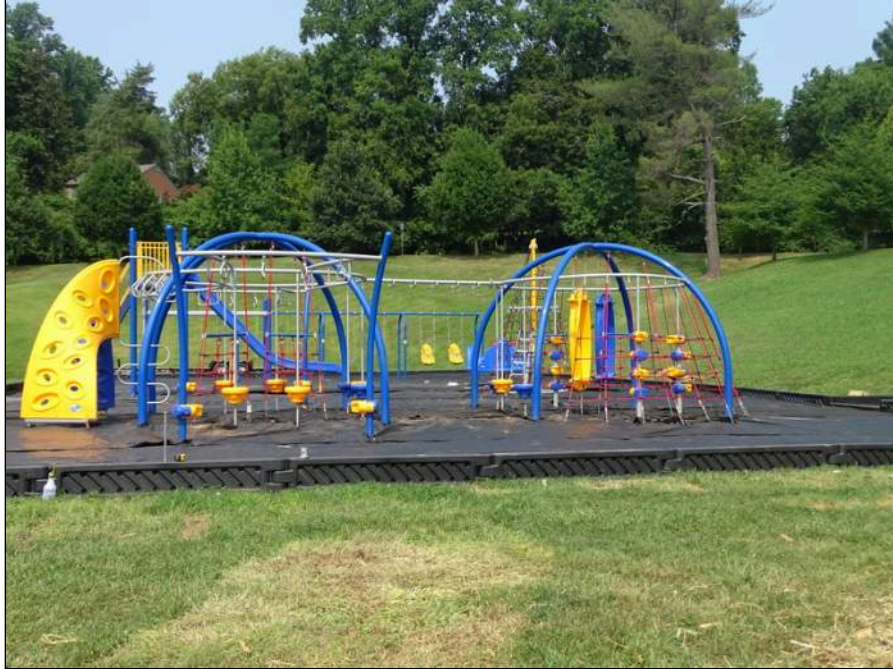
25 - Typical play ground

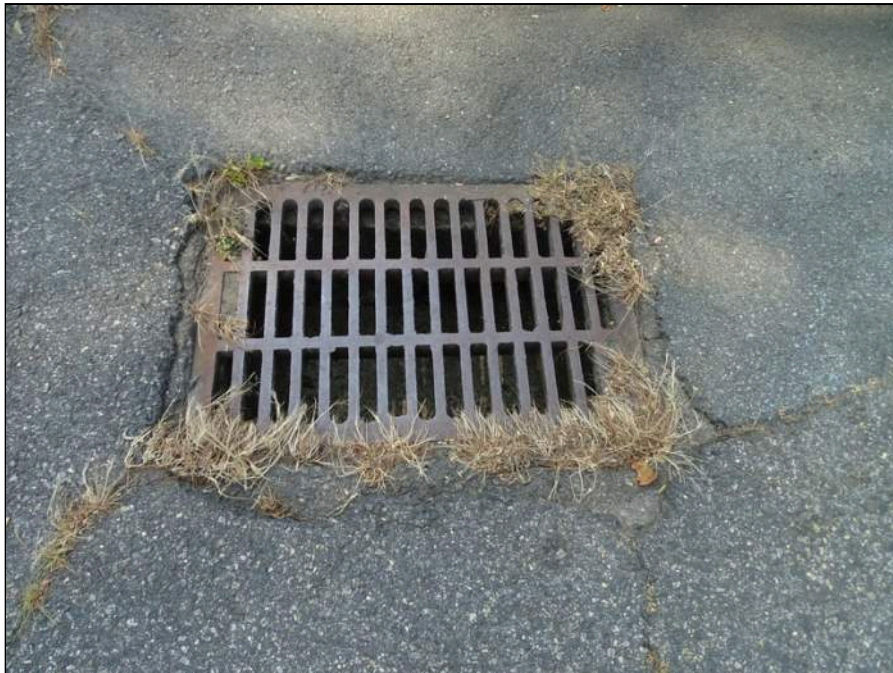
26 - Typical storm water drainage

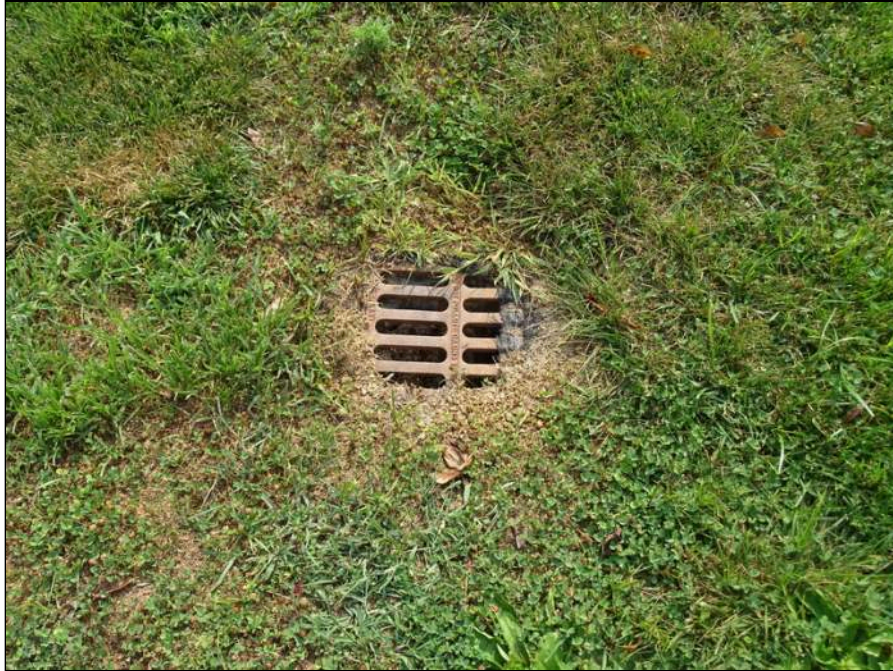
27 - Typical storm water drainage

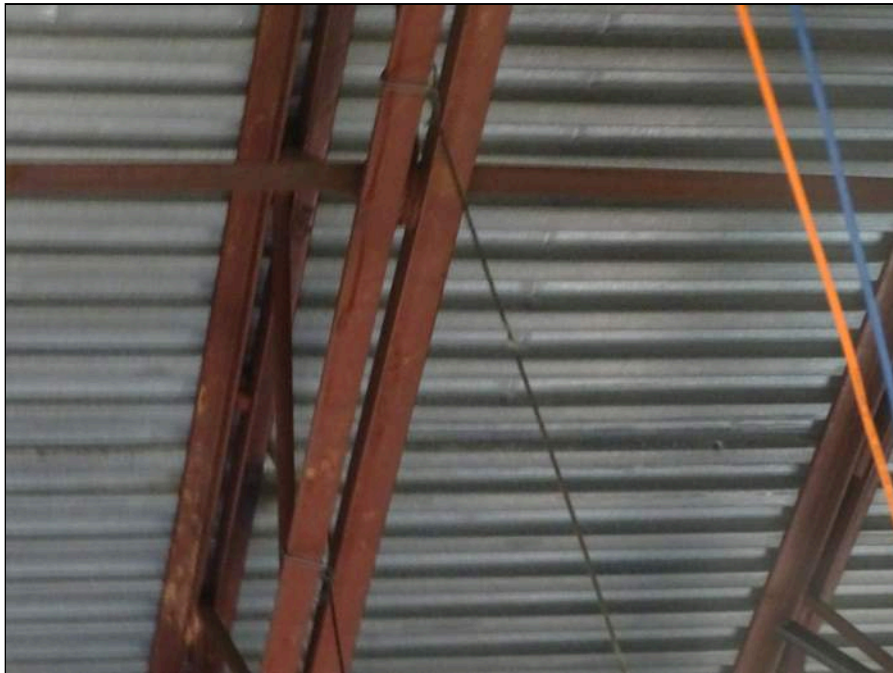
28 - Structural framing

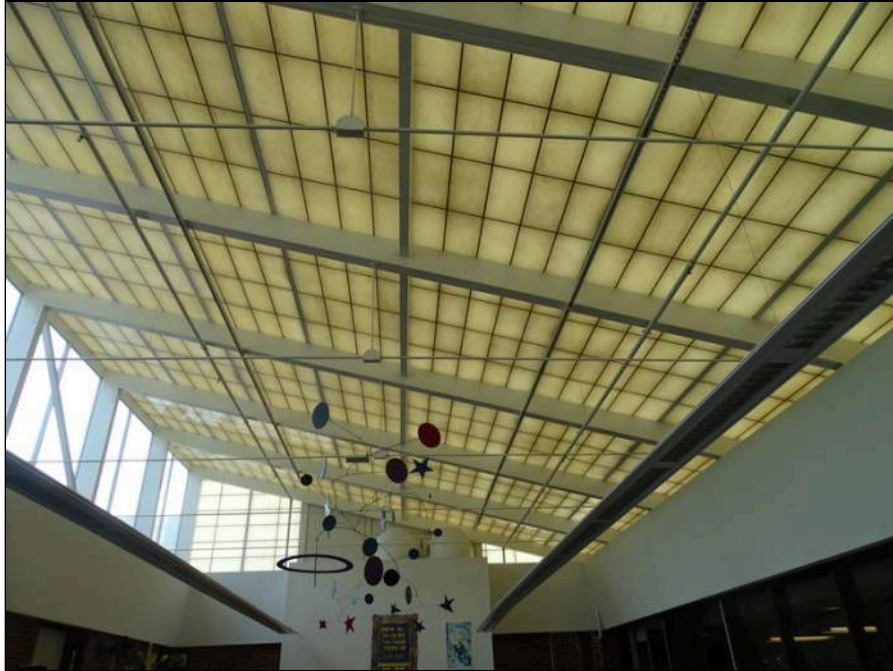
29 - Structural framing

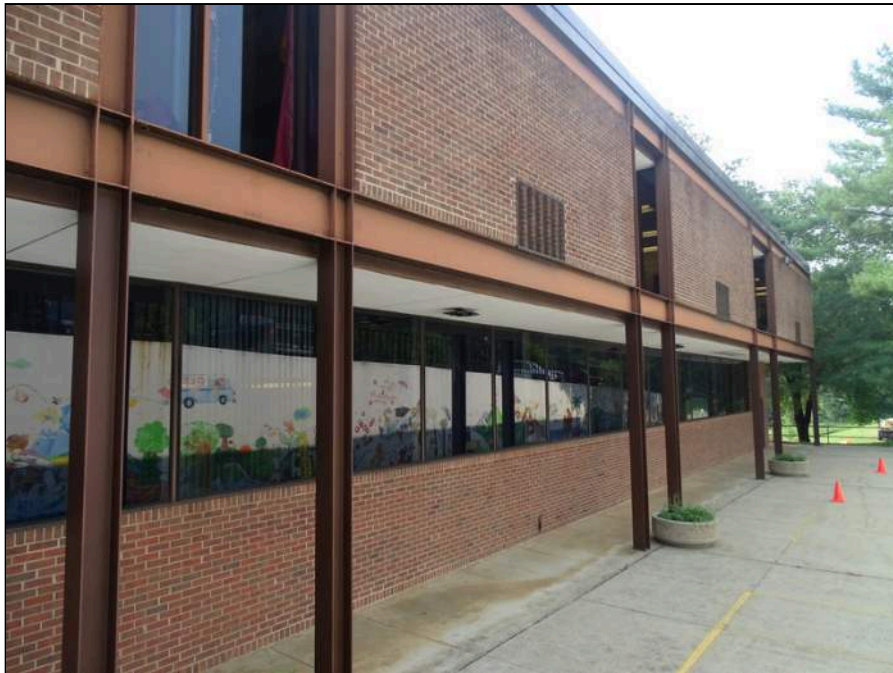
30 - Building exterior west side of main building

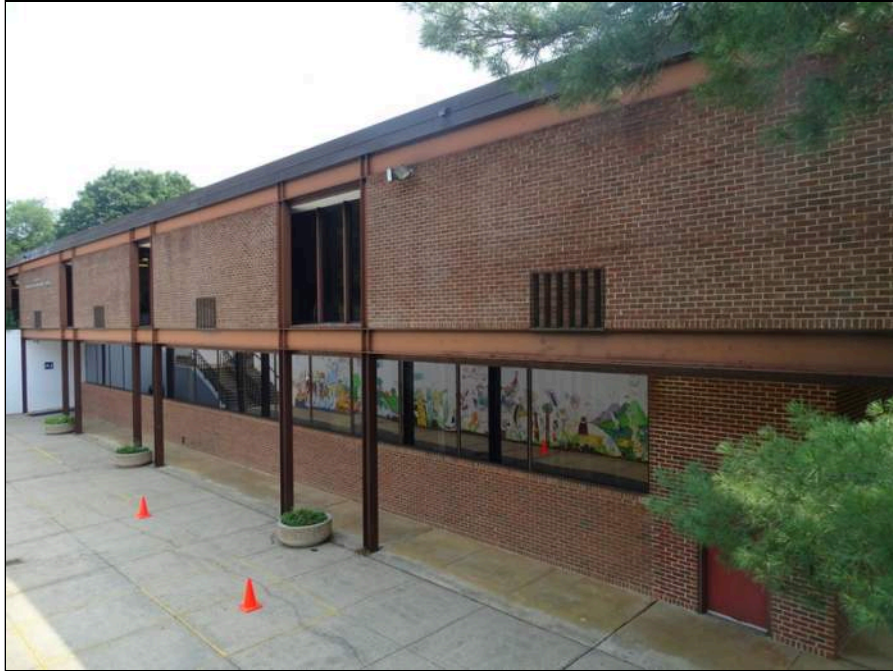
31 - Building exterior west side of main building

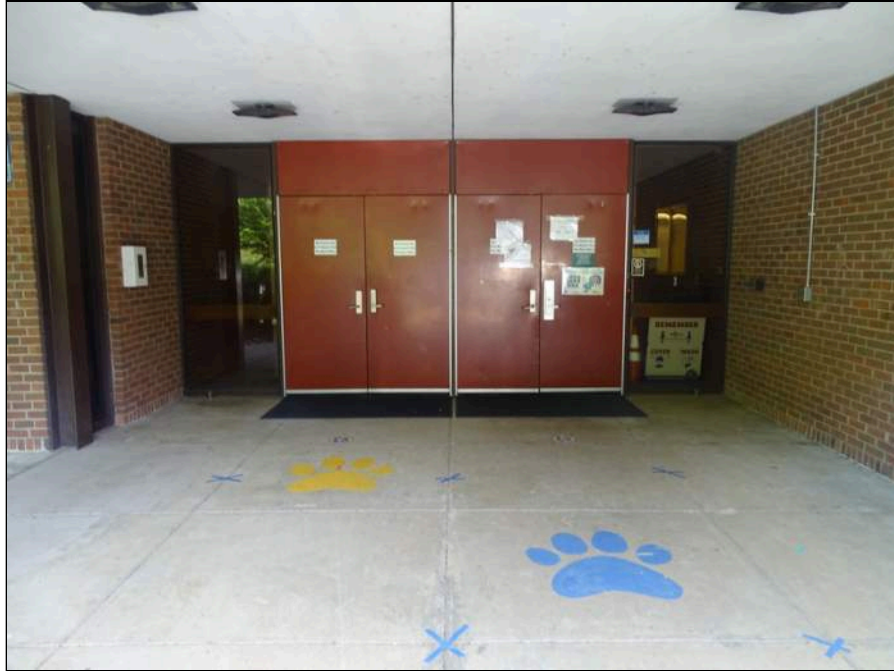
41 - Main building entrance exterior doors upper level

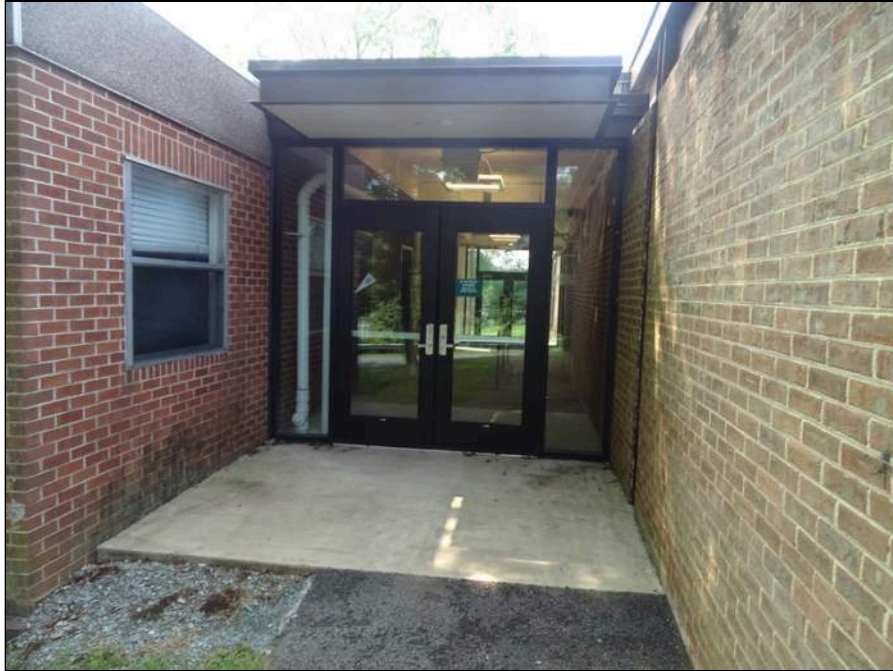
43 - Typical personnel door

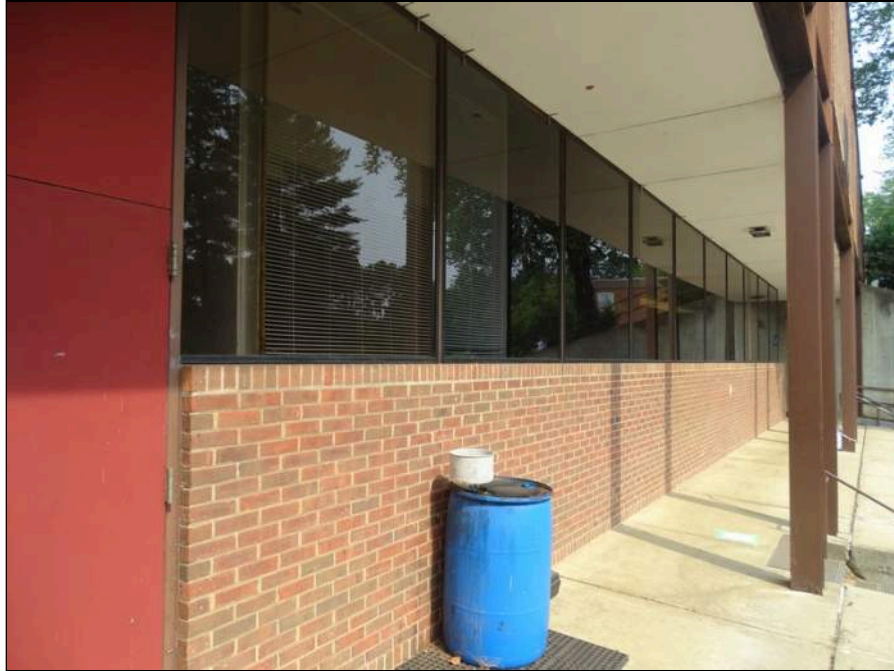
45 - Typical exterior windows
